SHAMS POWER COMPANY
ENGINEERING DIVISION
INSPECTION & CORROSION SECTION
SHAMS 1

CERTIFICATE OF INSPECTION

ITEM : Steam drum 2

TYPE OF INSPECTION : Major

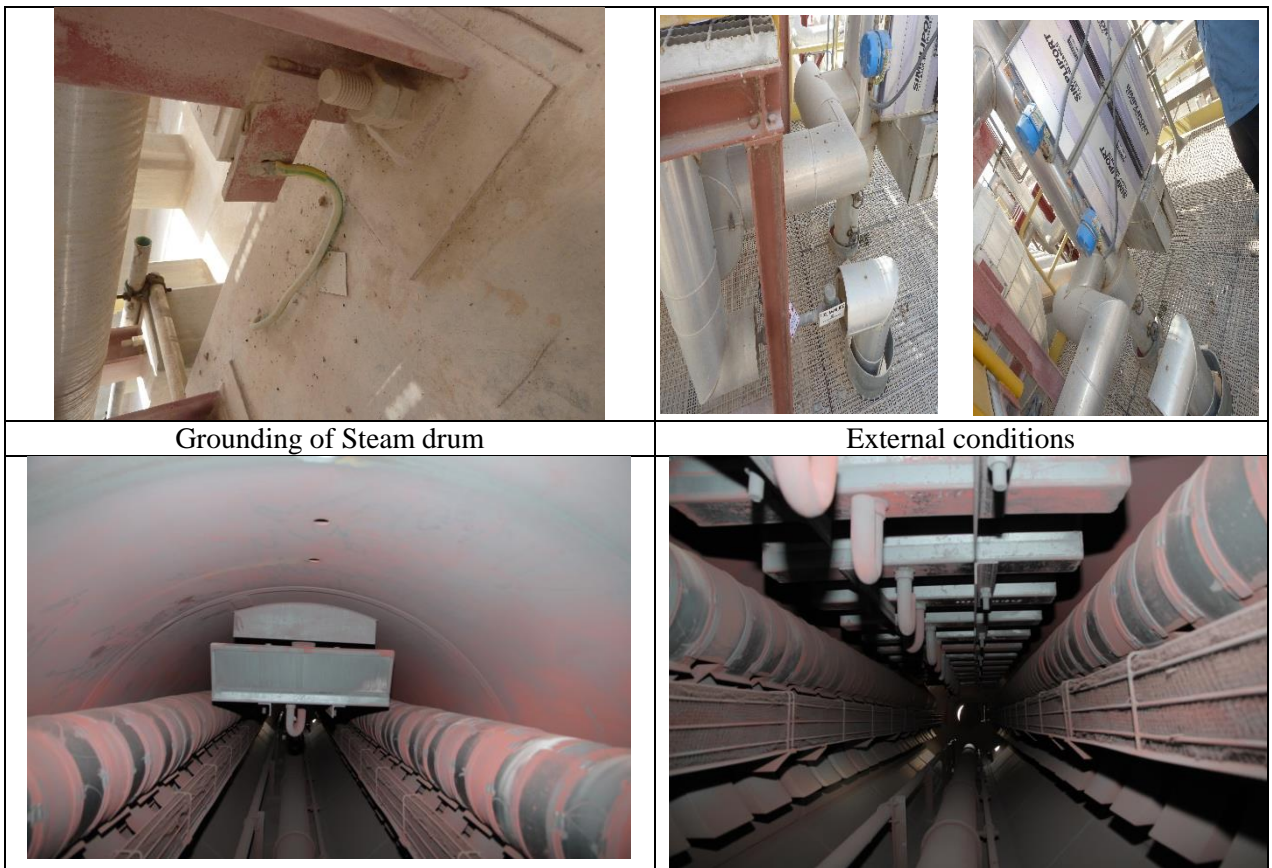
5.2.2 All internal surfaces of shell and heads found in satisfactory condition with black magnetite layer in the lower half of the drum apart from hematite layer in the upper half of the drum

Shell surfaces ,welds and Internals

- Review BFW deaerating process to assure absence of oxygen and mitigate any oxygen further corrosion.
- It is recommended to open steam drum -1 after 4 years as per SHAMS Code of Practice.
