MAJOR OUTAGE REPORT 2020

Message from General Manager

The major outage has a significant importance to the long term strategy of Shams plant and assets. The vast scope includes major overhaul and inspection of critical equipment such as steam turbine, generator, booster heaters, HTF heaters, DCS upgrade and others. These are critical assets and equipment that impact the business of Shams directly, thus it's of paramount importance to ensure its reliability, availability, and efficiency over its lifetime.

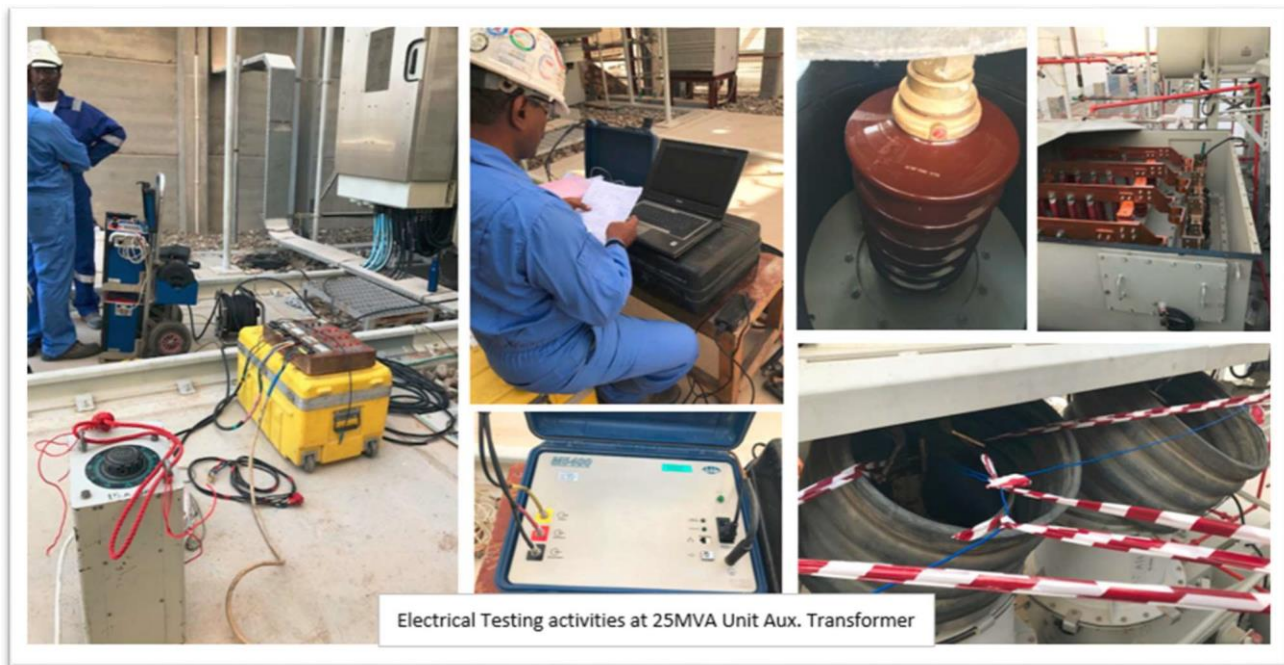
HV bushings were inspected and cleaned. LV cable termination compartment was inspected and cleaned. Neutral grounding Resistor was inspected and cleaned.

Figure 14: Electrical testing activities.

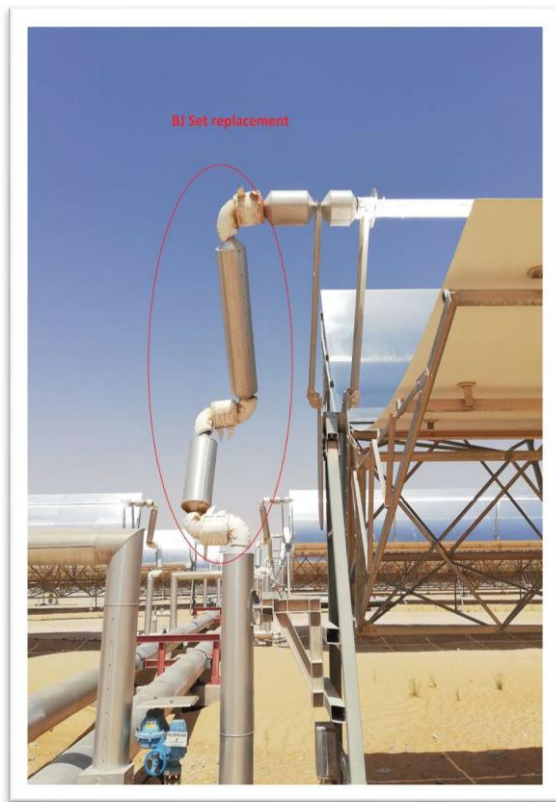
Figure 15: Ball Joint replacement.

- 1) 242 Damage absorber tube replacement. (Fig. 16)
- 2) 102 Ball joint replacement. (Fig. 15)
- 3) 384 Adjustment of ball joint double supports. (Fig. 17 & 18)
- 4) 32 Spools replacements. (Fig. 16)
- 5) 30 Hydraulic cylinder replacements. (Fig. 19 & 20)
- 6) 768 Hydraulic skid cleaning.
- 7) 150 Wind breaker patching.
- 8) 8 Re-coating of welding joints.
- 9) 9 Pressure safety valve replacements.
- 10) Flow Meter Gasket replacement.
- 11) Replacement of the bonnet/gasket of the passing loop isolation valve in GH99-100.

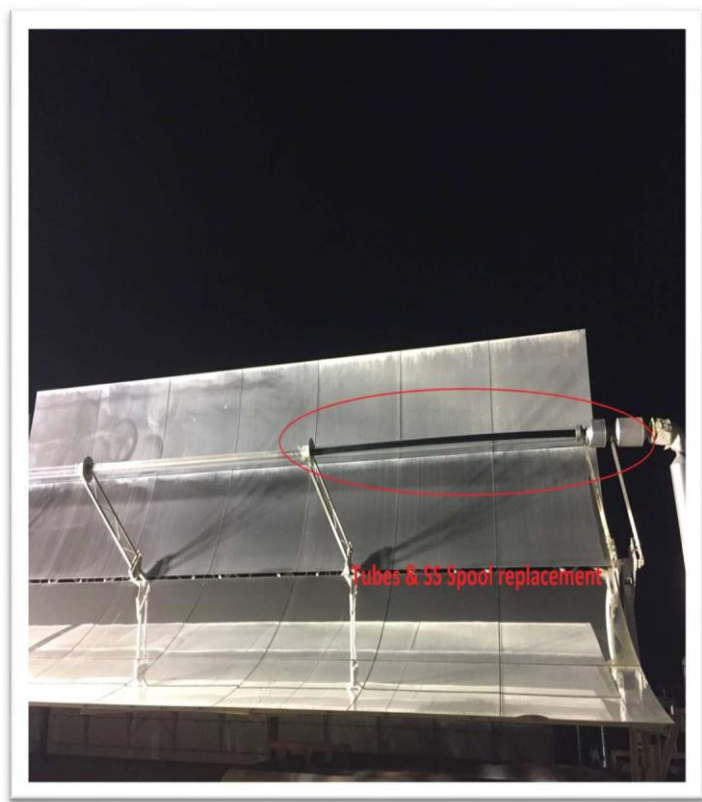
Figure 16: Tubes & SS Spools replacement.

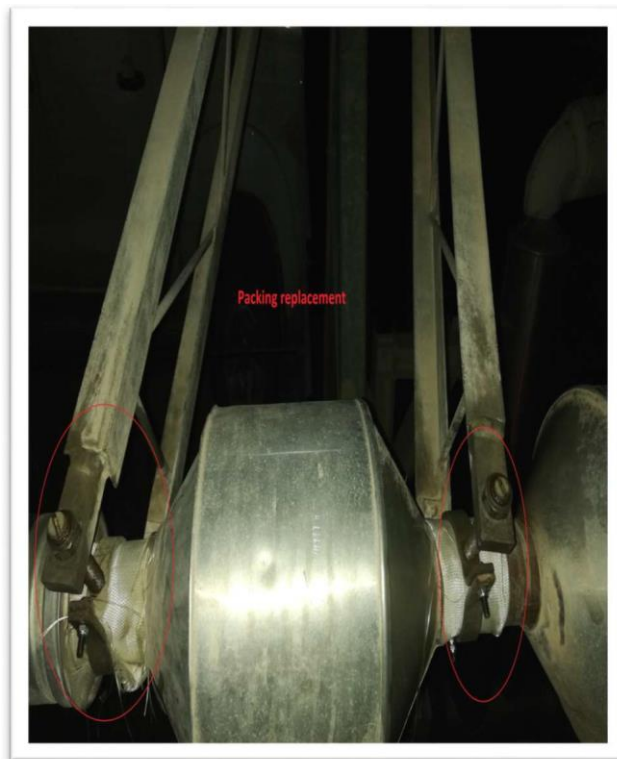
Figure 17: Ball Joint Double supports replacement.

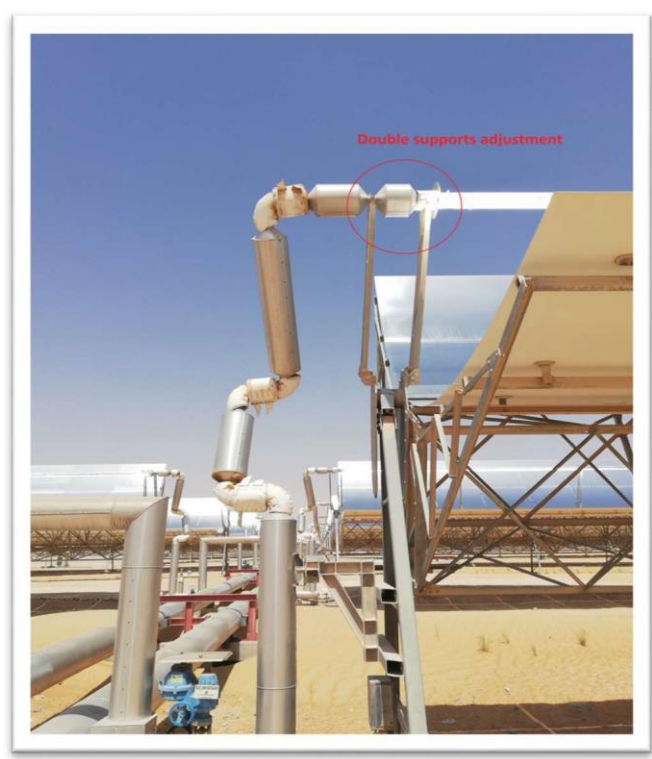
Figure 18: Tubes & SS Spools replacement.

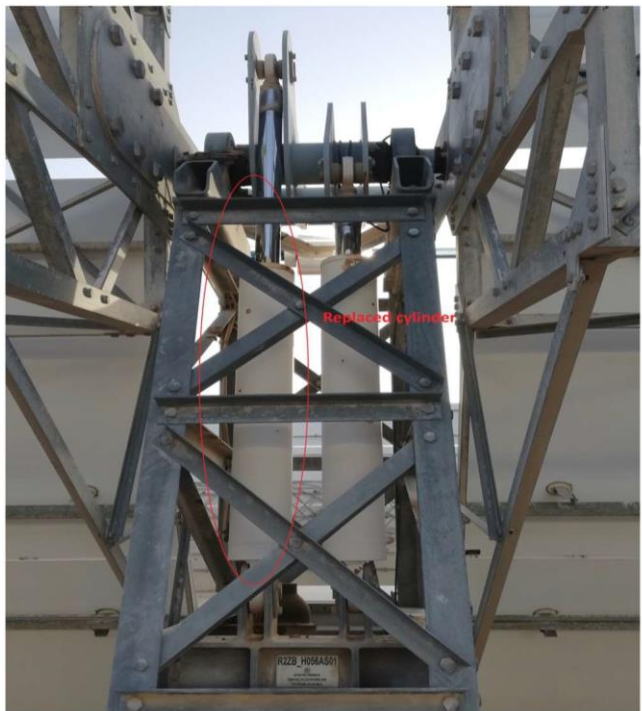
Figure 20: Hydraulic Cylinder replacement.

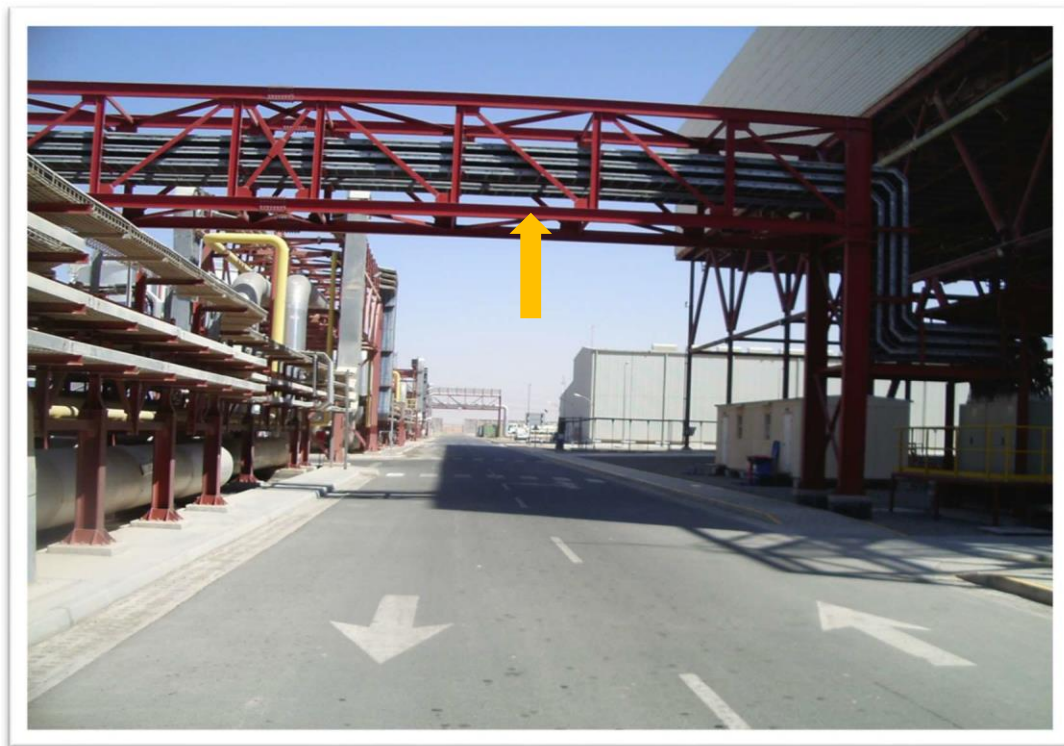
Figure 19: New cable bridge.

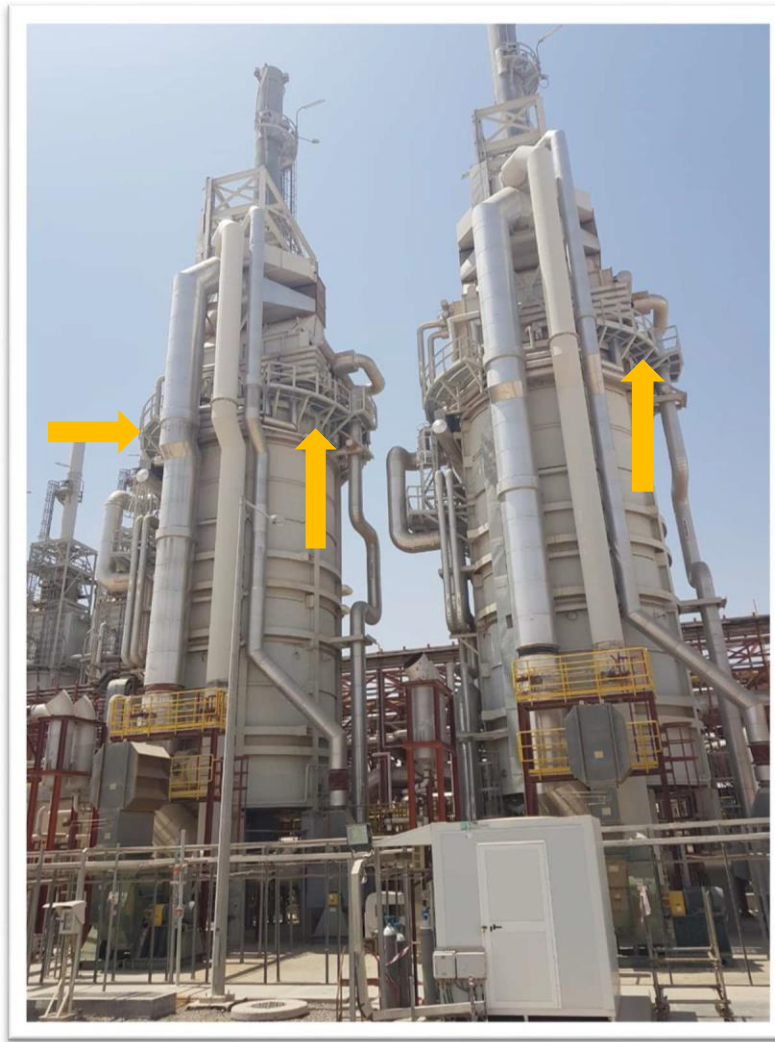
Booster Heaters 1 & 2 had no access platform in which maintenance personnel could access in order to address any technical issues. Scaffolding was always used in order to create such access, which were often time consuming and costly. Therefore, permeant platforms designed and installed during the outage period to ensure safe and permeant access.

Figure 20: Booster Heater 1 & 2 permeant platforms.

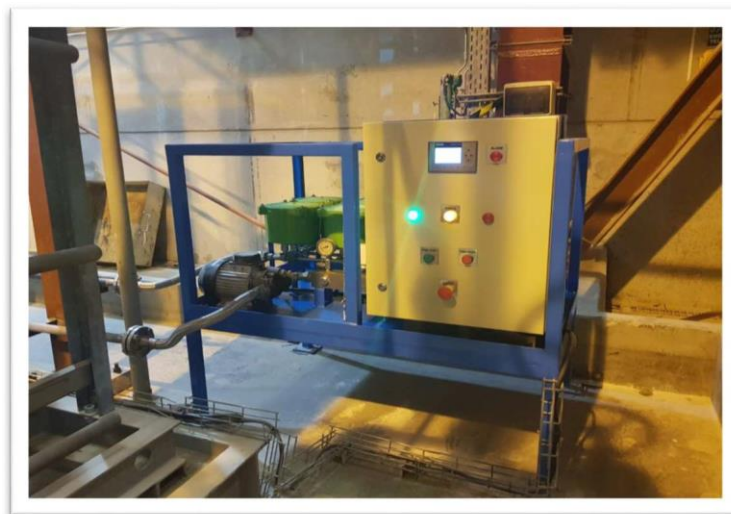
Figure 21: New Lube oil varnish removal system

Management of change created for Option 3, planned and implemented during outage successfully as shown in Fig. 21.

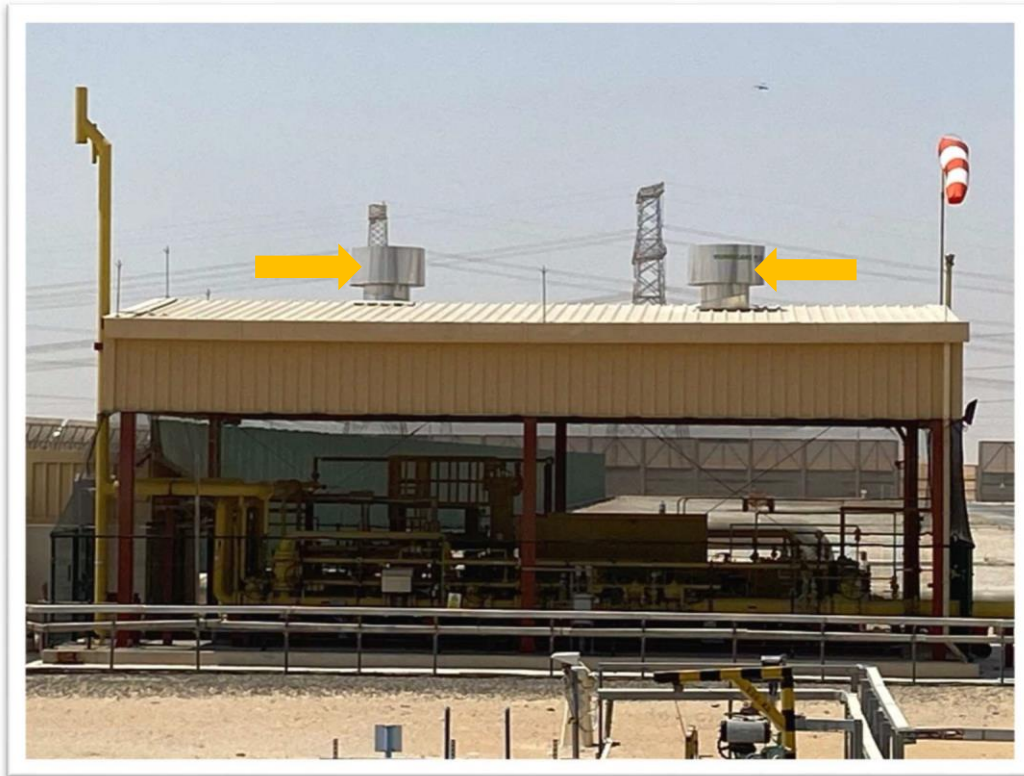
Figure 22: Installed GRMS Roof Vents.

Following an insurance audit, there was a recommendation to install Vents in the GRMS area, however this required the entire station to shut down and the outage was the perfect opportunity. This was planned and implemented successfully during the outage period as shown in Fig 22.
