CASE STUDY – MONOLITHIC

COMPOSITE PLATE

TFM – ASA: Non-Destructive Testing

GROUP 1:

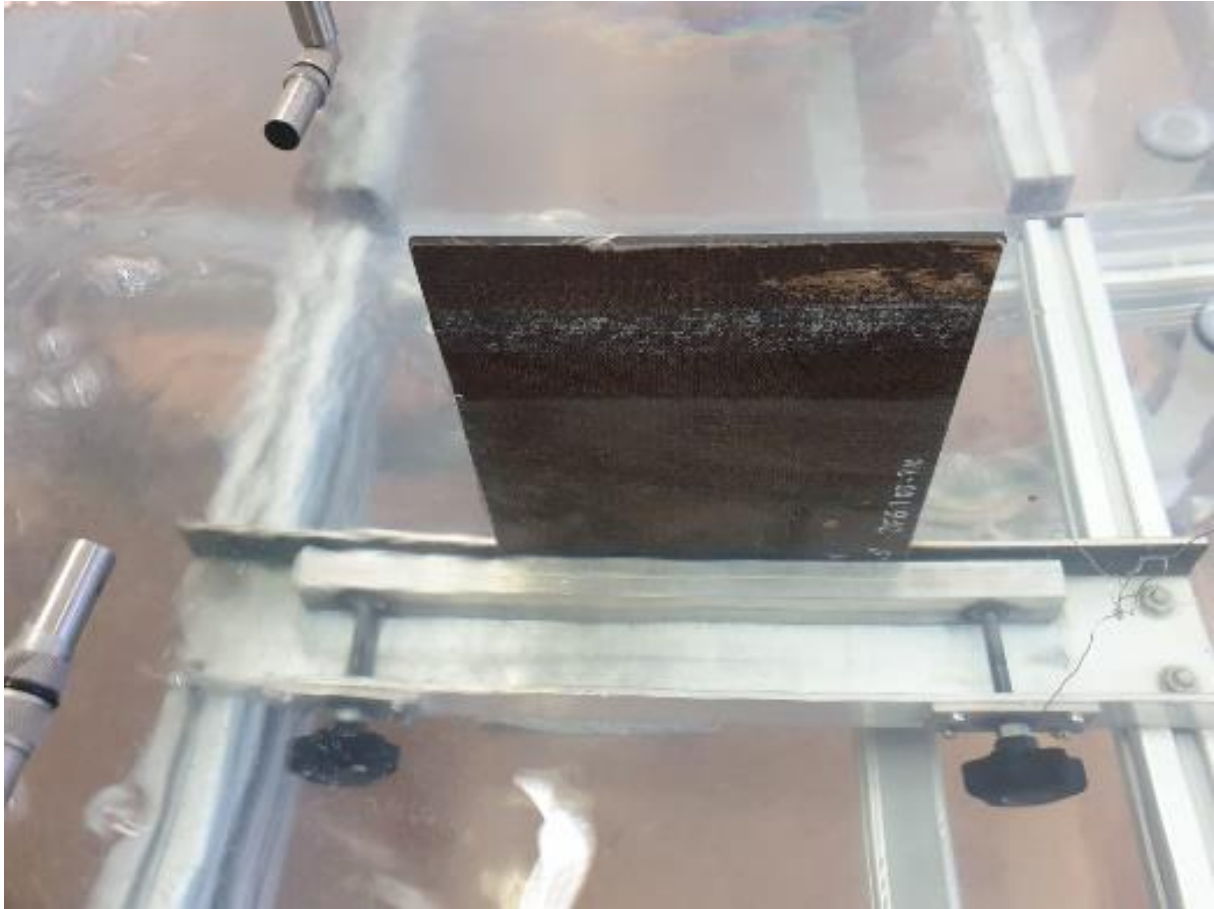
Fig. 14: The composite plate immersed in the water and placed in the ultrasonic apparatus

Fig. 13 and Fig. 14 are showing the original plate with defects been highlighted and also the placement of the composite plate in the ultrasonic machine inside water.
