Gopuram Status Report

January 17, 2015

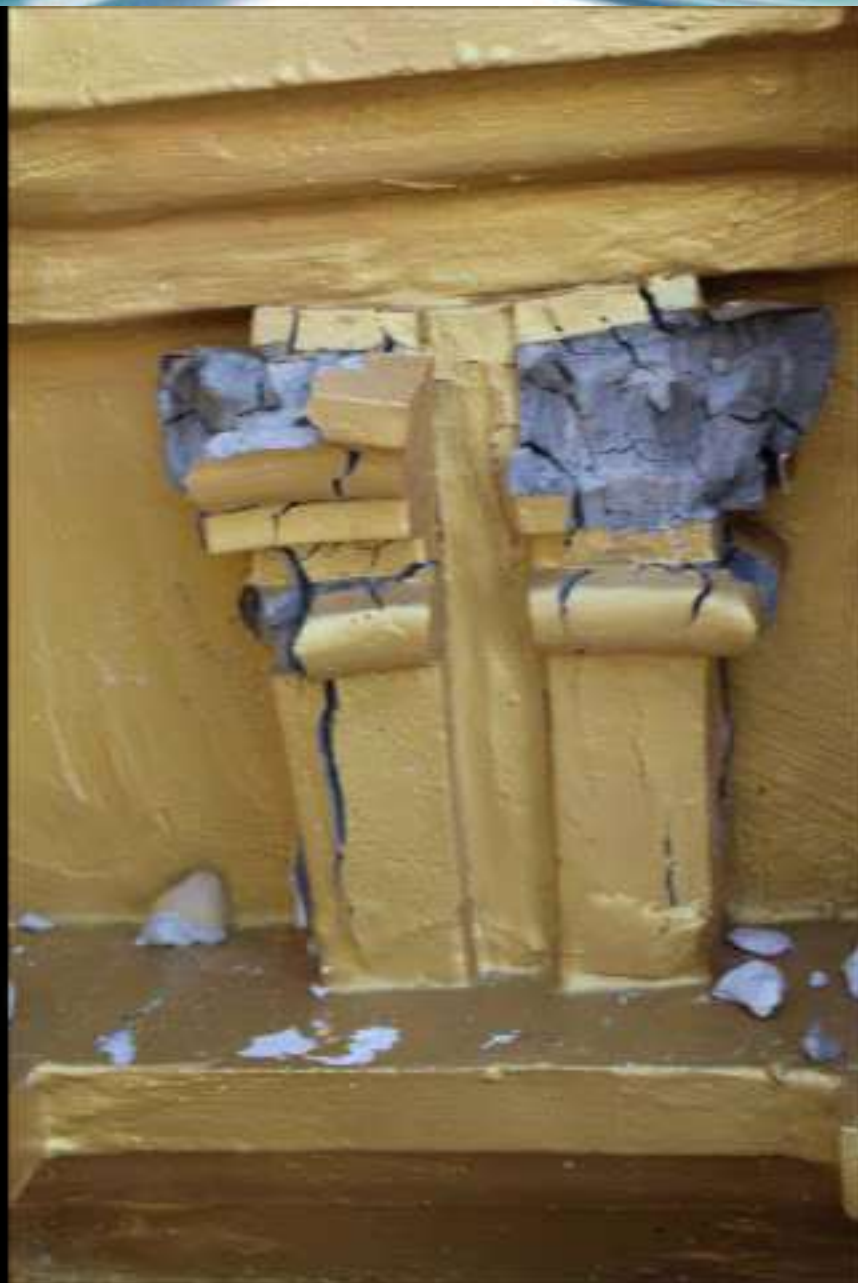
- Ornate Indian Decoration (Medallions) coming apart
 - Material Disintegration
 - Big Pieces Getting Unglued
- Material used
 - GFRC (Glass Fiber Reinforced Concrete)
 - Strength, Durability, Load Bearing Capacity, *Light Weight*
 - *Maybe not moldable easily?*
 - Mortar (Cement + Sand)
 - Cement
 - Gold Paint
- Noticed May 2014

- No Structural Issues
- Gopuram Construction
 - Steel Frame
 - Plywood Interior
 - Bulk Construction using GFRC
 - Big & Small Medallions attached*
- Roof Floor is Thick Membrane (Falling debris could puncture it)

- Material not suitable for exterior
- Improper Curing
- Ratio
- Improper Installation
 - Bonding Agent
 - Screw Anchor Not Secure
 - No Caulking
- Water Damage (Freeze/Expand)
- Interior Paint
- Staphis Lack Technical Knowledge
- Exterior Elements Unique to The Rocky Mountain Region
 - Lack of Humidity, UV, Hail

- Remove all loosely attached pieces
- Create new forms
- Create new medallions
 - Use Correct material
 - Proper Curing
 - Attach Correctly
- Strip and Repaint
- Spring/Summer 2015 Timeframe
