Inspection Result (Individual Data)

Lot number : 7

商品名	標準透明6-6-3	周長	
顧客名		Ex1	
CODE番号		Ex2	
基材		Ex3

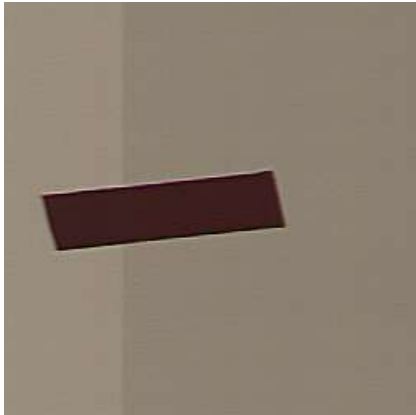
Defect image

No.	#66, \$49	Date	2023/8/9 下午 04:15:06
Segment	1	Camera	1
Pattern	2207	Position[x, y]	14.3 [mm], 1668.9 [m], (2.0 [m])
Type	点状疵点縱向刀絲疵點橫向刀絲	Size	H:25.6 ,V:19.2 [mm]
Result	-	Area	343.8 [mm2]
Inspection level	5/5,5/5,5/5,5/5,5/5	Label	-
Light	6,6,3/6,6,3

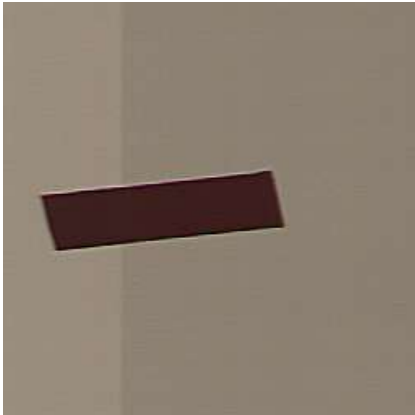
Defect image

No.	#63, \$48	Date	2023/8/9 下午 04:14:59
Segment	1	Camera	1
Pattern	2193	Position[x, y]	0.1 [mm], 1658.3 [m], (12.5 [m])
Type	縱向刀絲疵點	Size	H:0.5 ,V:223.2 [mm]
Result	-	Area	33.8 [mm2]
Inspection level	5/5,5/5,5/5,5/5,5/5	Label	-
Light	6,6,3/6,6,3

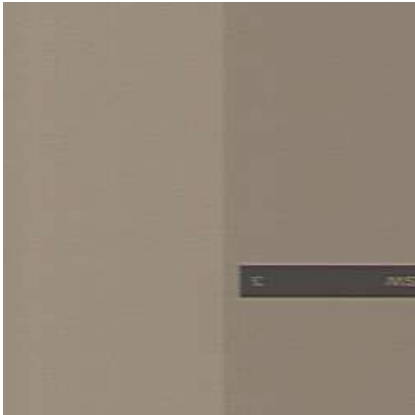
Defect image

No.	#63, \$48	Date	2023/8/9 下午 04:14:59
Segment	1	Camera	1
Pattern	2193	Position[x, y]	0.1 [mm], 1658.0 [m], (12.9 [m])
Type	縱向刀絲疵點	Size	H:0.5 ,V:516.4 [mm]
Result	-	Area	66.7 [mm2]
Inspection level	5/5,5/5,5/5,5/5,5/5	Label	-
Light	6,6,3/6,6,3

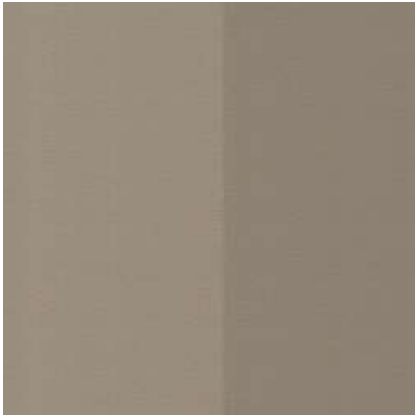
Defect image

No.	#62, \$47	Date	2023/8/9 下午 04:14:58
Segment	1	Camera	1
Pattern	2192	Position[x, y]	0.1 [mm], 1657.3 [m], (13.6 [m])
Type	縱向刀絲疵點	Size	H:0.5 ,V:802.0 [mm]
Result	-	Area	77.2 [mm2]
Inspection level	5/5,5/5,5/5,5/5,5/5	Label	-
Light	6,6,3/6,6,3

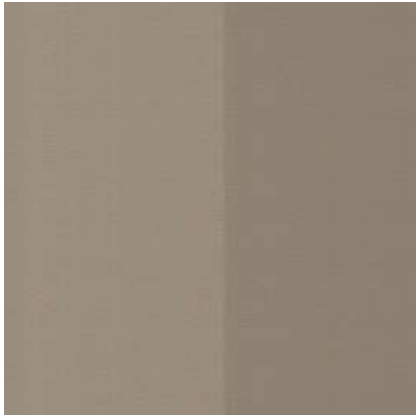
Defect image

No.	#61, \$46	Date	2023/8/9 下午 04:14:58
Segment	1	Camera	1
Pattern	2191	Position[x, y]	0.1 [mm], 1656.9 [m], (14.0 [m])
Type	縱向刀絲疵點	Size	H:0.5 ,V:144.4 [mm]
Result	-	Area	20.2 [mm2]
Inspection level	5/5,5/5,5/5,5/5,5/5	Label	-
Light	6,6,3/6,6,3

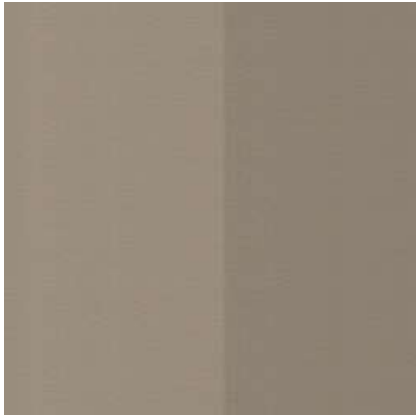
Defect image

No.	#60, \$45	Date	2023/8/9 下午 04:14:57
Segment	1	Camera	1
Pattern	2190	Position[x, y]	0.1 [mm], 1655.7 [m], (15.2 [m])
Type	縱向刀絲疵點	Size	H:0.5 ,V:46.8 [mm]
Result	-	Area	10.6 [mm2]
Inspection level	5/5,5/5,5/5,5/5,5/5	Label	-
Light	6,6,3/6,6,3

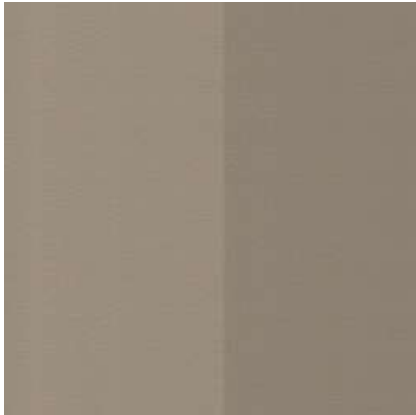
Defect image

No.	#60, \$45	Date	2023/8/9 下午 04:14:57
Segment	1	Camera	1
Pattern	2190	Position[x, y]	0.1 [mm], 1656.0 [m], (14.9 [m])
Type	縱向刀絲疵點	Size	H:0.5 ,V:401.2 [mm]
Result	-	Area	16.5 [mm2]
Inspection level	5/5,5/5,5/5,5/5,5/5	Label	-
Light	6,6,3/6,6,3

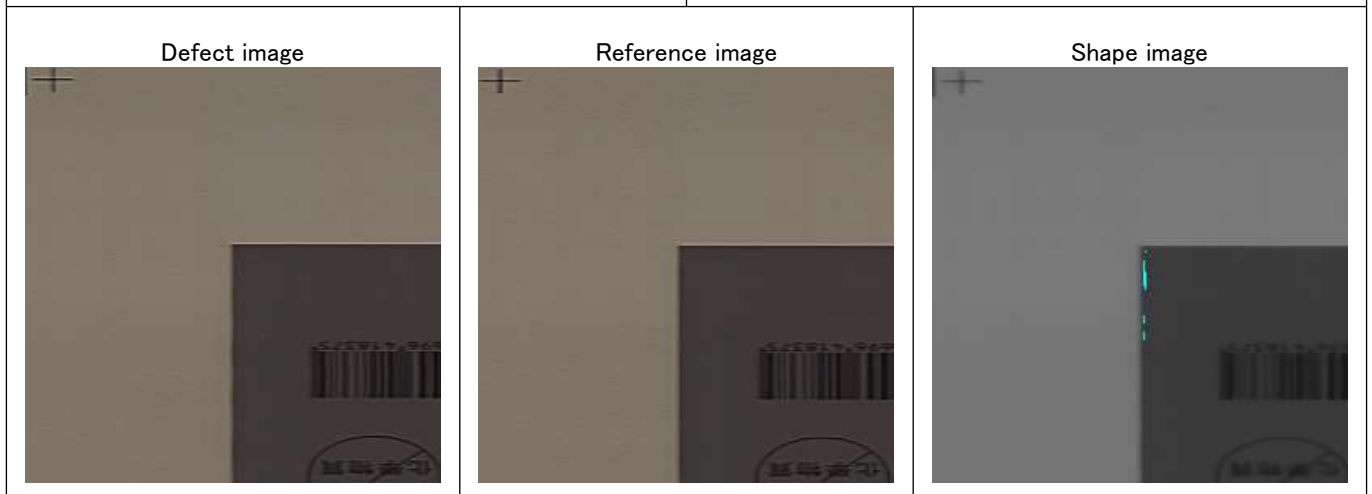
No.	#58, \$43	Date	2023/8/9 下午 04:14:15
Segment	1	Camera	1
Pattern	2110	Position[x, y]	701.8 [mm], 1595.5 [m], (75.4 [m])
Type	縱向刀絲疵點	Size	H:0.5 ,V:6.4 [mm]
Result	-	Area	2.2 [mm2]
Inspection level	5/5,5/5,5/5,5/5,5/5	Label	-
Light	6,6,3/6,6,3

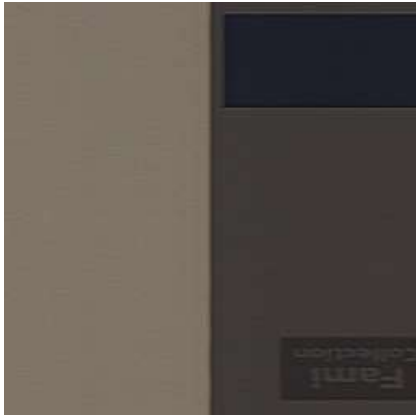
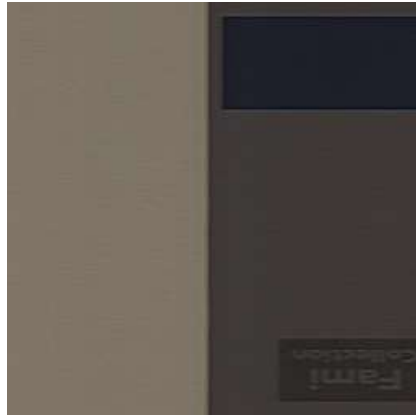
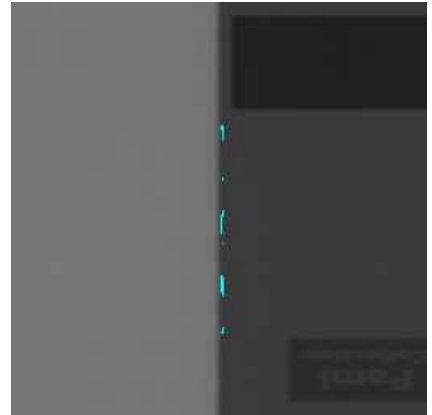
Defect image

No.	#56, \$41	Date	2023/8/9 下午 04:14:13
Segment	1	Camera	1
Pattern	2106	Position[x, y]	701.5 [mm], 1592.7 [m], (78.2 [m])
Type	縱向刀絲疵點	Size	H:0.5 ,V:41.2 [mm]
Result	-	Area	3.8 [mm2]
Inspection level	5/5,5/5,5/5,5/5,5/5	Label	-
Light	6,6,3/6,6,3

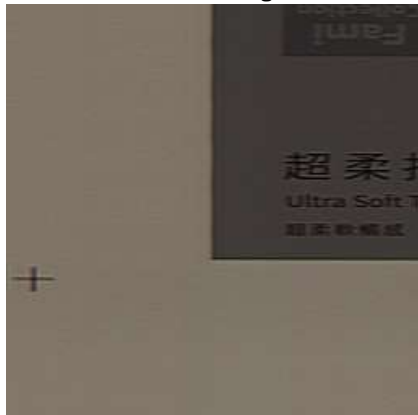
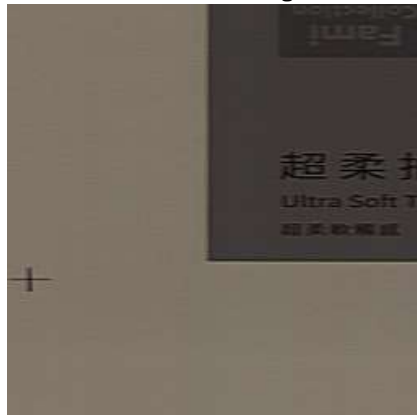
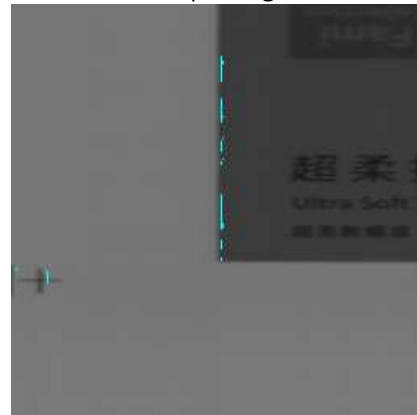
Defect image

No.	#55, \$40	Date	2023/8/9 下午 04:14:11
Segment	1	Camera	1
Pattern	2101	Position[x, y]	701.5 [mm], 1589.0 [m], (81.9 [m])
Type	縱向刀絲疵點	Size	H:0.5 ,V:8.0 [mm]
Result	-	Area	2.1 [mm2]
Inspection level	5/5,5/5,5/5,5/5,5/5	Label	-
Light	6,6,3/6,6,3

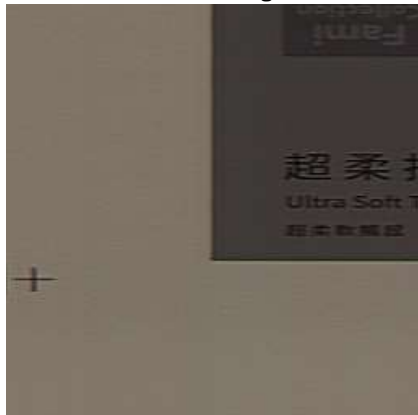
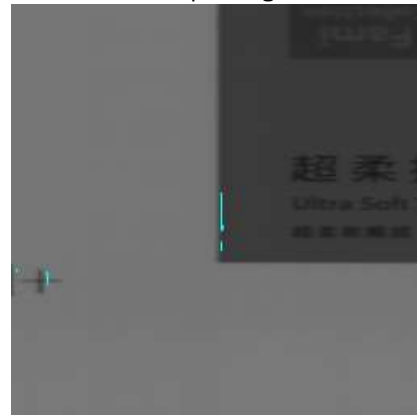
Defect image

No.	#54, \$39	Date	2023/8/9 下午 04:14:10
Segment	1	Camera	1
Pattern	2100	Position[x, y]	701.5 [mm], 1588.3 [m], (82.6 [m])
Type	縱向刀絲疵點	Size	H:0.5 ,V:8.8 [mm]
Result	-	Area	2.2 [mm2]
Inspection level	5/5,5/5,5/5,5/5,5/5	Label	-
Light	6,6,3/6,6,3

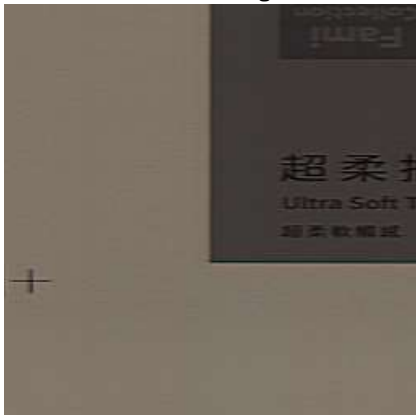
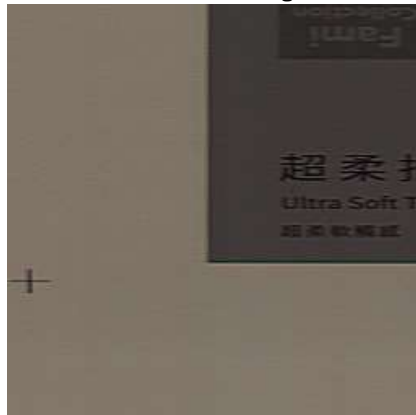
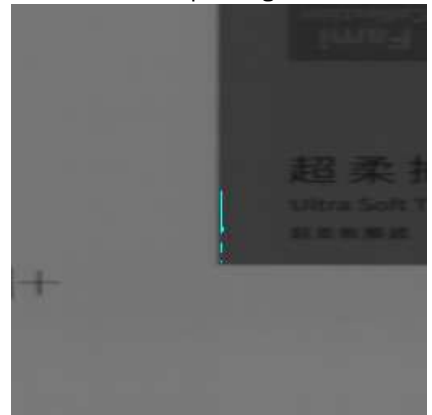
Defect image

No.	#52, \$37	Date	2023/8/9 下午 04:14:04
Segment	1	Camera	1
Pattern	2089	Position[x, y]	442.2 [mm], 1580.1 [m], (90.7 [m])
Type	縱向刀絲疵點	Size	H:20.5 ,V:28.4 [mm]
Result	-	Area	2.6 [mm2]
Inspection level	5/5,5/5,5/5,5/5,5/5	Label	-
Light	6,6,3/6,6,3

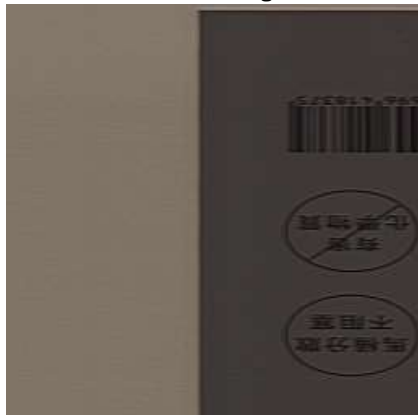
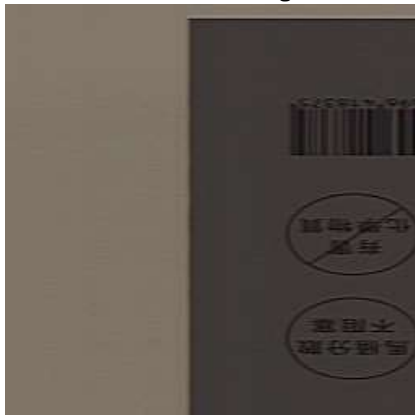
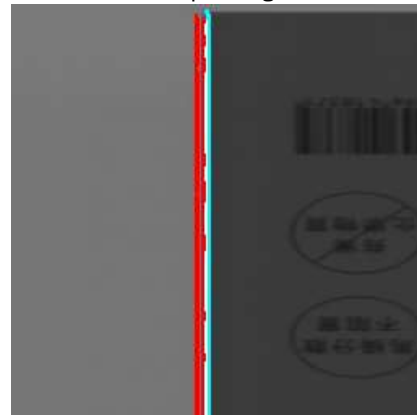
Defect image

No.	#48, \$35	Date	2023/8/9 下午 04:13:31
Segment	1	Camera	1
Pattern	2026	Position[x, y]	699.8 [mm], 1532.6 [m], (138.3 [m])
Type	点状疵点縱向刀絲疵點	Size	H:5.1 ,V:609.6 [mm]
Result	-	Area	550.9 [mm2]
Inspection level	5/5,5/5,5/5,5/5,5/5	Label	-
Light	6,6,3/6,6,3

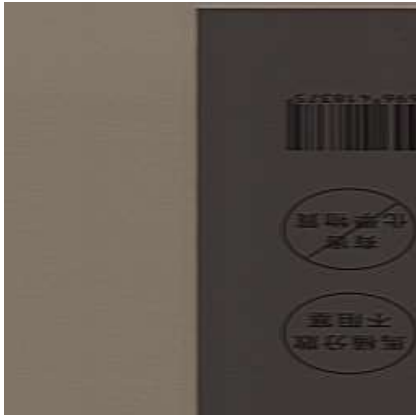
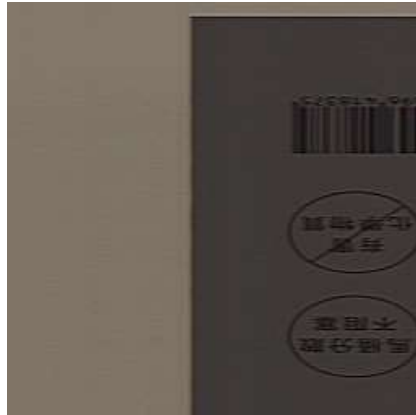
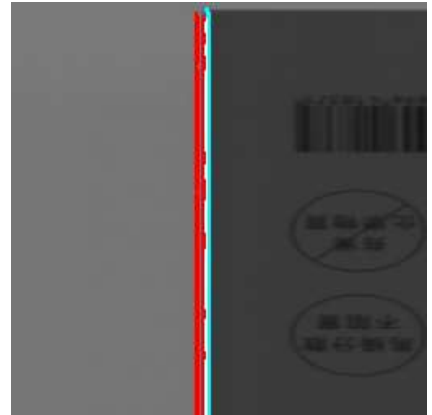
Defect image

No.	#47, \$34	Date	2023/8/9 下午 04:13:30
Segment	1	Camera	1
Pattern	2025	Position[x, y]	566.8 [mm], 1532.2 [m], (138.7 [m])
Type	点状疵点縱向刀絲疵點	Size	H:2.4 ,V:322.8 [mm]
Result	-	Area	201.4 [mm2]
Inspection level	5/5,5/5,5/5,5/5,5/5	Label	-
Light	6,6,3/6,6,3

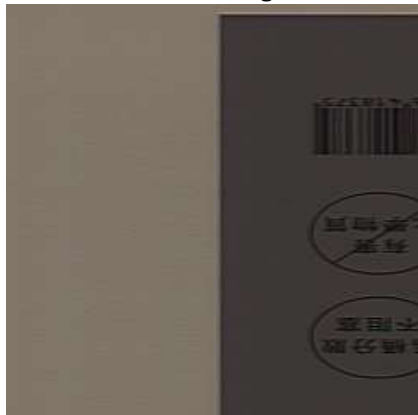
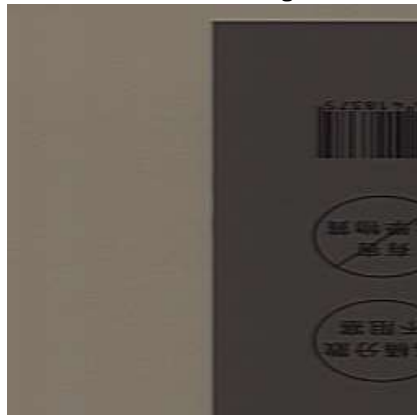
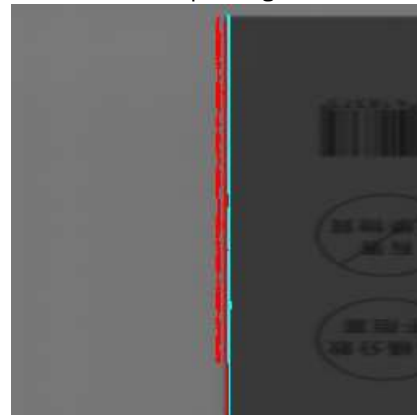
Defect image

No.	#47, \$34	Date	2023/8/9 下午 04:13:30
Segment	1	Camera	1
Pattern	2025	Position[x, y]	374.9 [mm], 1531.8 [m], (139.0 [m])
Type	点状疵点縱向刀絲疵點	Size	H:5.4 ,V:626.4 [mm]
Result	-	Area	294.2 [mm2]
Inspection level	5/5,5/5,5/5,5/5,5/5	Label	-
Light	6,6,3/6,6,3

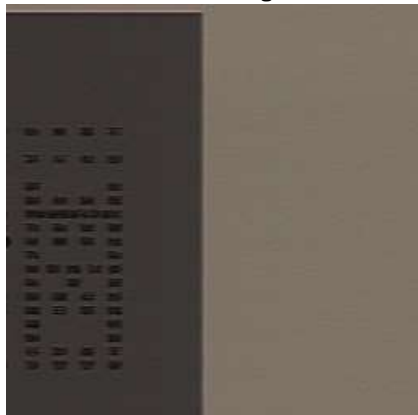
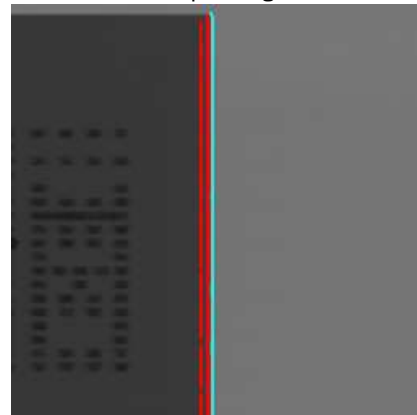
No.	#45, \$32	Date	2023/8/9 下午 04:13:29
Segment	1	Camera	1
Pattern	2023	Position[x, y]	242.0 [mm], 1530.6 [m], (140.2 [m])
Type	点状疵点縱向刀絲疵點	Size	H:2.2 ,V:415.6 [mm]
Result	-	Area	78.2 [mm2]
Inspection level	5/5,5/5,5/5,5/5,5/5	Label	-
Light	6,6,3/6,6,3

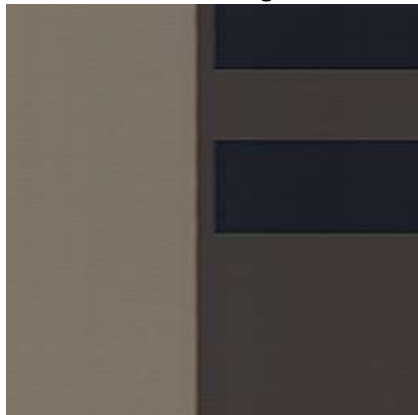
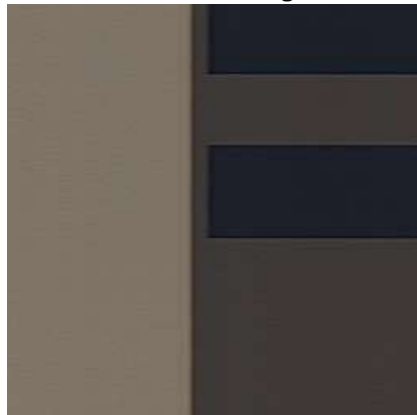
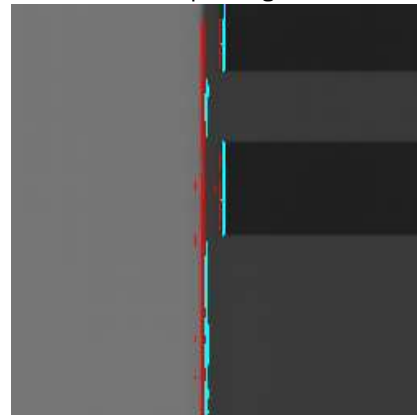
No.	#45, \$32	Date	2023/8/9 下午 04:13:29
Segment	1	Camera	1
Pattern	2023	Position[x, y]	699.8 [mm], 1530.4 [m], (140.5 [m])
Type	点状疵点縱向刀絲疵點	Size	H:4.6 ,V:458.4 [mm]
Result	-	Area	86.1 [mm2]
Inspection level	5/5,5/5,5/5,5/5,5/5	Label	-
Light	6,6,3/6,6,3

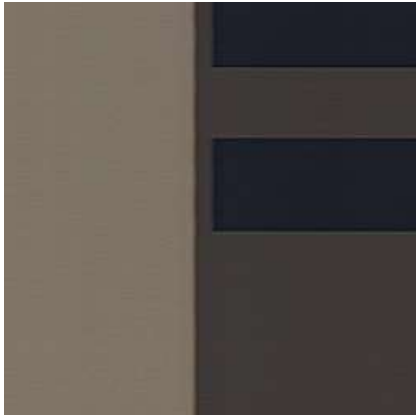
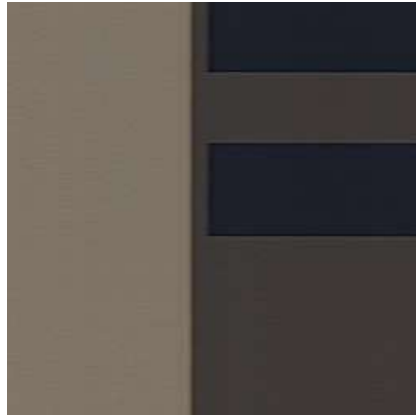
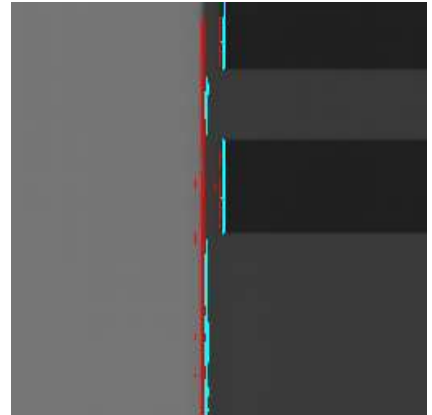
No.	#44, \$31	Date	2023/8/9 下午 04:13:28
Segment	1	Camera	1
Pattern	2022	Position[x, y]	450.1 [mm], 1529.6 [m], (141.3 [m])
Type	縱向刀絲疵點	Size	H:0.5 ,V:96.4 [mm]
Result	-	Area	31.9 [mm2]
Inspection level	5/5,5/5,5/5,5/5,5/5	Label	-
Light	6,6,3/6,6,3

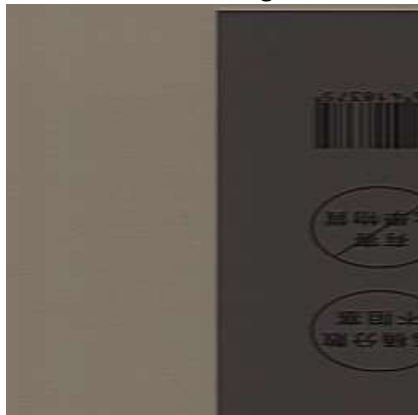
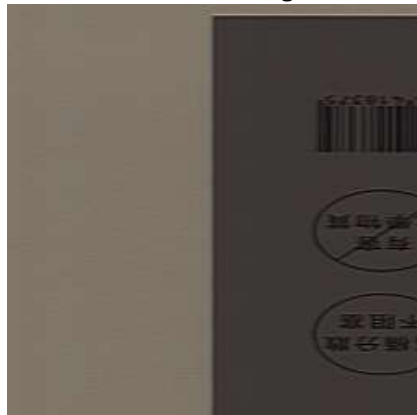
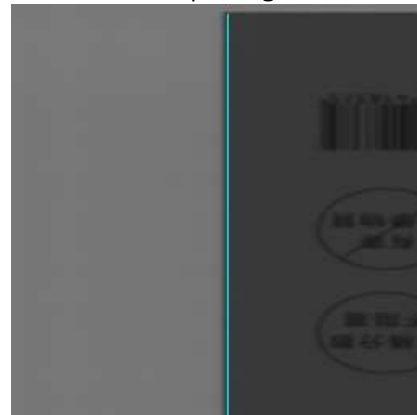
No.	#44, \$31	Date	2023/8/9 下午 04:13:28
Segment	1	Camera	1
Pattern	2022	Position[x, y]	375.1 [mm], 1529.9 [m], (141.0 [m])
Type	縱向刀絲疵點	Size	H:2.9 ,V:282.8 [mm]
Result	-	Area	34.3 [mm2]
Inspection level	5/5,5/5,5/5,5/5,5/5	Label	-
Light	6,6,3/6,6,3

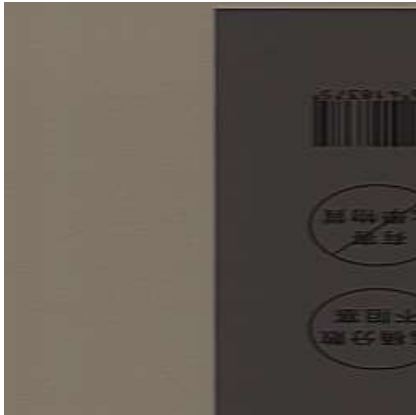
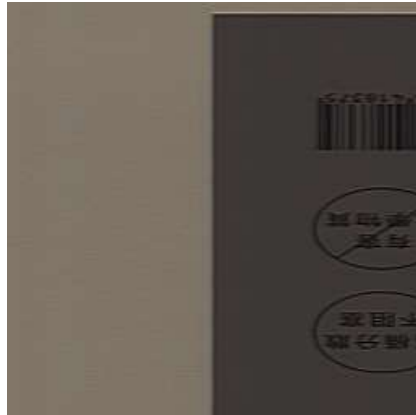
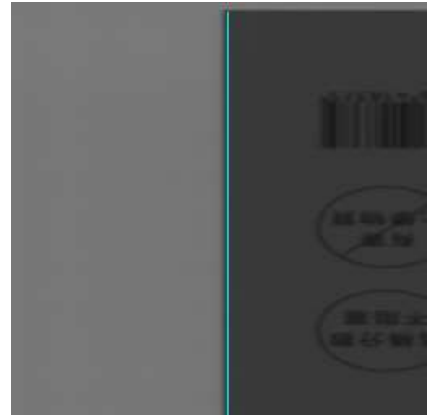
No.	#41, \$30	Date	2023/8/9 下午 04:13:21
Segment	1	Camera	1
Pattern	2010	Position[x, y]	113.1 [mm], 1520.8 [m], (150.1 [m])
Type	点状疵点縱向刀絲疵點橫向刀絲	Size	H:184.3 ,V:55.2 [mm]
Result	-	Area	275.5 [mm2]
Inspection level	5/5,5/5,5/5,5/5,5/5	Label	-
Light	6,6,3/6,6,3

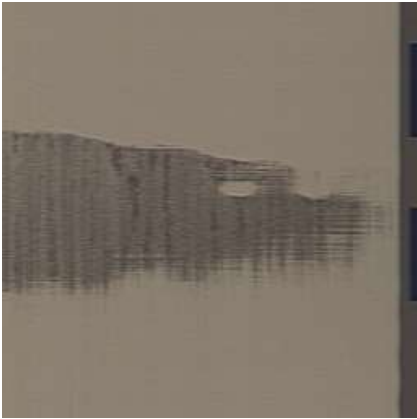
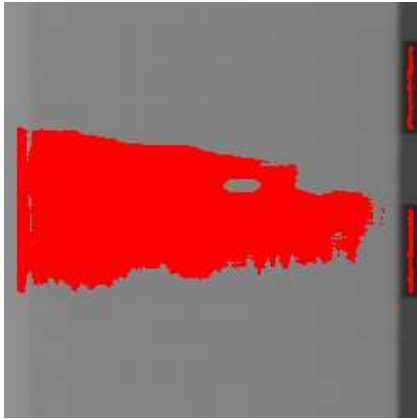
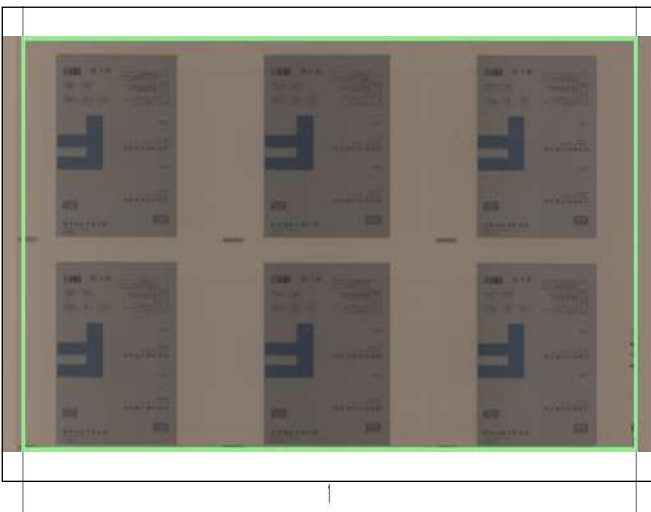
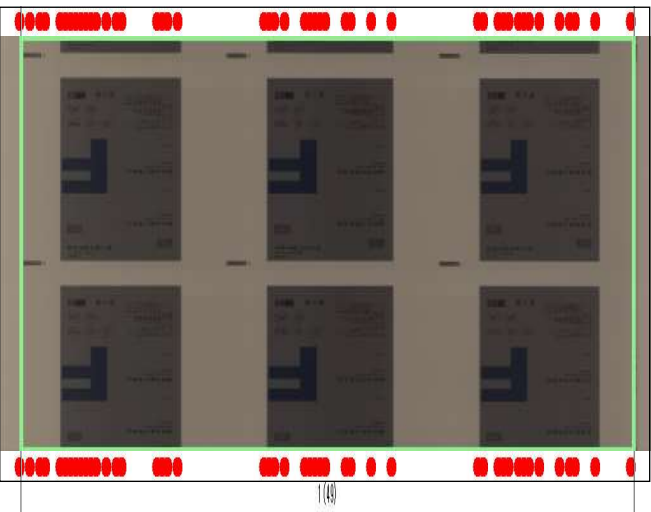
No.	#41, \$30	Date	2023/8/9 下午 04:13:21
Segment	1	Camera	1
Pattern	2010	Position[x, y]	15.0 [mm], 1520.6 [m], (150.3 [m])
Type	点状疵点	Size	H:53.5 ,V:40.0 [mm]
Result	-	Area	1447.7 [mm2]
Inspection level	5/5,5/5,5/5,5/5,5/5	Label	-
Light	6,6,3/6,6,3

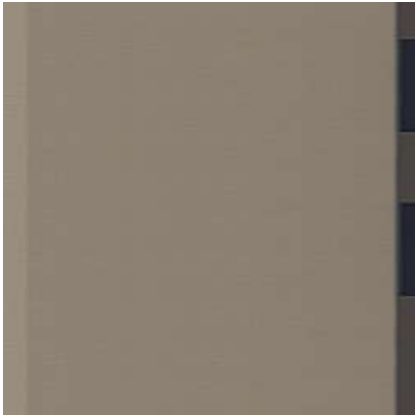
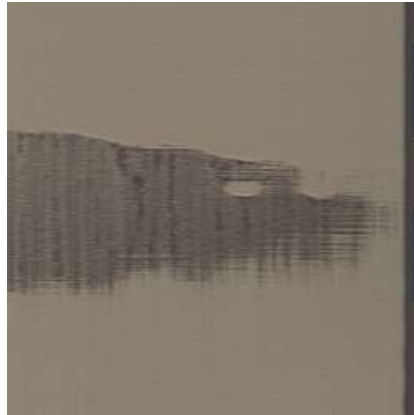
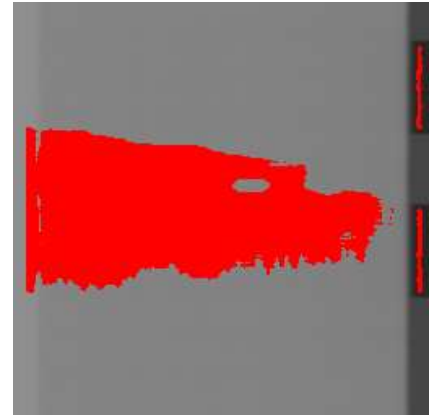
No.	#40, \$29	Date	2023/8/9 下午 04:13:20
Segment	1	Camera	1
Pattern	2009	Position[x, y]	32.3 [mm], 1519.8 [m], (151.0 [m])
Type	面狀重疵點	Size	H:26.9 ,V:25.2 [mm]
Result	-	Area	142.5 [mm2]
Inspection level	5/5,5/5,5/5,5/5,5/5	Label	-
Light	6,6,3/6,6,3

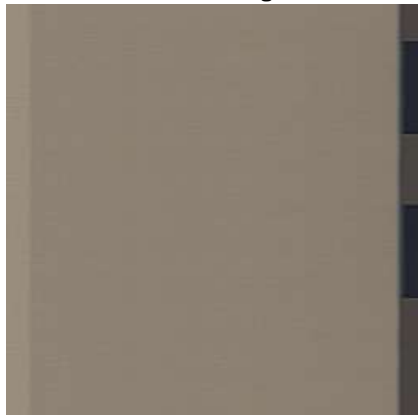
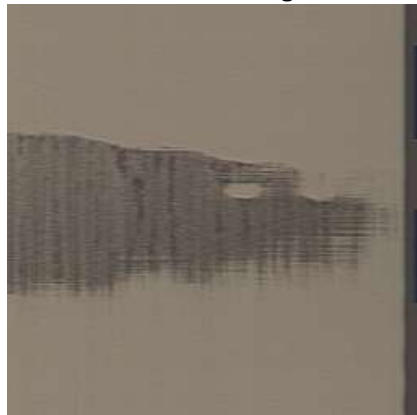
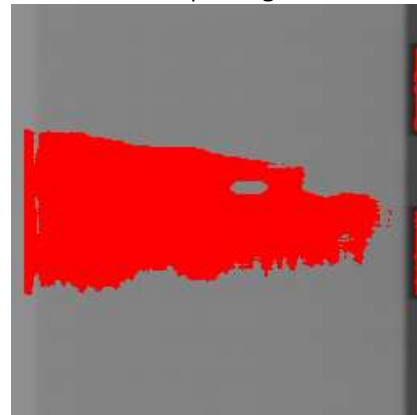
No.	#40, \$29	Date	2023/8/9 下午 04:13:20
Segment	1	Camera	1
Pattern	2009	Position[x, y]	100.4 [mm], 1519.6 [m], (151.3 [m])
Type	点状疵点縱向刀絲疵點橫向刀絲	Size	H:115.5 ,V:27.2 [mm]
Result	-	Area	167.7 [mm2]
Inspection level	5/5,5/5,5/5,5/5,5/5	Label	-
Light	6,6,3/6,6,3

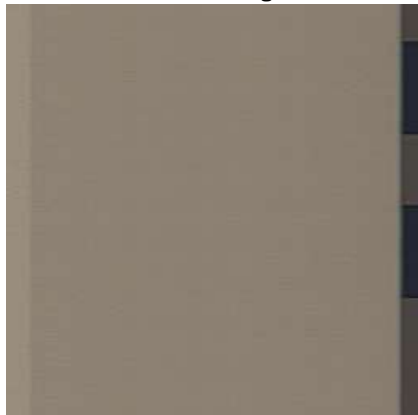
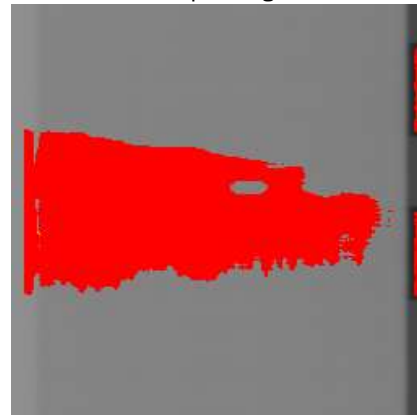
No.	#40, \$29	Date	2023/8/9 下午 04:13:20
Segment	1	Camera	1
Pattern	2009	Position[x, y]	15.0 [mm], 1519.8 [m], (151.0 [m])
Type	点状疵点	Size	H:53.7 ,V:40.0 [mm]
Result	-	Area	1447.8 [mm2]
Inspection level	5/5,5/5,5/5,5/5,5/5	Label	-
Light	6,6,3/6,6,3

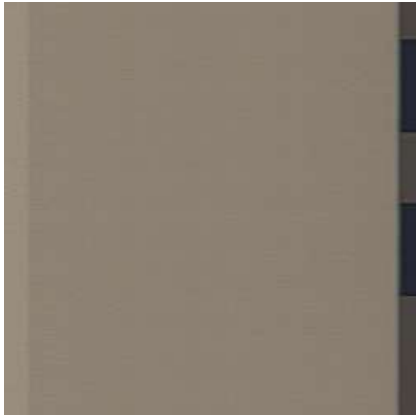
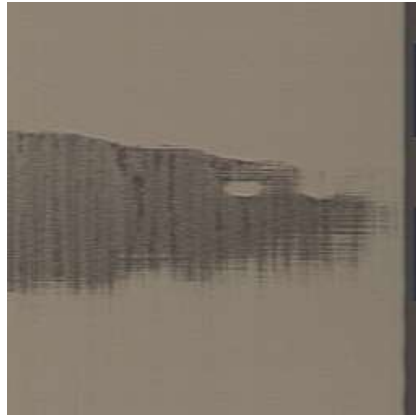
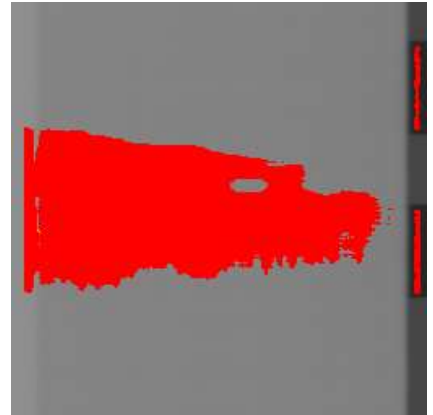
No.	#39, \$28	Date	2023/8/9 下午 04:13:20
Segment	1	Camera	1
Pattern	2008	Position[x, y]	32.3 [mm], 1519.1 [m], (151.8 [m])
Type	面狀重疵點	Size	H:26.9 ,V:25.2 [mm]
Result	-	Area	142.5 [mm2]
Inspection level	5/5,5/5,5/5,5/5,5/5	Label	-
Light	6,6,3/6,6,3

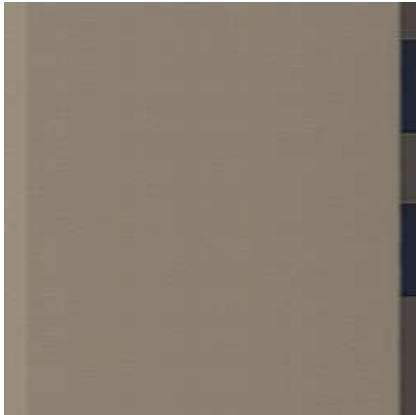
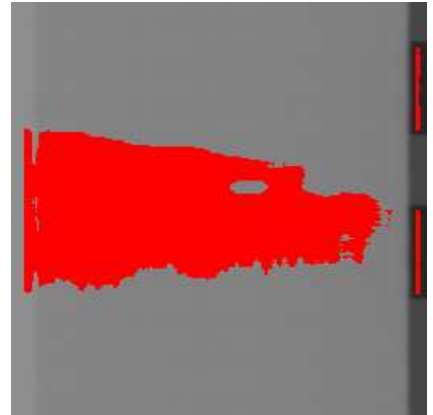
No.	#39, \$28	Date	2023/8/9 下午 04:13:20
Segment	1	Camera	1
Pattern	2008	Position[x, y]	15.0 [mm], 1519.1 [m], (151.8 [m])
Type	点状疵点	Size	H:53.7 ,V:39.6 [mm]
Result	-	Area	1430.4 [mm2]
Inspection level	5/5,5/5,5/5,5/5,5/5	Label	-
Light	6,6,3/6,6,3

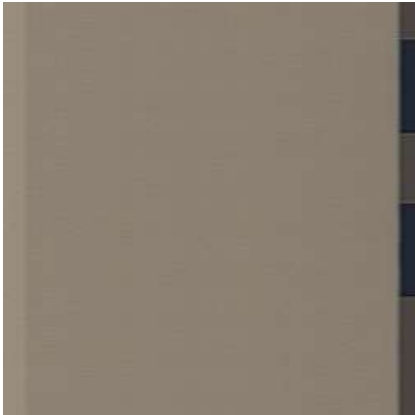
Defect image

No.	#38, \$27	Date	2023/8/9 下午 04:13:19
Segment	1	Camera	1
Pattern	2007	Position[x, y]	936.4 [mm], 1518.1 [m], (152.8 [m])
Type	縱向刀絲疵點	Size	H:5.4 ,V:30.4 [mm]
Result	-	Area	87.2 [mm2]
Inspection level	5/5,5/5,5/5,5/5,5/5	Label	-
Light	6,6,3/6,6,3

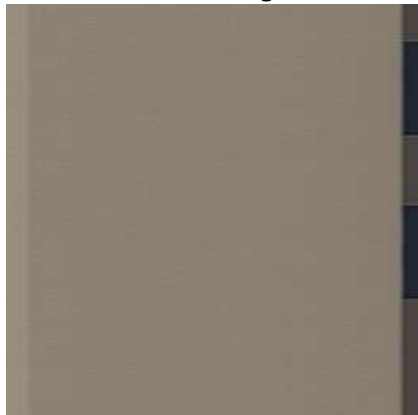
Defect image

No.	#38, \$27	Date	2023/8/9 下午 04:13:19
Segment	1	Camera	1
Pattern	2007	Position[x, y]	934.7 [mm], 1518.7 [m], (152.2 [m])
Type	面狀重疵點縱向刀絲疵點橫向刀絲	Size	H:9.3 ,V:122.8 [mm]
Result	-	Area	96.9 [mm2]
Inspection level	5/5,5/5,5/5,5/5,5/5	Label	-
Light	6,6,3/6,6,3

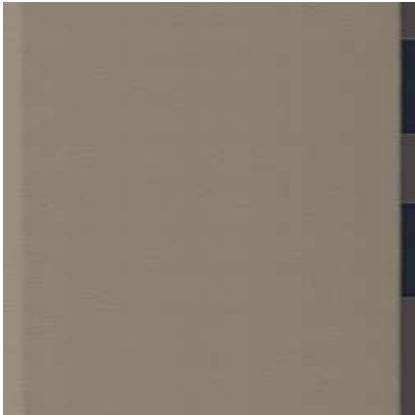
Defect image

No.	#38, \$27	Date	2023/8/9 下午 04:13:19
Segment	1	Camera	1
Pattern	2007	Position[x, y]	20.1 [mm], 1518.3 [m], (152.5 [m])
Type	点状疵点	Size	H:53.5 ,V:40.0 [mm]
Result	-	Area	1459.7 [mm2]
Inspection level	5/5,5/5,5/5,5/5,5/5	Label	-
Light	6,6,3/6,6,3

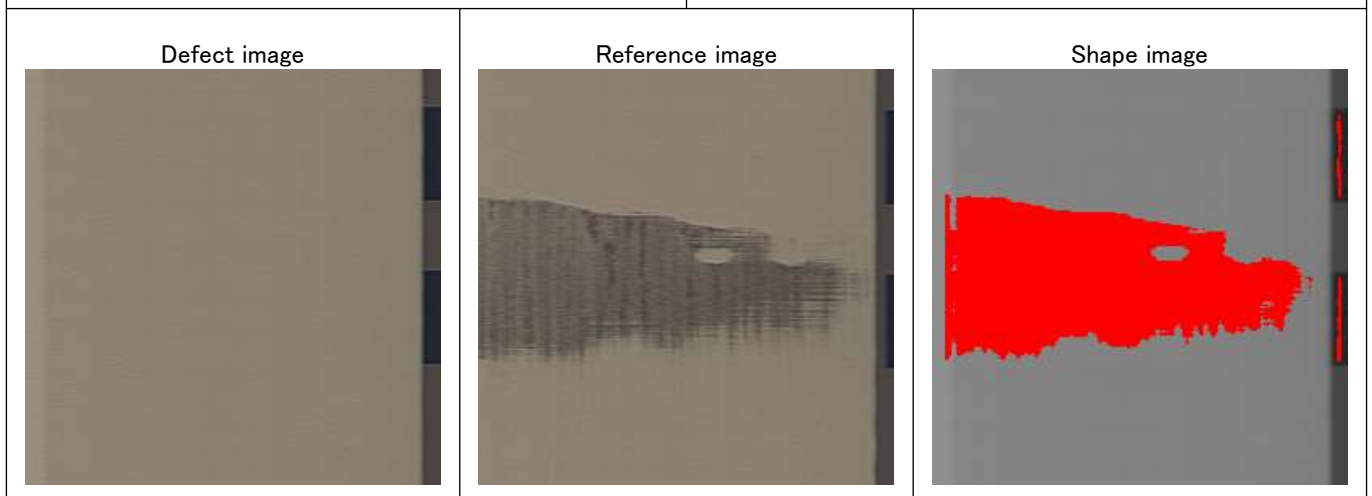
No.	#37, \$26	Date	2023/8/9 下午 04:13:19
Segment	1	Camera	1
Pattern	2006	Position[x, y]	934.7 [mm], 1518.1 [m], (152.8 [m])
Type	面狀重疵點縱向刀絲疵點橫向刀絲	Size	H:8.1 ,V:101.6 [mm]
Result	-	Area	107.0 [mm2]
Inspection level	5/5,5/5,5/5,5/5,5/5	Label	-
Light	6,6,3/6,6,3

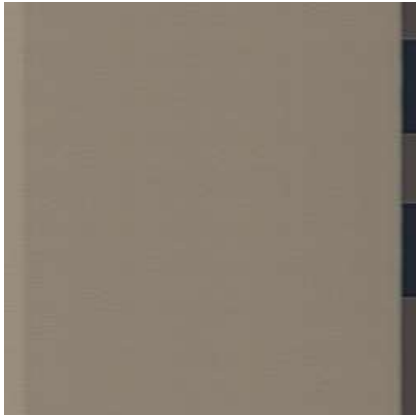
Defect image

No.	#37, \$26	Date	2023/8/9 下午 04:13:19
Segment	1	Camera	1
Pattern	2006	Position[x, y]	934.9 [mm], 1517.3 [m], (153.5 [m])
Type	縱向刀絲疵點橫向刀絲	Size	H:6.8 ,V:54.0 [mm]
Result	-	Area	111.0 [mm2]
Inspection level	5/5,5/5,5/5,5/5,5/5	Label	-
Light	6,6,3/6,6,3

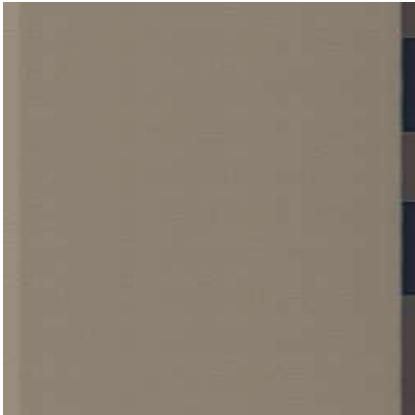
Defect image

No.	#37, \$26	Date	2023/8/9 下午 04:13:19
Segment	1	Camera	1
Pattern	2006	Position[x, y]	20.1 [mm], 1517.6 [m], (153.3 [m])
Type	点状疵点	Size	H:53.7 ,V:39.2 [mm]
Result	-	Area	1436.7 [mm2]
Inspection level	5/5,5/5,5/5,5/5,5/5	Label	-
Light	6,6,3/6,6,3

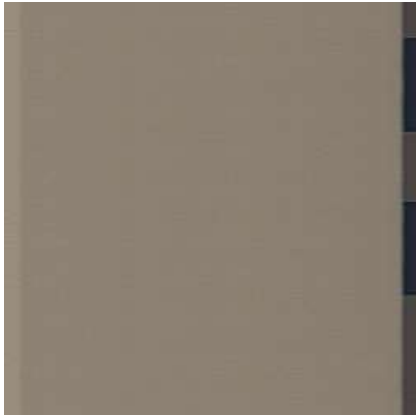
Defect image

No.	#32, \$25	Date	2023/8/9 下午 04:04:50
Segment	1	Camera	1
Pattern	1713	Position[x, y]	65.0 [mm], 1293.7 [m], (377.2 [m])
Type	点状疵点縱向刀絲疵點	Size	H:18.3 ,V:442.8 [mm]
Result	-	Area	925.5 [mm2]
Inspection level	5/5,5/5,5/5,5/5,5/5	Label	-
Light	6,6,3/6,6,3

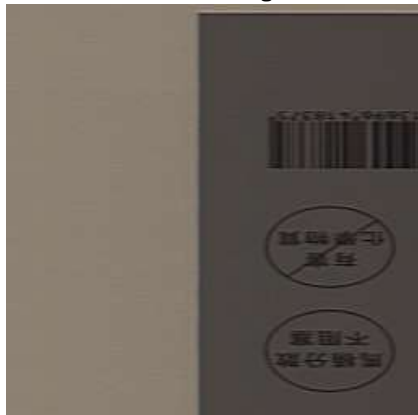
Defect image

No.	#32, \$25	Date	2023/8/9 下午 04:04:50
Segment	1	Camera	1
Pattern	1713	Position[x, y]	58.7 [mm], 1294.0 [m], (376.8 [m])
Type	点状疵点縱向刀絲疵點	Size	H:5.1 ,V:697.6 [mm]
Result	-	Area	927.5 [mm2]
Inspection level	5/5,5/5,5/5,5/5,5/5	Label	-
Light	6,6,3/6,6,3

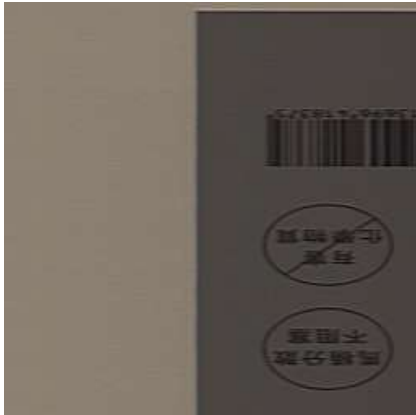
Defect image

No.	#31, \$24	Date	2023/8/9 下午 04:04:49
Segment	1	Camera	1
Pattern	1712	Position[x, y]	374.6 [mm], 1293.3 [m], (377.6 [m])
Type	点状疵点縱向刀絲疵點	Size	H:4.6 ,V:680.8 [mm]
Result	-	Area	660.3 [mm2]
Inspection level	5/5,5/5,5/5,5/5,5/5	Label	-
Light	6,6,3/6,6,3

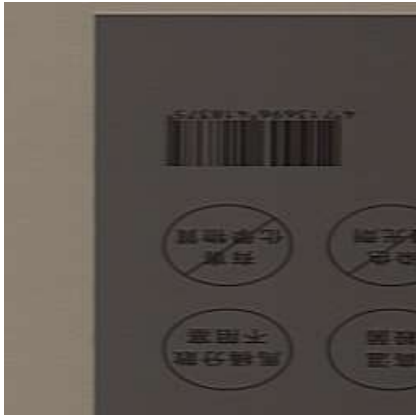
Defect image

No.	#31, \$24	Date	2023/8/9 下午 04:04:49
Segment	1	Camera	1
Pattern	1712	Position[x, y]	67.2 [mm], 1293.0 [m], (377.9 [m])
Type	点状疵点縱向刀絲疵點	Size	H:31.0 ,V:808.0 [mm]
Result	-	Area	812.5 [mm2]
Inspection level	5/5,5/5,5/5,5/5,5/5	Label	-
Light	6,6,3/6,6,3

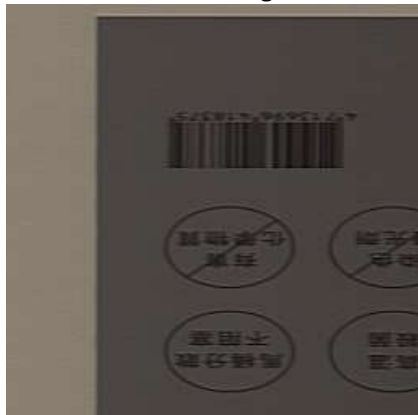
Defect image

No.	#30, \$23	Date	2023/8/9 下午 04:04:49
Segment	1	Camera	1
Pattern	1711	Position[x, y]	374.9 [mm], 1292.5 [m], (378.3 [m])
Type	点状疵点縱向刀絲疵點	Size	H:4.4 ,V:706.0 [mm]
Result	-	Area	593.4 [mm2]
Inspection level	5/5,5/5,5/5,5/5,5/5	Label	-
Light	6,6,3/6,6,3

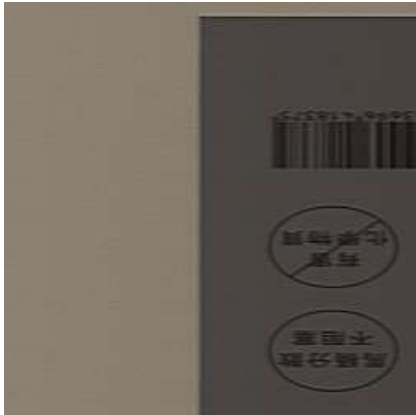
Defect image

No.	#30, \$23	Date	2023/8/9 下午 04:04:49
Segment	1	Camera	1
Pattern	1711	Position[x, y]	58.7 [mm], 1292.5 [m], (378.3 [m])
Type	点状疵点縱向刀絲疵點	Size	H:4.6 ,V:706.0 [mm]
Result	-	Area	766.9 [mm2]
Inspection level	5/5,5/5,5/5,5/5,5/5	Label	-
Light	6,6,3/6,6,3

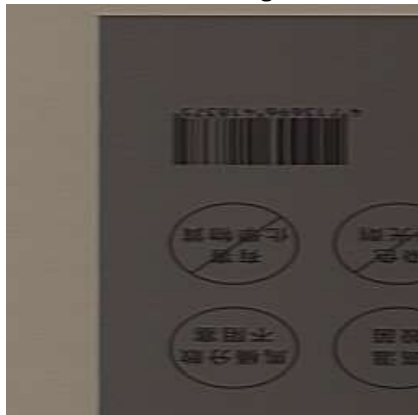
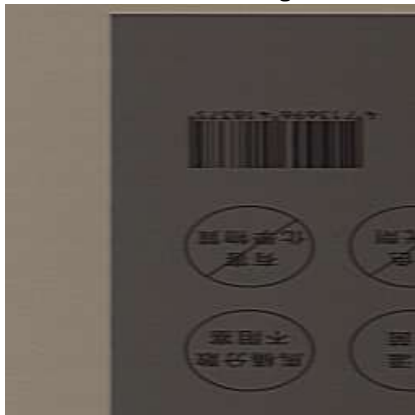
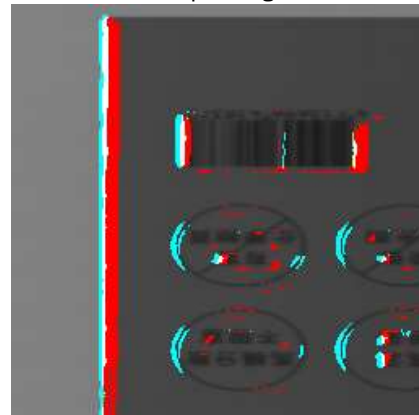
No.	#29, \$22	Date	2023/8/9 下午 04:04:48
Segment	1	Camera	1
Pattern	1710	Position[x, y]	66.0 [mm], 1291.4 [m], (379.4 [m])
Type	点状疵点縱向刀絲疵點	Size	H:30.8 ,V:441.6 [mm]
Result	-	Area	615.3 [mm2]
Inspection level	5/5,5/5,5/5,5/5,5/5	Label	-
Light	6,6,3/6,6,3

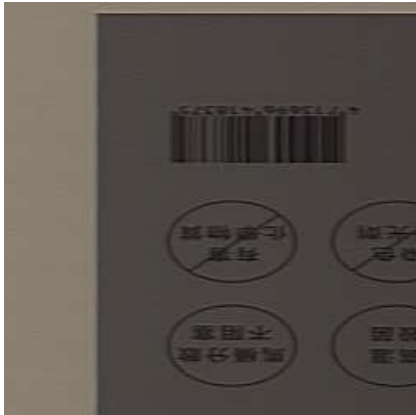
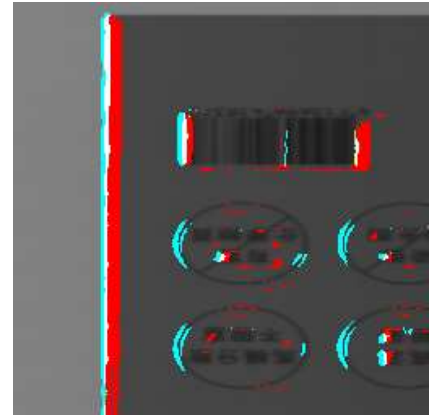
No.	#28, \$21	Date	2023/8/9 下午 04:04:48
Segment	1	Camera	1
Pattern	1709	Position[x, y]	64.6 [mm], 1290.5 [m], (380.3 [m])
Type	点状疵点縱向刀絲疵點	Size	H:11.7 ,V:87.2 [mm]
Result	-	Area	168.7 [mm2]
Inspection level	5/5,5/5,5/5,5/5,5/5	Label	-
Light	6,6,3/6,6,3

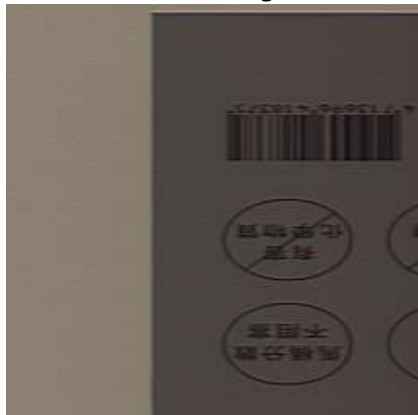
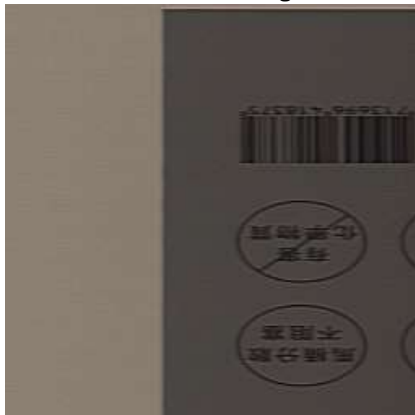
No.	#28, \$21	Date	2023/8/9 下午 04:04:48
Segment	1	Camera	1
Pattern	1709	Position[x, y]	64.6 [mm], 1290.6 [m], (380.2 [m])
Type	点状疵点縱向刀絲疵點	Size	H:13.4 ,V:462.8 [mm]
Result	-	Area	484.5 [mm2]
Inspection level	5/5,5/5,5/5,5/5,5/5	Label	-
Light	6,6,3/6,6,3

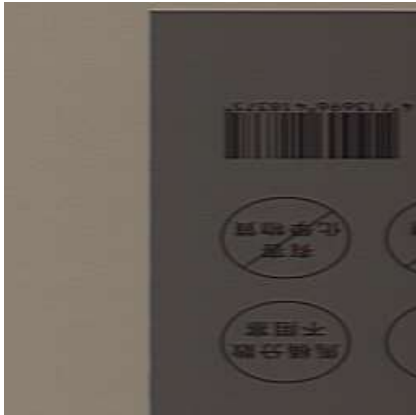
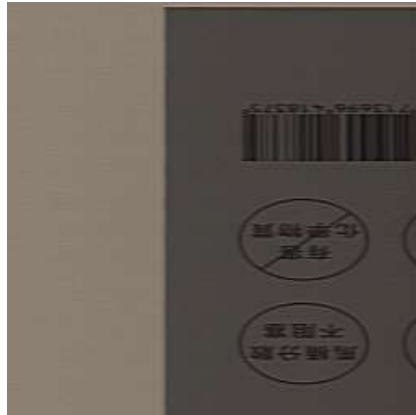
No.	#25, \$20	Date	2023/8/9 下午 04:04:40
Segment	1	Camera	1
Pattern	1698	Position[x, y]	460.3 [mm], 1281.5 [m], (389.4 [m])
Type	点状疵点縱向刀絲疵點	Size	H:193.8 ,V:230.8 [mm]
Result	-	Area	1182.4 [mm2]
Inspection level	5/5,5/5,5/5,5/5,5/5	Label	-
Light	6,6,3/6,6,3

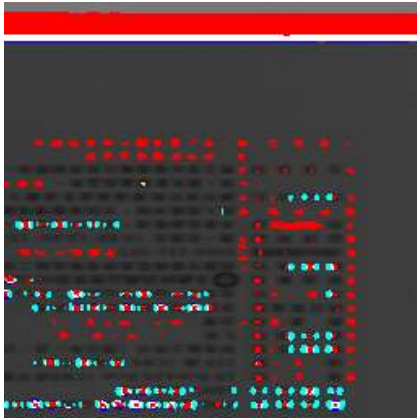
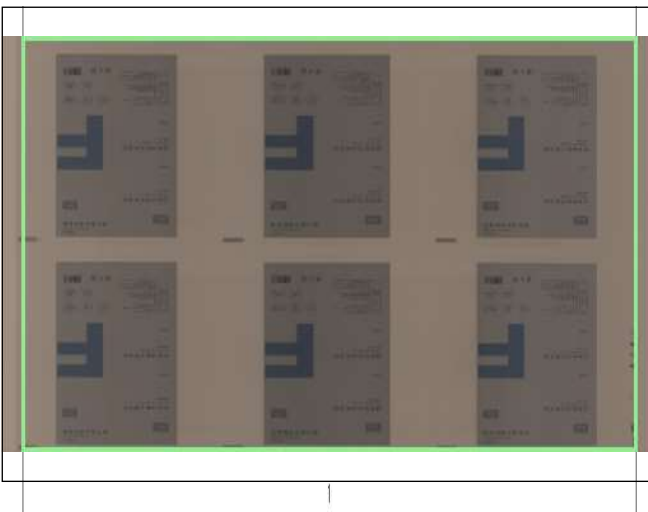
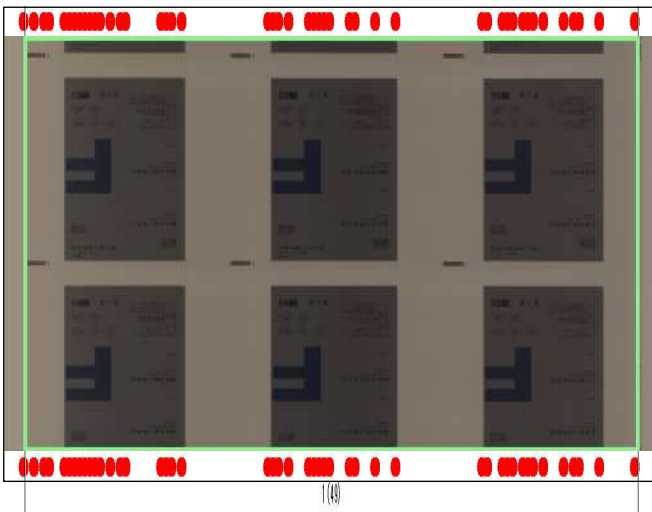
No.	#25, \$20	Date	2023/8/9 下午 04:04:40
Segment	1	Camera	1
Pattern	1698	Position[x, y]	782.6 [mm], 1281.7 [m], (389.2 [m])
Type	点状疵点縱向刀絲疵點橫向刀絲	Size	H:186.3 ,V:556.4 [mm]
Result	-	Area	5043.6 [mm2]
Inspection level	5/5,5/5,5/5,5/5,5/5	Label	-
Light	6,6,3/6,6,3

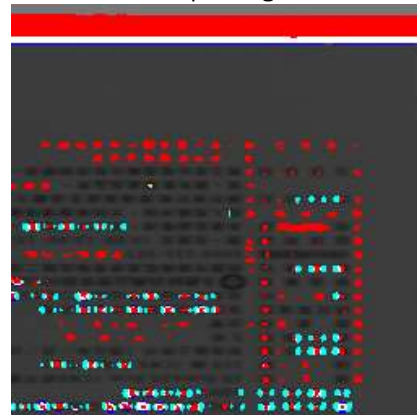
No.	#24, \$19	Date	2023/8/9 下午 04:04:40
Segment	1	Camera	1
Pattern	1697	Position[x, y]	804.8 [mm], 1280.8 [m], (390.0 [m])
Type	点状疵点縱向刀絲疵點	Size	H:185.5 ,V:432.4 [mm]
Result	-	Area	771.3 [mm2]
Inspection level	5/5,5/5,5/5,5/5,5/5	Label	-
Light	6,6,3/6,6,3

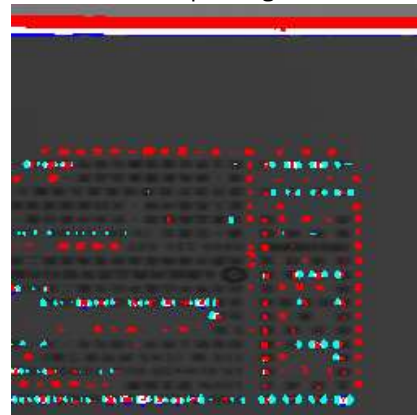
No.	#23, \$18	Date	2023/8/9 下午 04:04:39
Segment	1	Camera	1
Pattern	1696	Position[x, y]	755.0 [mm], 1280.1 [m], (390.8 [m])
Type	点状疵点縱向刀絲疵點	Size	H:185.3 ,V:446.4 [mm]
Result	-	Area	605.8 [mm2]
Inspection level	5/5,5/5,5/5,5/5,5/5	Label	-
Light	6,6,3/6,6,3

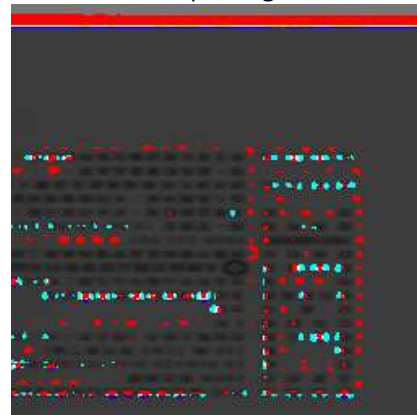
No.	#23, \$18	Date	2023/8/9 下午 04:04:39
Segment	1	Camera	1
Pattern	1696	Position[x, y]	786.7 [mm], 1280.1 [m], (390.7 [m])
Type	点状疵点縱向刀絲疵點橫向刀絲	Size	H:186.3 ,V:811.2 [mm]
Result	-	Area	2498.9 [mm2]
Inspection level	5/5,5/5,5/5,5/5,5/5	Label	-
Light	6,6,3/6,6,3

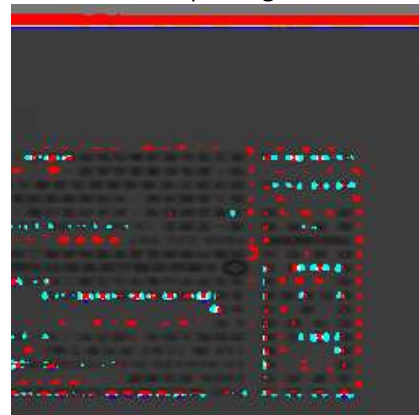
No.	#22, \$17	Date	2023/8/9 下午 04:04:39
Segment	1	Camera	1
Pattern	1695	Position[x, y]	704.9 [mm], 1279.6 [m], (391.2 [m])
Type	点状疵点縱向刀絲疵點	Size	H:13.7 ,V:510.0 [mm]
Result	-	Area	382.0 [mm2]
Inspection level	5/5,5/5,5/5,5/5,5/5	Label	-
Light	6,6,3/6,6,3

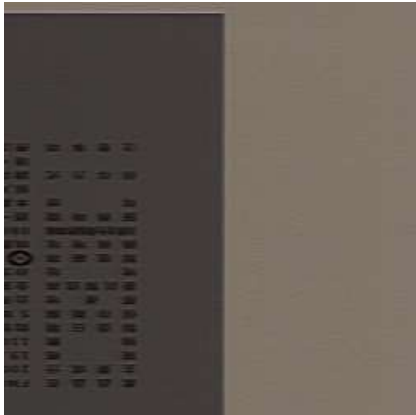
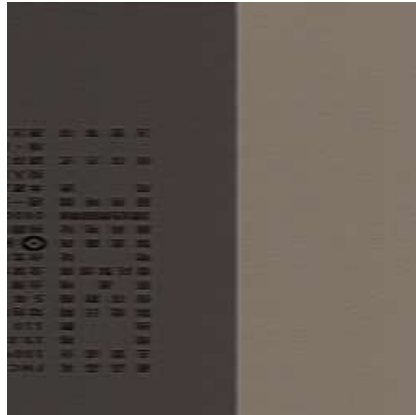
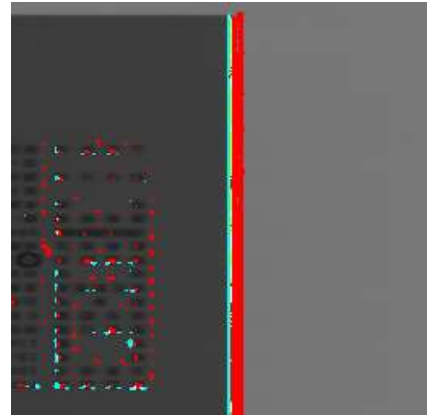
No.	#22, \$17	Date	2023/8/9 下午 04:04:39
Segment	1	Camera	1
Pattern	1695	Position[x, y]	882.7 [mm], 1279.7 [m], (391.1 [m])
Type	点状疵点縱向刀絲疵點	Size	H:2.9 ,V:538.4 [mm]
Result	-	Area	579.3 [mm2]
Inspection level	5/5,5/5,5/5,5/5,5/5	Label	-
Light	6,6,3/6,6,3

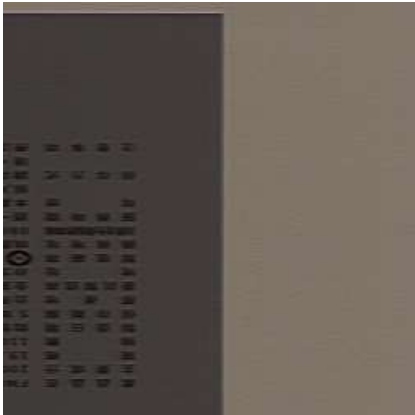
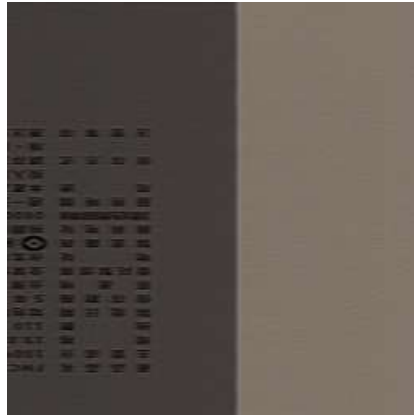
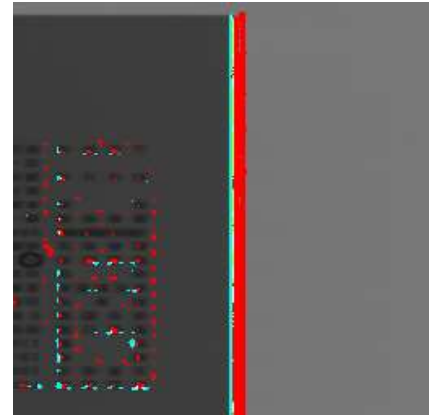
No.	#21, \$16	Date	2023/8/9 下午 04:04:38
Segment	1	Camera	1
Pattern	1694	Position[x, y]	748.2 [mm], 1279.0 [m], (391.8 [m])
Type	点状疵点縱向刀絲疵點	Size	H:2.0 ,V:71.6 [mm]
Result	-	Area	12.8 [mm2]
Inspection level	5/5,5/5,5/5,5/5,5/5	Label	-
Light	6,6,3/6,6,3

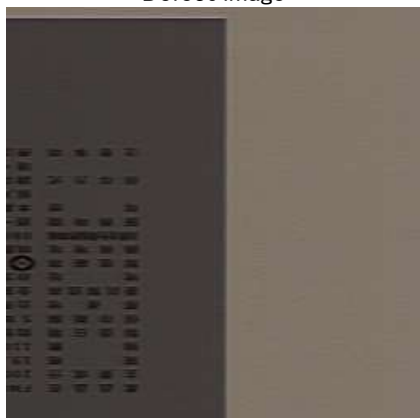
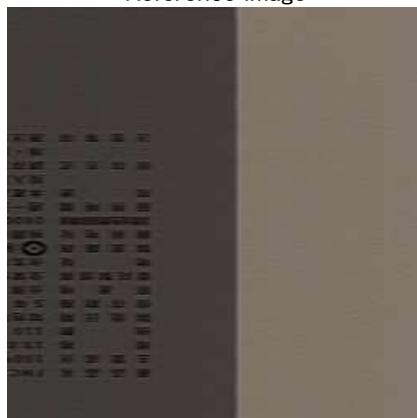
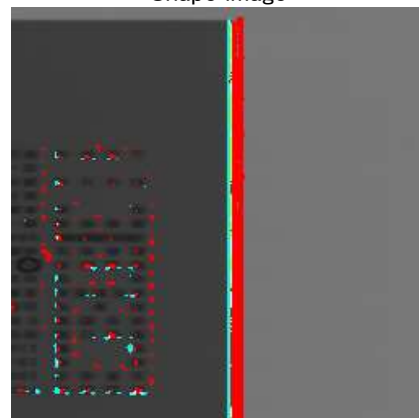
No.	#21, \$16	Date	2023/8/9 下午 04:04:38
Segment	1	Camera	1
Pattern	1694	Position[x, y]	772.6 [mm], 1279.1 [m], (391.8 [m])
Type	点状疵点縱向刀絲疵點	Size	H:2.0 ,V:97.6 [mm]
Result	-	Area	47.7 [mm2]
Inspection level	5/5,5/5,5/5,5/5,5/5	Label	-
Light	6,6,3/6,6,3

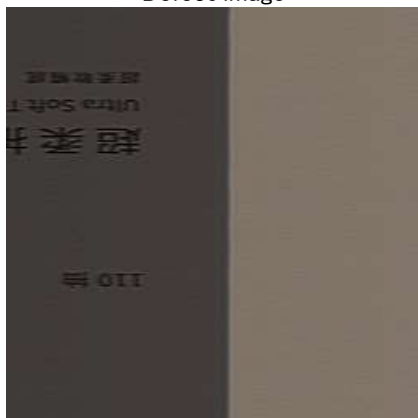
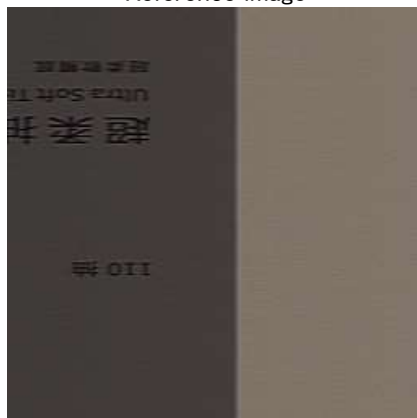
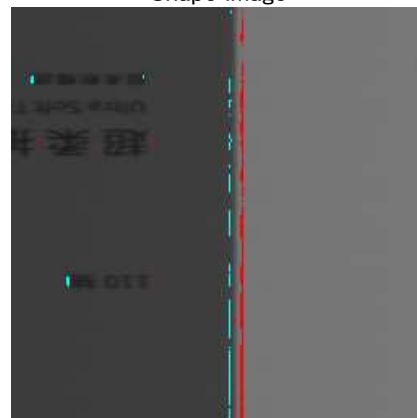
Defect image

No.	#21, \$16	Date	2023/8/9 下午 04:04:38
Segment	1	Camera	1
Pattern	1694	Position[x, y]	881.9 [mm], 1279.2 [m], (391.7 [m])
Type	点状疵点縱向刀絲疵點	Size	H:14.6 ,V:192.0 [mm]
Result	-	Area	91.8 [mm2]
Inspection level	5/5,5/5,5/5,5/5,5/5	Label	-
Light	6,6,3/6,6,3
