Inspection Result (Individual Data)

Lot number : 7

商品名	標準透明6-6-3	周長	
顧客名		Ex1	
CODE番号		Ex2	
基材		Ex3

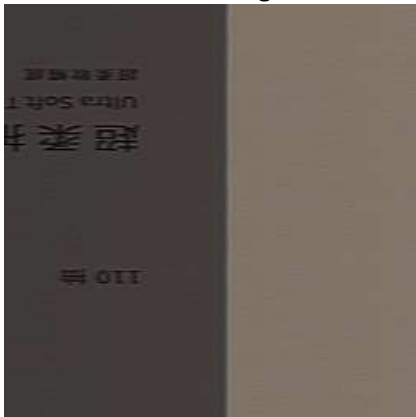
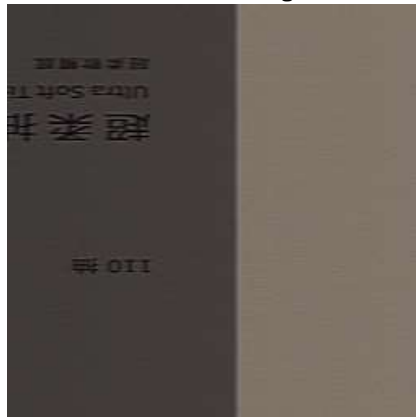
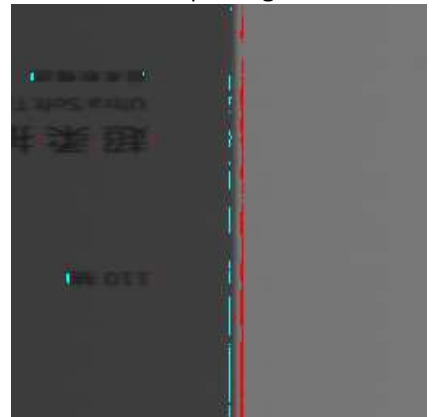
Defect image

No.	#18, \$15	Date	2023/8/9 下午 04:04:24
Segment	1	Camera	1
Pattern	1675	Position[x, y]	433.7 [mm], 1264.3 [m], (406.6 [m])
Type	点状疵点縱向刀絲疵點橫向刀絲	Size	H:193.1 ,V:637.6 [mm]
Result	-	Area	860.6 [mm2]
Inspection level	5/5,5/5,5/5,5/5,5/5	Label	-
Light	6,6,3/6,6,3

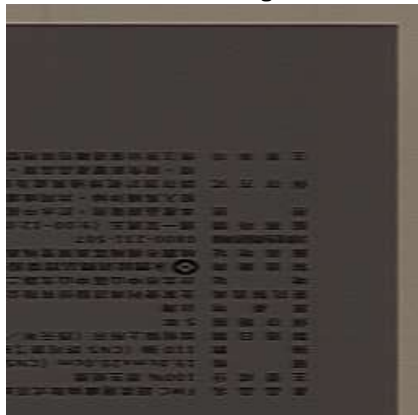
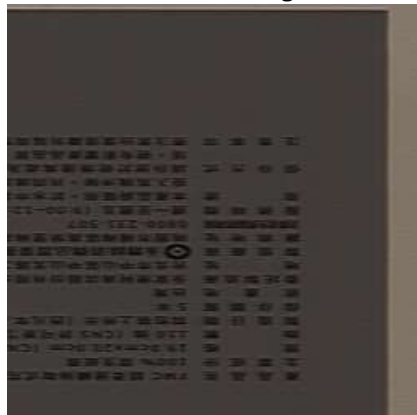
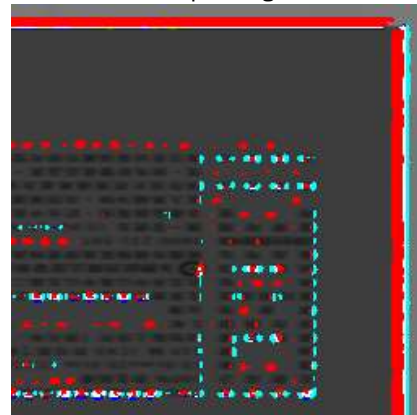
Defect image

No.	#18, \$15	Date	2023/8/9 下午 04:04:24
Segment	1	Camera	1
Pattern	1675	Position[x, y]	134.6 [mm], 1264.3 [m], (406.6 [m])
Type	点状疵点縱向刀絲疵點橫向刀絲	Size	H:187.0 ,V:451.2 [mm]
Result	-	Area	2152.8 [mm2]
Inspection level	5/5,5/5,5/5,5/5,5/5	Label	-
Light	6,6,3/6,6,3

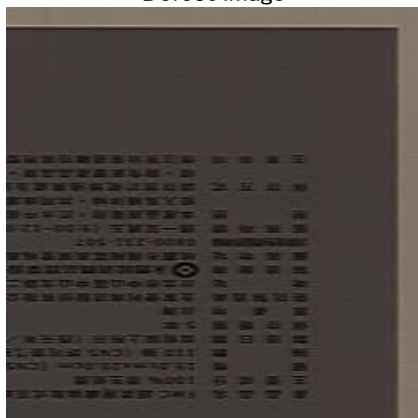
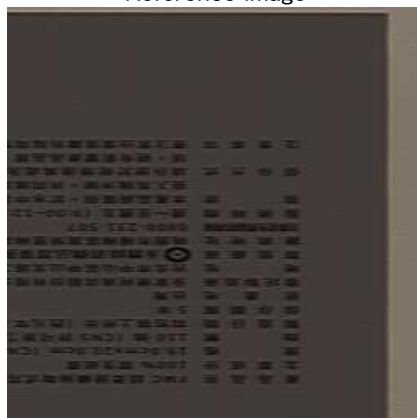
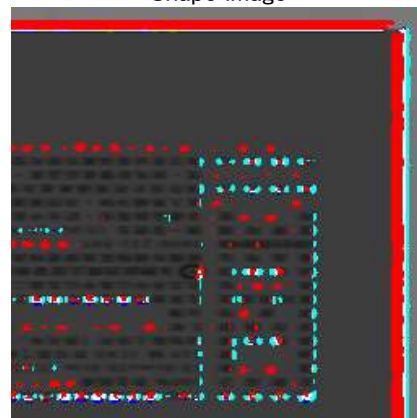
Defect image

No.	#17, \$14	Date	2023/8/9 下午 04:04:22
Segment	1	Camera	1
Pattern	1674	Position[x, y]	476.4 [mm], 1263.9 [m], (407.0 [m])
Type	点状疵点縱向刀絲疵點	Size	H:193.4 ,V:358.8 [mm]
Result	-	Area	1115.6 [mm2]
Inspection level	5/5,5/5,5/5,5/5,5/5	Label	-
Light	6,6,3/6,6,3

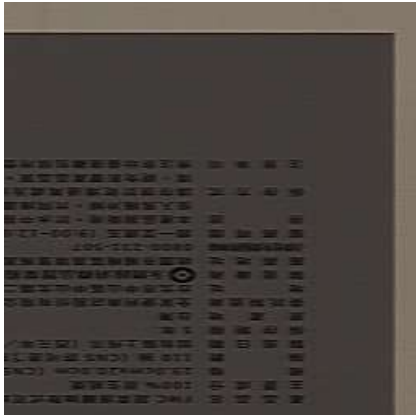
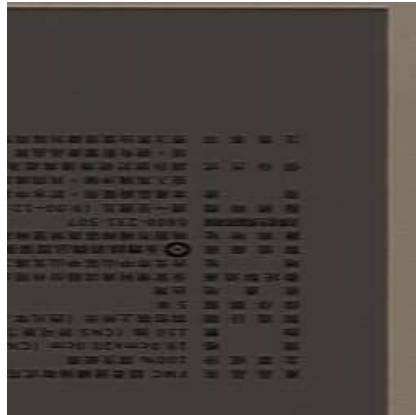
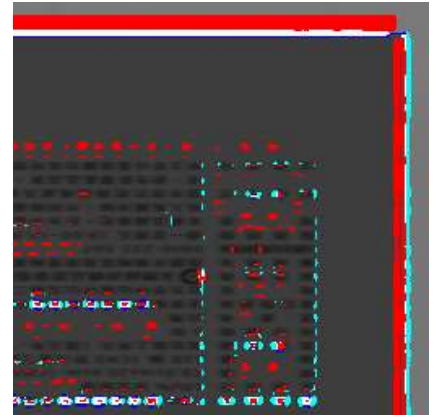
Defect image

No.	#17, \$14	Date	2023/8/9 下午 04:04:22
Segment	1	Camera	1
Pattern	1674	Position[x, y]	129.5 [mm], 1263.6 [m], (407.3 [m])
Type	点状疵点縱向刀絲疵點橫向刀絲	Size	H:186.8 ,V:469.6 [mm]
Result	-	Area	3355.0 [mm2]
Inspection level	5/5,5/5,5/5,5/5,5/5	Label	-
Light	6,6,3/6,6,3

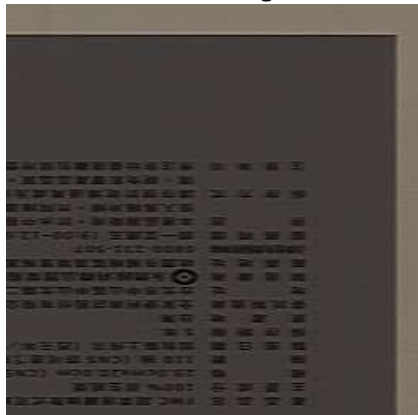
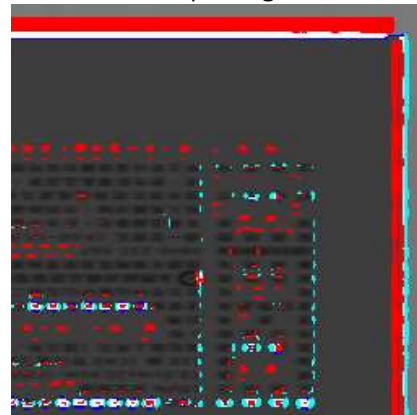
Defect image

No.	#16, \$13	Date	2023/8/9 下午 04:04:21
Segment	1	Camera	1
Pattern	1673	Position[x, y]	766.2 [mm], 1263.0 [m], (407.8 [m])
Type	点状疵点縱向刀絲疵點橫向刀絲	Size	H:184.6 ,V:130.4 [mm]
Result	-	Area	641.1 [mm2]
Inspection level	5/5,5/5,5/5,5/5,5/5	Label	-
Light	6,6,3/6,6,3

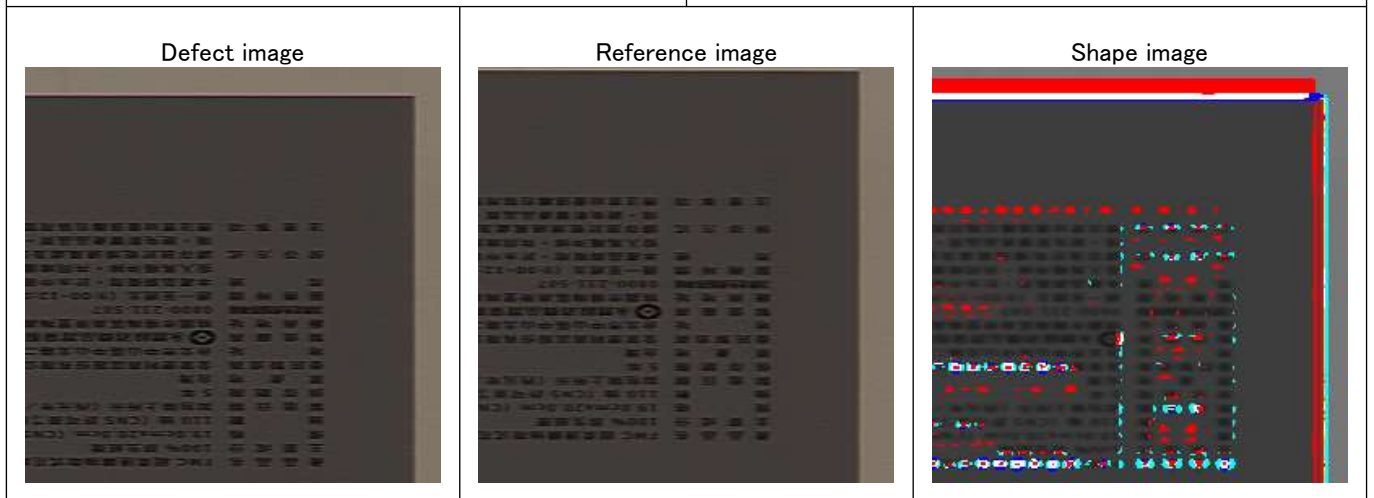
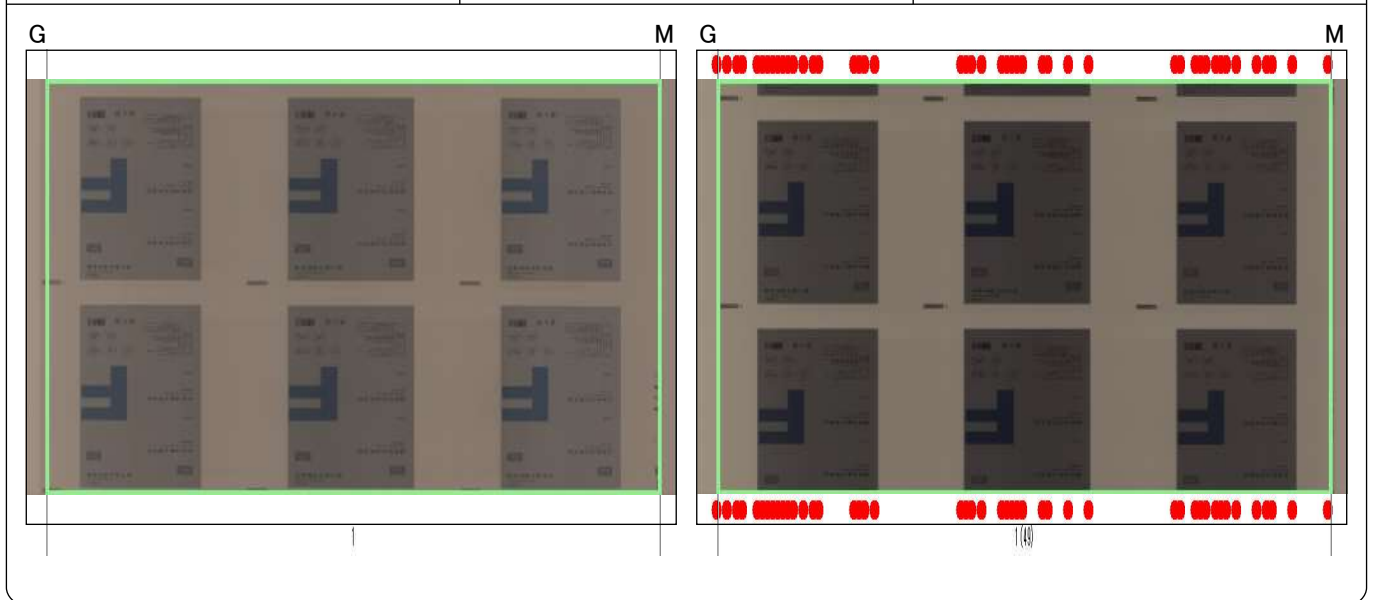
No.	#16, \$13	Date	2023/8/9 下午 04:04:21
Segment	1	Camera	1
Pattern	1673	Position[x, y]	181.7 [mm], 1263.2 [m], (407.7 [m])
Type	点状疵点縱向刀絲疵點橫向刀絲	Size	H:186.5 ,V:707.2 [mm]
Result	—	Area	3618.6 [mm2]
Inspection level	5/5,5/5,5/5,5/5,5/5	Label	—
Light	6,6,3/6,6,3

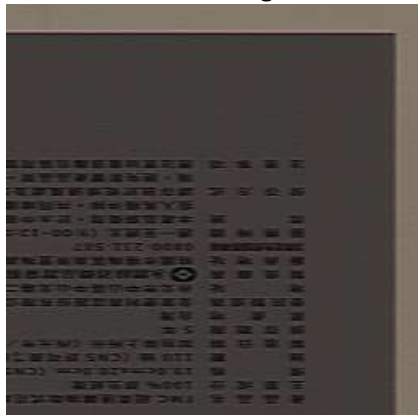
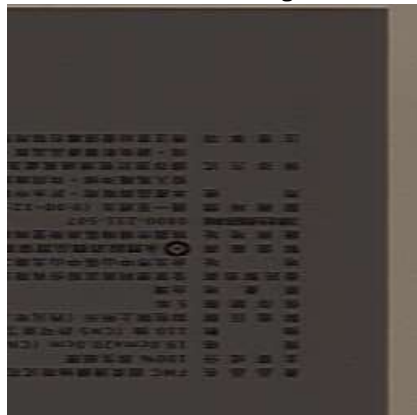
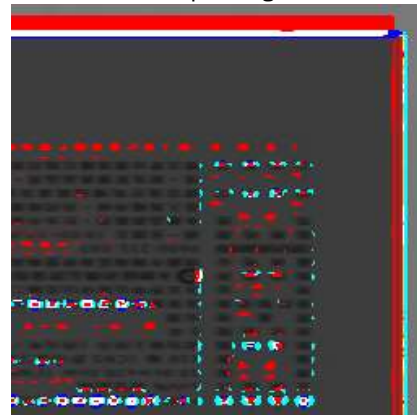
Defect image

No.	#15, \$12	Date	2023/8/9 下午 04:04:20
Segment	1	Camera	1
Pattern	1672	Position[x, y]	755.5 [mm], 1261.9 [m], (408.9 [m])
Type	点状疵点縱向刀絲疵點橫向刀絲	Size	H:185.8 ,V:162.4 [mm]
Result	-	Area	724.7 [mm2]
Inspection level	5/5,5/5,5/5,5/5,5/5	Label	-
Light	6,6,3/6,6,3

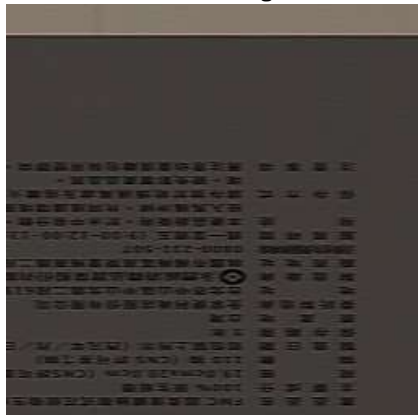
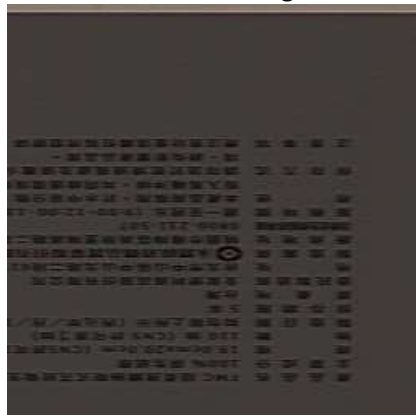
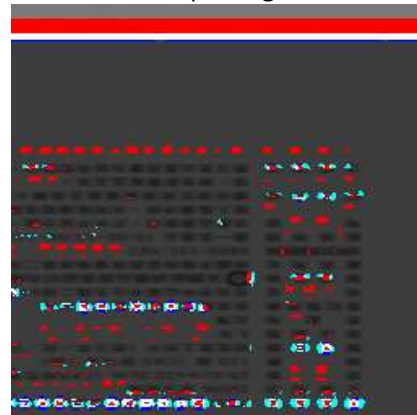
Defect image

No.	#15, \$12	Date	2023/8/9 下午 04:04:20
Segment	1	Camera	1
Pattern	1672	Position[x, y]	165.4 [mm], 1262.4 [m], (408.4 [m])
Type	点状疵点縱向刀絲疵點橫向刀絲	Size	H:185.5 ,V:374.0 [mm]
Result	-	Area	1647.5 [mm2]
Inspection level	5/5,5/5,5/5,5/5,5/5	Label	-
Light	6,6,3/6,6,3

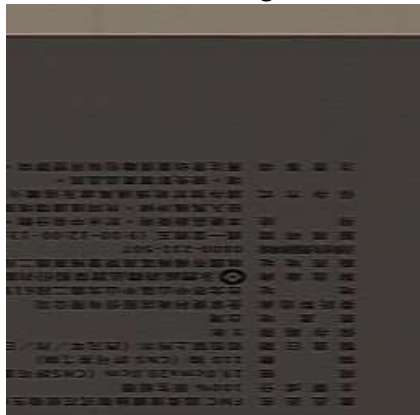
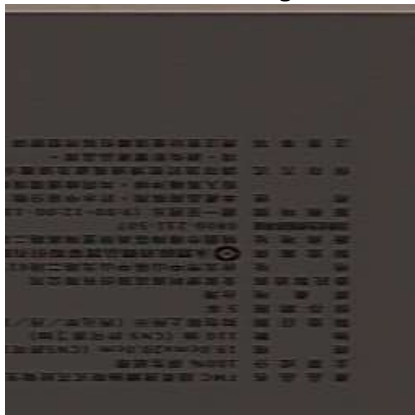
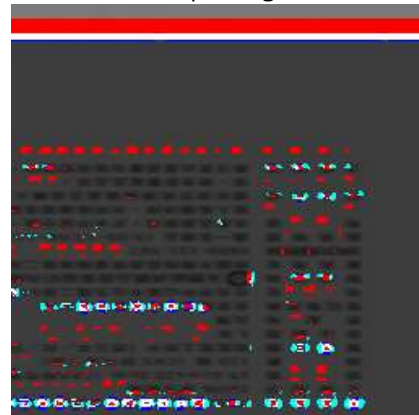
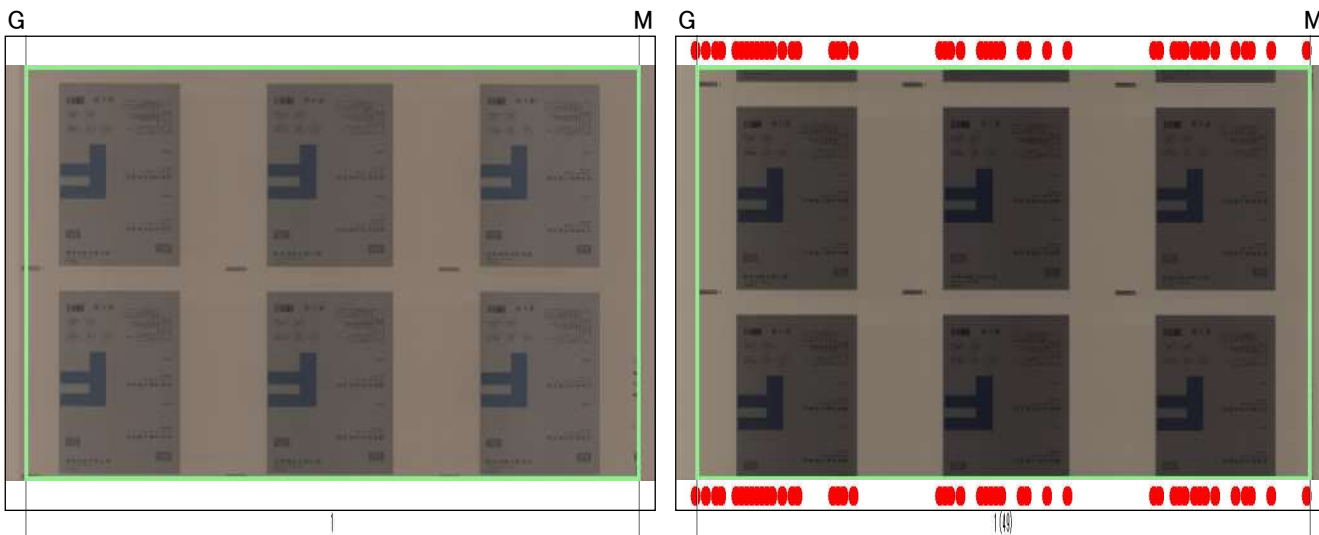
Defect image

No.	#14, \$11	Date	2023/8/9 下午 04:04:18
Segment	1	Camera	1
Pattern	1671	Position[x, y]	443.2 [mm], 1261.5 [m], (409.3 [m])
Type	点状疵点縱向刀絲疵點	Size	H:192.9 ,V:23.6 [mm]
Result	-	Area	584.9 [mm2]
Inspection level	5/5,5/5,5/5,5/5,5/5	Label	-
Light	6,6,3/6,6,3

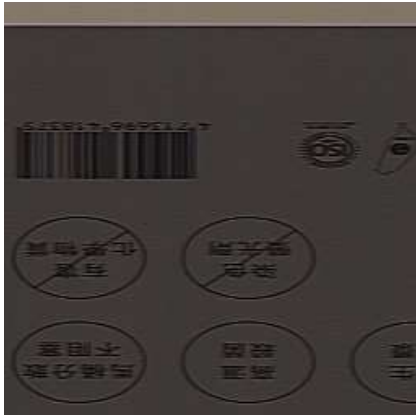
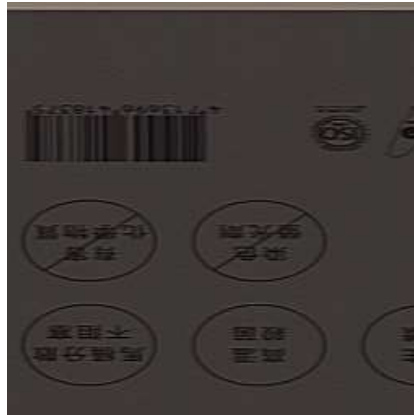
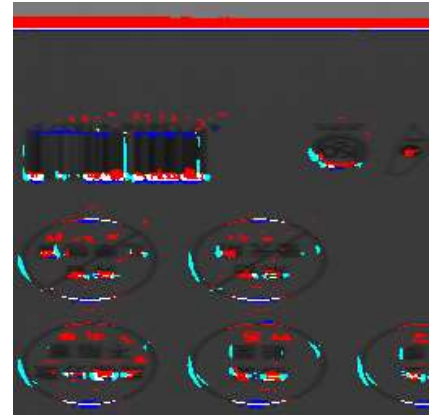
Defect image

No.	#14, \$11	Date	2023/8/9 下午 04:04:18
Segment	1	Camera	1
Pattern	1671	Position[x, y]	789.7 [mm], 1261.4 [m], (409.5 [m])
Type	点状疵点縱向刀絲疵點橫向刀絲	Size	H:185.1 ,V:776.8 [mm]
Result	-	Area	1132.9 [mm2]
Inspection level	5/5,5/5,5/5,5/5,5/5	Label	-
Light	6,6,3/6,6,3

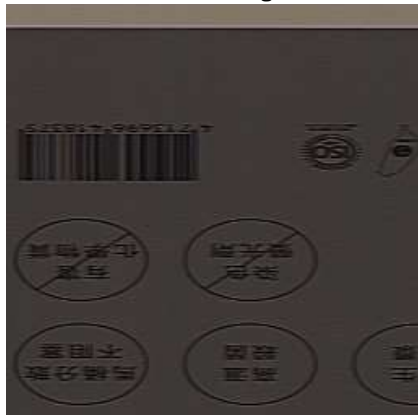
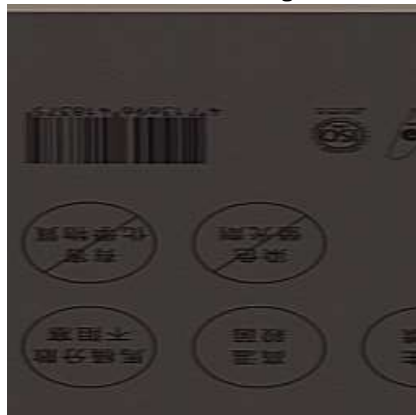
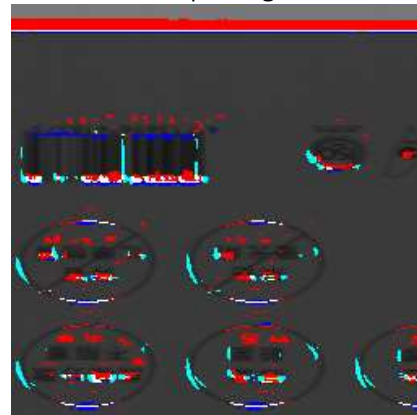
Defect image

No.	#12, \$10	Date	2023/8/9 下午 04:04:14
Segment	1	Camera	1
Pattern	1669	Position[x, y]	174.2 [mm], 1259.8 [m], (411.0 [m])
Type	点状疵点縱向刀絲疵點	Size	H:137.9 ,V:333.2 [mm]
Result	-	Area	330.6 [mm2]
Inspection level	5/5,5/5,5/5,5/5,5/5	Label	-
Light	6,6,3/6,6,3

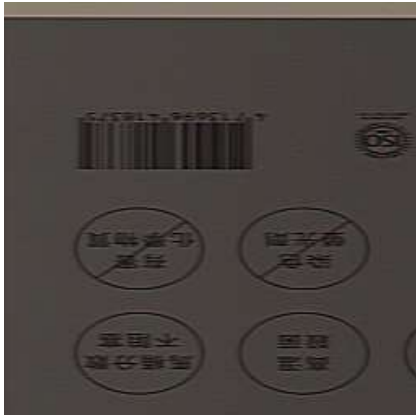
Defect image

No.	#12, \$10	Date	2023/8/9 下午 04:04:14
Segment	1	Camera	1
Pattern	1669	Position[x, y]	142.7 [mm], 1259.8 [m], (411.1 [m])
Type	点状疵点縱向刀絲疵點橫向刀絲	Size	H:186.5 ,V:620.8 [mm]
Result	-	Area	999.0 [mm2]
Inspection level	5/5,5/5,5/5,5/5,5/5	Label	-
Light	6,6,3/6,6,3

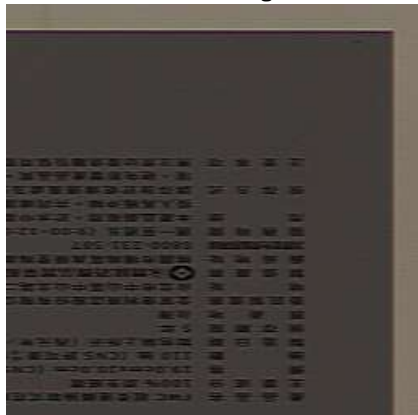
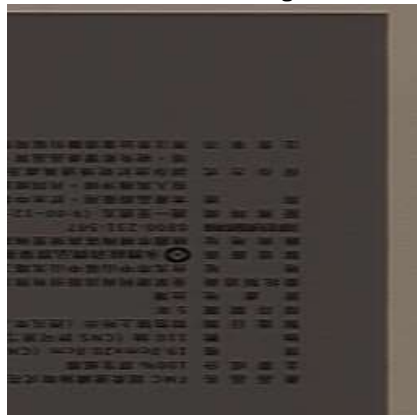
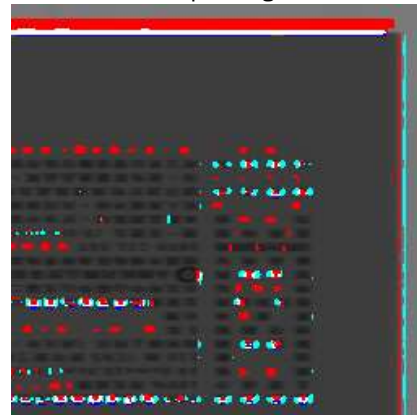
Defect image

No.	#11, \$9	Date	2023/8/9 下午 04:04:09
Segment	1	Camera	1
Pattern	1668	Position[x, y]	146.3 [mm], 1259.0 [m], (411.9 [m])
Type	点状疵点縱向刀絲疵點橫向刀絲	Size	H:186.3 ,V:453.6 [mm]
Result	-	Area	632.7 [mm2]
Inspection level	5/5,5/5,5/5,5/5,5/5	Label	-
Light	6,6,3/6,6,3

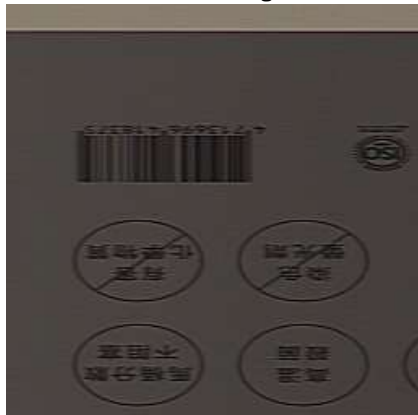
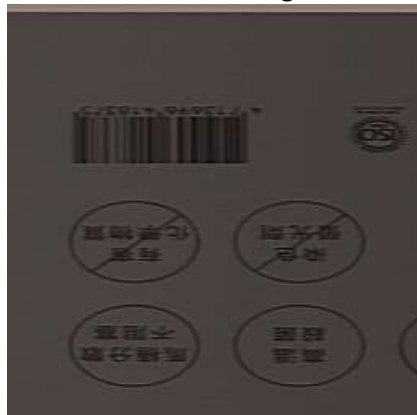
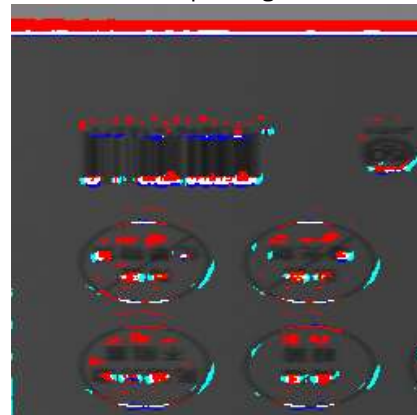
Defect image

No.	#9, \$8	Date	2023/8/9 下午 04:01:07
Segment	1	Camera	1
Pattern	1667	Position[x, y]	138.8 [mm], 1258.6 [m], (412.3 [m])
Type	点状疵点縱向刀絲疵點橫向刀絲	Size	H:185.1 ,V:136.8 [mm]
Result	-	Area	445.4 [mm2]
Inspection level	5/5,5/5,5/5,5/5,5/5	Label	-
Light	6,6,3/6,6,3

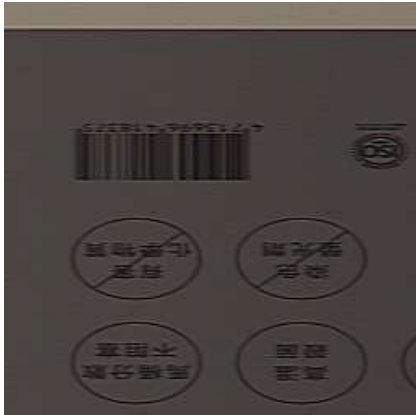
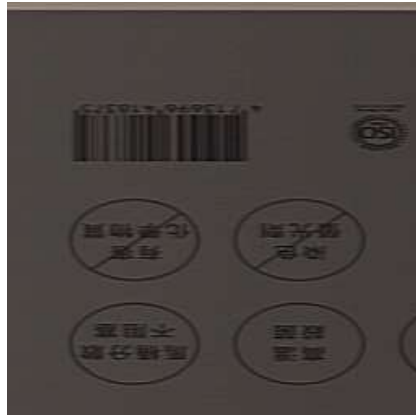
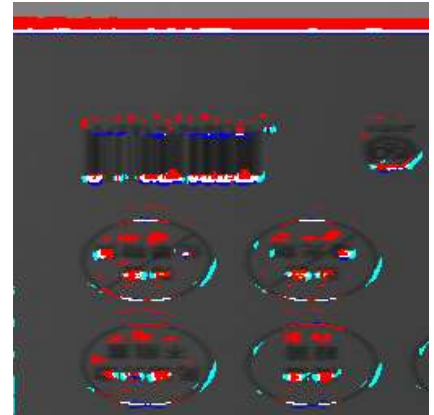
Defect image

No.	#8, \$7	Date	2023/8/9 下午 04:01:04
Segment	1	Camera	1
Pattern	1666	Position[x, y]	496.9 [mm], 1257.8 [m], (413.0 [m])
Type	点状疵点縱向刀絲疵點	Size	H:108.9 ,V:65.6 [mm]
Result	-	Area	117.7 [mm2]
Inspection level	5/5,5/5,5/5,5/5,5/5	Label	-
Light	6,6,3/6,6,3

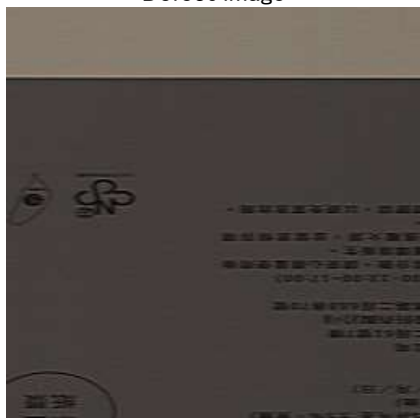
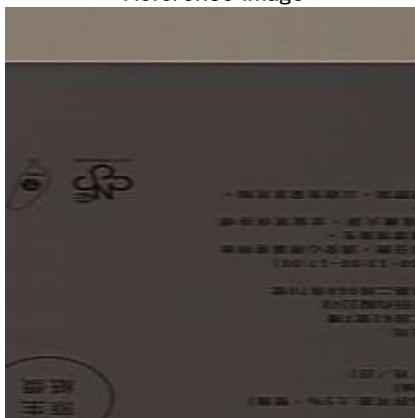
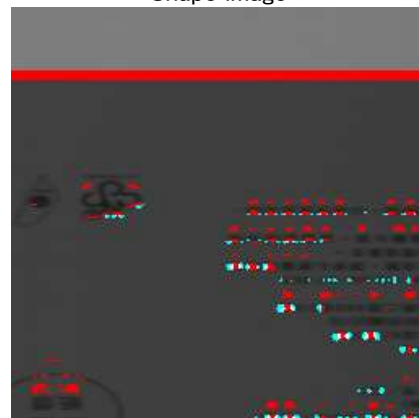
Defect image

No.	#8, \$7	Date	2023/8/9 下午 04:01:04
Segment	1	Camera	1
Pattern	1666	Position[x, y]	157.3 [mm], 1257.5 [m], (413.4 [m])
Type	点状疵点縱向刀絲疵點	Size	H:184.3 ,V:58.8 [mm]
Result	-	Area	293.2 [mm2]
Inspection level	5/5,5/5,5/5,5/5,5/5	Label	-
Light	6,6,3/6,6,3

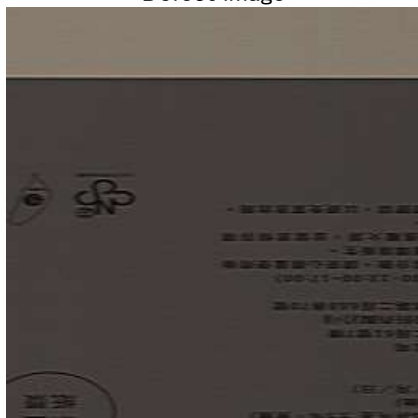
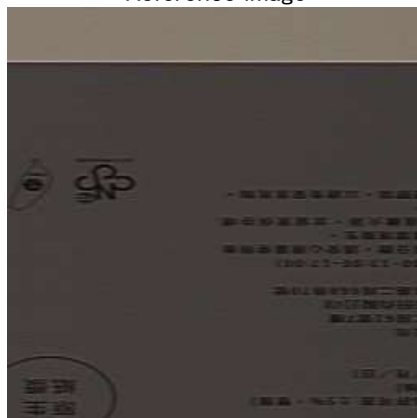
Defect image

No.	#7, \$6	Date	2023/8/9 下午 04:01:03
Segment	1	Camera	1
Pattern	1665	Position[x, y]	407.1 [mm], 1257.0 [m], (413.8 [m])
Type	点状疵点	Size	H:65.9 ,V:1.2 [mm]
Result	-	Area	72.9 [mm2]
Inspection level	5/5,5/5,5/5,5/5,5/5	Label	-
Light	6,6,3/6,6,3

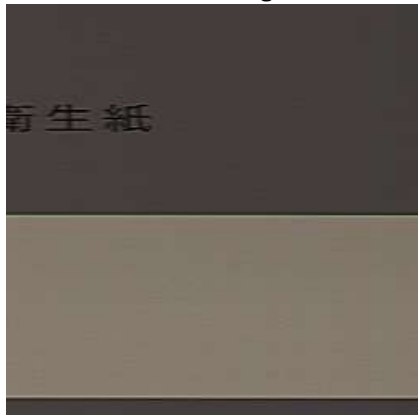
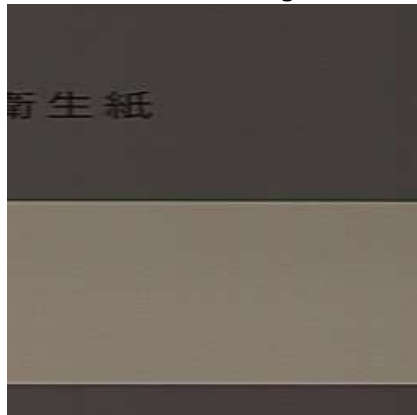
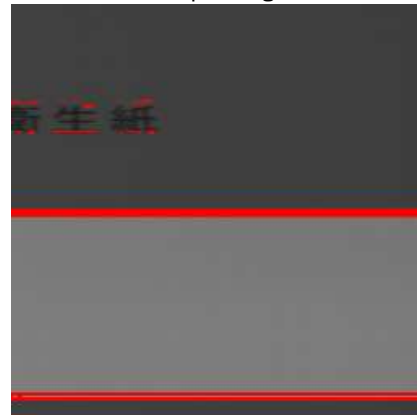
Defect image

No.	#7, \$6	Date	2023/8/9 下午 04:01:03
Segment	1	Camera	1
Pattern	1665	Position[x, y]	148.3 [mm], 1257.0 [m], (413.9 [m])
Type	点状疵点	Size	H:77.9 ,V:1.2 [mm]
Result	-	Area	77.0 [mm2]
Inspection level	5/5,5/5,5/5,5/5,5/5	Label	-
Light	6,6,3/6,6,3

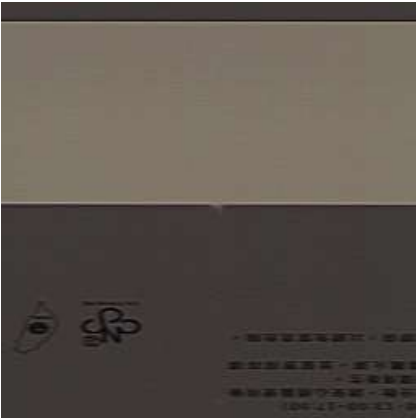
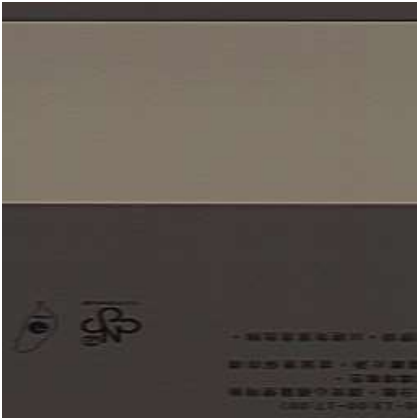
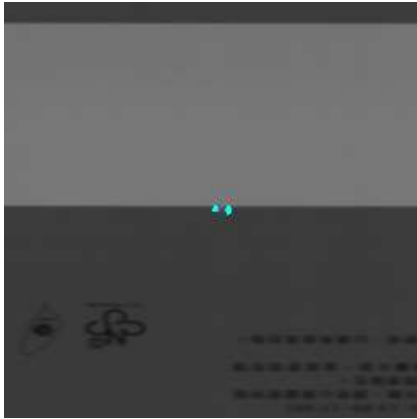
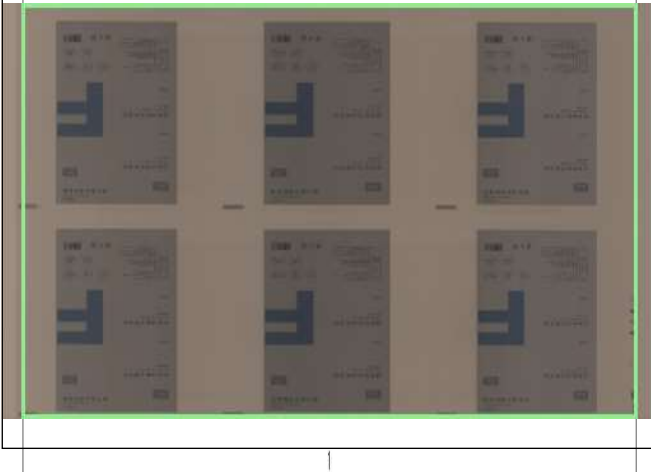
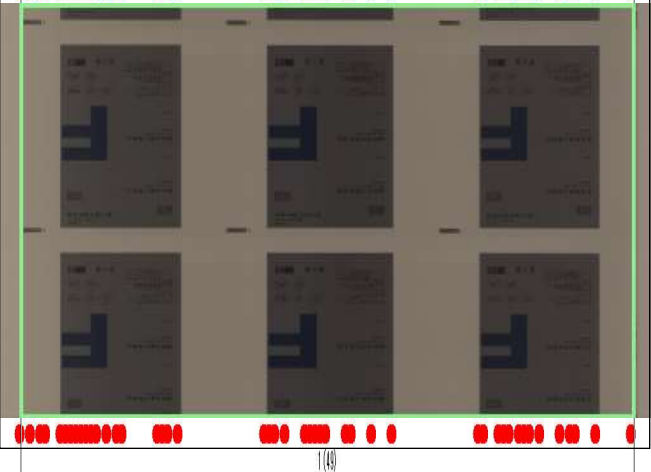
Defect image	Reference image	Shape image

No.	#6, \$5	Date	2023/8/9 下午 03:57:54
Segment	1	Camera	1
Pattern	1345	Position[x, y]	796.7 [mm], 1016.4 [m], (654.5 [m])
Type	縱向刀絲疵點	Size	H:2.9 ,V:1.6 [mm]
Result	-	Area	2.1 [mm2]
Inspection level	5/5,5/5,5/5,5/5,5/5	Label	-
Light	6,6,3/6,6,3

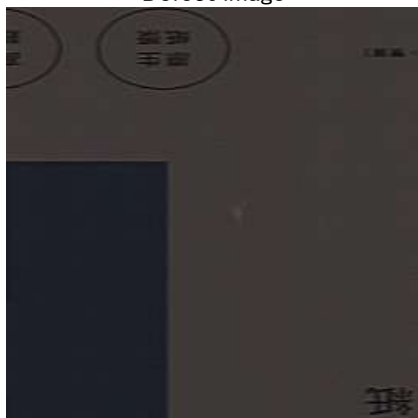
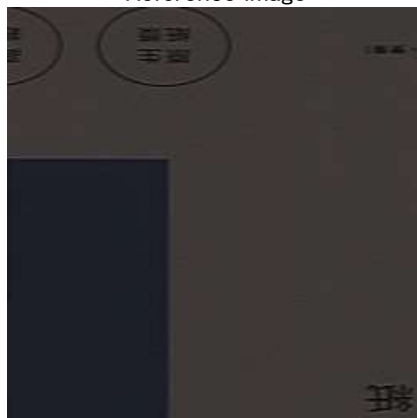
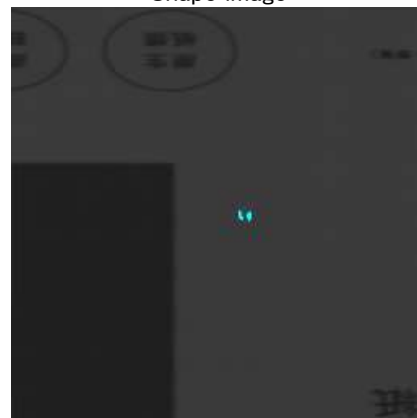
Defect image

No.	#5, \$4	Date	2023/8/9 下午 03:57:38
Segment	1	Camera	1
Pattern	1317	Position[x, y]	783.1 [mm], 995.8 [m], (675.0 [m])
Type	縱向刀絲疵點	Size	H:2.0 ,V:2.0 [mm]
Result	-	Area	2.0 [mm2]
Inspection level	5/5,5/5,5/5,5/5,5/5	Label	-
Light	6,6,3/6,6,3

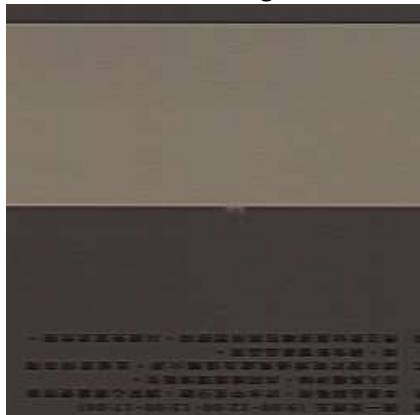
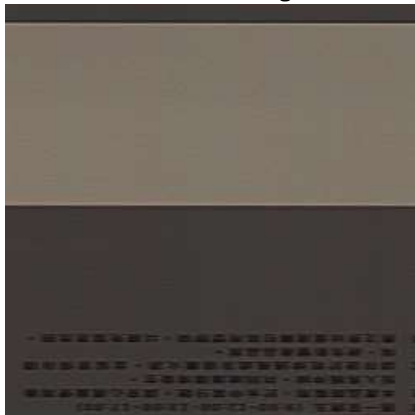
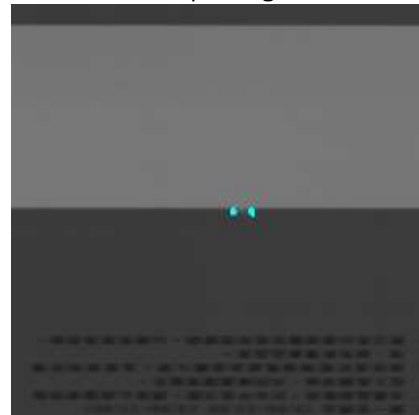
Defect image

No.	#4, \$3	Date	2023/8/9 下午 03:53:11
Segment	1	Camera	1
Pattern	863	Position[x, y]	829.7 [mm], 654.4 [m], (1016.5 [m])
Type	縱向刀絲疵點	Size	H:3.7 ,V:1.6 [mm]
Result	-	Area	2.5 [mm2]
Inspection level	5/5,5/5,5/5,5/5,5/5	Label	-
Light	6,6,3/6,6,3

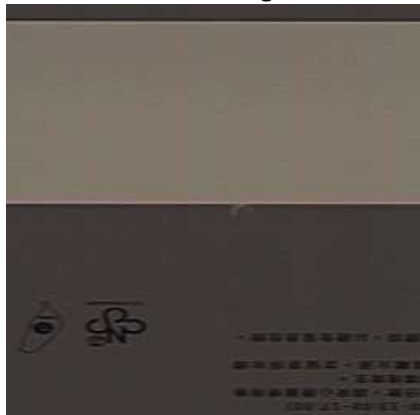
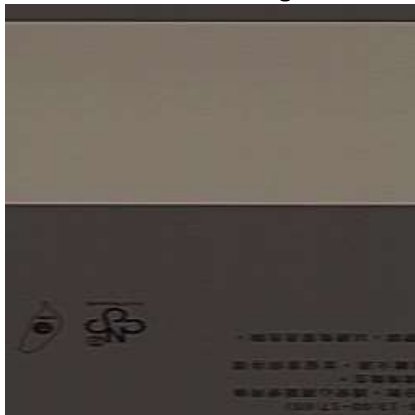
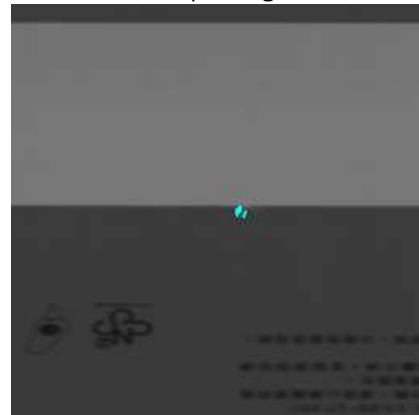
Defect image

No.	#3, \$2	Date	2023/8/9 下午 03:50:48
Segment	1	Camera	1
Pattern	620	Position[x, y]	798.0 [mm], 471.9 [m], (1199.0 [m])
Type	縱向刀絲疵點	Size	H:1.7 ,V:2.4 [mm]
Result	-	Area	2.1 [mm2]
Inspection level	5/5,5/5,5/5,5/5,5/5	Label	-
Light	6,6,3/6,6,3

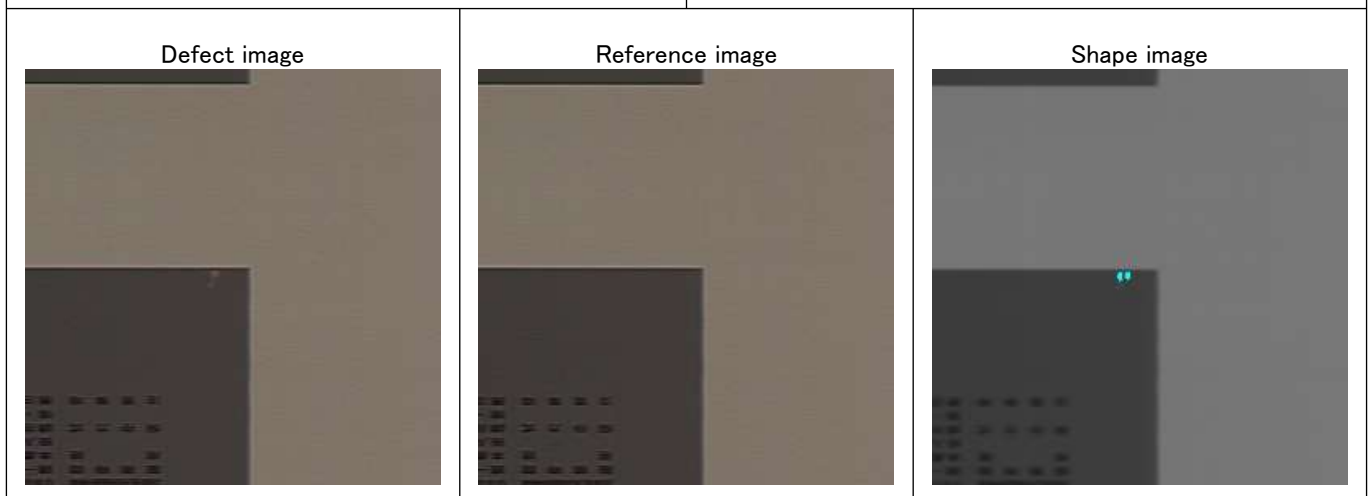
No.	#2, \$1	Date	2023/8/9 下午 03:45:05
Segment	1	Camera	1
Pattern	36	Position[x, y]	878.3 [mm], 33.7 [m], (1637.1 [m])
Type	縱向刀絲疵點	Size	H:2.0 ,V:1.6 [mm]
Result	-	Area	2.0 [mm2]
Inspection level	5/5,5/5,5/5,5/5,5/5	Label	-
Light	6,6,3/6,6,3
