# Inspection Result (Individual Data)

Lot number : 2

Inspected date : 2023/8/10 上午 07:56:43 ~ 2023/8/10 上午 09:15:18

商品名	標準透明6-6-3	周長
顧客名		Ex1
CODE番号		Ex2
基材		Ex3

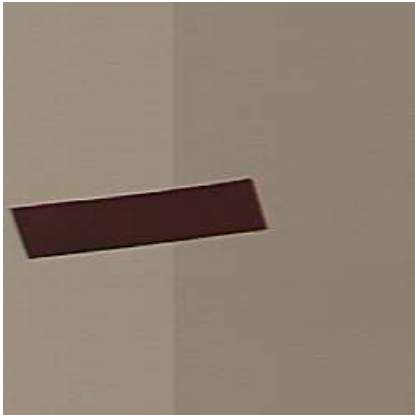
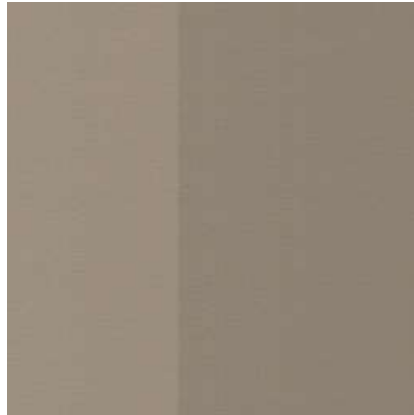
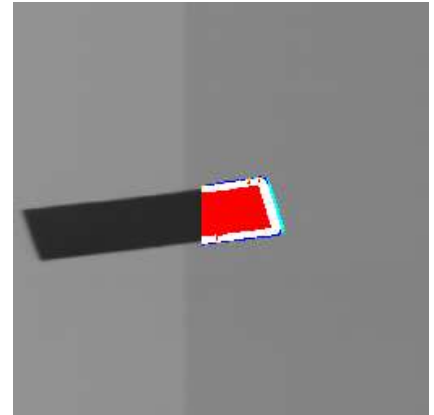
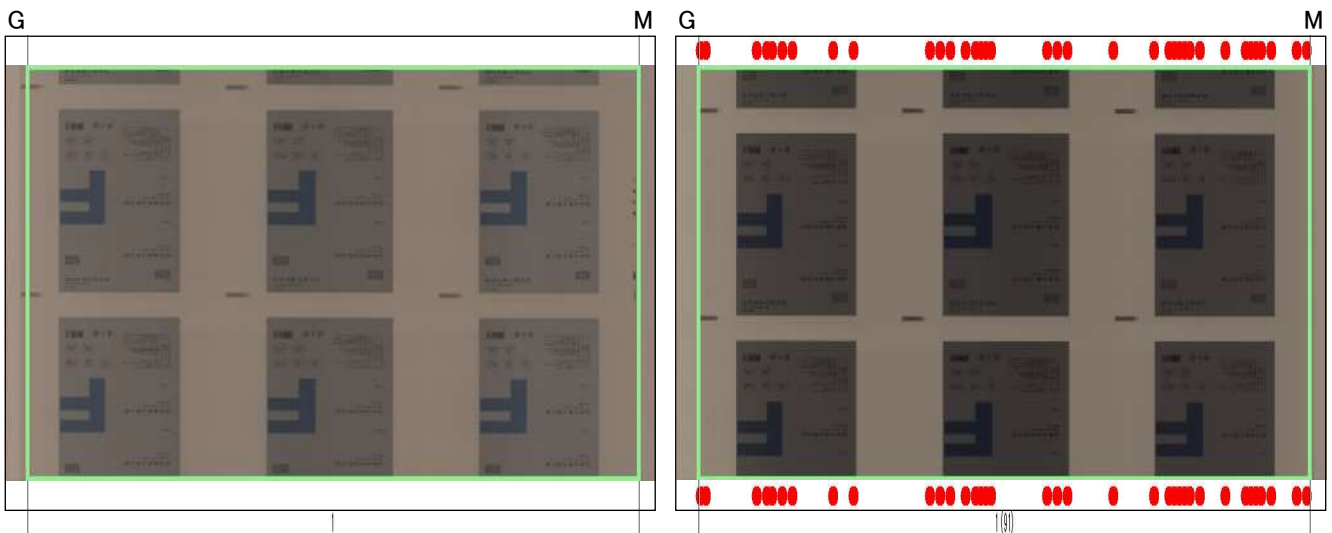
No.	#108, \$91	Date	2023/8/10 上午 09:15:10
Segment	1	Camera	1
Pattern	8036	Position[ x, y ]	6.2 [mm], 6043.4 [m], ( 3.1 [m] )
Type	点状疵点縱向刀絲疵點橫向刀絲	Size	H:12.5 ,V:16.4 [mm]
Result	-	Area	148.6 [mm2]
Inspection level	5/5,5/5,5/5,5/5,5/5	Label	-
Light	6,6,3/6,6,3

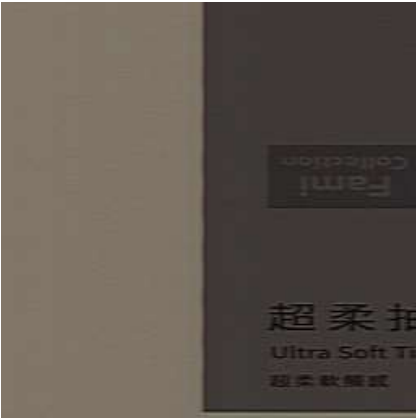
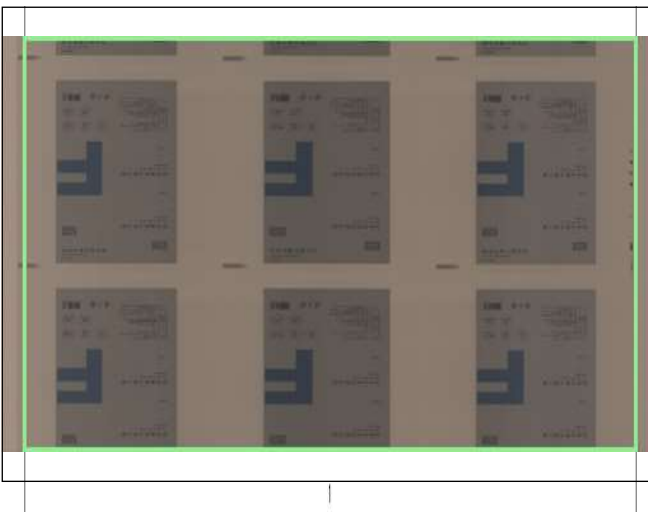
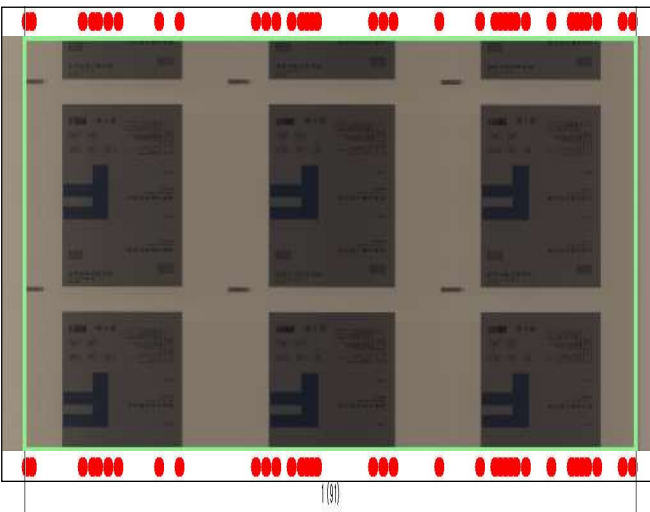
No.	#107, \$90	Date	2023/8/10 上午 09:14:54
Segment	1	Camera	1
Pattern	8009	Position[ x, y ]	698.1 [mm], 6022.9 [m], ( 23.6 [m] )
Type	縱向刀絲疵點	Size	H:0.5 ,V:14.0 [mm]
Result	-	Area	2.2 [mm2]
Inspection level	5/5,5/5,5/5,5/5,5/5	Label	-
Light	6,6,3/6,6,3

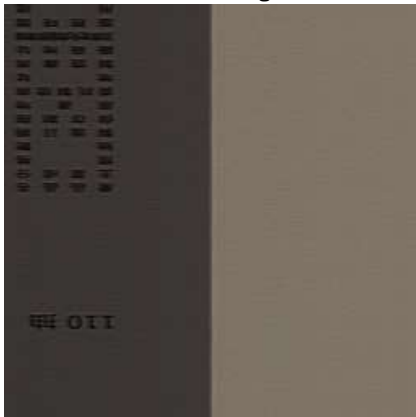
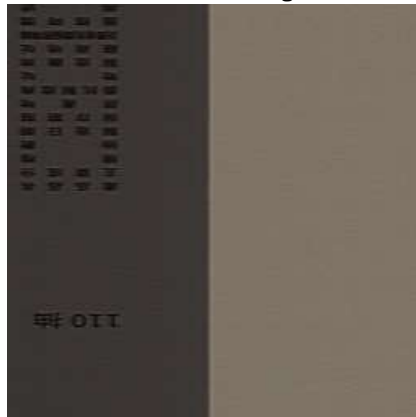
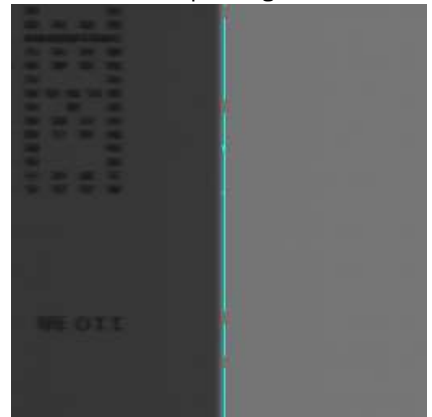
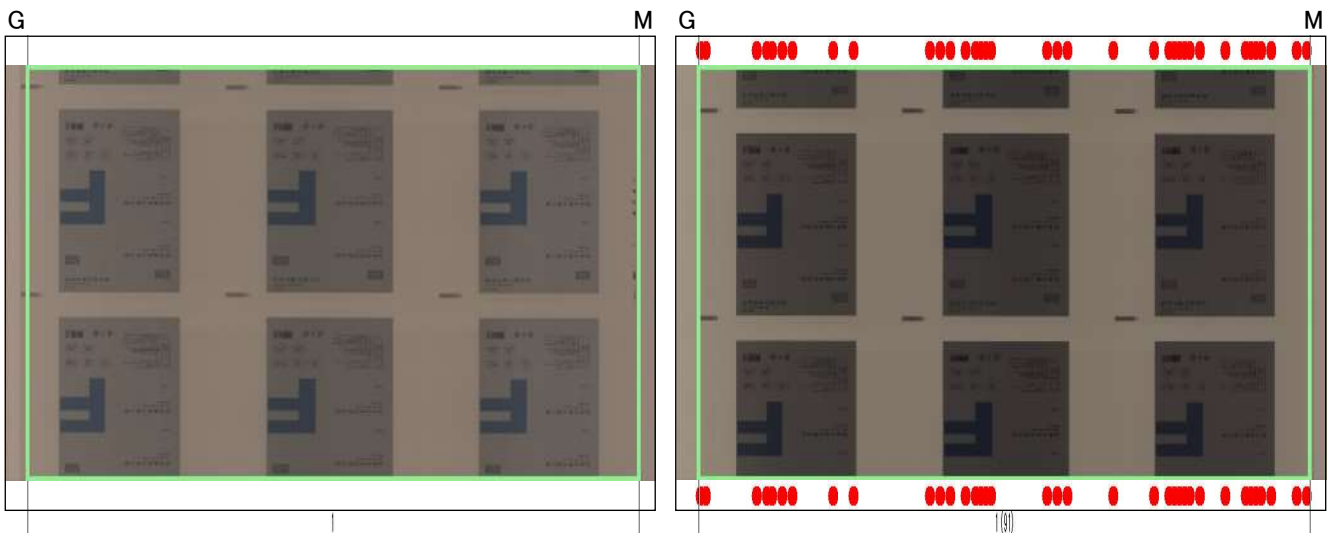
No.	#106, \$89	Date	2023/8/10 上午 09:14:53
Segment	1	Camera	1
Pattern	8007	Position[ x, y ]	566.1 [mm], 6021.6 [m], ( 24.9 [m] )
Type	縱向刀絲疵點	Size	H:0.5 ,V:48.0 [mm]
Result	-	Area	11.8 [mm2]
Inspection level	5/5,5/5,5/5,5/5,5/5	Label	-
Light	6,6,3/6,6,3

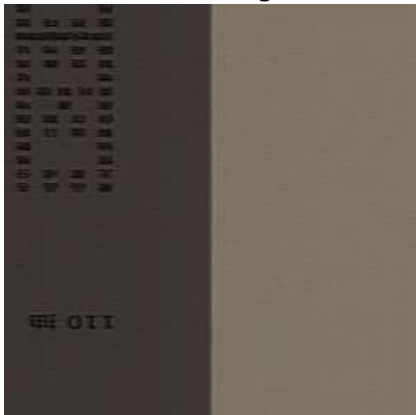
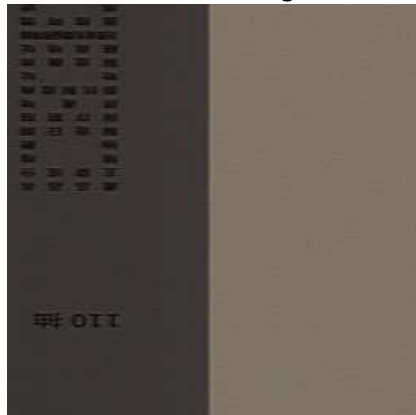
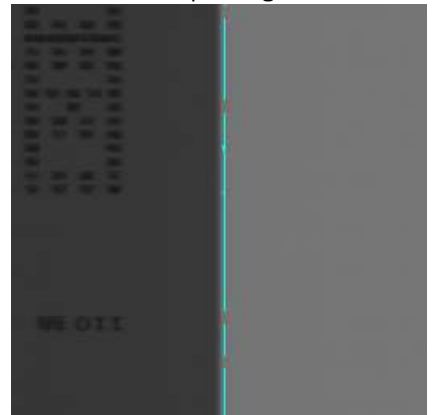
No.	#103, \$88	Date	2023/8/10 上午 09:14:28
Segment	1	Camera	1
Pattern	7965	Position[ x, y ]	564.1 [mm], 5990.2 [m], ( 56.4 [m] )
Type	点状疵点縱向刀絲疵點	Size	H:2.2 ,V:665.6 [mm]
Result	-	Area	163.5 [mm2]
Inspection level	5/5,5/5,5/5,5/5,5/5	Label	-
Light	6,6,3/6,6,3

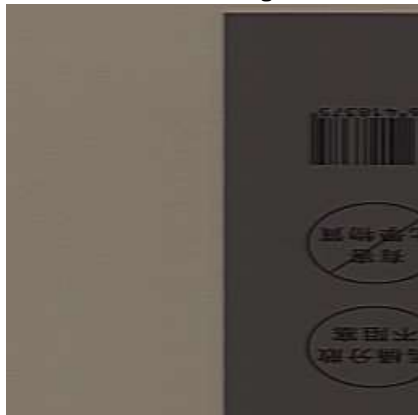
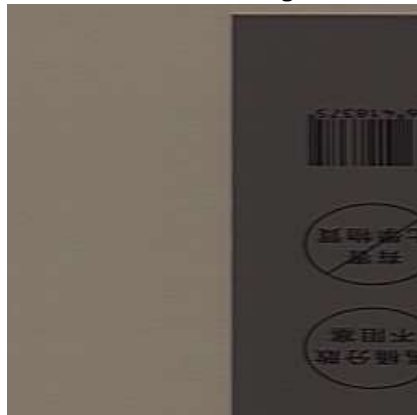
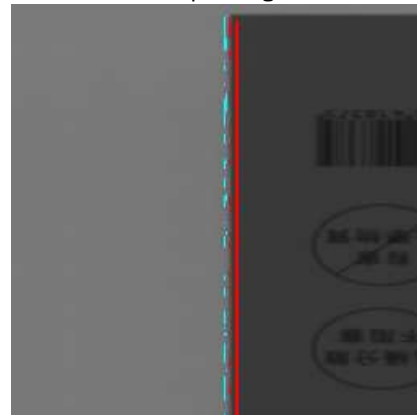
No.	#103, \$88	Date	2023/8/10 上午 09:14:28
Segment	1	Camera	1
Pattern	7965	Position[ x, y ]	371.5 [mm], 5990.1 [m], ( 56.5 [m] )
Type	点状疵点縱向刀絲疵點	Size	H:2.2 ,V:327.6 [mm]
Result	-	Area	167.8 [mm2]
Inspection level	5/5,5/5,5/5,5/5,5/5	Label	-
Light	6,6,3/6,6,3

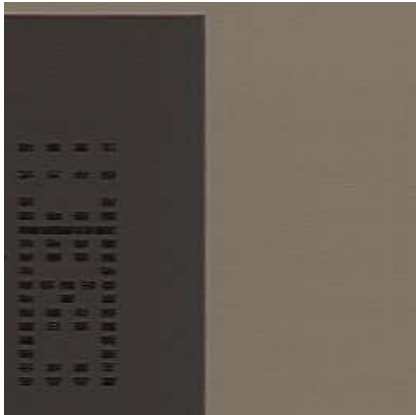
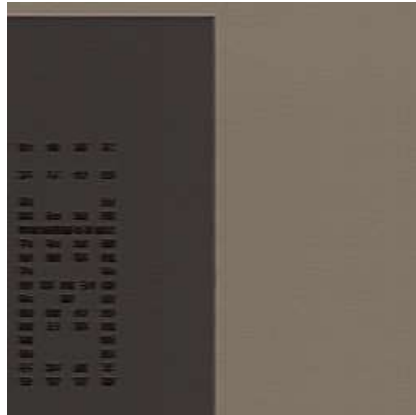
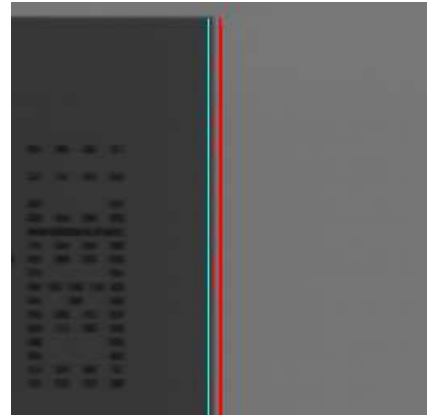
No.	#102, \$87	Date	2023/8/10 上午 09:14:28
Segment	1	Camera	1
Pattern	7964	Position[ x, y ]	564.3 [mm], 5989.7 [m], ( 56.9 [m] )
Type	点状疵点縱向刀絲疵點	Size	H:2.2 ,V:478.0 [mm]
Result	-	Area	153.5 [mm2]
Inspection level	5/5,5/5,5/5,5/5,5/5	Label	-
Light	6,6,3/6,6,3

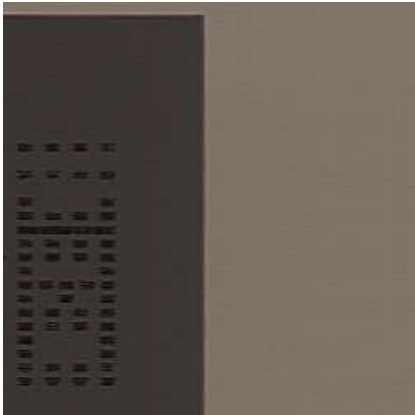
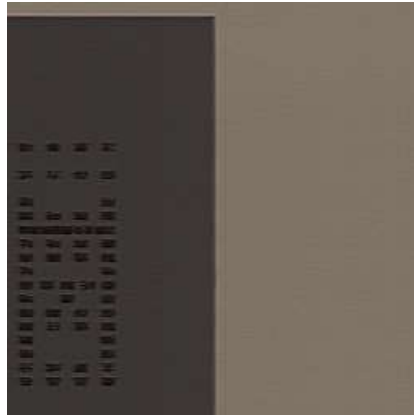
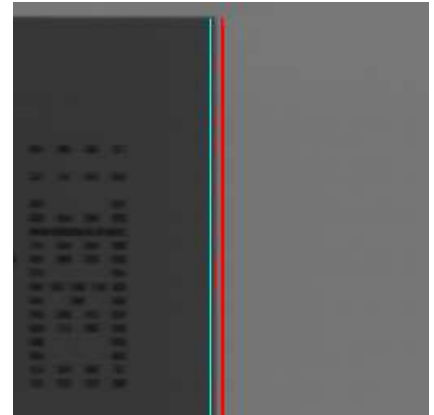
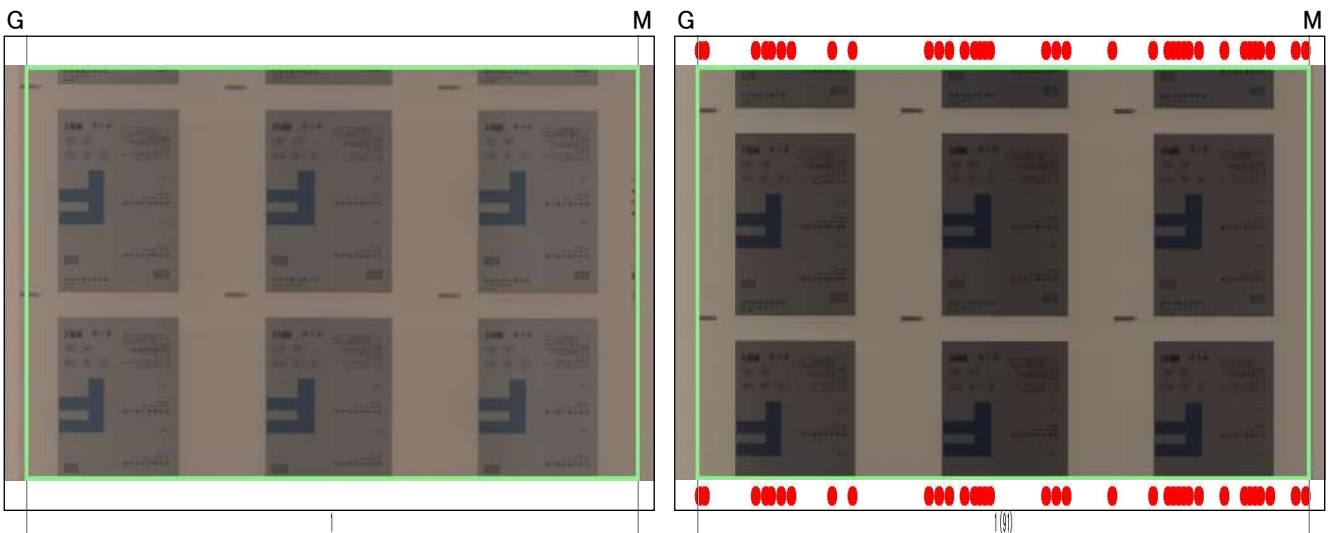
No.	#101, \$86	Date	2023/8/10 上午 09:14:27
Segment	1	Camera	1
Pattern	7963	Position[ x, y ]	371.7 [mm], 5989.0 [m], ( 57.6 [m] )
Type	点状疵点縱向刀絲疵點	Size	H:2.2 ,V:266.4 [mm]
Result	-	Area	126.1 [mm2]
Inspection level	5/5,5/5,5/5,5/5,5/5	Label	-
Light	6,6,3/6,6,3

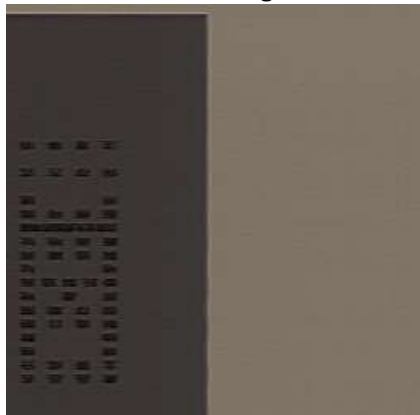
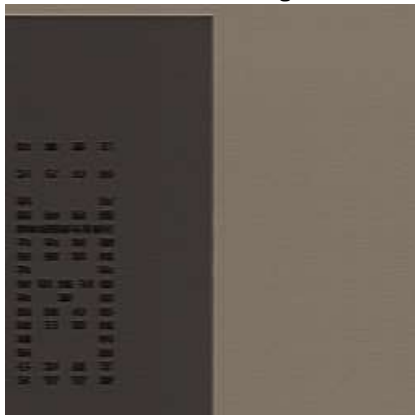
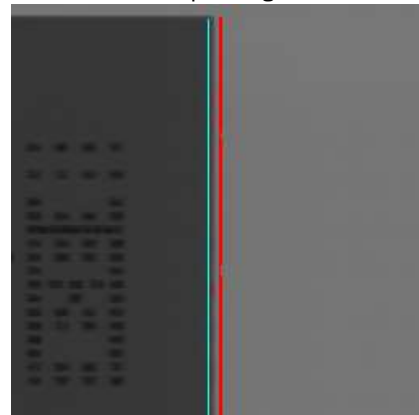
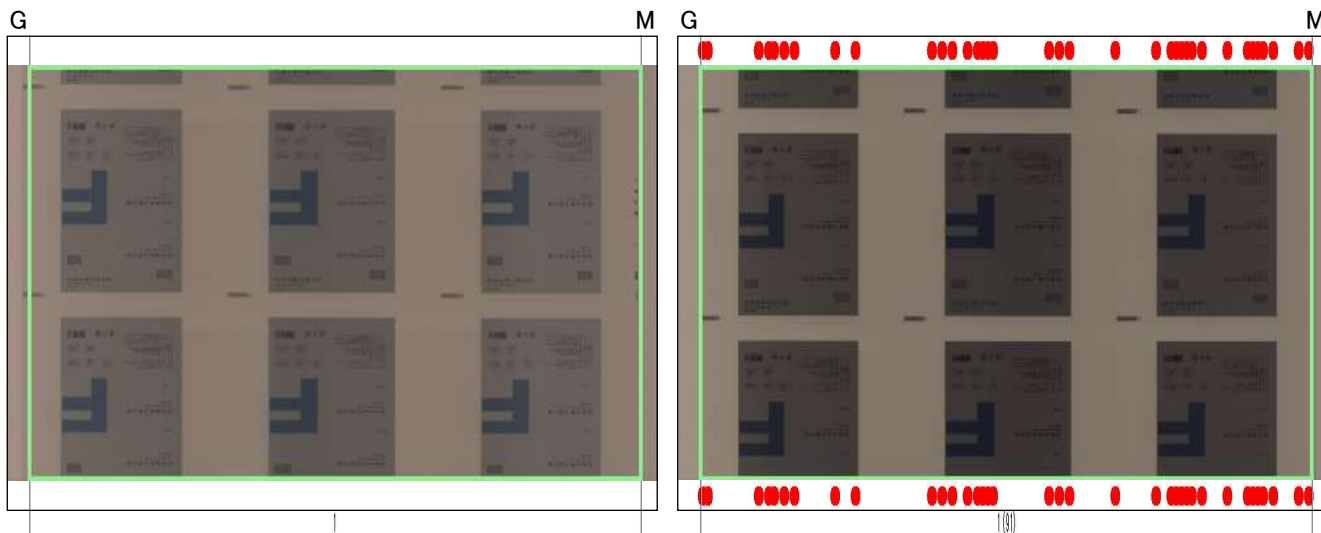
No.	#101, \$86	Date	2023/8/10 上午 09:14:27
Segment	1	Camera	1
Pattern	7963	Position[ x, y ]	564.1 [mm], 5988.7 [m], ( 57.8 [m] )
Type	点状疵点縱向刀絲疵點	Size	H:2.2 ,V:437.6 [mm]
Result	-	Area	157.2 [mm2]
Inspection level	5/5,5/5,5/5,5/5,5/5	Label	-
Light	6,6,3/6,6,3

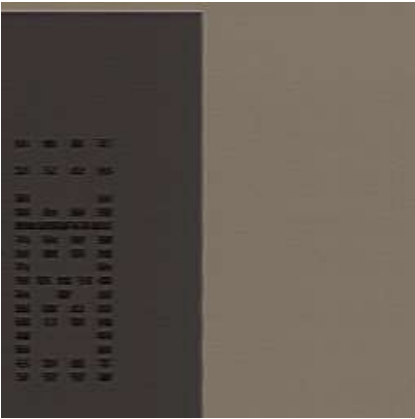
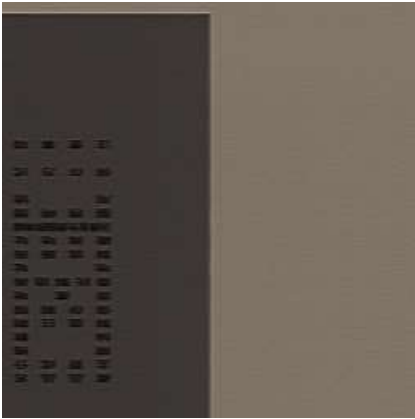
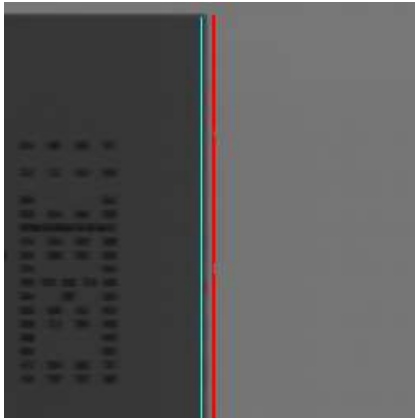
No.	#100, \$85	Date	2023/8/10 上午 09:14:27
Segment	1	Camera	1
Pattern	7962	Position[ x, y ]	371.7 [mm], 5987.9 [m], ( 58.6 [m] )
Type	点状疵点縱向刀絲疵點	Size	H:2.2 ,V:208.0 [mm]
Result	-	Area	42.1 [mm2]
Inspection level	5/5,5/5,5/5,5/5,5/5	Label	-
Light	6,6,3/6,6,3

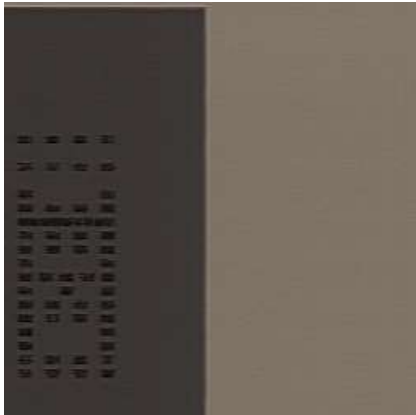
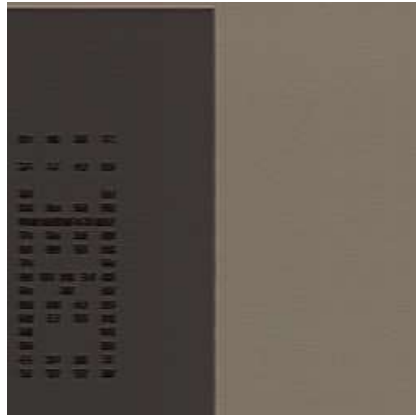
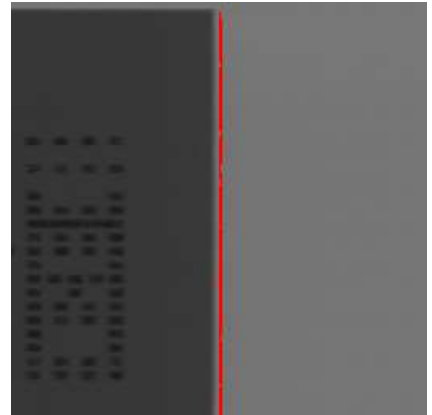
No.	#100, \$85	Date	2023/8/10 上午 09:14:27
Segment	1	Camera	1
Pattern	7962	Position[ x, y ]	565.6 [mm], 5988.3 [m], ( 58.3 [m] )
Type	点状疵点	Size	H:1.5 ,V:296.0 [mm]
Result	-	Area	140.6 [mm2]
Inspection level	5/5,5/5,5/5,5/5,5/5	Label	-
Light	6,6,3/6,6,3

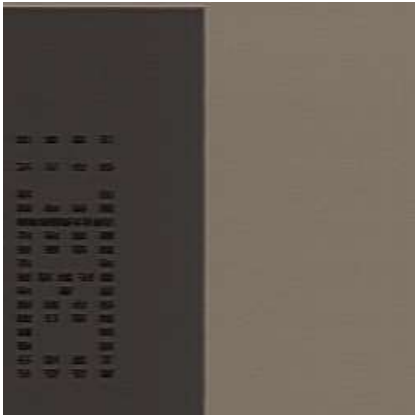
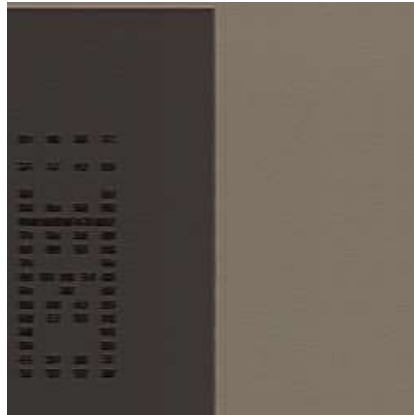
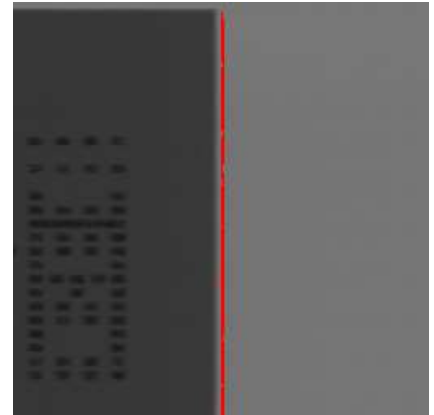
No.	#99, \$84	Date	2023/8/10 上午 09:14:26
Segment	1	Camera	1
Pattern	7961	Position[ x, y ]	240.6 [mm], 5987.6 [m], ( 58.9 [m] )
Type	点状疵点	Size	H:0.5 ,V:4.0 [mm]
Result	-	Area	1.2 [mm2]
Inspection level	5/5,5/5,5/5,5/5,5/5	Label	-
Light	6,6,3/6,6,3

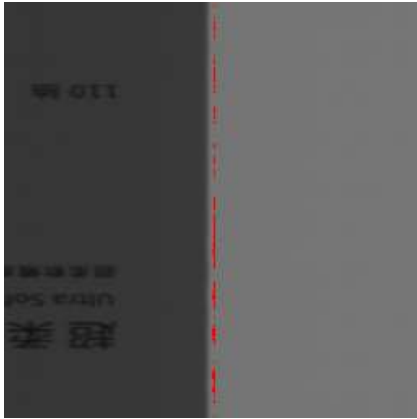
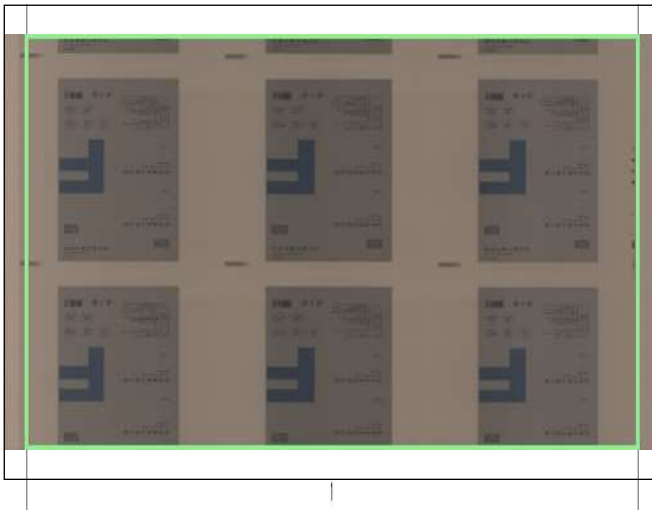
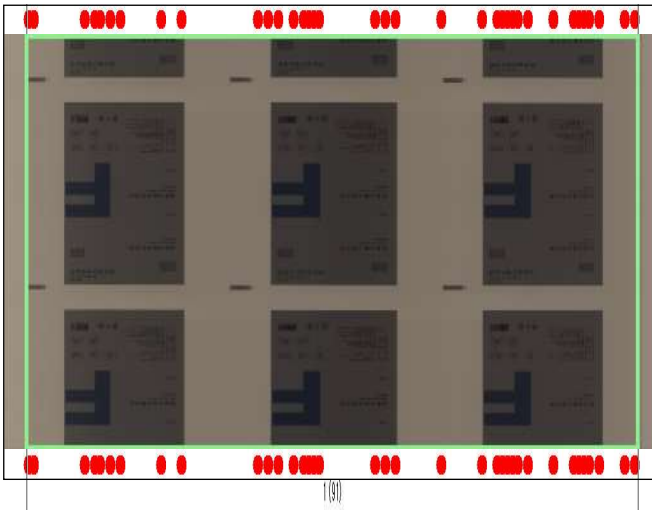
No.	#96, \$83	Date	2023/8/10 上午 09:14:18
Segment	1	Camera	1
Pattern	7947	Position[ x, y ]	565.6 [mm], 5976.9 [m], ( 69.6 [m] )
Type	点状疵点縱向刀絲疵點	Size	H:2.4 ,V:668.4 [mm]
Result	-	Area	407.1 [mm2]
Inspection level	5/5,5/5,5/5,5/5,5/5	Label	-
Light	6,6,3/6,6,3

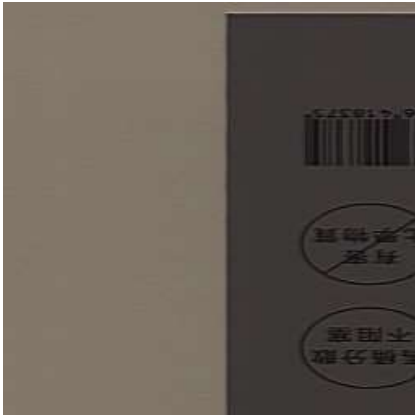
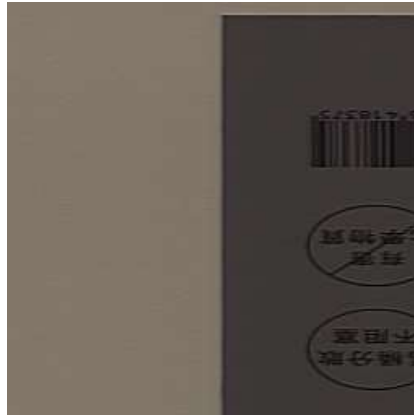
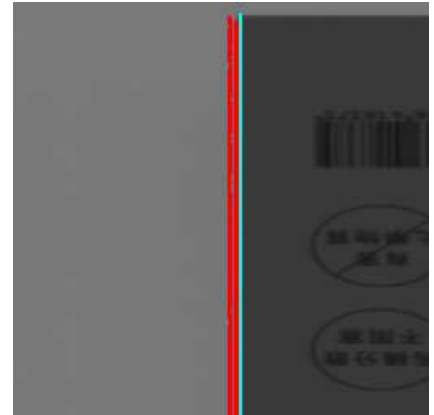
No.	#95, \$82	Date	2023/8/10 上午 09:14:17
Segment	1	Camera	1
Pattern	7946	Position[ x, y ]	698.4 [mm], 5976.1 [m], ( 70.4 [m] )
Type	点状疵点縱向刀絲疵點	Size	H:4.4 ,V:504.8 [mm]
Result	-	Area	267.4 [mm2]
Inspection level	5/5,5/5,5/5,5/5,5/5	Label	-
Light	6,6,3/6,6,3

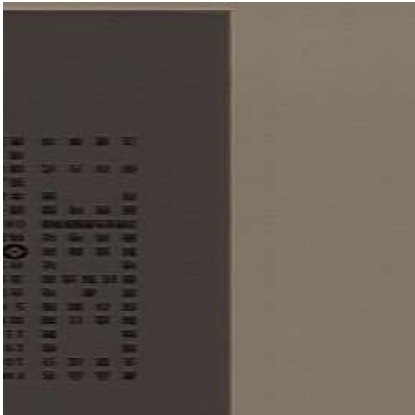
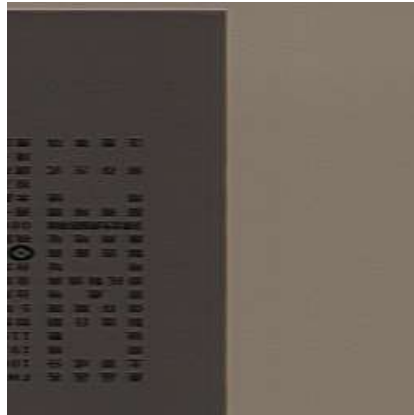
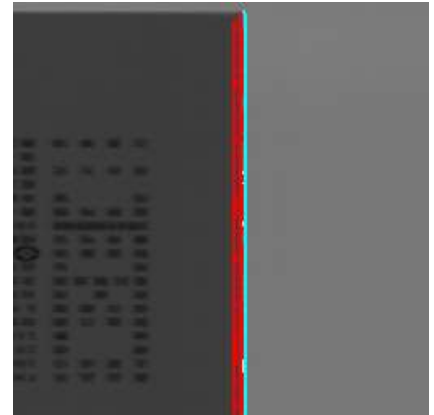
No.	#95, \$82	Date	2023/8/10 上午 09:14:17
Segment	1	Camera	1
Pattern	7946	Position[ x, y ]	240.6 [mm], 5976.2 [m], ( 70.4 [m] )
Type	点状疵点縱向刀絲疵點	Size	H:2.4 ,V:549.6 [mm]
Result	-	Area	316.1 [mm2]
Inspection level	5/5,5/5,5/5,5/5,5/5	Label	-
Light	6,6,3/6,6,3

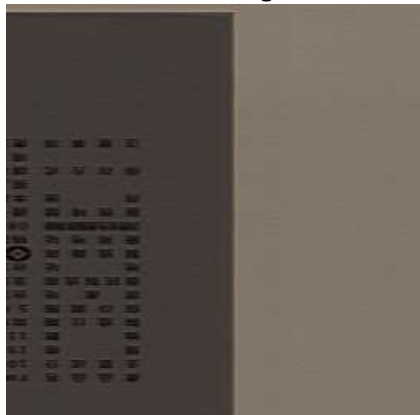
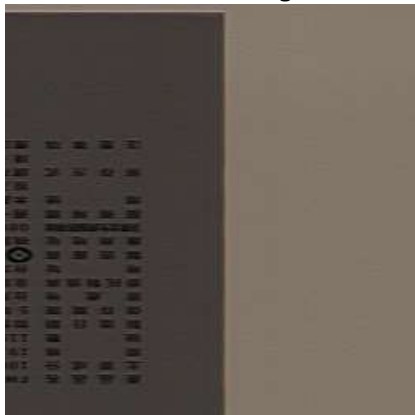
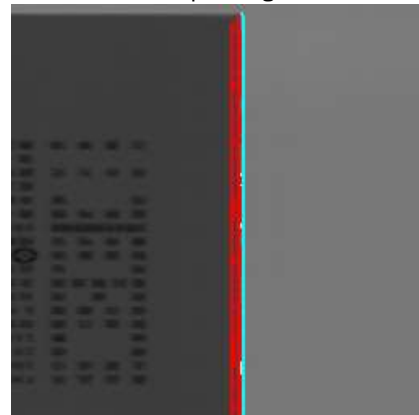
No.	#94, \$81	Date	2023/8/10 上午 09:14:17
Segment	1	Camera	1
Pattern	7945	Position[ x, y ]	697.9 [mm], 5975.6 [m], ( 71.0 [m] )
Type	点状疵点縱向刀絲疵點	Size	H:4.4 ,V:101.2 [mm]
Result	-	Area	56.6 [mm2]
Inspection level	5/5,5/5,5/5,5/5,5/5	Label	-
Light	6,6,3/6,6,3

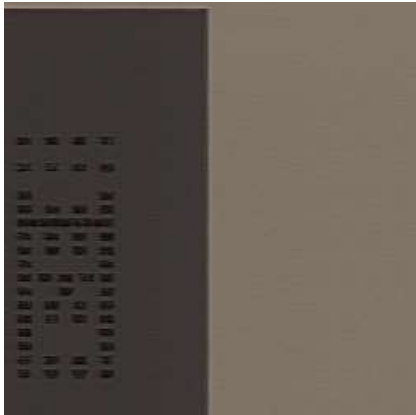
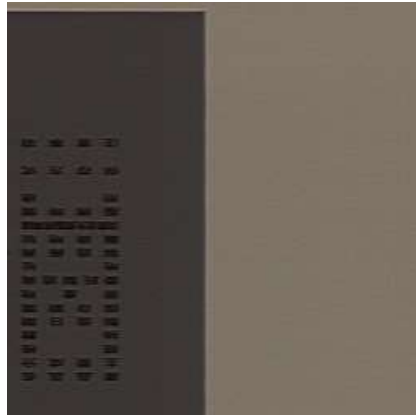
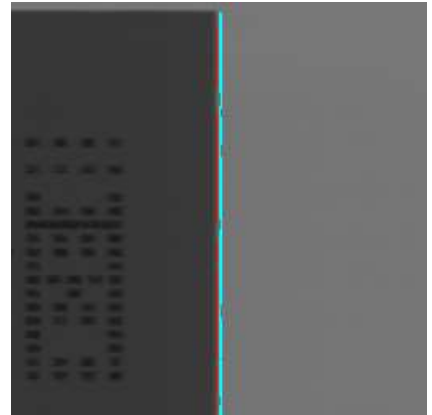
No.	#94, \$81	Date	2023/8/10 上午 09:14:17
Segment	1	Camera	1
Pattern	7945	Position[ x, y ]	565.6 [mm], 5975.2 [m], ( 71.3 [m] )
Type	点状疵点縱向刀絲疵點	Size	H:2.2 ,V:808.0 [mm]
Result	-	Area	152.1 [mm2]
Inspection level	5/5,5/5,5/5,5/5,5/5	Label	-
Light	6,6,3/6,6,3

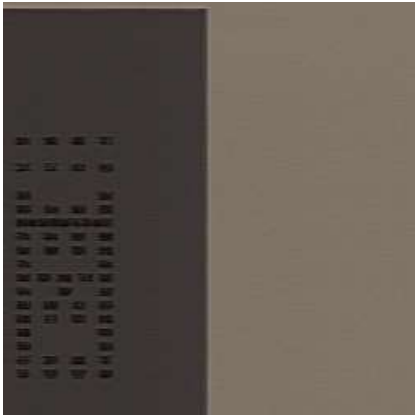
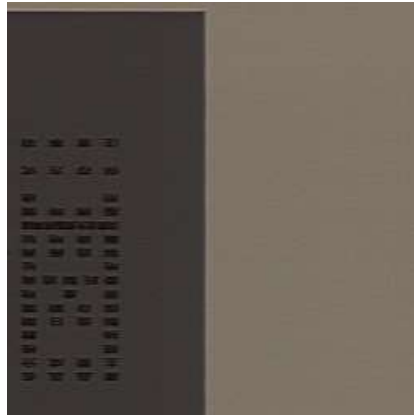
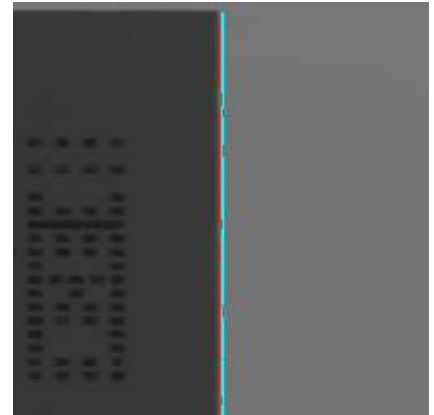
No.	#93, \$80	Date	2023/8/10 上午 09:14:16
Segment	1	Camera	1
Pattern	7944	Position[ x, y ]	127.8 [mm], 5974.8 [m], ( 71.8 [m] )
Type	縱向刀絲疵點	Size	H:0.5 ,V:96.0 [mm]
Result	-	Area	27.2 [mm2]
Inspection level	5/5,5/5,5/5,5/5,5/5	Label	-
Light	6,6,3/6,6,3

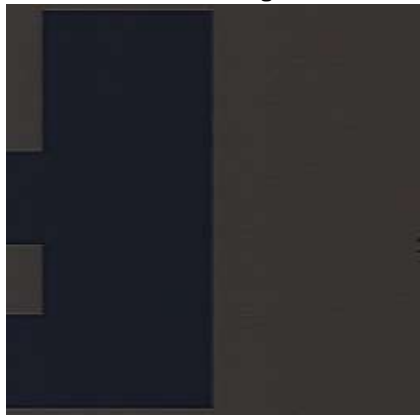
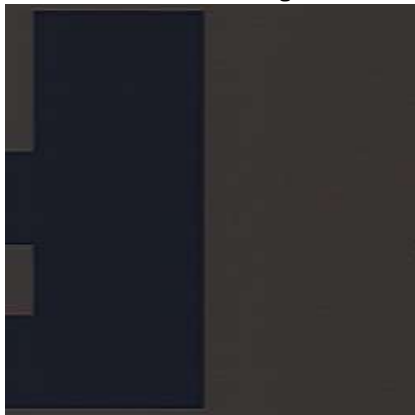
No.	#93, \$80	Date	2023/8/10 上午 09:14:16
Segment	1	Camera	1
Pattern	7944	Position[ x, y ]	448.1 [mm], 5974.8 [m], ( 71.8 [m] )
Type	点状疵点縱向刀絲疵點	Size	H:1.7 ,V:96.4 [mm]
Result	-	Area	45.2 [mm2]
Inspection level	5/5,5/5,5/5,5/5,5/5	Label	-
Light	6,6,3/6,6,3

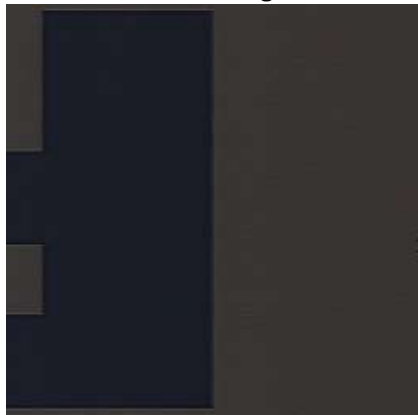
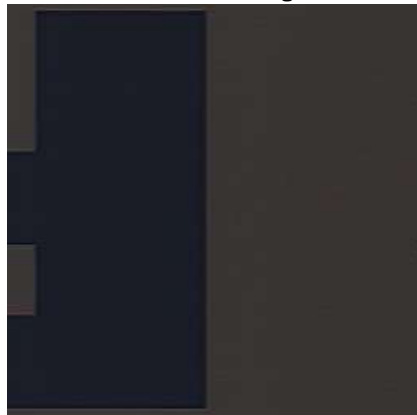
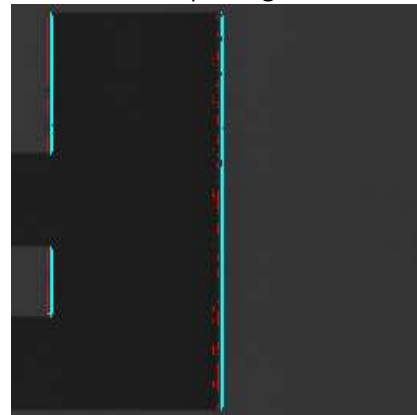
Defect image

No.	#92, \$79	Date	2023/8/10 上午 09:14:15
Segment	1	Camera	1
Pattern	7943	Position[ x, y ]	746.2 [mm], 5974.0 [m], ( 72.5 [m] )
Type	縱向刀絲疵點	Size	H:0.7 ,V:73.6 [mm]
Result	-	Area	20.2 [mm2]
Inspection level	5/5,5/5,5/5,5/5,5/5	Label	-
Light	6,6,3/6,6,3

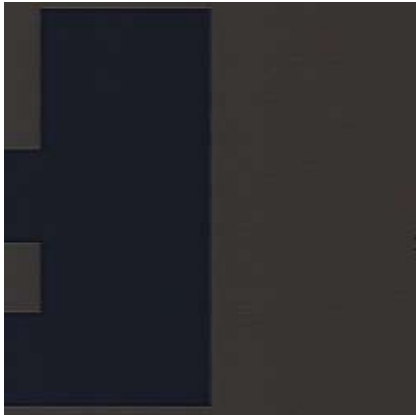
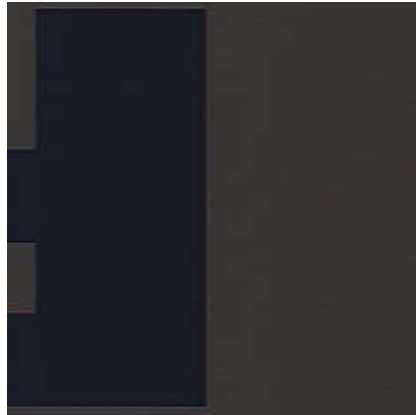
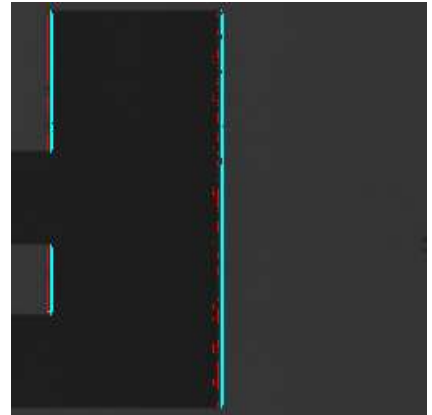
Defect image

No.	#92, \$79	Date	2023/8/10 上午 09:14:15
Segment	1	Camera	1
Pattern	7943	Position[ x, y ]	448.4 [mm], 5973.6 [m], ( 72.9 [m] )
Type	縱向刀絲疵點	Size	H:0.5 ,V:96.0 [mm]
Result	-	Area	26.8 [mm2]
Inspection level	5/5,5/5,5/5,5/5,5/5	Label	-
Light	6,6,3/6,6,3

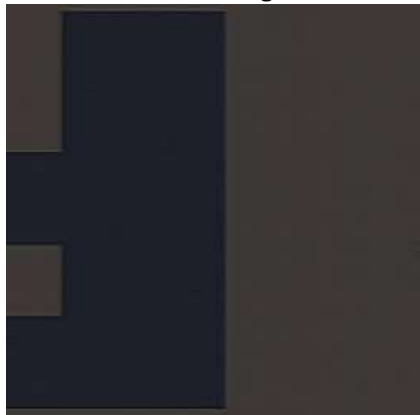
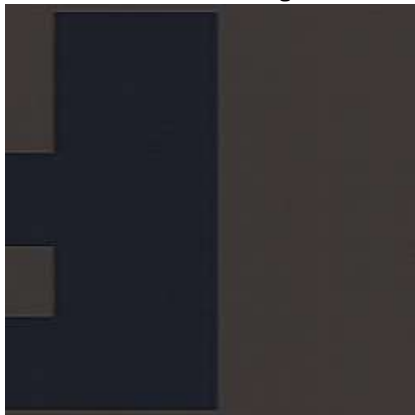
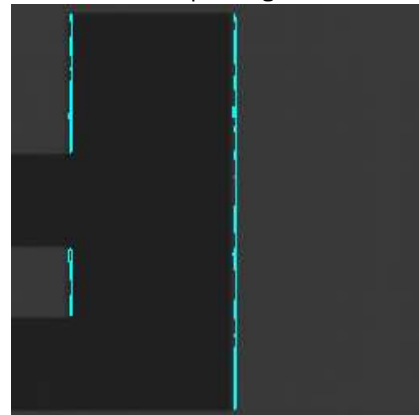
Defect image

No.	#92, \$79	Date	2023/8/10 上午 09:14:15
Segment	1	Camera	1
Pattern	7943	Position[ x, y ]	770.9 [mm], 5974.0 [m], ( 72.5 [m] )
Type	縱向刀絲疵點	Size	H:0.7 ,V:96.8 [mm]
Result	-	Area	35.0 [mm2]
Inspection level	5/5,5/5,5/5,5/5,5/5	Label	-
Light	6,6,3/6,6,3

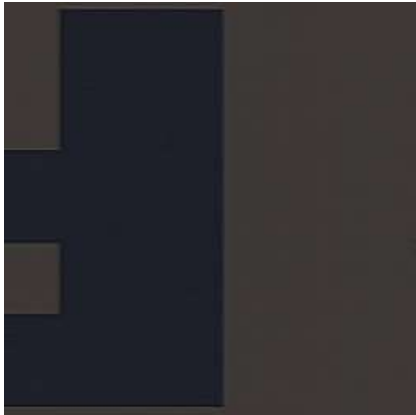
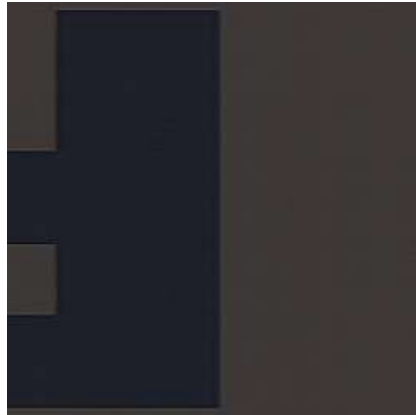
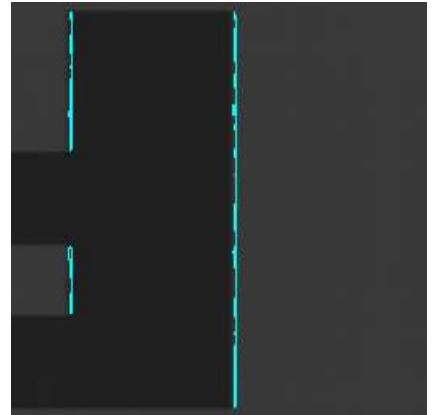
Defect image

No.	#89, \$78	Date	2023/8/10 上午 09:14:08
Segment	1	Camera	1
Pattern	7930	Position[ x, y ]	126.4 [mm], 5964.3 [m], ( 82.3 [m] )
Type	点状疵点縱向刀絲疵點	Size	H:2.4 ,V:98.0 [mm]
Result	-	Area	135.1 [mm2]
Inspection level	5/5,5/5,5/5,5/5,5/5	Label	-
Light	6,6,3/6,6,3

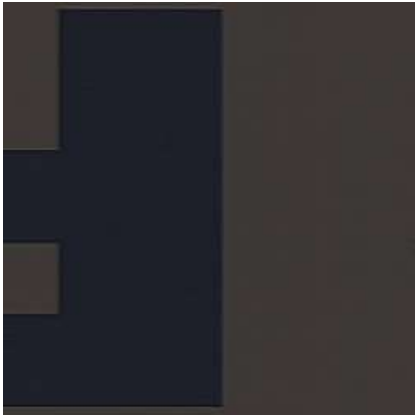
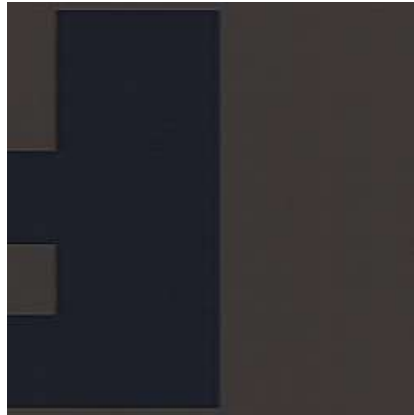
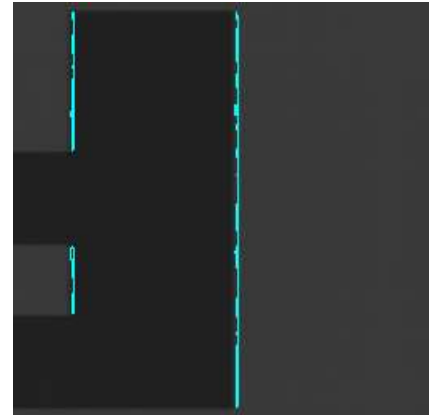
Defect image

No.	#89, \$78	Date	2023/8/10 上午 09:14:08
Segment	1	Camera	1
Pattern	7930	Position[ x, y ]	447.2 [mm], 5963.9 [m], ( 82.7 [m] )
Type	点状疵点縱向刀絲疵點	Size	H:2.2 ,V:98.0 [mm]
Result	-	Area	135.7 [mm2]
Inspection level	5/5,5/5,5/5,5/5,5/5	Label	-
Light	6,6,3/6,6,3

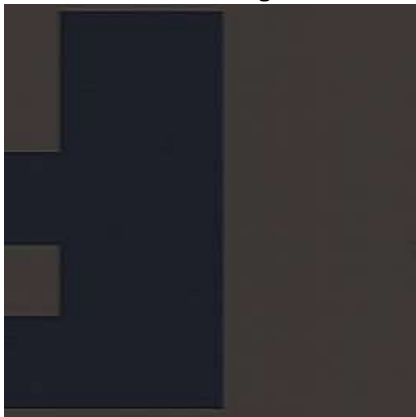
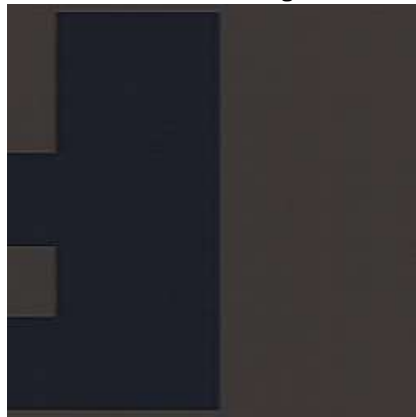
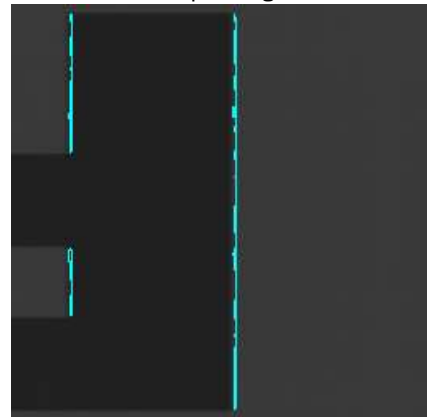
Defect image

No.	#89, \$78	Date	2023/8/10 上午 09:14:08
Segment	1	Camera	1
Pattern	7930	Position[ x, y ]	769.4 [mm], 5964.3 [m], ( 82.3 [m] )
Type	点状疵点縱向刀絲疵點	Size	H:2.2 ,V:98.0 [mm]
Result	-	Area	138.9 [mm2]
Inspection level	5/5,5/5,5/5,5/5,5/5	Label	-
Light	6,6,3/6,6,3

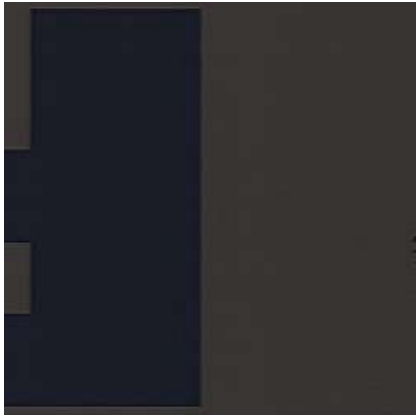
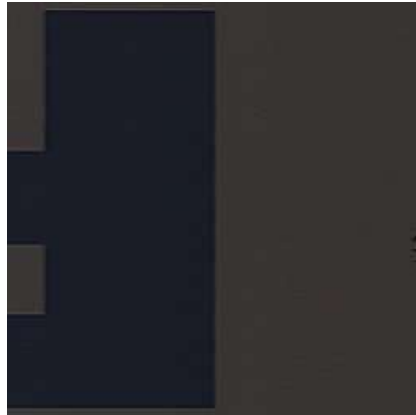
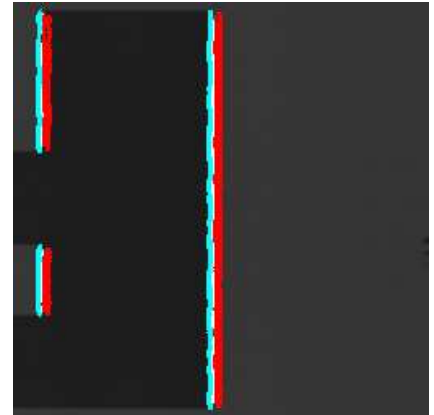
Defect image

No.	#89, \$78	Date	2023/8/10 上午 09:14:08
Segment	1	Camera	1
Pattern	7930	Position[ x, y ]	447.2 [mm], 5964.3 [m], ( 82.3 [m] )
Type	点状疵点縱向刀絲疵點	Size	H:2.4 ,V:97.6 [mm]
Result	-	Area	148.0 [mm2]
Inspection level	5/5,5/5,5/5,5/5,5/5	Label	-
Light	6,6,3/6,6,3

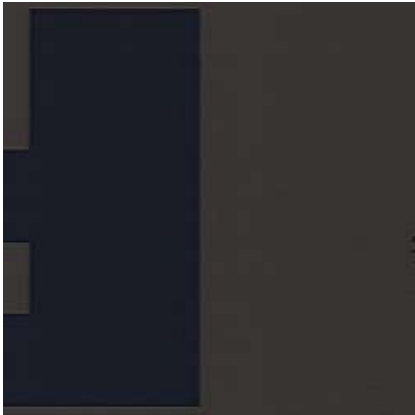
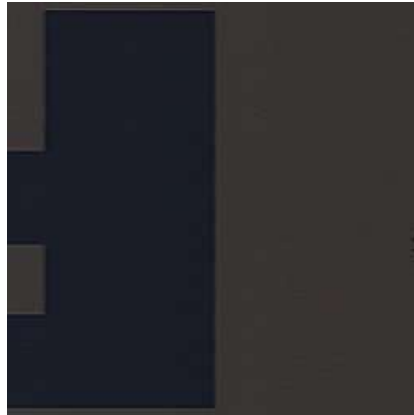
Defect image

No.	#88, \$77	Date	2023/8/10 上午 09:14:07
Segment	1	Camera	1
Pattern	7929	Position[ x, y ]	769.4 [mm], 5963.5 [m], ( 83.0 [m] )
Type	点状疵点縱向刀絲疵點	Size	H:2.2 ,V:98.0 [mm]
Result	-	Area	112.0 [mm2]
Inspection level	5/5,5/5,5/5,5/5,5/5	Label	-
Light	6,6,3/6,6,3

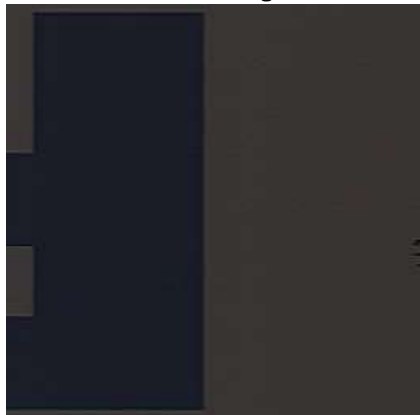
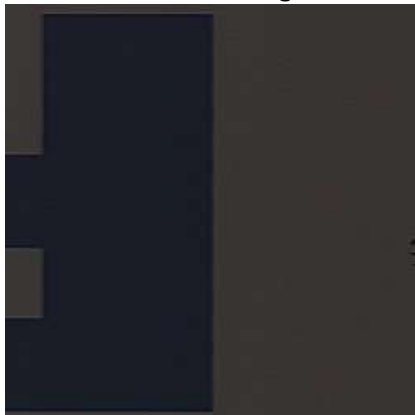
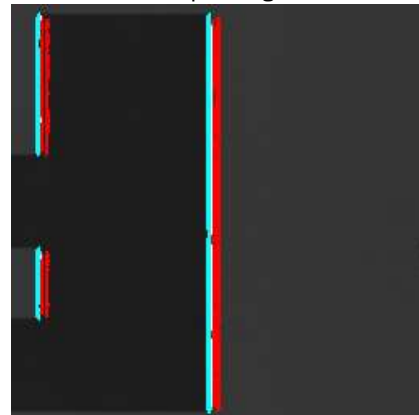
Defect image

No.	#88, \$77	Date	2023/8/10 上午 09:14:07
Segment	1	Camera	1
Pattern	7929	Position[ x, y ]	447.2 [mm], 5963.5 [m], ( 83.0 [m] )
Type	点状疵点縱向刀絲疵點	Size	H:2.2 ,V:98.0 [mm]
Result	-	Area	136.1 [mm2]
Inspection level	5/5,5/5,5/5,5/5,5/5	Label	-
Light	6,6,3/6,6,3

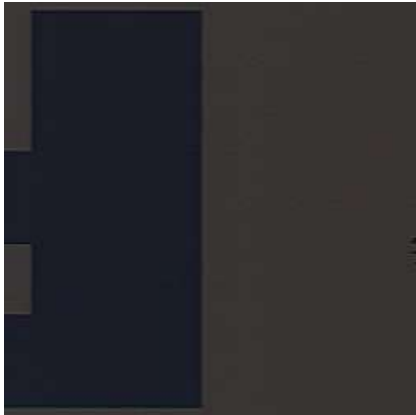
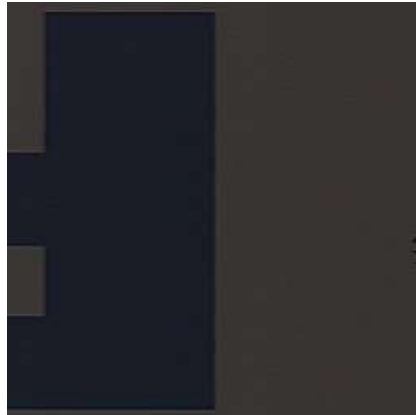
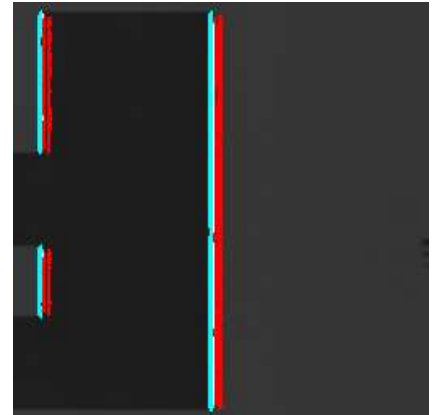
Defect image

No.	#87, \$76	Date	2023/8/10 上午 09:14:07
Segment	1	Camera	1
Pattern	7928	Position[ x, y ]	447.4 [mm], 5962.4 [m], ( 84.2 [m] )
Type	点状疵点縱向刀絲疵點	Size	H:2.0 ,V:98.0 [mm]
Result	-	Area	70.3 [mm2]
Inspection level	5/5,5/5,5/5,5/5,5/5	Label	-
Light	6,6,3/6,6,3

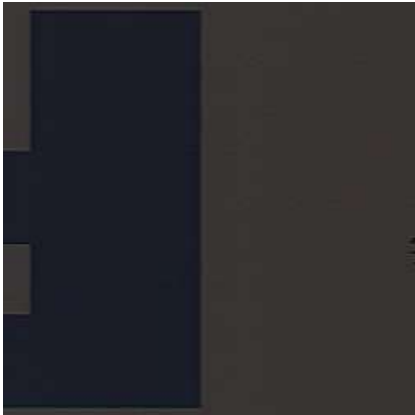
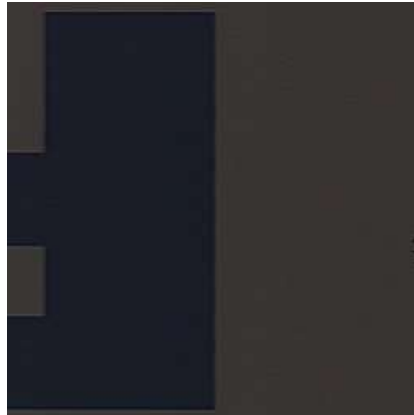
Defect image

No.	#87, \$76	Date	2023/8/10 上午 09:14:07
Segment	1	Camera	1
Pattern	7928	Position[ x, y ]	126.4 [mm], 5962.4 [m], ( 84.2 [m] )
Type	点状疵点縱向刀絲疵點	Size	H:2.0 ,V:98.0 [mm]
Result	-	Area	72.1 [mm2]
Inspection level	5/5,5/5,5/5,5/5,5/5	Label	-
Light	6,6,3/6,6,3

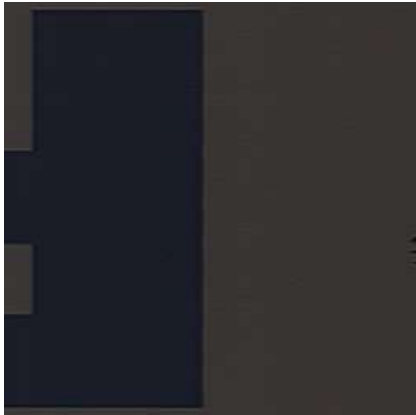
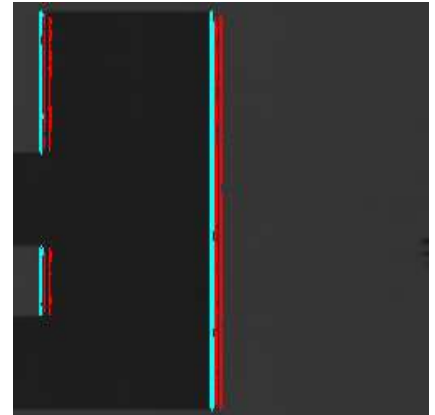
Defect image

No.	#87, \$76	Date	2023/8/10 上午 09:14:07
Segment	1	Camera	1
Pattern	7928	Position[ x, y ]	447.2 [mm], 5962.8 [m], ( 83.8 [m] )
Type	点状疵点縱向刀絲疵點	Size	H:2.0 ,V:98.0 [mm]
Result	-	Area	84.0 [mm2]
Inspection level	5/5,5/5,5/5,5/5,5/5	Label	-
Light	6,6,3/6,6,3

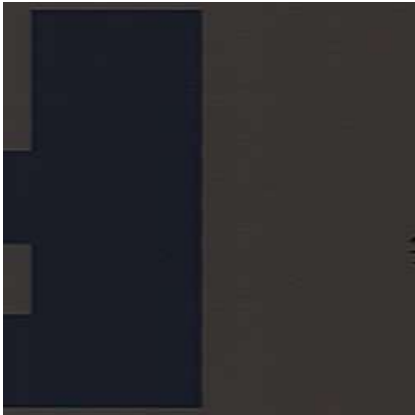
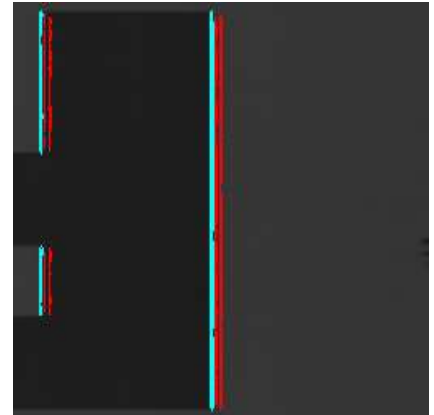
Defect image

No.	#86, \$75	Date	2023/8/10 上午 09:14:06
Segment	1	Camera	1
Pattern	7927	Position[ x, y ]	769.7 [mm], 5962.0 [m], ( 84.5 [m] )
Type	点状疵点縱向刀絲疵點	Size	H:1.7 ,V:96.4 [mm]
Result	-	Area	23.6 [mm2]
Inspection level	5/5,5/5,5/5,5/5,5/5	Label	-
Light	6,6,3/6,6,3

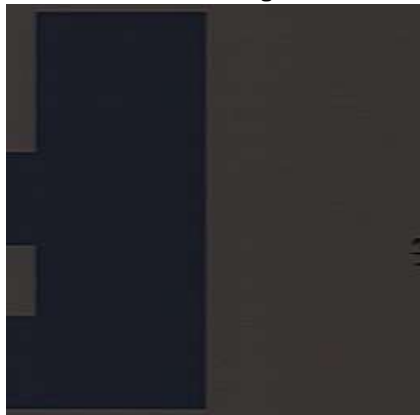
Defect image

No.	#86, \$75	Date	2023/8/10 上午 09:14:06
Segment	1	Camera	1
Pattern	7927	Position[ x, y ]	447.4 [mm], 5962.0 [m], ( 84.5 [m] )
Type	点状疵点縱向刀絲疵點	Size	H:2.0 ,V:97.2 [mm]
Result	-	Area	56.4 [mm2]
Inspection level	5/5,5/5,5/5,5/5,5/5	Label	-
Light	6,6,3/6,6,3

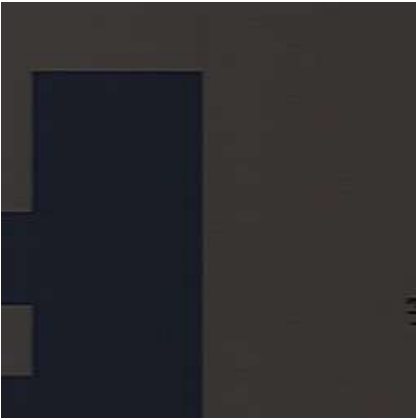
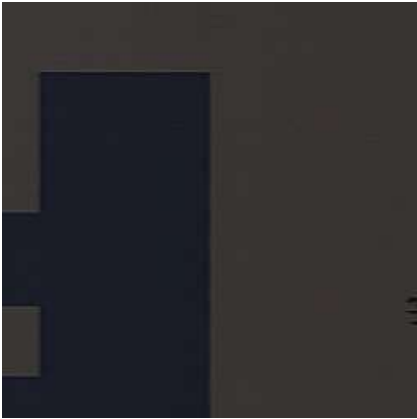
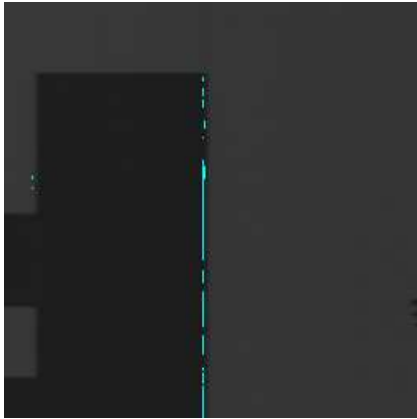
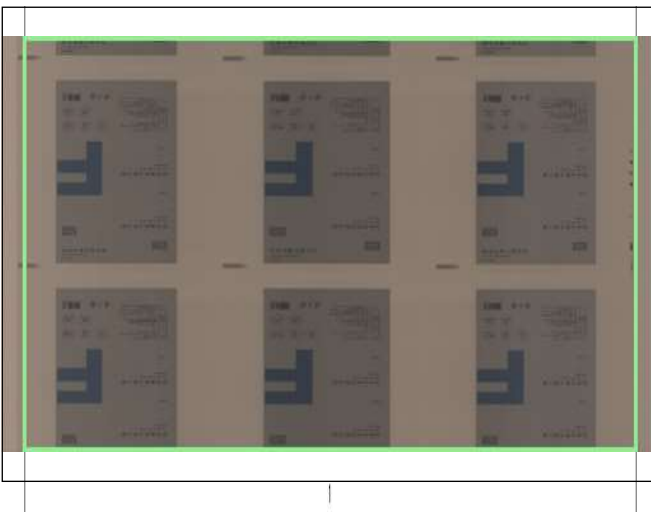
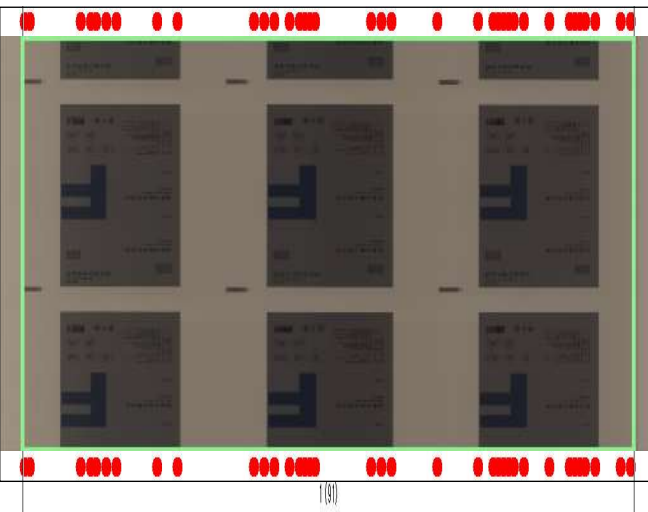
No.	#85, \$74	Date	2023/8/10 上午 09:14:06
Segment	1	Camera	1
Pattern	7926	Position[ x, y ]	446.9 [mm], 5961.3 [m], ( 85.3 [m] )
Type	縱向刀絲疵點	Size	H:0.5 ,V:24.0 [mm]
Result	-	Area	6.4 [mm2]
Inspection level	5/5,5/5,5/5,5/5,5/5	Label	-
Light	6,6,3/6,6,3
