# Inspection Result (Individual Data)

Lot number : 2

Inspected date : 2023/8/10 上午 07:56:43 ~ 2023/8/10 上午 09:15:18

商品名	標準透明6-6-3	周長
顧客名		Ex1
CODE番号		Ex2
基材		Ex3

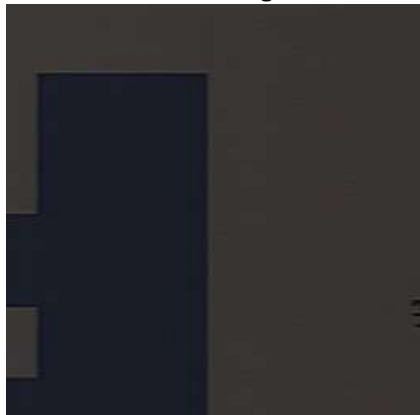
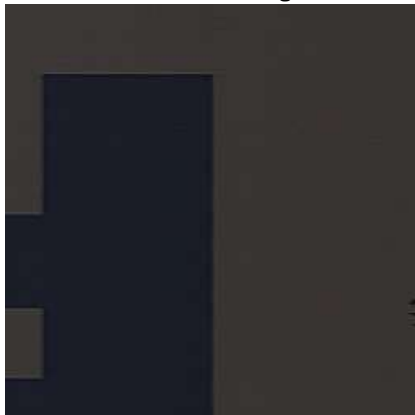
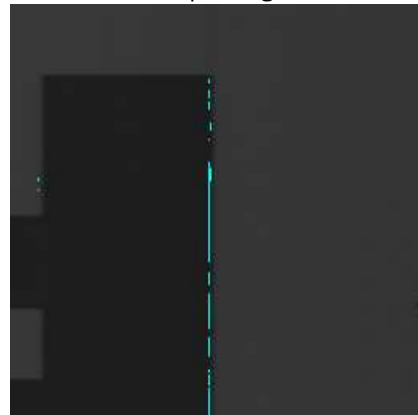
No.	#82, \$73	Date	2023/8/10 上午 09:13:57
Segment	1	Camera	1
Pattern	7912	Position[ x, y ]	240.1 [mm], 5950.7 [m], ( 95.9 [m] )
Type	点状疵点縱向刀絲疵點	Size	H:2.7 ,V:664.8 [mm]
Result	-	Area	496.9 [mm2]
Inspection level	5/5,5/5,5/5,5/5,5/5	Label	-
Light	6,6,3/6,6,3

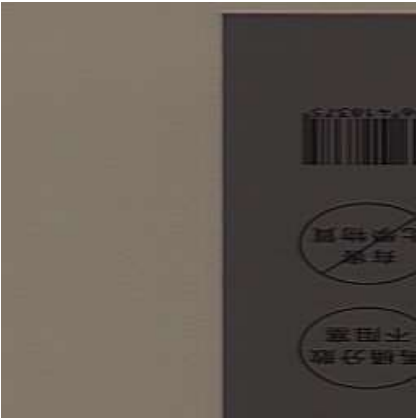
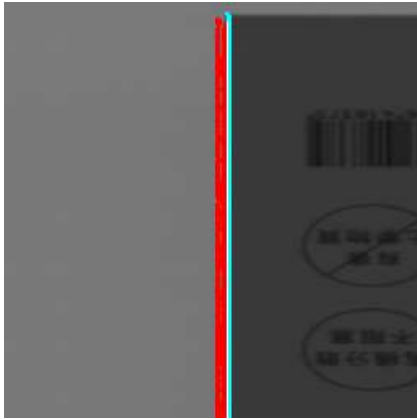
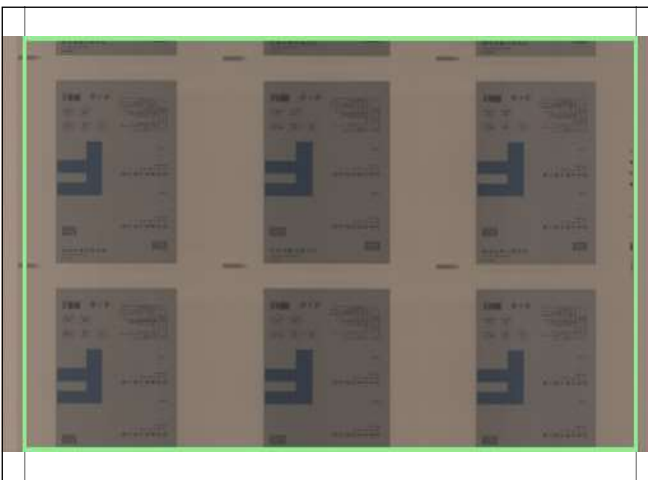
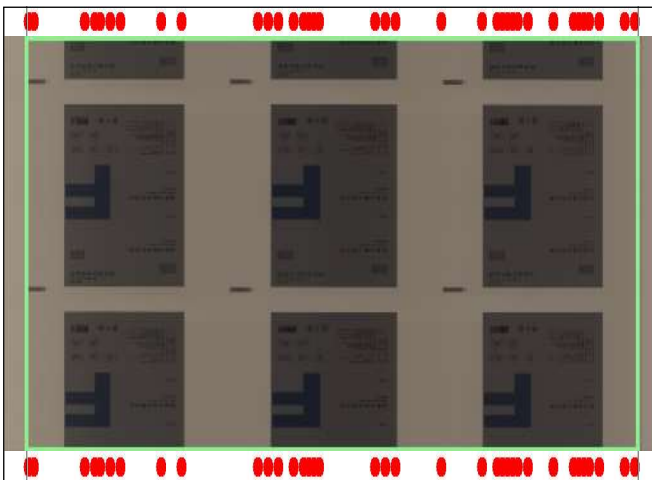
No.	#81, \$72	Date	2023/8/10 上午 09:13:57
Segment	1	Camera	1
Pattern	7911	Position[ x, y ]	697.6 [mm], 5950.0 [m], ( 96.6 [m] )
Type	点状疵点縱向刀絲疵點	Size	H:4.6 ,V:436.0 [mm]
Result	-	Area	278.1 [mm2]
Inspection level	5/5,5/5,5/5,5/5,5/5	Label	-
Light	6,6,3/6,6,3

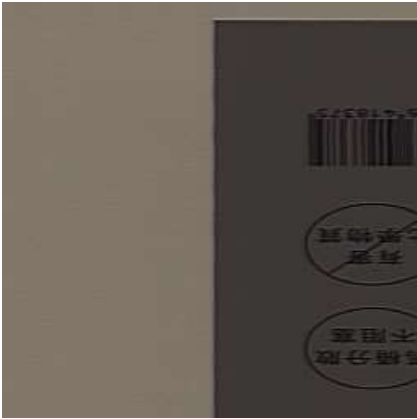
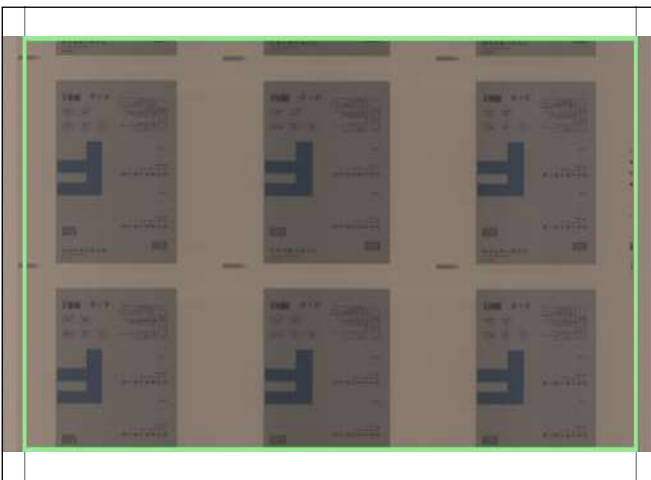
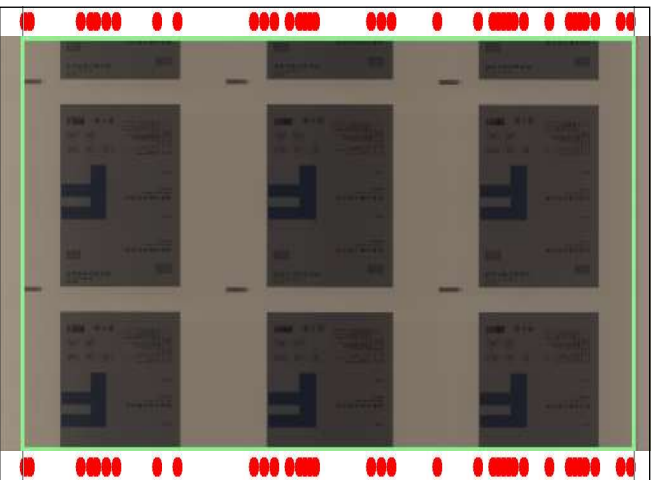
No.	#81, \$72	Date	2023/8/10 上午 09:13:57
Segment	1	Camera	1
Pattern	7911	Position[ x, y ]	373.2 [mm], 5950.0 [m], ( 96.6 [m] )
Type	点状疵点縱向刀絲疵點	Size	H:5.1 ,V:436.8 [mm]
Result	-	Area	289.6 [mm2]
Inspection level	5/5,5/5,5/5,5/5,5/5	Label	-
Light	6,6,3/6,6,3

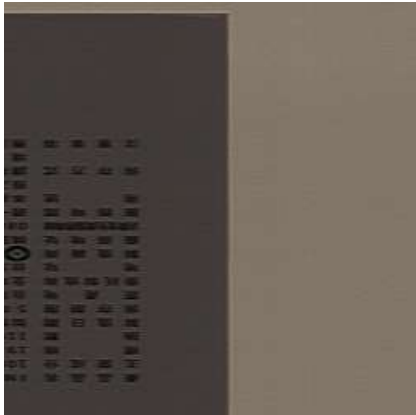
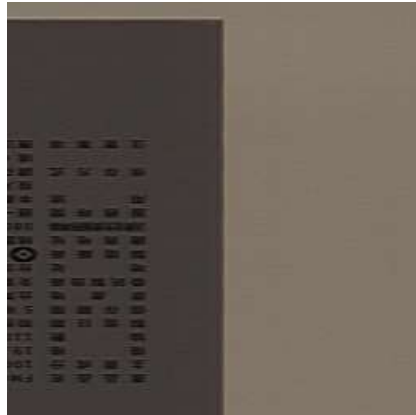
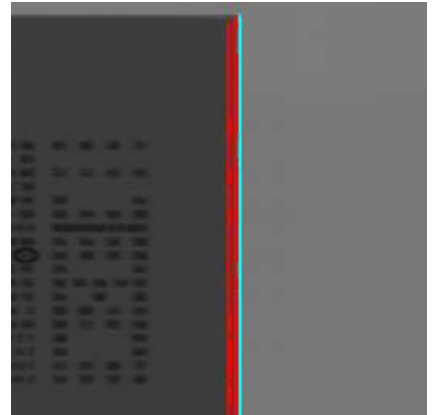
No.	#80, \$71	Date	2023/8/10 上午 09:13:56
Segment	1	Camera	1
Pattern	7910	Position[ x, y ]	239.9 [mm], 5948.9 [m], ( 97.7 [m] )
Type	点状疵点縱向刀絲疵點	Size	H:1.0 ,V:474.8 [mm]
Result	-	Area	64.4 [mm2]
Inspection level	5/5,5/5,5/5,5/5,5/5	Label	-
Light	6,6,3/6,6,3

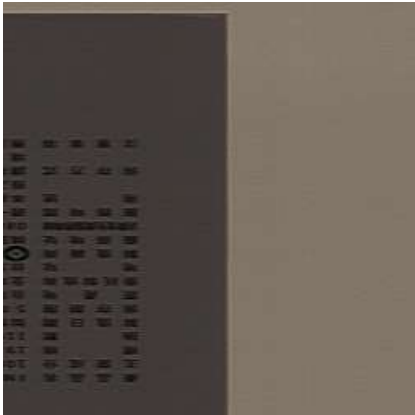
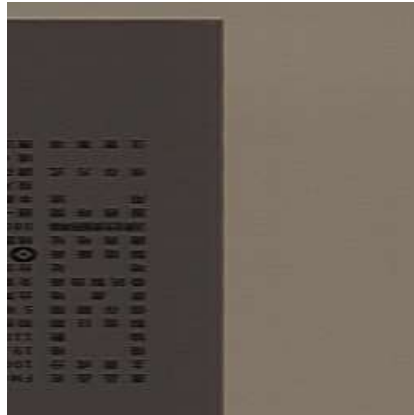
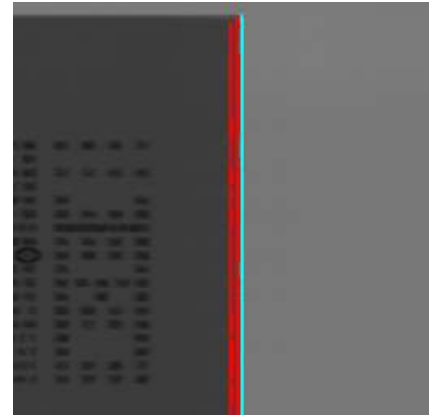
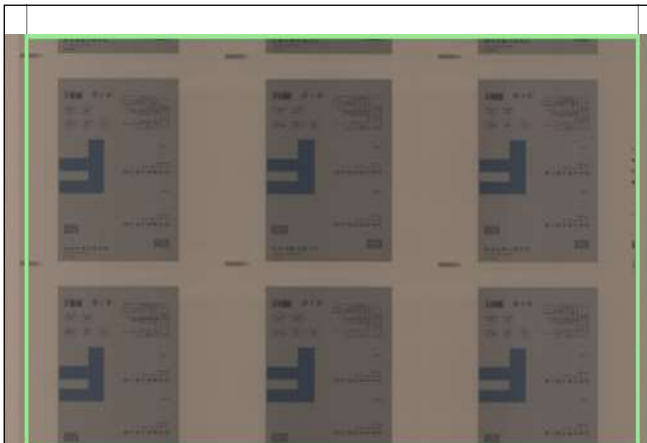
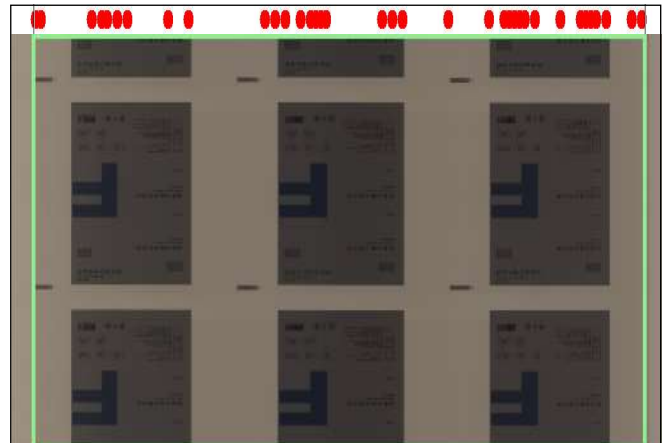
No.	#80, \$71	Date	2023/8/10 上午 09:13:56
Segment	1	Camera	1
Pattern	7910	Position[ x, y ]	770.2 [mm], 5948.9 [m], ( 97.7 [m] )
Type	点状疵点縱向刀絲疵點	Size	H:1.7 ,V:98.0 [mm]
Result	-	Area	69.7 [mm2]
Inspection level	5/5,5/5,5/5,5/5,5/5	Label	-
Light	6,6,3/6,6,3

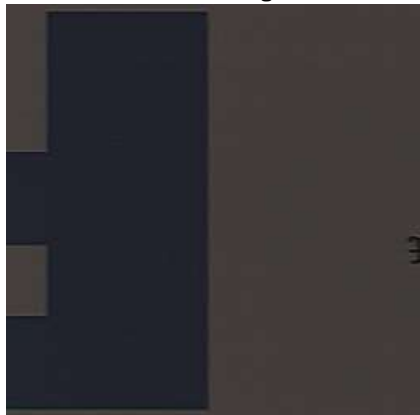
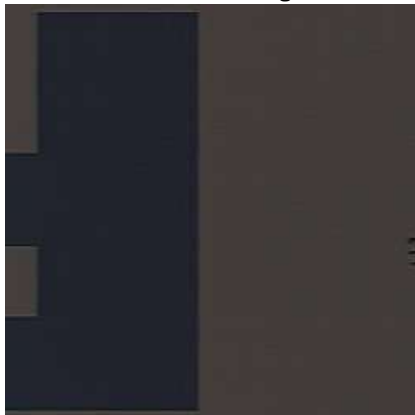
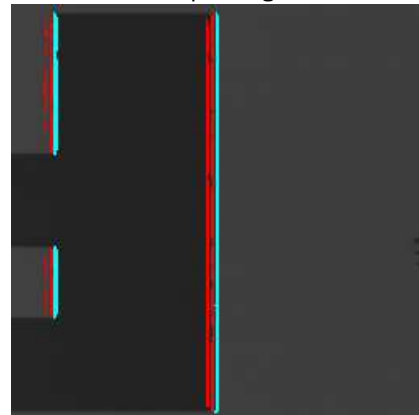
No.	#80, \$71	Date	2023/8/10 上午 09:13:56
Segment	1	Camera	1
Pattern	7910	Position[ x, y ]	127.1 [mm], 5948.9 [m], ( 97.7 [m] )
Type	点状疵点縱向刀絲疵點	Size	H:2.0 ,V:98.0 [mm]
Result	-	Area	89.3 [mm2]
Inspection level	5/5,5/5,5/5,5/5,5/5	Label	-
Light	6,6,3/6,6,3

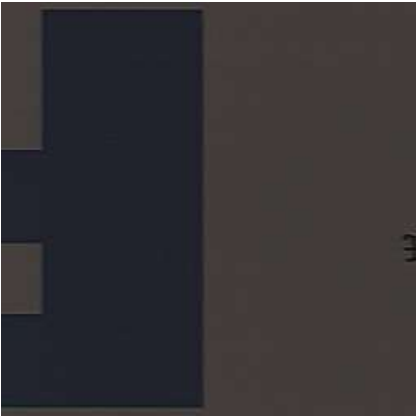
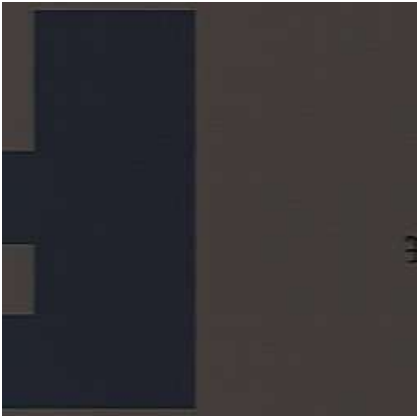
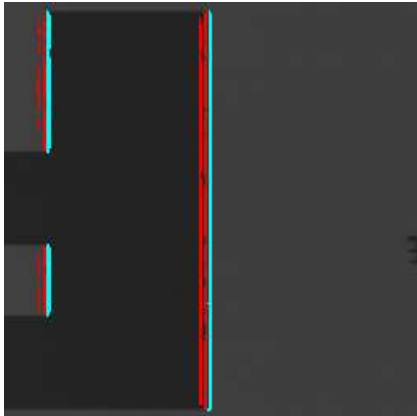
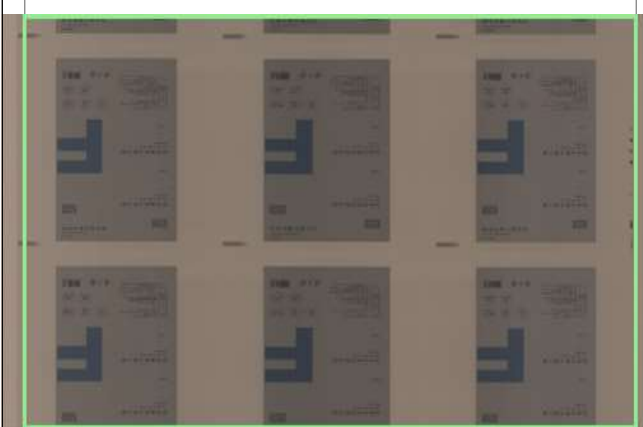
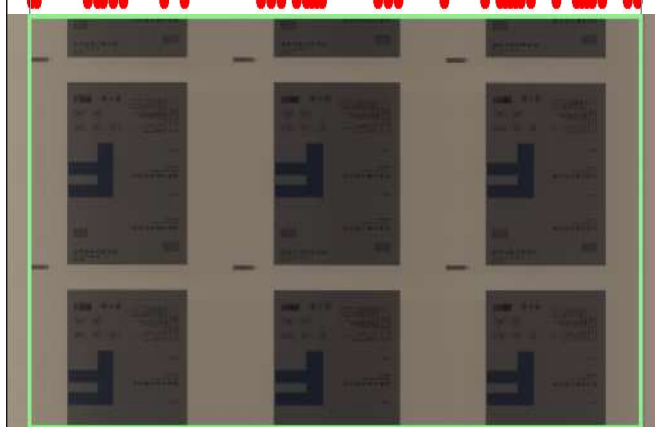
No.	#79, \$70	Date	2023/8/10 上午 09:13:56
Segment	1	Camera	1
Pattern	7909	Position[ x, y ]	447.6 [mm], 5948.1 [m], ( 98.4 [m] )
Type	点状疵点縱向刀絲疵點	Size	H:1.7 ,V:98.0 [mm]
Result	-	Area	47.8 [mm2]
Inspection level	5/5,5/5,5/5,5/5,5/5	Label	-
Light	6,6,3/6,6,3

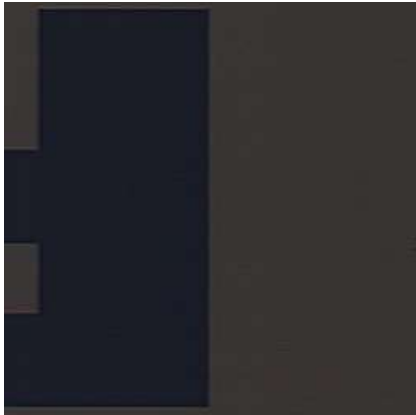
Defect image

No.	#79, \$70	Date	2023/8/10 上午 09:13:56
Segment	1	Camera	1
Pattern	7909	Position[ x, y ]	447.9 [mm], 5948.5 [m], ( 98.0 [m] )
Type	点状疵点縱向刀絲疵點	Size	H:2.0 ,V:97.6 [mm]
Result	-	Area	59.3 [mm2]
Inspection level	5/5,5/5,5/5,5/5,5/5	Label	-
Light	6,6,3/6,6,3

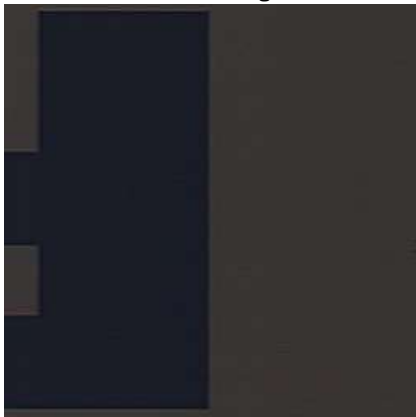
Defect image

No.	#78, \$69	Date	2023/8/10 上午 09:13:55
Segment	1	Camera	1
Pattern	7908	Position[ x, y ]	745.7 [mm], 5947.4 [m], ( 99.2 [m] )
Type	縱向刀絲疵點	Size	H:0.5 ,V:73.2 [mm]
Result	-	Area	18.6 [mm2]
Inspection level	5/5,5/5,5/5,5/5,5/5	Label	-
Light	6,6,3/6,6,3

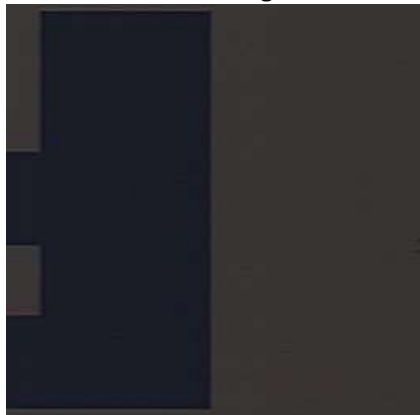
Defect image

No.	#78, \$69	Date	2023/8/10 上午 09:13:55
Segment	1	Camera	1
Pattern	7908	Position[ x, y ]	127.3 [mm], 5947.4 [m], ( 99.2 [m] )
Type	縱向刀絲疵點	Size	H:0.5 ,V:84.4 [mm]
Result	-	Area	20.7 [mm2]
Inspection level	5/5,5/5,5/5,5/5,5/5	Label	-
Light	6,6,3/6,6,3

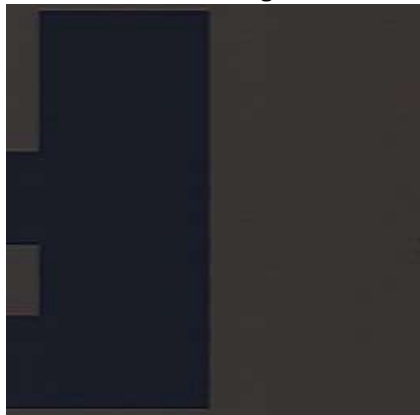
Defect image

No.	#78, \$69	Date	2023/8/10 上午 09:13:55
Segment	1	Camera	1
Pattern	7908	Position[ x, y ]	448.1 [mm], 5947.8 [m], ( 98.8 [m] )
Type	縱向刀絲疵點	Size	H:0.5 ,V:96.0 [mm]
Result	-	Area	42.9 [mm2]
Inspection level	5/5,5/5,5/5,5/5,5/5	Label	-
Light	6,6,3/6,6,3

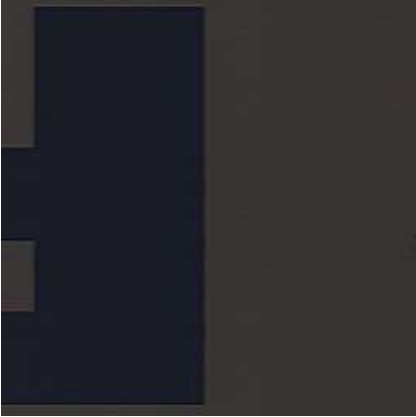
Defect image	Reference image	Shape image

No.	#75, \$68	Date	2023/8/10 上午 09:13:42
Segment	1	Camera	1
Pattern	7886	Position[ x, y ]	779.9 [mm], 5930.8 [m], ( 115.8 [m] )
Type	点状疵点縱向刀絲疵點	Size	H:187.3 ,V:464.0 [mm]
Result	-	Area	2272.7 [mm2]
Inspection level	5/5,5/5,5/5,5/5,5/5	Label	-
Light	6,6,3/6,6,3

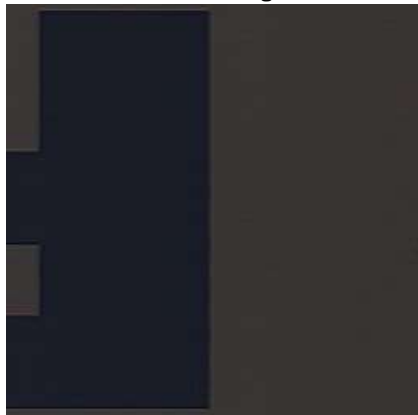
Defect image

No.	#75, \$68	Date	2023/8/10 上午 09:13:42
Segment	1	Camera	1
Pattern	7886	Position[ x, y ]	132.9 [mm], 5930.9 [m], ( 115.7 [m] )
Type	点状疵点縱向刀絲疵點橫向刀絲	Size	H:187.5 ,V:477.6 [mm]
Result	-	Area	7035.4 [mm2]
Inspection level	5/5,5/5,5/5,5/5,5/5	Label	-
Light	6,6,3/6,6,3

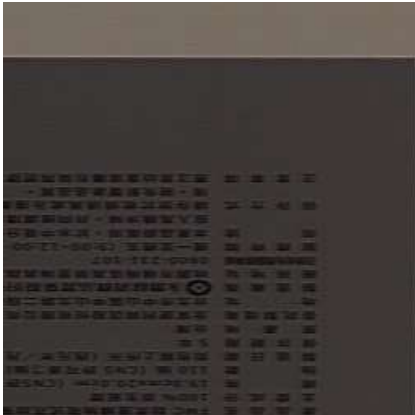
Defect image

No.	#75, \$68	Date	2023/8/10 上午 09:13:42
Segment	1	Camera	1
Pattern	7886	Position[ x, y ]	765.5 [mm], 5930.9 [m], ( 115.7 [m] )
Type	点状疵点縱向刀絲疵點橫向刀絲	Size	H:188.0 ,V:478.4 [mm]
Result	-	Area	7381.7 [mm2]
Inspection level	5/5,5/5,5/5,5/5,5/5	Label	-
Light	6,6,3/6,6,3

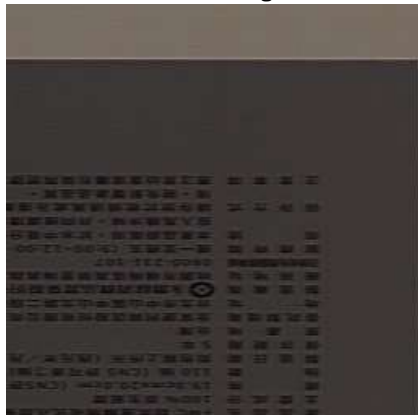
Defect image

No.	#74, \$67	Date	2023/8/10 上午 09:13:42
Segment	1	Camera	1
Pattern	7885	Position[ x, y ]	128.8 [mm], 5930.2 [m], ( 116.4 [m] )
Type	点状疵点縱向刀絲疵點橫向刀絲	Size	H:187.3 ,V:804.8 [mm]
Result	-	Area	6777.7 [mm2]
Inspection level	5/5,5/5,5/5,5/5,5/5	Label	-
Light	6,6,3/6,6,3

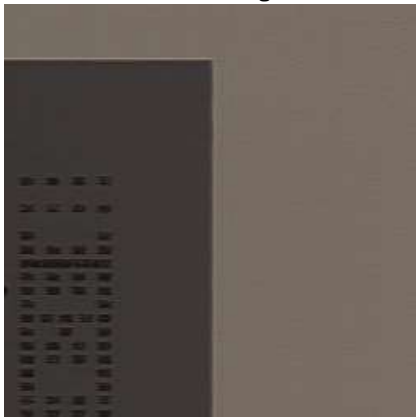
Defect image

No.	#74, \$67	Date	2023/8/10 上午 09:13:42
Segment	1	Camera	1
Pattern	7885	Position[ x, y ]	769.2 [mm], 5930.1 [m], ( 116.4 [m] )
Type	点状疵点縱向刀絲疵點橫向刀絲	Size	H:187.3 ,V:541.6 [mm]
Result	-	Area	7368.2 [mm2]
Inspection level	5/5,5/5,5/5,5/5,5/5	Label	-
Light	6,6,3/6,6,3

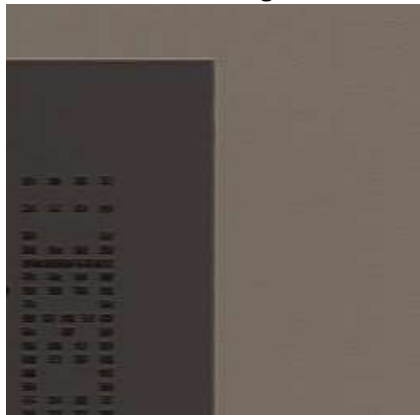
Defect image

No.	#73, \$66	Date	2023/8/10 上午 09:13:41
Segment	1	Camera	1
Pattern	7884	Position[ x, y ]	778.7 [mm], 5929.3 [m], ( 117.3 [m] )
Type	点状疵点縱向刀絲疵點	Size	H:186.3 ,V:455.2 [mm]
Result	-	Area	1945.7 [mm2]
Inspection level	5/5,5/5,5/5,5/5,5/5	Label	-
Light	6,6,3/6,6,3

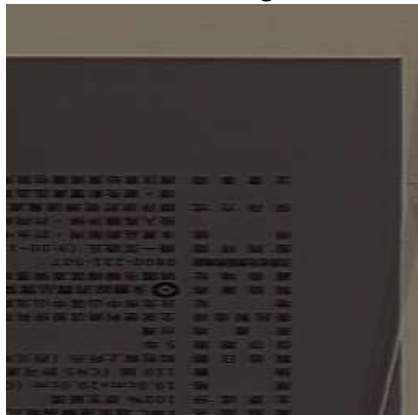
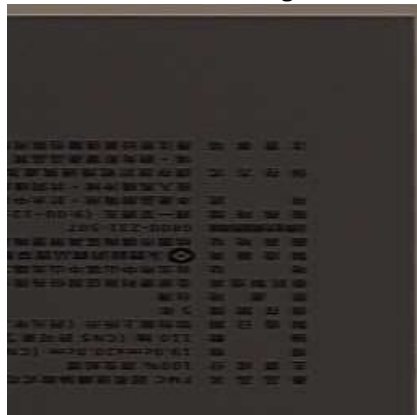
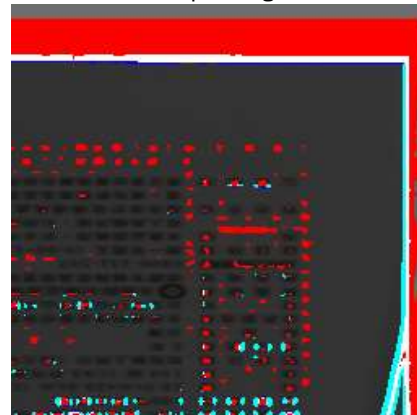
Defect image

No.	#72, \$65	Date	2023/8/10 上午 09:13:40
Segment	1	Camera	1
Pattern	7883	Position[ x, y ]	137.1 [mm], 5928.6 [m], ( 117.9 [m] )
Type	点状疵点縱向刀絲疵點橫向刀絲	Size	H:186.5 ,V:564.0 [mm]
Result	-	Area	6199.5 [mm2]
Inspection level	5/5,5/5,5/5,5/5,5/5	Label	-
Light	6,6,3/6,6,3

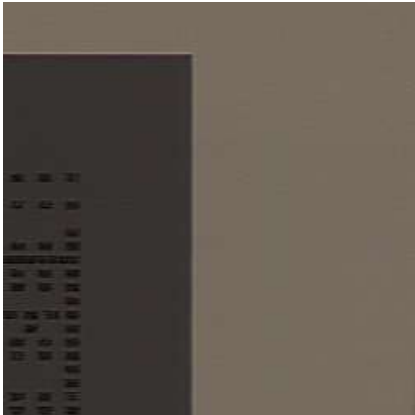
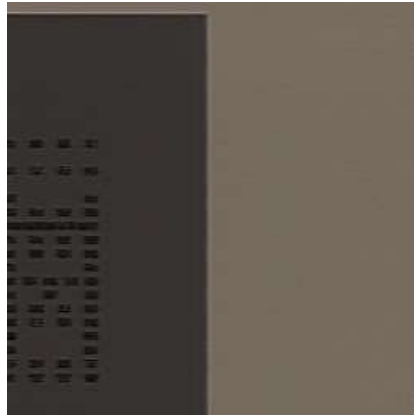
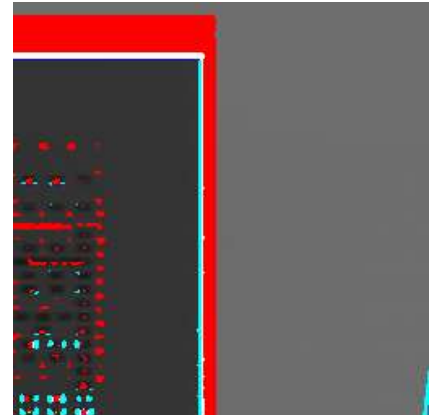
Defect image

No.	#71, \$64	Date	2023/8/10 上午 09:13:40
Segment	1	Camera	1
Pattern	7882	Position[ x, y ]	767.7 [mm], 5927.9 [m], ( 118.7 [m] )
Type	点状疵点縱向刀絲疵點橫向刀絲	Size	H:186.5 ,V:592.4 [mm]
Result	-	Area	6192.8 [mm2]
Inspection level	5/5,5/5,5/5,5/5,5/5	Label	-
Light	6,6,3/6,6,3

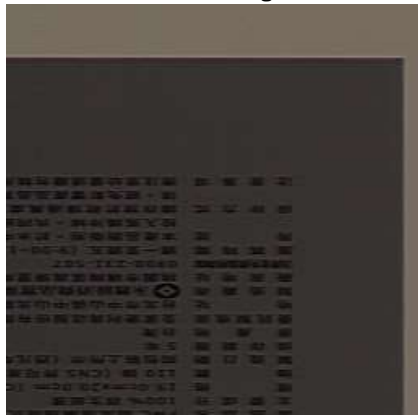
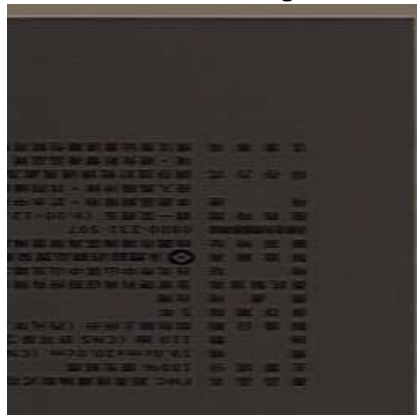
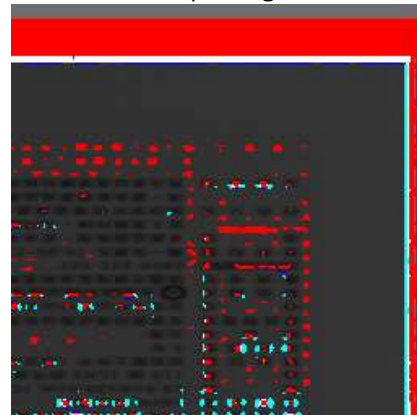
Defect image

No.	#71, \$64	Date	2023/8/10 上午 09:13:40
Segment	1	Camera	1
Pattern	7882	Position[ x, y ]	450.1 [mm], 5927.9 [m], ( 118.7 [m] )
Type	点状疵点縱向刀絲疵點橫向刀絲	Size	H:195.6 ,V:712.8 [mm]
Result	-	Area	6219.1 [mm2]
Inspection level	5/5,5/5,5/5,5/5,5/5	Label	-
Light	6,6,3/6,6,3

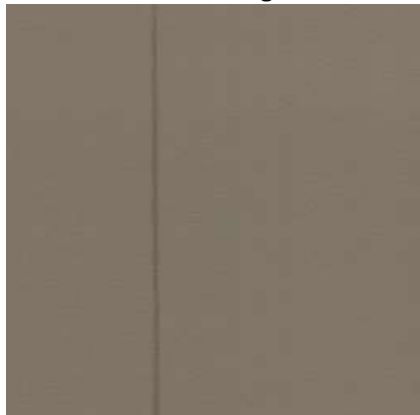
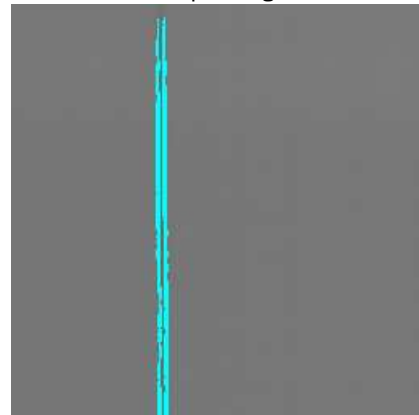
Defect image

No.	#67, \$62	Date	2023/8/10 上午 09:13:29
Segment	1	Camera	1
Pattern	7865	Position[ x, y ]	110.0 [mm], 5913.9 [m], ( 132.6 [m] )
Type	縱向刀絲疵點	Size	H:52.5 ,V:180.0 [mm]
Result	-	Area	68.5 [mm2]
Inspection level	5/5,5/5,5/5,5/5,5/5	Label	-
Light	6,6,3/6,6,3

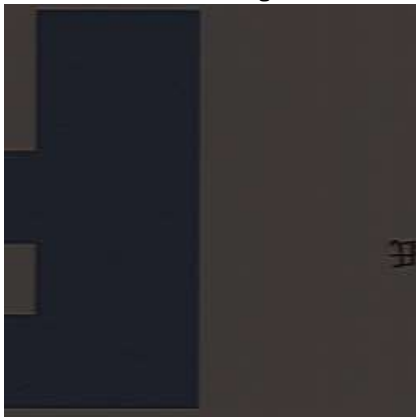
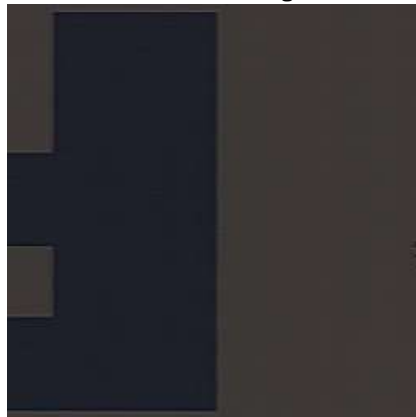
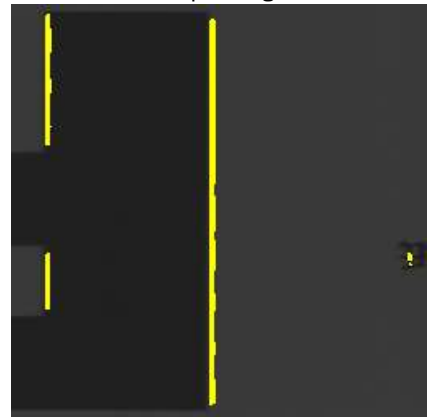
Defect image

No.	#67, \$62	Date	2023/8/10 上午 09:13:29
Segment	1	Camera	1
Pattern	7865	Position[ x, y ]	767.5 [mm], 5914.4 [m], ( 132.2 [m] )
Type	面狀重疵點	Size	H:1.0 ,V:94.4 [mm]
Result	-	Area	86.2 [mm2]
Inspection level	5/5,5/5,5/5,5/5,5/5	Label	-
Light	6,6,3/6,6,3

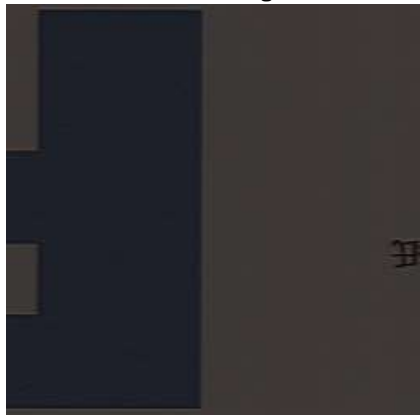
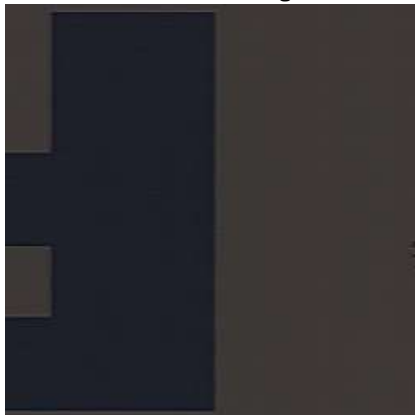
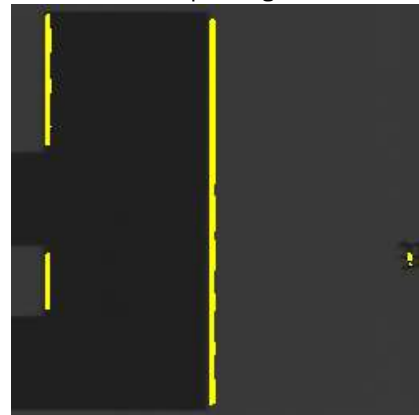
Defect image

No.	#66, \$61	Date	2023/8/10 上午 09:13:28
Segment	1	Camera	1
Pattern	7864	Position[ x, y ]	931.0 [mm], 5913.7 [m], ( 132.9 [m] )
Type	点状疵点縱向刀絲疵點	Size	H:9.0 ,V:6.8 [mm]
Result	-	Area	16.2 [mm2]
Inspection level	5/5,5/5,5/5,5/5,5/5	Label	-
Light	6,6,3/6,6,3

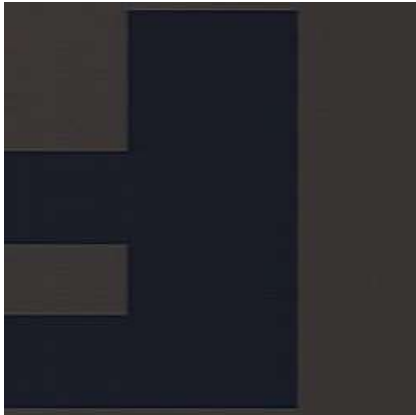
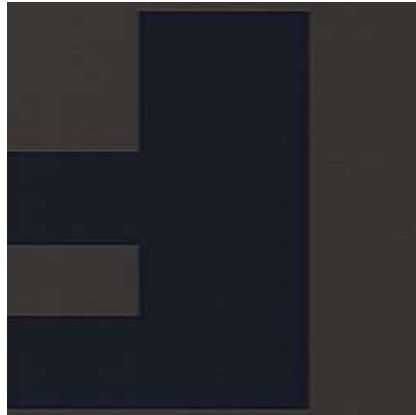
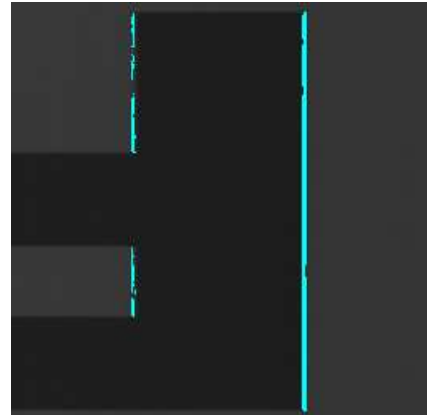
Defect image

No.	#65, \$60	Date	2023/8/10 上午 09:13:28
Segment	1	Camera	1
Pattern	7863	Position[ x, y ]	768.4 [mm], 5912.5 [m], ( 134.0 [m] )
Type	点状疵点縱向刀絲疵點	Size	H:2.0 ,V:97.6 [mm]
Result	-	Area	69.5 [mm2]
Inspection level	5/5,5/5,5/5,5/5,5/5	Label	-
Light	6,6,3/6,6,3

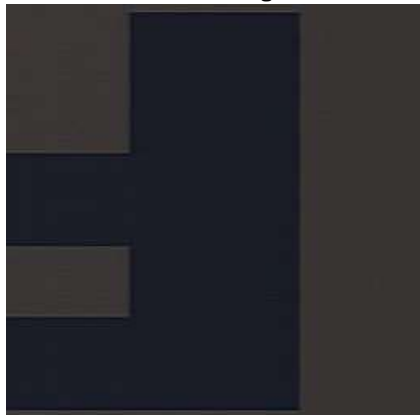
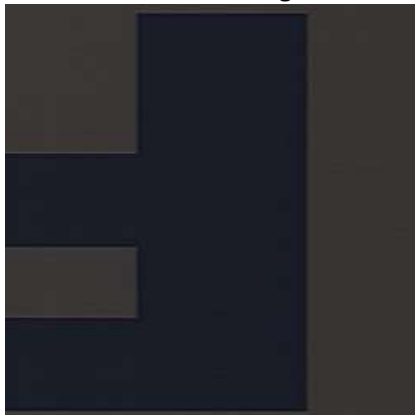
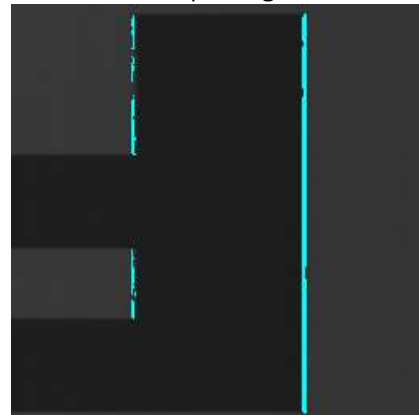
Defect image

No.	#65, \$60	Date	2023/8/10 上午 09:13:28
Segment	1	Camera	1
Pattern	7863	Position[ x, y ]	116.6 [mm], 5912.5 [m], ( 134.1 [m] )
Type	点状疵点縱向刀絲疵點	Size	H:38.8 ,V:152.4 [mm]
Result	-	Area	89.9 [mm2]
Inspection level	5/5,5/5,5/5,5/5,5/5	Label	-
Light	6,6,3/6,6,3

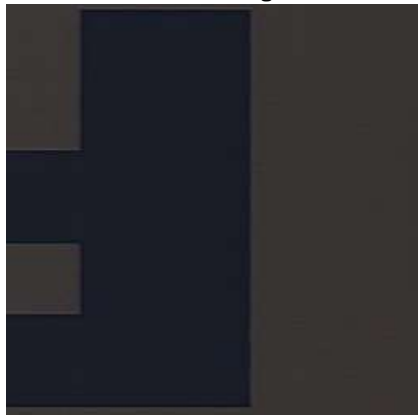
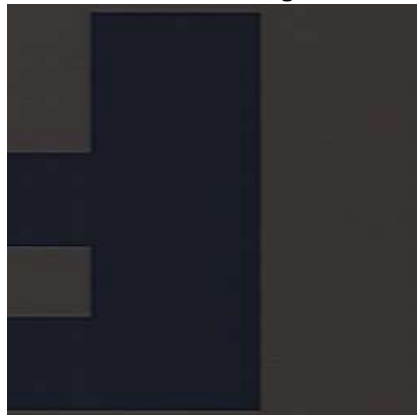
Defect image

No.	#65, \$60	Date	2023/8/10 上午 09:13:28
Segment	1	Camera	1
Pattern	7863	Position[ x, y ]	444.0 [mm], 5912.5 [m], ( 134.1 [m] )
Type	点状疵点縱向刀絲疵點	Size	H:15.4 ,V:180.0 [mm]
Result	-	Area	96.8 [mm2]
Inspection level	5/5,5/5,5/5,5/5,5/5	Label	-
Light	6,6,3/6,6,3

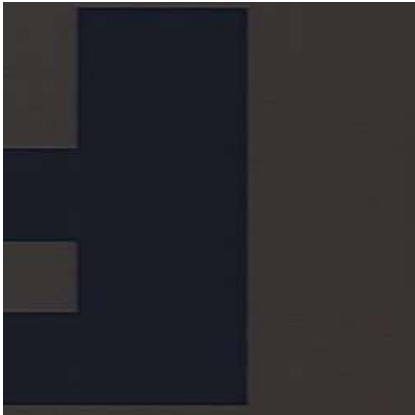
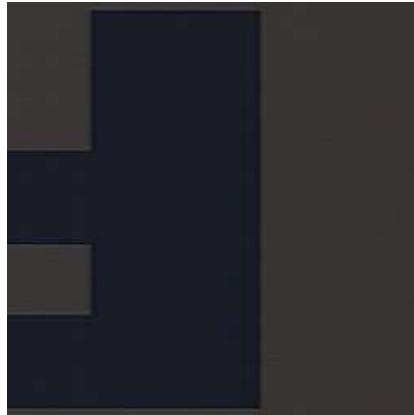
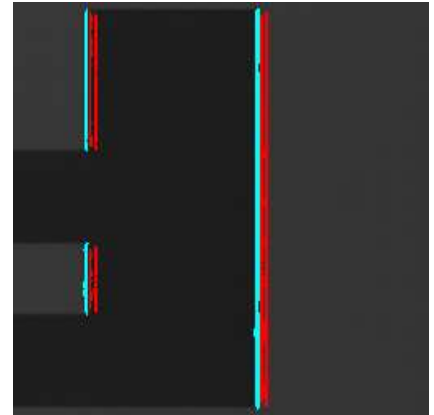
No.	#64, \$59	Date	2023/8/10 上午 09:13:27
Segment	1	Camera	1
Pattern	7862	Position[ x, y ]	445.9 [mm], 5911.8 [m], ( 134.8 [m] )
Type	縱向刀絲疵點	Size	H:0.5 ,V:81.6 [mm]
Result	-	Area	24.0 [mm2]
Inspection level	5/5,5/5,5/5,5/5,5/5	Label	-
Light	6,6,3/6,6,3

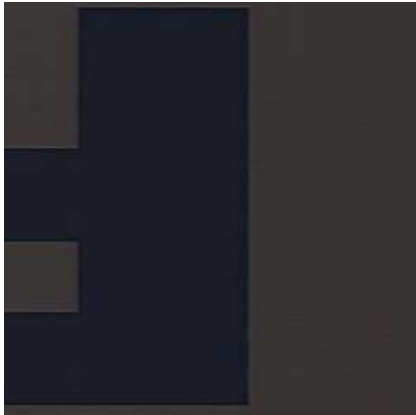
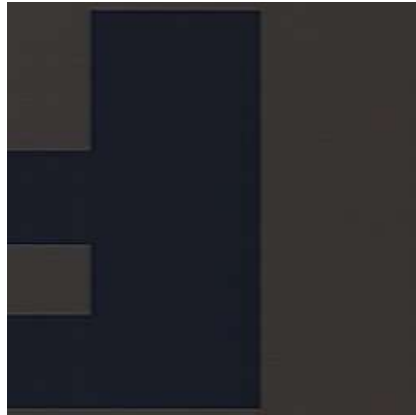
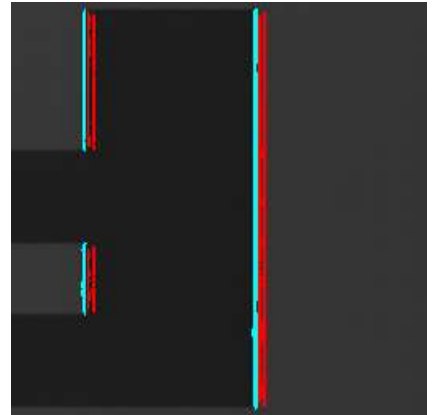
No.	#64, \$59	Date	2023/8/10 上午 09:13:27
Segment	1	Camera	1
Pattern	7862	Position[ x, y ]	446.4 [mm], 5912.2 [m], ( 134.4 [m] )
Type	点状疵点縱向刀絲疵點	Size	H:2.0 ,V:97.6 [mm]
Result	-	Area	53.2 [mm2]
Inspection level	5/5,5/5,5/5,5/5,5/5	Label	-
Light	6,6,3/6,6,3

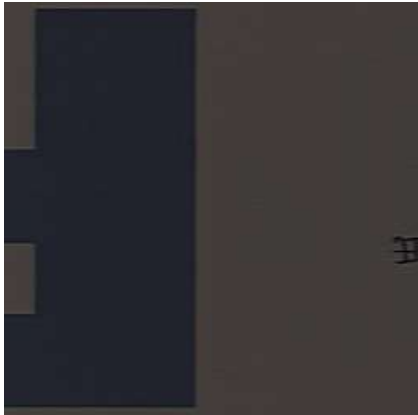
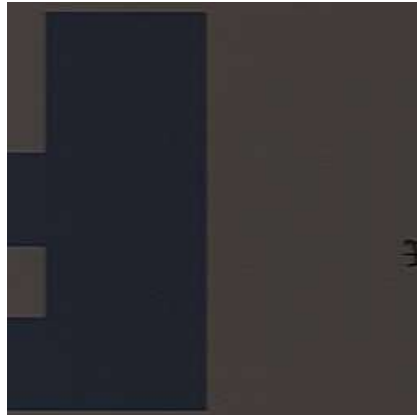
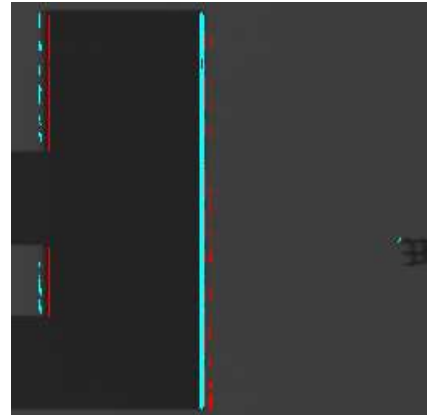
No.	#64, \$59	Date	2023/8/10 上午 09:13:27
Segment	1	Camera	1
Pattern	7862	Position[ x, y ]	125.6 [mm], 5912.2 [m], ( 134.4 [m] )
Type	点状疵点縱向刀絲疵點	Size	H:2.0 ,V:97.2 [mm]
Result	-	Area	69.8 [mm2]
Inspection level	5/5,5/5,5/5,5/5,5/5	Label	-
Light	6,6,3/6,6,3

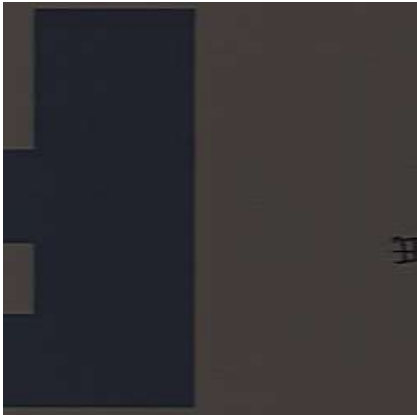
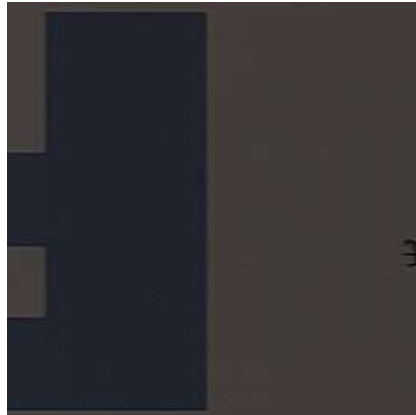
No.	#61, \$58	Date	2023/8/10 上午 09:12:58
Segment	1	Camera	1
Pattern	7812	Position[ x, y ]	446.9 [mm], 5874.2 [m], ( 172.3 [m] )
Type	縱向刀絲疵點	Size	H:0.5 ,V:96.8 [mm]
Result	-	Area	46.0 [mm2]
Inspection level	5/5,5/5,5/5,5/5,5/5	Label	-
Light	6,6,3/6,6,3

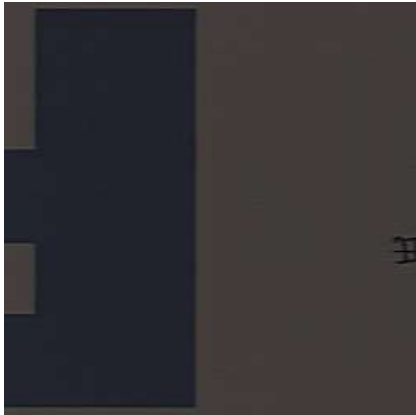
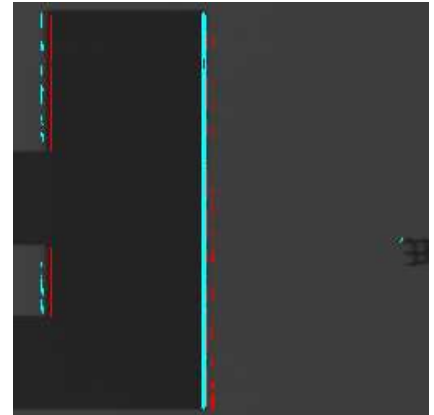
No.	#61, \$58	Date	2023/8/10 上午 09:12:58
Segment	1	Camera	1
Pattern	7812	Position[ x, y ]	126.6 [mm], 5874.2 [m], ( 172.3 [m] )
Type	点状疵点縱向刀絲疵點	Size	H:1.7 ,V:97.6 [mm]
Result	-	Area	68.9 [mm2]
Inspection level	5/5,5/5,5/5,5/5,5/5	Label	-
Light	6,6,3/6,6,3

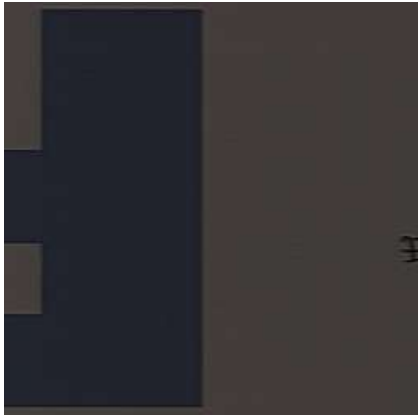
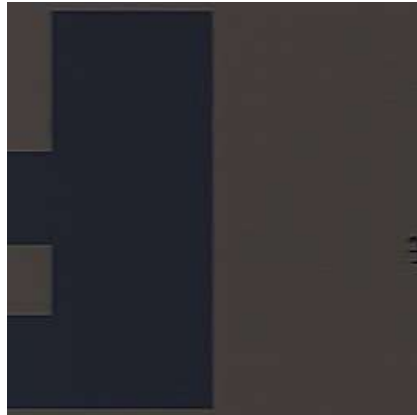
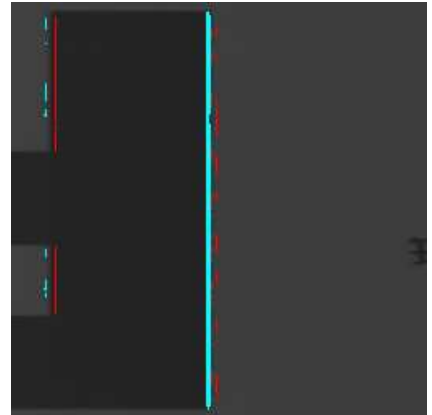
No.	#61, \$58	Date	2023/8/10 上午 09:12:58
Segment	1	Camera	1
Pattern	7812	Position[ x, y ]	126.6 [mm], 5874.6 [m], ( 172.0 [m] )
Type	点状疵点縱向刀絲疵點	Size	H:1.7 ,V:97.2 [mm]
Result	-	Area	69.9 [mm2]
Inspection level	5/5,5/5,5/5,5/5,5/5	Label	-
Light	6,6,3/6,6,3

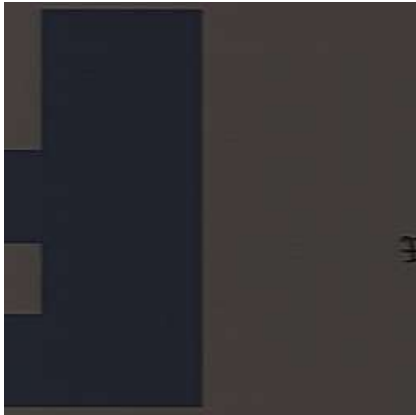
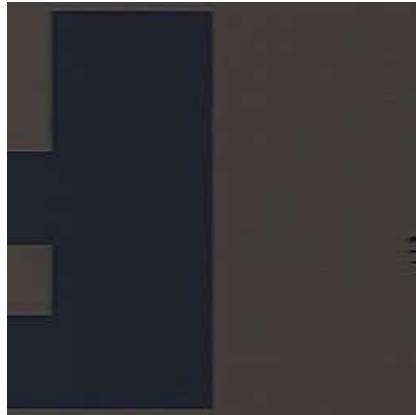
No.	#60, \$57	Date	2023/8/10 上午 09:12:57
Segment	1	Camera	1
Pattern	7811	Position[ x, y ]	446.9 [mm], 5873.8 [m], ( 172.7 [m] )
Type	縱向刀絲疵點	Size	H:0.5 ,V:97.2 [mm]
Result	-	Area	46.5 [mm2]
Inspection level	5/5,5/5,5/5,5/5,5/5	Label	-
Light	6,6,3/6,6,3

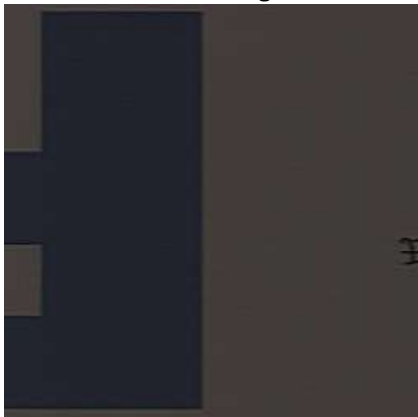
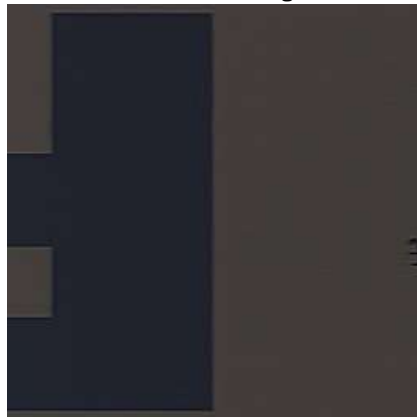
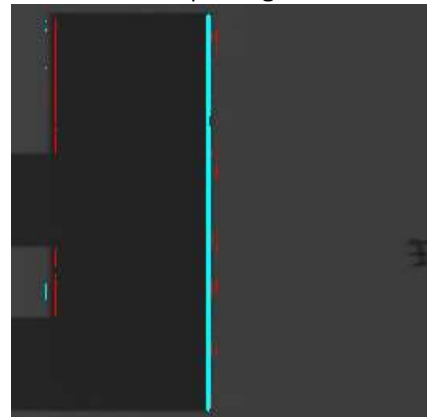
No.	#60, \$57	Date	2023/8/10 上午 09:12:57
Segment	1	Camera	1
Pattern	7811	Position[ x, y ]	126.6 [mm], 5873.8 [m], ( 172.7 [m] )
Type	点状疵点縱向刀絲疵點	Size	H:1.7 ,V:97.2 [mm]
Result	-	Area	70.0 [mm2]
Inspection level	5/5,5/5,5/5,5/5,5/5	Label	-
Light	6,6,3/6,6,3

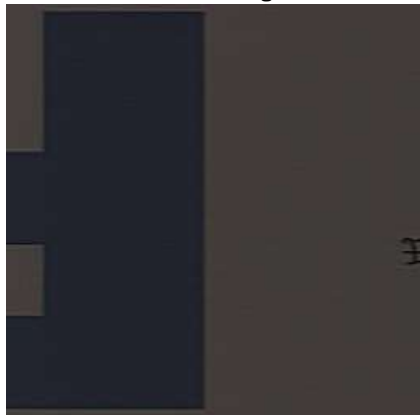
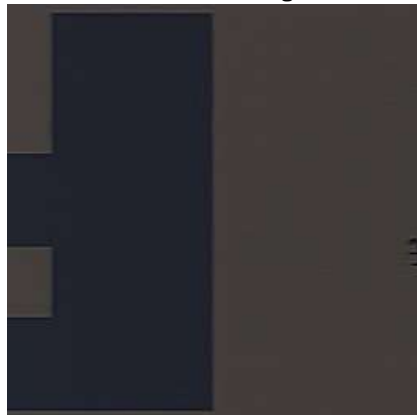
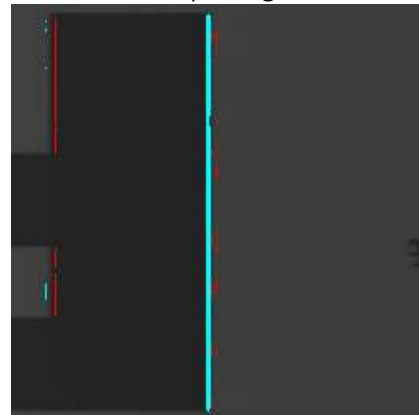
No.	#59, \$56	Date	2023/8/10 上午 09:12:57
Segment	1	Camera	1
Pattern	7810	Position[ x, y ]	446.9 [mm], 5872.7 [m], ( 173.8 [m] )
Type	縱向刀絲疵點	Size	H:0.5 ,V:67.6 [mm]
Result	-	Area	18.8 [mm2]
Inspection level	5/5,5/5,5/5,5/5,5/5	Label	-
Light	6,6,3/6,6,3

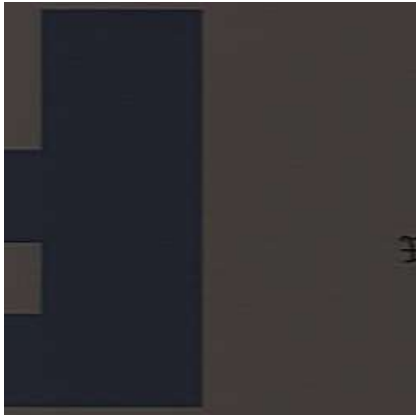
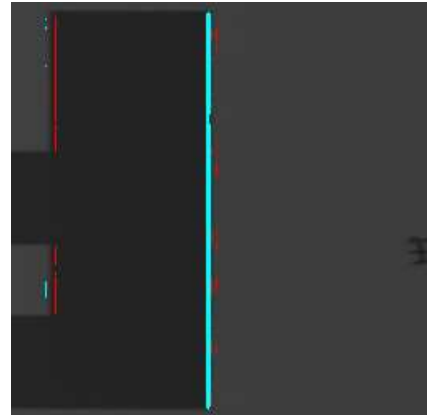
No.	#59, \$56	Date	2023/8/10 上午 09:12:57
Segment	1	Camera	1
Pattern	7810	Position[ x, y ]	126.4 [mm], 5872.7 [m], ( 173.8 [m] )
Type	縱向刀絲疵點	Size	H:0.7 ,V:97.2 [mm]
Result	-	Area	27.5 [mm2]
Inspection level	5/5,5/5,5/5,5/5,5/5	Label	-
Light	6,6,3/6,6,3

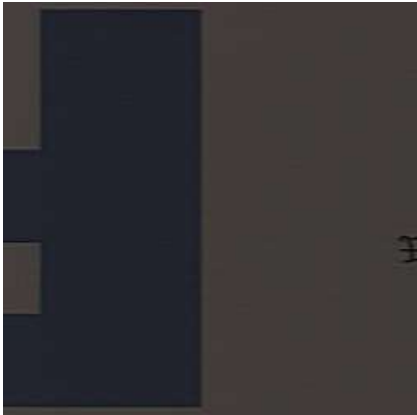
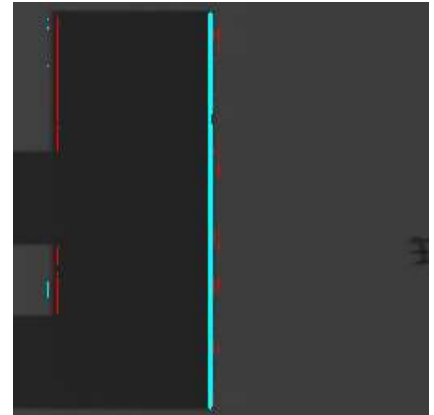
No.	#59, \$56	Date	2023/8/10 上午 09:12:57
Segment	1	Camera	1
Pattern	7810	Position[ x, y ]	446.9 [mm], 5873.1 [m], ( 173.5 [m] )
Type	縱向刀絲疵點	Size	H:0.5 ,V:96.4 [mm]
Result	-	Area	42.9 [mm2]
Inspection level	5/5,5/5,5/5,5/5,5/5	Label	-
Light	6,6,3/6,6,3

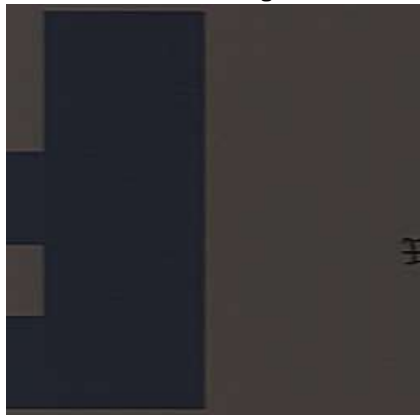
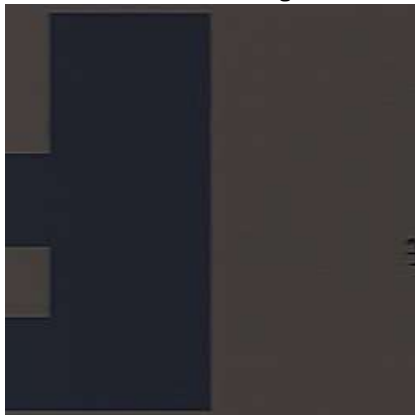
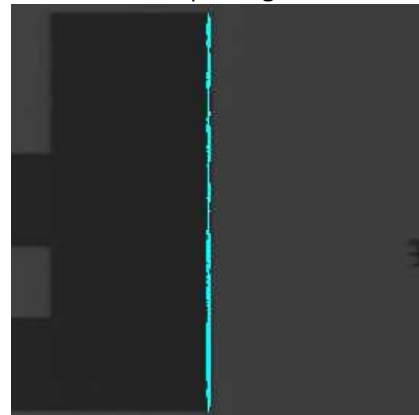
No.	#59, \$56	Date	2023/8/10 上午 09:12:57
Segment	1	Camera	1
Pattern	7810	Position[ x, y ]	126.4 [mm], 5873.1 [m], ( 173.5 [m] )
Type	縱向刀絲疵點	Size	H:0.7 ,V:97.2 [mm]
Result	-	Area	47.9 [mm2]
Inspection level	5/5,5/5,5/5,5/5,5/5	Label	-
Light	6,6,3/6,6,3

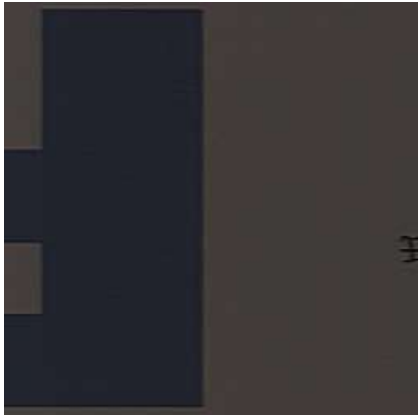
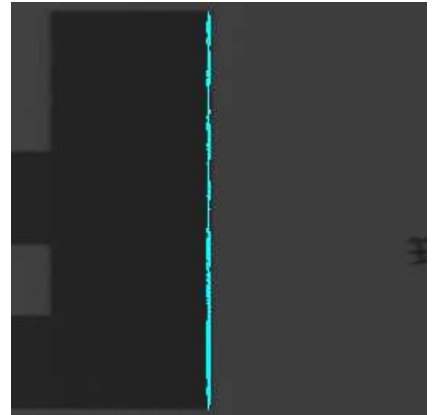
No.	#58, \$55	Date	2023/8/10 上午 09:12:56
Segment	1	Camera	1
Pattern	7809	Position[ x, y ]	446.9 [mm], 5872.0 [m], ( 174.6 [m] )
Type	縱向刀絲疵點	Size	H:0.5 ,V:22.8 [mm]
Result	-	Area	5.3 [mm2]
Inspection level	5/5,5/5,5/5,5/5,5/5	Label	-
Light	6,6,3/6,6,3

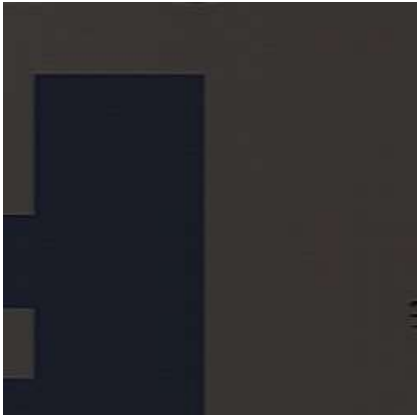
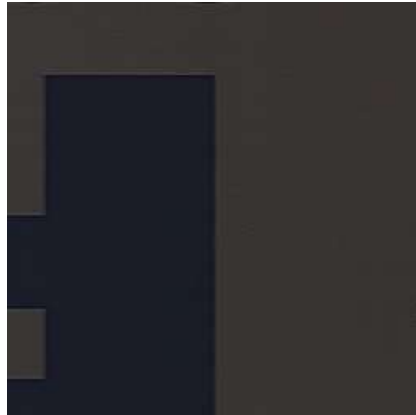
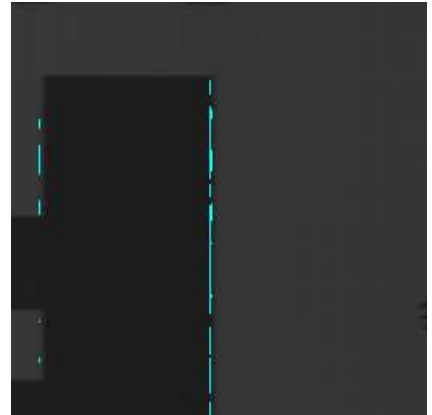
No.	#58, \$55	Date	2023/8/10 上午 09:12:56
Segment	1	Camera	1
Pattern	7809	Position[ x, y ]	446.9 [mm], 5872.3 [m], ( 174.2 [m] )
Type	縱向刀絲疵點	Size	H:0.5 ,V:50.4 [mm]
Result	-	Area	13.5 [mm2]
Inspection level	5/5,5/5,5/5,5/5,5/5	Label	-
Light	6,6,3/6,6,3

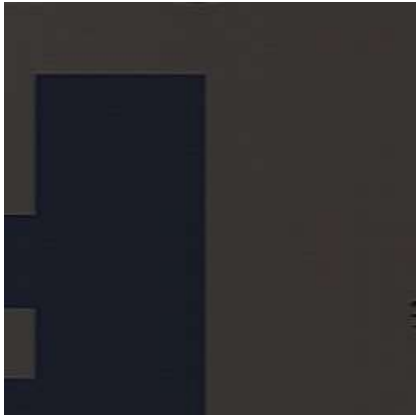
Defect image

No.	#57, \$54	Date	2023/8/10 上午 09:12:56
Segment	1	Camera	1
Pattern	7808	Position[ x, y ]	937.1 [mm], 5871.0 [m], ( 175.6 [m] )
Type	点状疵点	Size	H:0.5 ,V:5.6 [mm]
Result	-	Area	1.2 [mm2]
Inspection level	5/5,5/5,5/5,5/5,5/5	Label	-
Light	6,6,3/6,6,3

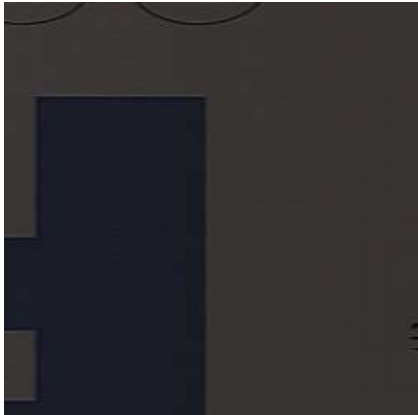
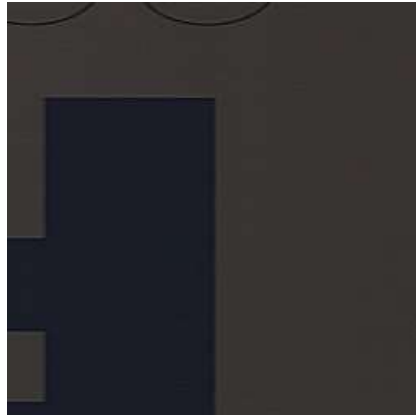
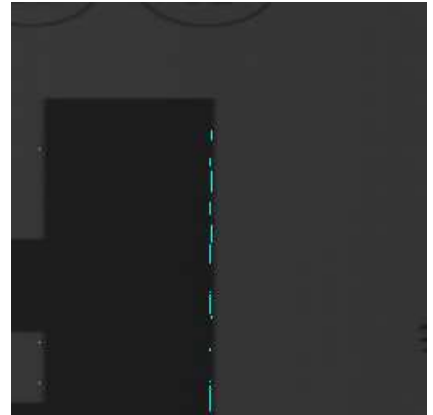
Defect image

No.	#57, \$54	Date	2023/8/10 上午 09:12:56
Segment	1	Camera	1
Pattern	7808	Position[ x, y ]	446.9 [mm], 5871.6 [m], ( 175.0 [m] )
Type	縱向刀絲疵點	Size	H:0.5 ,V:25.2 [mm]
Result	-	Area	3.2 [mm2]
Inspection level	5/5,5/5,5/5,5/5,5/5	Label	-
Light	6,6,3/6,6,3

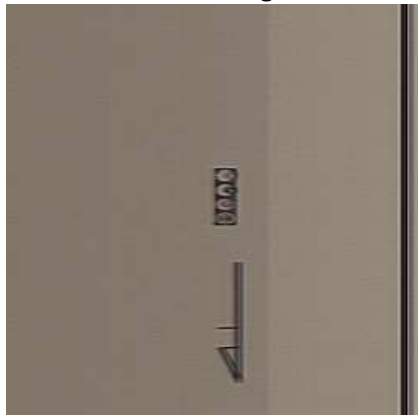
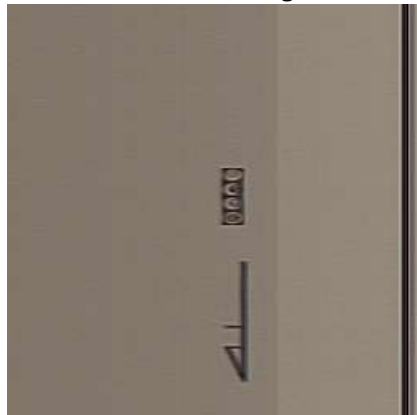
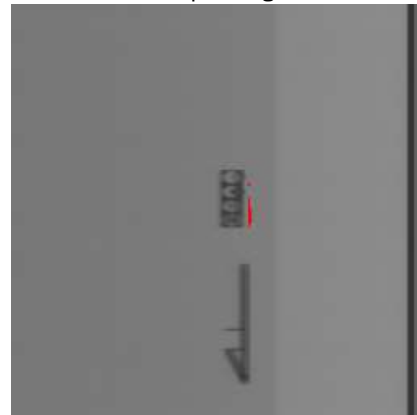
Defect image

No.	#56, \$53	Date	2023/8/10 上午 09:12:54
Segment	1	Camera	1
Pattern	7806	Position[ x, y ]	937.1 [mm], 5869.5 [m], ( 177.1 [m] )
Type	点状疵点	Size	H:0.5 ,V:6.4 [mm]
Result	-	Area	2.2 [mm2]
Inspection level	5/5,5/5,5/5,5/5,5/5	Label	-
Light	6,6,3/6,6,3

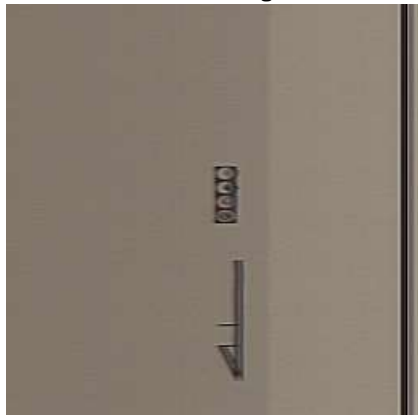
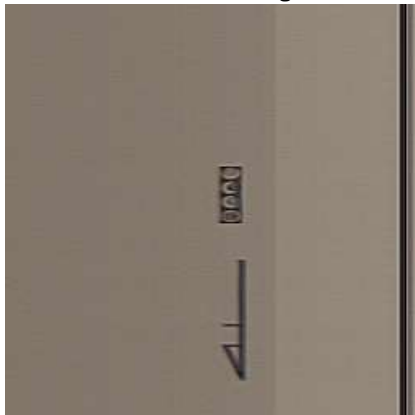
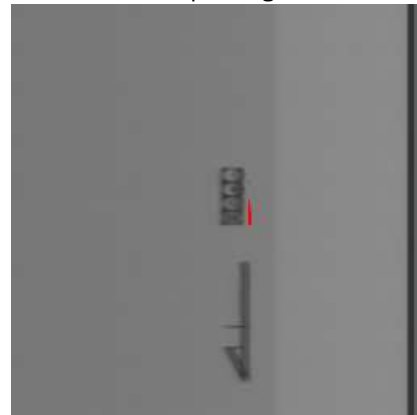
Defect image

No.	#55, \$52	Date	2023/8/10 上午 09:12:54
Segment	1	Camera	1
Pattern	7805	Position[ x, y ]	937.1 [mm], 5868.7 [m], ( 177.8 [m] )
Type	点状疵点	Size	H:0.5 ,V:5.2 [mm]
Result	-	Area	2.0 [mm2]
Inspection level	5/5,5/5,5/5,5/5,5/5	Label	-
Light	6,6,3/6,6,3
