# Inspection Result (Individual Data)

Lot number : 2

Inspected date : 2023/8/10 上午 07:56:43 ~ 2023/8/10 上午 09:15:18

商品名	標準透明6-6-3	周長
顧客名		Ex1
CODE番号		Ex2
基材		Ex3

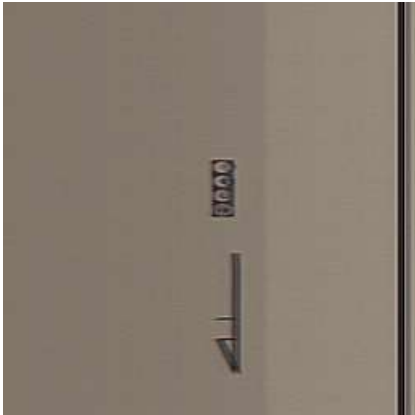
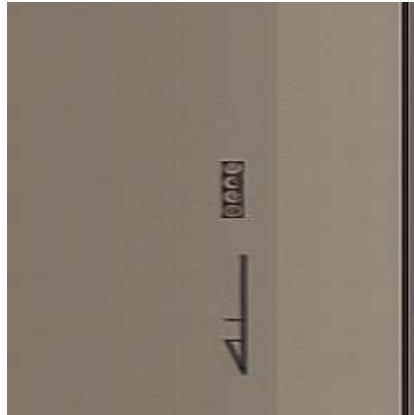
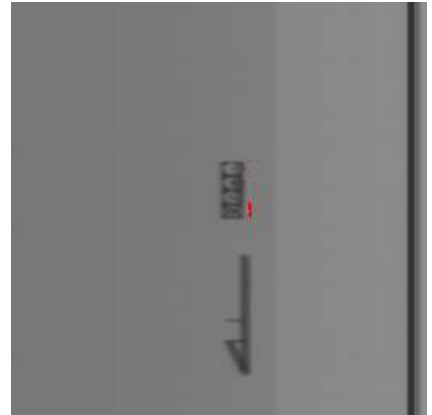
Defect image

No.	#50, \$49	Date	2023/8/10 上午 09:12:41
Segment	1	Camera	1
Pattern	7783	Position[ x, y ]	936.9 [mm], 5852.8 [m], ( 193.7 [m] )
Type	点状疵点	Size	H:1.5 ,V:25.6 [mm]
Result	-	Area	4.1 [mm2]
Inspection level	5/5,5/5,5/5,5/5,5/5	Label	-
Light	6,6,3/6,6,3

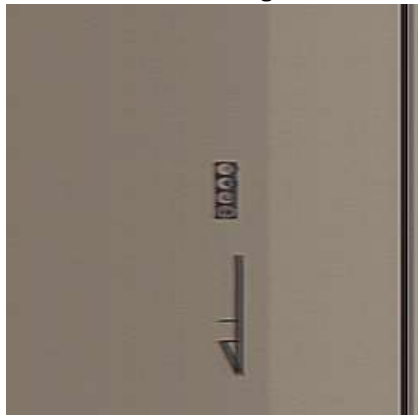
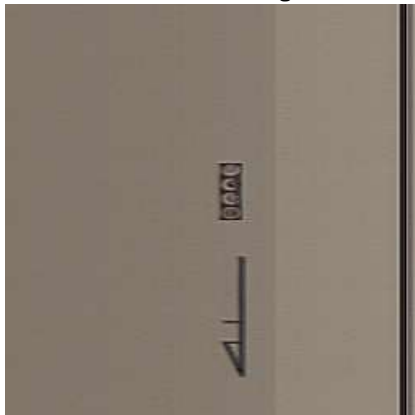
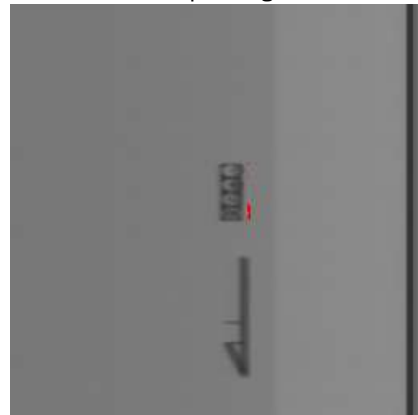
Defect image

No.	#50, \$49	Date	2023/8/10 上午 09:12:41
Segment	1	Camera	1
Pattern	7783	Position[ x, y ]	409.1 [mm], 5852.3 [m], ( 194.3 [m] )
Type	縱向刀絲疵點	Size	H:8.3 ,V:31.6 [mm]
Result	-	Area	4.6 [mm2]
Inspection level	5/5,5/5,5/5,5/5,5/5	Label	-
Light	6,6,3/6,6,3

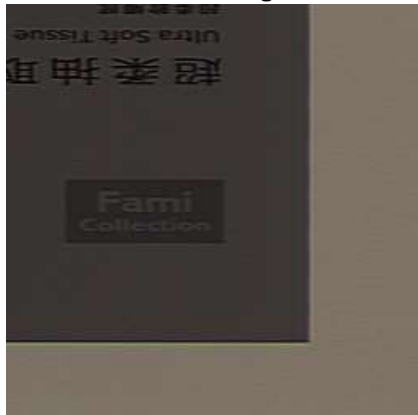
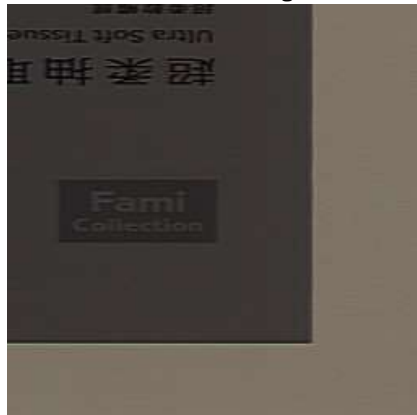
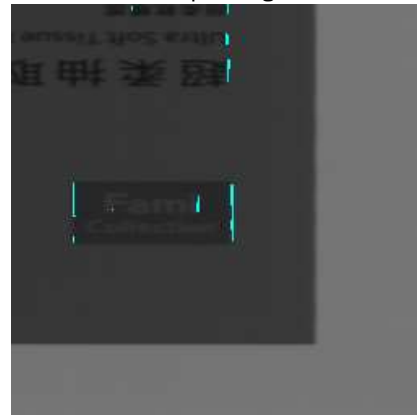
Defect image

No.	#50, \$49	Date	2023/8/10 上午 09:12:41
Segment	1	Camera	1
Pattern	7783	Position[ x, y ]	551.6 [mm], 5852.6 [m], ( 194.0 [m] )
Type	縱向刀絲疵點	Size	H:0.5 ,V:13.2 [mm]
Result	-	Area	4.7 [mm2]
Inspection level	5/5,5/5,5/5,5/5,5/5	Label	-
Light	6,6,3/6,6,3

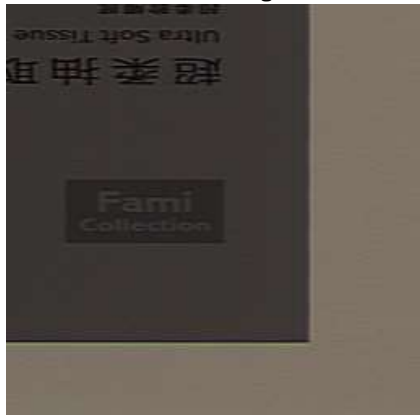
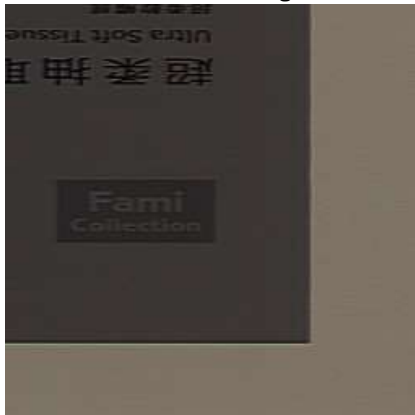
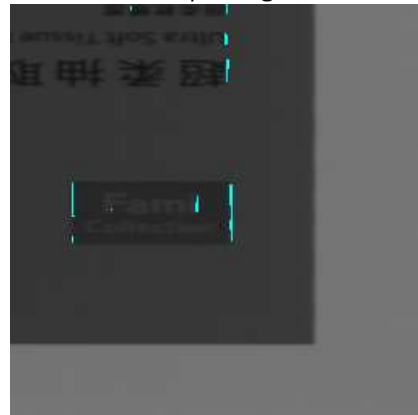
Defect image

No.	#49, \$48	Date	2023/8/10 上午 09:12:40
Segment	1	Camera	1
Pattern	7782	Position[ x, y ]	721.3 [mm], 5851.5 [m], ( 195.0 [m] )
Type	縱向刀絲疵點	Size	H:0.5 ,V:8.4 [mm]
Result	-	Area	3.9 [mm2]
Inspection level	5/5,5/5,5/5,5/5,5/5	Label	-
Light	6,6,3/6,6,3

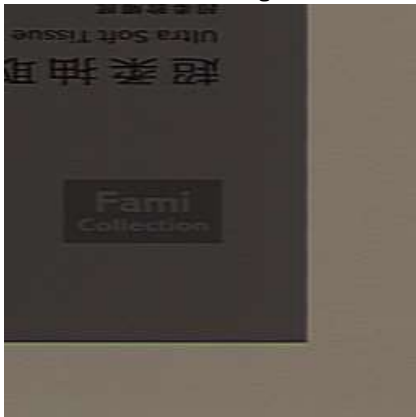
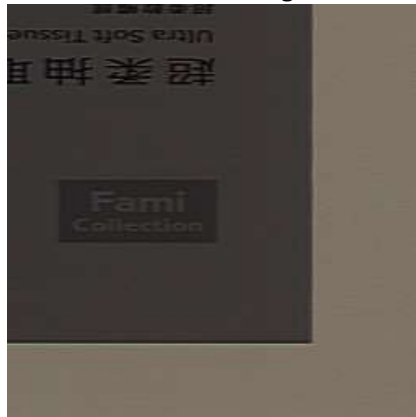
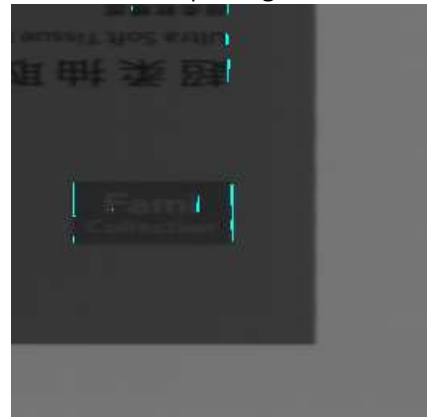
Defect image

No.	#49, \$48	Date	2023/8/10 上午 09:12:40
Segment	1	Camera	1
Pattern	7782	Position[ x, y ]	721.3 [mm], 5851.9 [m], ( 194.6 [m] )
Type	縱向刀絲疵點	Size	H:0.5 ,V:8.8 [mm]
Result	-	Area	4.2 [mm2]
Inspection level	5/5,5/5,5/5,5/5,5/5	Label	-
Light	6,6,3/6,6,3

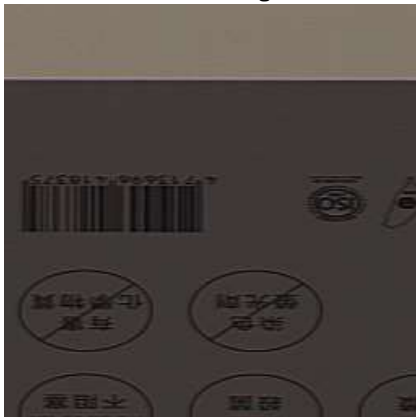
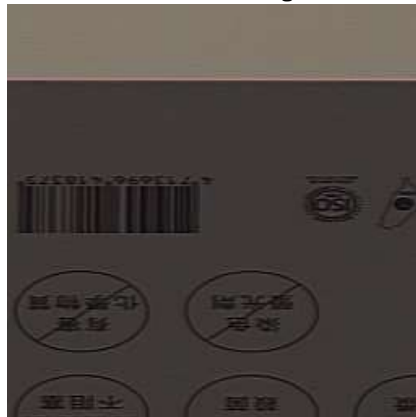
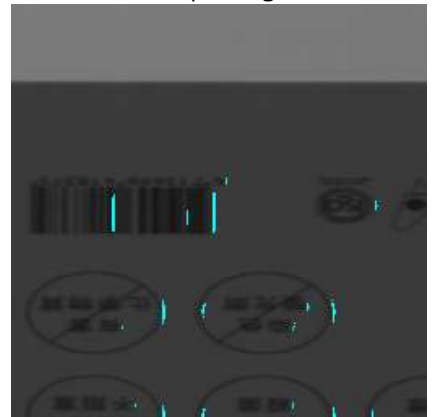
Defect image

No.	#49, \$48	Date	2023/8/10 上午 09:12:40
Segment	1	Camera	1
Pattern	7782	Position[ x, y ]	736.5 [mm], 5851.5 [m], ( 195.0 [m] )
Type	縱向刀絲疵點	Size	H:0.5 ,V:9.2 [mm]
Result	-	Area	4.4 [mm2]
Inspection level	5/5,5/5,5/5,5/5,5/5	Label	-
Light	6,6,3/6,6,3

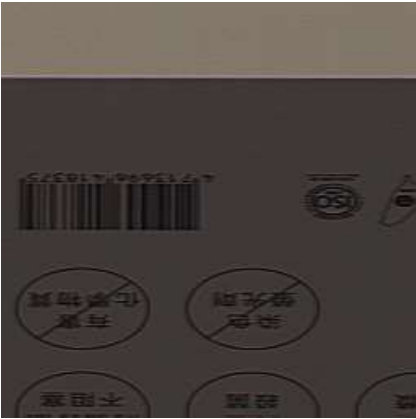
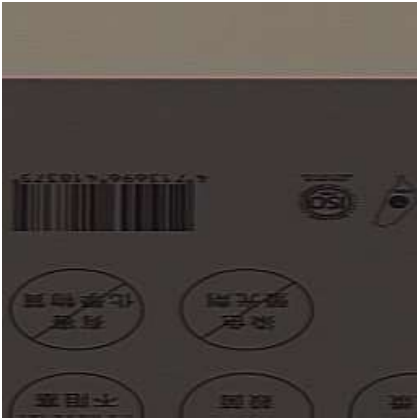
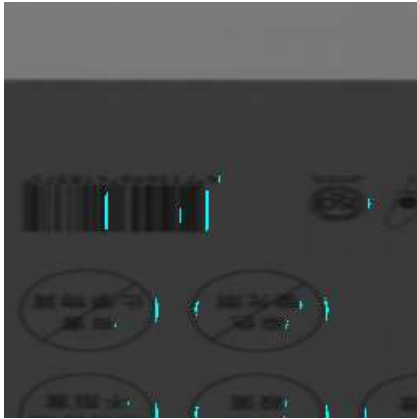
Defect image	Reference image	Shape image

No.	#48, \$47	Date	2023/8/10 上午 09:12:40
Segment	1	Camera	1
Pattern	7781	Position[ x, y ]	736.5 [mm], 5850.8 [m], ( 195.8 [m] )
Type	縱向刀絲疵點	Size	H:0.5 ,V:9.2 [mm]
Result	-	Area	3.4 [mm2]
Inspection level	5/5,5/5,5/5,5/5,5/5	Label	-
Light	6,6,3/6,6,3

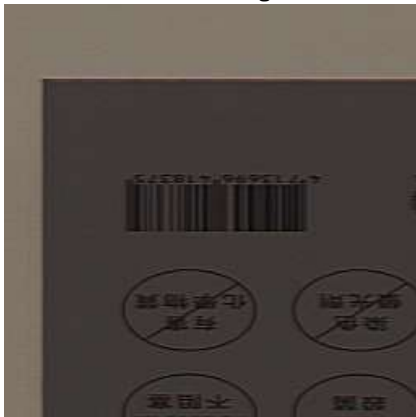
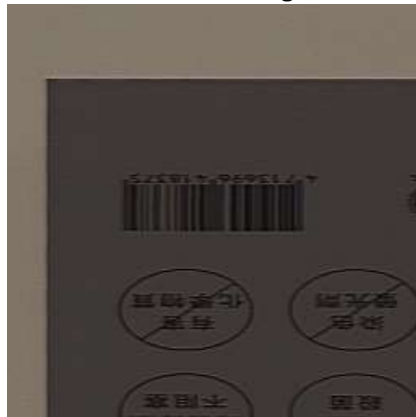
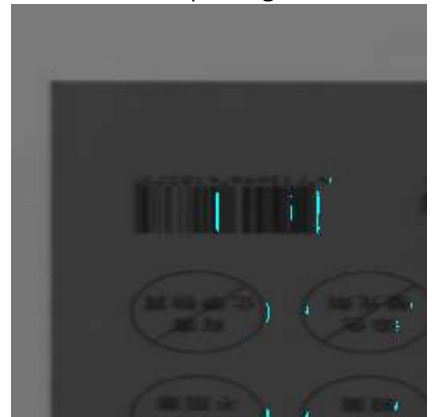
No.	#48, \$47	Date	2023/8/10 上午 09:12:40
Segment	1	Camera	1
Pattern	7781	Position[ x, y ]	721.3 [mm], 5851.2 [m], ( 195.4 [m] )
Type	縱向刀絲疵點	Size	H:0.5 ,V:8.8 [mm]
Result	-	Area	4.2 [mm2]
Inspection level	5/5,5/5,5/5,5/5,5/5	Label	-
Light	6,6,3/6,6,3

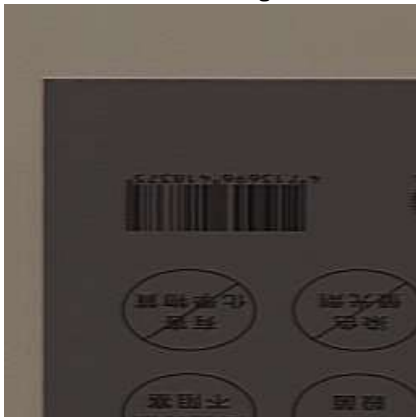
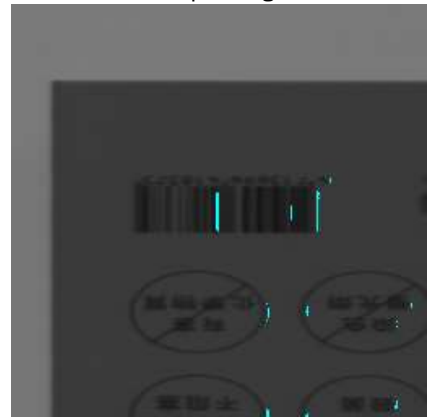
No.	#46, \$45	Date	2023/8/10 上午 09:12:39
Segment	1	Camera	1
Pattern	7779	Position[ x, y ]	721.3 [mm], 5849.3 [m], ( 197.3 [m] )
Type	縱向刀絲疵點	Size	H:0.5 ,V:6.4 [mm]
Result	-	Area	2.1 [mm2]
Inspection level	5/5,5/5,5/5,5,5/5,5/5	Label	-
Light	6,6,3/6,6,3

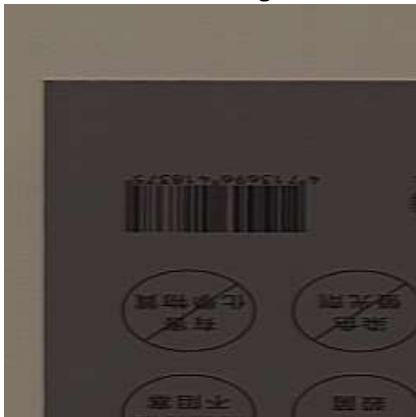
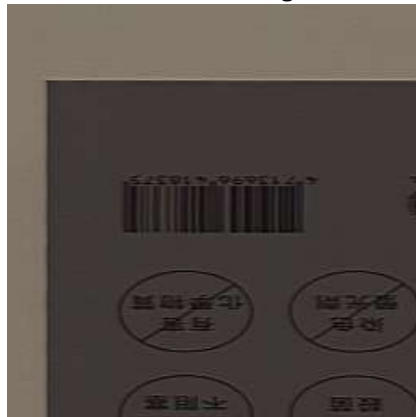
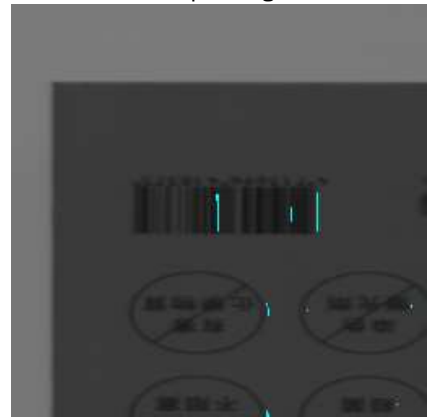
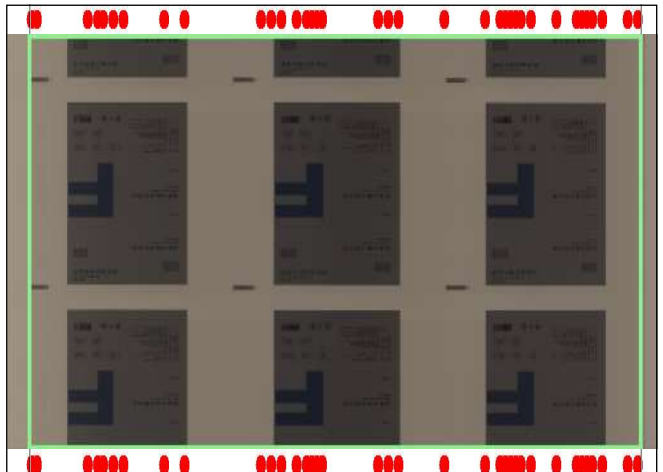
No.	#46, \$45	Date	2023/8/10 上午 09:12:39
Segment	1	Camera	1
Pattern	7779	Position[ x, y ]	721.3 [mm], 5849.7 [m], ( 196.9 [m] )
Type	縱向刀絲疵點	Size	H:0.5 ,V:8.4 [mm]
Result	-	Area	2.2 [mm2]
Inspection level	5/5,5/5,5/5,5/5,5/5	Label	-
Light	6,6,3/6,6,3

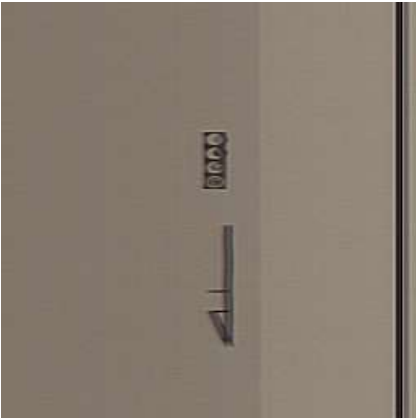
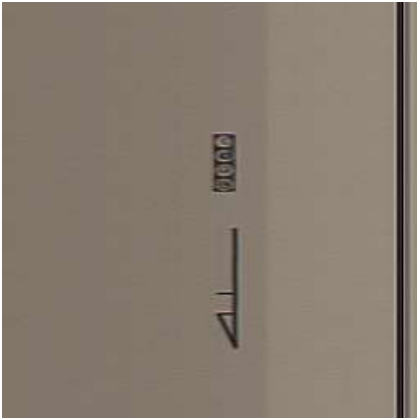
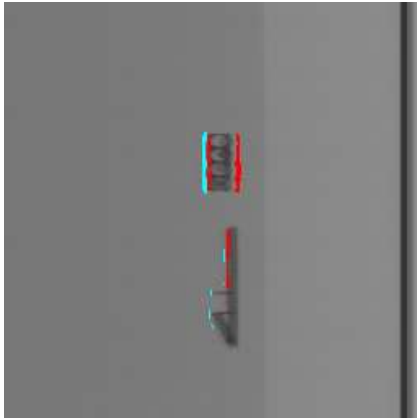
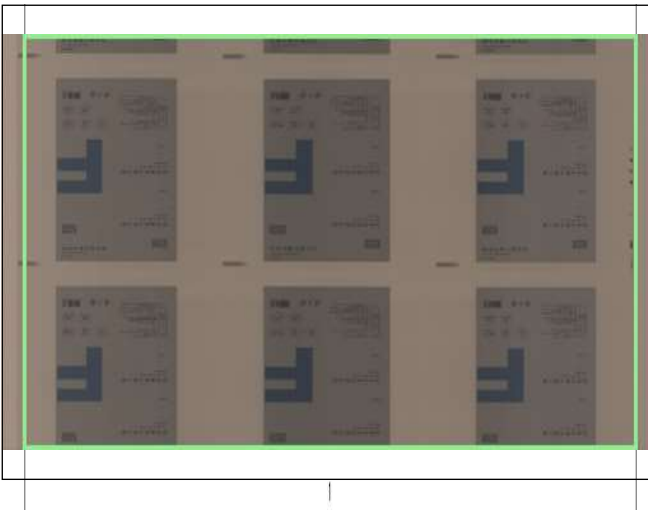
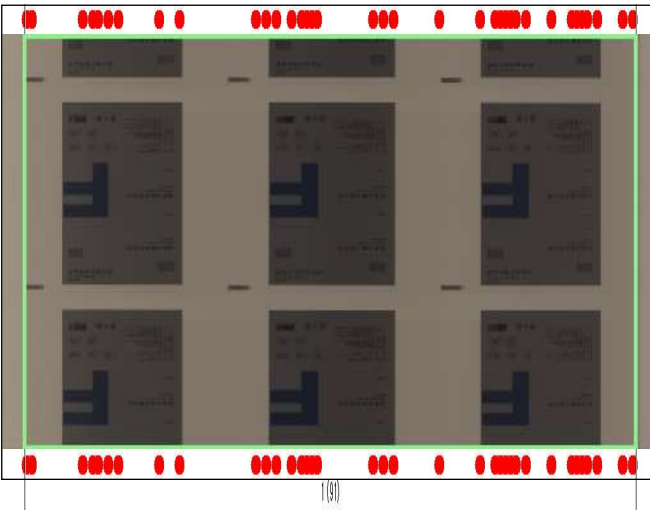
No.	#44, \$43	Date	2023/8/10 上午 09:12:28
Segment	1	Camera	1
Pattern	7761	Position[ x, y ]	857.1 [mm], 5836.1 [m], ( 210.5 [m] )
Type	点状疵点	Size	H:1.5 ,V:22.0 [mm]
Result	-	Area	16.7 [mm2]
Inspection level	5/5,5/5,5/5,5/5,5/5	Label	-
Light	6,6,3/6,6,3

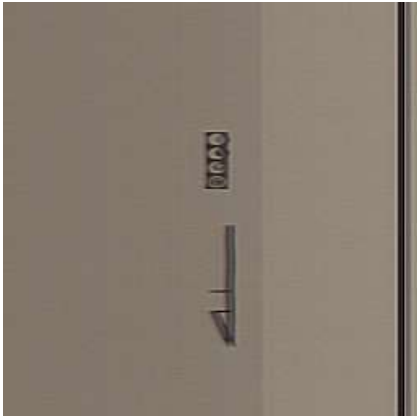
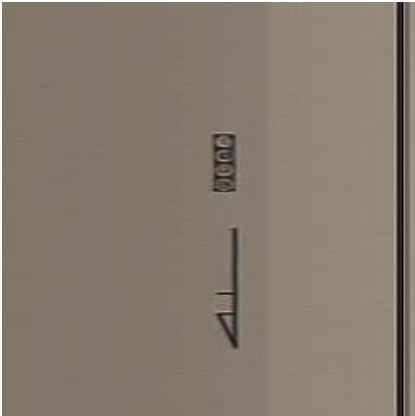
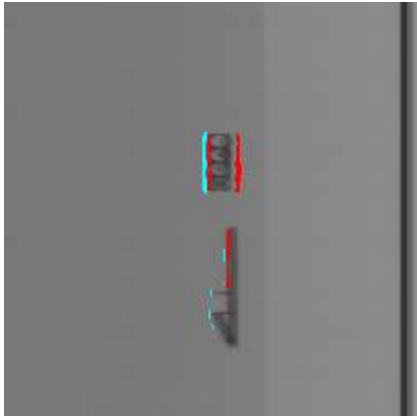
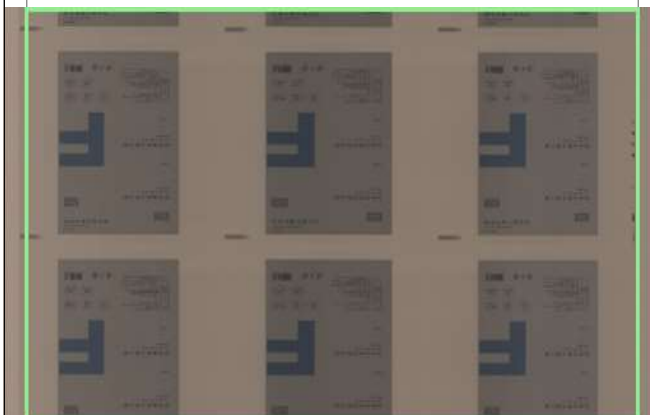
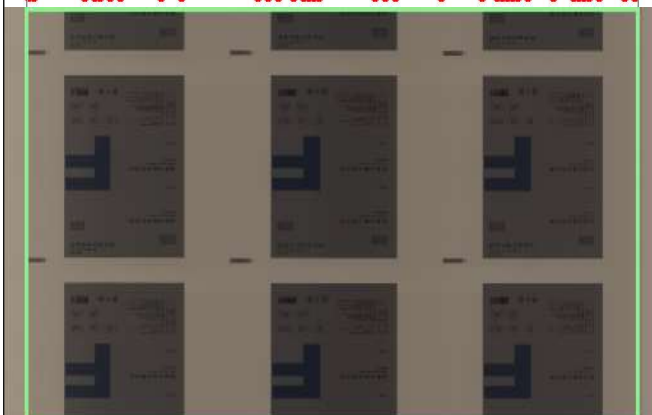
No.	#44, \$43	Date	2023/8/10 上午 09:12:28
Segment	1	Camera	1
Pattern	7761	Position[ x, y ]	862.7 [mm], 5836.3 [m], ( 210.3 [m] )
Type	点状疵点縱向刀絲疵點	Size	H:5.4 ,V:104.4 [mm]
Result	-	Area	42.2 [mm2]
Inspection level	5/5,5/5,5/5,5/5,5/5	Label	-
Light	6,6,3/6,6,3

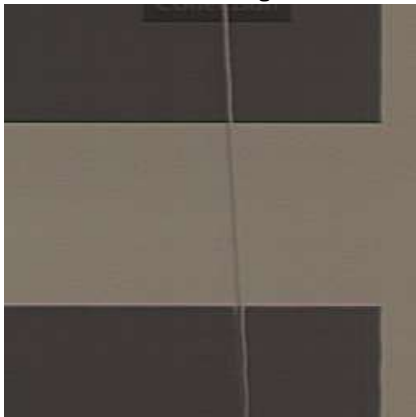
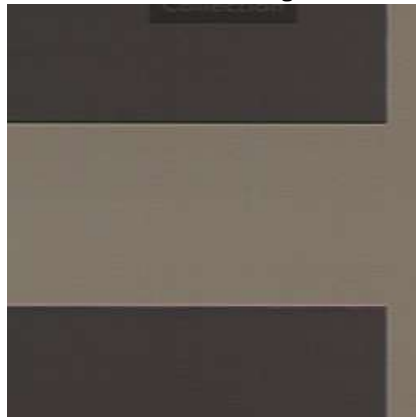
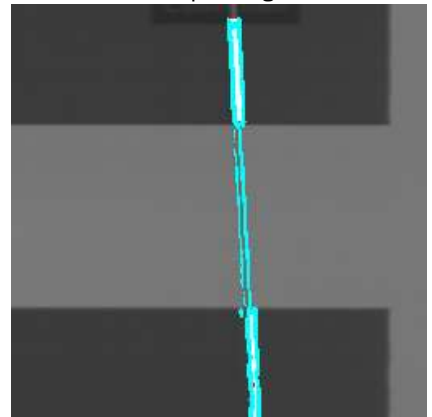
No.	#44, \$43	Date	2023/8/10 上午 09:12:28
Segment	1	Camera	1
Pattern	7761	Position[ x, y ]	855.6 [mm], 5836.0 [m], ( 210.5 [m] )
Type	点状疵点縱向刀絲疵點	Size	H:12.5 ,V:352.4 [mm]
Result	-	Area	146.1 [mm2]
Inspection level	5/5,5/5,5/5,5/5,5/5	Label	-
Light	6,6,3/6,6,3

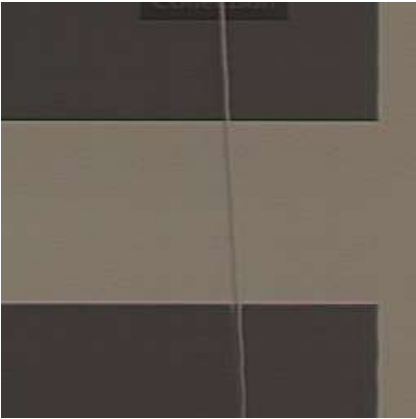
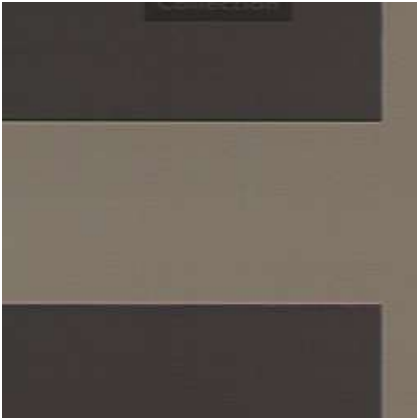
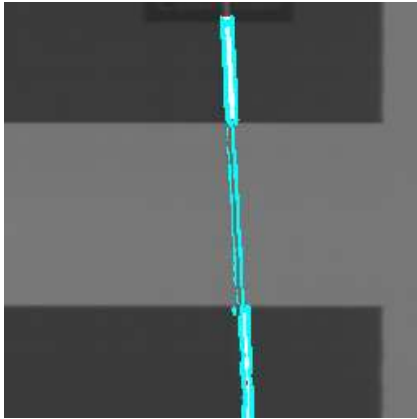
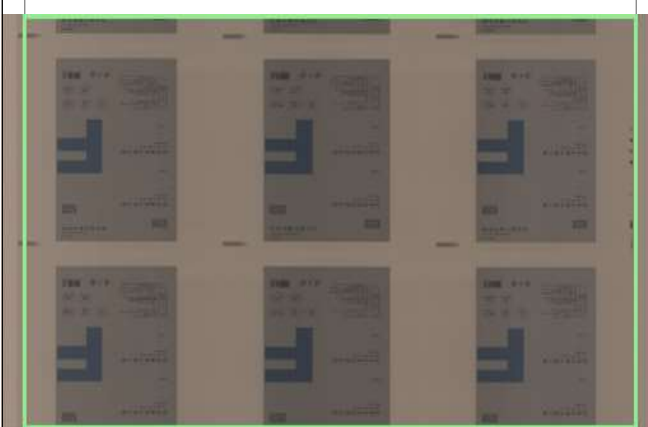
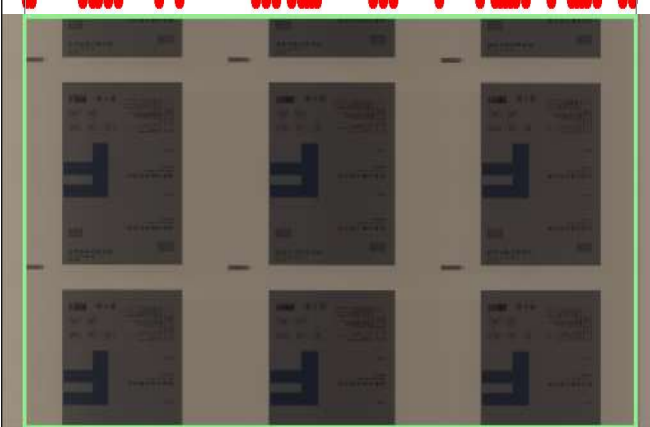
No.	#43, \$42	Date	2023/8/10 上午 09:12:28
Segment	1	Camera	1
Pattern	7760	Position[ x, y ]	841.2 [mm], 5835.2 [m], ( 211.3 [m] )
Type	点状疵点	Size	H:2.7 ,V:4.8 [mm]
Result	-	Area	3.1 [mm2]
Inspection level	5/5,5/5,5/5,5/5,5/5	Label	-
Light	6,6,3/6,6,3

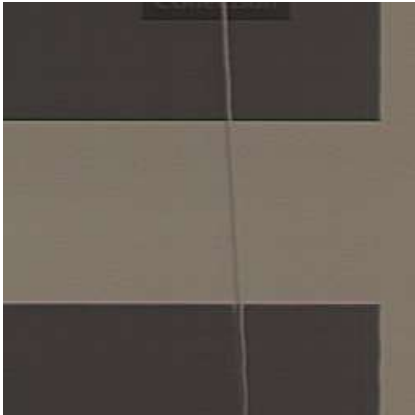
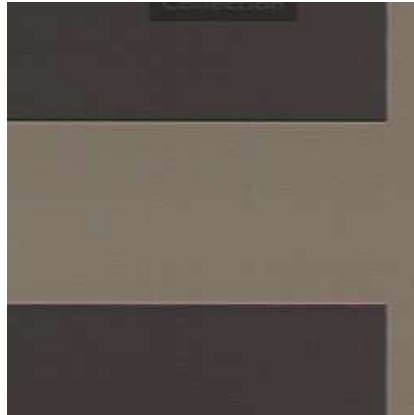
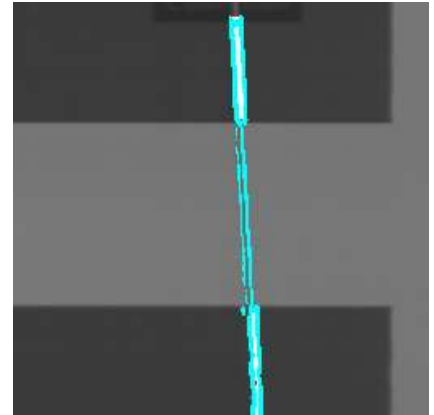
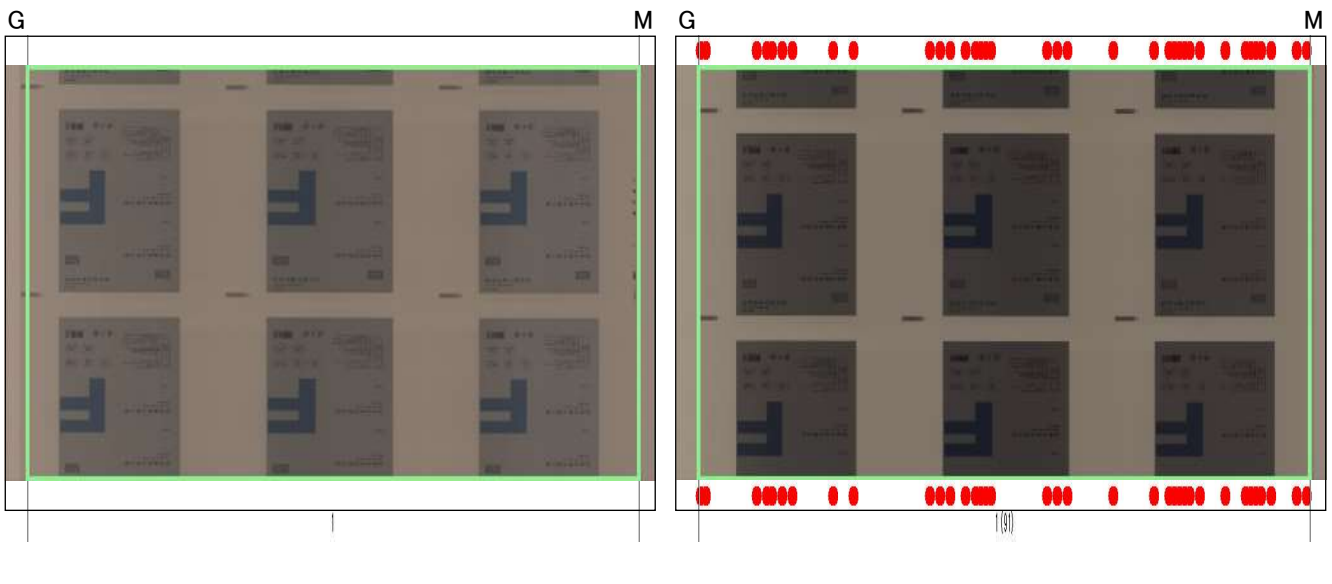
No.	#43, \$42	Date	2023/8/10 上午 09:12:28
Segment	1	Camera	1
Pattern	7760	Position[ x, y ]	840.0 [mm], 5835.5 [m], ( 211.0 [m] )
Type	点状疵点	Size	H:9.0 ,V:5.2 [mm]
Result	-	Area	4.9 [mm2]
Inspection level	5/5,5/5,5/5,5/5,5/5	Label	-
Light	6,6,3/6,6,3

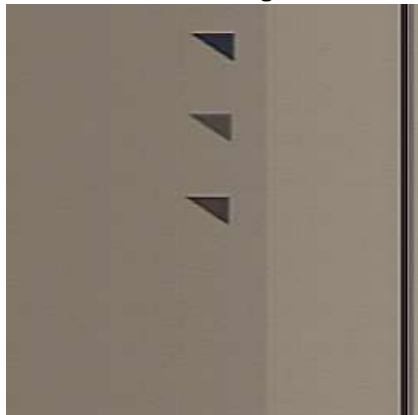
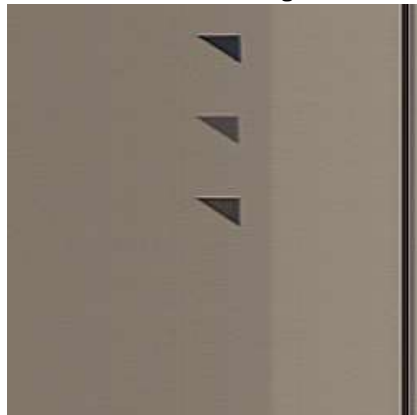
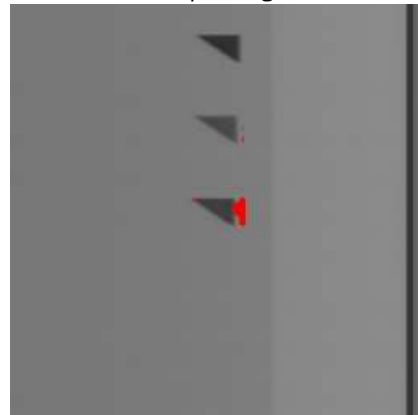
Defect image

No.	#43, \$42	Date	2023/8/10 上午 09:12:28
Segment	1	Camera	1
Pattern	7760	Position[ x, y ]	935.9 [mm], 5835.5 [m], ( 211.0 [m] )
Type	点状疵点	Size	H:2.0 ,V:6.4 [mm]
Result	-	Area	8.5 [mm2]
Inspection level	5/5,5/5,5/5,5/5,5/5	Label	-
Light	6,6,3/6,6,3

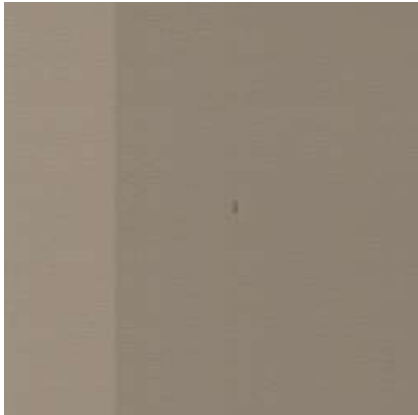
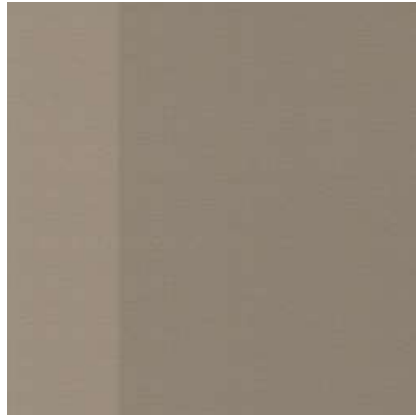
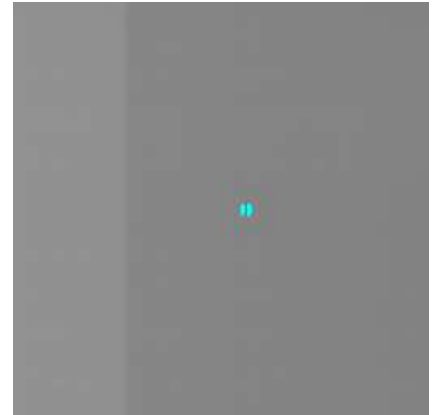
Defect image

No.	#42, \$41	Date	2023/8/10 上午 09:05:21
Segment	1	Camera	1
Pattern	7030	Position[ x, y ]	14.3 [mm], 5286.9 [m], ( 759.7 [m] )
Type	縱向刀絲疵點	Size	H:1.7 ,V:2.4 [mm]
Result	-	Area	3.3 [mm2]
Inspection level	5/5,5/5,5/5,5/5,5/5	Label	-
Light	6,6,3/6,6,3

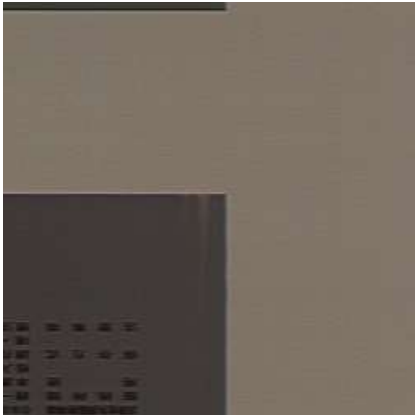
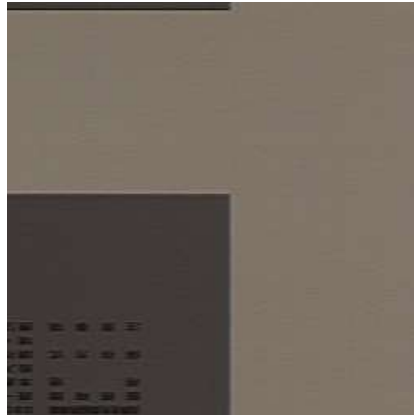
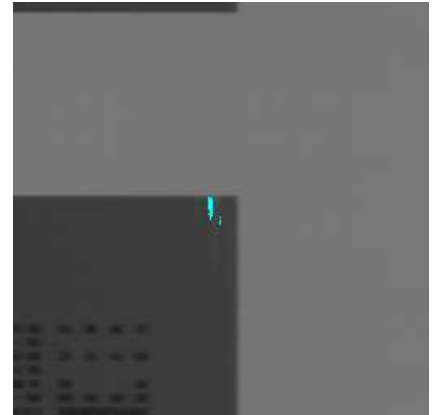
Defect image

No.	#41, \$40	Date	2023/8/10 上午 08:29:57
Segment	1	Camera	1
Pattern	3398	Position[ x, y ]	876.4 [mm], 2558.2 [m], ( 3488.4 [m] )
Type	縱向刀絲疵點	Size	H:2.0 ,V:6.0 [mm]
Result	-	Area	3.1 [mm2]
Inspection level	5/5,5/5,5/5,5/5,5/5	Label	-
Light	6,6,3/6,6,3

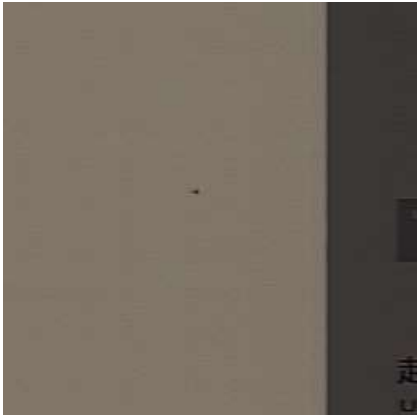
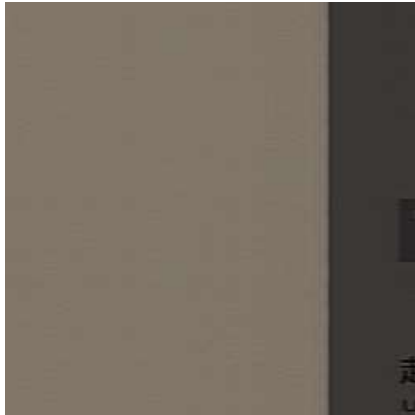
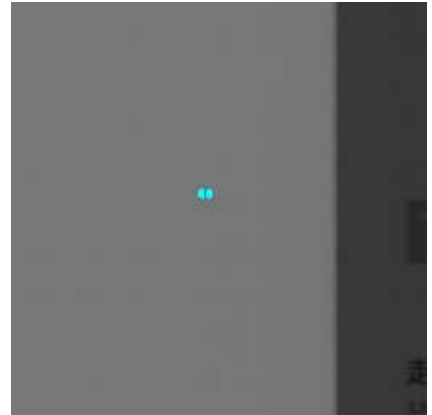
Defect image

No.	#40, \$39	Date	2023/8/10 上午 08:26:07
Segment	1	Camera	1
Pattern	3005	Position[ x, y ]	352.4 [mm], 2262.9 [m], ( 3783.7 [m] )
Type	縱向刀絲疵點	Size	H:2.2 ,V:1.6 [mm]
Result	-	Area	2.9 [mm2]
Inspection level	5/5,5/5,5/5,5/5,5/5	Label	-
Light	6,6,3/6,6,3

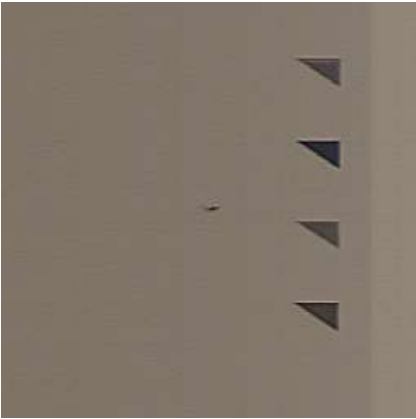
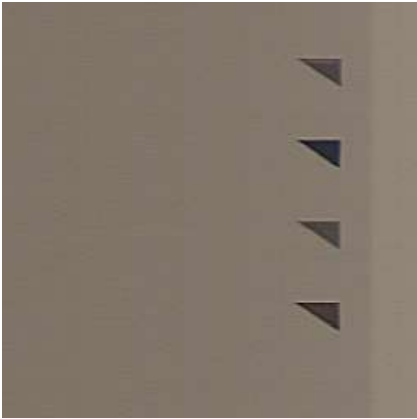
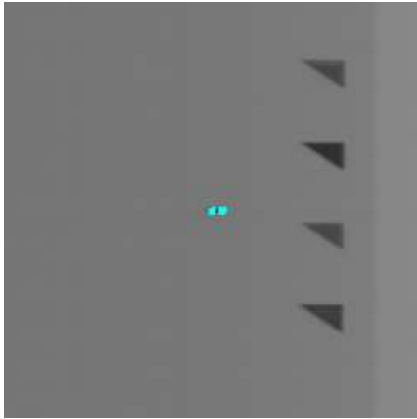
Defect image	Reference image	Shape image

No.	#39, \$38	Date	2023/8/10 上午 08:23:35
Segment	1	Camera	1
Pattern	2744	Position[ x, y ]	917.9 [mm], 2067.5 [m], ( 3979.1 [m] )
Type	縱向刀絲疵點	Size	H:2.7 ,V:1.2 [mm]
Result	-	Area	2.4 [mm2]
Inspection level	5/5,5/5,5/5,5/5,5/5	Label	-
Light	6,6,3/6,6,3

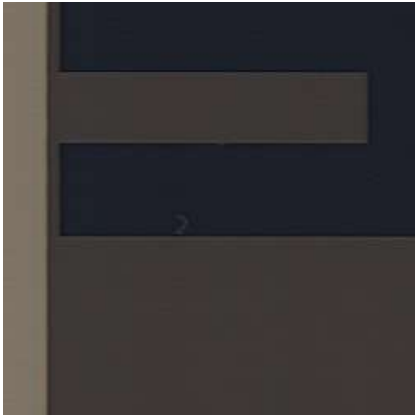
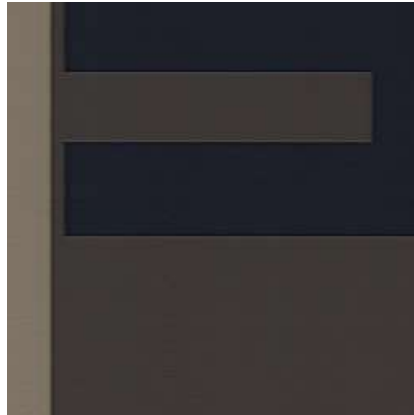
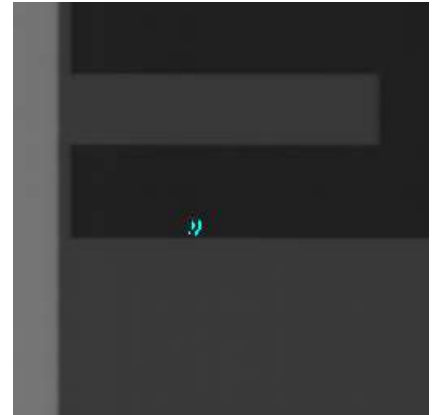
Defect image

No.	#37, \$36	Date	2023/8/10 上午 08:05:27
Segment	1	Camera	1
Pattern	887	Position[ x, y ]	717.9 [mm], 672.7 [m], ( 5373.9 [m] )
Type	縱向刀絲疵點	Size	H:1.5 ,V:3.2 [mm]
Result	-	Area	2.1 [mm2]
Inspection level	5/5,5/5,5/5,5/5,5/5	Label	-
Light	6,6,3/6,6,3

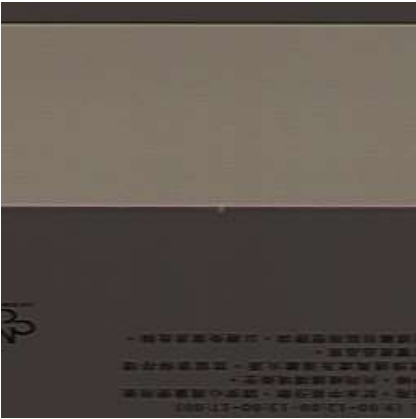
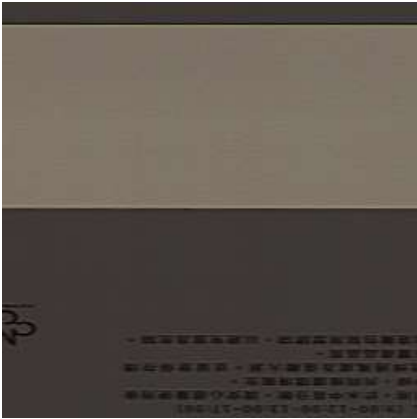
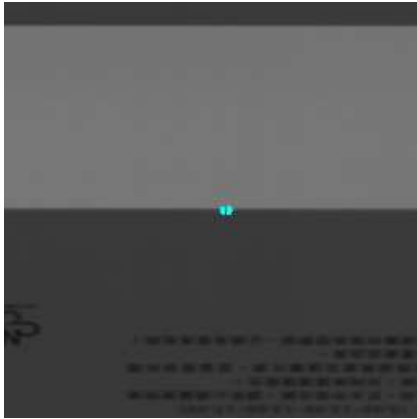
Defect image	Reference image	Shape image

No.	#35, \$34	Date	2023/8/10 上午 07:58:17
Segment	1	Camera	1
Pattern	160	Position[ x, y ]	809.7 [mm], 126.9 [m], ( 5919.7 [m] )
Type	縱向刀絲疵點	Size	H:2.0 ,V:1.6 [mm]
Result	-	Area	2.2 [mm2]
Inspection level	5/5,5/5,5/5,5/5,5/5	Label	-
Light	6,6,3/6,6,3

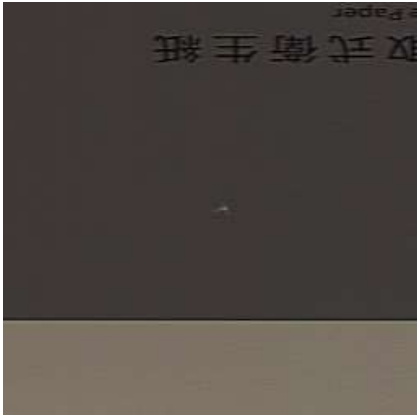
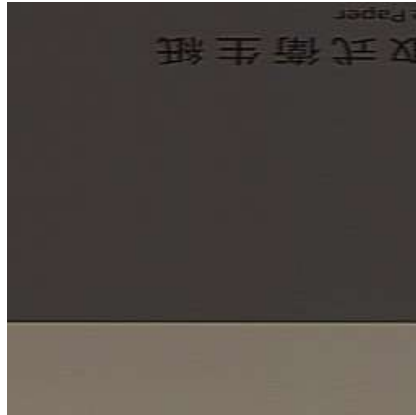
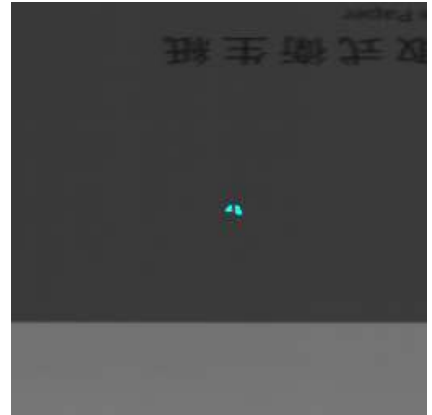
Defect image

No.	#34, \$33	Date	2023/8/10 上午 07:57:49
Segment	1	Camera	1
Pattern	113	Position[ x, y ]	809.9 [mm], 91.2 [m], ( 5955.4 [m] )
Type	縱向刀絲疵點	Size	H:2.4 ,V:1.6 [mm]
Result	-	Area	2.1 [mm2]
Inspection level	5/5,5/5,5/5,5/5,5/5	Label	-
Light	6,6,3/6,6,3

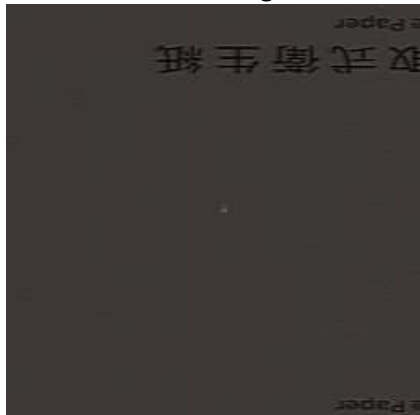
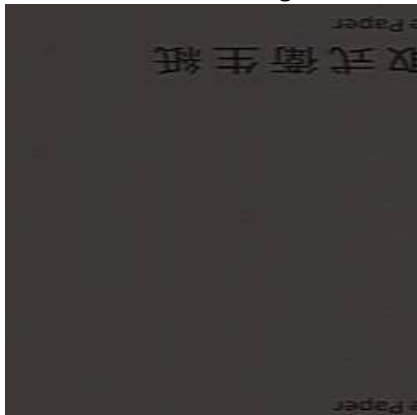
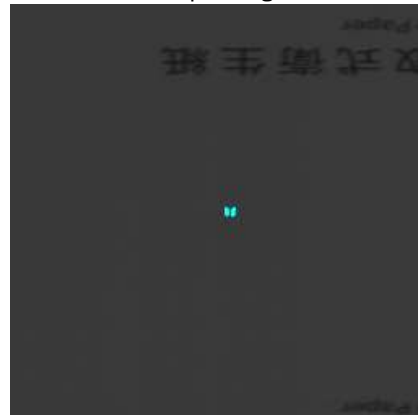
Defect image

No.	#32, \$31	Date	2023/8/10 上午 07:57:44
Segment	1	Camera	1
Pattern	105	Position[ x, y ]	809.2 [mm], 85.5 [m], ( 5961.1 [m] )
Type	縱向刀絲疵點	Size	H:1.7 ,V:1.6 [mm]
Result	-	Area	2.3 [mm2]
Inspection level	5/5,5/5,5/5,5/5,5/5	Label	-
Light	6,6,3/6,6,3

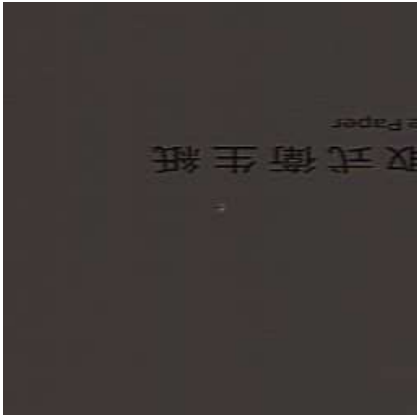
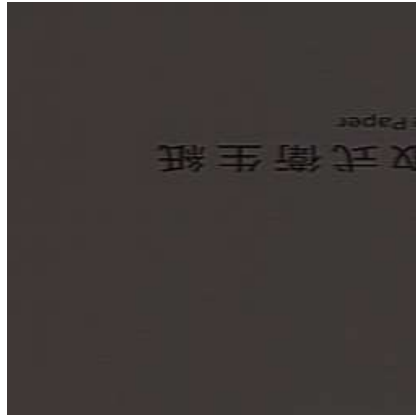
Defect image

No.	#31, \$30	Date	2023/8/10 上午 07:57:43
Segment	1	Camera	1
Pattern	103	Position[ x, y ]	809.5 [mm], 84.1 [m], ( 5962.5 [m] )
Type	縱向刀絲疵點	Size	H:2.0 ,V:1.2 [mm]
Result	-	Area	2.0 [mm2]
Inspection level	5/5,5/5,5/5,5/5,5/5	Label	-
Light	6,6,3/6,6,3

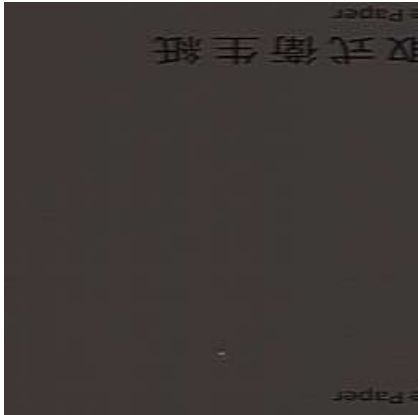
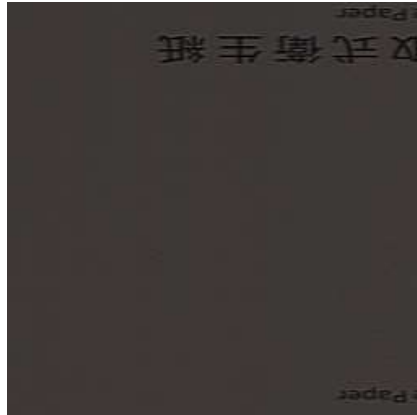
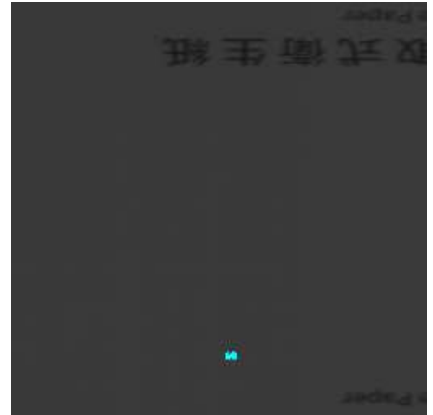
Defect image

No.	#30, \$29	Date	2023/8/10 上午 07:57:37
Segment	1	Camera	1
Pattern	93	Position[ x, y ]	809.5 [mm], 76.9 [m], ( 5969.7 [m] )
Type	縱向刀絲疵點	Size	H:1.7 ,V:1.2 [mm]
Result	-	Area	2.0 [mm2]
Inspection level	5/5,5/5,5/5,5/5,5/5	Label	-
Light	6,6,3/6,6,3

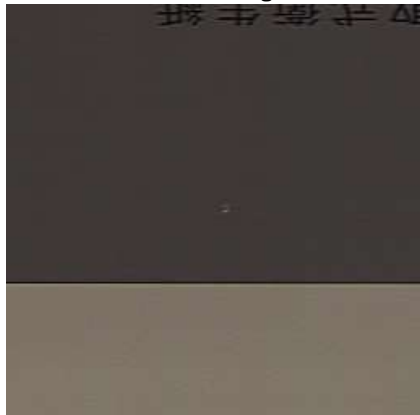
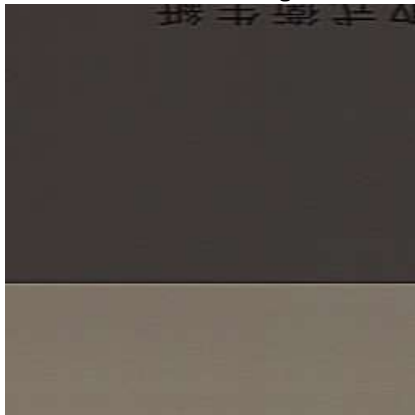
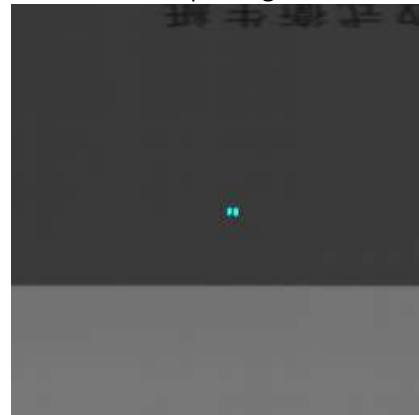
Defect image

No.	#29, \$28	Date	2023/8/10 上午 07:57:37
Segment	1	Camera	1
Pattern	92	Position[ x, y ]	809.7 [mm], 75.5 [m], ( 5971.1 [m] )
Type	縱向刀絲疵點	Size	H:1.7 ,V:1.6 [mm]
Result	-	Area	2.0 [mm2]
Inspection level	5/5,5/5,5/5,5/5,5/5	Label	-
Light	6,6,3/6,6,3

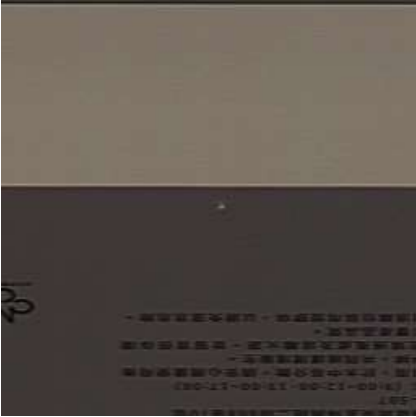
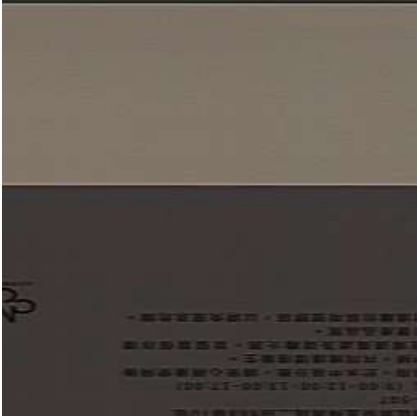
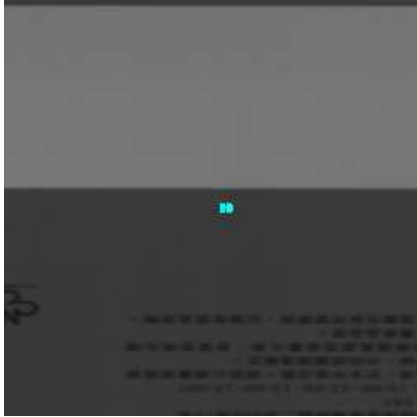
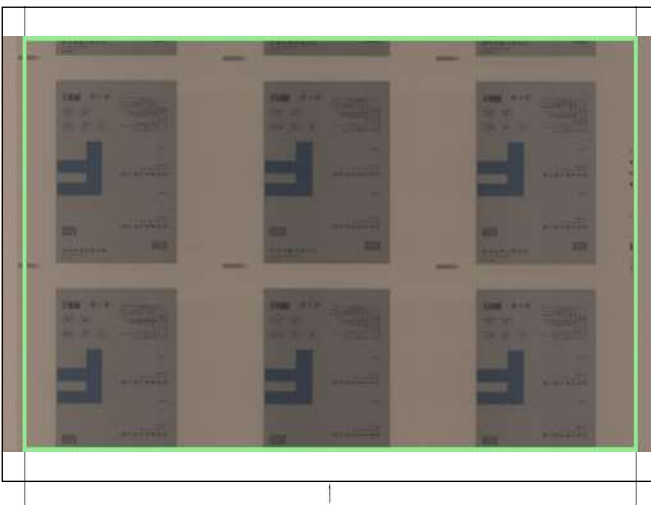
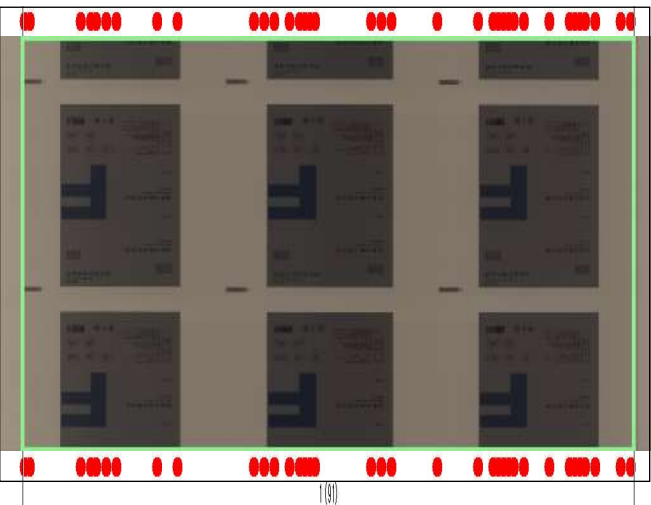
Defect image	Reference image	Shape image

No.	#28, \$27	Date	2023/8/10 上午 07:57:35
Segment	1	Camera	1
Pattern	90	Position[ x, y ]	809.7 [mm], 74.0 [m], ( 5972.5 [m] )
Type	縱向刀絲疵點	Size	H:2.0 ,V:1.6 [mm]
Result	-	Area	2.8 [mm2]
Inspection level	5/5,5/5,5/5,5/5,5/5	Label	-
Light	6,6,3/6,6,3

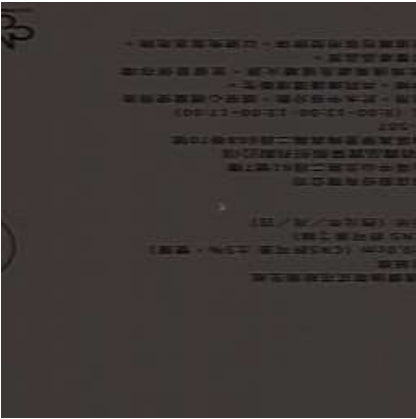
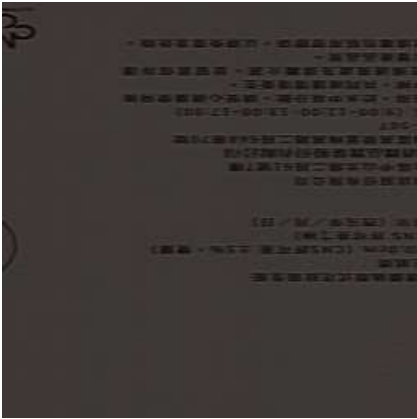
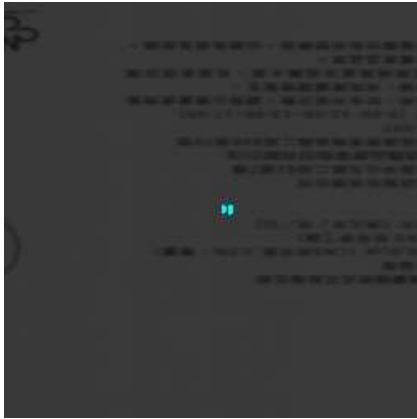
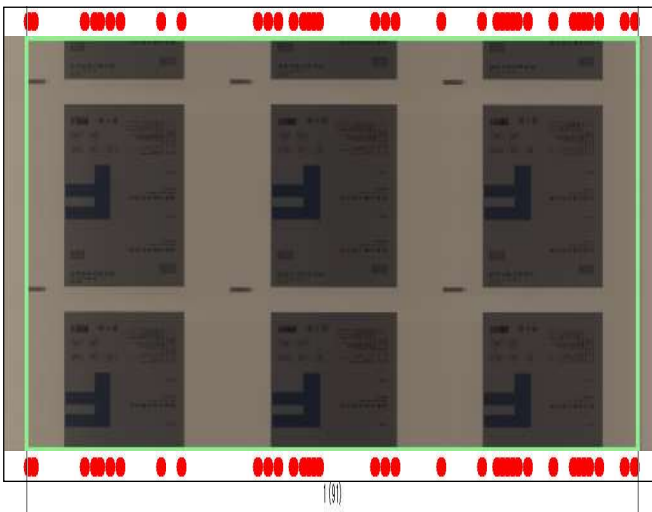
Defect image	Reference image	Shape image

No.	#27, \$26	Date	2023/8/10 上午 07:57:34
Segment	1	Camera	1
Pattern	88	Position[ x, y ]	809.9 [mm], 72.6 [m], ( 5974.0 [m] )
Type	縱向刀絲疵點	Size	H:1.7 ,V:1.6 [mm]
Result	-	Area	2.1 [mm2]
Inspection level	5/5,5/5,5/5,5/5,5/5	Label	-
Light	6,6,3/6,6,3

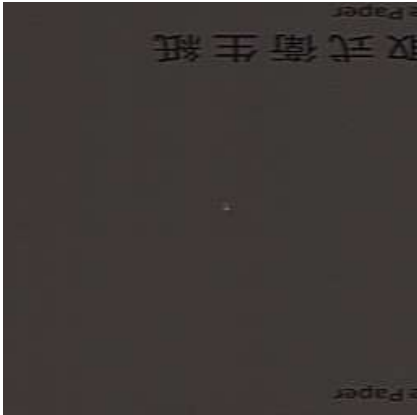
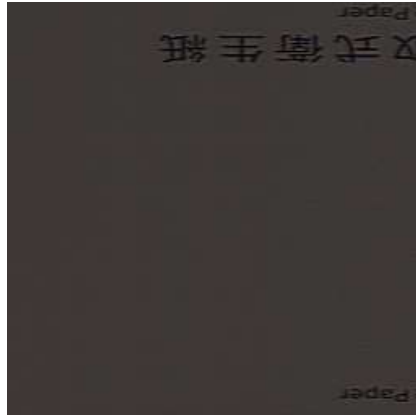
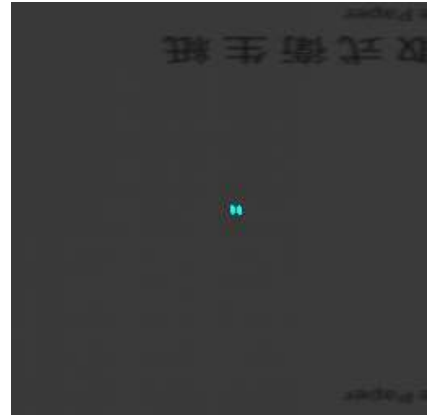
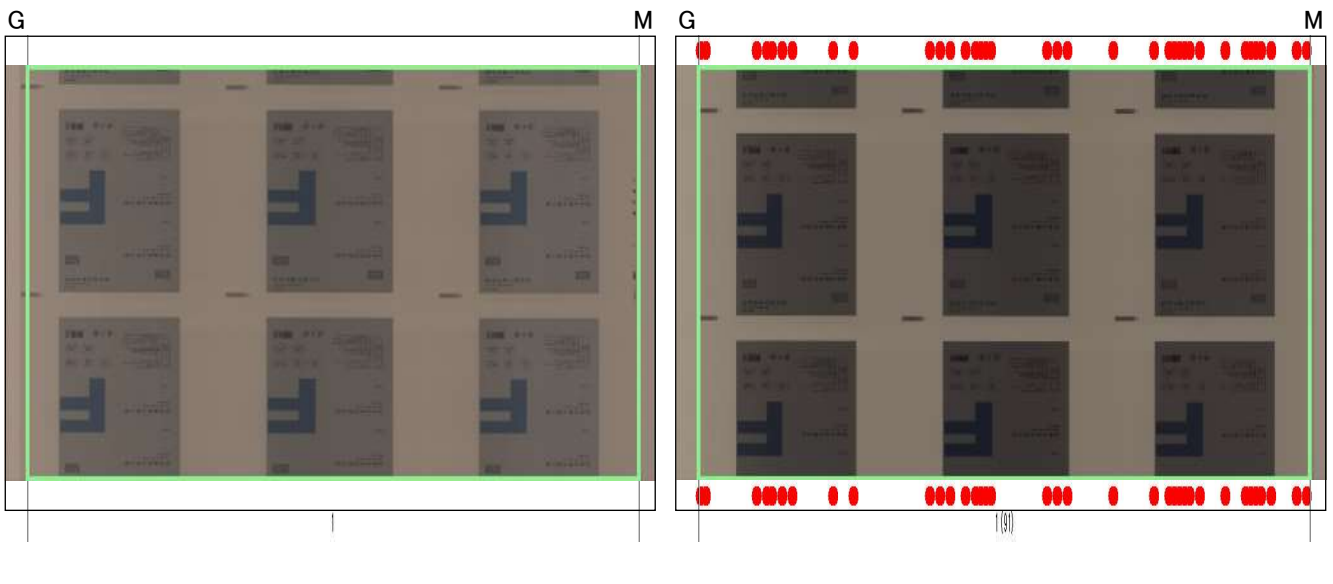
Defect image

No.	#26, \$25	Date	2023/8/10 上午 07:57:32
Segment	1	Camera	1
Pattern	84	Position[ x, y ]	810.2 [mm], 69.7 [m], ( 5976.8 [m] )
Type	縱向刀絲疵點	Size	H:1.7 ,V:1.6 [mm]
Result	-	Area	2.2 [mm2]
Inspection level	5/5,5/5,5/5,5/5,5/5	Label	-
Light	6,6,3/6,6,3

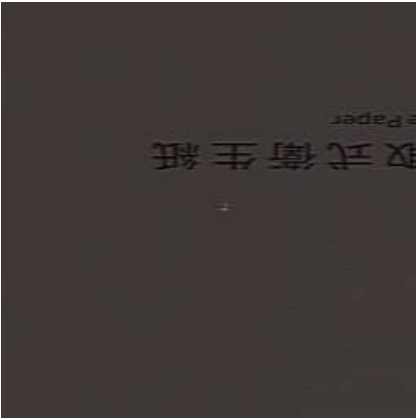
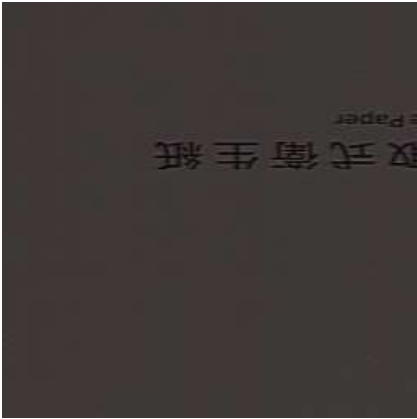
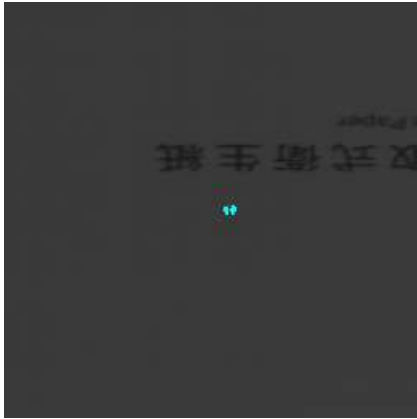
Defect image	Reference image	Shape image

No.	#25, \$24	Date	2023/8/10 上午 07:57:31
Segment	1	Camera	1
Pattern	82	Position[ x, y ]	810.2 [mm], 68.3 [m], ( 5978.2 [m] )
Type	縱向刀絲疵點	Size	H:2.0 ,V:1.6 [mm]
Result	-	Area	2.0 [mm2]
Inspection level	5/5,5/5,5/5,5/5,5/5	Label	-
Light	6,6,3/6,6,3
