# Inspection Result (Individual Data)

Lot number : 2

Inspected date : 2023/8/10 上午 07:56:43 ~ 2023/8/10 上午 09:15:18

商品名	標準透明6-6-3	周長
顧客名		Ex1
CODE番号		Ex2
基材		Ex3

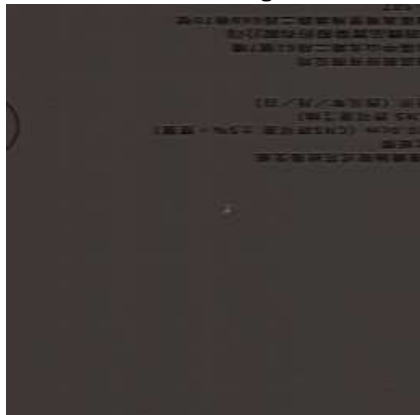
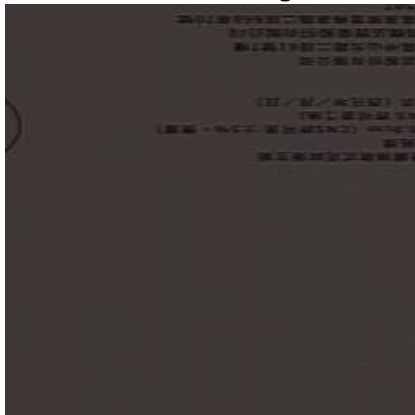
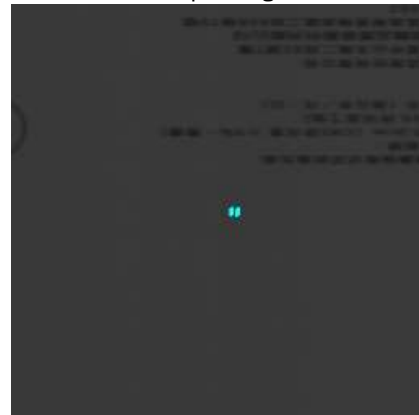
Defect image

No.	#24, \$23	Date	2023/8/10 上午 07:57:27
Segment	1	Camera	1
Pattern	76	Position[ x, y ]	809.7 [mm], 64.0 [m], ( 5982.5 [m] )
Type	縱向刀絲疵點	Size	H:1.7 ,V:1.6 [mm]
Result	-	Area	2.3 [mm2]
Inspection level	5/5,5/5,5/5,5/5,5/5	Label	-
Light	6,6,3/6,6,3

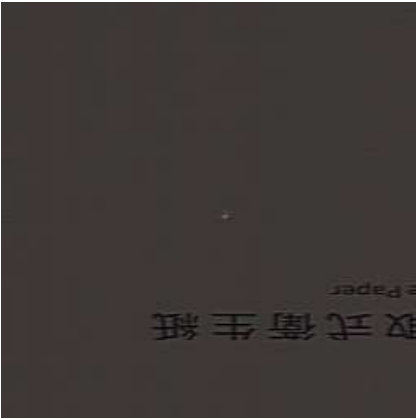
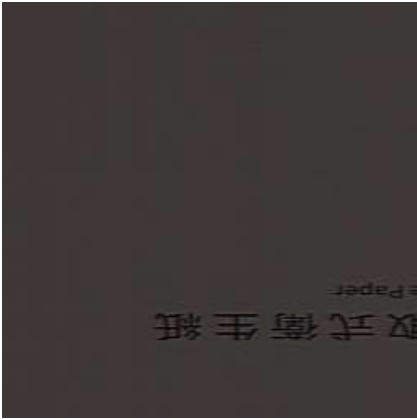
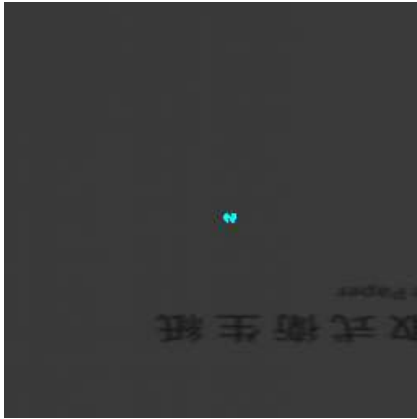
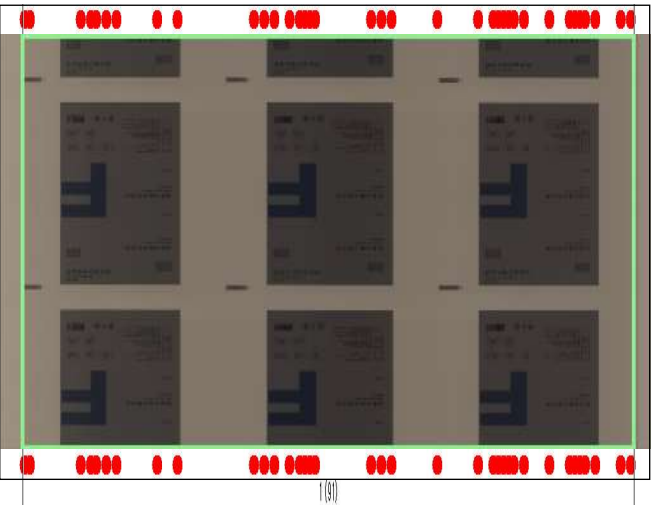
Defect image	Reference image	Shape image

No.	#23, \$22	Date	2023/8/10 上午 07:57:25
Segment	1	Camera	1
Pattern	72	Position[ x, y ]	810.2 [mm], 61.2 [m], ( 5985.4 [m] )
Type	縱向刀絲疵點	Size	H:2.0 ,V:1.6 [mm]
Result	-	Area	2.4 [mm2]
Inspection level	5/5,5/5,5/5,5/5,5/5	Label	-
Light	6,6,3/6,6,3

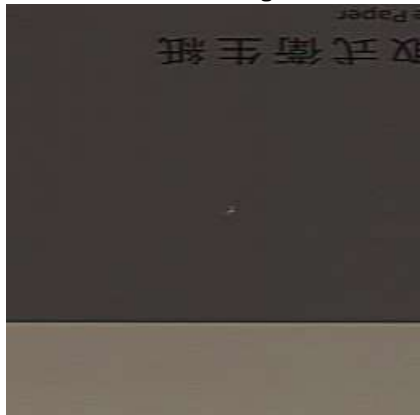
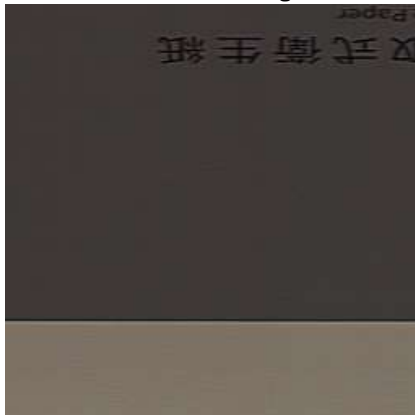
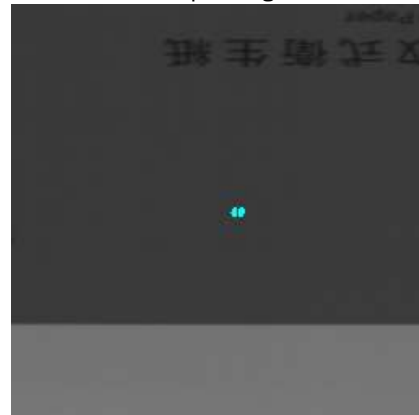
Defect image

No.	#22, \$21	Date	2023/8/10 上午 07:57:24
Segment	1	Camera	1
Pattern	71	Position[ x, y ]	810.4 [mm], 59.7 [m], ( 5986.8 [m] )
Type	縱向刀絲疵點	Size	H:2.2 ,V:1.6 [mm]
Result	-	Area	2.7 [mm2]
Inspection level	5/5,5/5,5/5,5/5,5/5	Label	-
Light	6,6,3/6,6,3

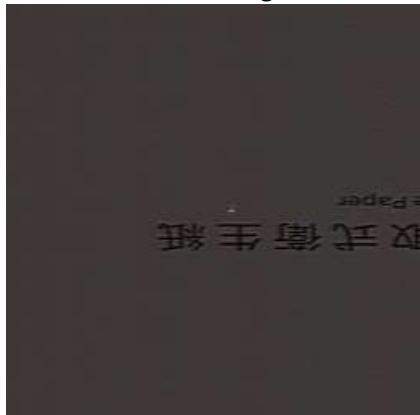
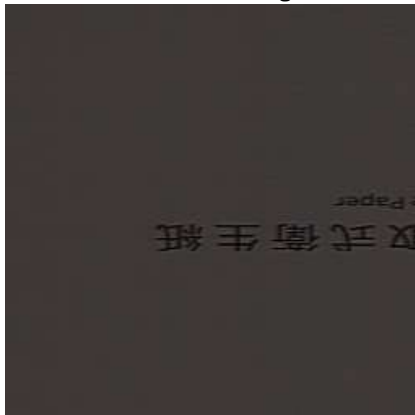
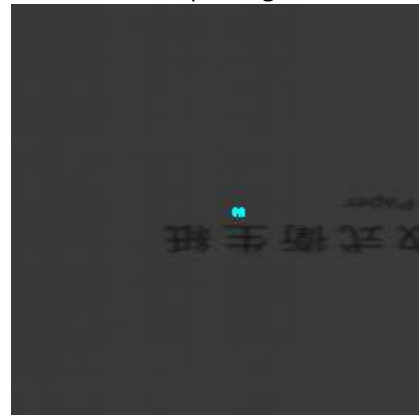
Defect image

No.	#21, \$20	Date	2023/8/10 上午 07:57:18
Segment	1	Camera	1
Pattern	61	Position[ x, y ]	810.4 [mm], 52.5 [m], ( 5994.0 [m] )
Type	縱向刀絲疵點	Size	H:2.0 ,V:1.6 [mm]
Result	-	Area	2.8 [mm2]
Inspection level	5/5,5/5,5/5,5/5,5/5	Label	-
Light	6,6,3/6,6,3

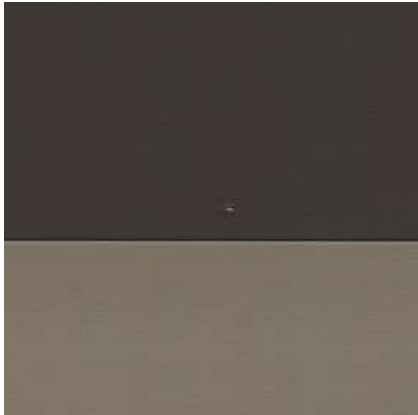
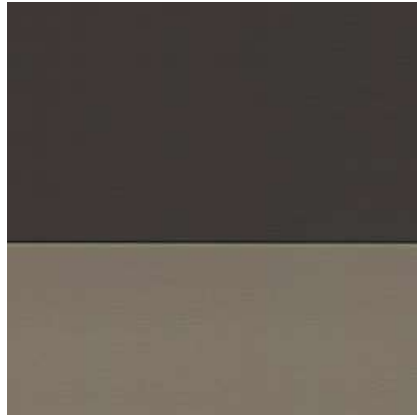
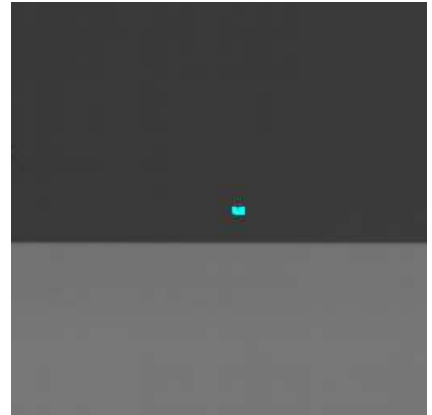
Defect image

No.	#20, \$19	Date	2023/8/10 上午 07:57:17
Segment	1	Camera	1
Pattern	59	Position[ x, y ]	810.4 [mm], 51.1 [m], ( 5995.4 [m] )
Type	縱向刀絲疵點	Size	H:2.0 ,V:1.2 [mm]
Result	-	Area	2.3 [mm2]
Inspection level	5/5,5/5,5/5,5/5,5/5	Label	-
Light	6,6,3/6,6,3

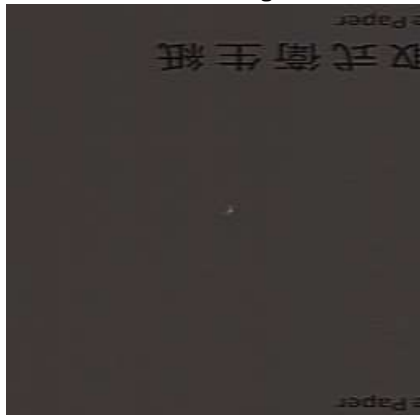
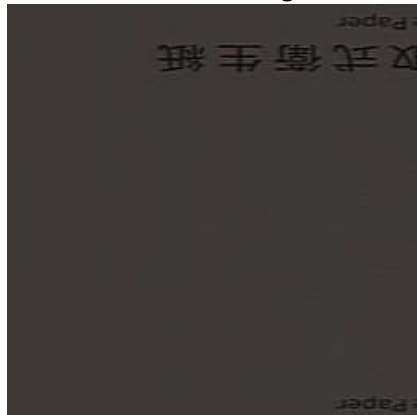
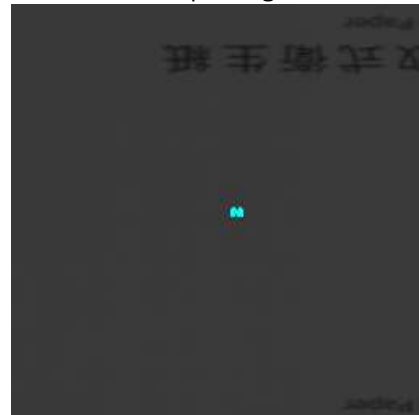
No.	#17, \$16	Date	2023/8/10 上午 07:57:12
Segment	1	Camera	1
Pattern	51	Position[ x, y ]	810.2 [mm], 45.4 [m], ( 6001.2 [m] )
Type	縱向刀絲疵點	Size	H:2.0 ,V:1.6 [mm]
Result	-	Area	2.9 [mm2]
Inspection level	5/5,5/5,5/5,5/5,5/5	Label	-
Light	6,6,3/6,6,3

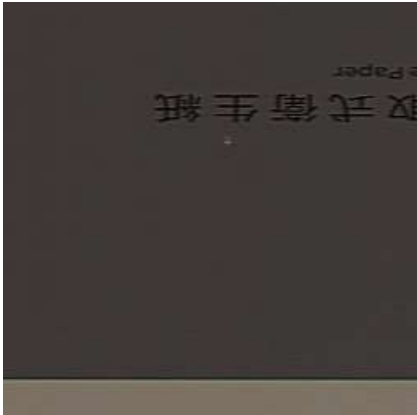
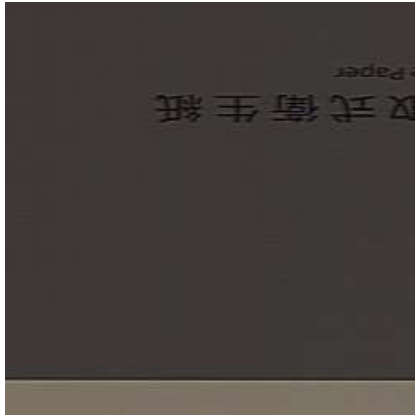
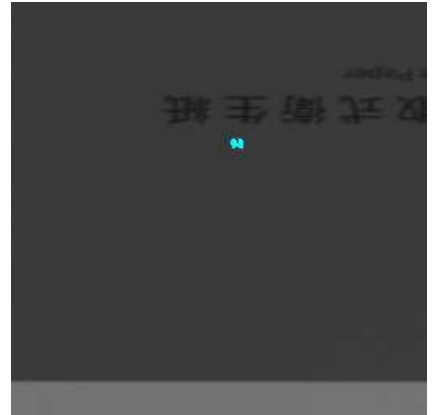
No.	#16, \$15	Date	2023/8/10 上午 07:57:12
Segment	1	Camera	1
Pattern	50	Position[ x, y ]	810.2 [mm], 43.9 [m], ( 6002.6 [m] )
Type	縱向刀絲疵點	Size	H:2.0 ,V:1.6 [mm]
Result	-	Area	2.8 [mm2]
Inspection level	5/5,5/5,5/5,5/5,5/5	Label	-
Light	6,6,3/6,6,3

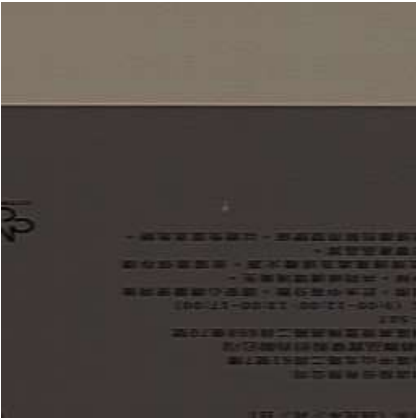
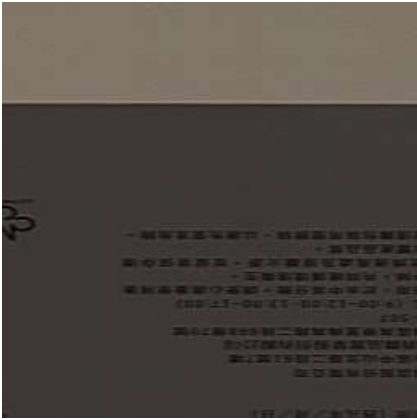
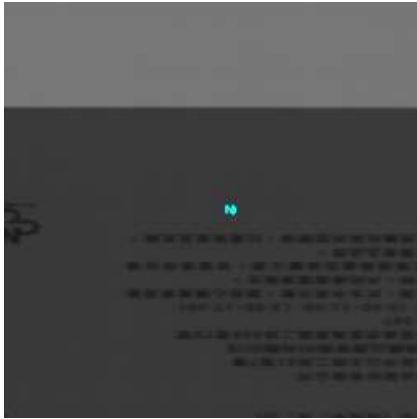
No.	#15, \$14	Date	2023/8/10 上午 07:57:09
Segment	1	Camera	1
Pattern	46	Position[ x, y ]	810.4 [mm], 41.1 [m], ( 6005.5 [m] )
Type	縱向刀絲疵點	Size	H:1.7 ,V:1.6 [mm]
Result	-	Area	2.2 [mm2]
Inspection level	5/5,5/5,5/5,5/5,5/5	Label	-
Light	6,6,3/6,6,3

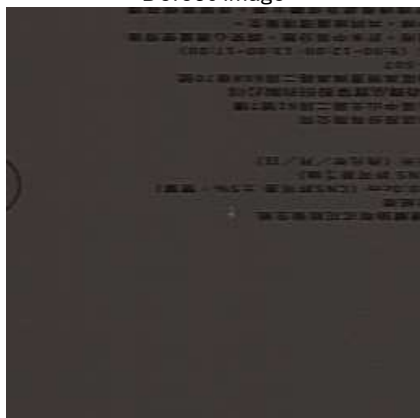
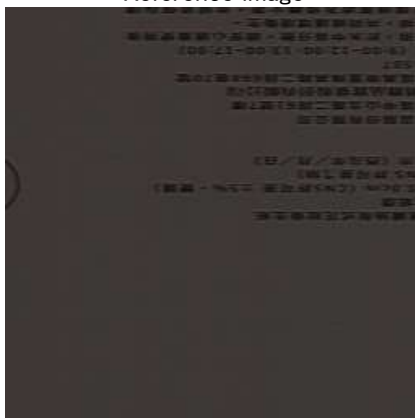
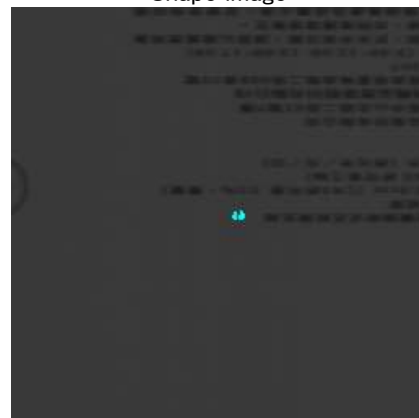
No.	#14, \$13	Date	2023/8/10 上午 07:57:08
Segment	1	Camera	1
Pattern	44	Position[ x, y ]	810.4 [mm], 39.6 [m], ( 6006.9 [m] )
Type	縱向刀絲疵點	Size	H:2.0 ,V:1.6 [mm]
Result	-	Area	2.1 [mm2]
Inspection level	5/5,5/5,5/5,5/5,5/5	Label	-
Light	6,6,3/6,6,3

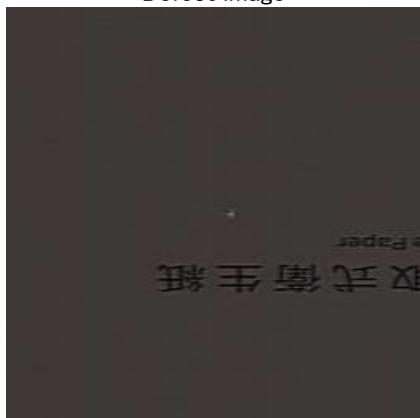
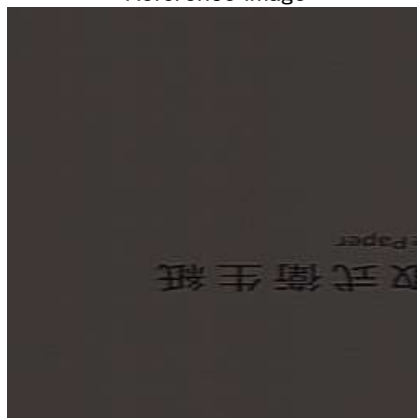
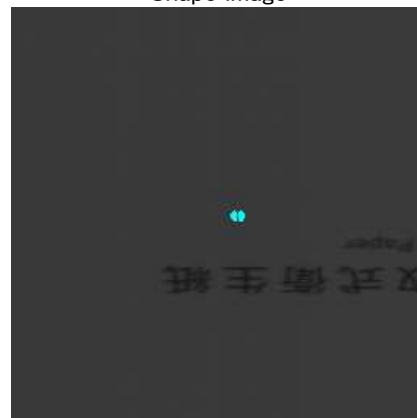
No.	#13, \$12	Date	2023/8/10 上午 07:57:07
Segment	1	Camera	1
Pattern	42	Position[ x, y ]	810.2 [mm], 38.2 [m], ( 6008.4 [m] )
Type	縱向刀絲疵點	Size	H:2.2 ,V:2.0 [mm]
Result	-	Area	3.5 [mm2]
Inspection level	5/5,5/5,5/5,5/5,5/5	Label	-
Light	6,6,3/6,6,3

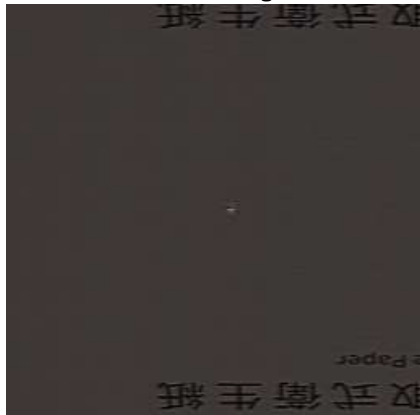
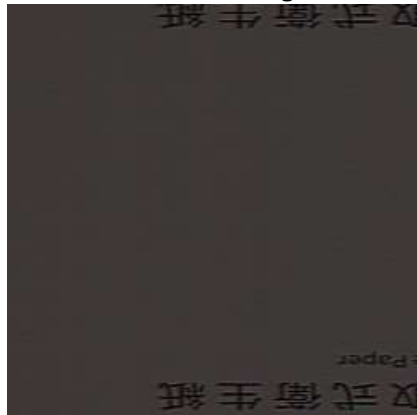
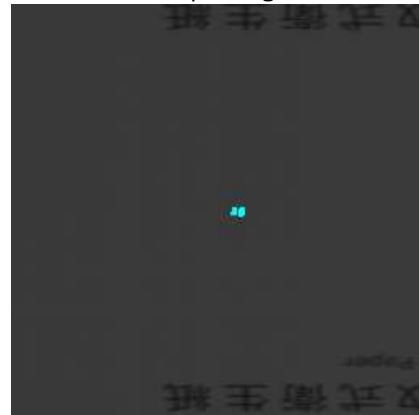
No.	#12, \$11	Date	2023/8/10 上午 07:57:06
Segment	1	Camera	1
Pattern	40	Position[ x, y ]	810.4 [mm], 36.8 [m], ( 6009.8 [m] )
Type	縱向刀絲疵點	Size	H:2.2 ,V:1.6 [mm]
Result	-	Area	2.5 [mm2]
Inspection level	5/5,5/5,5/5,5/5,5/5	Label	-
Light	6,6,3/6,6,3

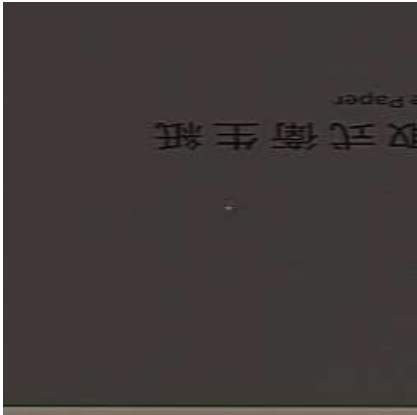
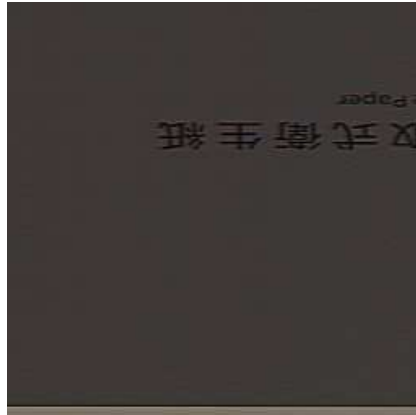
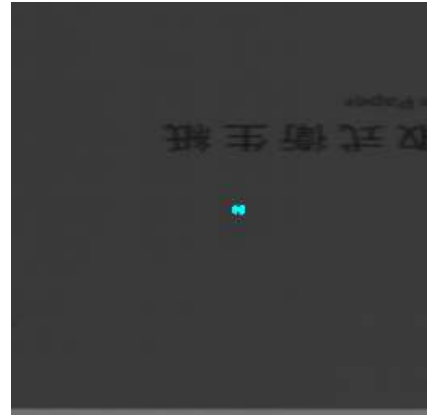
No.	#11, \$10	Date	2023/8/10 上午 07:57:05
Segment	1	Camera	1
Pattern	38	Position[ x, y ]	810.4 [mm], 35.3 [m], ( 6011.2 [m] )
Type	縱向刀絲疵點	Size	H:2.0 ,V:1.6 [mm]
Result	-	Area	2.8 [mm2]
Inspection level	5/5,5/5,5/5,5/5,5/5	Label	-
Light	6,6,3/6,6,3

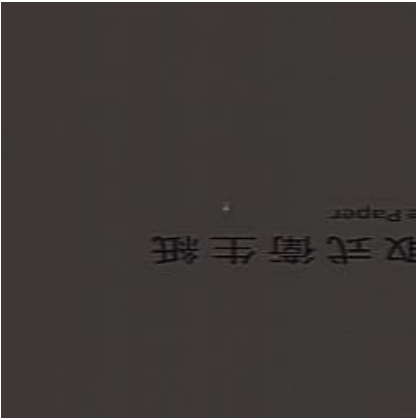
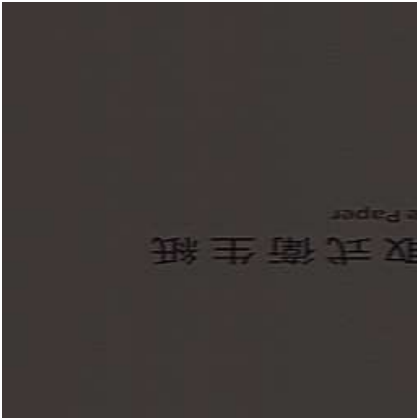
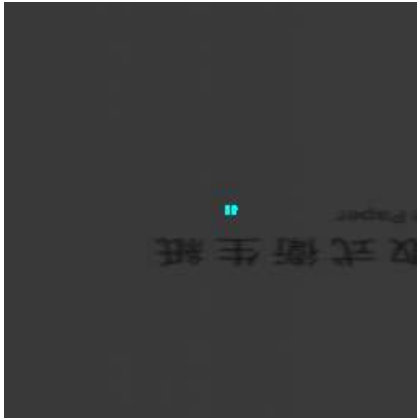
No.	#10, \$9	Date	2023/8/10 上午 07:57:00
Segment	1	Camera	1
Pattern	30	Position[ x, y ]	810.4 [mm], 29.6 [m], ( 6017.0 [m] )
Type	縱向刀絲疵點	Size	H:2.0 ,V:1.6 [mm]
Result	-	Area	2.5 [mm2]
Inspection level	5/5,5/5,5/5,5/5,5/5	Label	-
Light	6,6,3/6,6,3

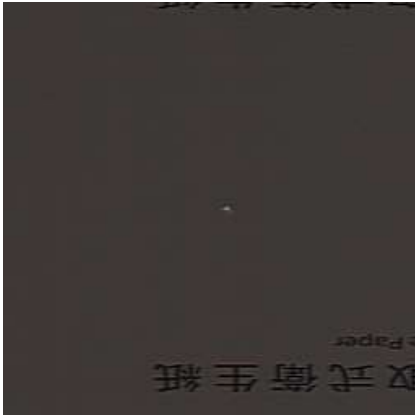
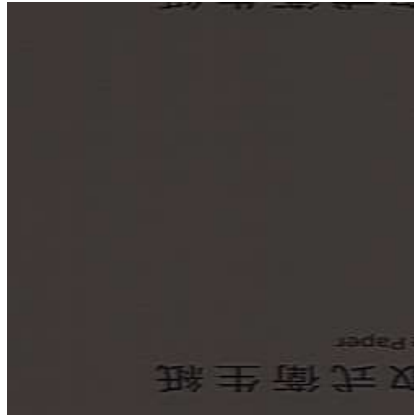
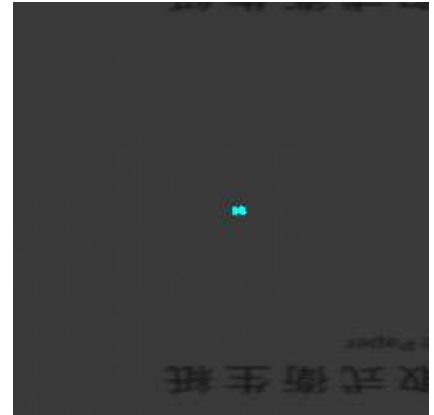
No.	#9, \$8	Date	2023/8/10 上午 07:56:59
Segment	1	Camera	1
Pattern	28	Position[ x, y ]	810.2 [mm], 28.1 [m], ( 6018.4 [m] )
Type	縱向刀絲疵點	Size	H:2.2 ,V:1.6 [mm]
Result	-	Area	2.7 [mm2]
Inspection level	5/5,5/5,5/5,5/5,5/5	Label	-
Light	6,6,3/6,6,3

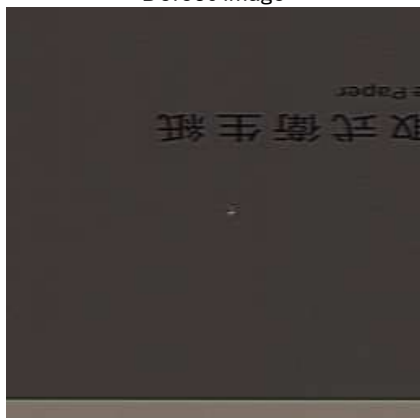
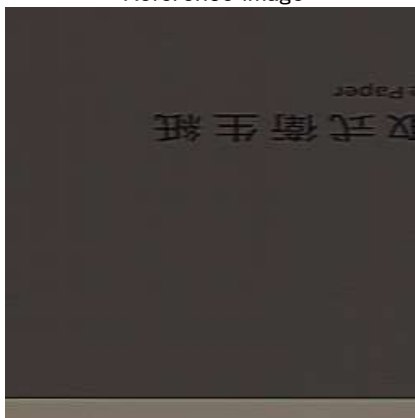
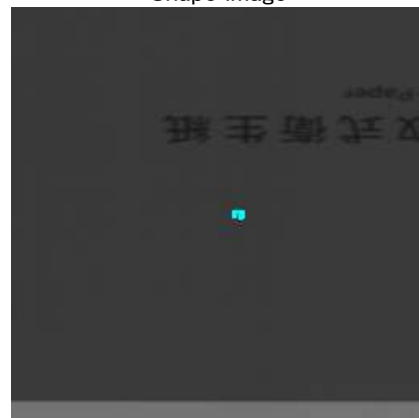
No.	#8, \$7	Date	2023/8/10 上午 07:56:58
Segment	1	Camera	1
Pattern	27	Position[ x, y ]	810.4 [mm], 26.7 [m], ( 6019.8 [m] )
Type	縱向刀絲疵點	Size	H:2.0 ,V:1.6 [mm]
Result	-	Area	2.5 [mm2]
Inspection level	5/5,5/5,5/5,5/5,5/5	Label	-
Light	6,6,3/6,6,3

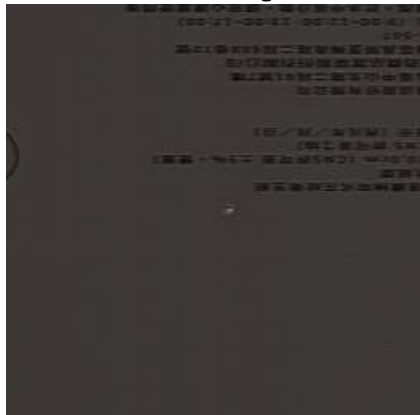
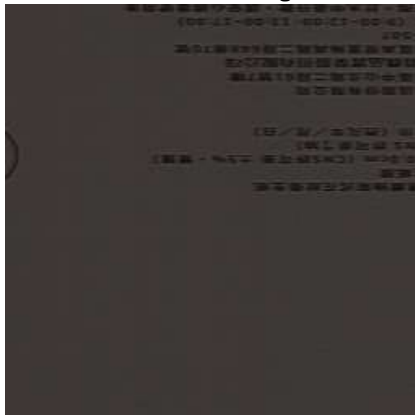
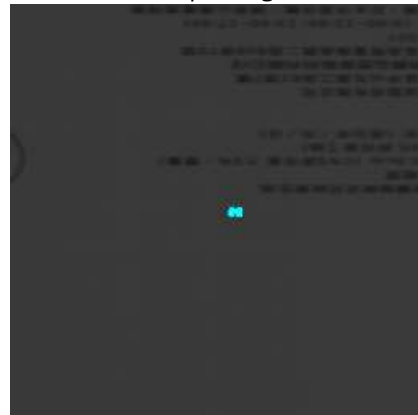
No.	#7, \$6	Date	2023/8/10 上午 07:56:55
Segment	1	Camera	1
Pattern	21	Position[ x, y ]	810.2 [mm], 22.4 [m], ( 6024.2 [m] )
Type	縱向刀絲疵點	Size	H:2.2 ,V:1.6 [mm]
Result	-	Area	3.3 [mm2]
Inspection level	5/5,5/5,5/5,5/5,5/5	Label	-
Light	6,6,3/6,6,3

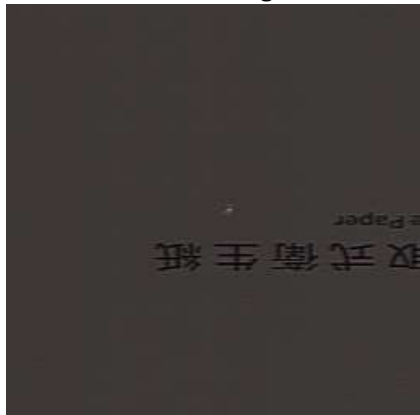
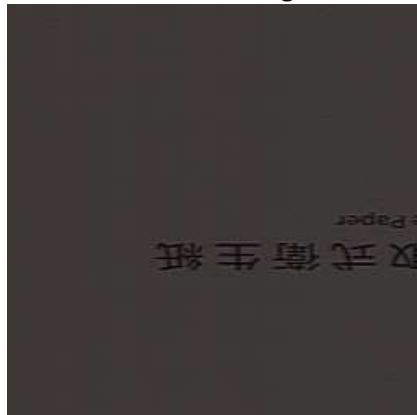
No.	#6, \$5	Date	2023/8/10 上午 07:56:53
Segment	1	Camera	1
Pattern	19	Position[ x, y ]	809.9 [mm], 21.0 [m], ( 6025.6 [m] )
Type	縱向刀絲疵點	Size	H:2.2 ,V:1.6 [mm]
Result	-	Area	3.3 [mm2]
Inspection level	5/5,5/5,5/5,5/5,5/5	Label	-
Light	6,6,3/6,6,3
