Inspection Result (Individual Data)

Lot number : 3

商品名	標準透明6-6-3	周長	
顧客名		Ex1	
CODE番号		Ex2	
基材		Ex3

Total defects	148	檢查範圍 : 83.6 ~ 1024.2 [mm]	寬度 : 940.6 [mm]
Web length	5508.4 [m]	參照更新 : 週期10<平時>/週期10<平時>	
Segments	1 (從左側)

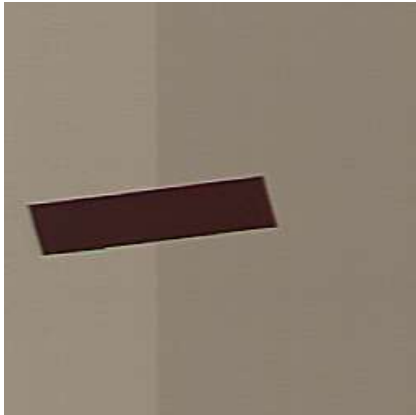
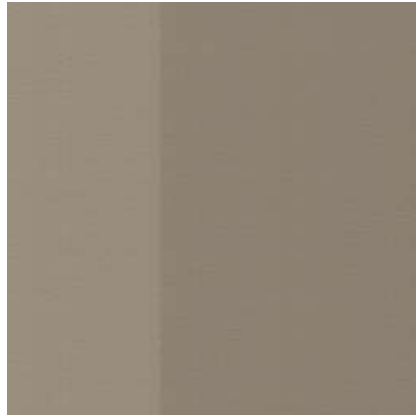
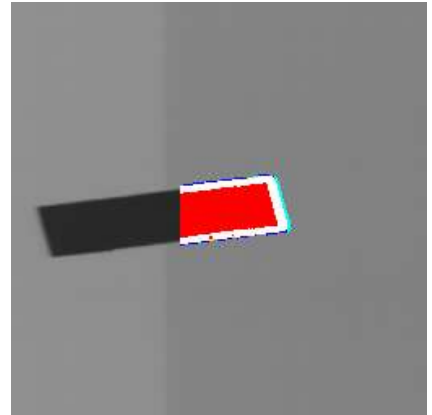
No.	#161, \$148	Date	2023/8/9 上午 11:34:57
Segment	1	Camera	1
Pattern	7282	Position[x, y]	8.2 [mm], 5506.5 [m], (1.9 [m])
Type	点状疵点縱向刀絲疵點橫向刀絲	Size	H:16.6 ,V:16.8 [mm]
Result	-	Area	206.6 [mm2]
Inspection level	5/5,5/5,5/5,5/5,5/5	Label	-
Light	6,6,3/6,6,3

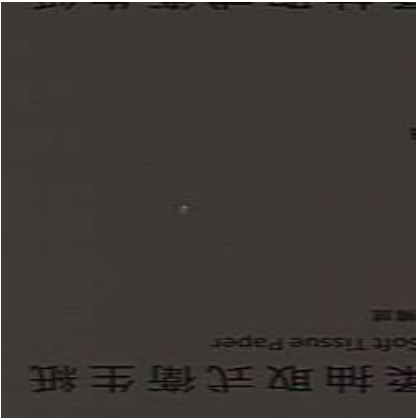
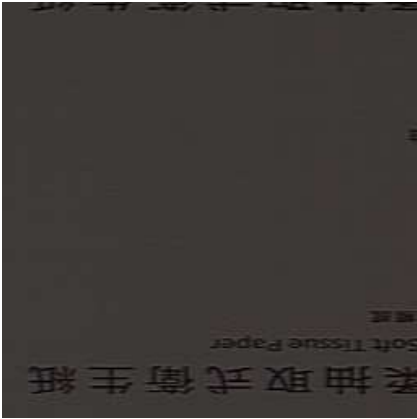
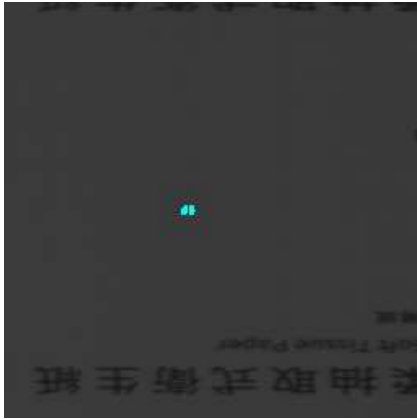
No.	#160, \$147	Date	2023/8/9 上午 11:33:57
Segment	1	Camera	1
Pattern	7180	Position[x, y]	181.7 [mm], 5430.5 [m], (77.9 [m])
Type	縱向刀絲疵點	Size	H:2.2 ,V:1.6 [mm]
Result	-	Area	2.7 [mm2]
Inspection level	5/5,5/5,5/5,5/5,5/5	Label	-
Light	6,6,3/6,6,3

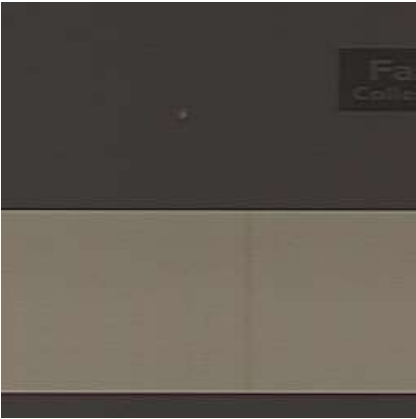
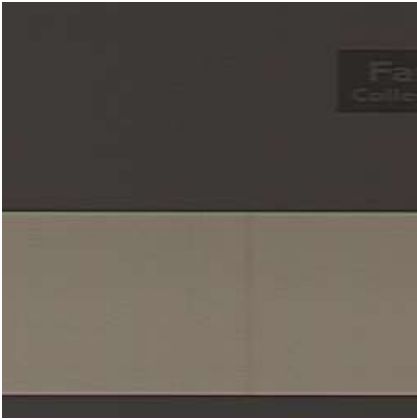
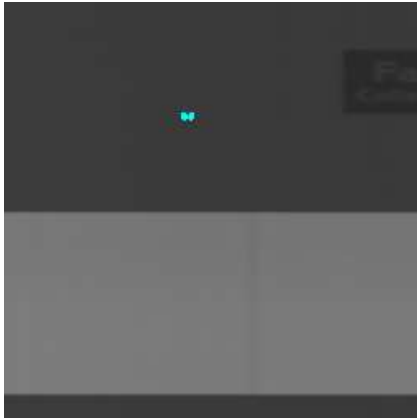
No.	#159, \$146	Date	2023/8/9 上午 11:33:56
Segment	1	Camera	1
Pattern	7179	Position[x, y]	181.7 [mm], 5429.1 [m], (79.3 [m])
Type	縱向刀絲疵點	Size	H:2.0 ,V:1.2 [mm]
Result	-	Area	2.2 [mm2]
Inspection level	5/5,5/5,5/5,5/5,5/5	Label	-
Light	6,6,3/6,6,3

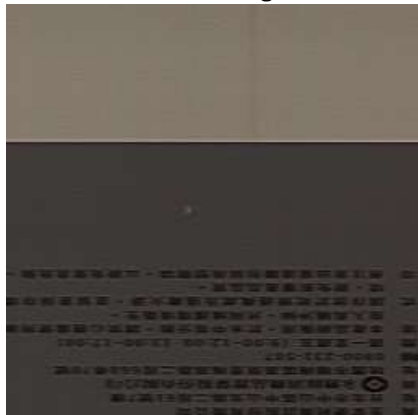
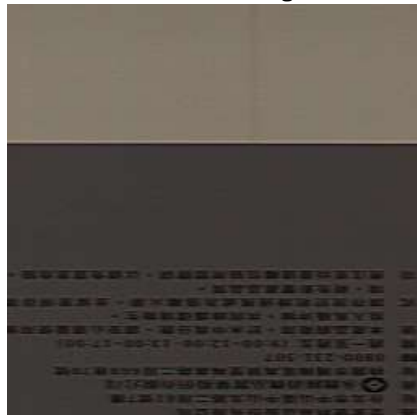
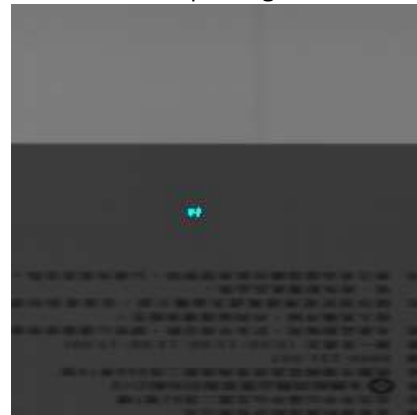
No.	#158, \$145	Date	2023/8/9 上午 11:33:55
Segment	1	Camera	1
Pattern	7177	Position[x, y]	181.7 [mm], 5427.7 [m], (80.7 [m])
Type	縱向刀絲疵點	Size	H:2.0 ,V:1.6 [mm]
Result	-	Area	2.2 [mm2]
Inspection level	5/5,5/5,5/5,5/5,5/5	Label	-
Light	6,6,3/6,6,3

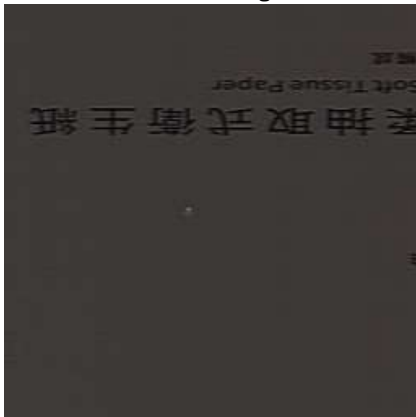
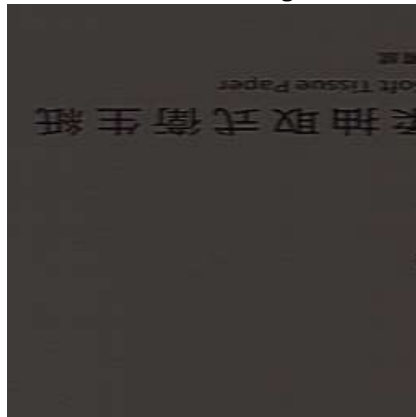
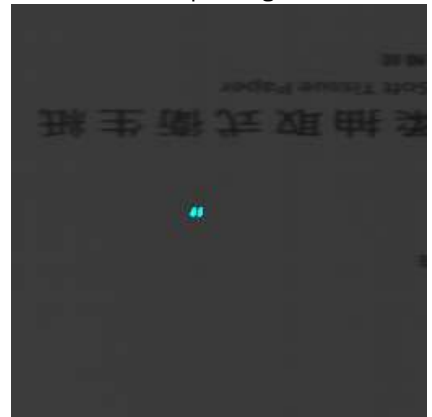
No.	#157, \$144	Date	2023/8/9 上午 11:33:32
Segment	1	Camera	1
Pattern	7139	Position[x, y]	182.0 [mm], 5399.3 [m], (109.1 [m])
Type	縱向刀絲疵點	Size	H:2.0 ,V:1.6 [mm]
Result	-	Area	2.4 [mm2]
Inspection level	5/5,5/5,5/5,5/5,5/5	Label	-
Light	6,6,3/6,6,3

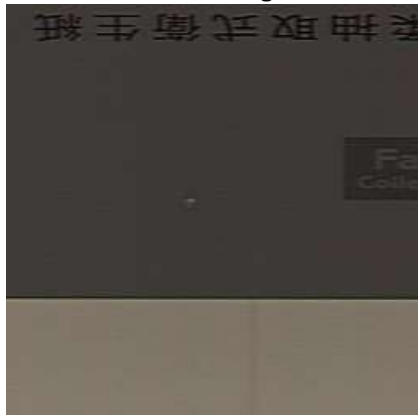
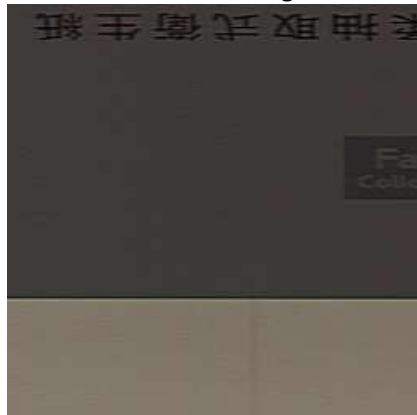
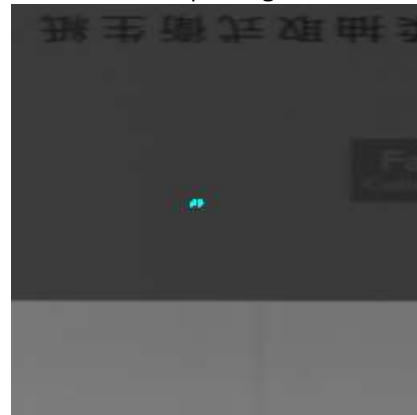
No.	#155, \$142	Date	2023/8/9 上午 11:33:26
Segment	1	Camera	1
Pattern	7128	Position[x, y]	182.0 [mm], 5390.8 [m], (117.6 [m])
Type	縱向刀絲疵點	Size	H:2.2 ,V:1.2 [mm]
Result	-	Area	2.0 [mm2]
Inspection level	5/5,5/5,5/5,5/5,5/5	Label	-
Light	6,6,3/6,6,3

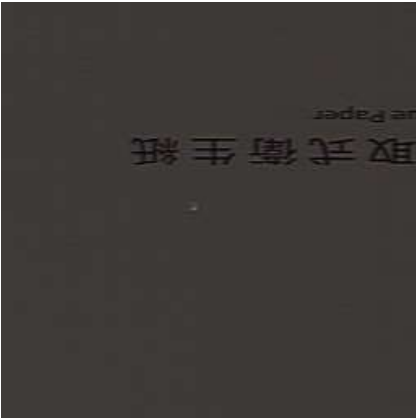
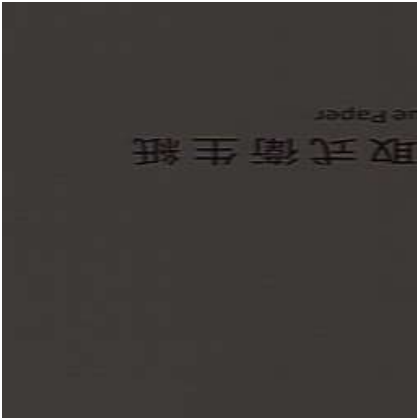
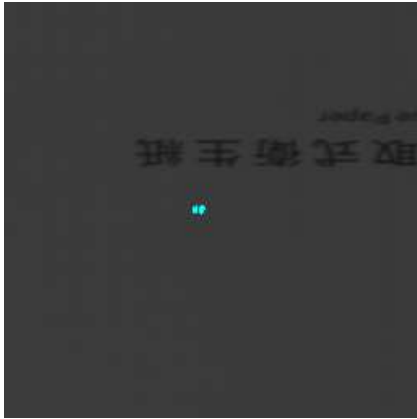
No.	#151, \$138	Date	2023/8/9 上午 11:33:15
Segment	1	Camera	1
Pattern	7109	Position[x, y]	167.8 [mm], 5376.8 [m], (131.6 [m])
Type	縱向刀絲疵點	Size	H:2.0 ,V:1.6 [mm]
Result	-	Area	2.1 [mm2]
Inspection level	5/5,5/5,5/5,5/5,5/5	Label	-
Light	6,6,3/6,6,3

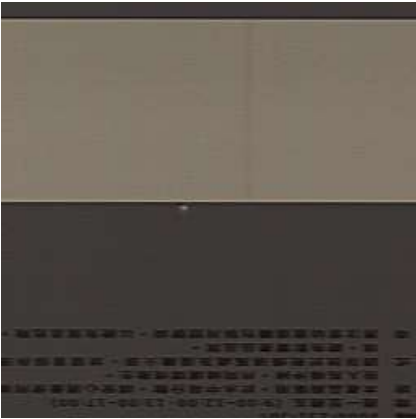
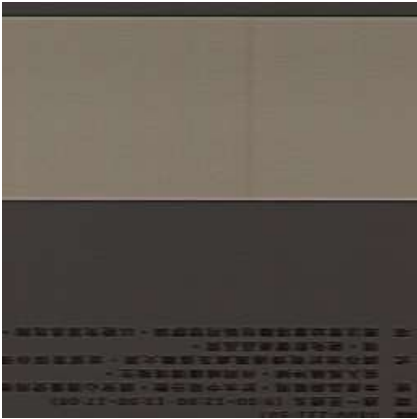
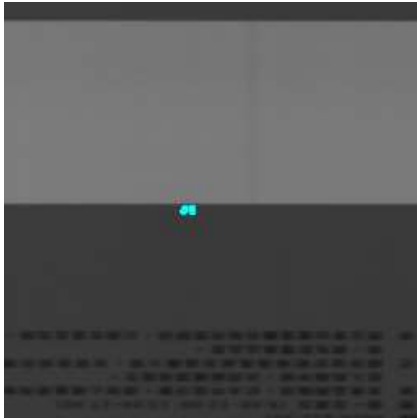
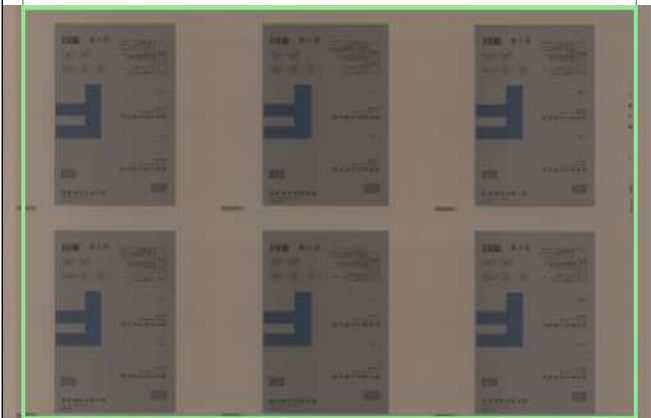
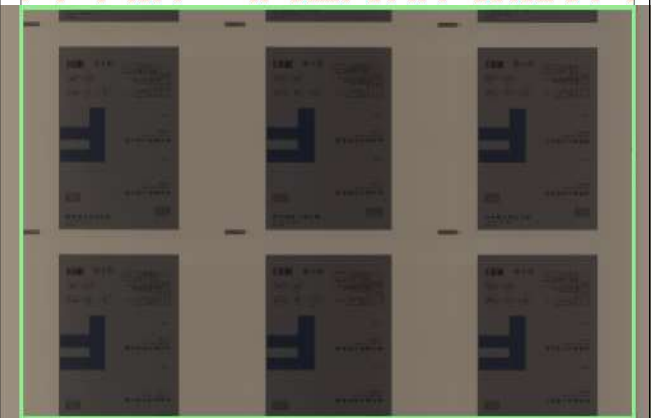
No.	#150, \$137	Date	2023/8/9 上午 11:33:09
Segment	1	Camera	1
Pattern	7099	Position[x, y]	181.7 [mm], 5369.5 [m], (138.9 [m])
Type	縱向刀絲疵點	Size	H:2.4 ,V:1.6 [mm]
Result	-	Area	3.6 [mm2]
Inspection level	5/5,5/5,5/5,5/5,5/5	Label	-
Light	6,6,3/6,6,3

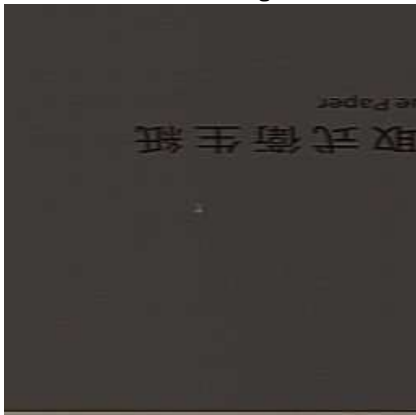
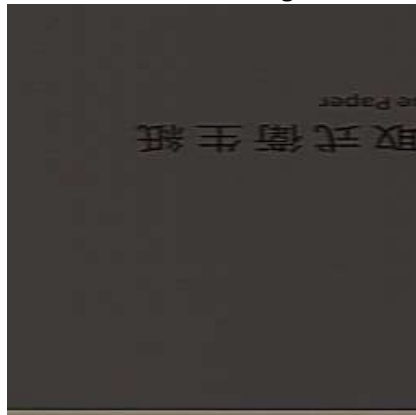
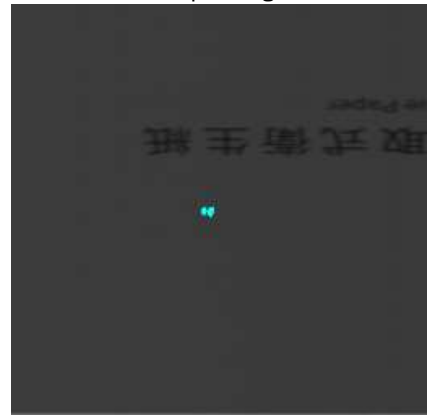
No.	#149, \$136	Date	2023/8/9 上午 11:33:08
Segment	1	Camera	1
Pattern	7097	Position[x, y]	168.1 [mm], 5368.3 [m], (140.1 [m])
Type	縱向刀絲疵點	Size	H:2.0 ,V:1.6 [mm]
Result	-	Area	2.4 [mm2]
Inspection level	5/5,5/5,5/5,5/5,5/5	Label	-
Light	6,6,3/6,6,3

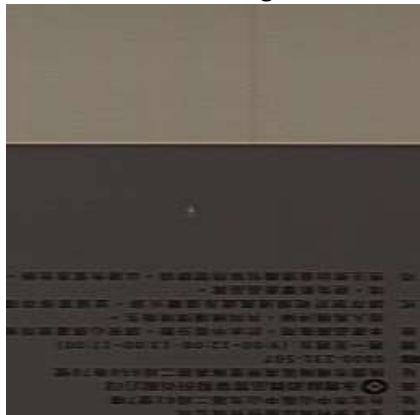
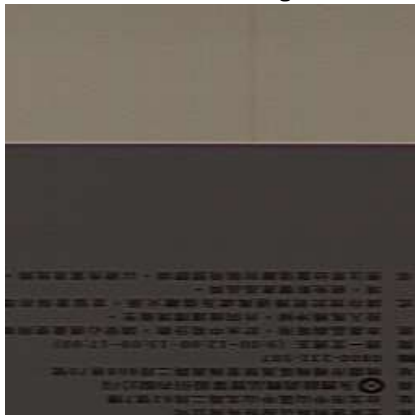
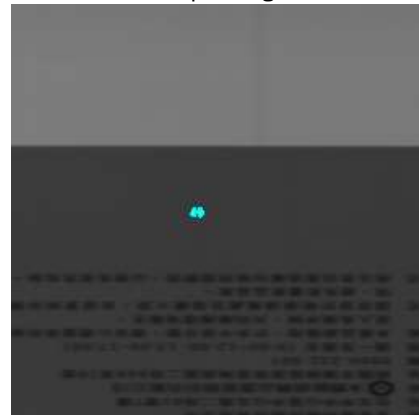
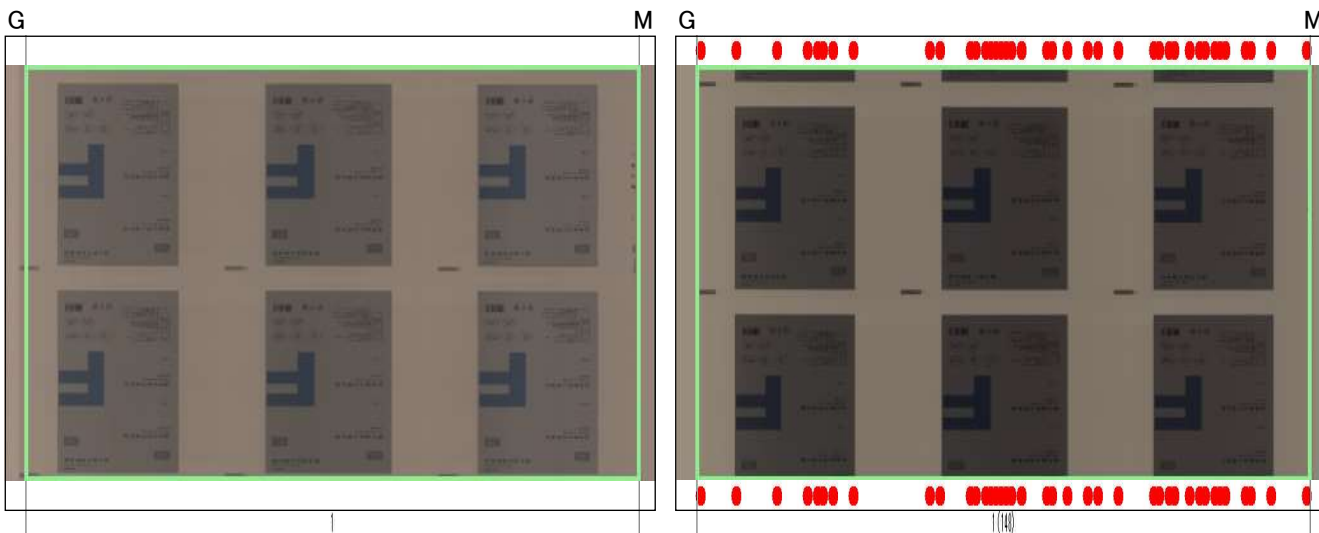
No.	#147, \$134	Date	2023/8/9 上午 11:33:03
Segment	1	Camera	1
Pattern	7090	Position[x, y]	182.2 [mm], 5362.4 [m], (146.0 [m])
Type	縱向刀絲疵點	Size	H:2.2 ,V:2.0 [mm]
Result	-	Area	3.3 [mm2]
Inspection level	5/5,5/5,5/5,5/5,5/5	Label	-
Light	6,6,3/6,6,3

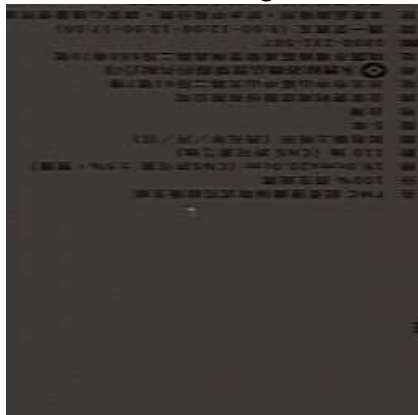
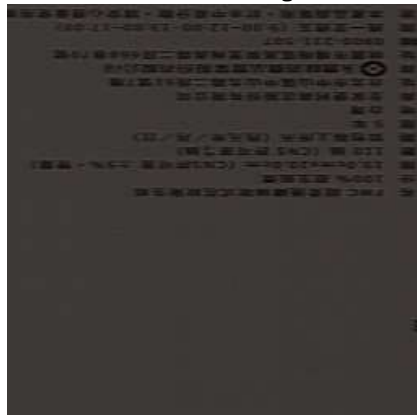
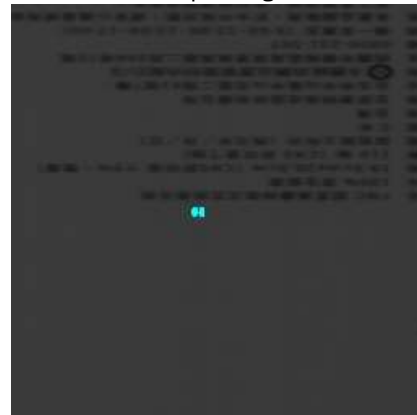
No.	#146, \$133	Date	2023/8/9 上午 11:33:02
Segment	1	Camera	1
Pattern	7088	Position[x, y]	182.2 [mm], 5360.9 [m], (147.4 [m])
Type	縱向刀絲疵點	Size	H:2.0 ,V:1.6 [mm]
Result	-	Area	2.7 [mm2]
Inspection level	5/5,5/5,5/5,5/5,5/5	Label	-
Light	6,6,3/6,6,3

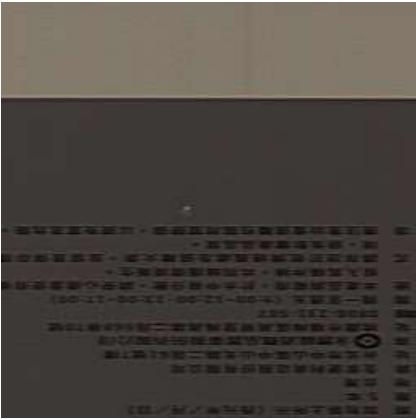
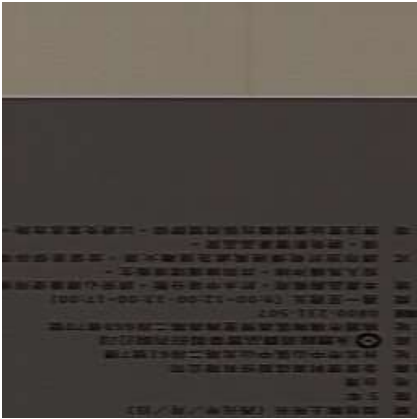
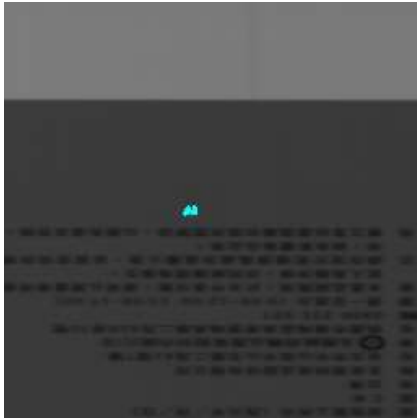
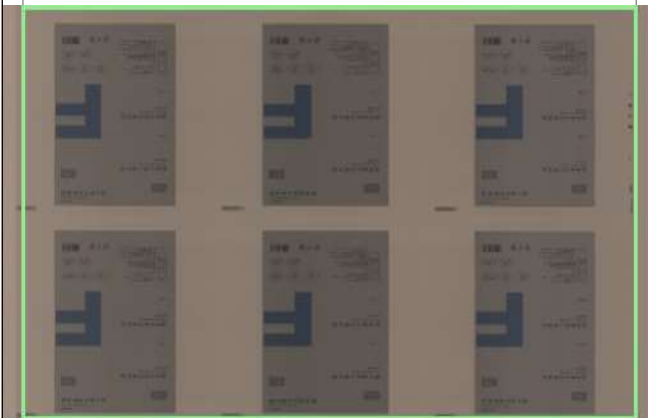
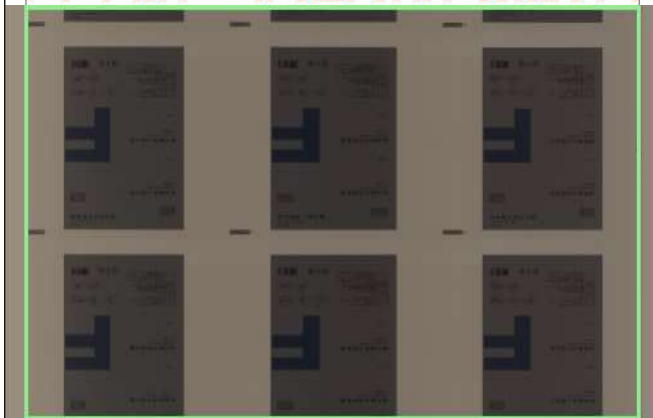
No.	#144, \$131	Date	2023/8/9 上午 11:32:58
Segment	1	Camera	1
Pattern	7080	Position[x, y]	182.2 [mm], 5355.2 [m], (153.1 [m])
Type	縱向刀絲疵點	Size	H:2.2 ,V:2.0 [mm]
Result	-	Area	3.2 [mm2]
Inspection level	5/5,5/5,5/5,5/5,5/5	Label	-
Light	6,6,3/6,6,3

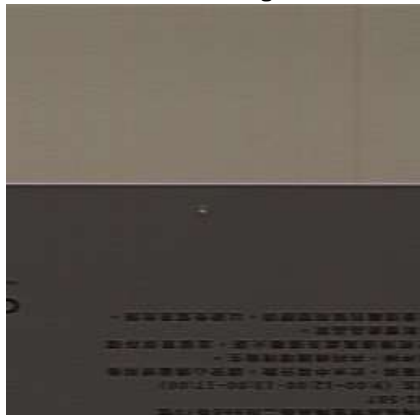
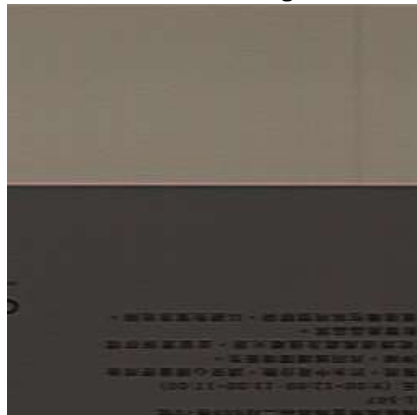
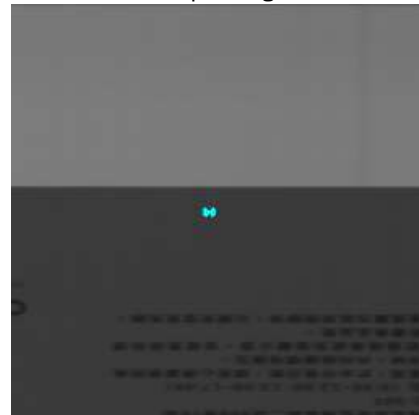
No.	#142, \$129	Date	2023/8/9 上午 11:32:56
Segment	1	Camera	1
Pattern	7077	Position[x, y]	168.3 [mm], 5352.6 [m], (155.8 [m])
Type	縱向刀絲疵點	Size	H:2.0 ,V:1.6 [mm]
Result	-	Area	2.8 [mm2]
Inspection level	5/5,5/5,5/5,5/5,5/5	Label	-
Light	6,6,3/6,6,3

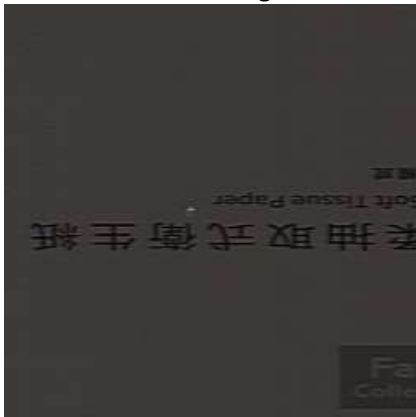
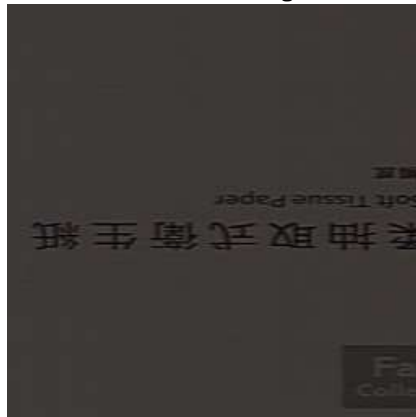
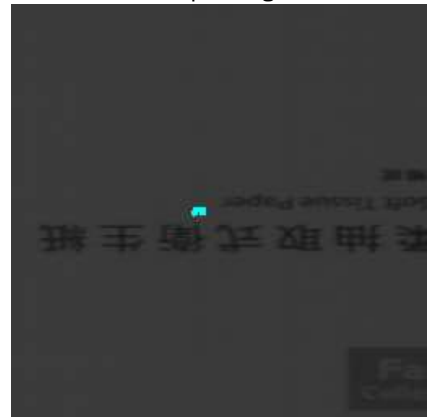
No.	#140, \$127	Date	2023/8/9 上午 11:32:54
Segment	1	Camera	1
Pattern	7074	Position[x, y]	182.2 [mm], 5351.0 [m], (157.4 [m])
Type	縱向刀絲疵點	Size	H:2.2 ,V:1.6 [mm]
Result	-	Area	2.7 [mm2]
Inspection level	5/5,5/5,5/5,5/5,5/5	Label	-
Light	6,6,3/6,6,3

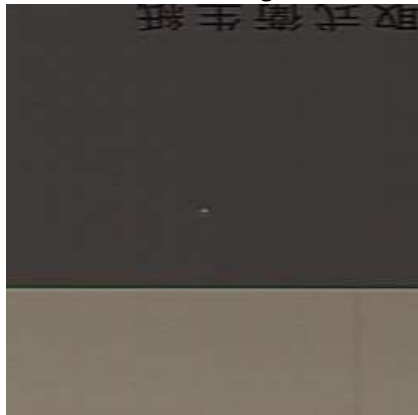
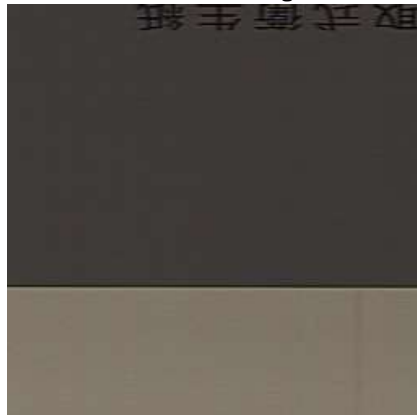
No.	#139, \$126	Date	2023/8/9 上午 11:32:51
Segment	1	Camera	1
Pattern	7069	Position[x, y]	168.6 [mm], 5346.9 [m], (161.5 [m])
Type	縱向刀絲疵點	Size	H:2.0 ,V:1.2 [mm]
Result	-	Area	2.3 [mm2]
Inspection level	5/5,5/5,5/5,5/5,5/5	Label	-
Light	6,6,3/6,6,3

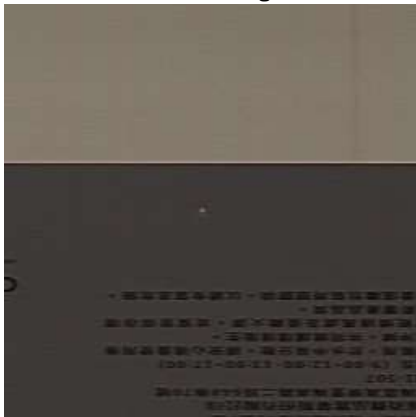
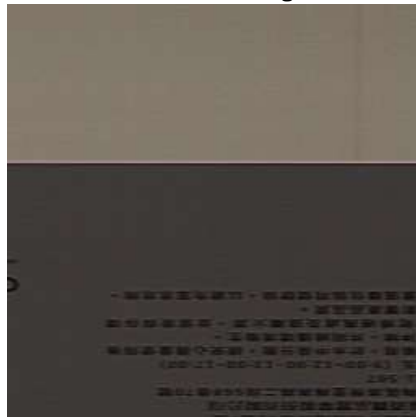
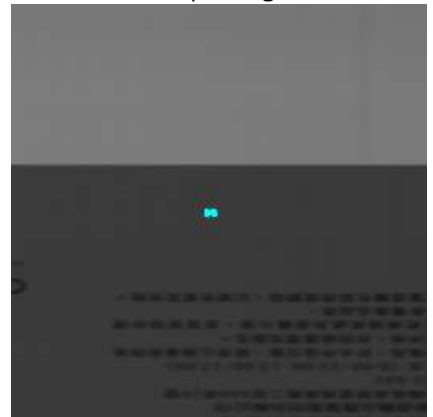
No.	#138, \$125	Date	2023/8/9 上午 11:32:50
Segment	1	Camera	1
Pattern	7067	Position[x, y]	168.6 [mm], 5345.5 [m], (162.9 [m])
Type	縱向刀絲疵點	Size	H:2.0 ,V:1.2 [mm]
Result	-	Area	2.3 [mm2]
Inspection level	5/5,5/5,5/5,5/5,5/5	Label	-
Light	6,6,3/6,6,3

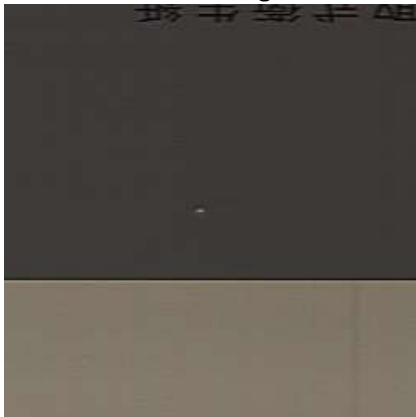
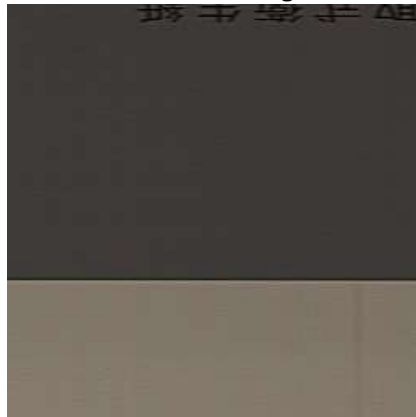
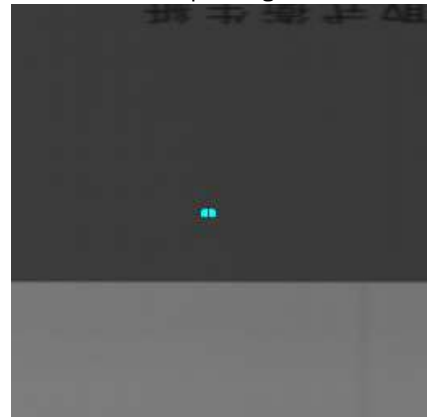
No.	#137, \$124	Date	2023/8/9 上午 11:32:46
Segment	1	Camera	1
Pattern	7060	Position[x, y]	168.1 [mm], 5339.8 [m], (168.6 [m])
Type	縱向刀絲疵點	Size	H:2.2 ,V:1.2 [mm]
Result	-	Area	2.3 [mm2]
Inspection level	5/5,5/5,5/5,5/5,5/5	Label	-
Light	6,6,3/6,6,3

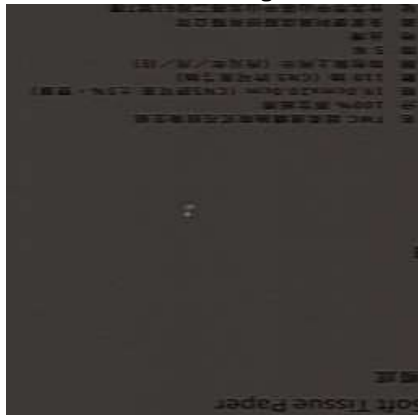
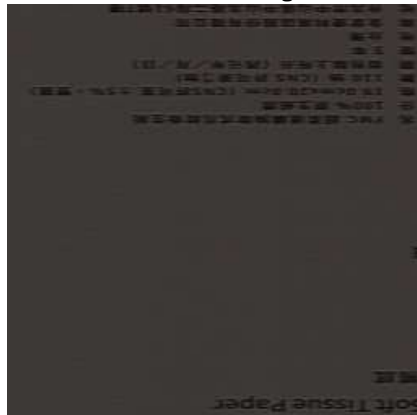
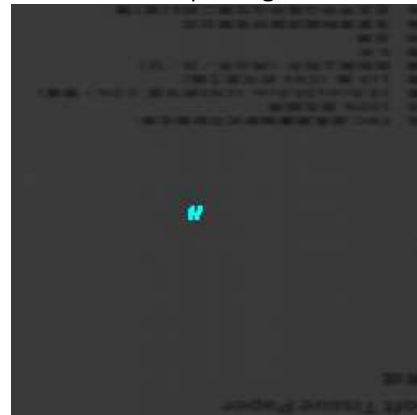
No.	#136, \$123	Date	2023/8/9 上午 11:32:45
Segment	1	Camera	1
Pattern	7059	Position[x, y]	181.7 [mm], 5339.6 [m], (168.8 [m])
Type	縱向刀絲疵點	Size	H:2.2 ,V:2.8 [mm]
Result	-	Area	4.8 [mm2]
Inspection level	5/5,5/5,5/5,5/5,5/5	Label	-
Light	6,6,3/6,6,3

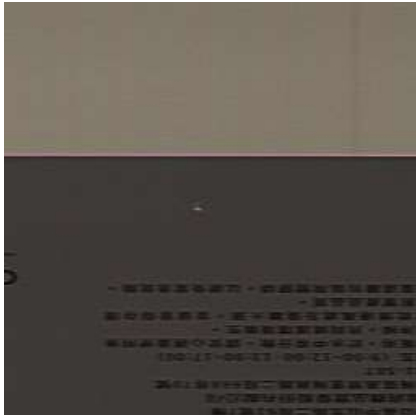
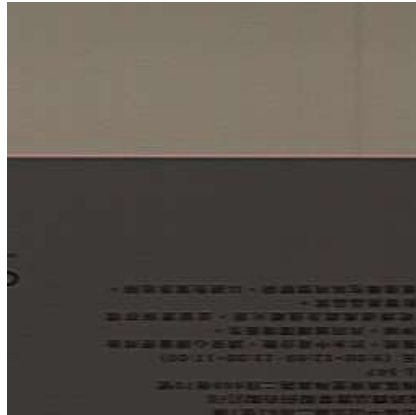
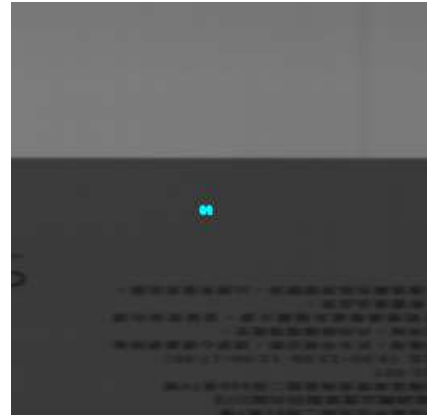
No.	#135, \$122	Date	2023/8/9 上午 11:32:45
Segment	1	Camera	1
Pattern	7058	Position[x, y]	167.8 [mm], 5338.3 [m], (170.0 [m])
Type	縱向刀絲疵點	Size	H:2.0 ,V:1.6 [mm]
Result	-	Area	3.0 [mm2]
Inspection level	5/5,5/5,5/5,5/5,5/5	Label	-
Light	6,6,3/6,6,3

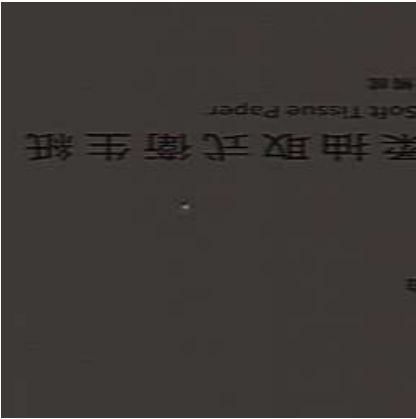
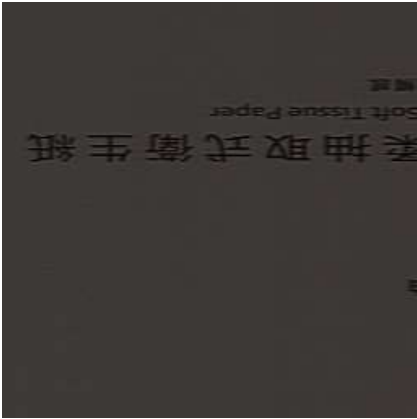
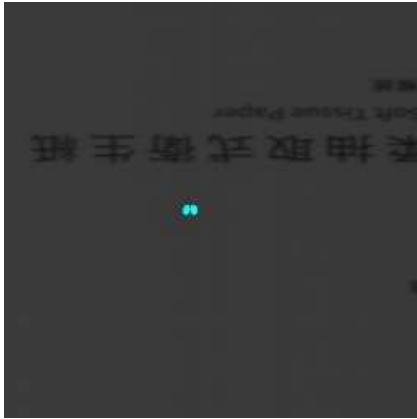
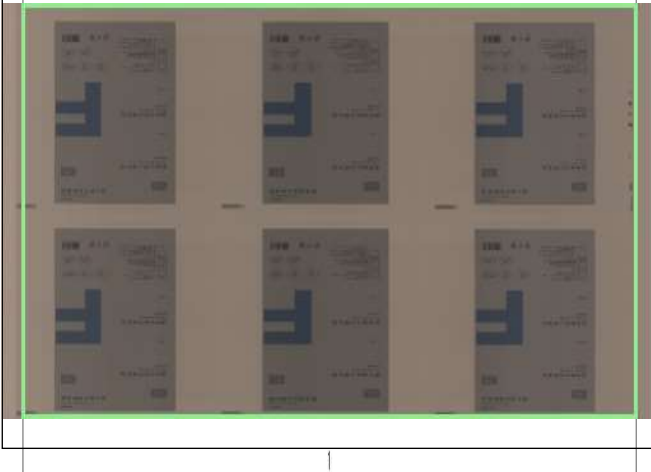
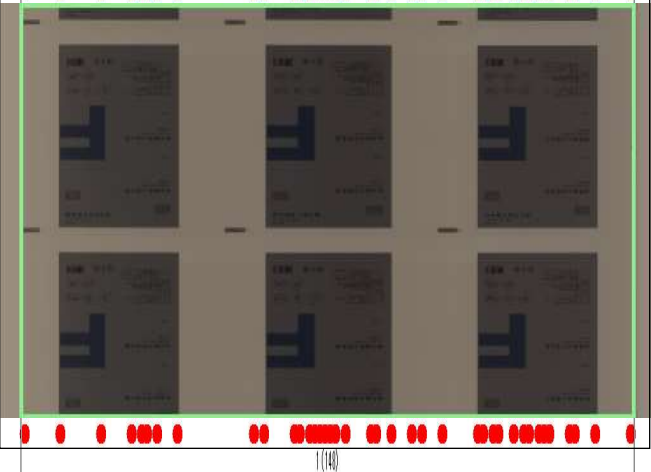
No.	#131, \$118	Date	2023/8/9 上午 11:32:39
Segment	1	Camera	1
Pattern	7048	Position[x, y]	182.2 [mm], 5331.0 [m], (177.4 [m])
Type	縱向刀絲疵點	Size	H:2.2 ,V:1.6 [mm]
Result	-	Area	3.1 [mm2]
Inspection level	5/5,5/5,5/5,5/5,5/5	Label	-
Light	6,6,3/6,6,3

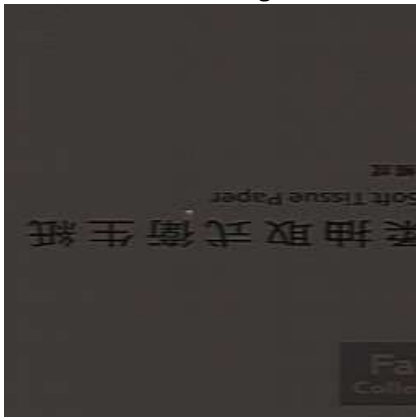
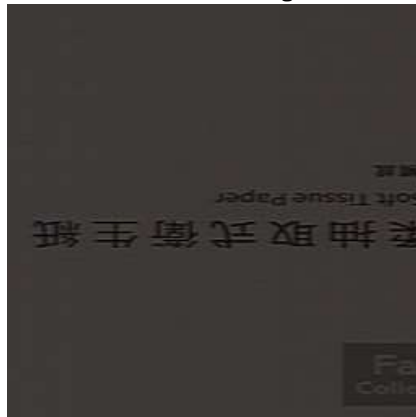
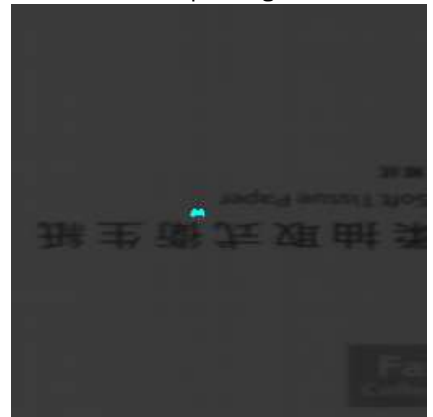
No.	#130, \$117	Date	2023/8/9 上午 11:32:37
Segment	1	Camera	1
Pattern	7046	Position[x, y]	182.2 [mm], 5329.6 [m], (178.8 [m])
Type	縱向刀絲疵點	Size	H:2.0 ,V:1.2 [mm]
Result	-	Area	2.0 [mm2]
Inspection level	5/5,5/5,5/5,5/5,5/5	Label	-
Light	6,6,3/6,6,3

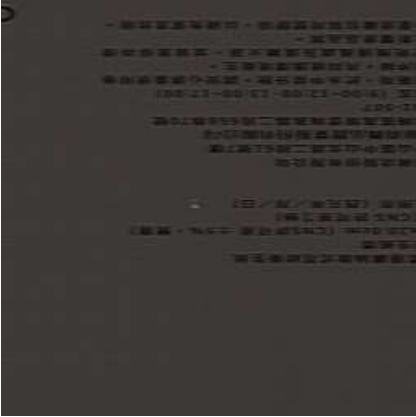
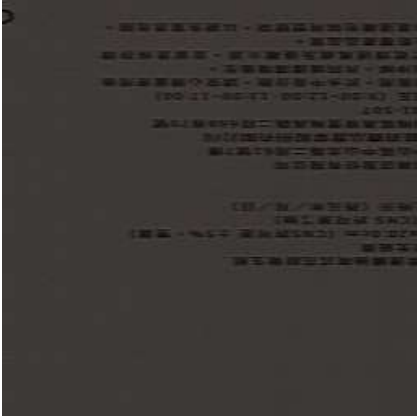
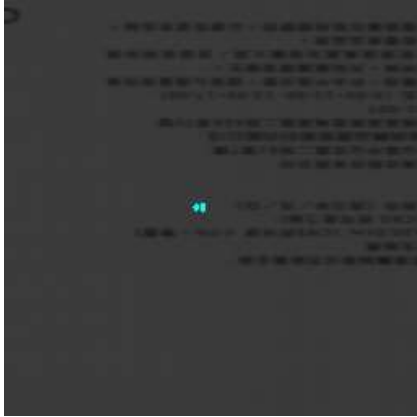
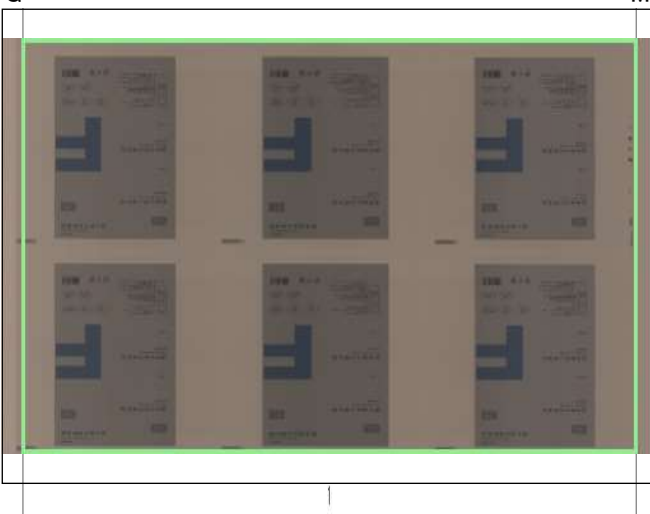
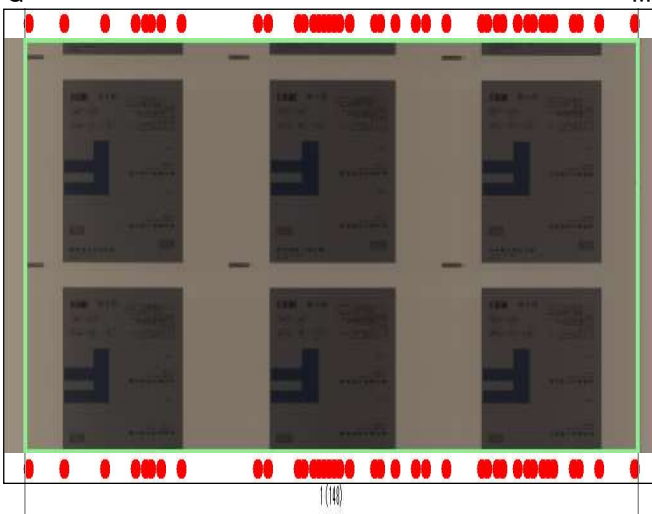
No.	#126, \$113	Date	2023/8/9 上午 11:32:32
Segment	1	Camera	1
Pattern	7037	Position[x, y]	168.1 [mm], 5322.7 [m], (185.7 [m])
Type	縱向刀絲疵點	Size	H:2.0 ,V:1.6 [mm]
Result	-	Area	2.1 [mm2]
Inspection level	5/5,5/5,5/5,5/5,5/5	Label	-
Light	6,6,3/6,6,3

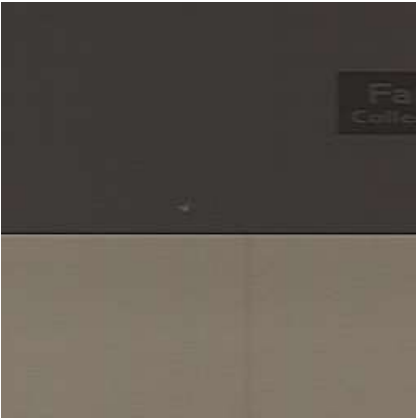
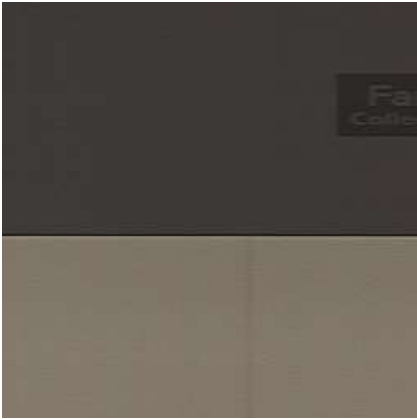
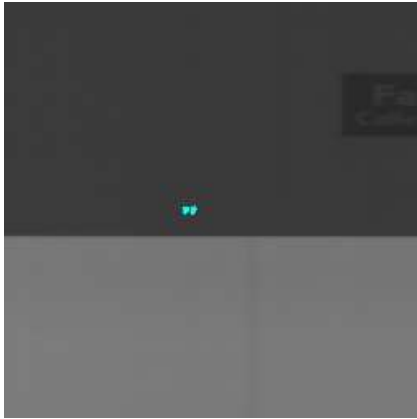
No.	#124, \$111	Date	2023/8/9 上午 11:32:31
Segment	1	Camera	1
Pattern	7035	Position[x, y]	182.0 [mm], 5321.0 [m], (187.4 [m])
Type	縱向刀絲疵點	Size	H:2.2 ,V:1.6 [mm]
Result	-	Area	2.1 [mm2]
Inspection level	5/5,5/5,5/5,5/5,5/5	Label	-
Light	6,6,3/6,6,3

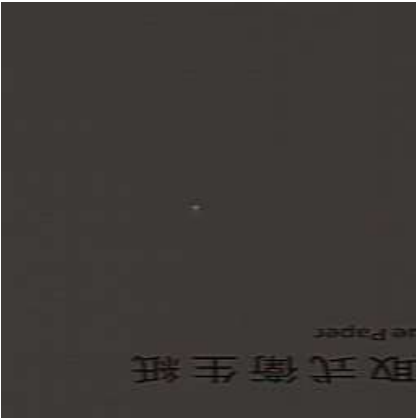
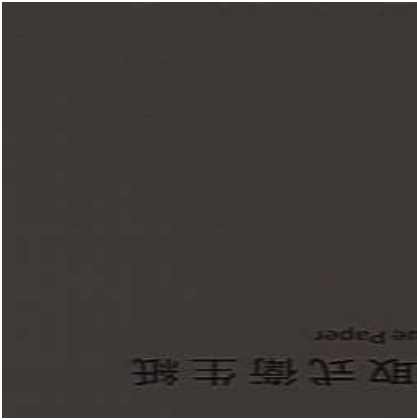
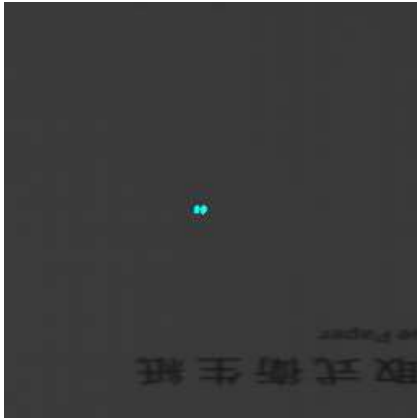
No.	#123, \$110	Date	2023/8/9 上午 11:32:30
Segment	1	Camera	1
Pattern	7033	Position[x, y]	168.1 [mm], 5319.8 [m], (188.6 [m])
Type	縱向刀絲疵點	Size	H:2.0 ,V:1.6 [mm]
Result	-	Area	2.4 [mm2]
Inspection level	5/5,5/5,5/5,5/5,5/5	Label	-
Light	6,6,3/6,6,3

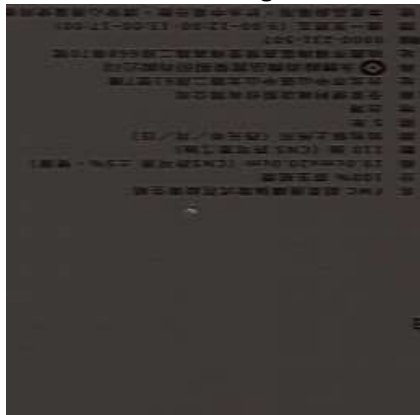
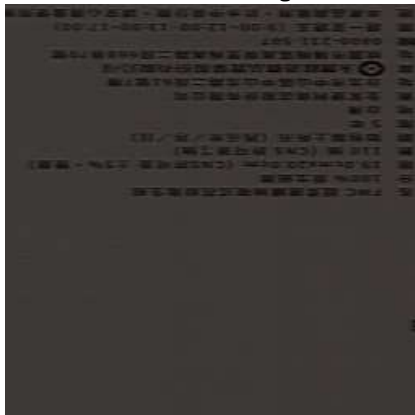
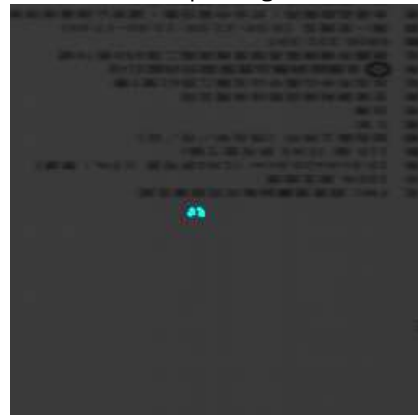
No.	#122, \$109	Date	2023/8/9 上午 11:32:29
Segment	1	Camera	1
Pattern	7031	Position[x, y]	182.2 [mm], 5318.2 [m], (190.2 [m])
Type	縱向刀絲疵點	Size	H:2.7 ,V:1.6 [mm]
Result	-	Area	3.2 [mm2]
Inspection level	5/5,5/5,5/5,5/5,5/5	Label	-
Light	6,6,3/6,6,3

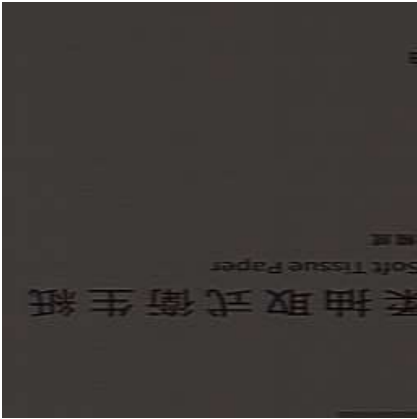
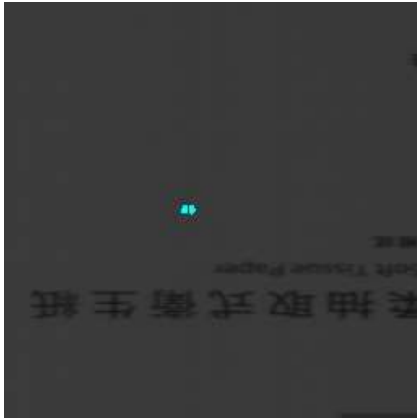
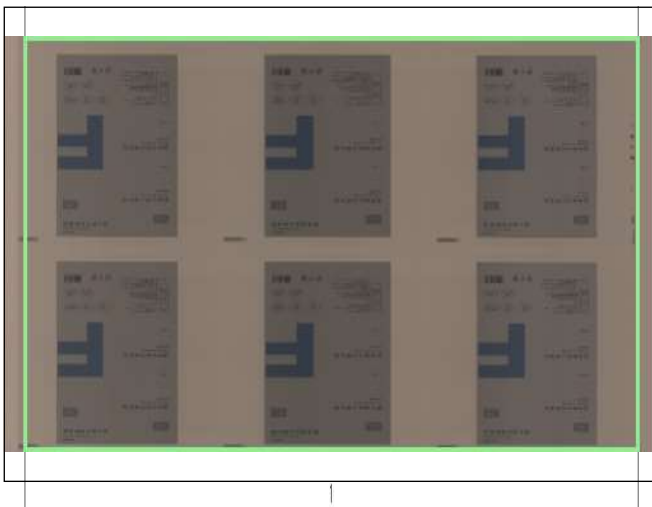
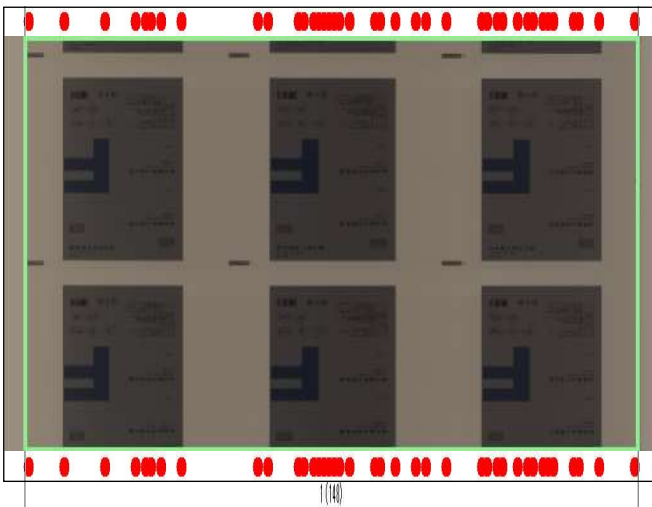
No.	#121, \$108	Date	2023/8/9 上午 11:32:26
Segment	1	Camera	1
Pattern	7027	Position[x, y]	182.0 [mm], 5315.3 [m], (193.1 [m])
Type	縱向刀絲疵點	Size	H:2.2 ,V:1.6 [mm]
Result	-	Area	2.4 [mm2]
Inspection level	5/5,5/5,5/5,5/5,5/5	Label	-
Light	6,6,3/6,6,3

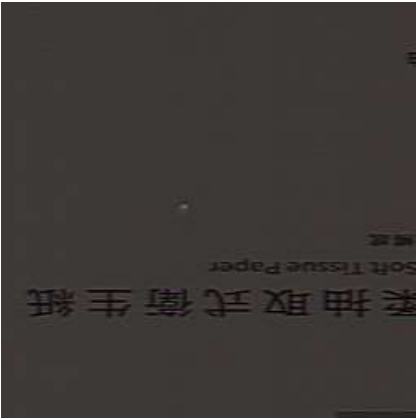
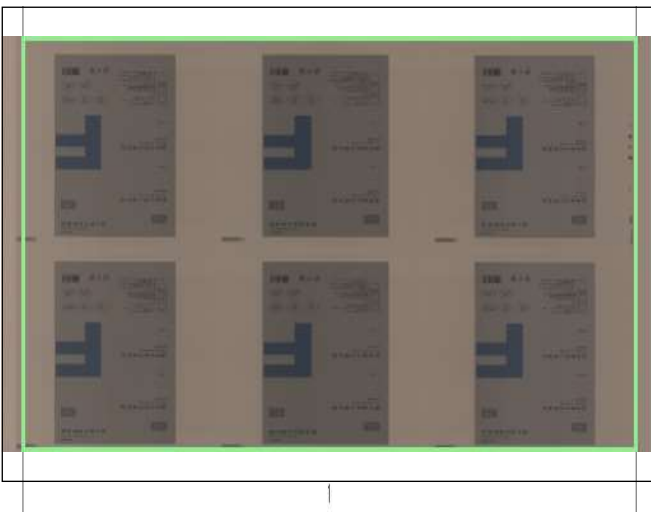
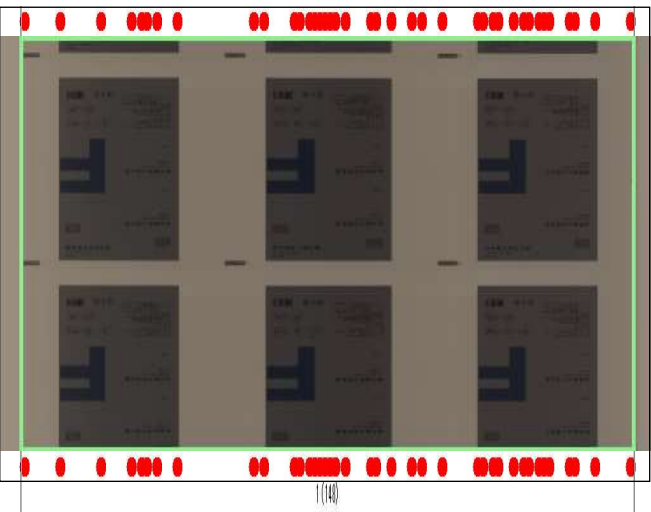
No.	#120, \$107	Date	2023/8/9 上午 11:32:25
Segment	1	Camera	1
Pattern	7025	Position[x, y]	181.7 [mm], 5313.9 [m], (194.5 [m])
Type	縱向刀絲疵點	Size	H:2.2 ,V:1.2 [mm]
Result	-	Area	2.0 [mm2]
Inspection level	5/5,5/5,5/5,5/5,5/5	Label	-
Light	6,6,3/6,6,3

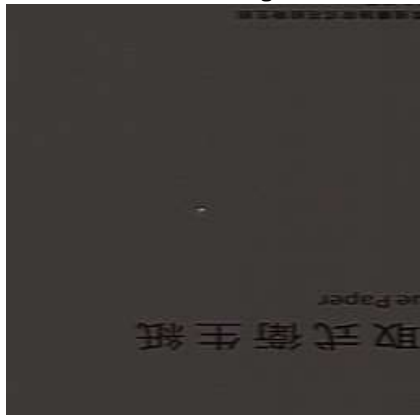
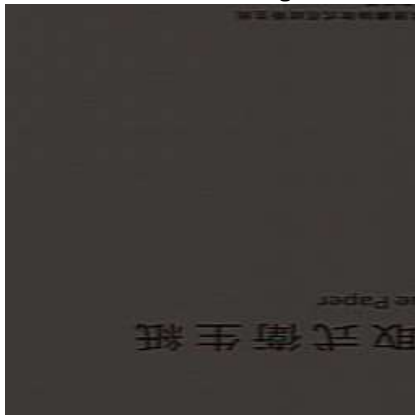
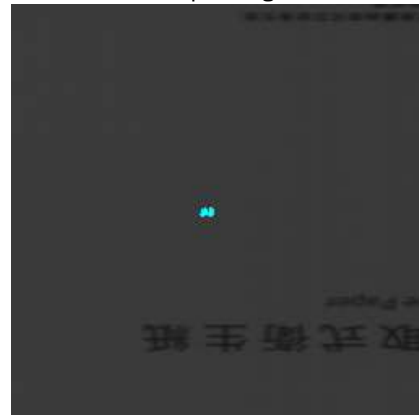
No.	#120, \$107	Date	2023/8/9 上午 11:32:25
Segment	1	Camera	1
Pattern	7025	Position[x, y]	168.1 [mm], 5314.1 [m], (194.3 [m])
Type	縱向刀絲疵點	Size	H:2.2 ,V:1.6 [mm]
Result	-	Area	2.8 [mm2]
Inspection level	5/5,5/5,5/5,5/5,5/5	Label	-
Light	6,6,3/6,6,3

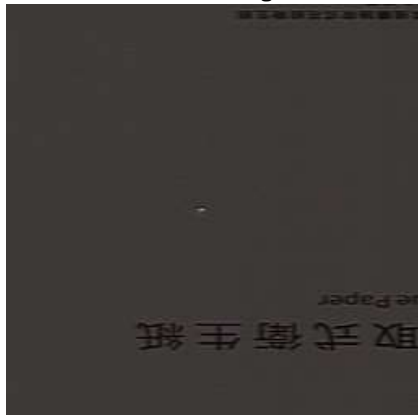
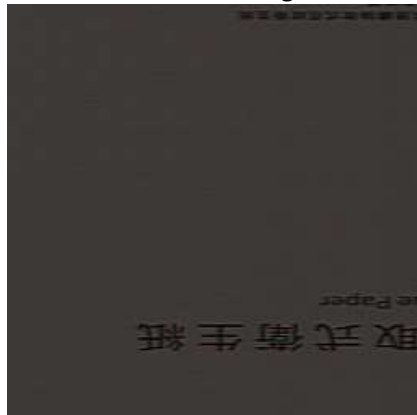
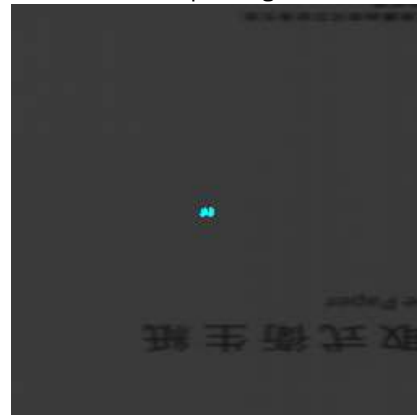
No.	#119, \$106	Date	2023/8/9 上午 11:32:24
Segment	1	Camera	1
Pattern	7023	Position[x, y]	168.1 [mm], 5312.7 [m], (195.7 [m])
Type	縱向刀絲疵點	Size	H:2.2 ,V:2.0 [mm]
Result	-	Area	3.5 [mm2]
Inspection level	5/5,5/5,5/5,5/5,5/5	Label	-
Light	6,6,3/6,6,3

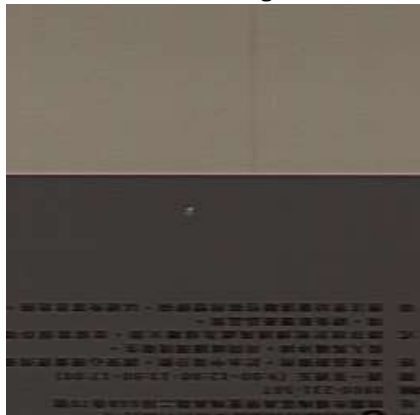
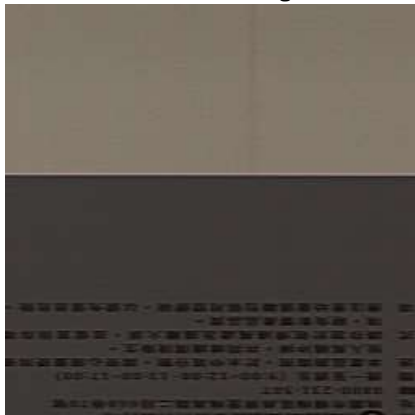
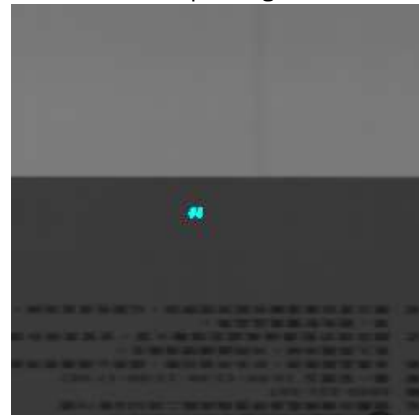
No.	#119, \$106	Date	2023/8/9 上午 11:32:24
Segment	1	Camera	1
Pattern	7023	Position[x, y]	182.0 [mm], 5312.5 [m], (195.9 [m])
Type	縱向刀絲疵點	Size	H:2.2 ,V:2.0 [mm]
Result	-	Area	3.8 [mm2]
Inspection level	5/5,5/5,5/5,5/5,5/5	Label	-
Light	6,6,3/6,6,3

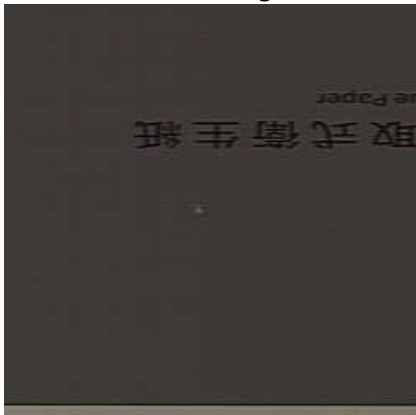
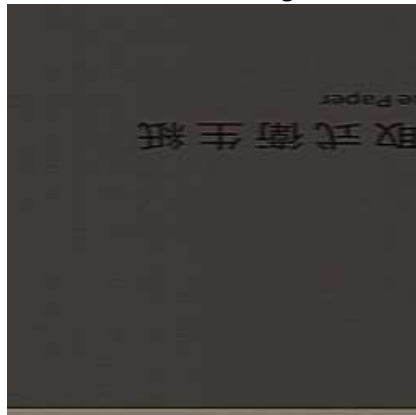
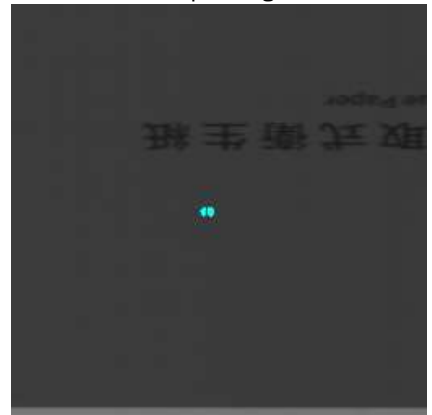
No.	#118, \$105	Date	2023/8/9 上午 11:32:23
Segment	1	Camera	1
Pattern	7021	Position[x, y]	168.1 [mm], 5311.2 [m], (197.2 [m])
Type	縱向刀絲疵點	Size	H:2.2 ,V:1.6 [mm]
Result	-	Area	2.7 [mm2]
Inspection level	5/5,5/5,5/5,5/5,5/5	Label	-
Light	6,6,3/6,6,3

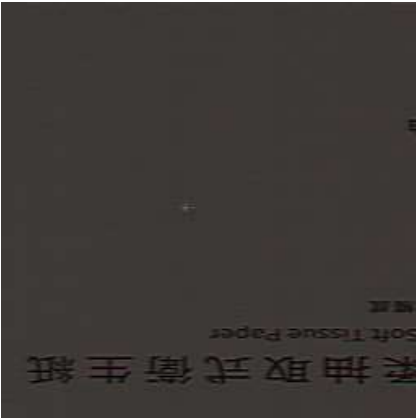
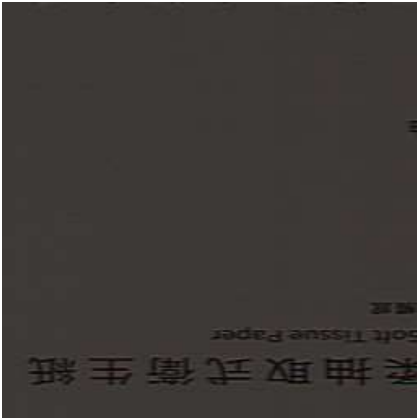
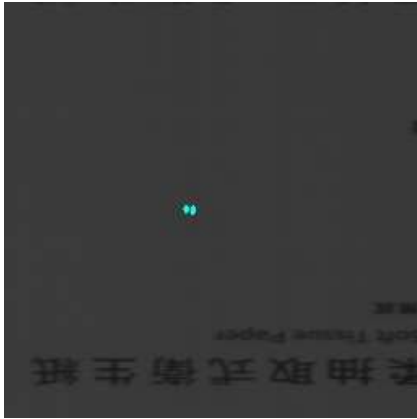
No.	#116, \$103	Date	2023/8/9 上午 11:32:20
Segment	1	Camera	1
Pattern	7017	Position[x, y]	182.0 [mm], 5308.2 [m], (200.2 [m])
Type	縱向刀絲疵點	Size	H:2.0 ,V:1.6 [mm]
Result	-	Area	2.0 [mm2]
Inspection level	5/5,5/5,5/5,5/5,5/5	Label	-
Light	6,6,3/6,6,3
