Inspection Result (Individual Data)

Lot number : 3

商品名	標準透明6-6-3	周長	
顧客名		Ex1	
CODE番号		Ex2	
基材		Ex3

Total defects	148	檢查範圍 : 83.6 ~ 1024.2 [mm]	寬度 : 940.6 [mm]
Web length	5508.4 [m]	參照更新 : 週期10<平時>/週期10<平時>	
Segments	1 (從左側)

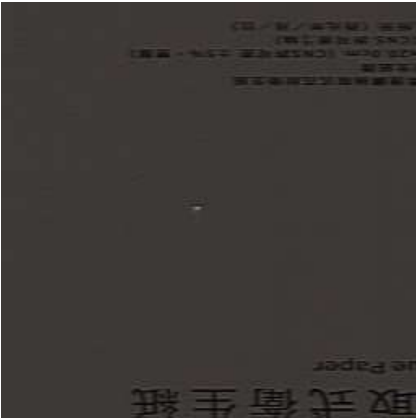
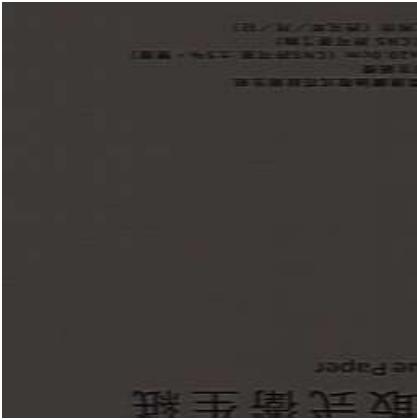
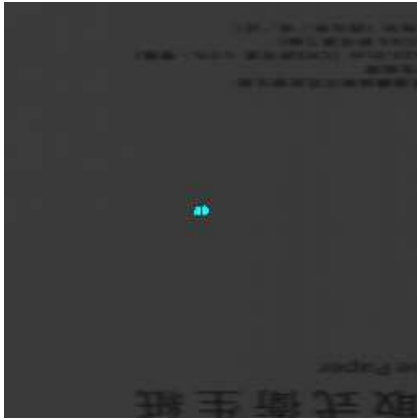
No.	#115, \$102	Date	2023/8/9 上午 11:32:20
Segment	1	Camera	1
Pattern	7016	Position[x, y]	168.3 [mm], 5306.9 [m], (201.4 [m])
Type	縱向刀絲疵點	Size	H:2.2 ,V:1.6 [mm]
Result	-	Area	2.4 [mm2]
Inspection level	5/5,5/5,5/5,5/5,5/5	Label	-
Light	6,6,3/6,6,3

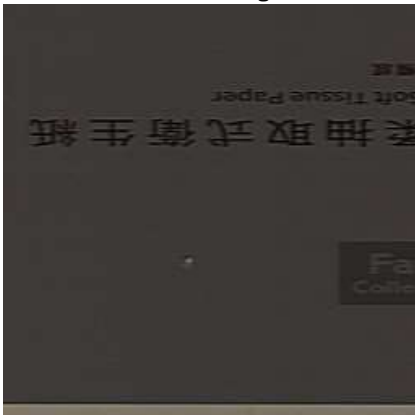
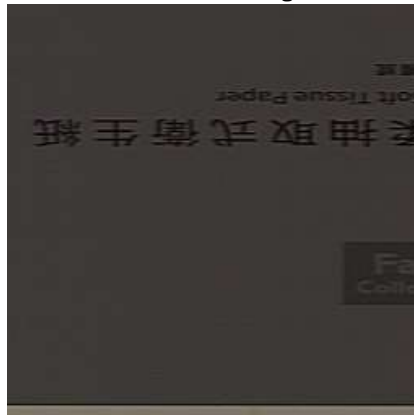
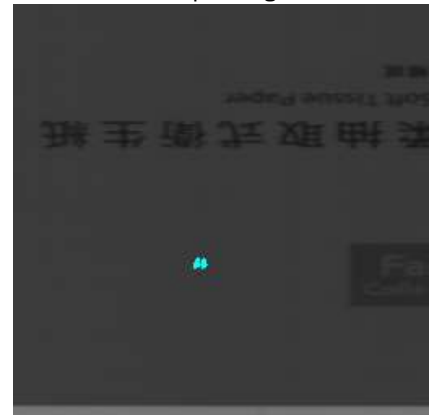
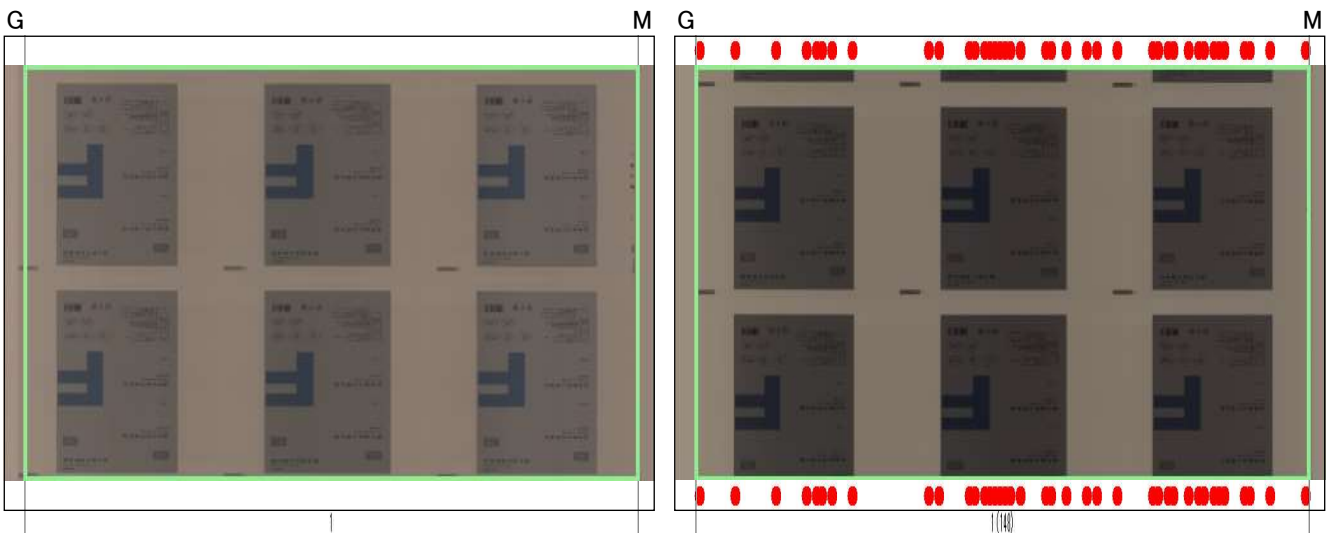
No.	#114, \$101	Date	2023/8/9 上午 11:32:19
Segment	1	Camera	1
Pattern	7015	Position[x, y]	182.2 [mm], 5306.7 [m], (201.7 [m])
Type	縱向刀絲疵點	Size	H:2.2 ,V:2.0 [mm]
Result	-	Area	3.3 [mm2]
Inspection level	5/5,5/5,5/5,5/5,5/5	Label	-
Light	6,6,3/6,6,3

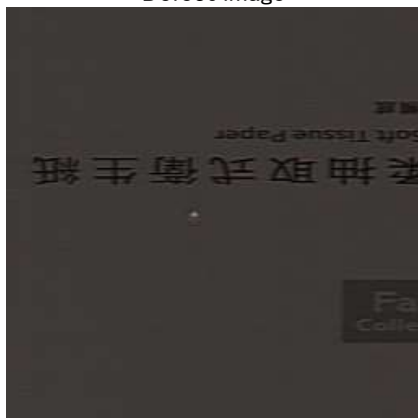
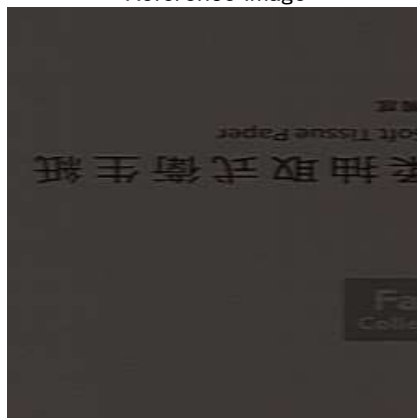
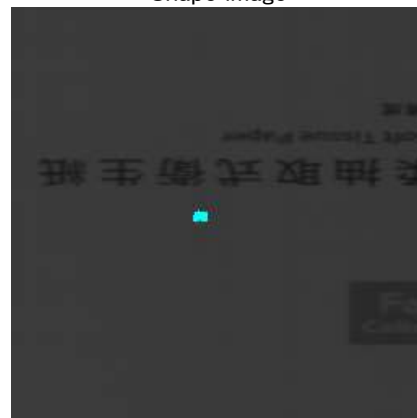
No.	#111, \$98	Date	2023/8/9 上午 11:32:14
Segment	1	Camera	1
Pattern	7006	Position[x, y]	182.7 [mm], 5299.6 [m], (208.8 [m])
Type	縱向刀絲疵點	Size	H:2.2 ,V:2.0 [mm]
Result	-	Area	3.7 [mm2]
Inspection level	5/5,5/5,5/5,5/5,5/5	Label	-
Light	6,6,3/6,6,3

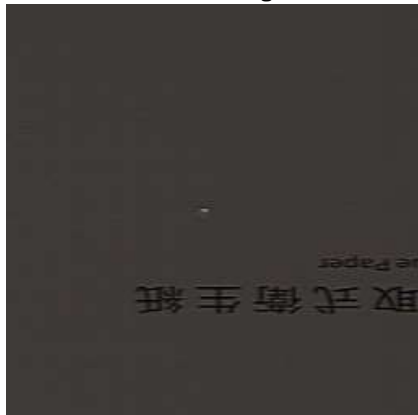
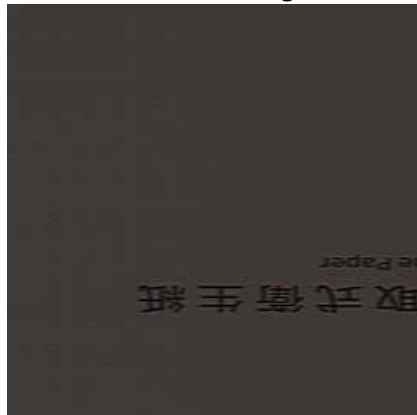
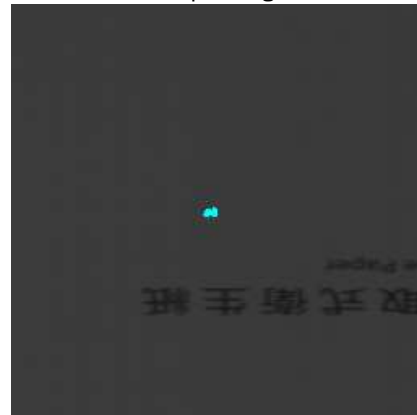
No.	#110, \$97	Date	2023/8/9 上午 11:32:11
Segment	1	Camera	1
Pattern	7002	Position[x, y]	168.6 [mm], 5296.9 [m], (211.5 [m])
Type	縱向刀絲疵點	Size	H:2.2 ,V:1.6 [mm]
Result	-	Area	2.7 [mm2]
Inspection level	5/5,5/5,5/5,5/5,5/5	Label	-
Light	6,6,3/6,6,3

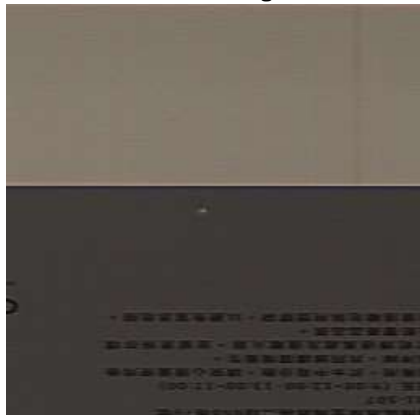
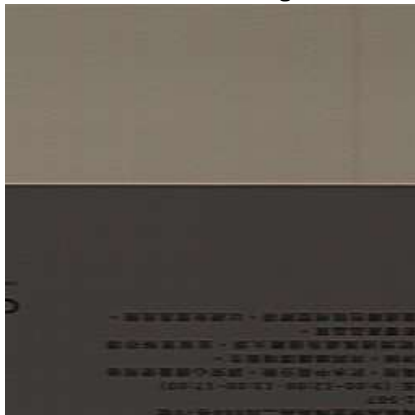
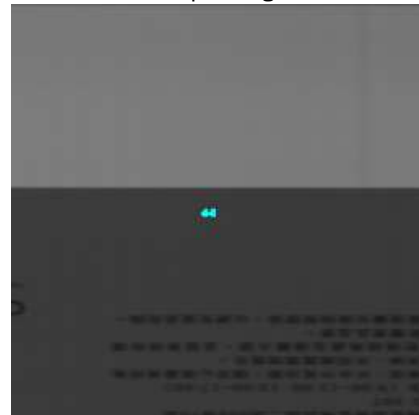
No.	#109, \$96	Date	2023/8/9 上午 11:32:10
Segment	1	Camera	1
Pattern	6999	Position[x, y]	168.3 [mm], 5294.1 [m], (214.3 [m])
Type	縱向刀絲疵點	Size	H:2.2 ,V:1.2 [mm]
Result	-	Area	2.3 [mm2]
Inspection level	5/5,5/5,5/5,5/5,5/5	Label	-
Light	6,6,3/6,6,3

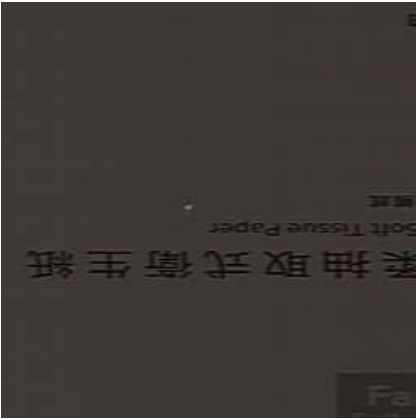
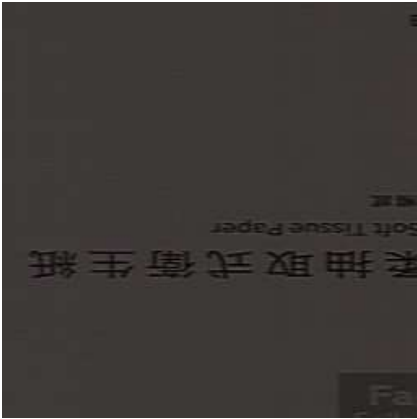
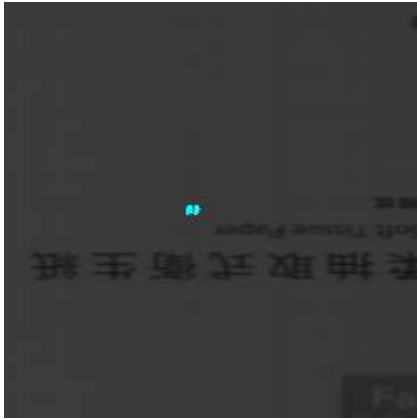
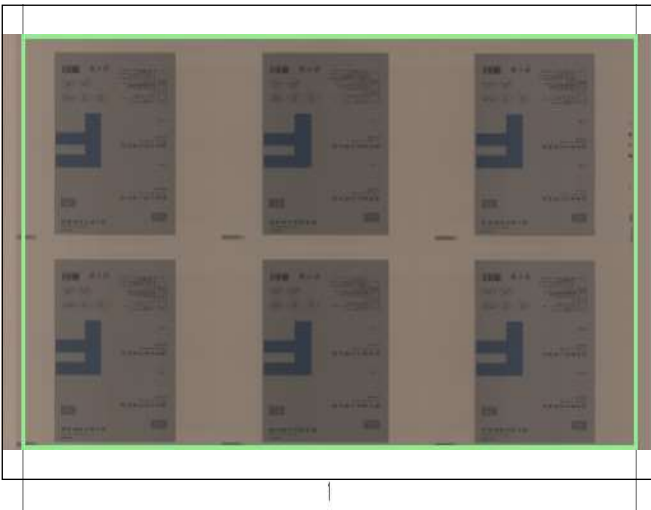
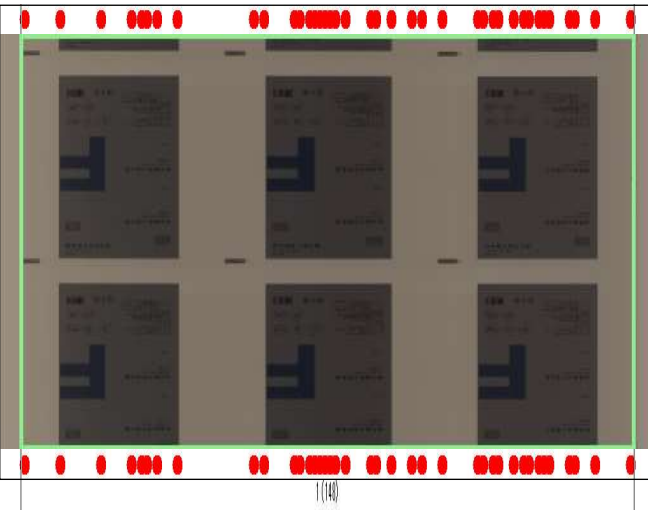
No.	#107, \$94	Date	2023/8/9 上午 11:32:08
Segment	1	Camera	1
Pattern	6996	Position[x, y]	182.5 [mm], 5292.4 [m], (216.0 [m])
Type	縱向刀絲疵點	Size	H:2.2 ,V:1.6 [mm]
Result	-	Area	2.8 [mm2]
Inspection level	5/5,5/5,5/5,5/5,5/5	Label	-
Light	6,6,3/6,6,3

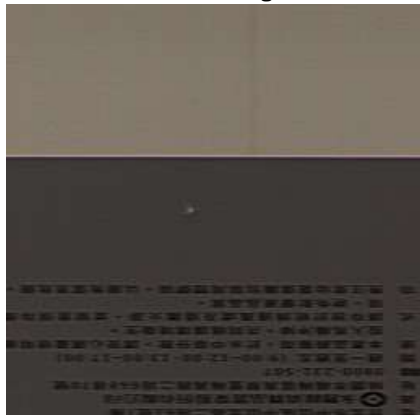
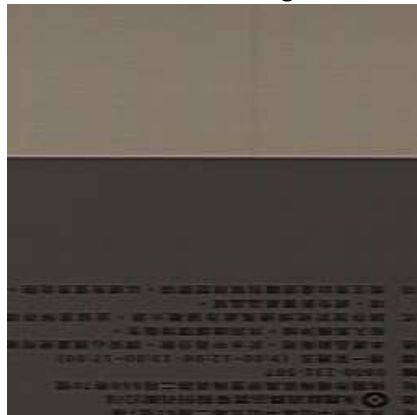
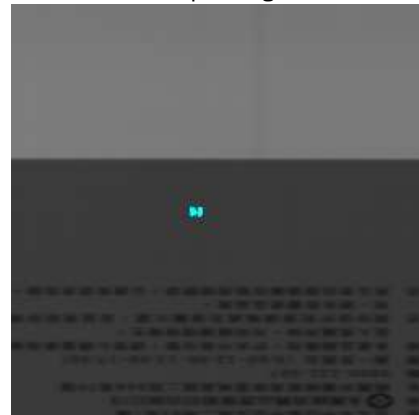
No.	#105, \$92	Date	2023/8/9 上午 11:32:06
Segment	1	Camera	1
Pattern	6993	Position[x, y]	182.0 [mm], 5289.6 [m], (218.8 [m])
Type	縱向刀絲疵點	Size	H:2.0 ,V:1.6 [mm]
Result	-	Area	2.7 [mm2]
Inspection level	5/5,5/5,5/5,5/5,5/5	Label	-
Light	6,6,3/6,6,3

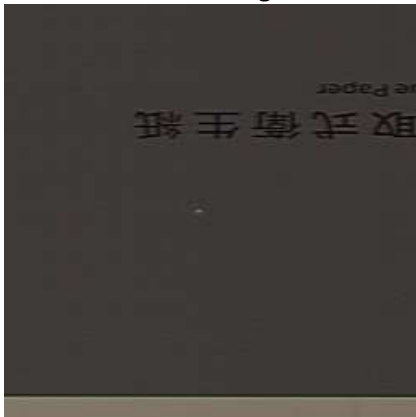
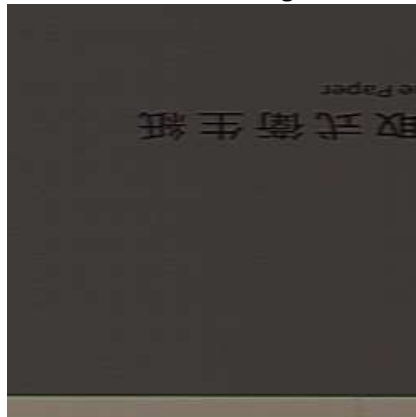
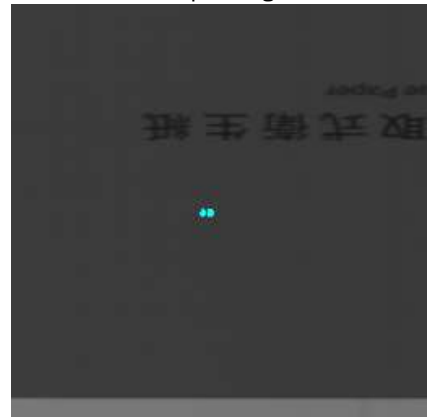
No.	#104, \$91	Date	2023/8/9 上午 11:32:05
Segment	1	Camera	1
Pattern	6991	Position[x, y]	168.1 [mm], 5288.3 [m], (220.0 [m])
Type	縱向刀絲疵點	Size	H:2.2 ,V:1.2 [mm]
Result	-	Area	2.2 [mm2]
Inspection level	5/5,5/5,5/5,5/5,5/5	Label	-
Light	6,6,3/6,6,3

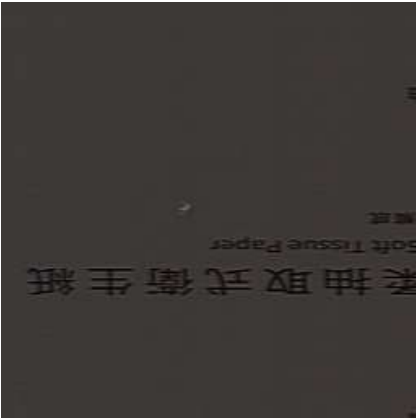
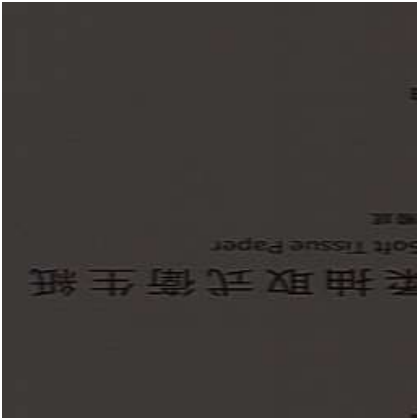
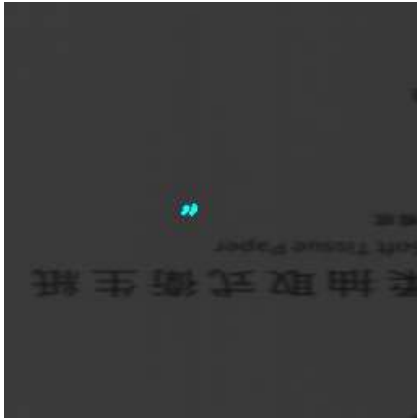
No.	#103, \$90	Date	2023/8/9 上午 11:32:04
Segment	1	Camera	1
Pattern	6989	Position[x, y]	182.2 [mm], 5286.7 [m], (221.7 [m])
Type	縱向刀絲疵點	Size	H:2.4 ,V:2.4 [mm]
Result	-	Area	3.7 [mm2]
Inspection level	5/5,5/5,5/5,5/5,5/5	Label	-
Light	6,6,3/6,6,3

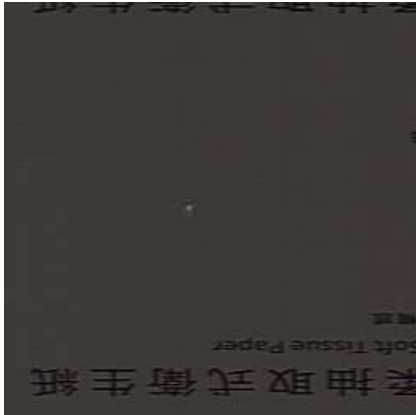
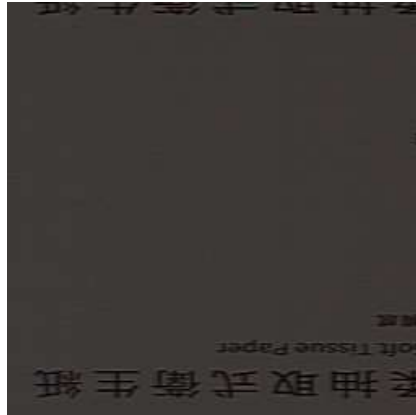
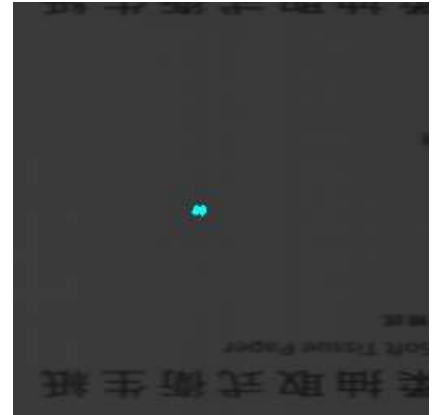
No.	#102, \$89	Date	2023/8/9 上午 11:32:03
Segment	1	Camera	1
Pattern	6987	Position[x, y]	182.2 [mm], 5285.3 [m], (223.1 [m])
Type	縱向刀絲疵點	Size	H:2.2 ,V:2.0 [mm]
Result	-	Area	3.6 [mm2]
Inspection level	5/5,5/5,5/5,5/5,5/5	Label	-
Light	6,6,3/6,6,3

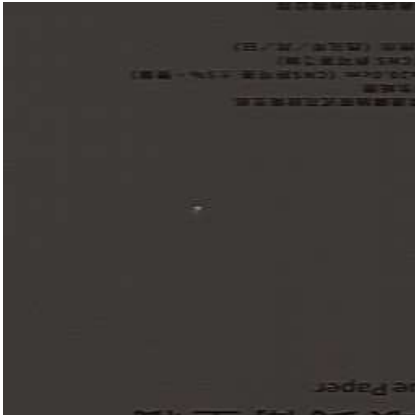
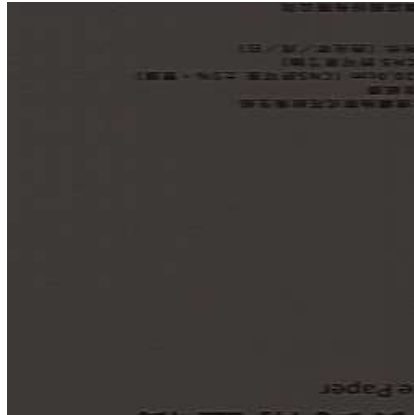
No.	#101, \$88	Date	2023/8/9 上午 11:32:01
Segment	1	Camera	1
Pattern	6985	Position[x, y]	168.1 [mm], 5284.0 [m], (224.3 [m])
Type	縱向刀絲疵點	Size	H:2.2 ,V:2.0 [mm]
Result	-	Area	3.9 [mm2]
Inspection level	5/5,5/5,5/5,5/5,5/5	Label	-
Light	6,6,3/6,6,3

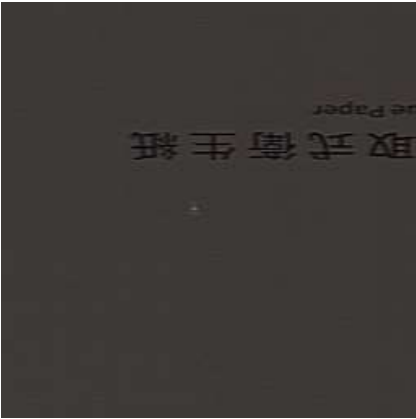
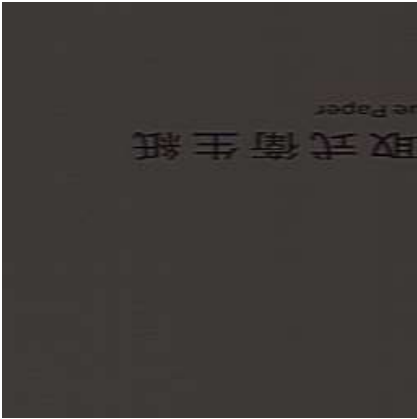
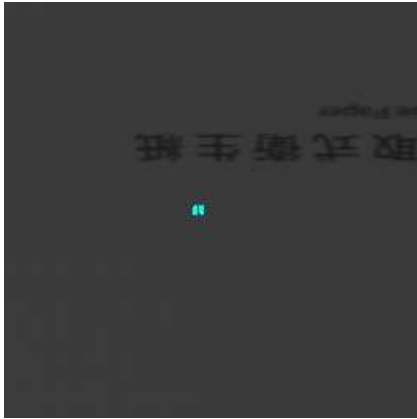
No.	#100, \$87	Date	2023/8/9 上午 11:32:00
Segment	1	Camera	1
Pattern	6983	Position[x, y]	167.8 [mm], 5282.6 [m], (225.8 [m])
Type	縱向刀絲疵點	Size	H:1.7 ,V:1.6 [mm]
Result	-	Area	2.2 [mm2]
Inspection level	5/5,5/5,5/5,5/5,5/5	Label	-
Light	6,6,3/6,6,3

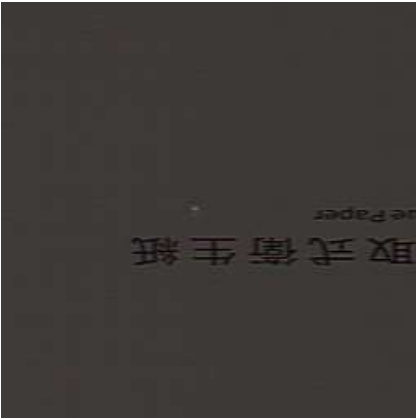
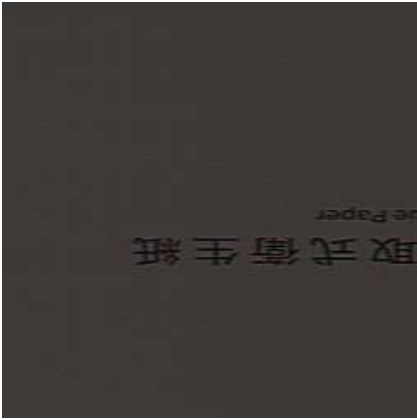
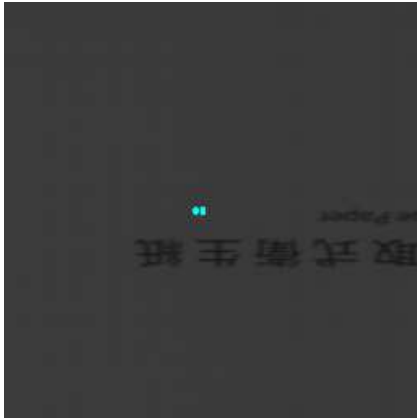
No.	#99, \$86	Date	2023/8/9 上午 11:31:59
Segment	1	Camera	1
Pattern	6981	Position[x, y]	167.8 [mm], 5281.2 [m], (227.2 [m])
Type	縱向刀絲疵點	Size	H:2.0 ,V:1.2 [mm]
Result	-	Area	2.1 [mm2]
Inspection level	5/5,5/5,5/5,5/5,5/5	Label	-
Light	6,6,3/6,6,3

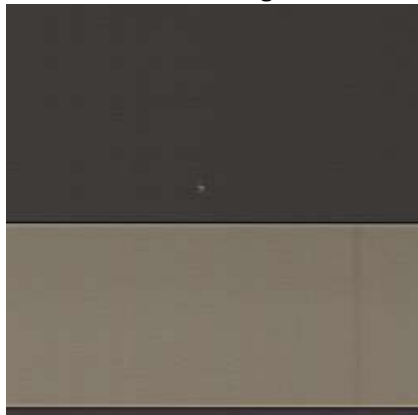
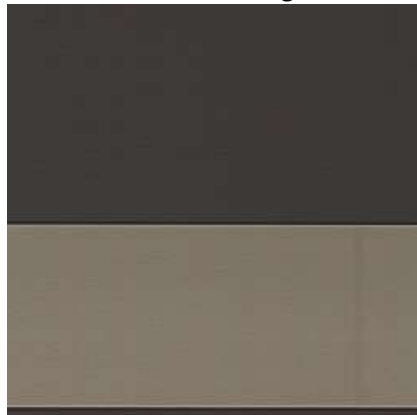
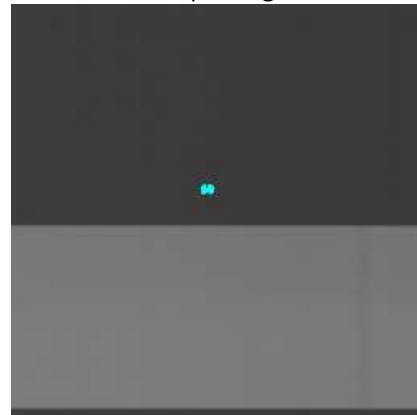
No.	#98, \$85	Date	2023/8/9 上午 11:31:58
Segment	1	Camera	1
Pattern	6980	Position[x, y]	168.1 [mm], 5279.7 [m], (228.6 [m])
Type	縱向刀絲疵點	Size	H:2.0 ,V:1.6 [mm]
Result	-	Area	3.0 [mm2]
Inspection level	5/5,5/5,5/5,5/5,5/5	Label	-
Light	6,6,3/6,6,3

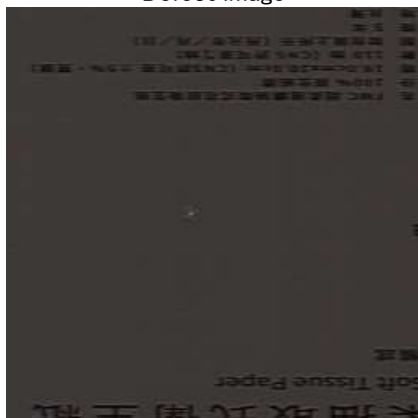
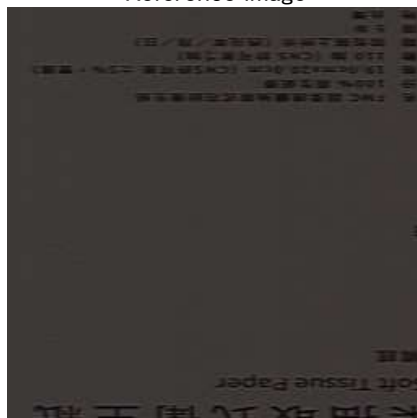
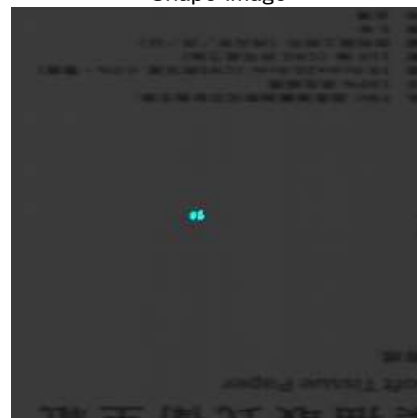
No.	#97, \$84	Date	2023/8/9 上午 11:31:58
Segment	1	Camera	1
Pattern	6979	Position[x, y]	182.2 [mm], 5279.5 [m], (228.8 [m])
Type	縱向刀絲疵點	Size	H:2.2 ,V:1.6 [mm]
Result	-	Area	2.5 [mm2]
Inspection level	5/5,5/5,5/5,5/5,5/5	Label	-
Light	6,6,3/6,6,3

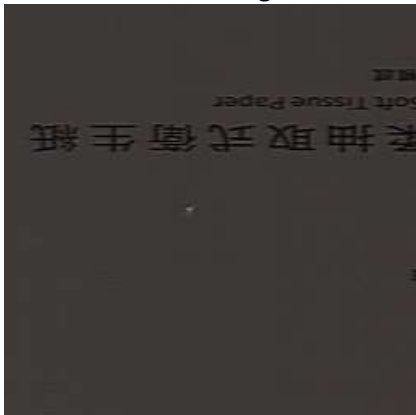
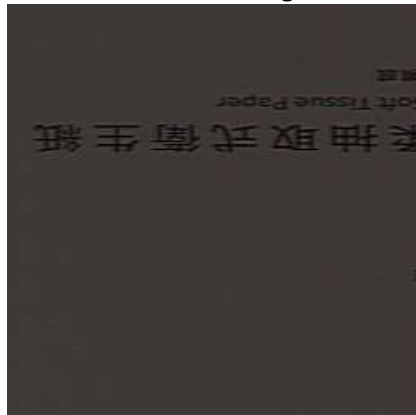
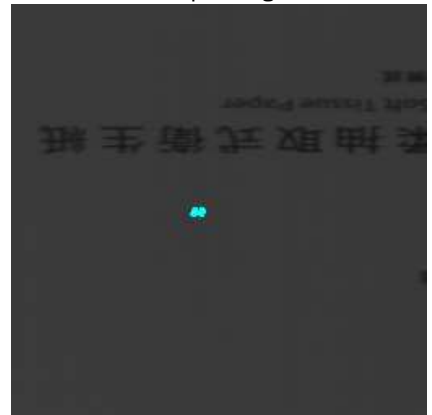
No.	#95, \$82	Date	2023/8/9 上午 11:31:57
Segment	1	Camera	1
Pattern	6977	Position[x, y]	182.2 [mm], 5278.1 [m], (230.3 [m])
Type	縱向刀絲疵點	Size	H:2.4 ,V:1.6 [mm]
Result	-	Area	3.5 [mm2]
Inspection level	5/5,5/5,5/5,5/5,5/5	Label	-
Light	6,6,3/6,6,3

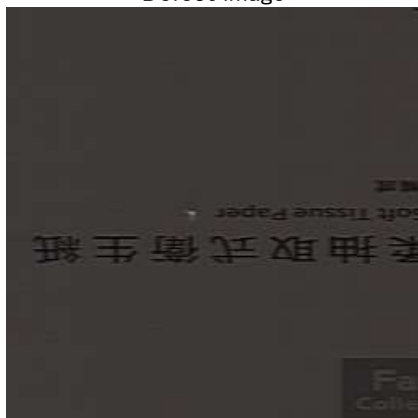
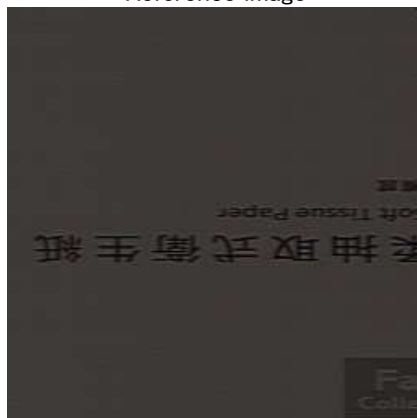
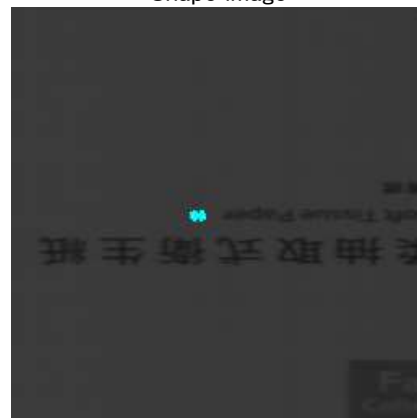
No.	#94, \$81	Date	2023/8/9 上午 11:31:55
Segment	1	Camera	1
Pattern	6975	Position[x, y]	182.2 [mm], 5276.7 [m], (231.7 [m])
Type	縱向刀絲疵點	Size	H:2.4 ,V:2.0 [mm]
Result	-	Area	4.3 [mm2]
Inspection level	5/5,5/5,5/5,5/5,5/5	Label	-
Light	6,6,3/6,6,3

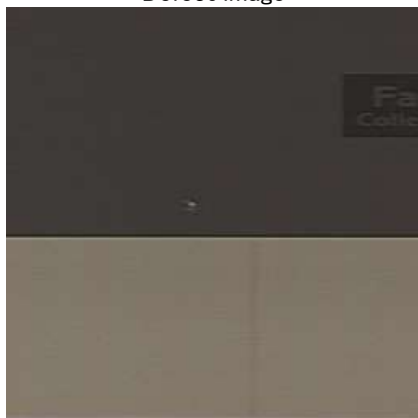
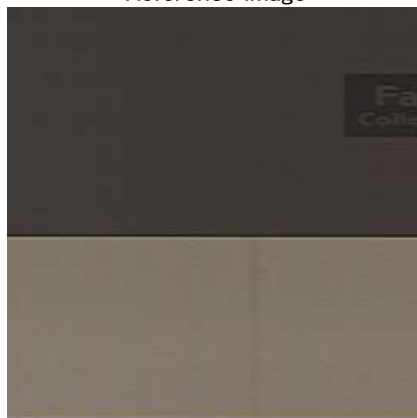
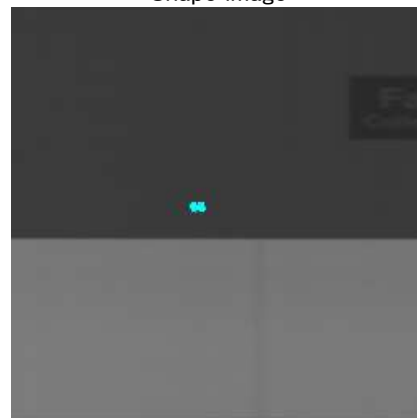
No.	#93, \$80	Date	2023/8/9 上午 11:31:55
Segment	1	Camera	1
Pattern	6974	Position[x, y]	182.2 [mm], 5275.2 [m], (233.1 [m])
Type	縱向刀絲疵點	Size	H:2.4 ,V:1.6 [mm]
Result	-	Area	3.5 [mm2]
Inspection level	5/5,5/5,5/5,5/5,5/5	Label	-
Light	6,6,3/6,6,3

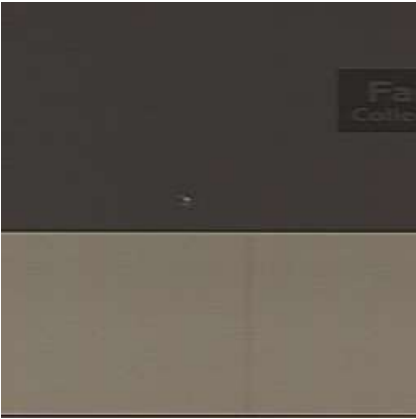
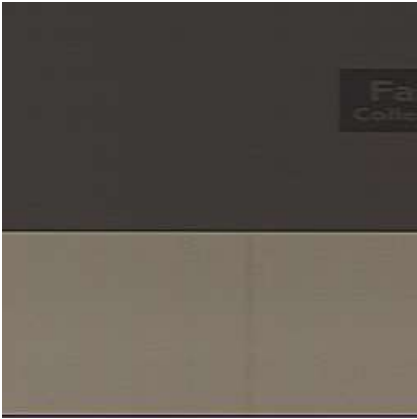
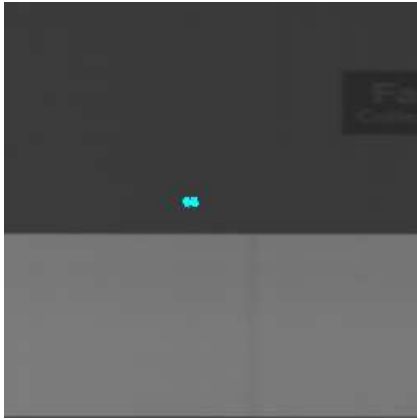
No.	#92, \$79	Date	2023/8/9 上午 11:31:54
Segment	1	Camera	1
Pattern	6972	Position[x, y]	167.8 [mm], 5274.0 [m], (234.4 [m])
Type	縱向刀絲疵點	Size	H:2.0 ,V:1.6 [mm]
Result	-	Area	3.0 [mm2]
Inspection level	5/5,5/5,5/5,5/5,5/5	Label	-
Light	6,6,3/6,6,3

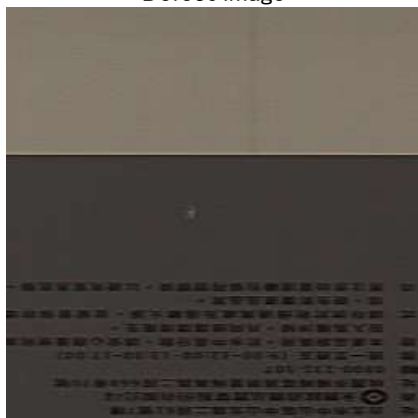
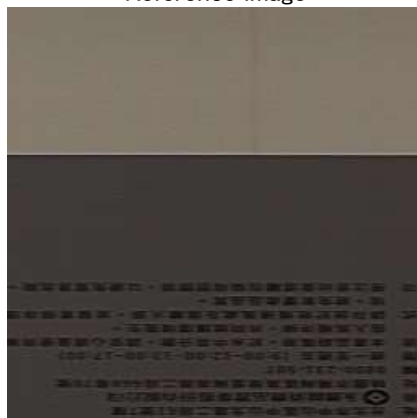
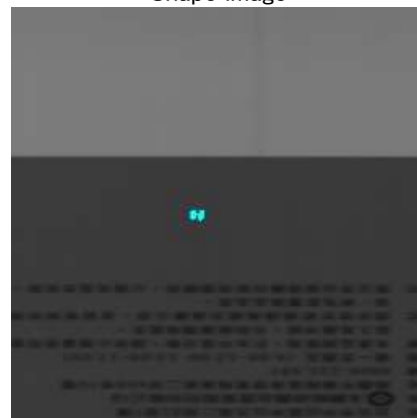
No.	#92, \$79	Date	2023/8/9 上午 11:31:54
Segment	1	Camera	1
Pattern	6972	Position[x, y]	182.2 [mm], 5273.8 [m], (234.6 [m])
Type	縱向刀絲疵點	Size	H:2.2 ,V:2.0 [mm]
Result	-	Area	3.4 [mm2]
Inspection level	5/5,5/5,5/5,5/5,5/5	Label	-
Light	6,6,3/6,6,3

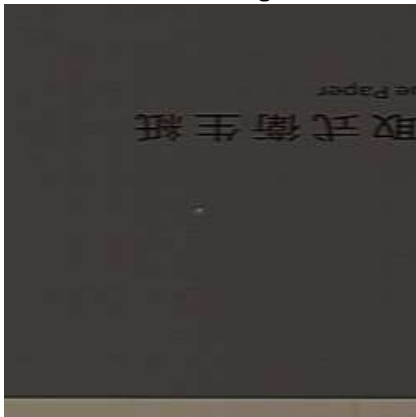
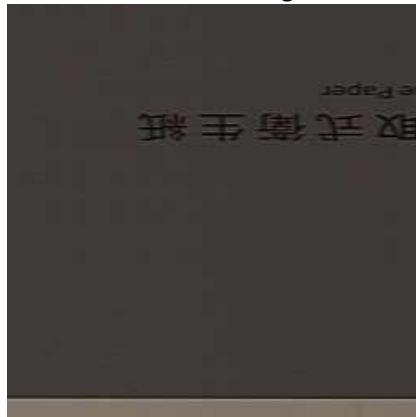
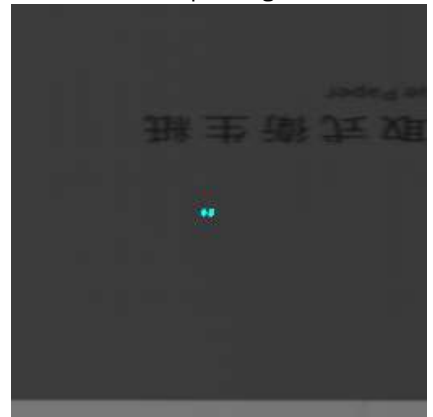
No.	#91, \$78	Date	2023/8/9 上午 11:31:52
Segment	1	Camera	1
Pattern	6970	Position[x, y]	168.1 [mm], 5272.6 [m], (235.8 [m])
Type	縱向刀絲疵點	Size	H:2.0 ,V:1.2 [mm]
Result	-	Area	2.0 [mm2]
Inspection level	5/5,5/5,5/5,5/5,5/5	Label	-
Light	6,6,3/6,6,3

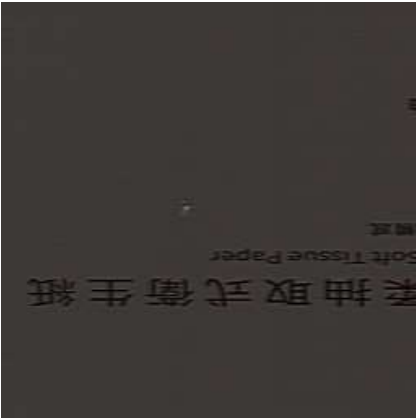
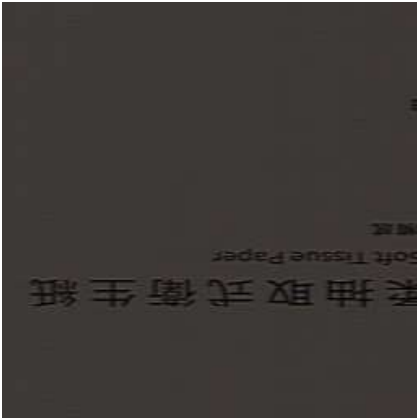
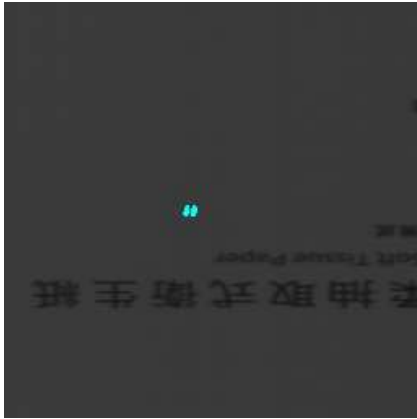
No.	#90, \$77	Date	2023/8/9 上午 11:31:51
Segment	1	Camera	1
Pattern	6968	Position[x, y]	182.2 [mm], 5270.9 [m], (237.4 [m])
Type	縱向刀絲疵點	Size	H:2.2 ,V:2.0 [mm]
Result	-	Area	3.3 [mm2]
Inspection level	5/5,5/5,5/5,5/5,5/5	Label	-
Light	6,6,3/6,6,3

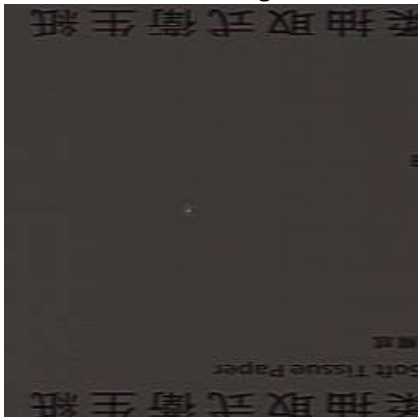
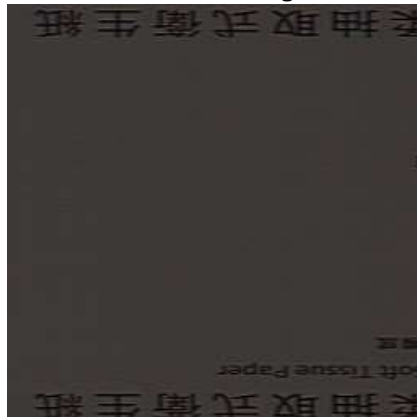
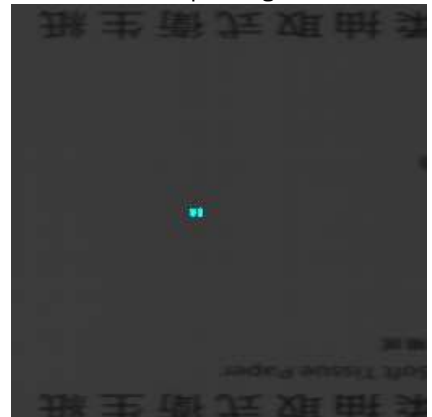
No.	#89, \$76	Date	2023/8/9 上午 11:31:50
Segment	1	Camera	1
Pattern	6966	Position[x, y]	182.0 [mm], 5269.5 [m], (238.9 [m])
Type	縱向刀絲疵點	Size	H:2.0 ,V:1.6 [mm]
Result	-	Area	2.3 [mm2]
Inspection level	5/5,5/5,5/5,5/5,5/5	Label	-
Light	6,6,3/6,6,3

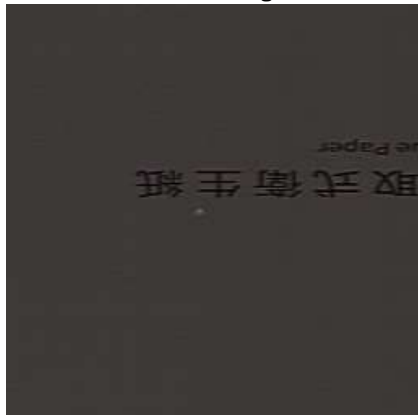
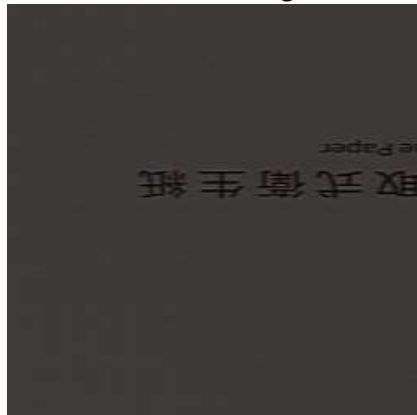
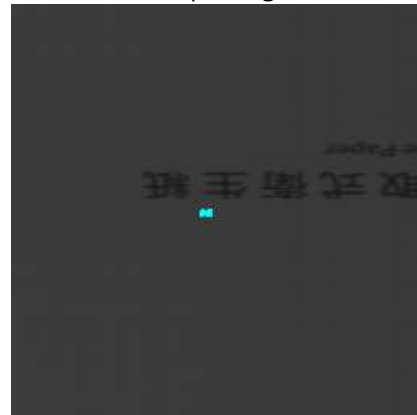
No.	#87, \$74	Date	2023/8/9 上午 11:31:48
Segment	1	Camera	1
Pattern	6962	Position[x, y]	167.8 [mm], 5266.8 [m], (241.5 [m])
Type	縱向刀絲疵點	Size	H:2.0 ,V:1.2 [mm]
Result	-	Area	2.3 [mm2]
Inspection level	5/5,5/5,5/5,5/5,5/5	Label	-
Light	6,6,3/6,6,3

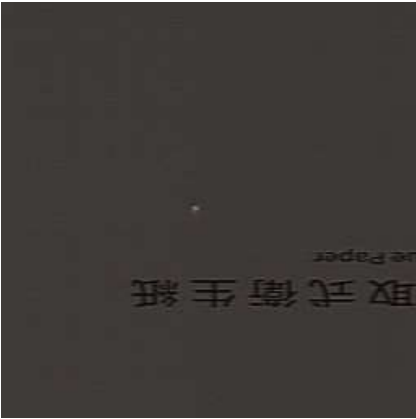
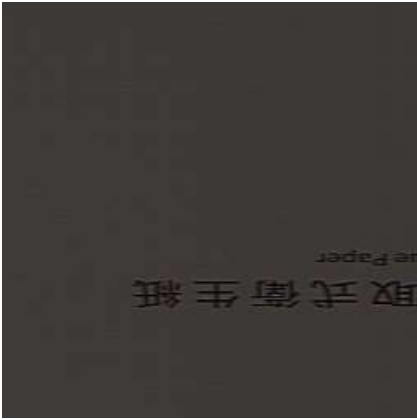
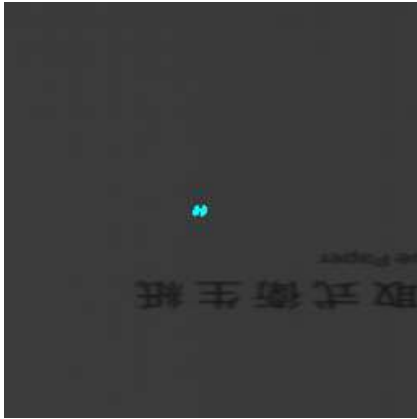
No.	#86, \$73	Date	2023/8/9 上午 11:31:47
Segment	1	Camera	1
Pattern	6960	Position[x, y]	168.1 [mm], 5265.4 [m], (243.0 [m])
Type	縱向刀絲疵點	Size	H:2.2 ,V:2.0 [mm]
Result	-	Area	3.6 [mm2]
Inspection level	5/5,5/5,5/5,5/5,5/5	Label	-
Light	6,6,3/6,6,3

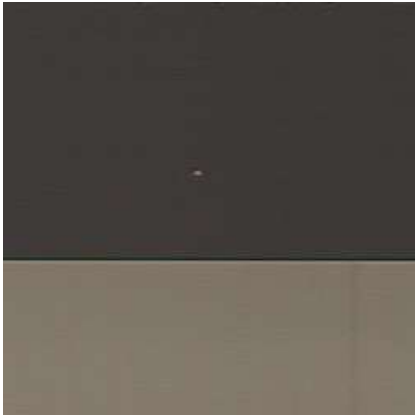
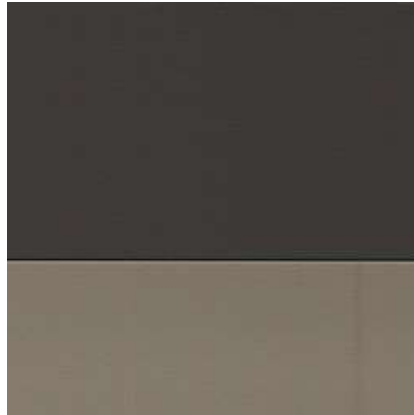
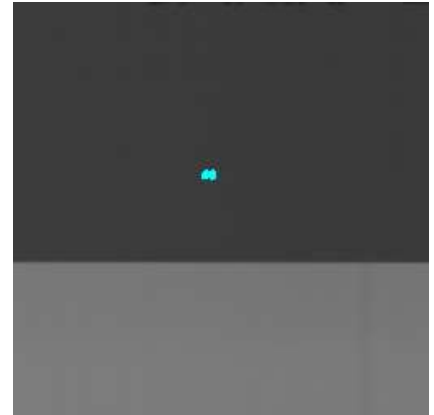
No.	#85, \$72	Date	2023/8/9 上午 11:31:46
Segment	1	Camera	1
Pattern	6959	Position[x, y]	168.1 [mm], 5264.0 [m], (244.4 [m])
Type	縱向刀絲疵點	Size	H:2.2 ,V:2.0 [mm]
Result	-	Area	3.6 [mm2]
Inspection level	5/5,5/5,5/5,5/5,5/5	Label	-
Light	6,6,3/6,6,3

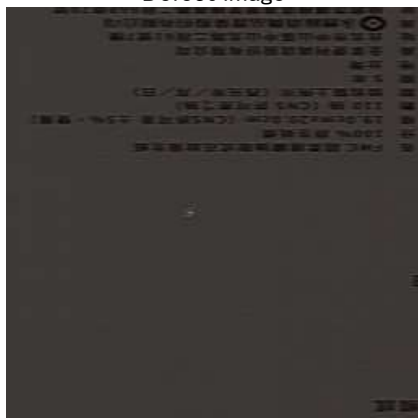
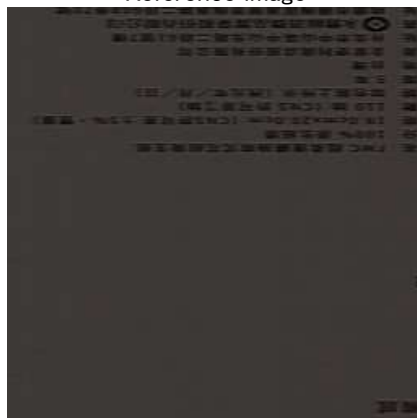
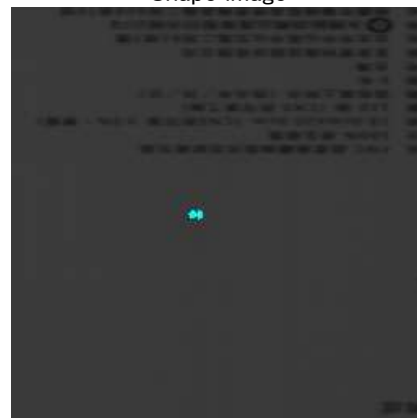
No.	#84, \$71	Date	2023/8/9 上午 11:31:45
Segment	1	Camera	1
Pattern	6958	Position[x, y]	182.0 [mm], 5263.8 [m], (244.6 [m])
Type	縱向刀絲疵點	Size	H:2.2 ,V:1.6 [mm]
Result	-	Area	2.4 [mm2]
Inspection level	5/5,5/5,5/5,5/5,5/5	Label	-
Light	6,6,3/6,6,3

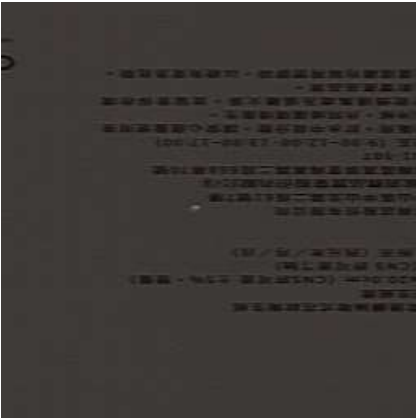
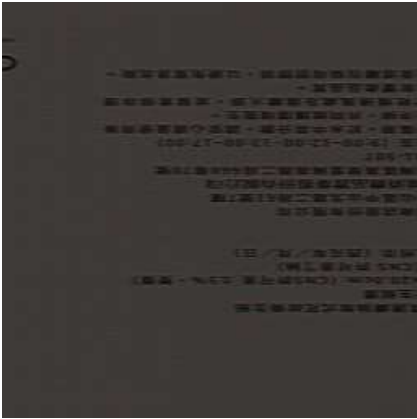
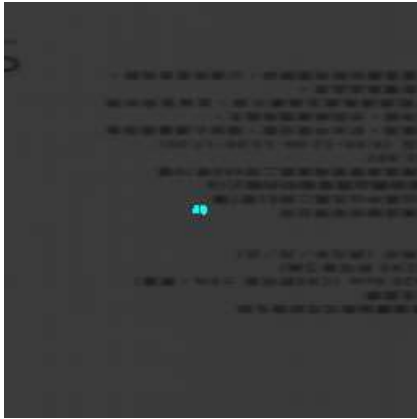
No.	#83, \$70	Date	2023/8/9 上午 11:31:44
Segment	1	Camera	1
Pattern	6955	Position[x, y]	168.1 [mm], 5261.1 [m], (247.3 [m])
Type	縱向刀絲疵點	Size	H:2.2 ,V:1.6 [mm]
Result	-	Area	2.6 [mm2]
Inspection level	5/5,5/5,5/5,5/5,5/5	Label	-
Light	6,6,3/6,6,3

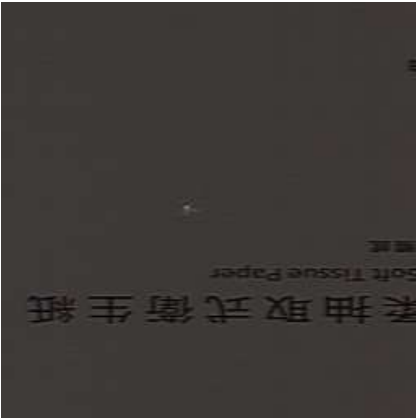
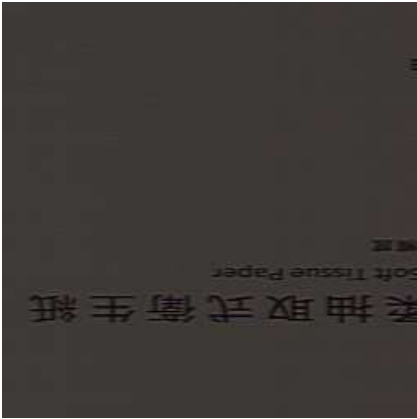
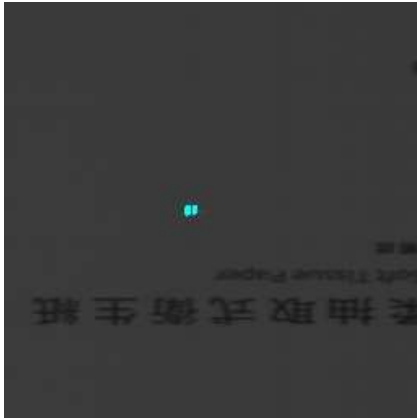
No.	#82, \$69	Date	2023/8/9 上午 11:31:43
Segment	1	Camera	1
Pattern	6954	Position[x, y]	182.2 [mm], 5260.9 [m], (247.5 [m])
Type	縱向刀絲疵點	Size	H:2.0 ,V:2.0 [mm]
Result	-	Area	3.0 [mm2]
Inspection level	5/5,5/5,5/5,5/5,5/5	Label	-
Light	6,6,3/6,6,3

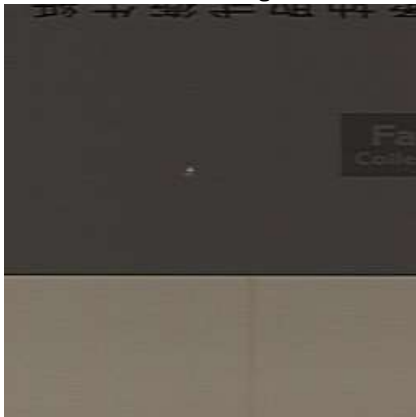
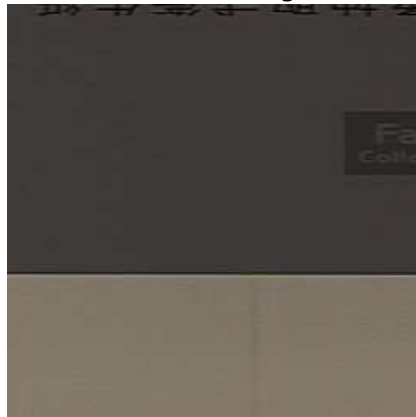
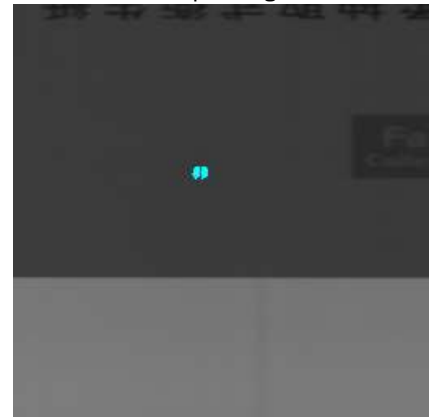
No.	#81, \$68	Date	2023/8/9 上午 11:31:42
Segment	1	Camera	1
Pattern	6953	Position[x, y]	182.2 [mm], 5259.5 [m], (248.9 [m])
Type	縱向刀絲疵點	Size	H:2.4 ,V:2.4 [mm]
Result	-	Area	4.4 [mm2]
Inspection level	5/5,5/5,5/5,5/5,5/5	Label	-
Light	6,6,3/6,6,3

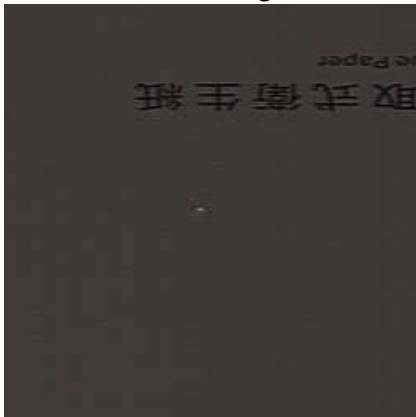
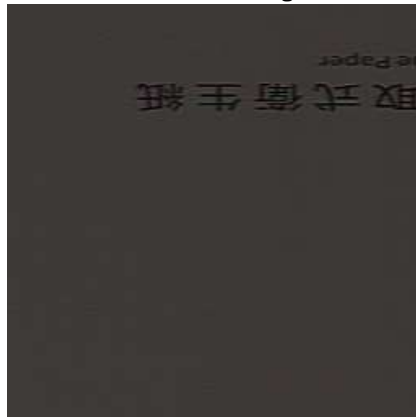
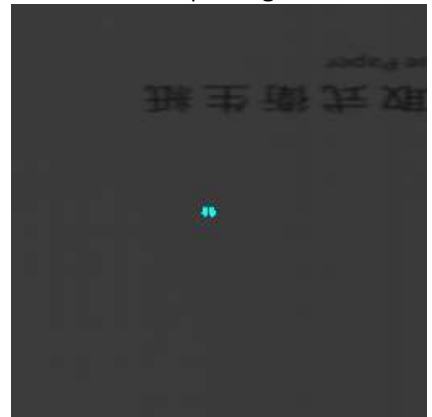
No.	#80, \$67	Date	2023/8/9 上午 11:31:41
Segment	1	Camera	1
Pattern	6951	Position[x, y]	168.3 [mm], 5258.2 [m], (250.2 [m])
Type	縱向刀絲疵點	Size	H:2.2 ,V:1.6 [mm]
Result	-	Area	2.6 [mm2]
Inspection level	5/5,5/5,5/5,5/5,5/5	Label	-
Light	6,6,3/6,6,3

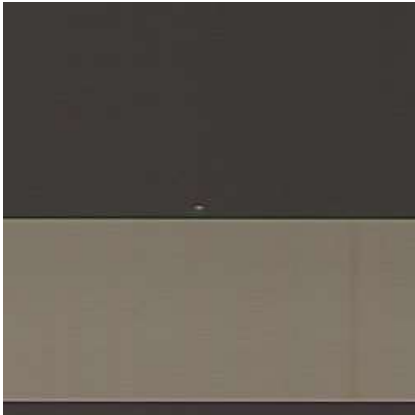
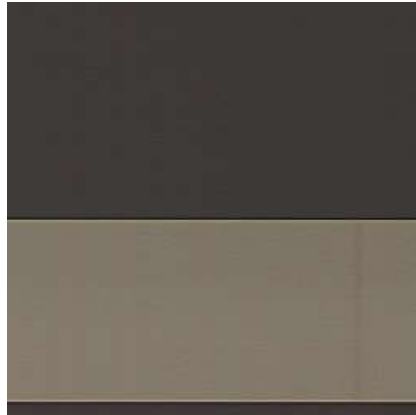
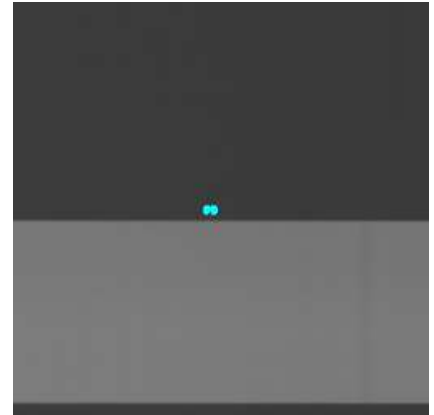
No.	#79, \$66	Date	2023/8/9 上午 11:31:39
Segment	1	Camera	1
Pattern	6947	Position[x, y]	168.1 [mm], 5255.4 [m], (253.0 [m])
Type	縱向刀絲疵點	Size	H:2.2 ,V:1.6 [mm]
Result	-	Area	3.4 [mm2]
Inspection level	5/5,5/5,5/5,5/5,5/5	Label	-
Light	6,6,3/6,6,3

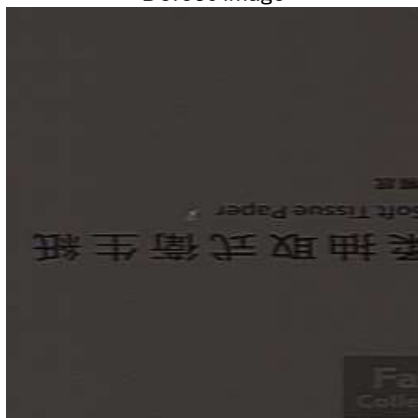
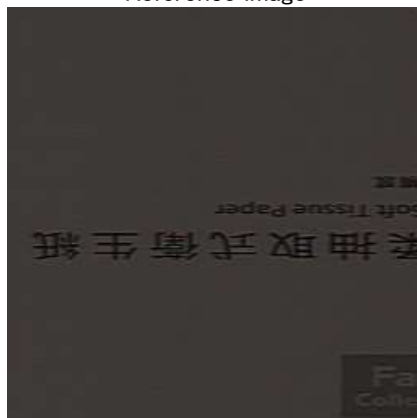
No.	#76, \$63	Date	2023/8/9 上午 11:31:35
Segment	1	Camera	1
Pattern	6941	Position[x, y]	168.1 [mm], 5251.1 [m], (257.3 [m])
Type	縱向刀絲疵點	Size	H:2.0 ,V:1.6 [mm]
Result	-	Area	2.7 [mm2]
Inspection level	5/5,5/5,5/5,5/5,5/5	Label	-
Light	6,6,3/6,6,3

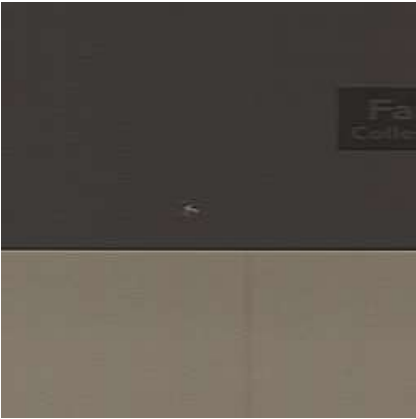
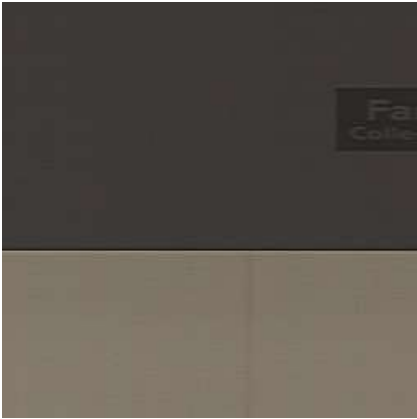
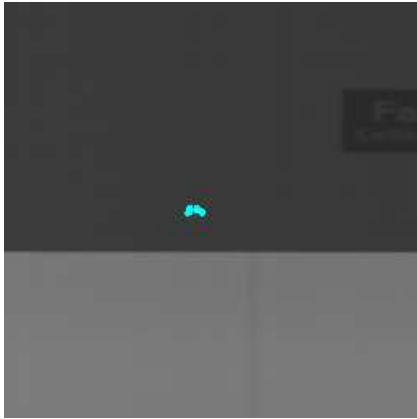
No.	#76, \$63	Date	2023/8/9 上午 11:31:35
Segment	1	Camera	1
Pattern	6941	Position[x, y]	182.7 [mm], 5250.9 [m], (257.5 [m])
Type	縱向刀絲疵點	Size	H:3.2 ,V:2.0 [mm]
Result	-	Area	4.6 [mm2]
Inspection level	5/5,5/5,5/5,5/5,5/5	Label	-
Light	6,6,3/6,6,3

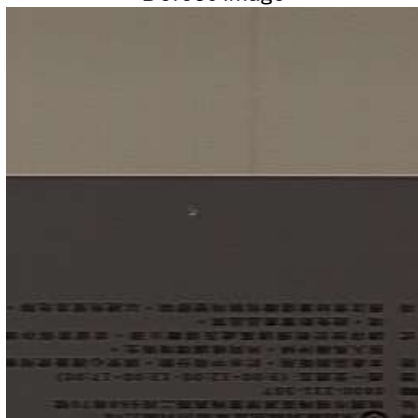
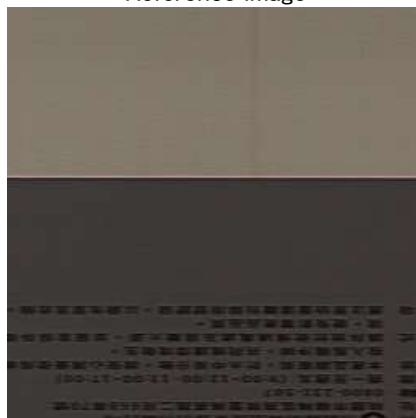
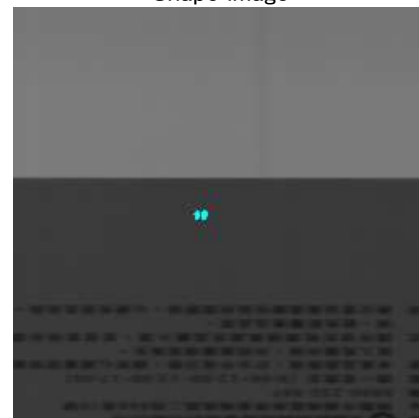
No.	#75, \$62	Date	2023/8/9 上午 11:31:34
Segment	1	Camera	1
Pattern	6939	Position[x, y]	182.5 [mm], 5249.4 [m], (259.0 [m])
Type	縱向刀絲疵點	Size	H:2.2 ,V:1.6 [mm]
Result	-	Area	2.7 [mm2]
Inspection level	5/5,5/5,5/5,5/5,5/5	Label	-
Light	6,6,3/6,6,3

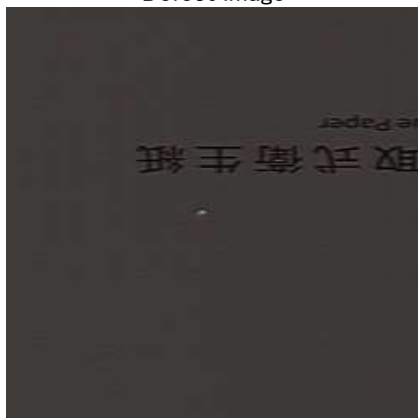
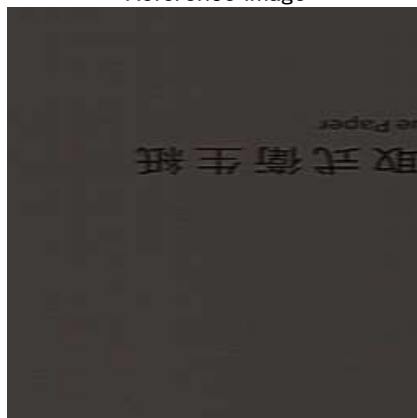
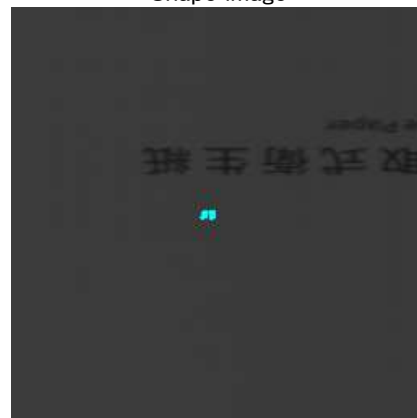
No.	#74, \$61	Date	2023/8/9 上午 11:31:33
Segment	1	Camera	1
Pattern	6937	Position[x, y]	168.1 [mm], 5248.2 [m], (260.2 [m])
Type	縱向刀絲疵點	Size	H:2.4 ,V:1.6 [mm]
Result	-	Area	3.2 [mm2]
Inspection level	5/5,5/5,5/5,5/5,5/5	Label	-
Light	6,6,3/6,6,3

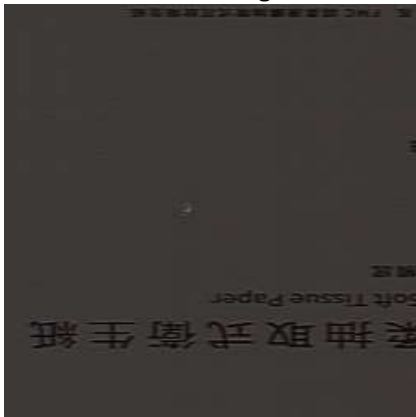
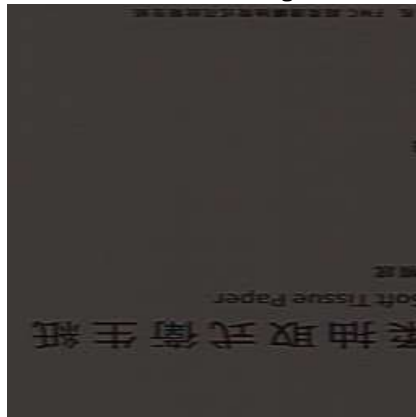
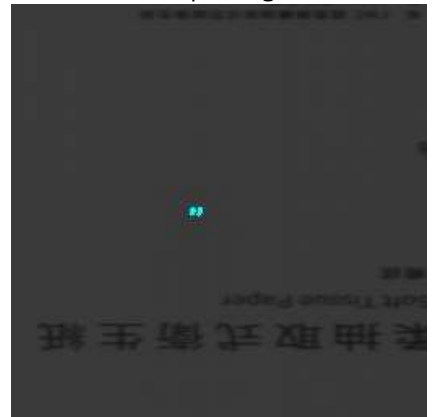
No.	#73, \$60	Date	2023/8/9 上午 11:31:32
Segment	1	Camera	1
Pattern	6935	Position[x, y]	182.0 [mm], 5246.5 [m], (261.8 [m])
Type	縱向刀絲疵點	Size	H:2.0 ,V:1.6 [mm]
Result	-	Area	2.2 [mm2]
Inspection level	5/5,5/5,5/5,5/5,5/5	Label	-
Light	6,6,3/6,6,3
