Inspection Result (Individual Data)

Lot number : 3

商品名	標準透明6-6-3	周長	
顧客名		Ex1	
CODE番号		Ex2	
基材		Ex3

Total defects	148	檢查範圍 : 83.6 ~ 1024.2 [mm]	寬度 : 940.6 [mm]
Web length	5508.4 [m]	參照更新 : 週期10<平時>/週期10<平時>	
Segments	1 (從左側)

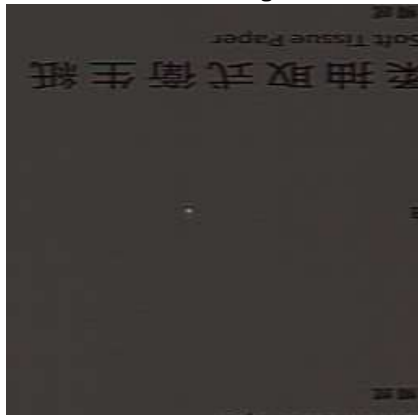
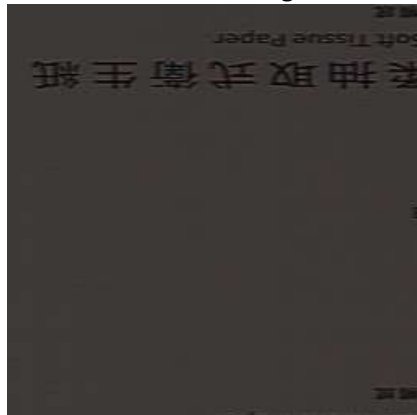
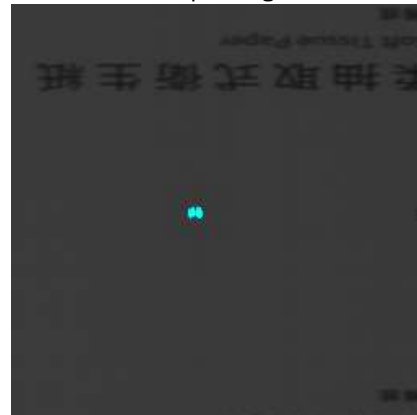
No.	#72, \$59	Date	2023/8/9 上午 11:31:31
Segment	1	Camera	1
Pattern	6933	Position[x, y]	181.7 [mm], 5245.1 [m], (263.3 [m])
Type	縱向刀絲疵點	Size	H:2.2 ,V:2.0 [mm]
Result	-	Area	3.8 [mm2]
Inspection level	5/5,5/5,5/5,5/5,5/5	Label	-
Light	6,6,3/6,6,3

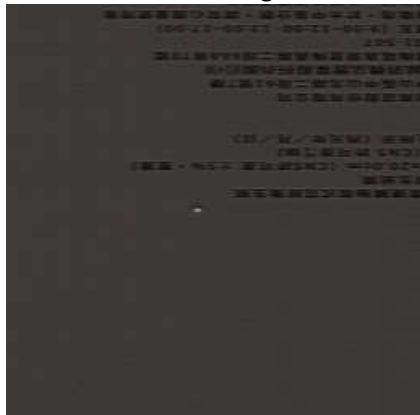
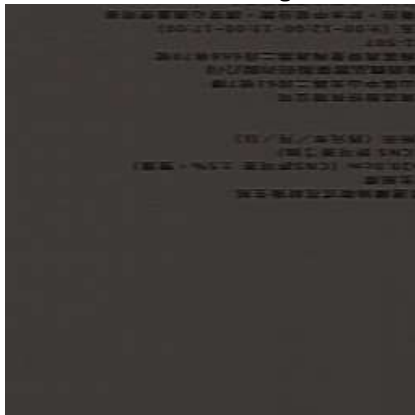
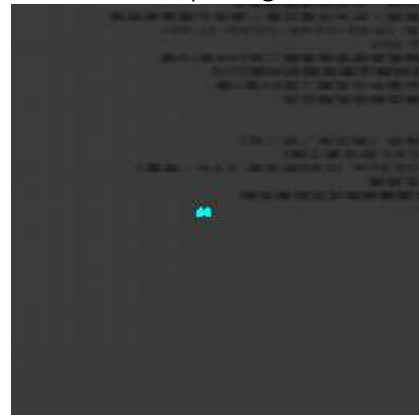
No.	#71, \$58	Date	2023/8/9 上午 11:31:30
Segment	1	Camera	1
Pattern	6932	Position[x, y]	167.6 [mm], 5243.9 [m], (264.5 [m])
Type	縱向刀絲疵點	Size	H:2.2 ,V:1.6 [mm]
Result	-	Area	3.2 [mm2]
Inspection level	5/5,5/5,5/5,5/5,5/5	Label	-
Light	6,6,3/6,6,3

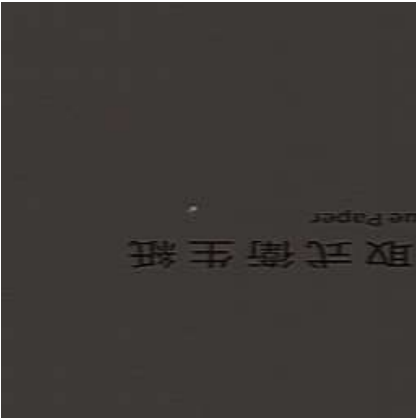
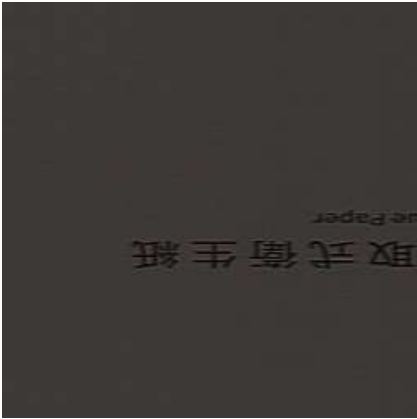
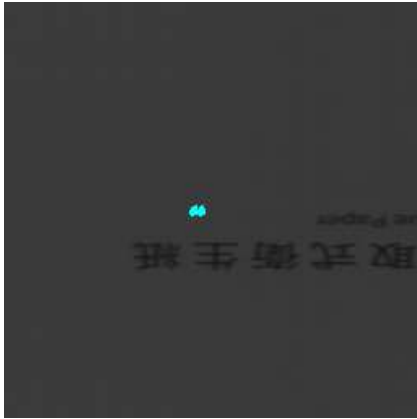
No.	#70, \$57	Date	2023/8/9 上午 11:31:29
Segment	1	Camera	1
Pattern	6930	Position[x, y]	167.6 [mm], 5242.4 [m], (265.9 [m])
Type	縱向刀絲疵點	Size	H:2.4 ,V:2.0 [mm]
Result	-	Area	4.1 [mm2]
Inspection level	5/5,5/5,5/5,5/5,5/5	Label	-
Light	6,6,3/6,6,3

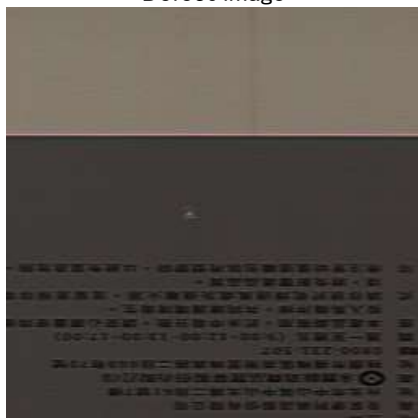
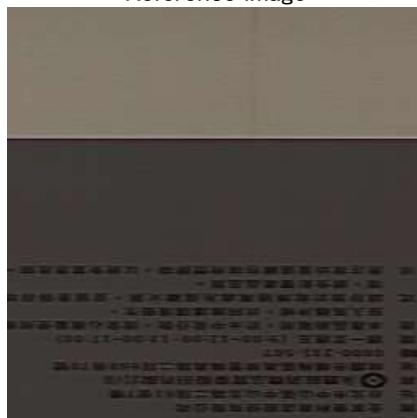
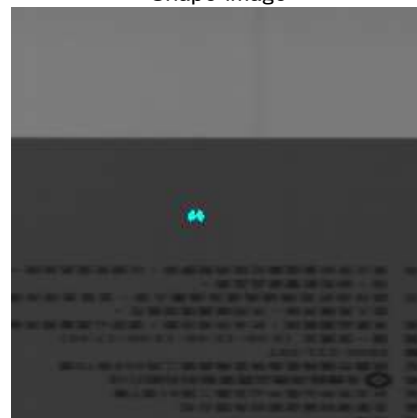
No.	#69, \$56	Date	2023/8/9 上午 11:31:28
Segment	1	Camera	1
Pattern	6928	Position[x, y]	182.0 [mm], 5240.8 [m], (267.6 [m])
Type	縱向刀絲疵點	Size	H:2.4 ,V:2.0 [mm]
Result	-	Area	3.8 [mm2]
Inspection level	5/5,5/5,5/5,5/5,5/5	Label	-
Light	6,6,3/6,6,3

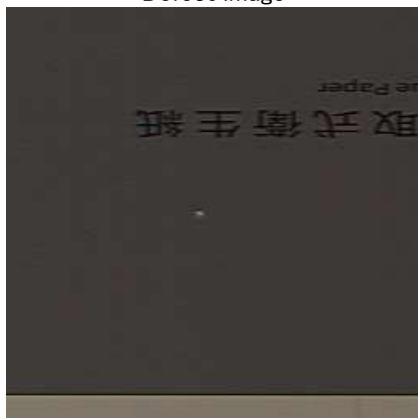
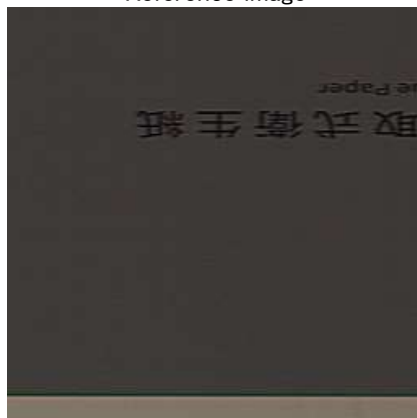
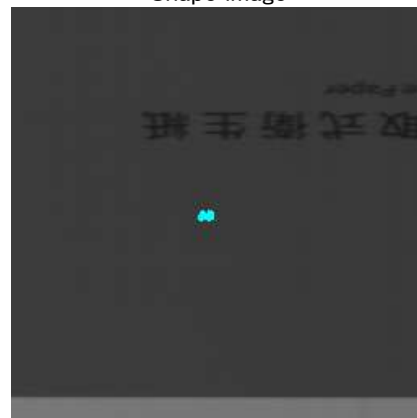
No.	#68, \$55	Date	2023/8/9 上午 11:31:26
Segment	1	Camera	1
Pattern	6926	Position[x, y]	167.8 [mm], 5239.6 [m], (268.8 [m])
Type	縱向刀絲疵點	Size	H:2.4 ,V:2.0 [mm]
Result	-	Area	4.4 [mm2]
Inspection level	5/5,5/5,5/5,5/5,5/5	Label	-
Light	6,6,3/6,6,3

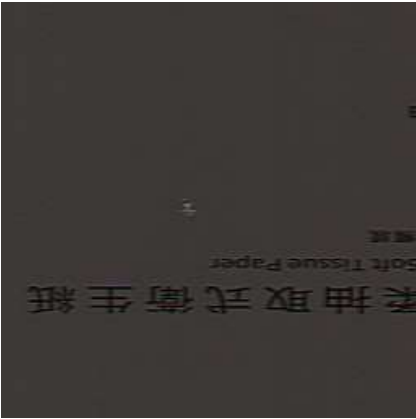
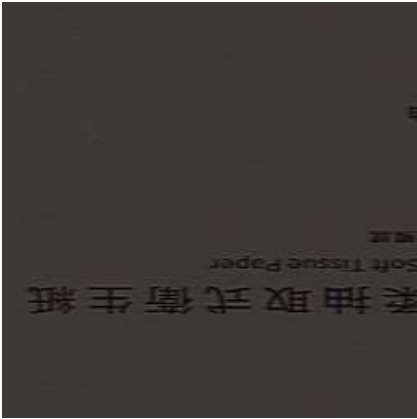
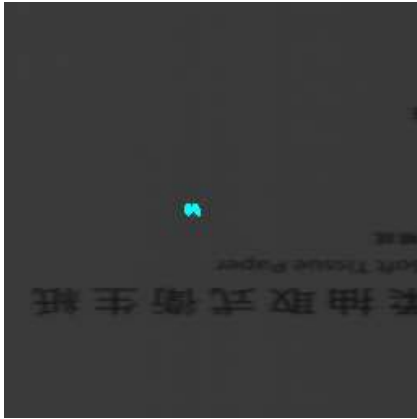
No.	#67, \$54	Date	2023/8/9 上午 11:31:25
Segment	1	Camera	1
Pattern	6924	Position[x, y]	182.5 [mm], 5237.9 [m], (270.5 [m])
Type	縱向刀絲疵點	Size	H:2.4 ,V:2.4 [mm]
Result	-	Area	5.1 [mm2]
Inspection level	5/5,5/5,5/5,5/5,5/5	Label	-
Light	6,6,3/6,6,3

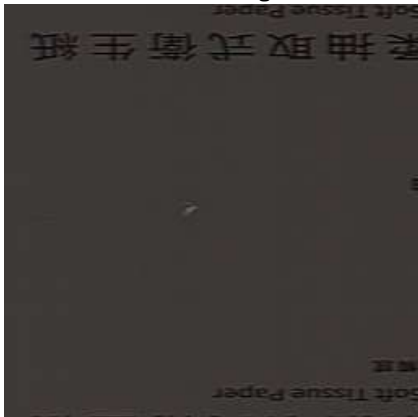
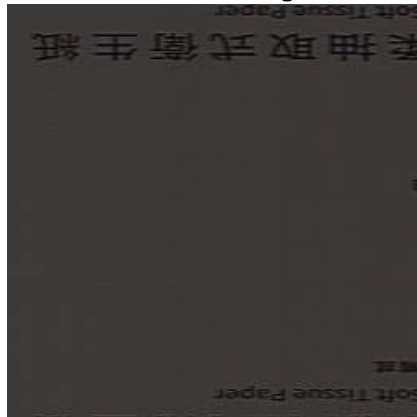
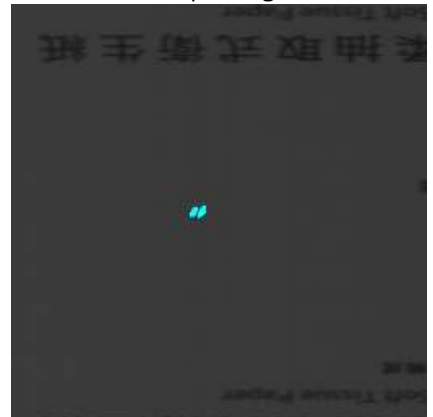
No.	#66, \$53	Date	2023/8/9 上午 11:31:24
Segment	1	Camera	1
Pattern	6922	Position[x, y]	182.2 [mm], 5236.5 [m], (271.9 [m])
Type	縱向刀絲疵點	Size	H:2.4 ,V:2.4 [mm]
Result	-	Area	3.7 [mm2]
Inspection level	5/5,5/5,5/5,5/5,5/5	Label	-
Light	6,6,3/6,6,3

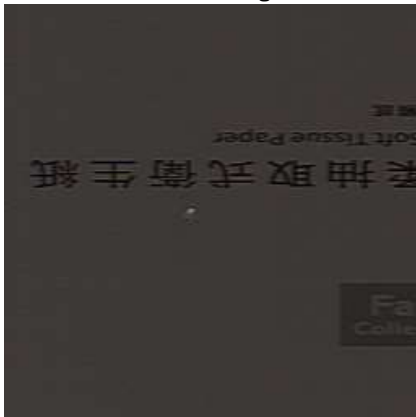
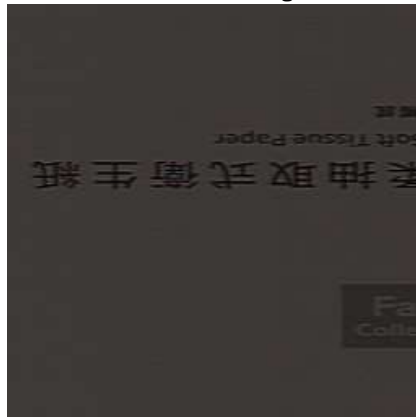
No.	#65, \$52	Date	2023/8/9 上午 11:31:23
Segment	1	Camera	1
Pattern	6920	Position[x, y]	182.5 [mm], 5235.0 [m], (273.3 [m])
Type	縱向刀絲疵點	Size	H:2.2 ,V:2.0 [mm]
Result	-	Area	4.2 [mm2]
Inspection level	5/5,5/5,5/5,5/5,5/5	Label	-
Light	6,6,3/6,6,3

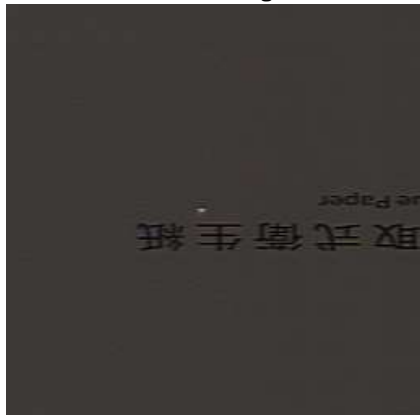
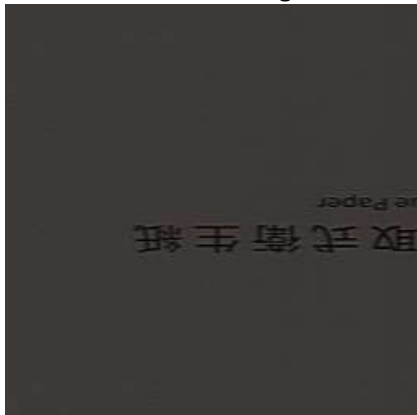
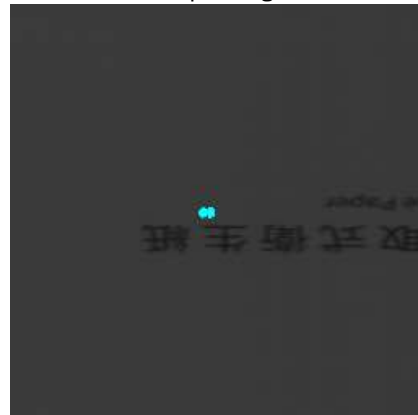
No.	#64, \$51	Date	2023/8/9 上午 11:31:22
Segment	1	Camera	1
Pattern	6918	Position[x, y]	168.1 [mm], 5233.8 [m], (274.6 [m])
Type	縱向刀絲疵點	Size	H:2.4 ,V:2.0 [mm]
Result	-	Area	4.4 [mm2]
Inspection level	5/5,5/5,5/5,5/5,5/5	Label	-
Light	6,6,3/6,6,3

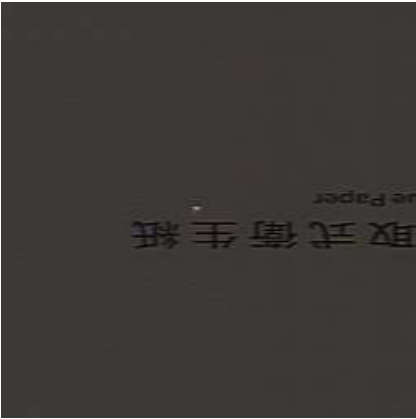
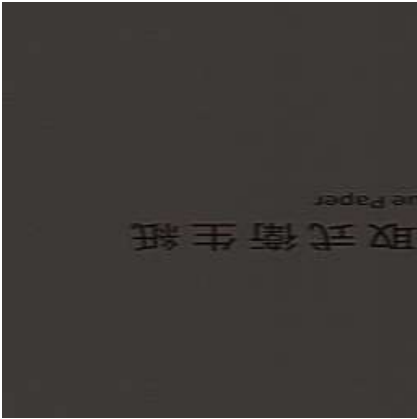
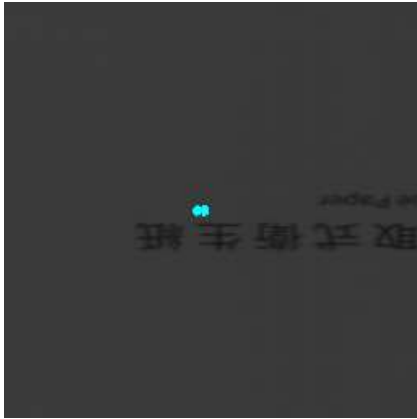
No.	#63, \$50	Date	2023/8/9 上午 11:31:21
Segment	1	Camera	1
Pattern	6916	Position[x, y]	182.2 [mm], 5232.2 [m], (276.2 [m])
Type	縱向刀絲疵點	Size	H:2.2 ,V:1.6 [mm]
Result	-	Area	2.9 [mm2]
Inspection level	5/5,5/5,5/5,5/5,5/5	Label	-
Light	6,6,3/6,6,3

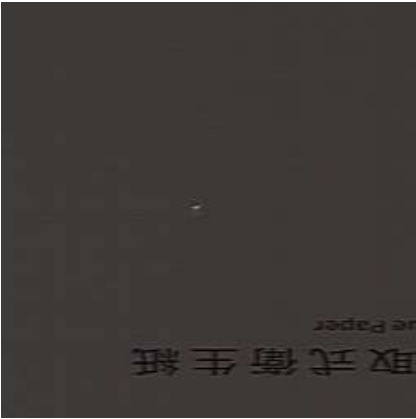
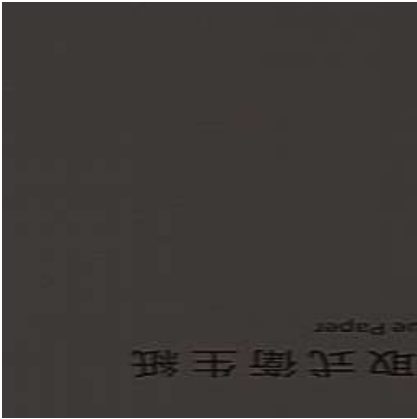
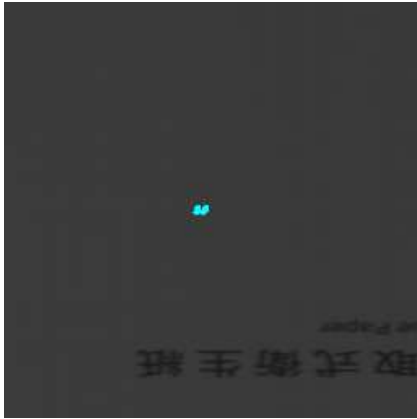
No.	#63, \$50	Date	2023/8/9 上午 11:31:21
Segment	1	Camera	1
Pattern	6916	Position[x, y]	168.1 [mm], 5232.4 [m], (276.0 [m])
Type	縱向刀絲疵點	Size	H:2.4 ,V:1.6 [mm]
Result	-	Area	3.3 [mm2]
Inspection level	5/5,5/5,5/5,5/5,5/5	Label	-
Light	6,6,3/6,6,3

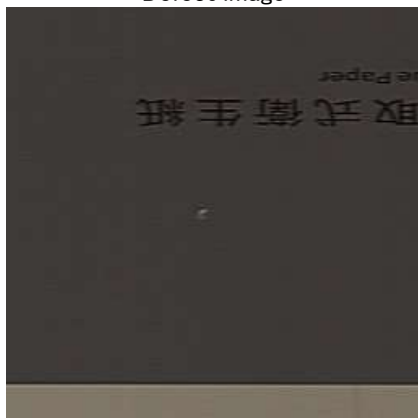
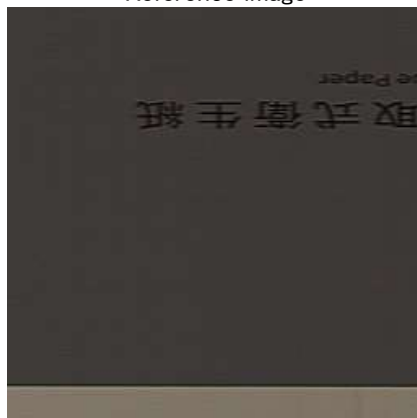
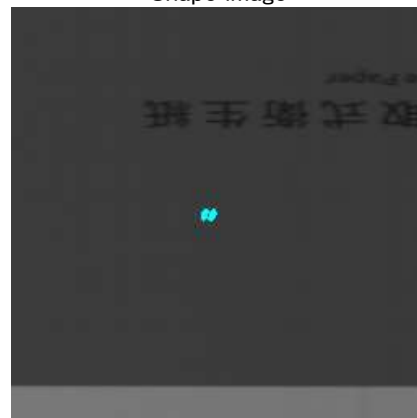
No.	#62, \$49	Date	2023/8/9 上午 11:31:19
Segment	1	Camera	1
Pattern	6914	Position[x, y]	168.3 [mm], 5230.9 [m], (277.5 [m])
Type	縱向刀絲疵點	Size	H:2.4 ,V:2.4 [mm]
Result	-	Area	4.9 [mm2]
Inspection level	5/5,5/5,5/5,5/5,5/5	Label	-
Light	6,6,3/6,6,3

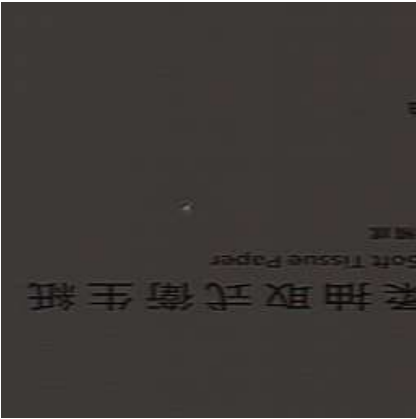
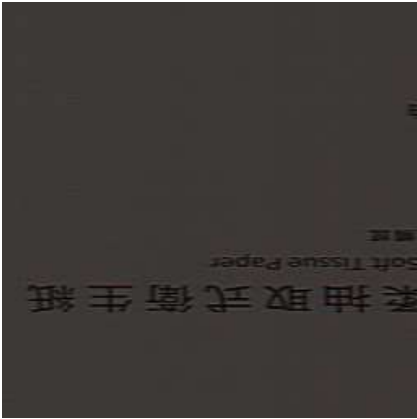
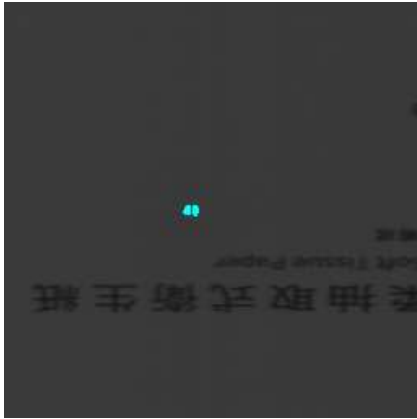
No.	#61, \$48	Date	2023/8/9 上午 11:31:18
Segment	1	Camera	1
Pattern	6912	Position[x, y]	182.2 [mm], 5229.3 [m], (279.1 [m])
Type	縱向刀絲疵點	Size	H:2.4 ,V:2.0 [mm]
Result	-	Area	3.6 [mm2]
Inspection level	5/5,5/5,5/5,5/5,5/5	Label	-
Light	6,6,3/6,6,3

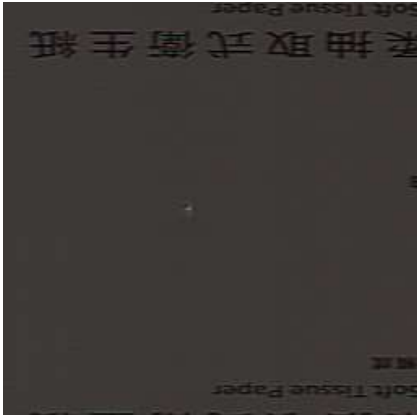
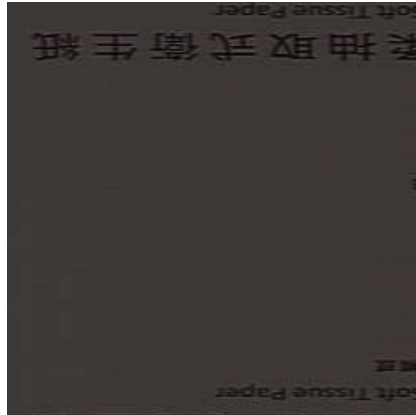
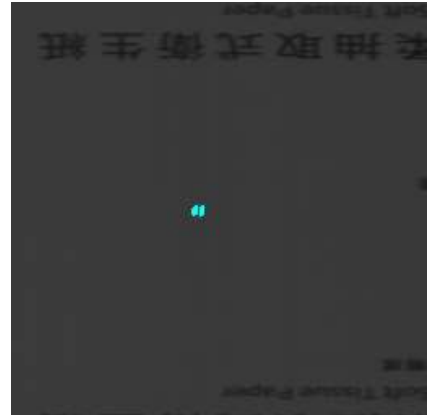
No.	#60, \$47	Date	2023/8/9 上午 11:31:17
Segment	1	Camera	1
Pattern	6910	Position[x, y]	182.2 [mm], 5227.9 [m], (280.5 [m])
Type	縱向刀絲疵點	Size	H:2.0 ,V:2.0 [mm]
Result	-	Area	3.2 [mm2]
Inspection level	5/5,5/5,5/5,5/5,5/5	Label	-
Light	6,6,3/6,6,3

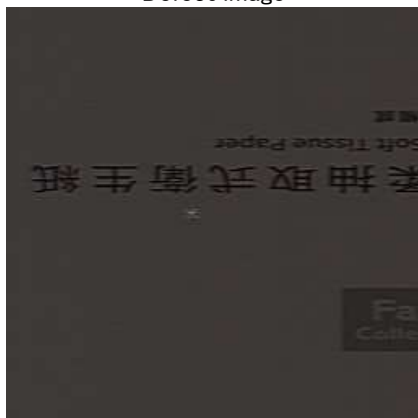
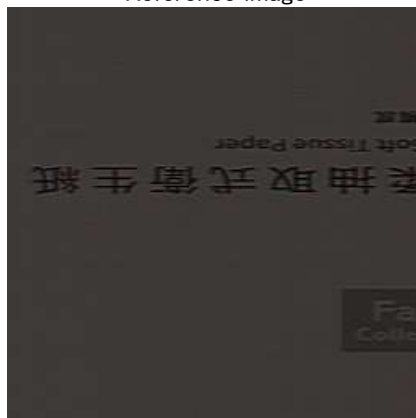
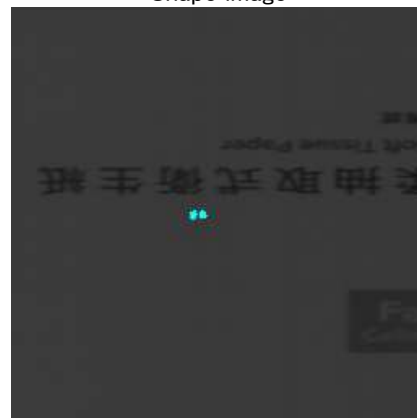
No.	#58, \$45	Date	2023/8/9 上午 11:31:16
Segment	1	Camera	1
Pattern	6908	Position[x, y]	182.2 [mm], 5226.4 [m], (282.0 [m])
Type	縱向刀絲疵點	Size	H:2.7 ,V:1.6 [mm]
Result	-	Area	2.8 [mm2]
Inspection level	5/5,5/5,5/5,5/5,5/5	Label	-
Light	6,6,3/6,6,3

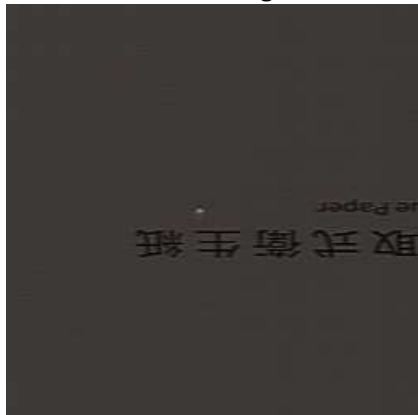
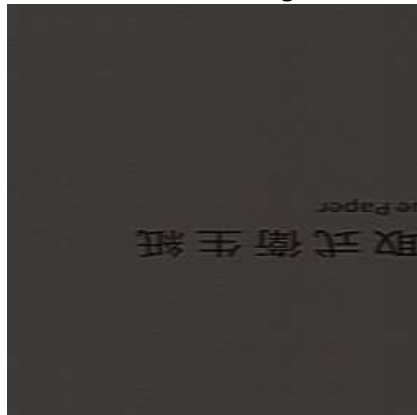
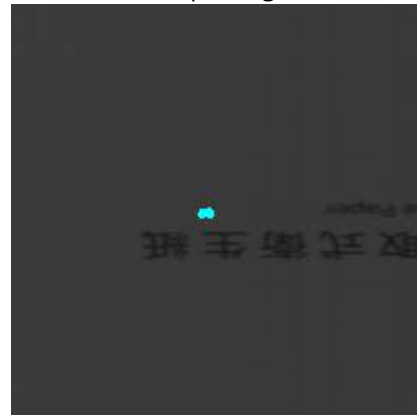
No.	#57, \$44	Date	2023/8/9 上午 11:31:15
Segment	1	Camera	1
Pattern	6907	Position[x, y]	167.8 [mm], 5225.2 [m], (283.2 [m])
Type	縱向刀絲疵點	Size	H:2.4 ,V:2.0 [mm]
Result	-	Area	4.2 [mm2]
Inspection level	5/5,5/5,5/5,5/5,5/5	Label	-
Light	6,6,3/6,6,3

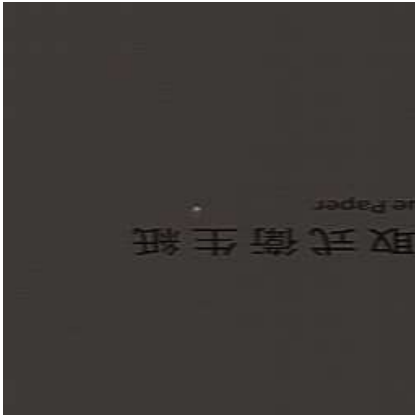
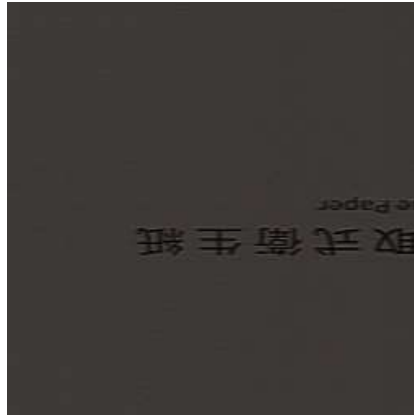
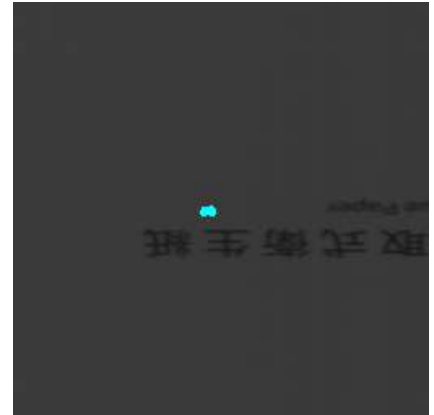
No.	#56, \$43	Date	2023/8/9 上午 11:31:14
Segment	1	Camera	1
Pattern	6905	Position[x, y]	182.0 [mm], 5223.5 [m], (284.8 [m])
Type	縱向刀絲疵點	Size	H:2.4 ,V:2.0 [mm]
Result	-	Area	3.3 [mm2]
Inspection level	5/5,5/5,5/5,5/5,5/5	Label	-
Light	6,6,3/6,6,3

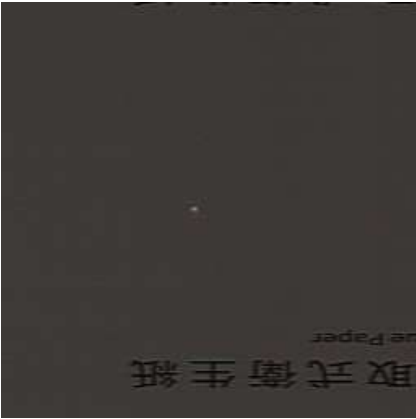
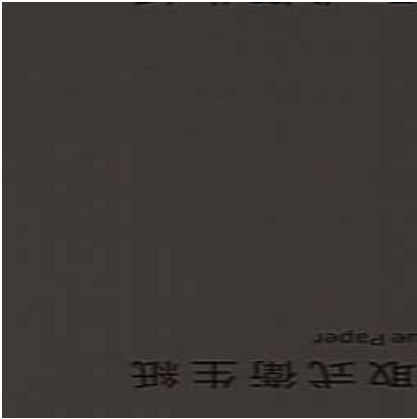
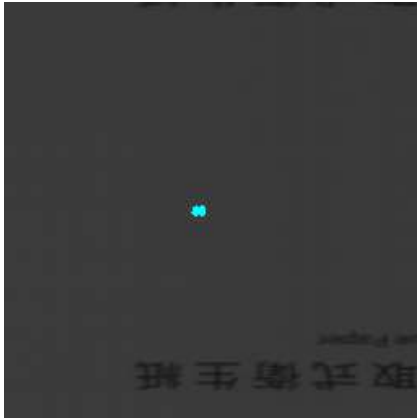
No.	#56, \$43	Date	2023/8/9 上午 11:31:14
Segment	1	Camera	1
Pattern	6905	Position[x, y]	167.8 [mm], 5223.7 [m], (284.6 [m])
Type	縱向刀絲疵點	Size	H:2.2 ,V:2.0 [mm]
Result	-	Area	3.8 [mm2]
Inspection level	5/5,5/5,5/5,5,5/5,5/5	Label	-
Light	6,6,3/6,6,3

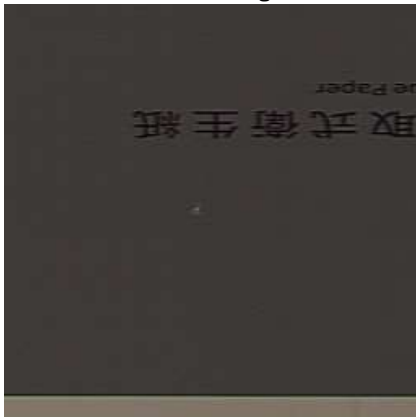
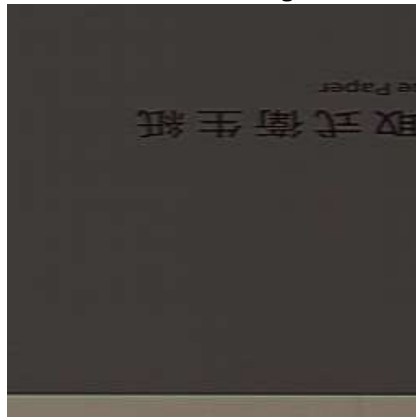
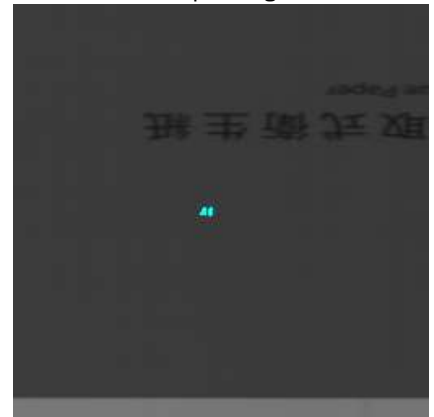
No.	#55, \$42	Date	2023/8/9 上午 11:31:13
Segment	1	Camera	1
Pattern	6903	Position[x, y]	167.8 [mm], 5222.3 [m], (286.1 [m])
Type	縱向刀絲疵點	Size	H:2.0 ,V:1.6 [mm]
Result	-	Area	2.1 [mm2]
Inspection level	5/5,5/5,5/5,5/5,5/5	Label	-
Light	6,6,3/6,6,3

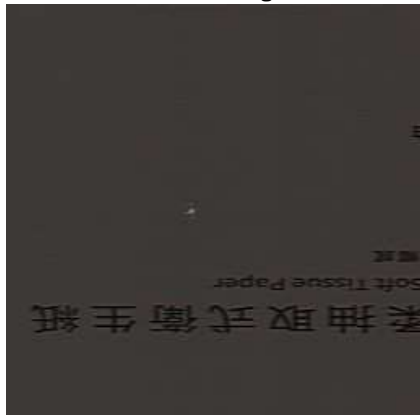
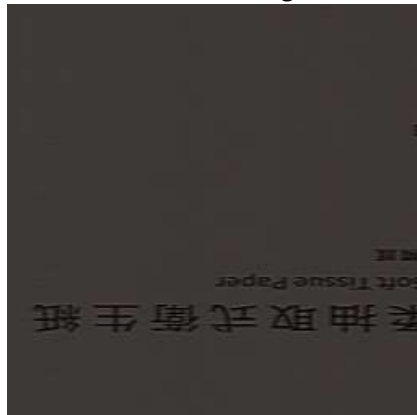
No.	#54, \$41	Date	2023/8/9 上午 11:31:12
Segment	1	Camera	1
Pattern	6901	Position[x, y]	182.2 [mm], 5220.7 [m], (287.7 [m])
Type	縱向刀絲疵點	Size	H:2.2 ,V:2.0 [mm]
Result	-	Area	4.1 [mm2]
Inspection level	5/5,5/5,5/5,5/5,5/5	Label	-
Light	6,6,3/6,6,3

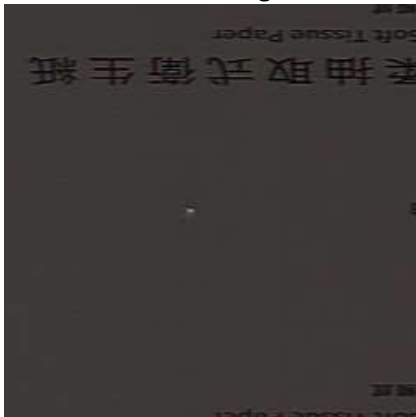
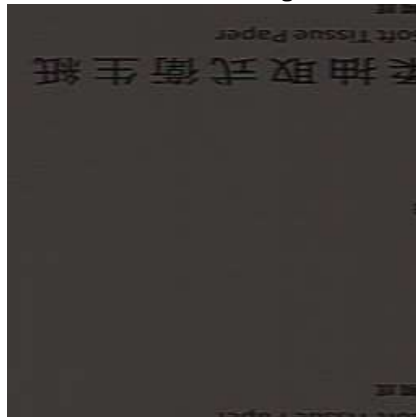
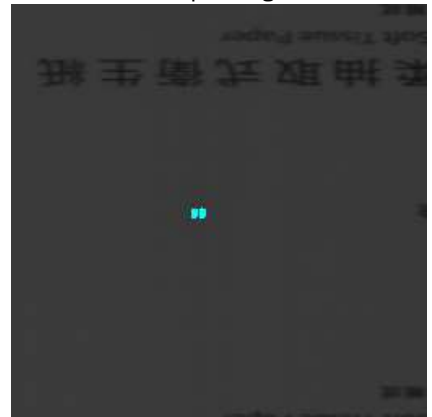
Defect image

No.	#53, \$40	Date	2023/8/9 上午 11:31:10
Segment	1	Camera	1
Pattern	6899	Position[x, y]	182.5 [mm], 5219.2 [m], (289.2 [m])
Type	縱向刀絲疵點	Size	H:2.2 ,V:2.0 [mm]
Result	-	Area	3.4 [mm2]
Inspection level	5/5,5/5,5/5,5/5,5/5	Label	-
Light	6,6,3/6,6,3

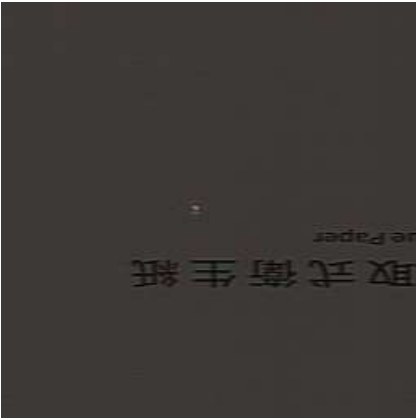
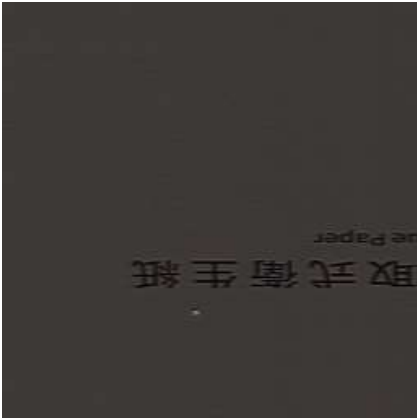
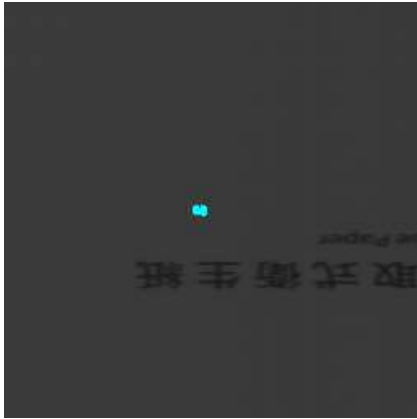
Defect image	Reference image	Shape image

No.	#51, \$38	Date	2023/8/9 上午 11:31:08
Segment	1	Camera	1
Pattern	6895	Position[x, y]	168.1 [mm], 5216.5 [m], (291.8 [m])
Type	縱向刀絲疵點	Size	H:2.2 ,V:2.0 [mm]
Result	-	Area	3.8 [mm2]
Inspection level	5/5,5/5,5/5,5/5,5/5	Label	-
Light	6,6,3/6,6,3

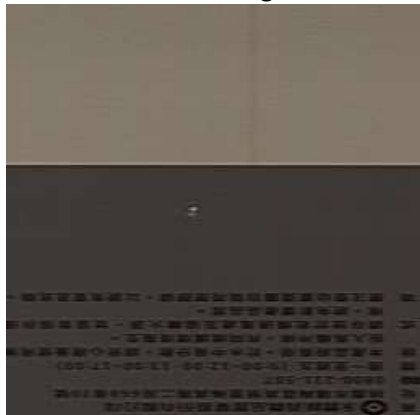
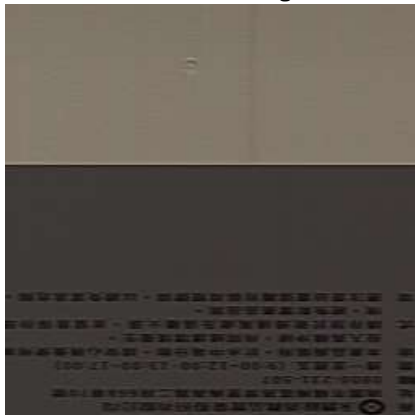
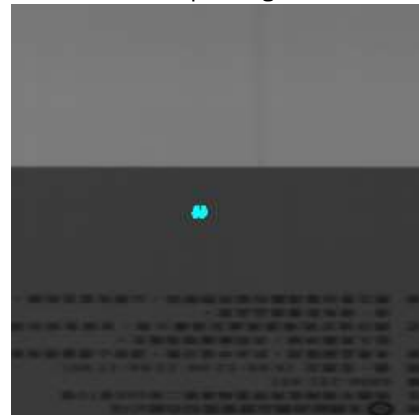
Defect image

No.	#50, \$37	Date	2023/8/9 上午 11:31:07
Segment	1	Camera	1
Pattern	6893	Position[x, y]	182.5 [mm], 5214.9 [m], (293.5 [m])
Type	縱向刀絲疵點	Size	H:2.4 ,V:2.4 [mm]
Result	-	Area	5.1 [mm2]
Inspection level	5/5,5/5,5/5,5/5,5/5	Label	-
Light	6,6,3/6,6,3

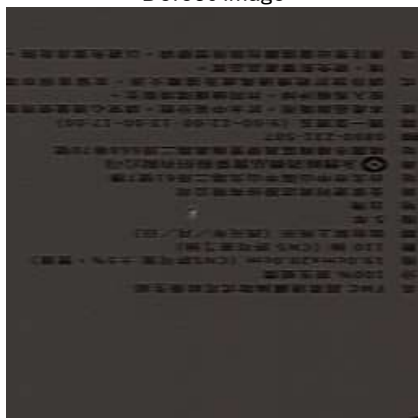
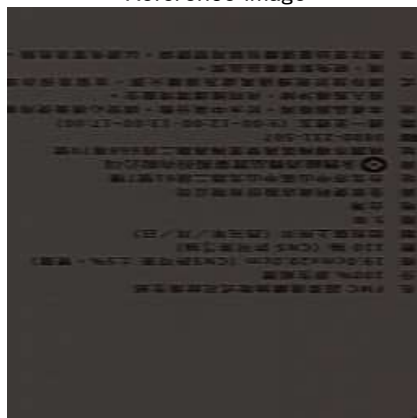
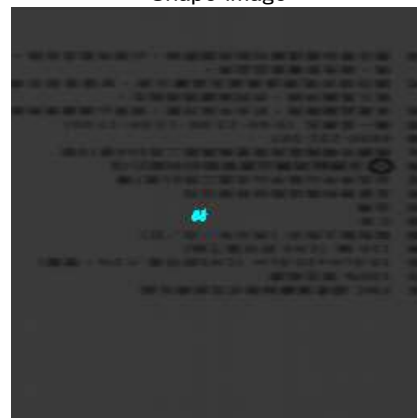
Defect image

No.	#49, \$36	Date	2023/8/9 上午 11:31:06
Segment	1	Camera	1
Pattern	6891	Position[x, y]	182.5 [mm], 5213.5 [m], (294.9 [m])
Type	縱向刀絲疵點	Size	H:2.4 ,V:2.4 [mm]
Result	-	Area	4.2 [mm2]
Inspection level	5/5,5/5,5/5,5/5,5/5	Label	-
Light	6,6,3/6,6,3

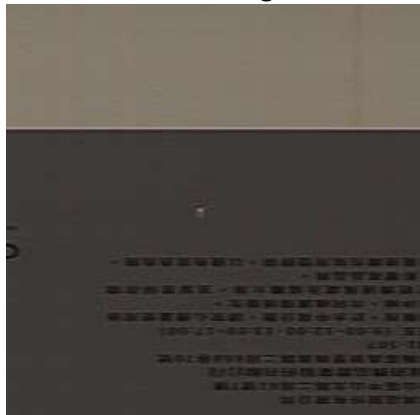
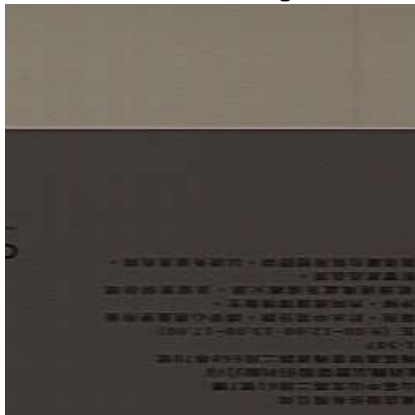
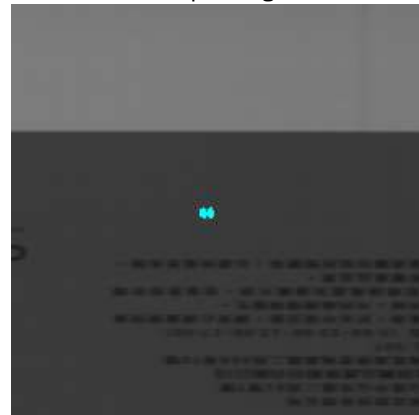
Defect image

No.	#46, \$35	Date	2023/8/9 上午 11:31:04
Segment	1	Camera	1
Pattern	6888	Position[x, y]	168.1 [mm], 5210.8 [m], (297.6 [m])
Type	縱向刀絲疵點	Size	H:2.2 ,V:2.0 [mm]
Result	-	Area	3.8 [mm2]
Inspection level	5/5,5/5,5/5,5/5,5/5	Label	-
Light	6,6,3/6,6,3

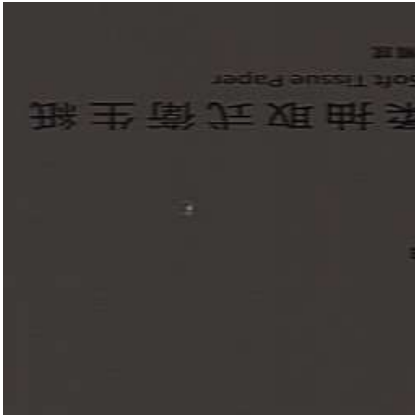
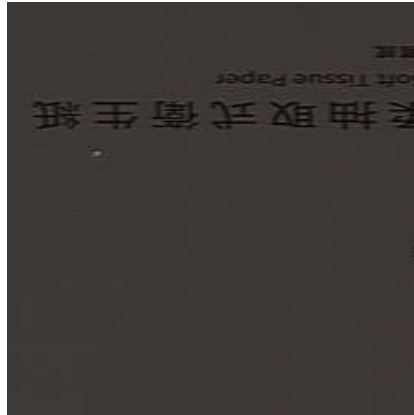
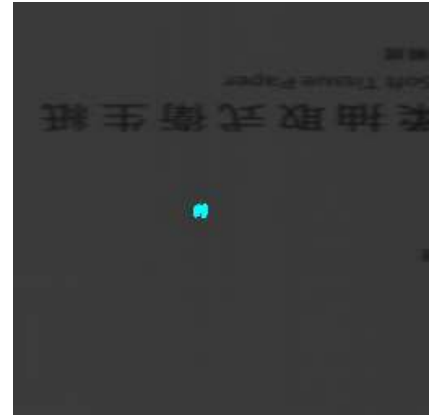
Defect image

No.	#45, \$34	Date	2023/8/9 上午 11:31:03
Segment	1	Camera	1
Pattern	6887	Position[x, y]	182.5 [mm], 5210.6 [m], (297.8 [m])
Type	縱向刀絲疵點	Size	H:2.2 ,V:2.8 [mm]
Result	-	Area	5.5 [mm2]
Inspection level	5/5,5/5,5/5,5/5,5/5	Label	-
Light	6,6,3/6,6,3

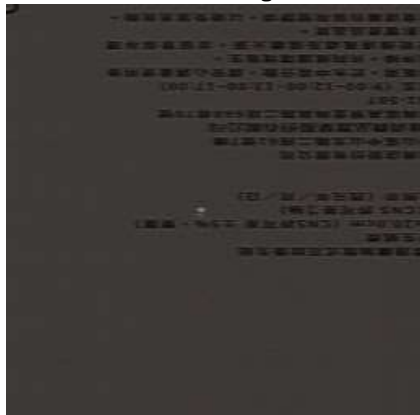
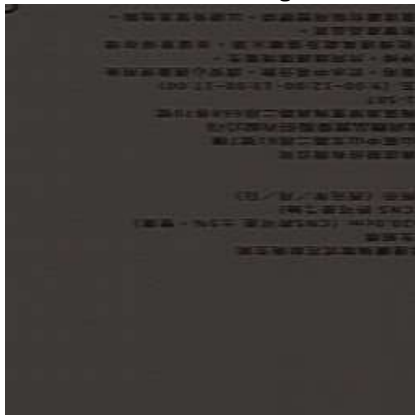
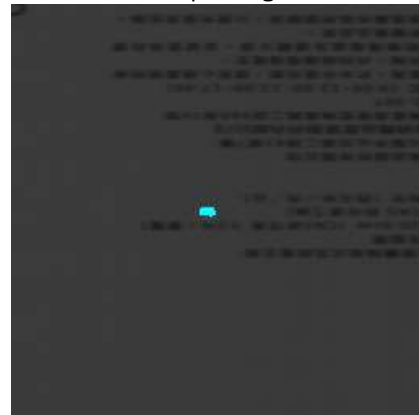
Defect image

No.	#44, \$33	Date	2023/8/9 上午 11:31:03
Segment	1	Camera	1
Pattern	6886	Position[x, y]	168.1 [mm], 5209.3 [m], (299.0 [m])
Type	縱向刀絲疵點	Size	H:2.4 ,V:1.6 [mm]
Result	-	Area	3.1 [mm2]
Inspection level	5/5,5/5,5/5,5/5,5/5	Label	-
Light	6,6,3/6,6,3

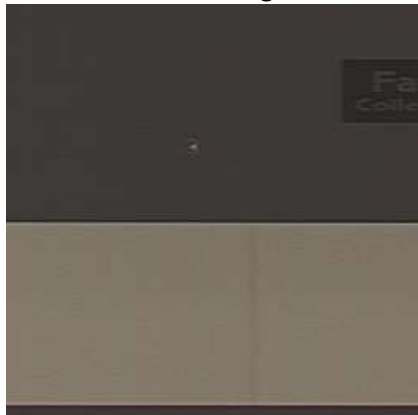
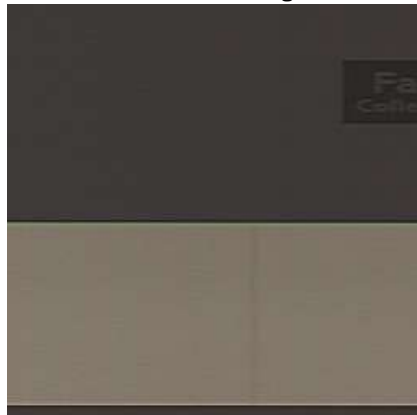
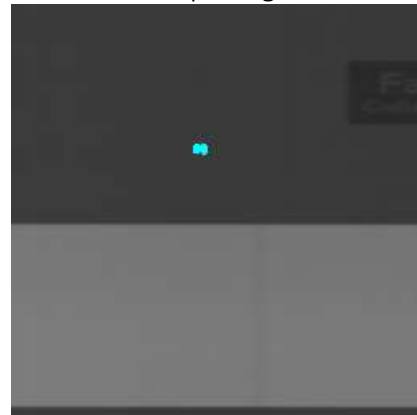
Defect image

No.	#42, \$31	Date	2023/8/9 上午 11:31:02
Segment	1	Camera	1
Pattern	6884	Position[x, y]	182.7 [mm], 5207.7 [m], (300.7 [m])
Type	縱向刀絲疵點	Size	H:2.2 ,V:2.0 [mm]
Result	-	Area	3.9 [mm2]
Inspection level	5/5,5/5,5/5,5/5,5/5	Label	-
Light	6,6,3/6,6,3

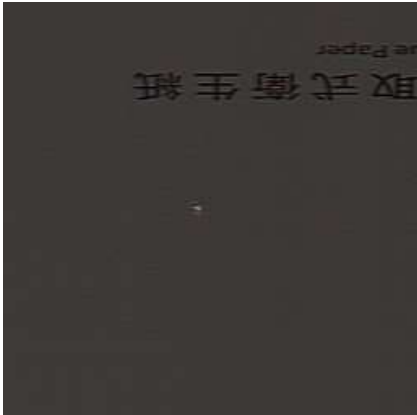
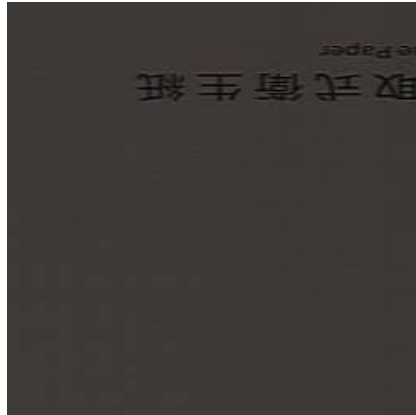
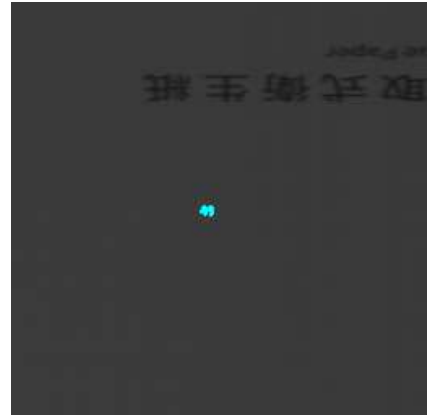
Defect image

No.	#41, \$30	Date	2023/8/9 上午 11:31:00
Segment	1	Camera	1
Pattern	6882	Position[x, y]	168.1 [mm], 5206.5 [m], (301.9 [m])
Type	縱向刀絲疵點	Size	H:2.2 ,V:2.0 [mm]
Result	-	Area	3.7 [mm2]
Inspection level	5/5,5/5,5/5,5/5,5/5	Label	-
Light	6,6,3/6,6,3

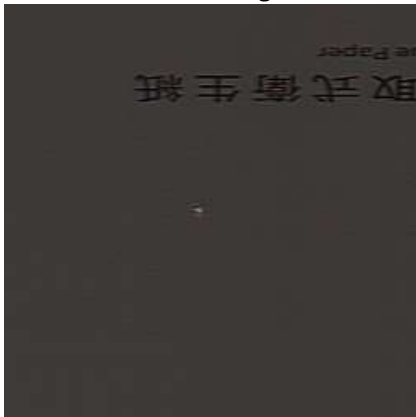
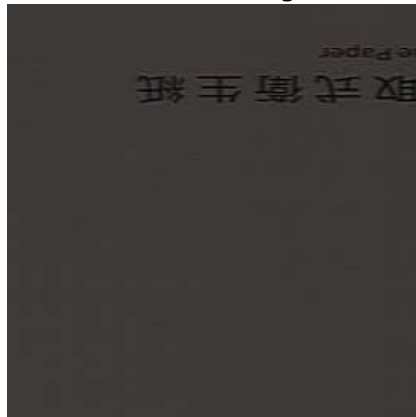
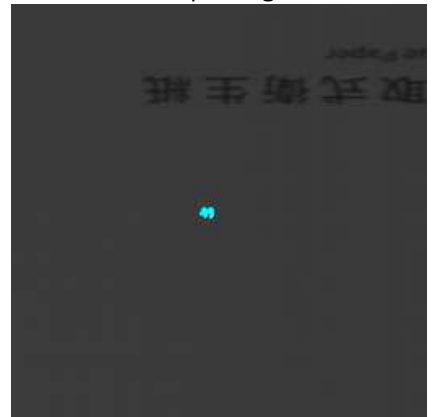
Defect image

No.	#40, \$29	Date	2023/8/9 上午 11:30:58
Segment	1	Camera	1
Pattern	6878	Position[x, y]	168.1 [mm], 5203.6 [m], (304.8 [m])
Type	縱向刀絲疵點	Size	H:1.7 ,V:2.0 [mm]
Result	-	Area	2.3 [mm2]
Inspection level	5/5,5/5,5/5,5/5,5/5	Label	-
Light	6,6,3/6,6,3

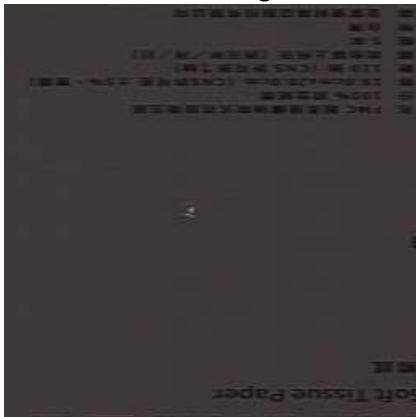
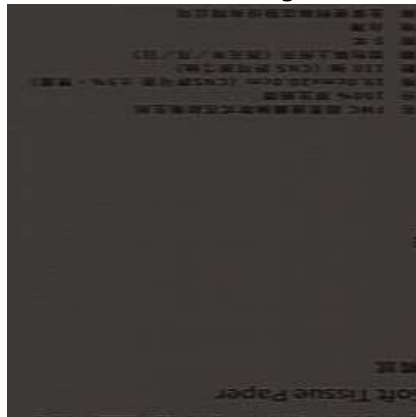
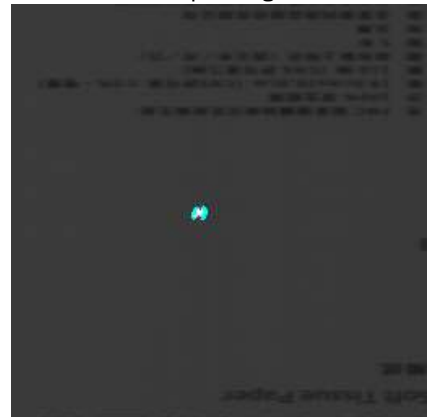
Defect image

No.	#40, \$29	Date	2023/8/9 上午 11:30:58
Segment	1	Camera	1
Pattern	6878	Position[x, y]	182.5 [mm], 5203.4 [m], (305.0 [m])
Type	点状疵点縱向刀絲疵點	Size	H:2.4 ,V:2.8 [mm]
Result	-	Area	5.3 [mm2]
Inspection level	5/5,5/5,5/5,5/5,5/5	Label	-
Light	6,6,3/6,6,3

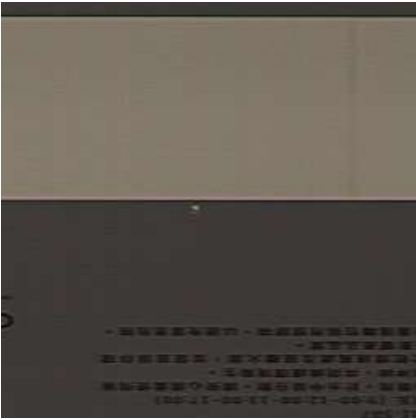
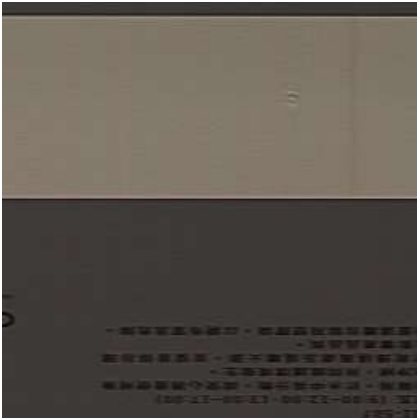
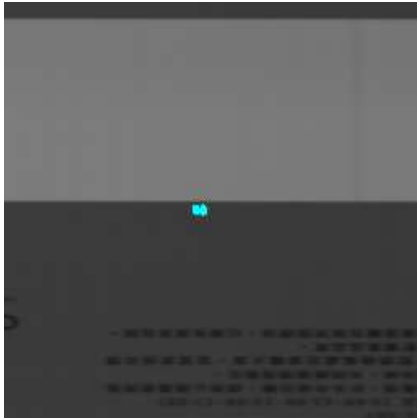
No.	#39, \$28	Date	2023/8/9 上午 11:30:57
Segment	1	Camera	1
Pattern	6876	Position[x, y]	168.1 [mm], 5202.1 [m], (306.3 [m])
Type	縱向刀絲疵點	Size	H:2.2 ,V:2.4 [mm]
Result	-	Area	4.0 [mm2]
Inspection level	5/5,5/5,5/5,5/5,5/5	Label	-
Light	6,6,3/6,6,3

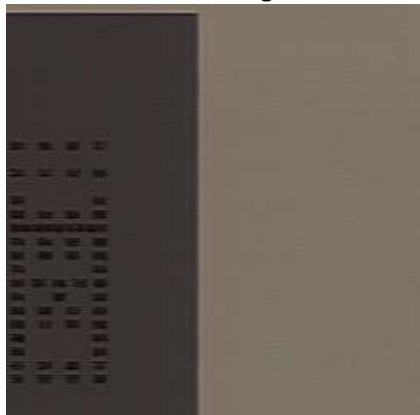
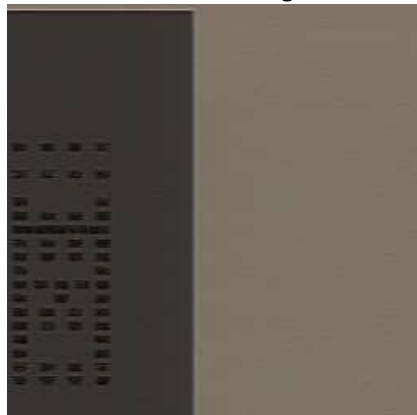
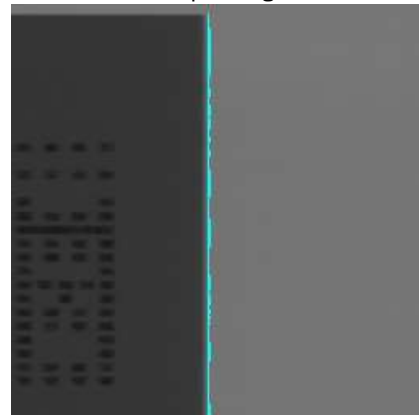
No.	#36, \$27	Date	2023/8/9 上午 11:30:49
Segment	1	Camera	1
Pattern	6863	Position[x, y]	566.8 [mm], 5192.1 [m], (316.3 [m])
Type	縱向刀絲疵點	Size	H:0.5 ,V:307.2 [mm]
Result	-	Area	71.8 [mm2]
Inspection level	5/5,5/5,5/5,5/5,5/5	Label	-
Light	6,6,3/6,6,3

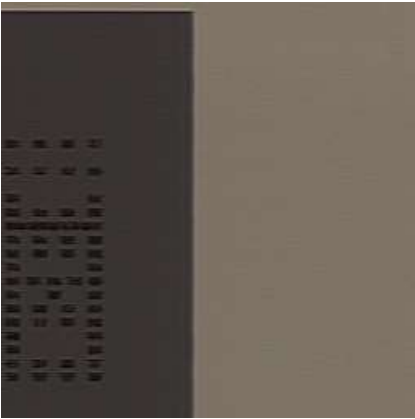
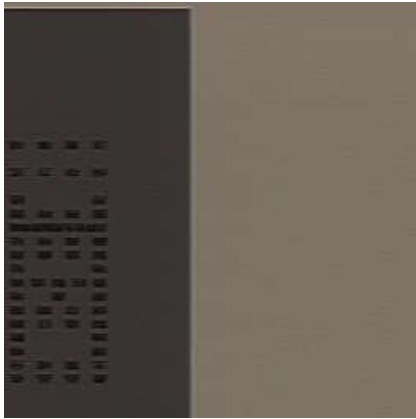
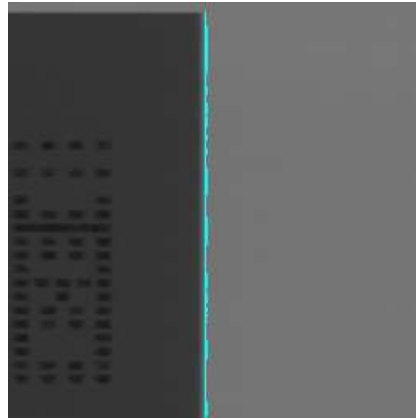
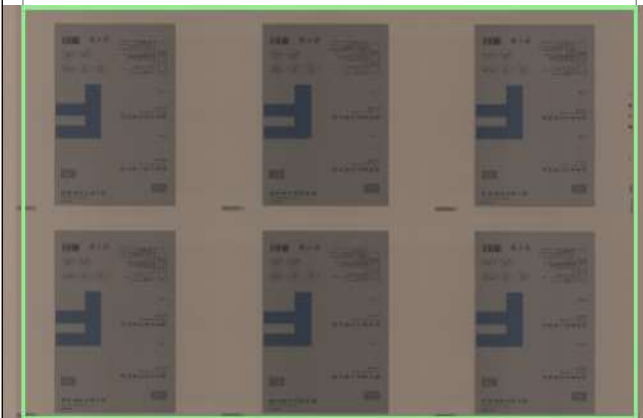
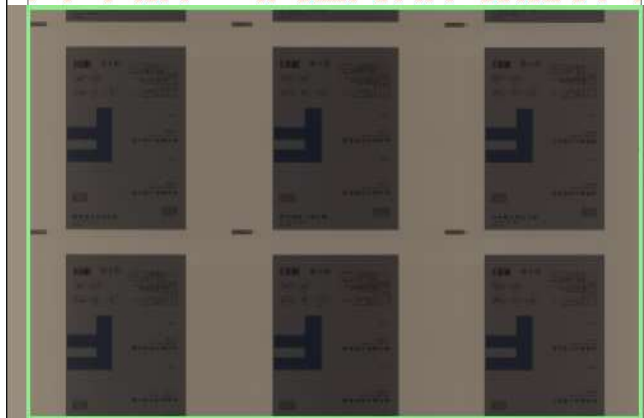
No.	#35, \$26	Date	2023/8/9 上午 11:30:49
Segment	1	Camera	1
Pattern	6862	Position[x, y]	882.4 [mm], 5191.4 [m], (317.0 [m])
Type	縱向刀絲疵點	Size	H:0.5 ,V:43.6 [mm]
Result	-	Area	2.2 [mm2]
Inspection level	5/5,5/5,5/5,5/5,5/5	Label	-
Light	6,6,3/6,6,3

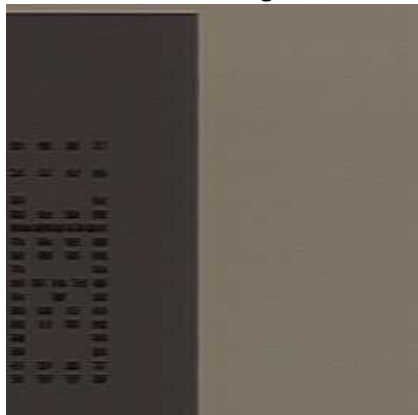
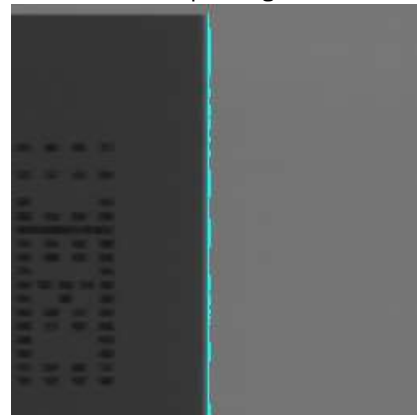
No.	#35, \$26	Date	2023/8/9 上午 11:30:49
Segment	1	Camera	1
Pattern	6862	Position[x, y]	698.8 [mm], 5191.7 [m], (316.7 [m])
Type	縱向刀絲疵點	Size	H:0.5 ,V:38.8 [mm]
Result	-	Area	3.0 [mm2]
Inspection level	5/5,5/5,5/5,5/5,5/5	Label	-
Light	6,6,3/6,6,3

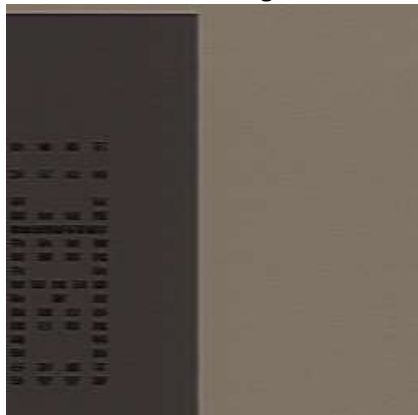
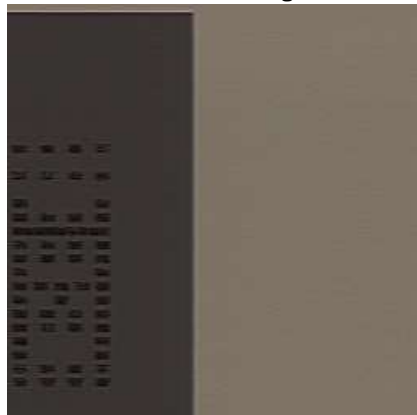
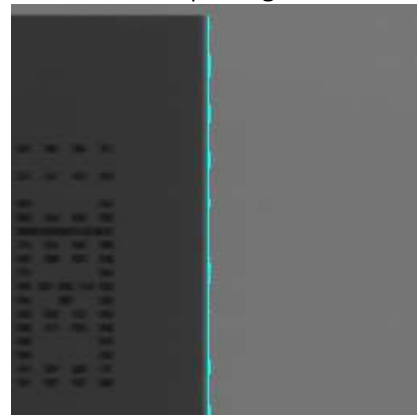
No.	#35, \$26	Date	2023/8/9 上午 11:30:49
Segment	1	Camera	1
Pattern	6862	Position[x, y]	566.8 [mm], 5191.4 [m], (317.0 [m])
Type	縱向刀絲疵點	Size	H:0.5 ,V:300.0 [mm]
Result	-	Area	36.6 [mm2]
Inspection level	5/5,5/5,5/5,5/5,5/5	Label	-
Light	6,6,3/6,6,3

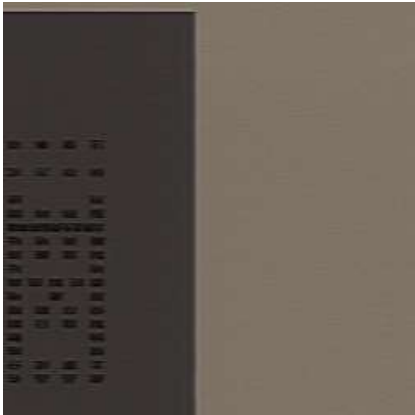
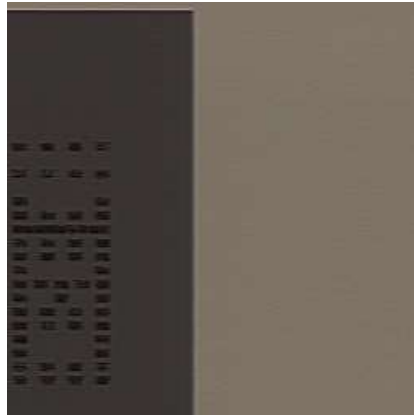
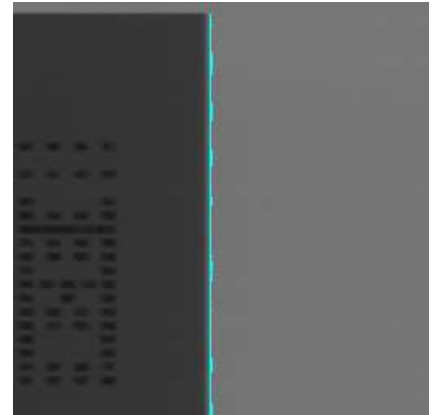
No.	#34, \$25	Date	2023/8/9 上午 11:30:48
Segment	1	Camera	1
Pattern	6861	Position[x, y]	167.8 [mm], 5190.6 [m], (317.8 [m])
Type	縱向刀絲疵點	Size	H:2.0 ,V:2.0 [mm]
Result	-	Area	3.6 [mm2]
Inspection level	5/5,5/5,5/5,5/5,5/5	Label	-
Light	6,6,3/6,6,3

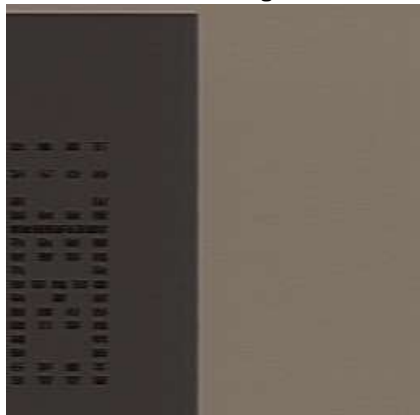
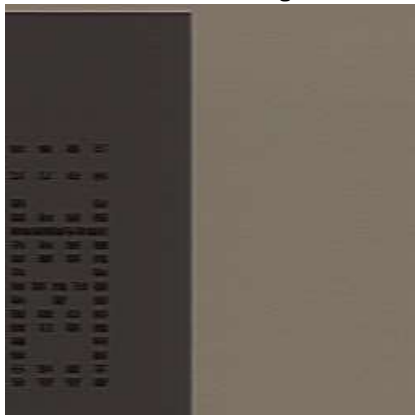
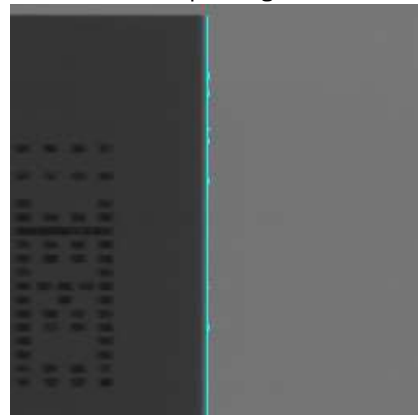
No.	#34, \$25	Date	2023/8/9 上午 11:30:48
Segment	1	Camera	1
Pattern	6861	Position[x, y]	566.8 [mm], 5190.6 [m], (317.8 [m])
Type	縱向刀絲疵點	Size	H:0.5 ,V:214.0 [mm]
Result	-	Area	47.3 [mm2]
Inspection level	5/5,5/5,5/5,5/5,5/5	Label	-
Light	6,6,3/6,6,3
