Inspection Result (Individual Data)

Lot number : 3

商品名	標準透明6-6-3	周長	
顧客名		Ex1	
CODE番号		Ex2	
基材		Ex3

Total defects	148	檢查範圍 : 83.6 ~ 1024.2 [mm]	寬度 : 940.6 [mm]
Web length	5508.4 [m]	參照更新 : 週期10<平時>/週期10<平時>	
Segments	1 (從左側)

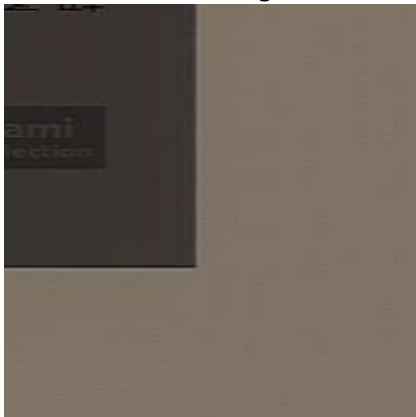
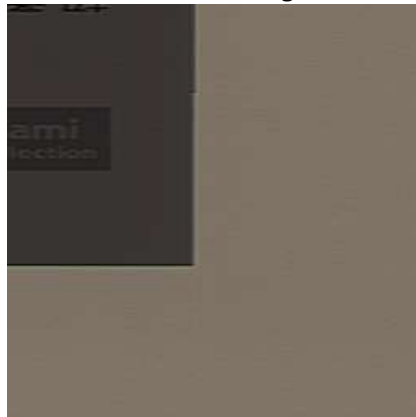
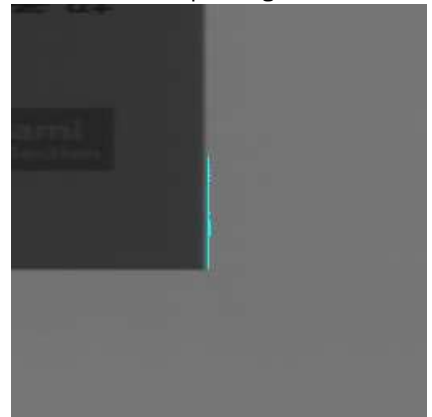
No.	#33, \$24	Date	2023/8/9 上午 11:30:47
Segment	1	Camera	1
Pattern	6860	Position[x, y]	566.8 [mm], 5189.7 [m], (318.7 [m])
Type	縱向刀絲疵點	Size	H:0.5 ,V:26.8 [mm]
Result	-	Area	7.3 [mm2]
Inspection level	5/5,5/5,5/5,5/5,5/5	Label	-
Light	6,6,3/6,6,3

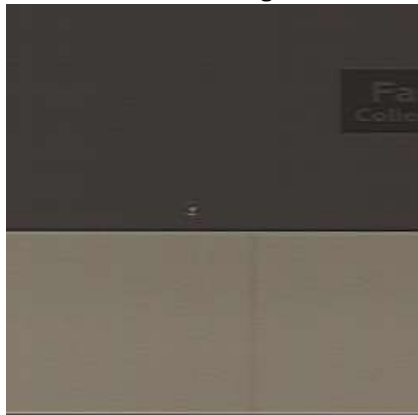
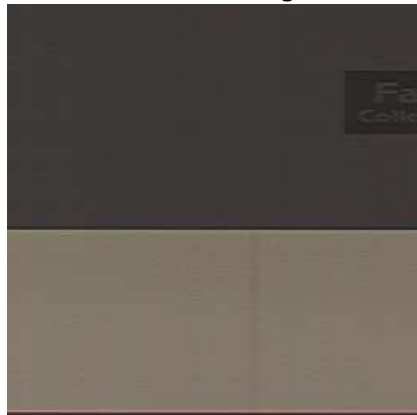
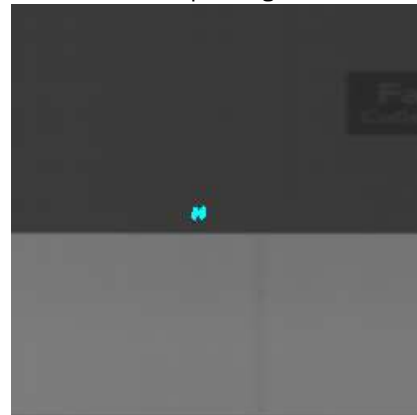
No.	#31, \$22	Date	2023/8/9 上午 11:30:46
Segment	1	Camera	1
Pattern	6857	Position[x, y]	167.8 [mm], 5187.7 [m], (320.7 [m])
Type	縱向刀絲疵點	Size	H:2.0 ,V:1.6 [mm]
Result	-	Area	3.0 [mm2]
Inspection level	5/5,5/5,5/5,5/5,5/5	Label	-
Light	6,6,3/6,6,3

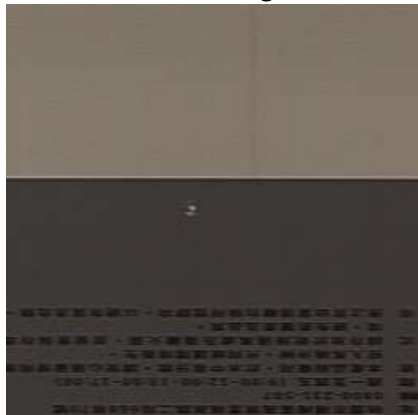
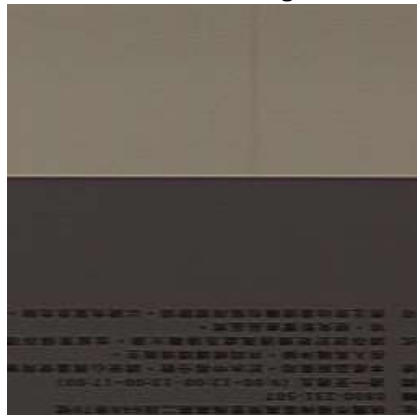
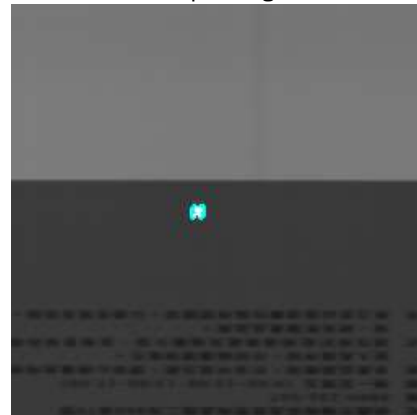
No.	#31, \$22	Date	2023/8/9 上午 11:30:46
Segment	1	Camera	1
Pattern	6857	Position[x, y]	182.2 [mm], 5187.5 [m], (320.9 [m])
Type	点状疵点縱向刀絲疵點	Size	H:2.4 ,V:3.2 [mm]
Result	-	Area	7.3 [mm2]
Inspection level	5/5,5/5,5/5,5/5,5/5	Label	-
Light	6,6,3/6,6,3

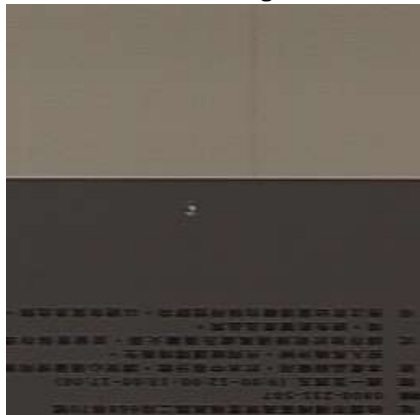
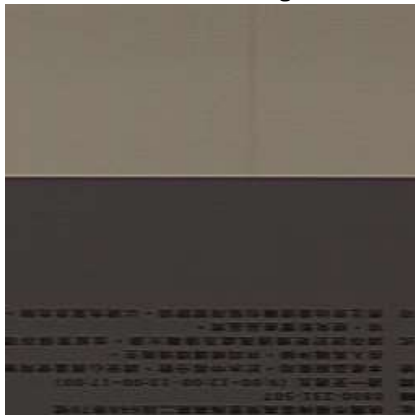
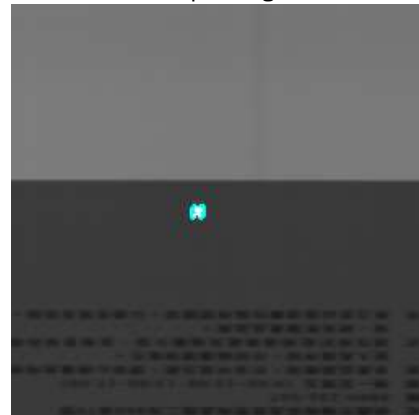
No.	#28, \$21	Date	2023/8/9 上午 11:30:37
Segment	1	Camera	1
Pattern	6843	Position[x, y]	133.4 [mm], 5177.0 [m], (331.4 [m])
Type	点状疵点縱向刀絲疵點橫向刀絲	Size	H:185.8 ,V:138.8 [mm]
Result	-	Area	2313.2 [mm2]
Inspection level	5/5,5/5,5/5,5/5,5/5	Label	-
Light	6,6,3/6,6,3

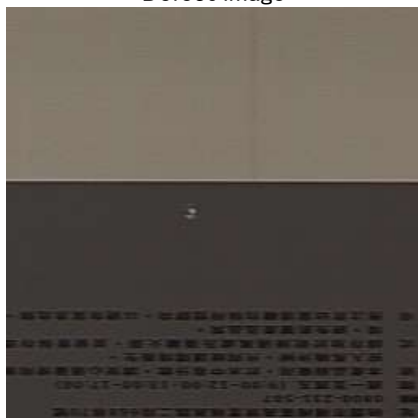
No.	#28, \$21	Date	2023/8/9 上午 11:30:37
Segment	1	Camera	1
Pattern	6843	Position[x, y]	773.1 [mm], 5177.3 [m], (331.1 [m])
Type	点状疵点縱向刀絲疵點	Size	H:184.3 ,V:38.4 [mm]
Result	-	Area	2368.9 [mm2]
Inspection level	5/5,5/5,5/5,5/5,5/5	Label	-
Light	6,6,3/6,6,3

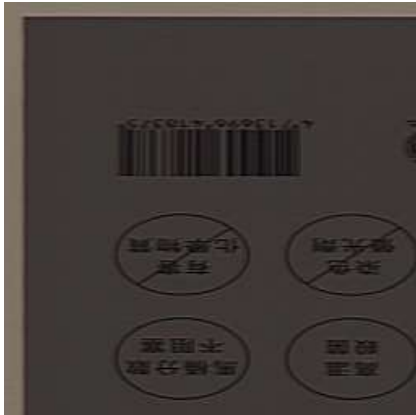
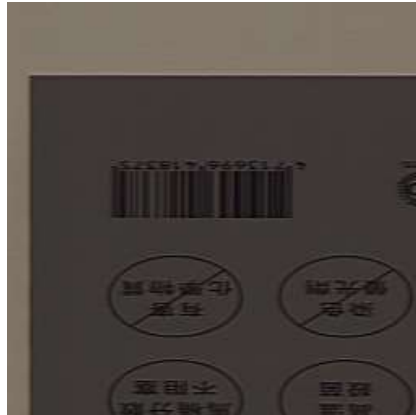
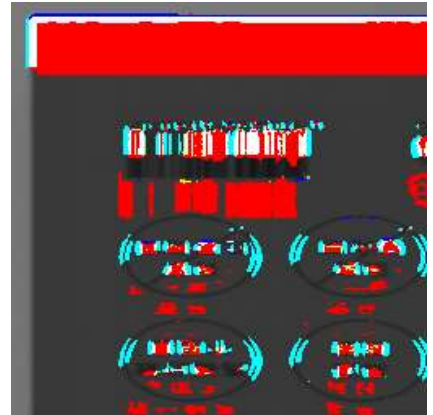
No.	#28, \$21	Date	2023/8/9 上午 11:30:37
Segment	1	Camera	1
Pattern	6843	Position[x, y]	771.8 [mm], 5177.4 [m], (331.0 [m])
Type	点状疵点縱向刀絲疵點橫向刀絲	Size	H:184.6 ,V:111.6 [mm]
Result	-	Area	2446.4 [mm2]
Inspection level	5/5,5/5,5/5,5/5,5/5	Label	-
Light	6,6,3/6,6,3

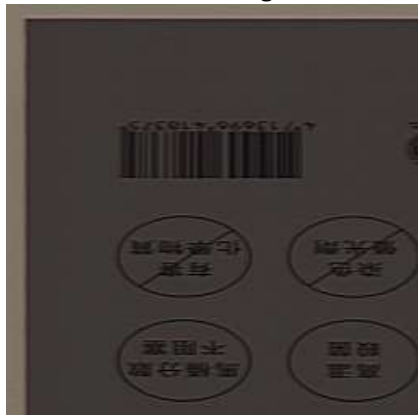
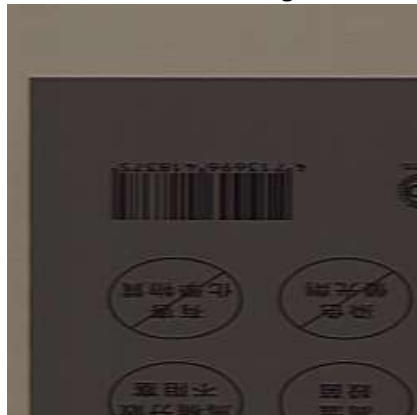
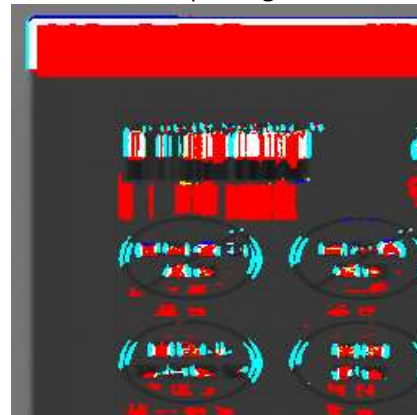
No.	#27, \$20	Date	2023/8/9 上午 11:30:37
Segment	1	Camera	1
Pattern	6842	Position[x, y]	768.7 [mm], 5176.7 [m], (331.7 [m])
Type	点状疵点縱向刀絲疵點橫向刀絲	Size	H:184.6 ,V:111.2 [mm]
Result	-	Area	2149.1 [mm2]
Inspection level	5/5,5/5,5/5,5/5,5/5	Label	-
Light	6,6,3/6,6,3

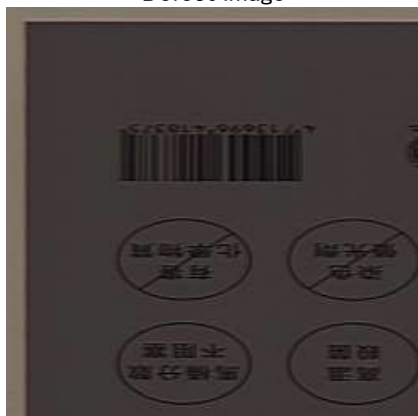
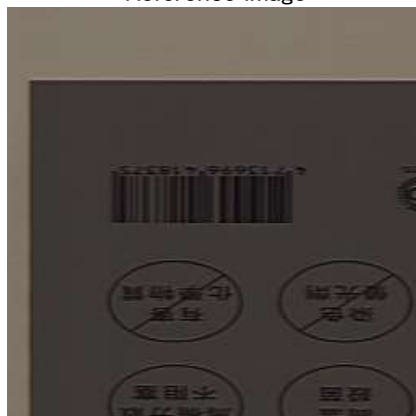
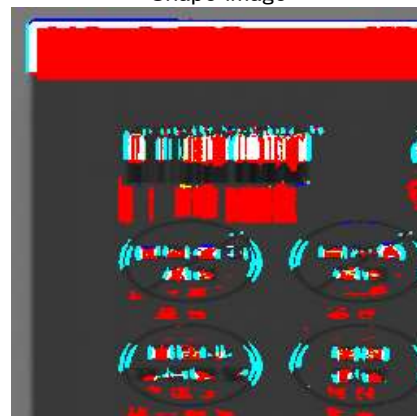
No.	#27, \$20	Date	2023/8/9 上午 11:30:37
Segment	1	Camera	1
Pattern	6842	Position[x, y]	126.6 [mm], 5176.6 [m], (331.8 [m])
Type	点状疵点縱向刀絲疵點橫向刀絲	Size	H:184.6 ,V:37.6 [mm]
Result	-	Area	2232.5 [mm2]
Inspection level	5/5,5/5,5/5,5/5,5/5	Label	-
Light	6,6,3/6,6,3

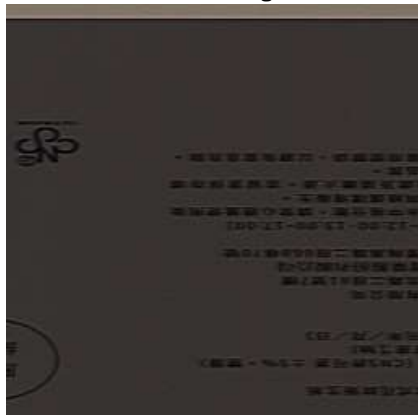
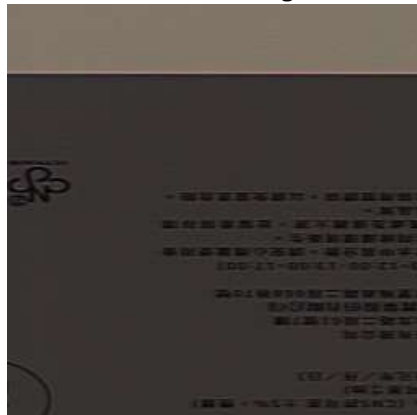
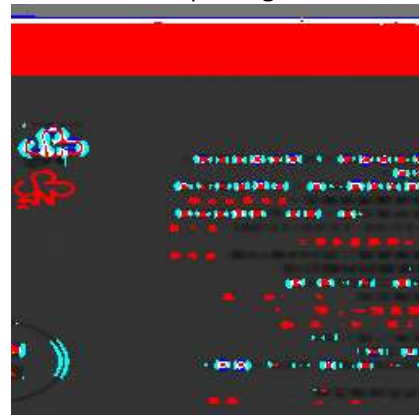
No.	#26, \$19	Date	2023/8/9 上午 11:30:36
Segment	1	Camera	1
Pattern	6841	Position[x, y]	473.3 [mm], 5175.9 [m], (332.5 [m])
Type	点状疵点縱向刀絲疵點橫向刀絲	Size	H:193.4 ,V:130.8 [mm]
Result	-	Area	2504.4 [mm2]
Inspection level	5/5,5/5,5/5,5/5,5/5	Label	-
Light	6,6,3/6,6,3

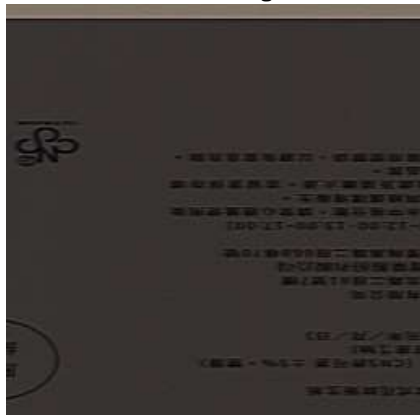
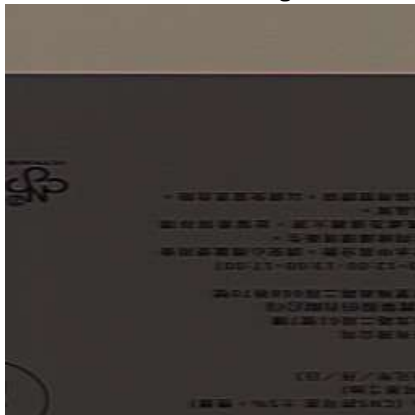
No.	#25, \$18	Date	2023/8/9 上午 11:30:36
Segment	1	Camera	1
Pattern	6840	Position[x, y]	781.8 [mm], 5174.8 [m], (333.6 [m])
Type	点状疵点縱向刀絲疵點橫向刀絲	Size	H:185.8 ,V:138.8 [mm]
Result	-	Area	2208.1 [mm2]
Inspection level	5/5,5/5,5/5,5/5,5/5	Label	-
Light	6,6,3/6,6,3

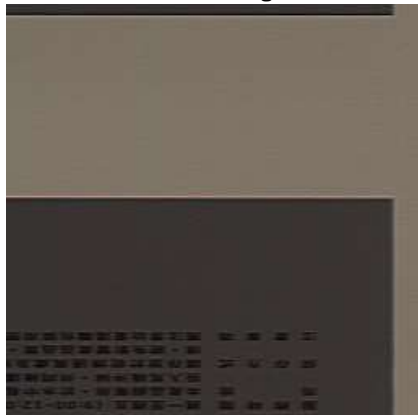
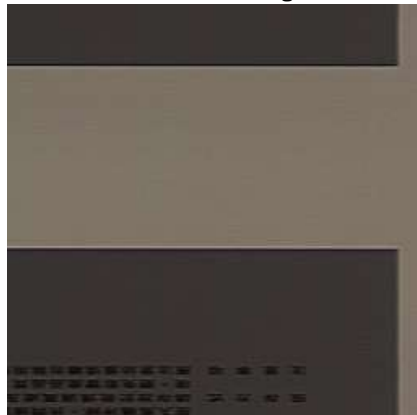
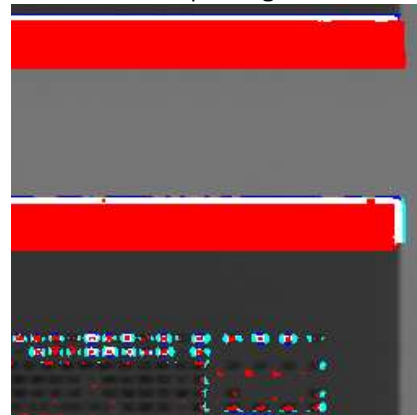
No.	#24, \$17	Date	2023/8/9 上午 11:30:35
Segment	1	Camera	1
Pattern	6839	Position[x, y]	434.4 [mm], 5174.0 [m], (334.4 [m])
Type	点状疵点縱向刀絲疵點橫向刀絲	Size	H:194.1 ,V:131.6 [mm]
Result	-	Area	2325.4 [mm2]
Inspection level	5/5,5/5,5/5,5/5,5/5	Label	-
Light	6,6,3/6,6,3

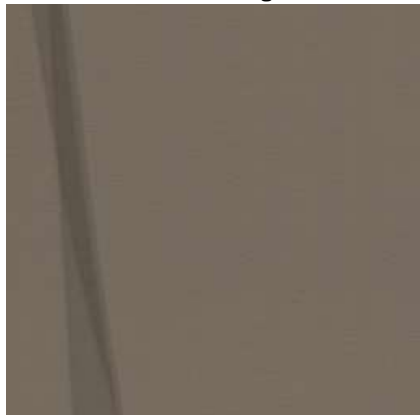
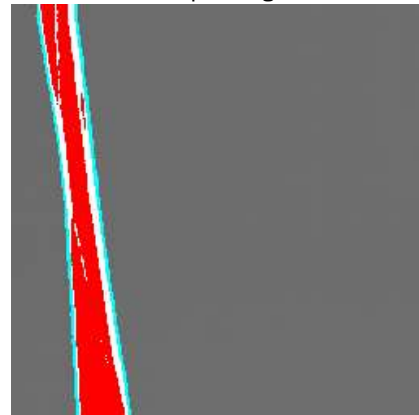
No.	#21, \$16	Date	2023/8/9 上午 11:30:18
Segment	1	Camera	1
Pattern	6810	Position[x, y]	590.9 [mm], 5152.2 [m], (356.2 [m])
Type	点状疵点縱向刀絲疵點	Size	H:65.2 ,V:806.4 [mm]
Result	-	Area	5914.7 [mm2]
Inspection level	5/5,5/5,5/5,5/5,5/5	Label	-
Light	6,6,3/6,6,3

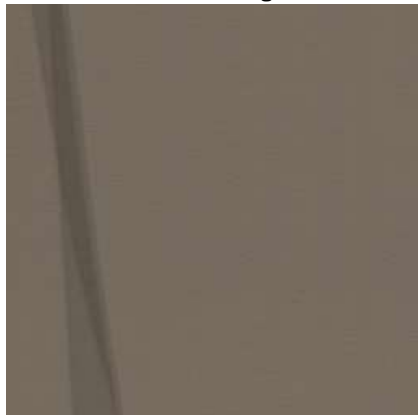
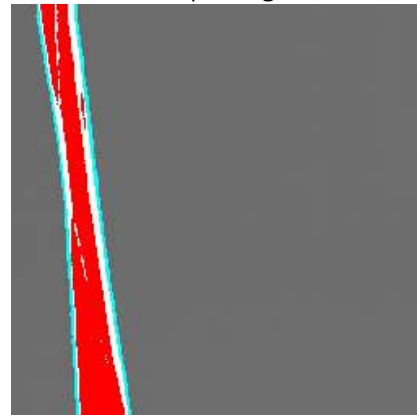
No.	#20, \$15	Date	2023/8/9 上午 11:30:17
Segment	1	Camera	1
Pattern	6809	Position[x, y]	238.4 [mm], 5151.1 [m], (357.3 [m])
Type	点状疵点縱向刀絲疵點	Size	H:58.8 ,V:200.4 [mm]
Result	-	Area	218.0 [mm2]
Inspection level	5/5,5/5,5/5,5/5,5/5	Label	-
Light	6,6,3/6,6,3

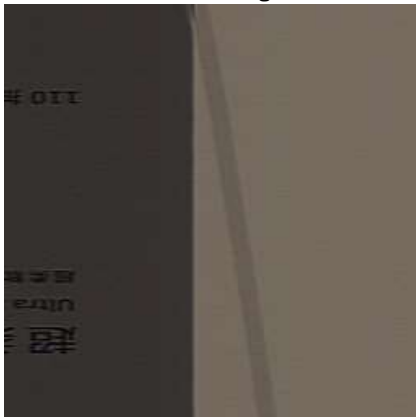
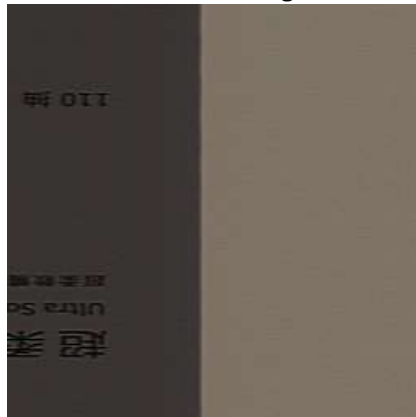
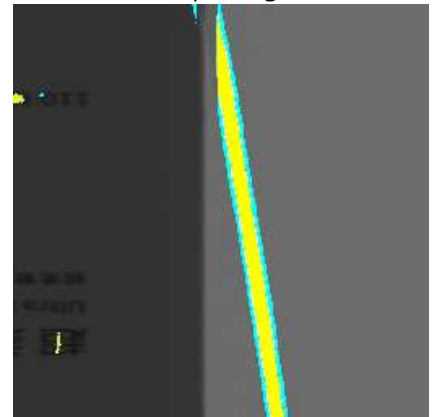
No.	#20, \$15	Date	2023/8/9 上午 11:30:17
Segment	1	Camera	1
Pattern	6809	Position[x, y]	561.9 [mm], 5151.3 [m], (357.1 [m])
Type	面状重疵点縱向刀絲疵點	Size	H:41.7 ,V:450.8 [mm]
Result	-	Area	575.9 [mm2]
Inspection level	5/5,5/5,5/5,5/5,5/5	Label	-
Light	6,6,3/6,6,3

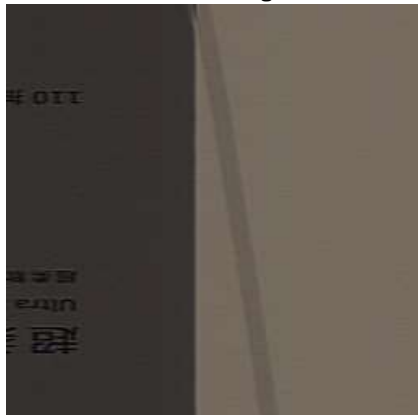
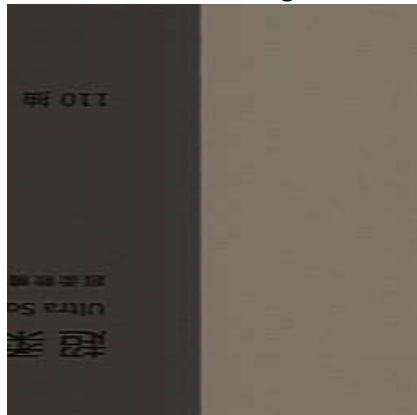
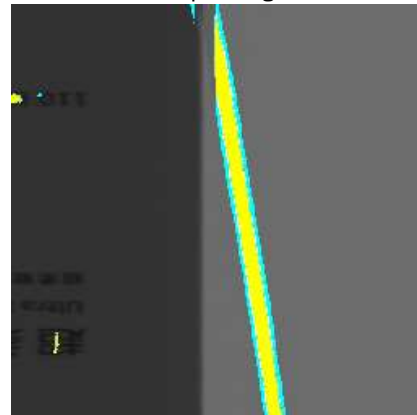
No.	#19, \$14	Date	2023/8/9 上午 11:30:16
Segment	1	Camera	1
Pattern	6808	Position[x, y]	415.9 [mm], 5150.5 [m], (357.9 [m])
Type	点状疵点縱向刀絲疵點	Size	H:74.7 ,V:383.2 [mm]
Result	-	Area	276.0 [mm2]
Inspection level	5/5,5/5,5/5,5/5,5/5	Label	-
Light	6,6,3/6,6,3

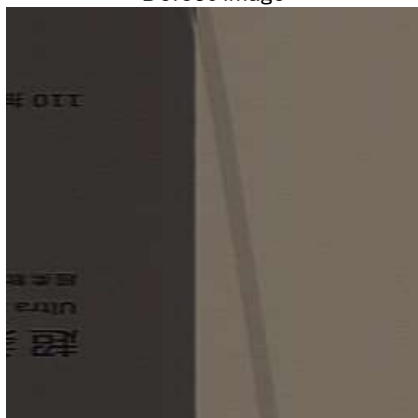
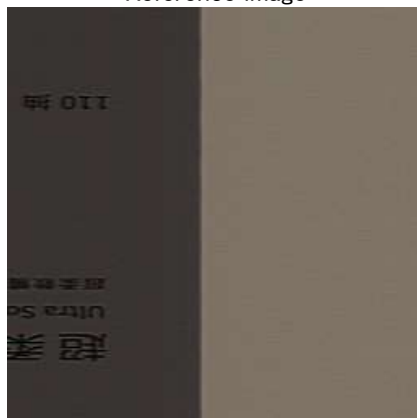
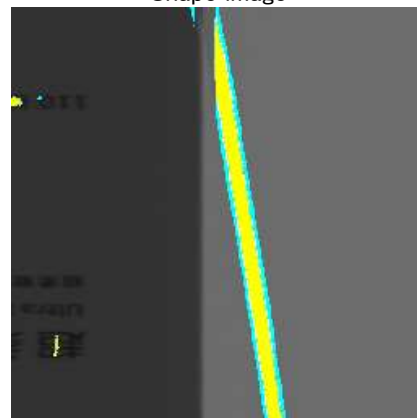
No.	#19, \$14	Date	2023/8/9 上午 11:30:16
Segment	1	Camera	1
Pattern	6808	Position[x, y]	58.2 [mm], 5150.5 [m], (357.9 [m])
Type	点状疵点縱向刀絲疵點	Size	H:12.0 ,V:416.0 [mm]
Result	-	Area	491.8 [mm2]
Inspection level	5/5,5/5,5/5,5/5,5/5	Label	-
Light	6,6,3/6,6,3

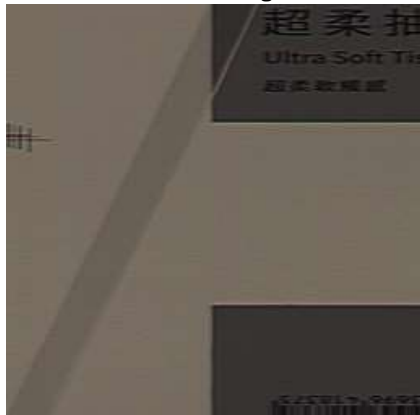
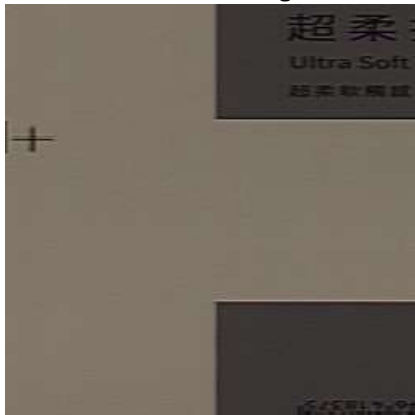
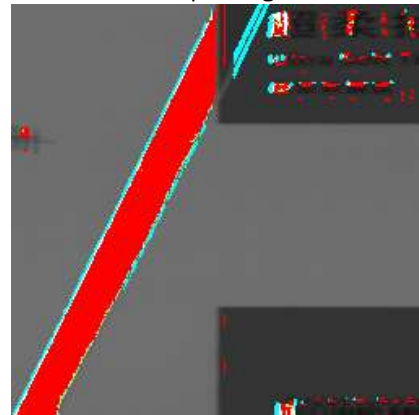
No.	#19, \$14	Date	2023/8/9 上午 11:30:16
Segment	1	Camera	1
Pattern	6808	Position[x, y]	355.6 [mm], 5150.8 [m], (357.5 [m])
Type	点状疵点縱向刀絲疵點	Size	H:161.1 ,V:423.2 [mm]
Result	-	Area	1977.1 [mm2]
Inspection level	5/5,5/5,5/5,5/5,5/5	Label	-
Light	6,6,3/6,6,3

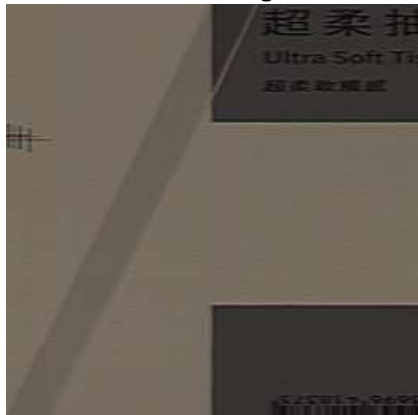
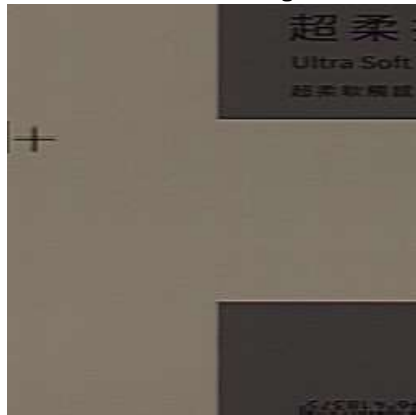
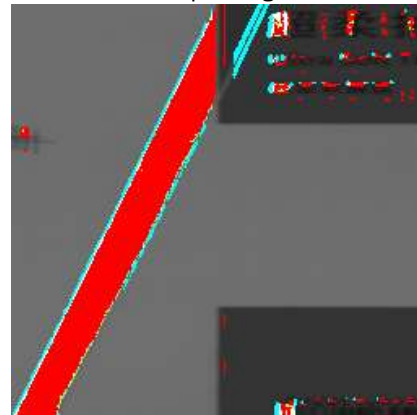
No.	#18, \$13	Date	2023/8/9 上午 11:30:16
Segment	1	Camera	1
Pattern	6807	Position[x, y]	58.5 [mm], 5149.9 [m], (358.5 [m])
Type	点状疵点縱向刀絲疵點	Size	H:11.0 ,V:144.0 [mm]
Result	-	Area	127.8 [mm2]
Inspection level	5/5,5/5,5/5,5/5,5/5	Label	-
Light	6,6,3/6,6,3

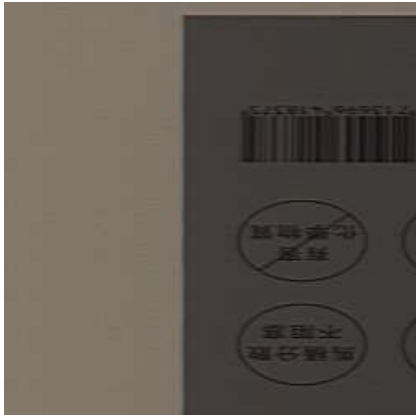
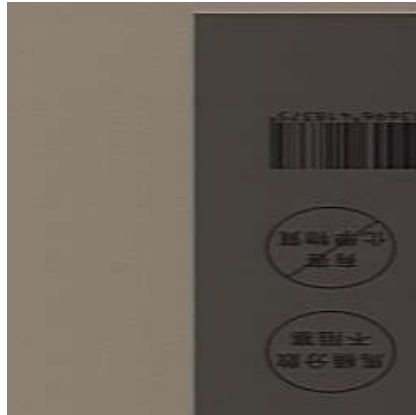
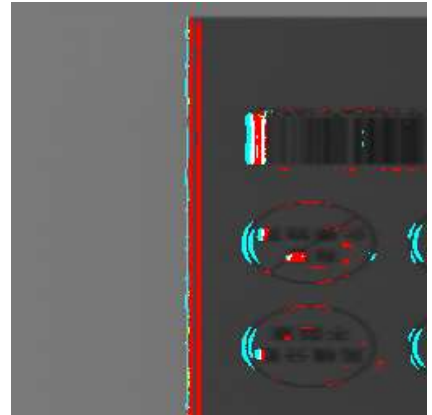
No.	#18, \$13	Date	2023/8/9 上午 11:30:16
Segment	1	Camera	1
Pattern	6807	Position[x, y]	63.3 [mm], 5150.1 [m], (358.3 [m])
Type	点状疵点縱向刀絲疵點	Size	H:11.7 ,V:326.8 [mm]
Result	-	Area	464.3 [mm2]
Inspection level	5/5,5/5,5/5,5/5,5/5	Label	-
Light	6,6,3/6,6,3

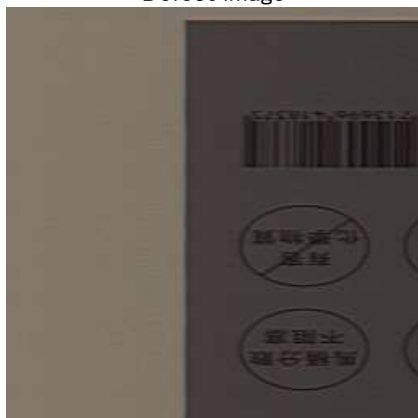
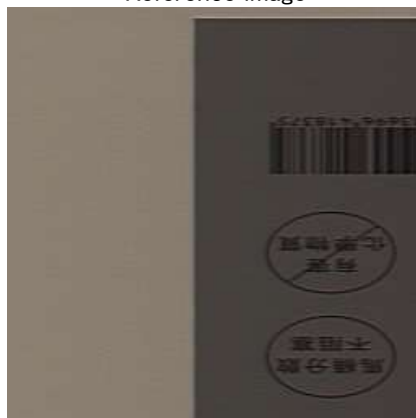
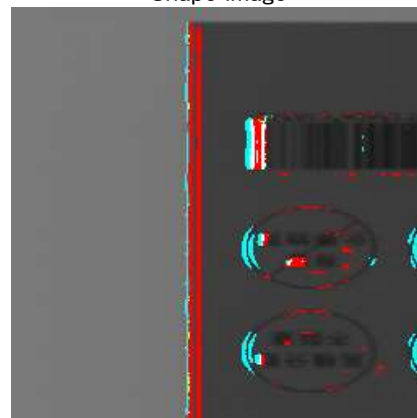
No.	#17, \$12	Date	2023/8/9 上午 11:30:15
Segment	1	Camera	1
Pattern	6806	Position[x, y]	456.4 [mm], 5148.9 [m], (359.5 [m])
Type	点状疵点縱向刀絲疵點	Size	H:29.8 ,V:213.2 [mm]
Result	-	Area	232.0 [mm2]
Inspection level	5/5,5/5,5/5,5/5,5/5	Label	-
Light	6,6,3/6,6,3

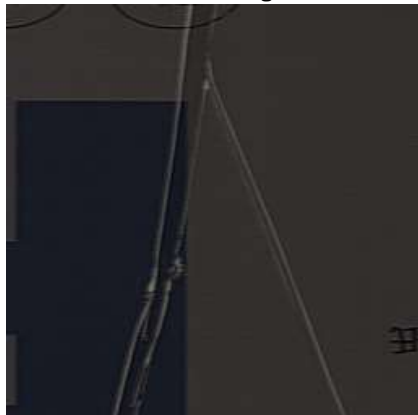
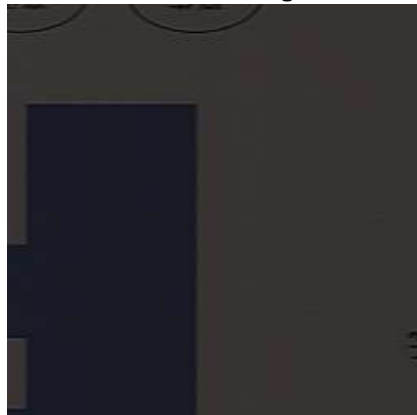
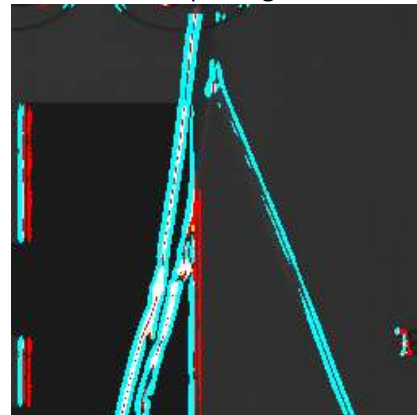
No.	#17, \$12	Date	2023/8/9 上午 11:30:15
Segment	1	Camera	1
Pattern	6806	Position[x, y]	437.4 [mm], 5149.0 [m], (359.4 [m])
Type	点状疵点縱向刀絲疵點	Size	H:81.8 ,V:460.0 [mm]
Result	-	Area	610.3 [mm2]
Inspection level	5/5,5/5,5/5,5/5,5/5	Label	-
Light	6,6,3/6,6,3

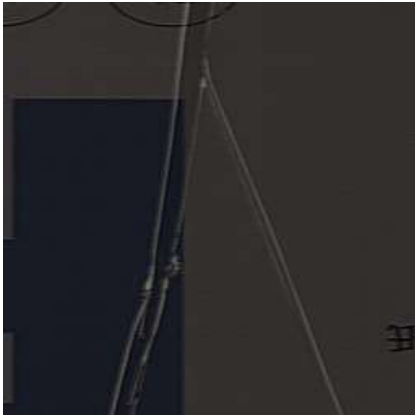
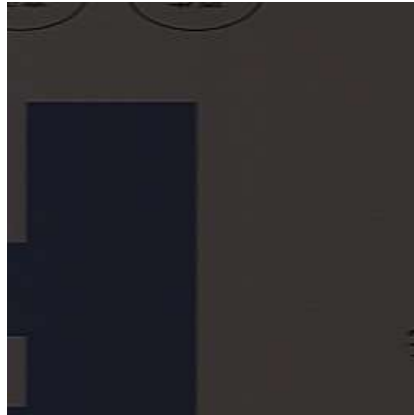
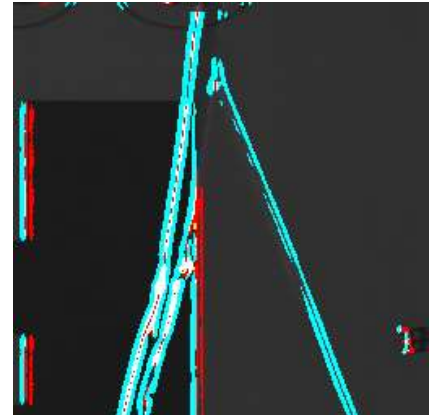
No.	#14, \$11	Date	2023/8/9 上午 11:30:06
Segment	1	Camera	1
Pattern	6791	Position[x, y]	646.1 [mm], 5137.5 [m], (370.9 [m])
Type	面狀重疵點	Size	H:3.2 ,V:229.2 [mm]
Result	-	Area	280.2 [mm2]
Inspection level	5/5,5/5,5/5,5/5,5/5	Label	-
Light	6,6,3/6,6,3

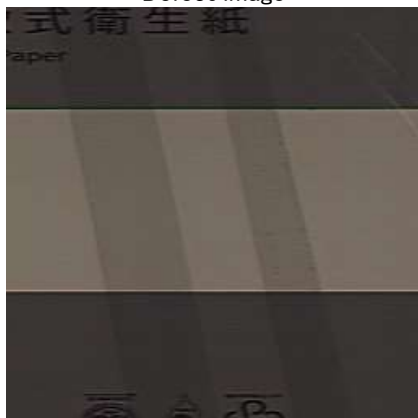
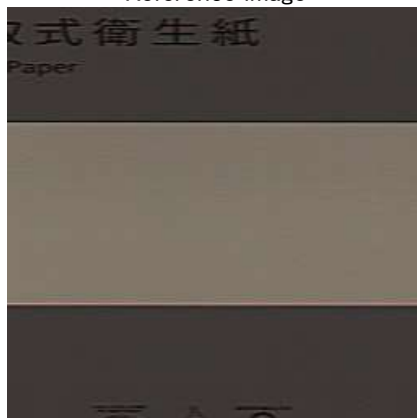
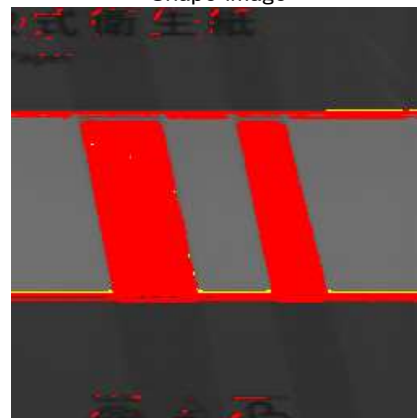
No.	#14, \$11	Date	2023/8/9 上午 11:30:06
Segment	1	Camera	1
Pattern	6791	Position[x, y]	767.9 [mm], 5137.6 [m], (370.7 [m])
Type	点状疵点	Size	H:145.5 ,V:46.4 [mm]
Result	-	Area	1072.1 [mm2]
Inspection level	5/5,5/5,5/5,5/5,5/5	Label	-
Light	6,6,3/6,6,3

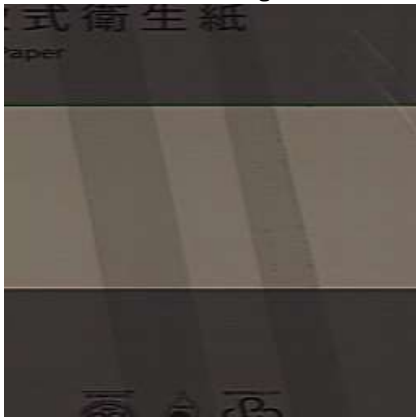
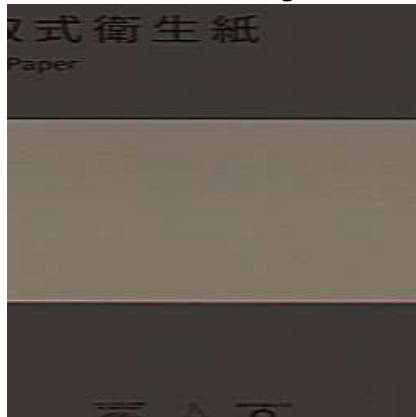
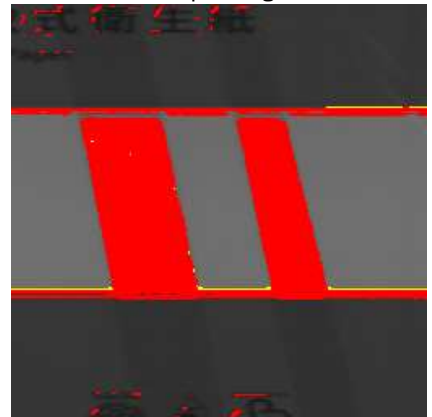
No.	#13, \$10	Date	2023/8/9 上午 11:30:05
Segment	1	Camera	1
Pattern	6790	Position[x, y]	880.2 [mm], 5136.7 [m], (371.6 [m])
Type	点状疵点縱向刀絲疵點	Size	H:2.7 ,V:676.4 [mm]
Result	-	Area	501.0 [mm2]
Inspection level	5/5,5/5,5/5,5/5,5/5	Label	-
Light	6,6,3/6,6,3

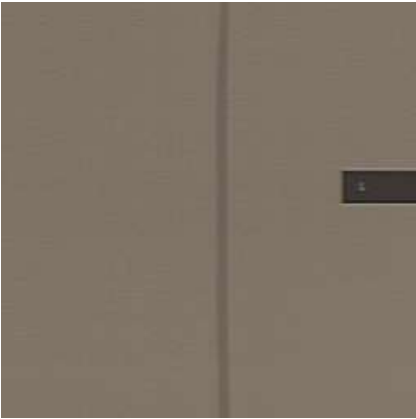
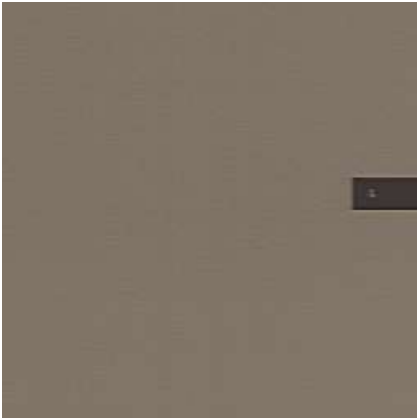
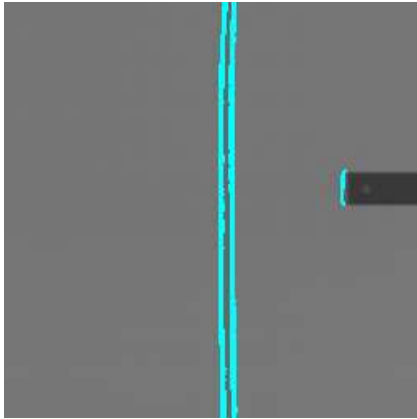
No.	#13, \$10	Date	2023/8/9 上午 11:30:05
Segment	1	Camera	1
Pattern	6790	Position[x, y]	618.3 [mm], 5136.6 [m], (371.8 [m])
Type	縱向刀絲疵點	Size	H:4.4 ,V:367.6 [mm]
Result	-	Area	599.9 [mm2]
Inspection level	5/5,5/5,5/5,5/5,5/5	Label	-
Light	6,6,3/6,6,3

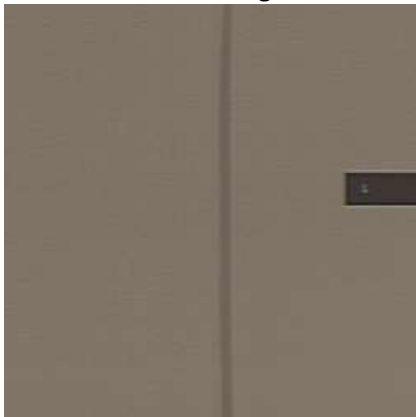
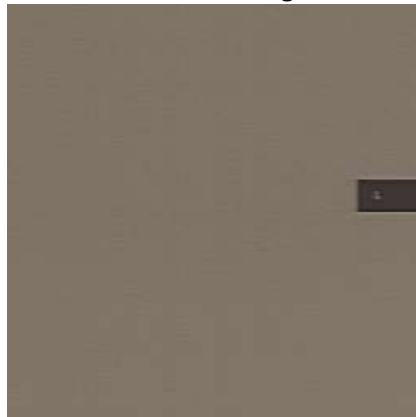
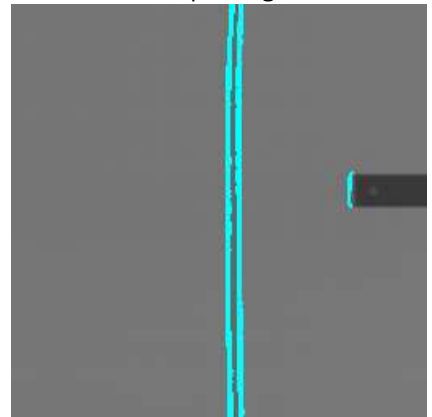
No.	#12, \$9	Date	2023/8/9 上午 11:30:05
Segment	1	Camera	1
Pattern	6789	Position[x, y]	932.2 [mm], 5136.1 [m], (372.3 [m])
Type	点状疵点縱向刀絲疵點橫向刀絲	Size	H:6.1 ,V:102.0 [mm]
Result	-	Area	50.2 [mm2]
Inspection level	5/5,5/5,5/5,5/5,5/5	Label	-
Light	6,6,3/6,6,3

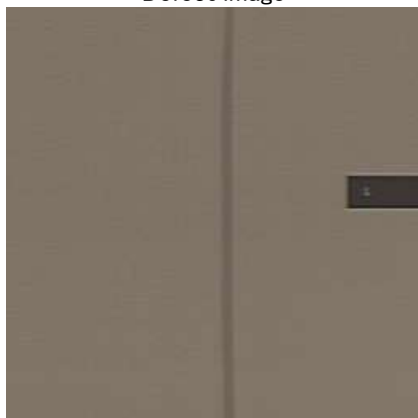
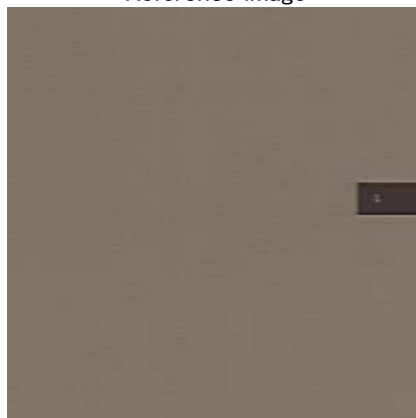
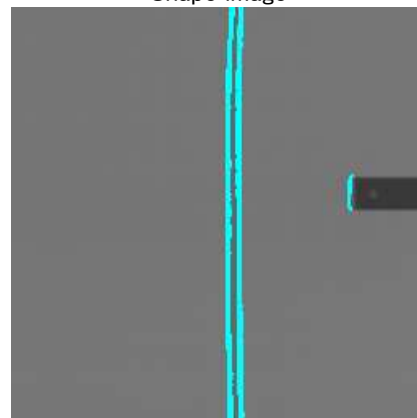
No.	#12, \$9	Date	2023/8/9 上午 11:30:05
Segment	1	Camera	1
Pattern	6789	Position[x, y]	705.7 [mm], 5136.1 [m], (372.3 [m])
Type	点状疵点縱向刀絲疵點	Size	H:32.2 ,V:98.4 [mm]
Result	-	Area	50.2 [mm2]
Inspection level	5/5,5/5,5/5,5/5,5/5	Label	-
Light	6,6,3/6,6,3

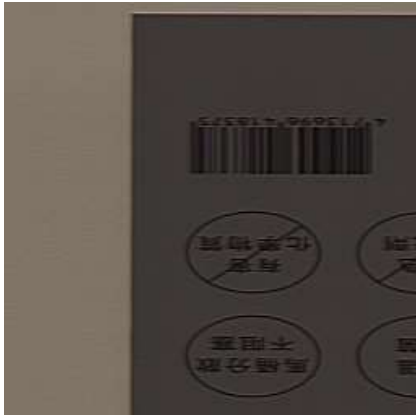
No.	#12, \$9	Date	2023/8/9 上午 11:30:05
Segment	1	Camera	1
Pattern	6789	Position[x, y]	698.8 [mm], 5136.3 [m], (372.1 [m])
Type	点状疵点	Size	H:21.0 ,V:329.6 [mm]
Result	-	Area	570.6 [mm2]
Inspection level	5/5,5/5,5/5,5/5,5/5	Label	-
Light	6,6,3/6,6,3

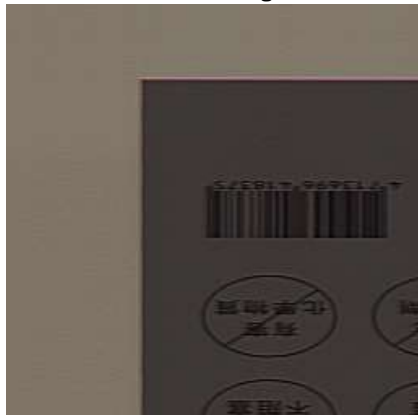
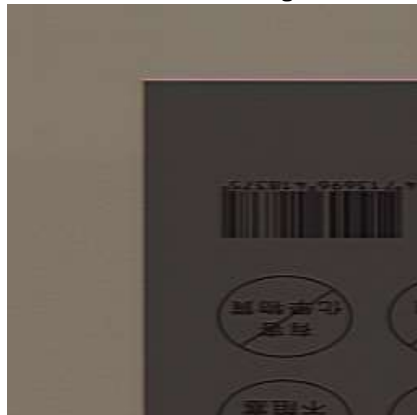
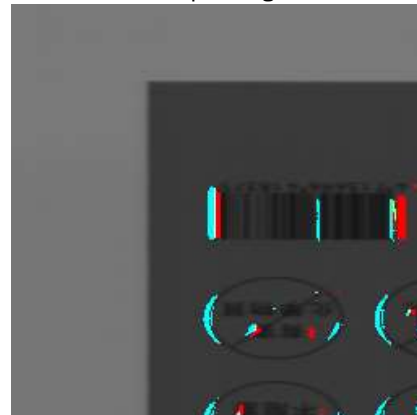
No.	#11, \$8	Date	2023/8/9 上午 11:30:04
Segment	1	Camera	1
Pattern	6788	Position[x, y]	708.4 [mm], 5135.4 [m], (372.9 [m])
Type	点状疵点縱向刀絲疵點	Size	H:2.0 ,V:12.4 [mm]
Result	-	Area	14.7 [mm2]
Inspection level	5/5,5/5,5/5,5/5,5/5	Label	-
Light	6,6,3/6,6,3

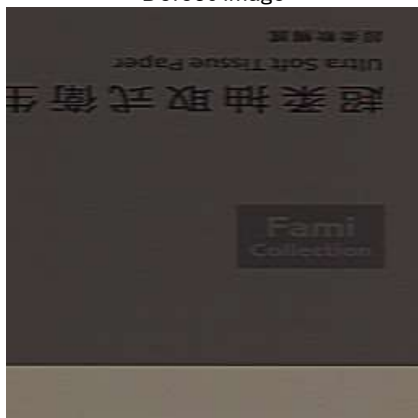
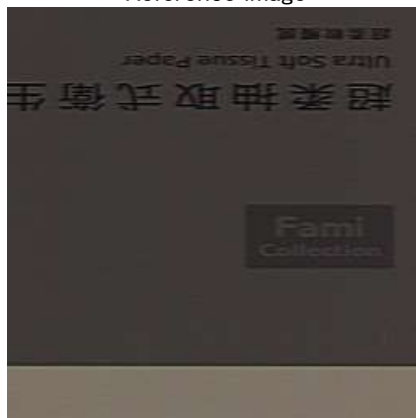
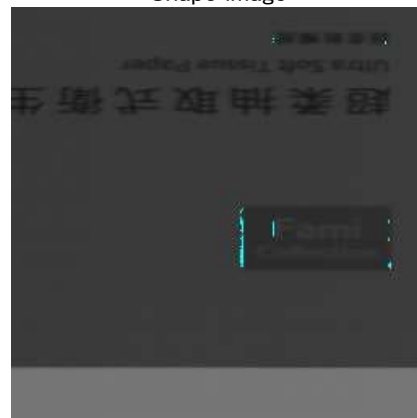
No.	#10, \$7	Date	2023/8/9 上午 11:30:04
Segment	1	Camera	1
Pattern	6787	Position[x, y]	845.1 [mm], 5135.0 [m], (373.4 [m])
Type	縱向刀絲疵點	Size	H:0.5 ,V:11.6 [mm]
Result	-	Area	3.0 [mm2]
Inspection level	5/5,5/5,5/5,5/5,5/5	Label	-
Light	6,6,3/6,6,3

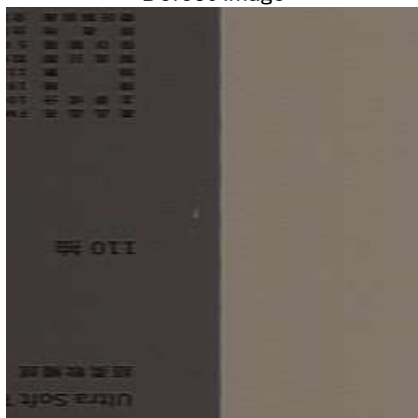
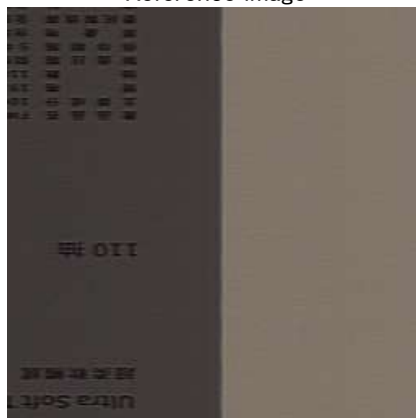
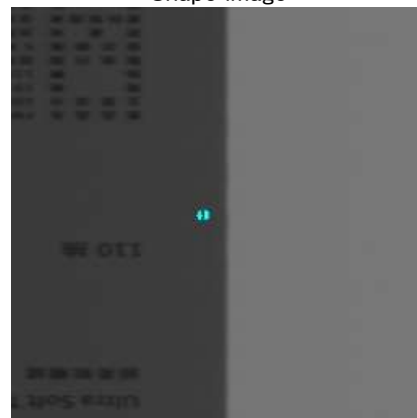
No.	#9, \$6	Date	2023/8/9 上午 11:08:29
Segment	1	Camera	1
Pattern	4602	Position[x, y]	878.3 [mm], 3492.9 [m], (2015.5 [m])
Type	縱向刀絲疵點	Size	H:2.0 ,V:1.6 [mm]
Result	-	Area	2.1 [mm2]
Inspection level	5/5,5/5,5/5,5/5,5/5	Label	-
Light	6,6,3/6,6,3

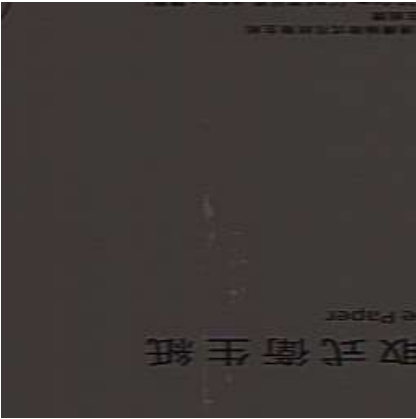
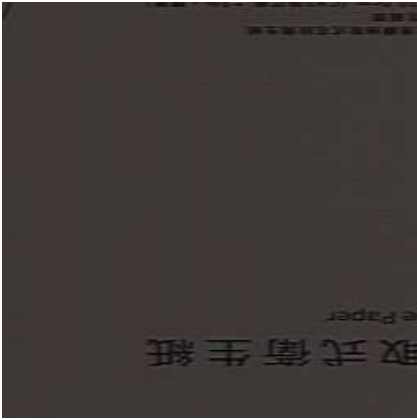
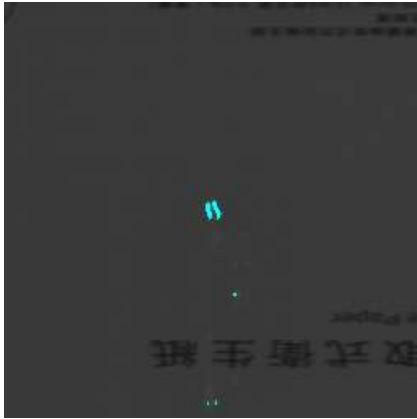
No.	#7, \$4	Date	2023/8/9 上午 11:08:12
Segment	1	Camera	1
Pattern	4573	Position[x, y]	810.4 [mm], 3471.5 [m], (2036.9 [m])
Type	縱向刀絲疵點	Size	H:2.4 ,V:4.0 [mm]
Result	-	Area	5.3 [mm2]
Inspection level	5/5,5/5,5/5,5/5,5/5	Label	-
Light	6,6,3/6,6,3

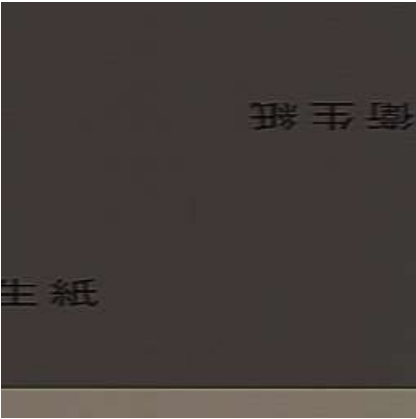
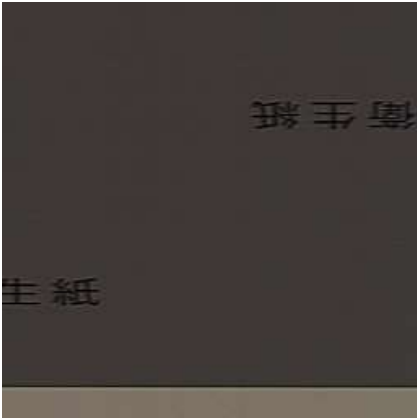
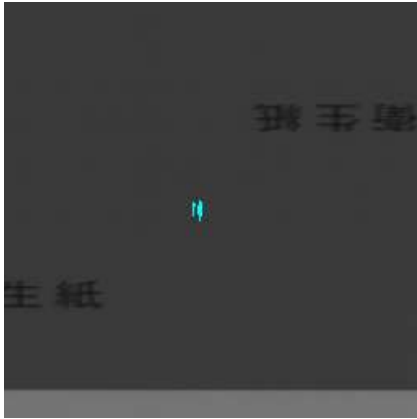
No.	#6, \$3	Date	2023/8/9 上午 11:04:14
Segment	1	Camera	1
Pattern	4172	Position[x, y]	792.8 [mm], 3170.0 [m], (2338.4 [m])
Type	縱向刀絲疵點	Size	H:1.5 ,V:4.4 [mm]
Result	-	Area	3.4 [mm2]
Inspection level	5/5,5/5,5/5,5/5,5/5	Label	-
Light	6,6,3/6,6,3

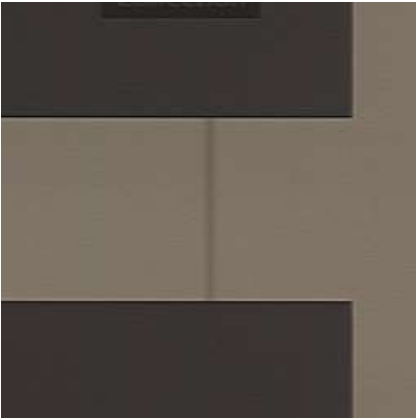
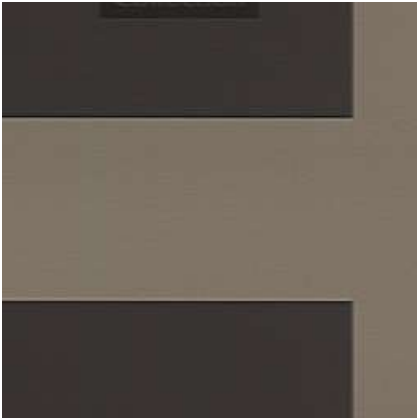
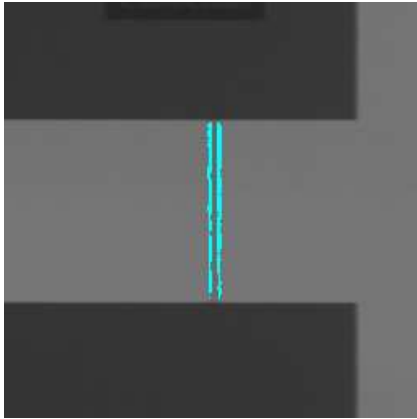
No.	#5, \$2	Date	2023/8/9 上午 11:00:53
Segment	1	Camera	1
Pattern	3833	Position[x, y]	545.3 [mm], 2915.4 [m], (2593.0 [m])
Type	縱向刀絲疵點	Size	H:2.2 ,V:42.8 [mm]
Result	-	Area	46.8 [mm2]
Inspection level	5/5,5/5,5/5,5/5,5/5	Label	-
Light	6,6,3/6,6,3

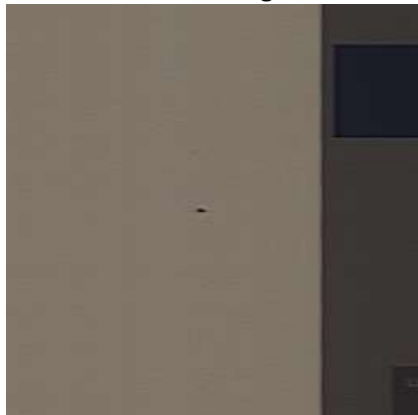
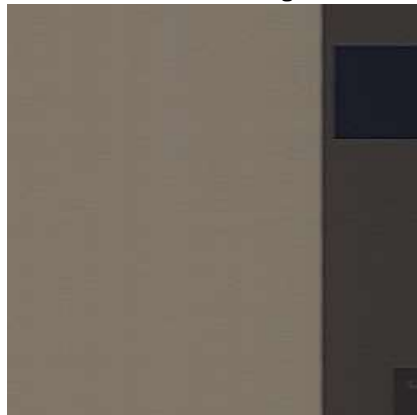
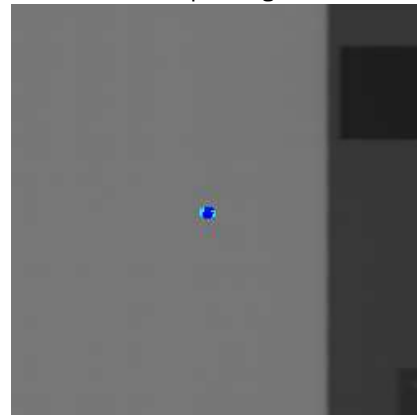
No.	#4, \$1	Date	2023/8/9 上午 10:34:25
Segment	1	Camera	1
Pattern	1152	Position[x, y]	355.6 [mm], 901.4 [m], (4607.0 [m])
Type	縱向刀絲疵點橫向刀絲	Size	H:2.4 ,V:2.0 [mm]
Result	-	Area	3.6 [mm2]
Inspection level	5/5,5/5,5/5,5/5,5/5	Label	-
Light	6,6,3/6,6,3

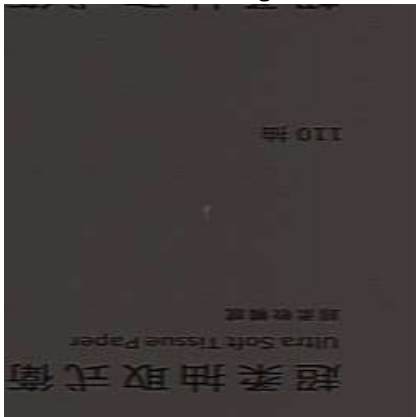
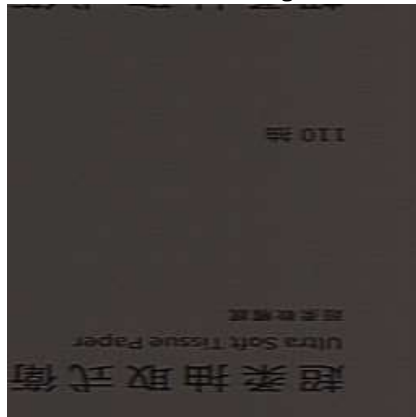
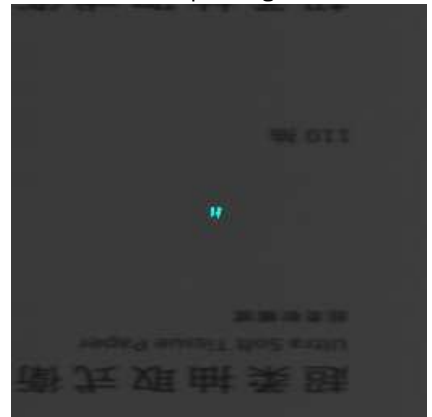
No.	#8, \$5	Date	2023/8/9 上午 11:08:28
Segment	1	Camera	1
Pattern	4601	Position[x, y]	849.0 [mm], 3492.6 [m], (2015.8 [m])
Type	縱向刀絲疵點	Size	H:1.7 ,V:2.0 [mm]
Result	-	Area	2.0 [mm2]
Inspection level	5/5,5/5,5/5,5/5,5/5	Label	-
Light	6,6,3/6,6,3
