# Inspection Result (Individual Data)

Lot number : 6

Inspected date : 2023/8/9 下午 02:20:08 ~ 2023/8/9 下午 03:44:45

商品名	標準透明6-6-3	周長	
顧客名		Ex1	
CODE番号		Ex2	
基材		Ex3

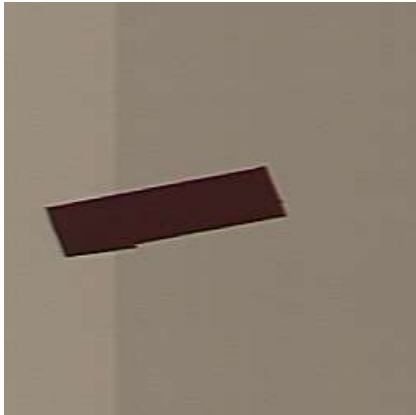
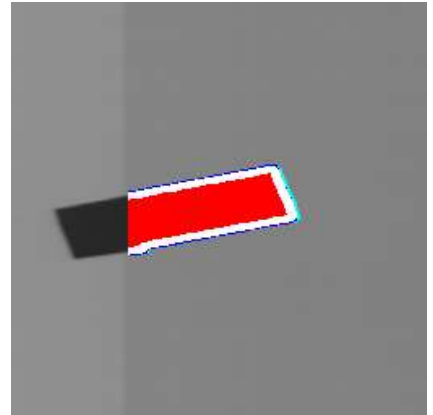
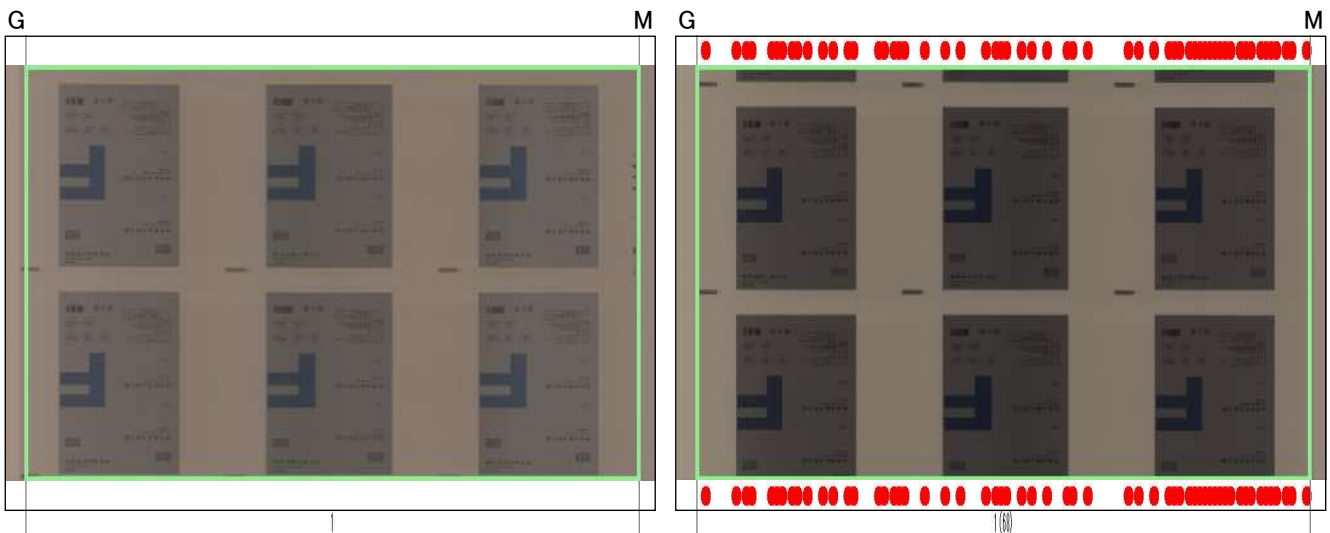
Defect image

No.	#77, \$68	Date	2023/8/9 下午 03:44:38
Segment	1	Camera	1
Pattern	8160	Position[ x, y ]	12.8 [mm], 6138.9 [m], ( 1.8 [m] )
Type	点状疵点縱向刀絲疵點橫向刀絲	Size	H:25.9 ,V:21.6 [mm]
Result	-	Area	339.2 [mm2]
Inspection level	5/5,5/5,5/5,5/5,5/5	Label	-
Light	6,6,3/6,6,3

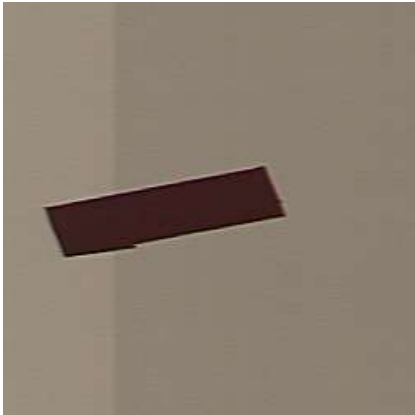
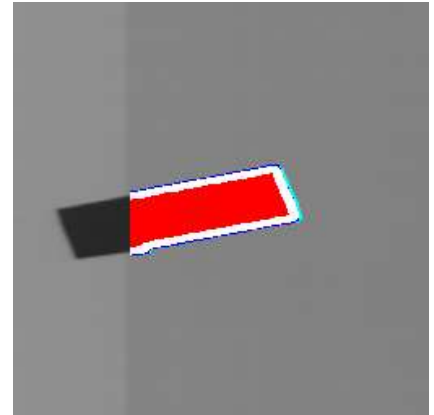
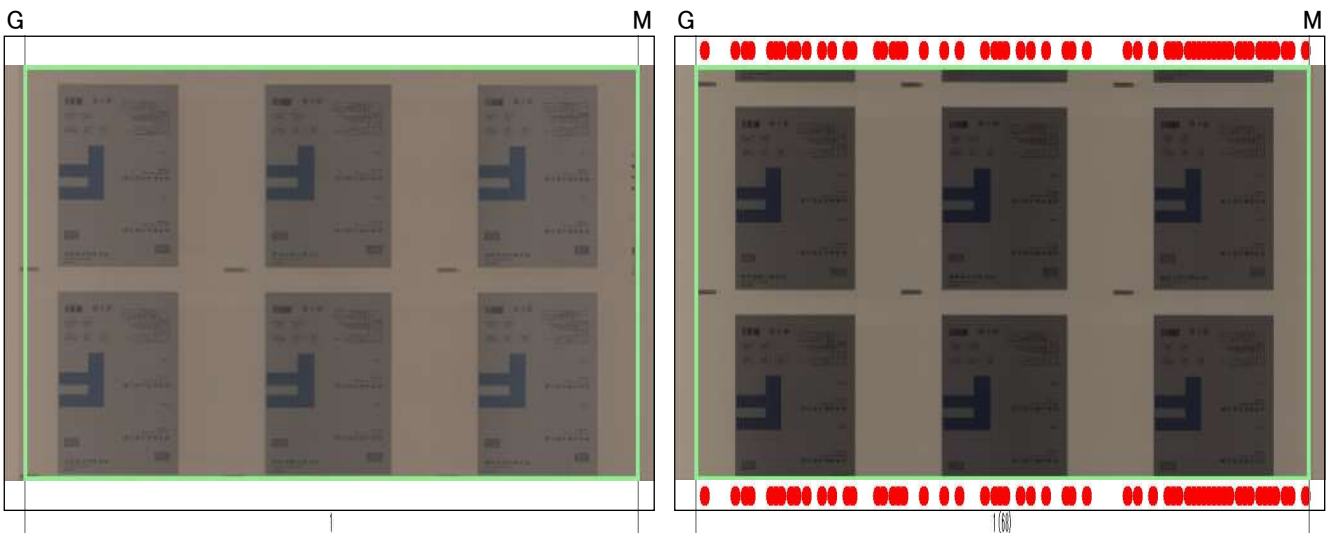
Defect image

No.	#74, \$67	Date	2023/8/9 下午 03:43:44
Segment	1	Camera	1
Pattern	8069	Position[ x, y ]	802.4 [mm], 6070.5 [m], ( 70.2 [m] )
Type	点状疵点縱向刀絲疵點橫向刀絲	Size	H:186.5 ,V:422.0 [mm]
Result	-	Area	1793.2 [mm2]
Inspection level	5/5,5/5,5/5,5/5,5/5	Label	-
Light	6,6,3/6,6,3

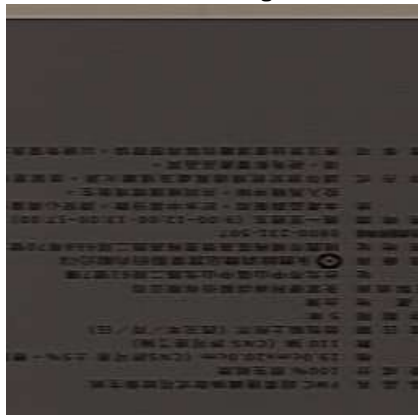
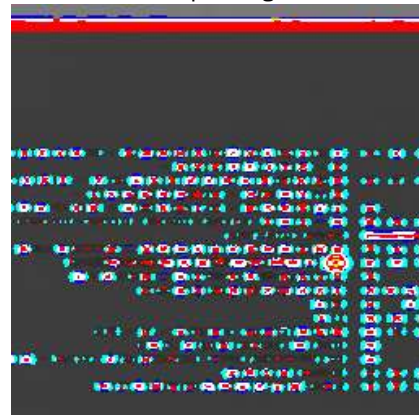
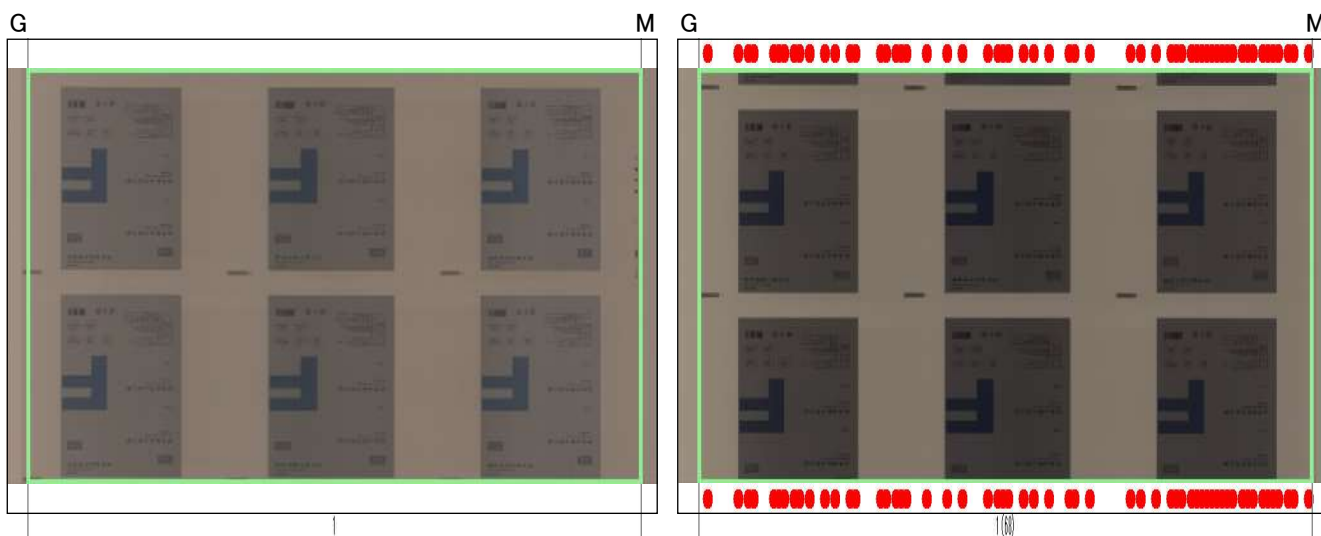
Defect image

No.	#74, \$67	Date	2023/8/9 下午 03:43:44
Segment	1	Camera	1
Pattern	8069	Position[ x, y ]	155.9 [mm], 6070.5 [m], ( 70.1 [m] )
Type	点状疵点縱向刀絲疵點橫向刀絲	Size	H:187.5 ,V:517.2 [mm]
Result	-	Area	2517.5 [mm2]
Inspection level	5/5,5/5,5/5,5/5,5/5	Label	-
Light	6,6,3/6,6,3

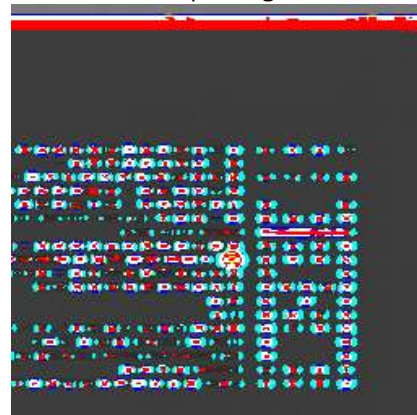
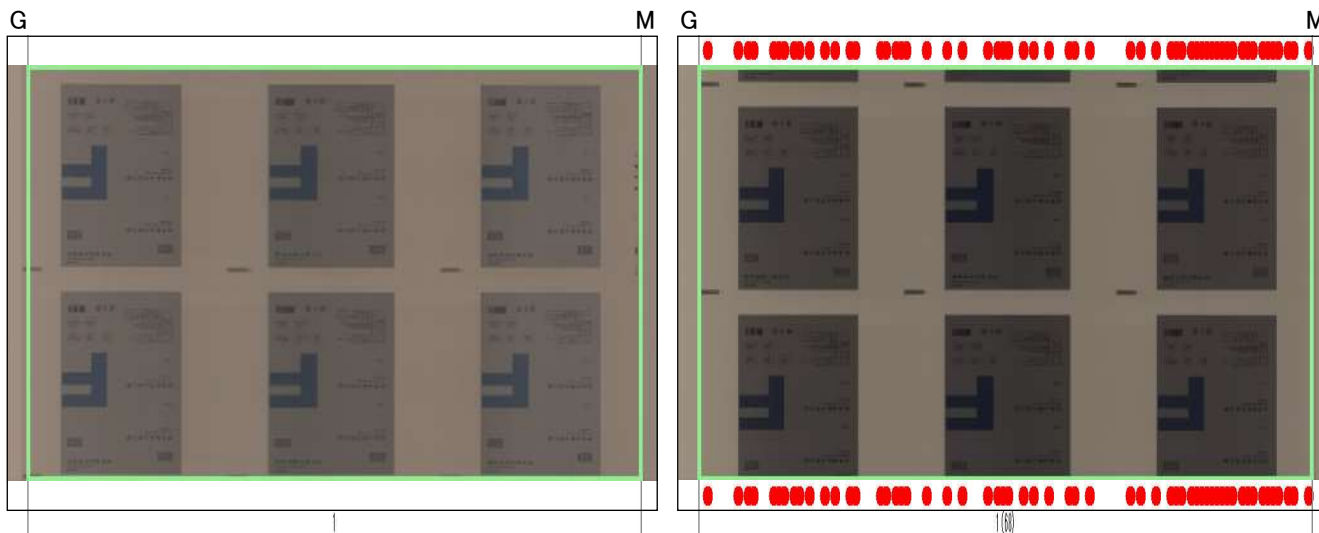
Defect image

No.	#73, \$66	Date	2023/8/9 下午 03:43:44
Segment	1	Camera	1
Pattern	8068	Position[ x, y ]	152.9 [mm], 6069.7 [m], ( 70.9 [m] )
Type	点状疵点縱向刀絲疵點橫向刀絲	Size	H:187.7 ,V:808.0 [mm]
Result	-	Area	2607.3 [mm2]
Inspection level	5/5,5/5,5/5,5/5,5/5	Label	-
Light	6,6,3/6,6,3

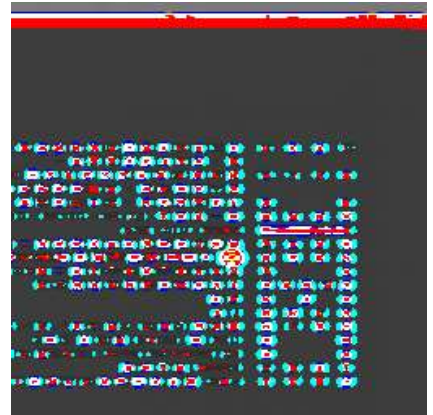
Defect image

No.	#72, \$65	Date	2023/8/9 下午 03:43:43
Segment	1	Camera	1
Pattern	8067	Position[ x, y ]	403.2 [mm], 6068.8 [m], ( 71.8 [m] )
Type	点状疵点縱向刀絲疵點	Size	H:195.3 ,V:78.8 [mm]
Result	-	Area	1296.6 [mm2]
Inspection level	5/5,5/5,5/5,5/5,5/5	Label	-
Light	6,6,3/6,6,3

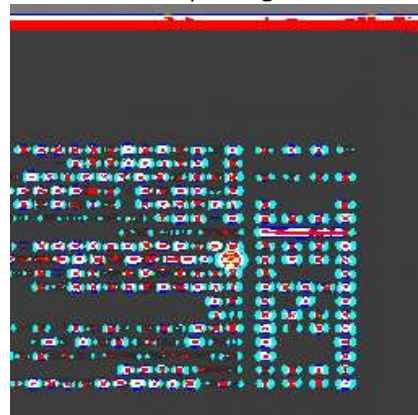
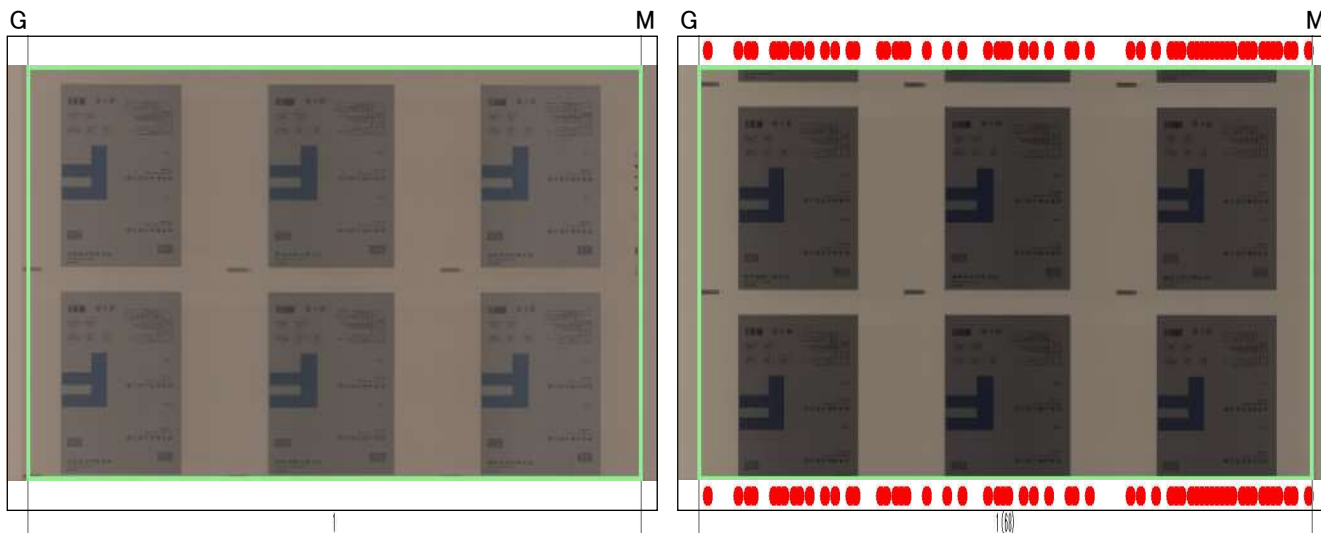
Defect image

No.	#72, \$65	Date	2023/8/9 下午 03:43:43
Segment	1	Camera	1
Pattern	8067	Position[ x, y ]	140.2 [mm], 6069.0 [m], ( 71.7 [m] )
Type	点状疵点縱向刀絲疵點橫向刀絲	Size	H:187.7 ,V:456.0 [mm]
Result	-	Area	3040.9 [mm2]
Inspection level	5/5,5/5,5/5,5/5,5/5	Label	-
Light	6,6,3/6,6,3

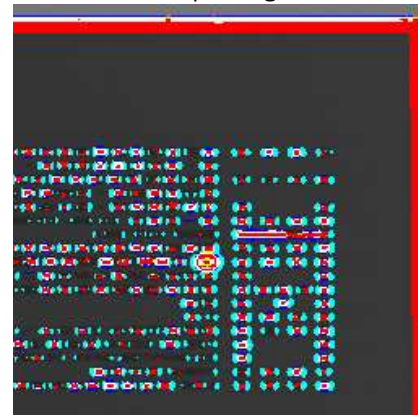
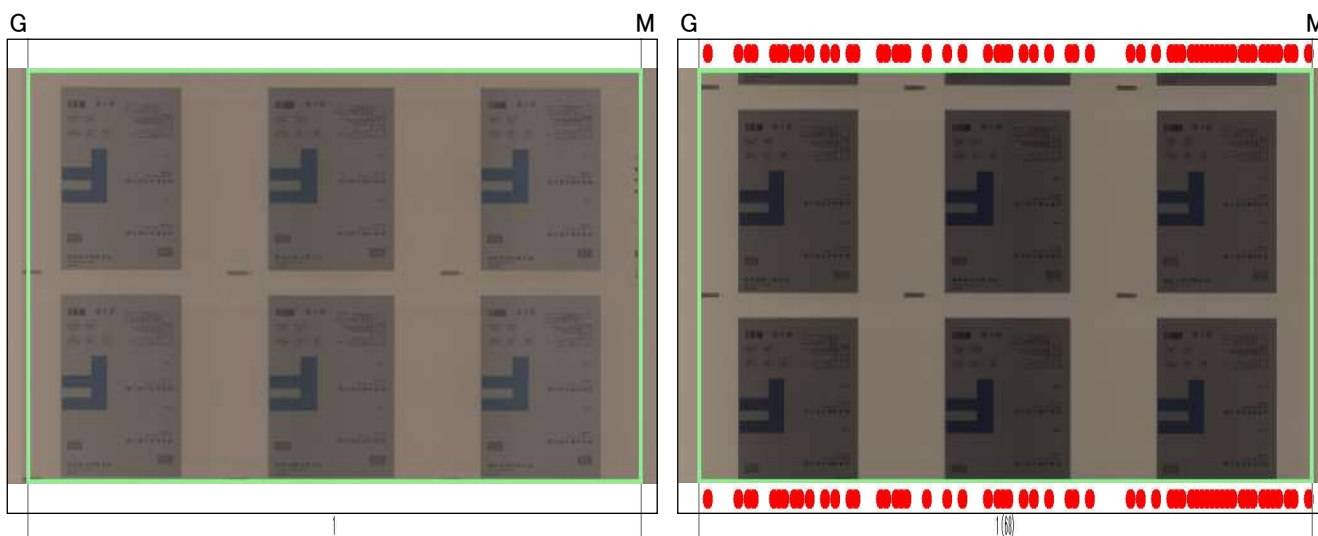
Defect image

No.	#72, \$65	Date	2023/8/9 下午 03:43:43
Segment	1	Camera	1
Pattern	8067	Position[ x, y ]	473.3 [mm], 6069.0 [m], ( 71.7 [m] )
Type	点状疵点縱向刀絲疵點橫向刀絲	Size	H:196.3 ,V:808.0 [mm]
Result	-	Area	3723.0 [mm2]
Inspection level	5/5,5/5,5/5,5/5,5/5	Label	-
Light	6,6,3/6,6,3

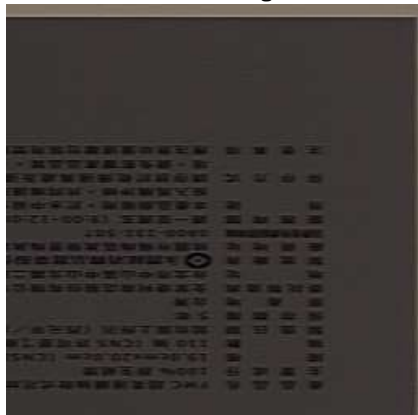
Defect image

No.	#71, \$64	Date	2023/8/9 下午 03:43:43
Segment	1	Camera	1
Pattern	8066	Position[ x, y ]	477.4 [mm], 6068.3 [m], ( 72.3 [m] )
Type	点状疵点縱向刀絲疵點橫向刀絲	Size	H:196.0 ,V:709.2 [mm]
Result	-	Area	3651.8 [mm2]
Inspection level	5/5,5/5,5/5,5/5,5/5	Label	-
Light	6,6,3/6,6,3

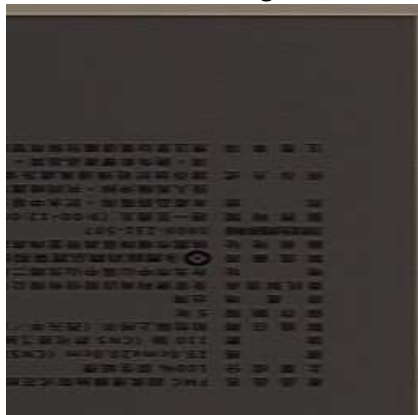
Defect image

No.	#70, \$63	Date	2023/8/9 下午 03:43:42
Segment	1	Camera	1
Pattern	8065	Position[ x, y ]	483.3 [mm], 6067.5 [m], ( 73.1 [m] )
Type	点状疵点縱向刀絲疵點橫向刀絲	Size	H:196.3 ,V:438.0 [mm]
Result	-	Area	2932.6 [mm2]
Inspection level	5/5,5/5,5/5,5/5,5/5	Label	-
Light	6,6,3/6,6,3

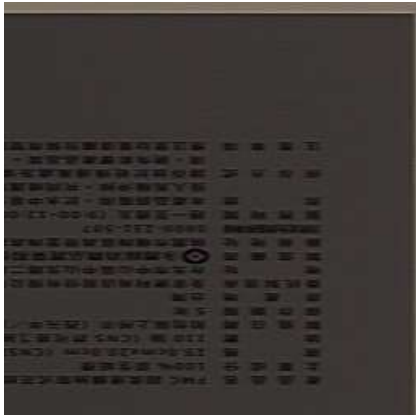
Defect image

No.	#68, \$62	Date	2023/8/9 下午 03:41:41
Segment	1	Camera	1
Pattern	7880	Position[ x, y ]	463.2 [mm], 5927.4 [m], ( 213.3 [m] )
Type	点状疵点	Size	H:193.4 ,V:2.8 [mm]
Result	-	Area	466.0 [mm2]
Inspection level	5/5,5/5,5/5,5/5,5/5	Label	-
Light	6,6,3/6,6,3

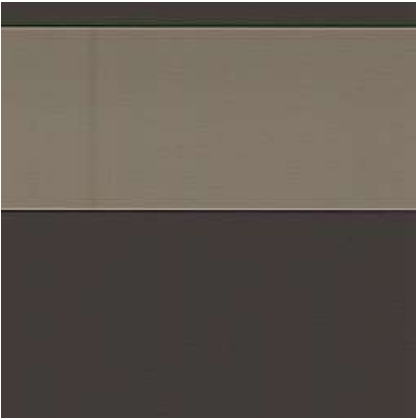
Defect image	Reference image	Shape image

No.	#66, \$61	Date	2023/8/9 下午 03:41:24
Segment	1	Camera	1
Pattern	7879	Position[ x, y ]	469.1 [mm], 5926.3 [m], ( 214.4 [m] )
Type	点状疵点	Size	H:193.4 ,V:2.4 [mm]
Result	-	Area	364.3 [mm2]
Inspection level	5/5,5/5,5/5,5/5,5/5	Label	-
Light	6,6,3/6,6,3

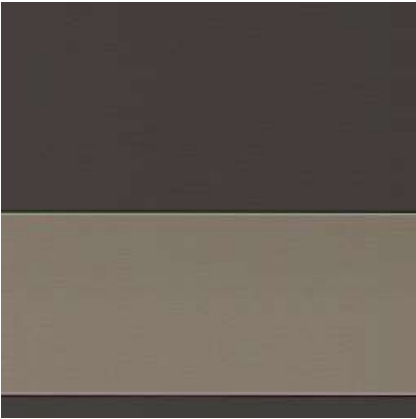
Defect image	Reference image	Shape image

No.	#65, \$60	Date	2023/8/9 下午 03:41:22
Segment	1	Camera	1
Pattern	7878	Position[ x, y ]	468.1 [mm], 5925.5 [m], ( 215.1 [m] )
Type	点状疵点	Size	H:193.4 ,V:2.0 [mm]
Result	-	Area	277.3 [mm2]
Inspection level	5/5,5/5,5/5,5/5,5/5	Label	-
Light	6,6,3/6,6,3

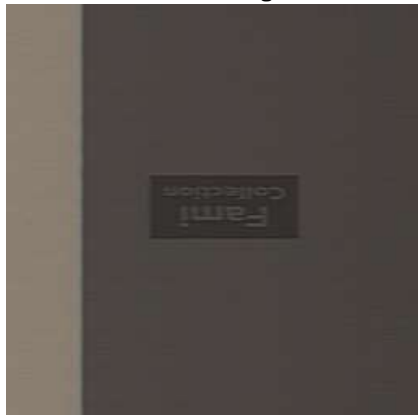
Defect image

No.	#64, \$59	Date	2023/8/9 下午 03:41:21
Segment	1	Camera	1
Pattern	7877	Position[ x, y ]	74.3 [mm], 5925.4 [m], ( 215.2 [m] )
Type	点状疵点	Size	H:10.5 ,V:1.2 [mm]
Result	-	Area	2.0 [mm2]
Inspection level	5/5,5/5,5/5,5/5,5/5	Label	-
Light	6,6,3/6,6,3

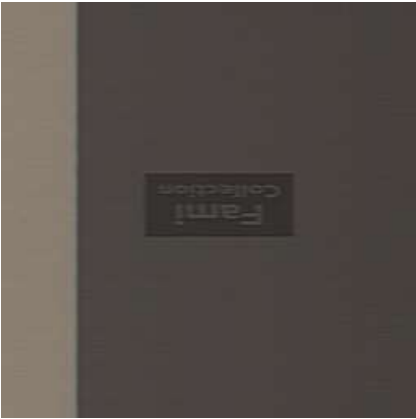
Defect image	Reference image	Shape image

No.	#61, \$58	Date	2023/8/9 下午 03:41:07
Segment	1	Camera	1
Pattern	7854	Position[ x, y ]	86.0 [mm], 5907.6 [m], ( 233.1 [m] )
Type	点状疵点	Size	H:19.0 ,V:13.2 [mm]
Result	-	Area	189.0 [mm2]
Inspection level	5/5,5/5,5/5,5/5,5/5	Label	-
Light	6,6,3/6,6,3

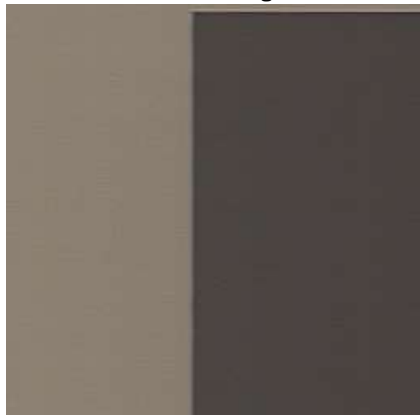
Defect image

No.	#61, \$58	Date	2023/8/9 下午 03:41:07
Segment	1	Camera	1
Pattern	7854	Position[ x, y ]	58.5 [mm], 5907.7 [m], ( 232.9 [m] )
Type	点状疵点縱向刀絲疵點	Size	H:15.6 ,V:538.4 [mm]
Result	-	Area	446.2 [mm2]
Inspection level	5/5,5/5,5/5,5/5,5/5	Label	-
Light	6,6,3/6,6,3

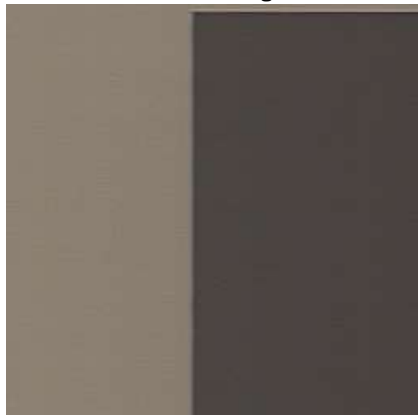
Defect image

No.	#60, \$57	Date	2023/8/9 下午 03:41:06
Segment	1	Camera	1
Pattern	7853	Position[ x, y ]	239.1 [mm], 5906.9 [m], ( 233.7 [m] )
Type	点状疵点縱向刀絲疵點	Size	H:16.4 ,V:607.2 [mm]
Result	-	Area	218.9 [mm2]
Inspection level	5/5,5/5,5/5,5/5,5/5	Label	-
Light	6,6,3/6,6,3

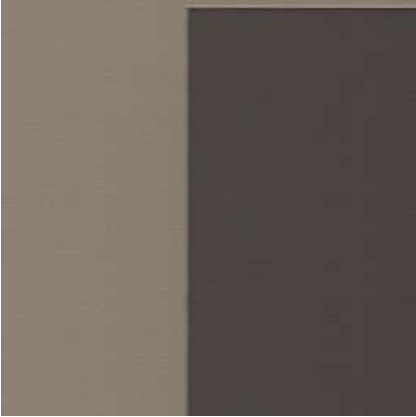
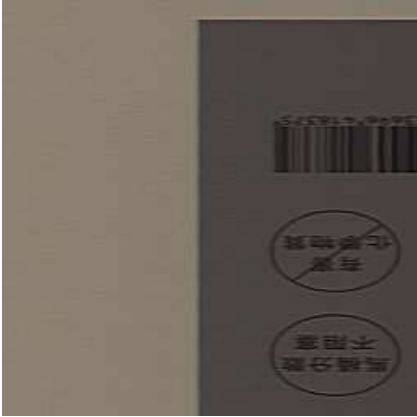
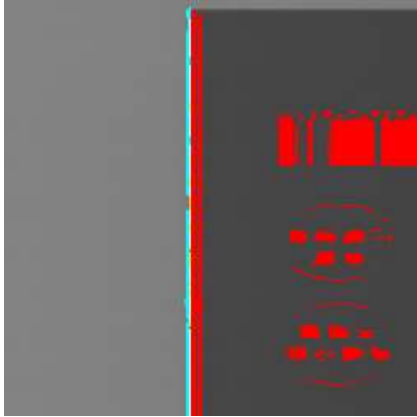
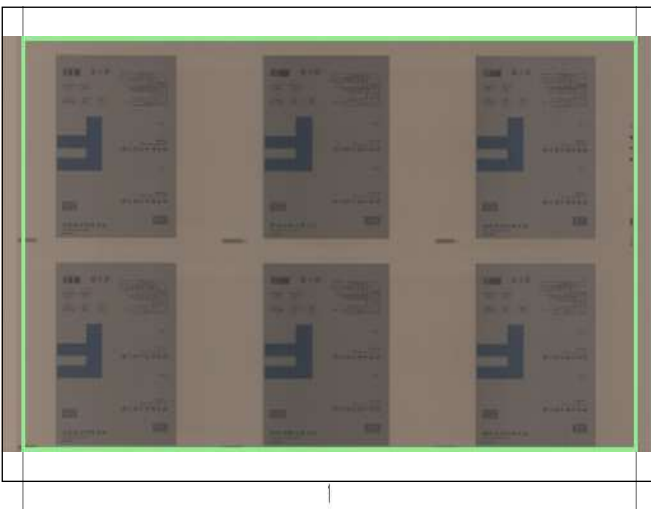
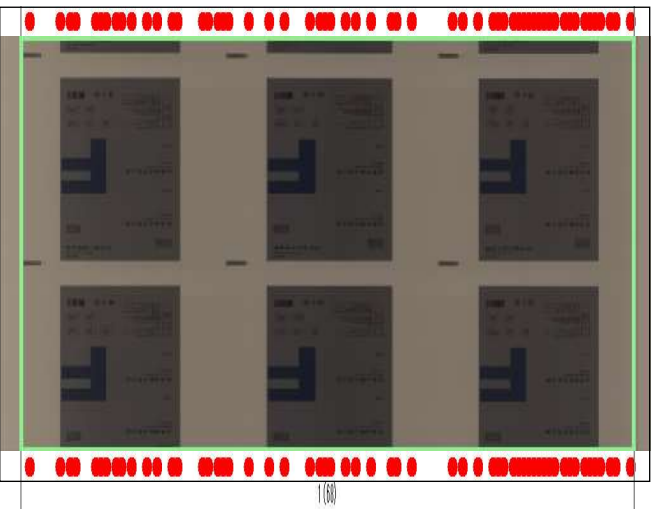
No.	#60, \$57	Date	2023/8/9 下午 03:41:06
Segment	1	Camera	1
Pattern	7853	Position[ x, y ]	56.7 [mm], 5906.9 [m], ( 233.7 [m] )
Type	点状疵点縱向刀絲疵點	Size	H:4.2 ,V:346.8 [mm]
Result	-	Area	281.0 [mm2]
Inspection level	5/5,5/5,5/5,5/5,5/5	Label	-
Light	6,6,3/6,6,3

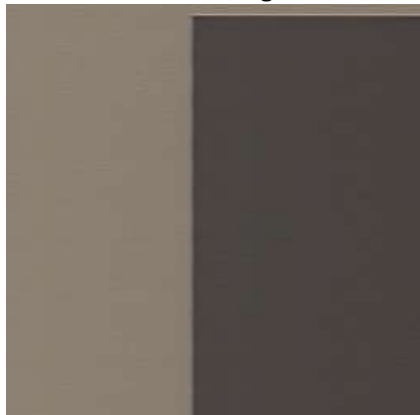
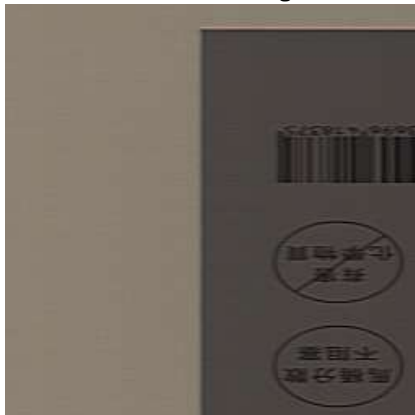
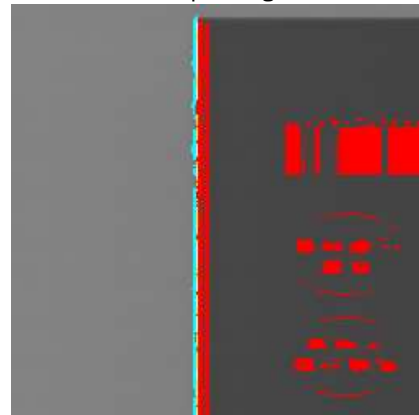
No.	#60, \$57	Date	2023/8/9 下午 03:41:06
Segment	1	Camera	1
Pattern	7853	Position[ x, y ]	58.7 [mm], 5907.2 [m], ( 233.4 [m] )
Type	点状疵点縱向刀絲疵點	Size	H:11.0 ,V:454.8 [mm]
Result	-	Area	433.8 [mm2]
Inspection level	5/5,5/5,5/5,5/5,5/5	Label	-
Light	6,6,3/6,6,3

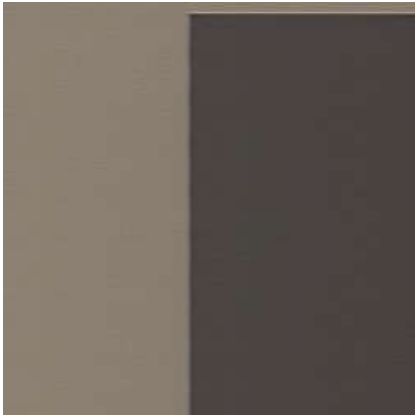
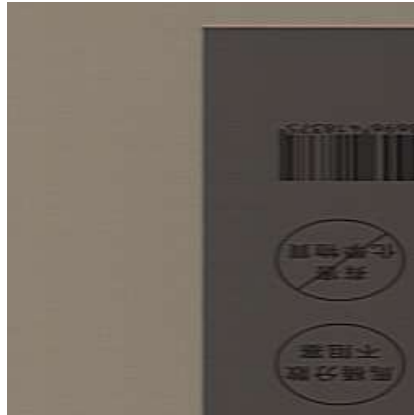
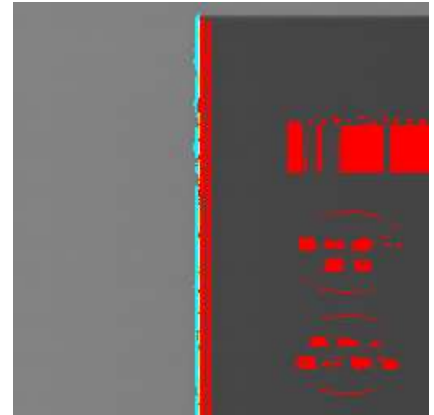
No.	#59, \$56	Date	2023/8/9 下午 03:41:06
Segment	1	Camera	1
Pattern	7852	Position[ x, y ]	58.0 [mm], 5906.4 [m], ( 234.3 [m] )
Type	点状疵点縱向刀絲疵點	Size	H:11.2 ,V:808.0 [mm]
Result	-	Area	294.1 [mm2]
Inspection level	5/5,5/5,5/5,5/5,5/5	Label	-
Light	6,6,3/6,6,3

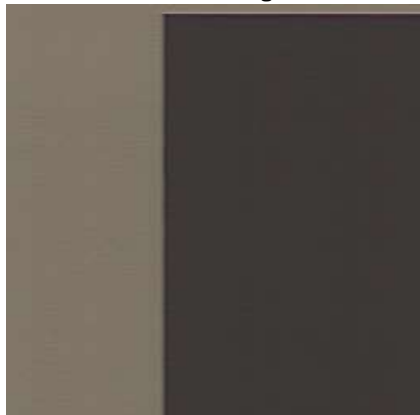
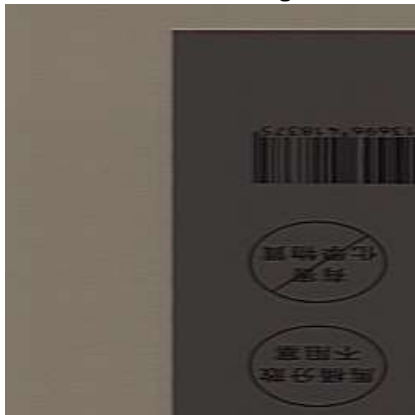
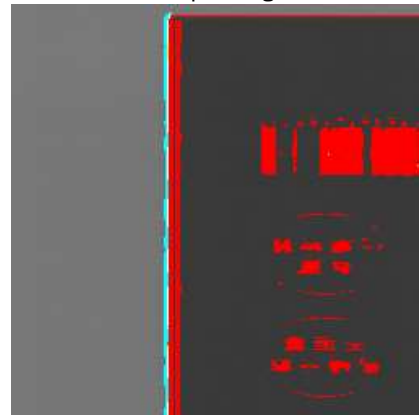
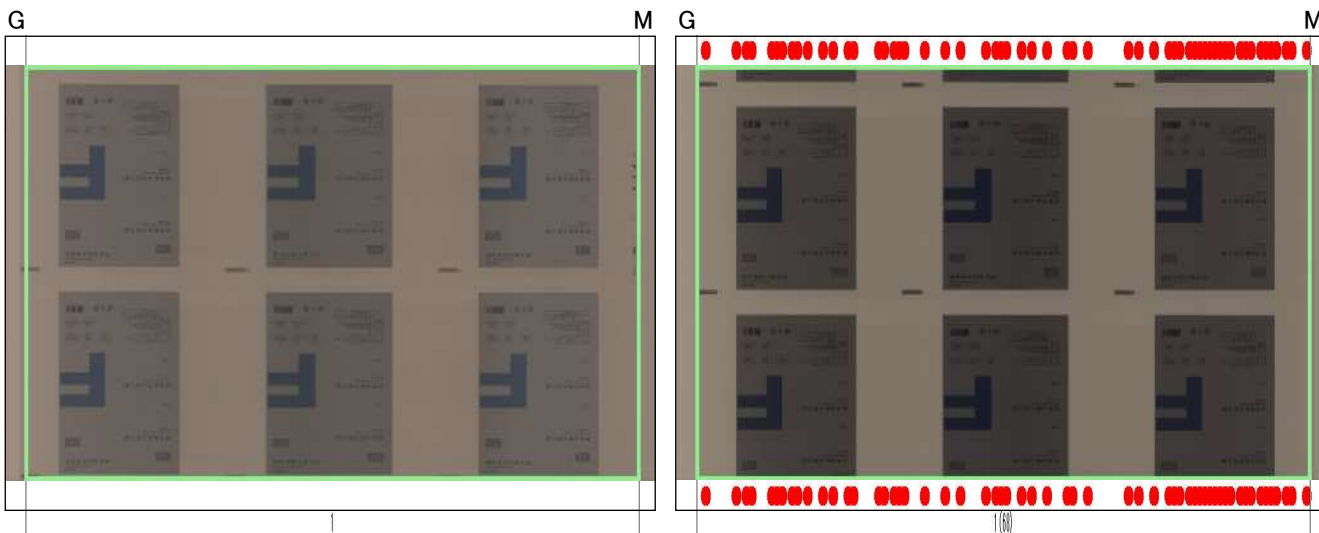
No.	#59, \$56	Date	2023/8/9 下午 03:41:06
Segment	1	Camera	1
Pattern	7852	Position[ x, y ]	374.4 [mm], 5906.3 [m], ( 234.4 [m] )
Type	点状疵点縱向刀絲疵點	Size	H:11.7 ,V:650.8 [mm]
Result	-	Area	401.7 [mm2]
Inspection level	5/5,5/5,5/5,5,5/5,5/5	Label	-
Light	6,6,3/6,6,3

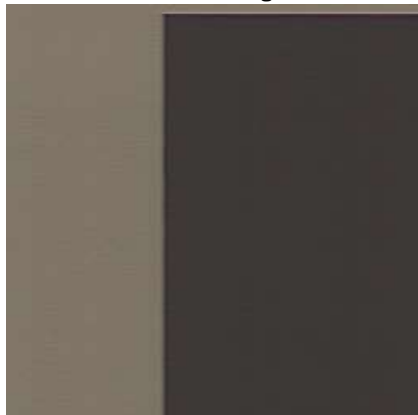
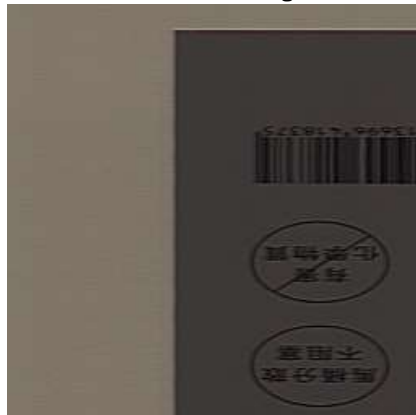
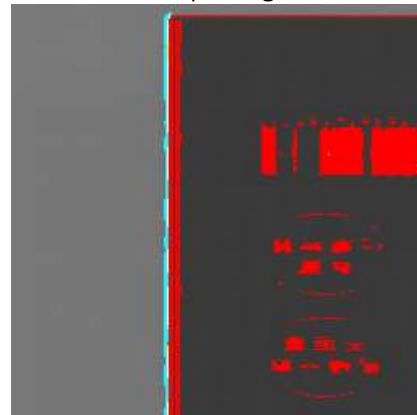
No.	#58, \$55	Date	2023/8/9 下午 03:41:05
Segment	1	Camera	1
Pattern	7851	Position[ x, y ]	421.7 [mm], 5905.3 [m], ( 235.4 [m] )
Type	点状疵点	Size	H:194.8 ,V:247.2 [mm]
Result	-	Area	641.4 [mm2]
Inspection level	5/5,5/5,5/5,5,5/5,5/5	Label	-
Light	6,6,3/6,6,3

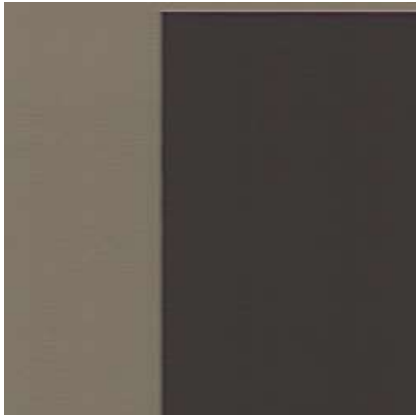
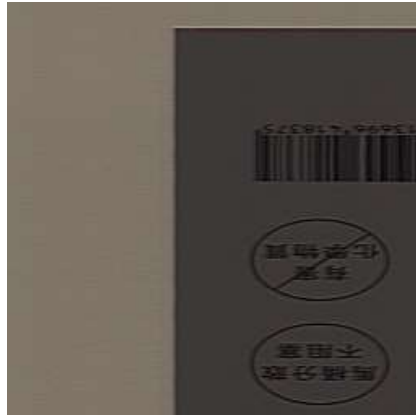
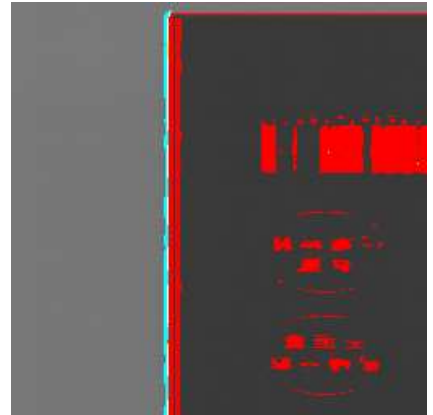
No.	#58, \$55	Date	2023/8/9 下午 03:41:05
Segment	1	Camera	1
Pattern	7851	Position[ x, y ]	462.5 [mm], 5905.5 [m], ( 235.1 [m] )
Type	点状疵点縱向刀絲疵點	Size	H:195.6 ,V:790.0 [mm]
Result	-	Area	1113.0 [mm2]
Inspection level	5/5,5/5,5/5,5,5/5,5/5	Label	-
Light	6,6,3/6,6,3

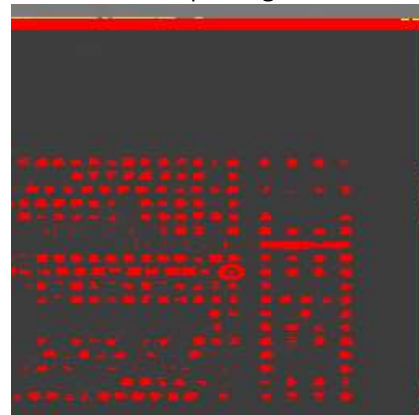
No.	#57, \$54	Date	2023/8/9 下午 03:41:04
Segment	1	Camera	1
Pattern	7850	Position[ x, y ]	121.2 [mm], 5904.8 [m], ( 235.9 [m] )
Type	点状疵点縱向刀絲疵點	Size	H:187.3 ,V:805.6 [mm]
Result	-	Area	2145.5 [mm2]
Inspection level	5/5,5/5,5/5,5/5,5/5	Label	-
Light	6,6,3/6,6,3

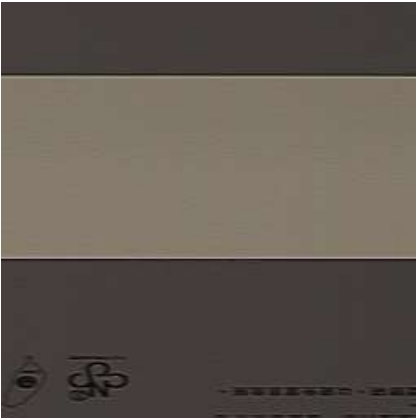
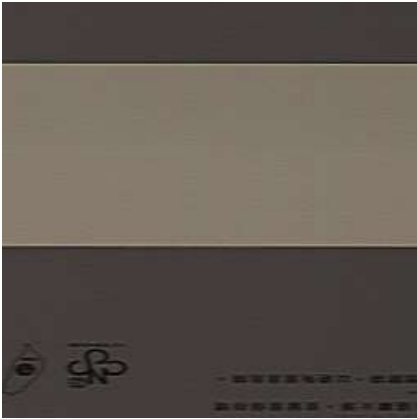
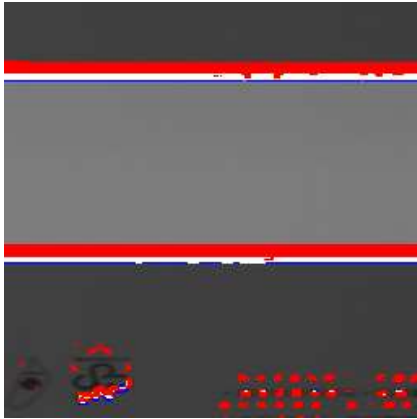
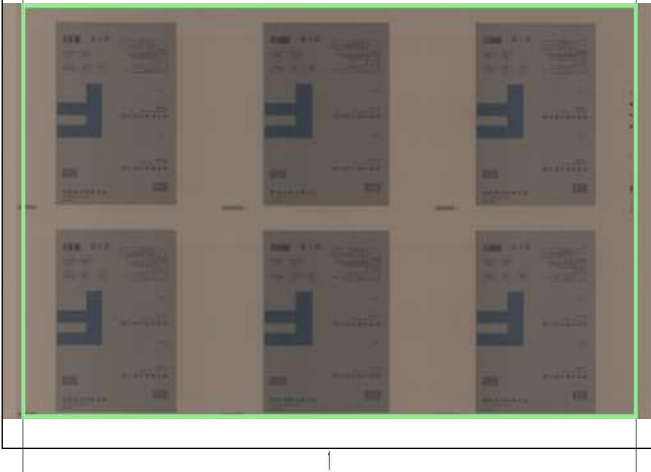
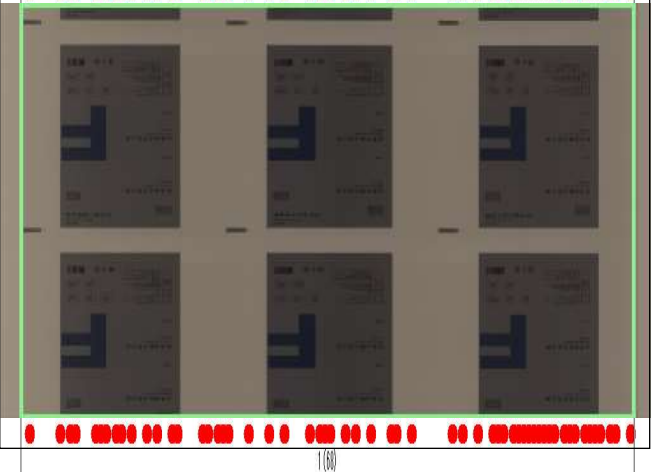
No.	#52, \$51	Date	2023/8/9 下午 03:36:31
Segment	1	Camera	1
Pattern	7780	Position[ x, y ]	740.8 [mm], 5851.1 [m], ( 289.6 [m] )
Type	点状疵点横向刀絲	Size	H:183.8 ,V:85.6 [mm]
Result	-	Area	333.3 [mm2]
Inspection level	5/5,5/5,5/5,5/5,5/5	Label	-
Light	6,6,3/6,6,3

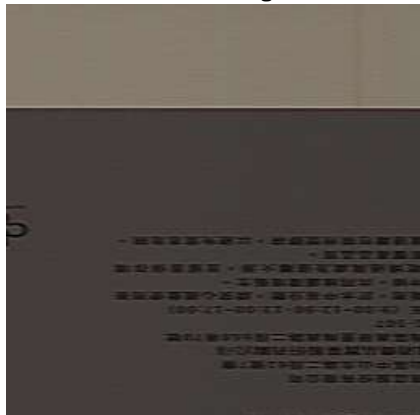
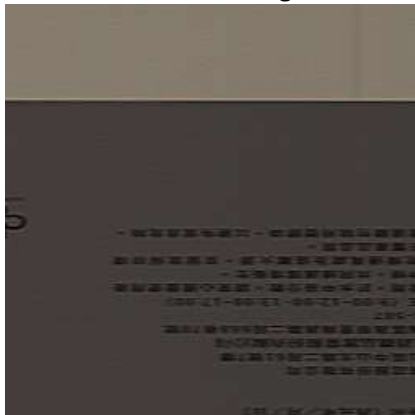
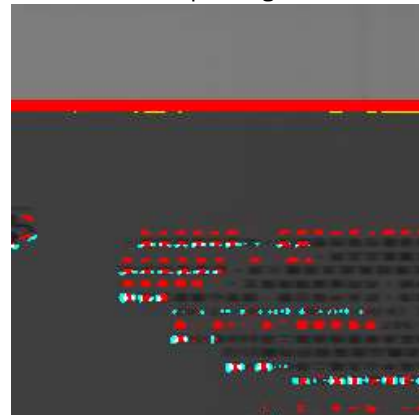
Defect image

No.	#52, \$51	Date	2023/8/9 下午 03:36:31
Segment	1	Camera	1
Pattern	7780	Position[ x, y ]	172.2 [mm], 5850.7 [m], ( 289.9 [m] )
Type	点状疵点縱向刀絲疵點	Size	H:184.3 ,V:59.2 [mm]
Result	-	Area	341.9 [mm2]
Inspection level	5/5,5/5,5/5,5/5,5/5	Label	-
Light	6,6,3/6,6,3

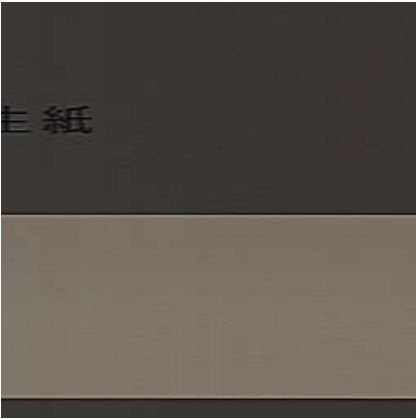
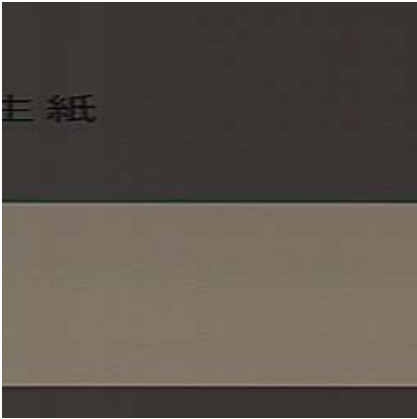
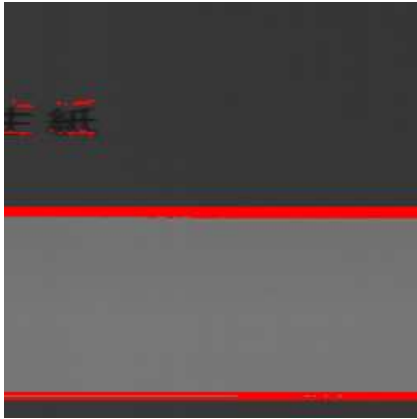
Defect image	Reference image	Shape image

No.	#51, \$50	Date	2023/8/9 下午 03:36:29
Segment	1	Camera	1
Pattern	7779	Position[ x, y ]	473.0 [mm], 5849.9 [m], ( 290.7 [m] )
Type	点状疵点	Size	H:192.9 ,V:2.0 [mm]
Result	-	Area	333.0 [mm2]
Inspection level	5/5,5/5,5/5,5/5,5/5	Label	-
Light	6,6,3/6,6,3

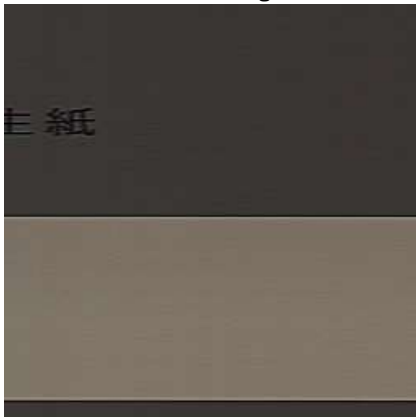
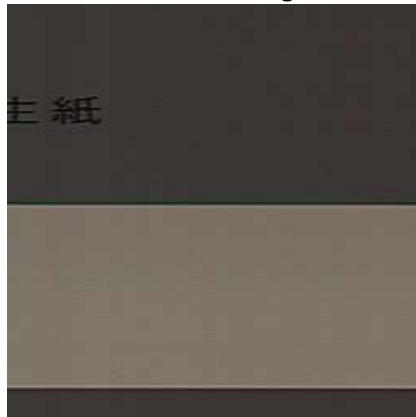
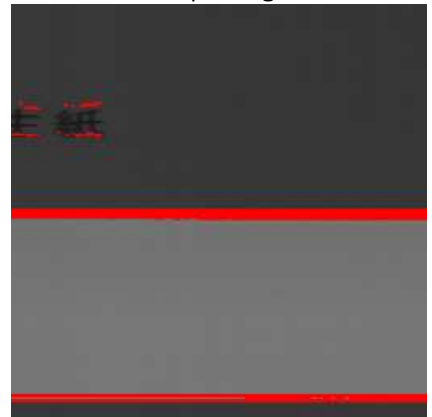
Defect image

No.	#50, \$49	Date	2023/8/9 下午 03:36:28
Segment	1	Camera	1
Pattern	7778	Position[ x, y ]	760.4 [mm], 5849.3 [m], ( 291.3 [m] )
Type	点状疵点	Size	H:24.4 ,V:1.2 [mm]
Result	-	Area	27.7 [mm2]
Inspection level	5/5,5/5,5/5,5/5,5/5	Label	-
Light	6,6,3/6,6,3

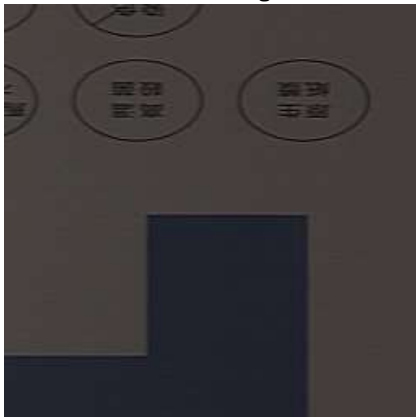
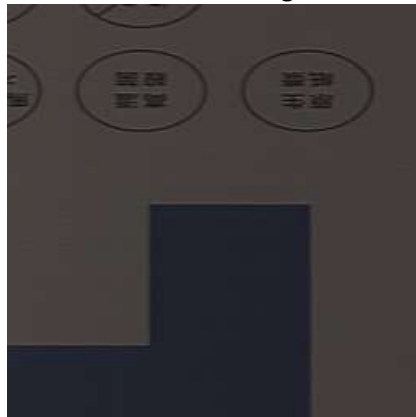
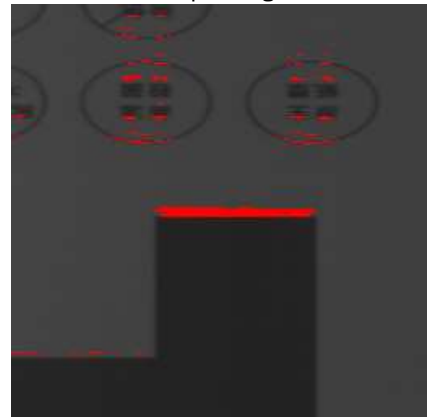
Defect image

No.	#50, \$49	Date	2023/8/9 下午 03:36:28
Segment	1	Camera	1
Pattern	7778	Position[ x, y ]	116.3 [mm], 5849.3 [m], ( 291.3 [m] )
Type	点状疵点	Size	H:23.7 ,V:1.6 [mm]
Result	-	Area	28.8 [mm2]
Inspection level	5/5,5/5,5/5,5/5,5/5	Label	-
Light	6,6,3/6,6,3

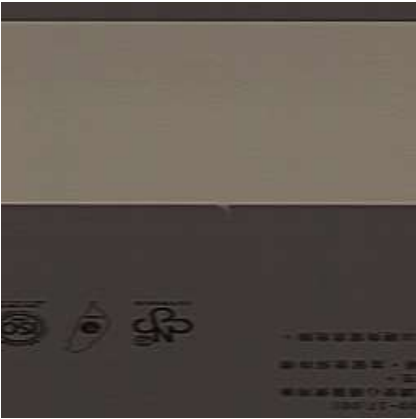
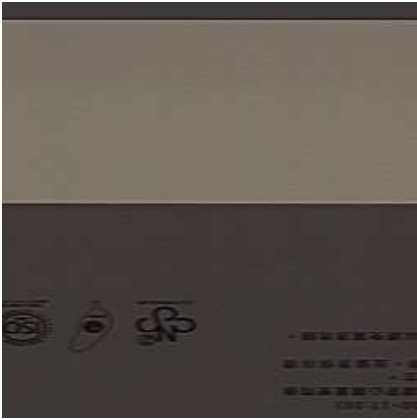
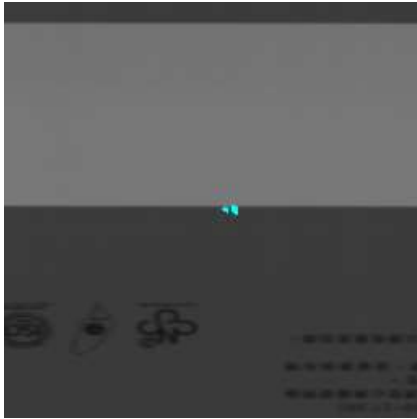
Defect image	Reference image	Shape image

No.	#49, \$48	Date	2023/8/9 下午 03:35:21
Segment	1	Camera	1
Pattern	7665	Position[ x, y ]	789.9 [mm], 5764.7 [m], ( 376.0 [m] )
Type	縱向刀絲疵點	Size	H:2.4 ,V:1.6 [mm]
Result	-	Area	2.1 [mm2]
Inspection level	5/5,5/5,5/5,5/5,5/5	Label	-
Light	6,6,3/6,6,3

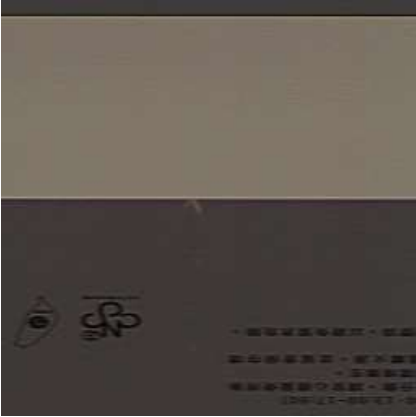
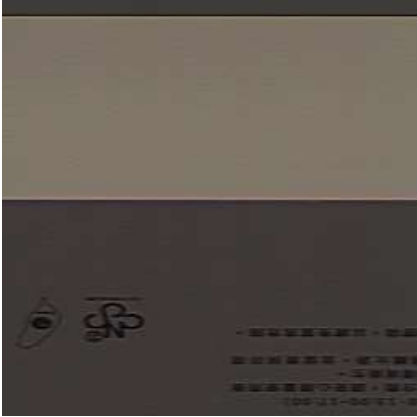
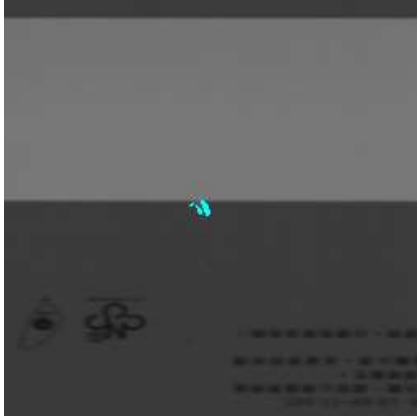
Defect image	Reference image	Shape image

No.	#48, \$47	Date	2023/8/9 下午 03:35:20
Segment	1	Camera	1
Pattern	7663	Position[ x, y ]	793.6 [mm], 5763.2 [m], ( 377.5 [m] )
Type	縱向刀絲疵點	Size	H:2.2 ,V:3.2 [mm]
Result	-	Area	3.8 [mm2]
Inspection level	5/5,5/5,5/5,5/5,5/5	Label	-
Light	6,6,3/6,6,3

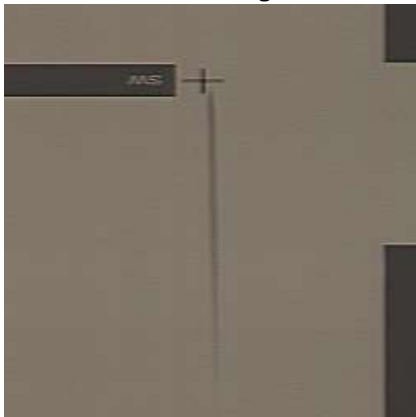
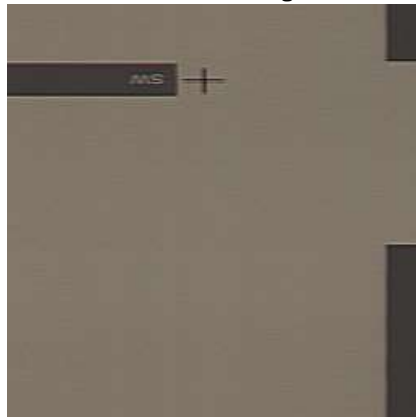
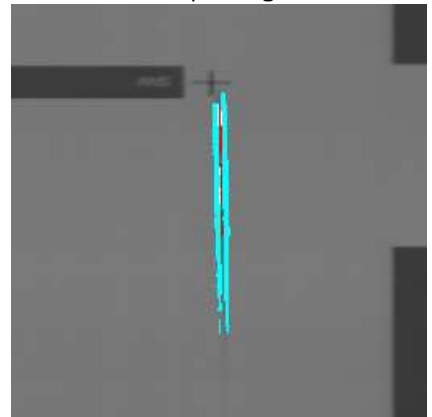
Defect image

No.	#47, \$46	Date	2023/8/9 下午 03:31:46
Segment	1	Camera	1
Pattern	7299	Position[ x, y ]	349.7 [mm], 5489.7 [m], ( 650.9 [m] )
Type	点状疵点縱向刀絲疵點	Size	H:2.7 ,V:58.8 [mm]
Result	-	Area	87.9 [mm2]
Inspection level	5/5,5/5,5/5,5/5,5/5	Label	-
Light	6,6,3/6,6,3

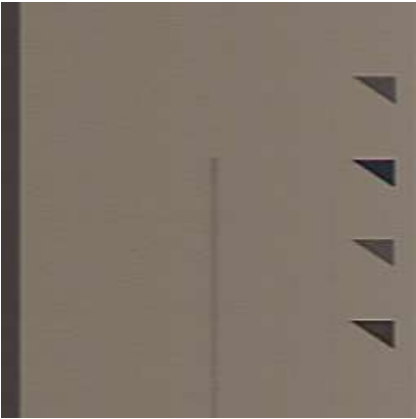
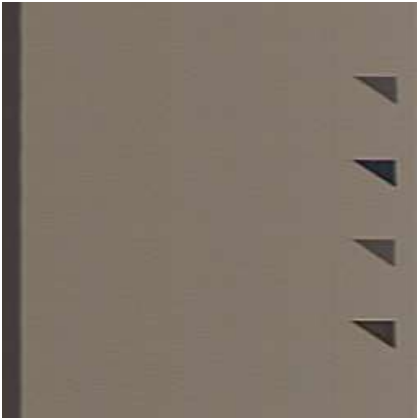
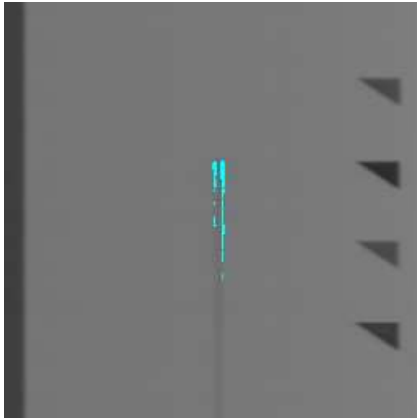
Defect image	Reference image	Shape image

No.	#44, \$43	Date	2023/8/9 下午 03:16:36
Segment	1	Camera	1
Pattern	5750	Position[ x, y ]	913.2 [mm], 4326.3 [m], ( 1814.4 [m] )
Type	縱向刀絲疵點	Size	H:2.0 ,V:24.4 [mm]
Result	-	Area	11.7 [mm2]
Inspection level	5/5,5/5,5/5,5/5,5/5	Label	-
Light	6,6,3/6,6,3

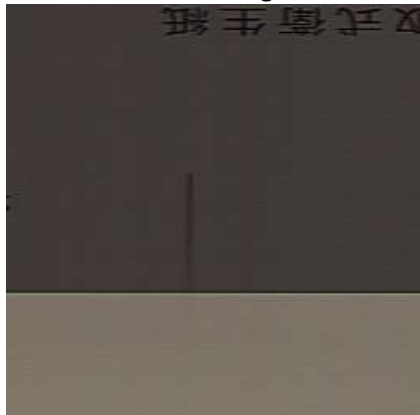
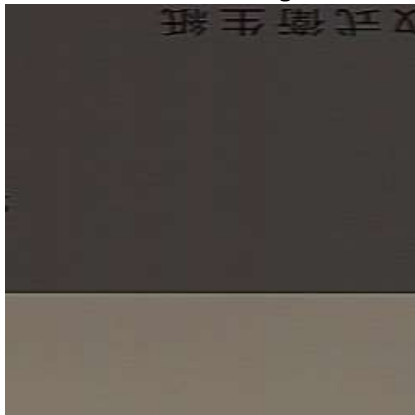
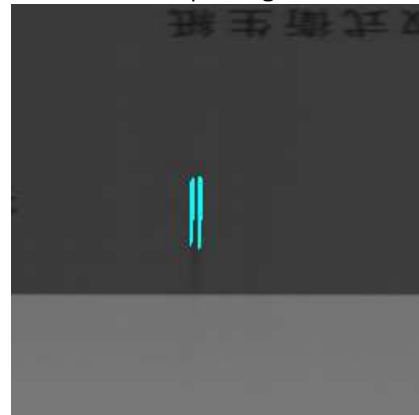
Defect image

No.	#42, \$41	Date	2023/8/9 下午 03:08:03
Segment	1	Camera	1
Pattern	4876	Position[ x, y ]	807.0 [mm], 3669.1 [m], ( 2471.5 [m] )
Type	縱向刀絲疵點	Size	H:2.0 ,V:17.2 [mm]
Result	-	Area	20.8 [mm2]
Inspection level	5/5,5/5,5/5,5/5,5/5	Label	-
Light	6,6,3/6,6,3

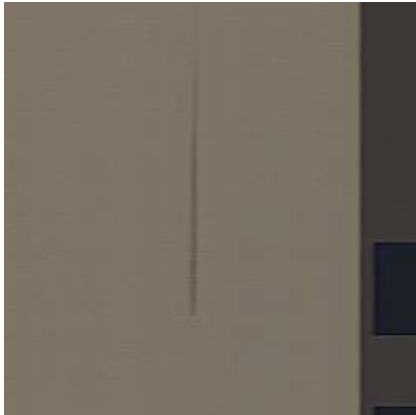
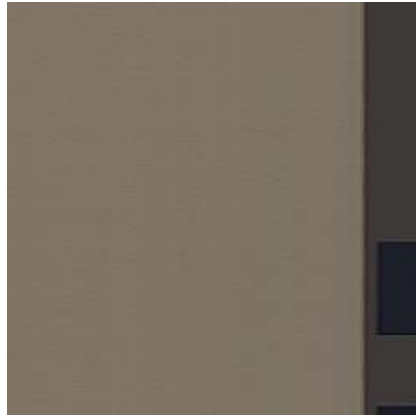
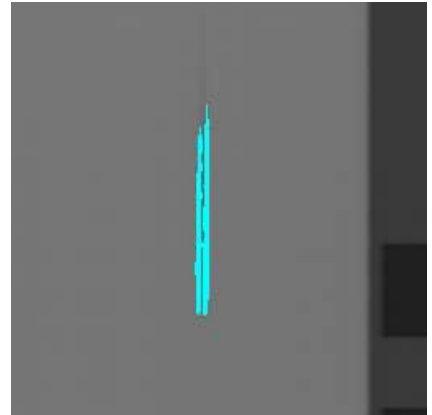
Defect image

No.	#40, \$39	Date	2023/8/9 下午 03:03:49
Segment	1	Camera	1
Pattern	4444	Position[ x, y ]	675.2 [mm], 3344.8 [m], ( 2795.9 [m] )
Type	縱向刀絲疵點	Size	H:2.2 ,V:51.2 [mm]
Result	-	Area	73.6 [mm2]
Inspection level	5/5,5/5,5/5,5/5,5/5	Label	-
Light	6,6,3/6,6,3

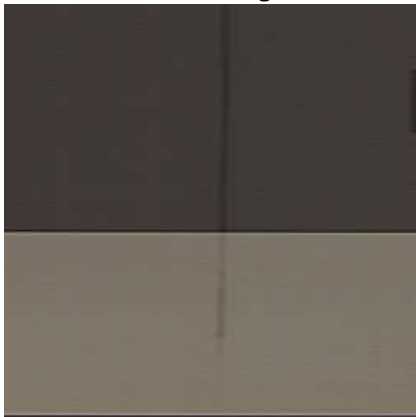
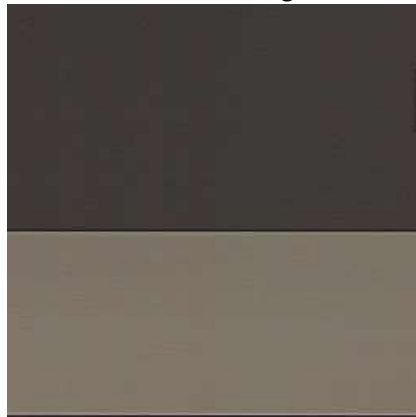
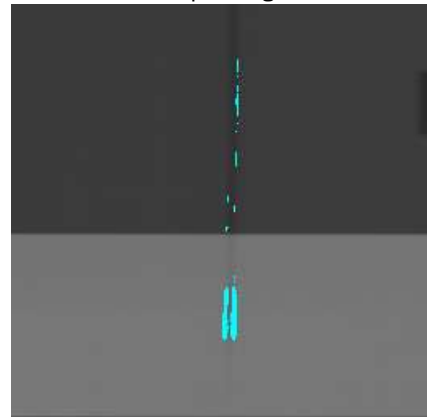
Defect image

No.	#38, \$37	Date	2023/8/9 下午 02:55:57
Segment	1	Camera	1
Pattern	3641	Position[ x, y ]	819.9 [mm], 2741.3 [m], ( 3399.3 [m] )
Type	縱向刀絲疵點	Size	H:2.4 ,V:62.0 [mm]
Result	-	Area	20.8 [mm2]
Inspection level	5/5,5/5,5/5,5/5,5/5	Label	-
Light	6,6,3/6,6,3

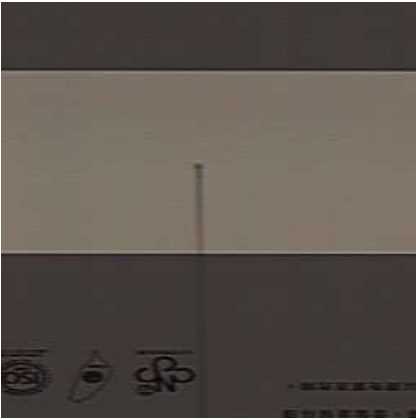
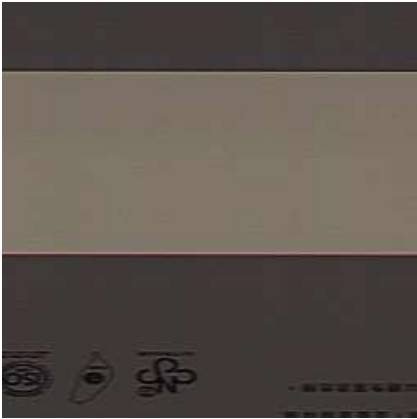
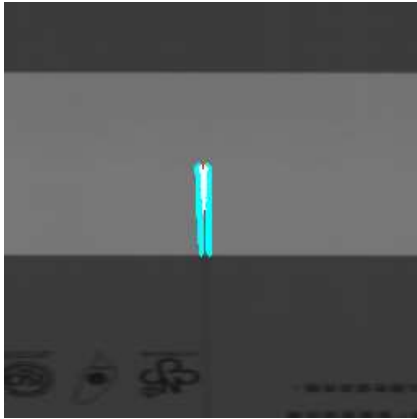
Defect image	Reference image	Shape image

No.	#36, \$35	Date	2023/8/9 下午 02:54:57
Segment	1	Camera	1
Pattern	3539	Position[ x, y ]	785.8 [mm], 2664.7 [m], ( 3476.0 [m] )
Type	点状疵点縱向刀絲疵點	Size	H:2.7 ,V:22.4 [mm]
Result	-	Area	48.6 [mm2]
Inspection level	5/5,5/5,5/5,5/5,5/5	Label	-
Light	6,6,3/6,6,3

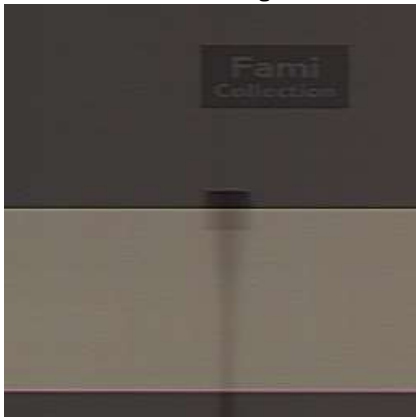
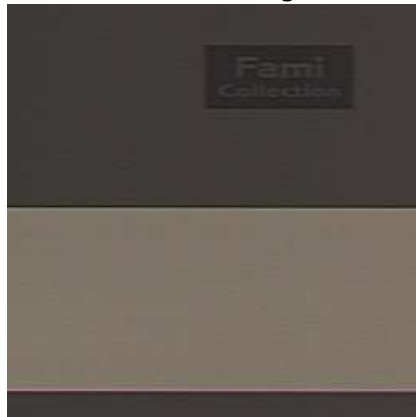
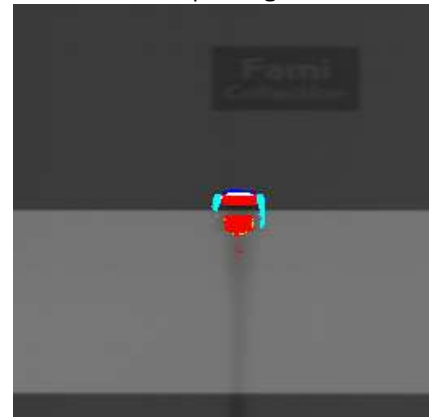
Defect image

No.	#34, \$33	Date	2023/8/9 下午 02:51:30
Segment	1	Camera	1
Pattern	3188	Position[ x, y ]	852.4 [mm], 2401.3 [m], ( 3739.3 [m] )
Type	点状疵点縱向刀絲疵點橫向刀絲	Size	H:8.1 ,V:10.8 [mm]
Result	-	Area	27.3 [mm2]
Inspection level	5/5,5/5,5/5,5/5,5/5	Label	-
Light	6,6,3/6,6,3
