# Inspection Result (Individual Data)

Lot number : 6

Inspected date : 2023/8/9 下午 02:20:08 ~ 2023/8/9 下午 03:44:45

商品名	標準透明6-6-3	周長	
顧客名		Ex1	
CODE番号		Ex2	
基材		Ex3

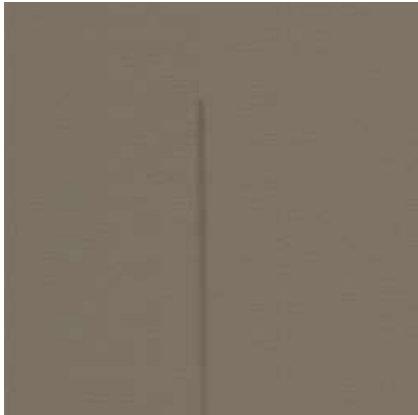
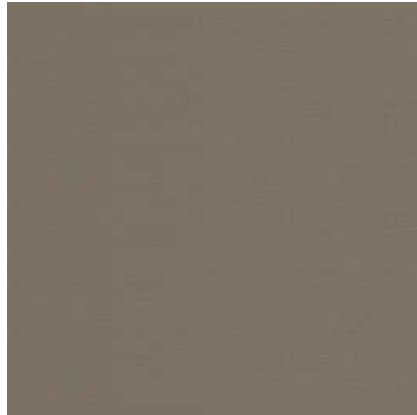
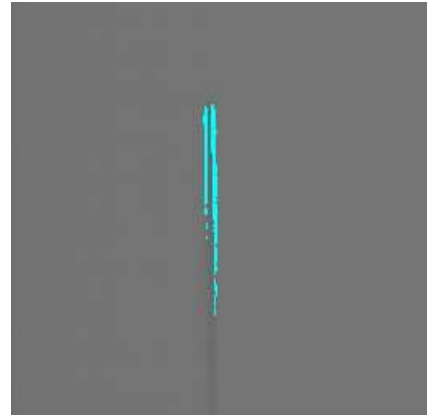
Defect image

No.	#30, \$29	Date	2023/8/9 下午 02:46:23
Segment	1	Camera	1
Pattern	2666	Position[ x, y ]	598.5 [mm], 2008.9 [m], ( 4131.7 [m] )
Type	縱向刀絲疵點	Size	H:2.2 ,V:51.2 [mm]
Result	-	Area	39.9 [mm2]
Inspection level	5/5,5/5,5/5,5/5,5/5	Label	-
Light	6,6,3/6,6,3

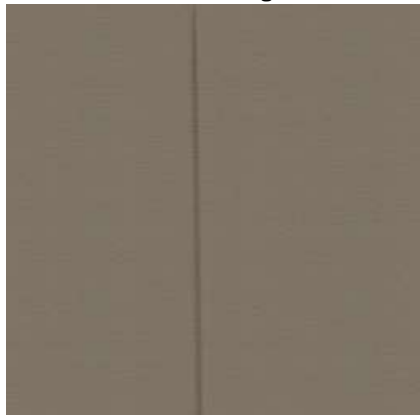
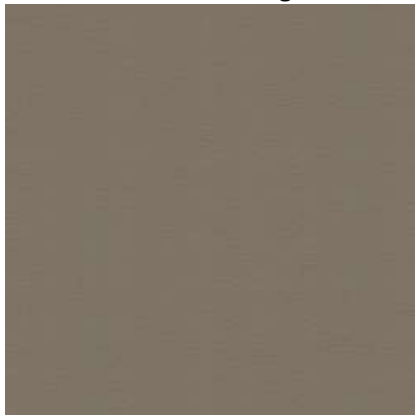
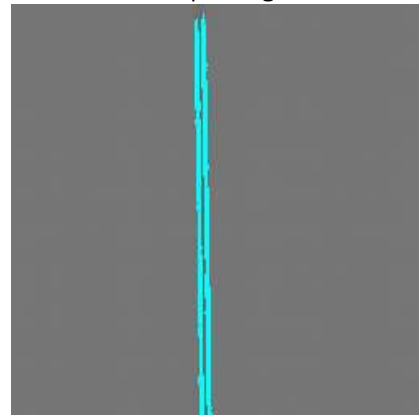
Defect image

No.	#28, \$27	Date	2023/8/9 下午 02:45:04
Segment	1	Camera	1
Pattern	2533	Position[ x, y ]	284.8 [mm], 1909.1 [m], ( 4231.6 [m] )
Type	縱向刀絲疵點	Size	H:2.9 ,V:203.6 [mm]
Result	-	Area	251.4 [mm2]
Inspection level	5/5,5/5,5/5,5/5,5/5	Label	-
Light	6,6,3/6,6,3

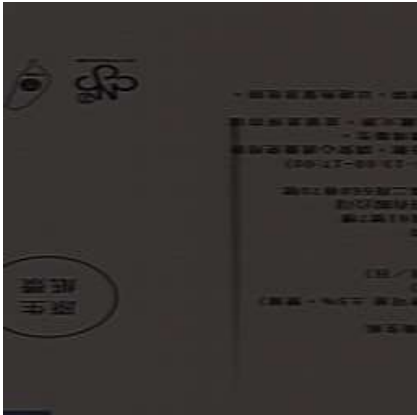
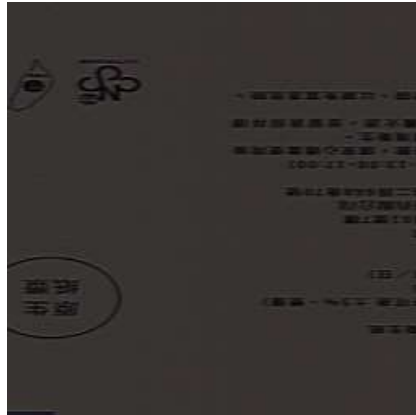
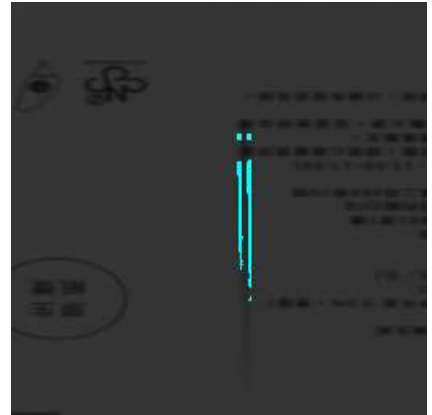
Defect image

No.	#27, \$26	Date	2023/8/9 下午 02:42:41
Segment	1	Camera	1
Pattern	2290	Position[ x, y ]	478.4 [mm], 1726.5 [m], ( 4414.2 [m] )
Type	縱向刀絲疵點	Size	H:2.2 ,V:37.2 [mm]
Result	-	Area	30.5 [mm2]
Inspection level	5/5,5/5,5/5,5/5,5/5	Label	-
Light	6,6,3/6,6,3

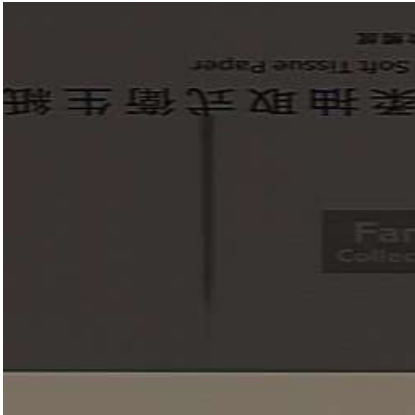
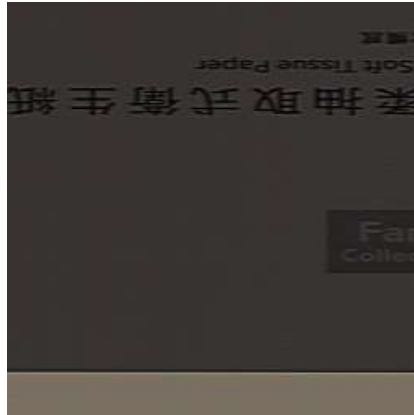
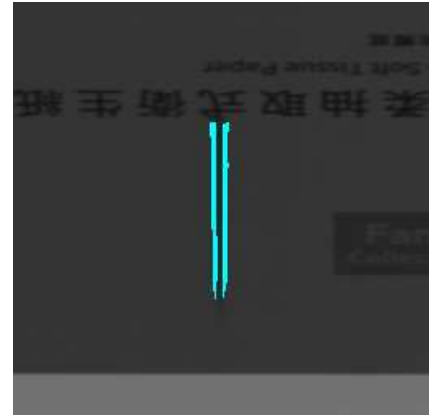
Defect image

No.	#25, \$24	Date	2023/8/9 下午 02:40:41
Segment	1	Camera	1
Pattern	2086	Position[ x, y ]	513.3 [mm], 1573.4 [m], ( 4567.2 [m] )
Type	縱向刀絲疵點	Size	H:2.9 ,V:42.8 [mm]
Result	-	Area	60.9 [mm2]
Inspection level	5/5,5/5,5/5,5/5,5/5	Label	-
Light	6,6,3/6,6,3

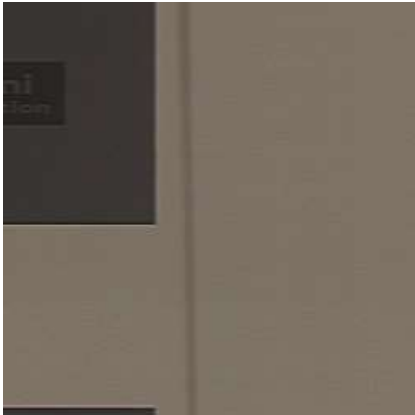
Defect image

No.	#24, \$23	Date	2023/8/9 下午 02:40:13
Segment	1	Camera	1
Pattern	2039	Position[ x, y ]	573.3 [mm], 1537.8 [m], ( 4602.8 [m] )
Type	縱向刀絲疵點	Size	H:4.6 ,V:215.6 [mm]
Result	-	Area	230.5 [mm2]
Inspection level	5/5,5/5,5/5,5/5,5/5	Label	-
Light	6,6,3/6,6,3

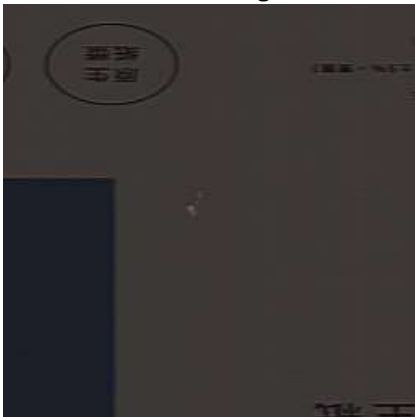
Defect image

No.	#17, \$16	Date	2023/8/9 下午 02:31:41
Segment	1	Camera	1
Pattern	1169	Position[ x, y ]	784.3 [mm], 884.7 [m], ( 5255.9 [m] )
Type	点状疵点縱向刀絲疵點	Size	H:2.2 ,V:2.4 [mm]
Result	-	Area	4.2 [mm2]
Inspection level	5/5,5/5,5/5,5/5,5/5	Label	-
Light	6,6,3/6,6,3

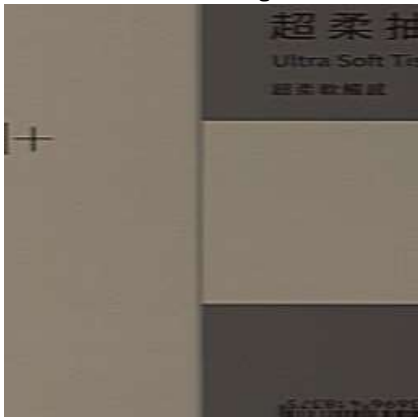
Defect image

No.	#16, \$15	Date	2023/8/9 下午 02:31:07
Segment	1	Camera	1
Pattern	1111	Position[ x, y ]	58.7 [mm], 841.0 [m], ( 5299.6 [m] )
Type	点状疵点縱向刀絲疵點	Size	H:2.7 ,V:42.0 [mm]
Result	-	Area	89.9 [mm2]
Inspection level	5/5,5/5,5/5,5/5,5/5	Label	-
Light	6,6,3/6,6,3

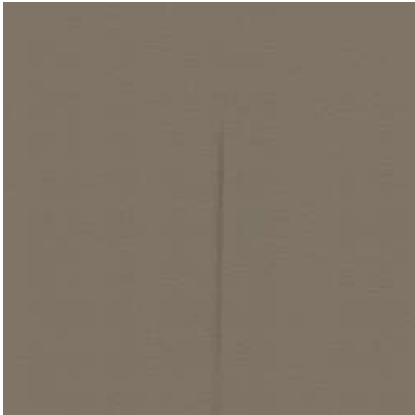
Defect image

No.	#15, \$14	Date	2023/8/9 下午 02:29:51
Segment	1	Camera	1
Pattern	982	Position[ x, y ]	304.8 [mm], 744.0 [m], ( 5396.7 [m] )
Type	縱向刀絲疵點	Size	H:0.7 ,V:29.2 [mm]
Result	-	Area	6.3 [mm2]
Inspection level	5/5,5/5,5/5,5/5,5/5	Label	-
Light	6,6,3/6,6,3

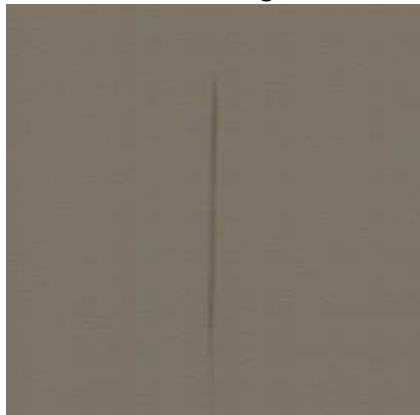
Defect image

No.	#14, \$13	Date	2023/8/9 下午 02:29:30
Segment	1	Camera	1
Pattern	946	Position[ x, y ]	279.2 [mm], 717.4 [m], ( 5423.2 [m] )
Type	縱向刀絲疵點	Size	H:2.4 ,V:61.6 [mm]
Result	-	Area	77.7 [mm2]
Inspection level	5/5,5/5,5/5,5/5,5/5	Label	-
Light	6,6,3/6,6,3

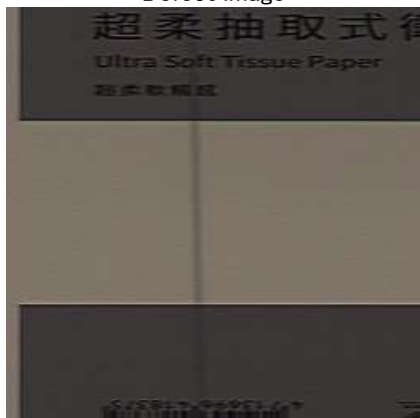
Defect image

No.	#13, \$12	Date	2023/8/9 下午 02:29:27
Segment	1	Camera	1
Pattern	941	Position[ x, y ]	401.7 [mm], 713.4 [m], ( 5427.3 [m] )
Type	縱向刀絲疵點	Size	H:2.9 ,V:44.8 [mm]
Result	-	Area	81.1 [mm2]
Inspection level	5/5,5/5,5/5,5/5,5/5	Label	-
Light	6,6,3/6,6,3

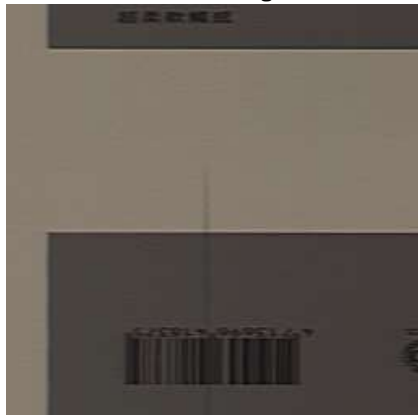
Defect image

No.	#12, \$11	Date	2023/8/9 下午 02:28:15
Segment	1	Camera	1
Pattern	820	Position[ x, y ]	83.1 [mm], 622.2 [m], ( 5518.5 [m] )
Type	縱向刀絲疵點	Size	H:1.7 ,V:10.4 [mm]
Result	-	Area	7.7 [mm2]
Inspection level	5/5,5/5,5/5,5/5,5/5	Label	-
Light	6,6,3/6,6,3

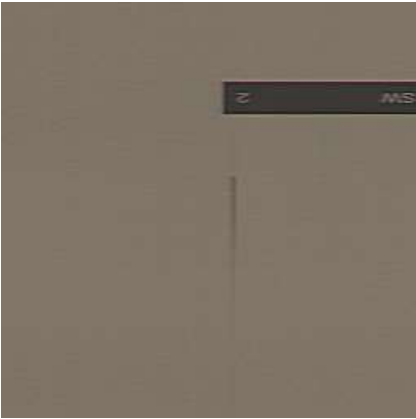
Defect image	Reference image	Shape image

No.	#11, \$10	Date	2023/8/9 下午 02:27:11
Segment	1	Camera	1
Pattern	711	Position[ x, y ]	314.3 [mm], 540.3 [m], ( 5600.4 [m] )
Type	縱向刀絲疵點	Size	H:2.2 ,V:15.2 [mm]
Result	-	Area	19.3 [mm2]
Inspection level	5/5,5/5,5/5,5/5,5/5	Label	-
Light	6,6,3/6,6,3

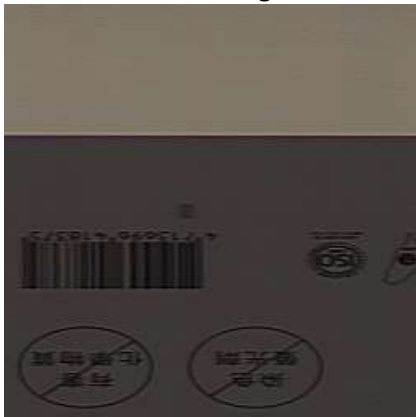
Defect image

No.	#10, \$9	Date	2023/8/9 下午 02:26:39
Segment	1	Camera	1
Pattern	656	Position[ x, y ]	736.4 [mm], 499.4 [m], ( 5641.3 [m] )
Type	縱向刀絲疵點	Size	H:3.2 ,V:2.0 [mm]
Result	-	Area	3.0 [mm2]
Inspection level	5/5,5/5,5/5,5/5,5/5	Label	-
Light	6,6,3/6,6,3

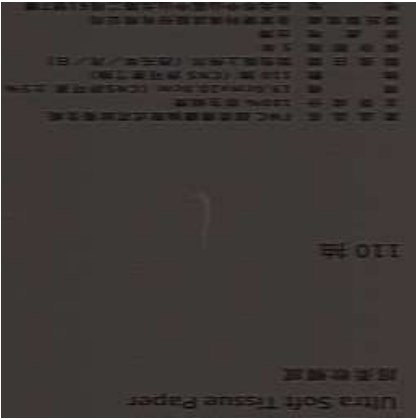
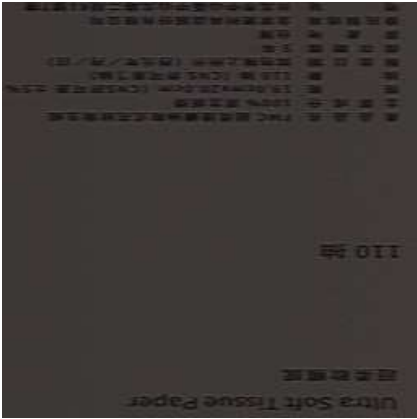
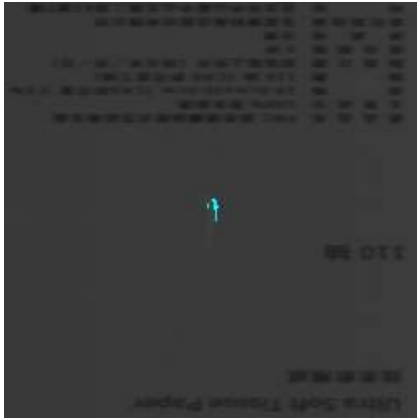
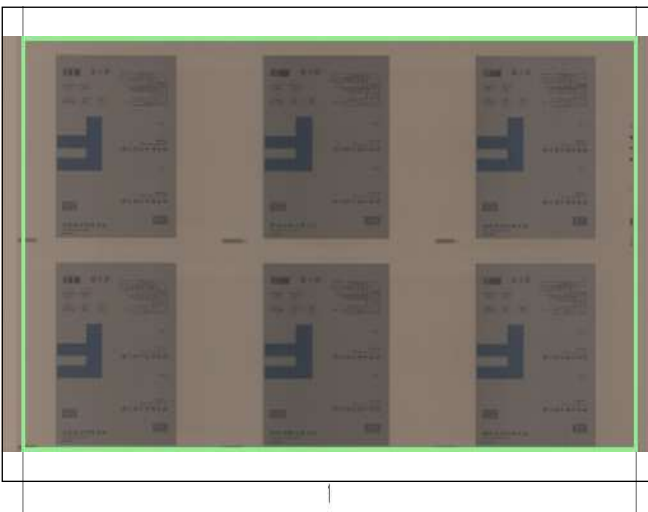
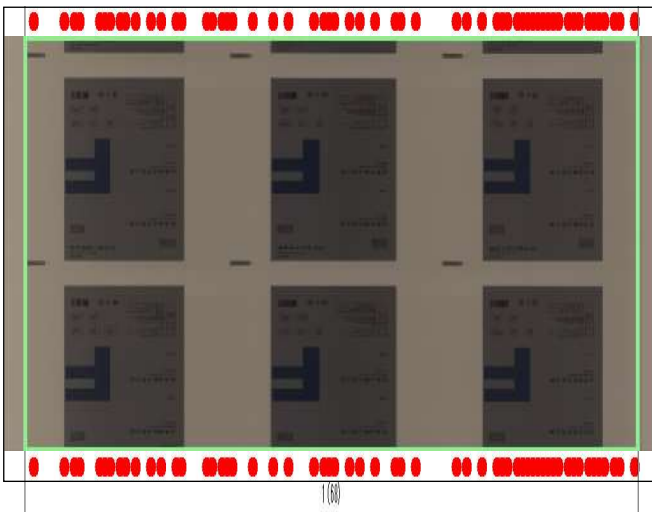
No.	#9, \$8	Date	2023/8/9 下午 02:26:36
Segment	1	Camera	1
Pattern	652	Position[ x, y ]	842.1 [mm], 496.5 [m], ( 5644.2 [m] )
Type	縱向刀絲疵點	Size	H:1.7 ,V:4.8 [mm]
Result	-	Area	2.1 [mm2]
Inspection level	5/5,5/5,5/5,5/5,5/5	Label	-
Light	6,6,3/6,6,3

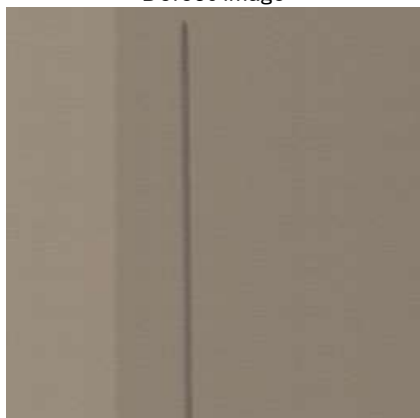
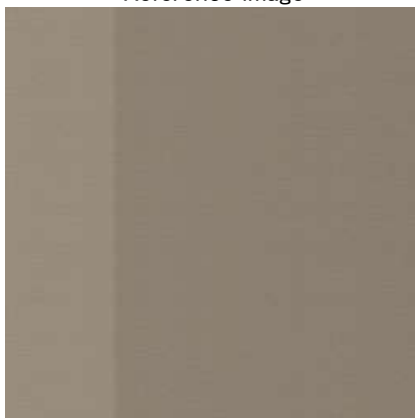
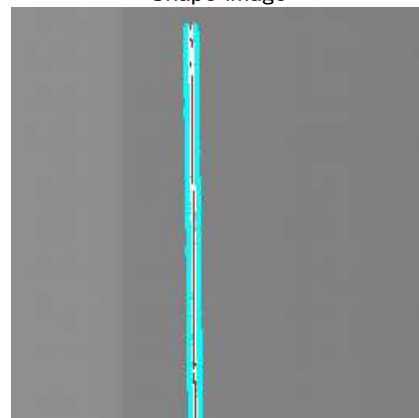
No.	#8, \$7	Date	2023/8/9 下午 02:24:36
Segment	1	Camera	1
Pattern	450	Position[ x, y ]	9.6 [mm], 344.5 [m], ( 5796.2 [m] )
Type	点状疵点縱向刀絲疵點	Size	H:3.2 ,V:169.6 [mm]
Result	-	Area	339.4 [mm2]
Inspection level	5/5,5/5,5/5,5/5,5/5	Label	-
Light	6,6,3/6,6,3

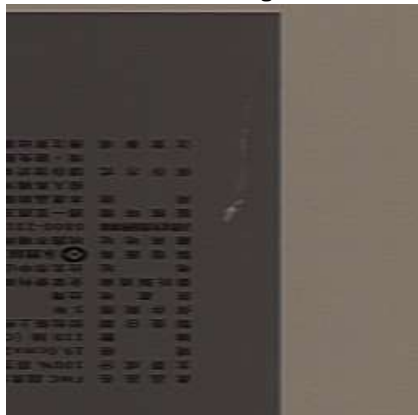
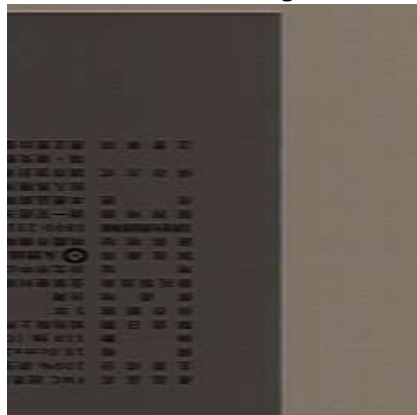
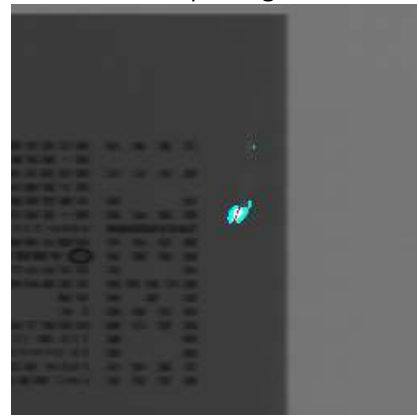
No.	#7, \$6	Date	2023/8/9 下午 02:23:16
Segment	1	Camera	1
Pattern	317	Position[ x, y ]	875.6 [mm], 244.9 [m], ( 5895.8 [m] )
Type	点状疵点縱向刀絲疵點	Size	H:3.7 ,V:4.8 [mm]
Result	-	Area	8.8 [mm2]
Inspection level	5/5,5/5,5/5,5/5,5/5	Label	-
Light	6,6,3/6,6,3

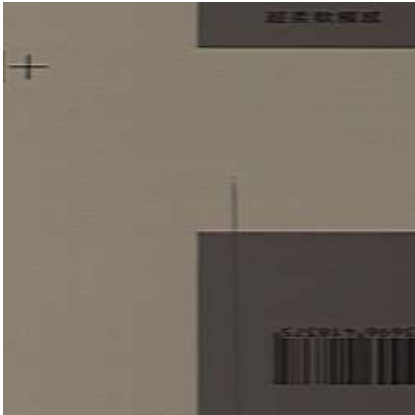
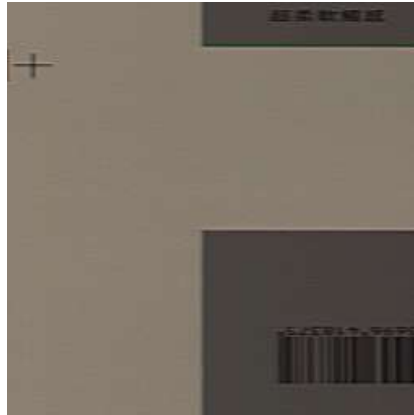
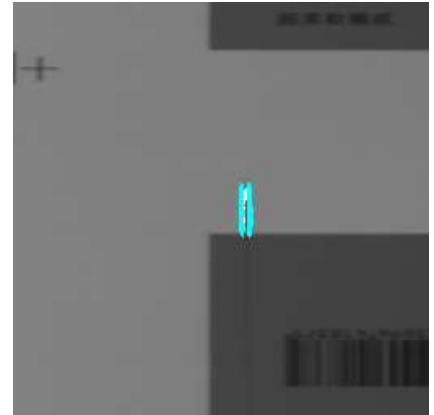
No.	#6, \$5	Date	2023/8/9 下午 02:22:06
Segment	1	Camera	1
Pattern	199	Position[ x, y ]	64.1 [mm], 155.8 [m], ( 5984.8 [m] )
Type	点状疵点縱向刀絲疵點	Size	H:2.2 ,V:12.8 [mm]
Result	-	Area	22.9 [mm2]
Inspection level	5/5,5/5,5/5,5/5,5/5	Label	-
Light	6,6,3/6,6,3

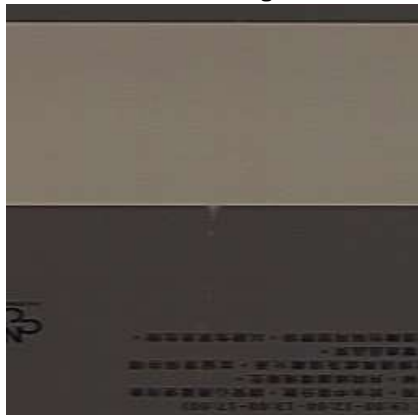
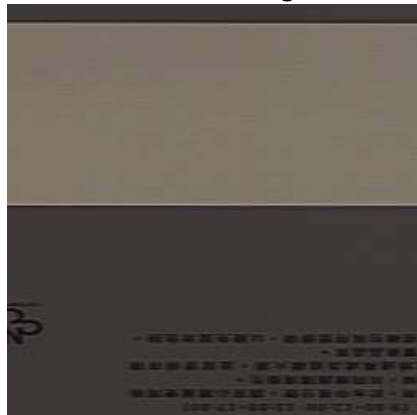
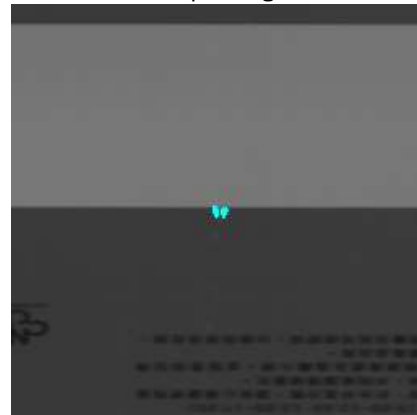
No.	#5, \$4	Date	2023/8/9 下午 02:22:03
Segment	1	Camera	1
Pattern	195	Position[ x, y ]	810.7 [mm], 153.2 [m], ( 5987.4 [m] )
Type	縱向刀絲疵點	Size	H:2.4 ,V:2.4 [mm]
Result	-	Area	4.0 [mm2]
Inspection level	5/5,5/5,5/5,5/5,5/5	Label	-
Light	6,6,3/6,6,3

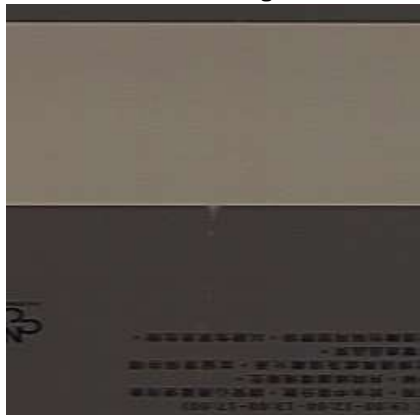
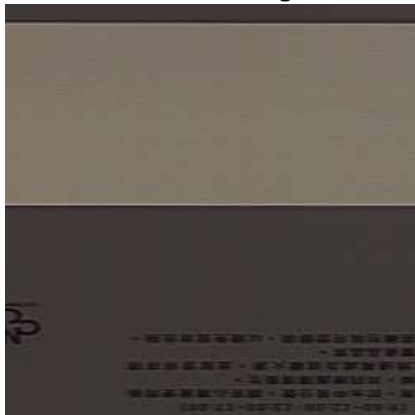
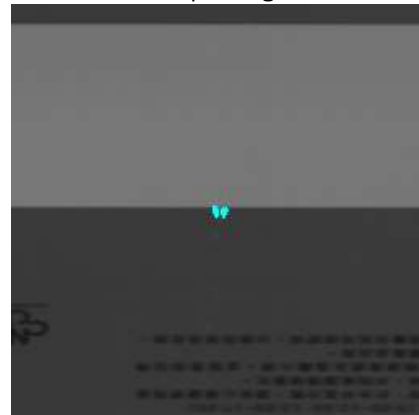
No.	#4, \$3	Date	2023/8/9 下午 02:20:57
Segment	1	Camera	1
Pattern	83	Position[ x, y ]	568.7 [mm], 68.7 [m], ( 6072.0 [m] )
Type	縱向刀絲疵點	Size	H:0.5 ,V:40.4 [mm]
Result	-	Area	10.1 [mm2]
Inspection level	5/5,5/5,5/5,5/5,5/5	Label	-
Light	6,6,3/6,6,3

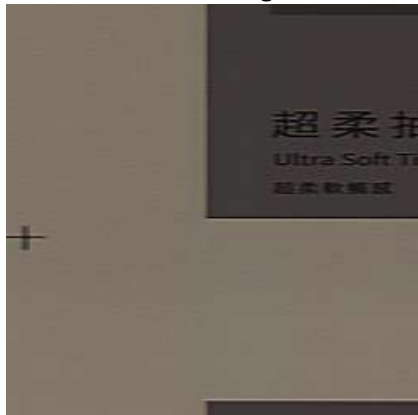
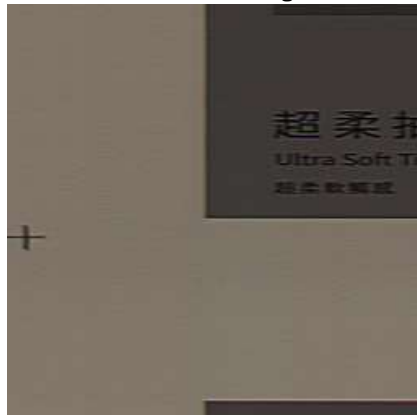
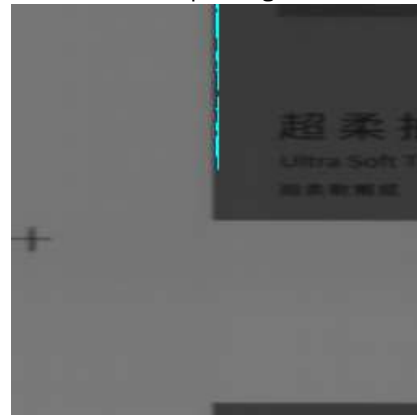
No.	#4, \$3	Date	2023/8/9 下午 02:20:57
Segment	1	Camera	1
Pattern	83	Position[ x, y ]	700.8 [mm], 68.7 [m], ( 6072.0 [m] )
Type	縱向刀絲疵點	Size	H:0.5 ,V:40.4 [mm]
Result	-	Area	12.5 [mm2]
Inspection level	5/5,5/5,5/5,5/5,5/5	Label	-
Light	6,6,3/6,6,3

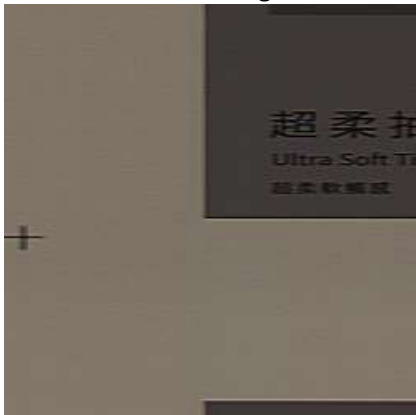
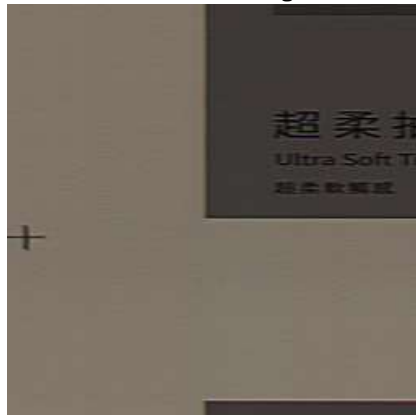
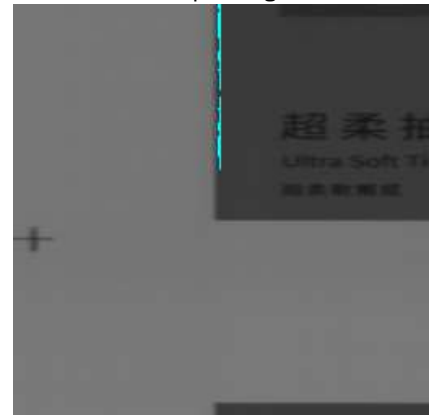
No.	#3, \$2	Date	2023/8/9 下午 02:20:56
Segment	1	Camera	1
Pattern	82	Position[ x, y ]	700.8 [mm], 68.6 [m], ( 6072.1 [m] )
Type	縱向刀絲疵點	Size	H:0.5 ,V:141.2 [mm]
Result	-	Area	32.7 [mm2]
Inspection level	5/5,5/5,5/5,5/5,5/5	Label	-
Light	6,6,3/6,6,3

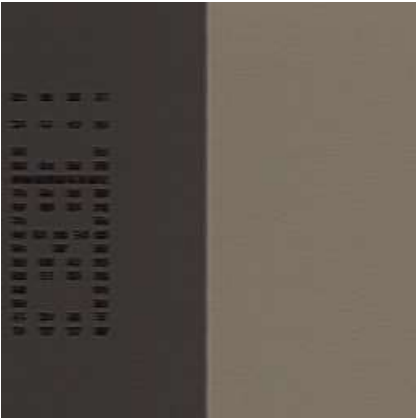
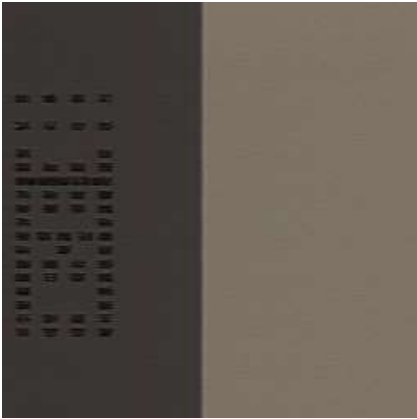
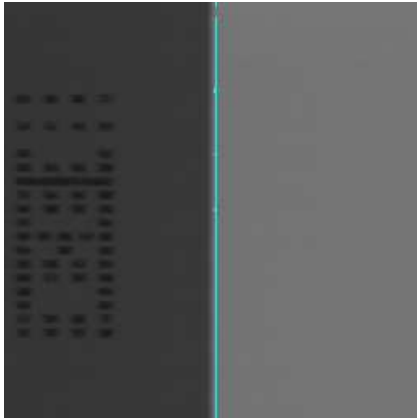
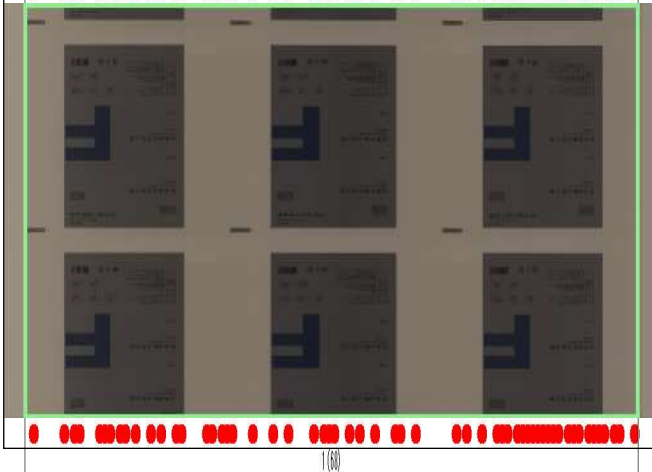
No.	#3, \$2	Date	2023/8/9 下午 02:20:56
Segment	1	Camera	1
Pattern	82	Position[ x, y ]	568.7 [mm], 68.5 [m], ( 6072.1 [m] )
Type	縱向刀絲疵點	Size	H:0.5 ,V:304.4 [mm]
Result	-	Area	77.1 [mm2]
Inspection level	5/5,5/5,5/5,5/5,5/5	Label	-
Light	6,6,3/6,6,3

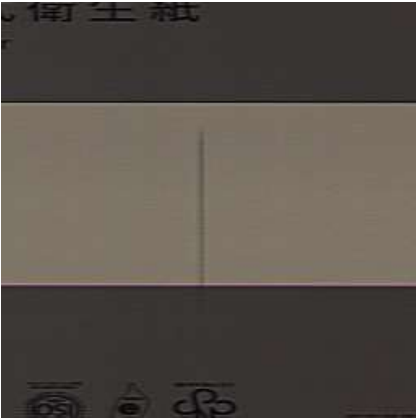
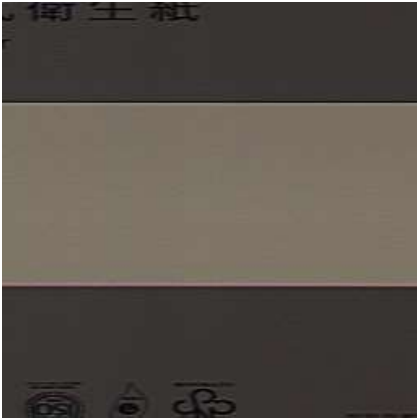
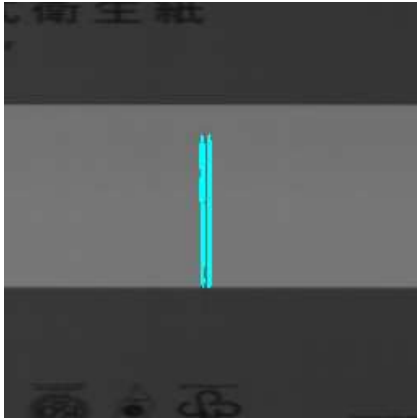
No.	#2, \$1	Date	2023/8/9 下午 02:20:22
Segment	1	Camera	1
Pattern	25	Position[ x, y ]	457.9 [mm], 25.2 [m], ( 6115.5 [m] )
Type	縱向刀絲疵點	Size	H:2.0 ,V:37.2 [mm]
Result	-	Area	55.5 [mm2]
Inspection level	5/5,5/5,5/5,5/5,5/5	Label	-
Light	6,6,3/6,6,3
