# Inspection Result (Individual Data)

Lot number : 4

Inspected date : 2023/8/10 上午 10:55:13 ~ 2023/8/10 下午 12:12:08

商品名	標準透明6-6-3	周長
顧客名		Ex1
CODE番号		Ex2
基材		Ex3

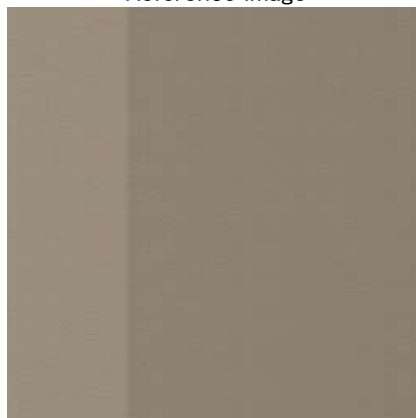
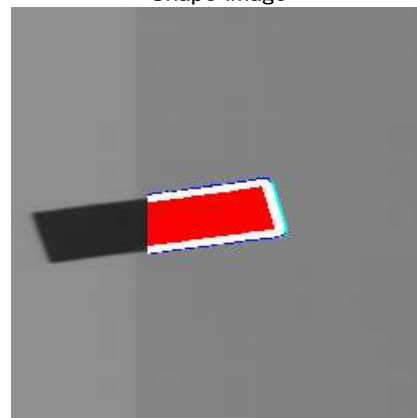
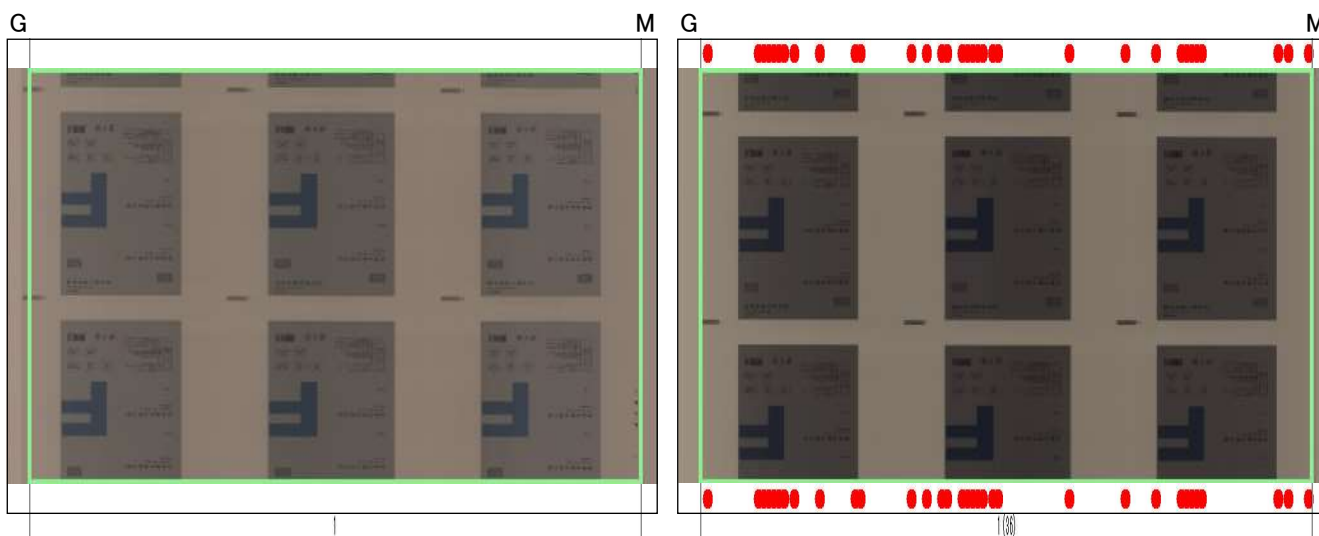
Reference image

No.	#47, \$36	Date	2023/8/10 下午 12:12:01
Segment	1	Camera	1
Pattern	7872	Position[ x, y ]	10.6 [mm], 5892.5 [m], ( 1.8 [m] )
Type	点状疵点縱向刀絲疵點橫向刀絲	Size	H:21.0 ,V:18.0 [mm]
Result	-	Area	268.4 [mm2]
Inspection level	5/5,5/5,5/5,5/5,5/5	Label	-
Light	6,6,3/6,6,3

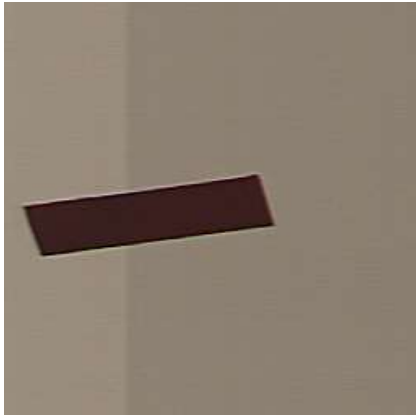
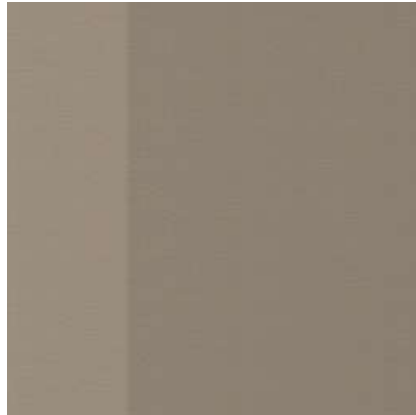
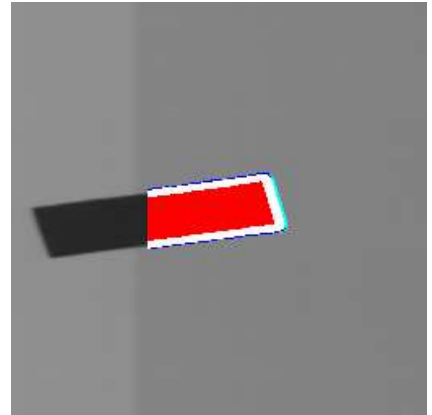
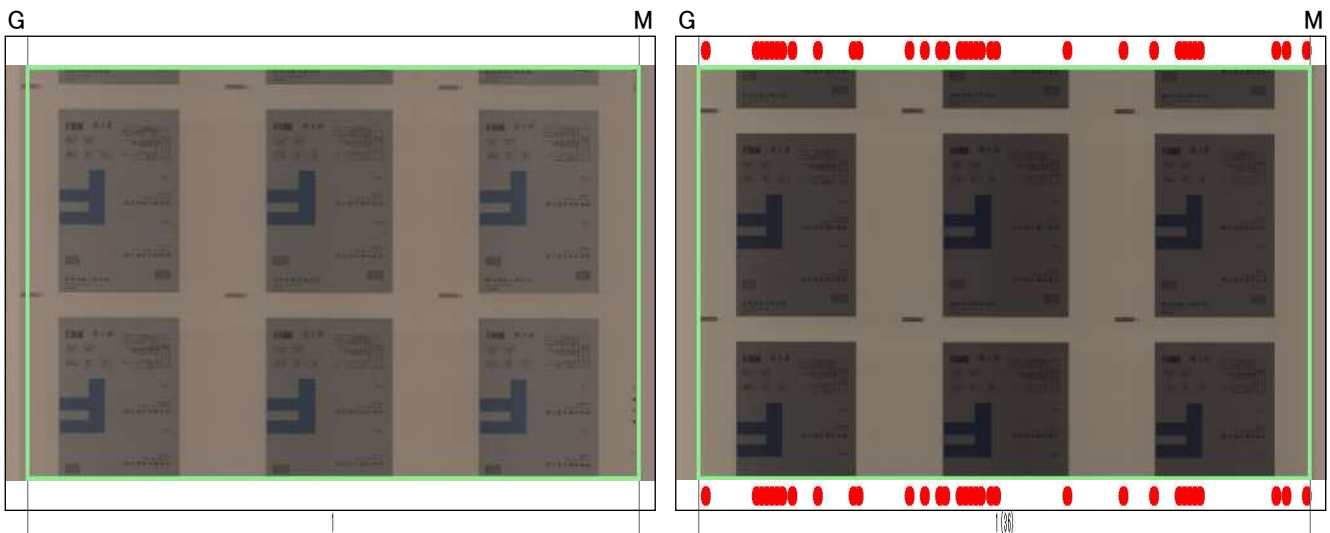
Defect image

No.	#44, \$35	Date	2023/8/10 下午 12:11:39
Segment	1	Camera	1
Pattern	7835	Position[ x, y ]	399.1 [mm], 5864.4 [m], ( 29.8 [m] )
Type	縱向刀絲疵點	Size	H:0.5 ,V:8.4 [mm]
Result	-	Area	3.0 [mm2]
Inspection level	5/5,5/5,5/5,5/5,5/5	Label	-
Light	6,6,3/6,6,3

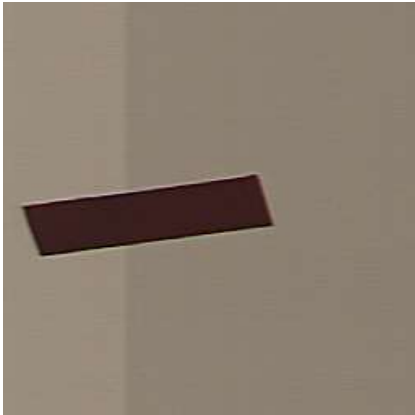
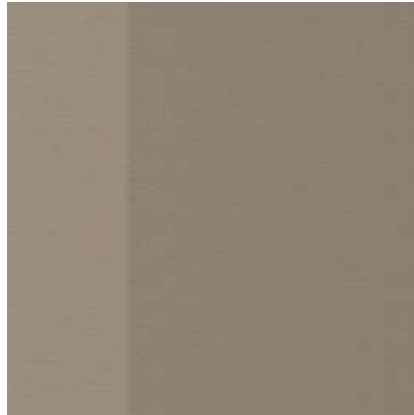
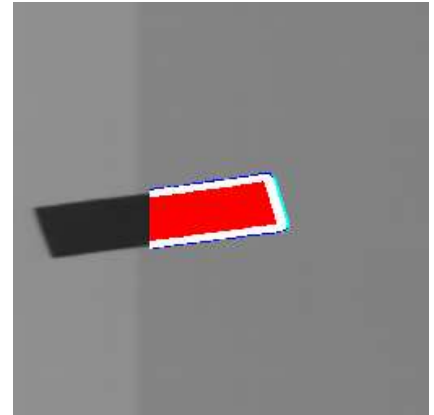
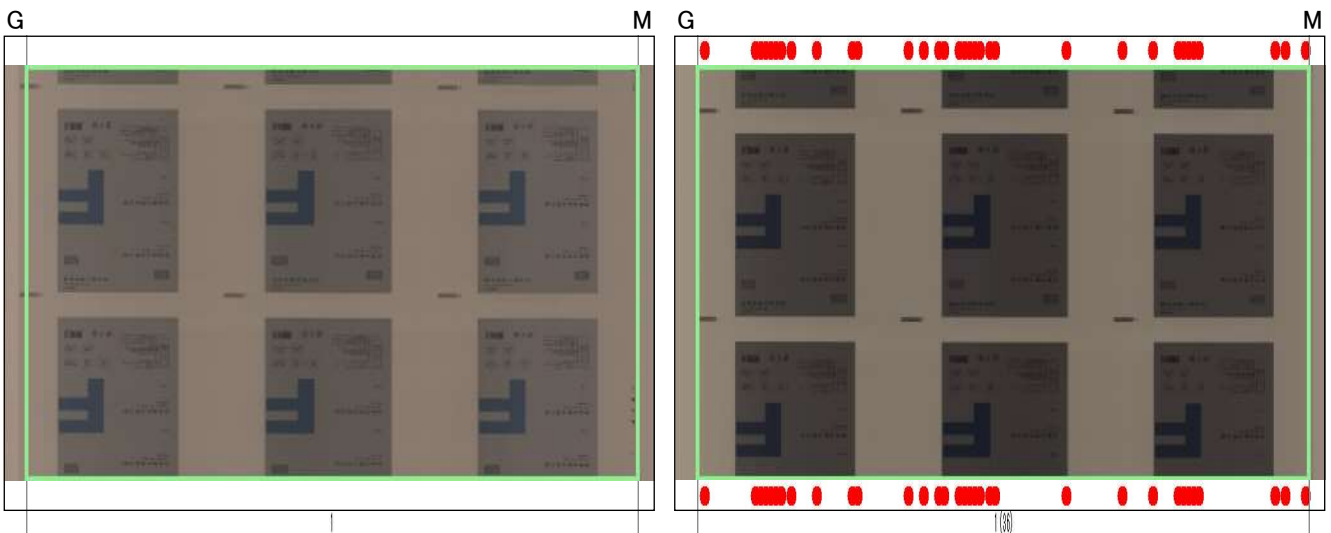
Defect image

No.	#44, \$35	Date	2023/8/10 下午 12:11:39
Segment	1	Camera	1
Pattern	7835	Position[ x, y ]	412.5 [mm], 5864.8 [m], ( 29.5 [m] )
Type	縱向刀絲疵點	Size	H:4.4 ,V:9.2 [mm]
Result	-	Area	3.7 [mm2]
Inspection level	5/5,5/5,5/5,5/5,5/5	Label	-
Light	6,6,3/6,6,3

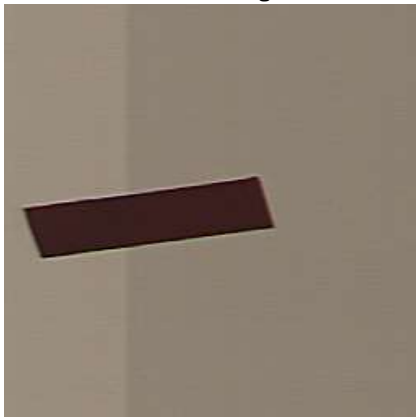
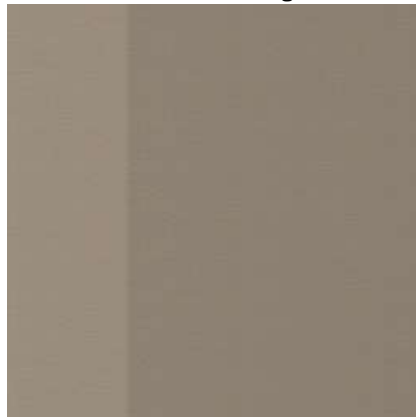
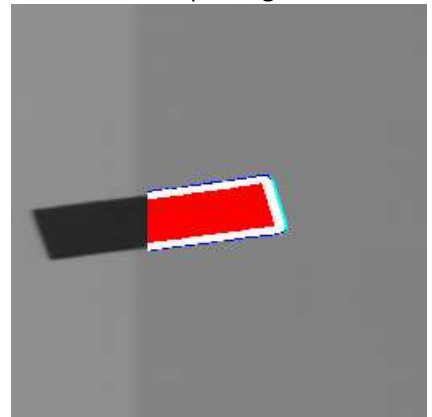
Defect image

No.	#44, \$35	Date	2023/8/10 下午 12:11:39
Segment	1	Camera	1
Pattern	7835	Position[ x, y ]	738.9 [mm], 5864.4 [m], ( 29.8 [m] )
Type	縱向刀絲疵點	Size	H:0.5 ,V:9.2 [mm]
Result	-	Area	4.0 [mm2]
Inspection level	5/5,5/5,5/5,5/5,5/5	Label	-
Light	6,6,3/6,6,3

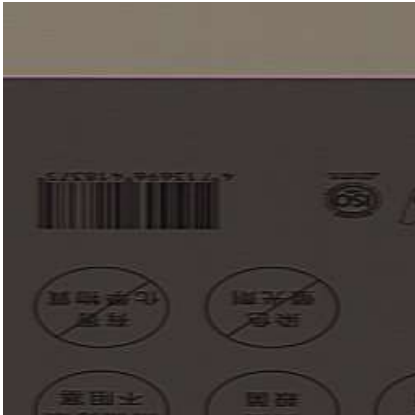
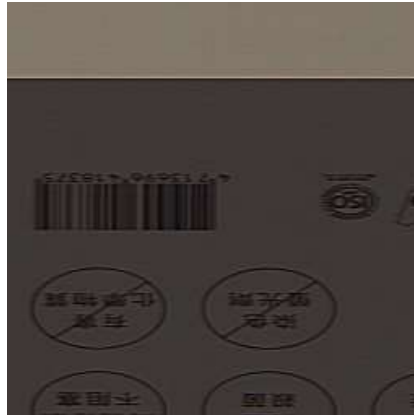
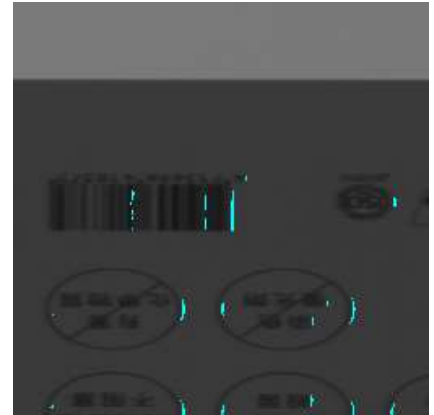
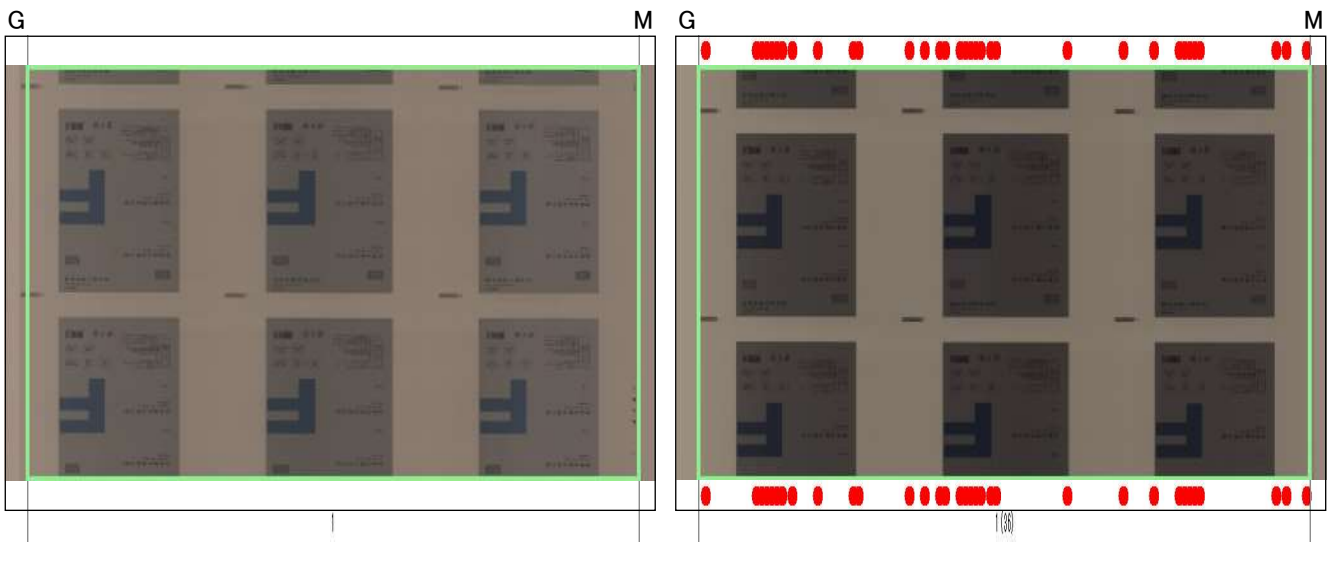
Defect image

No.	#42, \$33	Date	2023/8/10 下午 12:11:38
Segment	1	Camera	1
Pattern	7833	Position[ x, y ]	738.9 [mm], 5862.9 [m], ( 31.3 [m] )
Type	縱向刀絲疵點	Size	H:0.5 ,V:9.2 [mm]
Result	-	Area	3.9 [mm2]
Inspection level	5/5,5/5,5/5,5/5,5/5	Label	-
Light	6,6,3/6,6,3

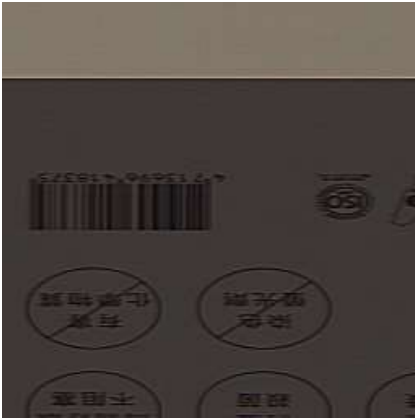
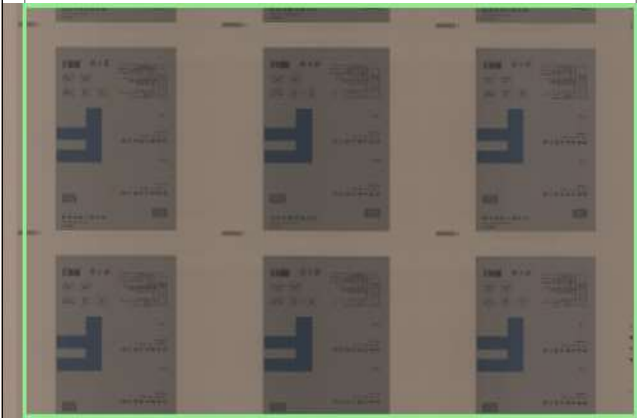
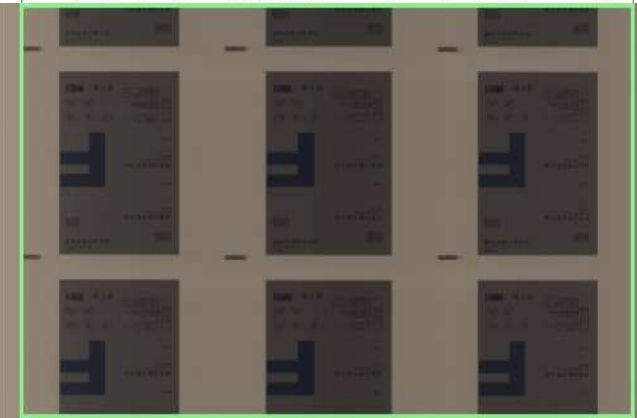
Defect image	Reference image	Shape image

No.	#41, \$32	Date	2023/8/10 下午 12:11:37
Segment	1	Camera	1
Pattern	7832	Position[ x, y ]	412.5 [mm], 5862.6 [m], ( 31.7 [m] )
Type	縱向刀絲疵點	Size	H:4.4 ,V:9.2 [mm]
Result	-	Area	3.1 [mm2]
Inspection level	5/5,5/5,5/5,5/5,5/5	Label	-
Light	6,6,3/6,6,3

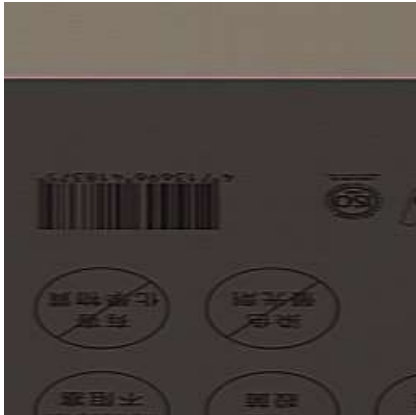
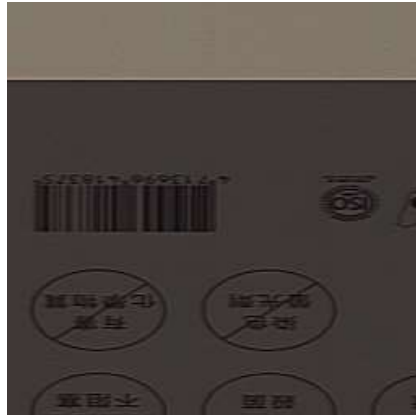
Defect image

No.	#40, \$31	Date	2023/8/10 下午 12:11:37
Segment	1	Camera	1
Pattern	7831	Position[ x, y ]	738.9 [mm], 5861.4 [m], ( 32.8 [m] )
Type	縱向刀絲疵點	Size	H:0.5 ,V:8.8 [mm]
Result	-	Area	3.7 [mm2]
Inspection level	5/5,5/5,5/5,5/5,5/5	Label	-
Light	6,6,3/6,6,3

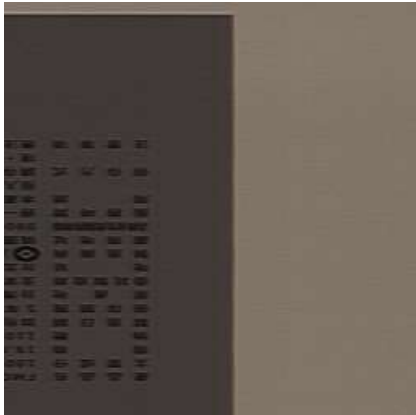
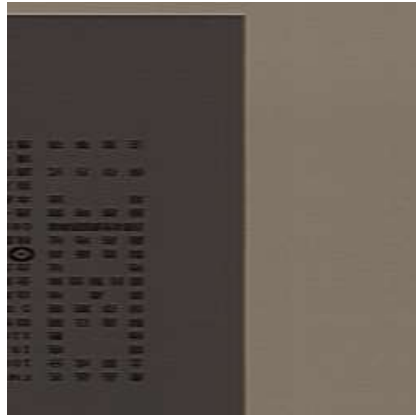
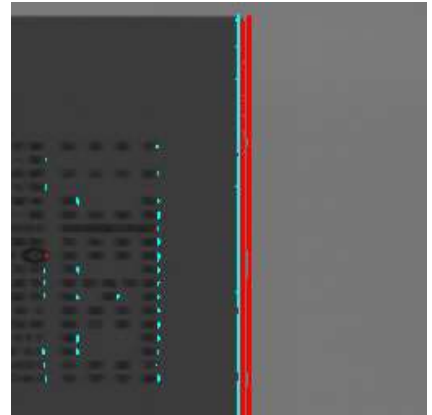
No.	#37, \$30	Date	2023/8/10 下午 12:11:21
Segment	1	Camera	1
Pattern	7805	Position[ x, y ]	237.2 [mm], 5842.0 [m], ( 52.3 [m] )
Type	点状疵点縱向刀絲疵點	Size	H:14.6 ,V:463.6 [mm]
Result	-	Area	358.9 [mm2]
Inspection level	5/5,5/5,5/5,5/5,5/5	Label	-
Light	6,6,3/6,6,3

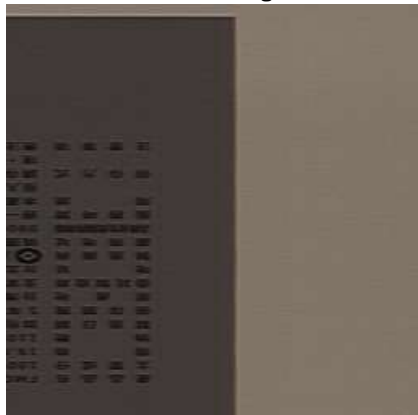
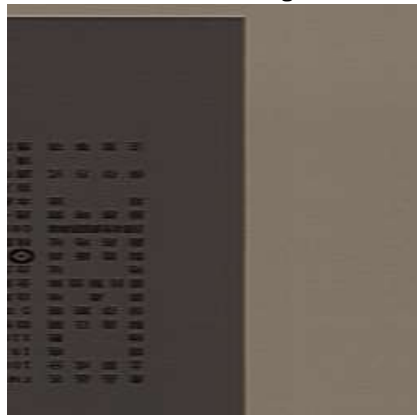
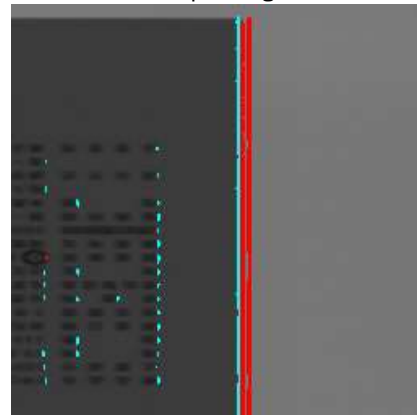
No.	#36, \$29	Date	2023/8/10 下午 12:11:21
Segment	1	Camera	1
Pattern	7804	Position[ x, y ]	373.7 [mm], 5841.7 [m], ( 52.6 [m] )
Type	点状疵点	Size	H:1.7 ,V:176.0 [mm]
Result	-	Area	133.1 [mm2]
Inspection level	5/5,5/5,5/5,5/5,5/5	Label	-
Light	6,6,3/6,6,3

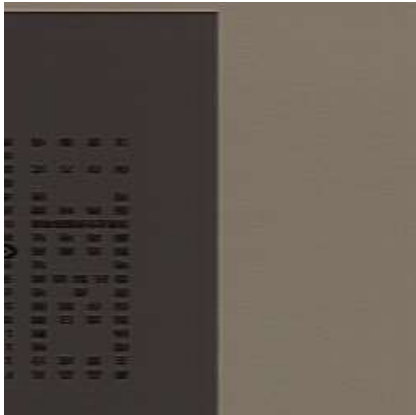
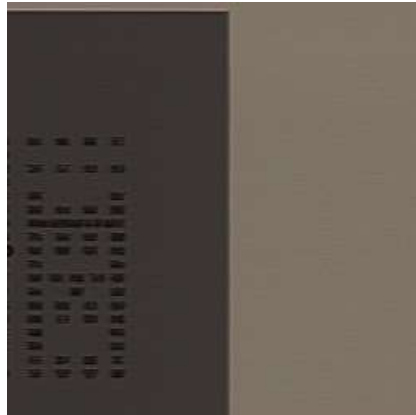
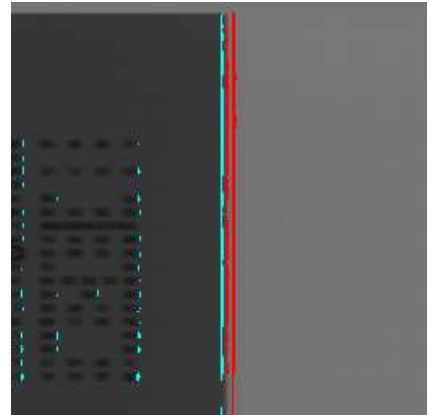
No.	#36, \$29	Date	2023/8/10 下午 12:11:21
Segment	1	Camera	1
Pattern	7804	Position[ x, y ]	565.8 [mm], 5841.4 [m], ( 52.9 [m] )
Type	点状疵点縱向刀絲疵點	Size	H:2.4 ,V:328.4 [mm]
Result	-	Area	196.1 [mm2]
Inspection level	5/5,5/5,5/5,5/5,5/5	Label	-
Light	6,6,3/6,6,3

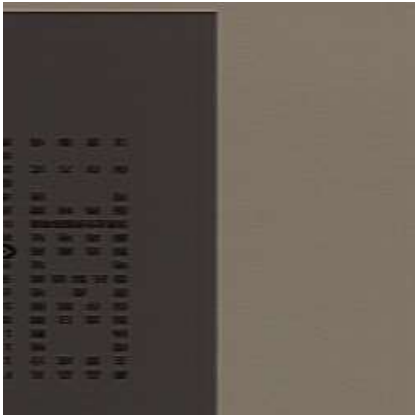
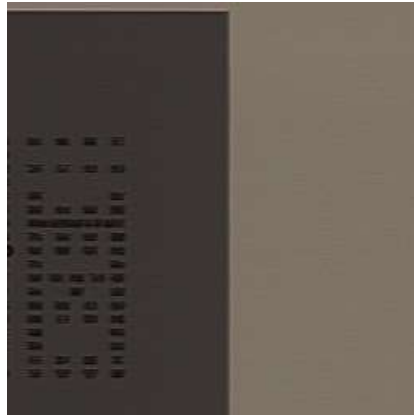
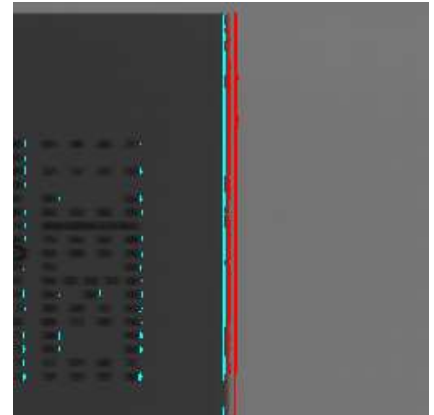
No.	#35, \$28	Date	2023/8/10 下午 12:11:20
Segment	1	Camera	1
Pattern	7803	Position[ x, y ]	566.1 [mm], 5840.6 [m], ( 53.7 [m] )
Type	点状疵点縱向刀絲疵點	Size	H:2.4 ,V:118.0 [mm]
Result	-	Area	82.0 [mm2]
Inspection level	5/5,5/5,5/5,5/5,5/5	Label	-
Light	6,6,3/6,6,3

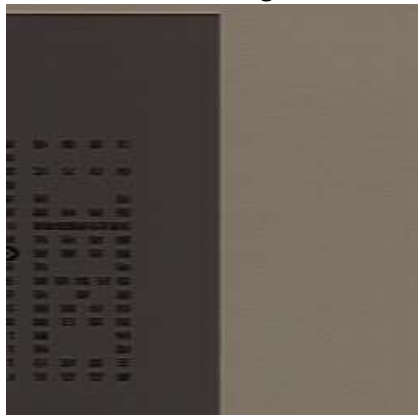
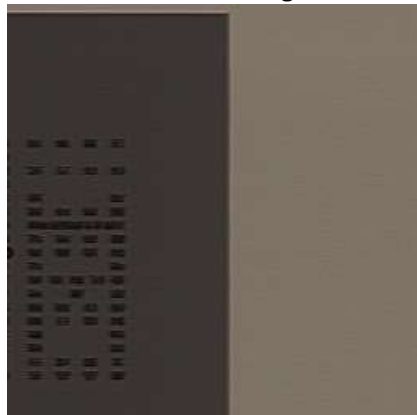
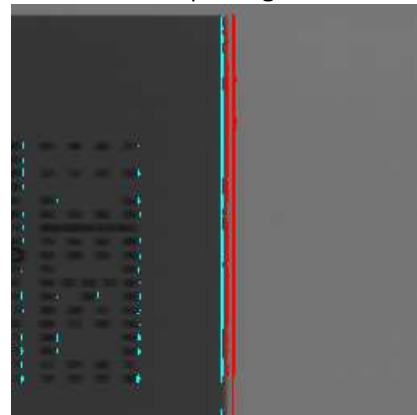
No.	#35, \$28	Date	2023/8/10 下午 12:11:20
Segment	1	Camera	1
Pattern	7803	Position[ x, y ]	236.2 [mm], 5841.0 [m], ( 53.3 [m] )
Type	点状疵点縱向刀絲疵點	Size	H:14.9 ,V:169.6 [mm]
Result	-	Area	85.2 [mm2]
Inspection level	5/5,5/5,5/5,5/5,5/5	Label	-
Light	6,6,3/6,6,3

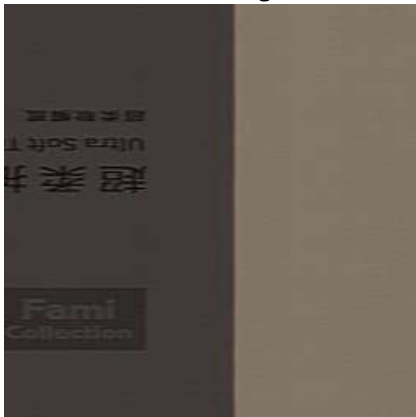
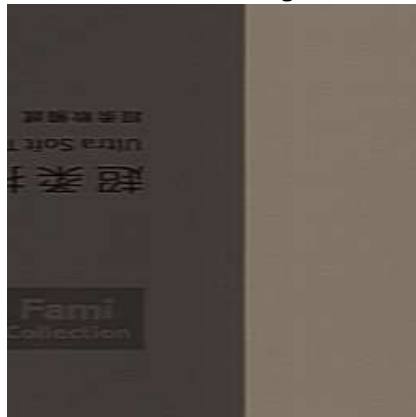
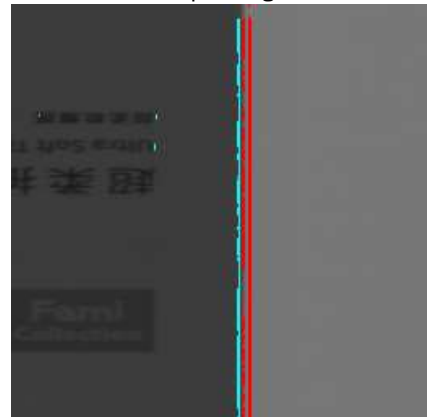
No.	#34, \$27	Date	2023/8/10 下午 12:11:20
Segment	1	Camera	1
Pattern	7802	Position[ x, y ]	240.6 [mm], 5840.1 [m], ( 54.1 [m] )
Type	点状疵点縱向刀絲疵點	Size	H:2.2 ,V:311.2 [mm]
Result	-	Area	50.0 [mm2]
Inspection level	5/5,5/5,5/5,5/5,5/5	Label	-
Light	6,6,3/6,6,3

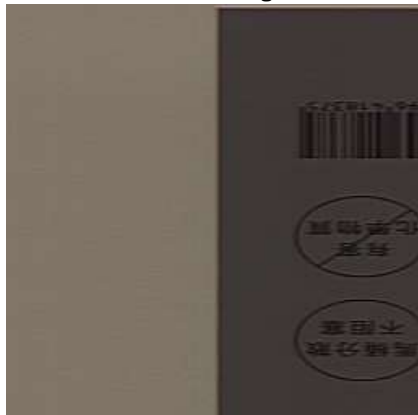
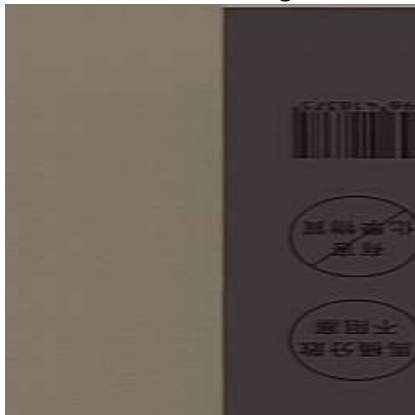
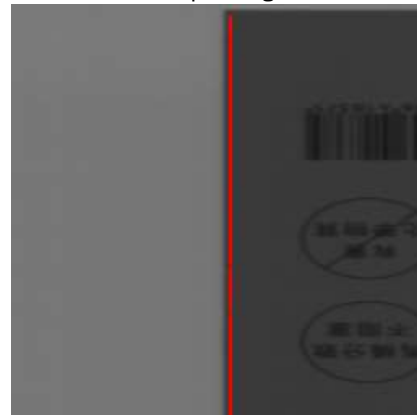
No.	#33, \$26	Date	2023/8/10 下午 12:11:19
Segment	1	Camera	1
Pattern	7801	Position[ x, y ]	422.3 [mm], 5839.1 [m], ( 55.1 [m] )
Type	縱向刀絲疵點	Size	H:0.7 ,V:5.6 [mm]
Result	-	Area	2.5 [mm2]
Inspection level	5/5,5/5,5/5,5/5,5/5	Label	-
Light	6,6,3/6,6,3

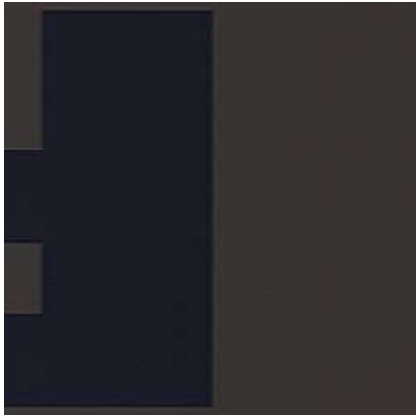
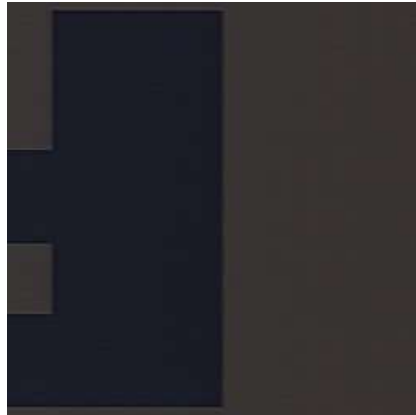
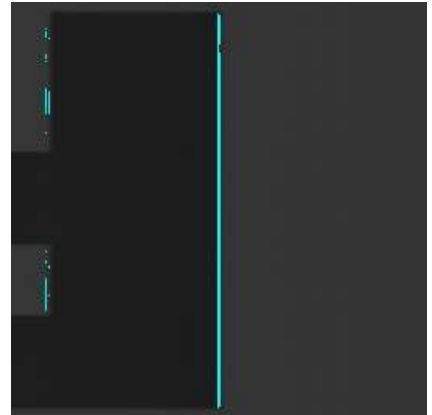
No.	#33, \$26	Date	2023/8/10 下午 12:11:19
Segment	1	Camera	1
Pattern	7801	Position[ x, y ]	448.1 [mm], 5839.2 [m], ( 55.1 [m] )
Type	縱向刀絲疵點	Size	H:0.5 ,V:96.4 [mm]
Result	-	Area	46.2 [mm2]
Inspection level	5/5,5/5,5/5,5/5,5/5	Label	-
Light	6,6,3/6,6,3

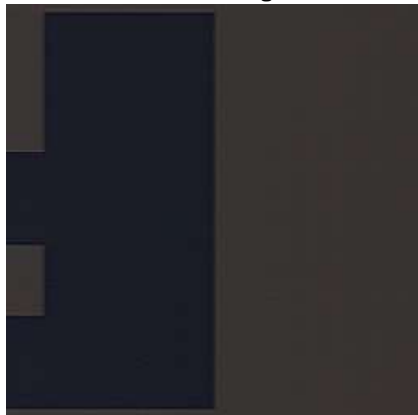
No.	#30, \$25	Date	2023/8/10 下午 12:10:48
Segment	1	Camera	1
Pattern	7748	Position[ x, y ]	565.6 [mm], 5799.5 [m], ( 94.8 [m] )
Type	点状疵点縱向刀絲疵點	Size	H:2.4 ,V:297.6 [mm]
Result	-	Area	111.7 [mm2]
Inspection level	5/5,5/5,5/5,5/5,5/5	Label	-
Light	6,6,3/6,6,3

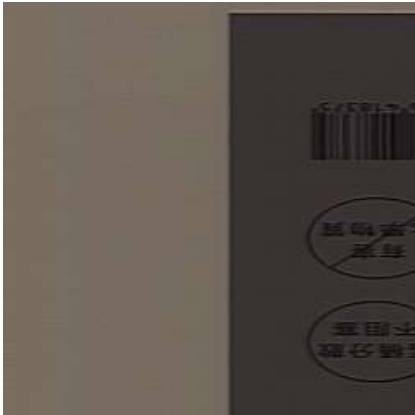
Defect image

No.	#30, \$25	Date	2023/8/10 下午 12:10:48
Segment	1	Camera	1
Pattern	7748	Position[ x, y ]	372.4 [mm], 5799.5 [m], ( 94.7 [m] )
Type	点状疵点縱向刀絲疵點	Size	H:3.9 ,V:311.2 [mm]
Result	-	Area	136.1 [mm2]
Inspection level	5/5,5/5,5/5,5/5,5/5	Label	-
Light	6,6,3/6,6,3

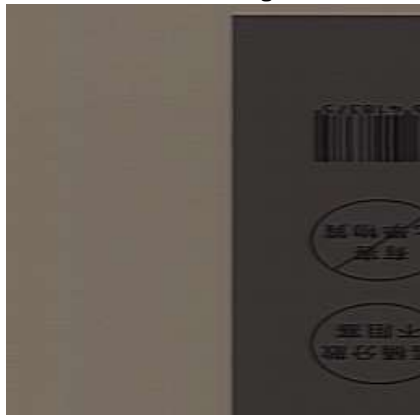
Defect image

No.	#29, \$24	Date	2023/8/10 下午 12:10:47
Segment	1	Camera	1
Pattern	7747	Position[ x, y ]	698.6 [mm], 5798.9 [m], ( 95.3 [m] )
Type	点状疵点縱向刀絲疵點	Size	H:2.2 ,V:121.6 [mm]
Result	-	Area	56.2 [mm2]
Inspection level	5/5,5/5,5/5,5/5,5/5	Label	-
Light	6,6,3/6,6,3

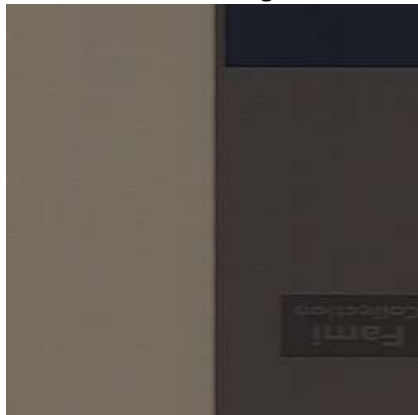
Defect image

No.	#29, \$24	Date	2023/8/10 下午 12:10:47
Segment	1	Camera	1
Pattern	7747	Position[ x, y ]	698.4 [mm], 5799.3 [m], ( 95.0 [m] )
Type	点状疵点縱向刀絲疵點	Size	H:3.7 ,V:101.2 [mm]
Result	-	Area	71.9 [mm2]
Inspection level	5/5,5/5,5/5,5/5,5/5	Label	-
Light	6,6,3/6,6,3

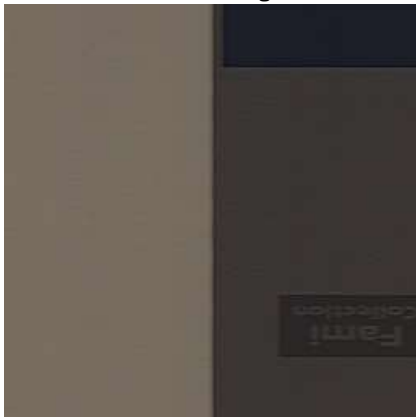
Defect image

No.	#28, \$23	Date	2023/8/10 下午 12:10:47
Segment	1	Camera	1
Pattern	7746	Position[ x, y ]	126.1 [mm], 5798.4 [m], ( 95.8 [m] )
Type	縱向刀絲疵點	Size	H:0.7 ,V:15.2 [mm]
Result	-	Area	8.7 [mm2]
Inspection level	5/5,5/5,5/5,5/5,5/5	Label	-
Light	6,6,3/6,6,3

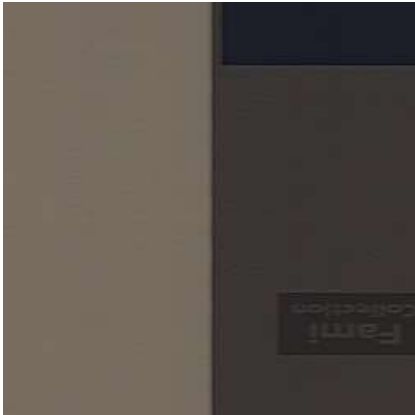
Defect image

No.	#28, \$23	Date	2023/8/10 下午 12:10:47
Segment	1	Camera	1
Pattern	7746	Position[ x, y ]	447.9 [mm], 5798.1 [m], ( 96.2 [m] )
Type	縱向刀絲疵點	Size	H:0.7 ,V:96.8 [mm]
Result	-	Area	33.6 [mm2]
Inspection level	5/5,5/5,5/5,5/5,5/5	Label	-
Light	6,6,3/6,6,3

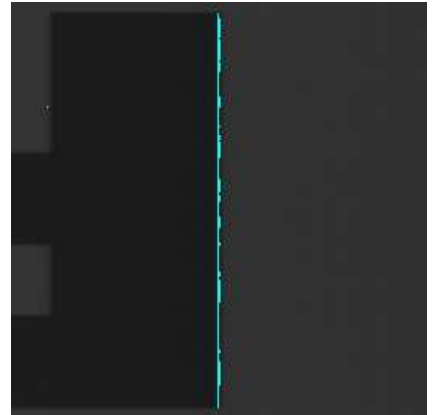
Defect image

No.	#23, \$20	Date	2023/8/10 下午 12:10:39
Segment	1	Camera	1
Pattern	7733	Position[ x, y ]	358.3 [mm], 5788.7 [m], ( 105.5 [m] )
Type	点状疵点縱向刀絲疵點橫向刀絲	Size	H:48.8 ,V:90.8 [mm]
Result	-	Area	197.9 [mm2]
Inspection level	5/5,5/5,5/5,5/5,5/5	Label	-
Light	6,6,3/6,6,3

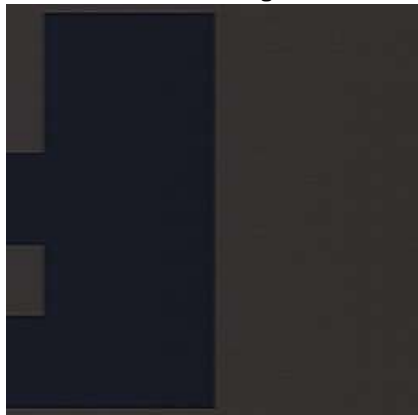
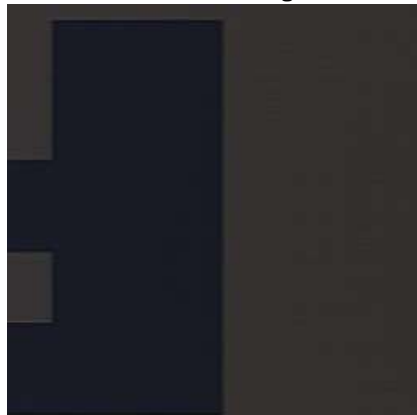
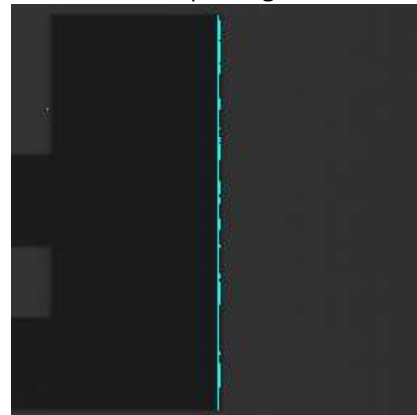
Defect image

No.	#23, \$20	Date	2023/8/10 下午 12:10:39
Segment	1	Camera	1
Pattern	7733	Position[ x, y ]	699.6 [mm], 5788.8 [m], ( 105.5 [m] )
Type	点状疵点縱向刀絲疵點	Size	H:36.6 ,V:258.8 [mm]
Result	-	Area	223.7 [mm2]
Inspection level	5/5,5/5,5/5,5/5,5/5	Label	-
Light	6,6,3/6,6,3

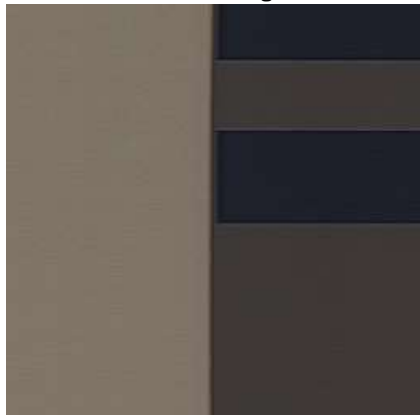
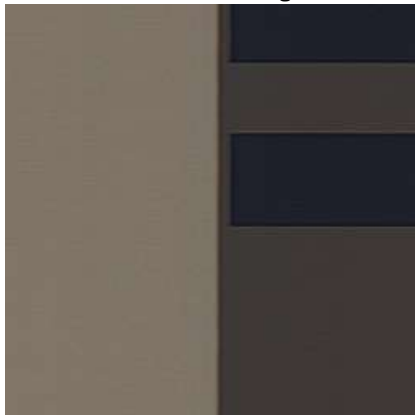
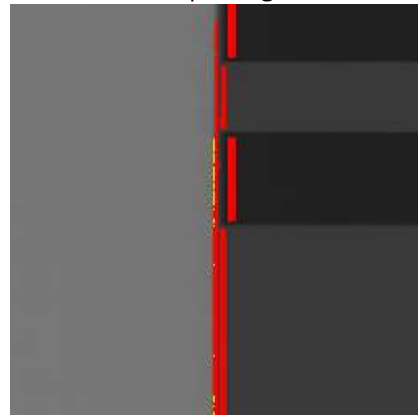
Defect image

No.	#23, \$20	Date	2023/8/10 下午 12:10:39
Segment	1	Camera	1
Pattern	7733	Position[ x, y ]	697.9 [mm], 5788.5 [m], ( 105.8 [m] )
Type	点状疵点	Size	H:3.4 ,V:171.2 [mm]
Result	-	Area	248.1 [mm2]
Inspection level	5/5,5/5,5/5,5/5,5/5	Label	-
Light	6,6,3/6,6,3

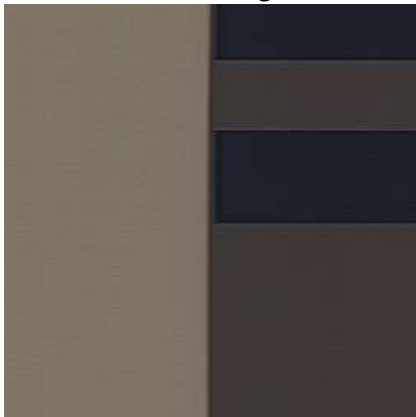
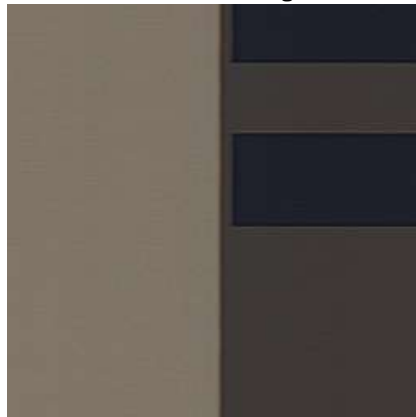
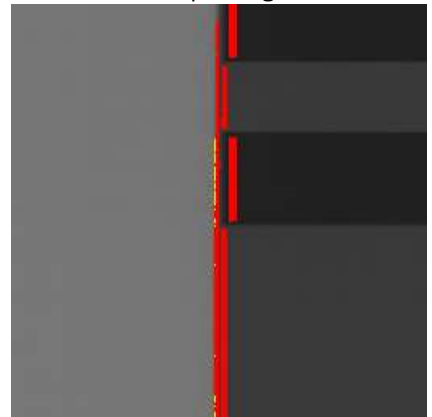
Defect image

No.	#22, \$19	Date	2023/8/10 下午 12:10:39
Segment	1	Camera	1
Pattern	7732	Position[ x, y ]	770.4 [mm], 5788.0 [m], ( 106.3 [m] )
Type	面狀重疵点	Size	H:1.0 ,V:93.2 [mm]
Result	-	Area	65.3 [mm2]
Inspection level	5/5,5/5,5/5,5/5,5/5	Label	-
Light	6,6,3/6,6,3

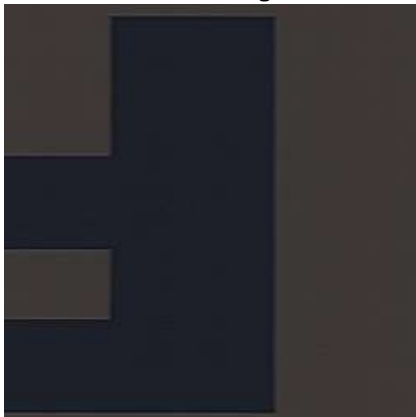
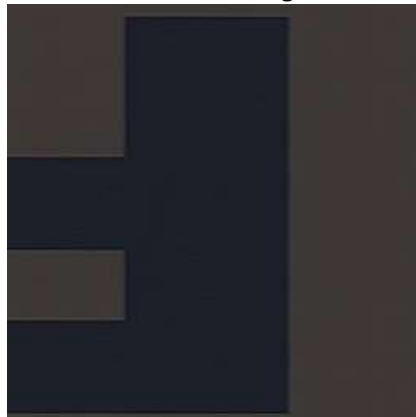
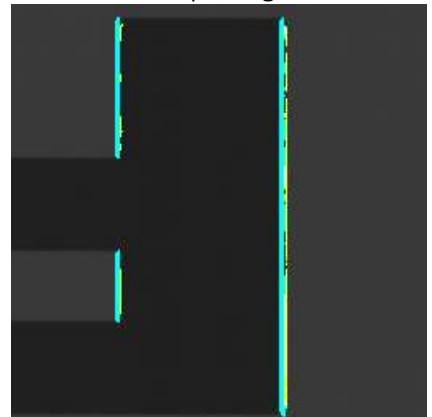
Defect image

No.	#22, \$19	Date	2023/8/10 下午 12:10:39
Segment	1	Camera	1
Pattern	7732	Position[ x, y ]	759.2 [mm], 5787.6 [m], ( 106.7 [m] )
Type	面狀重疵點縱向刀絲疵點	Size	H:40.5 ,V:179.2 [mm]
Result	-	Area	86.0 [mm2]
Inspection level	5/5,5/5,5/5,5/5,5/5	Label	-
Light	6,6,3/6,6,3

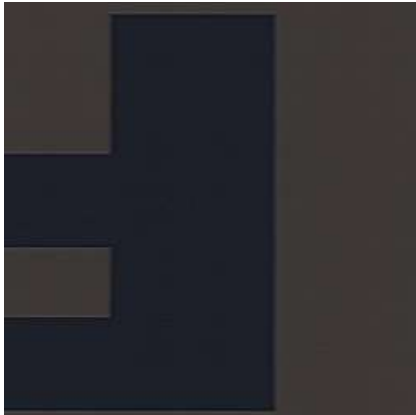
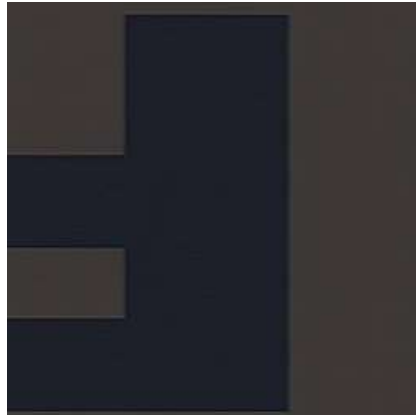
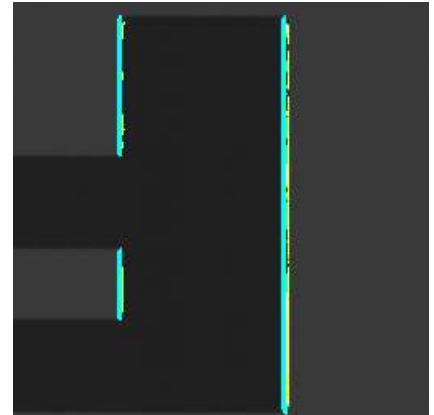
Defect image

No.	#21, \$18	Date	2023/8/10 下午 12:10:38
Segment	1	Camera	1
Pattern	7731	Position[ x, y ]	759.4 [mm], 5786.8 [m], ( 107.5 [m] )
Type	縱向刀絲疵點	Size	H:39.6 ,V:177.6 [mm]
Result	-	Area	38.3 [mm2]
Inspection level	5/5,5/5,5/5,5/5,5/5	Label	-
Light	6,6,3/6,6,3

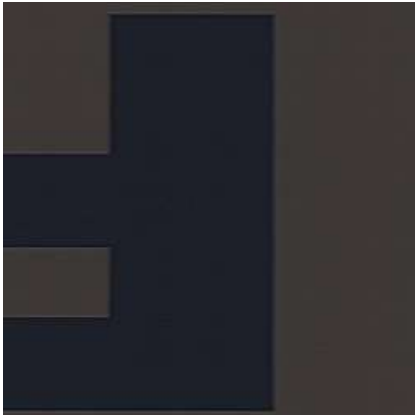
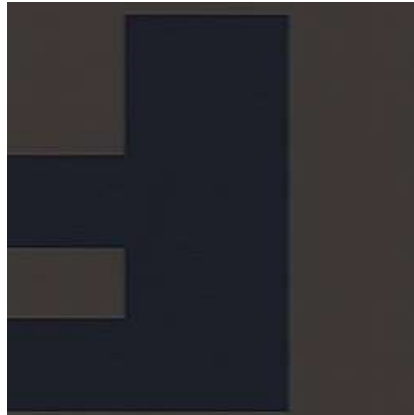
Defect image

No.	#21, \$18	Date	2023/8/10 下午 12:10:38
Segment	1	Camera	1
Pattern	7731	Position[ x, y ]	434.9 [mm], 5786.8 [m], ( 107.5 [m] )
Type	縱向刀絲疵點	Size	H:41.0 ,V:178.0 [mm]
Result	-	Area	52.5 [mm2]
Inspection level	5/5,5/5,5/5,5/5,5/5	Label	-
Light	6,6,3/6,6,3

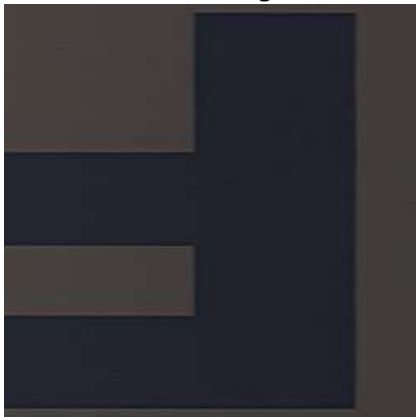
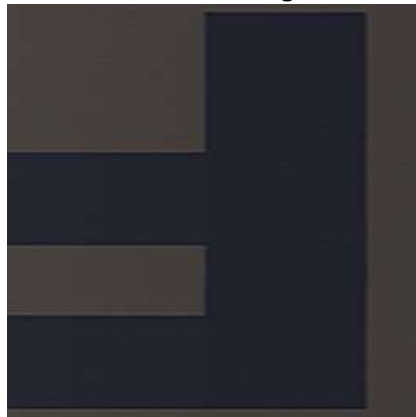
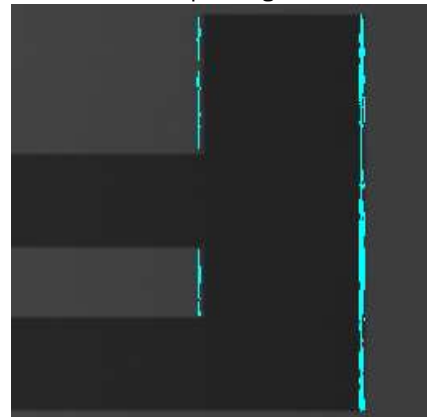
Defect image

No.	#21, \$18	Date	2023/8/10 下午 12:10:38
Segment	1	Camera	1
Pattern	7731	Position[ x, y ]	108.0 [mm], 5786.8 [m], ( 107.5 [m] )
Type	縱向刀絲疵點	Size	H:54.2 ,V:179.2 [mm]
Result	-	Area	59.1 [mm2]
Inspection level	5/5,5/5,5/5,5/5,5/5	Label	-
Light	6,6,3/6,6,3

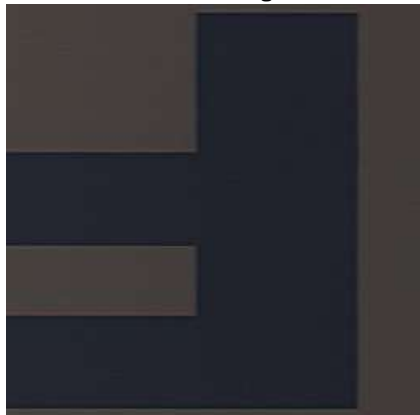
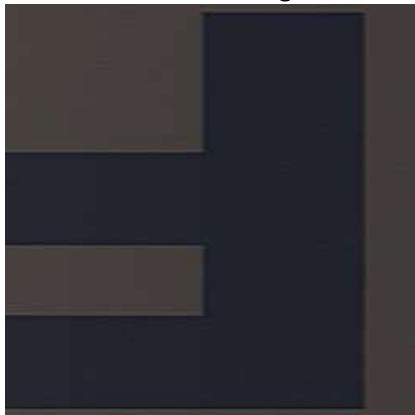
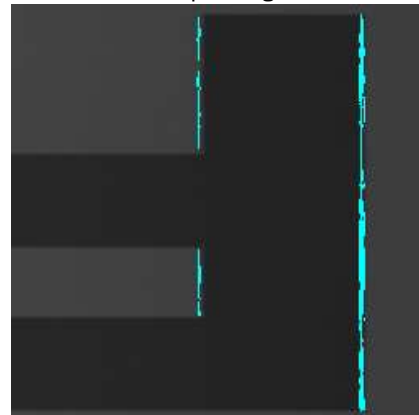
Defect image

No.	#20, \$17	Date	2023/8/10 下午 12:10:38
Segment	1	Camera	1
Pattern	7730	Position[ x, y ]	420.8 [mm], 5786.4 [m], ( 107.8 [m] )
Type	点状疵点縱向刀絲疵點	Size	H:21.0 ,V:89.2 [mm]
Result	-	Area	8.6 [mm2]
Inspection level	5/5,5/5,5/5,5/5,5/5	Label	-
Light	6,6,3/6,6,3

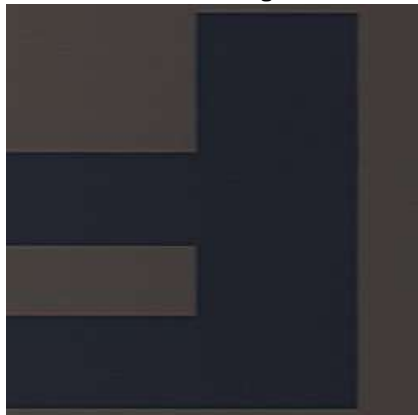
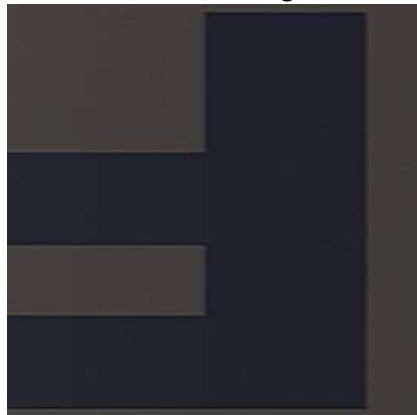
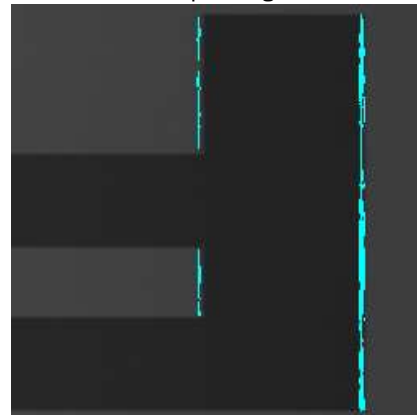
Defect image

No.	#20, \$17	Date	2023/8/10 下午 12:10:38
Segment	1	Camera	1
Pattern	7730	Position[ x, y ]	448.4 [mm], 5786.5 [m], ( 107.7 [m] )
Type	点状疵点	Size	H:1.0 ,V:25.6 [mm]
Result	-	Area	9.7 [mm2]
Inspection level	5/5,5/5,5/5,5/5,5/5	Label	-
Light	6,6,3/6,6,3

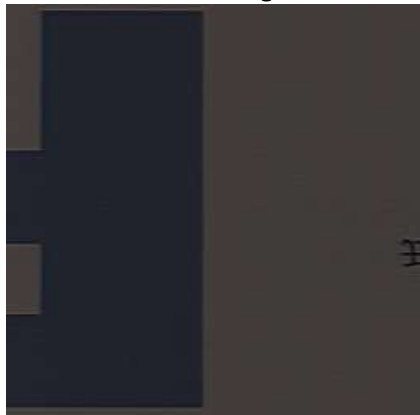
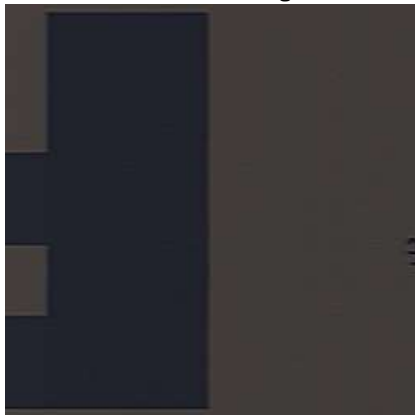
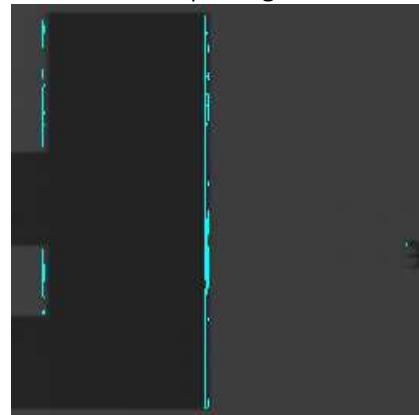
Defect image

No.	#20, \$17	Date	2023/8/10 下午 12:10:38
Segment	1	Camera	1
Pattern	7730	Position[ x, y ]	125.9 [mm], 5786.1 [m], ( 108.1 [m] )
Type	縱向刀絲疵點	Size	H:0.7 ,V:96.0 [mm]
Result	-	Area	33.2 [mm2]
Inspection level	5/5,5/5,5/5,5/5,5/5	Label	-
Light	6,6,3/6,6,3

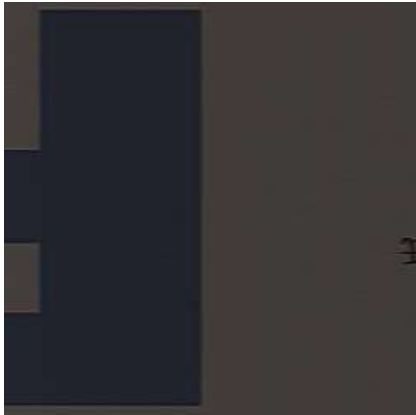
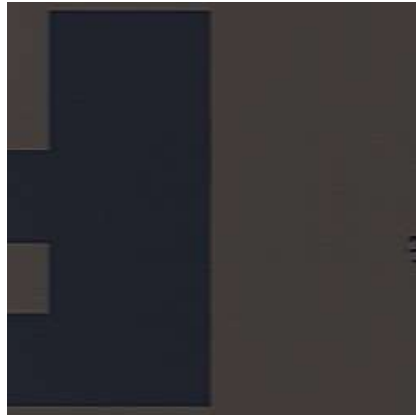
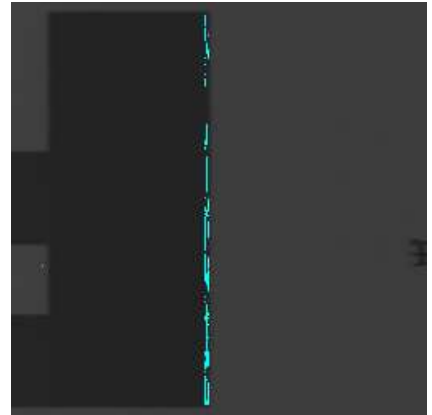
Defect image

No.	#19, \$16	Date	2023/8/10 下午 12:10:37
Segment	1	Camera	1
Pattern	7729	Position[ x, y ]	125.9 [mm], 5785.8 [m], ( 108.5 [m] )
Type	縱向刀絲疵點	Size	H:0.7 ,V:95.2 [mm]
Result	-	Area	17.8 [mm2]
Inspection level	5/5,5/5,5/5,5/5,5/5	Label	-
Light	6,6,3/6,6,3

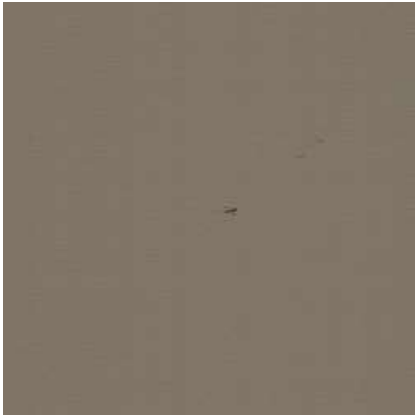
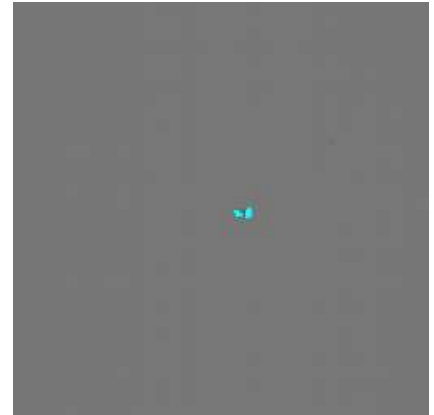
Defect image

No.	#16, \$13	Date	2023/8/10 上午 11:03:11
Segment	1	Camera	1
Pattern	818	Position[ x, y ]	754.3 [mm], 620.8 [m], ( 5273.5 [m] )
Type	点状疵点	Size	H:17.1 ,V:0.8 [mm]
Result	-	Area	11.3 [mm2]
Inspection level	5/5,5/5,5/5,5/5,5/5	Label	-
Light	6,6,3/6,6,3

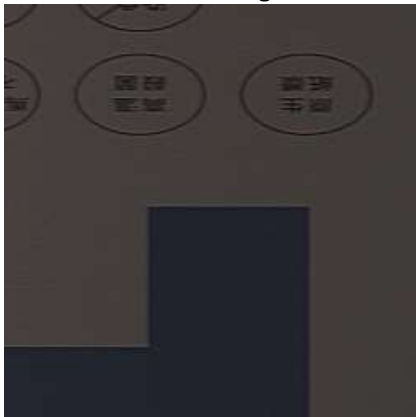
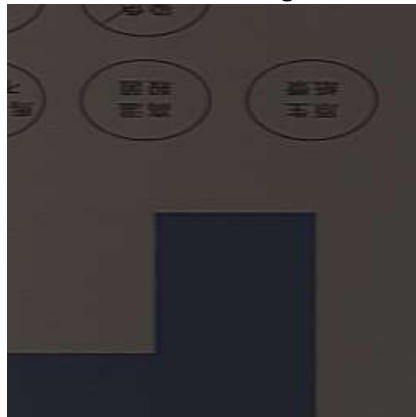
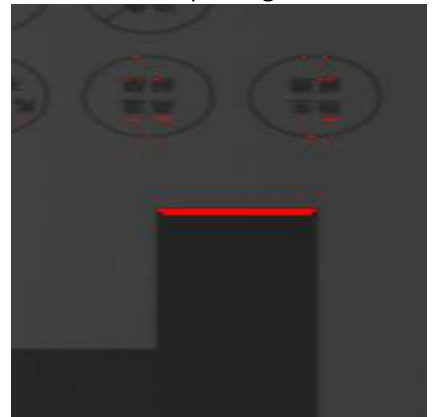
Defect image

No.	#16, \$13	Date	2023/8/10 上午 11:03:11
Segment	1	Camera	1
Pattern	818	Position[ x, y ]	115.1 [mm], 620.8 [m], ( 5273.5 [m] )
Type	点状疵点	Size	H:22.7 ,V:0.8 [mm]
Result	-	Area	17.9 [mm2]
Inspection level	5/5,5/5,5/5,5/5,5/5	Label	-
Light	6,6,3/6,6,3

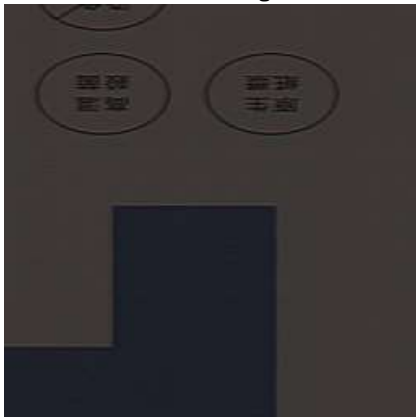
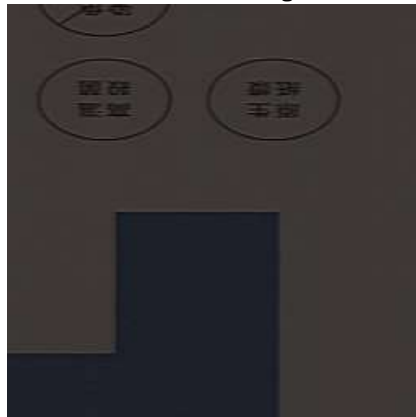
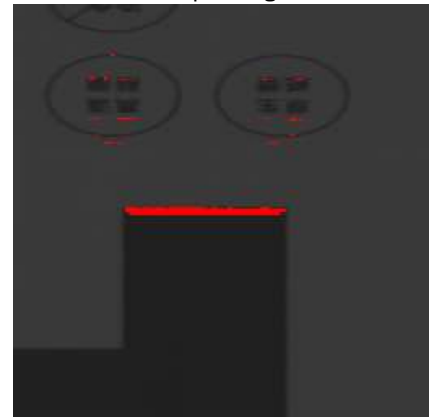
Defect image

No.	#13, \$10	Date	2023/8/10 上午 11:03:09
Segment	1	Camera	1
Pattern	814	Position[ x, y ]	758.2 [mm], 617.4 [m], ( 5276.8 [m] )
Type	点状疵点	Size	H:22.9 ,V:0.8 [mm]
Result	-	Area	18.2 [mm2]
Inspection level	5/5,5/5,5/5,5/5,5/5	Label	-
Light	6,6,3/6,6,3

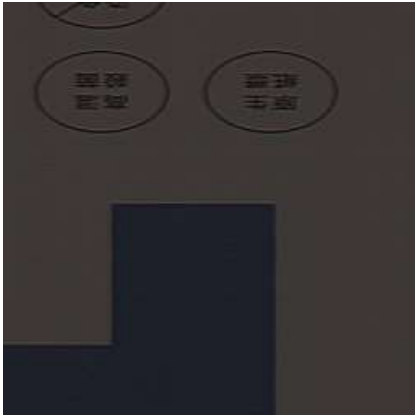
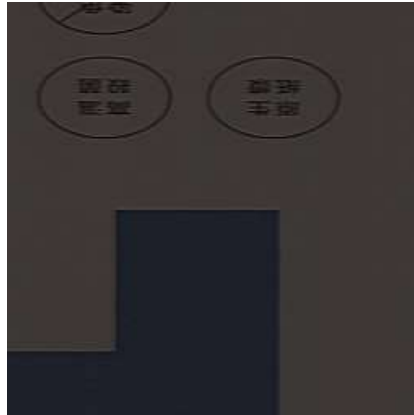
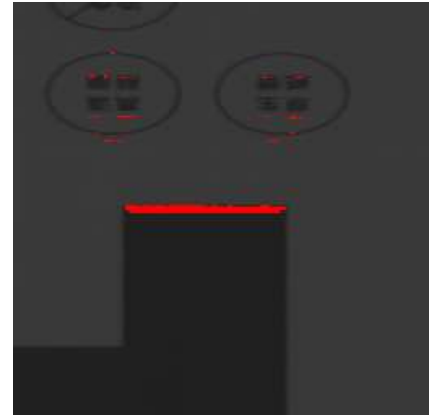
Defect image

No.	#12, \$9	Date	2023/8/10 上午 11:03:01
Segment	1	Camera	1
Pattern	801	Position[ x, y ]	184.2 [mm], 607.6 [m], ( 5286.7 [m] )
Type	点状疵点	Size	H:21.0 ,V:0.8 [mm]
Result	-	Area	10.4 [mm2]
Inspection level	5/5,5/5,5/5,5/5,5/5	Label	-
Light	6,6,3/6,6,3

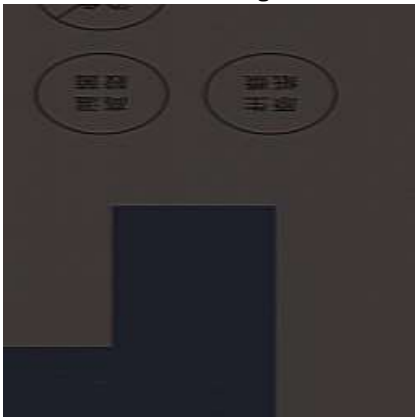
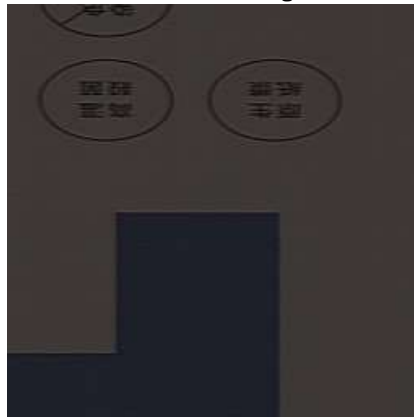
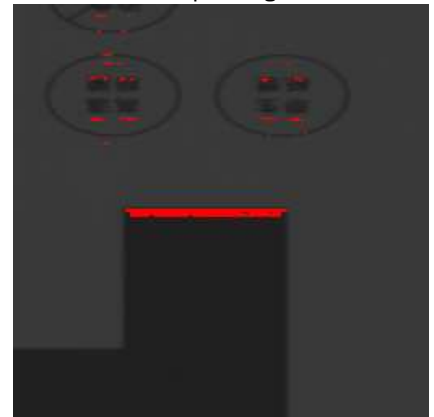
Defect image

No.	#11, \$8	Date	2023/8/10 上午 11:03:00
Segment	1	Camera	1
Pattern	800	Position[ x, y ]	757.5 [mm], 607.3 [m], ( 5287.0 [m] )
Type	点状疵点	Size	H:23.2 ,V:1.2 [mm]
Result	-	Area	22.8 [mm2]
Inspection level	5/5,5/5,5/5,5/5,5/5	Label	-
Light	6,6,3/6,6,3
