# Inspection Result (Individual Data)

Lot number : 4

Inspected date : 2023/8/10 上午 10:55:13 ~ 2023/8/10 下午 12:12:08

商品名	標準透明6-6-3	周長
顧客名		Ex1
CODE番号		Ex2
基材		Ex3

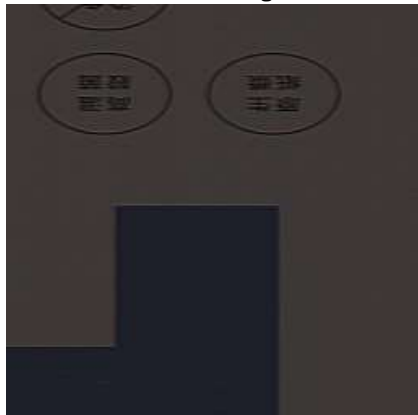
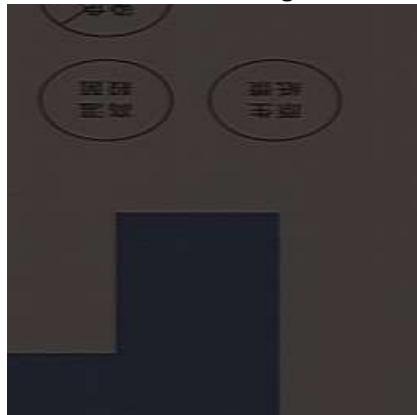
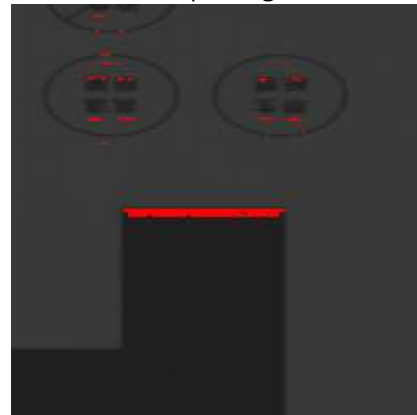
Defect image

No.	#10, \$7	Date	2023/8/10 上午 11:02:26
Segment	1	Camera	1
Pattern	742	Position[ x, y ]	435.2 [mm], 563.7 [m], ( 5330.6 [m] )
Type	点状疵点	Size	H:24.2 ,V:0.8 [mm]
Result	-	Area	11.9 [mm2]
Inspection level	5/5,5/5,5/5,5/5,5/5	Label	-
Light	6,6,3/6,6,3

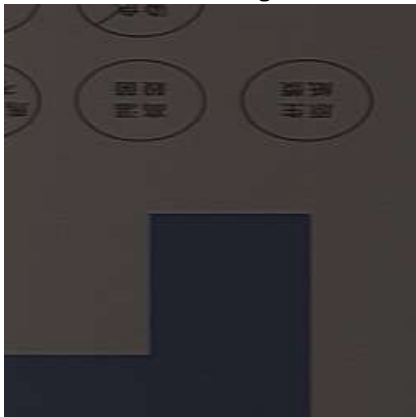
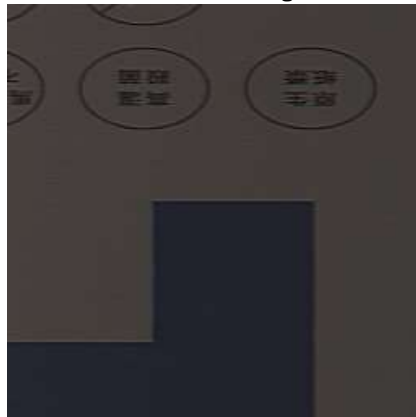
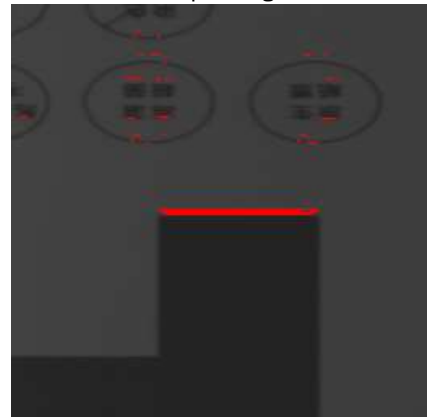
Defect image

No.	#10, \$7	Date	2023/8/10 上午 11:02:26
Segment	1	Camera	1
Pattern	742	Position[ x, y ]	114.4 [mm], 563.7 [m], ( 5330.6 [m] )
Type	点状疵点	Size	H:22.7 ,V:0.8 [mm]
Result	-	Area	17.0 [mm2]
Inspection level	5/5,5/5,5/5,5/5,5/5	Label	-
Light	6,6,3/6,6,3

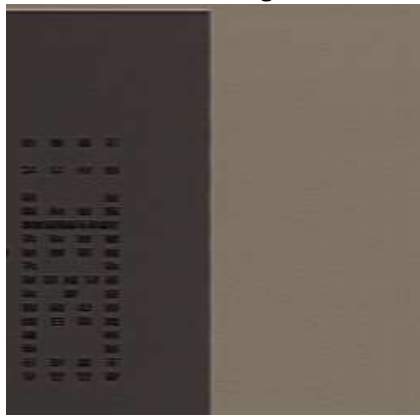
Defect image

No.	#7, \$6	Date	2023/8/10 上午 11:00:29
Segment	1	Camera	1
Pattern	542	Position[ x, y ]	564.3 [mm], 413.2 [m], ( 5481.0 [m] )
Type	点状疵点縱向刀絲疵點	Size	H:2.2 ,V:329.2 [mm]
Result	-	Area	169.8 [mm2]
Inspection level	5/5,5/5,5/5,5/5,5/5	Label	-
Light	6,6,3/6,6,3

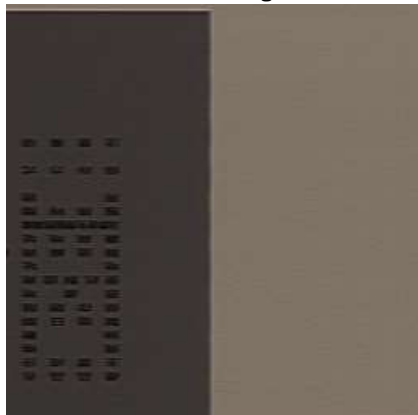
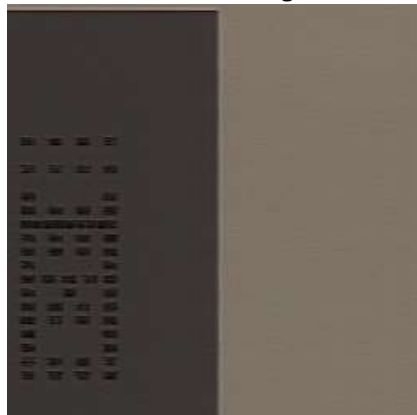
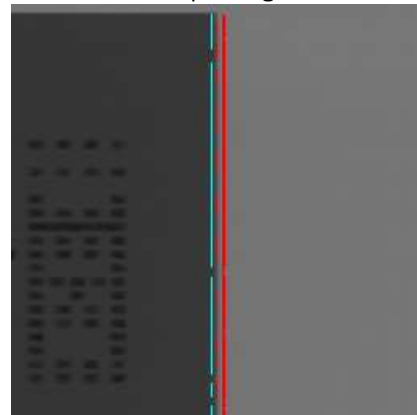
No.	#6, \$5	Date	2023/8/10 上午 11:00:29
Segment	1	Camera	1
Pattern	541	Position[ x, y ]	373.2 [mm], 412.8 [m], ( 5481.5 [m] )
Type	点状疵点	Size	H:1.5 ,V:288.4 [mm]
Result	-	Area	94.7 [mm2]
Inspection level	5/5,5/5,5/5,5/5,5/5	Label	-
Light	6,6,3/6,6,3

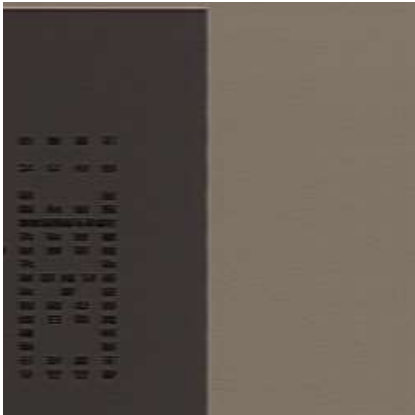
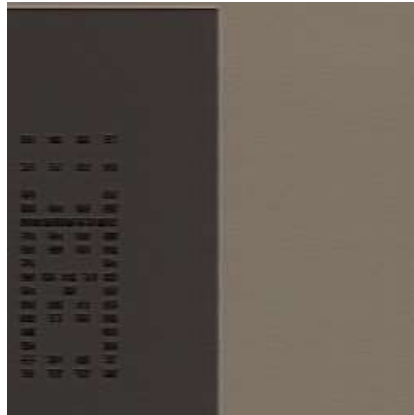
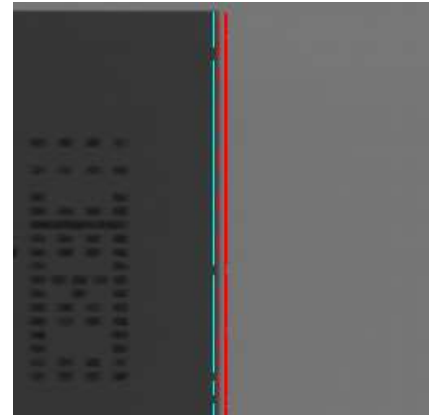
No.	#6, \$5	Date	2023/8/10 上午 11:00:29
Segment	1	Camera	1
Pattern	541	Position[ x, y ]	564.3 [mm], 412.5 [m], ( 5481.7 [m] )
Type	点状疵点縱向刀絲疵點	Size	H:2.2 ,V:176.0 [mm]
Result	-	Area	98.6 [mm2]
Inspection level	5/5,5/5,5/5,5/5,5/5	Label	-
Light	6,6,3/6,6,3

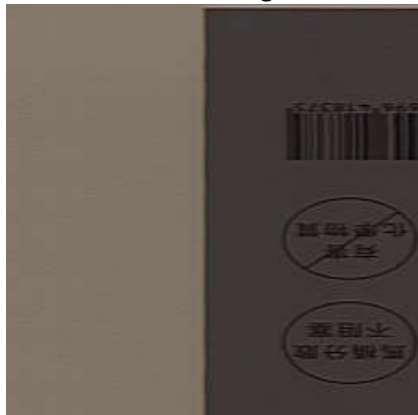
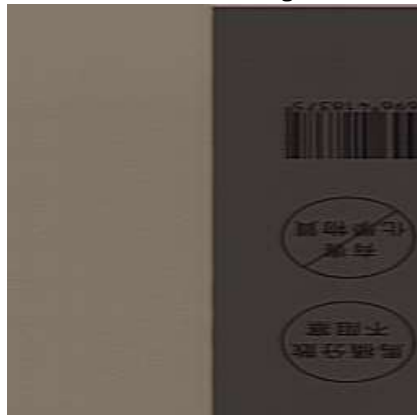
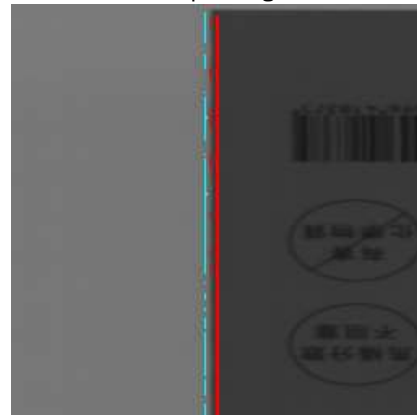
No.	#6, \$5	Date	2023/8/10 上午 11:00:29
Segment	1	Camera	1
Pattern	541	Position[ x, y ]	696.2 [mm], 412.8 [m], ( 5481.5 [m] )
Type	点状疵点縱向刀絲疵點	Size	H:2.4 ,V:356.4 [mm]
Result	-	Area	144.9 [mm2]
Inspection level	5/5,5/5,5/5,5/5,5/5	Label	-
Light	6,6,3/6,6,3

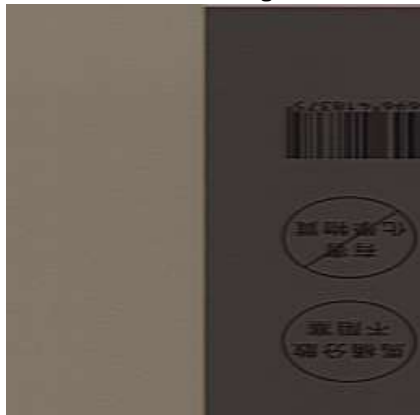
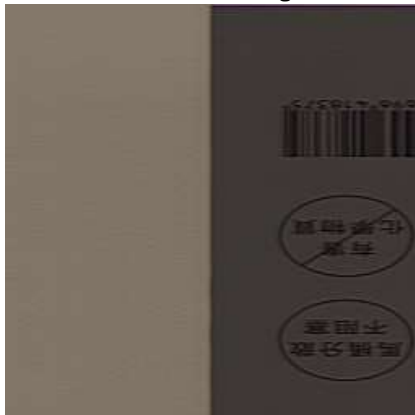
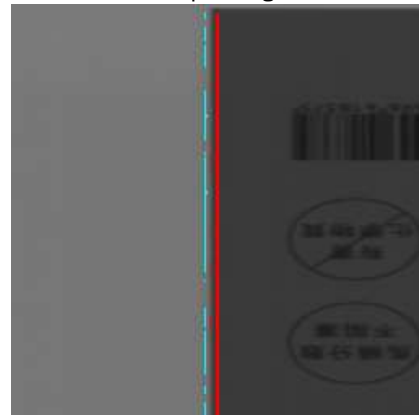
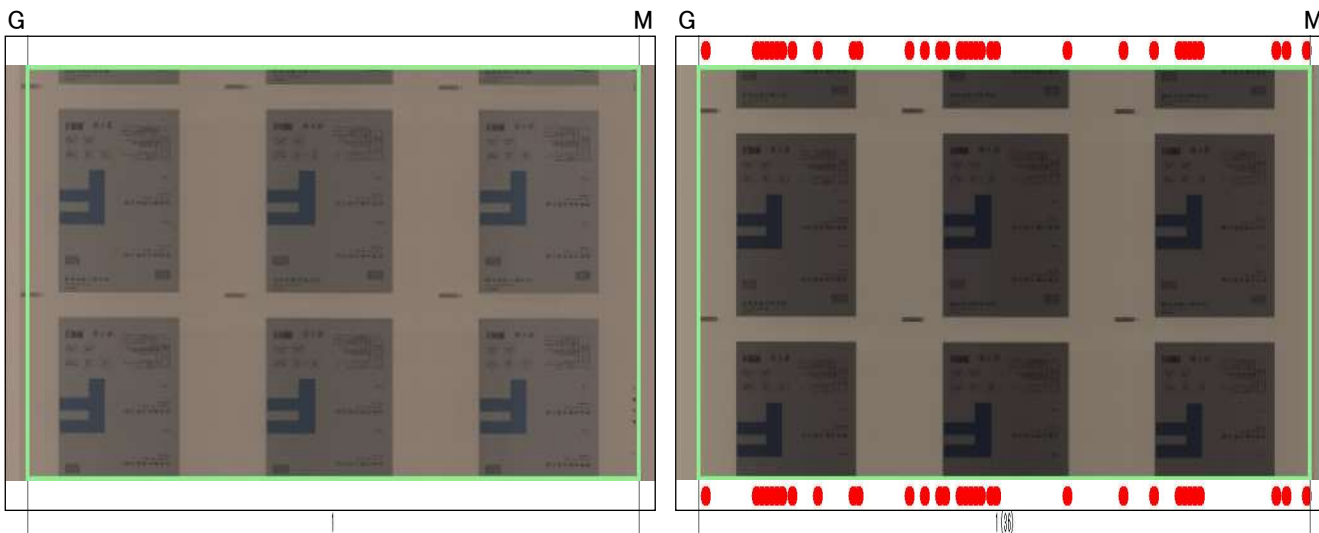
No.	#5, \$4	Date	2023/8/10 上午 11:00:28
Segment	1	Camera	1
Pattern	540	Position[ x, y ]	696.2 [mm], 412.1 [m], ( 5482.2 [m] )
Type	点状疵点縱向刀絲疵點	Size	H:2.4 ,V:270.4 [mm]
Result	-	Area	127.1 [mm2]
Inspection level	5/5,5/5,5/5,5/5,5/5	Label	-
Light	6,6,3/6,6,3

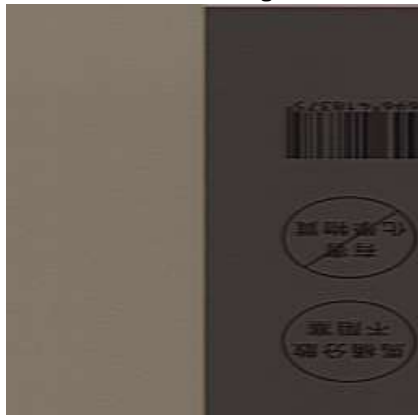
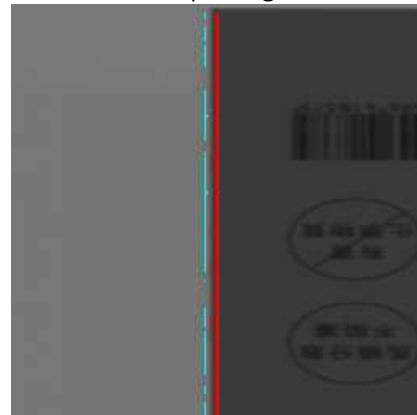
No.	#4, \$3	Date	2023/8/10 上午 11:00:28
Segment	1	Camera	1
Pattern	539	Position[ x, y ]	697.9 [mm], 411.2 [m], ( 5483.1 [m] )
Type	点状疵点	Size	H:0.5 ,V:100.0 [mm]
Result	-	Area	40.4 [mm2]
Inspection level	5/5,5/5,5/5,5/5,5/5	Label	-
Light	6,6,3/6,6,3

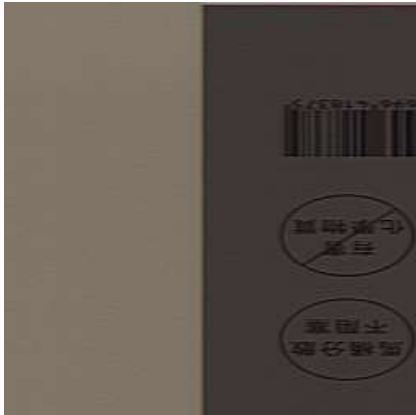
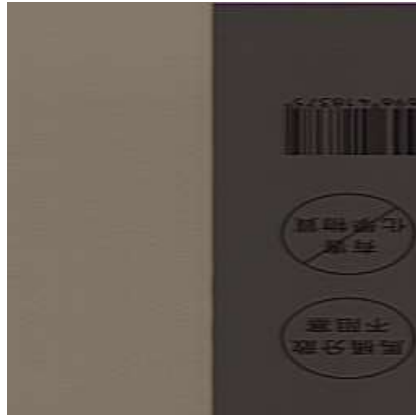
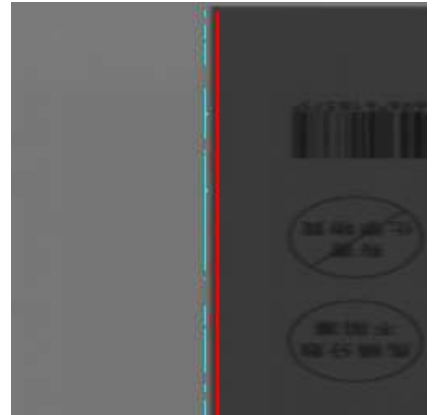
No.	#4, \$3	Date	2023/8/10 上午 11:00:28
Segment	1	Camera	1
Pattern	539	Position[ x, y ]	566.1 [mm], 410.9 [m], ( 5483.4 [m] )
Type	点状疵点	Size	H:1.5 ,V:99.6 [mm]
Result	-	Area	45.0 [mm2]
Inspection level	5/5,5/5,5/5,5/5,5/5	Label	-
Light	6,6,3/6,6,3

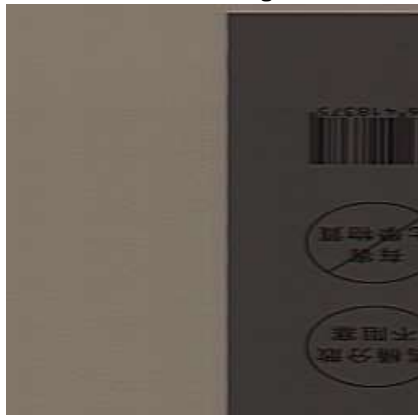
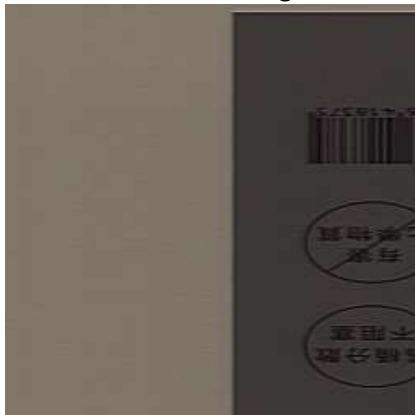
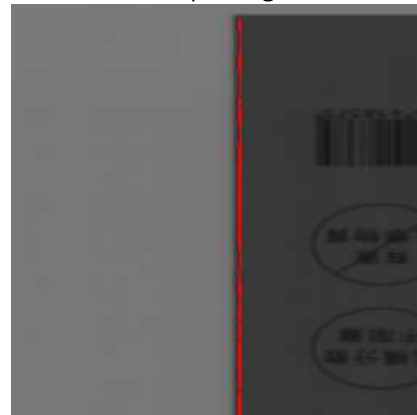
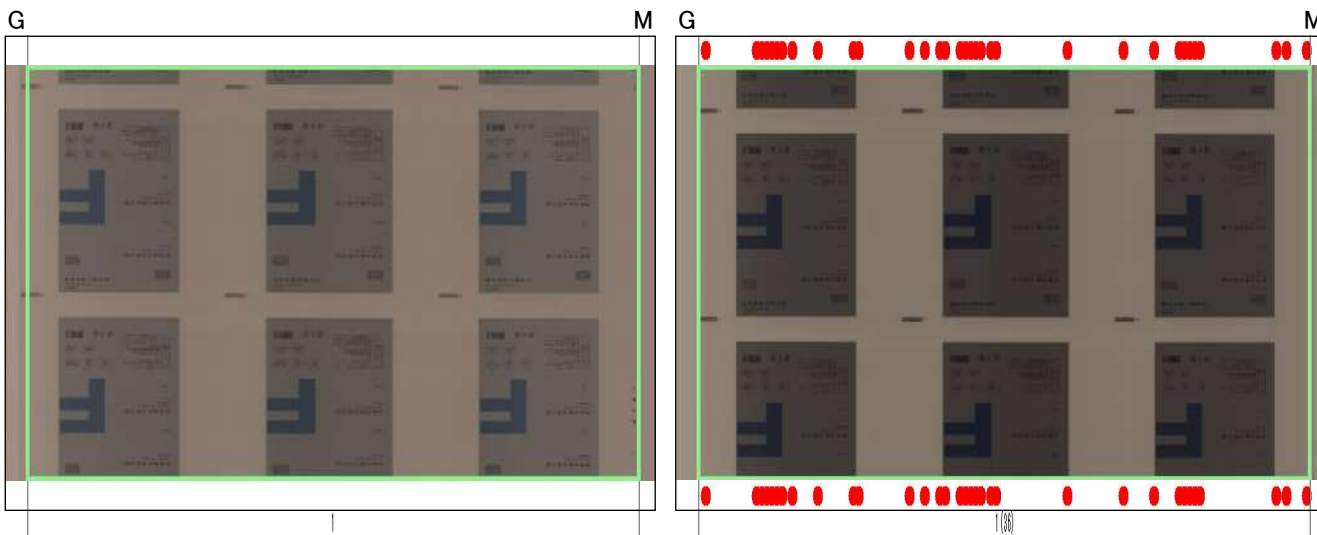
No.	#4, \$3	Date	2023/8/10 上午 11:00:28
Segment	1	Camera	1
Pattern	539	Position[ x, y ]	373.2 [mm], 410.9 [m], ( 5483.4 [m] )
Type	点状疵点	Size	H:0.5 ,V:149.6 [mm]
Result	-	Area	58.2 [mm2]
Inspection level	5/5,5/5,5/5,5/5,5/5	Label	-
Light	6,6,3/6,6,3

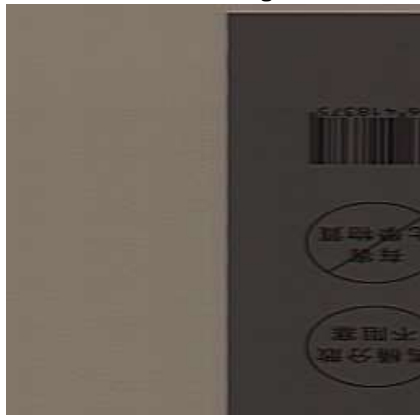
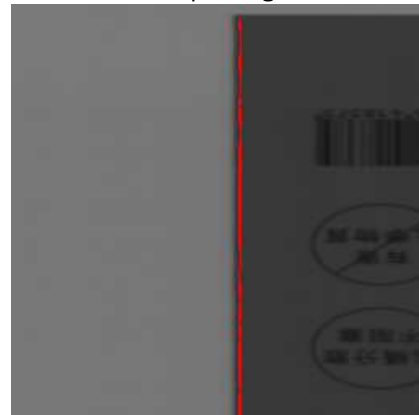
No.	#3, \$2	Date	2023/8/10 上午 11:00:27
Segment	1	Camera	1
Pattern	538	Position[ x, y ]	566.1 [mm], 410.5 [m], ( 5483.8 [m] )
Type	点状疵点	Size	H:0.5 ,V:44.4 [mm]
Result	-	Area	5.2 [mm2]
Inspection level	5/5,5/5,5/5,5/5,5/5	Label	-
Light	6,6,3/6,6,3

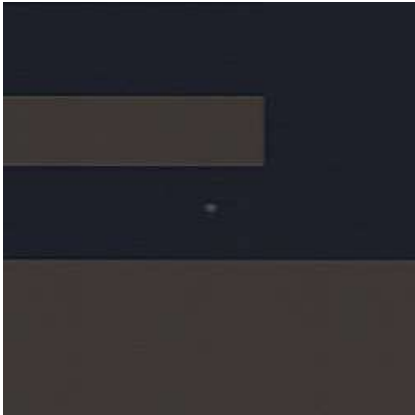
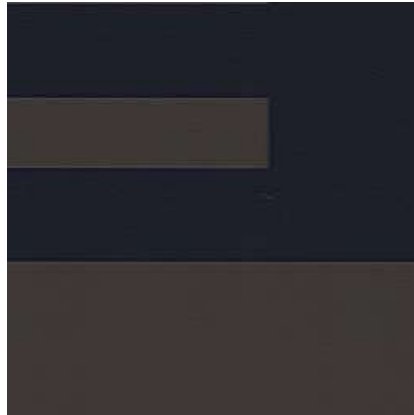
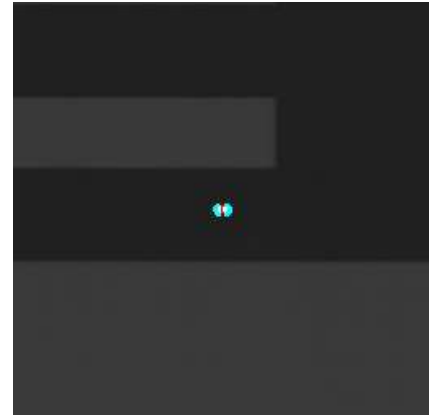
No.	#2, \$1	Date	2023/8/10 上午 10:57:00
Segment	1	Camera	1
Pattern	184	Position[ x, y ]	737.4 [mm], 144.9 [m], ( 5749.3 [m] )
Type	点状疵点縱向刀絲疵點	Size	H:2.9 ,V:2.4 [mm]
Result	-	Area	5.7 [mm2]
Inspection level	5/5,5/5,5/5,5/5,5/5	Label	-
Light	6,6,3/6,6,3
