Inspection Result (Individual Data)

Lot number : 4

商品名	標準透明6-6-3	周長	
顧客名		Ex1	
CODE番号		Ex2	
基材		Ex3

Total defects	26	検査範圍 : 83.6 ~ 1024.2 [mm] 寬度 : 940.6 [mm]
Web length	5749.9 [m]	參照更新 : 週期10<平時>/週期10<平時>
Segments	1 (從左側)

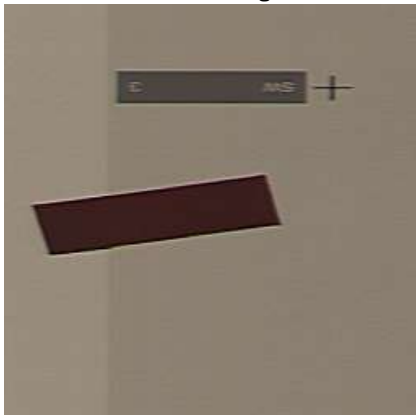
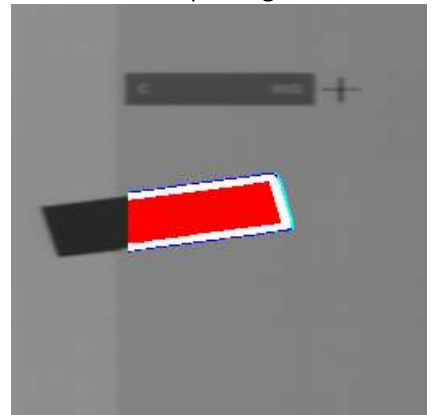
Defect image

No.	#35, \$26	Date	2023/8/9 下午 12:59:21
Segment	1	Camera	1
Pattern	7645	Position[x, y]	12.6 [mm], 5748.0 [m], (1.9 [m])
Type	点状疵点縱向刀絲疵點橫向刀絲	Size	H:24.9 ,V:18.8 [mm]
Result	-	Area	316.8 [mm2]
Inspection level	5/5,5/5,5/5,5/5,5/5	Label	-
Light	6,6,3/6,6,3

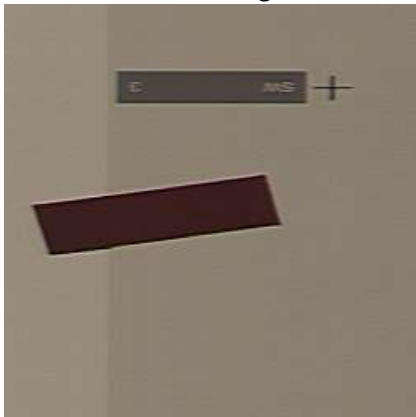
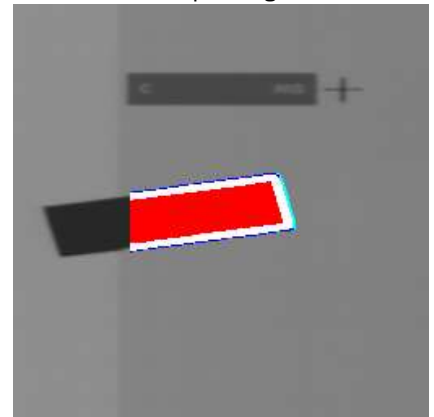
Defect image

No.	#32, \$25	Date	2023/8/9 下午 12:58:34
Segment	1	Camera	1
Pattern	7568	Position[x, y]	443.2 [mm], 5690.3 [m], (59.6 [m])
Type	縱向刀絲疵點	Size	H:36.9 ,V:180.0 [mm]
Result	-	Area	70.3 [mm2]
Inspection level	5/5,5/5,5/5,5/5,5/5	Label	-
Light	6,6,3/6,6,3

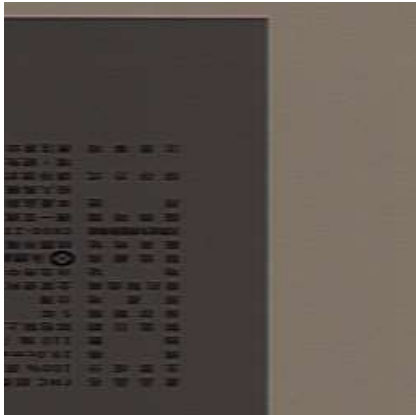
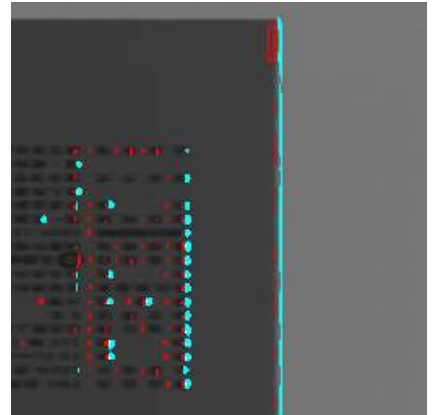
Defect image

No.	#32, \$25	Date	2023/8/9 下午 12:58:34
Segment	1	Camera	1
Pattern	7568	Position[x, y]	870.0 [mm], 5690.3 [m], (59.5 [m])
Type	点状疵点縱向刀絲疵點	Size	H:26.1 ,V:218.4 [mm]
Result	-	Area	92.2 [mm2]
Inspection level	5/5,5/5,5/5,5/5,5/5	Label	-
Light	6,6,3/6,6,3

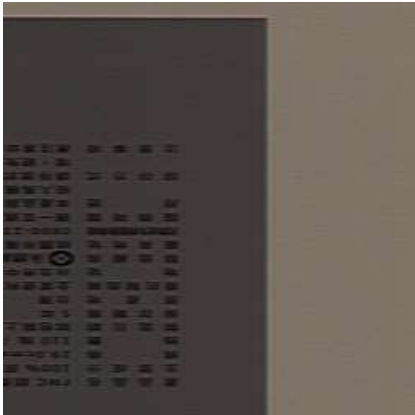
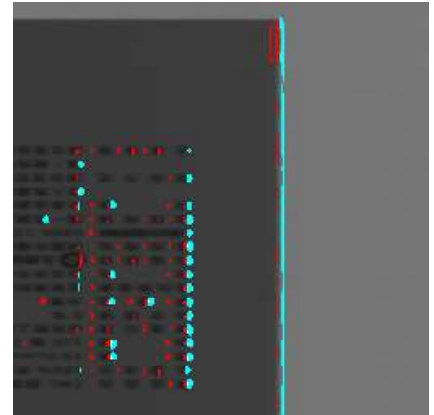
Defect image

No.	#31, \$24	Date	2023/8/9 下午 12:58:34
Segment	1	Camera	1
Pattern	7567	Position[x, y]	766.7 [mm], 5689.5 [m], (60.3 [m])
Type	縱向刀絲疵點	Size	H:35.9 ,V:181.2 [mm]
Result	-	Area	79.9 [mm2]
Inspection level	5/5,5/5,5/5,5/5,5/5	Label	-
Light	6,6,3/6,6,3

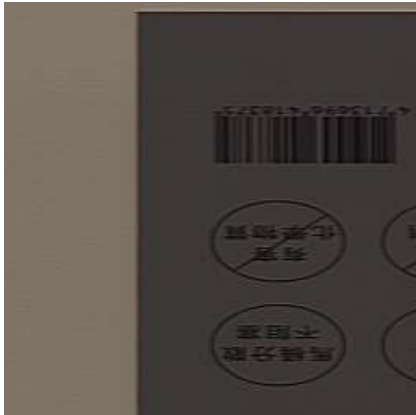
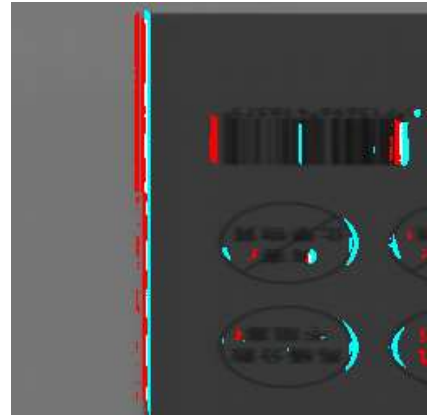
Defect image

No.	#31, \$24	Date	2023/8/9 下午 12:58:34
Segment	1	Camera	1
Pattern	7567	Position[x, y]	703.5 [mm], 5689.6 [m], (60.3 [m])
Type	点状疵点縱向刀絲疵點	Size	H:27.3 ,V:392.8 [mm]
Result	-	Area	114.0 [mm2]
Inspection level	5/5,5/5,5/5,5/5,5/5	Label	-
Light	6,6,3/6,6,3

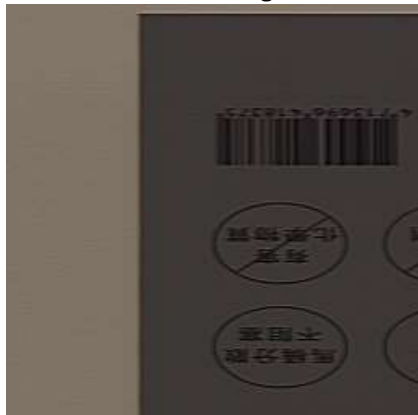
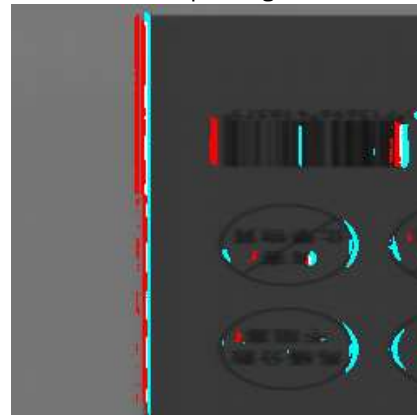
Defect image

No.	#30, \$23	Date	2023/8/9 下午 12:58:33
Segment	1	Camera	1
Pattern	7566	Position[x, y]	555.3 [mm], 5688.8 [m], (61.0 [m])
Type	点状疵点縱向刀絲疵點	Size	H:28.3 ,V:446.0 [mm]
Result	-	Area	136.0 [mm2]
Inspection level	5/5,5/5,5/5,5/5,5/5	Label	-
Light	6,6,3/6,6,3

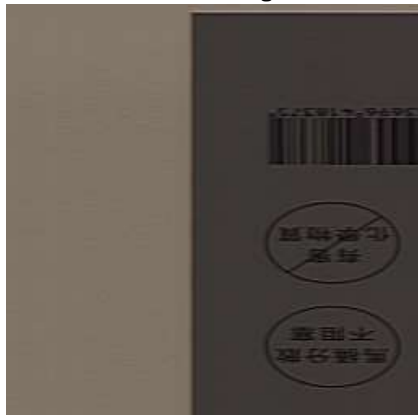
Defect image

No.	#30, \$23	Date	2023/8/9 下午 12:58:33
Segment	1	Camera	1
Pattern	7566	Position[x, y]	698.6 [mm], 5688.8 [m], (61.1 [m])
Type	点状疵点縱向刀絲疵點	Size	H:4.2 ,V:324.8 [mm]
Result	-	Area	169.8 [mm2]
Inspection level	5/5,5/5,5/5,5/5,5/5	Label	-
Light	6,6,3/6,6,3

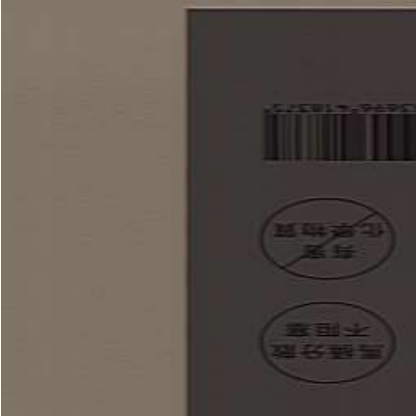
Defect image	Reference image	Shape image

No.	#29, \$22	Date	2023/8/9 下午 12:58:33
Segment	1	Camera	1
Pattern	7565	Position[x, y]	764.0 [mm], 5688.0 [m], (61.8 [m])
Type	縱向刀絲疵點	Size	H:35.6 ,V:180.4 [mm]
Result	-	Area	95.7 [mm2]
Inspection level	5/5,5/5,5/5,5/5,5/5	Label	-
Light	6,6,3/6,6,3

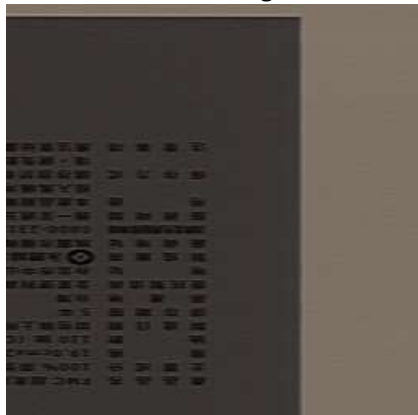
Defect image

No.	#29, \$22	Date	2023/8/9 下午 12:58:33
Segment	1	Camera	1
Pattern	7565	Position[x, y]	554.3 [mm], 5688.1 [m], (61.8 [m])
Type	点状疵点縱向刀絲疵點	Size	H:28.1 ,V:418.4 [mm]
Result	-	Area	146.3 [mm2]
Inspection level	5/5,5/5,5/5,5/5,5/5	Label	-
Light	6,6,3/6,6,3

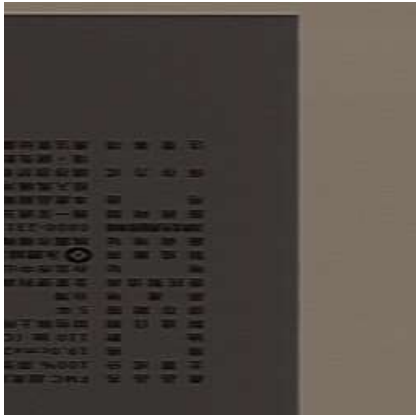
Defect image

No.	#28, \$21	Date	2023/8/9 下午 12:58:32
Segment	1	Camera	1
Pattern	7564	Position[x, y]	698.3 [mm], 5687.3 [m], (62.6 [m])
Type	点状疵点縱向刀絲疵點	Size	H:4.4 ,V:430.8 [mm]
Result	-	Area	163.6 [mm2]
Inspection level	5/5,5/5,5/5,5,5/5,5/5	Label	-
Light	6,6,3/6,6,3

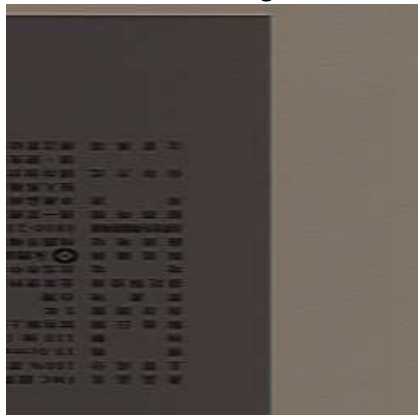
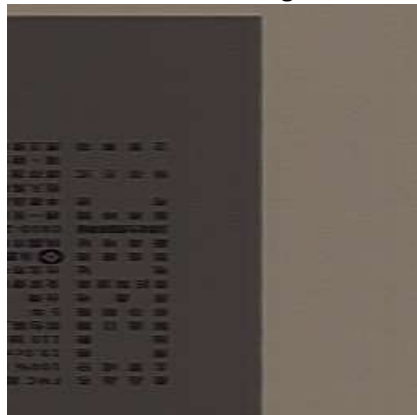
Defect image

No.	#26, \$20	Date	2023/8/9 下午 12:53:10
Segment	1	Camera	1
Pattern	7425	Position[x, y]	459.8 [mm], 5581.3 [m], (168.6 [m])
Type	点状疵点縱向刀絲疵點橫向刀絲	Size	H:192.6 ,V:79.2 [mm]
Result	-	Area	269.6 [mm2]
Inspection level	5/5,5/5,5/5,5/5,5/5	Label	-
Light	6,6,3/6,6,3

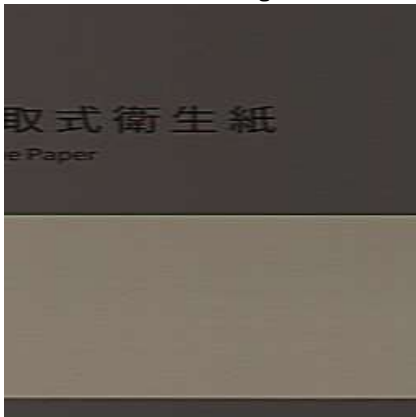
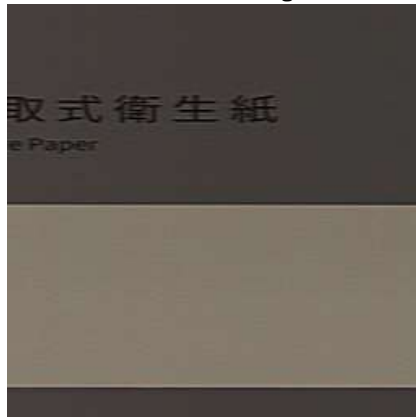
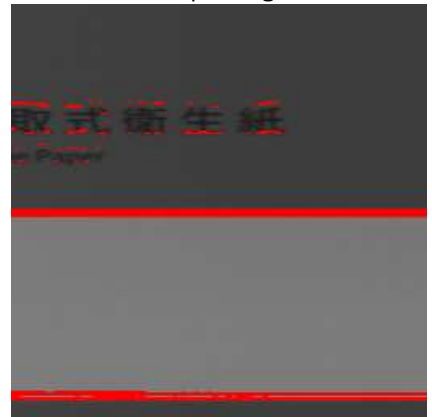
Defect image

No.	#24, \$19	Date	2023/8/9 下午 12:48:41
Segment	1	Camera	1
Pattern	7424	Position[x, y]	125.6 [mm], 5580.4 [m], (169.4 [m])
Type	点状疵点	Size	H:108.2 ,V:1.6 [mm]
Result	-	Area	123.0 [mm2]
Inspection level	5/5,5/5,5/5,5/5,5/5	Label	-
Light	6,6,3/6,6,3

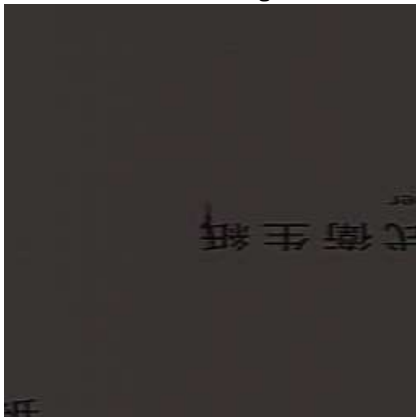
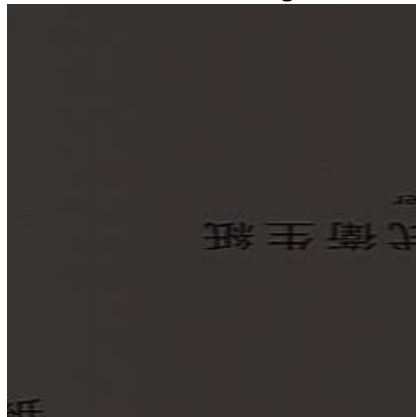
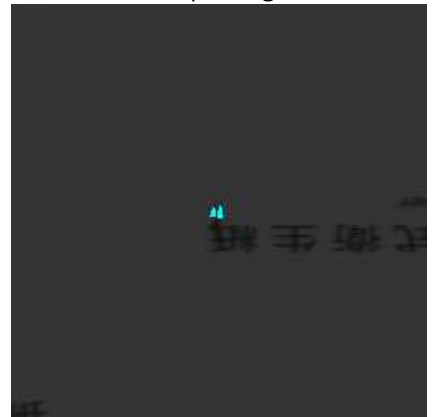
Defect image

No.	#21, \$16	Date	2023/8/9 下午 12:35:53
Segment	1	Camera	1
Pattern	6154	Position[x, y]	482.0 [mm], 4627.4 [m], (1122.5 [m])
Type	縱向刀絲疵點	Size	H:1.7 ,V:2.4 [mm]
Result	-	Area	2.6 [mm2]
Inspection level	5/5,5/5,5/5,5/5,5/5	Label	-
Light	6,6,3/6,6,3

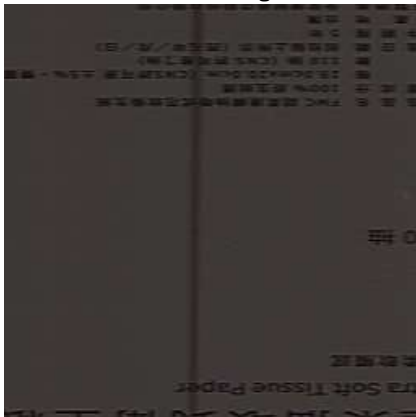
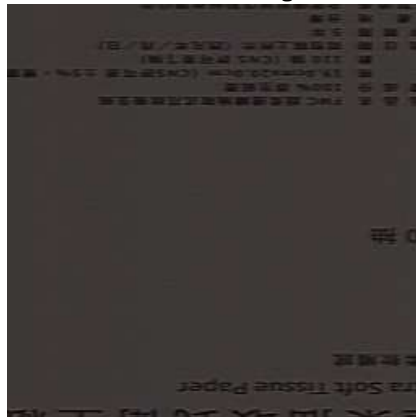
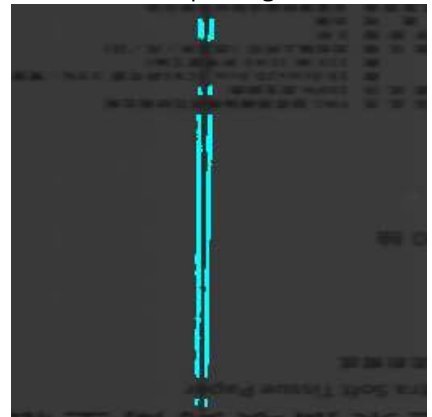
Defect image

No.	#20, \$15	Date	2023/8/9 下午 12:28:40
Segment	1	Camera	1
Pattern	5437	Position[x, y]	831.4 [mm], 4088.4 [m], (1661.4 [m])
Type	縱向刀絲疵點	Size	H:2.9 ,V:94.8 [mm]
Result	-	Area	101.2 [mm2]
Inspection level	5/5,5/5,5/5,5/5,5/5	Label	-
Light	6,6,3/6,6,3

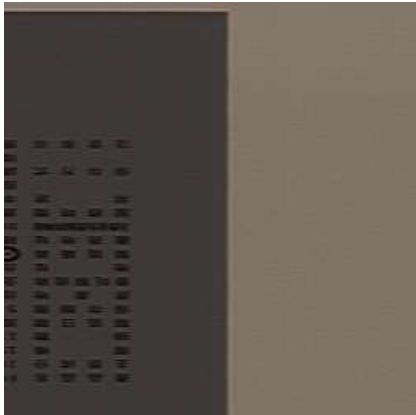
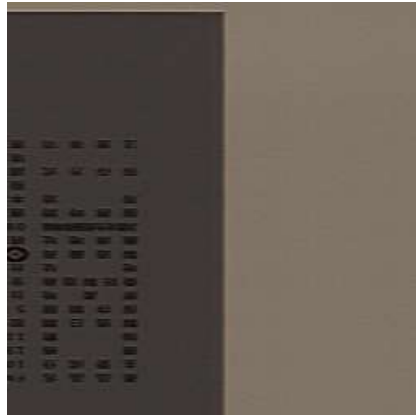
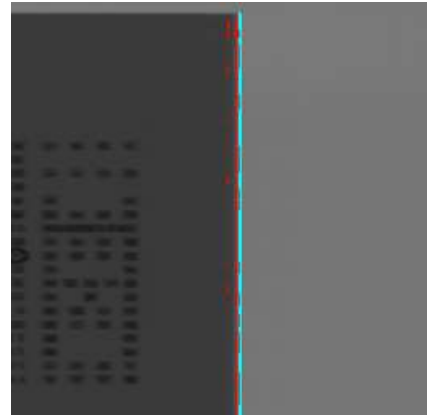
Defect image

No.	#15, \$12	Date	2023/8/9 下午 12:20:42
Segment	1	Camera	1
Pattern	4634	Position[x, y]	243.0 [mm], 3485.6 [m], (2264.2 [m])
Type	点状疵点縱向刀絲疵點	Size	H:2.2 ,V:808.0 [mm]
Result	-	Area	116.5 [mm2]
Inspection level	5/5,5/5,5/5,5/5,5/5	Label	-
Light	6,6,3/6,6,3

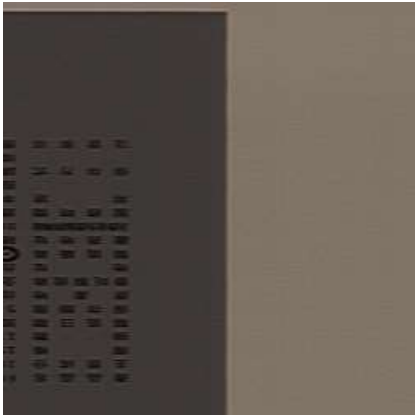
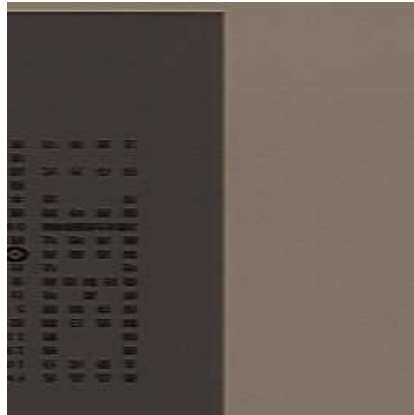
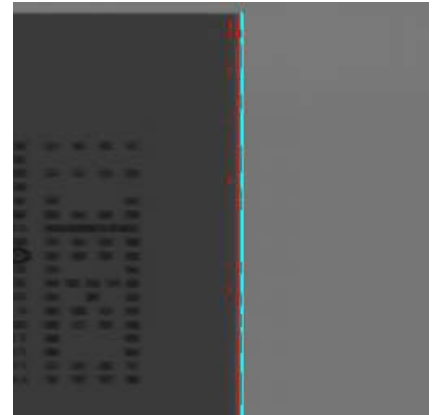
Defect image

No.	#15, \$12	Date	2023/8/9 下午 12:20:42
Segment	1	Camera	1
Pattern	4634	Position[x, y]	700.1 [mm], 3485.6 [m], (2264.3 [m])
Type	点状疵点縱向刀絲疵點	Size	H:1.2 ,V:623.6 [mm]
Result	-	Area	119.0 [mm2]
Inspection level	5/5,5/5,5/5,5/5,5/5	Label	-
Light	6,6,3/6,6,3

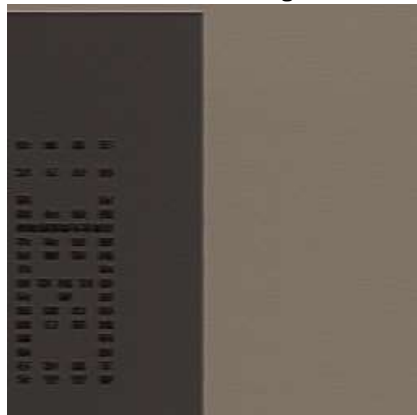
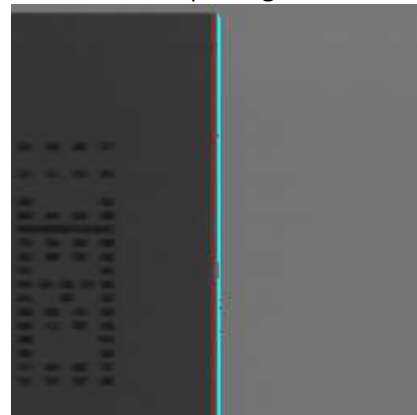
Defect image

No.	#13, \$10	Date	2023/8/9 下午 12:20:41
Segment	1	Camera	1
Pattern	4632	Position[x, y]	568.0 [mm], 3484.1 [m], (2265.7 [m])
Type	点状疵点縱向刀絲疵點	Size	H:1.2 ,V:793.6 [mm]
Result	-	Area	152.8 [mm2]
Inspection level	5/5,5/5,5/5,5/5,5/5	Label	-
Light	6,6,3/6,6,3

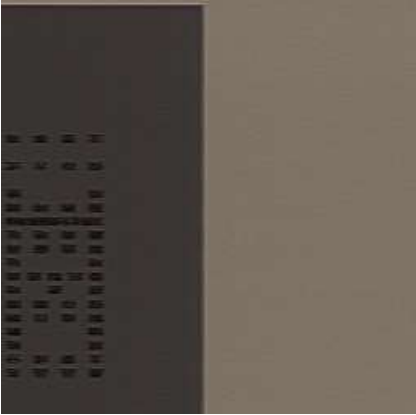
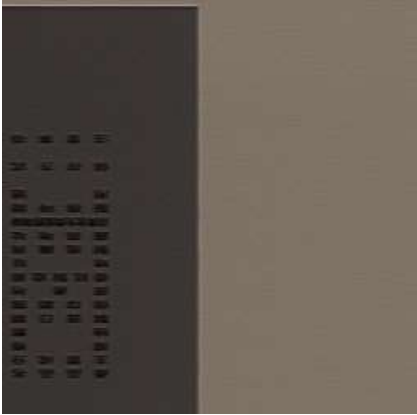
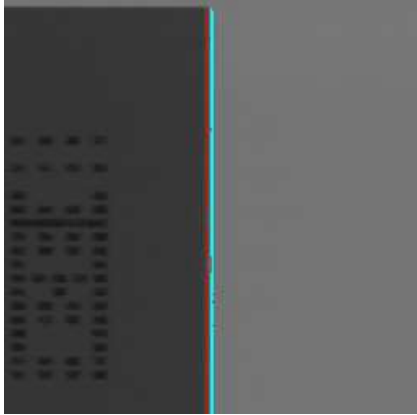
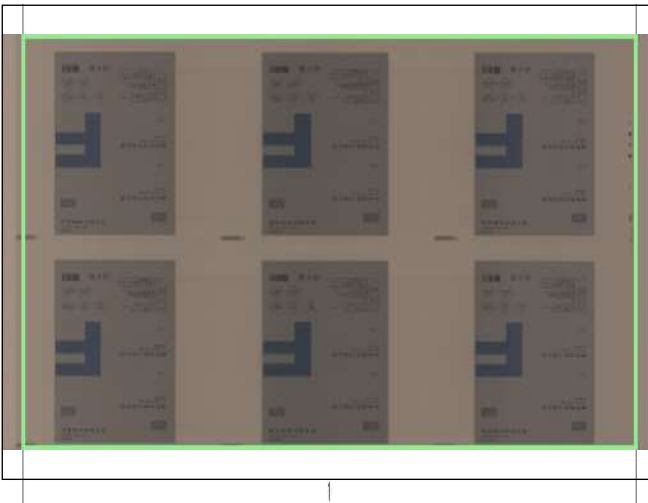
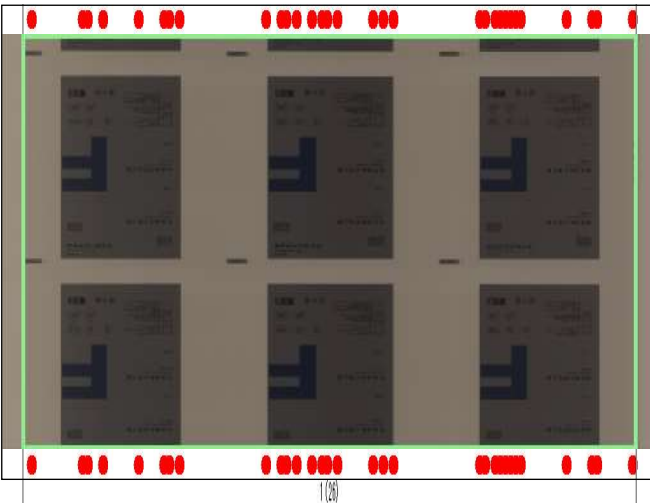
Defect image	Reference image	Shape image

No.	#12, \$9	Date	2023/8/9 下午 12:20:40
Segment	1	Camera	1
Pattern	4631	Position[x, y]	375.3 [mm], 3483.6 [m], (2266.2 [m])
Type	縱向刀絲疵點	Size	H:0.5 ,V:143.6 [mm]
Result	-	Area	35.5 [mm2]
Inspection level	5/5,5/5,5/5,5/5,5/5	Label	-
Light	6,6,3/6,6,3

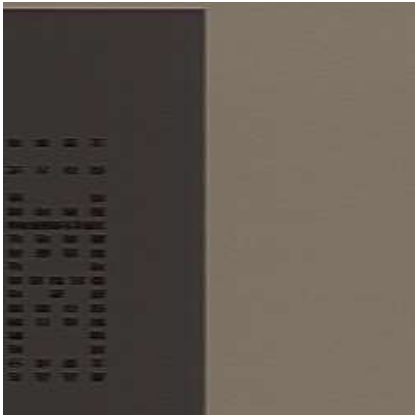
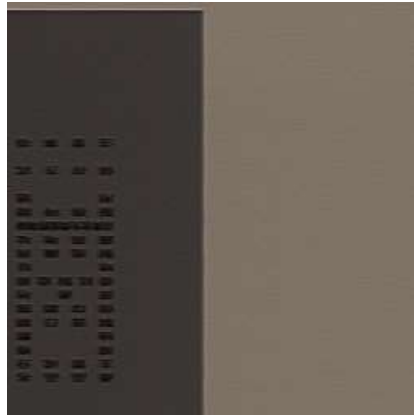
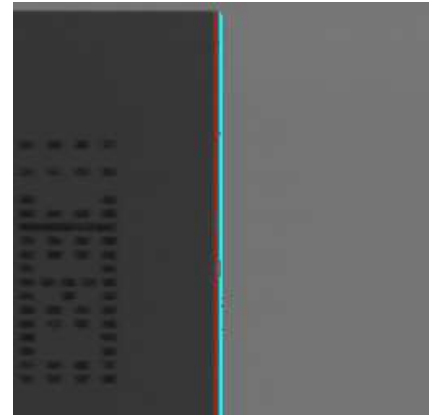
Defect image

No.	#12, \$9	Date	2023/8/9 下午 12:20:40
Segment	1	Camera	1
Pattern	4631	Position[x, y]	700.1 [mm], 3483.7 [m], (2266.1 [m])
Type	点状疵点縱向刀絲疵點	Size	H:1.2 ,V:326.4 [mm]
Result	-	Area	64.1 [mm2]
Inspection level	5/5,5/5,5/5,5/5,5/5	Label	-
Light	6,6,3/6,6,3

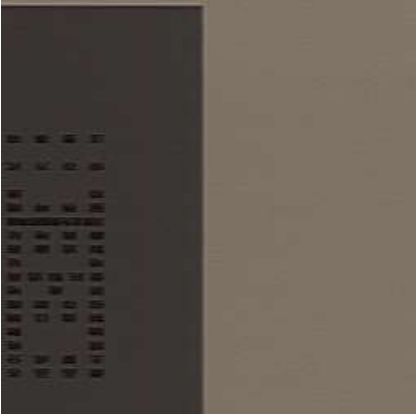
Defect image	Reference image	Shape image

No.	#9, \$8	Date	2023/8/9 下午 12:20:33
Segment	1	Camera	1
Pattern	4618	Position[x, y]	92.9 [mm], 3473.5 [m], (2276.4 [m])
Type	縱向刀絲疵點	Size	H:8.5 ,V:58.8 [mm]
Result	-	Area	7.1 [mm2]
Inspection level	5/5,5/5,5/5,5/5,5/5	Label	-
Light	6,6,3/6,6,3

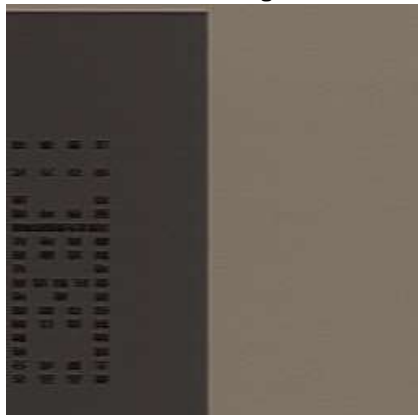
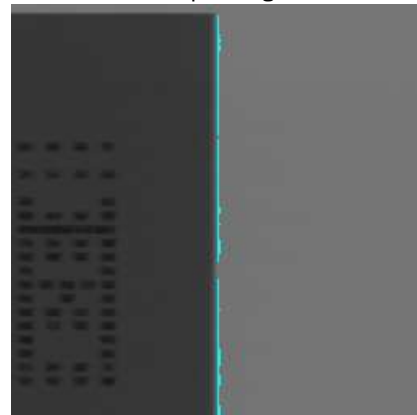
Defect image

No.	#9, \$8	Date	2023/8/9 下午 12:20:33
Segment	1	Camera	1
Pattern	4618	Position[x, y]	96.1 [mm], 3473.8 [m], (2276.0 [m])
Type	点状疵点縱向刀絲疵點	Size	H:2.9 ,V:13.2 [mm]
Result	-	Area	7.4 [mm2]
Inspection level	5/5,5/5,5/5,5/5,5/5	Label	-
Light	6,6,3/6,6,3

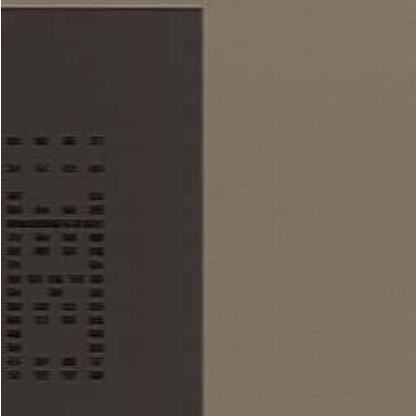
Defect image	Reference image	Shape image

No.	#9, \$8	Date	2023/8/9 下午 12:20:33
Segment	1	Camera	1
Pattern	4618	Position[x, y]	225.0 [mm], 3473.5 [m], (2276.4 [m])
Type	縱向刀絲疵點	Size	H:12.9 ,V:45.2 [mm]
Result	-	Area	8.6 [mm2]
Inspection level	5/5,5/5,5/5,5/5,5/5	Label	-
Light	6,6,3/6,6,3

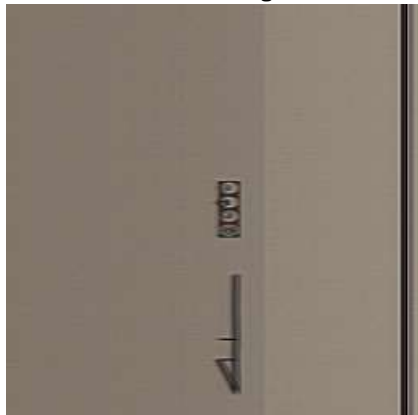
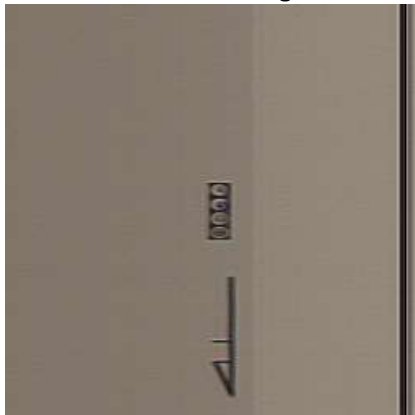
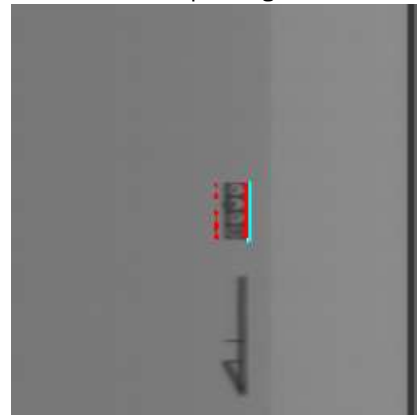
Defect image

No.	#8, \$7	Date	2023/8/9 下午 12:20:32
Segment	1	Camera	1
Pattern	4617	Position[x, y]	415.1 [mm], 3473.1 [m], (2276.8 [m])
Type	縱向刀絲疵點	Size	H:2.7 ,V:13.2 [mm]
Result	-	Area	6.7 [mm2]
Inspection level	5/5,5/5,5/5,5/5,5/5	Label	-
Light	6,6,3/6,6,3

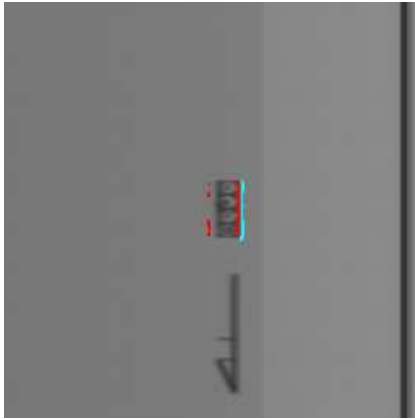
Defect image	Reference image	Shape image

No.	#6, \$5	Date	2023/8/9 下午 12:20:31
Segment	1	Camera	1
Pattern	4615	Position[x, y]	939.6 [mm], 3471.5 [m], (2278.4 [m])
Type	点状疵点縱向刀絲疵點	Size	H:1.0 ,V:14.0 [mm]
Result	-	Area	3.7 [mm2]
Inspection level	5/5,5/5,5/5,5/5,5/5	Label	-
Light	6,6,3/6,6,3

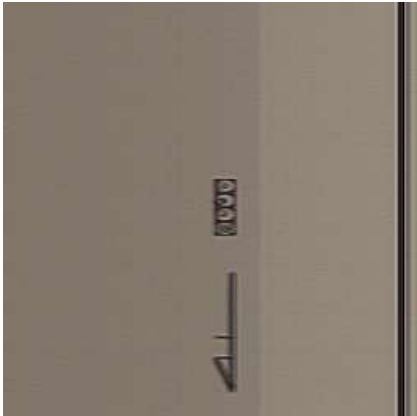
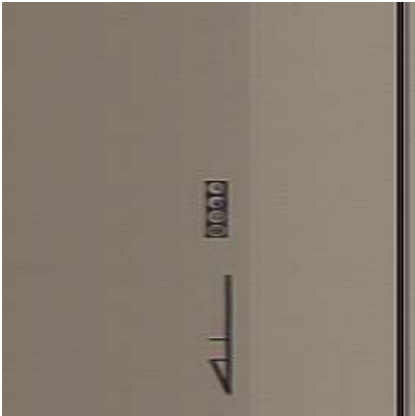
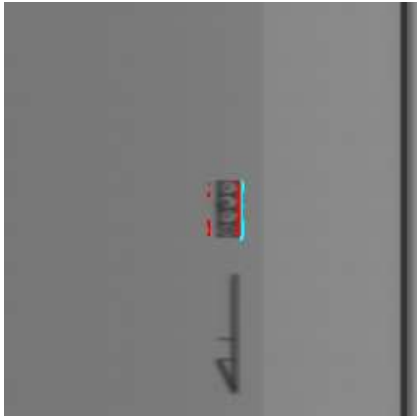
No.	#6, \$5	Date	2023/8/9 下午 12:20:31
Segment	1	Camera	1
Pattern	4615	Position[x, y]	723.5 [mm], 3471.6 [m], (2278.3 [m])
Type	縱向刀絲疵點	Size	H:0.5 ,V:8.4 [mm]
Result	-	Area	3.9 [mm2]
Inspection level	5/5,5/5,5/5,5/5,5/5	Label	-
Light	6,6,3/6,6,3

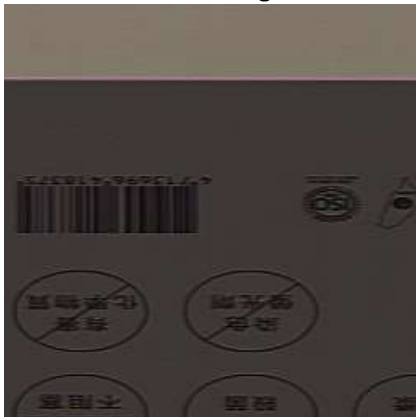
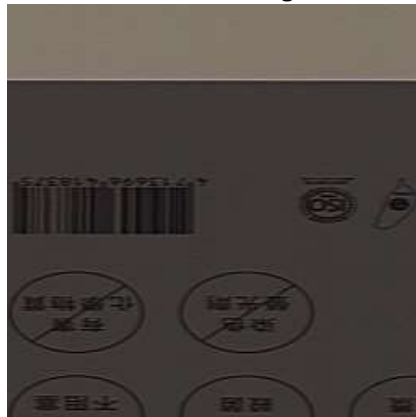
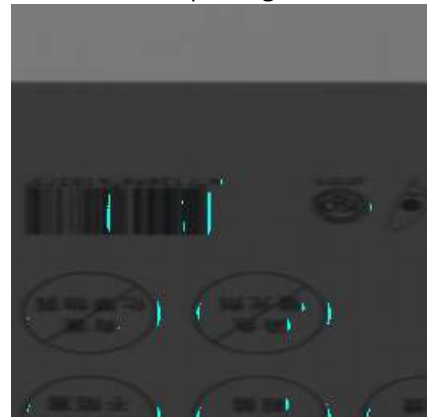
No.	#6, \$5	Date	2023/8/9 下午 12:20:31
Segment	1	Camera	1
Pattern	4615	Position[x, y]	738.6 [mm], 3471.2 [m], (2278.7 [m])
Type	縱向刀絲疵點	Size	H:0.5 ,V:9.2 [mm]
Result	-	Area	4.4 [mm2]
Inspection level	5/5,5/5,5/5,5/5,5/5	Label	-
Light	6,6,3/6,6,3

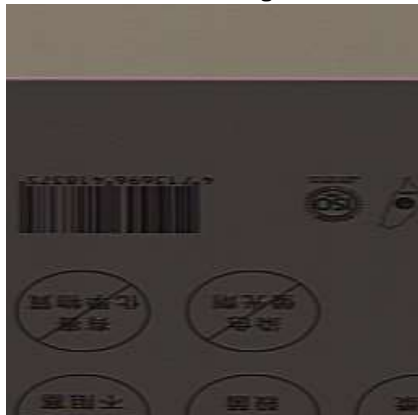
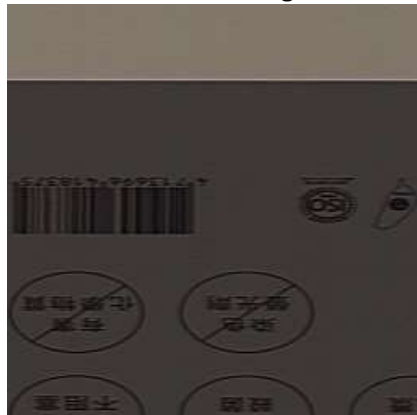
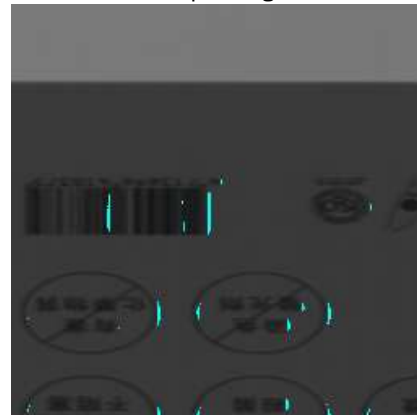
No.	#5, \$4	Date	2023/8/9 下午 12:20:30
Segment	1	Camera	1
Pattern	4614	Position[x, y]	735.7 [mm], 3470.4 [m], (2279.4 [m])
Type	縱向刀絲疵點	Size	H:8.1 ,V:55.6 [mm]
Result	-	Area	3.1 [mm2]
Inspection level	5/5,5/5,5/5,5/5,5/5	Label	-
Light	6,6,3/6,6,3

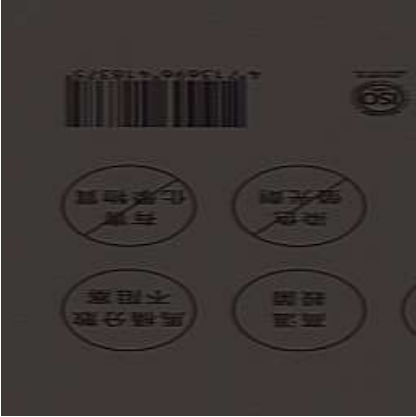
No.	#5, \$4	Date	2023/8/9 下午 12:20:30
Segment	1	Camera	1
Pattern	4614	Position[x, y]	734.7 [mm], 3470.8 [m], (2279.0 [m])
Type	縱向刀絲疵點	Size	H:8.1 ,V:53.6 [mm]
Result	-	Area	4.2 [mm2]
Inspection level	5/5,5/5,5/5,5/5,5/5	Label	-
Light	6,6,3/6,6,3

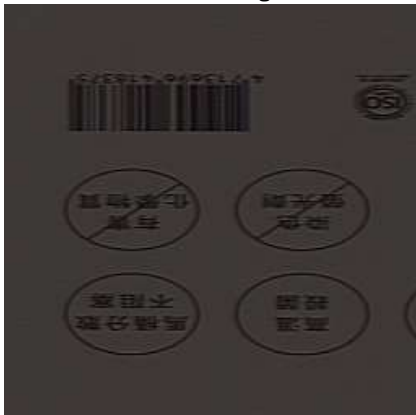
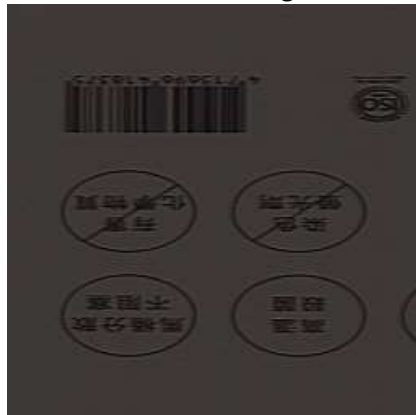
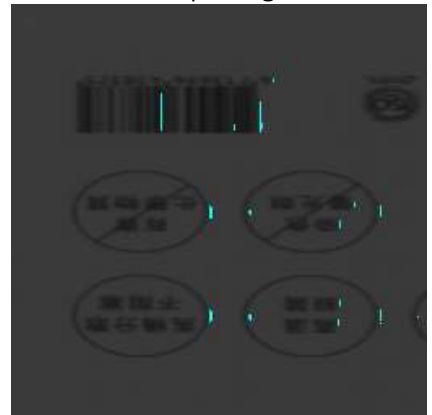
No.	#4, \$3	Date	2023/8/9 下午 12:20:20
Segment	1	Camera	1
Pattern	4596	Position[x, y]	400.7 [mm], 3457.3 [m], (2292.6 [m])
Type	縱向刀絲疵點	Size	H:0.5 ,V:9.6 [mm]
Result	-	Area	3.0 [mm2]
Inspection level	5/5,5/5,5/5,5/5,5/5	Label	-
Light	6,6,3/6,6,3

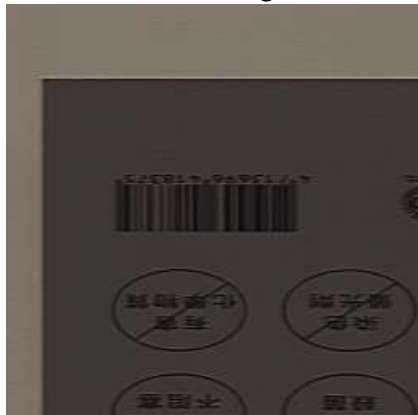
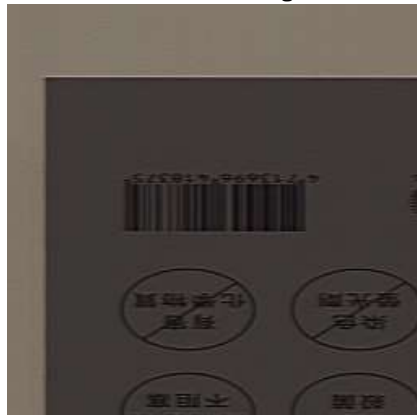
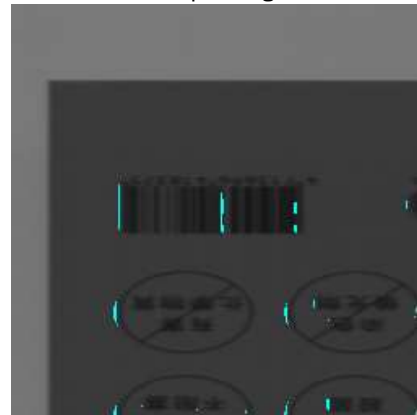
No.	#3, \$2	Date	2023/8/9 下午 12:20:19
Segment	1	Camera	1
Pattern	4595	Position[x, y]	939.3 [mm], 3456.4 [m], (2293.4 [m])
Type	点状疵点	Size	H:0.5 ,V:4.4 [mm]
Result	-	Area	1.5 [mm2]
Inspection level	5/5,5/5,5/5,5/5,5/5	Label	-
Light	6,6,3/6,6,3

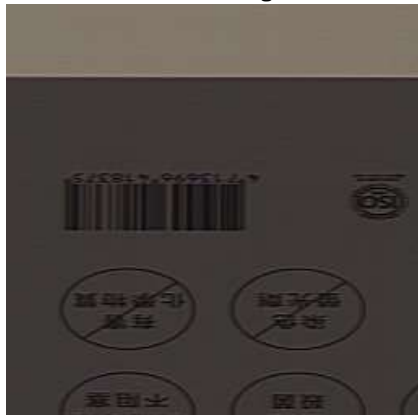
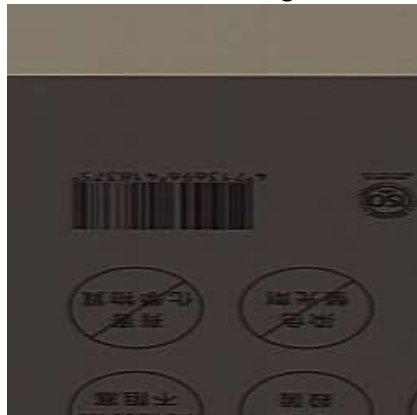
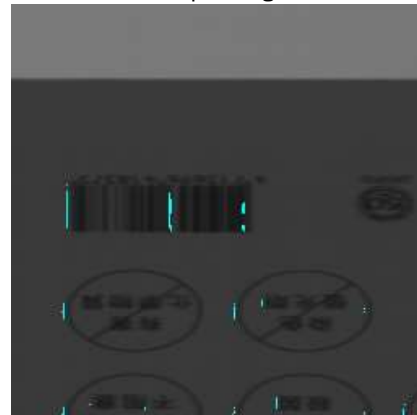
No.	#3, \$2	Date	2023/8/9 下午 12:20:19
Segment	1	Camera	1
Pattern	4595	Position[x, y]	727.6 [mm], 3456.6 [m], (2293.3 [m])
Type	縱向刀絲疵點	Size	H:11.5 ,V:8.4 [mm]
Result	-	Area	3.6 [mm2]
Inspection level	5/5,5/5,5/5,5/5,5/5	Label	-
Light	6,6,3/6,6,3

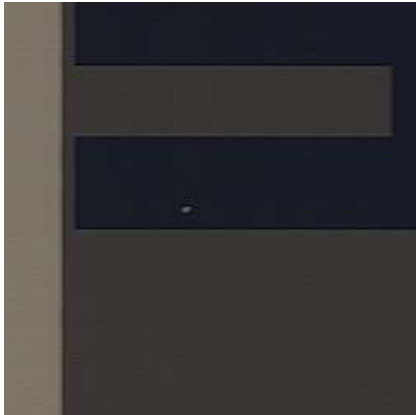
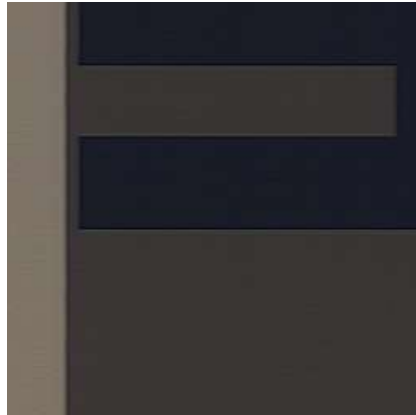
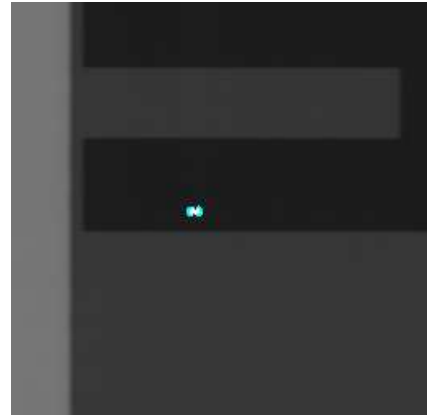
No.	#2, \$1	Date	2023/8/9 上午 11:43:19
Segment	1	Camera	1
Pattern	838	Position[x, y]	392.7 [mm], 636.0 [m], (5113.9 [m])
Type	点状疵点縱向刀絲疵點	Size	H:2.4 ,V:2.0 [mm]
Result	-	Area	4.0 [mm2]
Inspection level	5/5,5/5,5/5,5/5,5/5	Label	-
Light	6,6,3/6,6,3
