# Inspection Result (Individual Data)

Lot number : 3

Inspected date : 2023/8/10 上午 09:15:18 ~ 2023/8/10 上午 10:55:13

商品名	標準透明6-6-3	周長	
顧客名		Ex1	
CODE番号		Ex2	
基材		Ex3

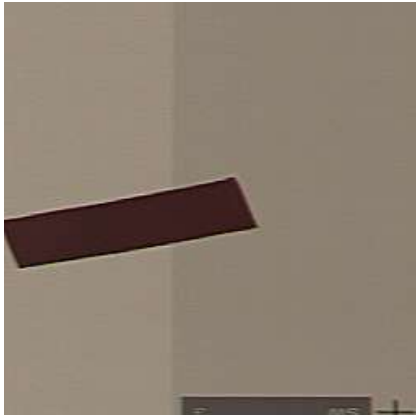
Defect image

No.	#82, \$59	Date	2023/8/10 上午 10:55:05
Segment	1	Camera	1
Pattern	8270	Position[ x, y ]	5.0 [mm], 6221.8 [m], ( 2.4 [m] )
Type	点状疵点縱向刀絲疵點橫向刀絲	Size	H:10.7 ,V:16.4 [mm]
Result	-	Area	122.7 [mm2]
Inspection level	5/5,5/5,5/5,5/5,5/5	Label	-
Light	6,6,3/6,6,3

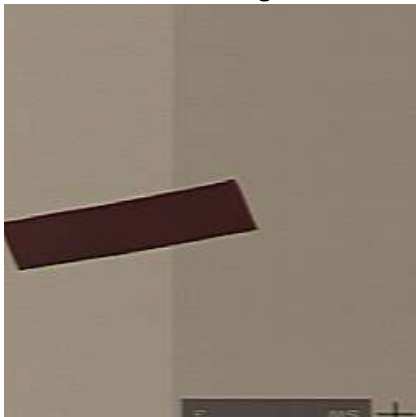
Defect image

No.	#79, \$58	Date	2023/8/10 上午 10:53:50
Segment	1	Camera	1
Pattern	8141	Position[ x, y ]	707.2 [mm], 6124.6 [m], ( 99.5 [m] )
Type	縱向刀絲疵點	Size	H:5.4 ,V:14.0 [mm]
Result	-	Area	8.4 [mm2]
Inspection level	5/5,5/5,5/5,5/5,5/5	Label	-
Light	6,6,3/6,6,3

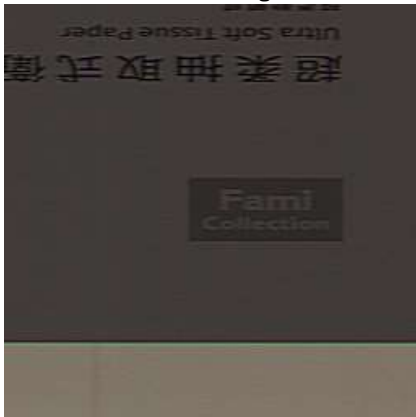
Defect image

No.	#78, \$57	Date	2023/8/10 上午 10:53:49
Segment	1	Camera	1
Pattern	8140	Position[ x, y ]	526.7 [mm], 6123.9 [m], ( 100.3 [m] )
Type	縱向刀絲疵點	Size	H:0.5 ,V:14.0 [mm]
Result	-	Area	5.9 [mm2]
Inspection level	5/5,5/5,5/5,5/5,5/5	Label	-
Light	6,6,3/6,6,3

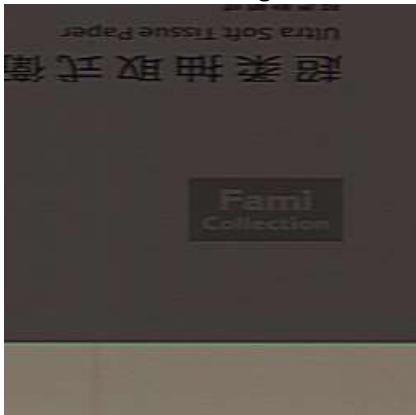
Defect image

No.	#78, \$57	Date	2023/8/10 上午 10:53:49
Segment	1	Camera	1
Pattern	8140	Position[ x, y ]	202.5 [mm], 6123.9 [m], ( 100.3 [m] )
Type	縱向刀絲疵點	Size	H:0.7 ,V:13.6 [mm]
Result	-	Area	6.4 [mm2]
Inspection level	5/5,5/5,5/5,5/5,5/5	Label	-
Light	6,6,3/6,6,3

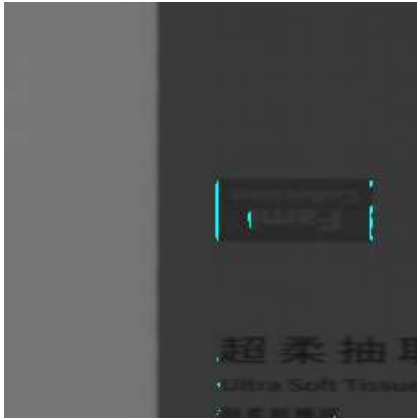
No.	#78, \$57	Date	2023/8/10 上午 10:53:49
Segment	1	Camera	1
Pattern	8140	Position[ x, y ]	706.7 [mm], 6124.3 [m], ( 99.9 [m] )
Type	縱向刀絲疵點	Size	H:0.5 ,V:14.0 [mm]
Result	-	Area	6.6 [mm2]
Inspection level	5/5,5/5,5/5,5,5/5,5/5	Label	-
Light	6,6,3/6,6,3

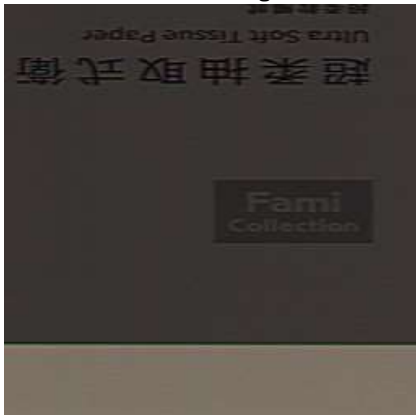
Defect image

No.	#76, \$55	Date	2023/8/10 上午 10:53:48
Segment	1	Camera	1
Pattern	8138	Position[ x, y ]	706.9 [mm], 6122.4 [m], ( 101.8 [m] )
Type	縱向刀絲疵點	Size	H:0.5 ,V:13.2 [mm]
Result	-	Area	3.9 [mm2]
Inspection level	5/5,5/5,5/5,5/5,5/5	Label	-
Light	6,6,3/6,6,3

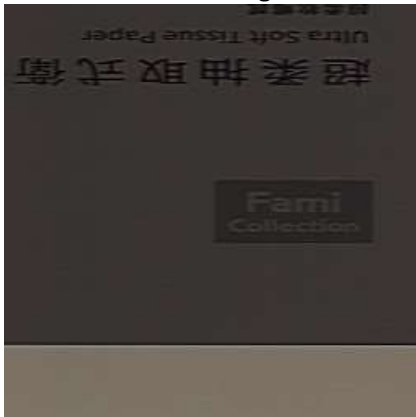
Defect image

No.	#76, \$55	Date	2023/8/10 上午 10:53:48
Segment	1	Camera	1
Pattern	8138	Position[ x, y ]	528.0 [mm], 6122.8 [m], ( 101.4 [m] )
Type	縱向刀絲疵點	Size	H:5.4 ,V:13.2 [mm]
Result	-	Area	5.7 [mm2]
Inspection level	5/5,5/5,5/5,5/5,5/5	Label	-
Light	6,6,3/6,6,3

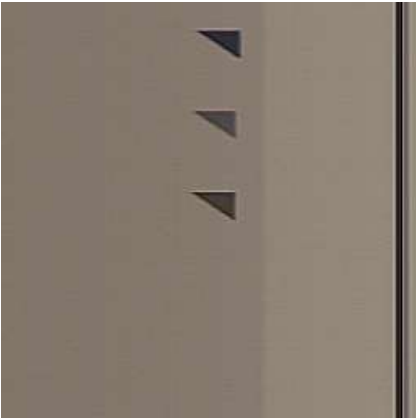
No.	#75, \$54	Date	2023/8/10 上午 10:53:47
Segment	1	Camera	1
Pattern	8137	Position[ x, y ]	937.4 [mm], 6122.3 [m], ( 101.9 [m] )
Type	点状疵点	Size	H:1.2 ,V:4.0 [mm]
Result	-	Area	1.3 [mm2]
Inspection level	5/5,5/5,5/5,5/5,5/5	Label	-
Light	6,6,3/6,6,3

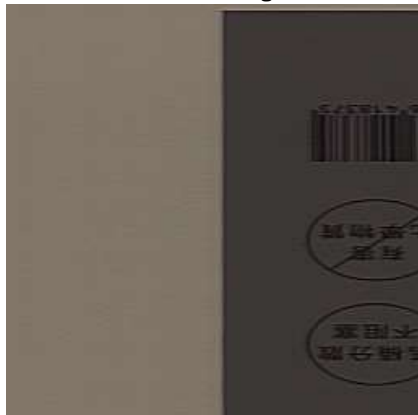
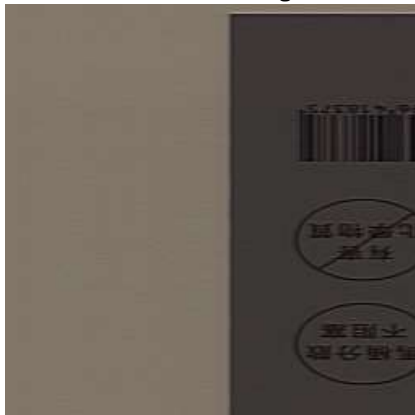
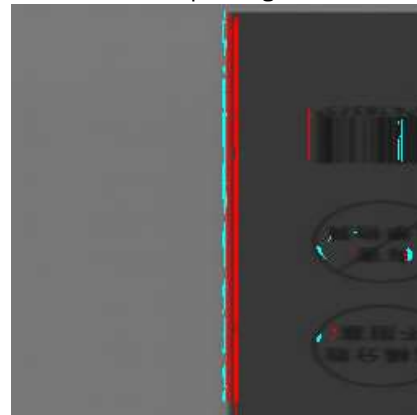
No.	#72, \$53	Date	2023/8/10 上午 10:53:37
Segment	1	Camera	1
Pattern	8119	Position[ x, y ]	371.0 [mm], 6108.3 [m], ( 115.9 [m] )
Type	点状疵点縱向刀絲疵點	Size	H:2.4 ,V:194.4 [mm]
Result	-	Area	122.6 [mm2]
Inspection level	5/5,5/5,5/5,5/5,5/5	Label	-
Light	6,6,3/6,6,3

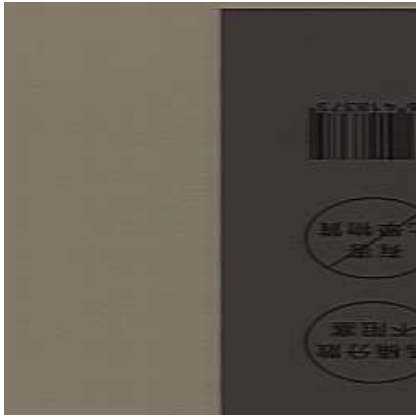
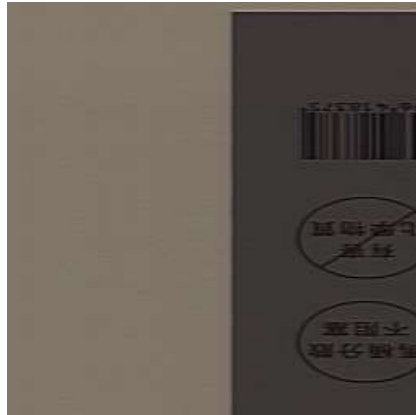
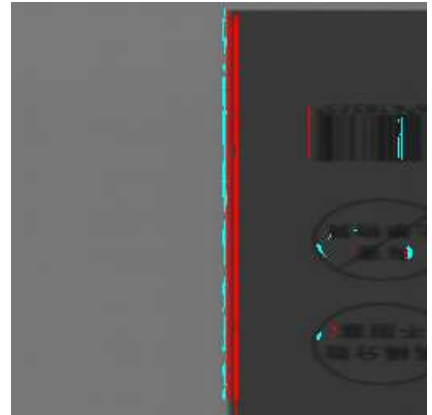
No.	#71, \$52	Date	2023/8/10 上午 10:53:36
Segment	1	Camera	1
Pattern	8118	Position[ x, y ]	371.0 [mm], 6107.5 [m], ( 116.6 [m] )
Type	点状疵点縱向刀絲疵點	Size	H:2.4 ,V:195.6 [mm]
Result	-	Area	145.4 [mm2]
Inspection level	5/5,5/5,5/5,5/5,5/5	Label	-
Light	6,6,3/6,6,3

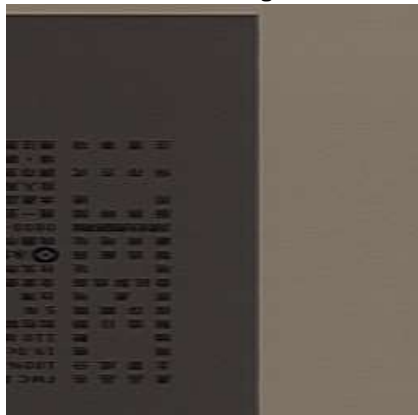
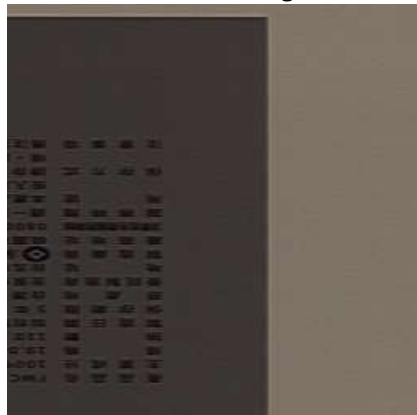
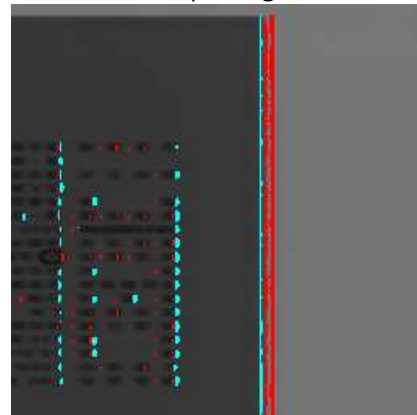
No.	#71, \$52	Date	2023/8/10 上午 10:53:36
Segment	1	Camera	1
Pattern	8118	Position[ x, y ]	559.0 [mm], 6107.6 [m], ( 116.6 [m] )
Type	点状疵点縱向刀絲疵點	Size	H:14.9 ,V:398.0 [mm]
Result	-	Area	247.9 [mm2]
Inspection level	5/5,5/5,5/5,5,5/5,5/5	Label	-
Light	6,6,3/6,6,3

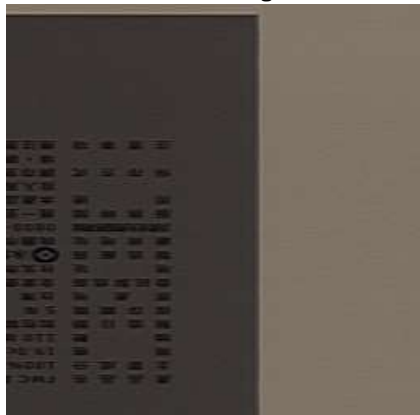
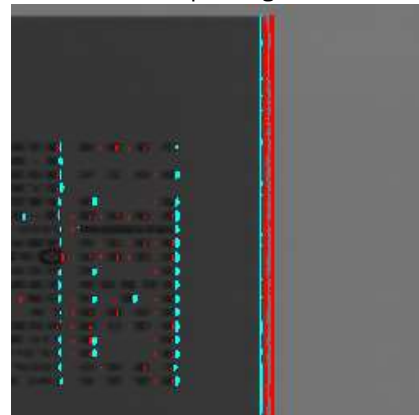
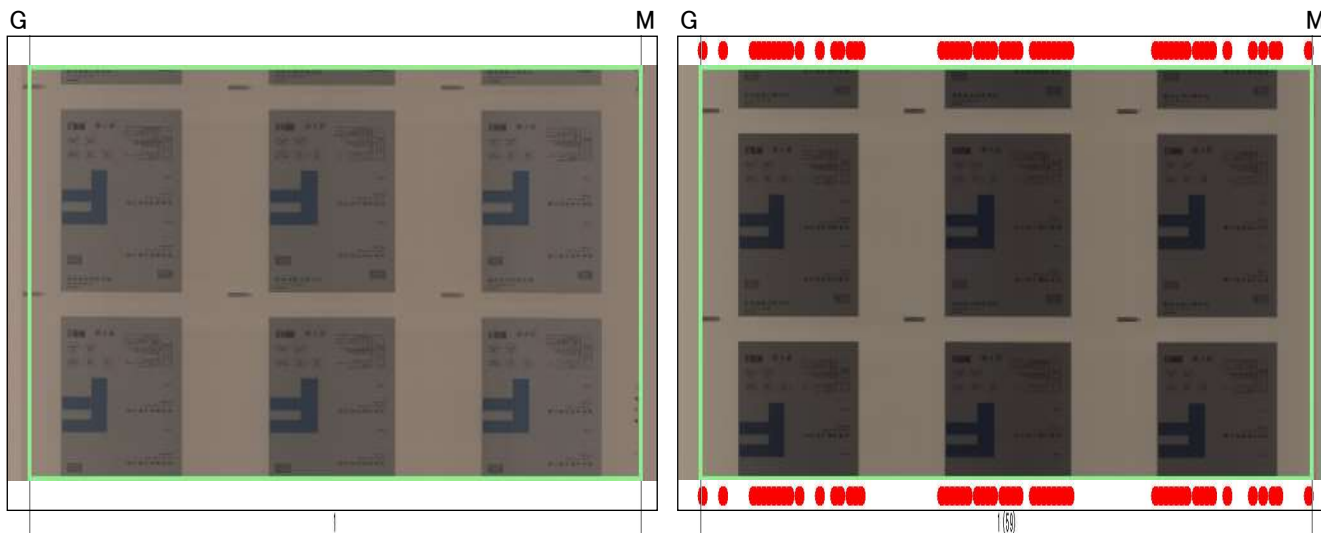
No.	#70, \$51	Date	2023/8/10 上午 10:53:35
Segment	1	Camera	1
Pattern	8117	Position[ x, y ]	565.3 [mm], 6107.2 [m], ( 117.0 [m] )
Type	点状疵点	Size	H:1.7 ,V:203.2 [mm]
Result	-	Area	101.9 [mm2]
Inspection level	5/5,5/5,5/5,5,5/5,5/5	Label	-
Light	6,6,3/6,6,3

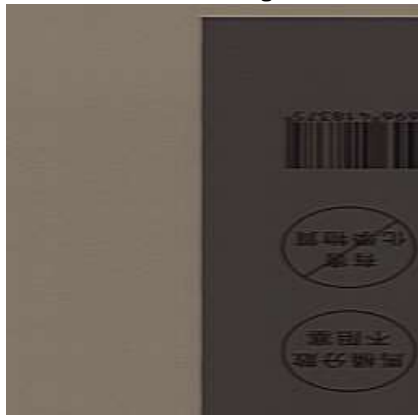
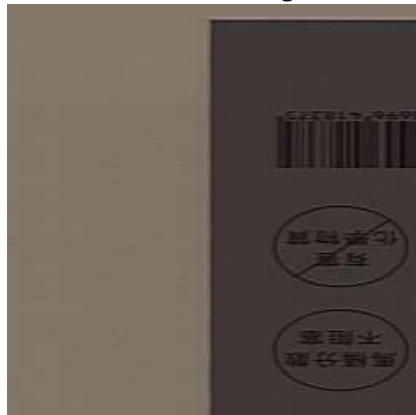
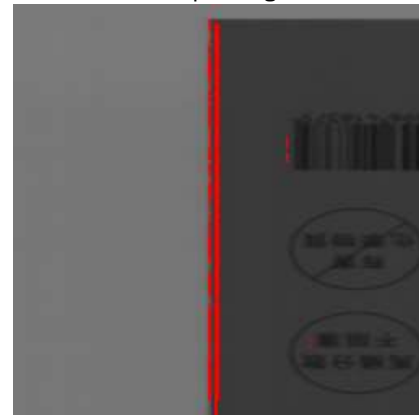
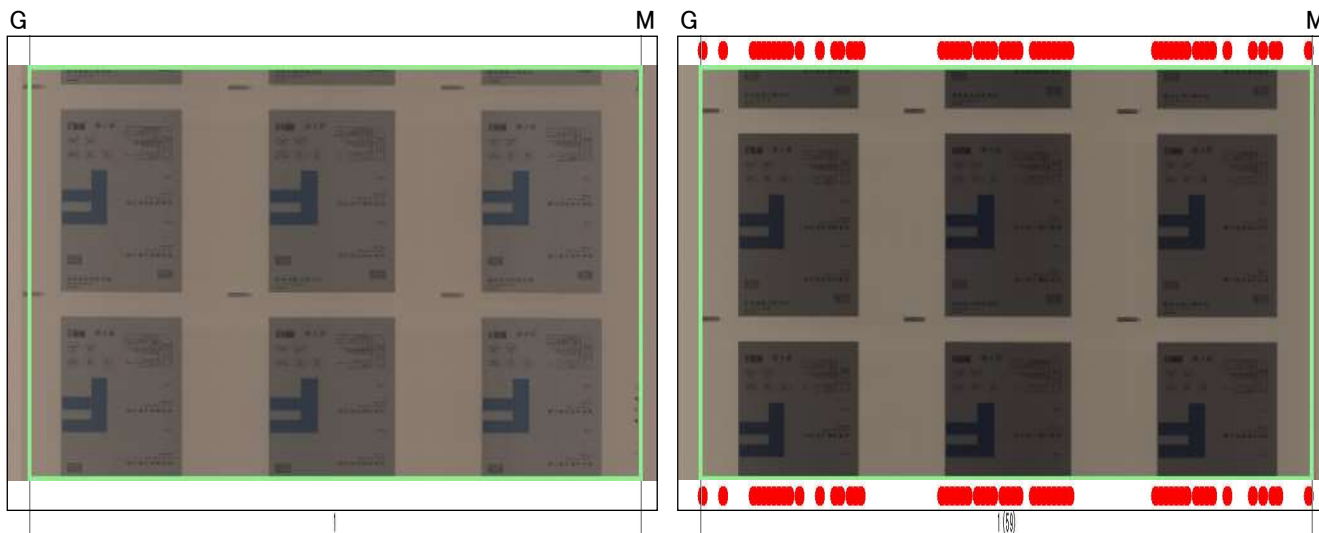
No.	#70, \$51	Date	2023/8/10 上午 10:53:35
Segment	1	Camera	1
Pattern	8117	Position[ x, y ]	697.2 [mm], 6107.2 [m], ( 117.0 [m] )
Type	点状疵点	Size	H:1.7 ,V:142.8 [mm]
Result	-	Area	114.4 [mm2]
Inspection level	5/5,5/5,5/5,5,5/5,5/5	Label	-
Light	6,6,3/6,6,3

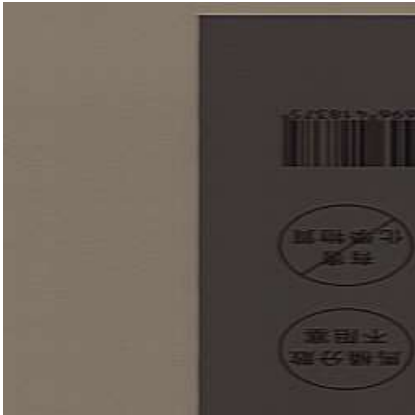
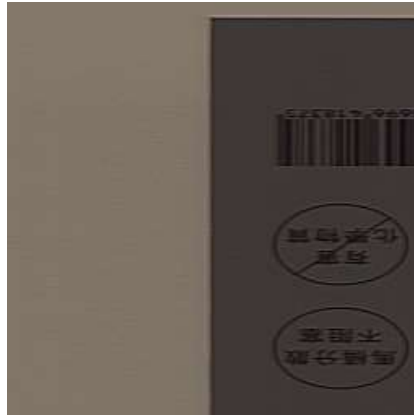
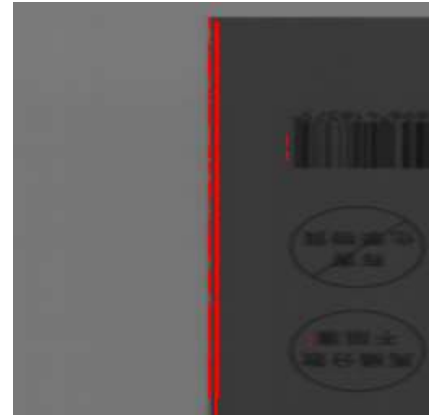
No.	#69, \$50	Date	2023/8/10 上午 10:53:35
Segment	1	Camera	1
Pattern	8116	Position[ x, y ]	565.3 [mm], 6106.3 [m], ( 117.9 [m] )
Type	点状疵点	Size	H:1.5 ,V:83.2 [mm]
Result	-	Area	59.3 [mm2]
Inspection level	5/5,5/5,5/5,5,5/5,5/5	Label	-
Light	6,6,3/6,6,3

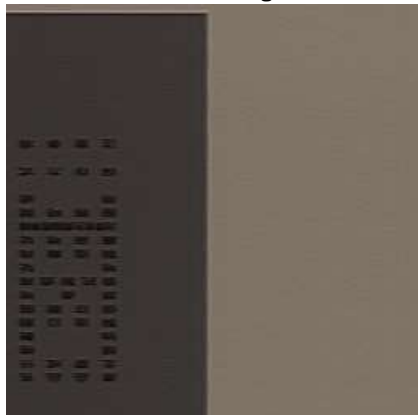
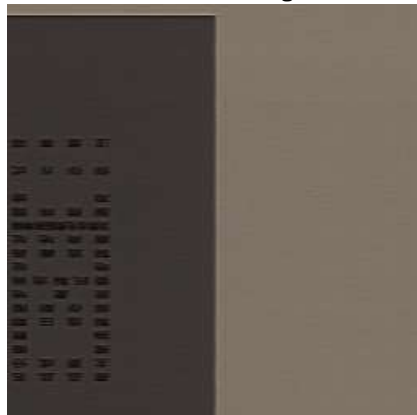
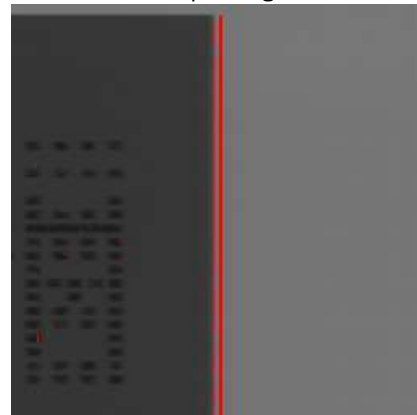
No.	#69, \$50	Date	2023/8/10 上午 10:53:35
Segment	1	Camera	1
Pattern	8116	Position[ x, y ]	565.3 [mm], 6106.4 [m], ( 117.7 [m] )
Type	点状疵点	Size	H:1.5 ,V:126.4 [mm]
Result	-	Area	86.8 [mm2]
Inspection level	5/5,5/5,5/5,5/5,5/5	Label	-
Light	6,6,3/6,6,3

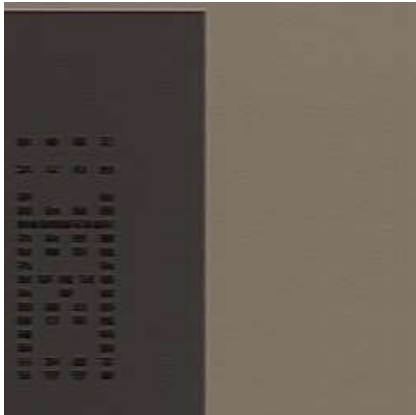
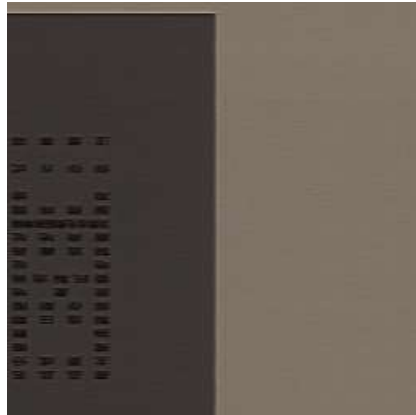
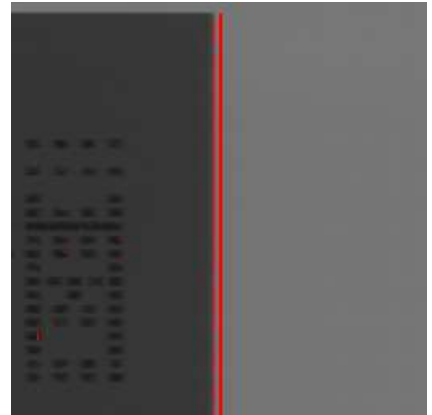
No.	#68, \$49	Date	2023/8/10 上午 10:53:34
Segment	1	Camera	1
Pattern	8115	Position[ x, y ]	565.6 [mm], 6105.7 [m], ( 118.5 [m] )
Type	点状疵点	Size	H:0.5 ,V:108.0 [mm]
Result	-	Area	27.1 [mm2]
Inspection level	5/5,5/5,5/5,5/5,5/5	Label	-
Light	6,6,3/6,6,3

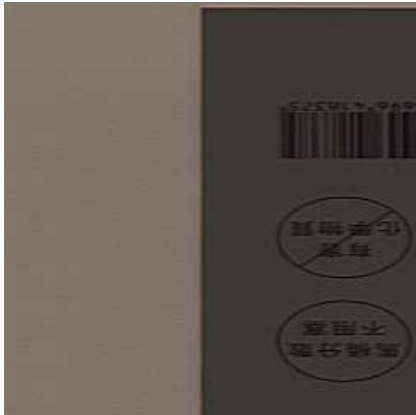
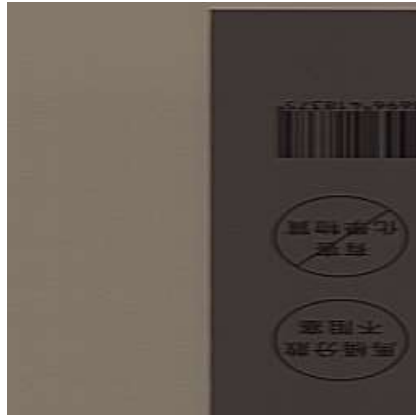
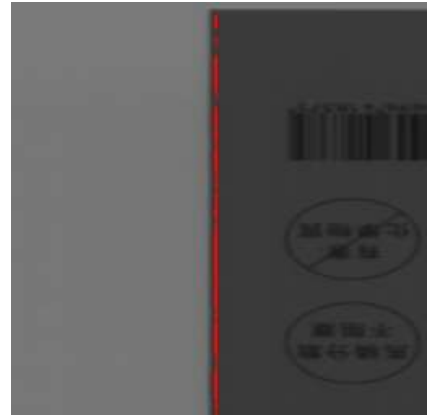
No.	#68, \$49	Date	2023/8/10 上午 10:53:34
Segment	1	Camera	1
Pattern	8115	Position[ x, y ]	697.6 [mm], 6105.7 [m], ( 118.5 [m] )
Type	点状疵点	Size	H:0.5 ,V:106.8 [mm]
Result	-	Area	37.3 [mm2]
Inspection level	5/5,5/5,5/5,5/5,5/5	Label	-
Light	6,6,3/6,6,3

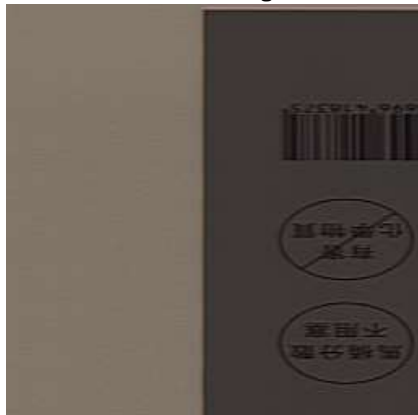
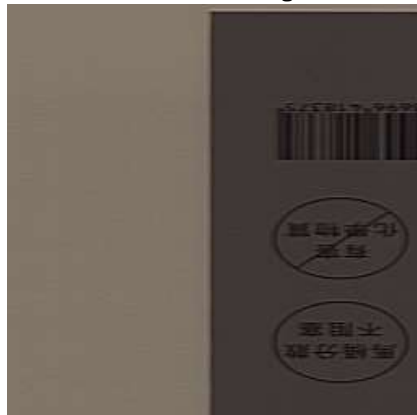
No.	#65, \$48	Date	2023/8/10 上午 10:53:26
Segment	1	Camera	1
Pattern	8101	Position[ x, y ]	881.2 [mm], 6094.9 [m], ( 129.3 [m] )
Type	点状疵点縱向刀絲疵點	Size	H:2.4 ,V:497.2 [mm]
Result	-	Area	185.6 [mm2]
Inspection level	5/5,5/5,5/5,5/5,5/5	Label	-
Light	6,6,3/6,6,3

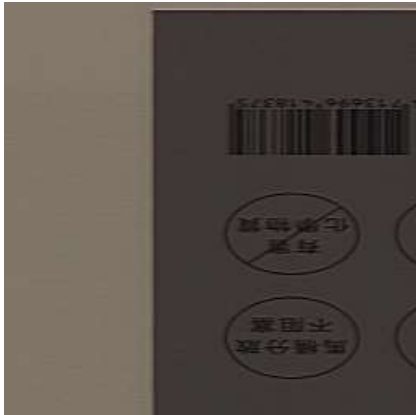
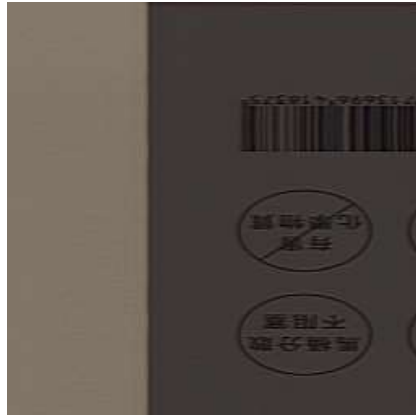
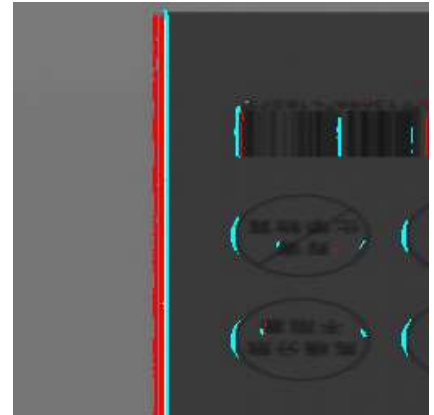
No.	#65, \$48	Date	2023/8/10 上午 10:53:26
Segment	1	Camera	1
Pattern	8101	Position[ x, y ]	702.3 [mm], 6094.8 [m], ( 129.4 [m] )
Type	点状疵点縱向刀絲疵點	Size	H:13.2 ,V:498.0 [mm]
Result	-	Area	212.3 [mm2]
Inspection level	5/5,5/5,5/5,5/5,5/5	Label	-
Light	6,6,3/6,6,3

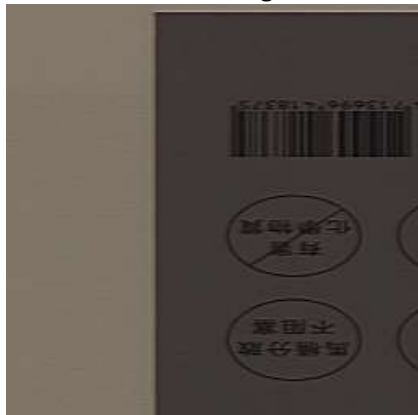
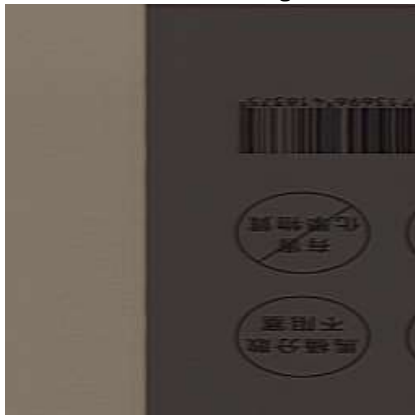
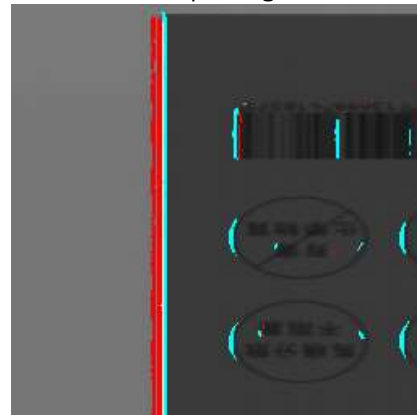
No.	#64, \$47	Date	2023/8/10 上午 10:53:26
Segment	1	Camera	1
Pattern	8100	Position[ x, y ]	697.4 [mm], 6094.3 [m], ( 129.9 [m] )
Type	点状疵点縱向刀絲疵點	Size	H:2.4 ,V:348.4 [mm]
Result	-	Area	113.1 [mm2]
Inspection level	5/5,5/5,5/5,5/5,5/5	Label	-
Light	6,6,3/6,6,3

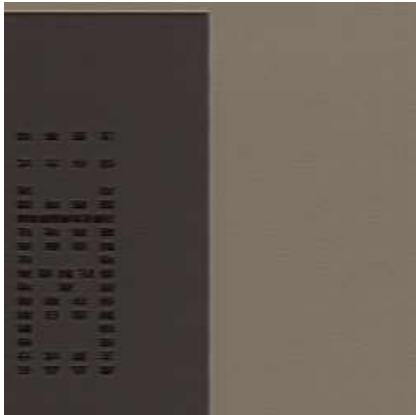
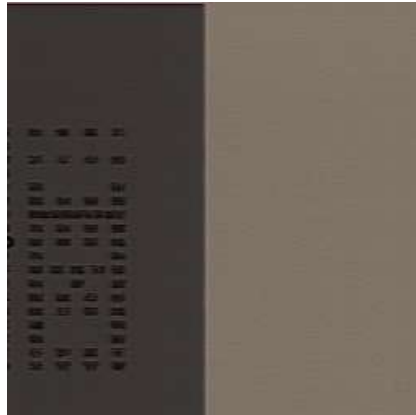
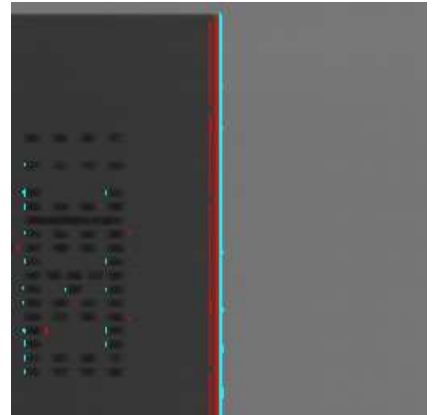
No.	#64, \$47	Date	2023/8/10 上午 10:53:26
Segment	1	Camera	1
Pattern	8100	Position[ x, y ]	565.3 [mm], 6094.2 [m], ( 130.0 [m] )
Type	点状疵点縱向刀絲疵點	Size	H:2.2 ,V:806.4 [mm]
Result	-	Area	170.7 [mm2]
Inspection level	5/5,5/5,5/5,5/5,5/5	Label	-
Light	6,6,3/6,6,3

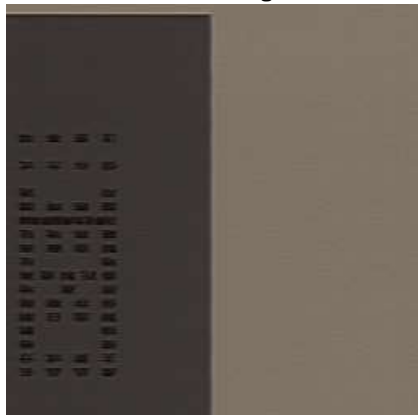
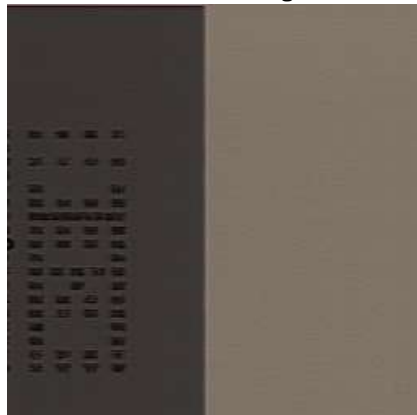
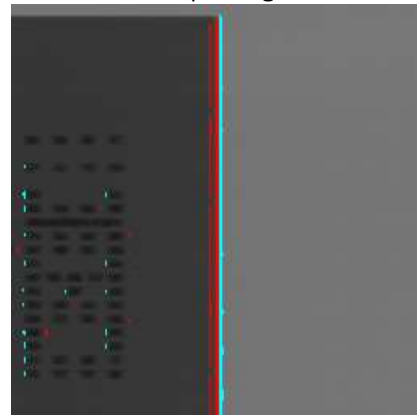
No.	#63, \$46	Date	2023/8/10 上午 10:53:25
Segment	1	Camera	1
Pattern	8099	Position[ x, y ]	880.8 [mm], 6093.7 [m], ( 130.5 [m] )
Type	点状疵点	Size	H:1.5 ,V:124.8 [mm]
Result	-	Area	49.4 [mm2]
Inspection level	5/5,5/5,5/5,5,5/5,5/5	Label	-
Light	6,6,3/6,6,3

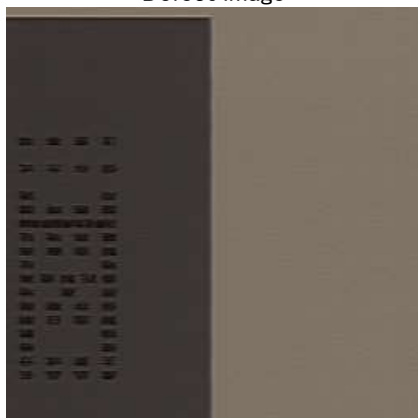
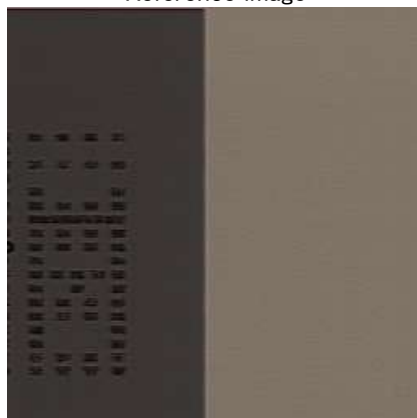
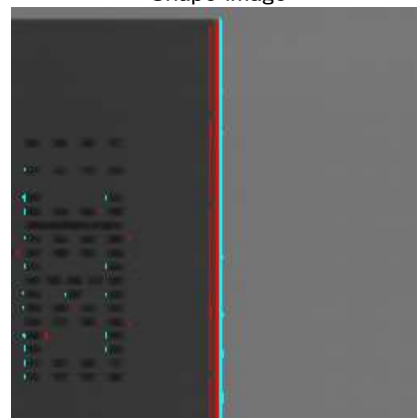
No.	#63, \$46	Date	2023/8/10 上午 10:53:25
Segment	1	Camera	1
Pattern	8099	Position[ x, y ]	697.4 [mm], 6093.5 [m], ( 130.7 [m] )
Type	点状疵点縱向刀絲疵點	Size	H:1.2 ,V:500.4 [mm]
Result	-	Area	61.1 [mm2]
Inspection level	5/5,5/5,5/5,5/5,5/5	Label	-
Light	6,6,3/6,6,3

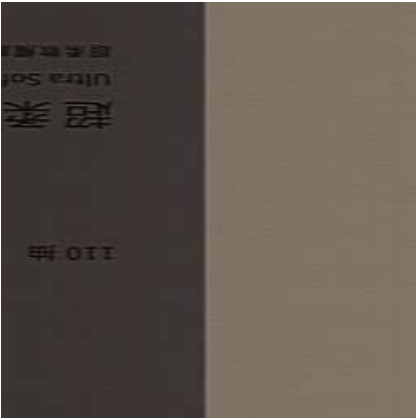
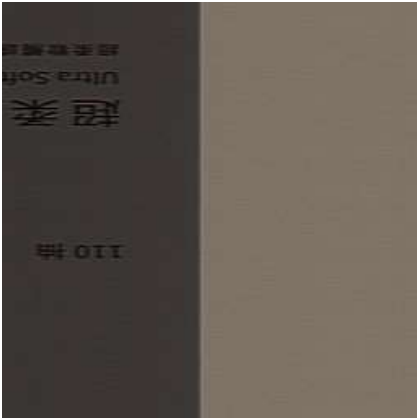
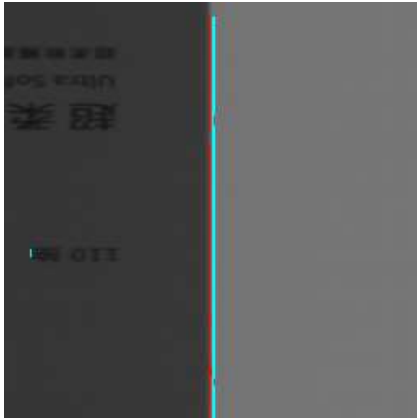
No.	#63, \$46	Date	2023/8/10 上午 10:53:25
Segment	1	Camera	1
Pattern	8099	Position[ x, y ]	565.3 [mm], 6093.5 [m], ( 130.7 [m] )
Type	点状疵点縱向刀絲疵點	Size	H:1.0 ,V:502.8 [mm]
Result	-	Area	88.1 [mm2]
Inspection level	5/5,5/5,5/5,5,5/5,5/5	Label	-
Light	6,6,3/6,6,3

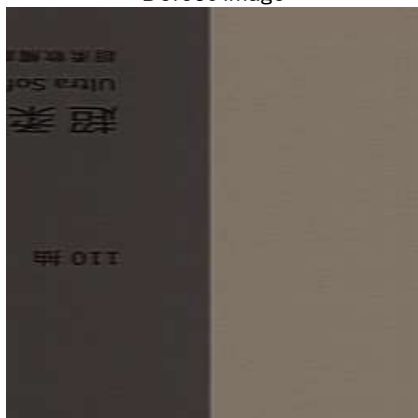
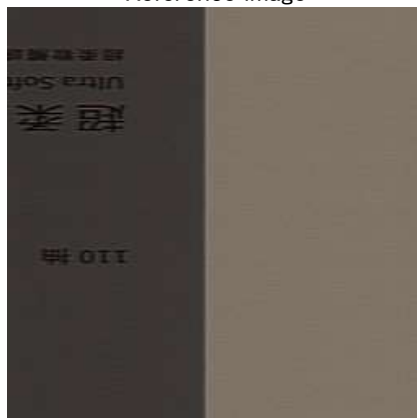
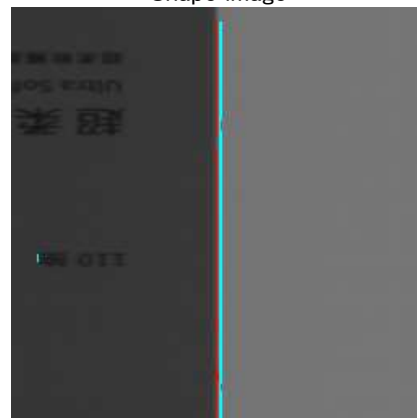
No.	#62, \$45	Date	2023/8/10 上午 10:53:24
Segment	1	Camera	1
Pattern	8098	Position[ x, y ]	697.4 [mm], 6092.4 [m], ( 131.8 [m] )
Type	縱向刀絲疵點	Size	H:0.5 ,V:50.4 [mm]
Result	-	Area	18.1 [mm2]
Inspection level	5/5,5/5,5/5,5,5/5,5/5	Label	-
Light	6,6,3/6,6,3

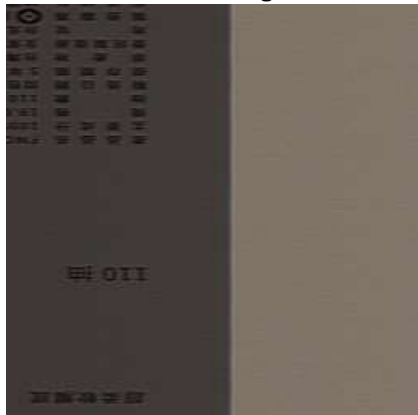
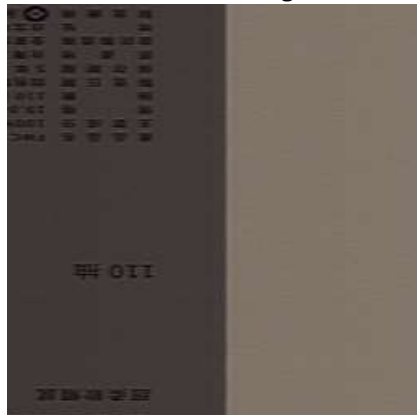
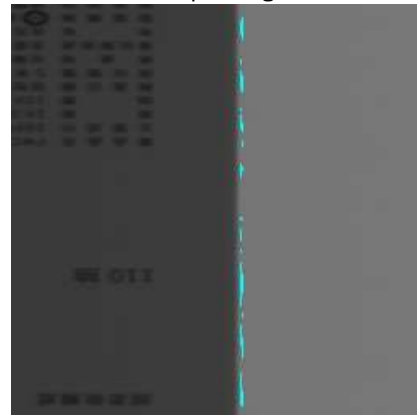
No.	#62, \$45	Date	2023/8/10 上午 10:53:24
Segment	1	Camera	1
Pattern	8098	Position[ x, y ]	881.2 [mm], 6093.1 [m], ( 131.1 [m] )
Type	縱向刀絲疵點	Size	H:0.5 ,V:202.4 [mm]
Result	-	Area	39.6 [mm2]
Inspection level	5/5,5/5,5/5,5/5,5/5	Label	-
Light	6,6,3/6,6,3

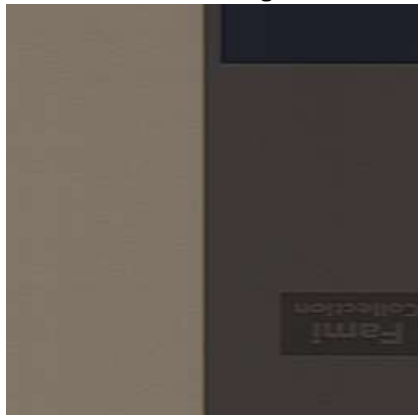
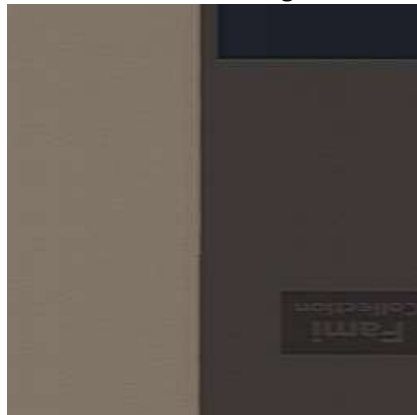
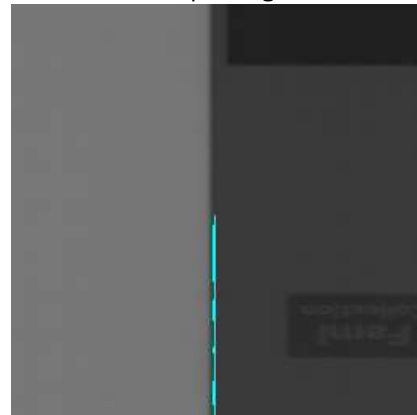
No.	#61, \$44	Date	2023/8/10 上午 10:53:24
Segment	1	Camera	1
Pattern	8097	Position[ x, y ]	697.4 [mm], 6092.4 [m], ( 131.8 [m] )
Type	縱向刀絲疵點	Size	H:0.5 ,V:50.0 [mm]
Result	-	Area	18.0 [mm2]
Inspection level	5/5,5/5,5/5,5/5,5/5	Label	-
Light	6,6,3/6,6,3

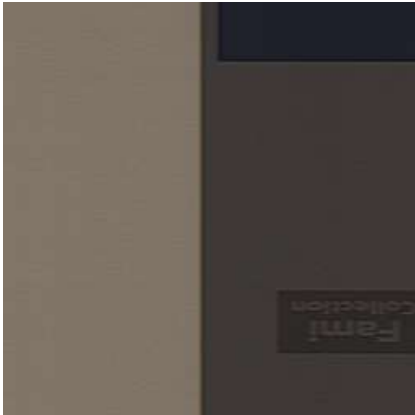
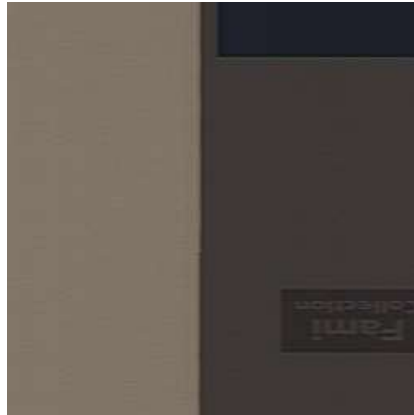
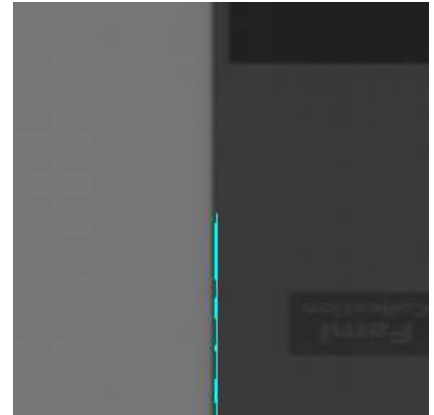
No.	#58, \$43	Date	2023/8/10 上午 10:52:59
Segment	1	Camera	1
Pattern	8055	Position[ x, y ]	126.6 [mm], 6060.4 [m], ( 163.8 [m] )
Type	点状疵点縱向刀絲疵點橫向刀絲	Size	H:187.0 ,V:530.8 [mm]
Result	-	Area	2165.7 [mm2]
Inspection level	5/5,5/5,5/5,5/5,5/5	Label	-
Light	6,6,3/6,6,3

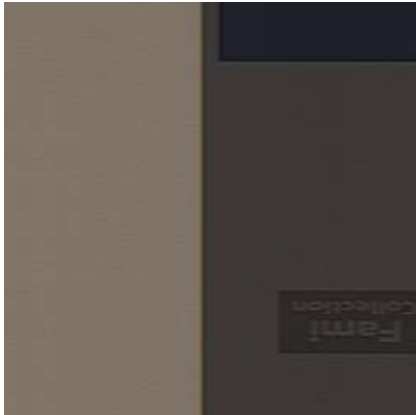
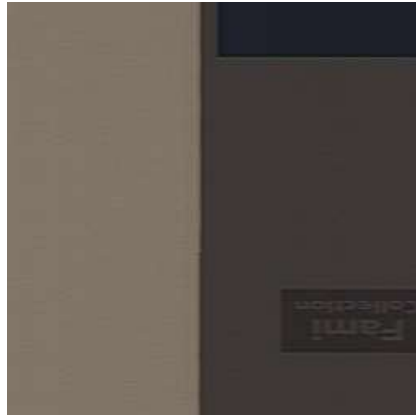
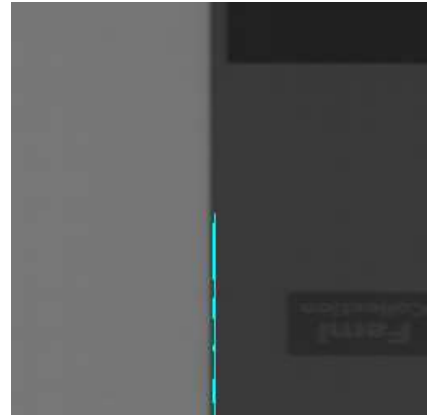
No.	#58, \$43	Date	2023/8/10 上午 10:52:59
Segment	1	Camera	1
Pattern	8055	Position[ x, y ]	430.1 [mm], 6060.4 [m], ( 163.8 [m] )
Type	点状疵点縱向刀絲疵點橫向刀絲	Size	H:261.5 ,V:808.0 [mm]
Result	-	Area	2357.7 [mm2]
Inspection level	5/5,5/5,5/5,5/5,5/5	Label	-
Light	6,6,3/6,6,3

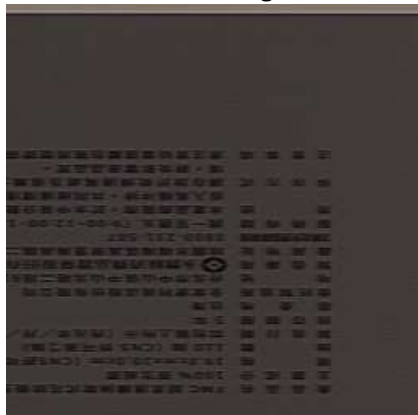
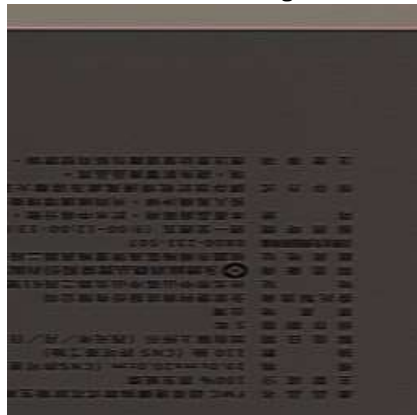
No.	#58, \$43	Date	2023/8/10 上午 10:52:59
Segment	1	Camera	1
Pattern	8055	Position[ x, y ]	762.1 [mm], 6060.3 [m], ( 163.8 [m] )
Type	点状疵点縱向刀絲疵點橫向刀絲	Size	H:187.3 ,V:532.4 [mm]
Result	-	Area	2383.8 [mm2]
Inspection level	5/5,5/5,5/5,5/5,5/5	Label	-
Light	6,6,3/6,6,3

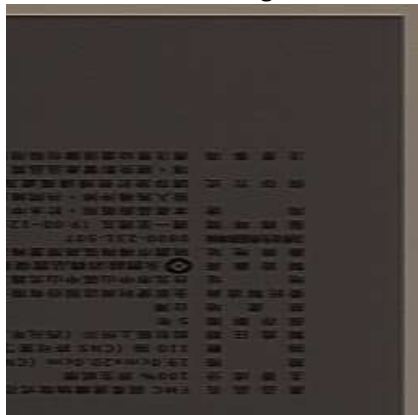
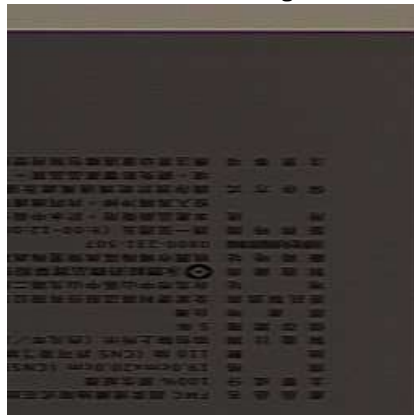
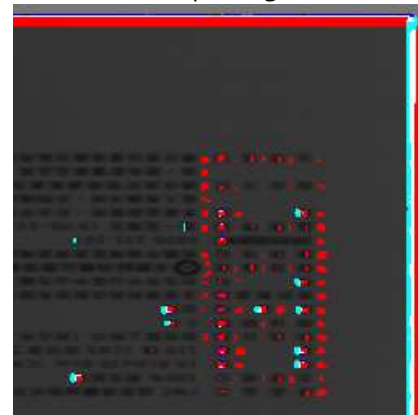
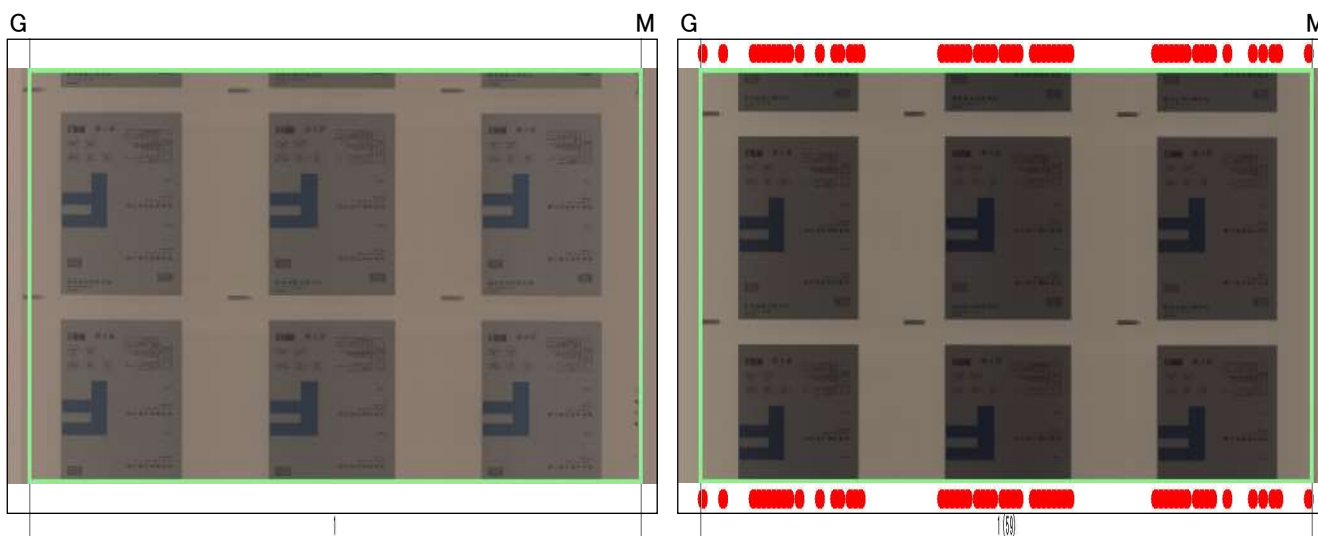
Defect image

No.	#57, \$42	Date	2023/8/10 上午 10:52:59
Segment	1	Camera	1
Pattern	8054	Position[ x, y ]	417.9 [mm], 6059.6 [m], ( 164.6 [m] )
Type	点状疵点縱向刀絲疵點橫向刀絲	Size	H:202.9 ,V:808.0 [mm]
Result	-	Area	2175.8 [mm2]
Inspection level	5/5,5/5,5/5,5/5,5/5	Label	-
Light	6,6,3/6,6,3

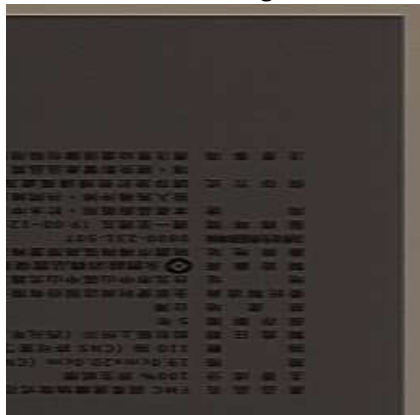
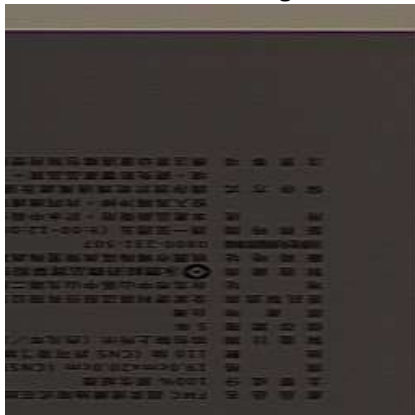
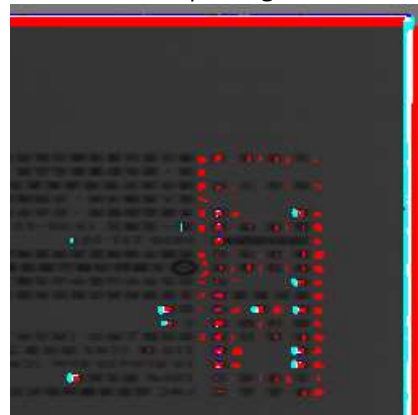
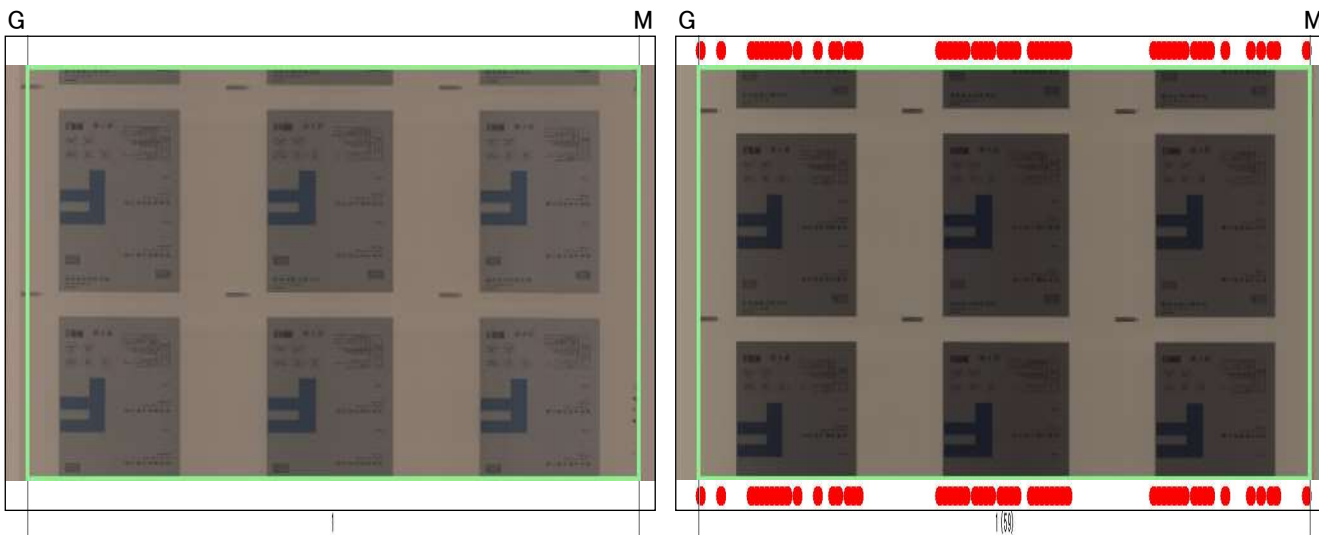
Defect image

No.	#56, \$41	Date	2023/8/10 上午 10:52:58
Segment	1	Camera	1
Pattern	8053	Position[ x, y ]	867.8 [mm], 6058.9 [m], ( 165.3 [m] )
Type	点状疵点縱向刀絲疵點	Size	H:34.4 ,V:811.2 [mm]
Result	-	Area	739.3 [mm2]
Inspection level	5/5,5/5,5/5,5/5,5/5	Label	-
Light	6,6,3/6,6,3

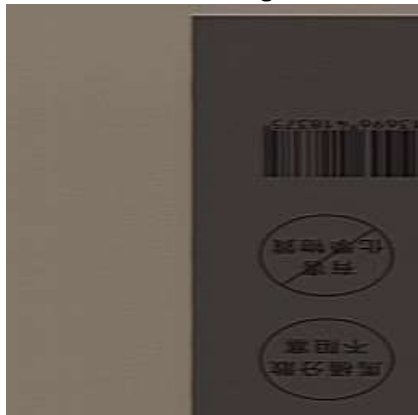
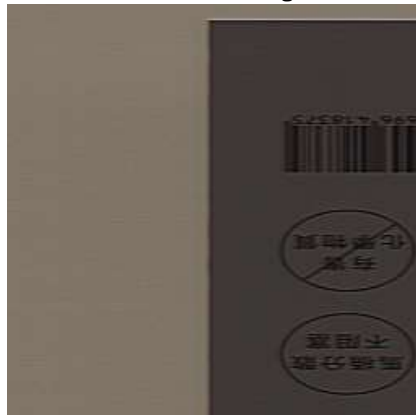
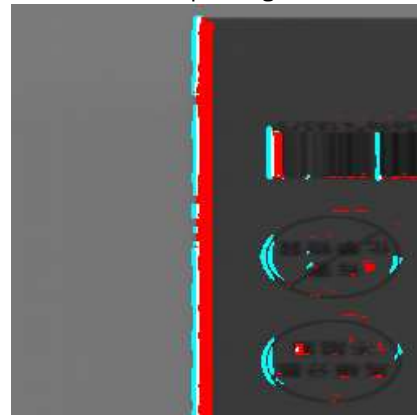
Defect image

No.	#56, \$41	Date	2023/8/10 上午 10:52:58
Segment	1	Camera	1
Pattern	8053	Position[ x, y ]	698.4 [mm], 6058.8 [m], ( 165.3 [m] )
Type	点状疵点縱向刀絲疵點	Size	H:13.7 ,V:727.2 [mm]
Result	-	Area	803.3 [mm2]
Inspection level	5/5,5/5,5/5,5/5,5/5	Label	-
Light	6,6,3/6,6,3

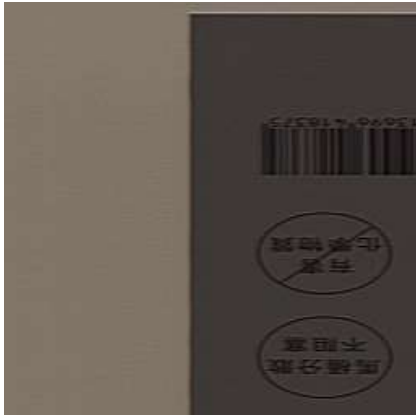
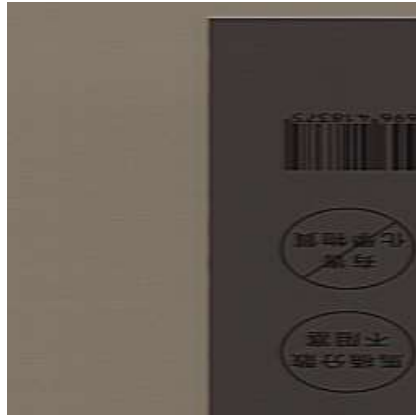
Defect image

No.	#55, \$40	Date	2023/8/10 上午 10:52:57
Segment	1	Camera	1
Pattern	8052	Position[ x, y ]	563.1 [mm], 6058.2 [m], ( 166.0 [m] )
Type	点状疵点縱向刀絲疵點	Size	H:2.9 ,V:808.0 [mm]
Result	-	Area	722.8 [mm2]
Inspection level	5/5,5/5,5/5,5/5,5/5	Label	-
Light	6,6,3/6,6,3

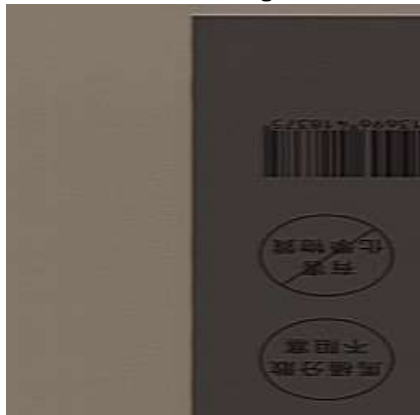
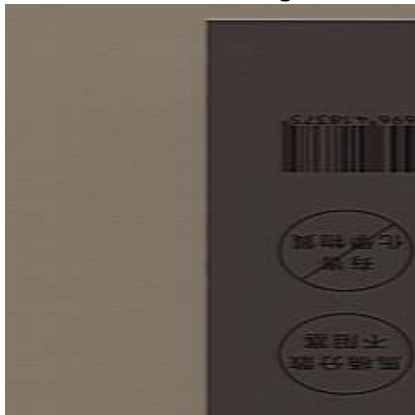
Defect image

No.	#55, \$40	Date	2023/8/10 上午 10:52:57
Segment	1	Camera	1
Pattern	8052	Position[ x, y ]	399.1 [mm], 6058.1 [m], ( 166.1 [m] )
Type	点状疵点縱向刀絲疵點	Size	H:79.8 ,V:807.6 [mm]
Result	-	Area	777.1 [mm2]
Inspection level	5/5,5/5,5/5,5/5,5/5	Label	-
Light	6,6,3/6,6,3

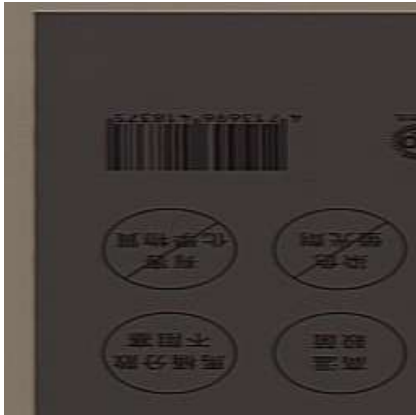
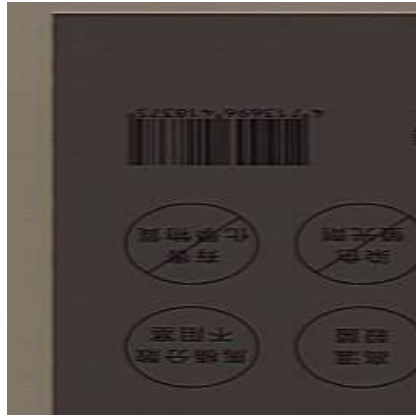
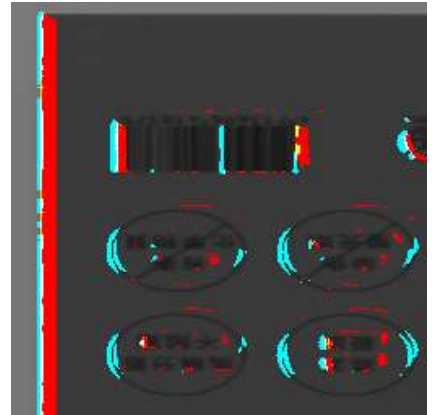
Defect image

No.	#55, \$40	Date	2023/8/10 上午 10:52:57
Segment	1	Camera	1
Pattern	8052	Position[ x, y ]	714.0 [mm], 6058.1 [m], ( 166.1 [m] )
Type	点状疵点縱向刀絲疵點	Size	H:64.0 ,V:407.2 [mm]
Result	-	Area	995.8 [mm2]
Inspection level	5/5,5/5,5/5,5/5,5/5	Label	-
Light	6,6,3/6,6,3

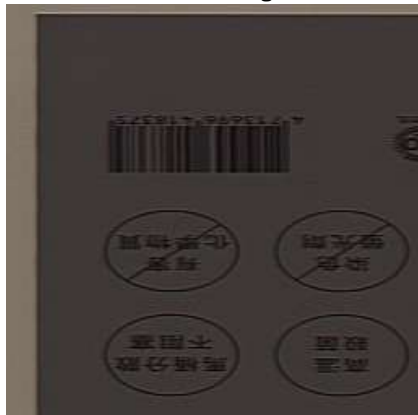
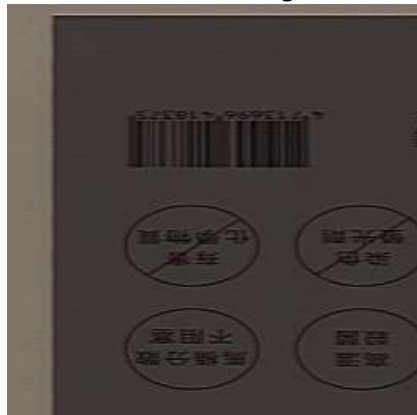
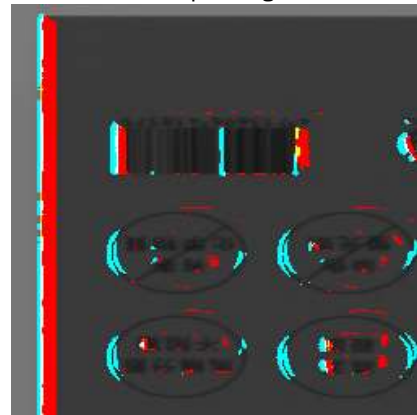
Defect image

No.	#54, \$39	Date	2023/8/10 上午 10:52:57
Segment	1	Camera	1
Pattern	8051	Position[ x, y ]	696.2 [mm], 6057.6 [m], ( 166.6 [m] )
Type	点状疵点	Size	H:46.4 ,V:626.8 [mm]
Result	-	Area	612.2 [mm2]
Inspection level	5/5,5/5,5/5,5/5,5/5	Label	-
Light	6,6,3/6,6,3

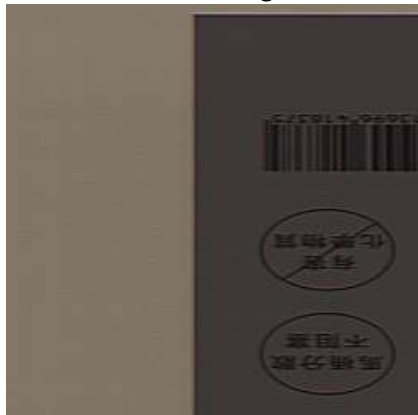
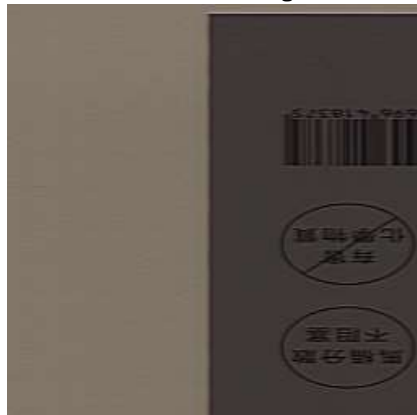
Defect image

No.	#54, \$39	Date	2023/8/10 上午 10:52:57
Segment	1	Camera	1
Pattern	8051	Position[ x, y ]	698.4 [mm], 6057.3 [m], ( 166.9 [m] )
Type	点状疵点縱向刀絲疵點	Size	H:13.2 ,V:705.2 [mm]
Result	-	Area	738.9 [mm2]
Inspection level	5/5,5/5,5/5,5,5/5,5/5	Label	-
Light	6,6,3/6,6,3

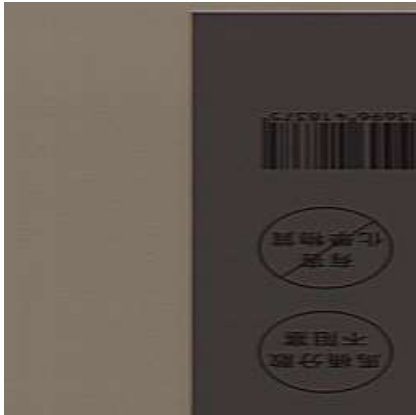
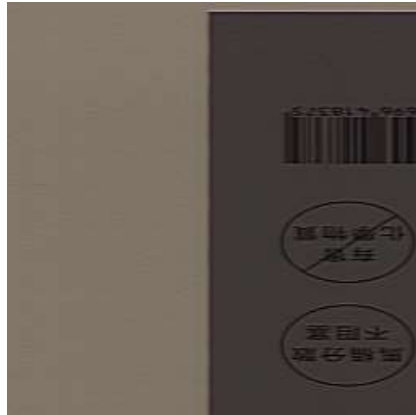
Defect image

No.	#51, \$38	Date	2023/8/10 上午 10:52:47
Segment	1	Camera	1
Pattern	8036	Position[ x, y ]	488.2 [mm], 6045.2 [m], ( 179.0 [m] )
Type	点状疵点横向刀絲	Size	H:193.1 ,V:48.4 [mm]
Result	-	Area	434.6 [mm2]
Inspection level	5/5,5/5,5/5,5,5/5,5/5	Label	-
Light	6,6,3/6,6,3

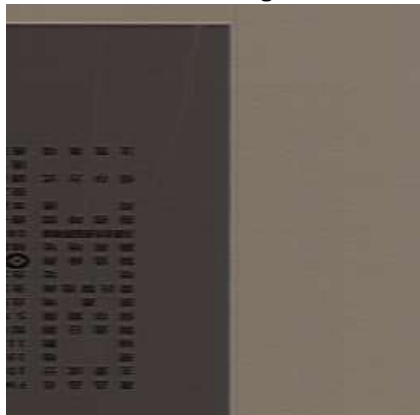
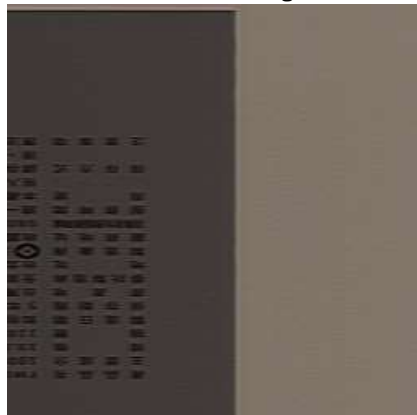
Defect image

No.	#51, \$38	Date	2023/8/10 上午 10:52:47
Segment	1	Camera	1
Pattern	8036	Position[ x, y ]	759.9 [mm], 6045.2 [m], ( 178.9 [m] )
Type	点状疵点縱向刀絲疵點橫向刀絲	Size	H:184.6 ,V:134.4 [mm]
Result	-	Area	440.2 [mm2]
Inspection level	5/5,5/5,5/5,5,5/5,5/5	Label	-
Light	6,6,3/6,6,3

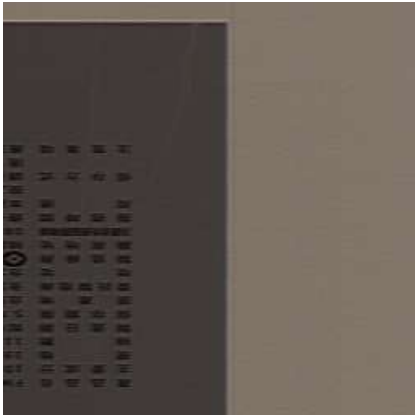
Defect image

No.	#50, \$37	Date	2023/8/10 上午 10:52:47
Segment	1	Camera	1
Pattern	8035	Position[ x, y ]	748.7 [mm], 6044.8 [m], ( 179.4 [m] )
Type	点状疵点縱向刀絲疵點	Size	H:184.1 ,V:61.2 [mm]
Result	-	Area	304.8 [mm2]
Inspection level	5/5,5/5,5/5,5/5,5/5	Label	-
Light	6,6,3/6,6,3
