# Inspection Result (Individual Data)

Lot number : 3

Inspected date : 2023/8/10 上午 09:15:18 ~ 2023/8/10 上午 10:55:13

商品名	標準透明6-6-3	周長	
顧客名		Ex1	
CODE番号		Ex2	
基材		Ex3

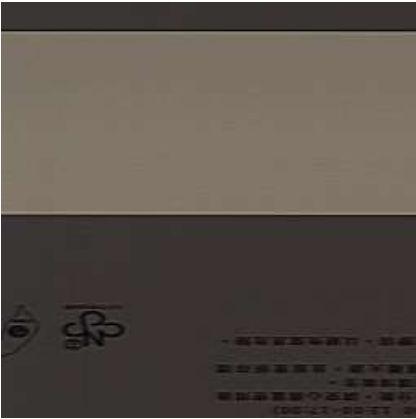
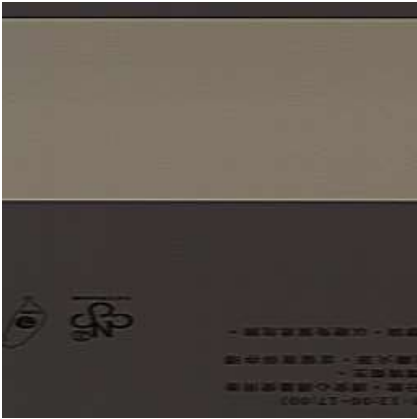
Defect image	Reference image	Shape image

No.	#50, \$37	Date	2023/8/10 上午 10:52:47
Segment	1	Camera	1
Pattern	8035	Position[ x, y ]	473.3 [mm], 6044.8 [m], ( 179.3 [m] )
Type	点状疵点	Size	H:193.4 ,V:2.0 [mm]
Result	-	Area	329.6 [mm2]
Inspection level	5/5,5/5,5/5,5/5,5/5	Label	-
Light	6,6,3/6,6,3

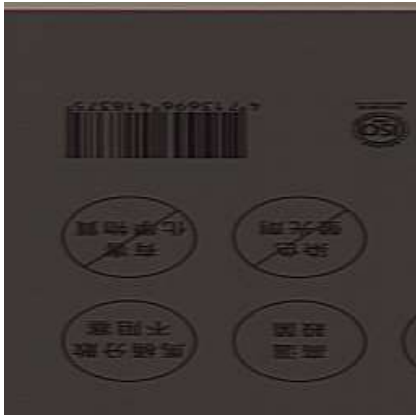
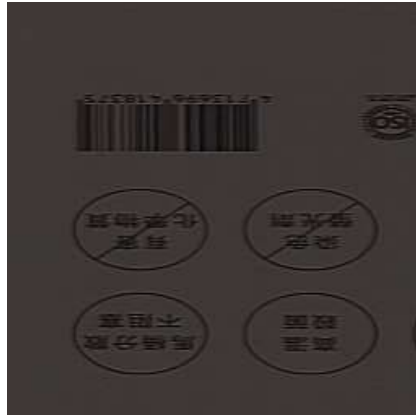
No.	#49, \$36	Date	2023/8/10 上午 10:52:46
Segment	1	Camera	1
Pattern	8034	Position[ x, y ]	728.2 [mm], 6044.1 [m], ( 180.0 [m] )
Type	点状疵点縱向刀絲疵點	Size	H:184.1 ,V:88.8 [mm]
Result	-	Area	335.2 [mm2]
Inspection level	5/5,5/5,5/5,5/5,5/5	Label	-
Light	6,6,3/6,6,3

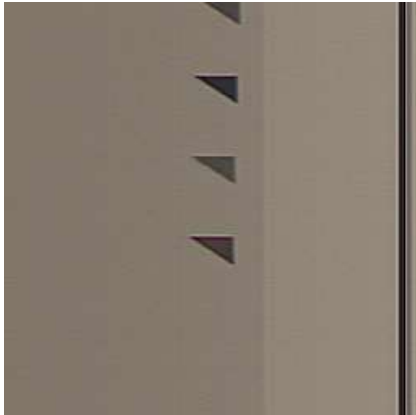
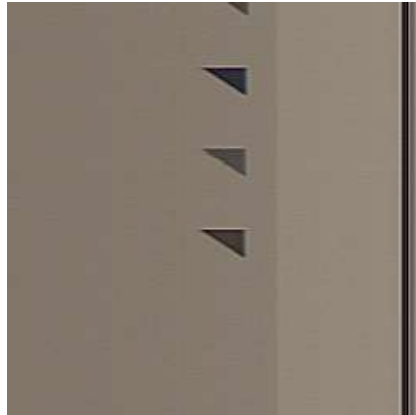
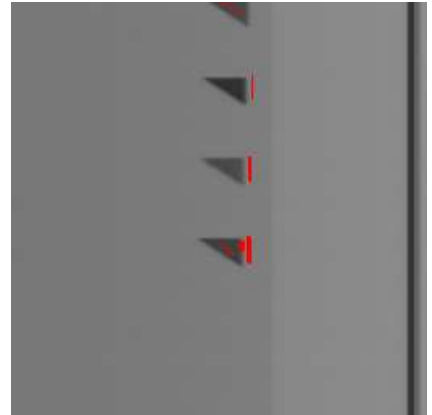
No.	#48, \$35	Date	2023/8/10 上午 10:52:46
Segment	1	Camera	1
Pattern	8033	Position[ x, y ]	936.9 [mm], 6043.5 [m], ( 180.7 [m] )
Type	点状疵点	Size	H:1.7 ,V:25.6 [mm]
Result	-	Area	8.7 [mm2]
Inspection level	5/5,5/5,5/5,5/5,5/5	Label	-
Light	6,6,3/6,6,3

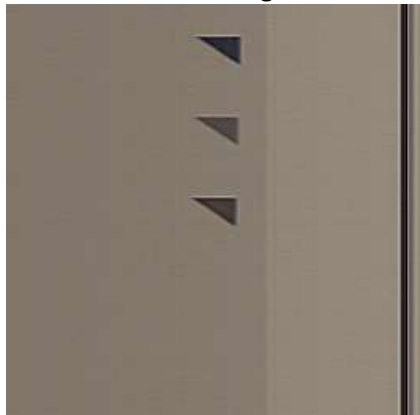
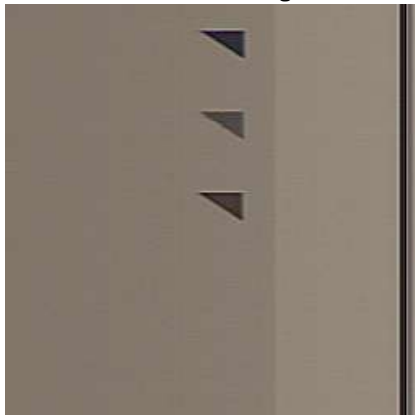
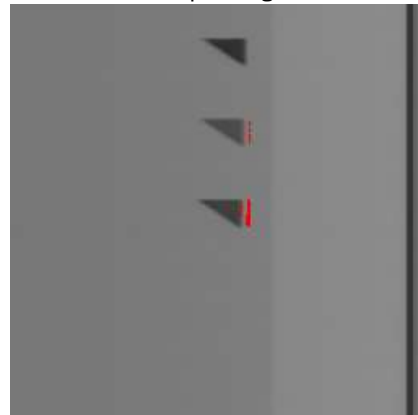
No.	#47, \$34	Date	2023/8/10 上午 10:52:45
Segment	1	Camera	1
Pattern	8032	Position[ x, y ]	936.9 [mm], 6042.8 [m], ( 181.4 [m] )
Type	点状疵点	Size	H:1.5 ,V:6.0 [mm]
Result	-	Area	4.1 [mm2]
Inspection level	5/5,5/5,5/5,5,5/5,5/5	Label	-
Light	6,6,3/6,6,3

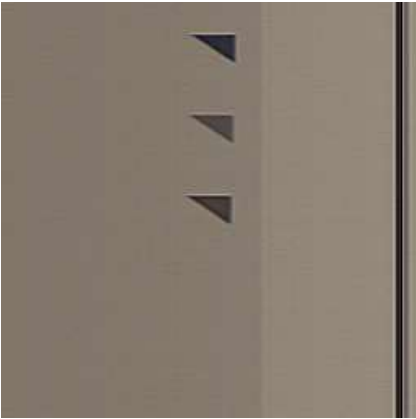
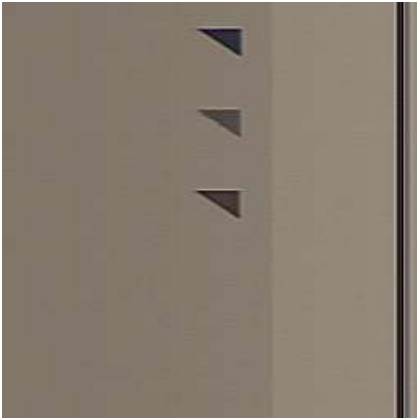
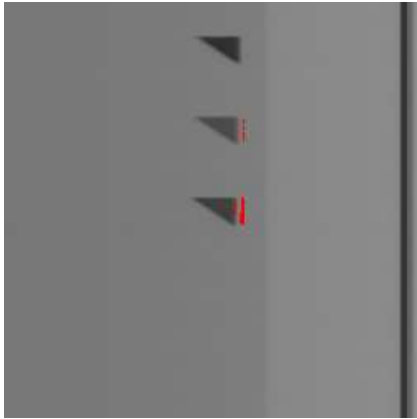
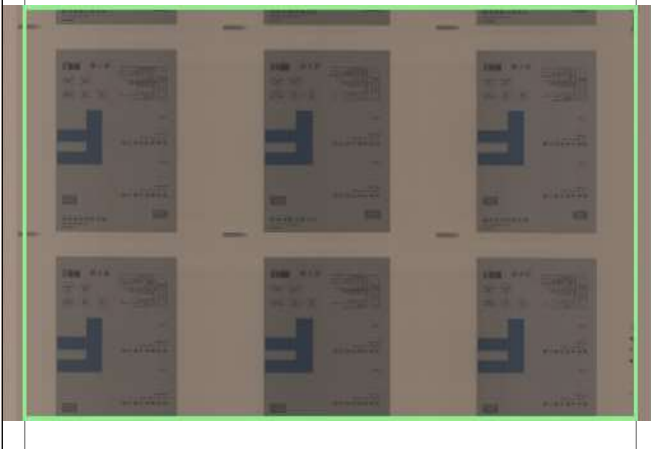
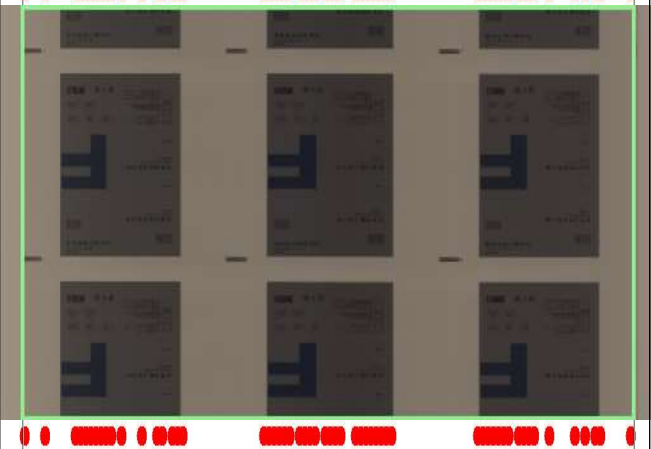
Defect image	Reference image	Shape image

No.	#46, \$33	Date	2023/8/10 上午 10:52:42
Segment	1	Camera	1
Pattern	8027	Position[ x, y ]	566.3 [mm], 6038.7 [m], ( 185.5 [m] )
Type	点状疵点	Size	H:0.5 ,V:16.8 [mm]
Result	-	Area	2.3 [mm2]
Inspection level	5/5,5/5,5/5,5/5,5/5	Label	-
Light	6,6,3/6,6,3

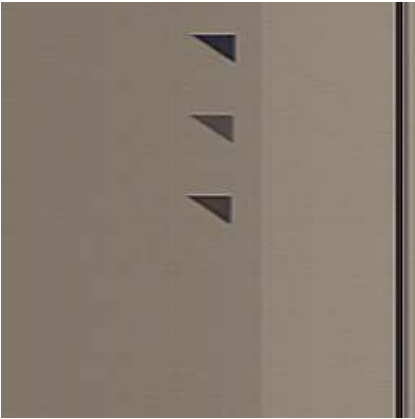
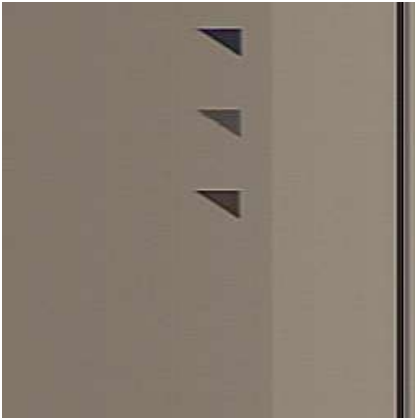
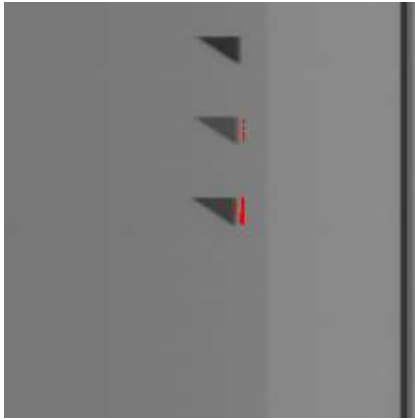
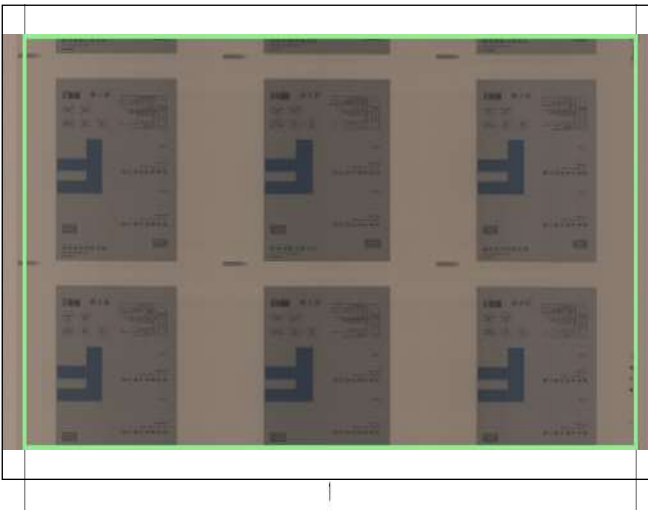
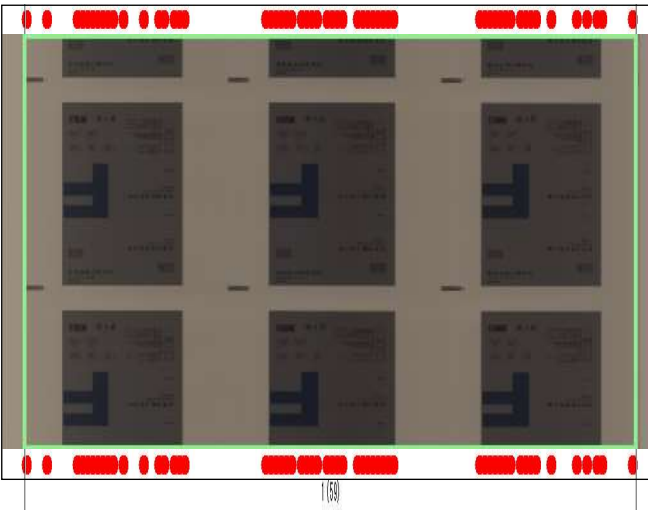
Defect image	Reference image	Shape image

No.	#46, \$33	Date	2023/8/10 上午 10:52:42
Segment	1	Camera	1
Pattern	8027	Position[ x, y ]	699.1 [mm], 6038.5 [m], ( 185.7 [m] )
Type	縱向刀絲疵點	Size	H:0.5 ,V:10.0 [mm]
Result	-	Area	3.2 [mm2]
Inspection level	5/5,5/5,5/5,5/5,5/5	Label	-
Light	6,6,3/6,6,3

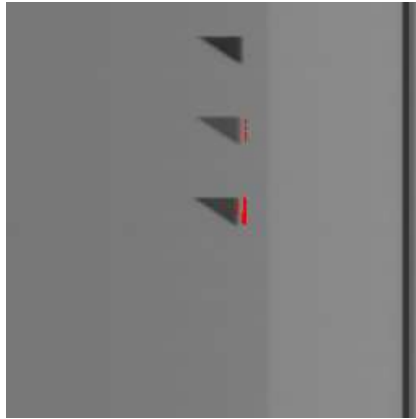
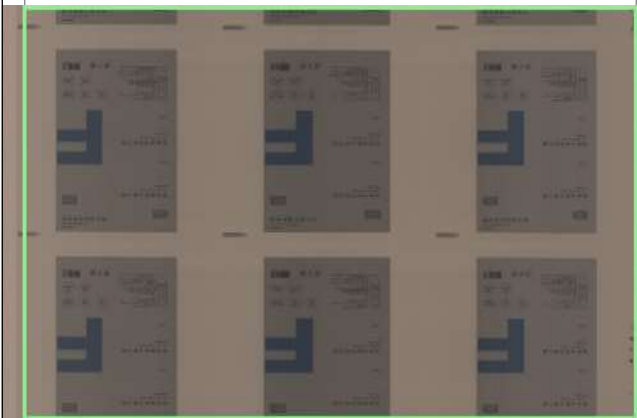
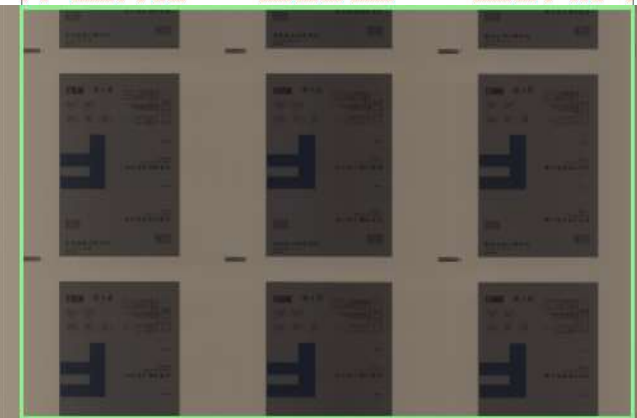
Defect image	Reference image	Shape image

No.	#46, \$33	Date	2023/8/10 上午 10:52:42
Segment	1	Camera	1
Pattern	8027	Position[ x, y ]	698.6 [mm], 6038.7 [m], ( 185.5 [m] )
Type	点状疵点縱向刀絲疵點	Size	H:1.0 ,V:34.0 [mm]
Result	-	Area	15.7 [mm2]
Inspection level	5/5,5/5,5/5,5/5,5/5	Label	-
Light	6,6,3/6,6,3

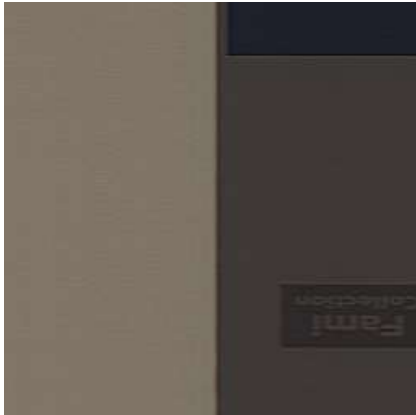
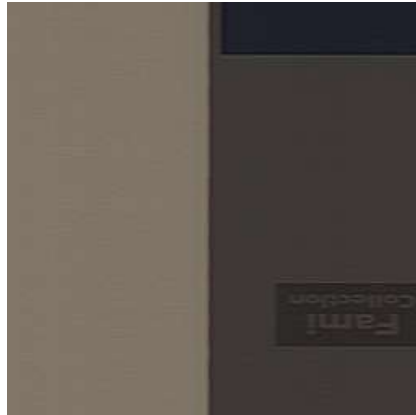
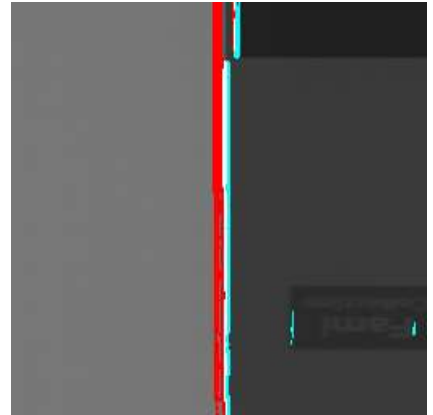
No.	#45, \$32	Date	2023/8/10 上午 10:52:41
Segment	1	Camera	1
Pattern	8026	Position[ x, y ]	699.1 [mm], 6037.7 [m], ( 186.5 [m] )
Type	点状疵点縱向刀絲疵點	Size	H:4.2 ,V:363.6 [mm]
Result	-	Area	195.2 [mm2]
Inspection level	5/5,5/5,5/5,5/5,5/5	Label	-
Light	6,6,3/6,6,3

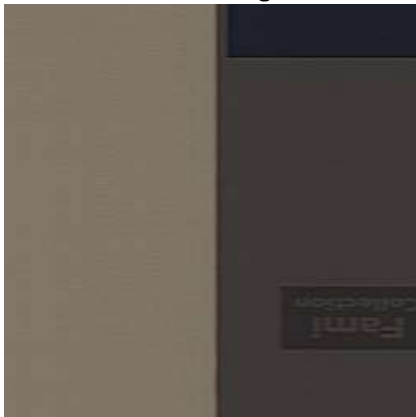
Defect image

No.	#42, \$31	Date	2023/8/10 上午 10:52:34
Segment	1	Camera	1
Pattern	8017	Position[ x, y ]	441.3 [mm], 6030.2 [m], ( 194.0 [m] )
Type	点状疵点縱向刀絲疵點橫向刀絲	Size	H:193.8 ,V:174.0 [mm]
Result	-	Area	1943.8 [mm2]
Inspection level	5/5,5/5,5/5,5/5,5/5	Label	-
Light	6,6,3/6,6,3

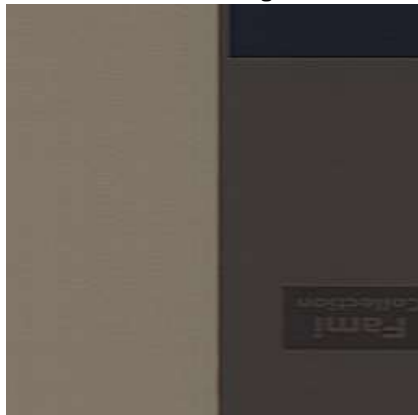
Defect image

No.	#42, \$31	Date	2023/8/10 上午 10:52:34
Segment	1	Camera	1
Pattern	8017	Position[ x, y ]	791.4 [mm], 6030.6 [m], ( 193.6 [m] )
Type	点状疵点縱向刀絲疵點	Size	H:184.3 ,V:107.2 [mm]
Result	-	Area	2024.9 [mm2]
Inspection level	5/5,5/5,5/5,5/5,5/5	Label	-
Light	6,6,3/6,6,3

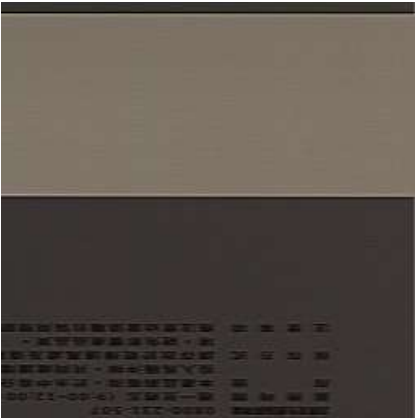
No.	#41, \$30	Date	2023/8/10 上午 10:52:33
Segment	1	Camera	1
Pattern	8016	Position[ x, y ]	137.1 [mm], 6029.5 [m], ( 194.7 [m] )
Type	点状疵点縱向刀絲疵點橫向刀絲	Size	H:186.0 ,V:107.2 [mm]
Result	-	Area	1560.7 [mm2]
Inspection level	5/5,5/5,5/5,5/5,5/5	Label	-
Light	6,6,3/6,6,3

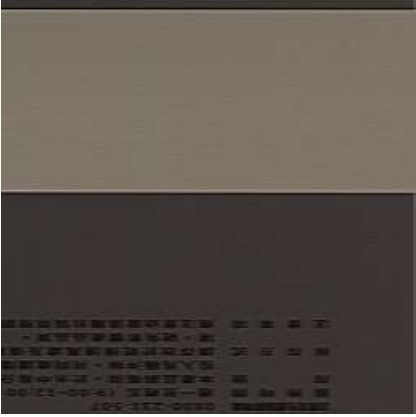
No.	#41, \$30	Date	2023/8/10 上午 10:52:33
Segment	1	Camera	1
Pattern	8016	Position[ x, y ]	762.1 [mm], 6029.8 [m], ( 194.4 [m] )
Type	点状疵点縱向刀絲疵點橫向刀絲	Size	H:184.3 ,V:36.0 [mm]
Result	-	Area	1596.0 [mm2]
Inspection level	5/5,5/5,5/5,5/5,5/5	Label	-
Light	6,6,3/6,6,3

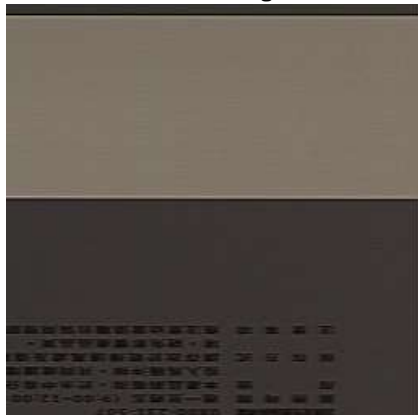
Defect image

No.	#41, \$30	Date	2023/8/10 上午 10:52:33
Segment	1	Camera	1
Pattern	8016	Position[ x, y ]	118.1 [mm], 6029.8 [m], ( 194.4 [m] )
Type	点状疵点縱向刀絲疵點橫向刀絲	Size	H:184.8 ,V:36.4 [mm]
Result	-	Area	1631.1 [mm2]
Inspection level	5/5,5/5,5/5,5/5,5/5	Label	-
Light	6,6,3/6,6,3

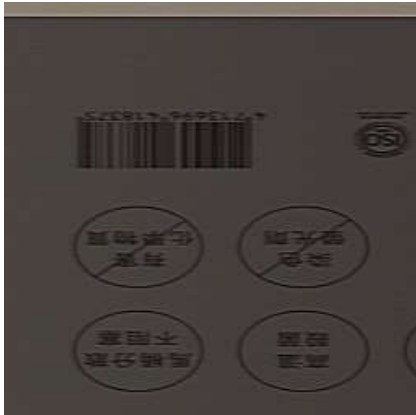
Defect image

No.	#41, \$30	Date	2023/8/10 上午 10:52:33
Segment	1	Camera	1
Pattern	8016	Position[ x, y ]	141.5 [mm], 6029.9 [m], ( 194.3 [m] )
Type	点状疵点縱向刀絲疵點	Size	H:185.1 ,V:128.8 [mm]
Result	-	Area	1686.9 [mm2]
Inspection level	5/5,5/5,5/5,5/5,5/5	Label	-
Light	6,6,3/6,6,3

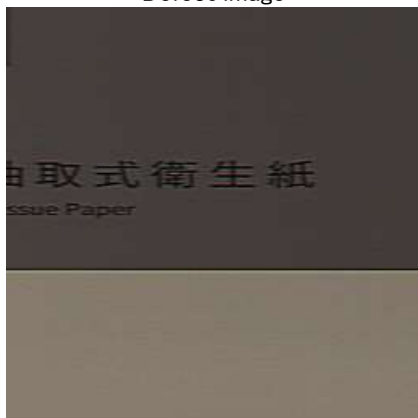
Defect image

No.	#39, \$28	Date	2023/8/10 上午 10:52:32
Segment	1	Camera	1
Pattern	8014	Position[ x, y ]	445.4 [mm], 6027.9 [m], ( 196.2 [m] )
Type	点状疵点縱向刀絲疵點橫向刀絲	Size	H:194.8 ,V:152.8 [mm]
Result	-	Area	1037.9 [mm2]
Inspection level	5/5,5/5,5/5,5,5/5,5/5	Label	-
Light	6,6,3/6,6,3

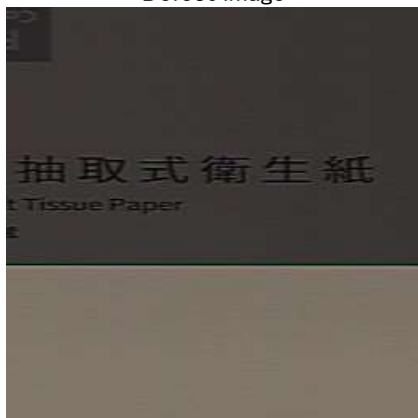
Defect image

No.	#39, \$28	Date	2023/8/10 上午 10:52:32
Segment	1	Camera	1
Pattern	8014	Position[ x, y ]	434.0 [mm], 6028.3 [m], ( 195.9 [m] )
Type	点状疵点縱向刀絲疵點橫向刀絲	Size	H:194.1 ,V:77.2 [mm]
Result	-	Area	1220.7 [mm2]
Inspection level	5/5,5/5,5/5,5,5/5,5/5	Label	-
Light	6,6,3/6,6,3

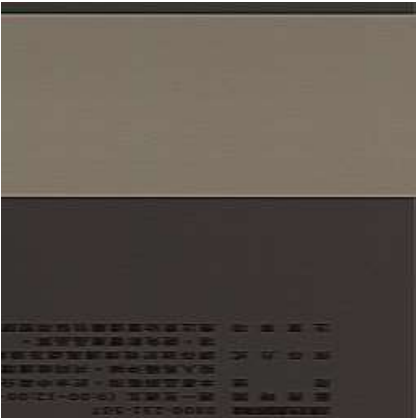
No.	#36, \$26	Date	2023/8/10 上午 10:43:16
Segment	1	Camera	1
Pattern	7899	Position[ x, y ]	473.3 [mm], 5940.9 [m], ( 283.3 [m] )
Type	点状疵点	Size	H:193.1 ,V:2.0 [mm]
Result	-	Area	361.7 [mm2]
Inspection level	5/5,5/5,5/5,5/5,5/5	Label	-
Light	6,6,3/6,6,3

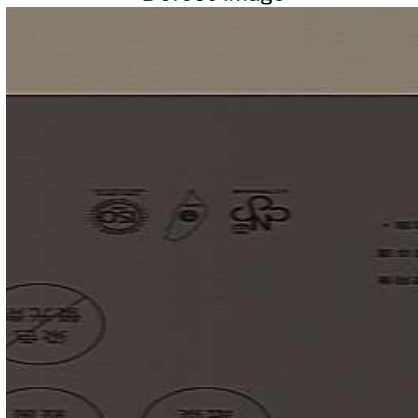
Defect image

No.	#36, \$26	Date	2023/8/10 上午 10:43:16
Segment	1	Camera	1
Pattern	7899	Position[ x, y ]	123.9 [mm], 5941.0 [m], ( 283.2 [m] )
Type	点状疵点縱向刀絲疵點	Size	H:184.6 ,V:64.0 [mm]
Result	-	Area	371.8 [mm2]
Inspection level	5/5,5/5,5/5,5/5,5/5	Label	-
Light	6,6,3/6,6,3

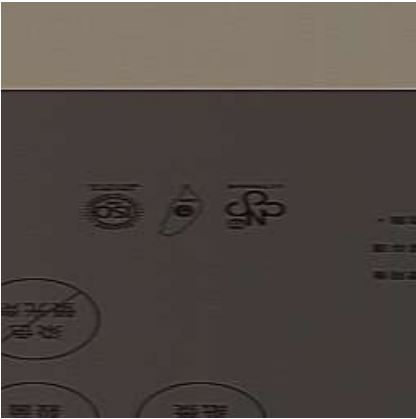
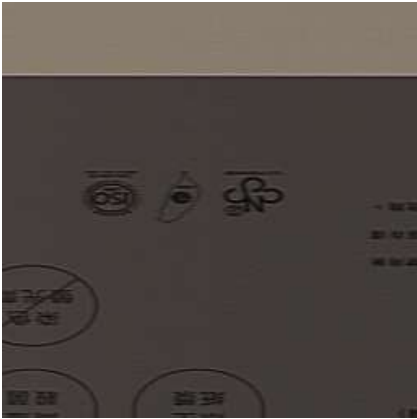
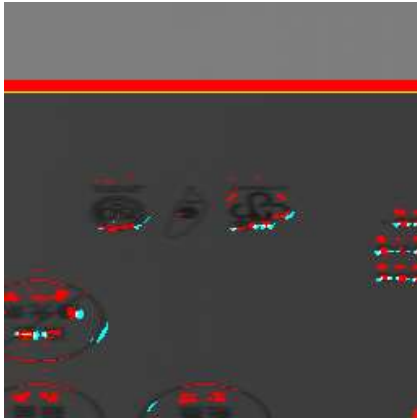
Defect image	Reference image	Shape image

No.	#34, \$25	Date	2023/8/10 上午 10:39:36
Segment	1	Camera	1
Pattern	7898	Position[ x, y ]	152.0 [mm], 5940.2 [m], ( 284.0 [m] )
Type	点状疵点	Size	H:184.6 ,V:2.0 [mm]
Result	-	Area	309.4 [mm2]
Inspection level	5/5,5/5,5/5,5/5,5/5	Label	-
Light	6,6,3/6,6,3

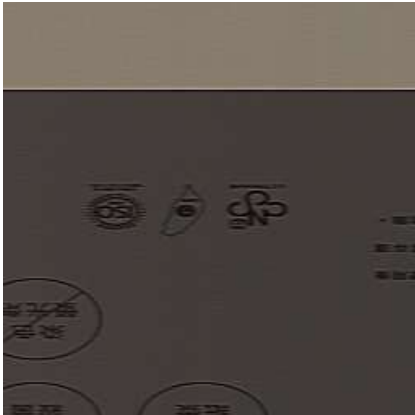
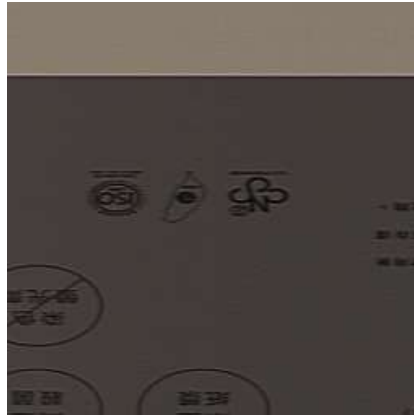
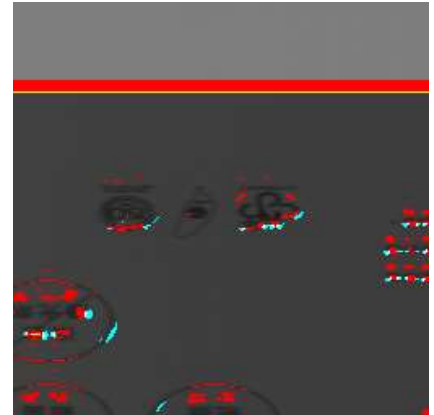
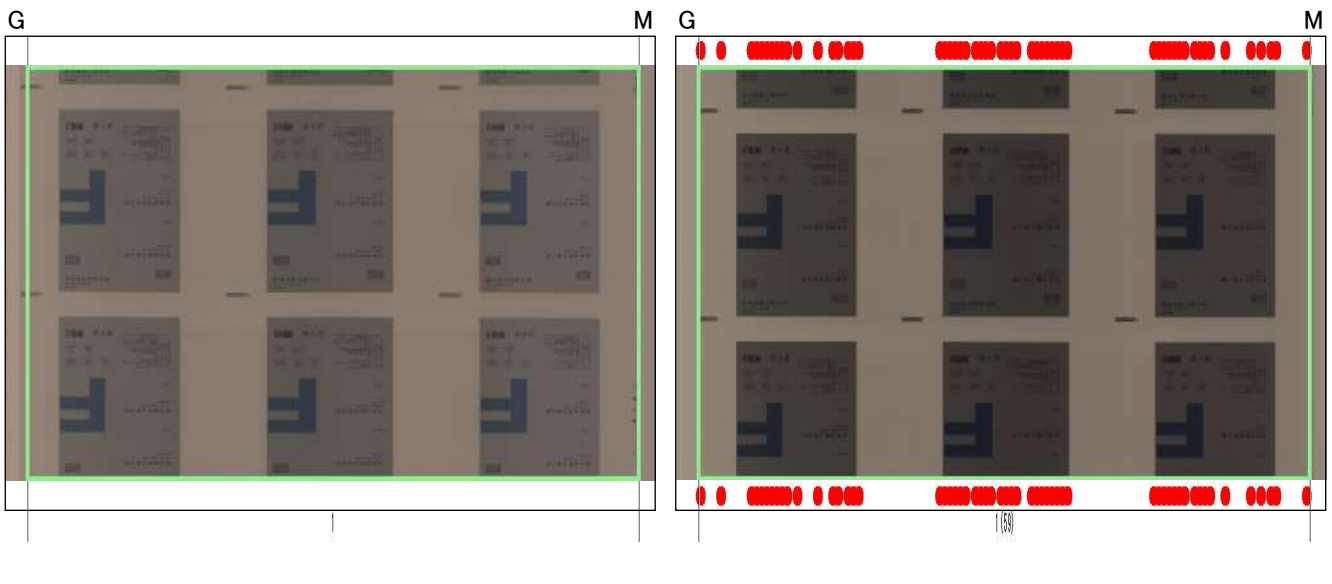
Defect image

No.	#34, \$25	Date	2023/8/10 上午 10:39:36
Segment	1	Camera	1
Pattern	7898	Position[ x, y ]	471.6 [mm], 5940.2 [m], ( 283.9 [m] )
Type	点状疵点縱向刀絲疵點橫向刀絲	Size	H:193.4 ,V:68.8 [mm]
Result	-	Area	353.3 [mm2]
Inspection level	5/5,5/5,5/5,5/5,5/5	Label	-
Light	6,6,3/6,6,3

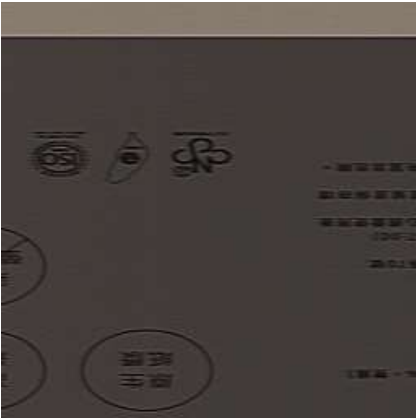
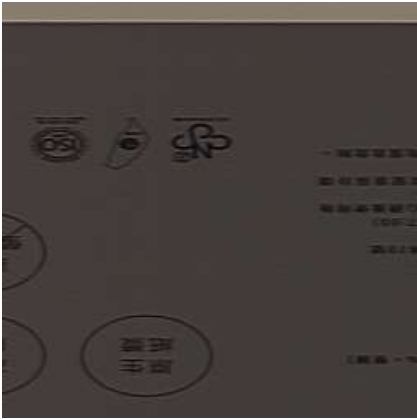
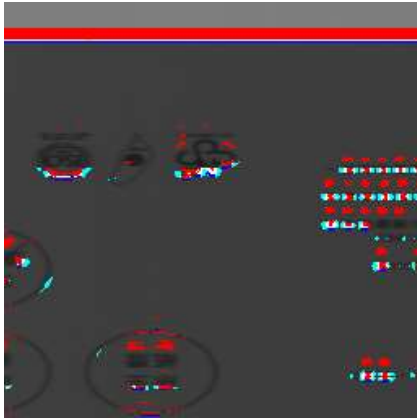
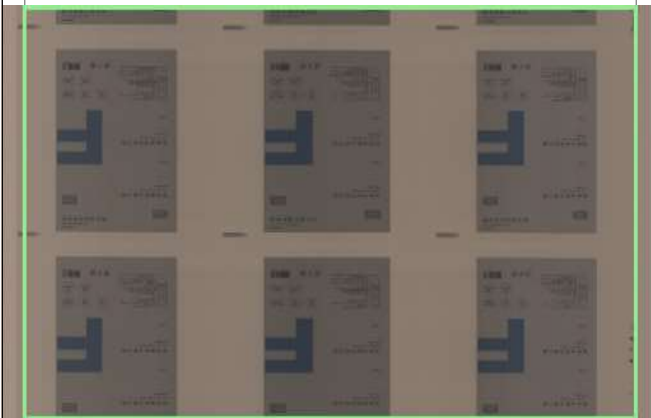
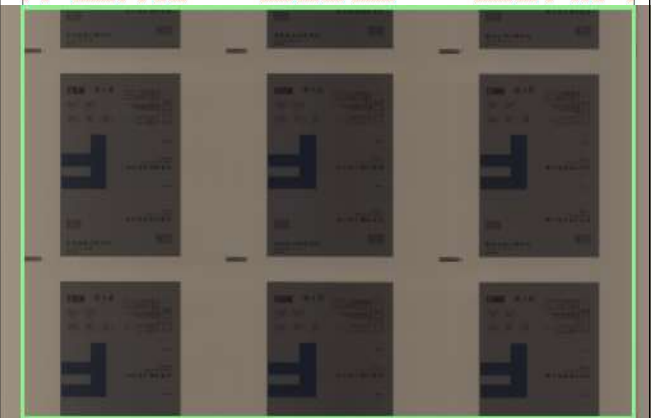
Defect image	Reference image	Shape image

No.	#34, \$25	Date	2023/8/10 上午 10:39:36
Segment	1	Camera	1
Pattern	7898	Position[ x, y ]	137.6 [mm], 5940.2 [m], ( 283.9 [m] )
Type	点状疵点縱向刀絲疵點橫向刀絲	Size	H:184.6 ,V:79.2 [mm]
Result	-	Area	353.7 [mm2]
Inspection level	5/5,5/5,5/5,5/5,5/5	Label	-
Light	6,6,3/6,6,3

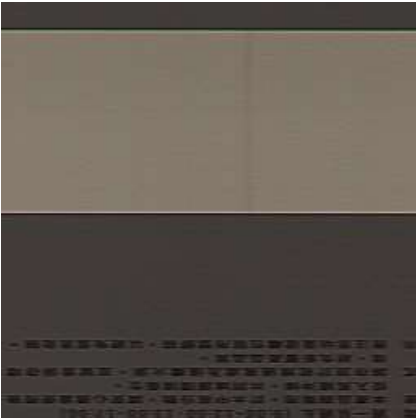
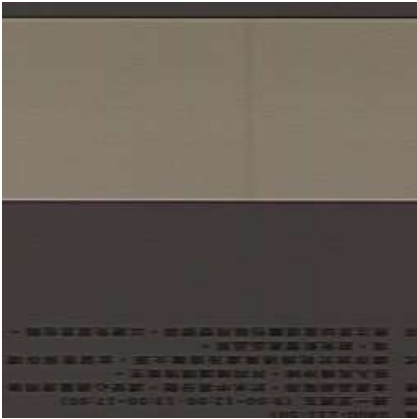
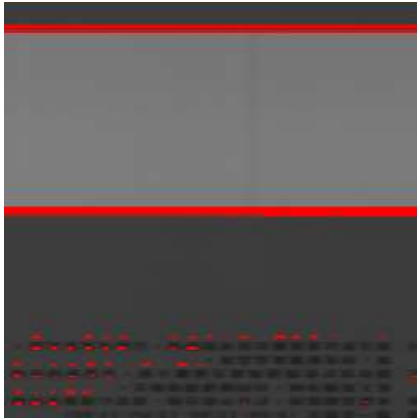
Defect image	Reference image	Shape image

No.	#33, \$24	Date	2023/8/10 上午 10:39:34
Segment	1	Camera	1
Pattern	7897	Position[ x, y ]	180.6 [mm], 5939.8 [m], ( 284.4 [m] )
Type	点状疵点	Size	H:126.0 ,V:1.6 [mm]
Result	-	Area	167.3 [mm2]
Inspection level	5/5,5/5,5/5,5/5,5/5	Label	-
Light	6,6,3/6,6,3

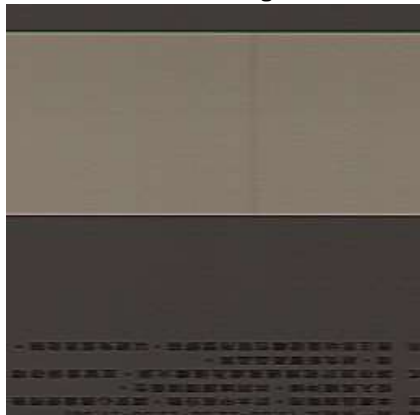
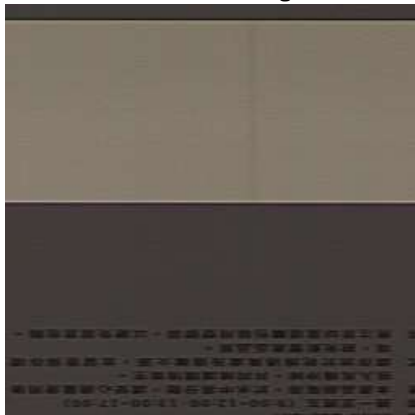
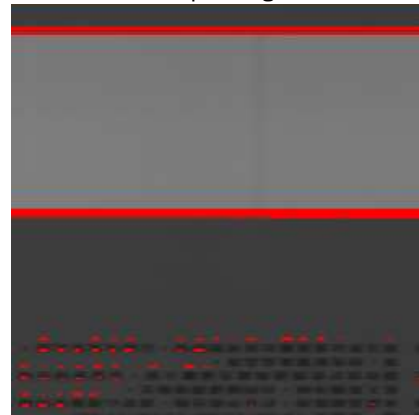
Defect image

No.	#30, \$23	Date	2023/8/10 上午 10:39:00
Segment	1	Camera	1
Pattern	7841	Position[ x, y ]	203.5 [mm], 5897.4 [m], ( 326.8 [m] )
Type	縱向刀絲疵點	Size	H:5.4 ,V:10.4 [mm]
Result	-	Area	4.9 [mm2]
Inspection level	5/5,5/5,5/5,5/5,5/5	Label	-
Light	6,6,3/6,6,3

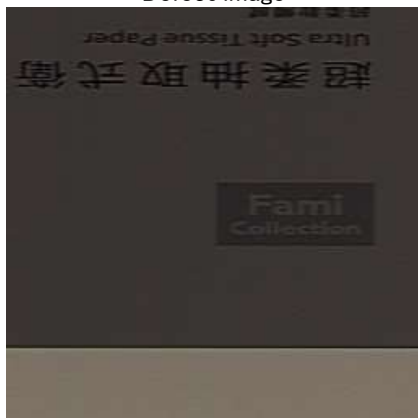
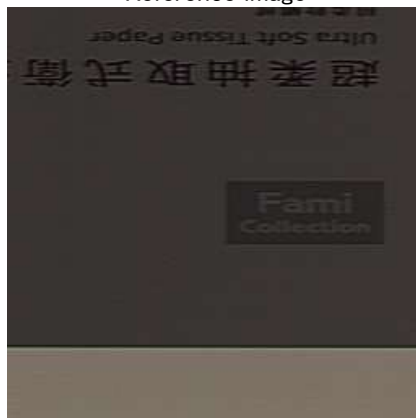
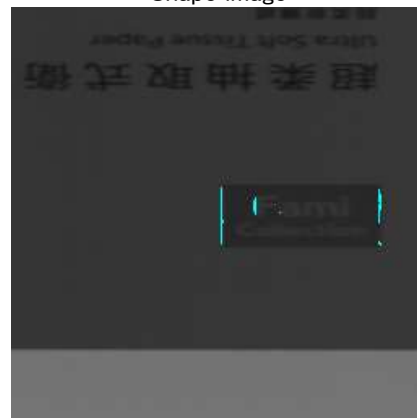
Defect image

No.	#30, \$23	Date	2023/8/10 上午 10:39:00
Segment	1	Camera	1
Pattern	7841	Position[ x, y ]	528.2 [mm], 5897.4 [m], ( 326.8 [m] )
Type	縱向刀絲疵點	Size	H:5.4 ,V:13.2 [mm]
Result	-	Area	5.0 [mm2]
Inspection level	5/5,5/5,5/5,5/5,5/5	Label	-
Light	6,6,3/6,6,3

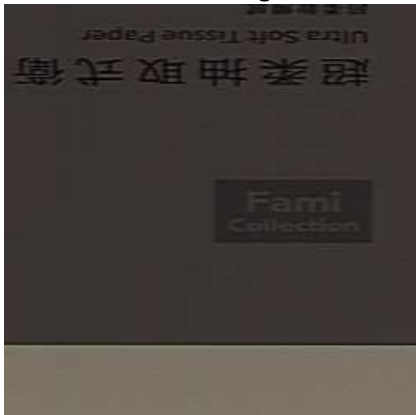
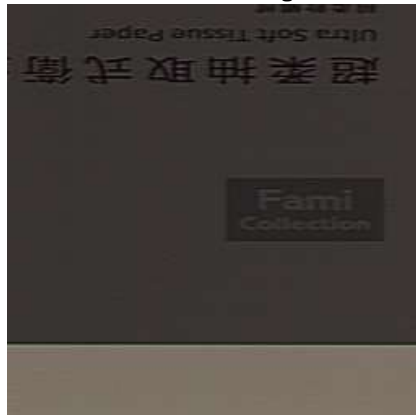
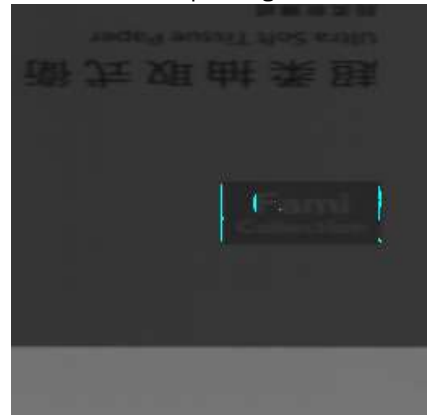
Defect image

No.	#29, \$22	Date	2023/8/10 上午 10:38:59
Segment	1	Camera	1
Pattern	7840	Position[ x, y ]	405.9 [mm], 5897.0 [m], ( 327.2 [m] )
Type	縱向刀絲疵點	Size	H:0.5 ,V:7.2 [mm]
Result	-	Area	2.8 [mm2]
Inspection level	5/5,5/5,5/5,5/5,5/5	Label	-
Light	6,6,3/6,6,3

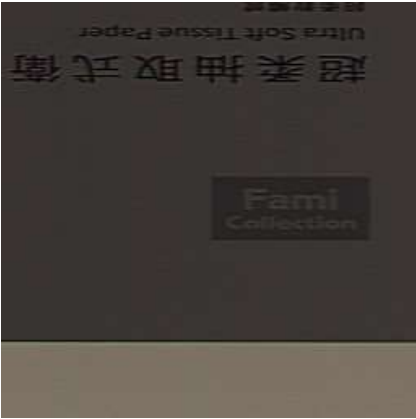
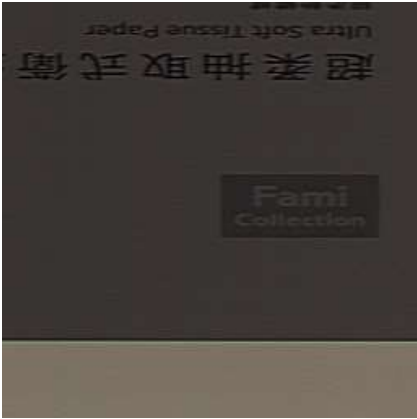
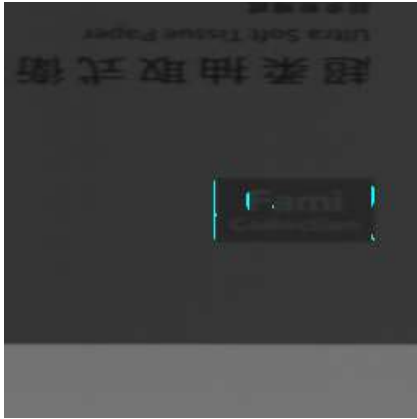
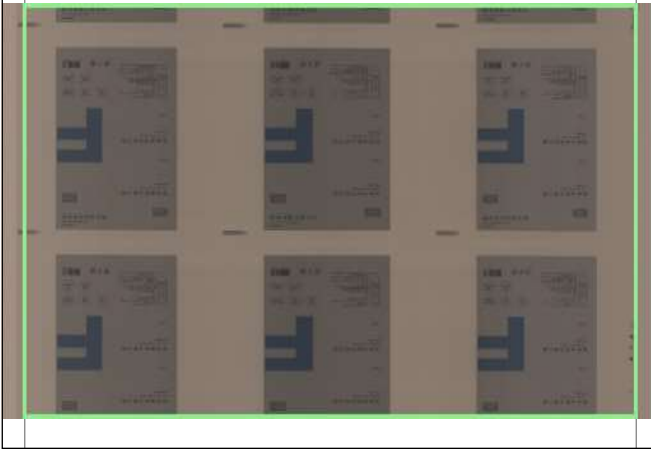
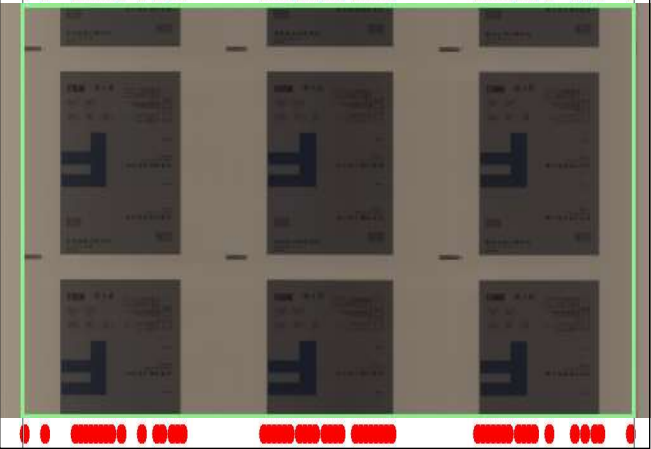
Defect image	Reference image	Shape image

No.	#29, \$22	Date	2023/8/10 上午 10:38:59
Segment	1	Camera	1
Pattern	7840	Position[ x, y ]	528.2 [mm], 5896.6 [m], ( 327.6 [m] )
Type	縱向刀絲疵點	Size	H:5.4 ,V:13.6 [mm]
Result	-	Area	5.2 [mm2]
Inspection level	5/5,5/5,5/5,5/5,5/5	Label	-
Light	6,6,3/6,6,3

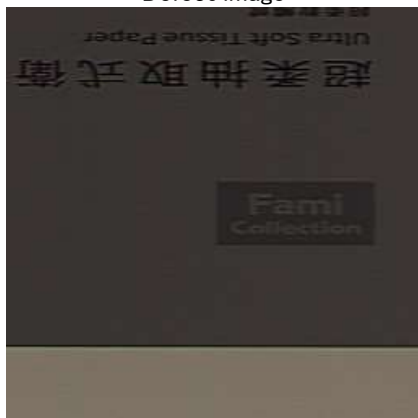
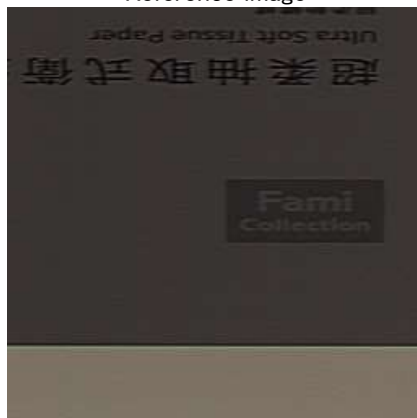
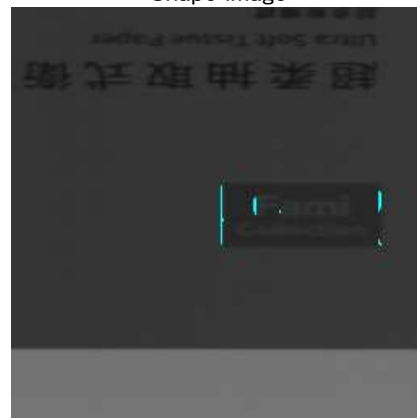
Defect image

No.	#28, \$21	Date	2023/8/10 上午 10:38:58
Segment	1	Camera	1
Pattern	7839	Position[ x, y ]	528.5 [mm], 5895.9 [m], ( 328.3 [m] )
Type	縱向刀絲疵點	Size	H:5.4 ,V:7.2 [mm]
Result	-	Area	2.8 [mm2]
Inspection level	5/5,5/5,5/5,5/5,5/5	Label	-
Light	6,6,3/6,6,3

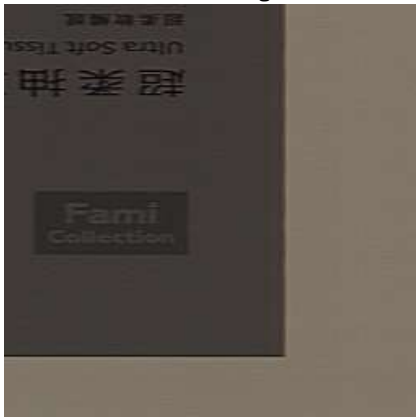
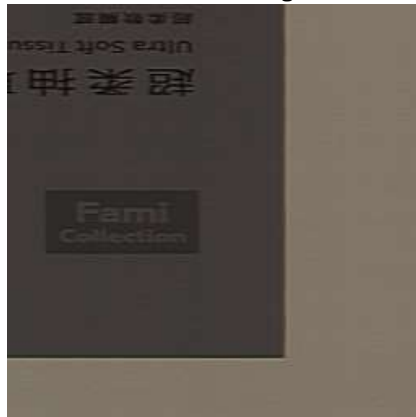
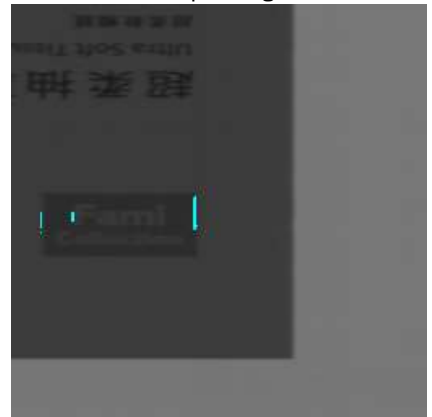
Defect image

No.	#28, \$21	Date	2023/8/10 上午 10:38:58
Segment	1	Camera	1
Pattern	7839	Position[ x, y ]	225.7 [mm], 5895.9 [m], ( 328.3 [m] )
Type	縱向刀絲疵點	Size	H:0.5 ,V:7.6 [mm]
Result	-	Area	3.6 [mm2]
Inspection level	5/5,5/5,5/5,5/5,5/5	Label	-
Light	6,6,3/6,6,3

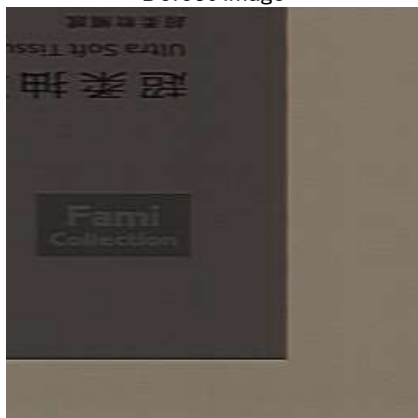
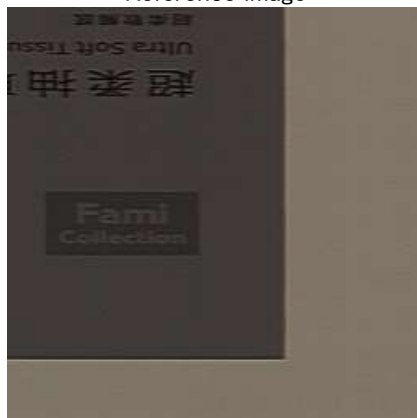
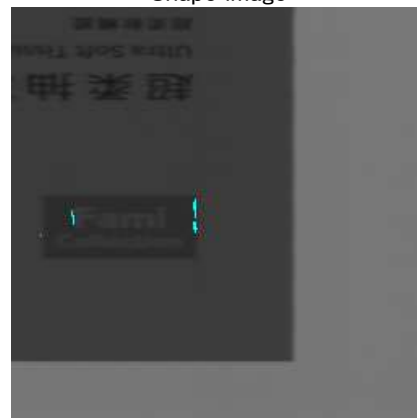
Defect image

No.	#27, \$20	Date	2023/8/10 上午 10:38:58
Segment	1	Camera	1
Pattern	7838	Position[ x, y ]	225.7 [mm], 5895.1 [m], ( 329.1 [m] )
Type	縱向刀絲疵點	Size	H:0.5 ,V:7.6 [mm]
Result	-	Area	2.1 [mm2]
Inspection level	5/5,5/5,5/5,5/5,5/5	Label	-
Light	6,6,3/6,6,3

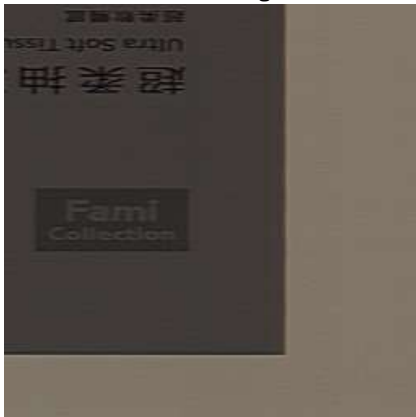
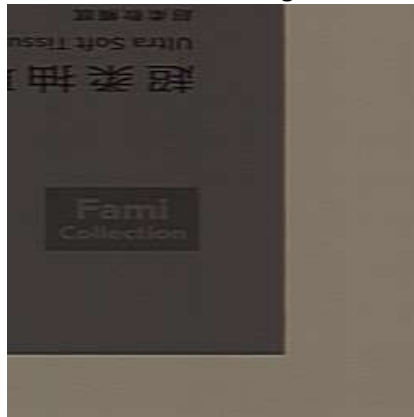
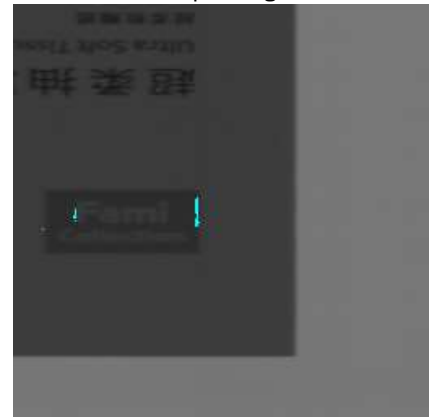
Defect image

No.	#23, \$18	Date	2023/8/10 上午 10:38:19
Segment	1	Camera	1
Pattern	7772	Position[ x, y ]	464.0 [mm], 5845.6 [m], ( 378.6 [m] )
Type	点状疵点縱向刀絲疵點	Size	H:194.6 ,V:114.0 [mm]
Result	-	Area	589.0 [mm2]
Inspection level	5/5,5/5,5/5,5/5,5/5	Label	-
Light	6,6,3/6,6,3

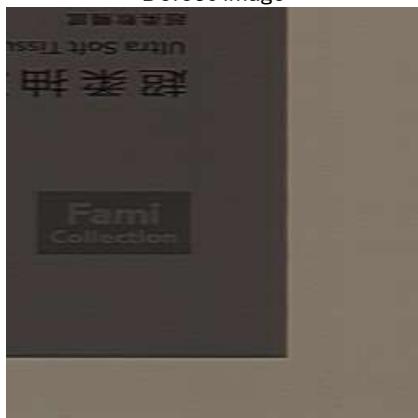
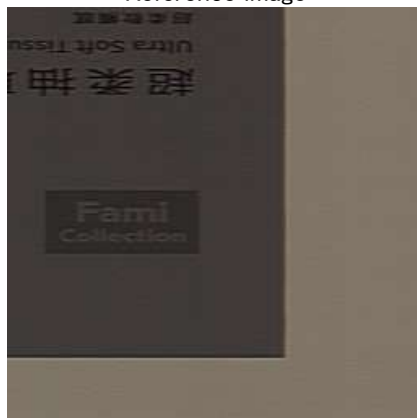
Defect image

No.	#23, \$18	Date	2023/8/10 上午 10:38:19
Segment	1	Camera	1
Pattern	7772	Position[ x, y ]	757.0 [mm], 5845.7 [m], ( 378.4 [m] )
Type	点状疵点縱向刀絲疵點橫向刀絲	Size	H:184.8 ,V:224.0 [mm]
Result	-	Area	604.0 [mm2]
Inspection level	5/5,5/5,5/5,5/5,5/5	Label	-
Light	6,6,3/6,6,3

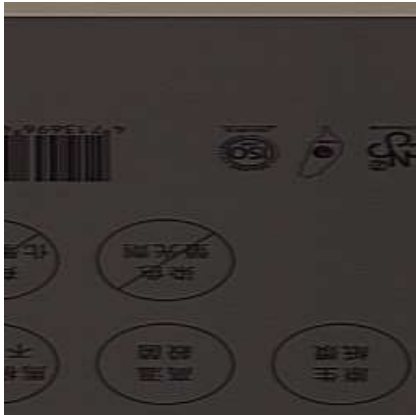
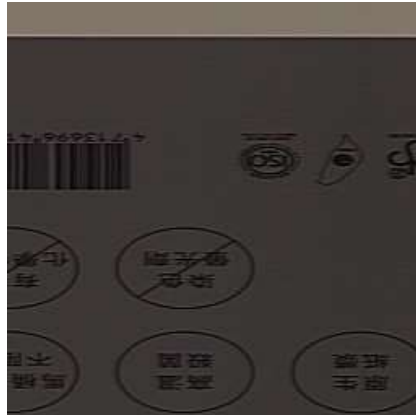
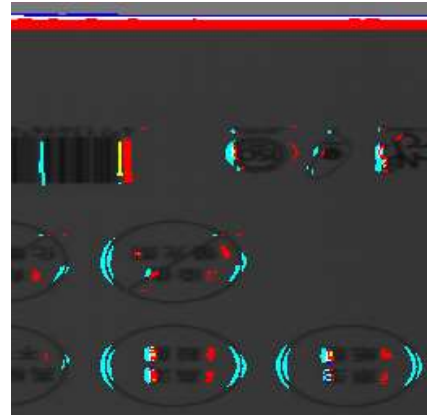
Defect image

No.	#23, \$18	Date	2023/8/10 上午 10:38:19
Segment	1	Camera	1
Pattern	7772	Position[ x, y ]	437.9 [mm], 5845.8 [m], ( 378.4 [m] )
Type	点状疵点縱向刀絲疵點橫向刀絲	Size	H:195.6 ,V:458.8 [mm]
Result	-	Area	1425.1 [mm2]
Inspection level	5/5,5/5,5/5,5/5,5/5	Label	-
Light	6,6,3/6,6,3

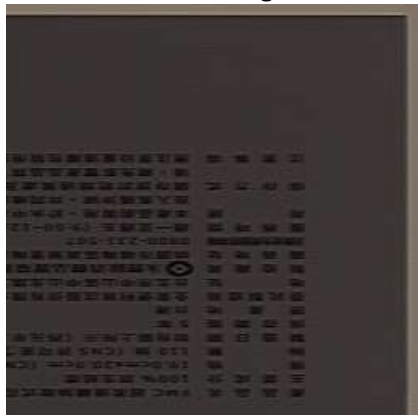
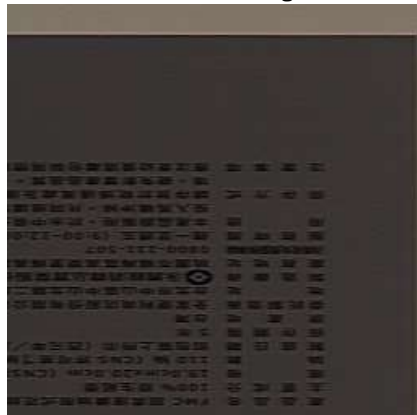
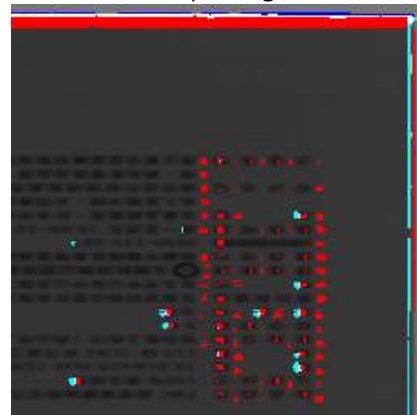
Defect image

No.	#22, \$17	Date	2023/8/10 上午 10:38:19
Segment	1	Camera	1
Pattern	7771	Position[ x, y ]	451.3 [mm], 5845.0 [m], ( 379.1 [m] )
Type	点状疵点縱向刀絲疵點橫向刀絲	Size	H:195.3 ,V:552.4 [mm]
Result	-	Area	1418.3 [mm2]
Inspection level	5/5,5/5,5/5,5/5,5/5	Label	-
Light	6,6,3/6,6,3

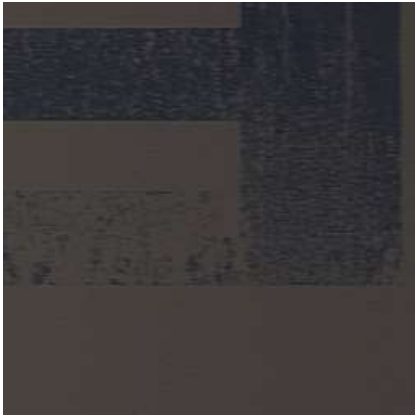
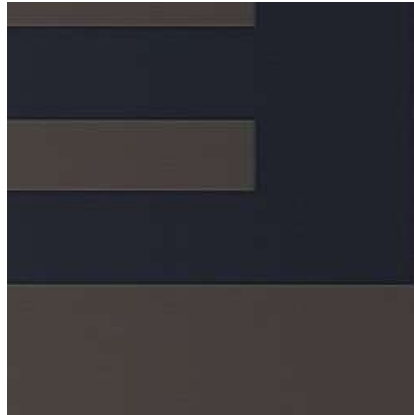
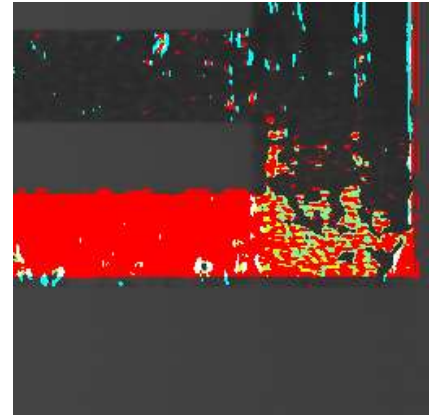
Defect image

No.	#21, \$16	Date	2023/8/10 上午 10:38:18
Segment	1	Camera	1
Pattern	7770	Position[ x, y ]	94.1 [mm], 5844.4 [m], ( 379.8 [m] )
Type	点状疵点縱向刀絲疵點	Size	H:68.8 ,V:53.2 [mm]
Result	-	Area	1146.3 [mm2]
Inspection level	5/5,5/5,5/5,5/5,5/5	Label	-
Light	6,6,3/6,6,3

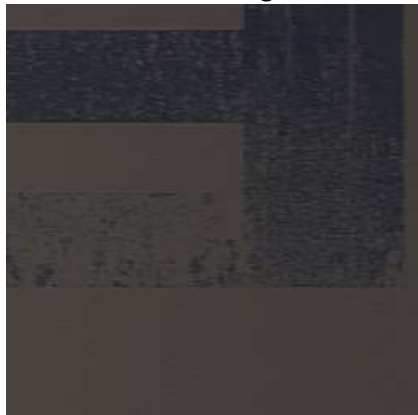
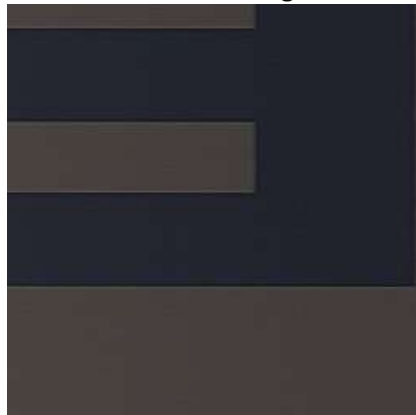
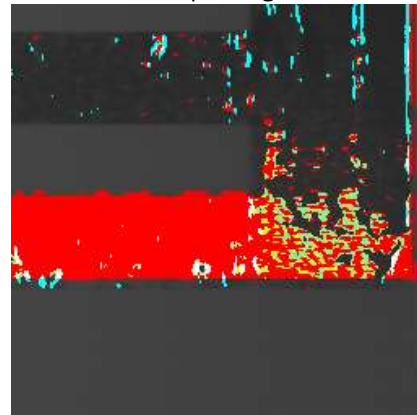
Defect image

No.	#20, \$15	Date	2023/8/10 上午 10:38:18
Segment	1	Camera	1
Pattern	7769	Position[ x, y ]	370.5 [mm], 5843.4 [m], ( 380.8 [m] )
Type	点状疵点縱向刀絲疵點	Size	H:2.4 ,V:110.0 [mm]
Result	-	Area	46.1 [mm2]
Inspection level	5/5,5/5,5/5,5/5,5/5	Label	-
Light	6,6,3/6,6,3

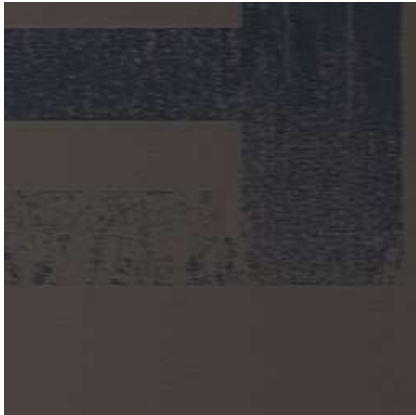
Defect image

No.	#20, \$15	Date	2023/8/10 上午 10:38:18
Segment	1	Camera	1
Pattern	7769	Position[ x, y ]	932.3 [mm], 5843.4 [m], ( 380.8 [m] )
Type	点状疵点	Size	H:4.6 ,V:15.2 [mm]
Result	-	Area	49.2 [mm2]
Inspection level	5/5,5/5,5/5,5/5,5/5	Label	-
Light	6,6,3/6,6,3

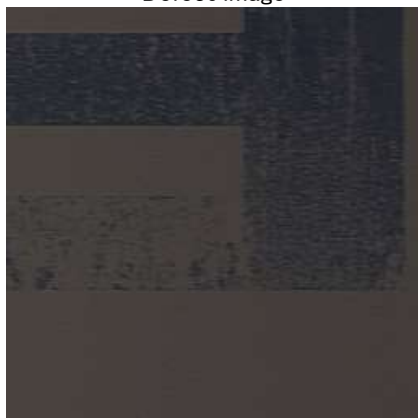
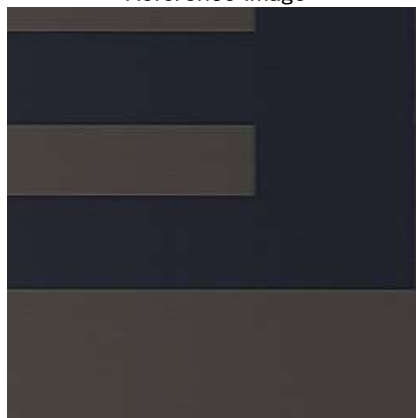
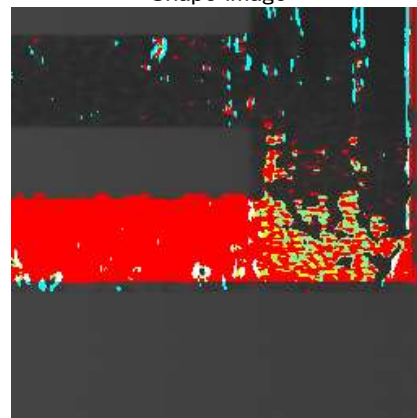
Defect image

No.	#20, \$15	Date	2023/8/10 上午 10:38:18
Segment	1	Camera	1
Pattern	7769	Position[ x, y ]	933.2 [mm], 5843.4 [m], ( 380.8 [m] )
Type	点状疵点縱向刀絲疵點橫向刀絲	Size	H:6.8 ,V:56.4 [mm]
Result	-	Area	121.7 [mm2]
Inspection level	5/5,5/5,5/5,5/5,5/5	Label	-
Light	6,6,3/6,6,3

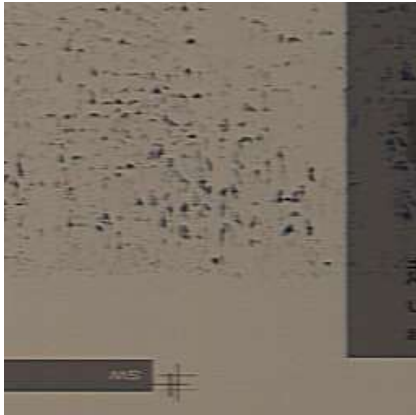
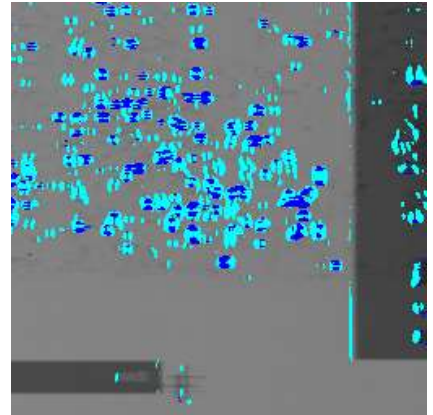
Defect image

No.	#20, \$15	Date	2023/8/10 上午 10:38:18
Segment	1	Camera	1
Pattern	7769	Position[ x, y ]	30.2 [mm], 5843.3 [m], ( 380.8 [m] )
Type	縱向刀絲疵點橫向刀絲	Size	H:68.1 ,V:48.8 [mm]
Result	-	Area	403.9 [mm2]
Inspection level	5/5,5/5,5/5,5/5,5/5	Label	-
Light	6,6,3/6,6,3

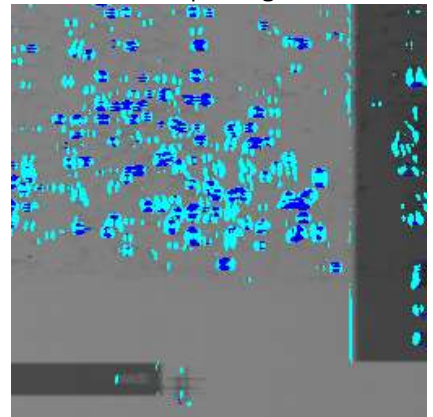
Defect image

No.	#19, \$14	Date	2023/8/10 上午 10:38:17
Segment	1	Camera	1
Pattern	7768	Position[ x, y ]	933.2 [mm], 5842.6 [m], ( 381.6 [m] )
Type	点状疵点縱向刀絲疵點橫向刀絲	Size	H:6.8 ,V:56.4 [mm]
Result	-	Area	120.0 [mm2]
Inspection level	5/5,5/5,5/5,5/5,5/5	Label	-
Light	6,6,3/6,6,3

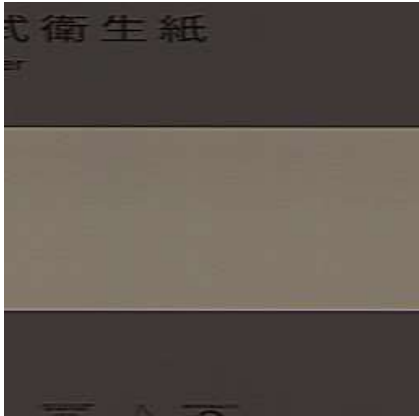
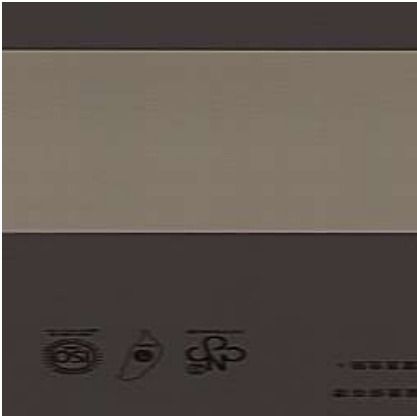
Defect image	Reference image	Shape image

No.	#16, \$13	Date	2023/8/10 上午 10:38:12
Segment	1	Camera	1
Pattern	7761	Position[ x, y ]	794.3 [mm], 5836.6 [m], ( 387.6 [m] )
Type	点状疵点縱向刀絲疵點橫向刀絲	Size	H:185.5 ,V:206.8 [mm]
Result	-	Area	3588.7 [mm2]
Inspection level	5/5,5/5,5/5,5/5,5/5	Label	-
Light	6,6,3/6,6,3

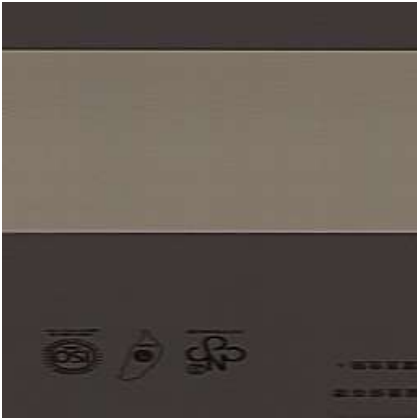
Defect image	Reference image	Shape image

No.	#15, \$12	Date	2023/8/10 上午 10:38:12
Segment	1	Camera	1
Pattern	7760	Position[ x, y ]	463.8 [mm], 5835.9 [m], ( 388.3 [m] )
Type	点状疵点縱向刀絲疵點橫向刀絲	Size	H:194.8 ,V:257.2 [mm]
Result	-	Area	3465.2 [mm2]
Inspection level	5/5,5/5,5/5,5/5,5/5	Label	-
Light	6,6,3/6,6,3

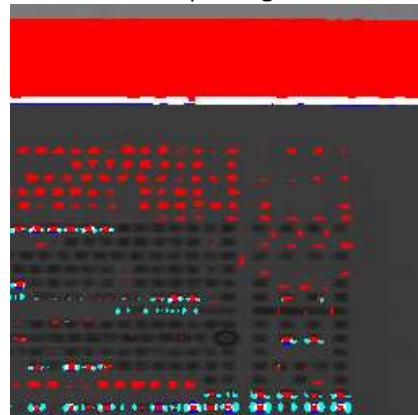
Defect image

No.	#15, \$12	Date	2023/8/10 上午 10:38:12
Segment	1	Camera	1
Pattern	7760	Position[ x, y ]	140.8 [mm], 5835.9 [m], ( 388.3 [m] )
Type	点状疵点縱向刀絲疵點橫向刀絲	Size	H:186.0 ,V:176.0 [mm]
Result	-	Area	3617.0 [mm2]
Inspection level	5/5,5/5,5/5,5/5,5/5	Label	-
Light	6,6,3/6,6,3
