# Inspection Result (Individual Data)

Lot number : 3

Inspected date : 2023/8/10 上午 09:15:18 ~ 2023/8/10 上午 10:55:13

商品名	標準透明6-6-3	周長	
顧客名		Ex1	
CODE番号		Ex2	
基材		Ex3

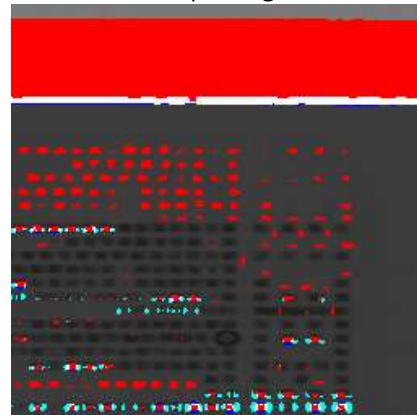
Defect image

No.	#14, \$11	Date	2023/8/10 上午 10:38:11
Segment	1	Camera	1
Pattern	7759	Position[ x, y ]	771.1 [mm], 5835.1 [m], ( 389.0 [m] )
Type	点状疵点縱向刀絲疵點橫向刀絲	Size	H:185.5 ,V:176.0 [mm]
Result	-	Area	3689.6 [mm2]
Inspection level	5/5,5/5,5/5,5/5,5/5	Label	-
Light	6,6,3/6,6,3

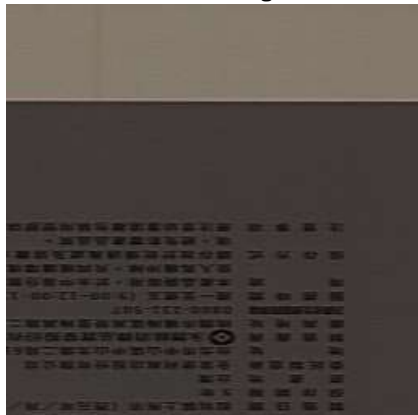
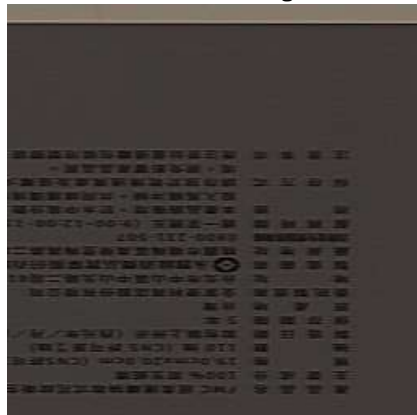
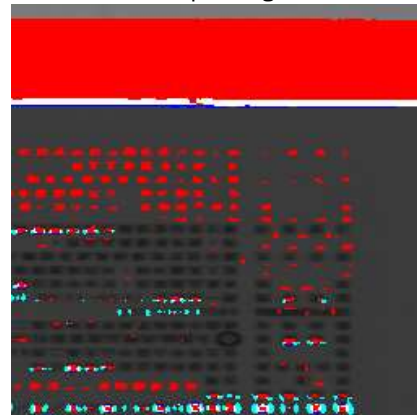
Defect image

No.	#14, \$11	Date	2023/8/10 上午 10:38:11
Segment	1	Camera	1
Pattern	7759	Position[ x, y ]	129.5 [mm], 5835.1 [m], ( 389.0 [m] )
Type	点状疵点縱向刀絲疵點橫向刀絲	Size	H:186.3 ,V:131.6 [mm]
Result	-	Area	3702.9 [mm2]
Inspection level	5/5,5/5,5/5,5/5,5/5	Label	-
Light	6,6,3/6,6,3

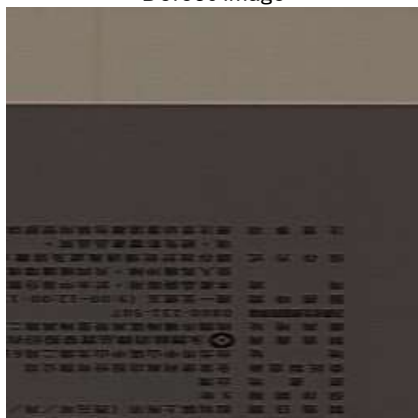
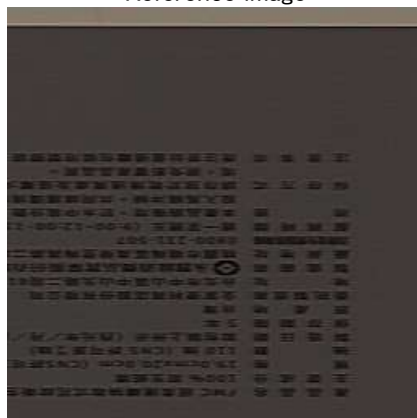
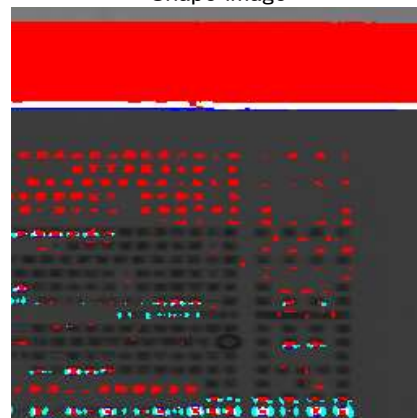
Defect image

No.	#13, \$10	Date	2023/8/10 上午 10:38:11
Segment	1	Camera	1
Pattern	7758	Position[ x, y ]	463.0 [mm], 5834.3 [m], ( 389.8 [m] )
Type	点状疵点縱向刀絲疵點	Size	H:193.6 ,V:178.4 [mm]
Result	-	Area	3446.2 [mm2]
Inspection level	5/5,5/5,5/5,5/5,5/5	Label	-
Light	6,6,3/6,6,3

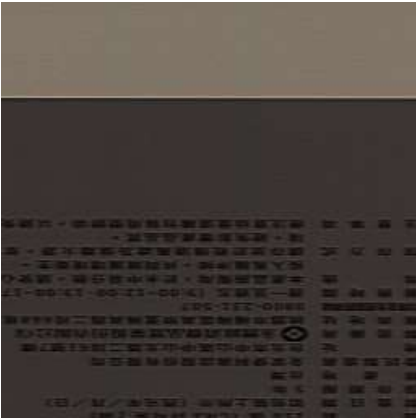
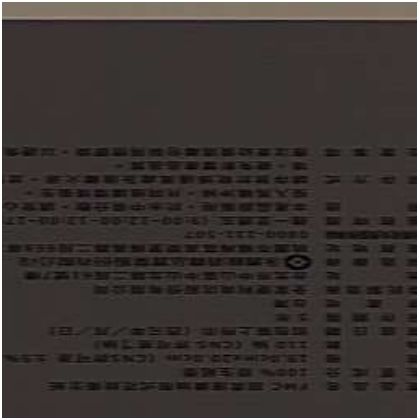
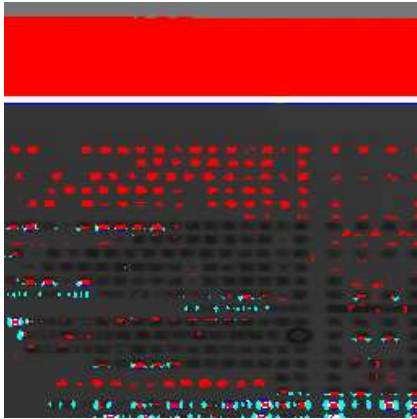
Defect image	Reference image	Shape image

No.	#12, \$9	Date	2023/8/10 上午 10:38:10
Segment	1	Camera	1
Pattern	7757	Position[ x, y ]	793.8 [mm], 5833.6 [m], ( 390.6 [m] )
Type	点状疵点縱向刀絲疵點橫向刀絲	Size	H:185.5 ,V:162.8 [mm]
Result	-	Area	3476.7 [mm2]
Inspection level	5/5,5/5,5/5,5/5,5/5	Label	-
Light	6,6,3/6,6,3

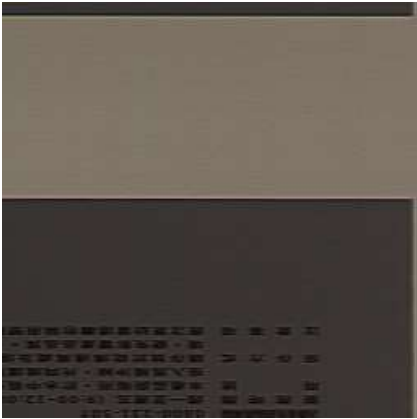
No.	#10, \$8	Date	2023/8/10 上午 10:36:05
Segment	1	Camera	1
Pattern	7724	Position[ x, y ]	487.2 [mm], 5804.6 [m], ( 419.6 [m] )
Type	点状疵点縱向刀絲疵點橫向刀絲	Size	H:194.8 ,V:185.2 [mm]
Result	-	Area	9617.3 [mm2]
Inspection level	5/5,5/5,5/5,5/5,5/5	Label	-
Light	6,6,3/6,6,3

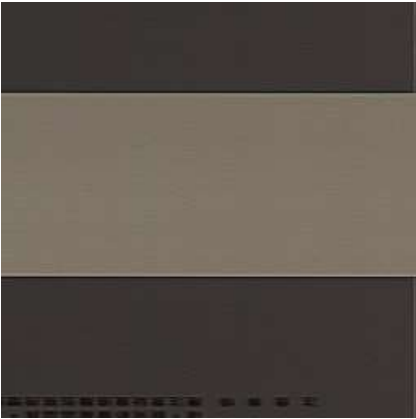
No.	#10, \$8	Date	2023/8/10 上午 10:36:05
Segment	1	Camera	1
Pattern	7724	Position[ x, y ]	139.1 [mm], 5804.7 [m], ( 419.4 [m] )
Type	点状疵点縱向刀絲疵點橫向刀絲	Size	H:199.0 ,V:558.0 [mm]
Result	-	Area	44577.1 [mm2]
Inspection level	5/5,5/5,5/5,5/5,5/5	Label	-
Light	6,6,3/6,6,3

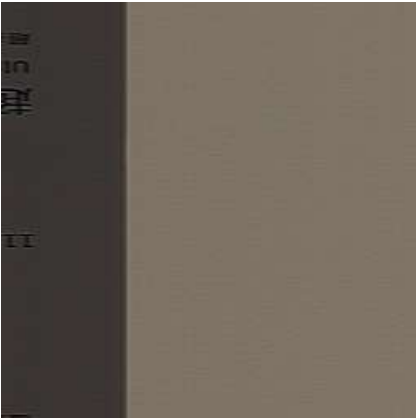
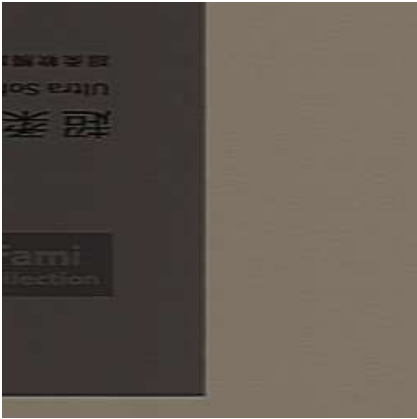
No.	#10, \$8	Date	2023/8/10 上午 10:36:05
Segment	1	Camera	1
Pattern	7724	Position[ x, y ]	455.0 [mm], 5804.8 [m], ( 419.4 [m] )
Type	点状疵点縱向刀絲疵點橫向刀絲	Size	H:206.8 ,V:558.8 [mm]
Result	-	Area	46562.9 [mm2]
Inspection level	5/5,5/5,5/5,5/5,5/5	Label	-
Light	6,6,3/6,6,3

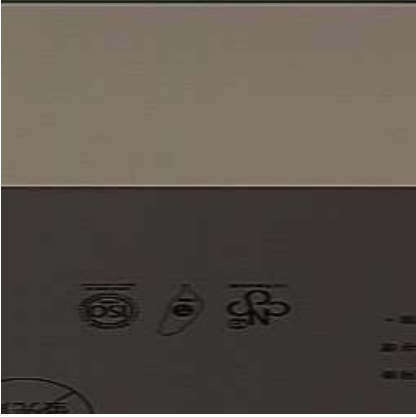
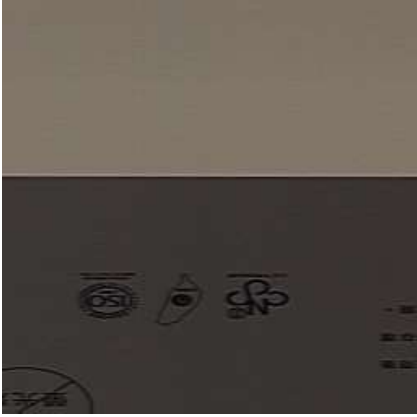
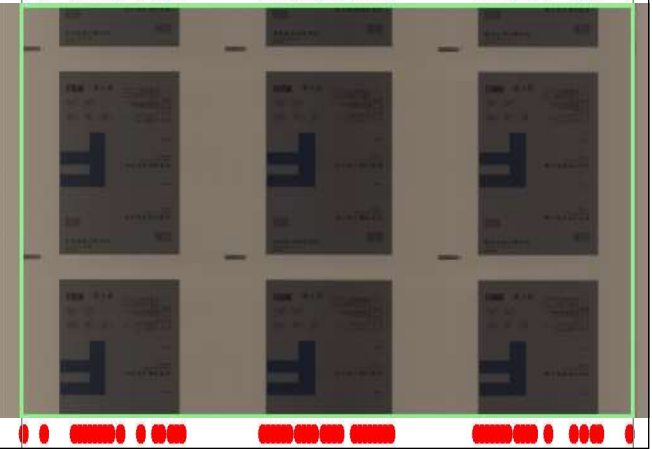
No.	#8, \$7	Date	2023/8/10 上午 10:30:38
Segment	1	Camera	1
Pattern	7722	Position[ x, y ]	447.6 [mm], 5804.4 [m], ( 419.8 [m] )
Type	点状疵点縱向刀絲疵點橫向刀絲	Size	H:193.1 ,V:85.2 [mm]
Result	-	Area	416.4 [mm2]
Inspection level	5/5,5/5,5/5,5/5,5/5	Label	-
Light	6,6,3/6,6,3

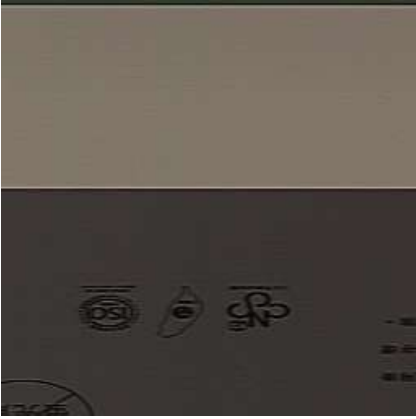
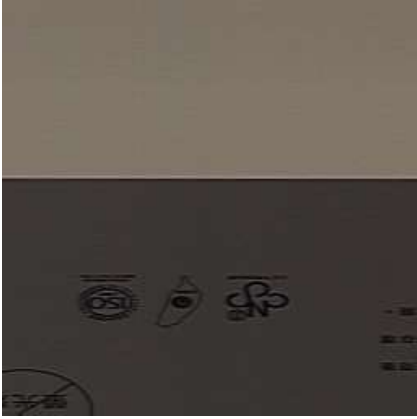
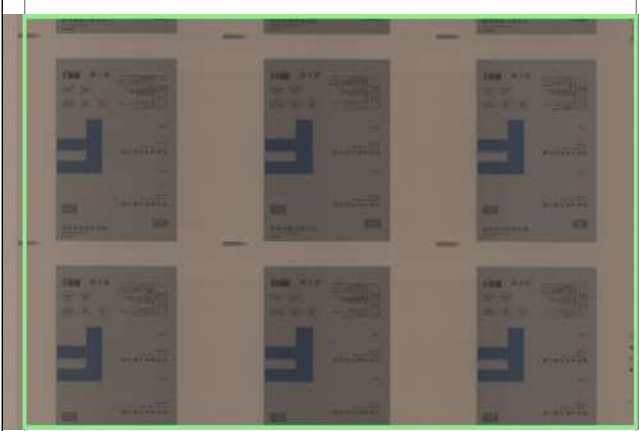
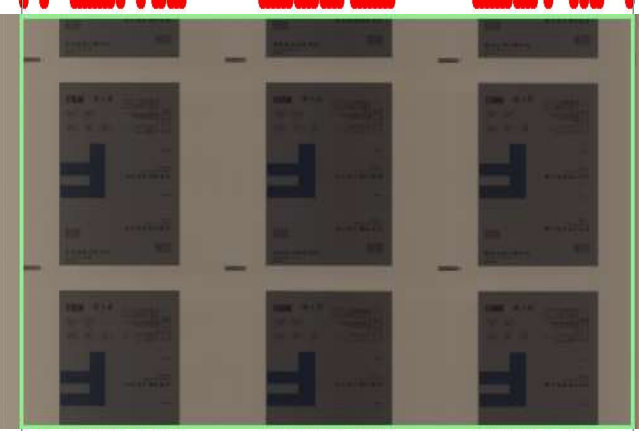
No.	#7, \$6	Date	2023/8/10 上午 10:30:36
Segment	1	Camera	1
Pattern	7721	Position[ x, y ]	149.5 [mm], 5803.2 [m], ( 420.9 [m] )
Type	点状疵点	Size	H:184.1 ,V:1.6 [mm]
Result	-	Area	231.7 [mm2]
Inspection level	5/5,5/5,5/5,5/5,5/5	Label	-
Light	6,6,3/6,6,3

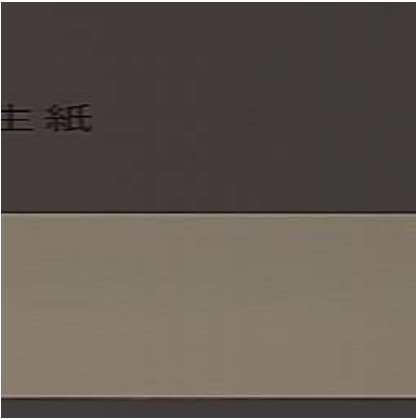
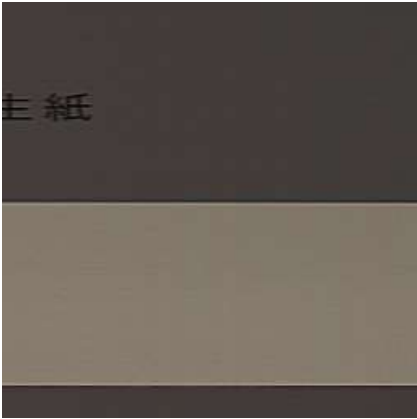
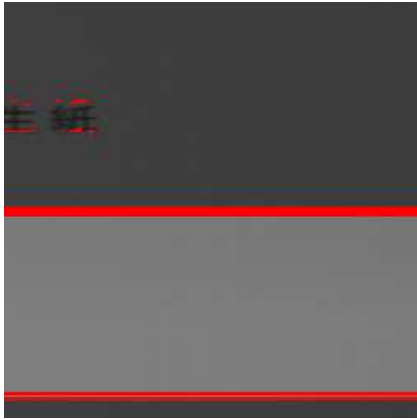
No.	#7, \$6	Date	2023/8/10 上午 10:30:36
Segment	1	Camera	1
Pattern	7721	Position[ x, y ]	149.8 [mm], 5803.6 [m], ( 420.6 [m] )
Type	点状疵点	Size	H:183.6 ,V:2.0 [mm]
Result	-	Area	280.9 [mm2]
Inspection level	5/5,5/5,5/5,5/5,5/5	Label	-
Light	6,6,3/6,6,3

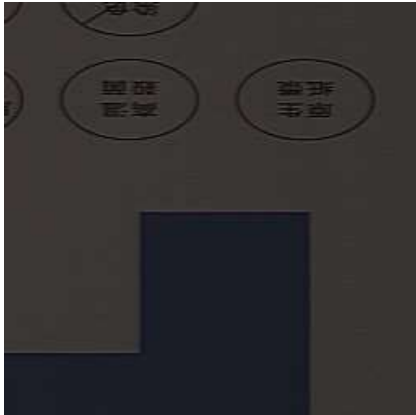
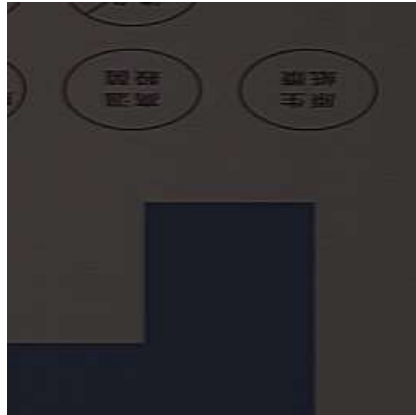
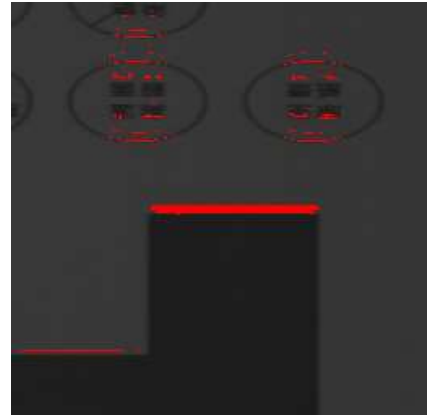
No.	#6, \$5	Date	2023/8/10 上午 10:30:34
Segment	1	Camera	1
Pattern	7720	Position[ x, y ]	434.9 [mm], 5803.0 [m], ( 421.2 [m] )
Type	点状疵点	Size	H:25.1 ,V:1.6 [mm]
Result	-	Area	29.9 [mm2]
Inspection level	5/5,5/5,5/5,5,5/5,5/5	Label	-
Light	6,6,3/6,6,3

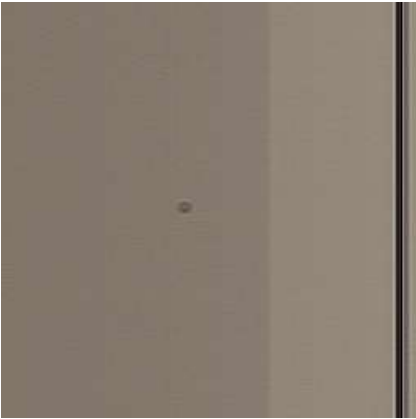
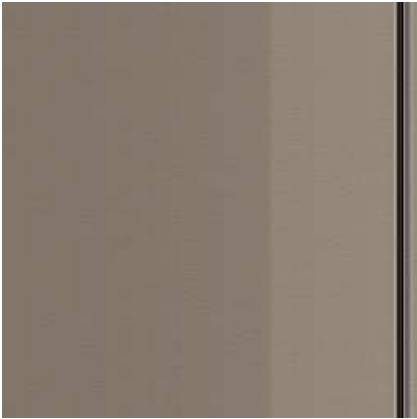
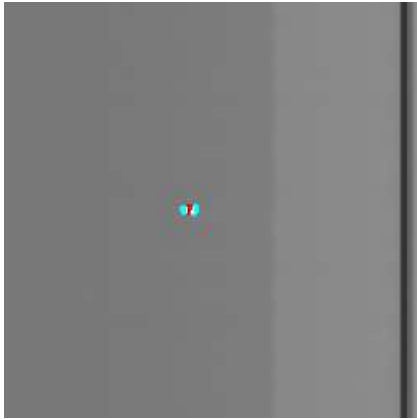
No.	#5, \$4	Date	2023/8/10 上午 10:13:32
Segment	1	Camera	1
Pattern	5973	Position[ x, y ]	929.1 [mm], 4491.3 [m], ( 1732.9 [m] )
Type	点状疵点縱向刀絲疵點	Size	H:2.9 ,V:2.4 [mm]
Result	-	Area	4.3 [mm2]
Inspection level	5/5,5/5,5/5,5/5,5/5	Label	-
Light	6,6,3/6,6,3

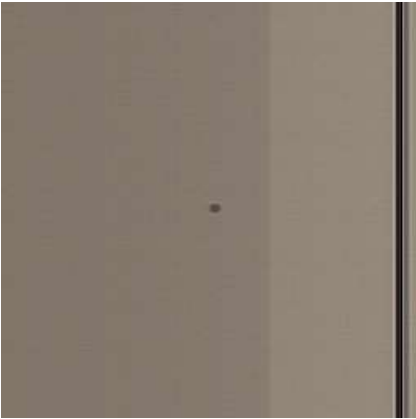
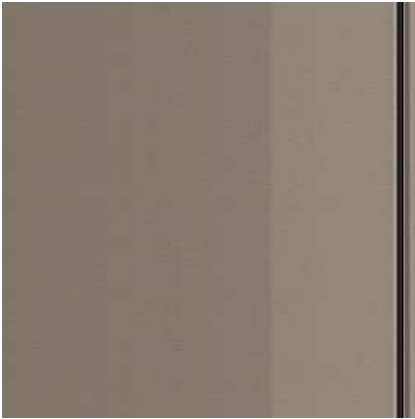
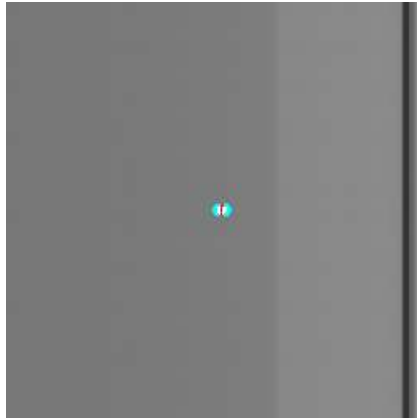
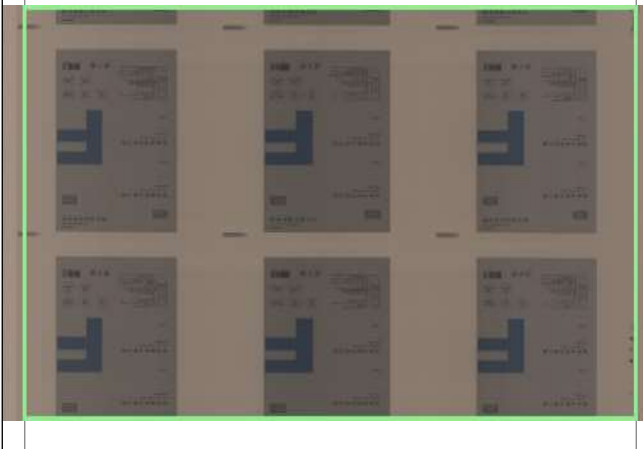
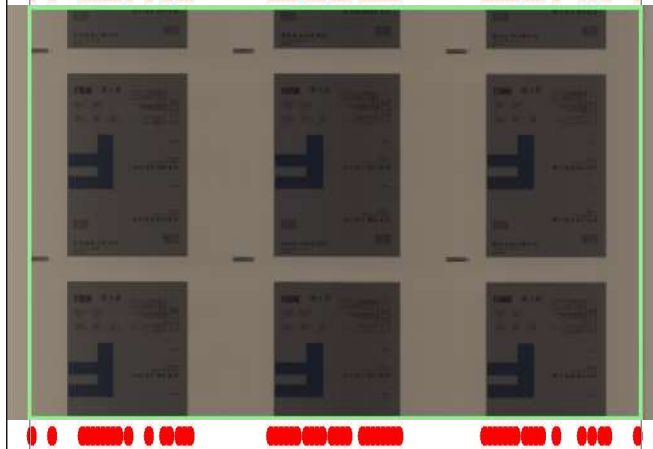
No.	#3, \$2	Date	2023/8/10 上午 09:24:14
Segment	1	Camera	1
Pattern	918	Position[ x, y ]	933.7 [mm], 695.8 [m], ( 5528.3 [m] )
Type	点状疵点縱向刀絲疵點	Size	H:2.9 ,V:2.4 [mm]
Result	-	Area	5.8 [mm2]
Inspection level	5/5,5/5,5/5,5/5,5/5	Label	-
Light	6,6,3/6,6,3

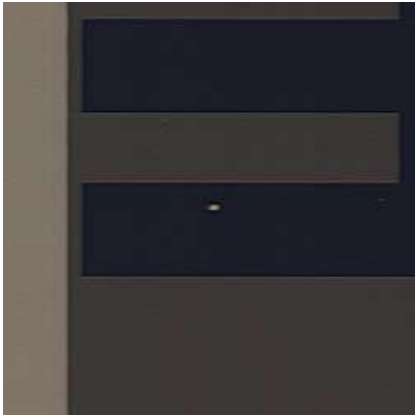
No.	#2, \$1	Date	2023/8/10 上午 09:19:26
Segment	1	Camera	1
Pattern	425	Position[ x, y ]	394.2 [mm], 325.5 [m], ( 5898.6 [m] )
Type	点状疵点縱向刀絲疵點橫向刀絲	Size	H:2.9 ,V:2.4 [mm]
Result	-	Area	5.3 [mm2]
Inspection level	5/5,5/5,5/5,5/5,5/5	Label	-
Light	6,6,3/6,6,3
