Inspection Result (Individual Data)

Lot number : 5

Inspected date : 2023/8/10 下午 12:12:08 ~ 2023/8/10 下午 01:31:18

商品名	標準透明6-6-3	周長
顧客名		Ex1
CODE番号		Ex2
基材		Ex3

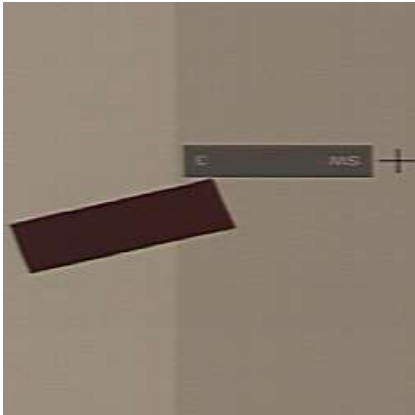
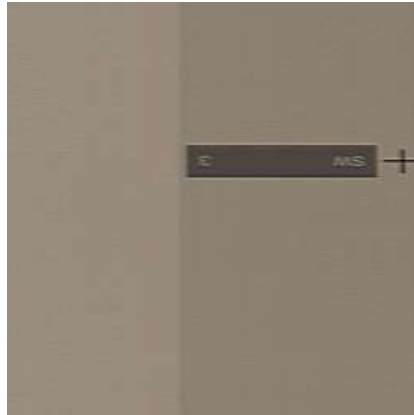
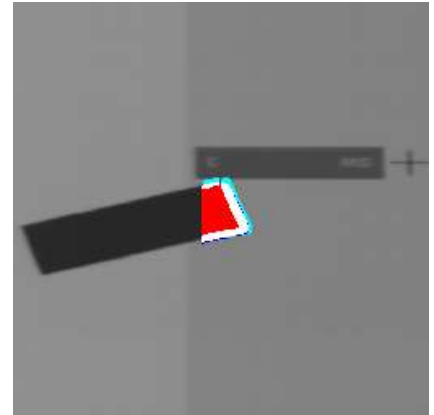
No.	#51, \$38	Date	2023/8/10 下午 01:31:10
Segment	1	Camera	1
Pattern	8109	Position[x, y]	3.6 [mm], 6063.3 [m], (3.0 [m])
Type	点状疵点縱向刀絲疵點橫向刀絲	Size	H:7.6 ,V:15.6 [mm]
Result	-	Area	71.7 [mm2]
Inspection level	5/5,5/5,5/5,5/5,5/5	Label	-
Light	6,6,3/6,6,3

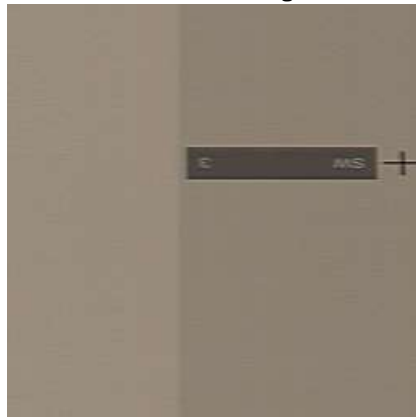
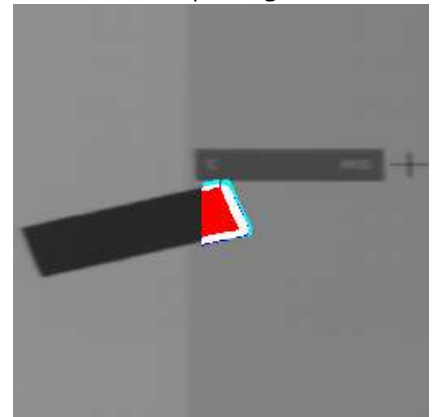
No.	#48, \$37	Date	2023/8/10 下午 01:30:38
Segment	1	Camera	1
Pattern	8055	Position[x, y]	700.1 [mm], 6023.0 [m], (43.4 [m])
Type	点状疵点縱向刀絲疵點	Size	H:1.0 ,V:307.2 [mm]
Result	-	Area	68.8 [mm2]
Inspection level	5/5,5/5,5/5,5/5,5/5	Label	-
Light	6,6,3/6,6,3

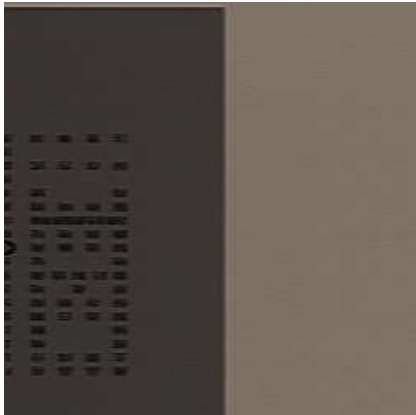
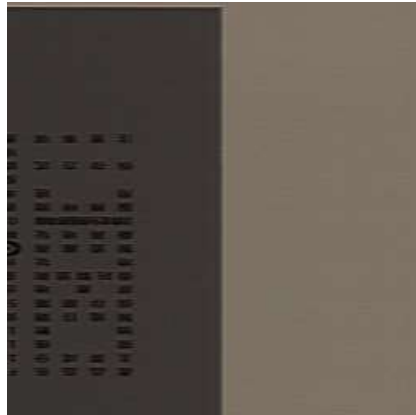
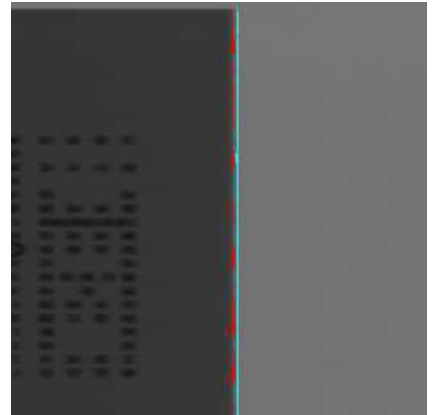
No.	#48, \$37	Date	2023/8/10 下午 01:30:38
Segment	1	Camera	1
Pattern	8055	Position[x, y]	567.8 [mm], 6023.2 [m], (43.2 [m])
Type	点状疵点縱向刀絲疵點	Size	H:2.0 ,V:803.2 [mm]
Result	-	Area	80.4 [mm2]
Inspection level	5/5,5/5,5/5,5/5,5/5	Label	-
Light	6,6,3/6,6,3

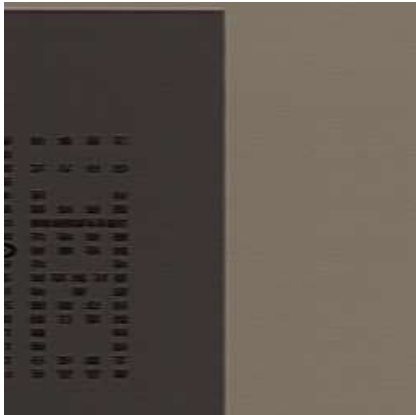
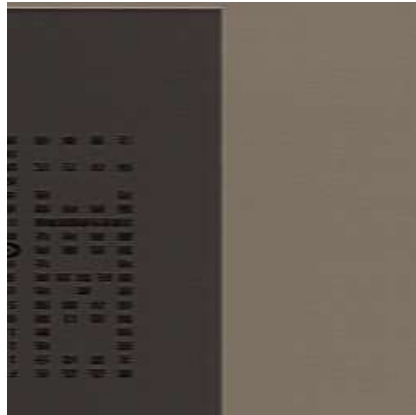
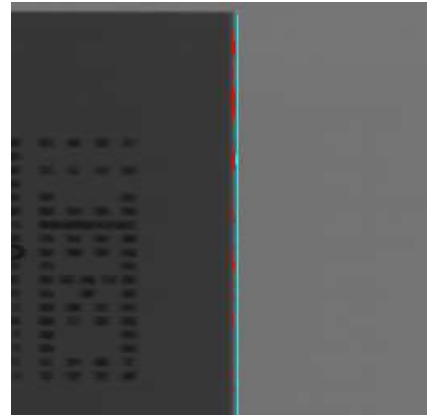
No.	#47, \$36	Date	2023/8/10 下午 01:30:38
Segment	1	Camera	1
Pattern	8054	Position[x, y]	567.8 [mm], 6022.5 [m], (43.9 [m])
Type	点状疵点縱向刀絲疵點	Size	H:1.0 ,V:803.2 [mm]
Result	-	Area	80.3 [mm2]
Inspection level	5/5,5/5,5/5,5/5,5/5	Label	-
Light	6,6,3/6,6,3

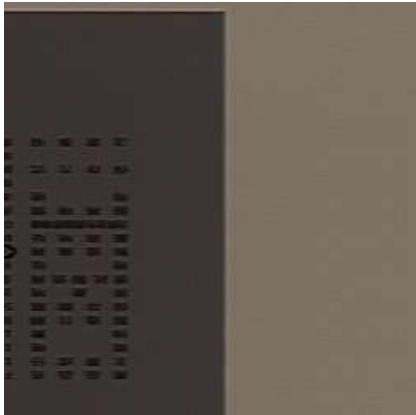
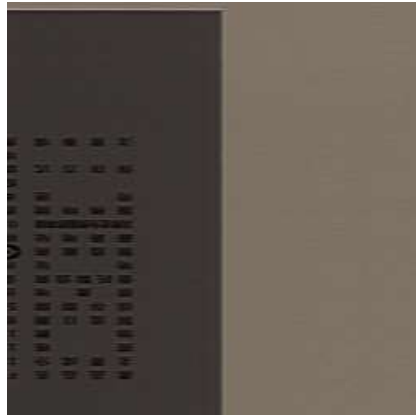
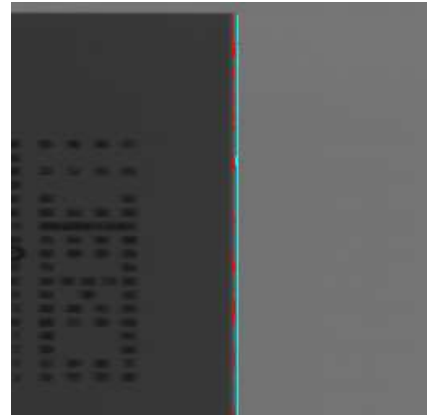
No.	#46, \$35	Date	2023/8/10 下午 01:30:37
Segment	1	Camera	1
Pattern	8053	Position[x, y]	567.8 [mm], 6021.7 [m], (44.7 [m])
Type	点状疵点縱向刀絲疵點	Size	H:1.0 ,V:744.8 [mm]
Result	-	Area	80.1 [mm2]
Inspection level	5/5,5/5,5/5,5/5,5/5	Label	-
Light	6,6,3/6,6,3

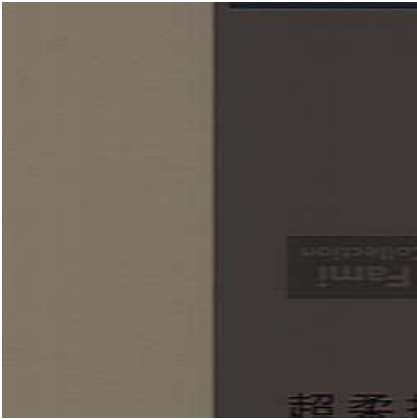
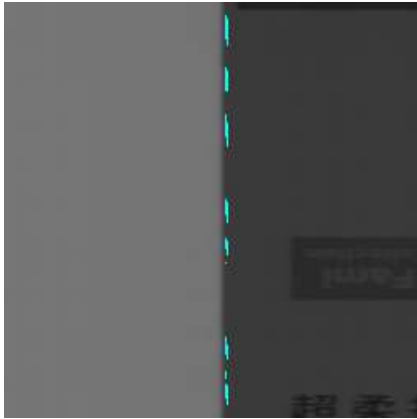
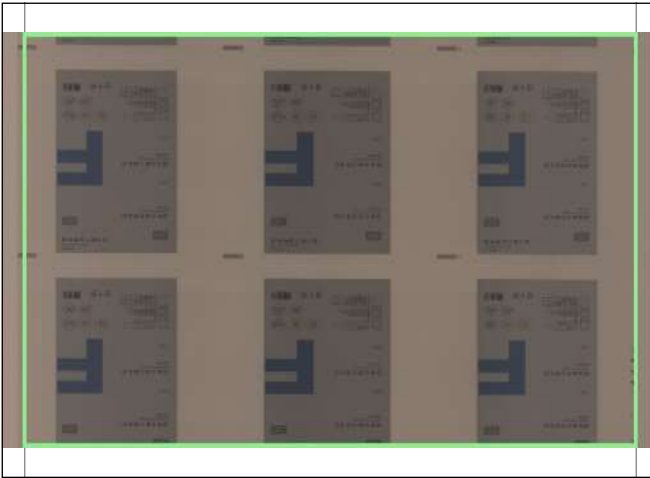
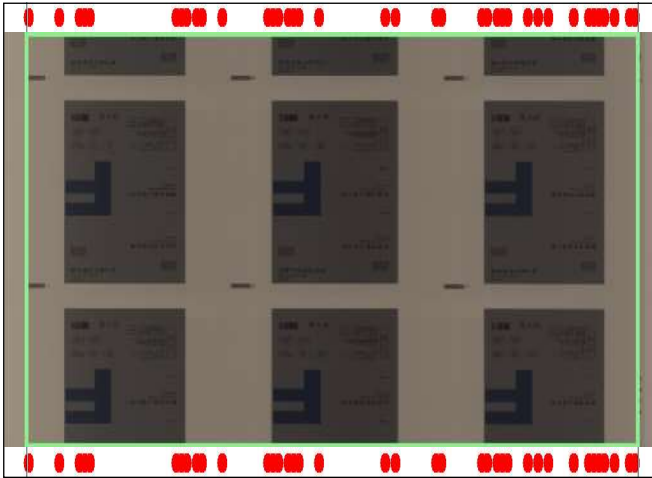
Defect image	Reference image	Shape image

No.	#41, \$32	Date	2023/8/10 下午 01:30:28
Segment	1	Camera	1
Pattern	8038	Position[x, y]	373.2 [mm], 6010.9 [m], (55.5 [m])
Type	点状疵点縱向刀絲疵點	Size	H:2.2 ,V:257.6 [mm]
Result	-	Area	62.9 [mm2]
Inspection level	5/5,5/5,5/5,5/5,5/5	Label	-
Light	6,6,3/6,6,3

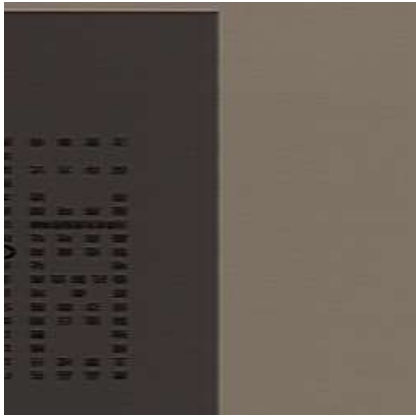
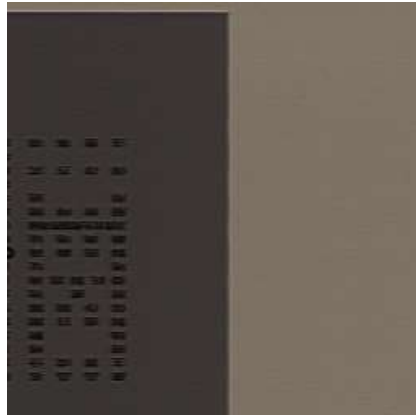
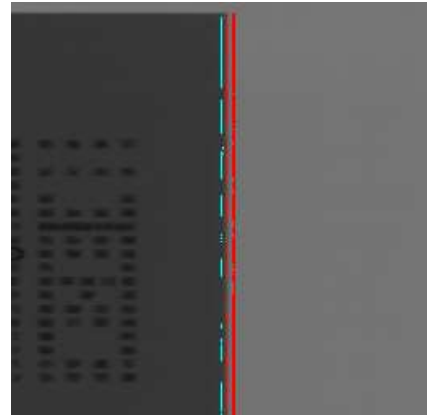
Defect image

No.	#40, \$31	Date	2023/8/10 下午 01:30:28
Segment	1	Camera	1
Pattern	8037	Position[x, y]	565.8 [mm], 6009.8 [m], (56.6 [m])
Type	点状疵点縱向刀絲疵點	Size	H:2.2 ,V:327.6 [mm]
Result	-	Area	184.4 [mm2]
Inspection level	5/5,5/5,5/5,5/5,5/5	Label	-
Light	6,6,3/6,6,3

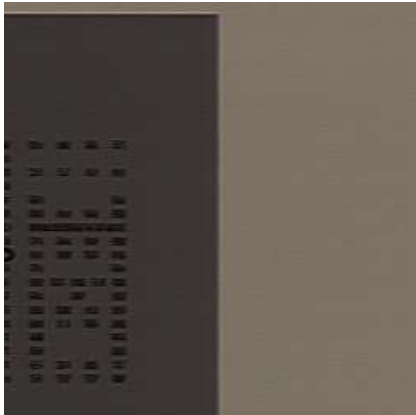
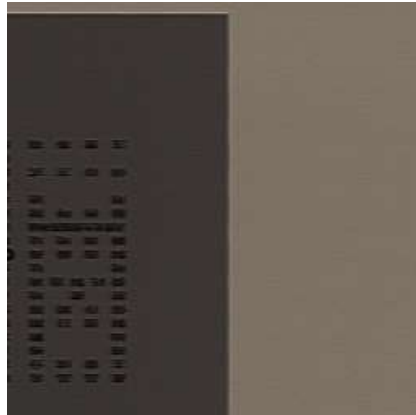
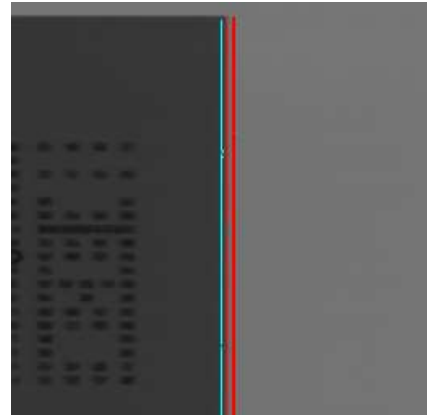
Defect image

No.	#39, \$30	Date	2023/8/10 下午 01:30:27
Segment	1	Camera	1
Pattern	8036	Position[x, y]	565.8 [mm], 6009.0 [m], (57.4 [m])
Type	点状疵点縱向刀絲疵點	Size	H:2.2 ,V:650.0 [mm]
Result	-	Area	220.7 [mm2]
Inspection level	5/5,5/5,5/5,5/5,5/5	Label	-
Light	6,6,3/6,6,3

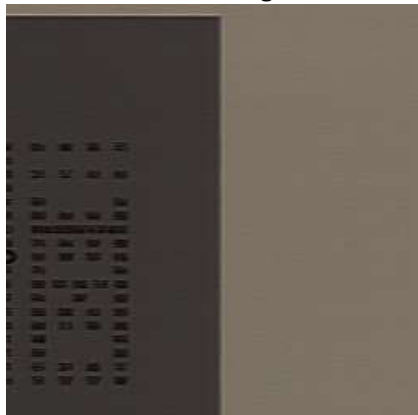
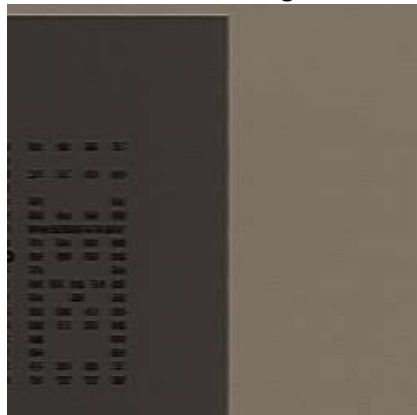
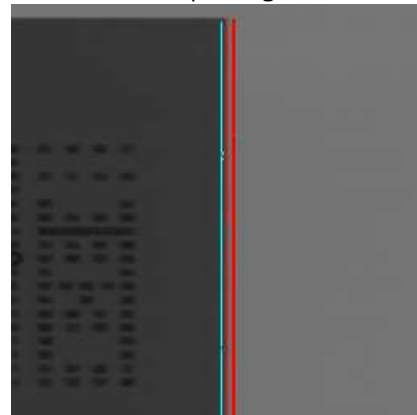
Defect image

No.	#38, \$29	Date	2023/8/10 下午 01:30:26
Segment	1	Camera	1
Pattern	8035	Position[x, y]	372.9 [mm], 6008.3 [m], (58.1 [m])
Type	点状疵点縱向刀絲疵點	Size	H:2.4 ,V:325.6 [mm]
Result	-	Area	81.4 [mm2]
Inspection level	5/5,5/5,5/5,5/5,5/5	Label	-
Light	6,6,3/6,6,3

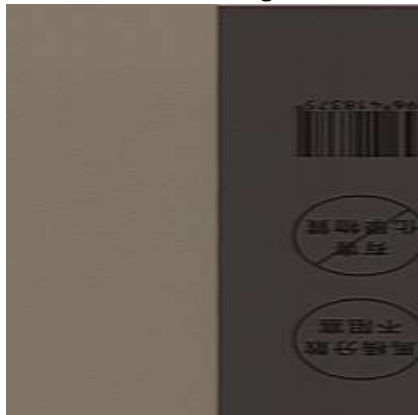
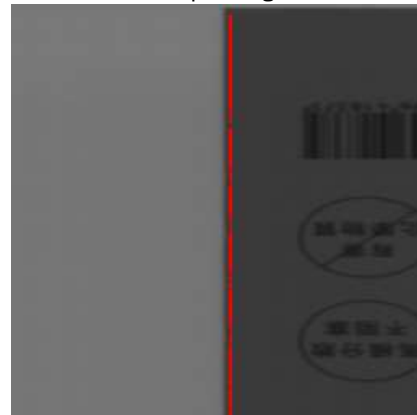
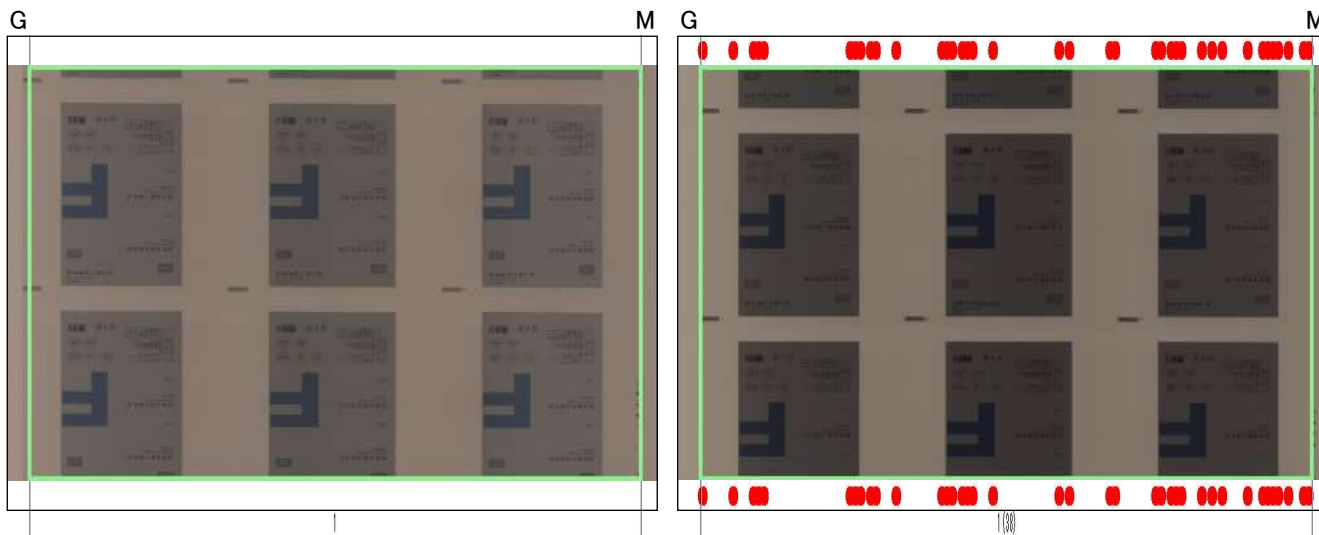
Defect image

No.	#38, \$29	Date	2023/8/10 下午 01:30:26
Segment	1	Camera	1
Pattern	8035	Position[x, y]	699.8 [mm], 6008.3 [m], (58.1 [m])
Type	点状疵点	Size	H:0.5 ,V:325.2 [mm]
Result	-	Area	126.1 [mm2]
Inspection level	5/5,5/5,5/5,5/5,5/5	Label	-
Light	6,6,3/6,6,3

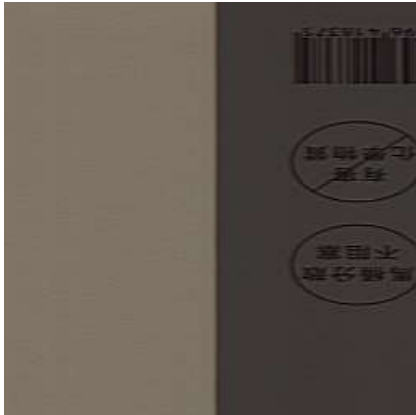
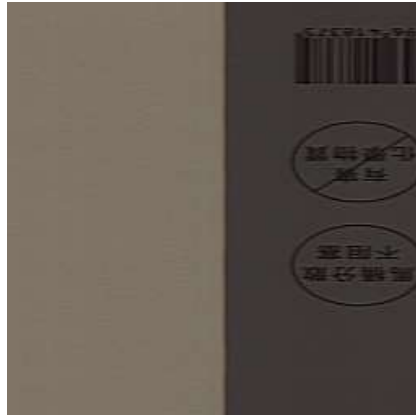
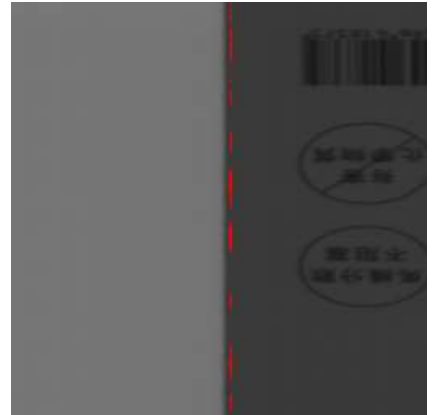
Defect image

No.	#34, \$27	Date	2023/8/10 下午 01:30:18
Segment	1	Camera	1
Pattern	8021	Position[x, y]	567.5 [mm], 5997.8 [m], (68.6 [m])
Type	点状疵点縱向刀絲疵點	Size	H:2.4 ,V:803.2 [mm]
Result	-	Area	444.0 [mm2]
Inspection level	5/5,5/5,5/5,5/5,5/5	Label	-
Light	6,6,3/6,6,3

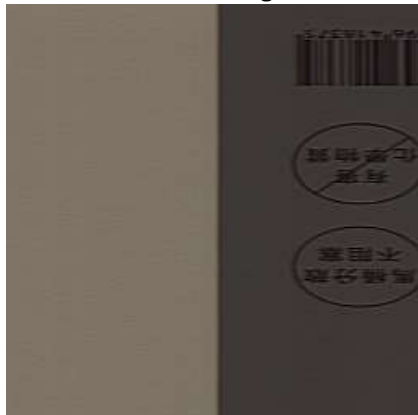
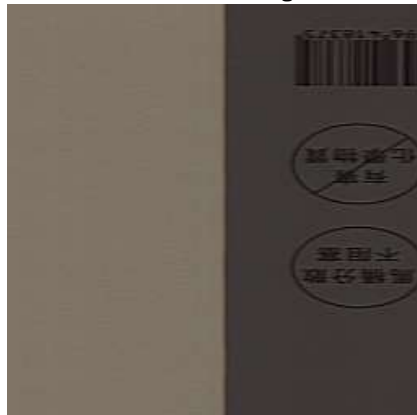
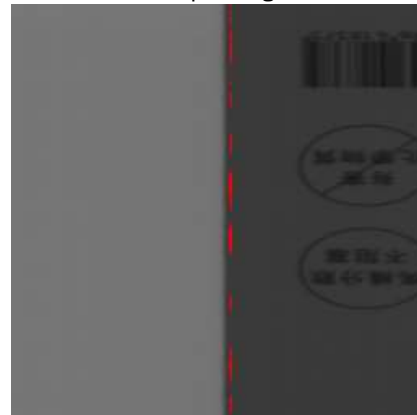
Defect image

No.	#34, \$27	Date	2023/8/10 下午 01:30:18
Segment	1	Camera	1
Pattern	8021	Position[x, y]	700.6 [mm], 5997.8 [m], (68.6 [m])
Type	点状疵点縱向刀絲疵點	Size	H:5.1 ,V:743.2 [mm]
Result	-	Area	460.3 [mm2]
Inspection level	5/5,5/5,5/5,5/5,5/5	Label	-
Light	6,6,3/6,6,3

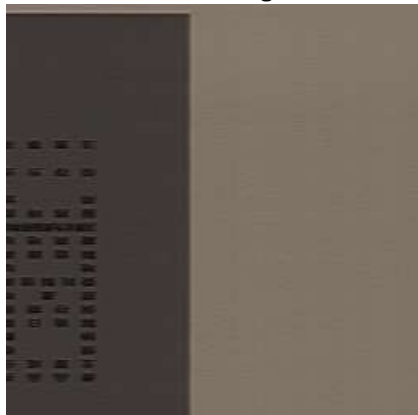
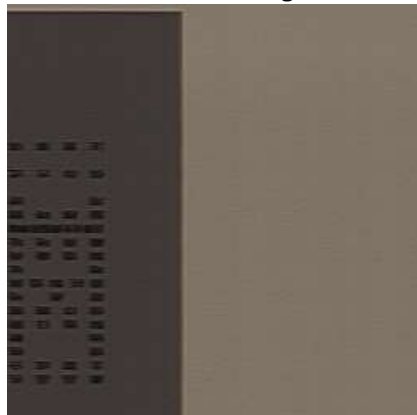
Defect image

No.	#34, \$27	Date	2023/8/10 下午 01:30:18
Segment	1	Camera	1
Pattern	8021	Position[x, y]	241.8 [mm], 5997.8 [m], (68.5 [m])
Type	点状疵点縱向刀絲疵點	Size	H:2.7 ,V:803.2 [mm]
Result	-	Area	463.7 [mm2]
Inspection level	5/5,5/5,5/5,5/5,5/5	Label	-
Light	6,6,3/6,6,3

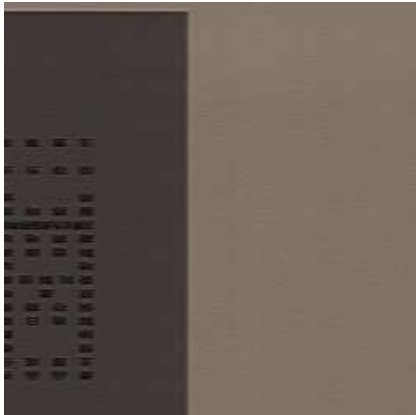
Defect image

No.	#33, \$26	Date	2023/8/10 下午 01:30:18
Segment	1	Camera	1
Pattern	8020	Position[x, y]	567.0 [mm], 5997.5 [m], (68.9 [m])
Type	点状疵点	Size	H:2.0 ,V:284.4 [mm]
Result	-	Area	344.0 [mm2]
Inspection level	5/5,5/5,5/5,5/5,5/5	Label	-
Light	6,6,3/6,6,3

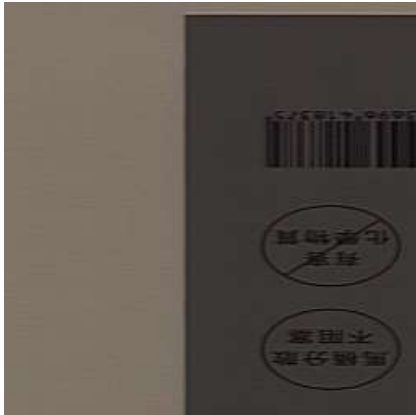
Defect image

No.	#33, \$26	Date	2023/8/10 下午 01:30:18
Segment	1	Camera	1
Pattern	8020	Position[x, y]	374.6 [mm], 5997.1 [m], (69.3 [m])
Type	点状疵点縱向刀絲疵點	Size	H:5.1 ,V:803.2 [mm]
Result	-	Area	359.2 [mm2]
Inspection level	5/5,5/5,5/5,5/5,5/5	Label	-
Light	6,6,3/6,6,3

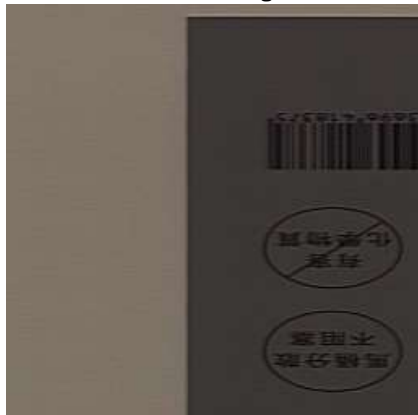
Defect image

No.	#32, \$25	Date	2023/8/10 下午 01:30:17
Segment	1	Camera	1
Pattern	8019	Position[x, y]	883.7 [mm], 5996.4 [m], (70.0 [m])
Type	点状疵点縱向刀絲疵點	Size	H:2.2 ,V:788.4 [mm]
Result	-	Area	205.5 [mm2]
Inspection level	5/5,5/5,5/5,5/5,5/5	Label	-
Light	6,6,3/6,6,3

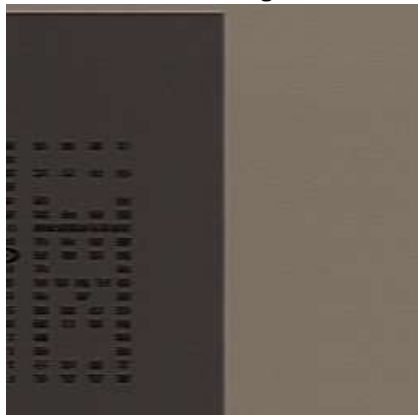
Defect image

No.	#32, \$25	Date	2023/8/10 下午 01:30:17
Segment	1	Camera	1
Pattern	8019	Position[x, y]	567.3 [mm], 5996.3 [m], (70.0 [m])
Type	点状疵点縱向刀絲疵點	Size	H:2.2 ,V:803.2 [mm]
Result	-	Area	234.4 [mm2]
Inspection level	5/5,5/5,5/5,5/5,5/5	Label	-
Light	6,6,3/6,6,3

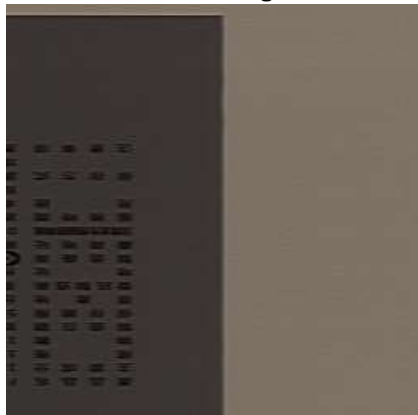
Defect image

No.	#31, \$24	Date	2023/8/10 下午 01:30:16
Segment	1	Camera	1
Pattern	8018	Position[x, y]	567.3 [mm], 5995.7 [m], (70.7 [m])
Type	点状疵点縱向刀絲疵點	Size	H:2.0 ,V:803.2 [mm]
Result	-	Area	140.5 [mm2]
Inspection level	5/5,5/5,5/5,5/5,5/5	Label	-
Light	6,6,3/6,6,3

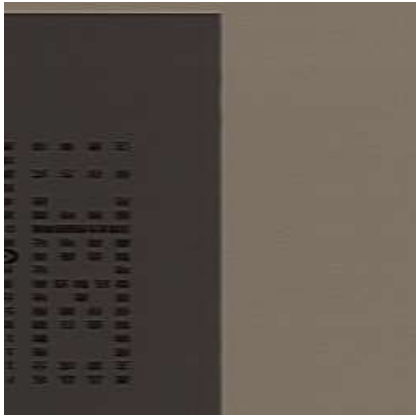
Defect image

No.	#30, \$23	Date	2023/8/10 下午 01:30:16
Segment	1	Camera	1
Pattern	8017	Position[x, y]	883.7 [mm], 5995.2 [m], (71.1 [m])
Type	縱向刀絲疵點	Size	H:0.5 ,V:135.6 [mm]
Result	-	Area	24.4 [mm2]
Inspection level	5/5,5/5,5/5,5/5,5/5	Label	-
Light	6,6,3/6,6,3

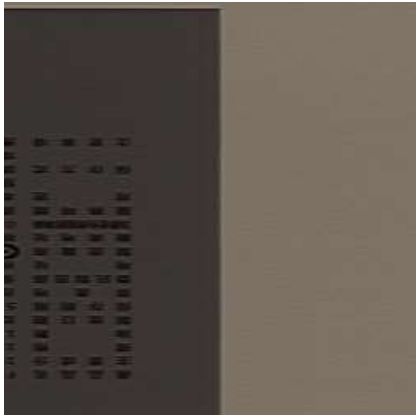
Defect image

No.	#30, \$23	Date	2023/8/10 下午 01:30:16
Segment	1	Camera	1
Pattern	8017	Position[x, y]	567.5 [mm], 5994.9 [m], (71.4 [m])
Type	縱向刀絲疵點	Size	H:0.5 ,V:408.0 [mm]
Result	-	Area	96.9 [mm2]
Inspection level	5/5,5/5,5/5,5/5,5/5	Label	-
Light	6,6,3/6,6,3

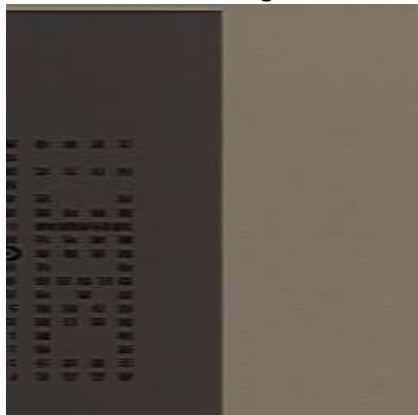
Defect image

No.	#27, \$22	Date	2023/8/10 下午 01:29:45
Segment	1	Camera	1
Pattern	7965	Position[x, y]	4.5 [mm], 5955.8 [m], (110.6 [m])
Type	縱向刀絲疵點	Size	H:9.8 ,V:156.0 [mm]
Result	-	Area	82.8 [mm2]
Inspection level	5/5,5/5,5/5,5/5,5/5	Label	-
Light	6,6,3/6,6,3

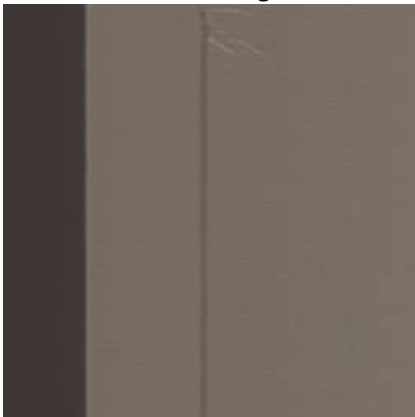
Defect image

No.	#26, \$21	Date	2023/8/10 下午 01:29:45
Segment	1	Camera	1
Pattern	7964	Position[x, y]	62.1 [mm], 5955.1 [m], (111.3 [m])
Type	点状疵点縱向刀絲疵點	Size	H:39.6 ,V:398.0 [mm]
Result	-	Area	251.6 [mm2]
Inspection level	5/5,5/5,5/5,5/5,5/5	Label	-
Light	6,6,3/6,6,3

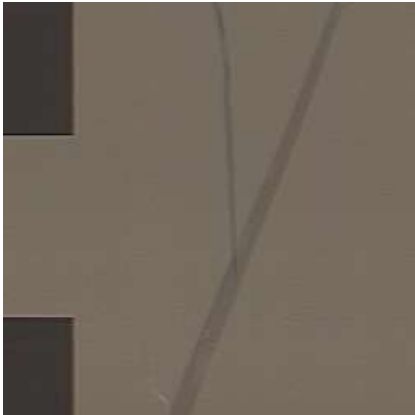
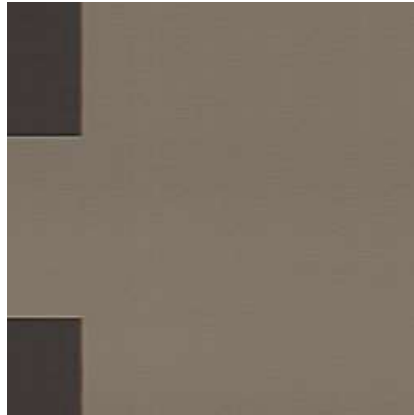
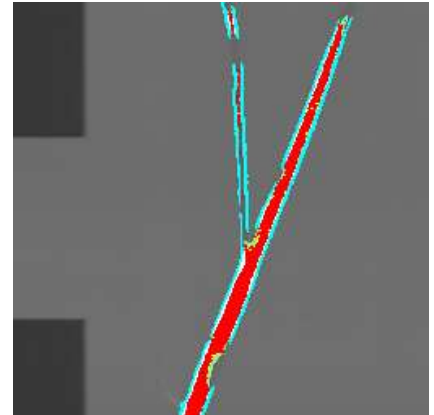
No.	#26, \$21	Date	2023/8/10 下午 01:29:45
Segment	1	Camera	1
Pattern	7964	Position[x, y]	260.1 [mm], 5955.1 [m], (111.3 [m])
Type	点状疵点縱向刀絲疵點	Size	H:41.7 ,V:336.8 [mm]
Result	-	Area	634.3 [mm2]
Inspection level	5/5,5/5,5/5,5/5,5/5	Label	-
Light	6,6,3/6,6,3

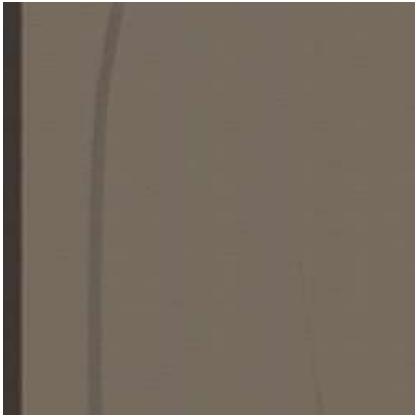
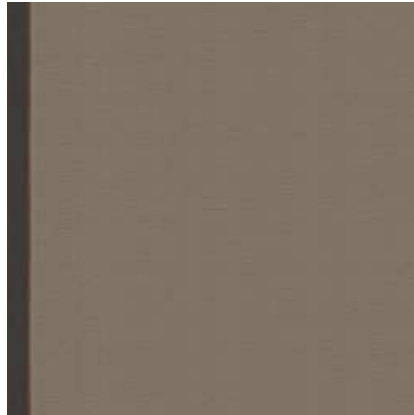
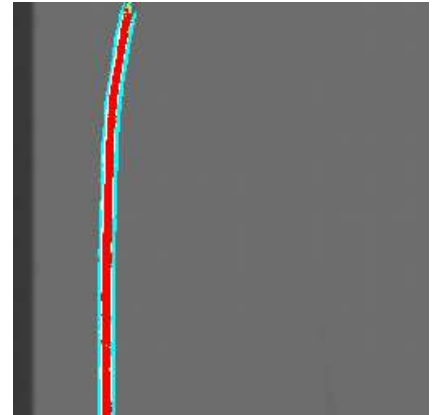
No.	#25, \$20	Date	2023/8/10 下午 01:29:44
Segment	1	Camera	1
Pattern	7963	Position[x, y]	266.2 [mm], 5954.6 [m], (111.8 [m])
Type	点状疵点縱向刀絲疵點	Size	H:42.2 ,V:700.4 [mm]
Result	-	Area	731.0 [mm2]
Inspection level	5/5,5/5,5/5,5/5,5/5	Label	-
Light	6,6,3/6,6,3

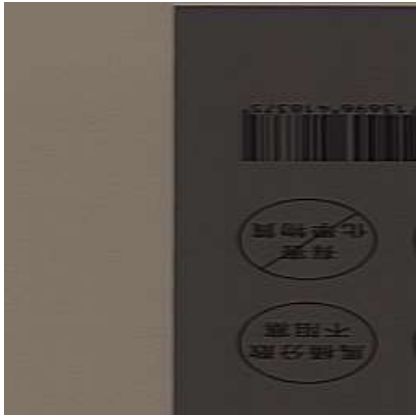
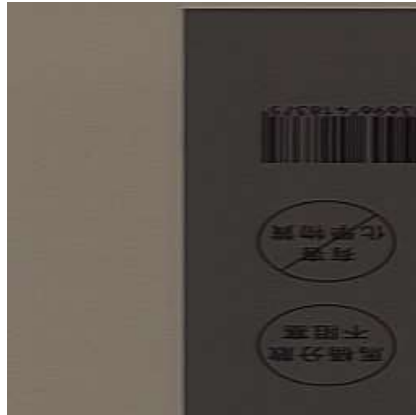
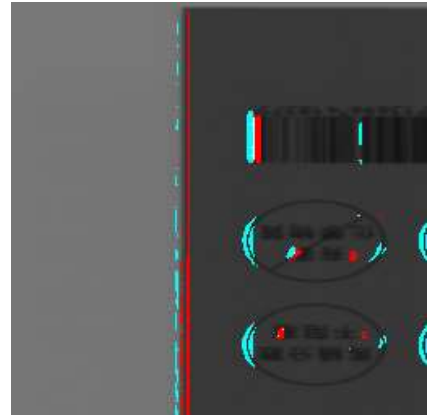
No.	#24, \$19	Date	2023/8/10 下午 01:29:44
Segment	1	Camera	1
Pattern	7962	Position[x, y]	378.3 [mm], 5953.8 [m], (112.6 [m])
Type	点状疵点縱向刀絲疵點	Size	H:18.3 ,V:459.2 [mm]
Result	-	Area	267.7 [mm2]
Inspection level	5/5,5/5,5/5,5/5,5/5	Label	-
Light	6,6,3/6,6,3

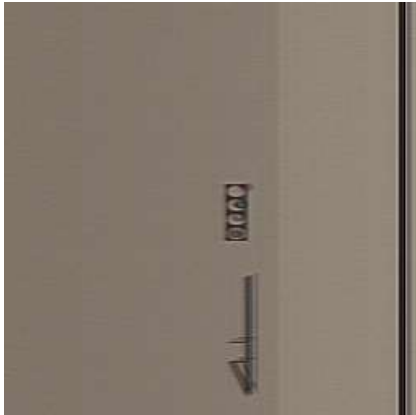
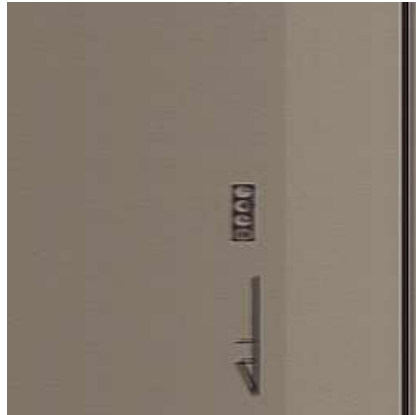
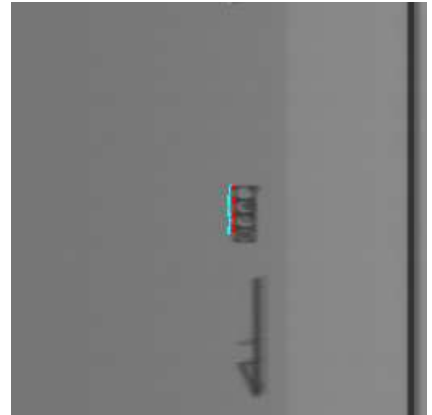
No.	#22, \$17	Date	2023/8/10 下午 01:29:42
Segment	1	Camera	1
Pattern	7959	Position[x, y]	934.2 [mm], 5951.3 [m], (115.1 [m])
Type	点状疵点縱向刀絲疵點	Size	H:1.2 ,V:11.2 [mm]
Result	-	Area	4.4 [mm2]
Inspection level	5/5,5/5,5/5,5/5,5/5	Label	-
Light	6,6,3/6,6,3

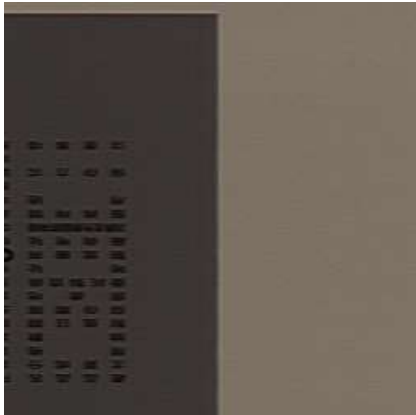
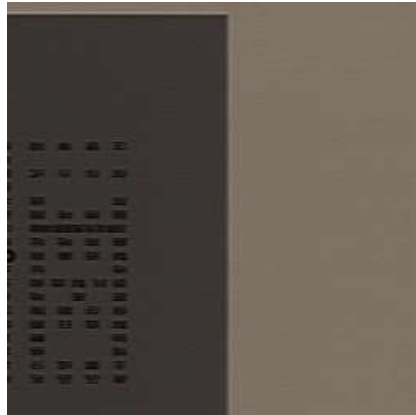
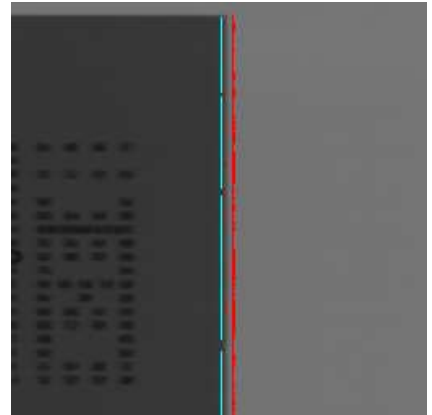
No.	#18, \$15	Date	2023/8/10 下午 01:28:42
Segment	1	Camera	1
Pattern	7856	Position[x, y]	565.8 [mm], 5874.6 [m], (191.8 [m])
Type	点状疵点縱向刀絲疵點	Size	H:2.2 ,V:508.0 [mm]
Result	-	Area	105.8 [mm2]
Inspection level	5/5,5/5,5/5,5/5,5/5	Label	-
Light	6,6,3/6,6,3

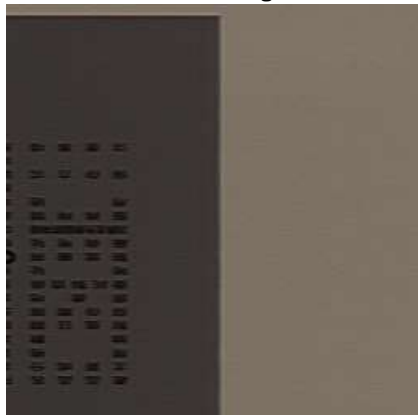
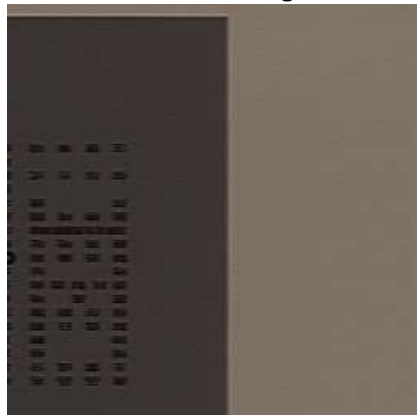
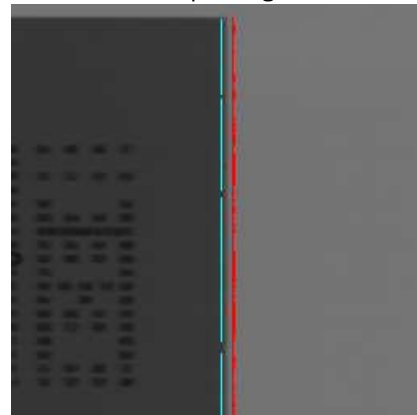
No.	#17, \$14	Date	2023/8/10 下午 01:28:41
Segment	1	Camera	1
Pattern	7855	Position[x, y]	372.9 [mm], 5873.7 [m], (192.7 [m])
Type	点状疵点縱向刀絲疵點	Size	H:2.2 ,V:104.8 [mm]
Result	-	Area	63.7 [mm2]
Inspection level	5/5,5/5,5/5,5/5,5/5	Label	-
Light	6,6,3/6,6,3

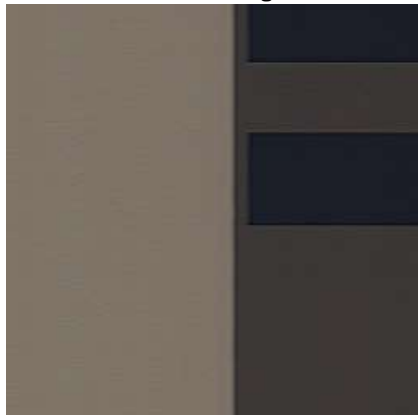
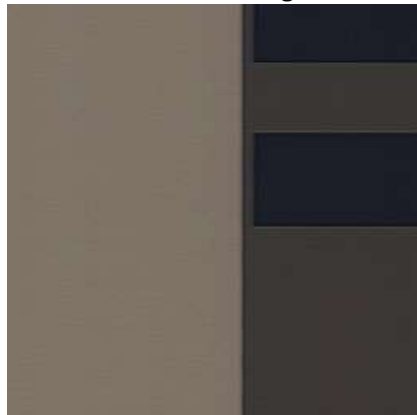
No.	#16, \$13	Date	2023/8/10 下午 01:28:41
Segment	1	Camera	1
Pattern	7854	Position[x, y]	698.1 [mm], 5873.1 [m], (193.3 [m])
Type	点状疵点縱向刀絲疵點	Size	H:2.4 ,V:403.6 [mm]
Result	-	Area	110.1 [mm2]
Inspection level	5/5,5/5,5/5,5/5,5/5	Label	-
Light	6,6,3/6,6,3

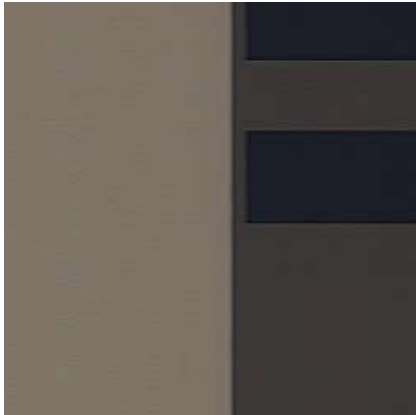
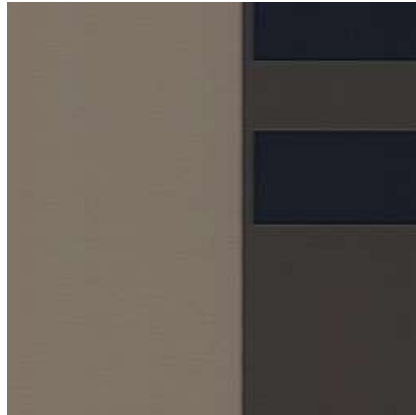
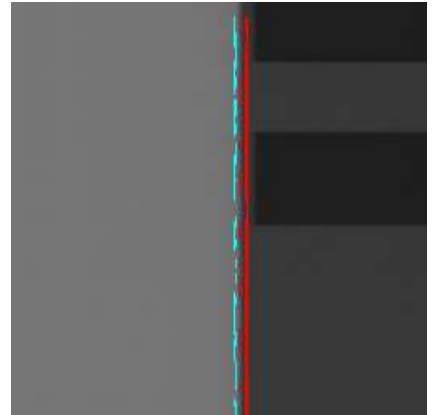
Defect image

No.	#16, \$13	Date	2023/8/10 下午 01:28:41
Segment	1	Camera	1
Pattern	7854	Position[x, y]	565.8 [mm], 5873.1 [m], (193.3 [m])
Type	点状疵点縱向刀絲疵點	Size	H:2.2 ,V:508.4 [mm]
Result	-	Area	127.6 [mm2]
Inspection level	5/5,5/5,5/5,5/5,5/5	Label	-
Light	6,6,3/6,6,3

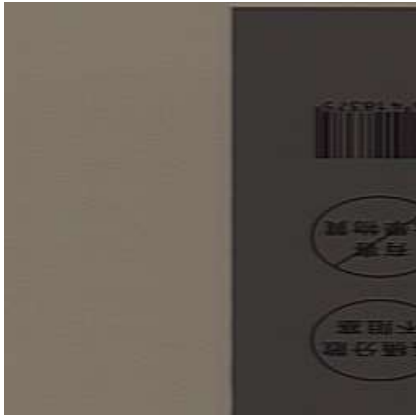
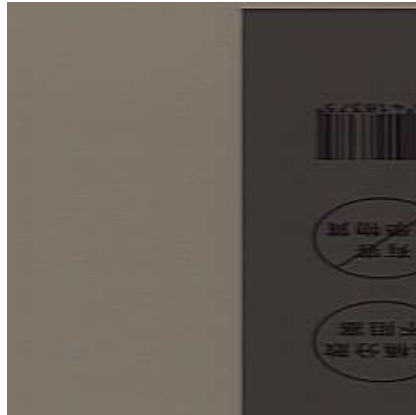
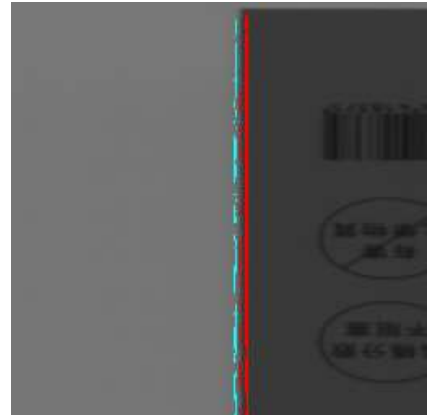
Defect image

No.	#16, \$13	Date	2023/8/10 下午 01:28:41
Segment	1	Camera	1
Pattern	7854	Position[x, y]	372.4 [mm], 5873.1 [m], (193.3 [m])
Type	点状疵点縱向刀絲疵點	Size	H:2.2 ,V:326.8 [mm]
Result	-	Area	166.1 [mm2]
Inspection level	5/5,5/5,5/5,5/5,5/5	Label	-
Light	6,6,3/6,6,3

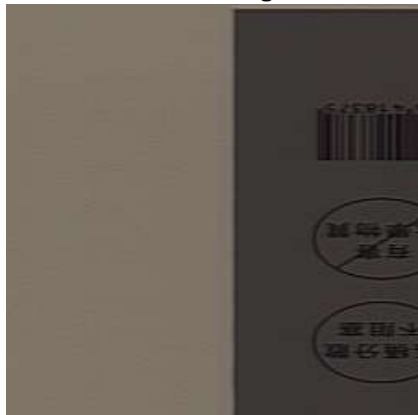
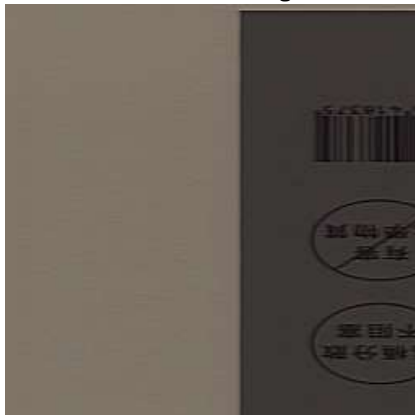
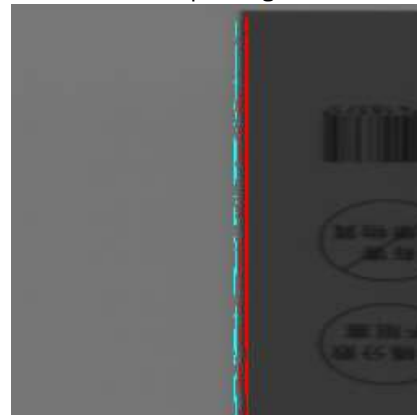
Defect image

No.	#15, \$12	Date	2023/8/10 下午 01:28:40
Segment	1	Camera	1
Pattern	7853	Position[x, y]	372.9 [mm], 5872.7 [m], (193.7 [m])
Type	点状疵点縱向刀絲疵點	Size	H:2.2 ,V:101.2 [mm]
Result	-	Area	50.3 [mm2]
Inspection level	5/5,5/5,5/5,5/5,5/5	Label	-
Light	6,6,3/6,6,3

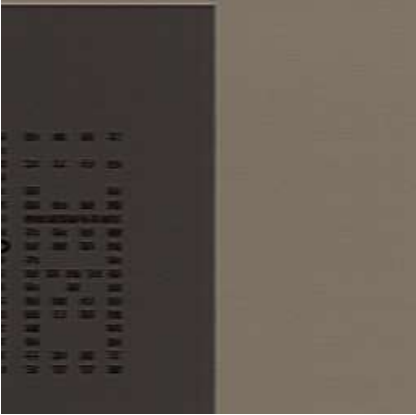
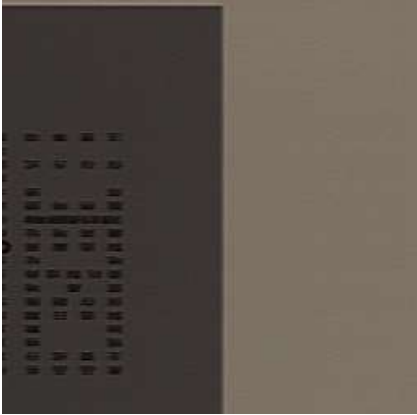
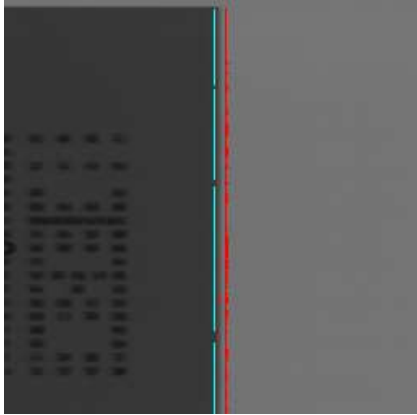
Defect image	Reference image	Shape image

No.	#15, \$12	Date	2023/8/10 下午 01:28:40
Segment	1	Camera	1
Pattern	7853	Position[x, y]	565.8 [mm], 5872.3 [m], (194.0 [m])
Type	点状疵点縱向刀絲疵點	Size	H:2.2 ,V:434.0 [mm]
Result	-	Area	99.7 [mm2]
Inspection level	5/5,5/5,5/5,5/5,5/5	Label	-
Light	6,6,3/6,6,3

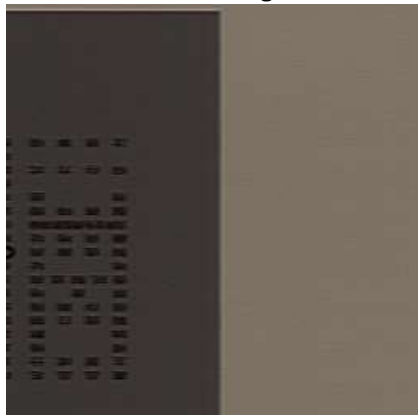
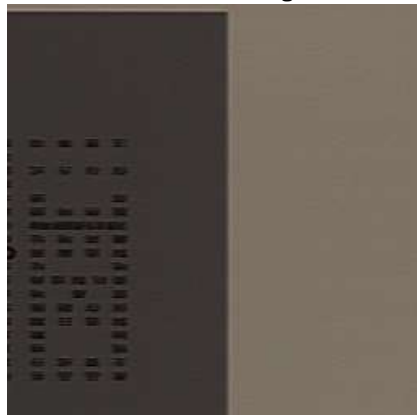
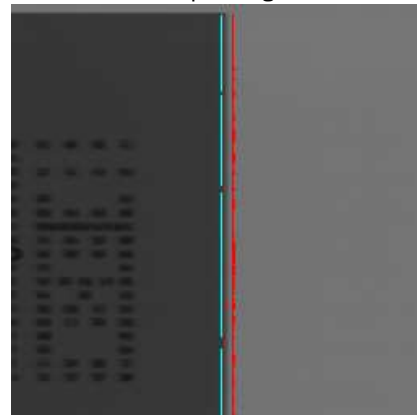
Defect image

No.	#14, \$11	Date	2023/8/10 下午 01:28:39
Segment	1	Camera	1
Pattern	7852	Position[x, y]	567.5 [mm], 5871.9 [m], (194.5 [m])
Type	点状疵点	Size	H:0.5 ,V:18.0 [mm]
Result	-	Area	3.5 [mm2]
Inspection level	5/5,5/5,5/5,5/5,5/5	Label	-
Light	6,6,3/6,6,3

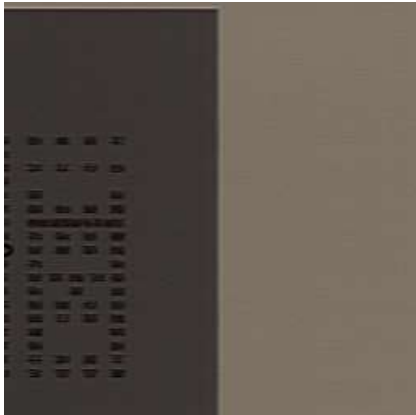
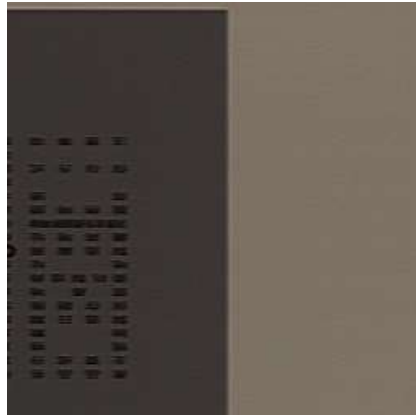
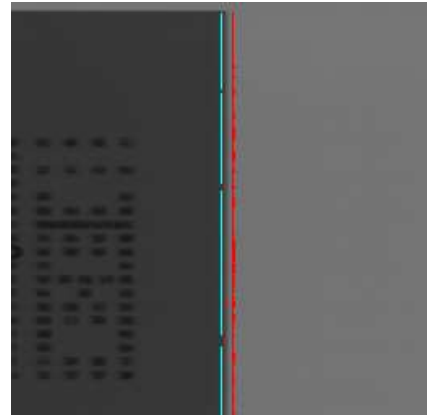
Defect image

No.	#14, \$11	Date	2023/8/10 下午 01:28:39
Segment	1	Camera	1
Pattern	7852	Position[x, y]	567.5 [mm], 5872.1 [m], (194.3 [m])
Type	点状疵点	Size	H:0.5 ,V:50.0 [mm]
Result	-	Area	11.9 [mm2]
Inspection level	5/5,5/5,5/5,5/5,5/5	Label	-
Light	6,6,3/6,6,3

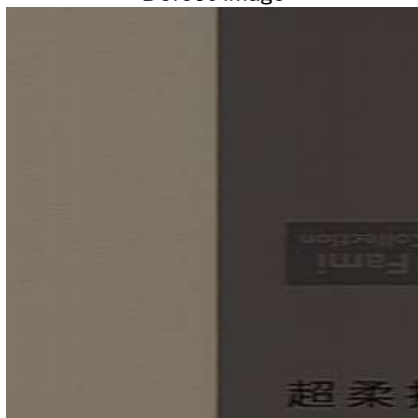
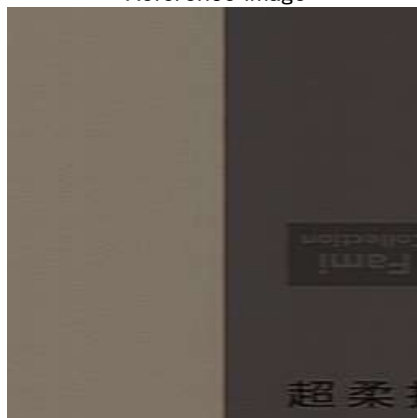
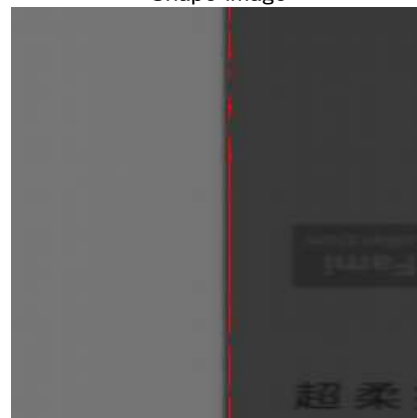
Defect image

No.	#14, \$11	Date	2023/8/10 下午 01:28:39
Segment	1	Camera	1
Pattern	7852	Position[x, y]	699.8 [mm], 5871.7 [m], (194.7 [m])
Type	点状疵点	Size	H:0.5 ,V:58.4 [mm]
Result	-	Area	13.3 [mm2]
Inspection level	5/5,5/5,5/5,5/5,5/5	Label	-
Light	6,6,3/6,6,3

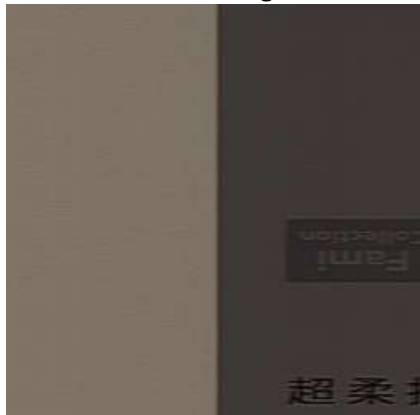
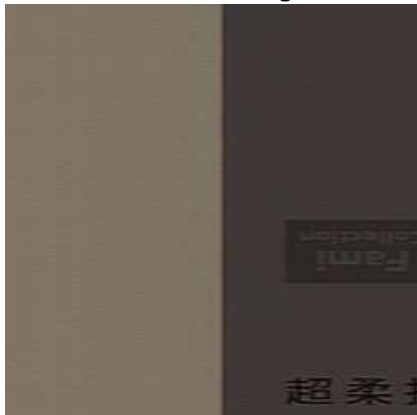
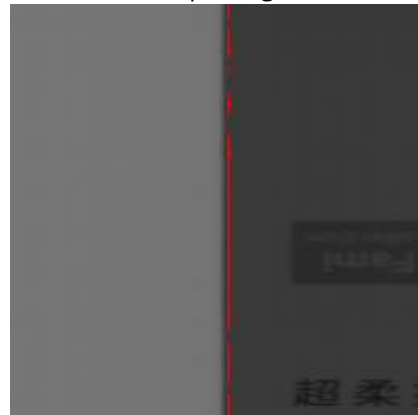
Defect image

No.	#11, \$10	Date	2023/8/10 下午 01:28:25
Segment	1	Camera	1
Pattern	7827	Position[x, y]	94.1 [mm], 5852.8 [m], (213.6 [m])
Type	点状疵点縱向刀絲疵點	Size	H:20.0 ,V:58.8 [mm]
Result	-	Area	7.0 [mm2]
Inspection level	5/5,5/5,5/5,5/5,5/5	Label	-
Light	6,6,3/6,6,3

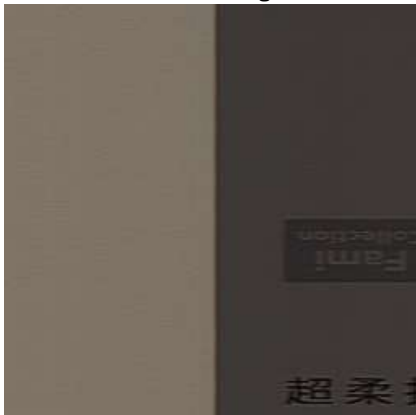
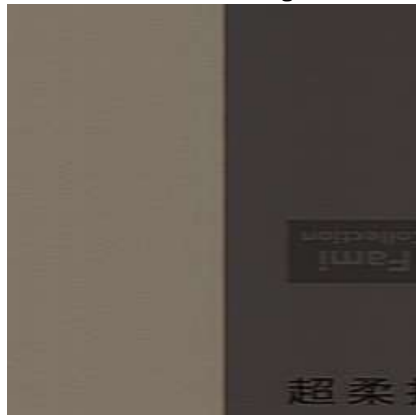
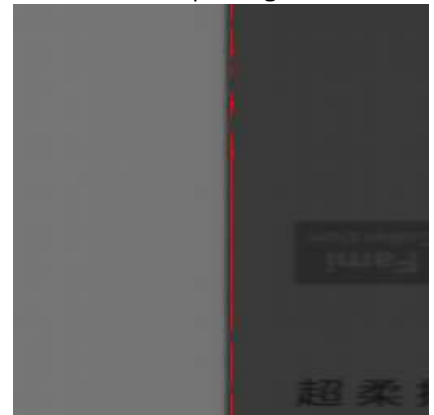
Defect image

No.	#11, \$10	Date	2023/8/10 下午 01:28:25
Segment	1	Camera	1
Pattern	7827	Position[x, y]	414.9 [mm], 5852.8 [m], (213.6 [m])
Type	縱向刀絲疵點	Size	H:41.3 ,V:59.2 [mm]
Result	-	Area	7.6 [mm2]
Inspection level	5/5,5/5,5/5,5/5,5/5	Label	-
Light	6,6,3/6,6,3

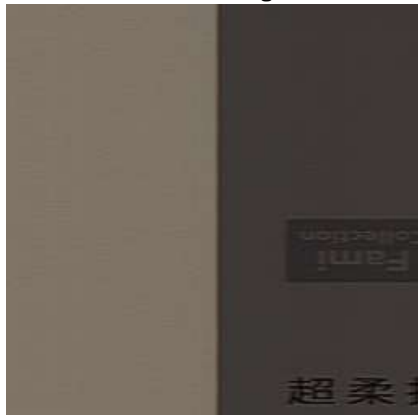
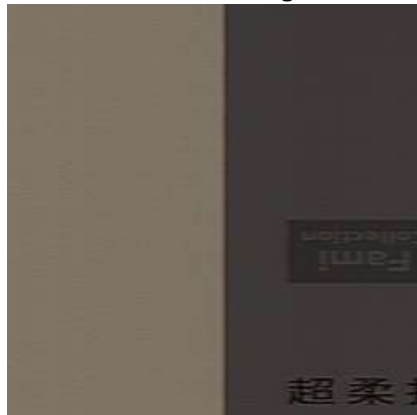
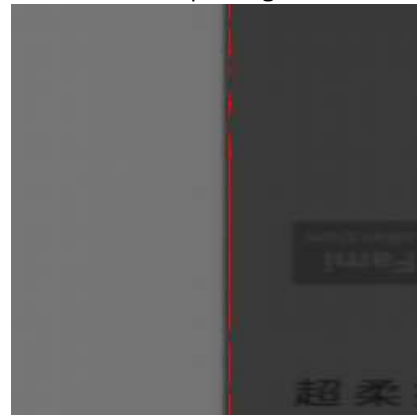
Defect image

No.	#11, \$10	Date	2023/8/10 下午 01:28:25
Segment	1	Camera	1
Pattern	7827	Position[x, y]	869.0 [mm], 5852.9 [m], (213.5 [m])
Type	縱向刀絲疵點	Size	H:12.5 ,V:206.4 [mm]
Result	-	Area	8.4 [mm2]
Inspection level	5/5,5/5,5/5,5/5,5/5	Label	-
Light	6,6,3/6,6,3

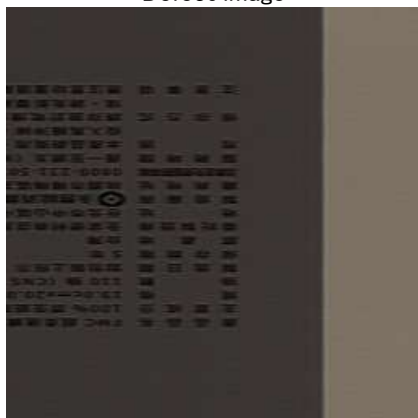
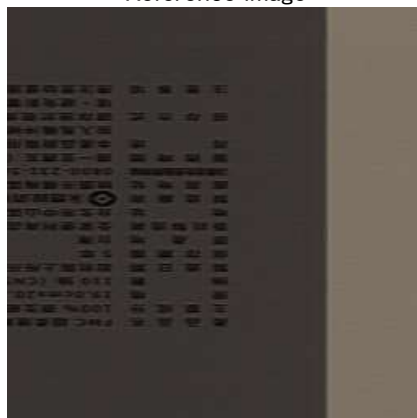
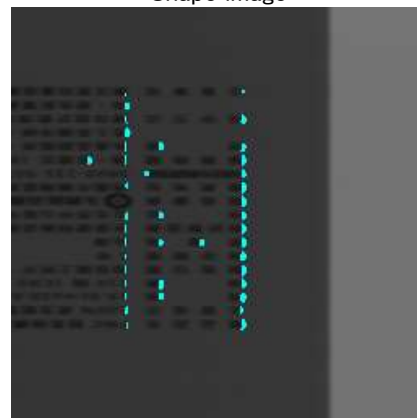
Defect image

No.	#11, \$10	Date	2023/8/10 下午 01:28:25
Segment	1	Camera	1
Pattern	7827	Position[x, y]	553.4 [mm], 5852.8 [m], (213.6 [m])
Type	縱向刀絲疵點	Size	H:1.0 ,V:34.8 [mm]
Result	-	Area	9.9 [mm2]
Inspection level	5/5,5/5,5/5,5/5,5/5	Label	-
Light	6,6,3/6,6,3

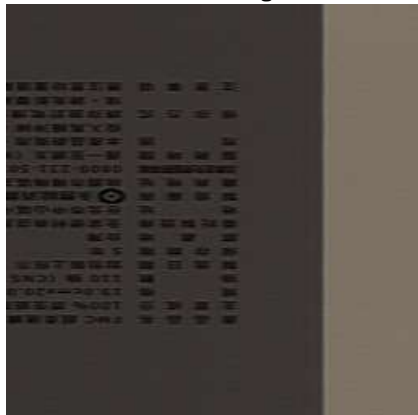
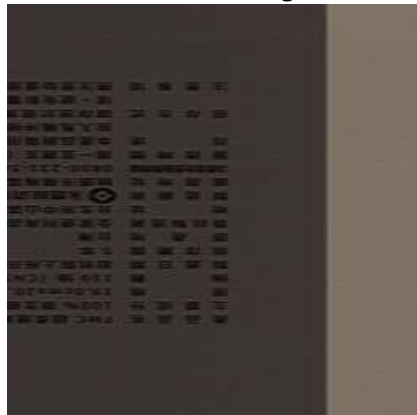
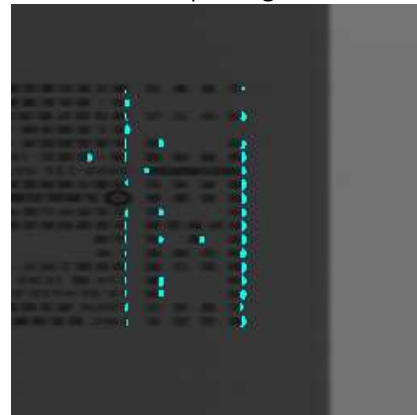
Defect image

No.	#10, \$9	Date	2023/8/10 下午 01:28:24
Segment	1	Camera	1
Pattern	7826	Position[x, y]	91.7 [mm], 5852.1 [mm], (214.3 [mm])
Type	縱向刀絲疵點	Size	H:8.5 ,V:59.2 [mm]
Result	-	Area	6.9 [mm2]
Inspection level	5/5,5/5,5/5,5/5,5/5	Label	-
Light	6,6,3/6,6,3

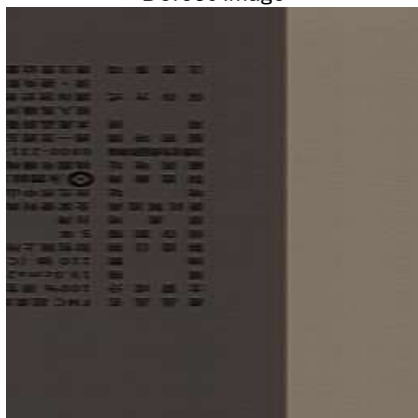
Defect image

No.	#10, \$9	Date	2023/8/10 下午 01:28:24
Segment	1	Camera	1
Pattern	7826	Position[x, y]	228.2 [mm], 5852.1 [m], (214.3 [m])
Type	縱向刀絲疵點	Size	H:1.0 ,V:45.2 [mm]
Result	-	Area	7.5 [mm2]
Inspection level	5/5,5/5,5/5,5/5,5/5	Label	-
Light	6,6,3/6,6,3

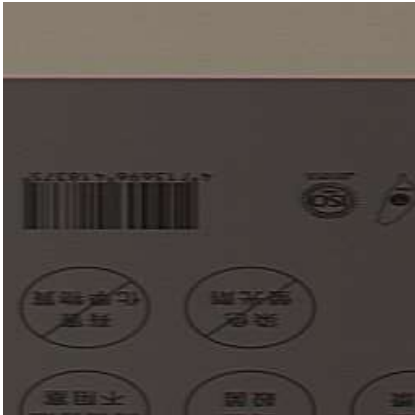
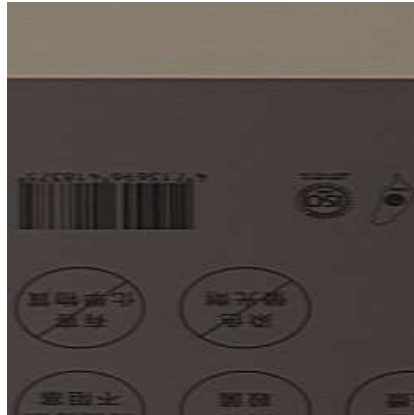
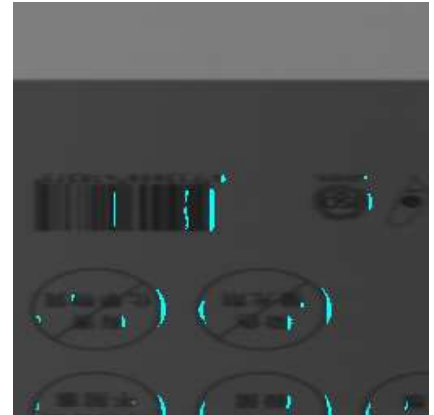
No.	#9, \$8	Date	2023/8/10 下午 01:28:24
Segment	1	Camera	1
Pattern	7825	Position[x, y]	93.2 [mm], 5851.7 [m], (214.7 [m])
Type	縱向刀絲疵點	Size	H:4.6 ,V:9.6 [mm]
Result	-	Area	6.8 [mm2]
Inspection level	5/5,5/5,5/5,5/5,5/5	Label	-
Light	6,6,3/6,6,3
