Inspection Result (Individual Data)

Lot number : 5

Inspected date : 2023/8/10 下午 12:12:08 ~ 2023/8/10 下午 01:31:18

商品名	標準透明6-6-3	周長
顧客名		Ex1
CODE番号		Ex2
基材		Ex3

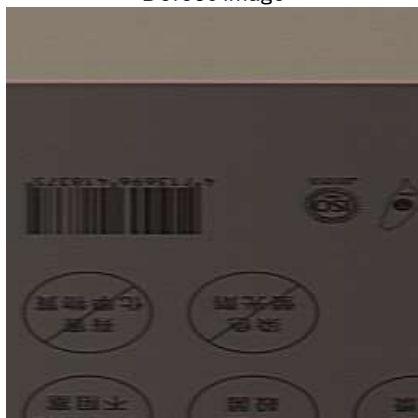
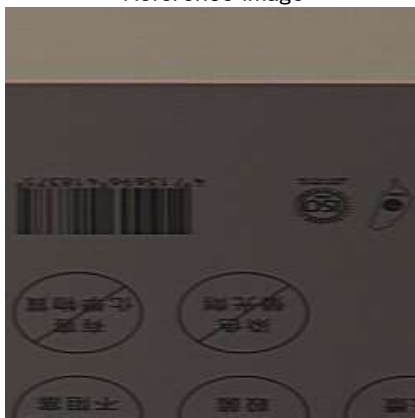
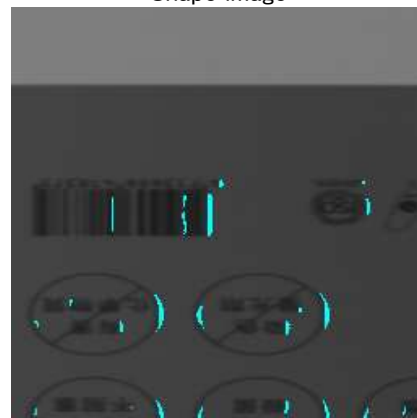
No.	#8, \$7	Date	2023/8/10 下午 01:28:23
Segment	1	Camera	1
Pattern	7824	Position[x, y]	88.5 [mm], 5850.5 [m], (215.8 [m])
Type	縱向刀絲疵點	Size	H:15.1 ,V:31.2 [mm]
Result	-	Area	4.6 [mm2]
Inspection level	5/5,5/5,5/5,5,5/5,5/5	Label	-
Light	6,6,3/6,6,3

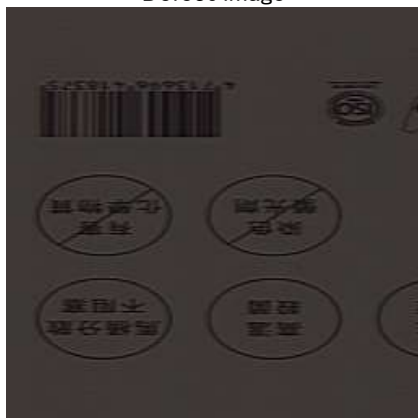
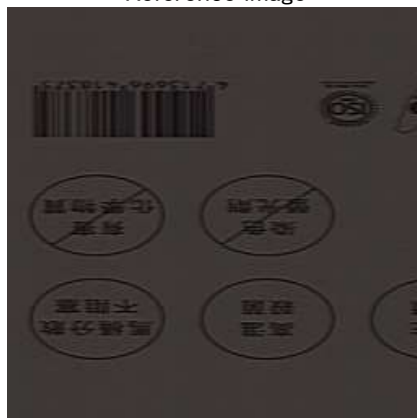
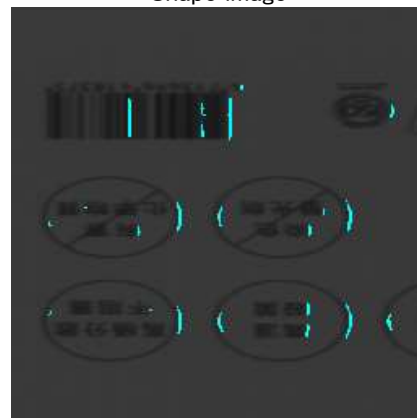
No.	#8, \$7	Date	2023/8/10 下午 01:28:23
Segment	1	Camera	1
Pattern	7824	Position[x, y]	733.8 [mm], 5850.6 [m], (215.8 [m])
Type	縱向刀絲疵點	Size	H:8.3 ,V:57.2 [mm]
Result	-	Area	4.7 [mm2]
Inspection level	5/5,5/5,5/5,5,5/5,5/5	Label	-
Light	6,6,3/6,6,3

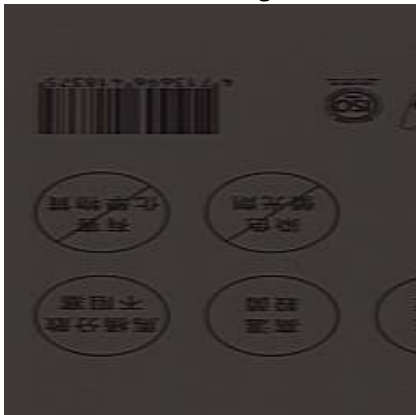
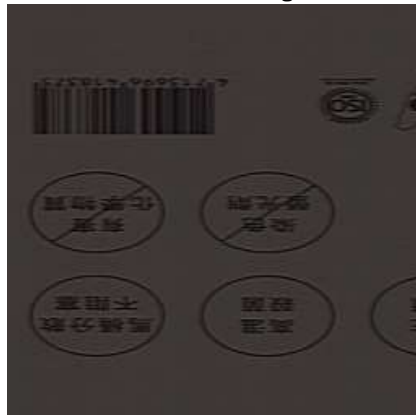
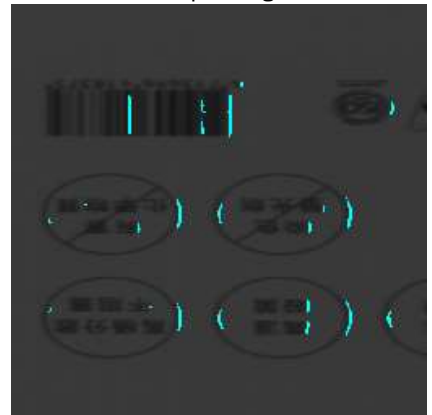
No.	#7, \$6	Date	2023/8/10 下午 01:28:22
Segment	1	Camera	1
Pattern	7823	Position[x, y]	412.2 [mm], 5849.8 [m], (216.6 [m])
Type	縱向刀絲疵點	Size	H:4.4 ,V:9.2 [mm]
Result	-	Area	3.1 [mm2]
Inspection level	5/5,5/5,5/5,5/5,5/5	Label	-
Light	6,6,3/6,6,3

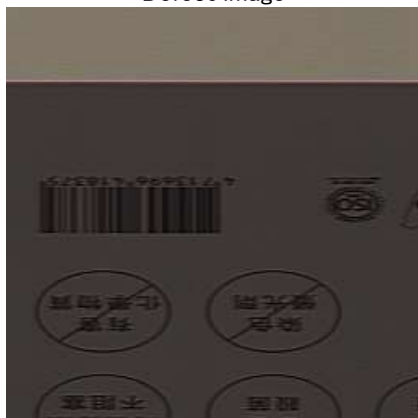
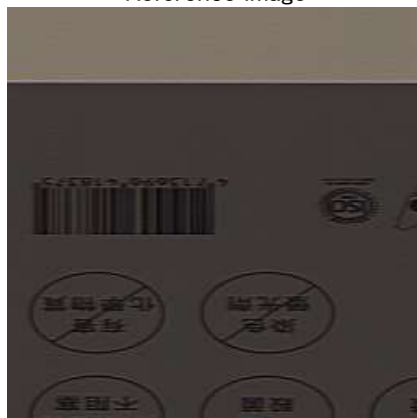
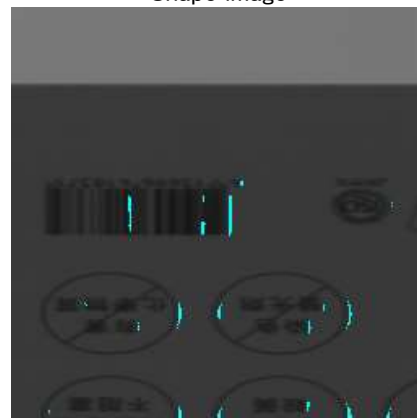
No.	#7, \$6	Date	2023/8/10 下午 01:28:22
Segment	1	Camera	1
Pattern	7823	Position[x, y]	738.9 [mm], 5850.2 [m], (216.2 [m])
Type	縱向刀絲疵點	Size	H:0.5 ,V:9.2 [mm]
Result	-	Area	4.4 [mm2]
Inspection level	5/5,5/5,5/5,5/5,5/5	Label	-
Light	6,6,3/6,6,3

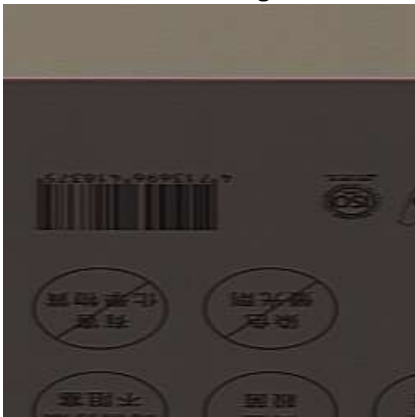
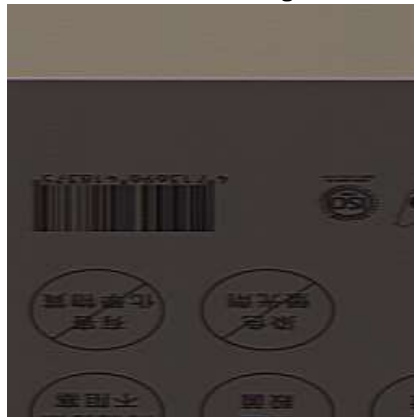
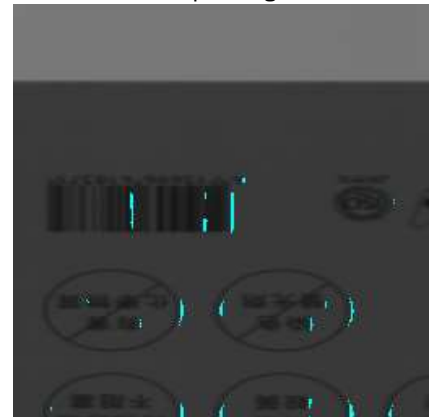
No.	#6, \$5	Date	2023/8/10 下午 01:28:14
Segment	1	Camera	1
Pattern	7808	Position[x, y]	81.4 [mm], 5838.6 [m], (227.8 [m])
Type	縱向刀絲疵點	Size	H:0.5 ,V:8.4 [mm]
Result	-	Area	2.7 [mm2]
Inspection level	5/5,5/5,5/5,5/5,5/5	Label	-
Light	6,6,3/6,6,3

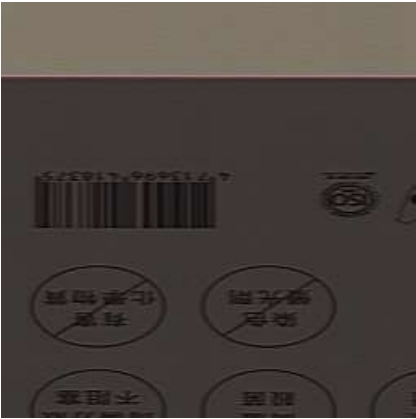
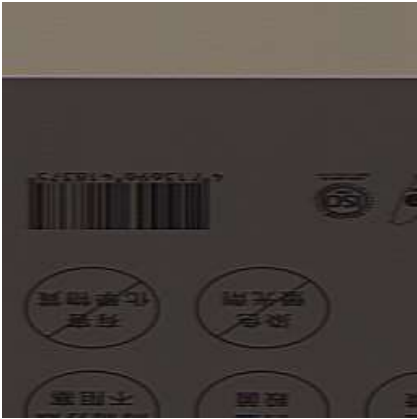
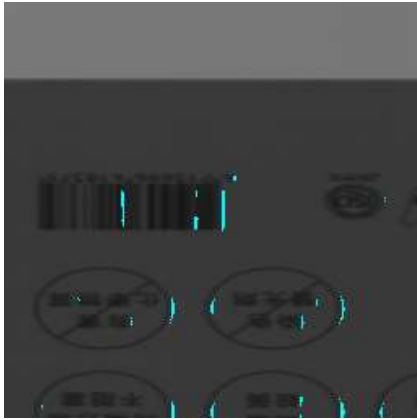
No.	#6, \$5	Date	2023/8/10 下午 01:28:14
Segment	1	Camera	1
Pattern	7808	Position[x, y]	874.2 [mm], 5838.6 [m], (227.8 [m])
Type	点状疵点	Size	H:1.7 ,V:16.8 [mm]
Result	-	Area	3.9 [mm2]
Inspection level	5/5,5/5,5/5,5/5,5/5	Label	-
Light	6,6,3/6,6,3

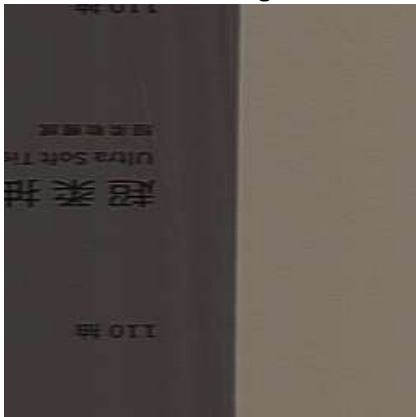
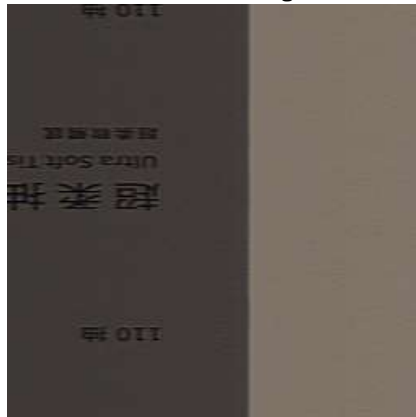
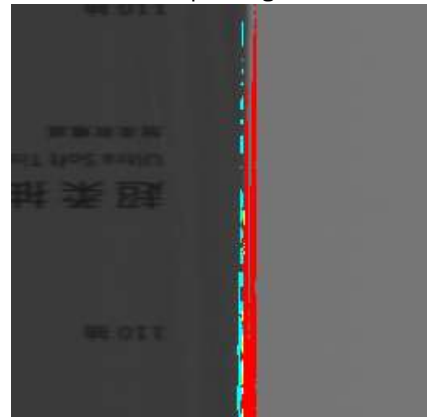
No.	#6, \$5	Date	2023/8/10 下午 01:28:14
Segment	1	Camera	1
Pattern	7808	Position[x, y]	880.3 [mm], 5838.7 [m], (227.6 [m])
Type	点状疵点縱向刀絲疵點	Size	H:11.2 ,V:318.4 [mm]
Result	-	Area	306.3 [mm2]
Inspection level	5/5,5/5,5/5,5/5,5/5	Label	-
Light	6,6,3/6,6,3

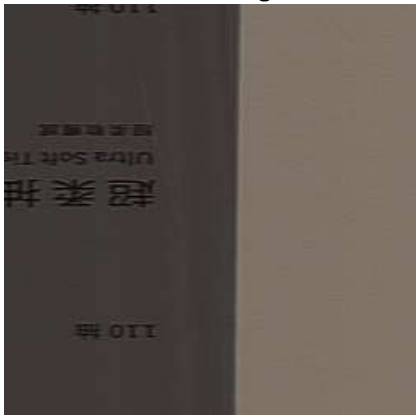
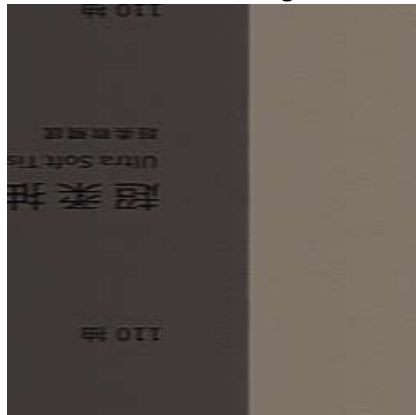
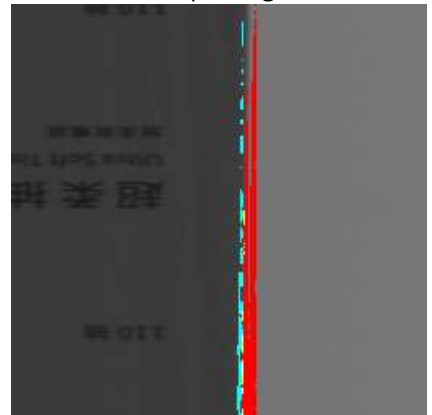
No.	#5, \$4	Date	2023/8/10 下午 01:28:13
Segment	1	Camera	1
Pattern	7807	Position[x, y]	838.3 [mm], 5838.1 [m], (228.3 [m])
Type	点状疵点	Size	H:19.5 ,V:4.8 [mm]
Result	-	Area	3.7 [mm2]
Inspection level	5/5,5/5,5/5,5/5,5/5	Label	-
Light	6,6,3/6,6,3

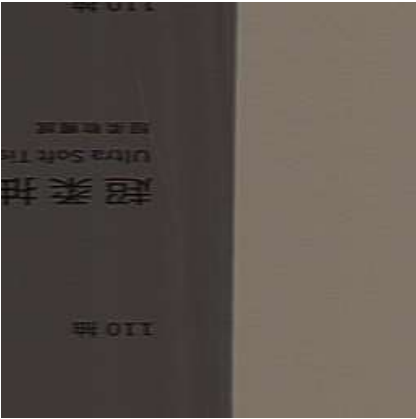
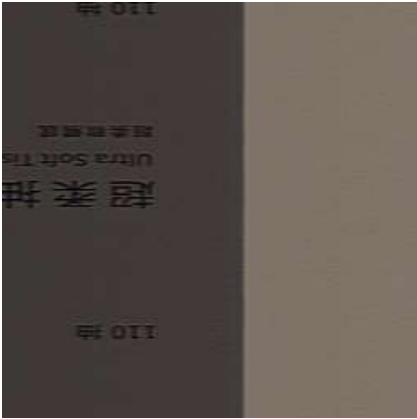
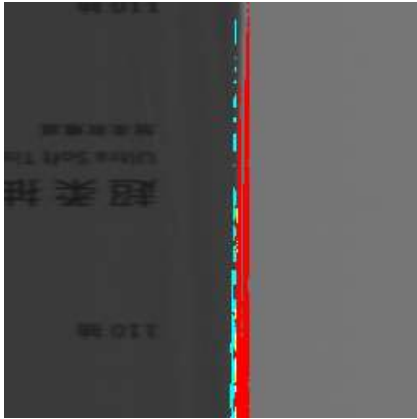
No.	#5, \$4	Date	2023/8/10 下午 01:28:13
Segment	1	Camera	1
Pattern	7807	Position[x, y]	86.8 [mm], 5838.2 [m], (228.2 [m])
Type	縱向刀絲疵點	Size	H:11.2 ,V:30.0 [mm]
Result	-	Area	5.9 [mm2]
Inspection level	5/5,5/5,5/5,5/5,5/5	Label	-
Light	6,6,3/6,6,3

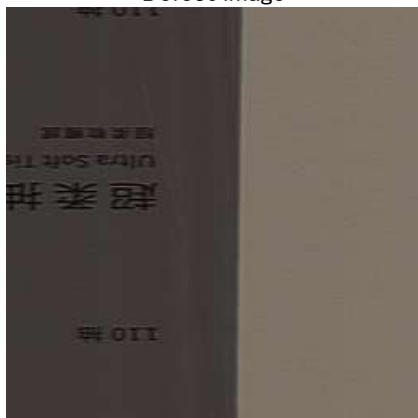
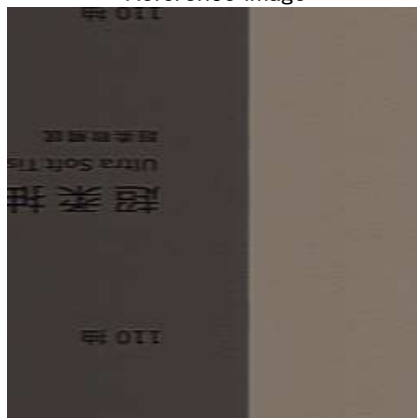
No.	#5, \$4	Date	2023/8/10 下午 01:28:13
Segment	1	Camera	1
Pattern	7807	Position[x, y]	883.2 [mm], 5838.2 [m], (228.2 [m])
Type	点状疵点	Size	H:1.5 ,V:58.4 [mm]
Result	-	Area	14.7 [mm2]
Inspection level	5/5,5/5,5/5,5/5,5/5	Label	-
Light	6,6,3/6,6,3

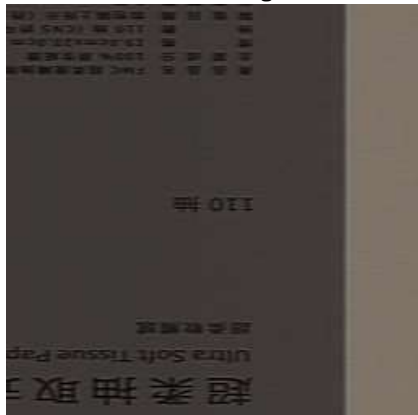
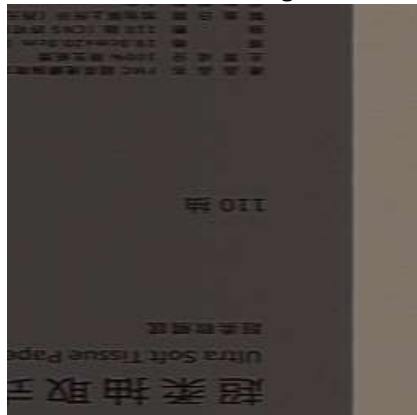
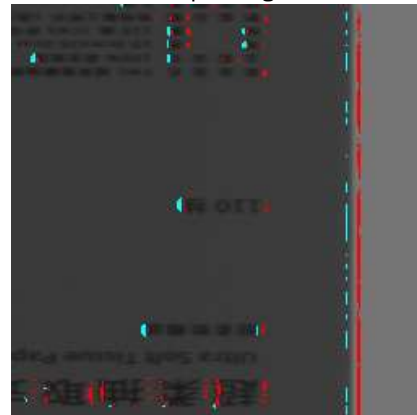
Defect image

No.	#5, \$4	Date	2023/8/10 下午 01:28:13
Segment	1	Camera	1
Pattern	7807	Position[x, y]	866.6 [mm], 5837.9 [m], (228.5 [m])
Type	点状疵点縱向刀絲疵點	Size	H:49.6 ,V:216.0 [mm]
Result	-	Area	60.7 [mm2]
Inspection level	5/5,5/5,5/5,5/5,5/5	Label	-
Light	6,6,3/6,6,3

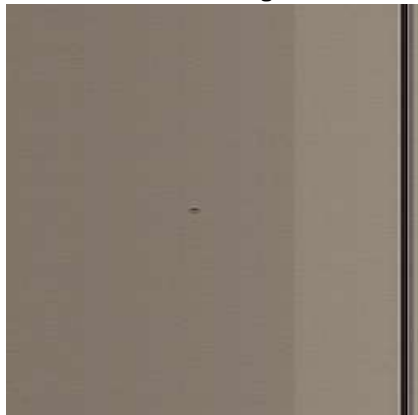
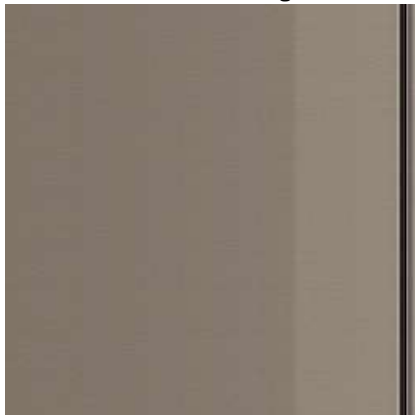
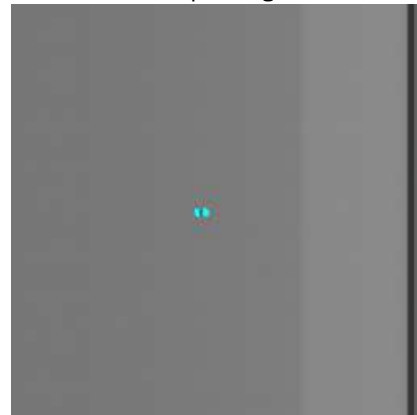
Defect image

No.	#4, \$3	Date	2023/8/10 下午 12:43:42
Segment	1	Camera	1
Pattern	3239	Position[x, y]	930.1 [mm], 2425.4 [m], (3641.0 [m])
Type	縱向刀絲疵點	Size	H:2.2 ,V:1.6 [mm]
Result	-	Area	2.3 [mm2]
Inspection level	5/5,5/5,5/5,5/5,5/5	Label	-
Light	6,6,3/6,6,3

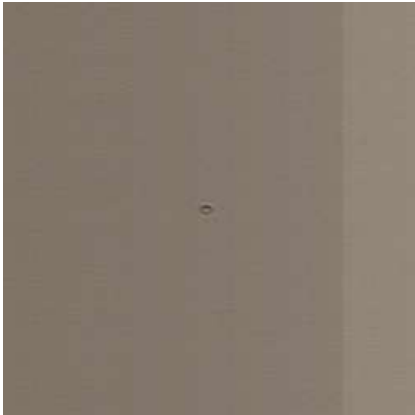
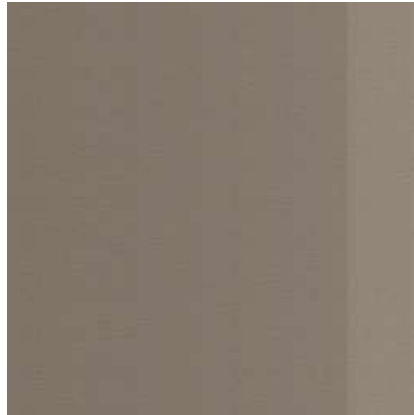
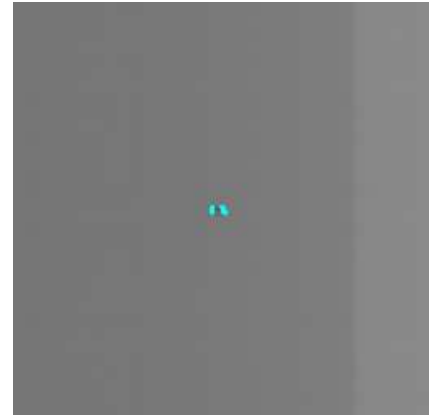
Defect image

No.	#3, \$2	Date	2023/8/10 下午 12:42:59
Segment	1	Camera	1
Pattern	3166	Position[x, y]	924.2 [mm], 2370.9 [m], (3695.5 [m])
Type	縱向刀絲疵點	Size	H:2.7 ,V:1.6 [mm]
Result	-	Area	2.6 [mm2]
Inspection level	5/5,5/5,5/5,5/5,5/5	Label	-
Light	6,6,3/6,6,3

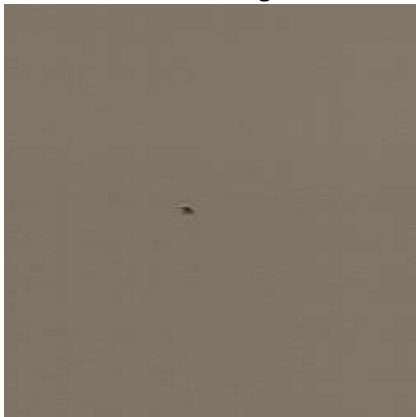
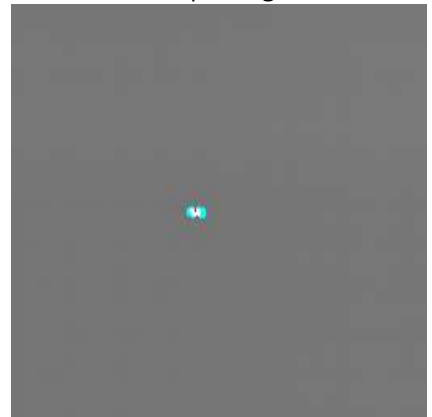
Defect image

No.	#2, \$1	Date	2023/8/10 下午 12:18:31
Segment	1	Camera	1
Pattern	657	Position[x, y]	624.4 [mm], 496.6 [m], (5569.8 [m])
Type	点状疵点縱向刀絲疵點	Size	H:2.9 ,V:2.4 [mm]
Result	-	Area	5.9 [mm2]
Inspection level	5/5,5/5,5/5,5/5,5/5	Label	-
Light	6,6,3/6,6,3
