# Inspection Result (Individual Data)

Lot number : 5

Inspected date : 2023/8/9 下午 12:59:28 ~ 2023/8/9 下午 02:20:08

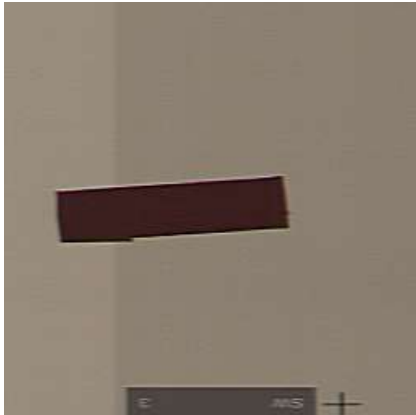
Defect image

No.	#55, \$42	Date	2023/8/9 下午 02:20:00
Segment	1	Camera	1
Pattern	8014	Position[ x, y ]	12.8 [mm], 6025.2 [m], ( 1.9 [m] )
Type	点状疵点縱向刀絲疵點橫向刀絲	Size	H:26.4 ,V:17.2 [mm]
Result	-	Area	342.8 [mm2]
Inspection level	5/5,5/5,5/5,5/5,5/5	Label	-
Light	6,6,3/6,6,3

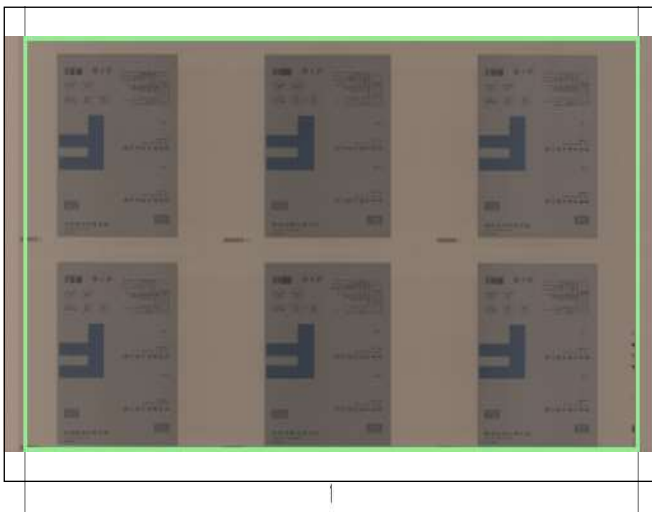
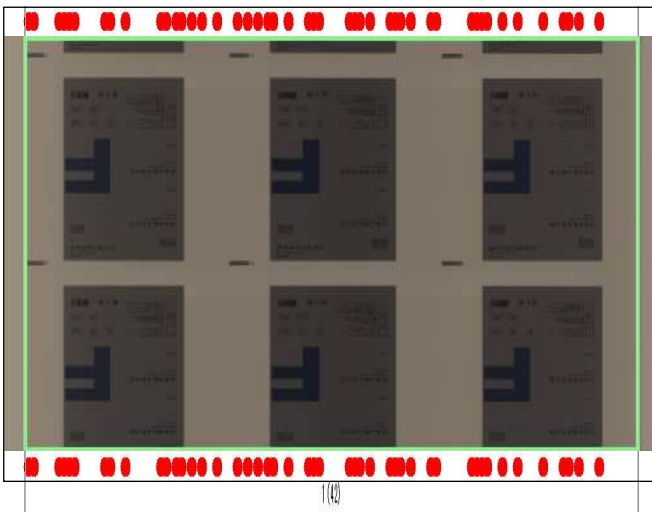
No.	#54, \$41	Date	2023/8/9 下午 02:19:59
Segment	1	Camera	1
Pattern	8012	Position[ x, y ]	157.3 [mm], 6023.7 [m], ( 3.5 [m] )
Type	縱向刀絲疵點	Size	H:2.9 ,V:17.6 [mm]
Result	-	Area	23.1 [mm2]
Inspection level	5/5,5/5,5/5,5/5,5/5	Label	-
Light	6,6,3/6,6,3

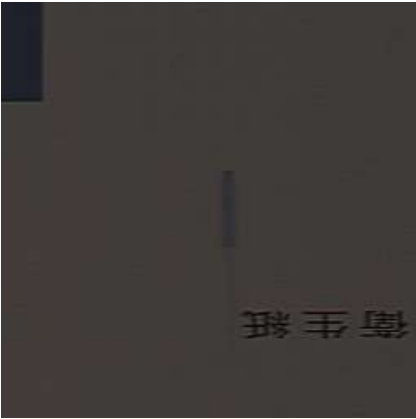
No.	#51, \$40	Date	2023/8/9 下午 02:19:31
Segment	1	Camera	1
Pattern	7967	Position[ x, y ]	15.0 [mm], 5989.2 [m], ( 37.9 [m] )
Type	点状疵点	Size	H:28.8 ,V:7.2 [mm]
Result	-	Area	200.3 [mm2]
Inspection level	5/5,5/5,5/5,5/5,5/5	Label	-
Light	6,6,3/6,6,3

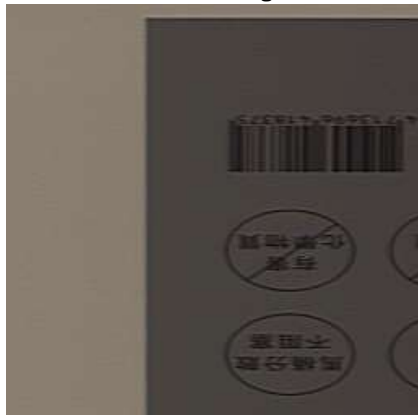
Defect image

No.	#51, \$40	Date	2023/8/9 下午 02:19:31
Segment	1	Camera	1
Pattern	7967	Position[ x, y ]	64.8 [mm], 5989.3 [m], ( 37.8 [m] )
Type	点状疵点	Size	H:16.4 ,V:172.8 [mm]
Result	-	Area	1978.7 [mm2]
Inspection level	5/5,5/5,5/5,5/5,5/5	Label	-
Light	6,6,3/6,6,3

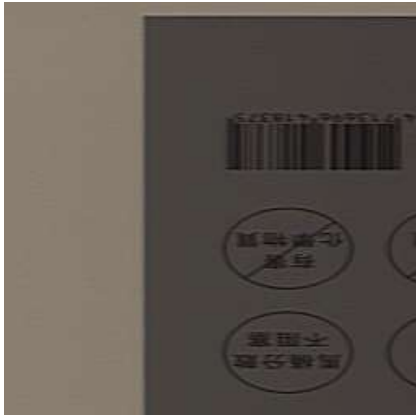
Defect image

No.	#50, \$39	Date	2023/8/9 下午 02:19:31
Segment	1	Camera	1
Pattern	7966	Position[ x, y ]	18.2 [mm], 5988.5 [m], ( 38.7 [m] )
Type	点状疵点縱向刀絲疵點橫向刀絲	Size	H:29.8 ,V:9.2 [mm]
Result	-	Area	211.5 [mm2]
Inspection level	5/5,5/5,5/5,5/5,5/5	Label	-
Light	6,6,3/6,6,3

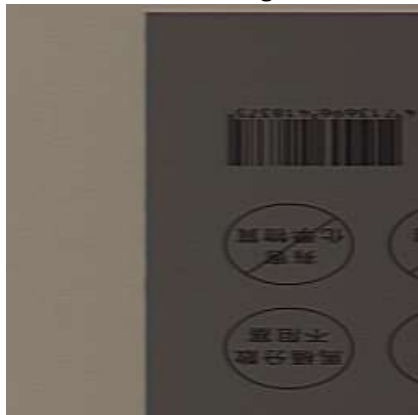
Defect image

No.	#50, \$39	Date	2023/8/9 下午 02:19:31
Segment	1	Camera	1
Pattern	7966	Position[ x, y ]	64.6 [mm], 5988.6 [m], ( 38.6 [m] )
Type	点状疵点	Size	H:16.6 ,V:173.2 [mm]
Result	-	Area	1968.1 [mm2]
Inspection level	5/5,5/5,5/5,5/5,5/5	Label	-
Light	6,6,3/6,6,3

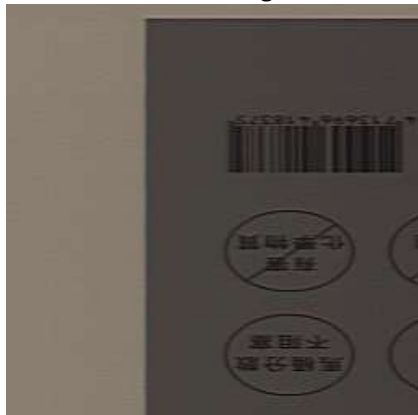
Defect image

No.	#49, \$38	Date	2023/8/9 下午 02:19:30
Segment	1	Camera	1
Pattern	7965	Position[ x, y ]	64.6 [mm], 5987.8 [m], ( 39.3 [m] )
Type	点状疵点	Size	H:16.6 ,V:173.2 [mm]
Result	-	Area	1976.1 [mm2]
Inspection level	5/5,5/5,5/5,5/5,5/5	Label	-
Light	6,6,3/6,6,3

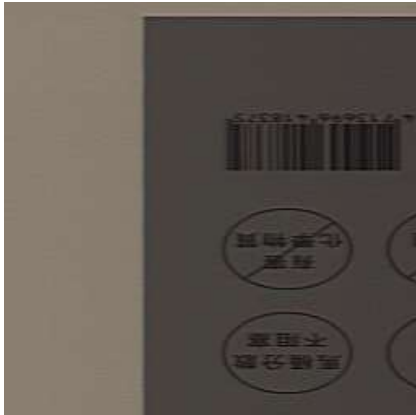
Defect image

No.	#48, \$37	Date	2023/8/9 下午 02:19:30
Segment	1	Camera	1
Pattern	7964	Position[ x, y ]	65.5 [mm], 5987.0 [m], ( 40.2 [m] )
Type	点状疵点	Size	H:16.4 ,V:42.0 [mm]
Result	-	Area	551.1 [mm2]
Inspection level	5/5,5/5,5/5,5/5,5/5	Label	-
Light	6,6,3/6,6,3

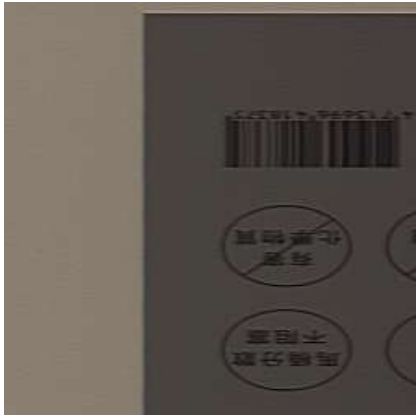
Defect image

No.	#47, \$36	Date	2023/8/9 下午 02:19:29
Segment	1	Camera	1
Pattern	7963	Position[ x, y ]	64.8 [mm], 5986.3 [m], ( 40.8 [m] )
Type	点状疵点	Size	H:16.6 ,V:173.2 [mm]
Result	-	Area	1970.7 [mm2]
Inspection level	5/5,5/5,5/5,5/5,5/5	Label	-
Light	6,6,3/6,6,3

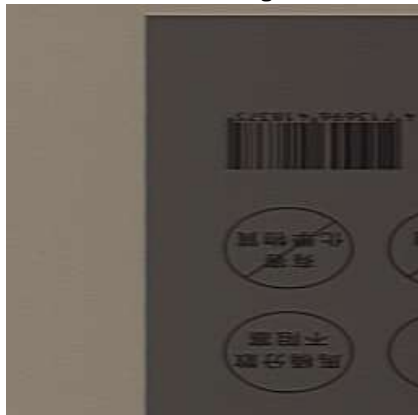
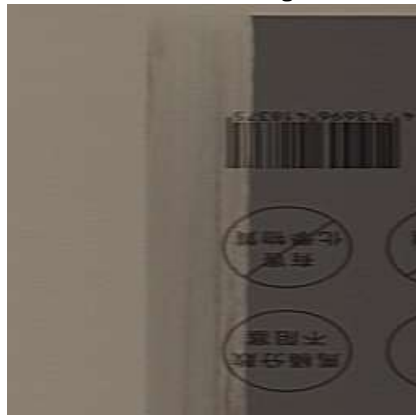
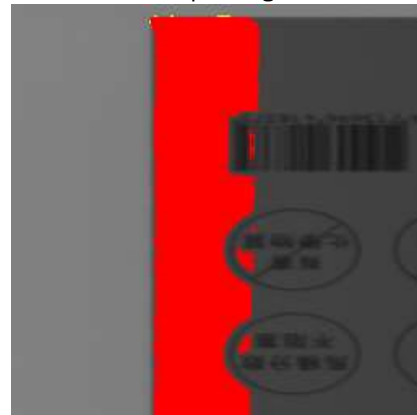
No.	#44, \$35	Date	2023/8/9 下午 02:19:23
Segment	1	Camera	1
Pattern	7953	Position[ x, y ]	77.3 [mm], 5979.0 [m], ( 48.2 [m] )
Type	面状重疵点縱向刀絲疵點	Size	H:23.4 ,V:160.0 [mm]
Result	-	Area	1678.0 [mm2]
Inspection level	5/5,5/5,5/5,5/5,5/5	Label	-
Light	6,6,3/6,6,3

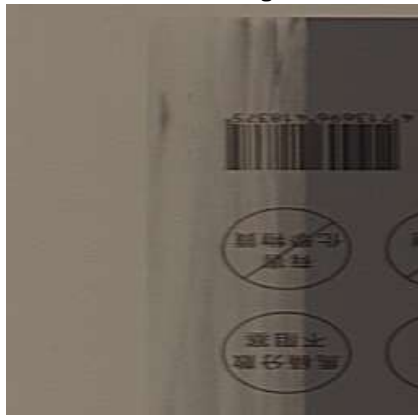
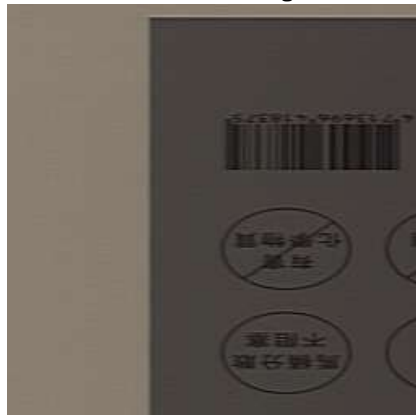
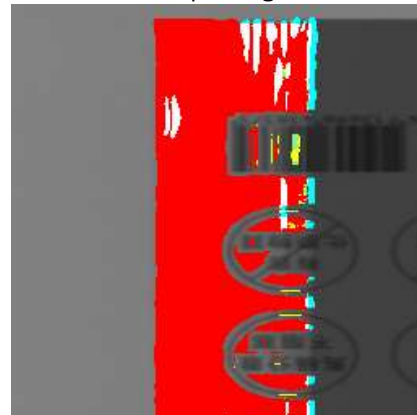
No.	#44, \$35	Date	2023/8/9 下午 02:19:23
Segment	1	Camera	1
Pattern	7953	Position[ x, y ]	74.8 [mm], 5979.3 [m], ( 47.9 [m] )
Type	点状疵点縱向刀絲疵點	Size	H:24.9 ,V:359.2 [mm]
Result	-	Area	4963.3 [mm2]
Inspection level	5/5,5/5,5/5,5/5,5/5	Label	-
Light	6,6,3/6,6,3

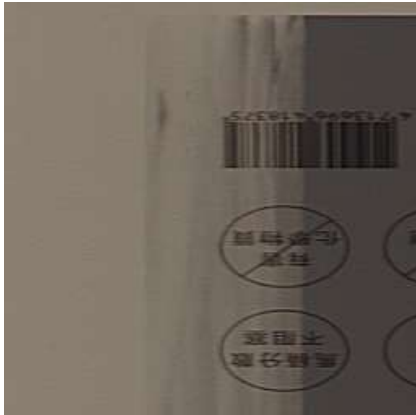
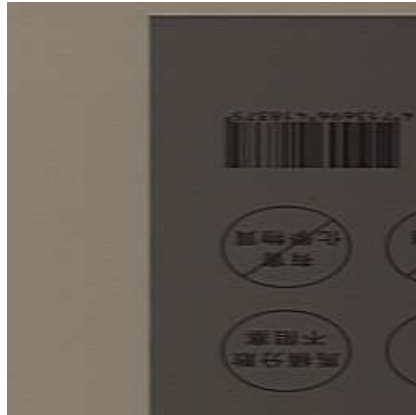
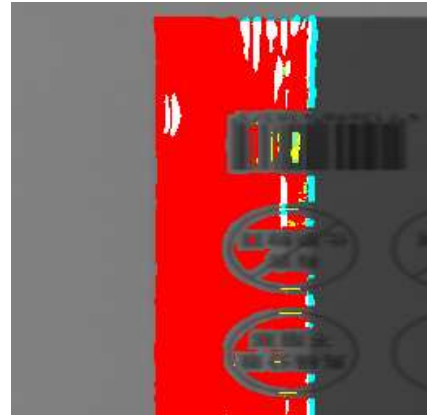
No.	#43, \$34	Date	2023/8/9 下午 02:19:22
Segment	1	Camera	1
Pattern	7952	Position[ x, y ]	67.0 [mm], 5978.3 [mm], ( 48.9 [mm] )
Type	面狀重疵點	Size	H:17.6 ,V:118.0 [mm]
Result	-	Area	1534.5 [mm2]
Inspection level	5/5,5/5,5/5,5/5,5/5	Label	-
Light	6,6,3/6,6,3

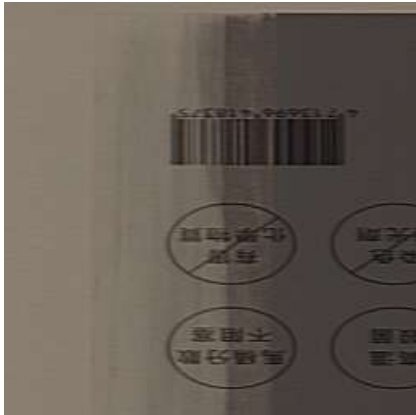
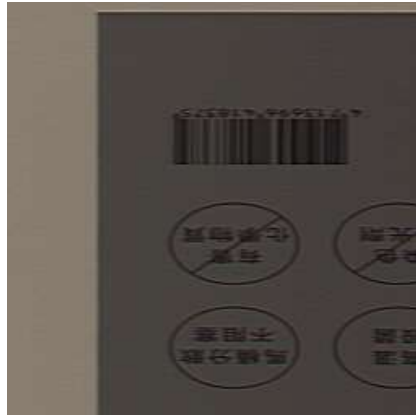
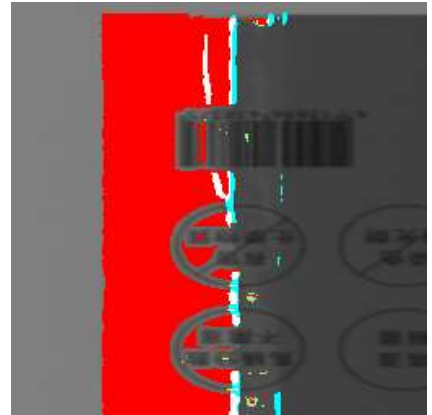
No.	#43, \$34	Date	2023/8/9 下午 02:19:22
Segment	1	Camera	1
Pattern	7952	Position[ x, y ]	70.7 [mm], 5978.4 [m], ( 48.7 [m] )
Type	点状疵点縱向刀絲疵點	Size	H:28.1 ,V:706.0 [mm]
Result	-	Area	4490.1 [mm2]
Inspection level	5/5,5/5,5/5,5/5,5/5	Label	-
Light	6,6,3/6,6,3

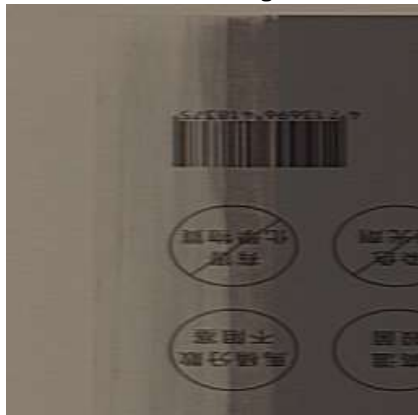
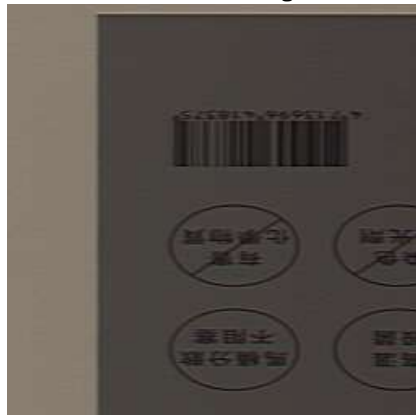
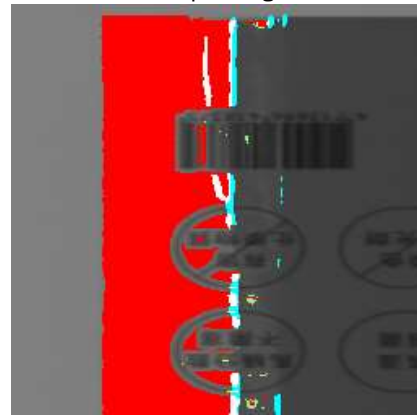
No.	#42, \$33	Date	2023/8/9 下午 02:19:22
Segment	1	Camera	1
Pattern	7951	Position[ x, y ]	67.0 [mm], 5977.9 [m], ( 49.2 [m] )
Type	面狀重疵點	Size	H:16.6 ,V:116.0 [mm]
Result	-	Area	1463.0 [mm2]
Inspection level	5/5,5/5,5/5,5/5,5/5	Label	-
Light	6,6,3/6,6,3

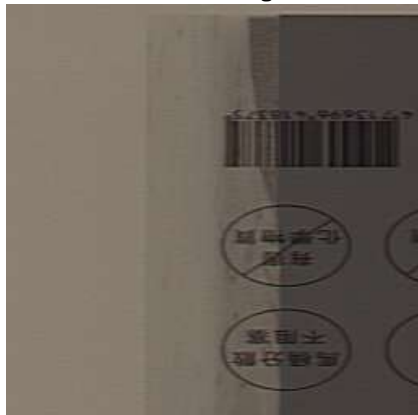
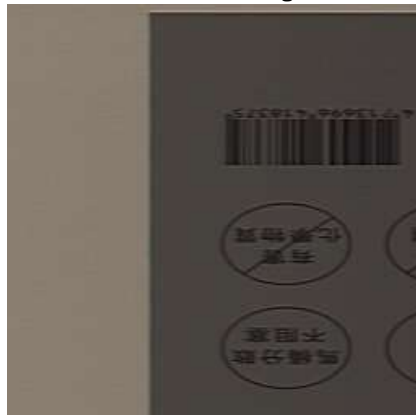
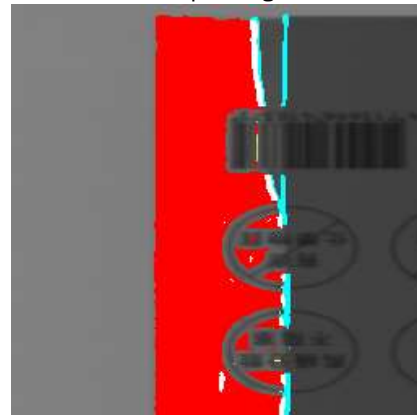
No.	#42, \$33	Date	2023/8/9 下午 02:19:22
Segment	1	Camera	1
Pattern	7951	Position[ x, y ]	69.2 [mm], 5977.7 [m], ( 49.4 [m] )
Type	点状疵点縱向刀絲疵點	Size	H:24.9 ,V:533.2 [mm]
Result	-	Area	4121.0 [mm2]
Inspection level	5/5,5/5,5/5,5/5,5/5	Label	-
Light	6,6,3/6,6,3

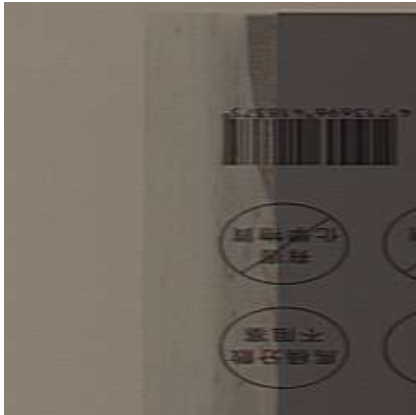
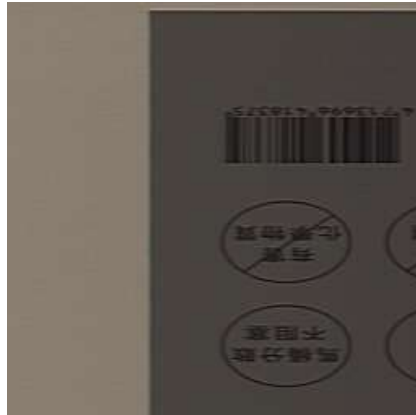
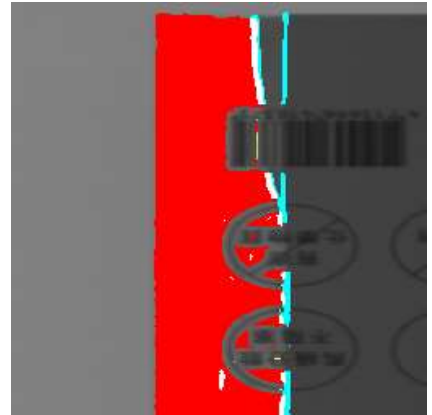
No.	#41, \$32	Date	2023/8/9 下午 02:19:21
Segment	1	Camera	1
Pattern	7950	Position[ x, y ]	12.6 [mm], 5976.5 [m], ( 50.7 [m] )
Type	点状疵点縱向刀絲疵點	Size	H:16.6 ,V:70.4 [mm]
Result	-	Area	84.2 [mm2]
Inspection level	5/5,5/5,5/5,5/5,5/5	Label	-
Light	6,6,3/6,6,3

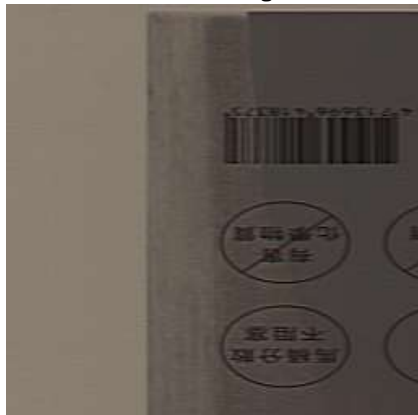
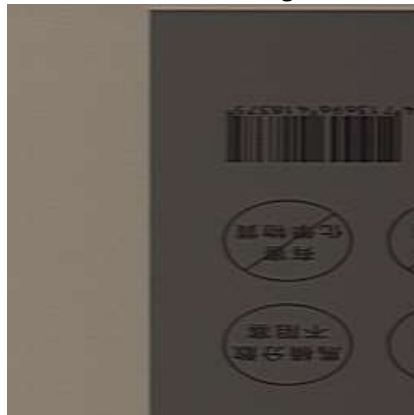
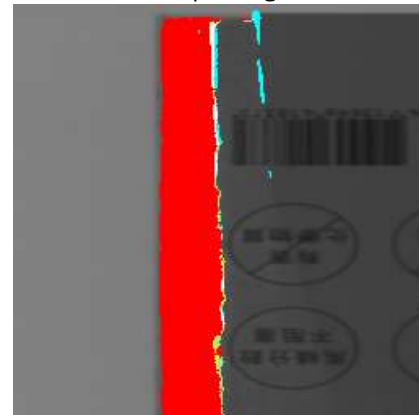
No.	#41, \$32	Date	2023/8/9 下午 02:19:21
Segment	1	Camera	1
Pattern	7950	Position[ x, y ]	65.5 [mm], 5977.0 [m], ( 50.1 [m] )
Type	点状疵点縱向刀絲疵點	Size	H:15.9 ,V:309.6 [mm]
Result	-	Area	1452.3 [mm2]
Inspection level	5/5,5/5,5/5,5/5,5/5	Label	-
Light	6,6,3/6,6,3

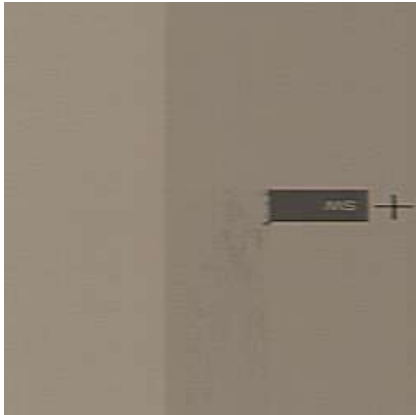
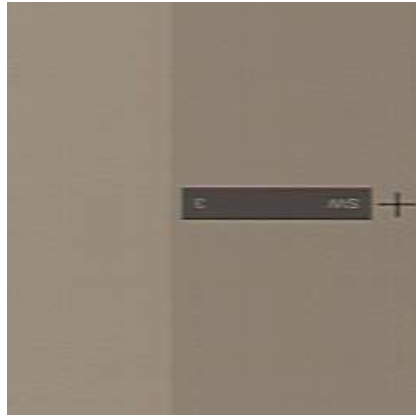
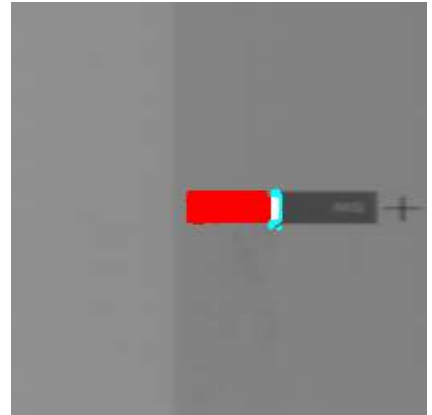
No.	#40, \$31	Date	2023/8/9 下午 02:19:21
Segment	1	Camera	1
Pattern	7949	Position[ x, y ]	10.6 [mm], 5976.1 [m], ( 51.1 [m] )
Type	点状疵点縱向刀絲疵點	Size	H:14.6 ,V:9.6 [mm]
Result	-	Area	97.5 [mm2]
Inspection level	5/5,5/5,5/5,5/5,5/5	Label	-
Light	6,6,3/6,6,3

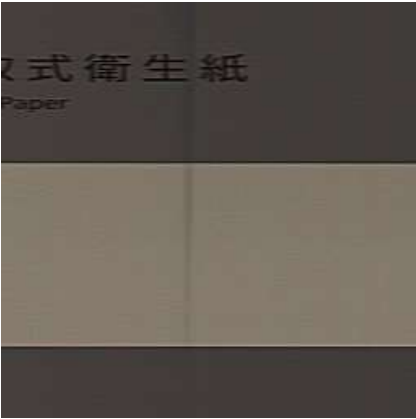
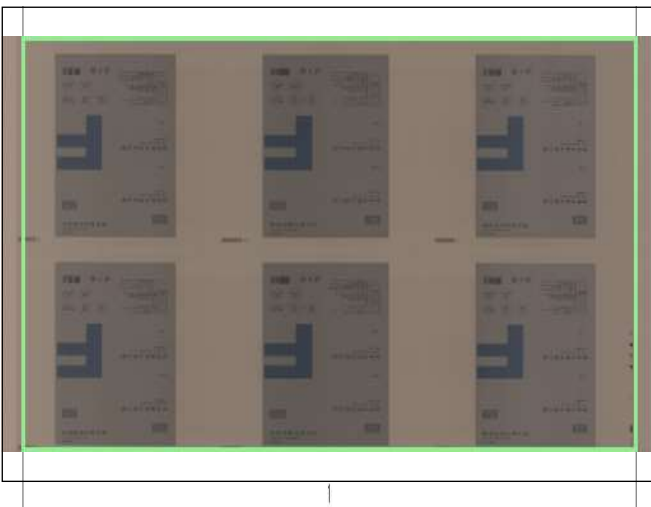
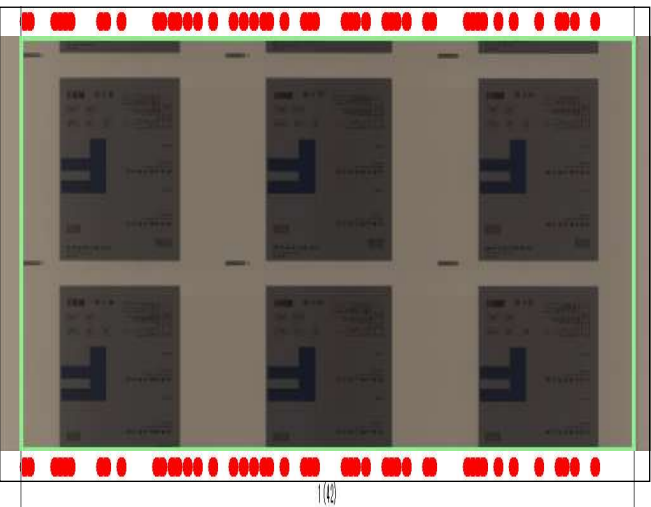
No.	#37, \$28	Date	2023/8/9 下午 02:18:38
Segment	1	Camera	1
Pattern	7879	Position[ x, y ]	450.1 [mm], 5923.2 [m], ( 104.0 [m] )
Type	点状疵点縱向刀絲疵點	Size	H:8.8 ,V:42.8 [mm]
Result	-	Area	223.6 [mm2]
Inspection level	5/5,5/5,5/5,5/5,5/5	Label	-
Light	6,6,3/6,6,3

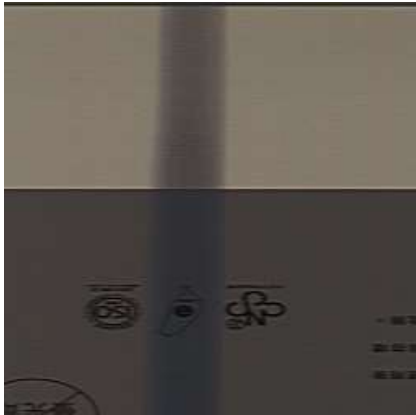
No.	#36, \$27	Date	2023/8/9 下午 02:18:38
Segment	1	Camera	1
Pattern	7878	Position[ x, y ]	381.5 [mm], 5922.8 [m], ( 104.3 [m] )
Type	点状疵点縱向刀絲疵點	Size	H:10.3 ,V:26.4 [mm]
Result	-	Area	131.8 [mm2]
Inspection level	5/5,5/5,5/5,5/5,5/5	Label	-
Light	6,6,3/6,6,3

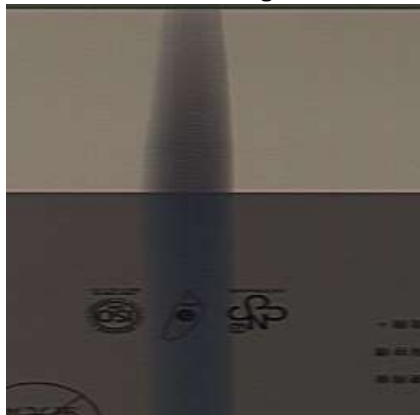
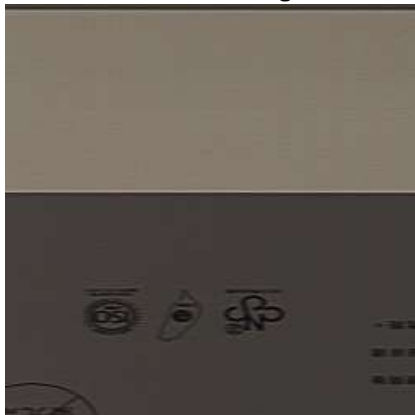
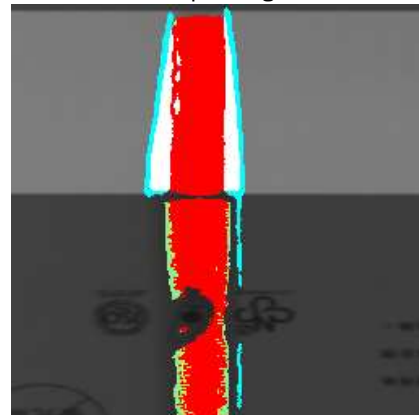
Defect image

No.	#36, \$27	Date	2023/8/9 下午 02:18:38
Segment	1	Camera	1
Pattern	7878	Position[ x, y ]	127.8 [mm], 5922.8 [m], ( 104.3 [m] )
Type	点状疵点縱向刀絲疵點	Size	H:15.4 ,V:160.8 [mm]
Result	-	Area	1037.4 [mm2]
Inspection level	5/5,5/5,5/5,5/5,5/5	Label	-
Light	6,6,3/6,6,3

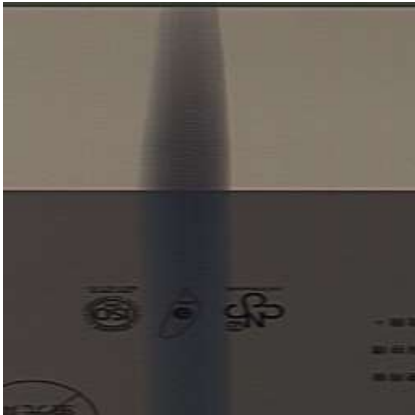
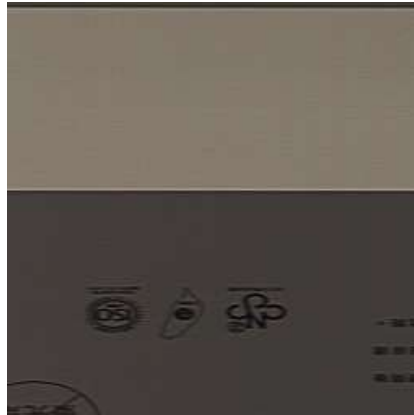
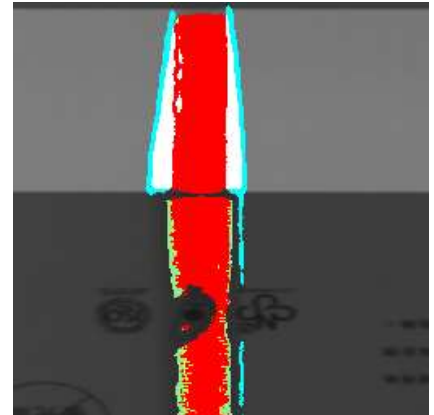
Defect image

No.	#35, \$26	Date	2023/8/9 下午 02:18:18
Segment	1	Camera	1
Pattern	7845	Position[ x, y ]	441.3 [mm], 5897.9 [m], ( 129.2 [m] )
Type	点状疵点	Size	H:5.9 ,V:52.8 [mm]
Result	-	Area	109.0 [mm2]
Inspection level	5/5,5/5,5/5,5/5,5/5	Label	-
Light	6,6,3/6,6,3

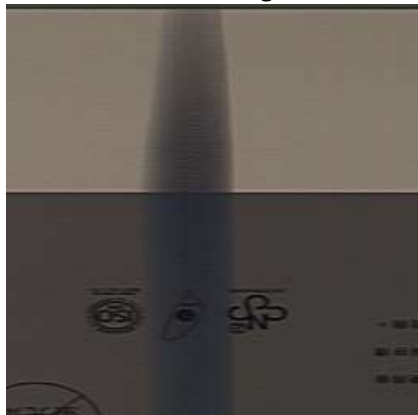
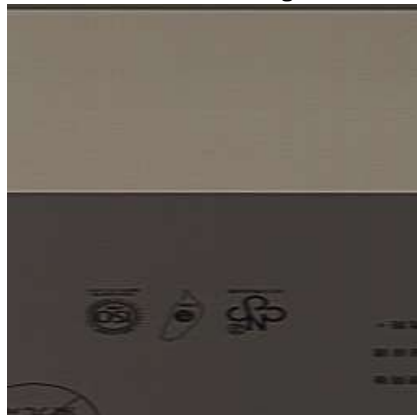
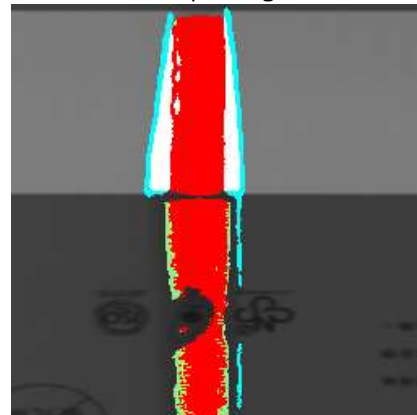
Defect image

No.	#35, \$26	Date	2023/8/9 下午 02:18:18
Segment	1	Camera	1
Pattern	7845	Position[ x, y ]	374.9 [mm], 5898.1 [m], ( 129.1 [m] )
Type	点状疵点縱向刀絲疵點	Size	H:11.2 ,V:342.8 [mm]
Result	-	Area	882.0 [mm2]
Inspection level	5/5,5/5,5/5,5/5,5/5	Label	-
Light	6,6,3/6,6,3

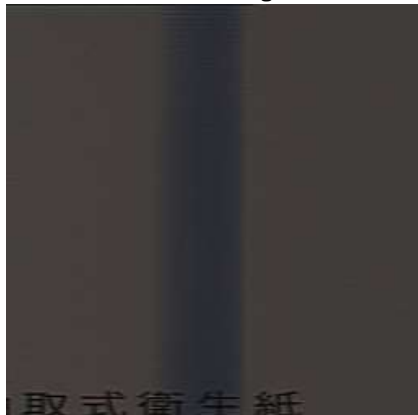
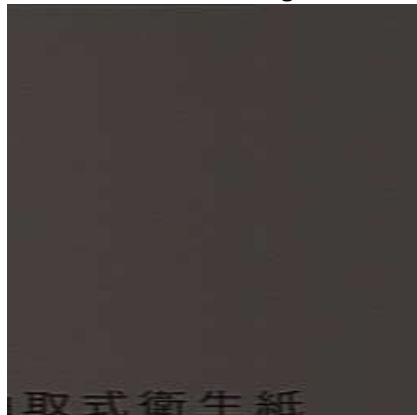
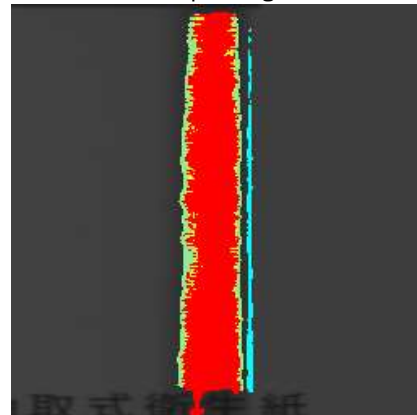
Defect image

No.	#34, \$25	Date	2023/8/9 下午 02:18:17
Segment	1	Camera	1
Pattern	7844	Position[ x, y ]	449.1 [mm], 5896.9 [m], ( 130.2 [m] )
Type	点状疵点縱向刀絲疵點	Size	H:12.2 ,V:44.8 [mm]
Result	-	Area	414.6 [mm2]
Inspection level	5/5,5/5,5/5,5/5,5/5	Label	-
Light	6,6,3/6,6,3

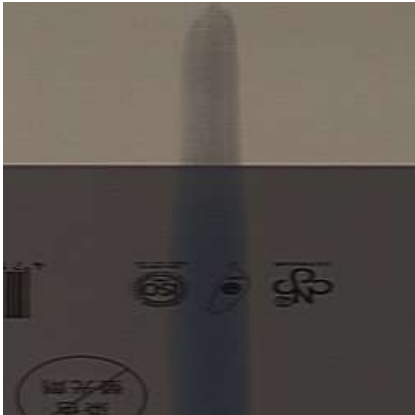
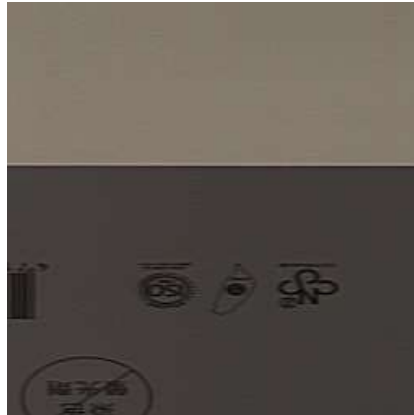
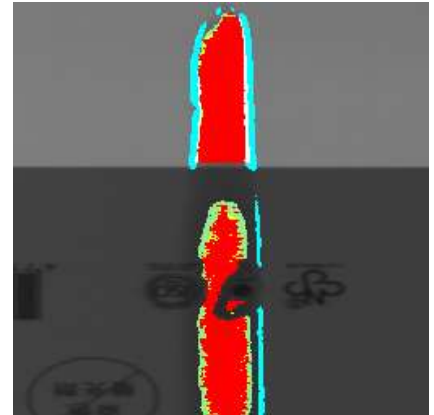
Defect image

No.	#30, \$23	Date	2023/8/9 下午 02:18:08
Segment	1	Camera	1
Pattern	7829	Position[ x, y ]	442.2 [mm], 5886.0 [m], ( 141.1 [m] )
Type	点状疵点縱向刀絲疵點	Size	H:12.0 ,V:46.0 [mm]
Result	-	Area	415.2 [mm2]
Inspection level	5/5,5/5,5/5,5/5,5/5	Label	-
Light	6,6,3/6,6,3

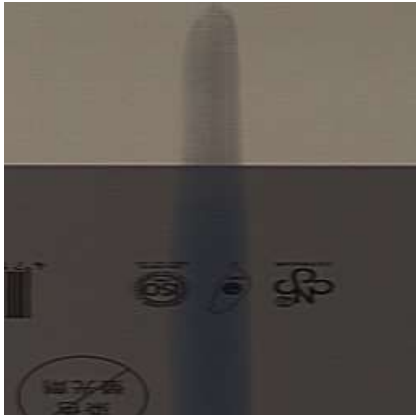
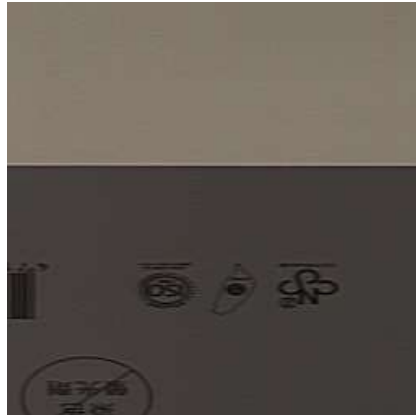
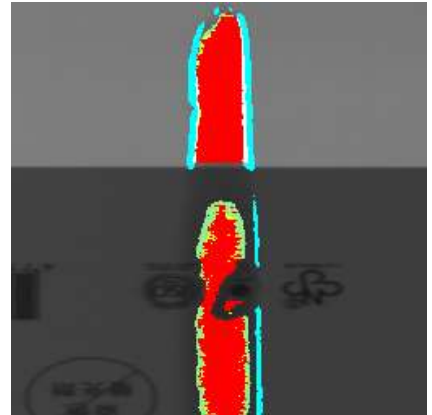
Defect image

No.	#30, \$23	Date	2023/8/9 下午 02:18:08
Segment	1	Camera	1
Pattern	7829	Position[ x, y ]	125.8 [mm], 5886.3 [m], ( 140.8 [m] )
Type	点状疵点縱向刀絲疵點	Size	H:11.2 ,V:102.8 [mm]
Result	-	Area	684.5 [mm2]
Inspection level	5/5,5/5,5/5,5/5,5/5	Label	-
Light	6,6,3/6,6,3

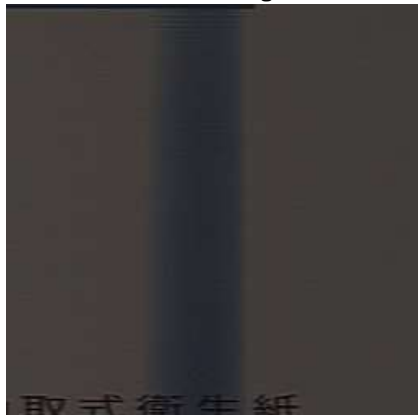
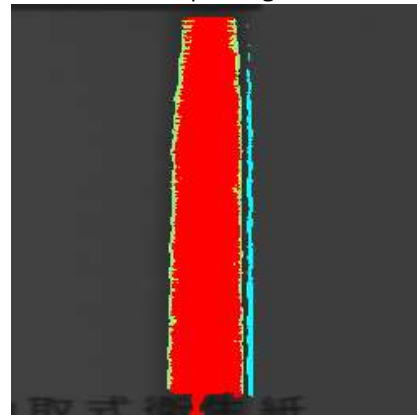
Defect image

No.	#30, \$23	Date	2023/8/9 下午 02:18:08
Segment	1	Camera	1
Pattern	7829	Position[ x, y ]	123.9 [mm], 5886.1 [m], ( 141.1 [m] )
Type	点状疵点縱向刀絲疵點	Size	H:18.1 ,V:274.0 [mm]
Result	-	Area	2896.1 [mm2]
Inspection level	5/5,5/5,5/5,5/5,5/5	Label	-
Light	6,6,3/6,6,3

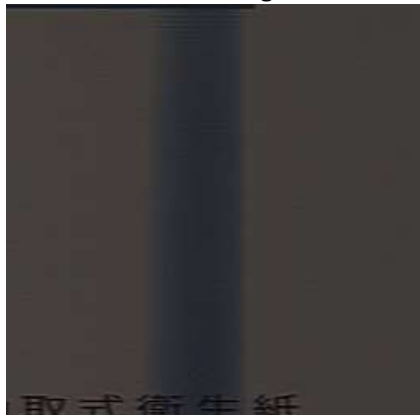
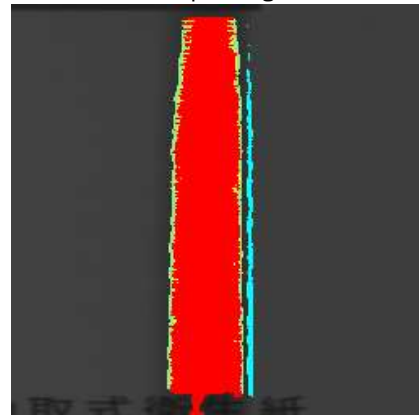
Defect image

No.	#29, \$22	Date	2023/8/9 下午 02:18:08
Segment	1	Camera	1
Pattern	7828	Position[ x, y ]	243.0 [mm], 5885.1 [m], ( 142.0 [m] )
Type	点状疵点縱向刀絲疵點	Size	H:2.2 ,V:793.2 [mm]
Result	-	Area	126.4 [mm2]
Inspection level	5/5,5/5,5/5,5/5,5/5	Label	-
Light	6,6,3/6,6,3

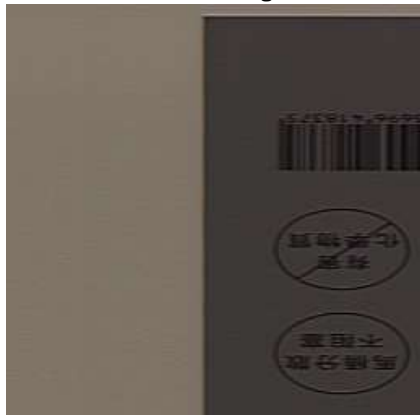
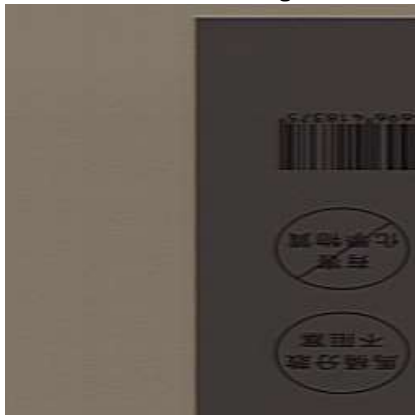
Defect image

No.	#29, \$22	Date	2023/8/9 下午 02:18:08
Segment	1	Camera	1
Pattern	7828	Position[ x, y ]	700.1 [mm], 5885.1 [m], ( 142.0 [m] )
Type	点状疵点縱向刀絲疵點	Size	H:2.2 ,V:794.0 [mm]
Result	-	Area	160.6 [mm2]
Inspection level	5/5,5/5,5/5,5/5,5/5	Label	-
Light	6,6,3/6,6,3

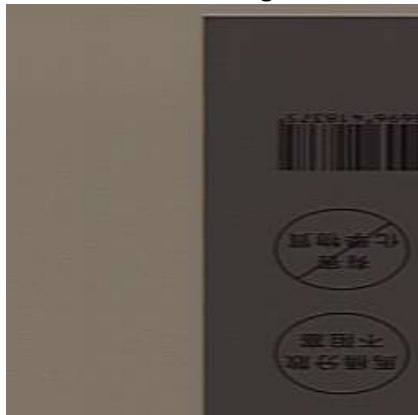
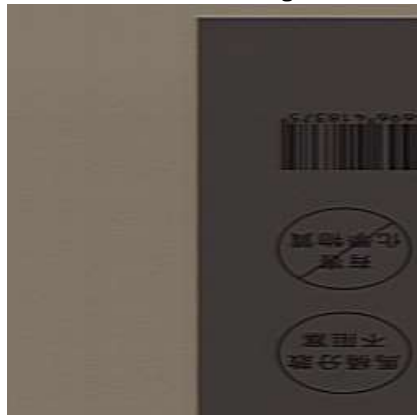
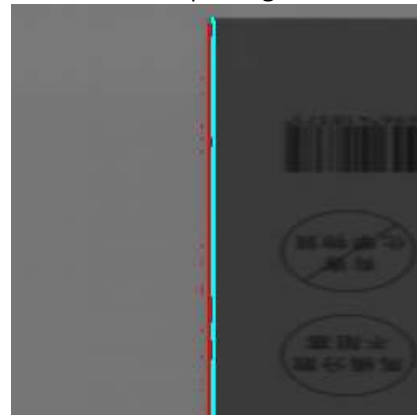
No.	#28, \$21	Date	2023/8/9 下午 02:18:07
Segment	1	Camera	1
Pattern	7827	Position[ x, y ]	243.0 [mm], 5884.4 [m], ( 142.8 [m] )
Type	点状疵点縱向刀絲疵點	Size	H:2.2 ,V:808.0 [mm]
Result	-	Area	113.0 [mm2]
Inspection level	5/5,5/5,5/5,5/5,5/5	Label	-
Light	6,6,3/6,6,3

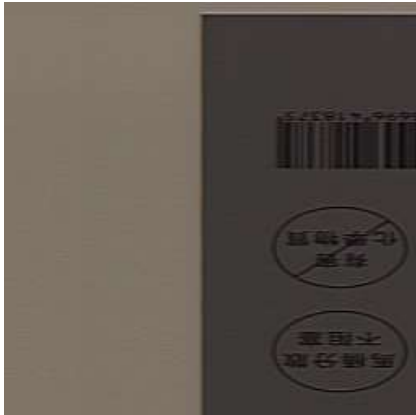
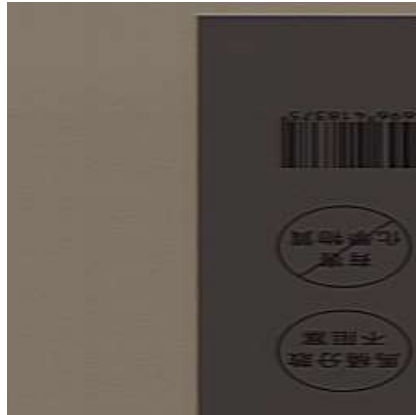
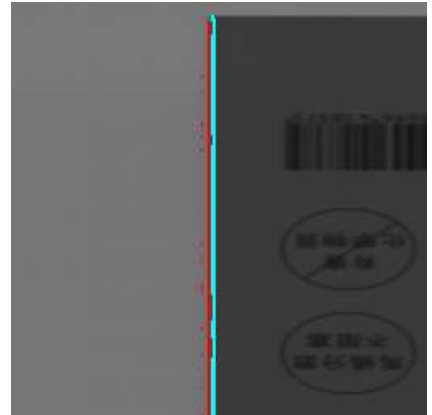
No.	#28, \$21	Date	2023/8/9 下午 02:18:07
Segment	1	Camera	1
Pattern	7827	Position[ x, y ]	883.9 [mm], 5884.4 [m], ( 142.8 [m] )
Type	縱向刀絲疵點	Size	H:0.5 ,V:657.6 [mm]
Result	-	Area	122.1 [mm2]
Inspection level	5/5,5/5,5/5,5/5,5/5	Label	-
Light	6,6,3/6,6,3

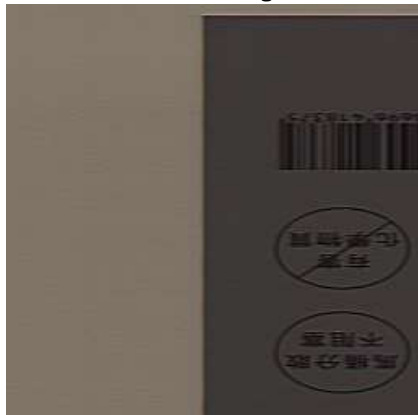
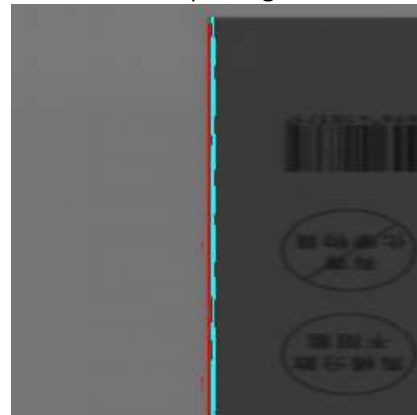
No.	#28, \$21	Date	2023/8/9 下午 02:18:07
Segment	1	Camera	1
Pattern	7827	Position[ x, y ]	700.1 [mm], 5884.4 [m], ( 142.8 [m] )
Type	点状疵点縱向刀絲疵點	Size	H:2.2 ,V:665.6 [mm]
Result	-	Area	149.0 [mm2]
Inspection level	5/5,5/5,5/5,5/5,5/5	Label	-
Light	6,6,3/6,6,3

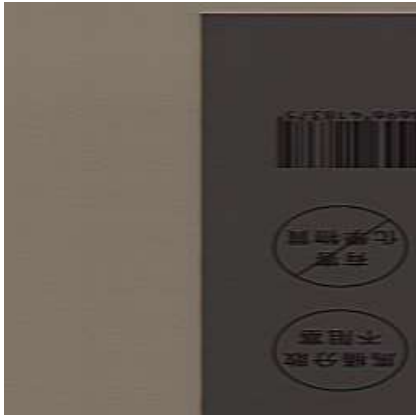
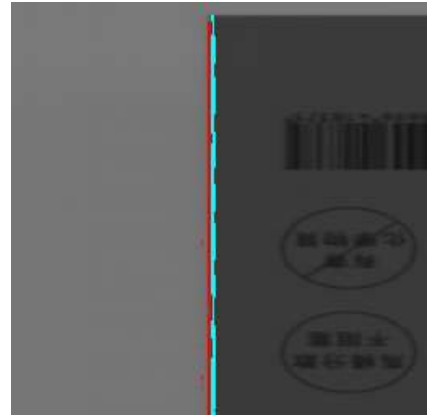
No.	#27, \$20	Date	2023/8/9 下午 02:18:06
Segment	1	Camera	1
Pattern	7826	Position[ x, y ]	243.0 [mm], 5884.0 [m], ( 143.1 [m] )
Type	点状疵点縱向刀絲疵點	Size	H:2.2 ,V:178.0 [mm]
Result	-	Area	36.4 [mm2]
Inspection level	5/5,5/5,5/5,5/5,5/5	Label	-
Light	6,6,3/6,6,3

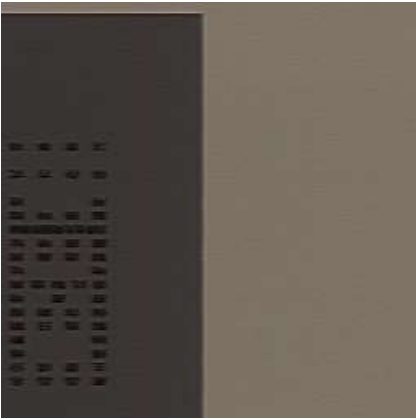
No.	#27, \$20	Date	2023/8/9 下午 02:18:06
Segment	1	Camera	1
Pattern	7826	Position[ x, y ]	568.2 [mm], 5883.7 [m], ( 143.5 [m] )
Type	縱向刀絲疵點	Size	H:0.5 ,V:328.8 [mm]
Result	-	Area	79.3 [mm2]
Inspection level	5/5,5/5,5/5,5/5,5/5	Label	-
Light	6,6,3/6,6,3

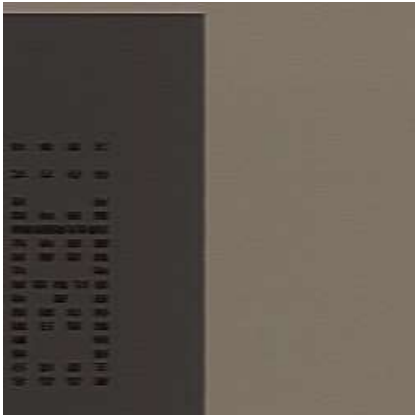
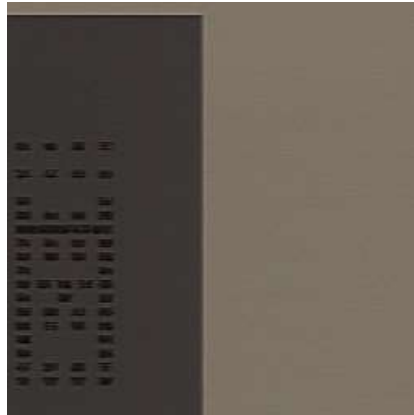
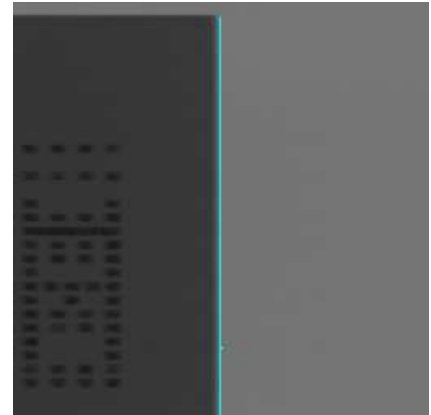
No.	#26, \$19	Date	2023/8/9 下午 02:18:06
Segment	1	Camera	1
Pattern	7825	Position[ x, y ]	567.5 [mm], 5883.4 [m], ( 143.8 [m] )
Type	点状疵点	Size	H:0.5 ,V:3.6 [mm]
Result	-	Area	1.0 [mm2]
Inspection level	5/5,5/5,5/5,5/5,5/5	Label	-
Light	6,6,3/6,6,3

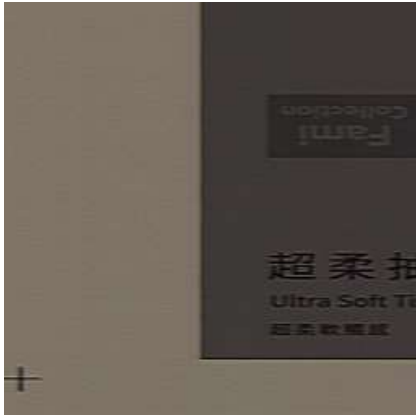
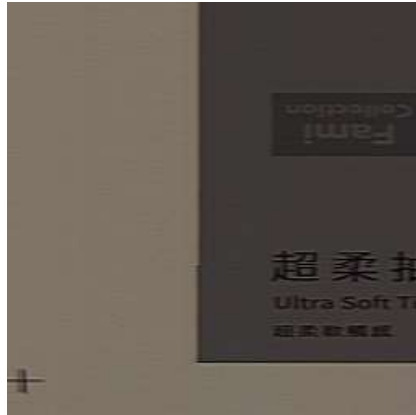
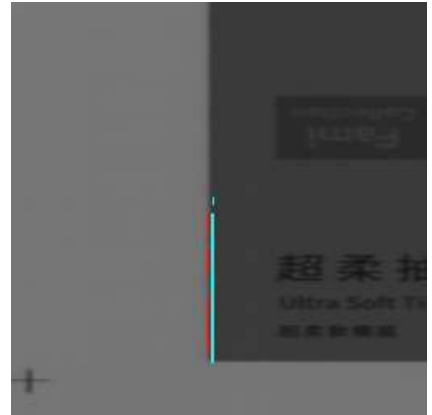
No.	#26, \$19	Date	2023/8/9 下午 02:18:06
Segment	1	Camera	1
Pattern	7825	Position[ x, y ]	699.8 [mm], 5883.4 [m], ( 143.8 [m] )
Type	点状疵点縱向刀絲疵點	Size	H:1.0 ,V:36.0 [mm]
Result	-	Area	17.5 [mm2]
Inspection level	5/5,5/5,5/5,5/5,5/5	Label	-
Light	6,6,3/6,6,3

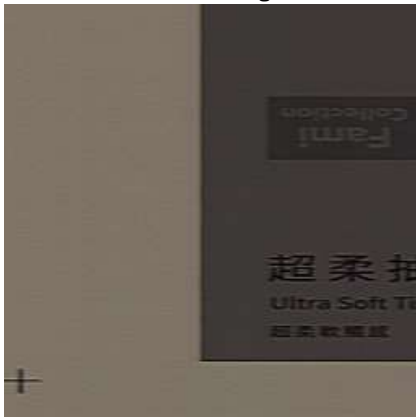
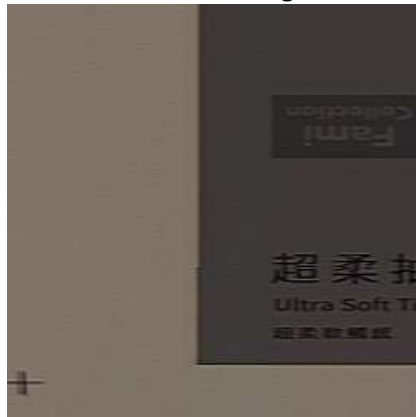
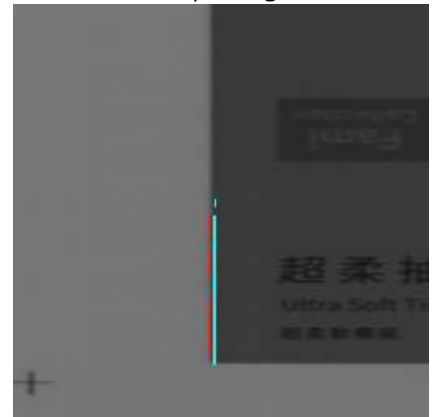
No.	#23, \$18	Date	2023/8/9 下午 02:17:46
Segment	1	Camera	1
Pattern	7793	Position[ x, y ]	58.5 [mm], 5859.1 [m], ( 168.0 [m] )
Type	点状疵点縱向刀絲疵點	Size	H:12.0 ,V:468.4 [mm]
Result	-	Area	737.0 [mm2]
Inspection level	5/5,5/5,5/5,5/5,5/5	Label	-
Light	6,6,3/6,6,3

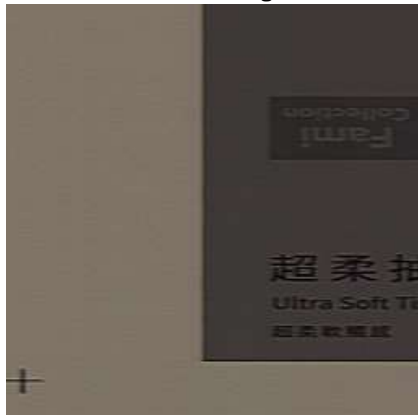
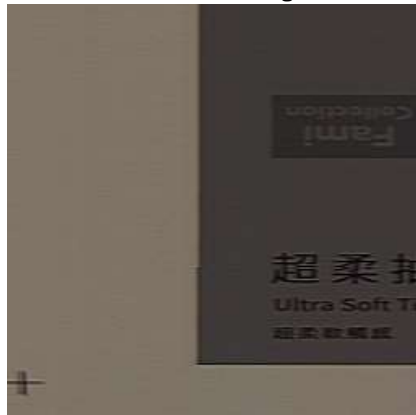
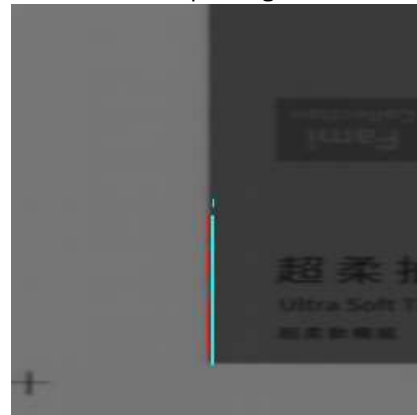
No.	#23, \$18	Date	2023/8/9 下午 02:17:46
Segment	1	Camera	1
Pattern	7793	Position[ x, y ]	392.9 [mm], 5859.3 [m], ( 167.8 [m] )
Type	点状疵点縱向刀絲疵點橫向刀絲	Size	H:63.5 ,V:222.0 [mm]
Result	-	Area	749.9 [mm2]
Inspection level	5/5,5/5,5/5,5/5,5/5	Label	-
Light	6,6,3/6,6,3

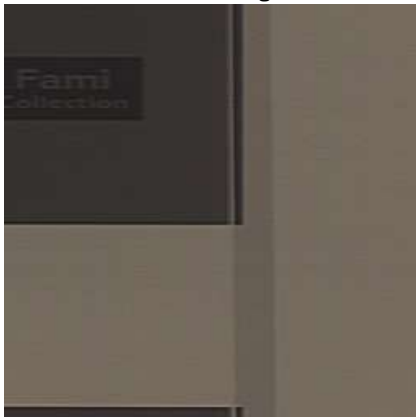
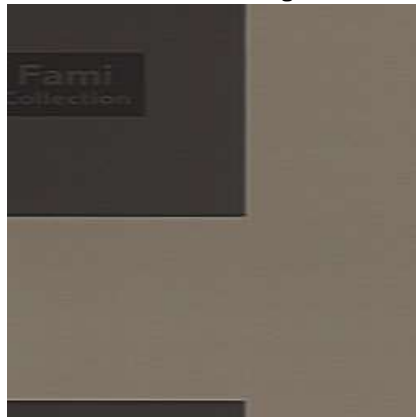
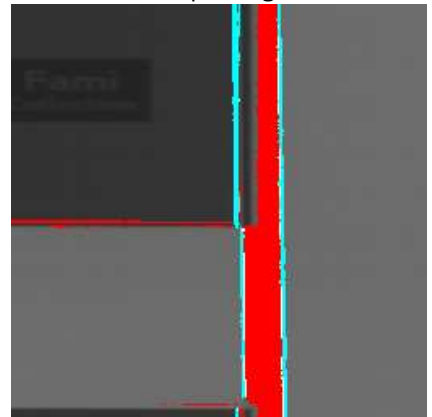
No.	#22, \$17	Date	2023/8/9 下午 02:17:46
Segment	1	Camera	1
Pattern	7792	Position[ x, y ]	567.2 [mm], 5858.5 [m], ( 168.7 [m] )
Type	面狀重疵點	Size	H:7.1 ,V:357.2 [mm]
Result	-	Area	803.6 [mm2]
Inspection level	5/5,5/5,5/5,5/5,5/5	Label	-
Light	6,6,3/6,6,3

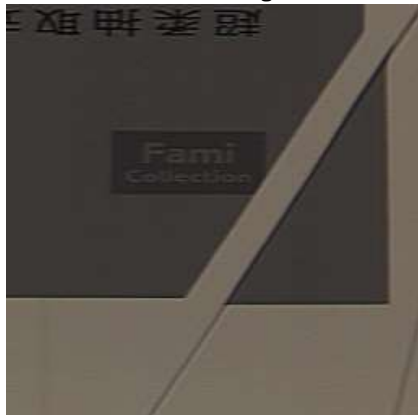
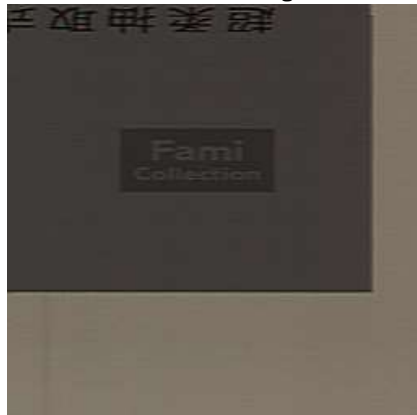
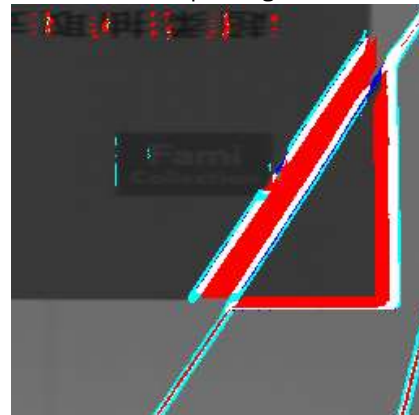
No.	#22, \$17	Date	2023/8/9 下午 02:17:46
Segment	1	Camera	1
Pattern	7792	Position[ x, y ]	150.7 [mm], 5858.1 [m], ( 169.1 [m] )
Type	点状疵点縱向刀絲疵點橫向刀絲	Size	H:197.8 ,V:806.4 [mm]
Result	-	Area	3715.8 [mm2]
Inspection level	5/5,5/5,5/5,5/5,5/5	Label	-
Light	6,6,3/6,6,3

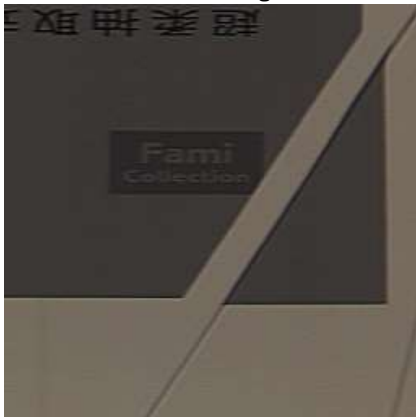
No.	#21, \$16	Date	2023/8/9 下午 02:17:45
Segment	1	Camera	1
Pattern	7791	Position[ x, y ]	486.7 [mm], 5857.8 [m], ( 169.4 [m] )
Type	点状疵点縱向刀絲疵點	Size	H:46.6 ,V:161.6 [mm]
Result	-	Area	797.1 [mm2]
Inspection level	5/5,5/5,5/5,5/5,5/5	Label	-
Light	6,6,3/6,6,3

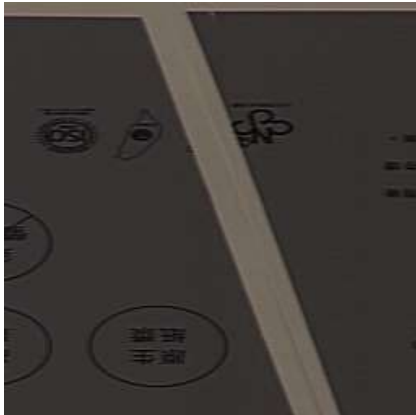
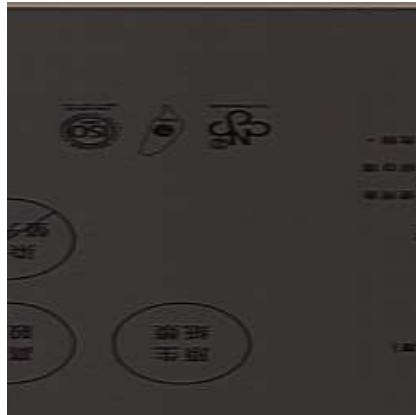
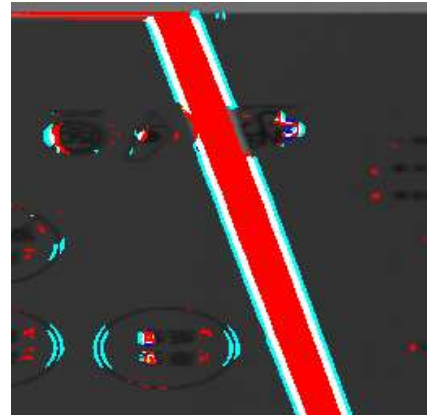
No.	#21, \$16	Date	2023/8/9 下午 02:17:45
Segment	1	Camera	1
Pattern	7791	Position[ x, y ]	459.8 [mm], 5857.6 [m], ( 169.5 [m] )
Type	点状疵点縱向刀絲疵點橫向刀絲	Size	H:156.5 ,V:659.2 [mm]
Result	—	Area	1993.6 [mm2]
Inspection level	5/5,5/5,5/5,5/5,5/5	Label	—
Light	6,6,3/6,6,3

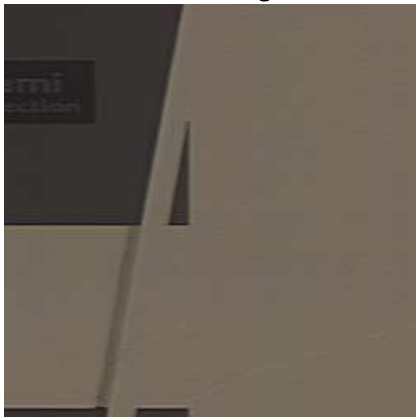
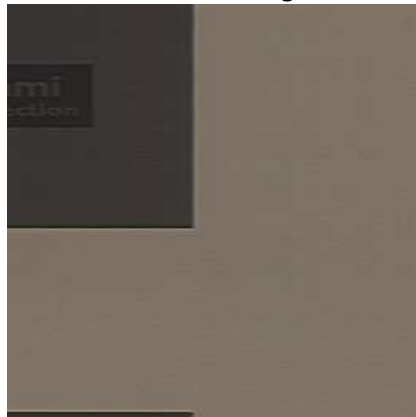
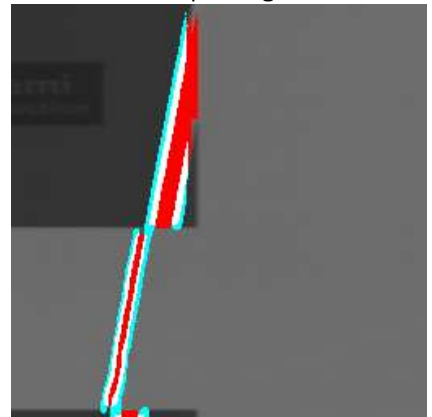
Defect image

No.	#19, \$14	Date	2023/8/9 下午 02:17:44
Segment	1	Camera	1
Pattern	7789	Position[ x, y ]	403.9 [mm], 5855.6 [m], ( 171.5 [m] )
Type	点状疵点縱向刀絲疵點	Size	H:22.9 ,V:153.6 [mm]
Result	-	Area	166.1 [mm2]
Inspection level	5/5,5/5,5/5,5/5,5/5	Label	-
Light	6,6,3/6,6,3

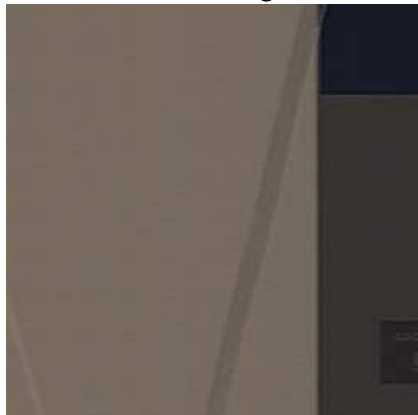
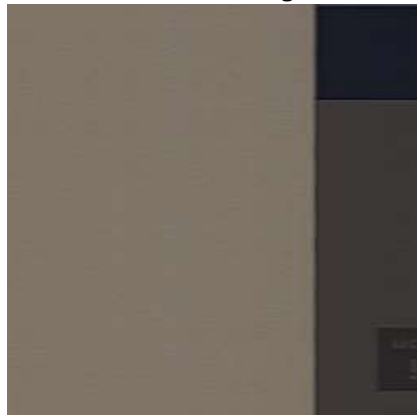
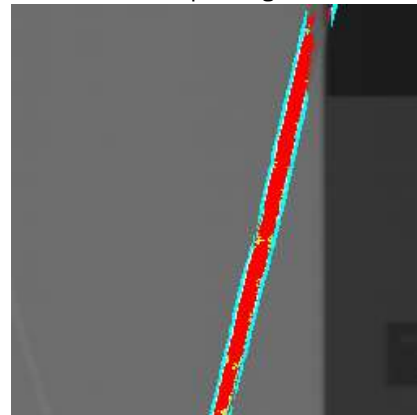
Defect image

No.	#16, \$13	Date	2023/8/9 下午 02:17:35
Segment	1	Camera	1
Pattern	7775	Position[ x, y ]	95.1 [mm], 5844.8 [m], ( 182.3 [m] )
Type	点状疵点縱向刀絲疵點橫向刀絲	Size	H:240.7 ,V:167.2 [mm]
Result	-	Area	1254.4 [mm2]
Inspection level	5/5,5/5,5/5,5/5,5/5	Label	-
Light	6,6,3/6,6,3

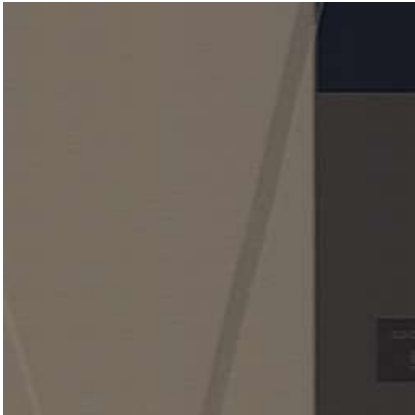
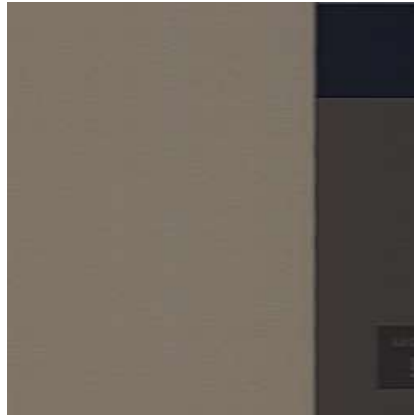
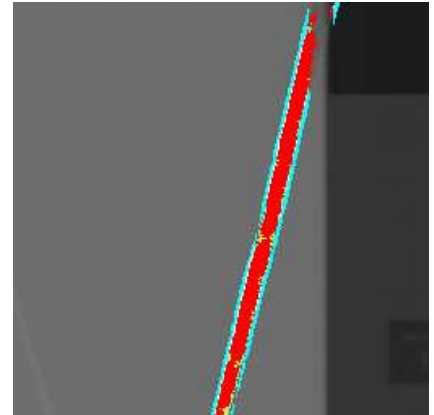
Defect image

No.	#16, \$13	Date	2023/8/9 下午 02:17:35
Segment	1	Camera	1
Pattern	7775	Position[ x, y ]	809.4 [mm], 5844.8 [m], ( 182.3 [m] )
Type	点状疵点縱向刀絲疵點橫向刀絲	Size	H:185.5 ,V:104.4 [mm]
Result	-	Area	1906.3 [mm2]
Inspection level	5/5,5/5,5/5,5/5,5/5	Label	-
Light	6,6,3/6,6,3
