# Inspection Result (Individual Data)

Lot number : 5

Inspected date : 2023/8/9 下午 12:59:28 ~ 2023/8/9 下午 02:20:08

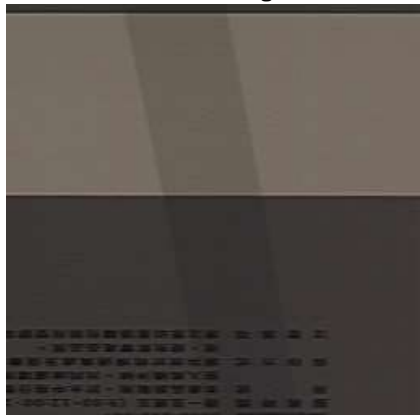
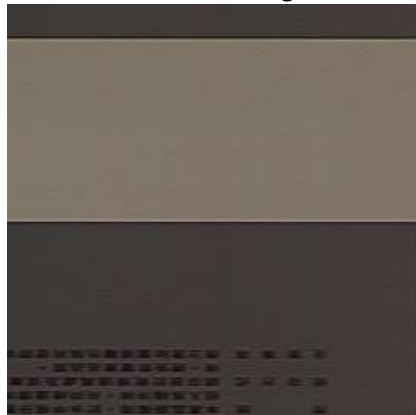
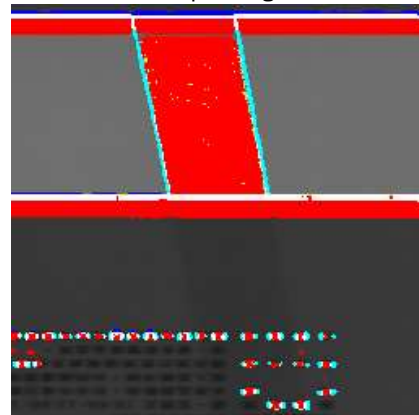
Defect image

No.	#16, \$13	Date	2023/8/9 下午 02:17:35
Segment	1	Camera	1
Pattern	7775	Position[ x, y ]	769.4 [mm], 5845.2 [m], ( 182.0 [m] )
Type	点状疵点縱向刀絲疵點橫向刀絲	Size	H:185.3 ,V:109.6 [mm]
Result	-	Area	2142.6 [mm2]
Inspection level	5/5,5/5,5/5,5/5,5/5	Label	-
Light	6,6,3/6,6,3

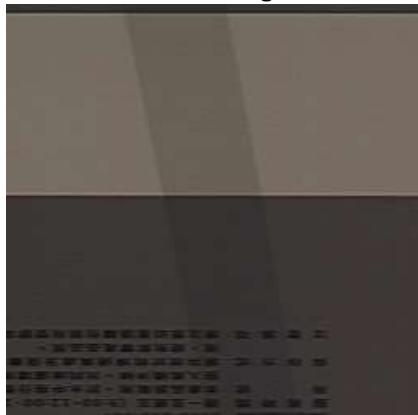
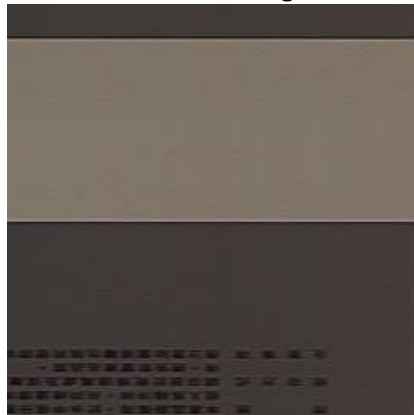
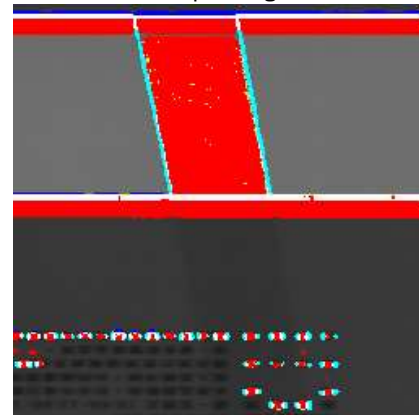
Defect image

No.	#15, \$12	Date	2023/8/9 下午 02:17:35
Segment	1	Camera	1
Pattern	7774	Position[ x, y ]	691.3 [mm], 5844.1 [m], ( 183.1 [m] )
Type	点状疵点縱向刀絲疵點	Size	H:37.1 ,V:180.0 [mm]
Result	-	Area	502.2 [mm2]
Inspection level	5/5,5/5,5/5,5/5,5/5	Label	-
Light	6,6,3/6,6,3

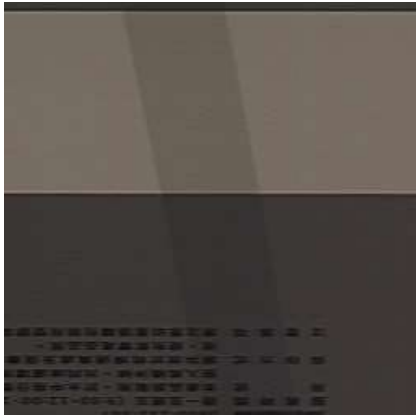
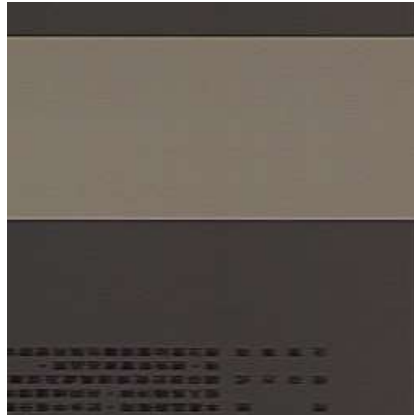
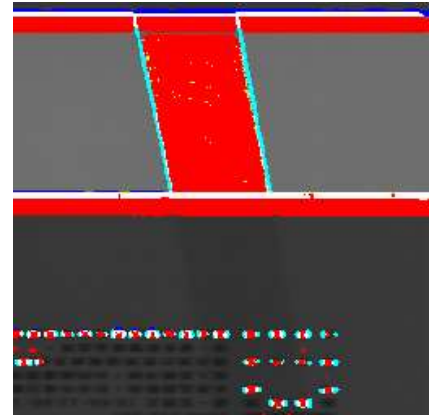
Defect image

No.	#15, \$12	Date	2023/8/9 下午 02:17:35
Segment	1	Camera	1
Pattern	7774	Position[ x, y ]	792.6 [mm], 5844.4 [m], ( 182.7 [m] )
Type	点状疵点縱向刀絲疵點橫向刀絲	Size	H:208.3 ,V:49.2 [mm]
Result	-	Area	1599.7 [mm2]
Inspection level	5/5,5/5,5/5,5/5,5/5	Label	-
Light	6,6,3/6,6,3

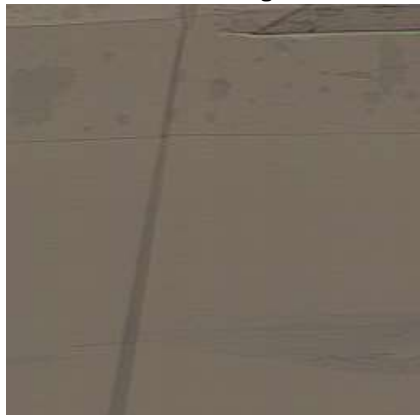
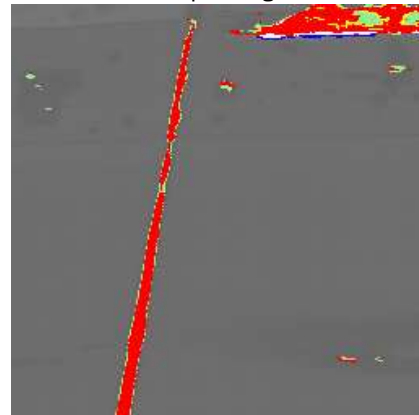
Defect image

No.	#15, \$12	Date	2023/8/9 下午 02:17:35
Segment	1	Camera	1
Pattern	7774	Position[ x, y ]	238.9 [mm], 5844.3 [m], ( 182.8 [m] )
Type	点状疵点横向刀絲	Size	H:305.9 ,V:501.6 [mm]
Result	-	Area	1623.7 [mm2]
Inspection level	5/5,5/5,5/5,5/5,5/5	Label	-
Light	6,6,3/6,6,3

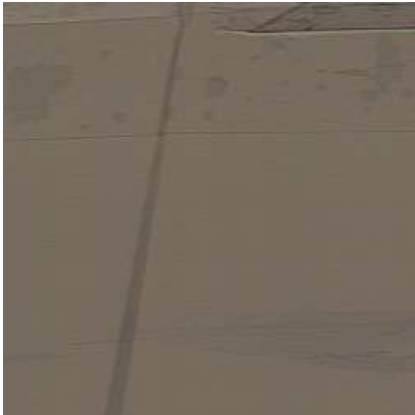
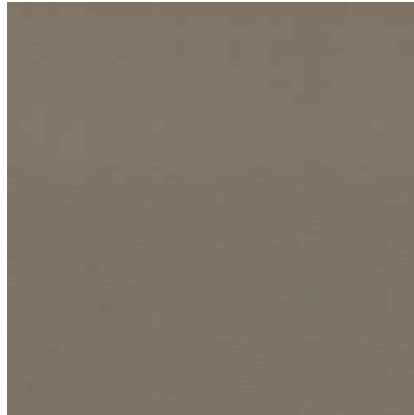
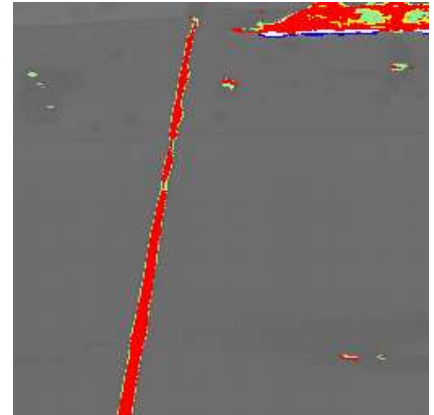
Defect image

No.	#14, \$11	Date	2023/8/9 下午 02:17:34
Segment	1	Camera	1
Pattern	7773	Position[ x, y ]	879.3 [mm], 5843.8 [m], ( 183.3 [m] )
Type	点状疵点縱向刀絲疵點	Size	H:2.7 ,V:448.0 [mm]
Result	-	Area	355.3 [mm2]
Inspection level	5/5,5/5,5/5,5/5,5/5	Label	-
Light	6,6,3/6,6,3

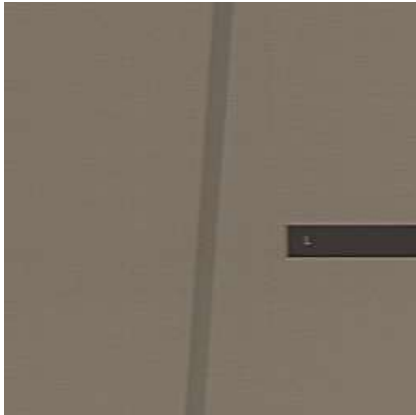
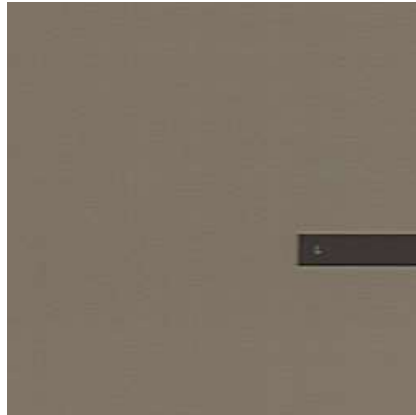
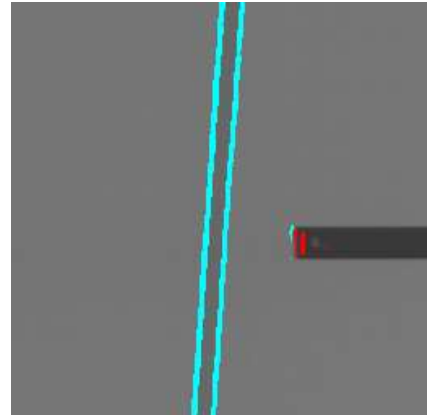
Defect image

No.	#13, \$10	Date	2023/8/9 下午 02:17:34
Segment	1	Camera	1
Pattern	7772	Position[ x, y ]	700.3 [mm], 5843.1 [m], ( 184.1 [m] )
Type	点状疵点縱向刀絲疵點橫向刀絲	Size	H:12.7 ,V:315.6 [mm]
Result	-	Area	368.9 [mm2]
Inspection level	5/5,5/5,5/5,5/5,5/5	Label	-
Light	6,6,3/6,6,3

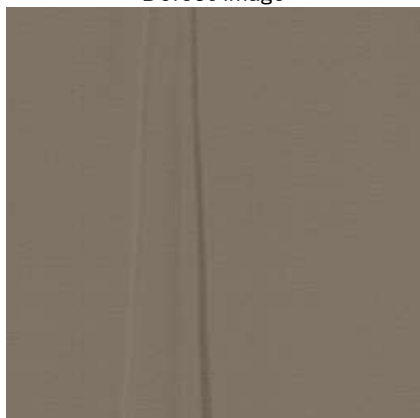
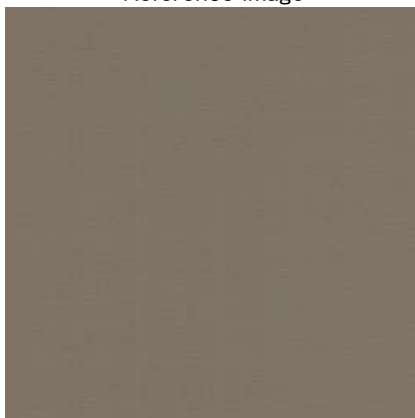
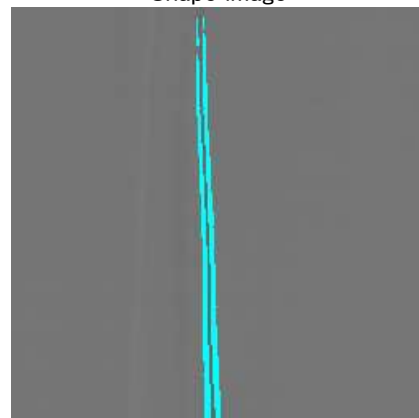
Defect image

No.	#13, \$10	Date	2023/8/9 下午 02:17:34
Segment	1	Camera	1
Pattern	7772	Position[ x, y ]	630.7 [mm], 5842.9 [m], ( 184.3 [m] )
Type	点状疵点縱向刀絲疵點	Size	H:14.6 ,V:542.4 [mm]
Result	-	Area	872.4 [mm2]
Inspection level	5/5,5/5,5/5,5/5,5/5	Label	-
Light	6,6,3/6,6,3

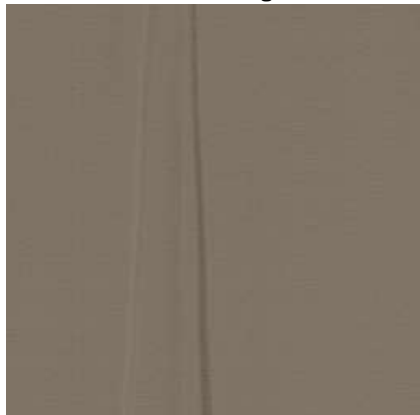
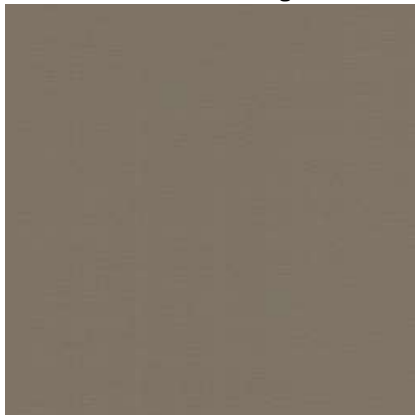
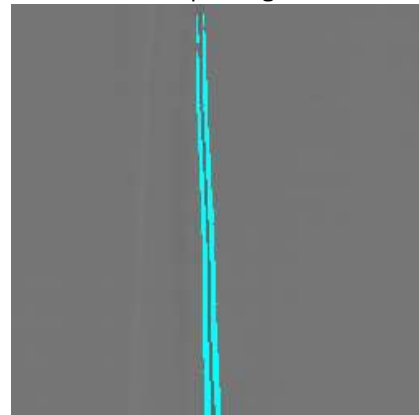
Defect image

No.	#12, \$9	Date	2023/8/9 下午 02:17:33
Segment	1	Camera	1
Pattern	7771	Position[ x, y ]	735.7 [mm], 5842.3 [m], ( 184.8 [m] )
Type	点状疵点縱向刀絲疵點	Size	H:22.5 ,V:158.0 [mm]
Result	-	Area	55.2 [mm2]
Inspection level	5/5,5/5,5/5,5/5,5/5	Label	-
Light	6,6,3/6,6,3

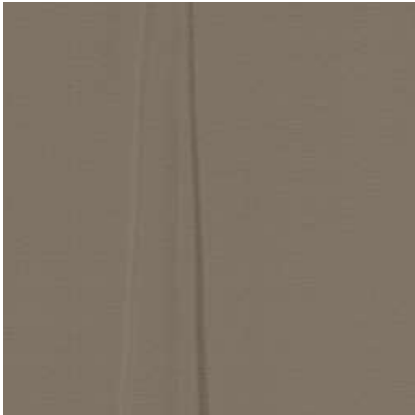
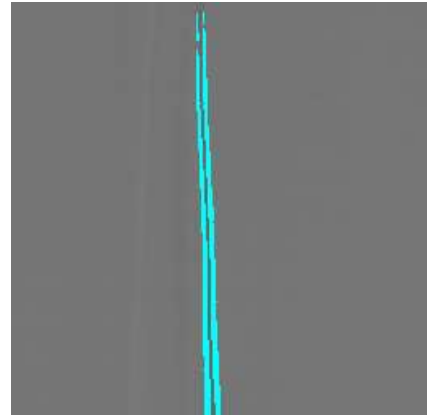
Defect image

No.	#12, \$9	Date	2023/8/9 下午 02:17:33
Segment	1	Camera	1
Pattern	7771	Position[ x, y ]	755.2 [mm], 5842.3 [m], ( 184.9 [m] )
Type	点状疵点縱向刀絲疵點	Size	H:43.9 ,V:180.4 [mm]
Result	-	Area	160.1 [mm2]
Inspection level	5/5,5/5,5/5,5/5,5/5	Label	-
Light	6,6,3/6,6,3

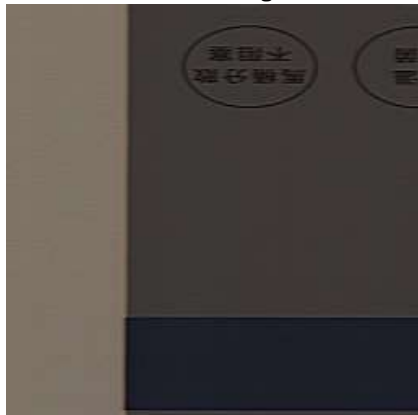
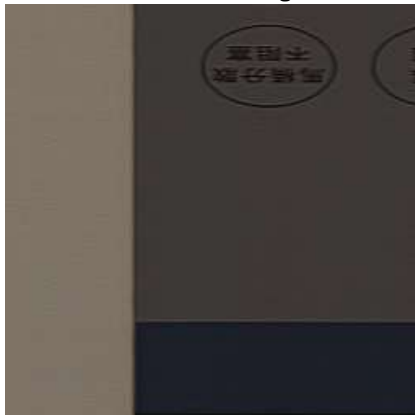
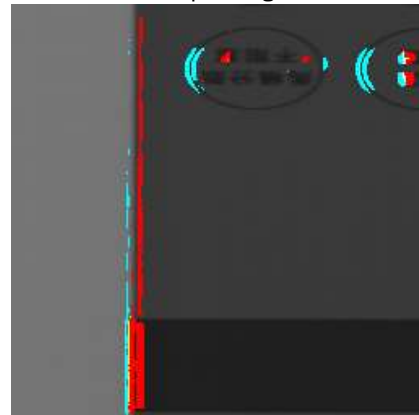
Defect image

No.	#12, \$9	Date	2023/8/9 下午 02:17:33
Segment	1	Camera	1
Pattern	7771	Position[ x, y ]	706.2 [mm], 5842.4 [m], ( 184.8 [m] )
Type	点状疵点縱向刀絲疵點	Size	H:32.5 ,V:303.2 [mm]
Result	-	Area	334.5 [mm2]
Inspection level	5/5,5/5,5/5,5/5,5/5	Label	-
Light	6,6,3/6,6,3

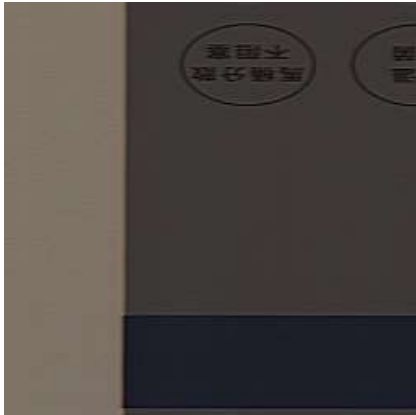
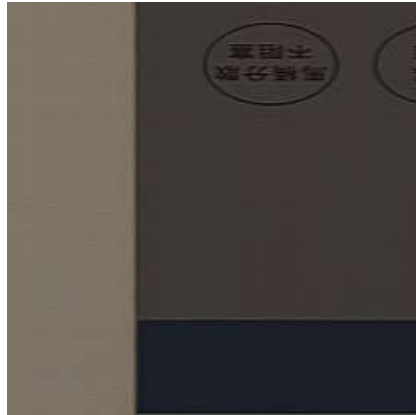
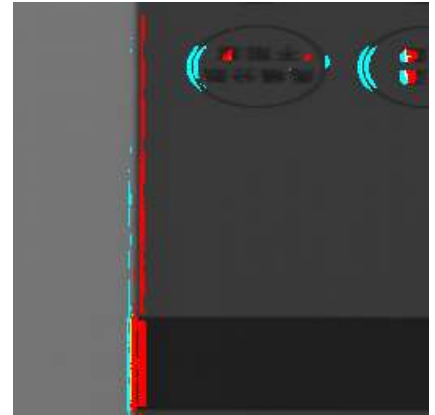
Defect image

No.	#9, \$8	Date	2023/8/9 下午 02:17:26
Segment	1	Camera	1
Pattern	7759	Position[ x, y ]	56.3 [mm], 5833.4 [m], ( 193.7 [m] )
Type	点状疵点縱向刀絲疵點	Size	H:1.2 ,V:46.4 [mm]
Result	-	Area	15.4 [mm2]
Inspection level	5/5,5/5,5/5,5/5,5/5	Label	-
Light	6,6,3/6,6,3

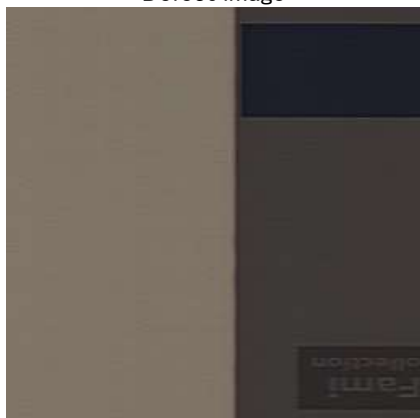
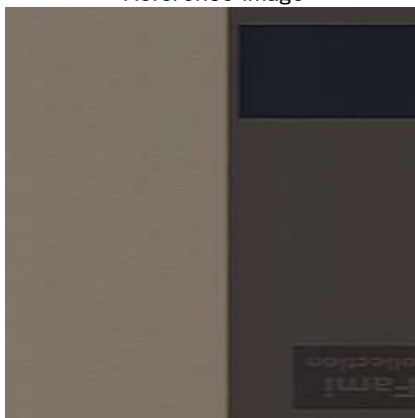
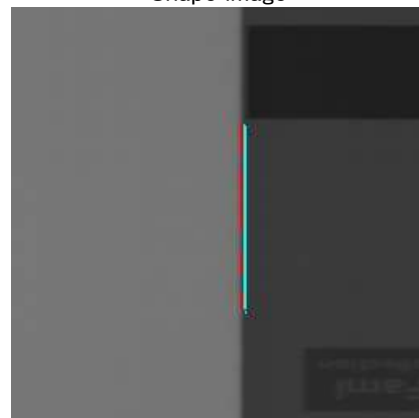
Defect image

No.	#9, \$8	Date	2023/8/9 下午 02:17:26
Segment	1	Camera	1
Pattern	7759	Position[ x, y ]	696.9 [mm], 5833.4 [m], ( 193.7 [m] )
Type	点状疵点縱向刀絲疵點	Size	H:1.0 ,V:45.2 [mm]
Result	-	Area	21.8 [mm2]
Inspection level	5/5,5/5,5/5,5/5,5/5	Label	-
Light	6,6,3/6,6,3

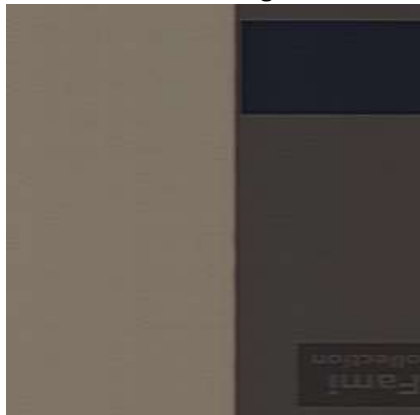
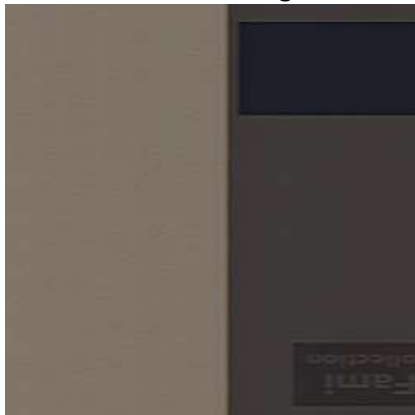
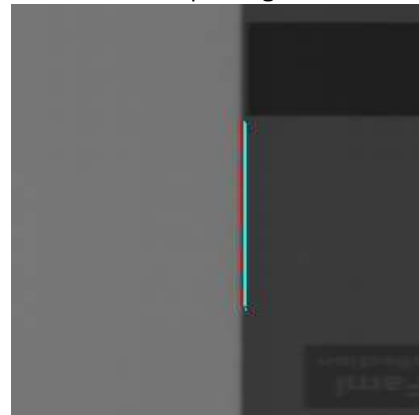
Defect image

No.	#8, \$7	Date	2023/8/9 下午 02:17:25
Segment	1	Camera	1
Pattern	7758	Position[ x, y ]	240.1 [mm], 5832.6 [m], ( 194.5 [m] )
Type	点状疵点縱向刀絲疵點	Size	H:2.2 ,V:54.0 [mm]
Result	-	Area	20.8 [mm2]
Inspection level	5/5,5/5,5/5,5/5,5/5	Label	-
Light	6,6,3/6,6,3

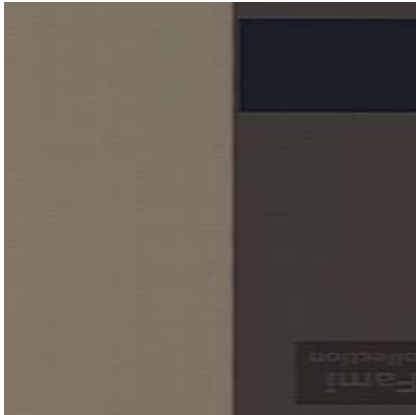
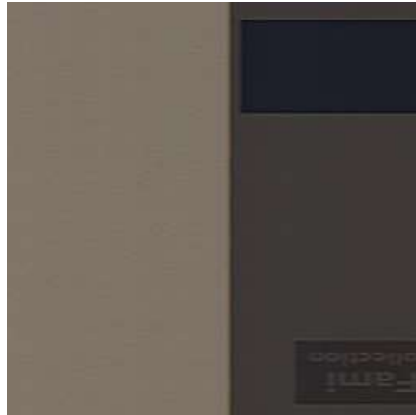
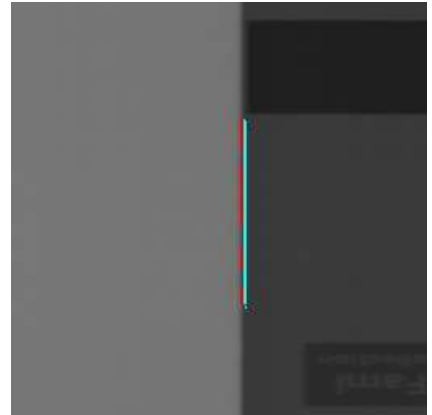
Defect image

No.	#8, \$7	Date	2023/8/9 下午 02:17:25
Segment	1	Camera	1
Pattern	7758	Position[ x, y ]	240.3 [mm], 5832.3 [m], ( 194.9 [m] )
Type	点状疵点縱向刀絲疵點	Size	H:2.2 ,V:127.2 [mm]
Result	-	Area	31.8 [mm2]
Inspection level	5/5,5/5,5/5,5/5,5/5	Label	-
Light	6,6,3/6,6,3

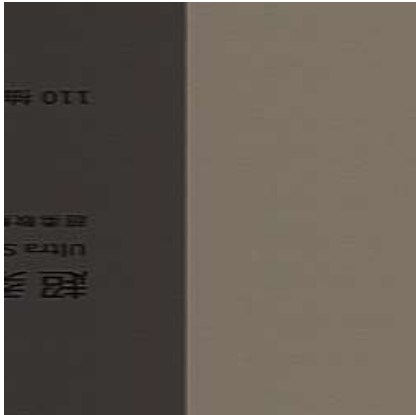
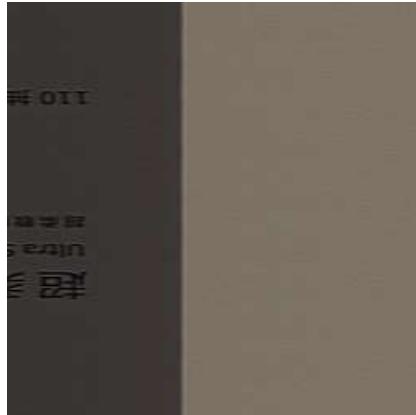
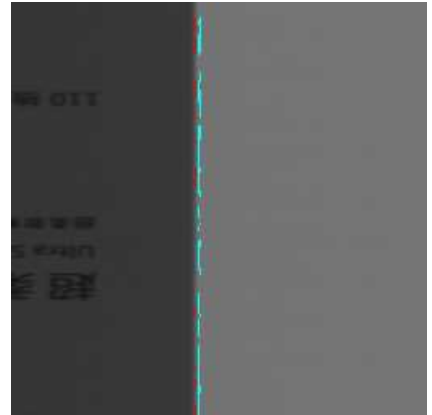
No.	#8, \$7	Date	2023/8/9 下午 02:17:25
Segment	1	Camera	1
Pattern	7758	Position[ x, y ]	564.8 [mm], 5832.3 [m], ( 194.9 [m] )
Type	点状疵点縱向刀絲疵點	Size	H:2.2 ,V:152.8 [mm]
Result	-	Area	35.6 [mm2]
Inspection level	5/5,5/5,5/5,5/5,5/5	Label	-
Light	6,6,3/6,6,3

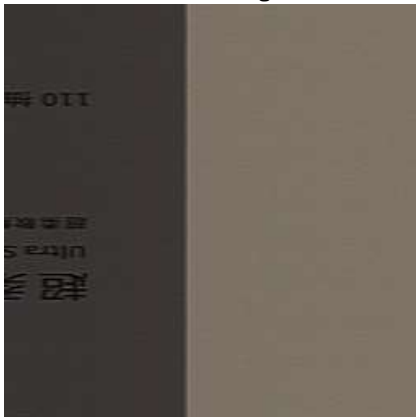
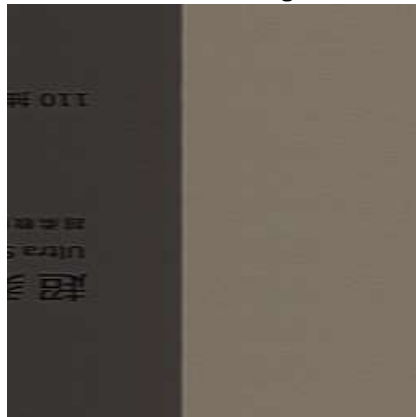
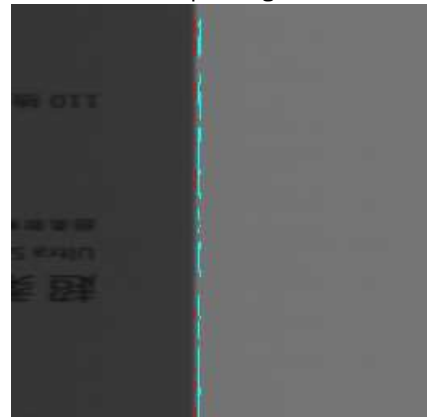
No.	#7, \$6	Date	2023/8/9 下午 02:17:24
Segment	1	Camera	1
Pattern	7757	Position[ x, y ]	564.8 [mm], 5831.9 [m], ( 195.3 [m] )
Type	点状疵点縱向刀絲疵點	Size	H:2.2 ,V:65.2 [mm]
Result	-	Area	29.5 [mm2]
Inspection level	5/5,5/5,5/5,5/5,5/5	Label	-
Light	6,6,3/6,6,3

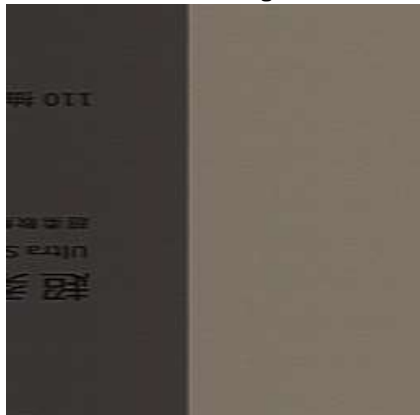
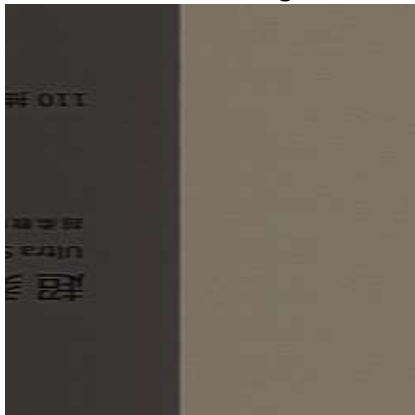
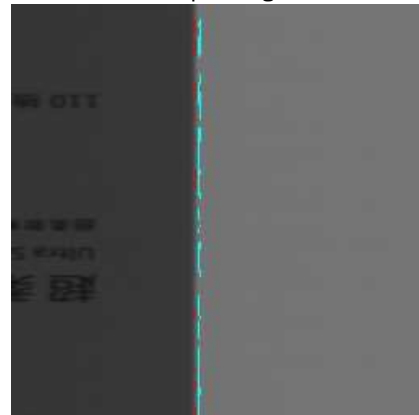
No.	#7, \$6	Date	2023/8/9 下午 02:17:24
Segment	1	Camera	1
Pattern	7757	Position[ x, y ]	240.1 [mm], 5831.9 [m], ( 195.3 [m] )
Type	点状疵点縱向刀絲疵點	Size	H:2.2 ,V:56.0 [mm]
Result	-	Area	30.2 [mm2]
Inspection level	5/5,5/5,5/5,5/5,5/5	Label	-
Light	6,6,3/6,6,3

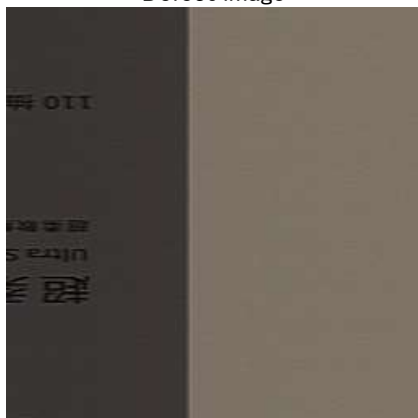
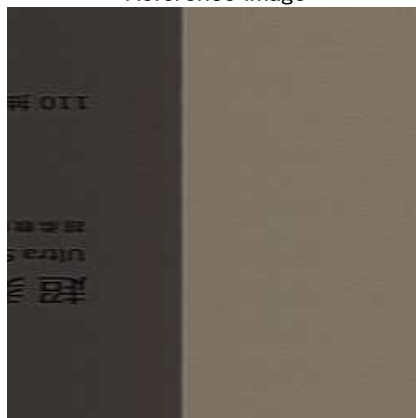
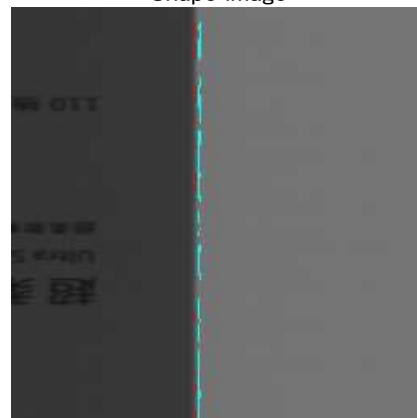
No.	#7, \$6	Date	2023/8/9 下午 02:17:24
Segment	1	Camera	1
Pattern	7757	Position[ x, y ]	240.1 [mm], 5831.5 [m], ( 195.6 [m] )
Type	点状疵点縱向刀絲疵點	Size	H:2.2 ,V:128.0 [mm]
Result	-	Area	45.2 [mm2]
Inspection level	5/5,5/5,5/5,5/5,5/5	Label	-
Light	6,6,3/6,6,3

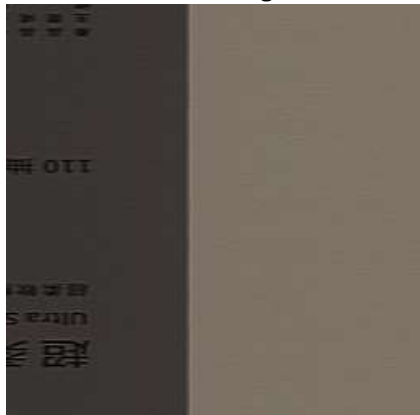
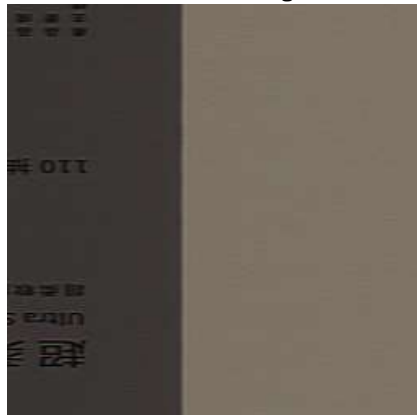
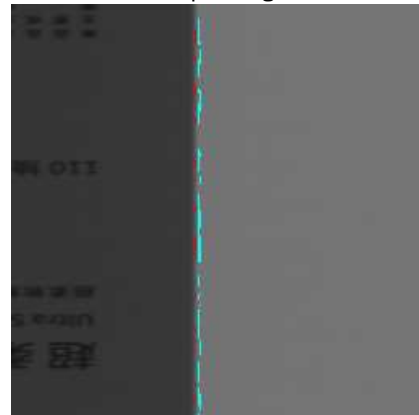
No.	#7, \$6	Date	2023/8/9 下午 02:17:24
Segment	1	Camera	1
Pattern	7757	Position[ x, y ]	564.8 [mm], 5831.5 [m], ( 195.6 [m] )
Type	点状疵点縱向刀絲疵點	Size	H:2.2 ,V:186.0 [mm]
Result	-	Area	52.6 [mm2]
Inspection level	5/5,5/5,5/5,5/5,5/5	Label	-
Light	6,6,3/6,6,3

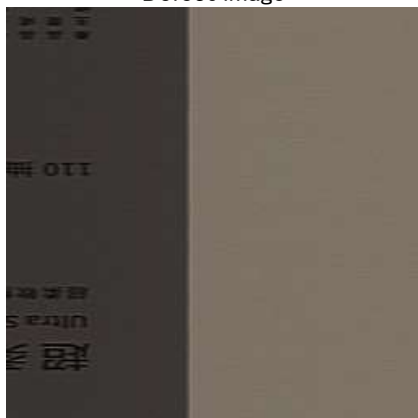
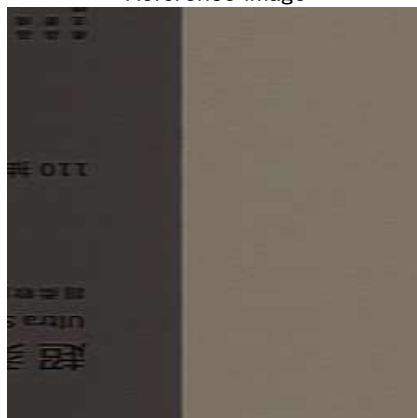
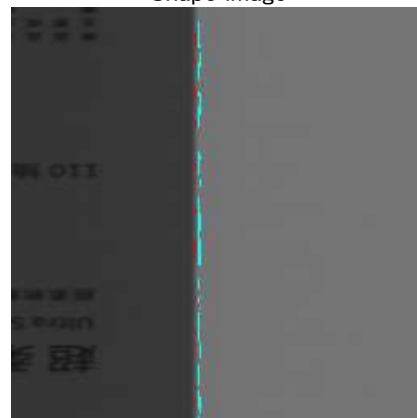
No.	#6, \$5	Date	2023/8/9 下午 02:17:24
Segment	1	Camera	1
Pattern	7756	Position[ x, y ]	240.1 [mm], 5830.7 [m], ( 196.4 [m] )
Type	点状疵点縱向刀絲疵點	Size	H:2.2 ,V:50.4 [mm]
Result	-	Area	24.3 [mm2]
Inspection level	5/5,5/5,5/5,5/5,5/5	Label	-
Light	6,6,3/6,6,3

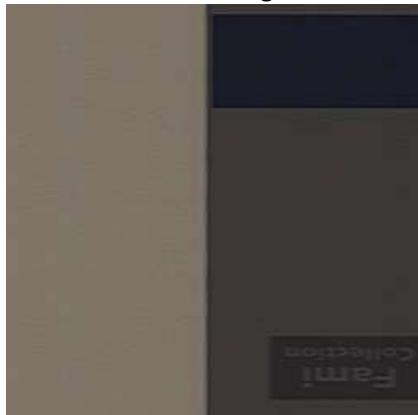
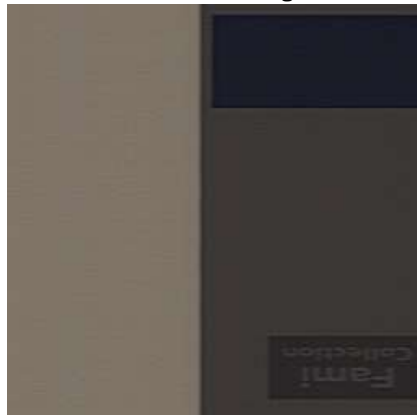
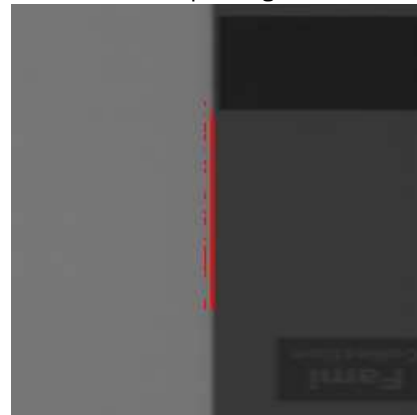
No.	#6, \$5	Date	2023/8/9 下午 02:17:24
Segment	1	Camera	1
Pattern	7756	Position[ x, y ]	371.9 [mm], 5831.2 [m], ( 196.0 [m] )
Type	点状疵点	Size	H:1.5 ,V:48.0 [mm]
Result	-	Area	25.9 [mm2]
Inspection level	5/5,5/5,5/5,5/5,5/5	Label	-
Light	6,6,3/6,6,3

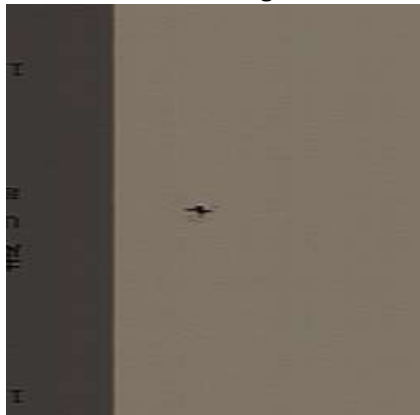
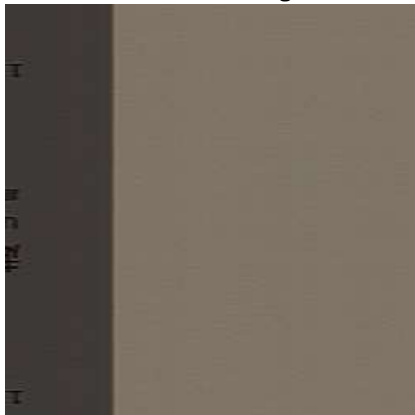
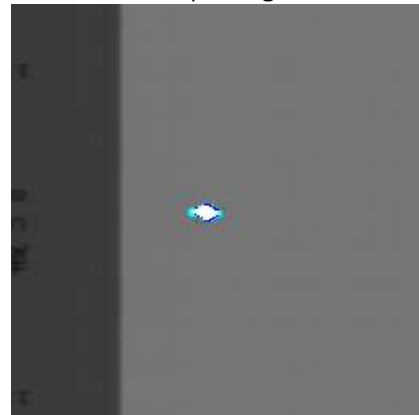
No.	#4, \$3	Date	2023/8/9 下午 02:14:45
Segment	1	Camera	1
Pattern	7492	Position[ x, y ]	253.8 [mm], 5632.8 [m], ( 394.4 [m] )
Type	点状疵点縱向刀絲疵點橫向刀絲	Size	H:5.1 ,V:3.6 [mm]
Result	-	Area	12.2 [mm2]
Inspection level	5/5,5/5,5/5,5/5,5/5	Label	-
Light	6,6,3/6,6,3

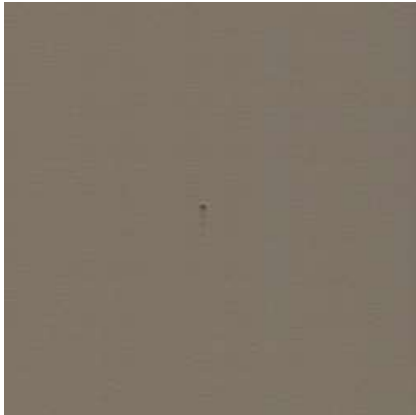
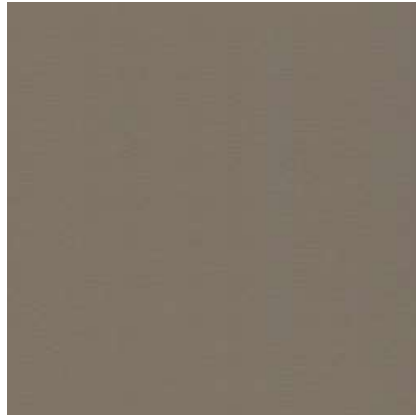
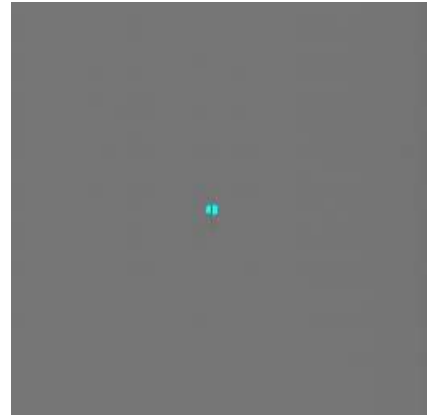
No.	#3, \$2	Date	2023/8/9 下午 02:11:56
Segment	1	Camera	1
Pattern	7212	Position[ x, y ]	340.7 [mm], 5422.5 [m], ( 604.7 [m] )
Type	縱向刀絲疵點	Size	H:1.7 ,V:1.6 [mm]
Result	-	Area	2.1 [mm2]
Inspection level	5/5,5/5,5/5,5/5,5/5	Label	-
Light	6,6,3/6,6,3

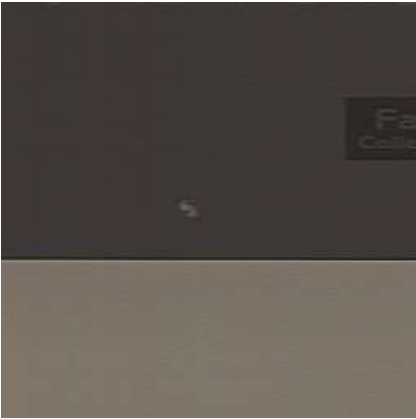
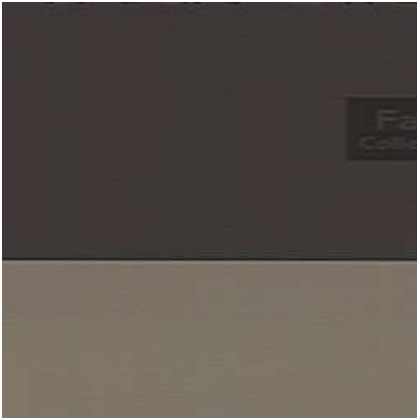
No.	#2, \$1	Date	2023/8/9 下午 01:05:12
Segment	1	Camera	1
Pattern	569	Position[ x, y ]	823.1 [mm], 433.4 [m], ( 5593.7 [m] )
Type	点状疵点縱向刀絲疵點	Size	H:3.7 ,V:3.6 [mm]
Result	-	Area	7.8 [mm2]
Inspection level	5/5,5/5,5/5,5/5,5/5	Label	-
Light	6,6,3/6,6,3
