# Inspection Result (Individual Data)

Lot number : 8

商品名	標準透明6-6-3	周長	
顧客名		Ex1	
CODE番号		Ex2	
基材		Ex3

Total defects	21	検査範圍 : 83.6 ~ 1024.2 [mm]	寬度 : 940.6 [mm]
Web length	4343.0 [m]	參照更新 : 無更新/無更新	
Segments	1 ( 從左側 )

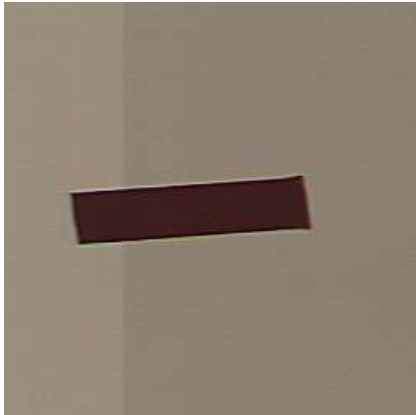
Defect image

No.	#28, \$21	Date	2023/8/9 下午 05:05:08
Segment	1	Camera	1
Pattern	5775	Position[ x, y ]	17.4 [mm], 4341.0 [m], ( 2.0 [m] )
Type	点状疵点縱向刀絲疵點橫向刀絲	Size	H:29.5 ,V:17.6 [mm]
Result	-	Area	365.8 [mm2]
Inspection level	5/5,5/5,5/5,5/5,5/5	Label	-
Light	6,6,3/6,6,3

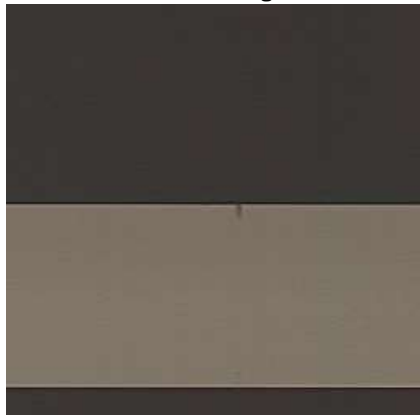
Defect image

No.	#26, \$19	Date	2023/8/9 下午 05:04:28
Segment	1	Camera	1
Pattern	5697	Position[ x, y ]	494.0 [mm], 4282.3 [m], ( 60.7 [m] )
Type	縱向刀絲疵點	Size	H:2.0 ,V:3.2 [mm]
Result	-	Area	4.6 [mm2]
Inspection level	5/5,5/5,5/5,5/5,5/5	Label	-
Light	6,6,3/6,6,3

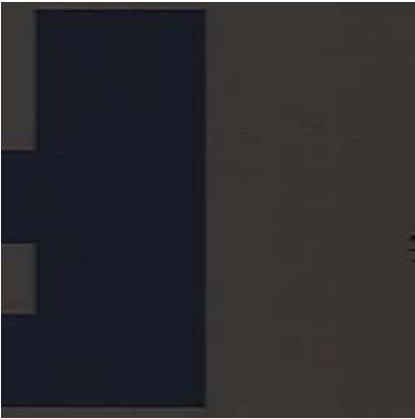
No.	#21, \$16	Date	2023/8/9 下午 05:03:49
Segment	1	Camera	1
Pattern	5622	Position[ x, y ]	450.3 [mm], 4226.2 [m], ( 116.8 [m] )
Type	縱向刀絲疵點	Size	H:0.5 ,V:96.0 [mm]
Result	-	Area	34.7 [mm2]
Inspection level	5/5,5/5,5/5,5/5,5/5	Label	-
Light	6,6,3/6,6,3

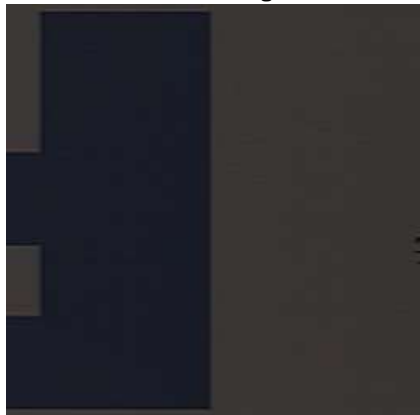
Defect image

No.	#20, \$15	Date	2023/8/9 下午 05:03:48
Segment	1	Camera	1
Pattern	5621	Position[ x, y ]	385.4 [mm], 4225.5 [m], ( 117.4 [m] )
Type	縱向刀絲疵點	Size	H:0.5 ,V:14.0 [mm]
Result	-	Area	6.8 [mm2]
Inspection level	5/5,5/5,5/5,5/5,5/5	Label	-
Light	6,6,3/6,6,3

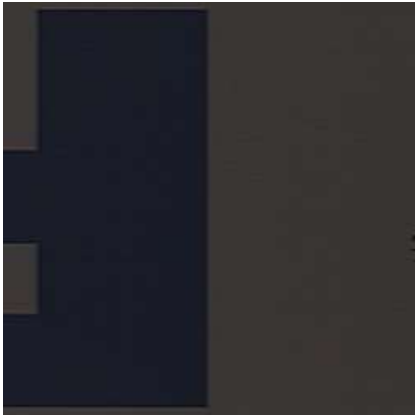
Defect image

No.	#20, \$15	Date	2023/8/9 下午 05:03:48
Segment	1	Camera	1
Pattern	5621	Position[ x, y ]	205.7 [mm], 4225.9 [m], ( 117.0 [m] )
Type	縱向刀絲疵點	Size	H:0.7 ,V:13.6 [mm]
Result	-	Area	8.6 [mm2]
Inspection level	5/5,5/5,5/5,5/5,5/5	Label	-
Light	6,6,3/6,6,3

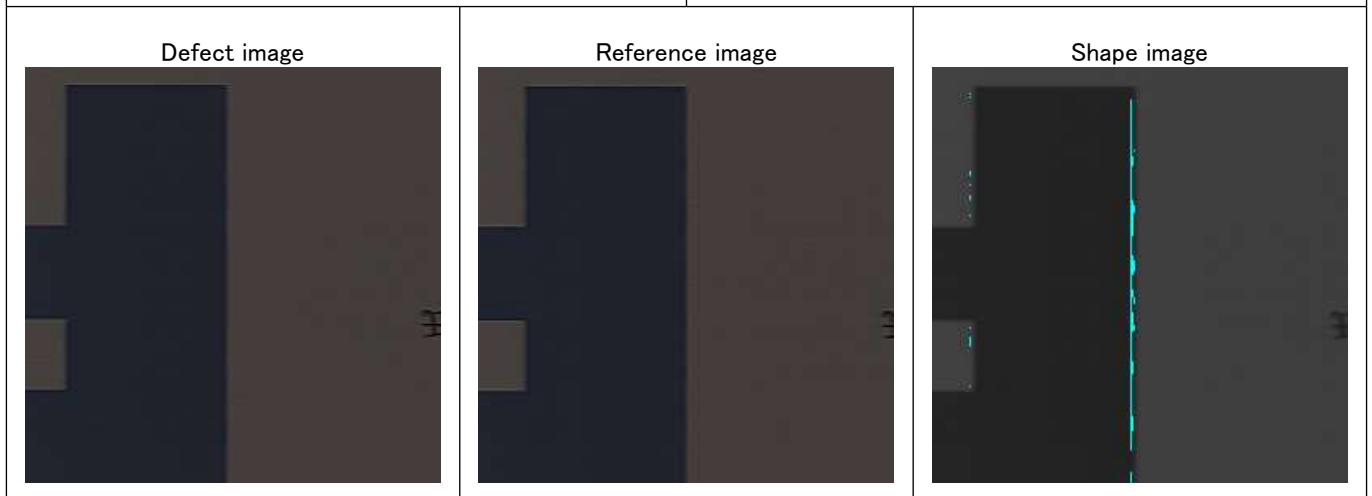
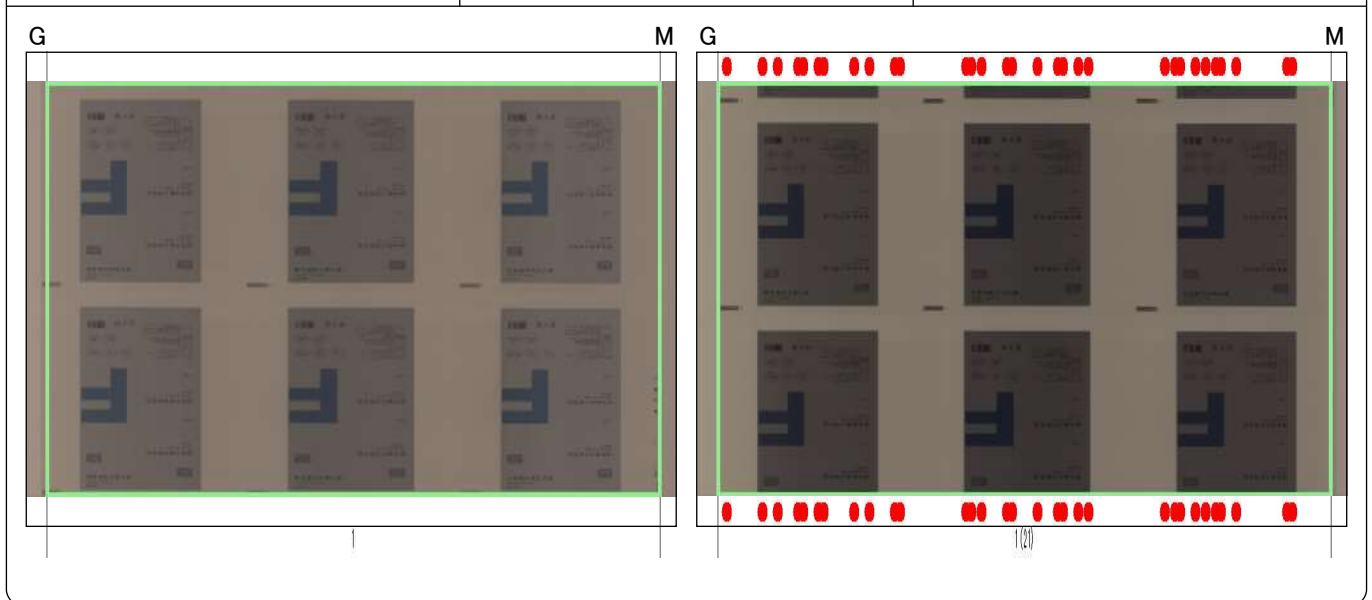
No.	#20, \$15	Date	2023/8/9 下午 05:03:48
Segment	1	Camera	1
Pattern	5621	Position[ x, y ]	129.5 [mm], 4225.8 [m], ( 117.2 [m] )
Type	縱向刀絲疵點	Size	H:0.7 ,V:85.6 [mm]
Result	-	Area	27.8 [mm2]
Inspection level	5/5,5/5,5/5,5/5,5/5	Label	-
Light	6,6,3/6,6,3

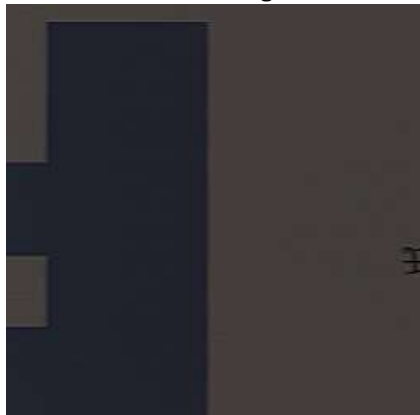
Defect image

No.	#19, \$14	Date	2023/8/9 下午 05:03:48
Segment	1	Camera	1
Pattern	5620	Position[ x, y ]	229.1 [mm], 4224.8 [m], ( 118.2 [m] )
Type	縱向刀絲疵點	Size	H:0.7 ,V:8.0 [mm]
Result	-	Area	4.3 [mm2]
Inspection level	5/5,5/5,5/5,5/5,5/5	Label	-
Light	6,6,3/6,6,3

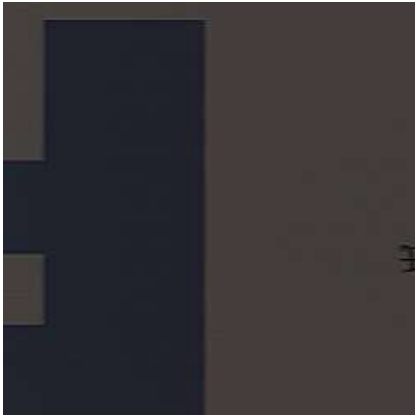
Defect image

No.	#19, \$14	Date	2023/8/9 下午 05:03:48
Segment	1	Camera	1
Pattern	5620	Position[ x, y ]	385.4 [mm], 4225.2 [m], ( 117.8 [m] )
Type	縱向刀絲疵點	Size	H:0.5 ,V:13.6 [mm]
Result	-	Area	5.6 [mm2]
Inspection level	5/5,5/5,5/5,5/5,5/5	Label	-
Light	6,6,3/6,6,3

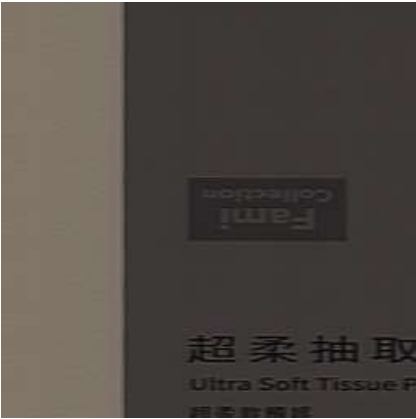
Defect image	Reference image	Shape image

No.	#18, \$13	Date	2023/8/9 下午 05:03:47
Segment	1	Camera	1
Pattern	5619	Position[ x, y ]	386.1 [mm], 4224.4 [m], ( 118.6 [m] )
Type	縱向刀絲疵點	Size	H:5.6 ,V:14.0 [mm]
Result	-	Area	5.7 [mm2]
Inspection level	5/5,5/5,5/5,5/5,5/5	Label	-
Light	6,6,3/6,6,3

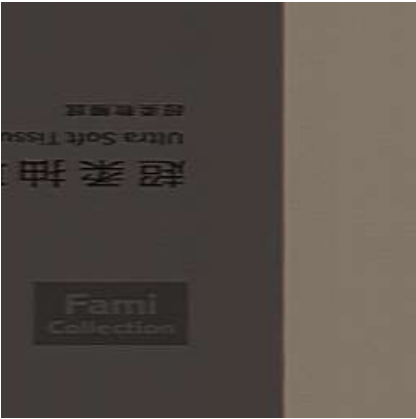
Defect image	Reference image	Shape image

No.	#14, \$11	Date	2023/8/9 下午 05:03:39
Segment	1	Camera	1
Pattern	5602	Position[ x, y ]	450.5 [mm], 4211.2 [m], ( 131.8 [m] )
Type	点状疵点縱向刀絲疵點	Size	H:2.2 ,V:97.6 [mm]
Result	-	Area	140.8 [mm2]
Inspection level	5/5,5/5,5/5,5/5,5/5	Label	-
Light	6,6,3/6,6,3

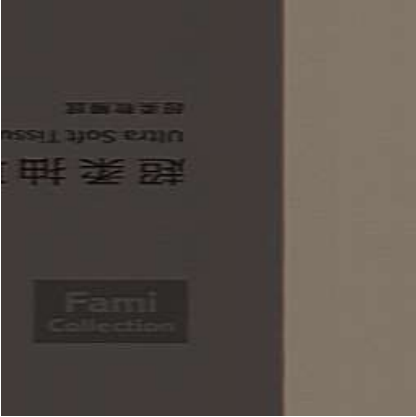
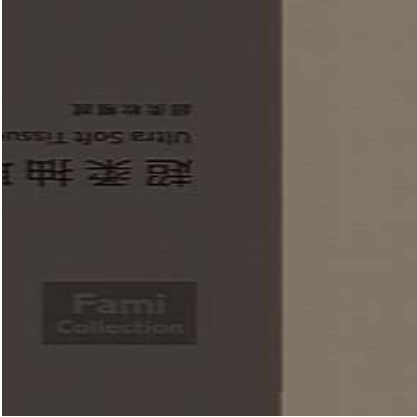
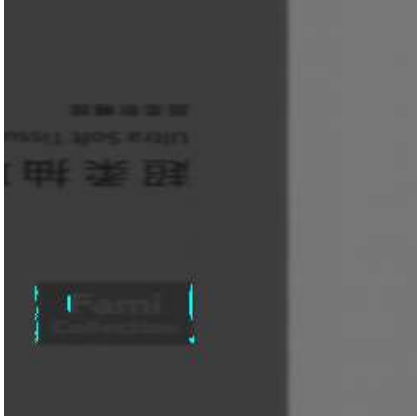
Defect image	Reference image	Shape image

No.	#14, \$11	Date	2023/8/9 下午 05:03:39
Segment	1	Camera	1
Pattern	5602	Position[ x, y ]	450.5 [mm], 4211.6 [m], ( 131.4 [m] )
Type	点状疵点縱向刀絲疵點	Size	H:2.4 ,V:98.0 [mm]
Result	-	Area	147.3 [mm2]
Inspection level	5/5,5/5,5/5,5/5,5/5	Label	-
Light	6,6,3/6,6,3

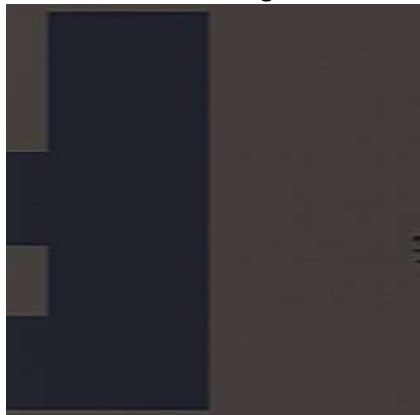
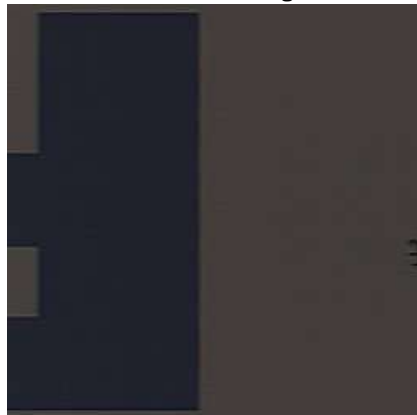
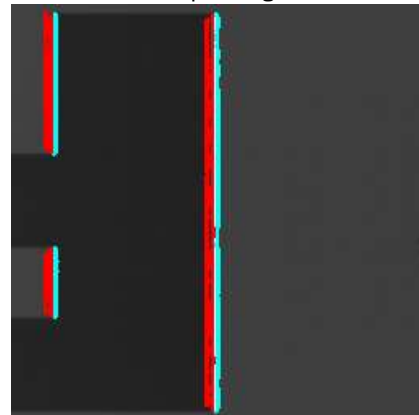
Defect image

No.	#14, \$11	Date	2023/8/9 下午 05:03:39
Segment	1	Camera	1
Pattern	5602	Position[ x, y ]	130.0 [mm], 4211.6 [m], ( 131.4 [m] )
Type	点状疵点縱向刀絲疵點	Size	H:2.4 ,V:98.0 [mm]
Result	-	Area	151.9 [mm2]
Inspection level	5/5,5/5,5/5,5/5,5/5	Label	-
Light	6,6,3/6,6,3

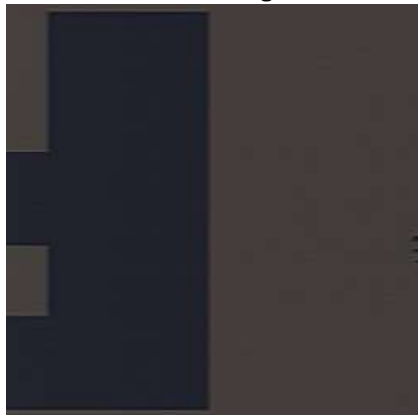
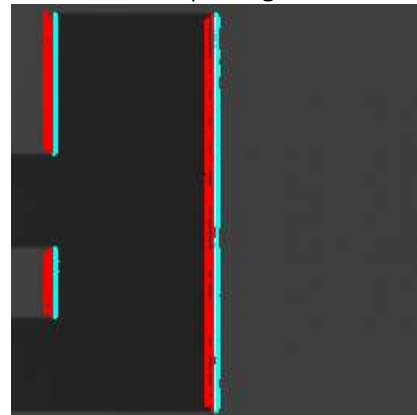
Defect image

No.	#13, \$10	Date	2023/8/9 下午 05:03:38
Segment	1	Camera	1
Pattern	5601	Position[ x, y ]	450.5 [mm], 4210.4 [m], ( 132.5 [m] )
Type	点状疵点縱向刀絲疵點	Size	H:2.0 ,V:98.0 [mm]
Result	-	Area	91.2 [mm2]
Inspection level	5/5,5/5,5/5,5/5,5/5	Label	-
Light	6,6,3/6,6,3

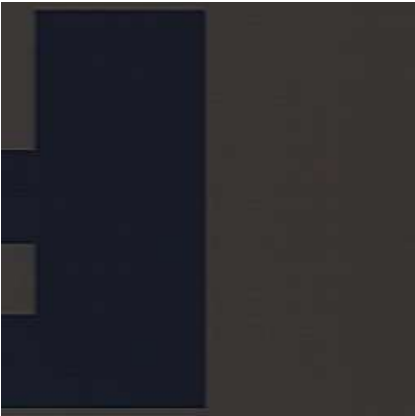
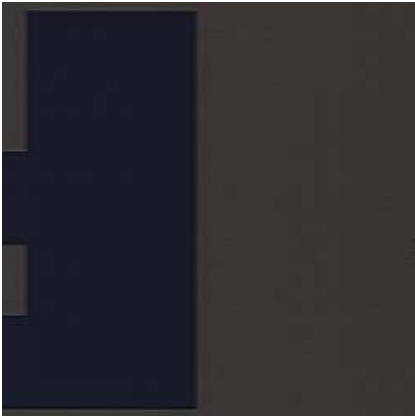
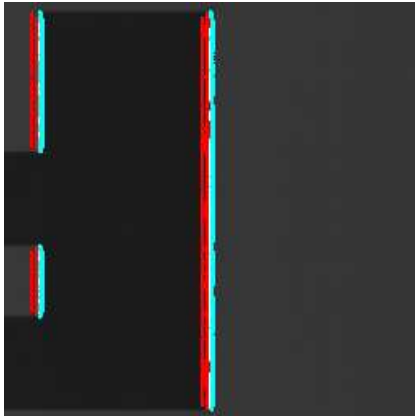
Defect image	Reference image	Shape image

No.	#13, \$10	Date	2023/8/9 下午 05:03:38
Segment	1	Camera	1
Pattern	5601	Position[ x, y ]	450.5 [mm], 4210.8 [m], ( 132.2 [m] )
Type	点状疵点縱向刀絲疵點	Size	H:2.2 ,V:98.0 [mm]
Result	-	Area	123.6 [mm2]
Inspection level	5/5,5/5,5/5,5/5,5/5	Label	-
Light	6,6,3/6,6,3

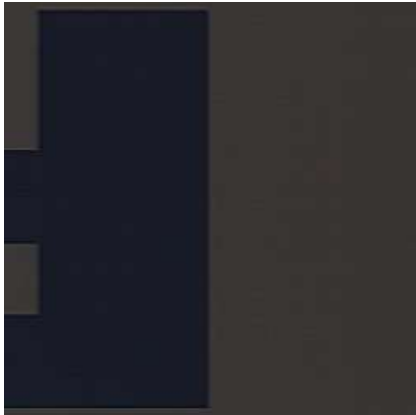
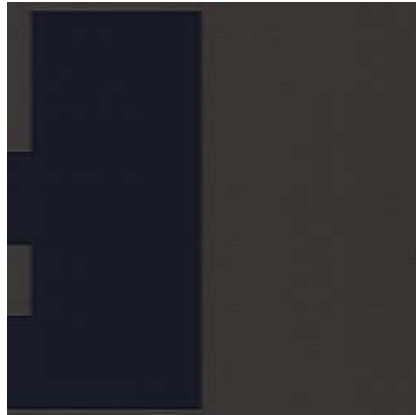
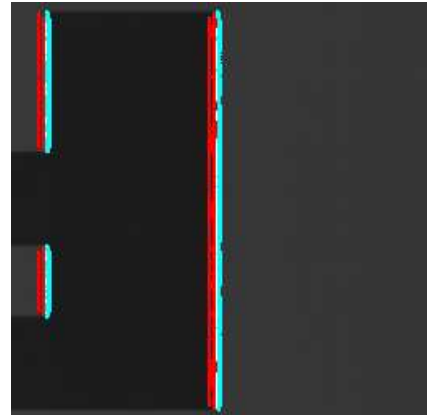
Defect image

No.	#12, \$9	Date	2023/8/9 下午 05:03:37
Segment	1	Camera	1
Pattern	5600	Position[ x, y ]	129.7 [mm], 4210.1 [m], ( 132.9 [m] )
Type	点状疵点縱向刀絲疵點	Size	H:2.0 ,V:98.0 [mm]
Result	-	Area	46.5 [mm2]
Inspection level	5/5,5/5,5/5,5/5,5/5	Label	-
Light	6,6,3/6,6,3

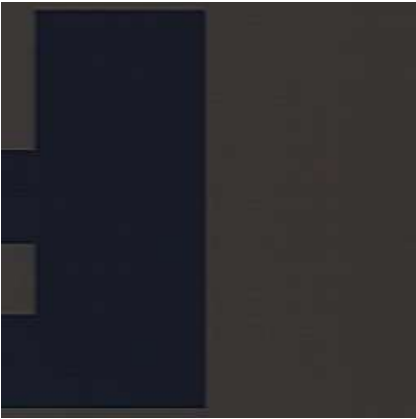
Defect image	Reference image	Shape image

No.	#12, \$9	Date	2023/8/9 下午 05:03:37
Segment	1	Camera	1
Pattern	5600	Position[ x, y ]	450.5 [mm], 4210.1 [m], ( 132.9 [m] )
Type	点状疵点縱向刀絲疵點	Size	H:2.0 ,V:98.0 [mm]
Result	-	Area	65.4 [mm2]
Inspection level	5/5,5/5,5/5,5/5,5/5	Label	-
Light	6,6,3/6,6,3

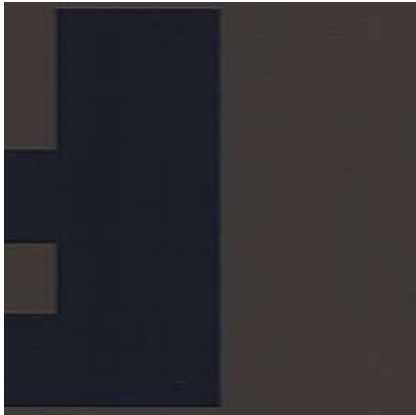
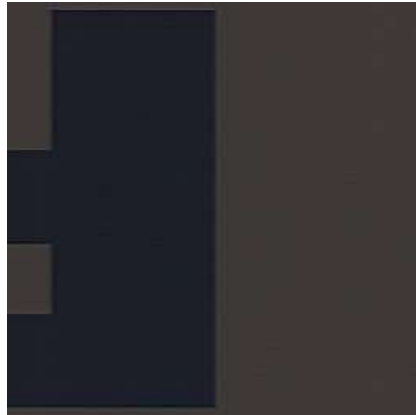
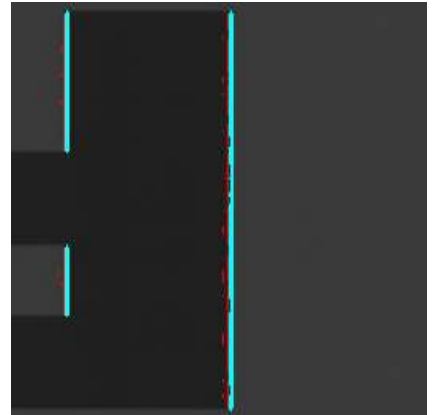
Defect image

No.	#12, \$9	Date	2023/8/9 下午 05:03:37
Segment	1	Camera	1
Pattern	5600	Position[ x, y ]	772.8 [mm], 4210.1 [m], ( 132.9 [m] )
Type	点状疵点縱向刀絲疵點	Size	H:1.7 ,V:98.0 [mm]
Result	-	Area	66.2 [mm2]
Inspection level	5/5,5/5,5/5,5/5,5/5	Label	-
Light	6,6,3/6,6,3

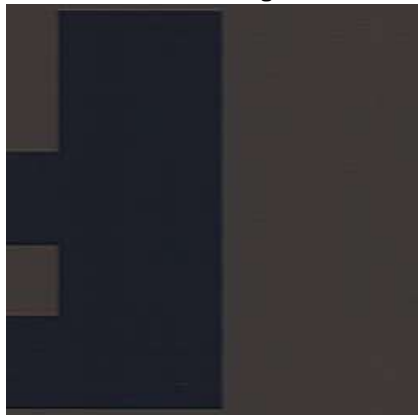
Defect image

No.	#11, \$8	Date	2023/8/9 下午 05:03:37
Segment	1	Camera	1
Pattern	5599	Position[ x, y ]	748.4 [mm], 4208.9 [m], ( 134.1 [m] )
Type	縱向刀絲疵點	Size	H:0.5 ,V:73.2 [mm]
Result	-	Area	12.0 [mm2]
Inspection level	5/5,5/5,5/5,5/5,5/5	Label	-
Light	6,6,3/6,6,3

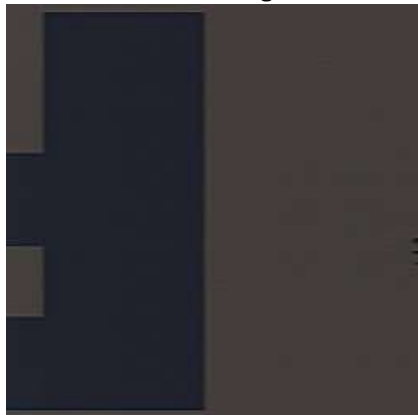
Defect image

No.	#11, \$8	Date	2023/8/9 下午 05:03:37
Segment	1	Camera	1
Pattern	5599	Position[ x, y ]	130.0 [mm], 4209.3 [m], ( 133.7 [m] )
Type	縱向刀絲疵點	Size	H:0.2 ,V:96.4 [mm]
Result	-	Area	12.6 [mm2]
Inspection level	5/5,5/5,5/5,5/5,5/5	Label	-
Light	6,6,3/6,6,3

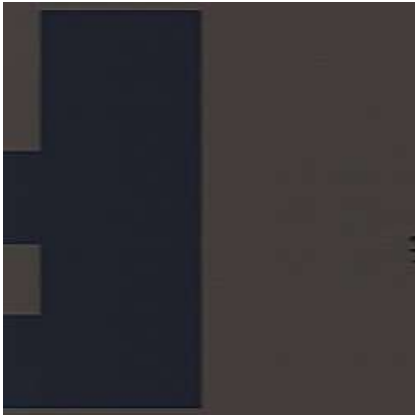
Defect image

No.	#10, \$7	Date	2023/8/9 下午 05:03:36
Segment	1	Camera	1
Pattern	5598	Position[ x, y ]	553.8 [mm], 4208.3 [m], ( 134.7 [m] )
Type	縱向刀絲疵點	Size	H:5.6 ,V:14.0 [mm]
Result	-	Area	8.2 [mm2]
Inspection level	5/5,5/5,5/5,5/5,5/5	Label	-
Light	6,6,3/6,6,3

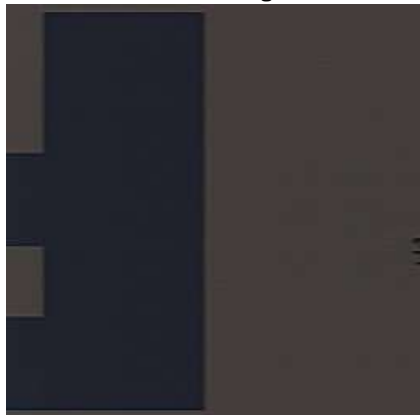
Defect image

No.	#10, \$7	Date	2023/8/9 下午 05:03:36
Segment	1	Camera	1
Pattern	5598	Position[ x, y ]	733.0 [mm], 4208.7 [m], ( 134.3 [m] )
Type	縱向刀絲疵點	Size	H:5.4 ,V:14.0 [mm]
Result	-	Area	9.3 [mm2]
Inspection level	5/5,5/5,5/5,5/5,5/5	Label	-
Light	6,6,3/6,6,3

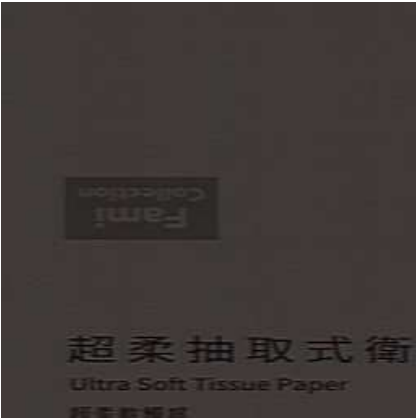
No.	#7, \$6	Date	2023/8/9 下午 05:03:15
Segment	1	Camera	1
Pattern	5556	Position[ x, y ]	788.2 [mm], 4176.5 [m], ( 166.4 [m] )
Type	点状疵点縱向刀絲疵點橫向刀絲	Size	H:184.6 ,V:102.8 [mm]
Result	-	Area	937.6 [mm2]
Inspection level	5/5,5/5,5/5,5/5,5/5	Label	-
Light	6,6,3/6,6,3

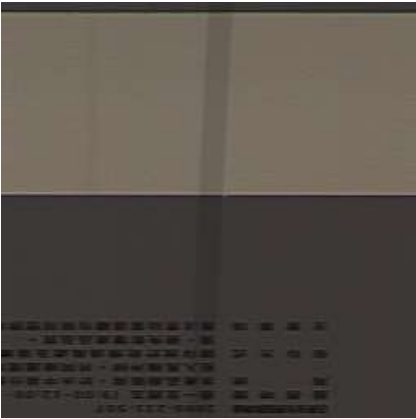
No.	#7, \$6	Date	2023/8/9 下午 05:03:15
Segment	1	Camera	1
Pattern	5556	Position[ x, y ]	116.6 [mm], 4176.6 [m], ( 166.3 [m] )
Type	点状疵点縱向刀絲疵點橫向刀絲	Size	H:242.4 ,V:384.4 [mm]
Result	-	Area	1759.4 [mm2]
Inspection level	5/5,5/5,5/5,5/5,5/5	Label	-
Light	6,6,3/6,6,3

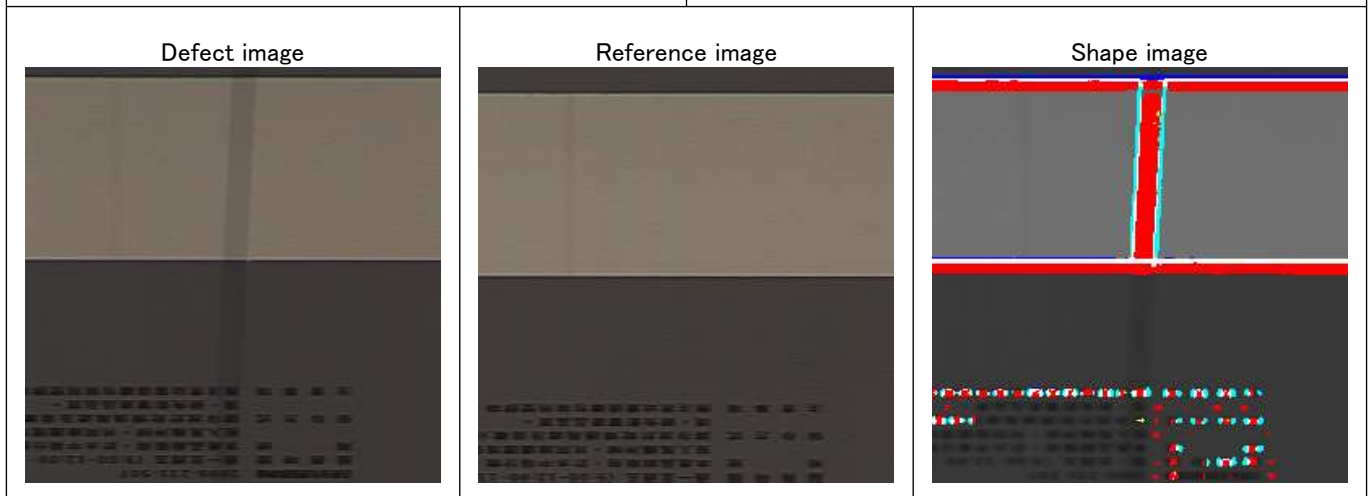
No.	#6, \$5	Date	2023/8/9 下午 05:03:15
Segment	1	Camera	1
Pattern	5555	Position[ x, y ]	156.6 [mm], 4175.8 [m], ( 167.2 [m] )
Type	面狀重疵点	Size	H:22.9 ,V:40.4 [mm]
Result	-	Area	642.0 [mm2]
Inspection level	5/5,5/5,5/5,5/5,5/5	Label	-
Light	6,6,3/6,6,3

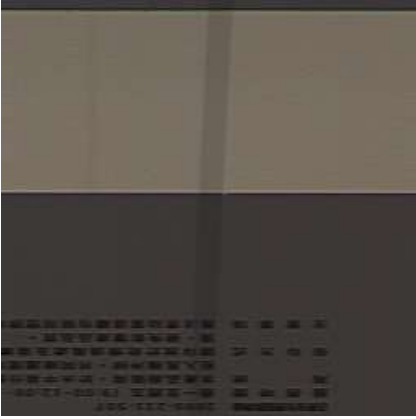
No.	#6, \$5	Date	2023/8/9 下午 05:03:15
Segment	1	Camera	1
Pattern	5555	Position[ x, y ]	156.1 [mm], 4175.7 [m], ( 167.2 [m] )
Type	淡瑕疵縱向刀絲疵點	Size	H:23.2 ,V:71.2 [mm]
Result	-	Area	683.2 [mm2]
Inspection level	5/5,5/5,5/5,5/5,5/5	Label	-
Light	6,6,3/6,6,3

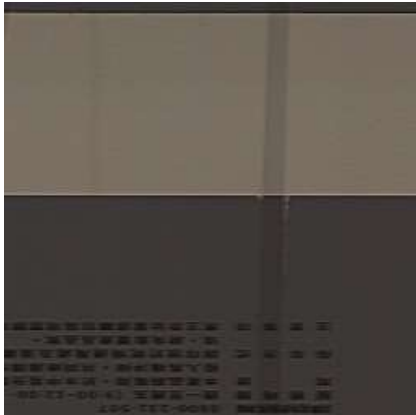
Defect image

No.	#6, \$5	Date	2023/8/9 下午 05:03:15
Segment	1	Camera	1
Pattern	5555	Position[ x, y ]	143.4 [mm], 4176.2 [m], ( 166.8 [m] )
Type	点状疵点縱向刀絲疵點	Size	H:185.3 ,V:155.2 [mm]
Result	-	Area	1848.3 [mm2]
Inspection level	5/5,5/5,5/5,5/5,5/5	Label	-
Light	6,6,3/6,6,3

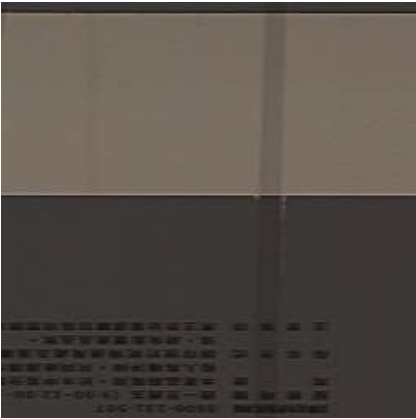
No.	#5, \$4	Date	2023/8/9 下午 05:03:14
Segment	1	Camera	1
Pattern	5554	Position[ x, y ]	699.1 [mm], 4175.0 [m], ( 168.0 [m] )
Type	点状疵点縱向刀絲疵點	Size	H:2.4 ,V:122.4 [mm]
Result	-	Area	83.2 [mm2]
Inspection level	5/5,5/5,5/5,5/5,5/5	Label	-
Light	6,6,3/6,6,3

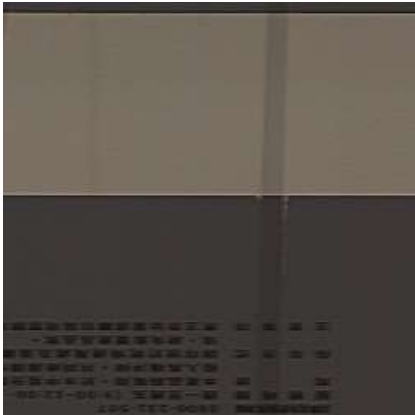
Defect image

No.	#5, \$4	Date	2023/8/9 下午 05:03:14
Segment	1	Camera	1
Pattern	5554	Position[ x, y ]	688.3 [mm], 4175.4 [m], ( 167.6 [m] )
Type	面狀重疵點	Size	H:25.6 ,V:185.6 [mm]
Result	-	Area	300.0 [mm2]
Inspection level	5/5,5/5,5/5,5/5,5/5	Label	-
Light	6,6,3/6,6,3

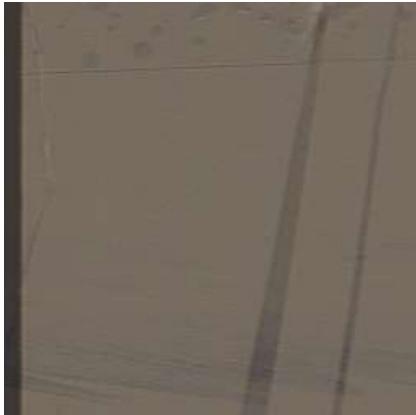
Defect image

No.	#5, \$4	Date	2023/8/9 下午 05:03:14
Segment	1	Camera	1
Pattern	5554	Position[ x, y ]	273.1 [mm], 4175.4 [m], ( 167.6 [m] )
Type	面狀重疵點縱向刀絲疵點	Size	H:59.8 ,V:575.2 [mm]
Result	-	Area	2723.1 [mm2]
Inspection level	5/5,5/5,5/5,5/5,5/5	Label	-
Light	6,6,3/6,6,3

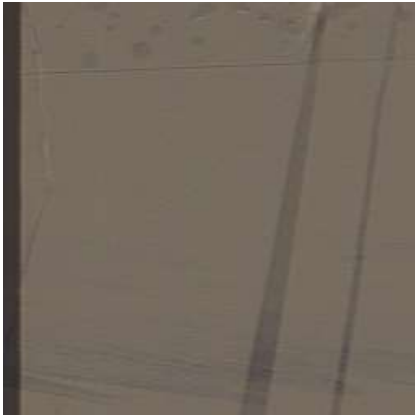
Defect image

No.	#4, \$3	Date	2023/8/9 下午 05:03:13
Segment	1	Camera	1
Pattern	5553	Position[ x, y ]	760.8 [mm], 4174.4 [m], ( 168.6 [m] )
Type	点状疵点縱向刀絲疵點	Size	H:39.8 ,V:180.8 [mm]
Result	-	Area	135.9 [mm2]
Inspection level	5/5,5/5,5/5,5/5,5/5	Label	-
Light	6,6,3/6,6,3

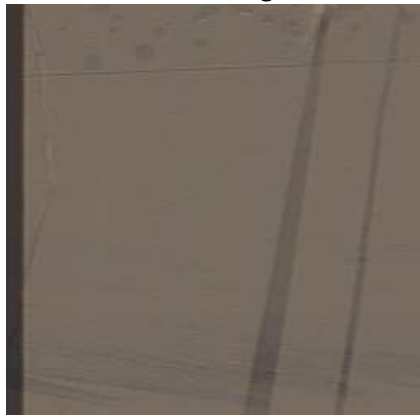
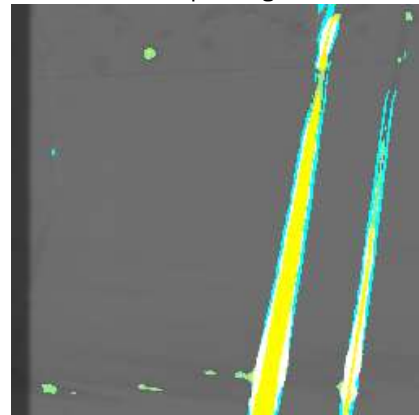
No.	#4, \$3	Date	2023/8/9 下午 05:03:13
Segment	1	Camera	1
Pattern	5553	Position[ x, y ]	704.2 [mm], 4174.4 [m], ( 168.6 [m] )
Type	点状疵点縱向刀絲疵點	Size	H:12.9 ,V:384.0 [mm]
Result	-	Area	314.0 [mm2]
Inspection level	5/5,5/5,5/5,5/5,5/5	Label	-
Light	6,6,3/6,6,3

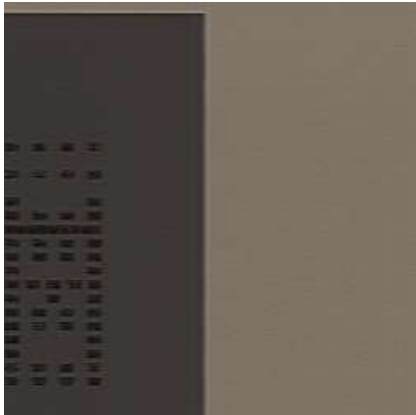
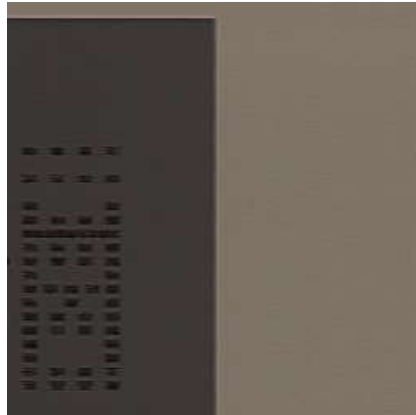
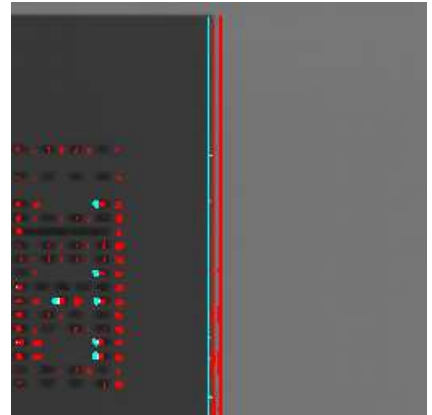
No.	#4, \$3	Date	2023/8/9 下午 05:03:13
Segment	1	Camera	1
Pattern	5553	Position[ x, y ]	567.2 [mm], 4174.5 [m], ( 168.5 [m] )
Type	点状疵点縱向刀絲疵點	Size	H:2.7 ,V:330.4 [mm]
Result	-	Area	427.6 [mm2]
Inspection level	5/5,5/5,5/5,5/5,5/5	Label	-
Light	6,6,3/6,6,3

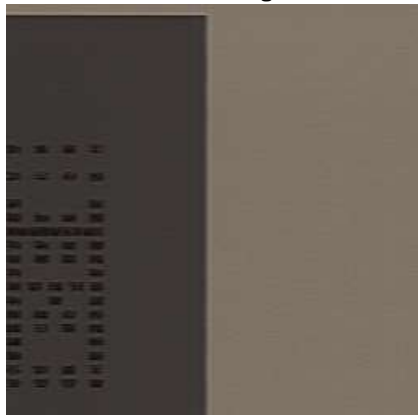
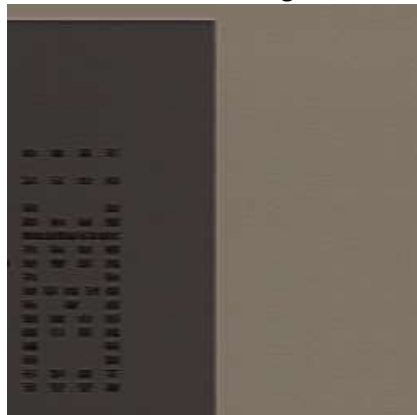
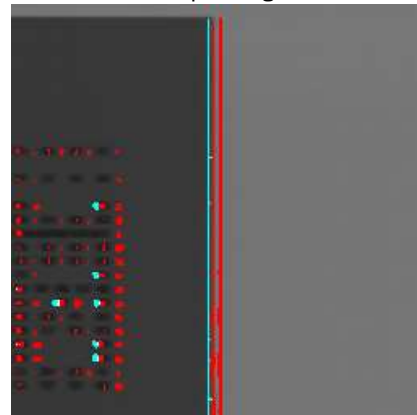
No.	#3, \$2	Date	2023/8/9 下午 05:03:13
Segment	1	Camera	1
Pattern	5552	Position[ x, y ]	381.0 [mm], 4174.2 [m], ( 168.8 [m] )
Type	縱向刀絲疵點	Size	H:8.1 ,V:110.0 [mm]
Result	-	Area	26.9 [mm2]
Inspection level	5/5,5/5,5/5,5/5,5/5	Label	-
Light	6,6,3/6,6,3

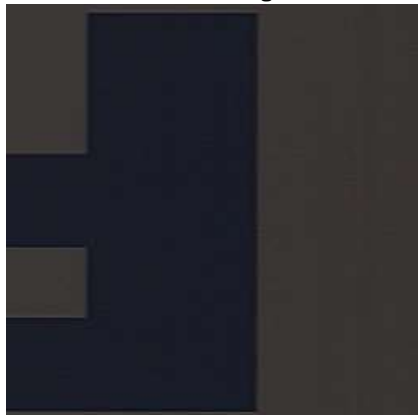
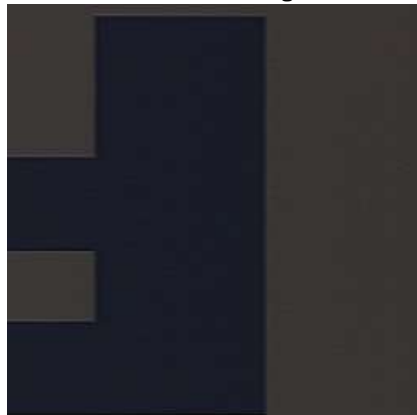
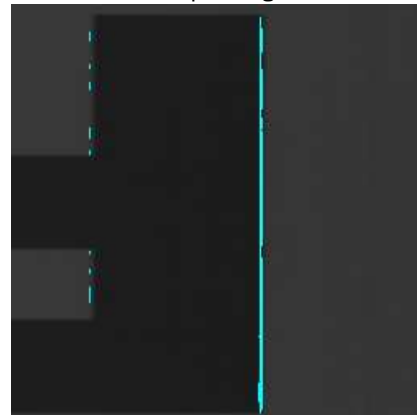
No.	#3, \$2	Date	2023/8/9 下午 05:03:13
Segment	1	Camera	1
Pattern	5552	Position[ x, y ]	444.4 [mm], 4174.0 [m], ( 169.0 [m] )
Type	縱向刀絲疵點	Size	H:27.3 ,V:129.6 [mm]
Result	-	Area	44.6 [mm2]
Inspection level	5/5,5/5,5/5,5/5,5/5	Label	-
Light	6,6,3/6,6,3
