# Aerial Infrared Thermography of a Utility-Scale PV Plant After a Meteorological Tsunami in Brazil

**Abstract** — Aerial Infrared Thermography (aIRT) is a non-destructive and cost-effective method for detecting faults in large-scale PV plants. In this paper, a 1 MW multi-crystalline PV plant-block that was hit by a meteorological tsunami in Brazil in 2016, is inspected systematically using the aIRT method. The main objective was to validate this inspection technique for commercial application. Various failures like hotspots, bypassed substrings, short-circuited and disconnected PV strings were detected at the PV plant using aIRT inspection in less than one hour. The results have proven that this semi-autonomous method is very fast, reliable and effective for large scale PV plants.

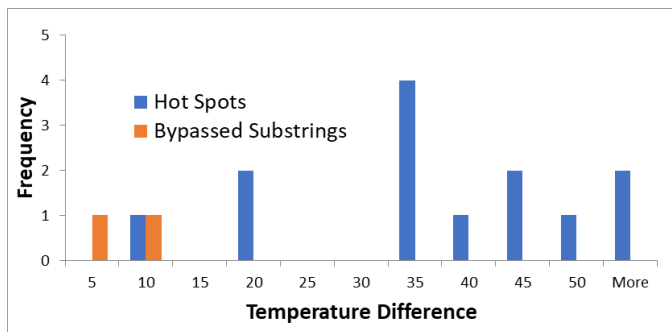
Fig. 8. Histogram of temperature differences between defective and healthy cell.

After gathering data of all detected hotspots and bypassed substrings, the histogram presented in Fig. 8 was plotted. It shows that most of the damaged modules detected presented a temperature difference greater than 30°C on their surface. This indicates that most of the defects could be detected much faster if taken from a higher altitude.

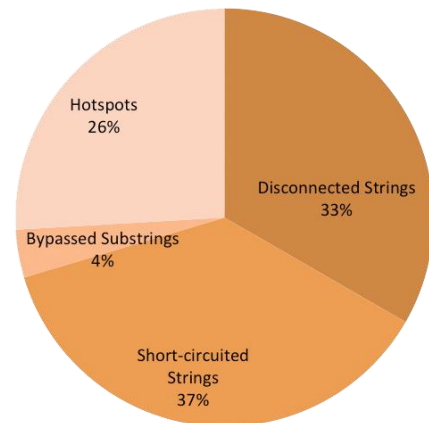
Fig. 10. Summary of detected failures.

The pie diagram in Fig. 10 presents the results of the aIRT inspection with the proposed scheme. Altogether 54 defects were detected during the PV plant inspection. Disconnected PV strings, short-circuited PV strings and PV module level defects account for approximately 1/3 of the detected defects in equal parts. Defects on the PV module level can be subdivided into hotspots that make up the major part (26%) and bypassed substrings (4%). The inspection time for the 1MW multi-crystalline PV plant-block was 1 hour.
