**Reference:** LM-PR-011 CC130J Program – Issue Reporting Procedure

Table 1 – Damage Description – Gouges on Cargo Tie-Down Wells

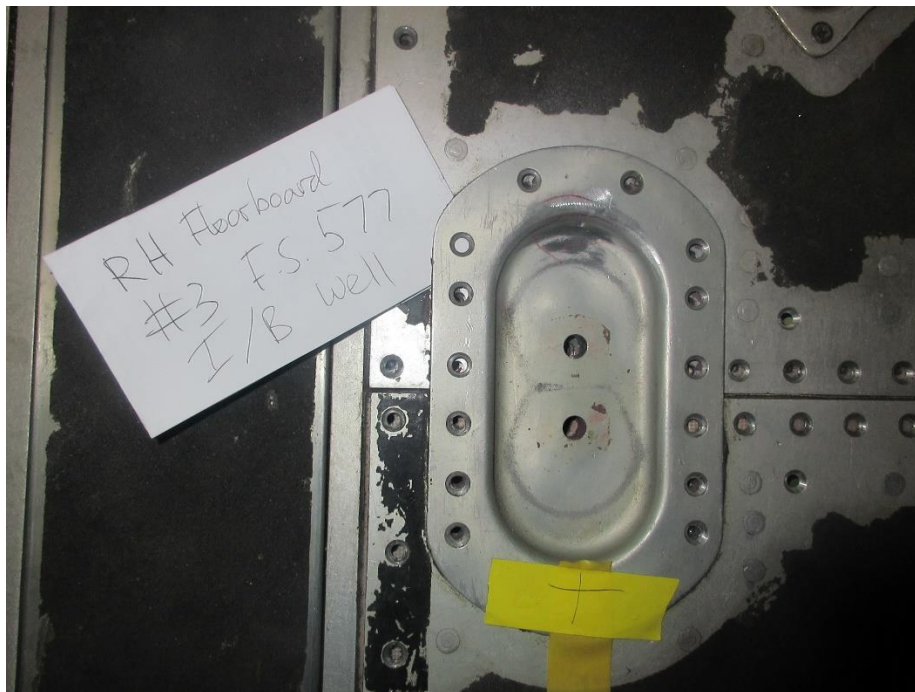
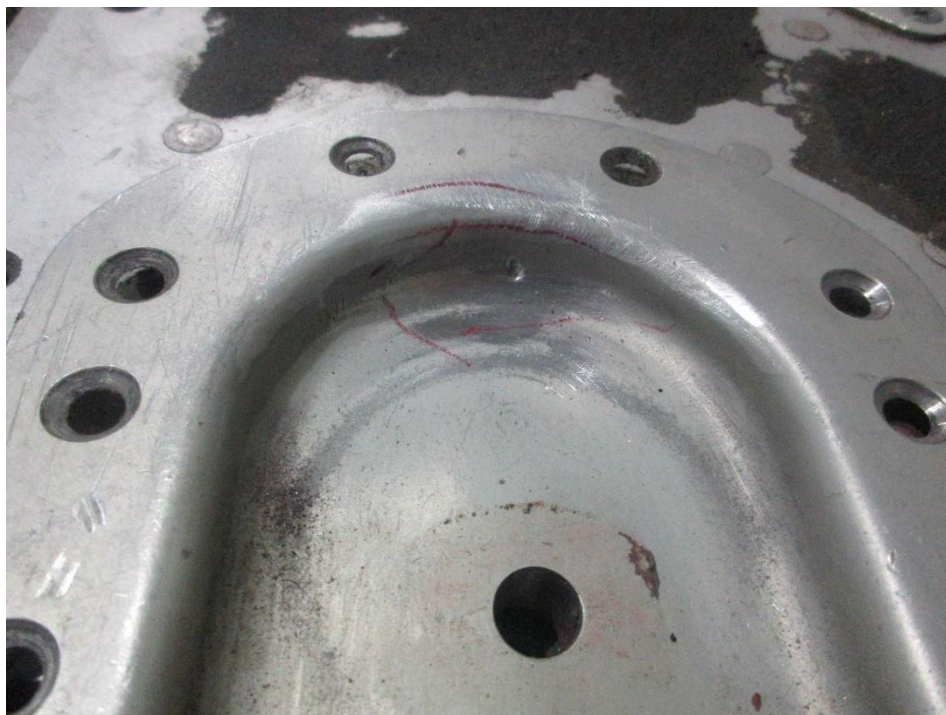
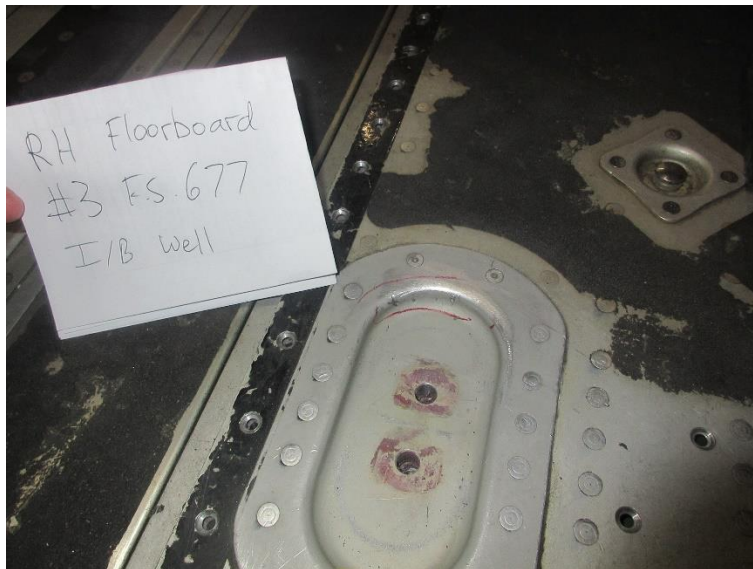
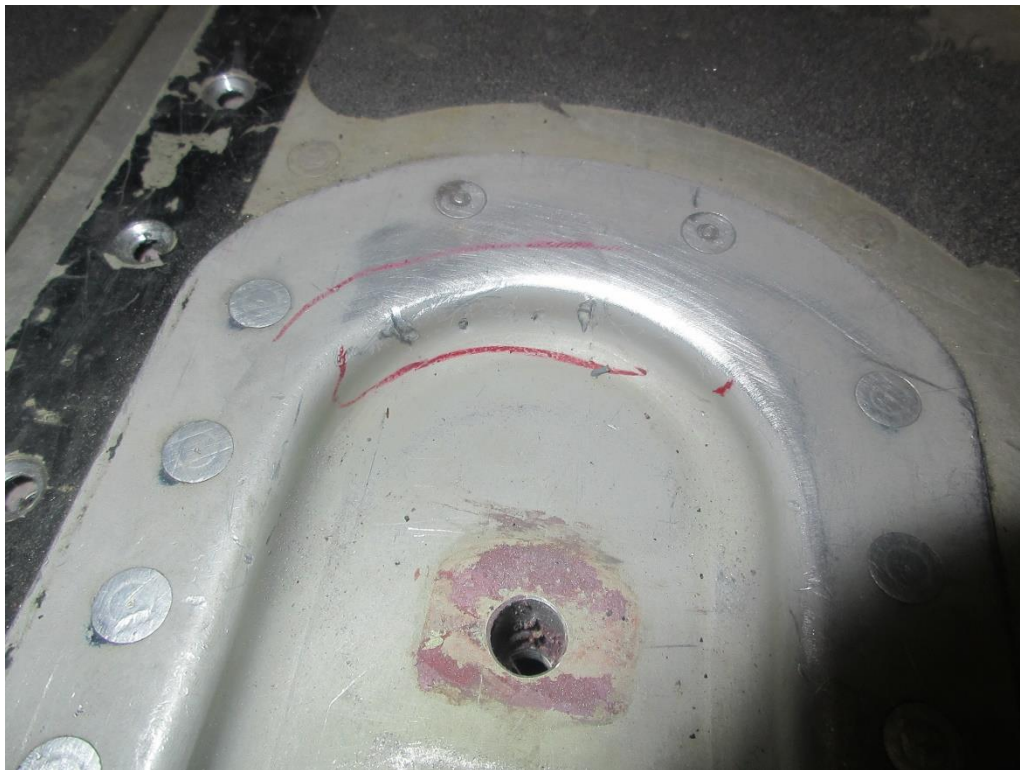
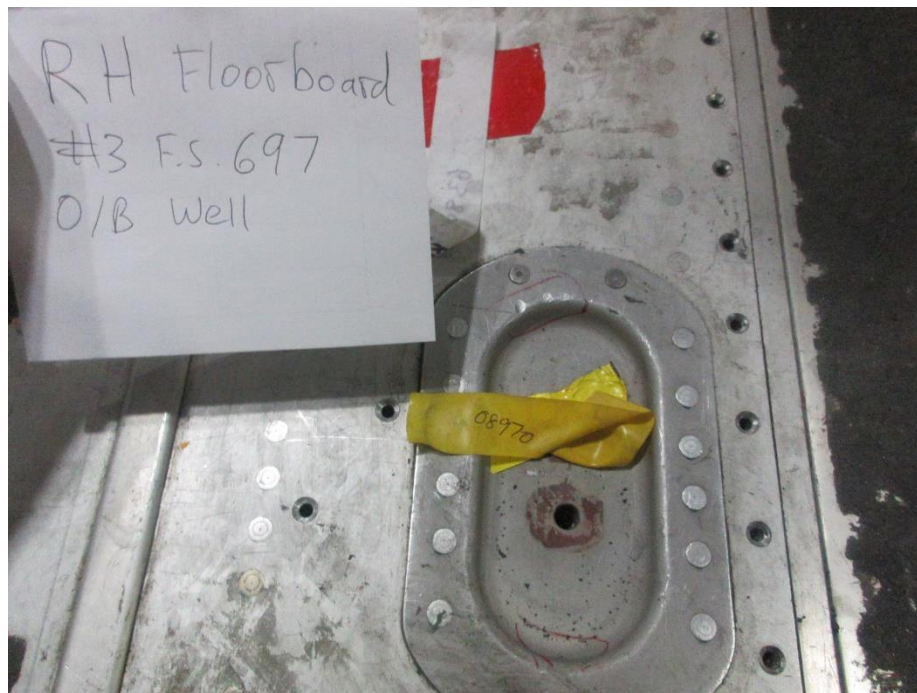
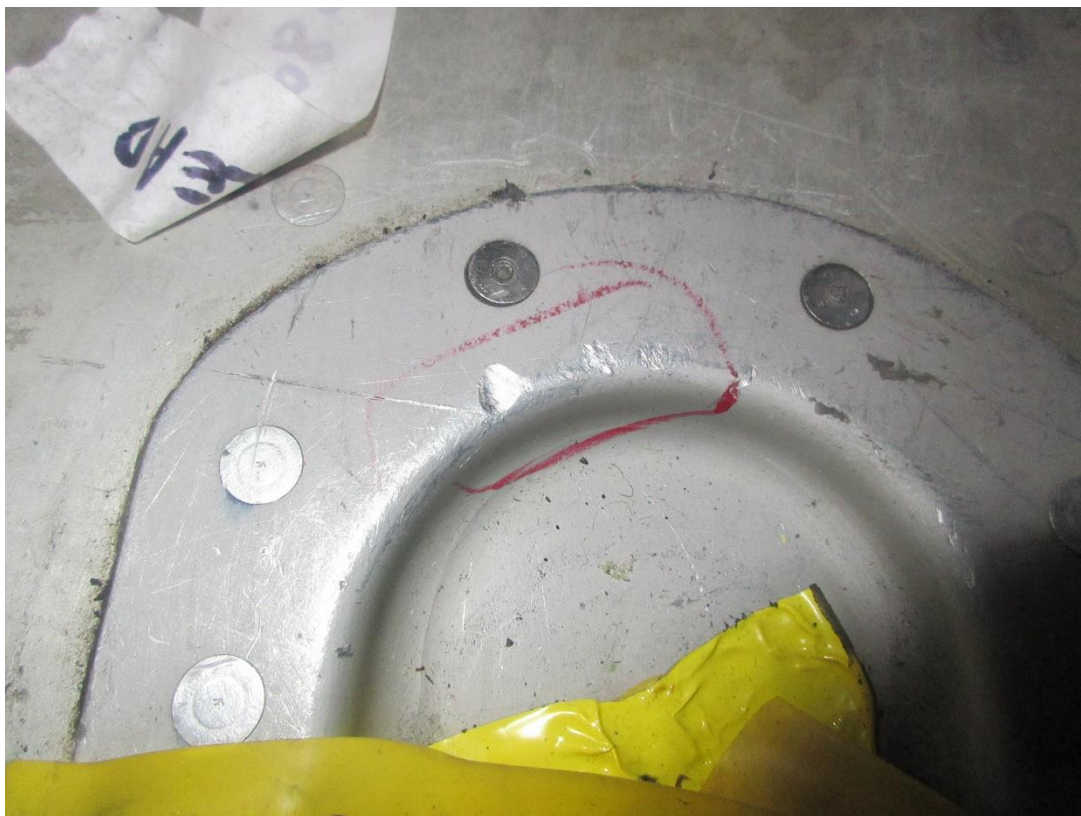
**Raw Photos (For Reference Only)**

Identification	Tie-down Well P/N	Length (L)	Width (W)	Depth	Distance to closest fastener (X)
FS 577 Damage, D1	356244-3	0.133"	0.155"	0.014"	0.808"
FS 677 Damage, D2	354122-12	0.335"	0.149"	0.017"	0.680"
FS 697 Damage, D3	354122-12	0.206"	0.174"	0.018"	0.600"
