WEEK3

18.Mar-25.Mar

Xingchen MA

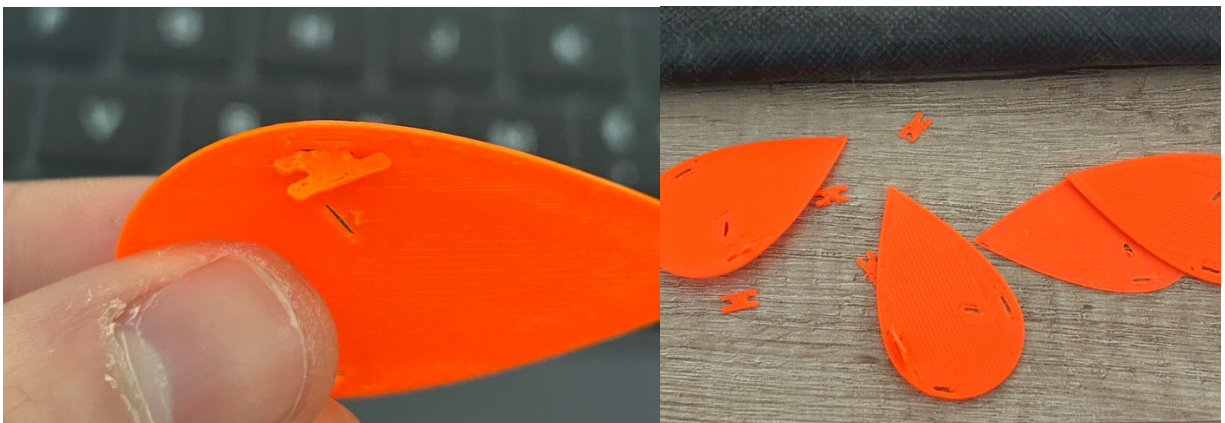
The printing result is a failure. The reasons are as follows: 1. Due to precision issues, my connection part cannot be inserted into the gap. I can scale my design to solve this problem; 2. Even if the connection part can be inserted, it is not long enough to provide a certain degree of mobility for the entire component.
