TWIN PEAKS PROPERTY INSPECTIONS

RESIDENTIAL INSPECTION

1234 Main Street
Oshawa, ON L1G 3V2

Buyer Name
02/01/2023 9:00AM

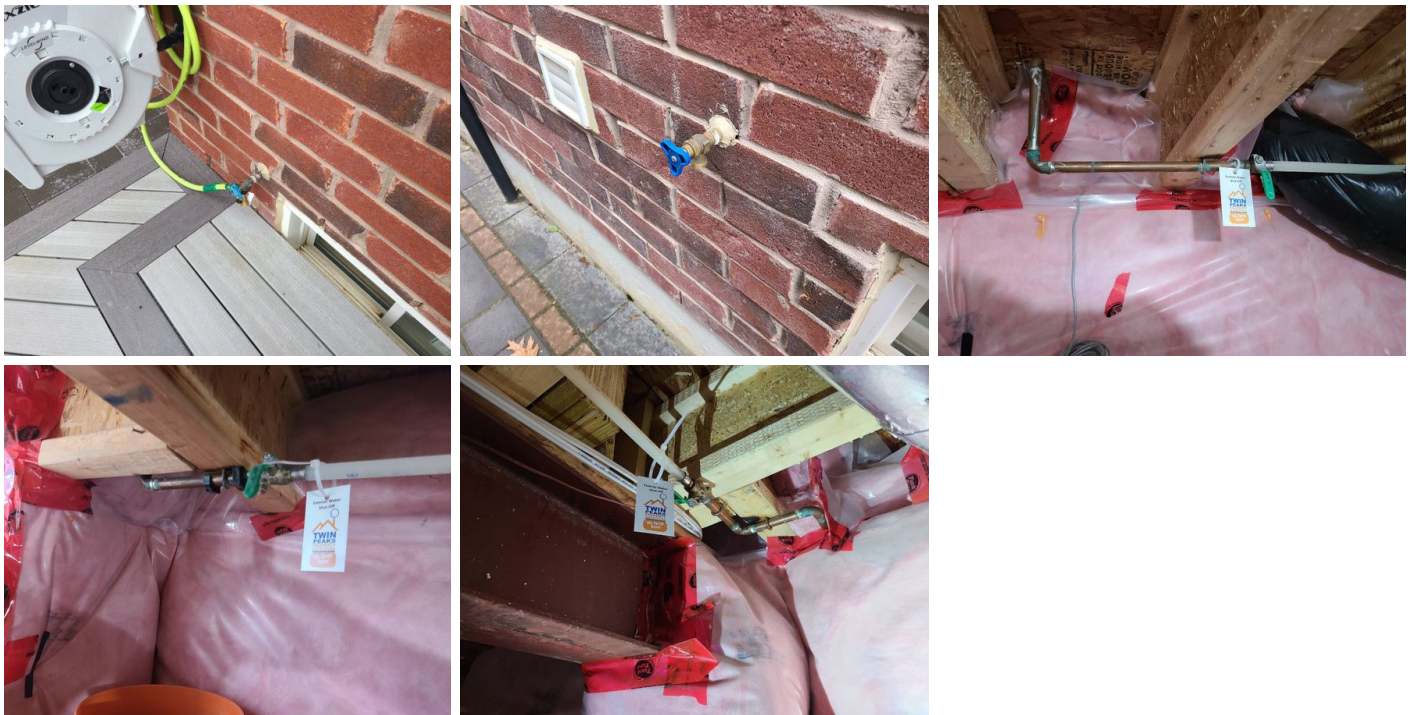
Water Supply, Distribution Systems & Fixtures: Water Supply Material Copper, Pex	Hot Water Systems: Water Heater Type Standard tank	Hot Water Systems: Year Of Manufacture 2016
Hot Water Systems: Typical Life Expectancy 10 to 15 years	Hot Water Systems: Location Basement	Hot Water Systems: Manufacturer Johnwood Here is a helpful maintenance guide to help.
Hot Water Systems: Power Source Natural Gas

A reminder to turn off all exterior water outlets each fall before freezing exterior temperatures. Frozen water pipes can lead to burst pipes and interior damage.

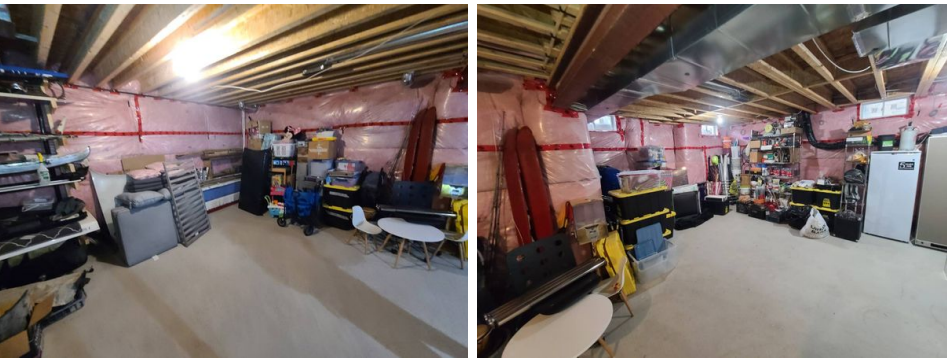
BASEMENT

Limited access due to furnishings and storage.
