Report on the investigation of  
the enclosed space accident  
on board the fishing vessel

***Sunbeam (FR487)***

in Fraserburgh, Scotland

on 14 August 2018

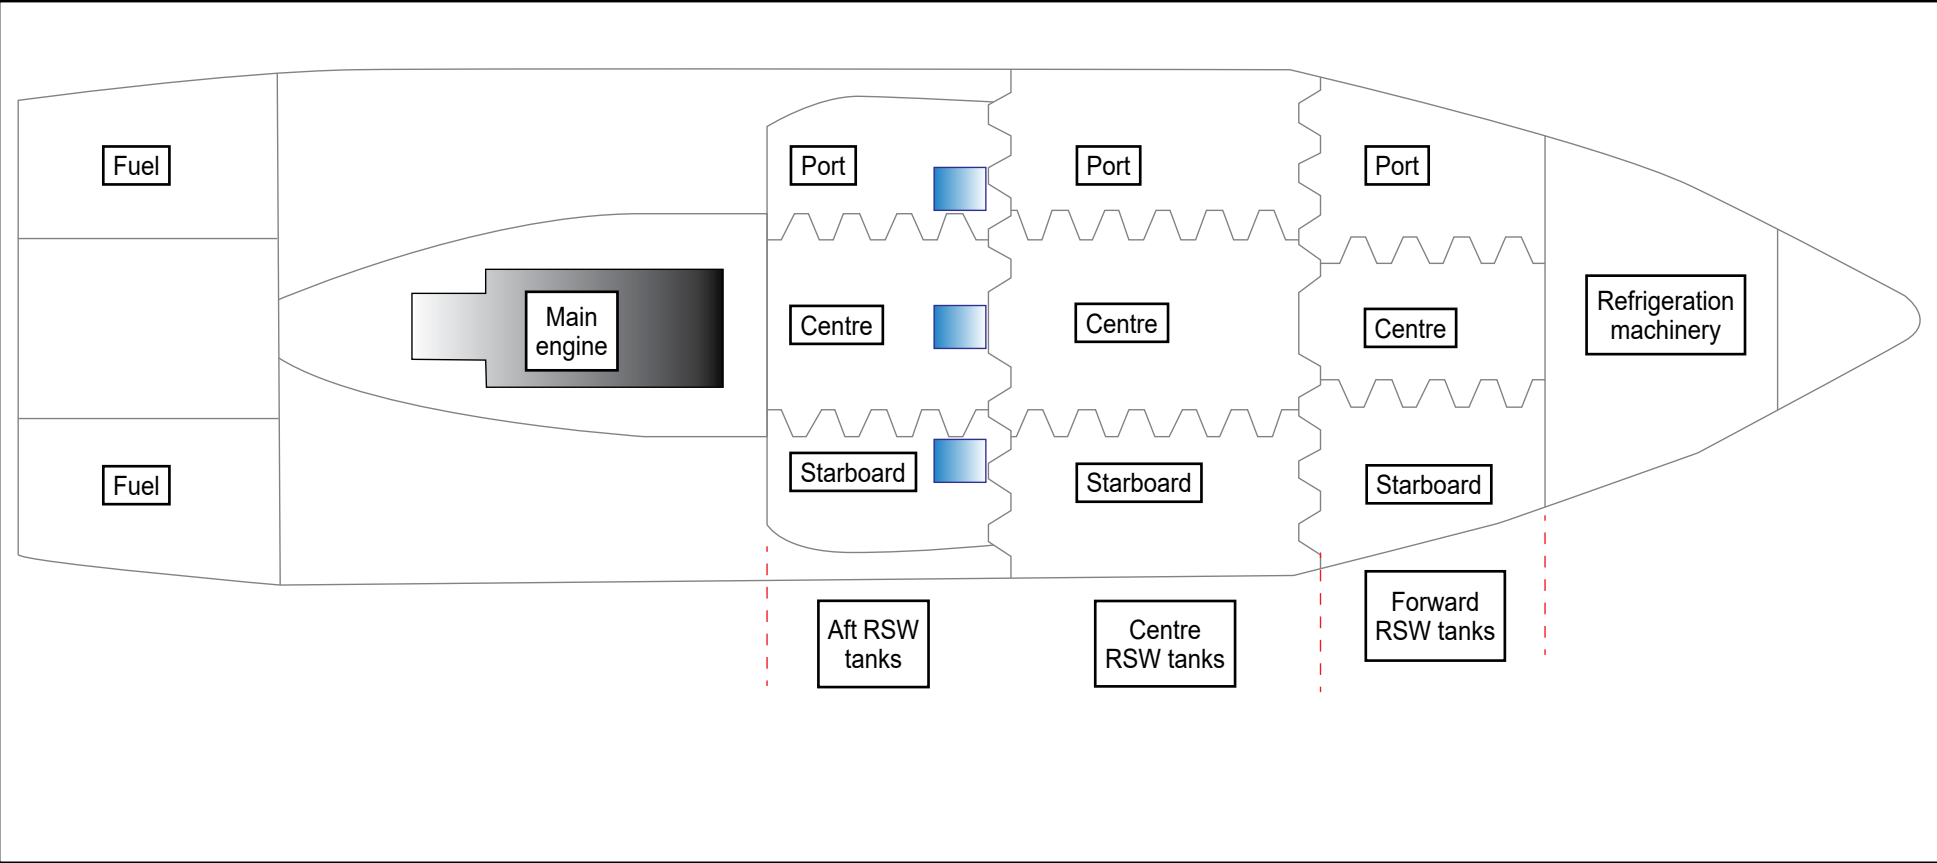
**Figure 1:** *Sunbeam* - general arrangement showing the layout of RSW tanks, access hatches and the refrigeration plant forward

*Sunbeam*'s nine RSW tanks were arranged in three rows forward to aft (**Figure 1**). The tanks' purpose was to store and preserve caught fish in chilled water. The aft centre RSW tank had an internal volume of approximately 154m<sup>3</sup>. There was no forced ventilation in the RSW tanks, and each had a single point of entry / exit at main deck level (**Figure 2**). Seawater for the RSW tanks was chilled by two refrigeration plants. The RSW system (**Figure 3**) functioned as follows:

*Sunbeam* was fitted with two refrigeration plants in a dedicated compartment forward of the RSW tanks (**Figure 1**). The refrigeration plants could be operated individually or in parallel to chill seawater. The refrigeration plants (**Figure 4**) were designed and manufactured by Technotherm A/S of Halden, Norway, and had been installed at build. The main components of each refrigeration plant were a

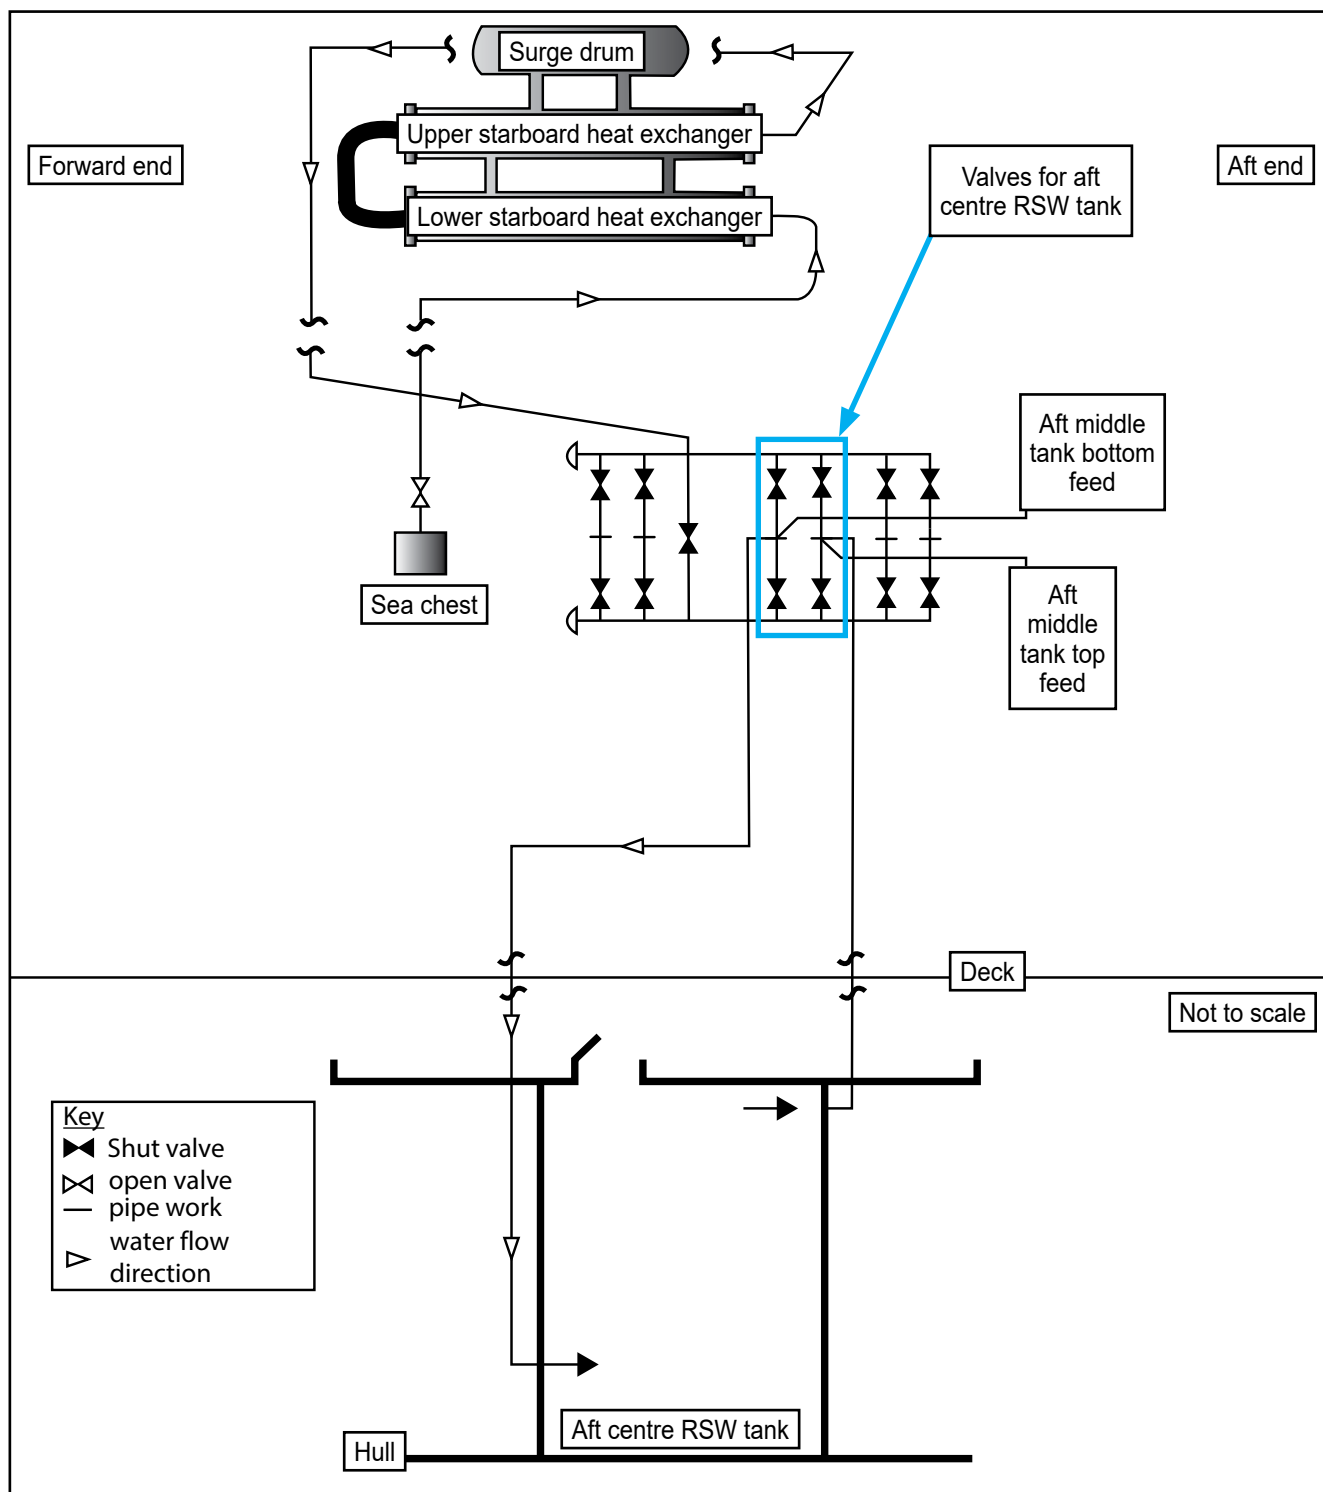
**Figure 3:** Schematic diagram of *Sunbeam's* RSW system

RSW tank suction and discharge isolating valves were fully lugged pattern marine butterfly valves; when in the shut position, they were designed to be watertight but not gastight. At the time of the accident, all of *Sunbeam*'s RSW tanks were empty and all pipework was drained of seawater (**Figure 3**).

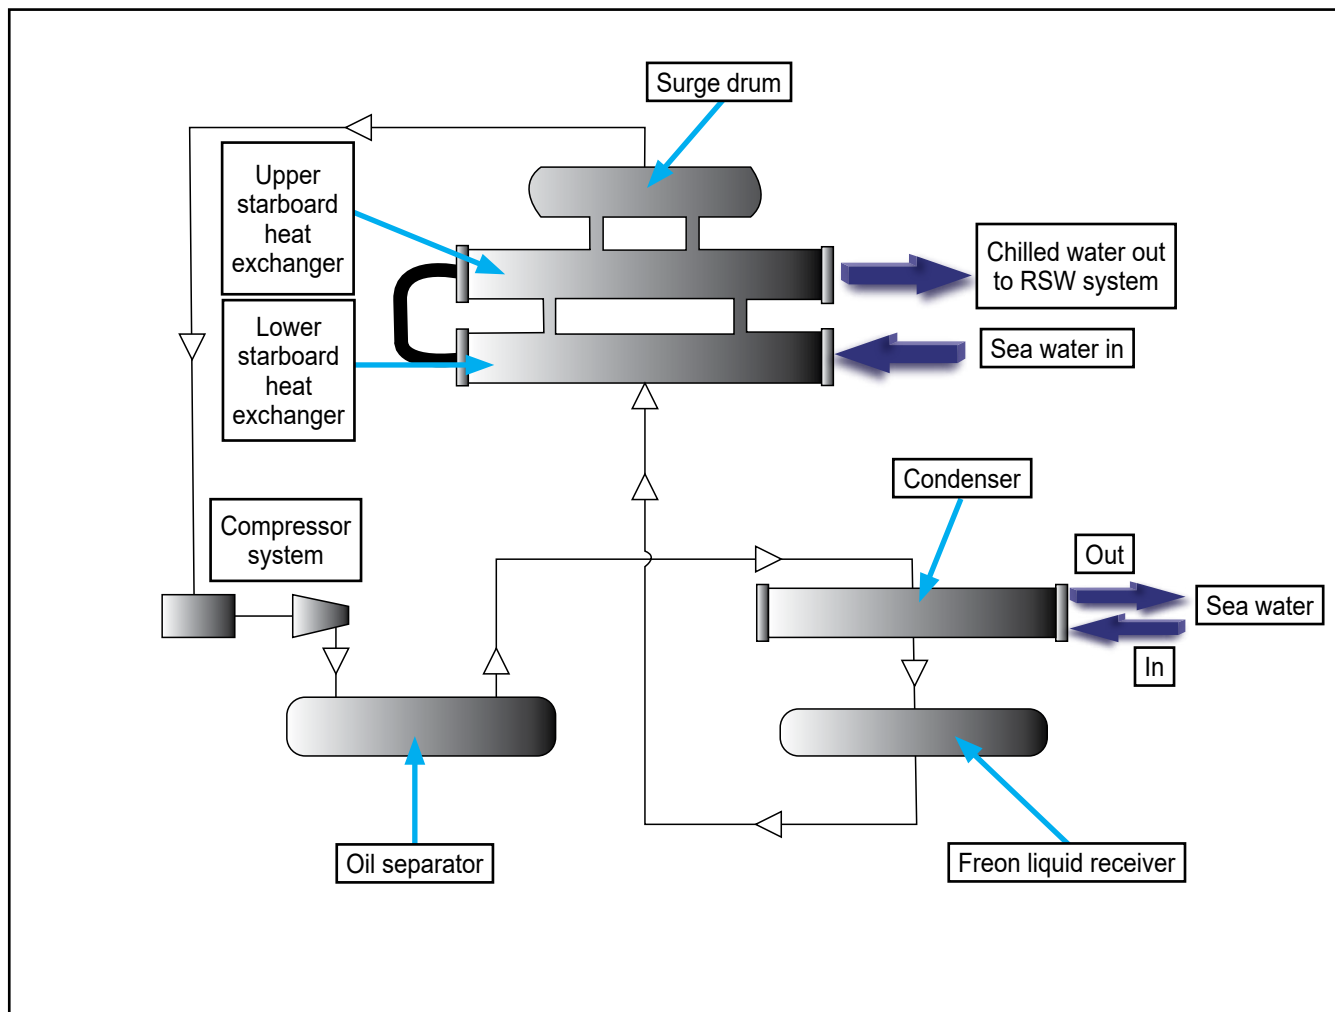
**Figure 4:** Schematic diagram showing one of *Sunbeam's* two refrigeration plants

compressor, a condenser, a liquid receiver and an evaporator. Each evaporator comprised two 'shell and tube' heat exchangers mounted horizontally, and each heat exchanger contained 142 corrosion resistant aluminium-brass alloy<sup>6</sup> tubes. Seawater was chilled as it passed through the evaporators' tubes with the liquid Freon refrigerant evaporated on the shell side.
