MA2020-6

MARINE ACCIDENT INVESTIGATION REPORT

Accident type	Collision
Date and time	Around 4:22 on September 2, 2019 (local time, UTC+9 hours)
Location	Akashi Kaikyo Traffic Route Around 019° true bearing, 1.3 nautical miles (M) from Esaki Lighthouse (approximately 34°37.6'N, 135°00.0'E)
Summary of the Accident	<p>The car carrier GLOVIS COMPANION was proceeding west in the Akashi-Kaikyo Traffic Route and the fishing vessel HIGASHIDA MARU was proceeding southeast and attempting to cross the Akashi-Kaikyo Traffic Route when both vessels collided in the Akashi-Kaikyo Traffic Route.</p> <p>The master of HIGASHIDA MARU was injured, and her bow sustained crushing and other damage, while GLOVIS COMPANION sustained abrasions on her starboard- side shell plating.</p>
Process and Progress of the Investigation	<p>(1) Set up of the Investigation</p> <p>The Japan Transport Safety Board (hereinafter referred to as “JTSB”) appointed an investigator-in-charge and two other marine accident investigators to investigate this accident on September 2, 2019.</p> <p>(2) Collection of Evidence</p> <p>September 3 to 5, December 9 and 10, 2019: On-site investigations and Interviews</p> <p>October 7, and 1

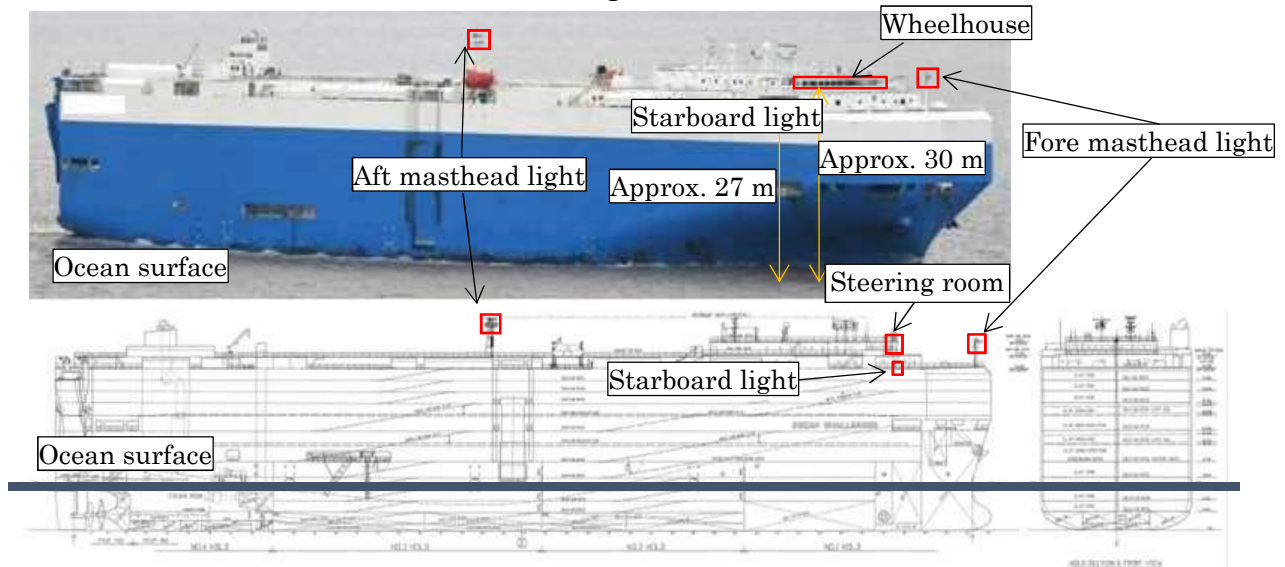
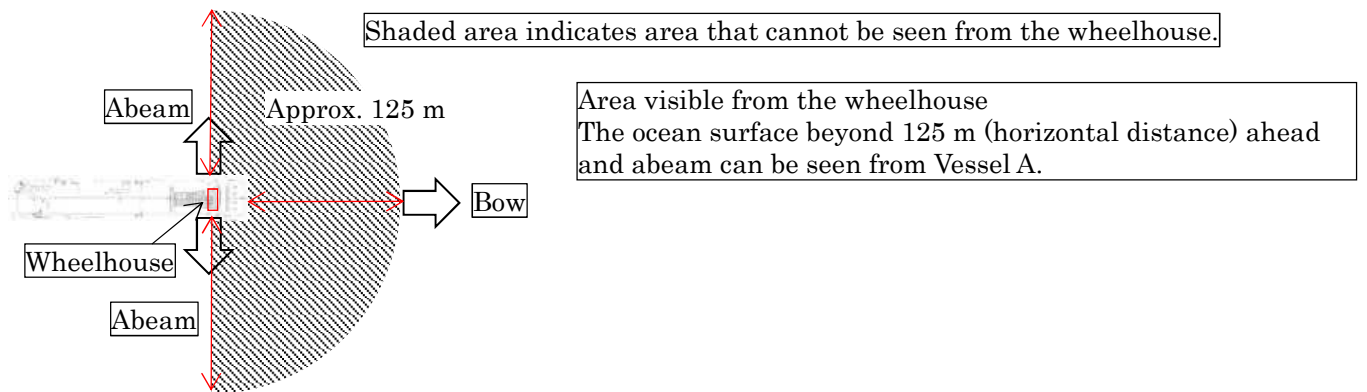
Attached Figure 2 Vessel A

Other Matters	<p>(1) Circumstances of visual sighting, etc., from Vessel A's wheelhouse</p> <p>According to the reply to the questionnaire by Master A, the wheelhouse is approximately 30 m above the ocean's surface, and the visible area from the wheelhouse was the ocean's surface beyond approximately 125 m directly abeam and forward at horizontal distance.</p> <p>According to Vessel A's general arrangement plan, the navigation lights were at a height of approximately 27 m or higher from the ocean's surface.</p> <p>(Attached Figure 2)</p> <p>(2) Circumstances, etc., of Vessel B's navigation lights</p> <p>(a) An awning was installed from the bow to the stern, and a masthead light and a bi-colored light were installed above the awning and below the awning, respectively.</p> <p>(b) The angles from the bi-colored light to the awning at the bow's end and both sides were approximately 10° upward in the direction of the bow and approximately 20° upward directly</p>
