Report on the investigation of
the grounding of

Astral

on Princessa Shoal,

10 March 2008

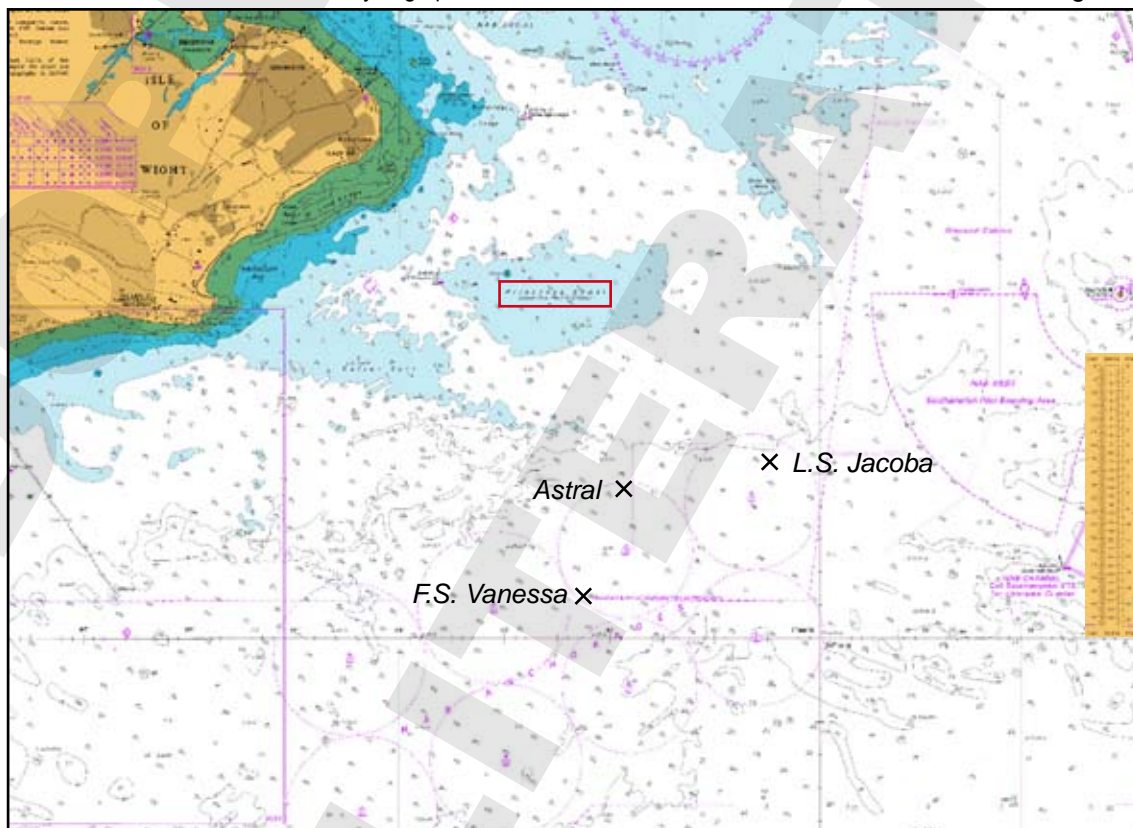
Figure 1

There were two vessels at anchor nearby as *Astral* made her approach to the No.3 anchorage. The 143m long tanker *LS Jacoba*, which was also scheduled to berth at the Esso terminal, was already anchored in the adjacent Nab anchorage No.4. The chemical tanker *FS Vanessa* was at anchor south of the boundary of No.2 and No.3 anchorages (**Figure 1**).

Position of anchored vessels when *Astral* dropped anchor at 1545, 7 March 2008

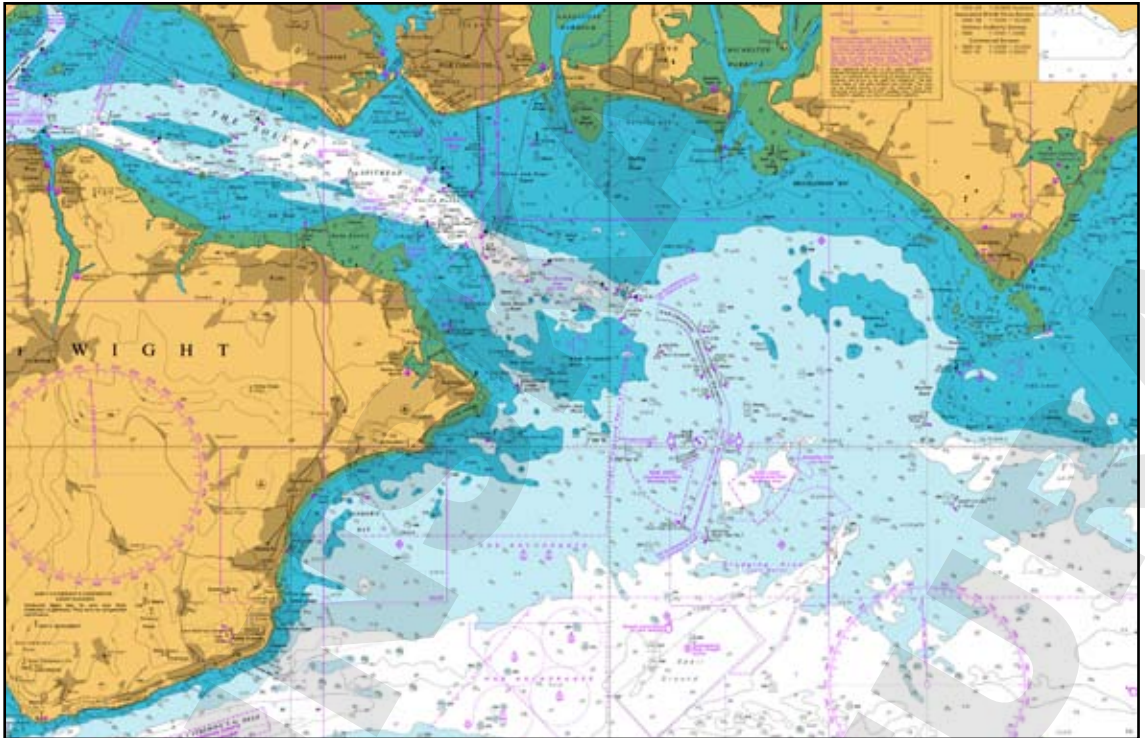
The Nab anchorage was developed by the Port of Southampton and the Dockyard Port of Portsmouth to manage the anchoring of waiting vessels, and to keep them from anchoring directly in the approaches to the pilot boarding position at the Nab Tower. Twelve designated anchoring positions, 8 inner and 4 outer anchorages (**Figure 11**), are situated between 2.5 and 6.5nm south-west of Nab Tower in depths between 15 and 27m. Of the 8 inner anchorages, 1 lies entirely within, and 4 lie partially within the Dockyard Port of Portsmouth Statutory Harbour Area (SHA) (**Figure 5**).

Chart showing overview of NAB anchorages

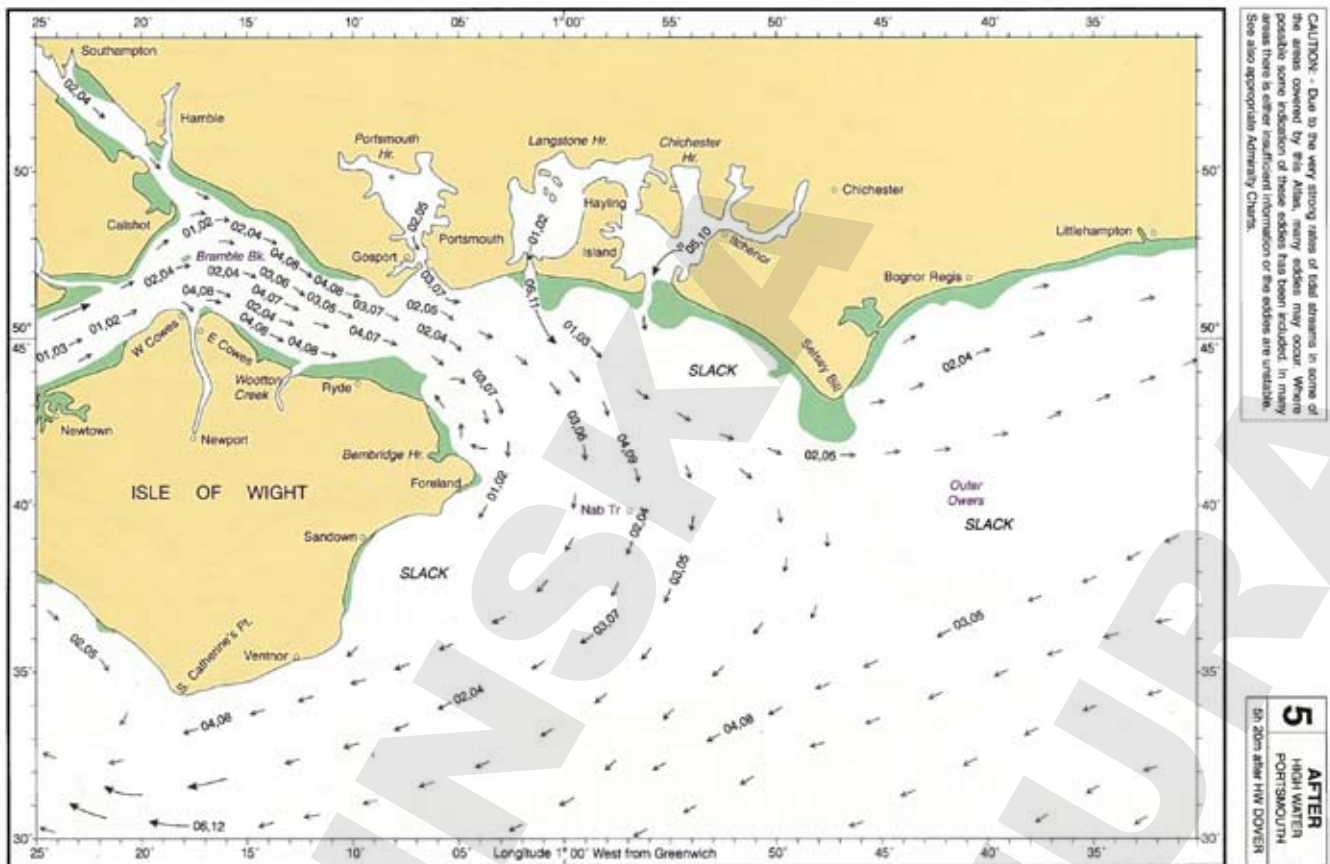
The Admiralty tidal stream atlas for The Solent and Adjacent Waters is shown for 0644 and 0744 on 10 March (**Figure 13**). The tide can be seen to change from slack water to a NNE'ly flow of around 1kt at the time *Astral* started to drag anchor.

Tidal flow at 0644 (ship's time)

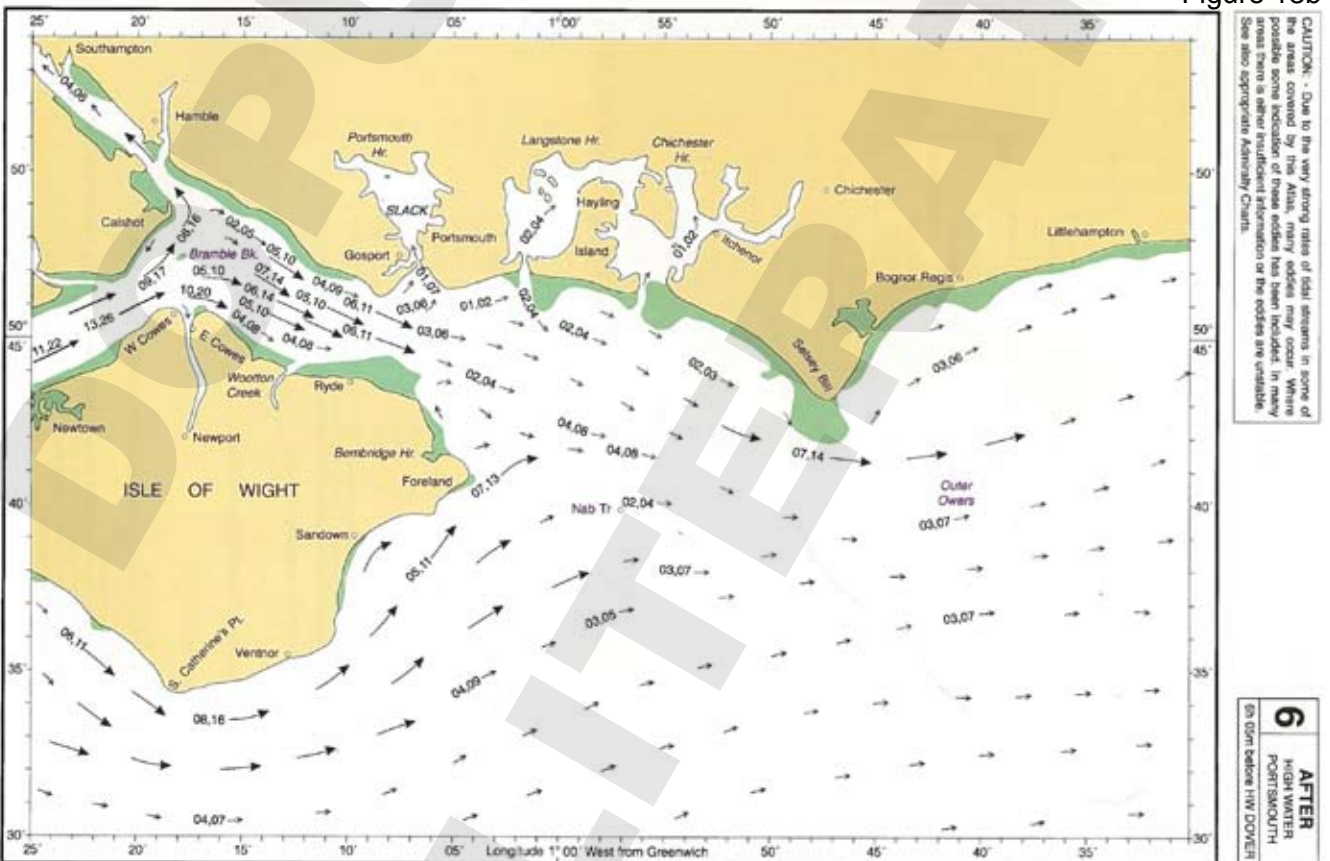
Figure 13b

Tidal flow at 0744 (ship's time)
