Report on the investigation of  
the capsizing and foundering of the fishing vessel

***Sarah Jayne (BM 249)***

6nm east of Berry Head, Brixham

11 September 2012

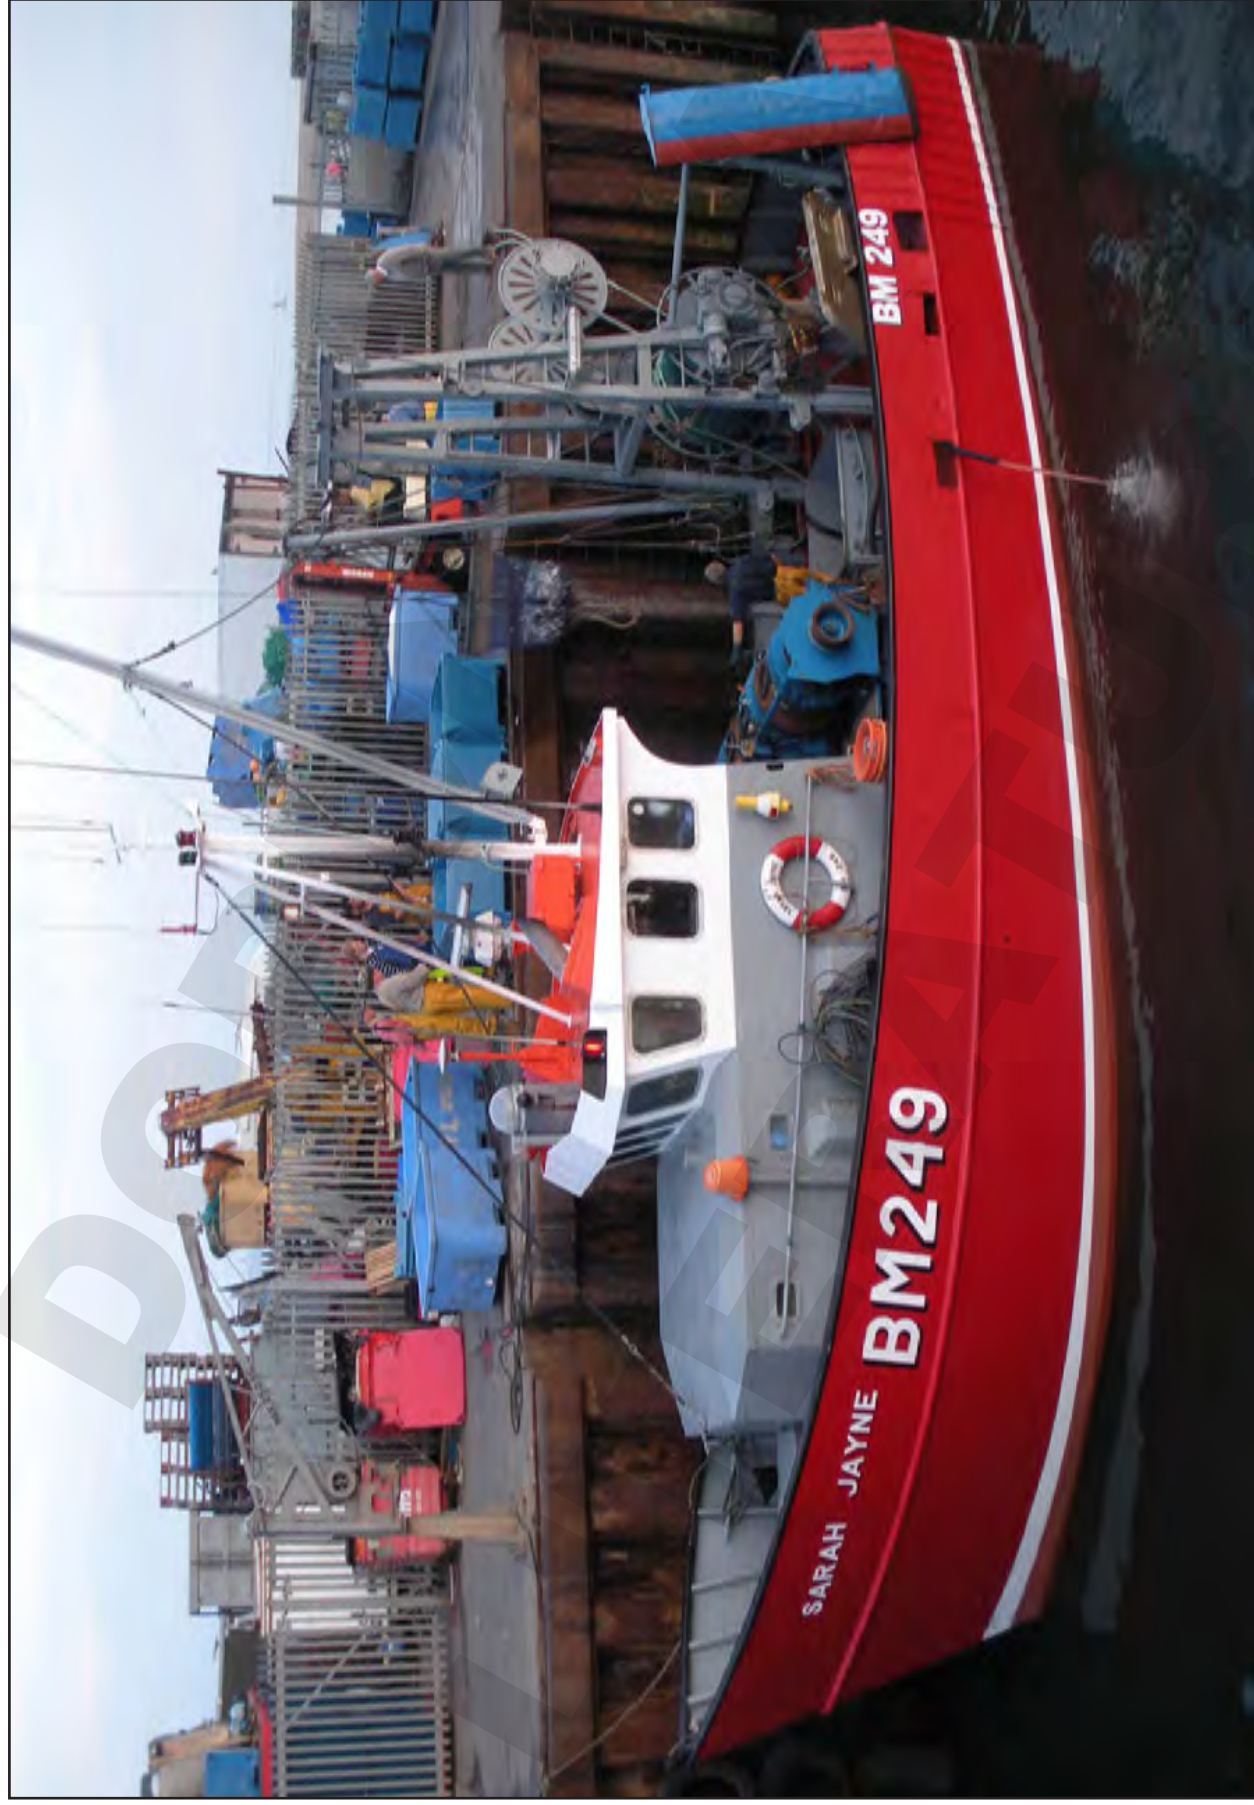
Figure 1: Sarah Jayne, rigged for stern trawling

*Sarah Jayne* (**Figure 1**) was based in Exmouth. She was used primarily for scallop dredging but also carried out stern trawling, particularly for sprats between August and January. The start and length of the sprat season depended on fish stocks. At the time of the accident, sprat stocks were abundant and local fishing vessels were landing large catches.

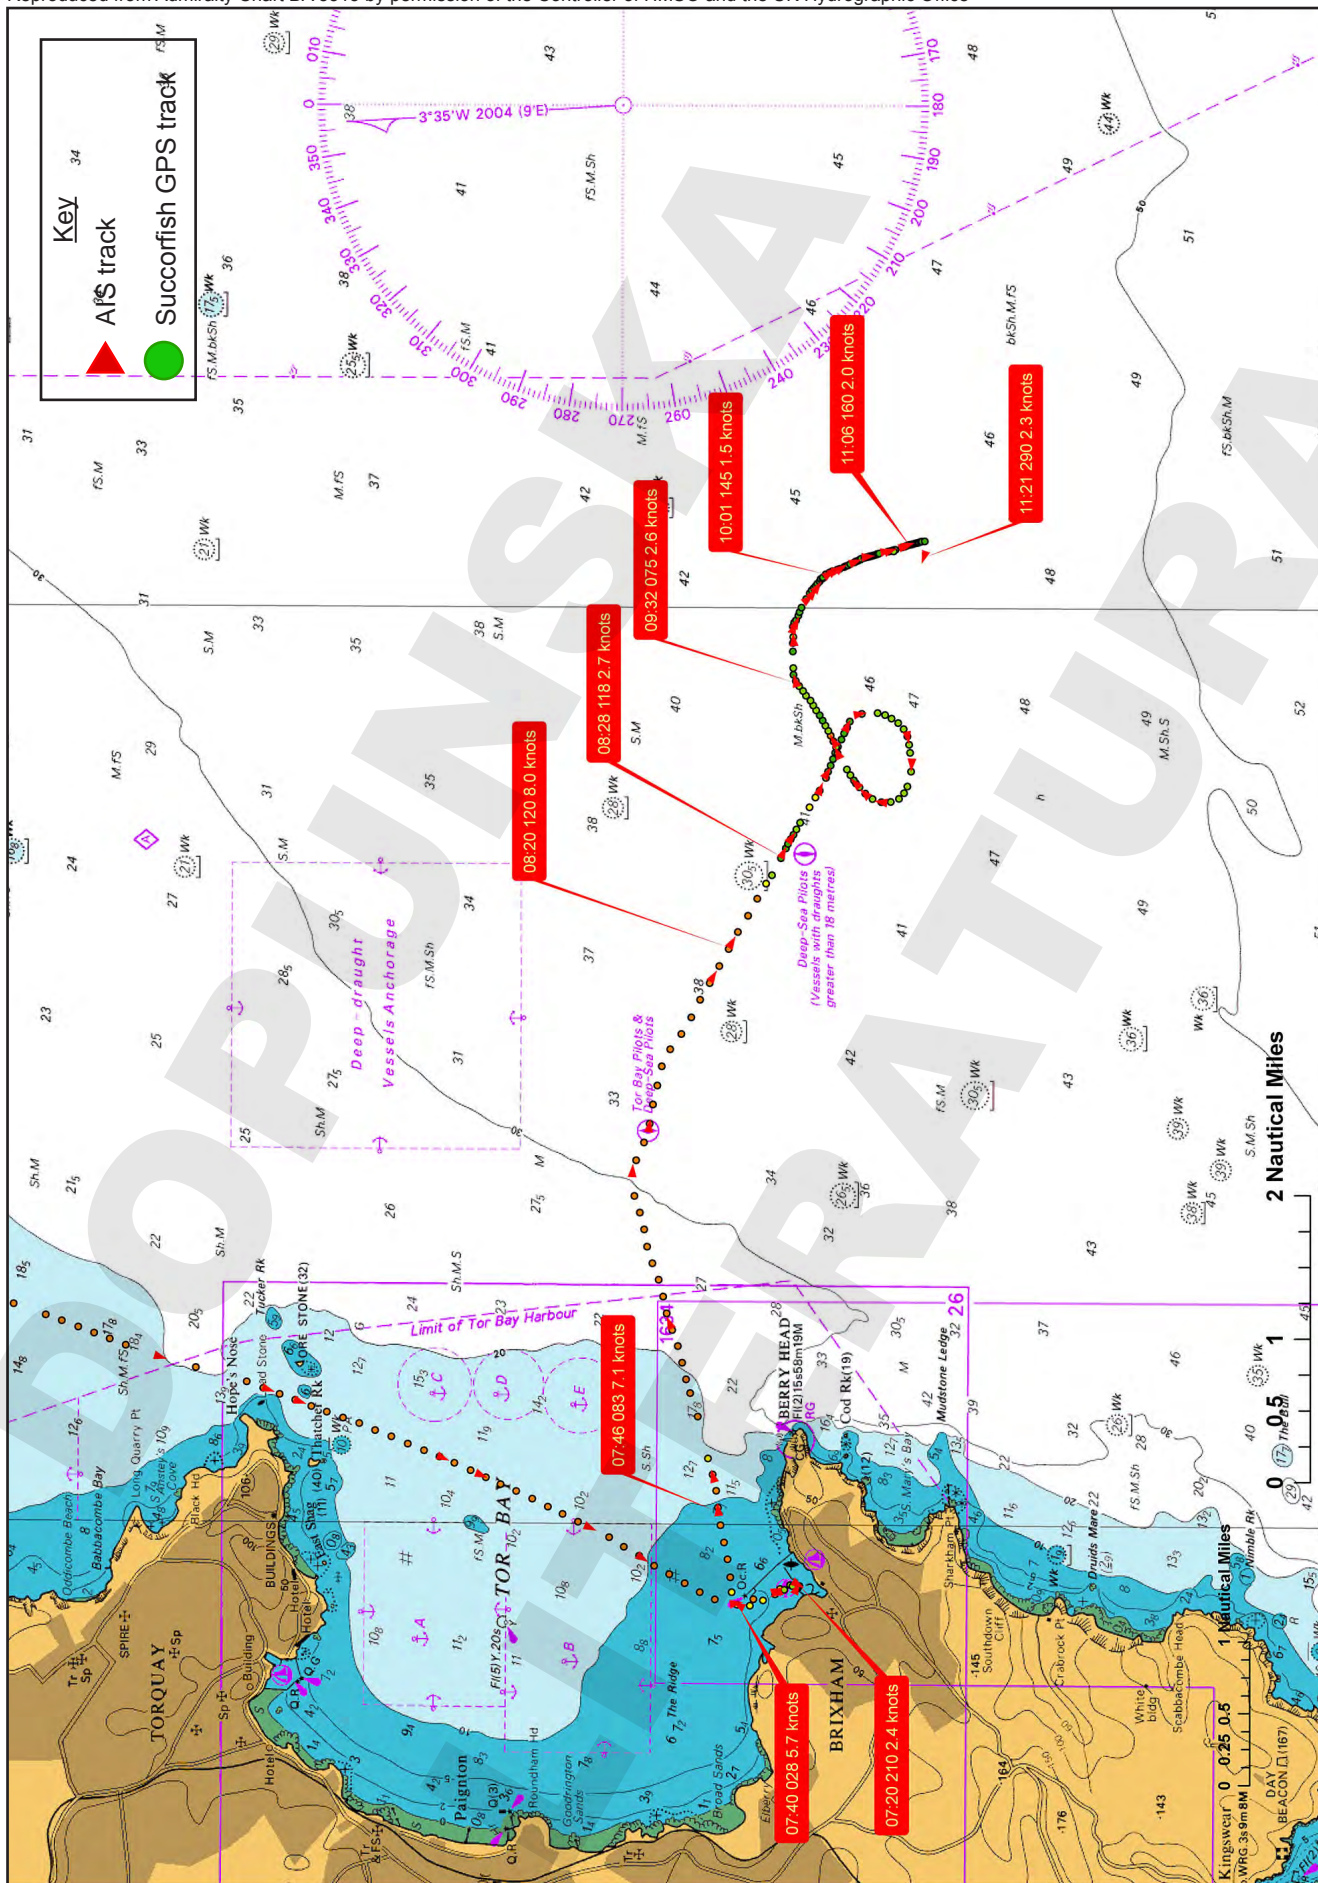
Figure 2: Sarah Jayne's track from AIS and Succorfish GPS tracking system

Fishing vessels *Constant Friend* and *Girl Rona*, with which *Sarah Jayne* often fished, were already heading towards the fishing grounds in Torbay. At about 0740, *Sarah Jayne* departed Brixham and a course was set for the fishing grounds. During the passage to the fishing grounds the mate rested, but he was called to assist with shooting the gear, which occurred around 0830-0845. The skipper started his tow in a south-easterly direction with 90 fathoms of wire deployed. Later, another 20 fathoms of trawl wire length was veered as the shoal of fish the vessel was tracking had swum deeper. At about 1000, the skipper decided to haul the net. **Figure 2** shows *Sarah Jayne*'s track from AIS and the Succorfish GPS tracking system.

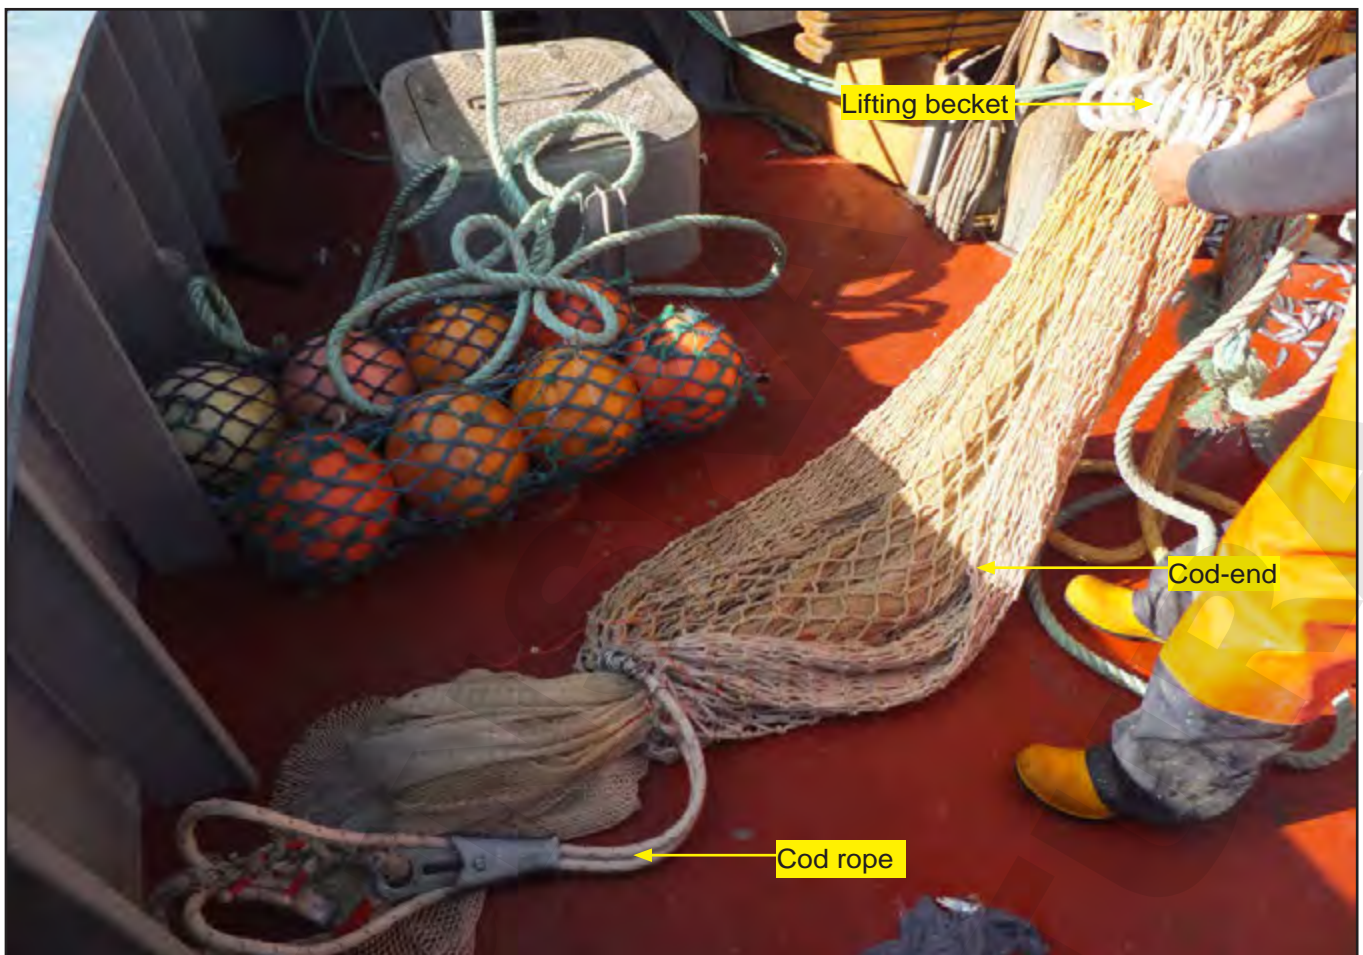
Figure 4: Cod-end

After hauling the net sufficiently to retrieve the dog rope, the skipper returned to the wheelhouse, took the engine out of gear and allowed the vessel to drift with the starboard beam to the wind. This enabled the net to be brought round on to the starboard quarter and secured alongside with a rope. The lifting becket<sup>1</sup> was hauled and the cod-end (**Figure 4**) lifted over the rail and held against the bag rope (**Figure 3**). The cod-end was released into the fish hold through the flush deck scuttle opening. The cod-end was then re-secured and dropped back into the water, the lifting becket was released allowing fish to fill the cod-end again, and the lifting procedure was repeated. Each time the cod-end was lifted on board it contained about 1te of fish.

<sup>1</sup> Besides providing a lifting point, the lifting becket also tightened around the cod-end, so that only the fish between the becket and the opening in the end of the cod-end were released onto deck.

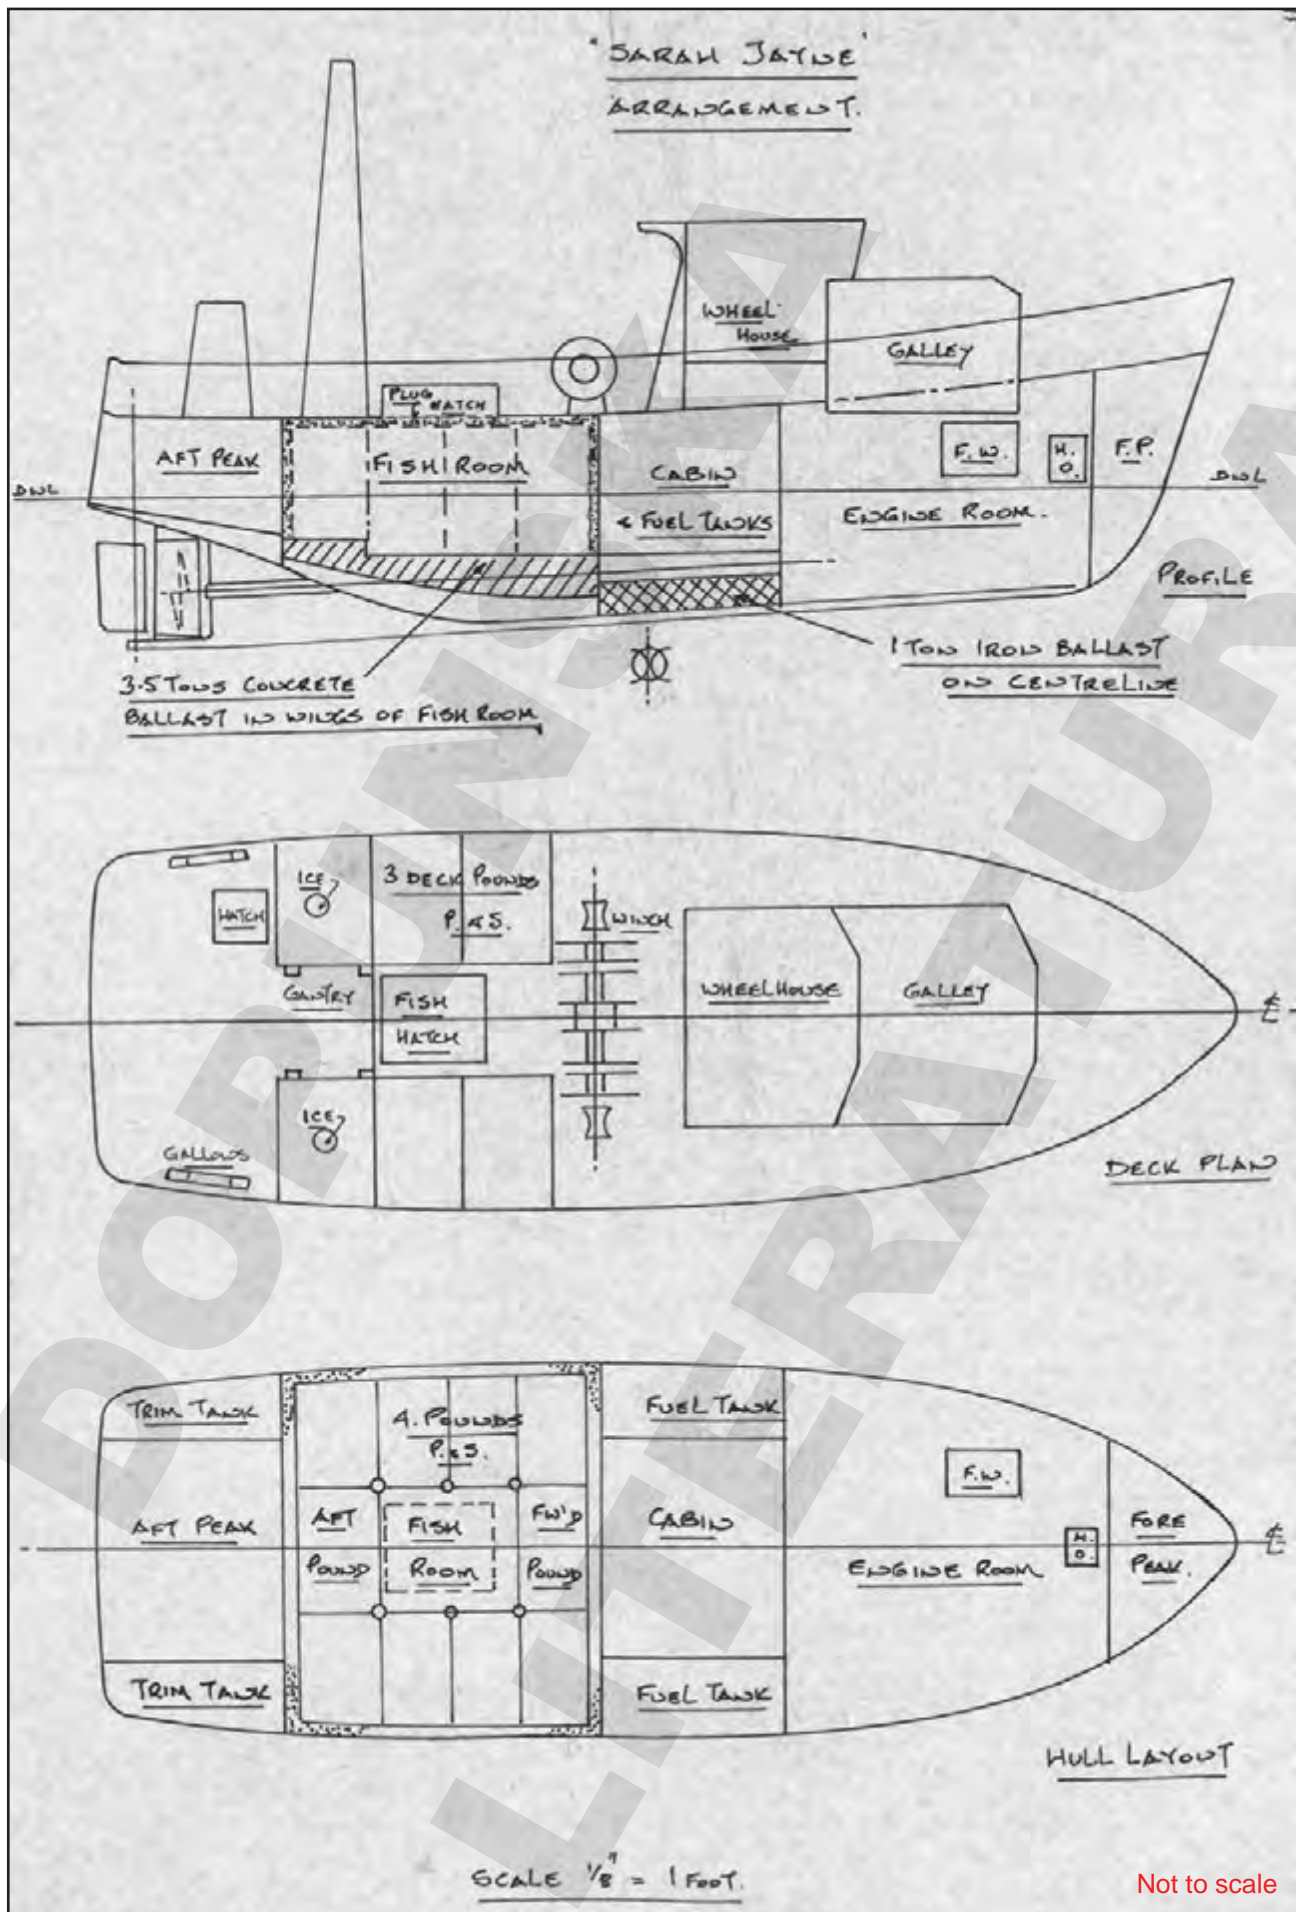
Figure 5: Sarah Jayne general arrangement

*Sarah Jayne* was built in 1979 by W. Visick & Sons Ltd, Truro. She was a multi-purpose fishing vessel, capable of being used for scallop dredging as well as beam and stern trawling (**Figure 5**). However, the owner had never used the vessel for beam trawling and had not sought a licence to do so.

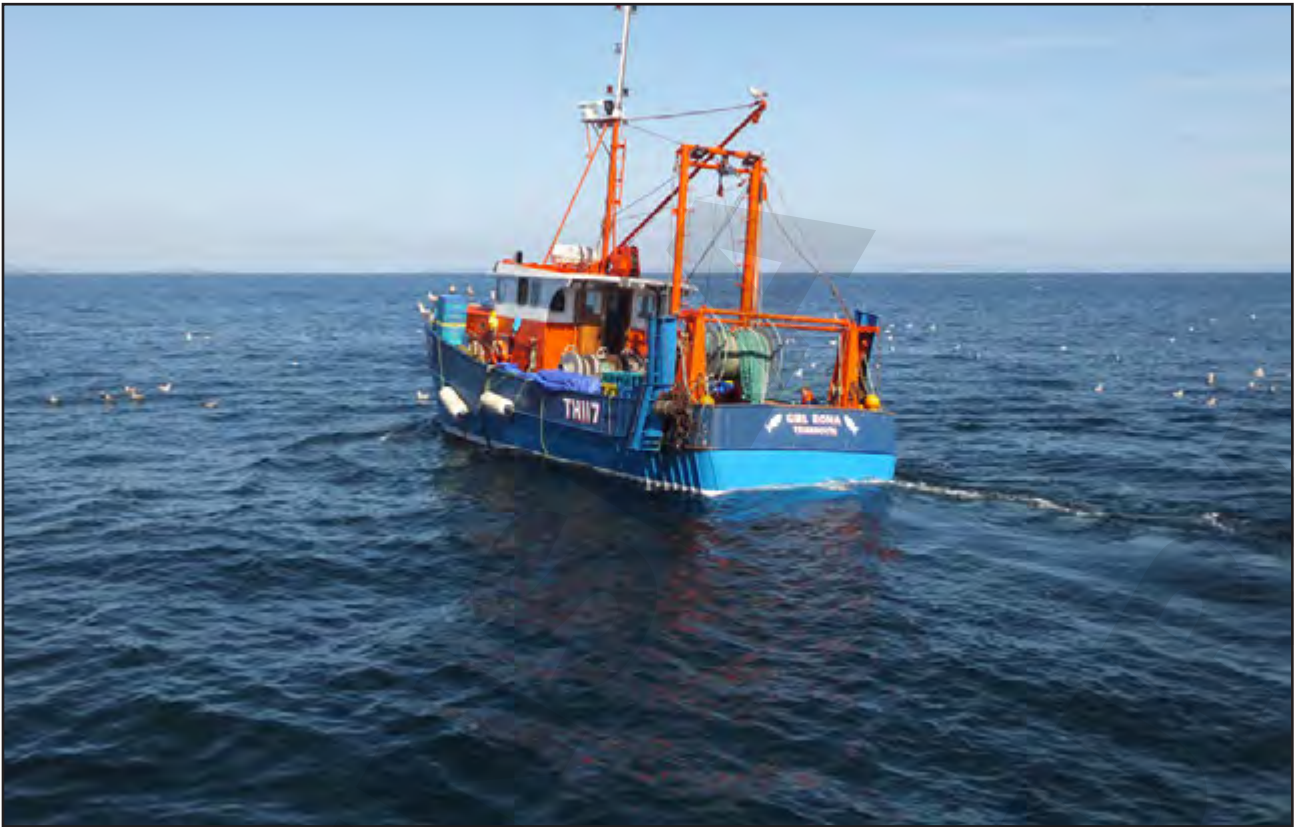
**Figure 6:** FV *Girl Rona*

*Sarah Jayne* was built as the second in a series of three similar sister vessels all developed by the same designer. The first, *Gerry Ann C* (TH 257), was constructed in 1975 and the third, *Girl Rona* (TH 117) (**Figure 6**), was completed in 1980. All three vessels operated in the Torbay and Lyme Bay area.
