MARINE SAFETY INVESTIGATION REPORT

Safety investigation into the grounding of the
Maltese registered container vessel

APL DANUBE

MARINE SAFETY INVESTIGATION REPORT NO. 08/2020

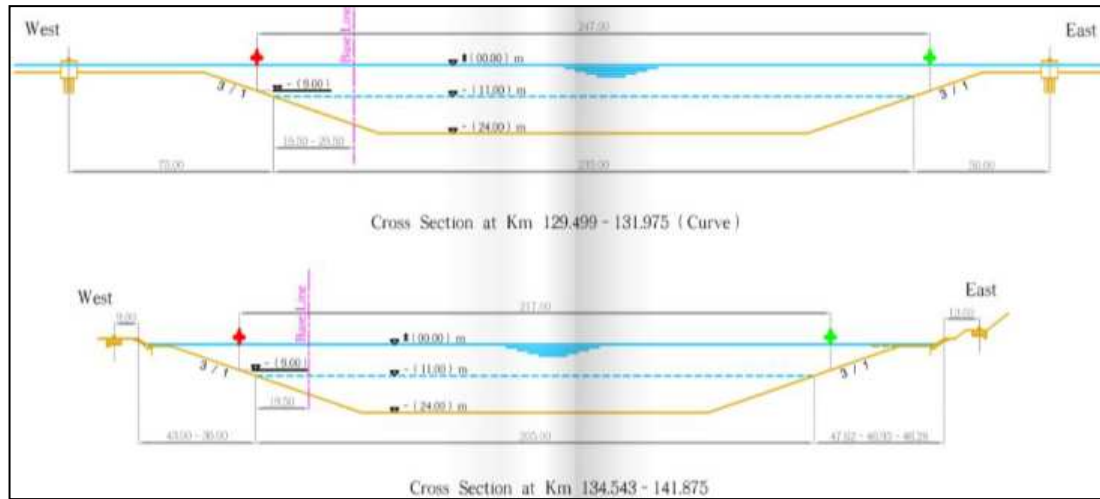
Figure 4: Cross sections before and after Km 133

The channel's cross sections were indicated to be trapezoidal in shape, having side slopes of 4/1 in its Northern part, and 3/1 in its Southern part. The Rules contained various drawings of cross sections of the channel. Figure 4 details the cross section before and after Km 133. From Figure 5 it can be seen that near Km 133, the channel's width is enlarged to include a garage⁷ section.

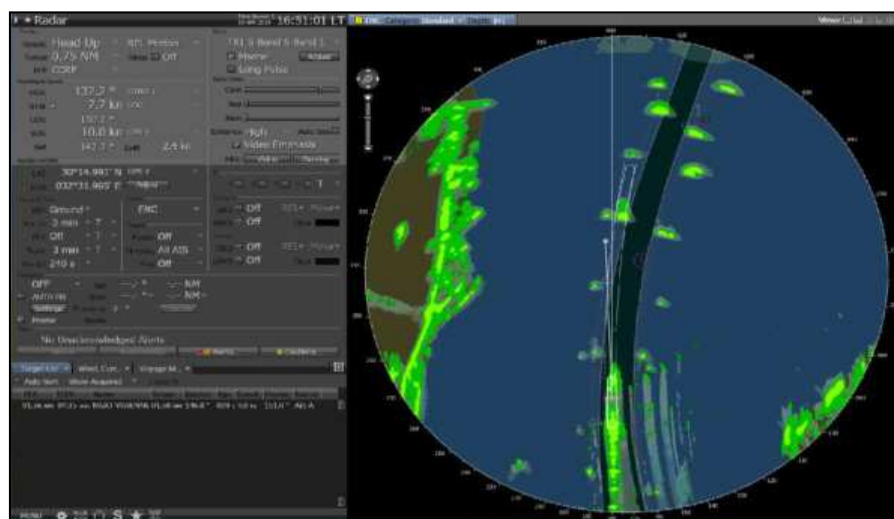
Figure 7: Extract from S-band radar showing the vessels' position at 1651

At 1651 (Figure 7), the chief officer entered the bridge.
