**Fall of a suspended load, resulting in injuries
to two crewmen on board the general cargo vessel
ZEA Servant
in Campbeltown, Scotland
on 2 March 2019**

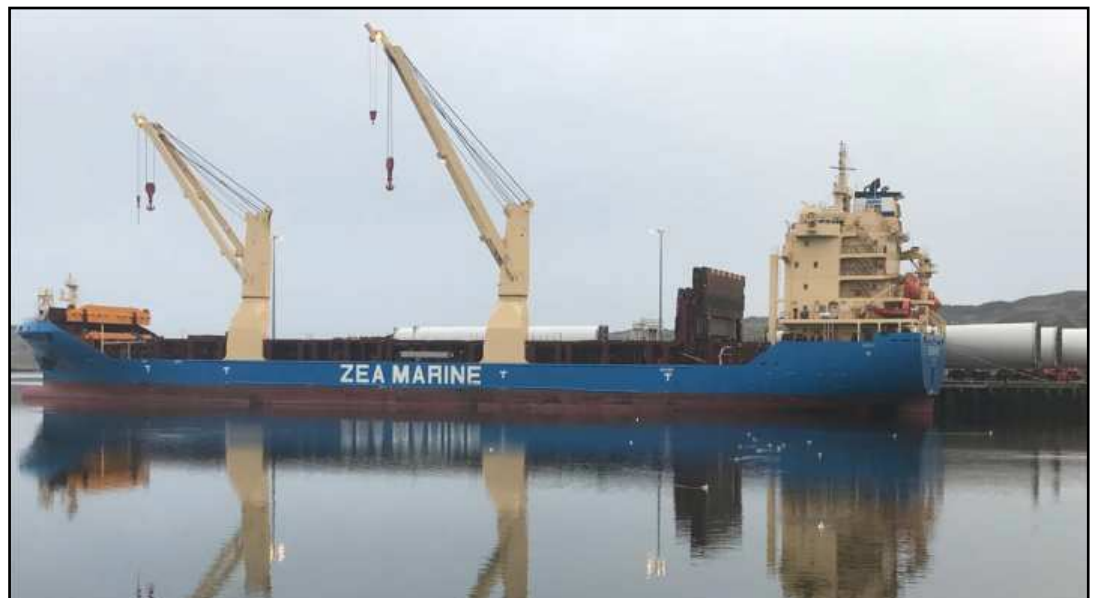
ZEA Servant arrived in Campbeltown, Scotland on 1 March 2019 to load a cargo of wind turbine tower sections (**Figure 1**). On 2 March 2019 the deck crew, supervised by the chief officer, began preparing the vessel for cargo loading. This work was halted in the afternoon due to adverse wind conditions, but was scheduled to recommence later in the evening when the weather was expected to improve. At 2100, the chief officer held a safety briefing and took up position as supervisor, accompanied by the bosun. By this time, the wind was light, and it was dark and dry; the vessel's deck working lights were on, illuminating the area where the crew were working.
