Report on the investigation into the contact  
made by the tanker

***Vallermosa,***

***Navion Fennia*** and ***BW Orinoco***

at the Fawley Marine Terminal

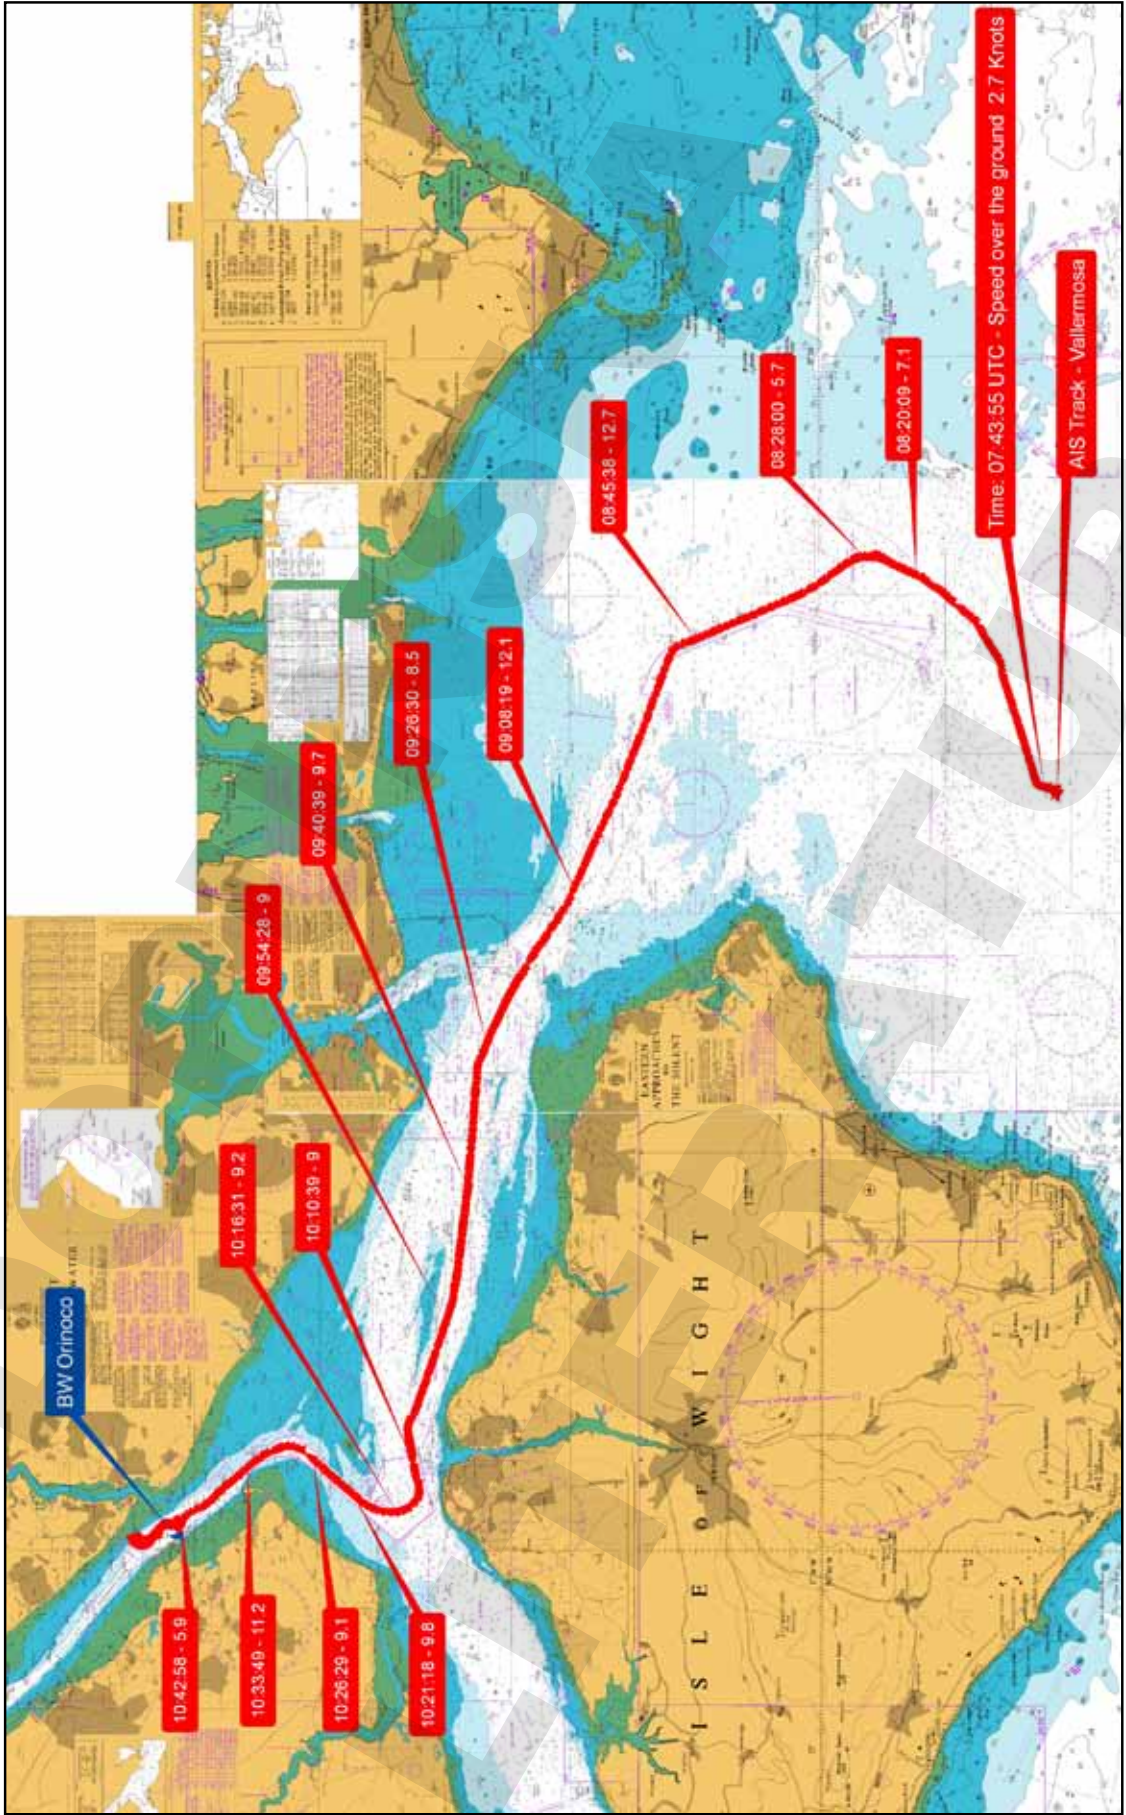
Figure 1

*Vallermosa* completed loading in Rotterdam at 0106 CET on 24 February, and the ship cleared harbour at 0648 that morning. Following an uneventful voyage, the vessel anchored at 2212 the same day at the Nab Anchorage No.10, south-east of the Isle of Wight (**Figure 1**)<sup>1</sup>, to await her berth at the next high water.

Route taken by Vallermosa

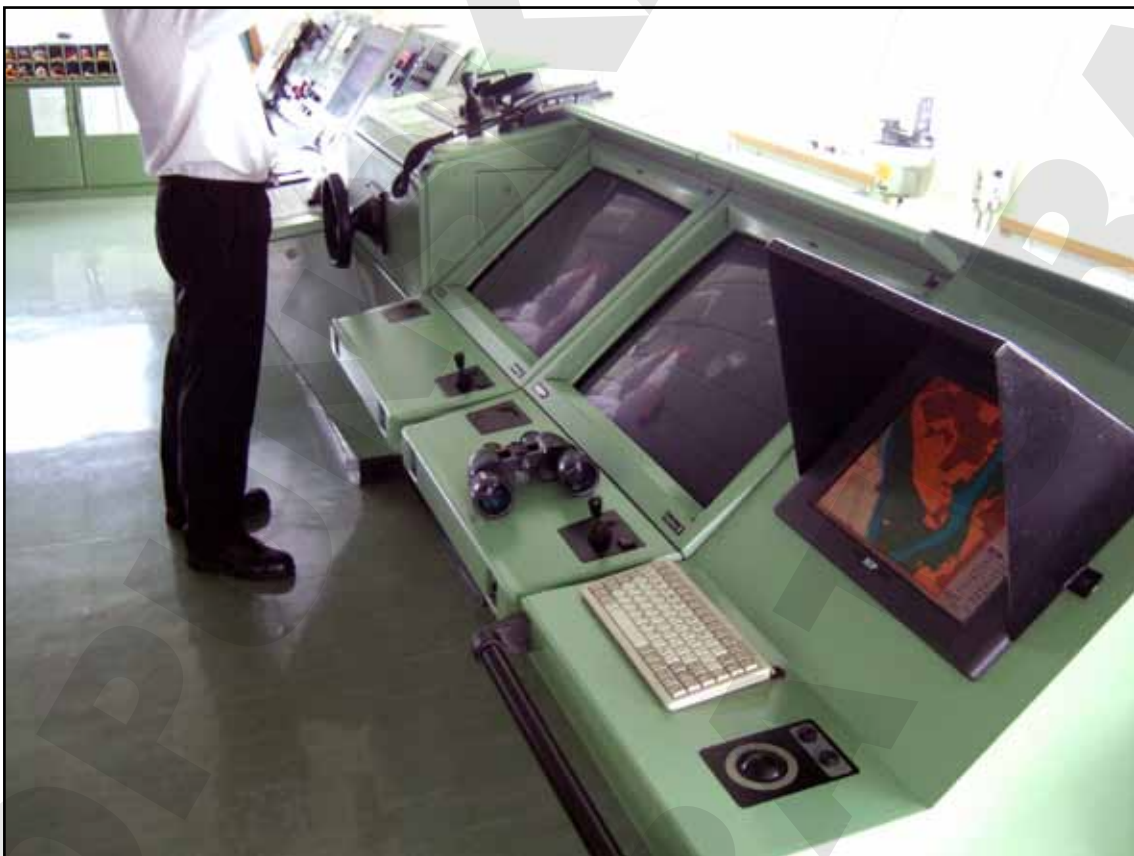
Figure 4

As *Vallermosa* proceeded inbound, the bridge was manned by the master, the 3/O, a cadet and a helmsman. The cadet was plotting the vessel's position on the paper chart, the 3/O was responding to the pilot's engine instructions, and the helmsman steered the vessel to the pilot's orders. The pilot was standing by the starboard radar display (**Figure 4**). The master remained on the bridge throughout and allowed the pilot to con the ship.

Pilot's position next to the starboard radar display

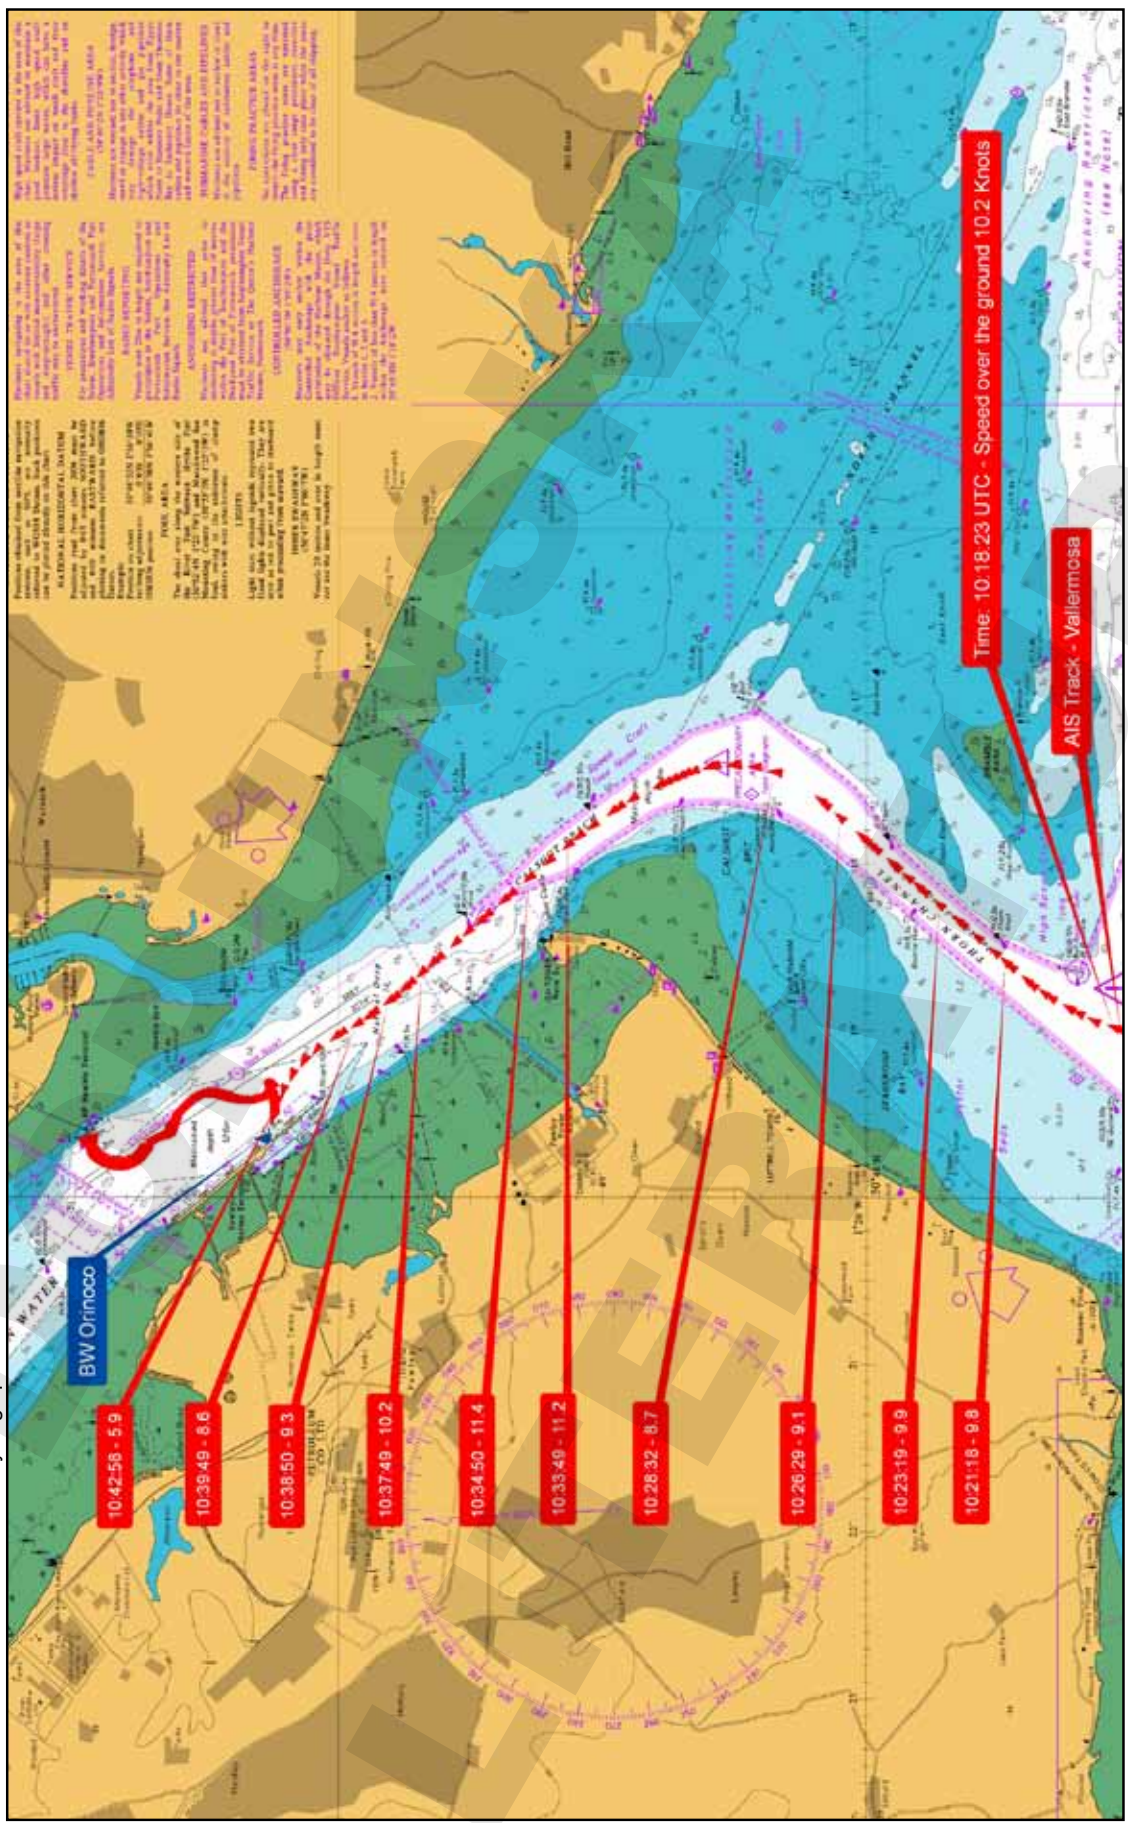
Figure 5

At 1021, once *Vallermosa* had completed the turn and was steady on a course of 040° (**Figure 5**), the pilot called Southampton VTS to confirm that the vessel was required to return to anchor. The Vessel Traffic Services Officer (VTSO) confirmed the information and explained that the vessel should return to the Nab anchorage, rather than the closer Ryde Middle anchorages, as the time required to rectify the paperwork problem was unknown.

Route taken by Vallemorsa

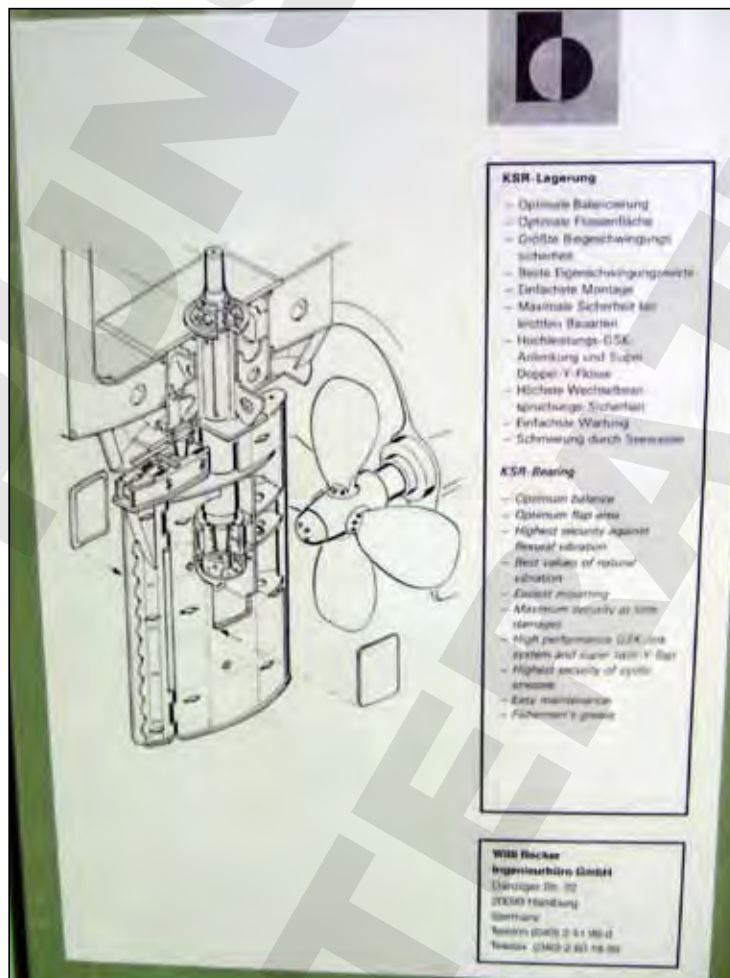
Figure 12

*Vallermosa* was designed and fitted with a Becker rudder. The main advantage of the Becker rudder (**Figure 12**) is that it generates greater lateral forces than conventional rudders at small rudder angles. The flap at the trailing edge of the rudder turns to almost twice the angle of the main rudder blade. The maximum lateral force was achieved at a main rudder angle of about 35° with the flap at an angle of around 70° from amidships.

Photograph of Becker rudder information

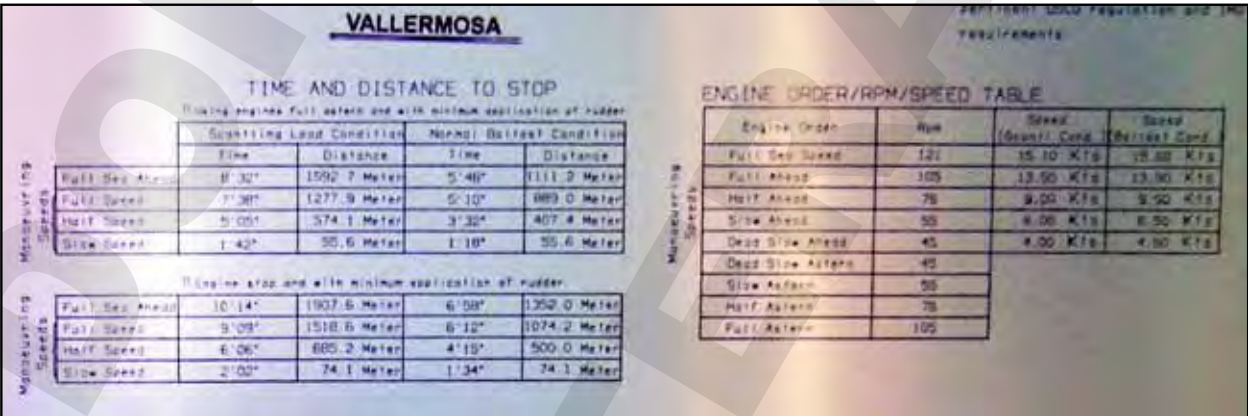
Figure 14

Vallermosa's manoeuvring data was provided to the pilot during the pilot / master exchange discussion held when he arrived on board, and on the pilot card (Figure 3). Additional data was available on the bridge, located below the forward bridge window, but the pilot was unaware of it. The stopping data (Figure 14) indicates that, for example, with an ahead speed of 9 knots in the loaded condition, had the main engine operated full astern, Vallermosa would have stopped in 574.1m (3.1 cables). The effect on the heading, on a vessel which is directionally unstable, is not shown.

Stopping data from Vallermosa

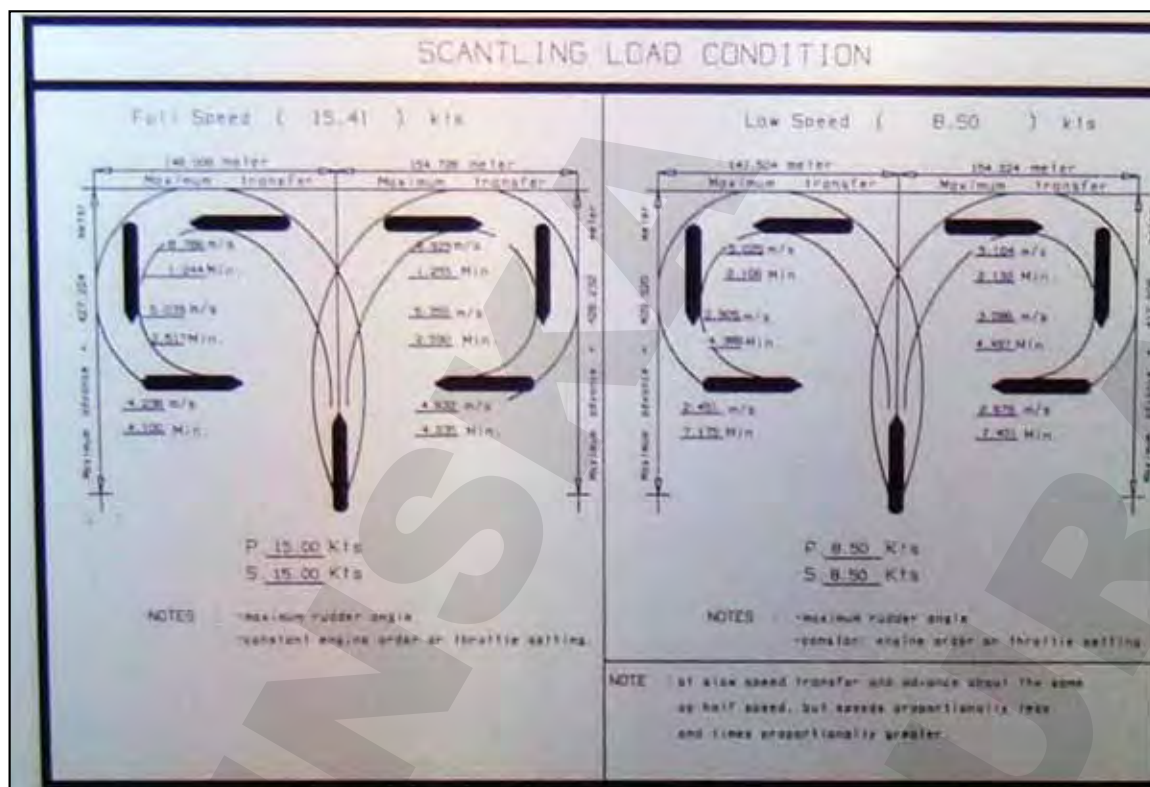
The turning data (Figure 15) indicates that in the loaded condition at 8.5 kts with maximum rudder angle and constant engine speed, Vallermosa would advance by a maximum of 410m (2.2 cables) and transfer 150m (0.8 cables) during a full round turn. This distance would be affected by the environmental conditions; notably, the advance and transfer could have increased due to the depth of water.

Turning data from *Vallermosa*

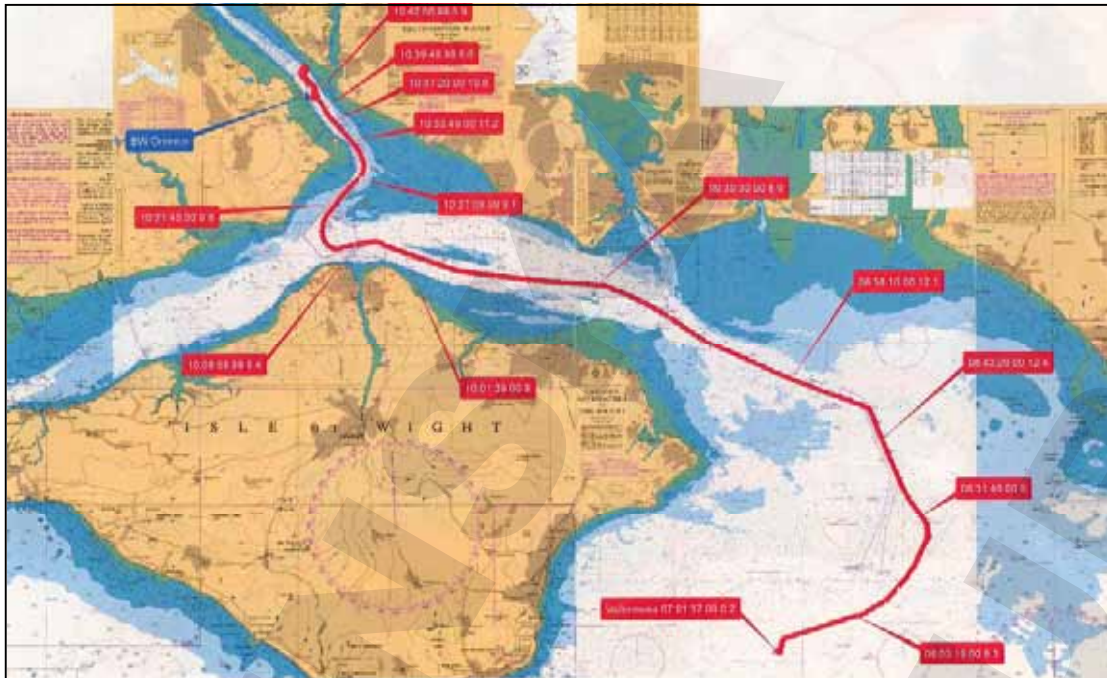
The Vallermosa was planning to berth at the BP Hamble Terminal and left her anchorage off the south east of the Isle of Wight with this intent at about 0700 UTC hours on 25 February, 2009 (see Figure 1). She then proceeded to take the a course along part of the Nab Channel into the Eastern Solent where she arrived making about 12 knots over ground, a speed which was reduced to around 9 knots off Ryde at which point she appears to have followed the radar reference line to the turn past Calshot Spit. She was still making 9 knots overground past Ryde Middle and on entry to the Thorn Channel.

Figure 1: Route of the Vallermosa on 25 February 2009

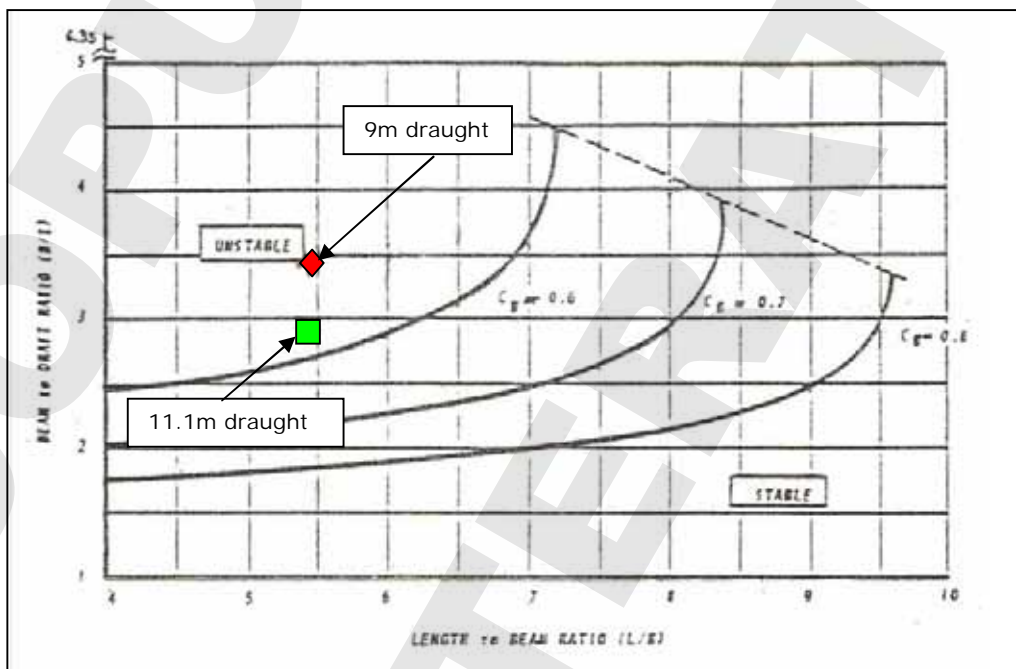
The first plot is shown in Figure 2 and is taken from Reference 1. Boundary lines are plotted as stability boundaries with the "stable" and "unstable" regions marked. It is seen that the ship as originally designed fell on the "unstable" side of the boundary for block coefficients around 0.8 and was improved at the deeper draught, although still classed as unstable.

Figure 2: Directional Stability Check 1 from Reference 1

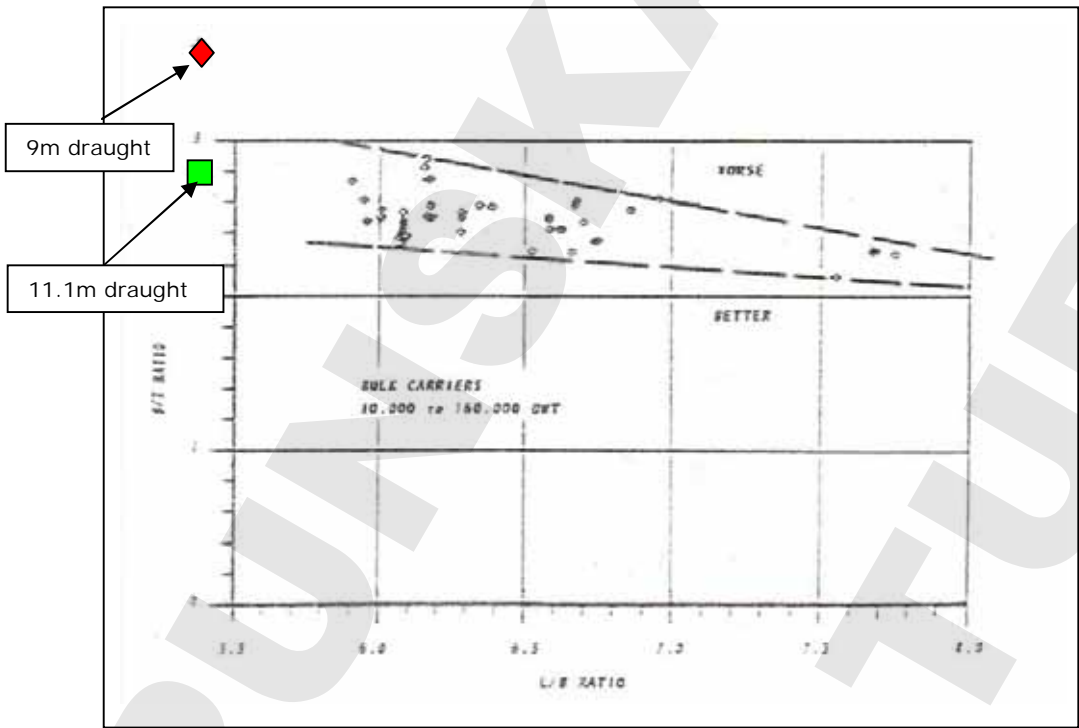
Figure 3 shows an alternative plot from Reference 2 which shows the Vallermosa to be more stable (and just on the stability margin) at the deeper load draught, by virtue of its smaller beam/draught ratio.

These two plots suggest that the Vallermosa at the time of the incident may have had a tendency to directional instability as is often the case with ships having block coefficients in excess of 0.8 and length/beam ratios less than 5.5.

Figure 3: Directional Stability Check 2 from Reference 2

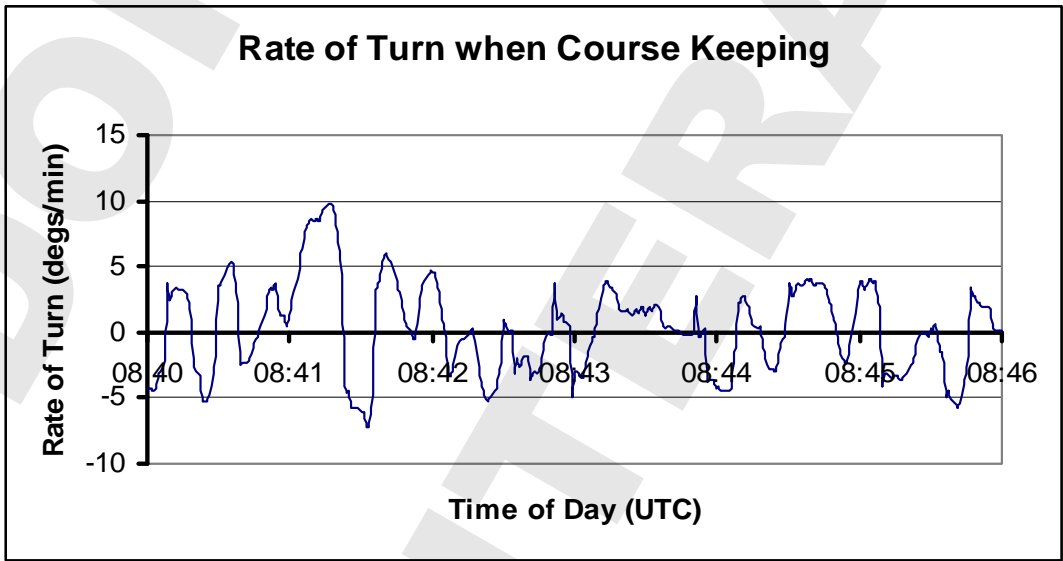
Further assessments of this were made using data from the Vallermosa VDR for the period of time from her leaving the anchorage to exit from the Thorn Channel. Figure 4 shows the rate of turn plot against time of day for a period from 08:40 UTC to 08:46 UTC, a time when, as can be seen from Figure 1, the ship was on a nominally steady course in the Nab Channel off the eastern extremity of the Isle of Wight.

Figure 4: Vallermosa Measured Rate of Turn while on a Steady Course

It is seen that the rate of turn is hardly ever steady or close to zero, as one might have expected on a day when the winds were light and the sea slight. The plot in Figure 4 was made from data sampled every second, so the undulations, whose periodicity is well in excess of the sampling period, cannot be ascribed to noise in

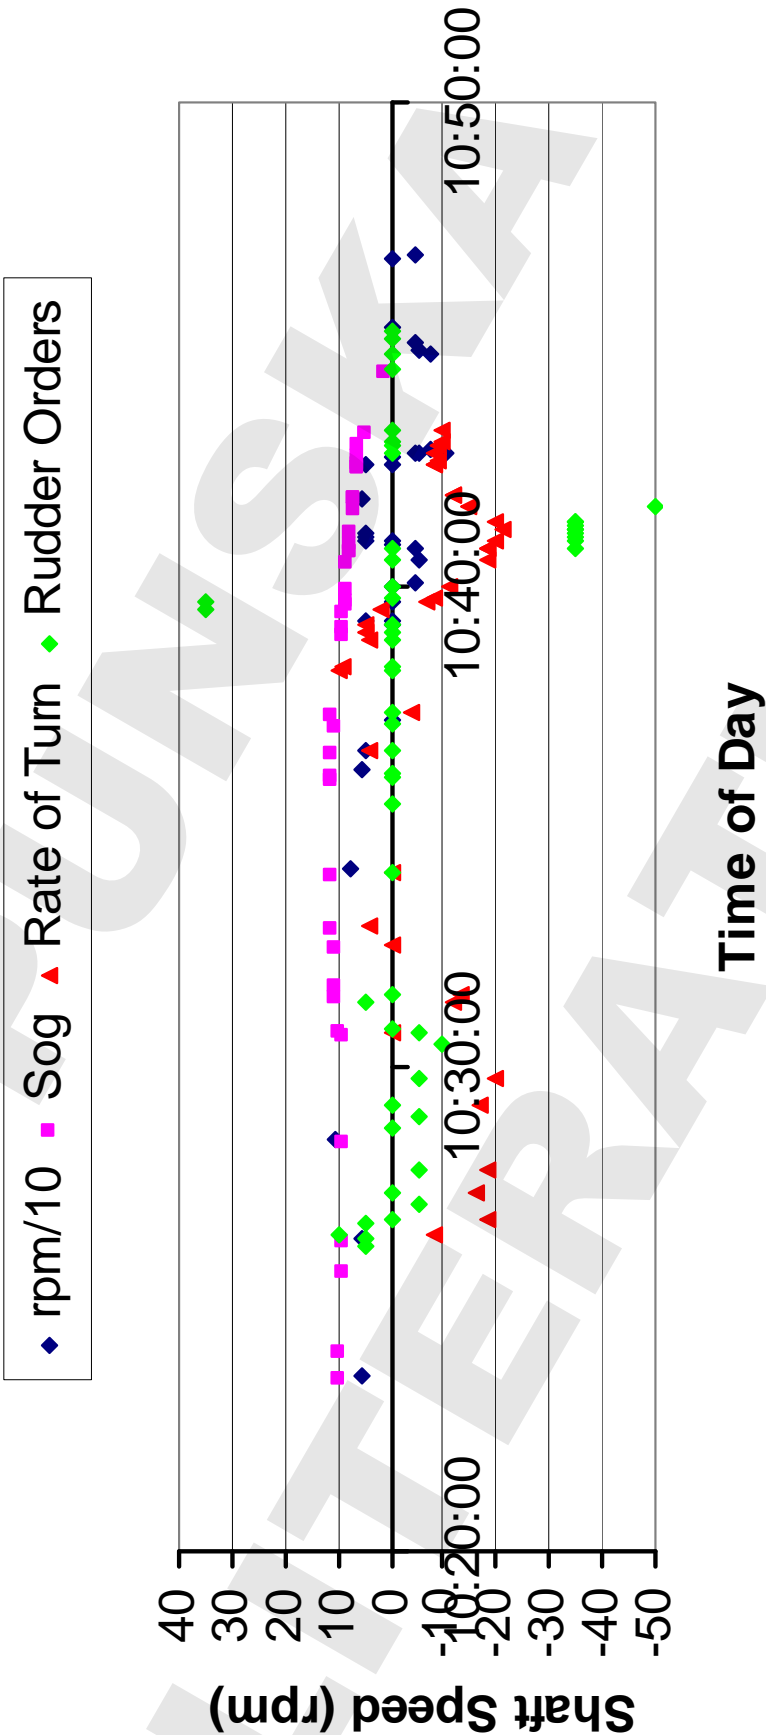
# Vallermosa Log 25/2/09, 1020-1050

Figure 5: Data from Vallermosa VDR and Bridge Voice Recorder

The period from 10:21 to 10:34 saw the ship navigating the bend round Calshot Spit successfully and heading to leave the Hook buoy to starboard. Figure 5 shows that the overground speed was of the order of 10 knots at this point and reducing, with the engine on slow ahead. Full ahead was achieved at about 10:28, as the ship was turning to port and about to exit the Calshot Spit bend. As can be seen from Figure 6, this may well have been to increase the turn rate to ensure the vessel made the turn, but it was quickly reduced as the vessel came out of the turn, only to be increased quite noticeably again as a further correction to port was made off the Reach buoy. This does not indicate a “good bend” and the upshot was that, as “full ahead” was maintained until about 10:34 (some 6 minutes later), the overground speed had increased to around 11 knots at the end of this leg, with the ship more-or-less steady on course.

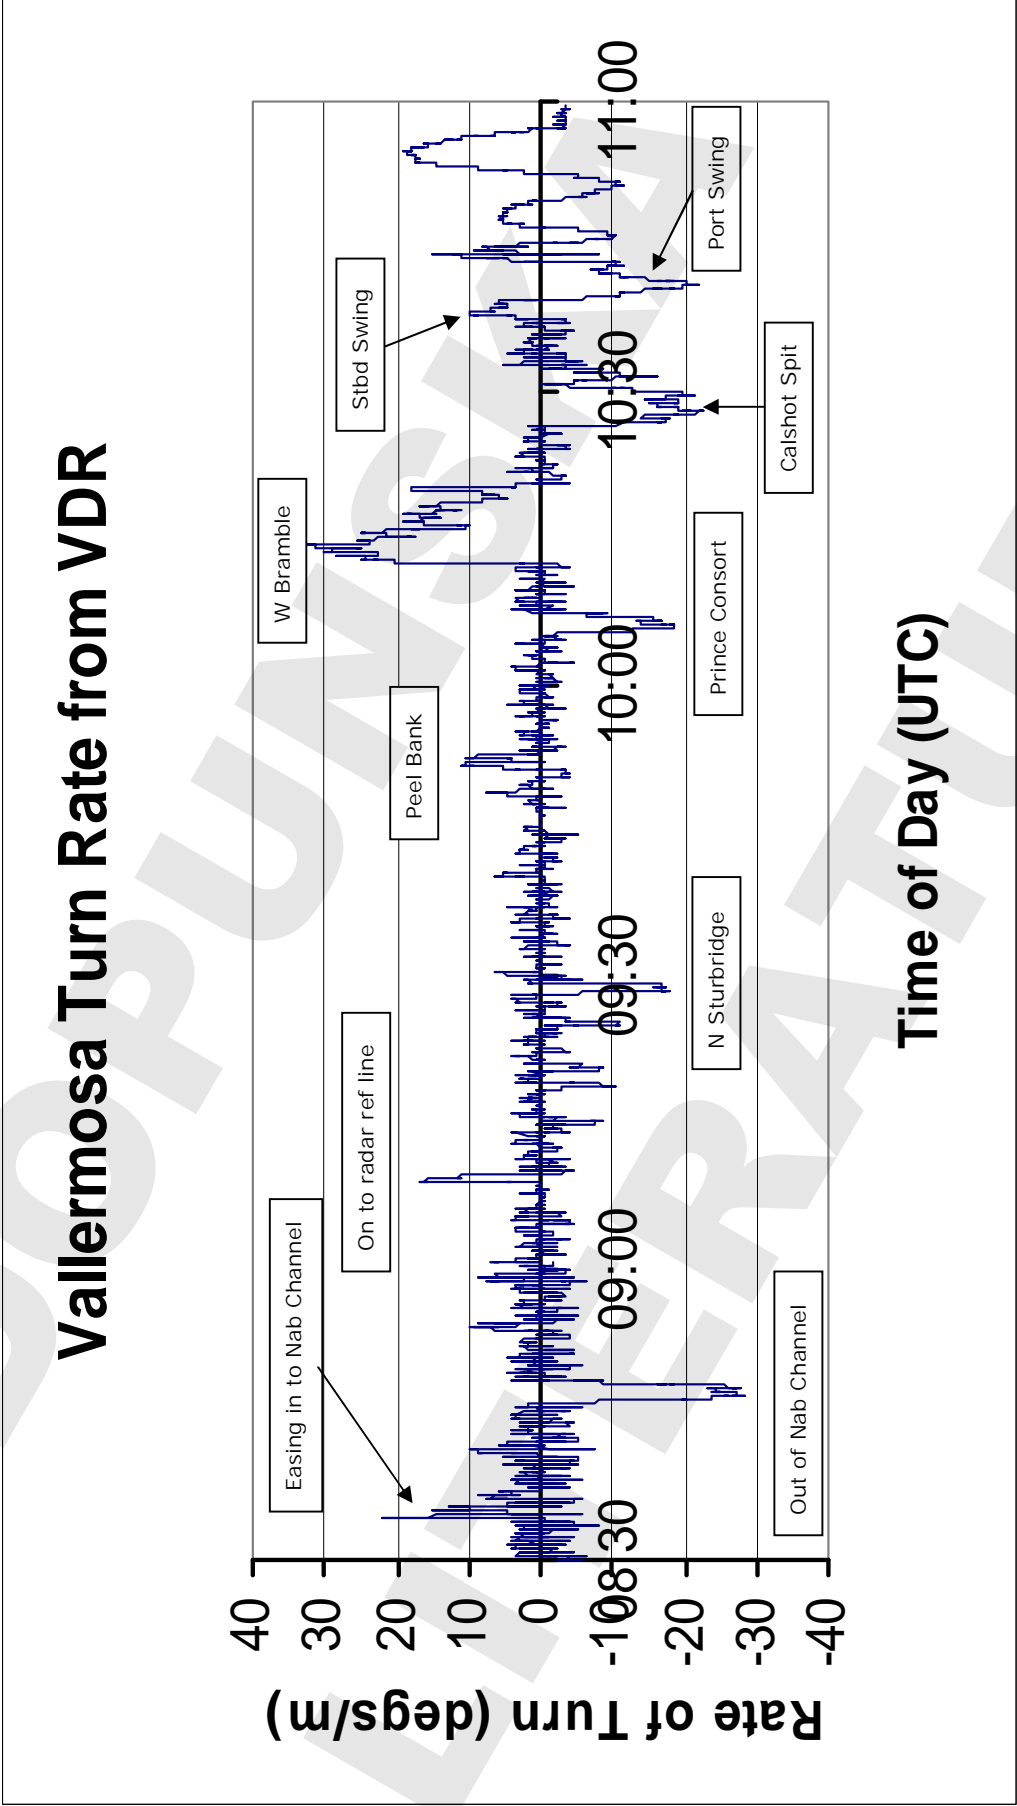
Passage from 08:30 to 10:00 took the vessel from entry to the Nab Channel to Ryde Middle. It is seen from Figure 1 that the track shows no anomalies and the transit over this part of the passage appears quite normal. Figure 6, however, reveals a continuous turn rate variation about zero which reinforces the comment, made in Section 5.2 above, that the ship was not able to steady on a course on a day when the weather was benign. Any turns appear to be hesitant with a number of incremental heading changes, a feature which is seen frequently in the whole passage.

Once again the number of changes in the rate of turn plot in Figure 6 suggests a ship that was slightly course unstable and liable to wander off course if not checked.

Figure 6: Rate of Turn Measurements from Vallermosa VDR
