MARINE TRANSPORTATION SAFETY INVESTIGATION REPORT M18P0014

ENGINE ROOM FIRE

Container vessel *MOL Prestige*

31 January 2018

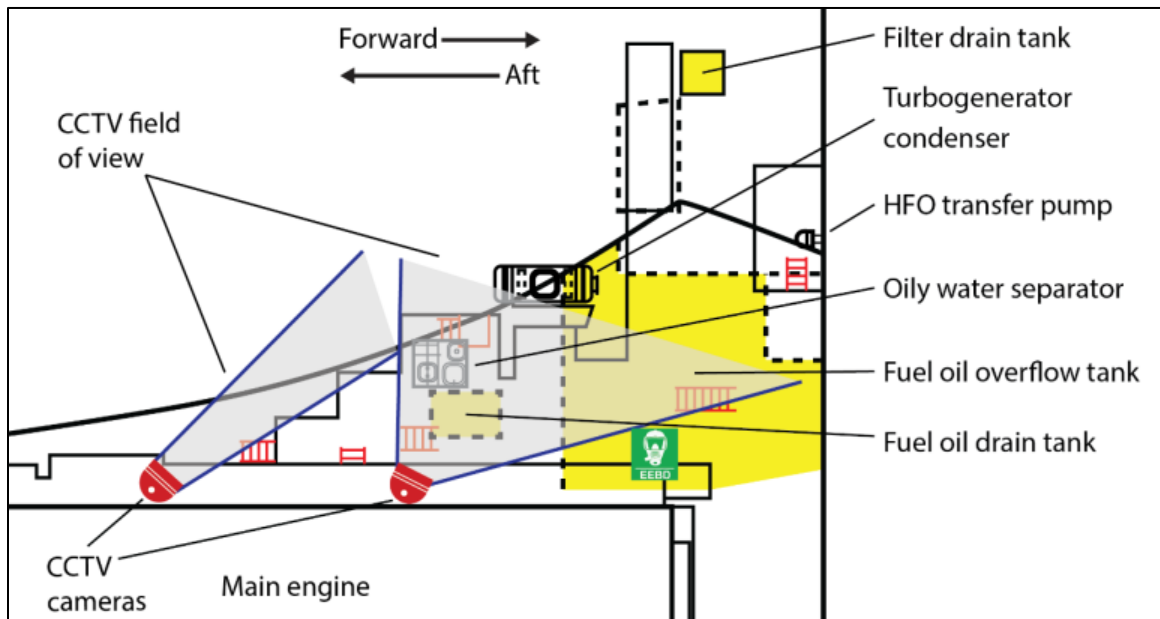
Figure 6. Locations of closed-circuit television cameras on Deck 4 and their field of view (Source: TSB)

The second engineer ordered motorman 1 to check the decks below. At 2118:06, the CCTV captured footage of oil spraying onto the oily bilge water separator located on the bottom deck. Motorman 1 exited the ECR and was partly down the stairs from deck 2 to deck 3 when smoke and flames were observed on deck 3 near the auxiliary boiler area. He returned to the ECR and informed the second engineer. The junior engineer informed the second engineer that he had inadvertently turned off the boiler circulating pump on deck 4. The junior engineer then exited the ECR through the starboard-side door and restarted the pump at 2118:34. At 2118:39, burning oil and flames were observed near the stairs between deck 3 and 4, close to the No. 3 generator.²⁸ Soon after, the engine room started rapidly filling with black smoke. At 2119:05, the junior engineer rushed back into the ECR. At this time, the generator frequency also began fluctuating.

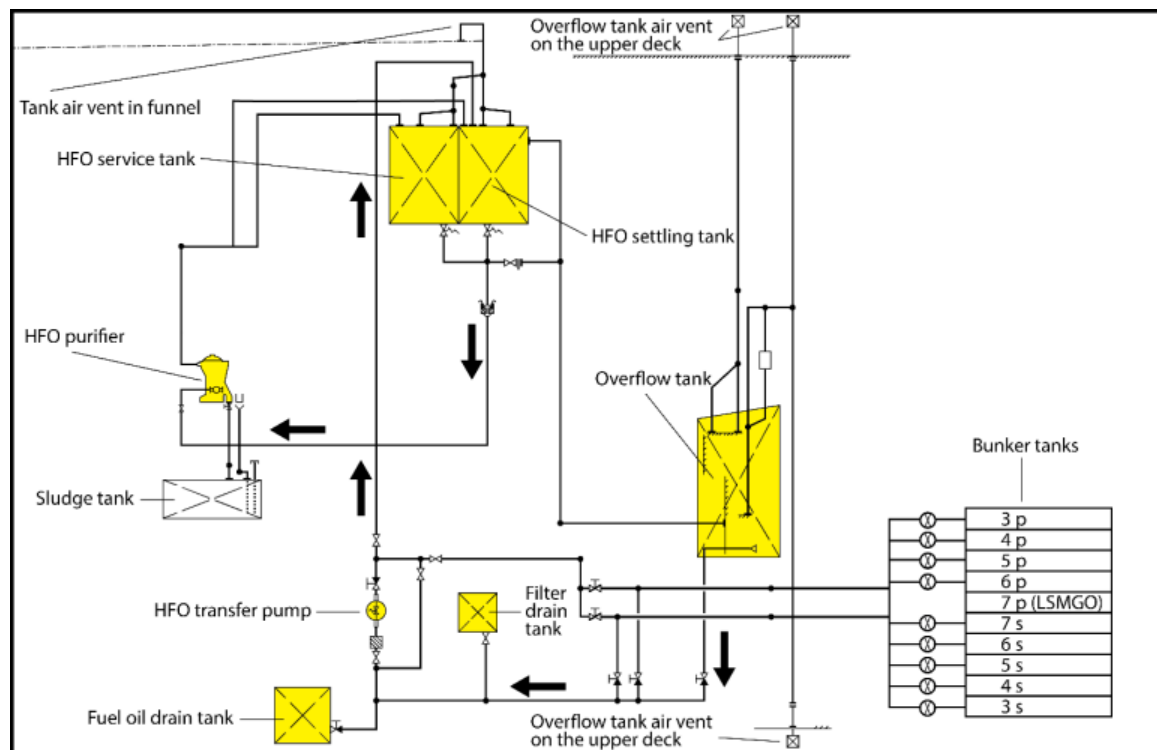
Figure 12. HFO fuel system components (Source: TSB, based on the vessel's piping diagram)

At the time of the occurrence, the crew was transferring HFO from bunker tank 7S to the HFO settling tank using the transfer pump. They were also transferring oil from the HFO settling tank through the purifier into the HFO service tank.

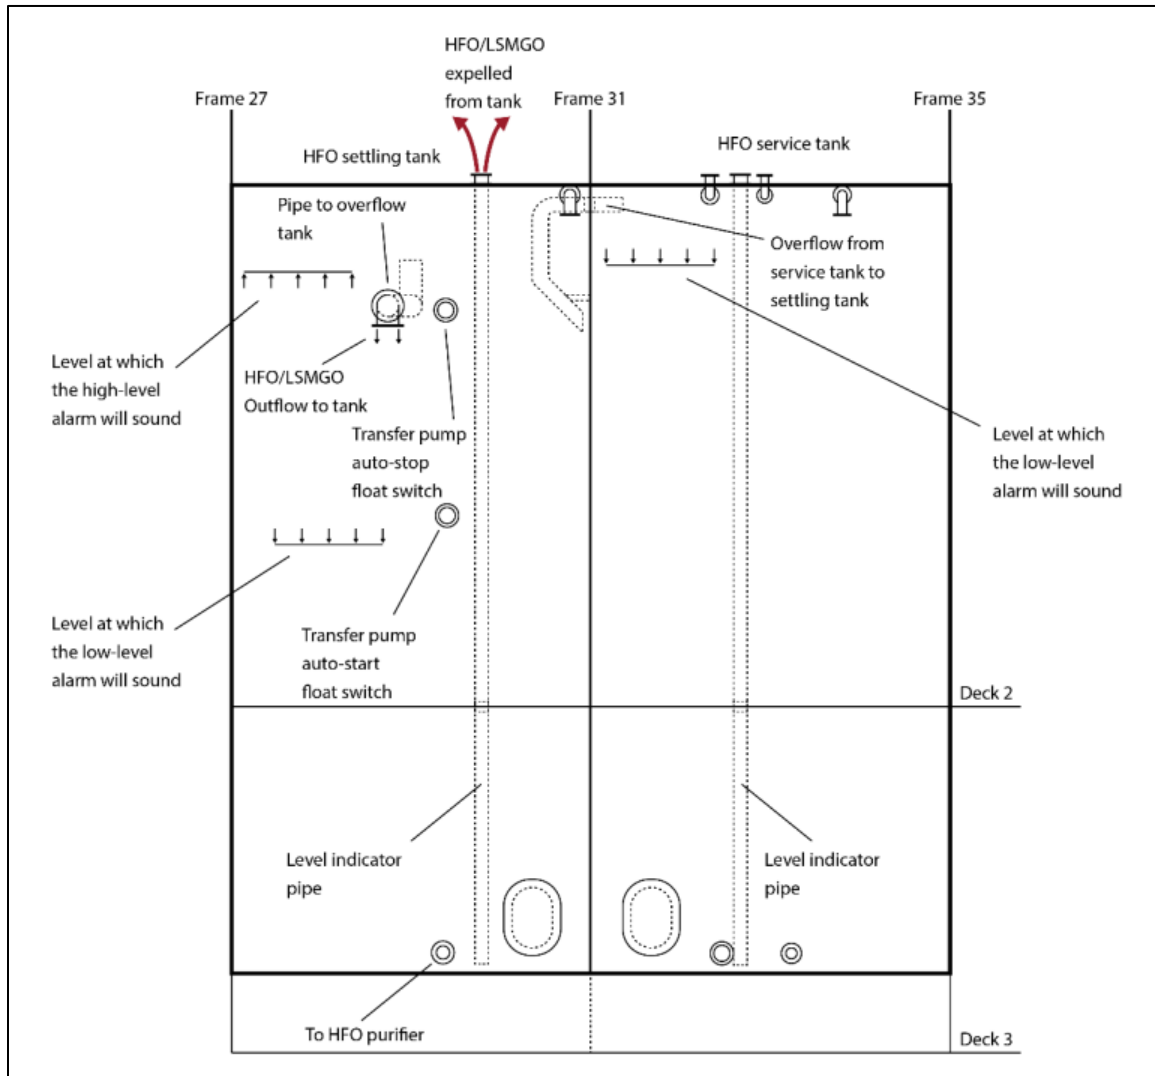
Figure 13. Settling and service tanks, cross-section view (Source: TSB, based on the tank schematics)

The settling tank was normally maintained at a temperature of 85 °C. It had a local temperature gauge and a high-temperature detector that was designed to sound an alarm in the ECR when a temperature of approximately 90 °C was detected. Before the occurrence, the seat of the valves for the steam heating coils was leaking steam, and the steam was passing through the valves even when they were closed, continuously heating the settling tank's content.

At the time of the occurrence, the temperature of the HFO in the settling tank was 120 °C. Following the occurrence, the TSB examined the alarm logs from 15 January until the day of the occurrence and found that the high-temperature alarm for the settling tank had activated on 26 January on the engine room alarm panel. The TSB could not determine if the HFO settling tank temperature was checked or whether any other action was taken as a result of the alarm.

In order to take a manual sounding, a crew member would need to climb onto the top of the settling tank, unbolt and remove the blind flange, sound the tank,⁵⁸ and bolt the blind flange back on. There was minimal space on top of the settling tank. At some point, the blind flange had been left off the pipe for ease of taking manual soundings. It is not known when the last manual sounding of the settling tank was taken. The engine room sounding log did not include records of manual soundings. It was also the crew's practice to determine the level in the settling tank by manually running the transfer pump until it cut out at the high level and then estimating the quantity in the tank. After the occurrence, a blind flange, 3 nuts, and 2 bolts were found on top of the tank near the indicator pipe opening (Figure 15).

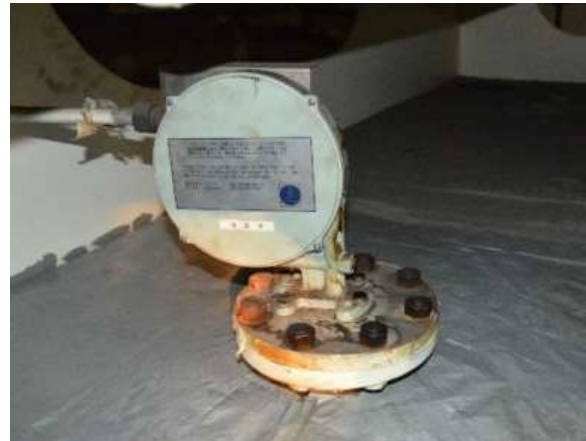
Figure 14. Type of float level indicator that was originally fitted over the opening of the sounding pipe for the settling and service tanks (Source: TSB)

The top of the tank had originally been fitted with a float-type indicator⁵⁶ that continuously transmitted information about the level of the tank to a monitor on the tank bulkhead. The monitor visually indicated the levels and sounded alarms in the ECR when the tank contents reached high or low levels (Figure 14). On the settling tank, the indicator had been fitted by a flanged connection to a pipe 10 cm in diameter that extended to the tank bottom. The wire and float for the indicator moved up and down inside this pipe. At some point, the indicator had been removed for repair or replacement, and the pipe opening had been covered with a blind flange.⁵⁷ The tank did not have a designated sounding pipe to take manual soundings.

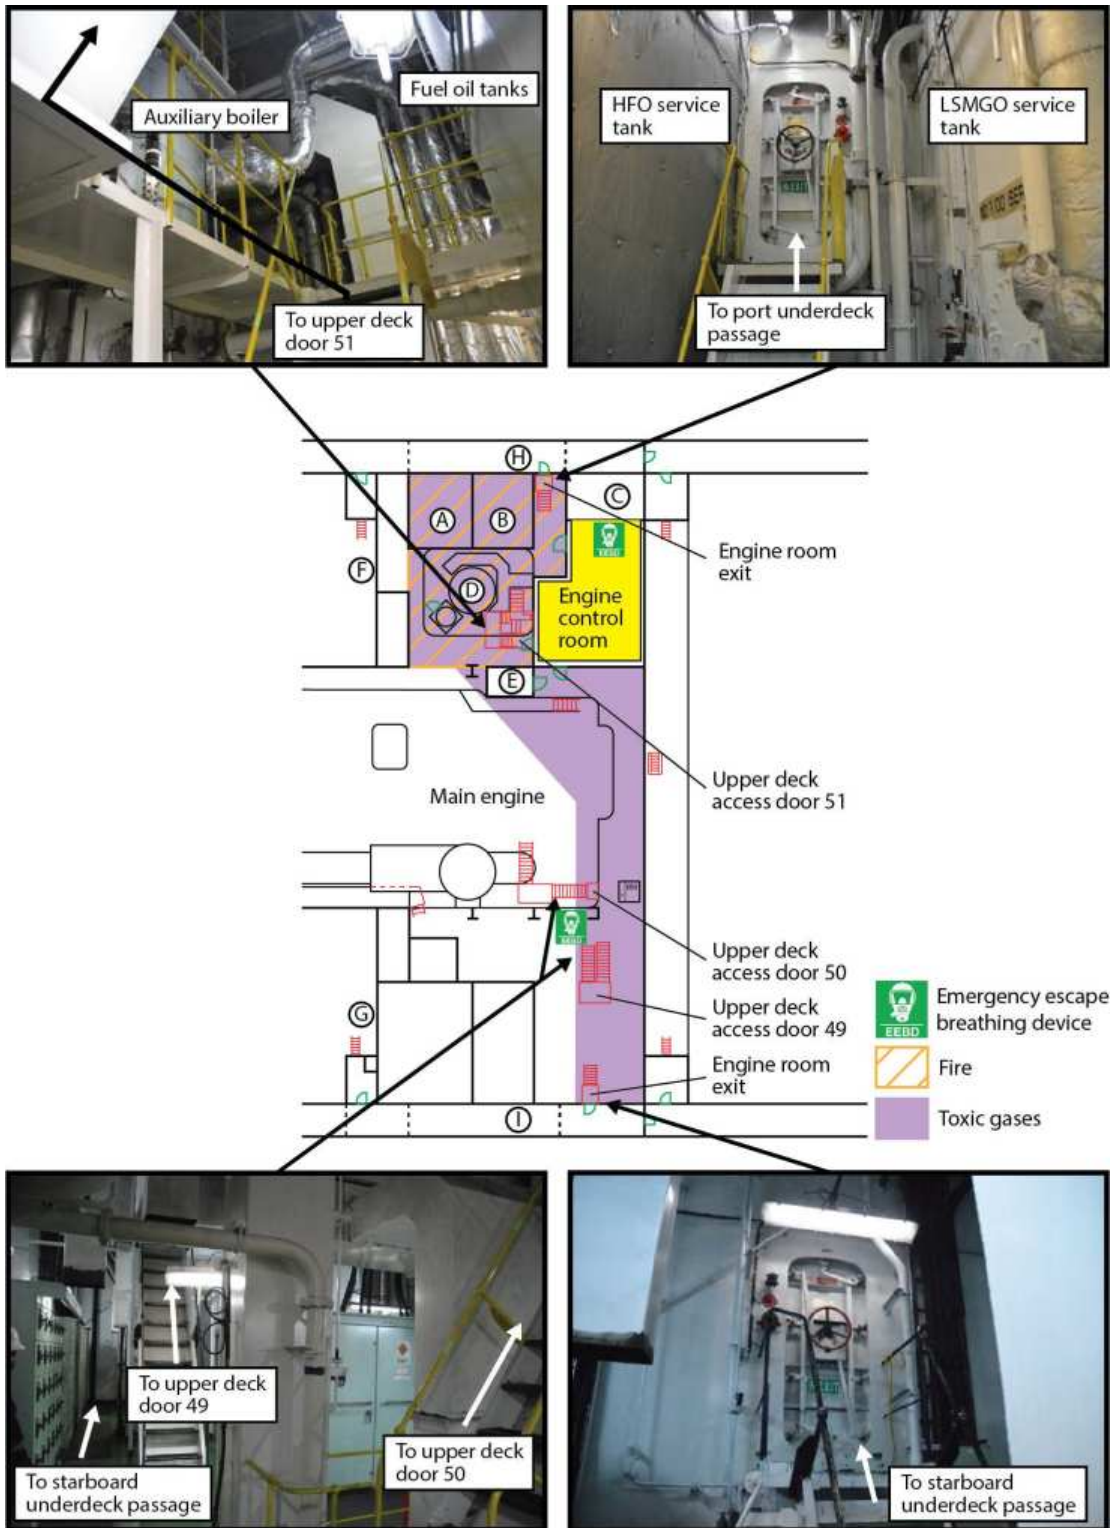
Figure 20. Photos and diagram showing the means of escape from the engine room. The diagram provides an overhead view of deck 2, showing the 5 possible exits from the engine room. The photos show these exits, with black lines indicating the location of the photos. (Source: MOL Prestige deck 2 plan, with TSB photos and annotations)

At the beginning of their watch, the crew would typically first enter the ECR using the elevator. Although the crew knew about the other exits, they rarely used them as part of daily activities. During shifts, the ECR was the usual place the engine crew gathered when they needed to have a face-to-face discussion away from the noise of the engine room machinery. When the engine room crew tried to exit the ECR, all means of escape were engulfed in thick black smoke and exposed to high heat from the fire near the auxiliary boiler and the HFO settling and service tanks.

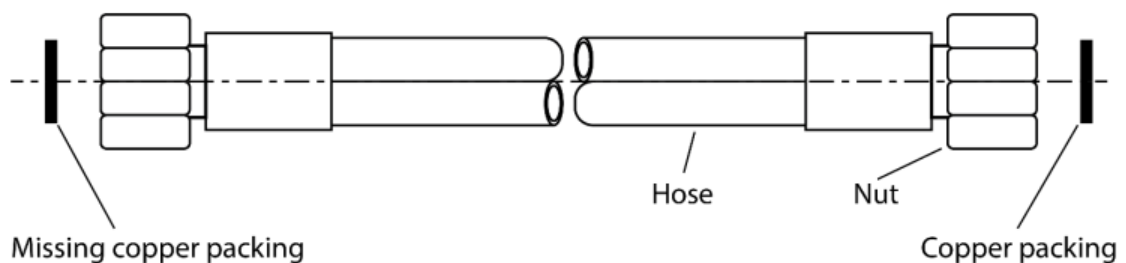
Figure 24. CO₂ cylinder hose (Source: Original equipment manufacturer manual, with TSB annotations)

- A fitting that connected the line from the time-delay unit to the actuation lines of the engine room cylinders was loose where it was secured on the time-delay unit and was leaking heavily in the CO₂ room.
- As a result of the leak, at least 70 cylinders furthest from the time-delay unit were deprived of the necessary actuating pressure, and these cylinders did not release their CO₂.
- Two of the check valves in the actuation line were leaking inside the CO₂ room.
- Copper tubing runs from the remote-release cabinets at the fire station, through the engine room, to the CO₂ room; this tubing was damaged.
- A number of copper packings were missing from the CO₂ cylinder hoses, and the hoses were leaking CO₂ in the CO₂ room (Figure 24).
