Report on the investigation
of the fatal crush accident
on the general cargo vessel

Karina C

at Seville, Spain

on 24 May 2019

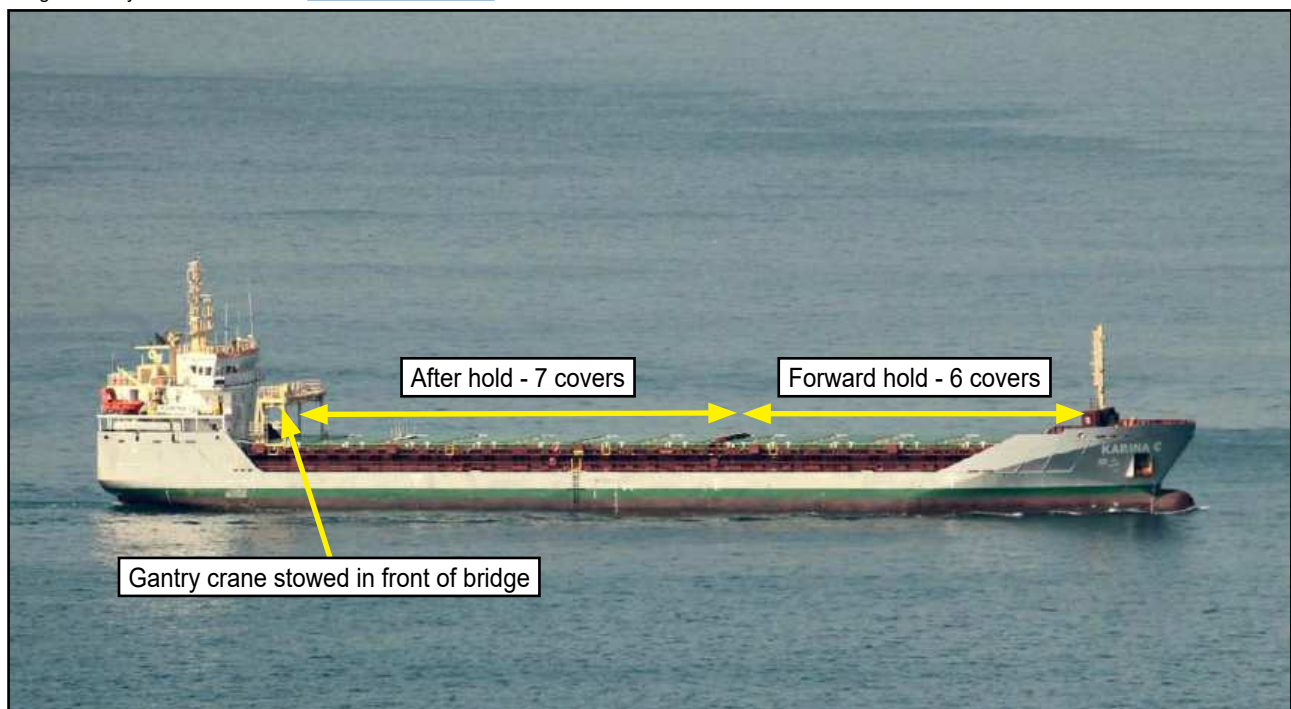
Karina C had two cargo holds; the forward hold had six pontoon-type hatch covers and the aft hold had seven (**Figure 6**). Each hold had a moveable partition bulkhead, which allowed further subdivision to accommodate different cargoes, giving a total of four hold compartments. Hatch covers and partition bulkheads were moved with the gantry crane. The hatch covers were not interchangeable and had to be placed onto the hatch coaming in sequence (**Figure 7**) before cleats were used to secure them. The coamings were provided with water drain channels.

Figure 6: *Karina C*'s cargo hold and hatch cover arrangements

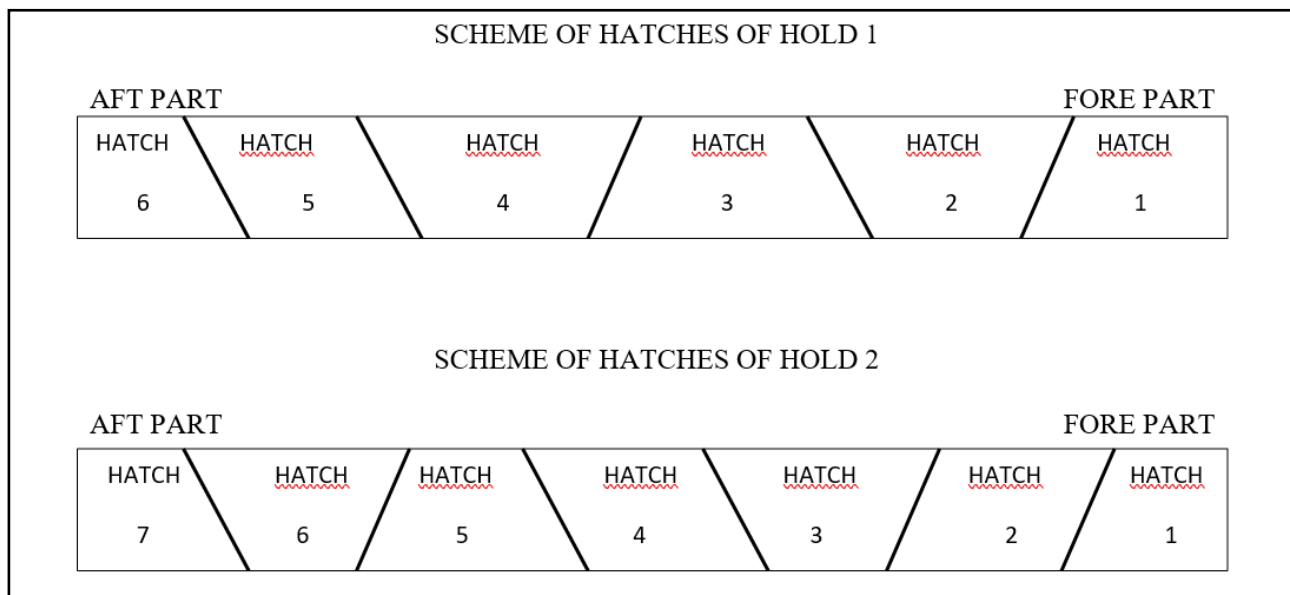
Figure 7: Cargo hold hatch cover scheme – all covers were unique

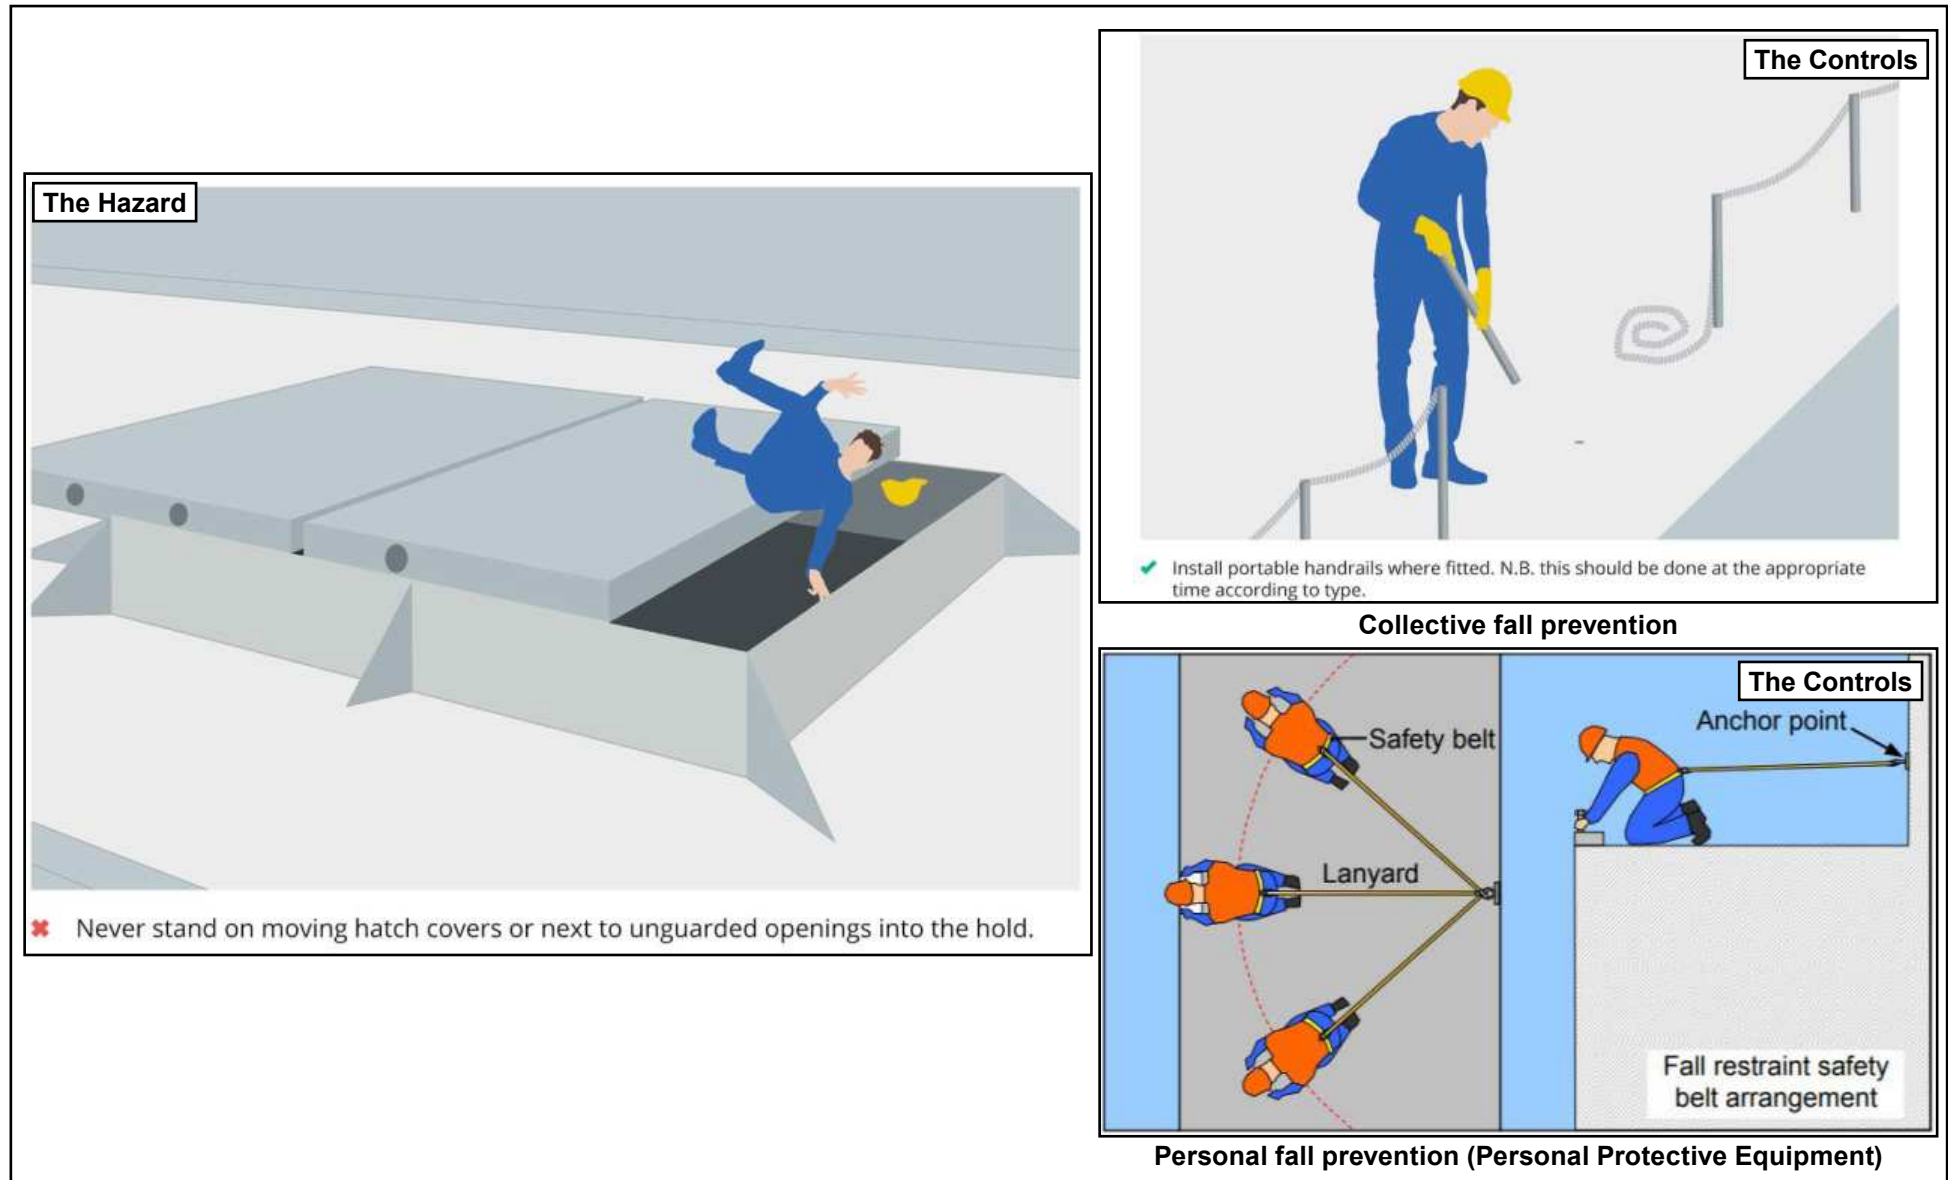
During the task of clearing the cement residue from the hatch covers and coamings, one AB was observed walking along and leaning over the unprotected edge of a hatch cover (**Figure 1**). Working close to unprotected open hatch covers is a well-recognised hazard and the consequence of a simple slip or trip, or even a medical event, can often have fatal consequences. The UK Working at Height Regulations require personnel working in such areas to be protected, either by the rigging of temporary guardrails, or by the wearing of a safety harness and the rigging of a fall prevention system (**Figure 18**). This requirement was repeated in Carisbrooke's SMS manual, but on the day of the accident, portable guardrails were not rigged and safety harnesses and fall prevention lanyards were not used.

Figure 18: Fall prevention methods while working close to open hatches
