MARINE SAFETY INVESTIGATION REPORT

Safety investigation into the grounding of the
Maltese registered LPG

SEASURFER

in the Port of Praia
Ilha de Santiago, Cabo Verde
on 12 October 2019

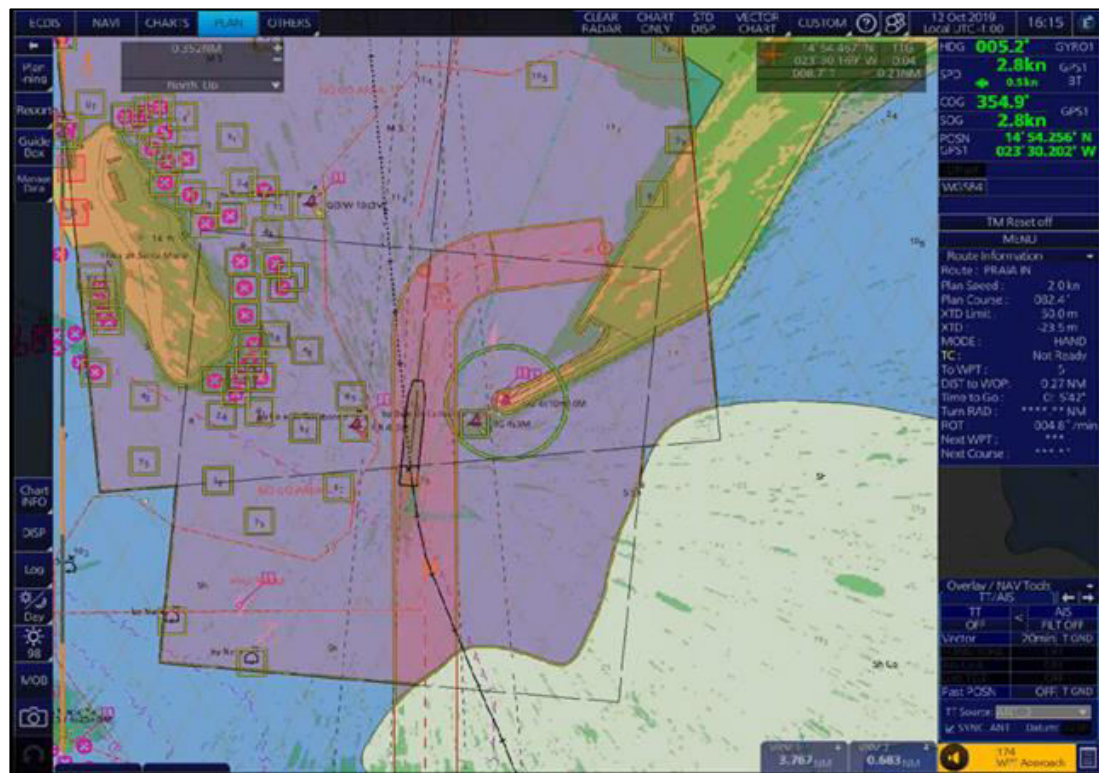
Figure 5: ECDIS image at 1615, showing *Seasurfer* off the breakwater bullnose

Escorted by tug *Praia Maria*⁶, the pilot guided *Seasurfer* into the port's navigable channel. The master reported that a 0.5 knot current was flowing Northeast and he repeatedly corrected the pilot's course directions⁷. At 1615 (Figure 5), *Seasurfer* entered the port's turning basin at 2.8 knots. The main engine was stopped and her course was altered to starboard, towards the middle of the turning basin.

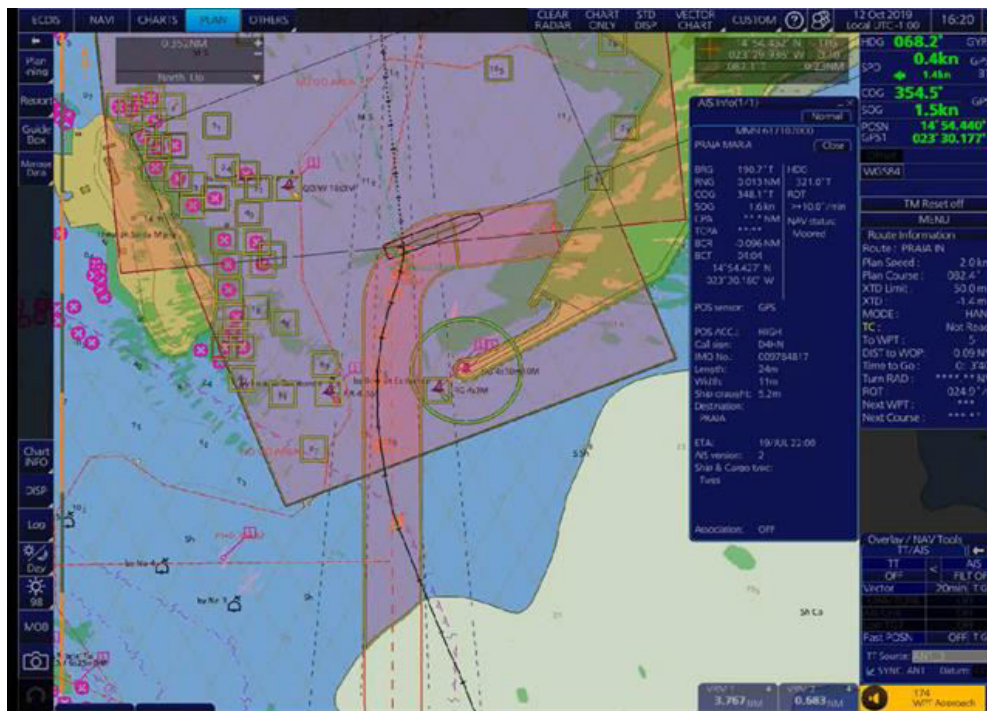
Figure 6: ECDIS image at 1620 showing *Seasurfer* turning to starboard

At 1620 (Figure 6), the pilot ordered half astern on the main engine and the tug was instructed to push on the starboard quarter. The master, however, revised the pilot's order to full astern. As soon as the forward speed dropped, the main engine was stopped and the pilot turned the vessel to starboard. In the meantime, the forward station reported that the bow was passing clear off the jetty.

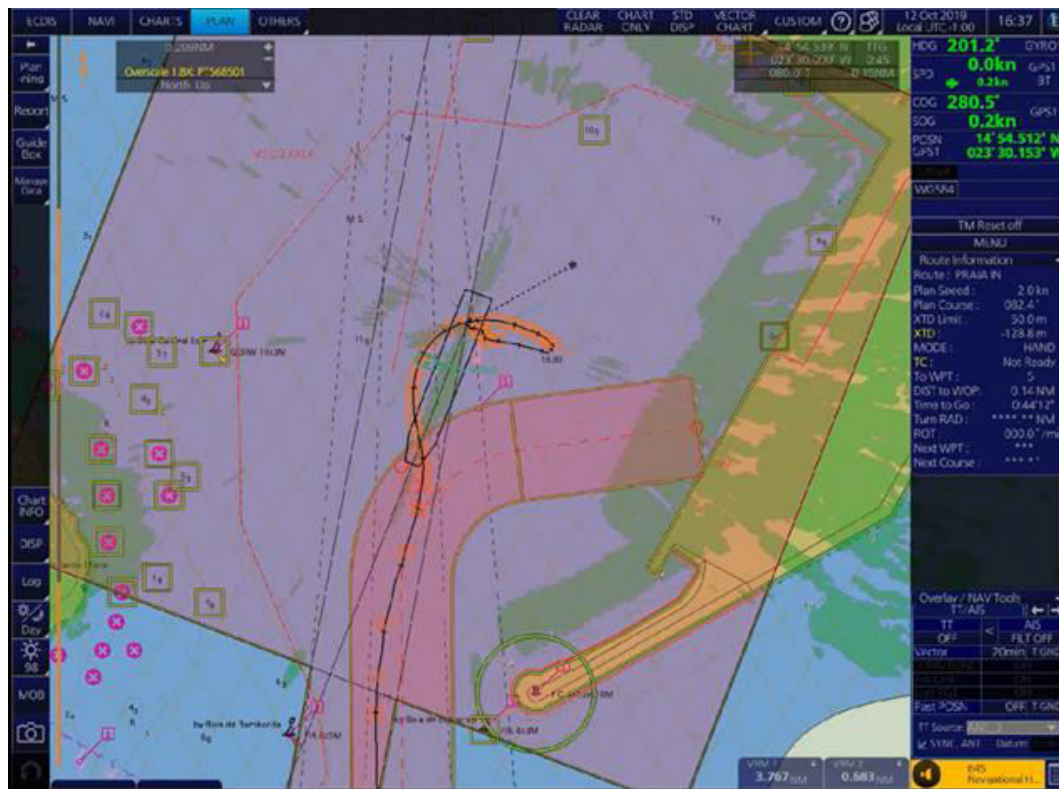
Figure 9: ECDIS image showing *Seasurfer's* position at 1637

At 1637, *Seasurfer* was manoeuvred back parallel to the jetty (Figure 9). The anchor chain was on moderate stay, leading abaft the beam. The stern started to swing to port and the pilot requested the chain to be slackened. It appeared that a kick ahead on the main engine, and with the helm hard to port, the bridge team had controlled the swing. The pilot then ordered the tug to start pushing from starboard midship and again requested the master to slacken the chain. The master replied that slackening the chain would restrict the vessel's movement. At that point, seven shackles were out and the master advised the pilot the need to shorten the chain and drag the anchor (along the seabed), since the anchor chain would be insufficient to reach the berth.

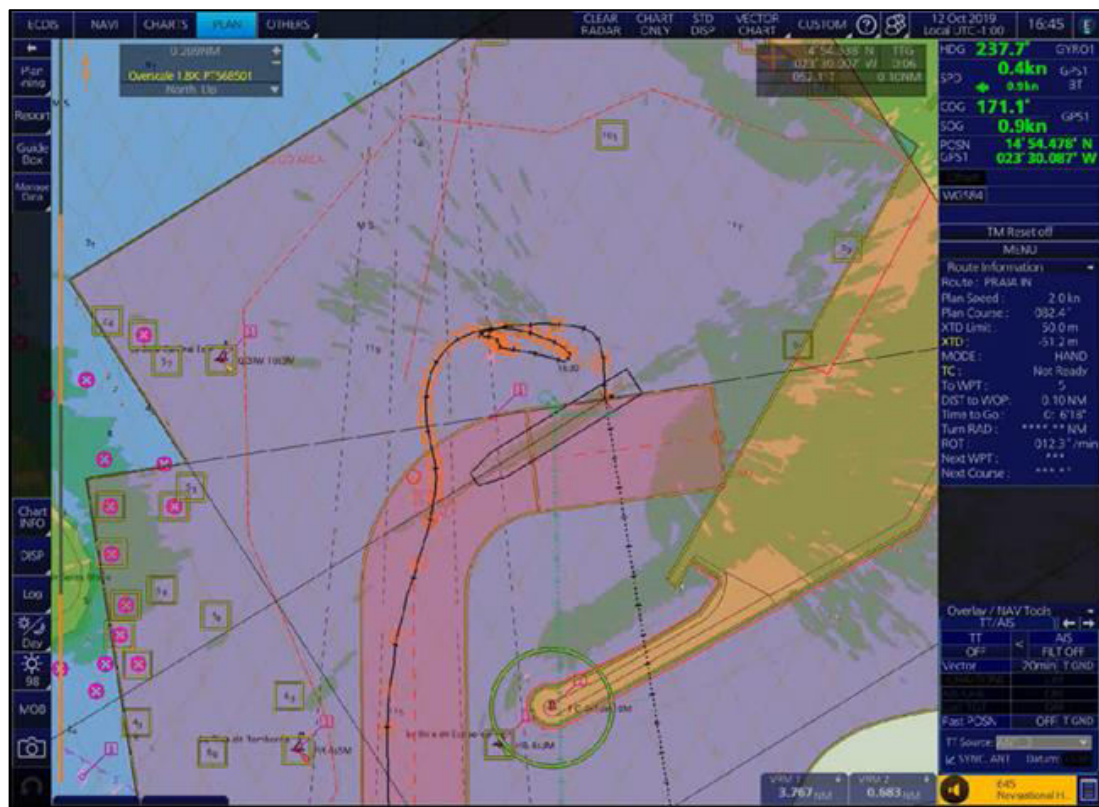
Figure 10: *Seasurfer* at 1645, when the stern was swinging to port

The master also advised the pilot that the stern was moving towards the berth faster than the bow and to this effect, he instructed the crew at the forward station to heave up the anchor. He also directed the pilot to shift the tug towards the bow. The manoeuvre accelerated the stern's swing to port. By 1645 (Figure 10), the ECDIS was displaying a course and speed over the ground of 171° and 0.90 knots respectively.

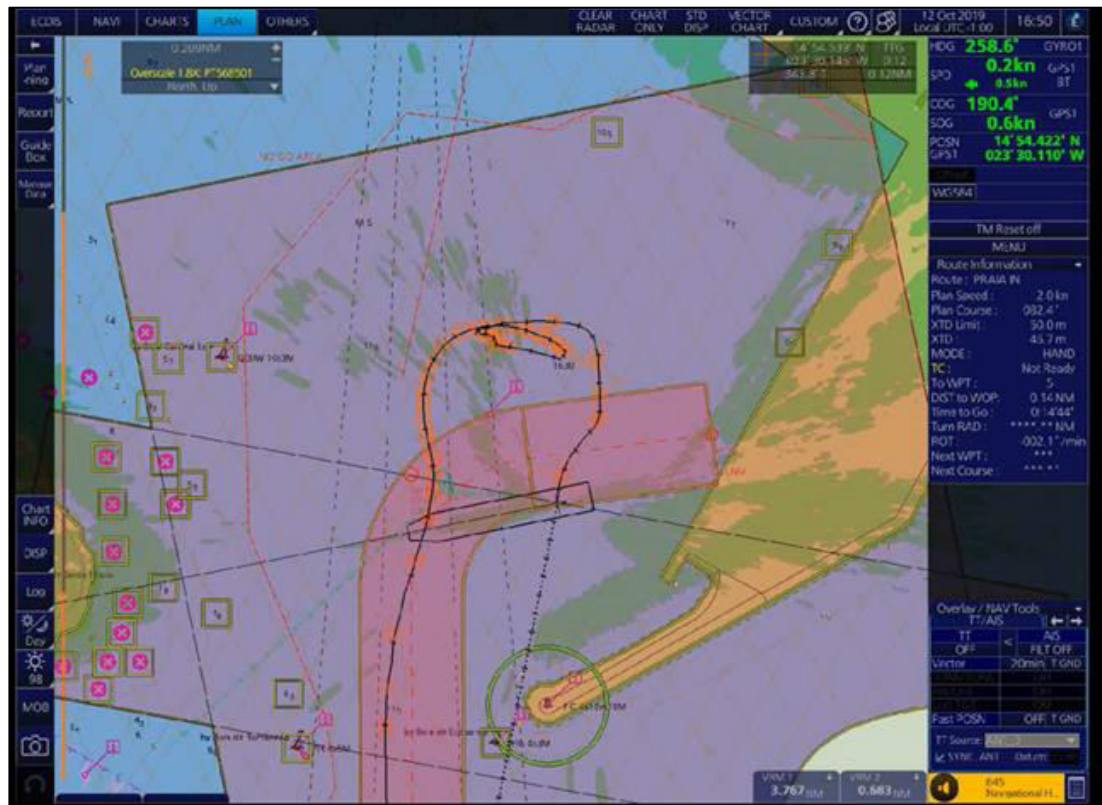
Figure 11: ECDIS image showing position of *Seasurfer* at 1650

Five minutes later, at 1650 (Figure 11), six shackles of anchor chain had been recovered on deck. At this point in time, the tug was pushing on the vessel's starboard shoulder. The pilot requested dead slow and slow ahead on the main engine and the helm to port, to check the swing. A few minutes later, the main engine was stopped. Almost instantly, the master ordered the main engine on slow ahead.

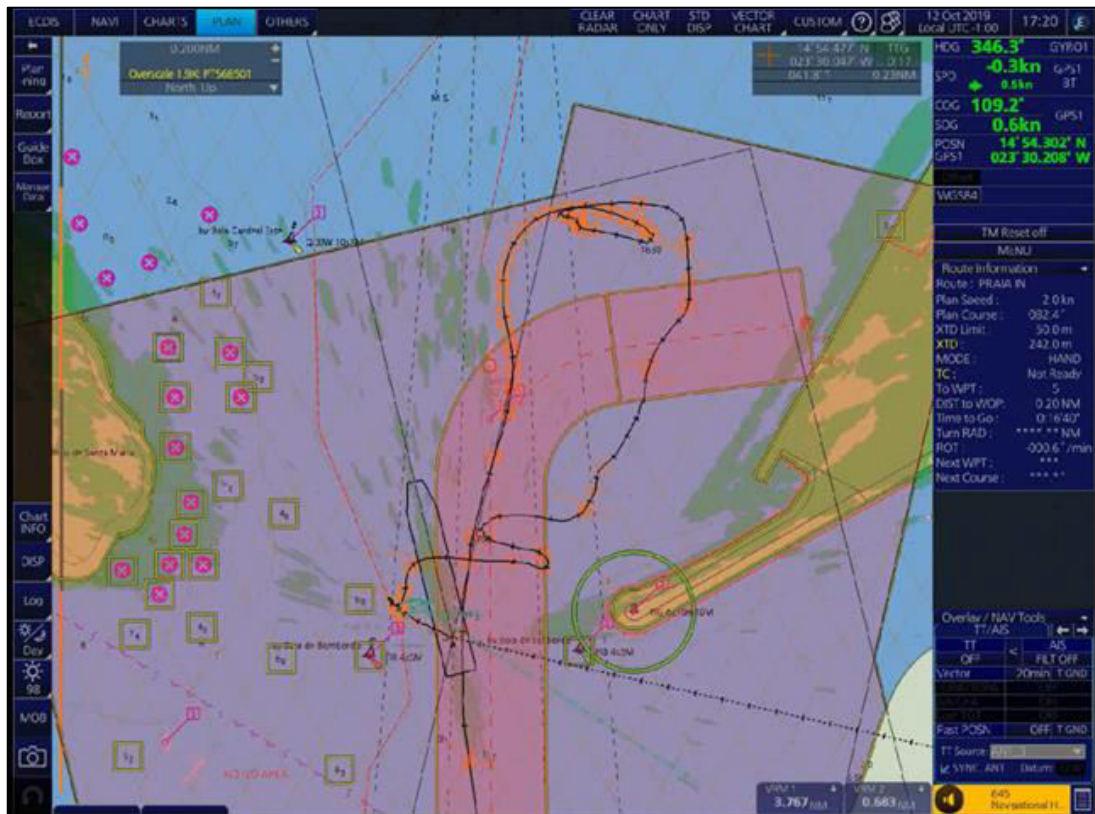
Figure 17: ECDIS image at 1720

The forward station was instructed to weigh the anchor and with the tug pushing on the port side, the vessel was manoeuvred back in the turning basin (Figure 17). With the main engine set to dead slow ahead, the vessel advanced towards her berth. At 1735, the starboard anchor was recovered and the port anchor was prepared for letting go. As soon as the bow came close to the jetty, the port anchor was dropped. The vessel was in position at 1805 and the crew sent out the mooring lines ashore. At 1840, *Seasurfer* was all fast starboard side to on Jetty no. 1.
