Report on the investigation of

Young Lady

Dragging anchor 5 miles east of Teesport and
snagging the CATS gas pipeline,
resulting in material damage to the pipe

25 June 2007

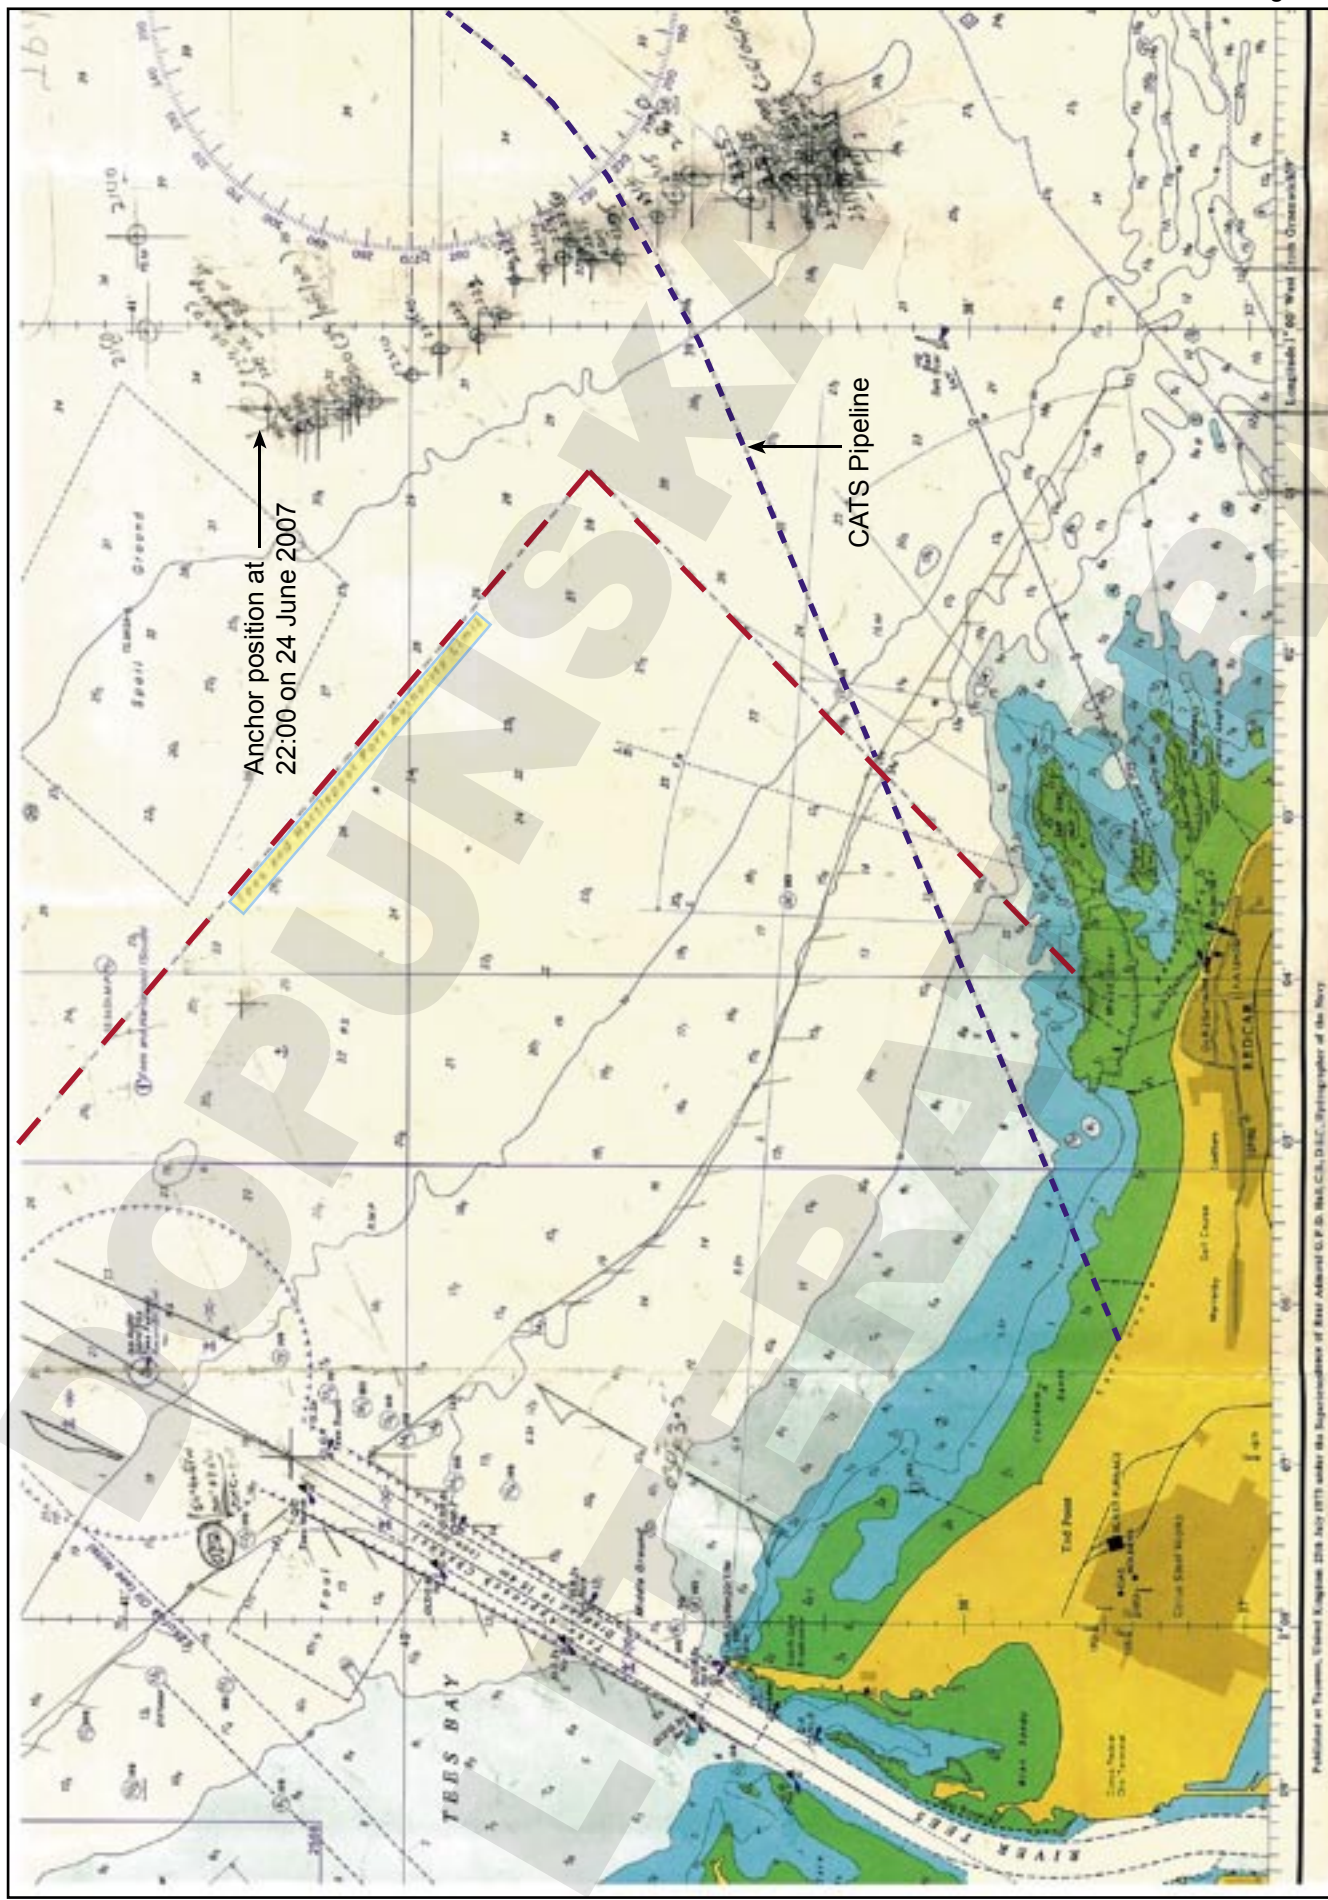
Position of anchor and its location with reference to harbour limits, spoil ground areas and pipelines

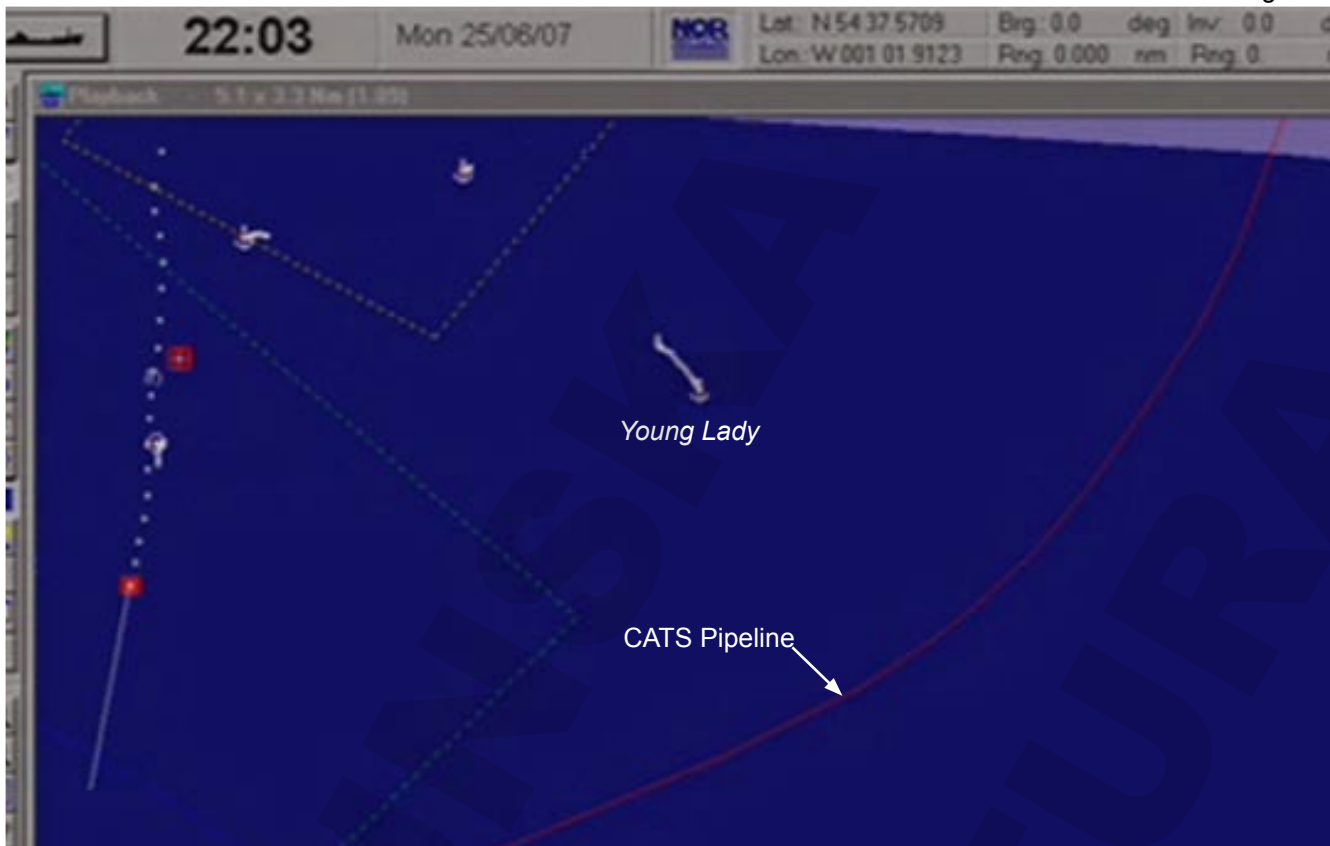
Figure 2

At 2200, the OOW placed a DGPS position on the chart, which showed the vessel lying outside of the swinging circle. He had concerns that the vessel was dragging anchor and called the master at around 2203 (**Figure 2**). The master ordered the third officer to contact the duty engineer to make ready the main engine, and the chief officer to stand by forward. When the master arrived on the bridge he fixed the vessel's position on the chart, and confirmed that *Young Lady* was dragging anchor².

VTS screenshot at 22:03

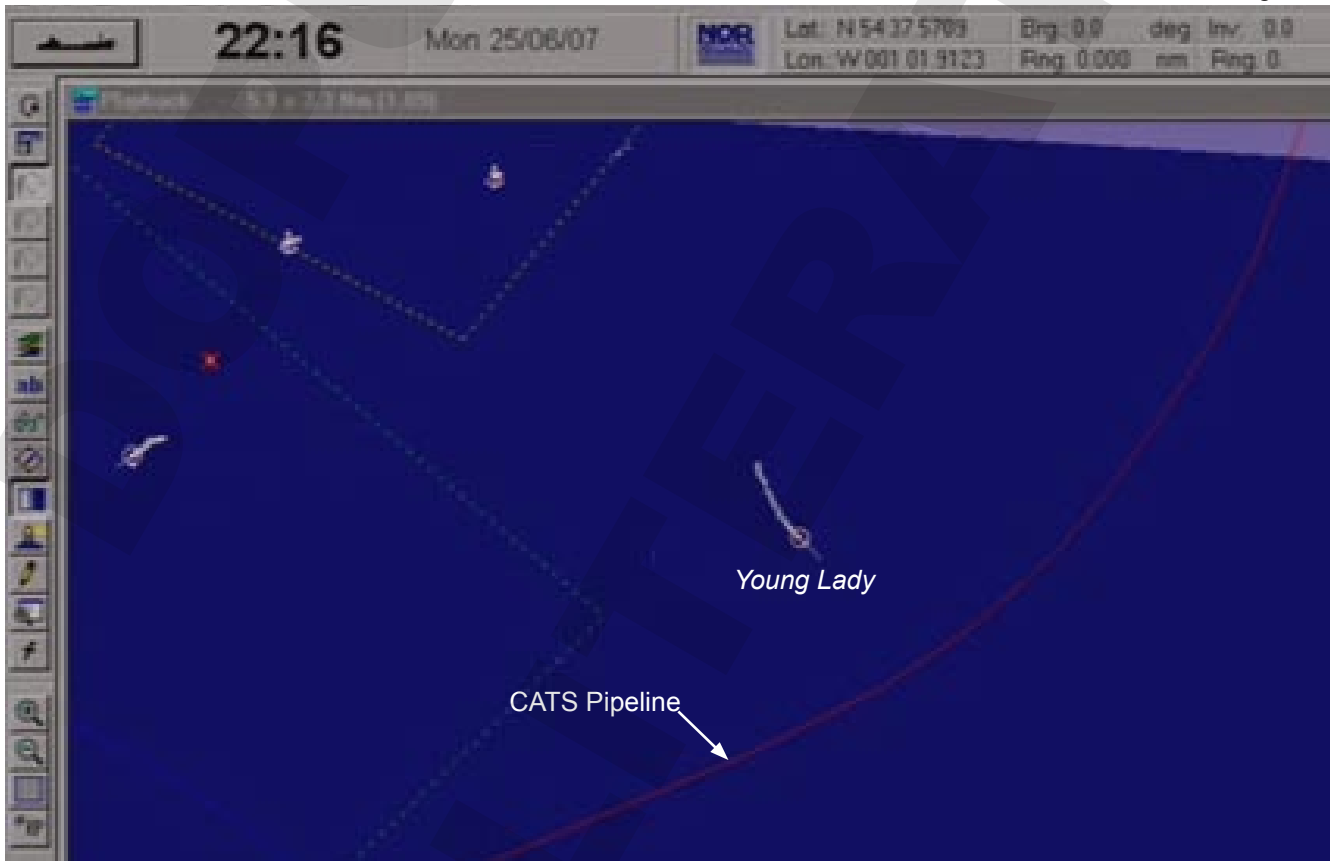
Figure 3

At 2215, the main engine was successfully tested, and at 2216 the engine room was then placed on stand by. Between the times of identifying that the vessel was dragging anchor at 2200, and the main engine being made ready for use at 2216, the vessel had dragged a distance of 0.8 nm at a rate of 3 kts (**Figure 3**).

VTS screenshot at 22:16

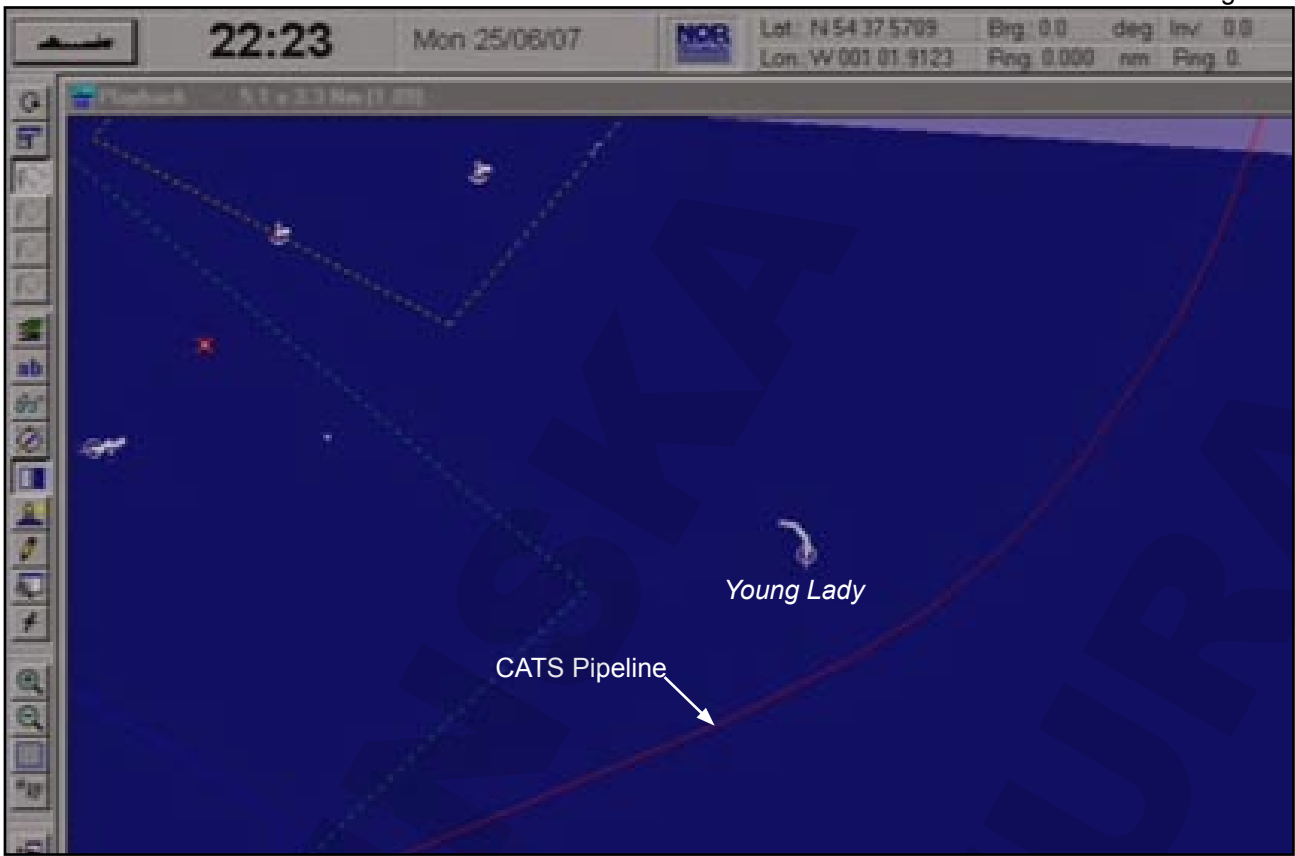
Figure 4

The first engine order was a kick of 'dead slow ahead' recorded at 2223 (**Figure 4**). The chief officer continued to report the direction of the cable which, with the vessel swinging wildly, was leading at very long stay from between starboard 90° to port 180°. The ship's head was recorded as swinging between 068° and 320° over the same period.

VTS screen shot at 22:23

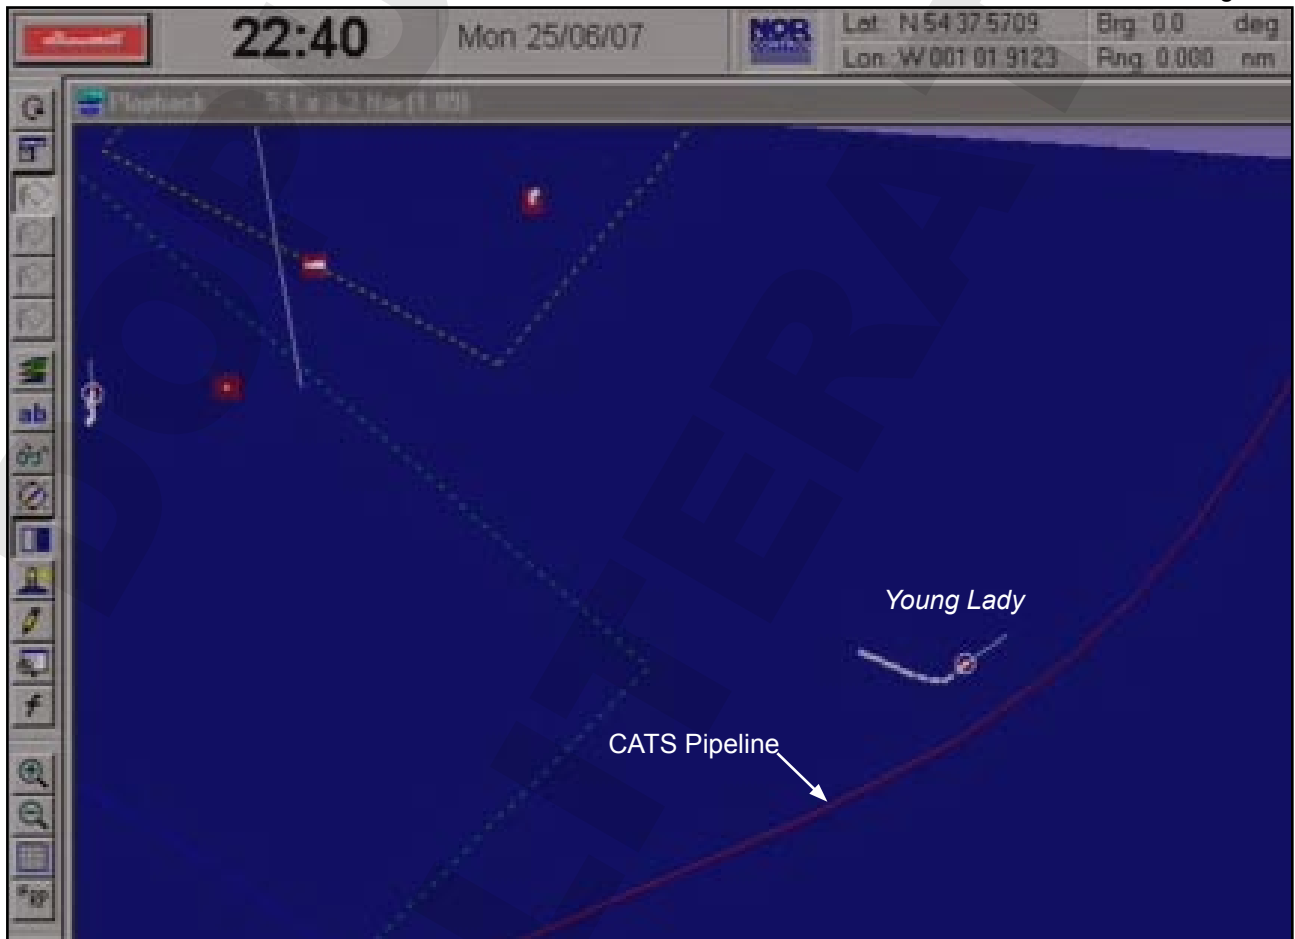
Figure 5

At 2235, the engine was stopped and the rate of drift increased markedly. The next period of engine movements, between 2238 and 2245, succeeded in arresting the drift, and at about 2240 (**Figure 5**) *Young Lady* was stopped over the ground. The vessel had now dragged a total distance of 1.3 nm, and lay only 2 cables north of the charted CATS (Everest) gas pipeline. The wind was steady at about 45 kts from the north-west, and the ship's head was yawing between 310° and 070°. Seas were breaking over the forecastle in the 5m to 6m swell.

VTS screen shot at 22:40

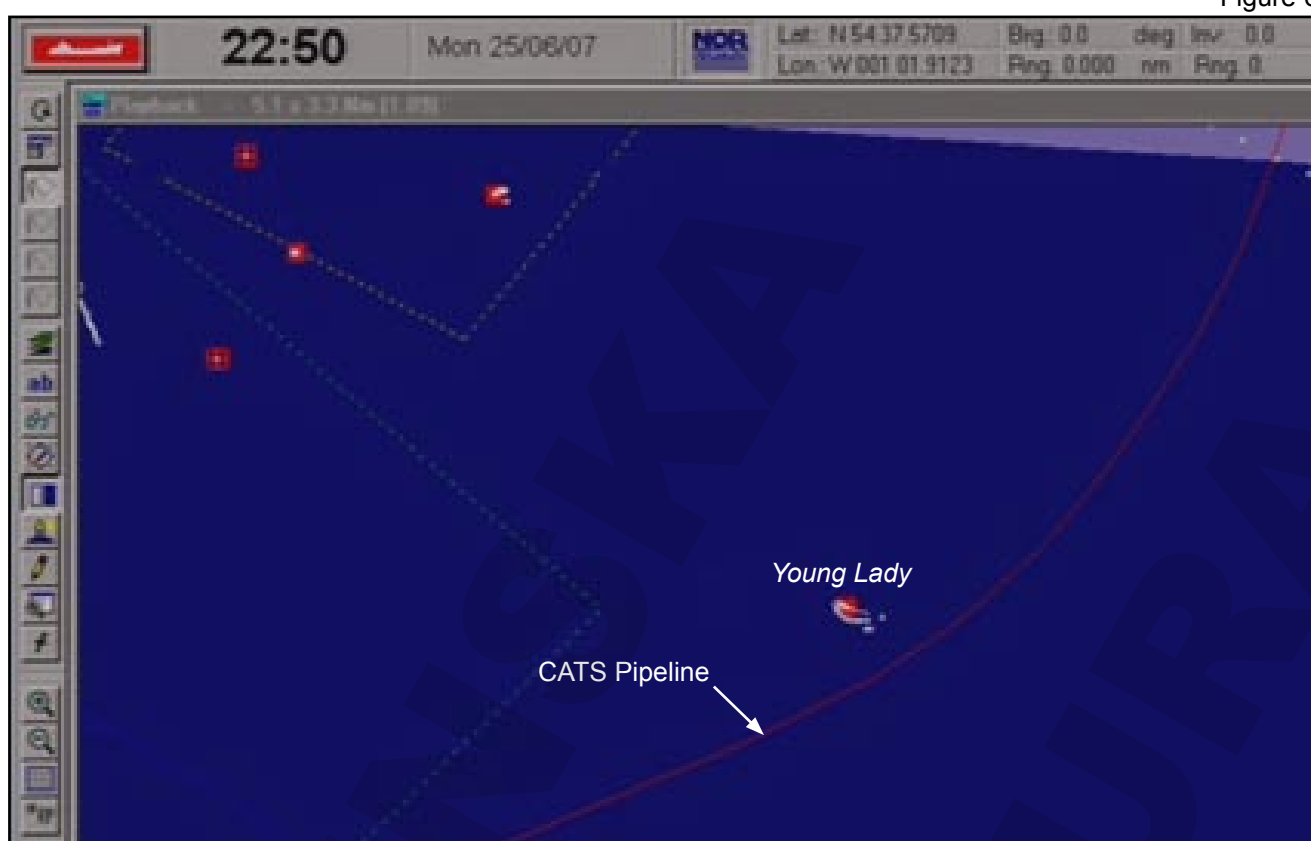
VTS screen shot at 22:50

Following a succession of engine movements up to 'half ahead', the vessel started to make slight headway toward the north-west. At 2250 (**Figure 6**), with the main engine set at 'half ahead' and the third joining shackle visible between the sea and the hawse pipe, the chief officer reported that the cable was leading nearly astern along the port side. The same report advised the bridge that there was too much weight on the cable, and it was the intention to apply the brake and hold on. As the brake was being applied and the crew made the final adjustment, the port windlass, which was still in gear with the control lever in the neutral position, suffered a catastrophic failure of the hydraulic motor unit (**Figure 7**). The cable ran out immediately, the brake lining started to smoke, and sparks from the brake shoe were observed as the lining disintegrated. Hydraulic oil from the windlass motor was spraying over the forecastle at a pressure of 220 bar.

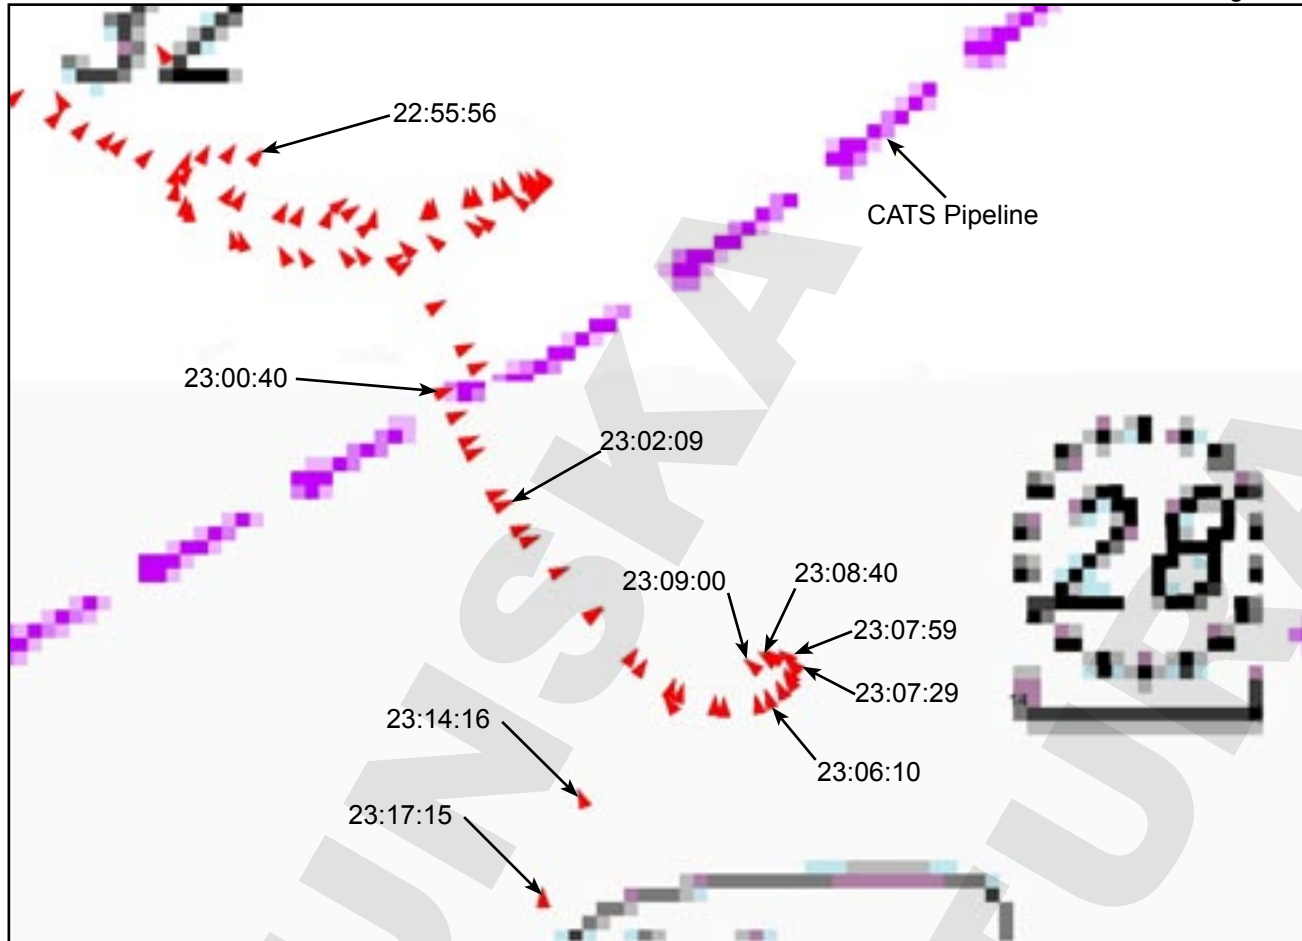
Timings of *Young Lady*'s movement over the CATS Pipeline

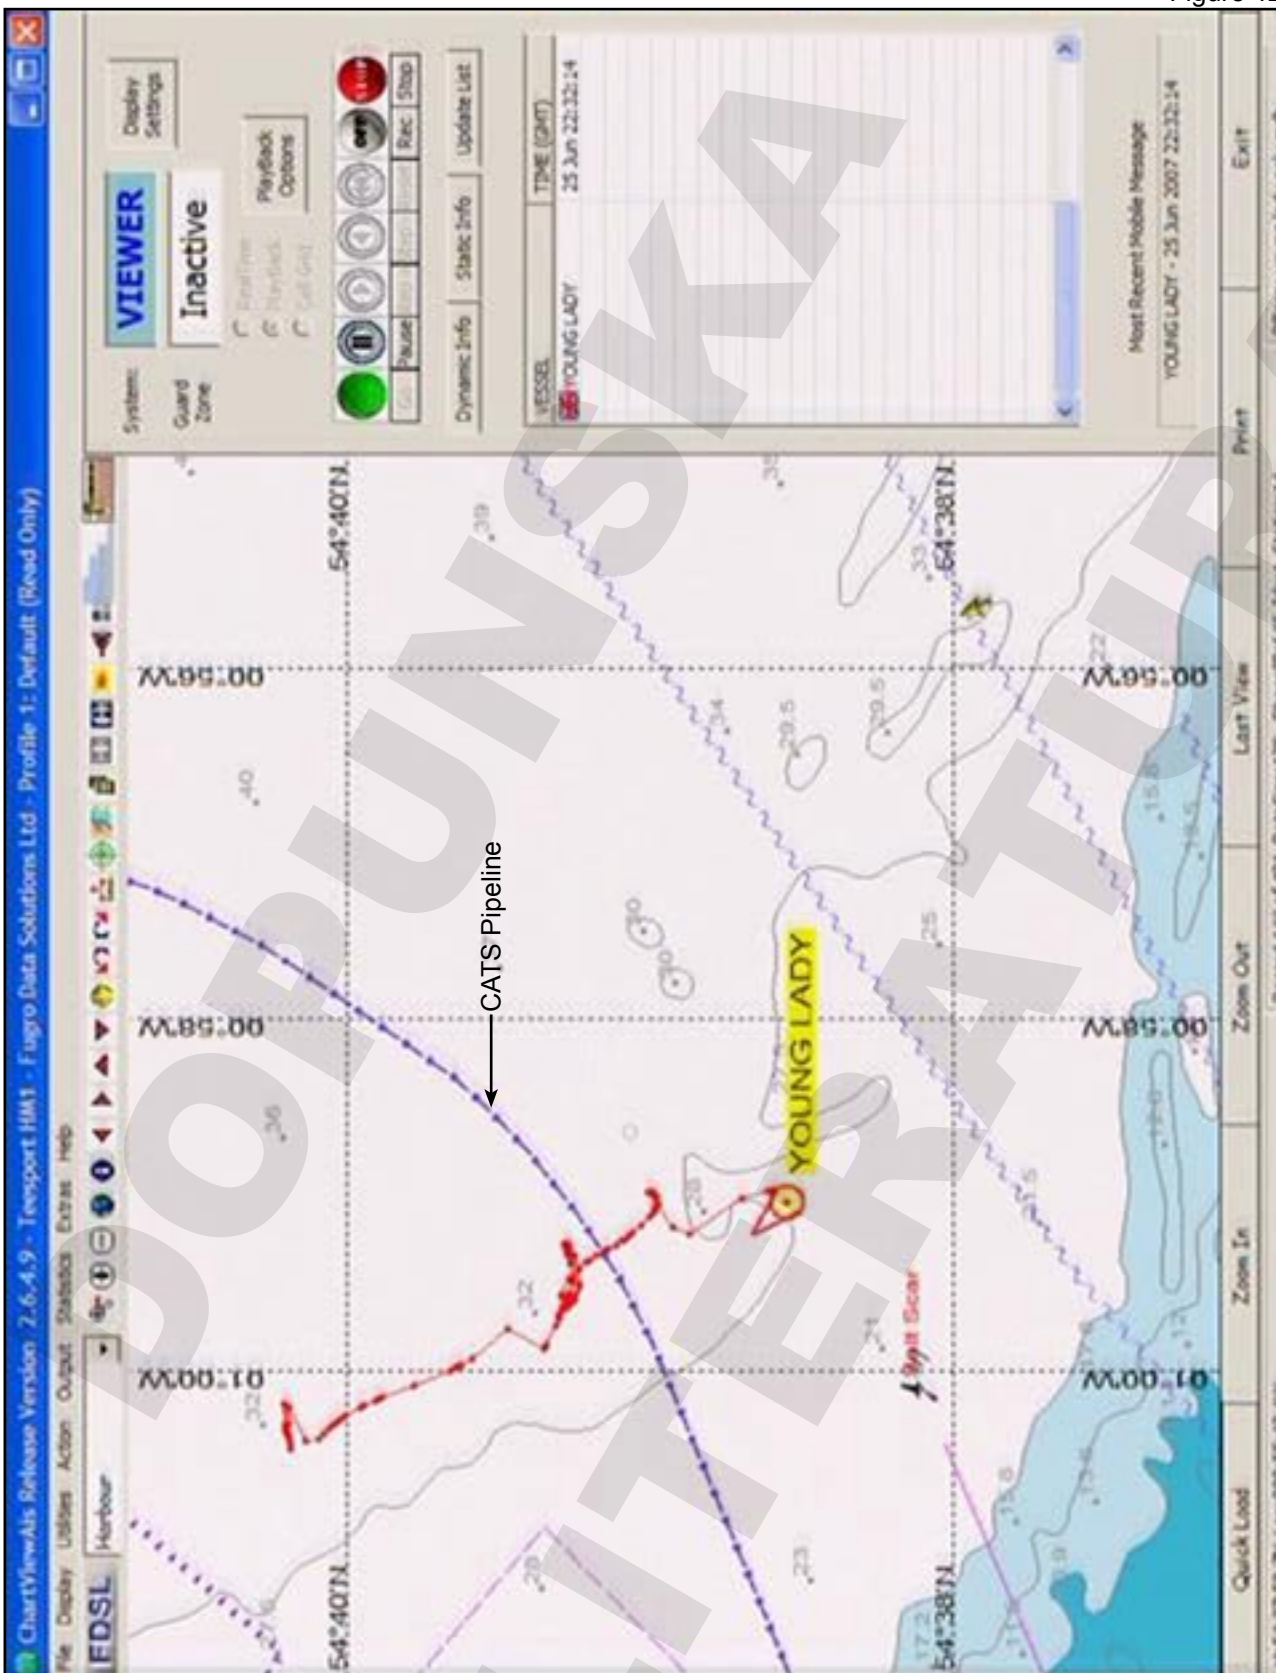
Figure 12

AIS Screen shot, showing *Young Lady*'s movement from 22:00 to 23:32 BST
