STONE I

Marine accident report on loss of control

4 JANUARY 2020

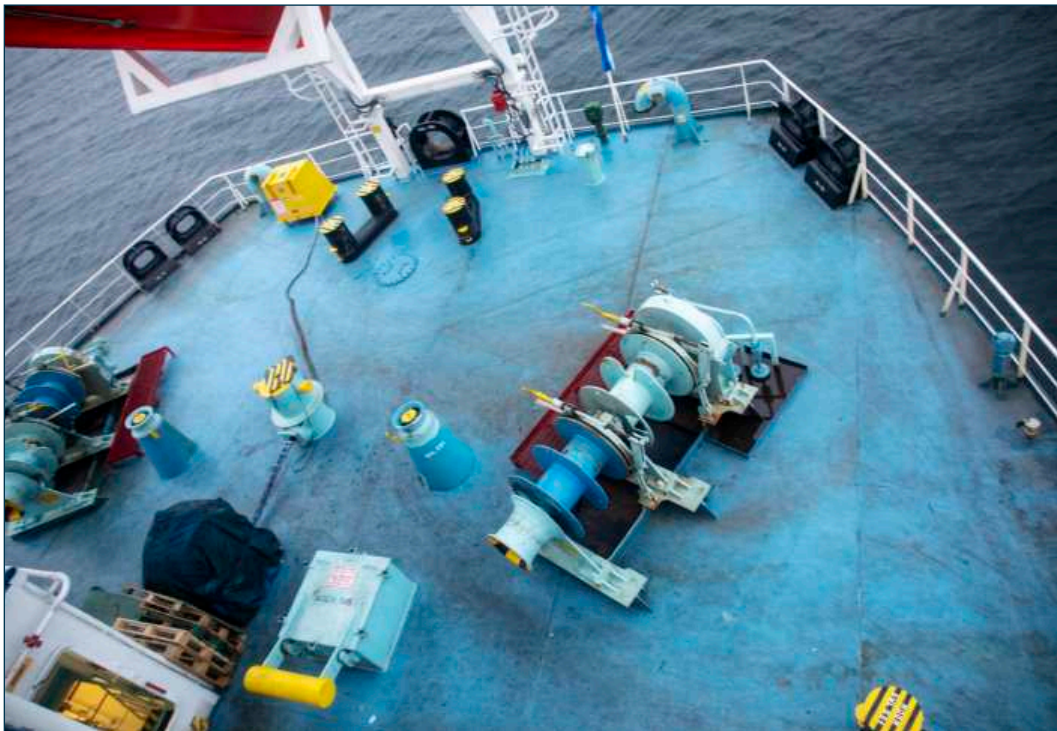
Figure 13: Mooring arrangement aft deck
Source: DMAIB

STONE I had four mooring stations: one aft, two on the main deck and one on the forecastle. On the aft mooring station, the mooring fittings consisted of two double drum mooring winches, Panama fairleads, bollards and pedestal rollers. Both winches had two specific fairleads allocated in each side of the ship to which the mooring lines could be led directly. The pedestal rollers could not be used for directing mooring lines from the winches to any other fairlead, because they were not aligned with the tension drum on the winches. The pedestal rollers were aligned with the winch head and were thus meant to be used for tightening loose mooring lines or bringing towing lines on board through the centre fairlead. It was only possible to use the centre fairlead for loose mooring lines or towing lines (figures 13 and 14, next page).

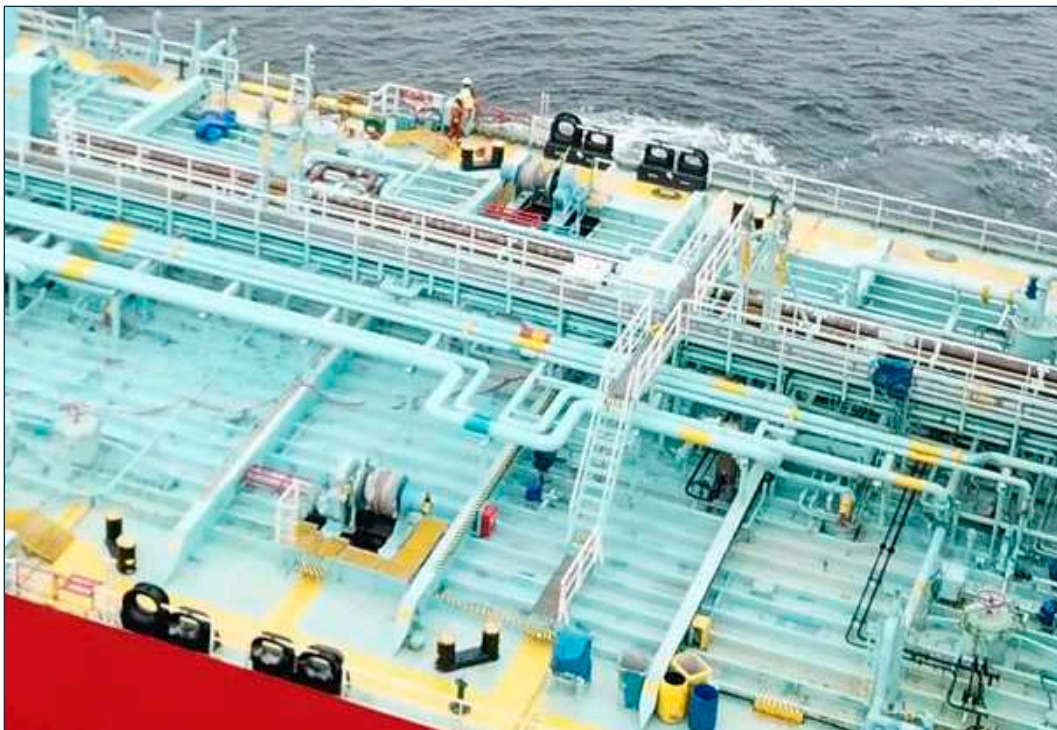
Figure 15: Mooring arrangement on the main deck
Source: DMAIB

The two mooring stations on the main deck had a similar layout. On each of the mooring stations, the mooring fittings comprised two single split drums, fairleads and bollards. The winches were located on each side of the ship and had one designated fairlead in each side of the ship. The bollards also had designated fairleads in each side. It was not possible to use the bollards for loose mooring lines, as there were no aligned winches to tighten the lines (figure 15, next page).

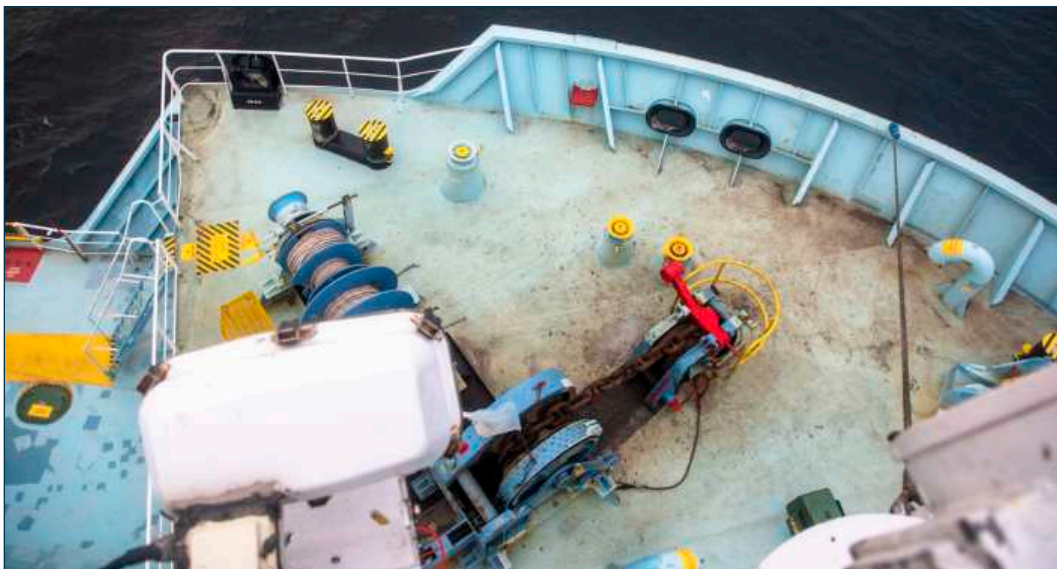
Figure 16: Mooring arrangement forecastle port side
Source: DMAIB

From a review of the general arrangement it was noted that the bollards located near the centre fairlead were symmetrically placed, however on the ship they were not. Additionally, two pedestal rollers were placed on portside, which did not appear on the general arrangement. It was only possible to use the centre fairlead for loose mooring lines or towing lines (figures 16 and 17).

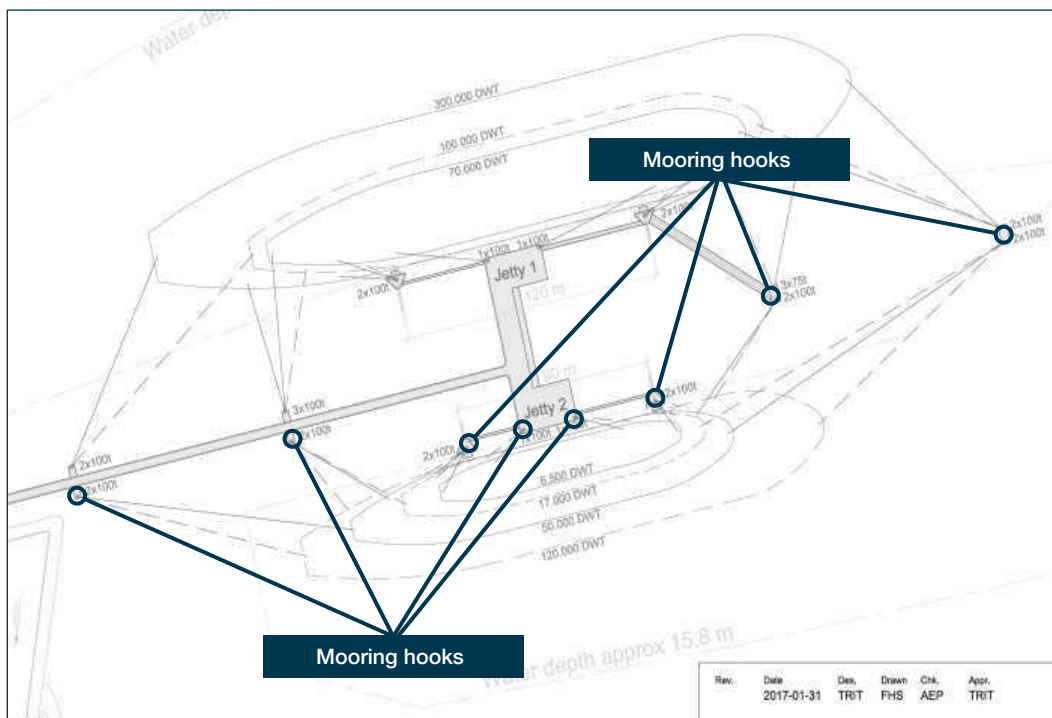
Figure 20: Ensted Oil Terminal mooring plan
Source: Inter Terminals Denmark EOT Aps / DMAIB

Due to the ship's size, STONE I berthed at Jetty 2. Jetty 2 had 14 mooring hooks (figure 20, next page). Jetty 2 was fitted with two loading arms. When berthing the ship, the jetty's loading arms determined the position of the ship, as these needed to be aligned with the ship's manifolds. When the loading arms and manifolds were aligned, the possibilities for mooring the ship depended on the interface between the ship and the jetty and their available mooring equipment.
