Report on the investigation of
the grounding of

Antari

Near Larne, Northern Ireland

29 June 2008

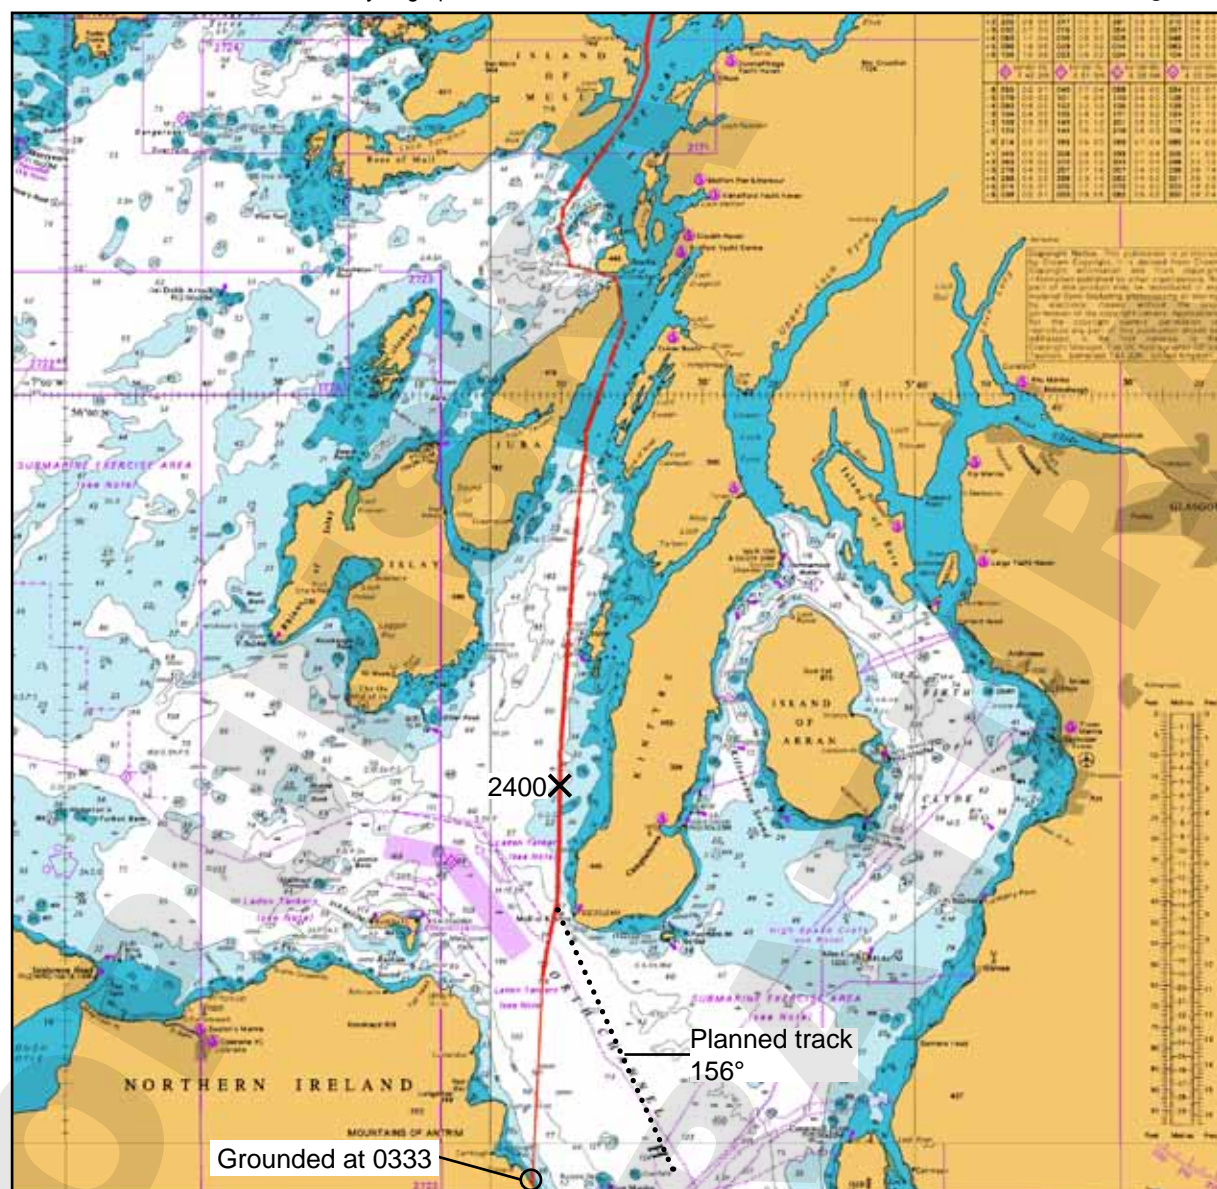
BA Chart 2724, extract showing *Antari*'s AIS track

At 2000, with the master as the sole bridge watchkeeper, *Antari* transited the Gulf of Corryvreckan before heading south to run parallel with the west coast of the Kintyre peninsula (**Figure 1**).

At midnight, the vessel's course was 182° (T), speed 11 knots and she was about 11 miles from the next planned alteration of course position, which was due west of the Mull of Kintyre lighthouse.
