MARINE TRANSPORTATION SAFETY INVESTIGATION REPORT M18C0240

Crew member seriously injured

Passenger vessel *Amadea*

09 September 2018

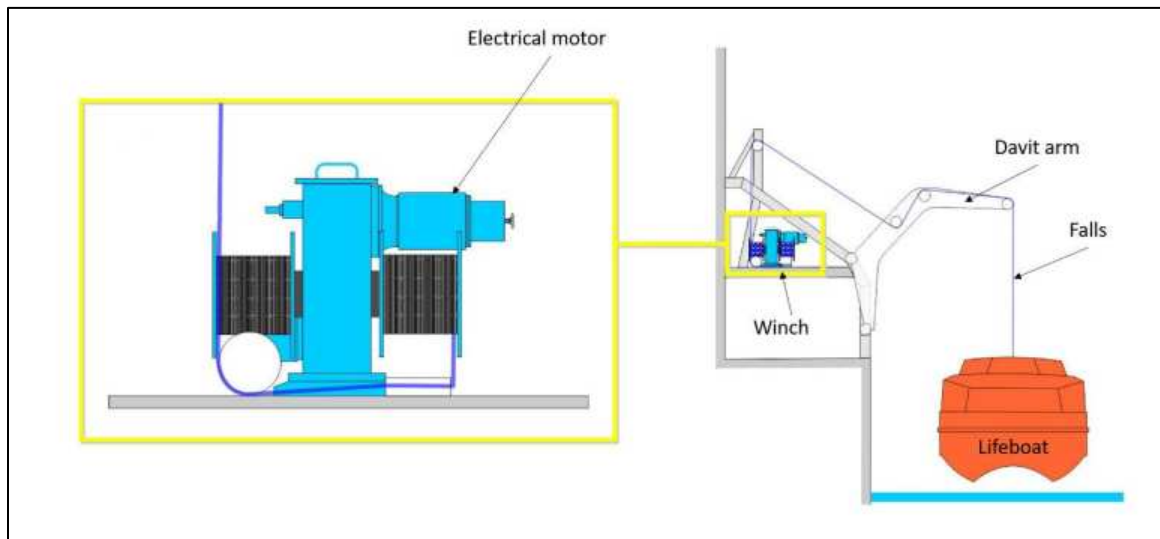
Figure 4. Diagram showing how lifeboat No. 4 hangs over the water, secured on its wire falls with davit arms fully deployed, and close-up view of the winch and its electrical motor (Source: TSB)

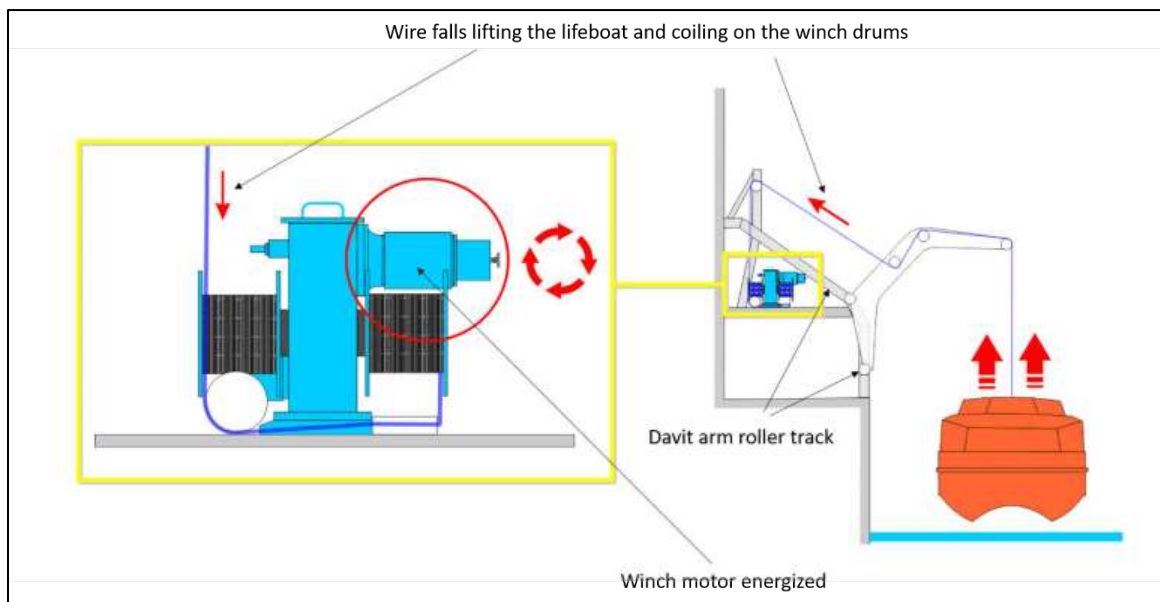
Figure 5. Diagram illustrating the lifting of the lifeboat: the winch motor is energized, the drums turn, and the wire falls coil onto the drums (Source: TSB)

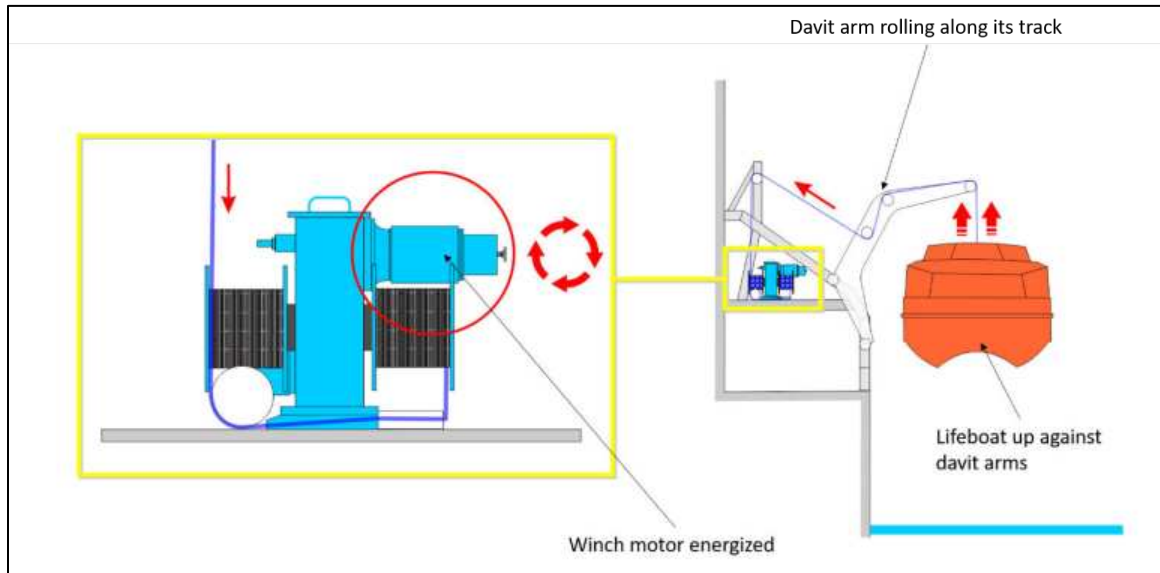
Figure 6. Diagram illustrating the lifting of the lifeboat: the davit arms roll along the roller track and are pulled inboard (Source: TSB)

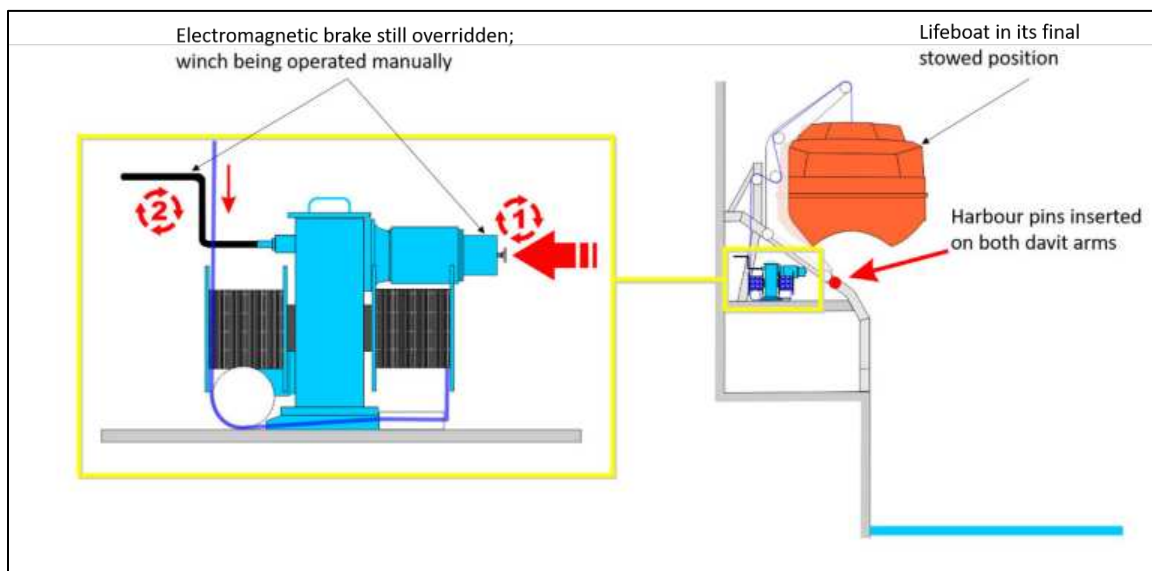
Once operators winch the lifeboat to its final stowed position, they secure the lifeboat with gripes. At this point, the holes in the davit arms and davit framed are aligned and the harbour pins can be inserted while the vessel is in port or during maintenance, to further secure the arrangement (Figure 9). The electromagnetic brake is still overridden in this situation, because the winch is being operated manually.

Figure 9. Diagram illustrating the lifeboat in its final stowed position, with the harbour pins inserted in the davit arms (Source: TSB)

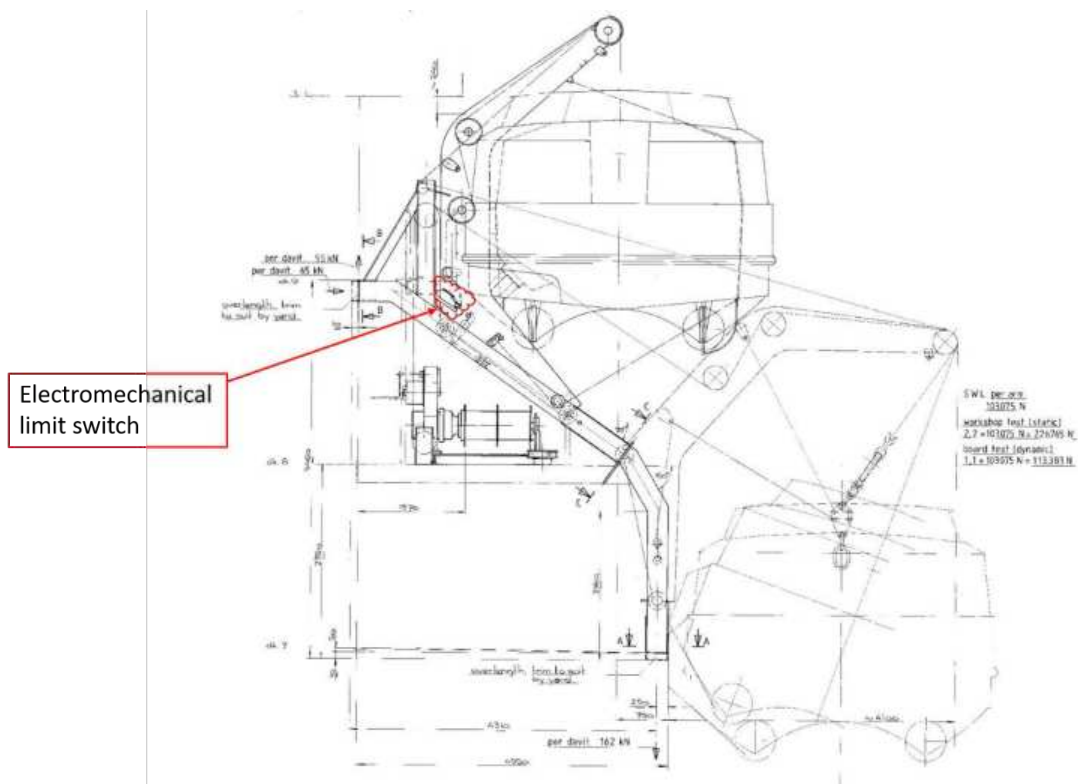
Appendix C – Technical drawing of Lifeboat No. 4 showing electromechanical limit switch

No. 3 and 4 davits are fitted with twin-arms that are paired with a single winch. Each davit arm has an adjustable lever-operated electromechanical limit switch that interrupts the winch motor's power supply once each davit arm approaches its uppermost position, immediately before contacting its stop, during lifeboat stowage (Figure 2 and Appendix C).

The fixed end of the wire falls of the *Amadea*'s lifeboat davits is fitted with a turnbuckle so that adjustments can be made to ensure that the davit arms remain aligned while they are moving (Appendix D). Overloading of the wire falls and damage to the mechanical components of the davit (Figure 2, Figure 7, and Appendix C) is prevented by means of an electromechanical limit switch to each davit arm.

Both electromechanical limit switches are adjustable, and their levers can be repositioned to vary the point at which the winch motor de-energizes before the davit arms reach their stops. At the time of the occurrence, the switches were adjusted so that the winch motor would de-energize 20 cm before the davit arm reached its stop.
