DANISH MARITIME ACCIDENT  
INVESTIGATION BOARD

# EXPRESS1 & BALTIC CONDOR

Summary report on collision

10 MAY 2019

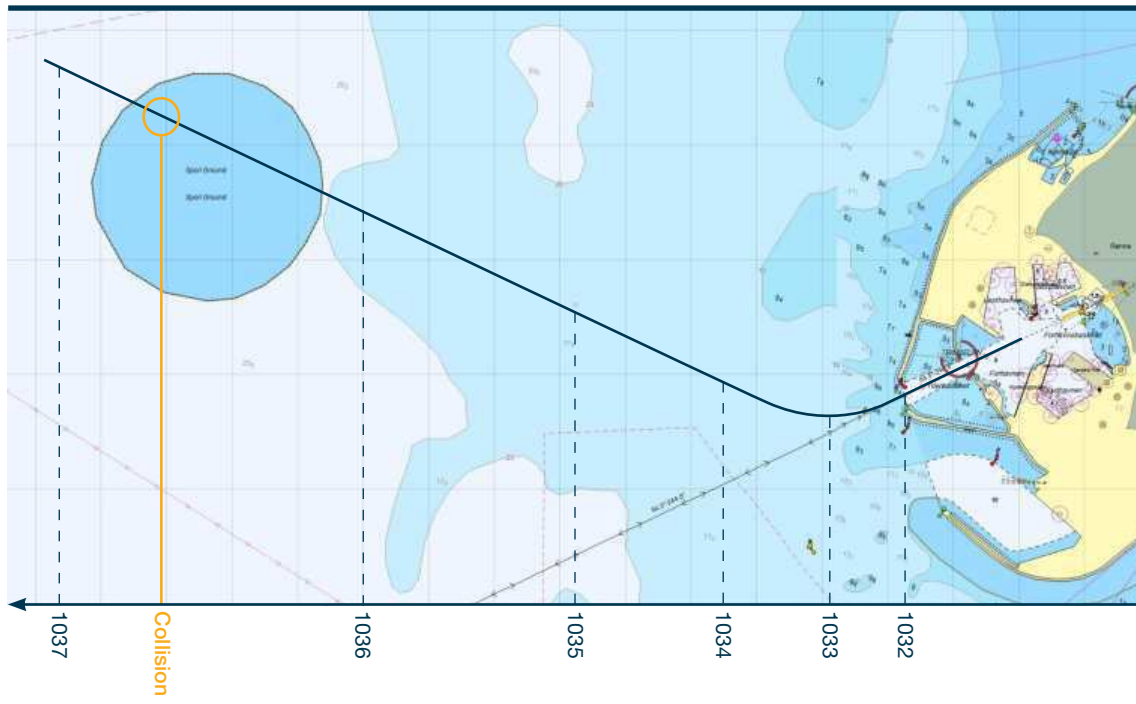
Figure 2: EXPRESS 1's route at the collision

10 minutes after departure, when the ship was 1.65 nm from Rønne Harbour, the crew of the bridge heard a bump and wondered what could have caused the sound (figure 2, next page).

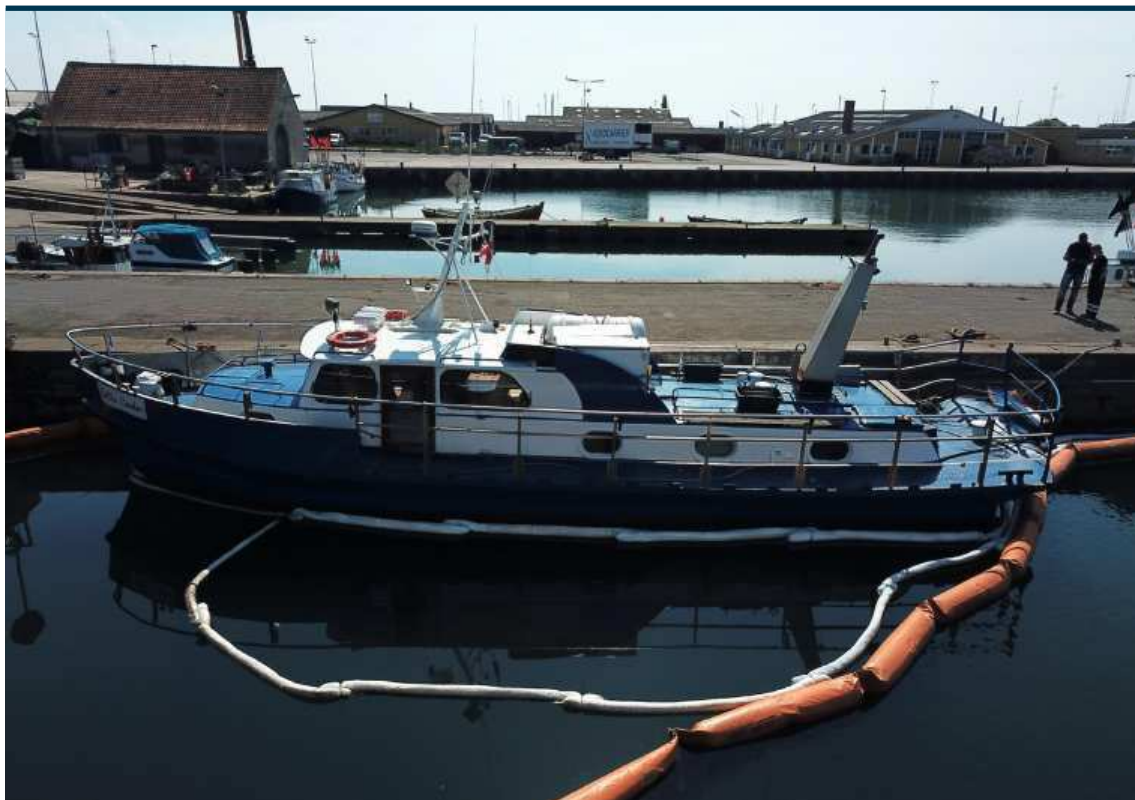
Figure 4: BALTIC CONDOR  
Source: DMAIB, 2019

The ship with which the EXPRESS 1 collided was a Polish tour boat named BALTIC CONDOR (figure 4). BALTIC CONDOR had three Polish crew-members and nine German anglers on board.

the port radar in Kołobrzeg (Poland) and the radars on the rescue services ships were able to detect the BALTIC CONDOR. This indicates that the ship did not possess characteristics to inhibit the detection of its echo. However, the BALTIC CONDOR was not equipped with an AIS transmitter and would therefore not be shown with an AIS marker on the radar screen. This means that the display of its position on the radar screen was less salient compared to ships with an AIS.

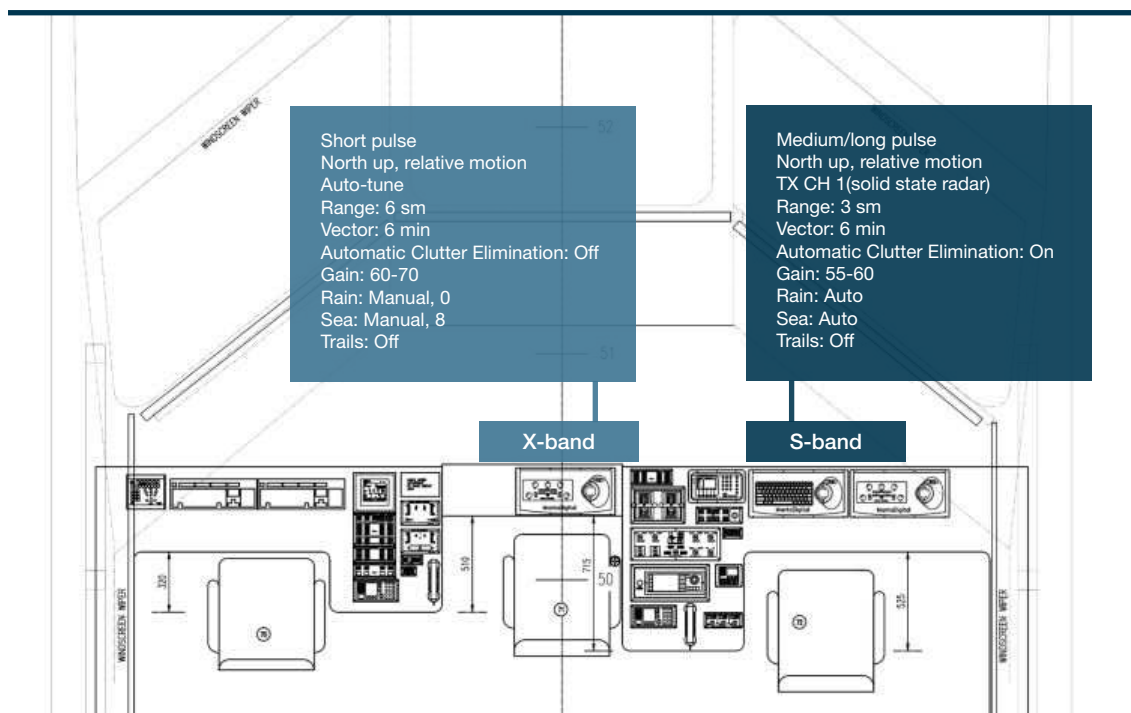
Figur 10: Indretningen af EXPRESS 1's bro  
Kilde: Molslinjen/DMAIB, 2019

During the voyages that DMAIB joined, it was found that the bridge area on EXPRESS 1 testified to the shortage of staff space on the vessel, which in general meant that many different activities took place on the bridge apart from navigation. Space shortage in the ship's mess, for example, meant that some crew members had their meals on the bridge. In addition, no toilet was installed on the bridge, which meant that the navigators would have to leave the bridge to make use of the facilities. Thus, the bridge on EXPRESS 1 could not be described as a sterile bridge environment in which the navigators were ensured the least possible disturbance from the rest of the staff and from tasks not related to navigation.
