Report on the investigation of
the collision between

Scot Isles

Wadi Halfa

Dover Strait

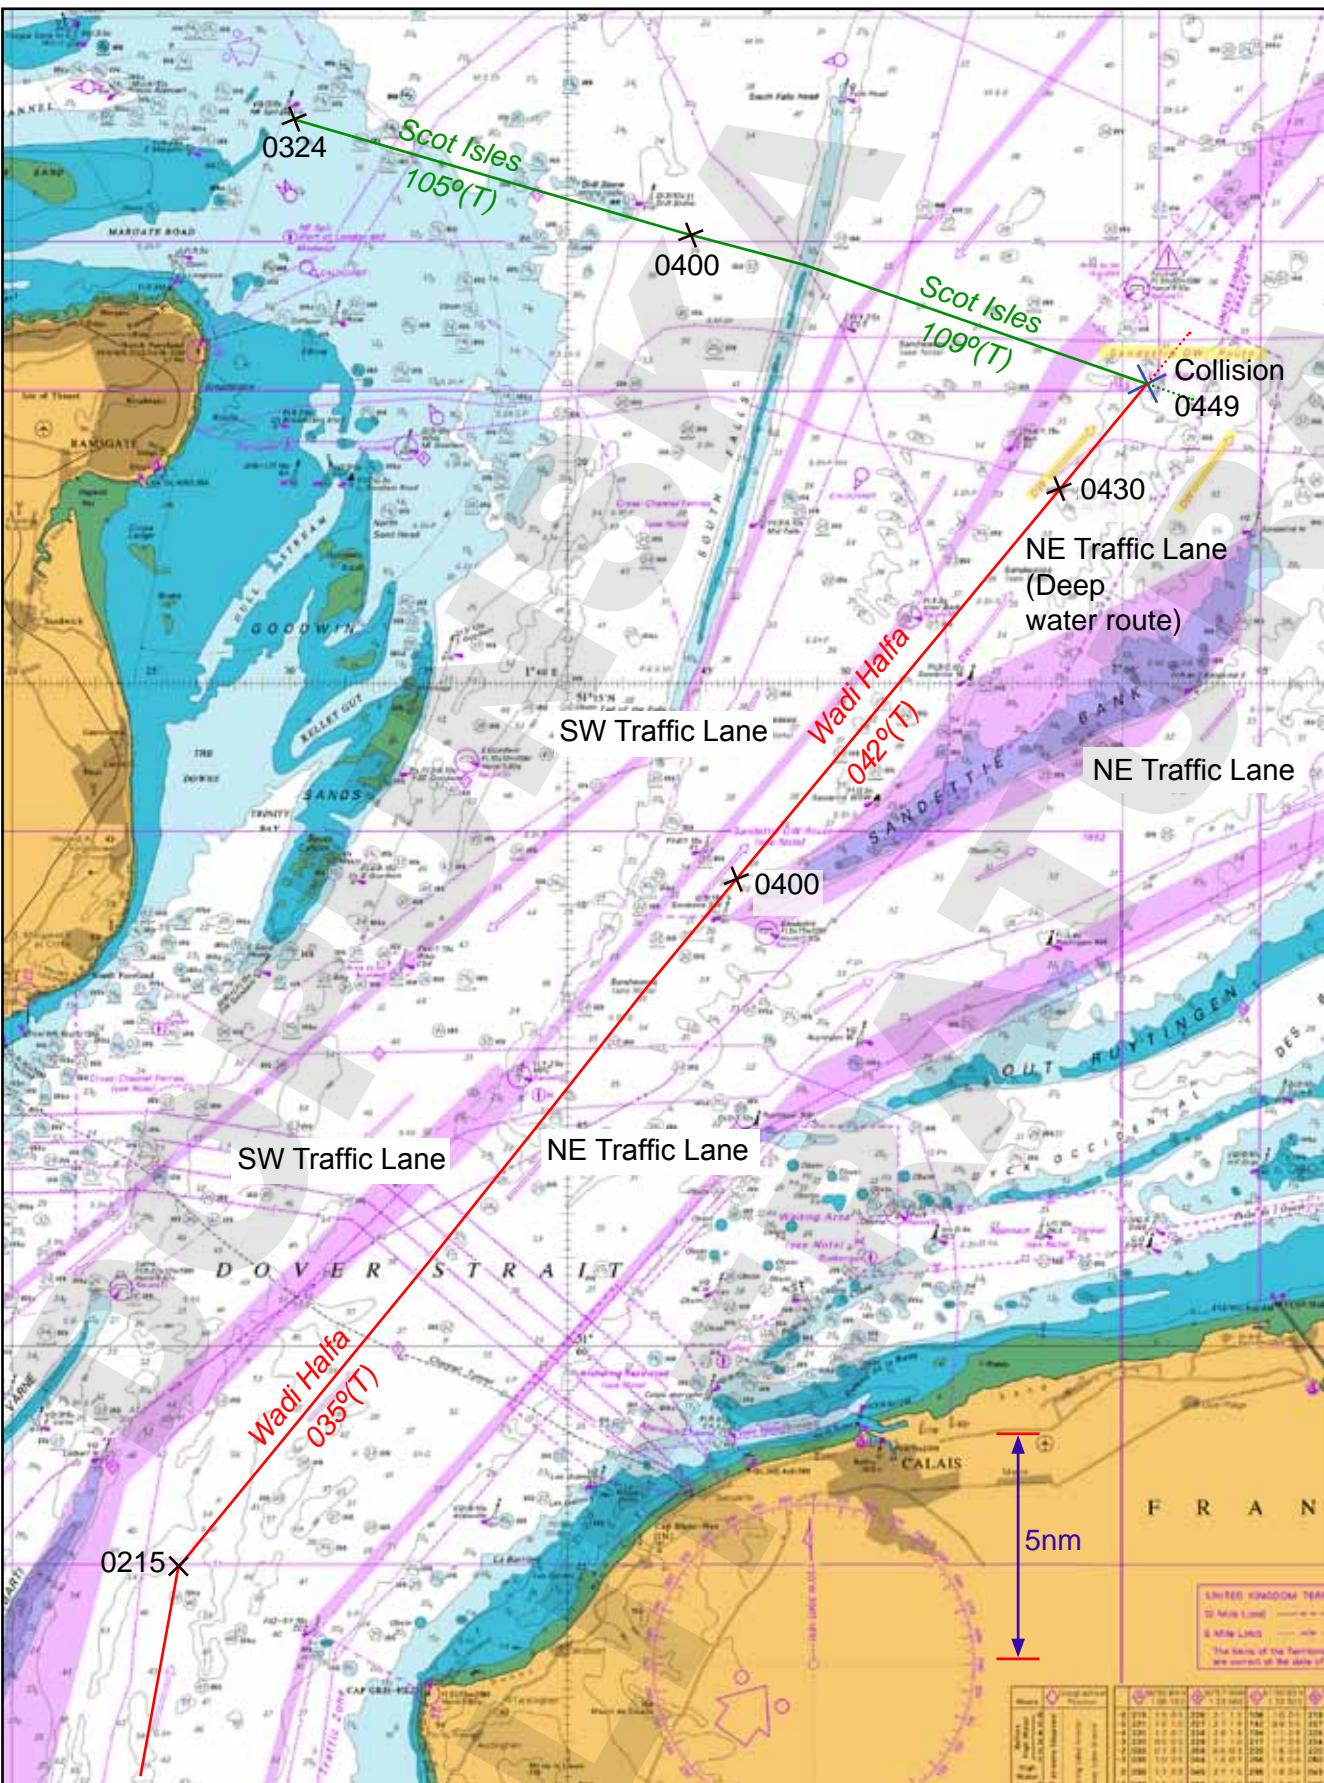
Scot Isles cleared the Thames estuary and at 0324 the second officer set a course of 105°(T) as the vessel approached the northern Dover Strait (**Figure 1**).

Extract from chart BA 2449, with passages of both vessels

At 0410, *Scot Isles* altered course to 109°(T), and at 0421 she began to cross the SW traffic lane of the TSS. The vessel's position was not plotted on the chart after 0400, so this reconstruction is based on radar replay information obtained from the Channel Navigation Information Service (CNIS) at Dover following the accident (**Figure 2**).

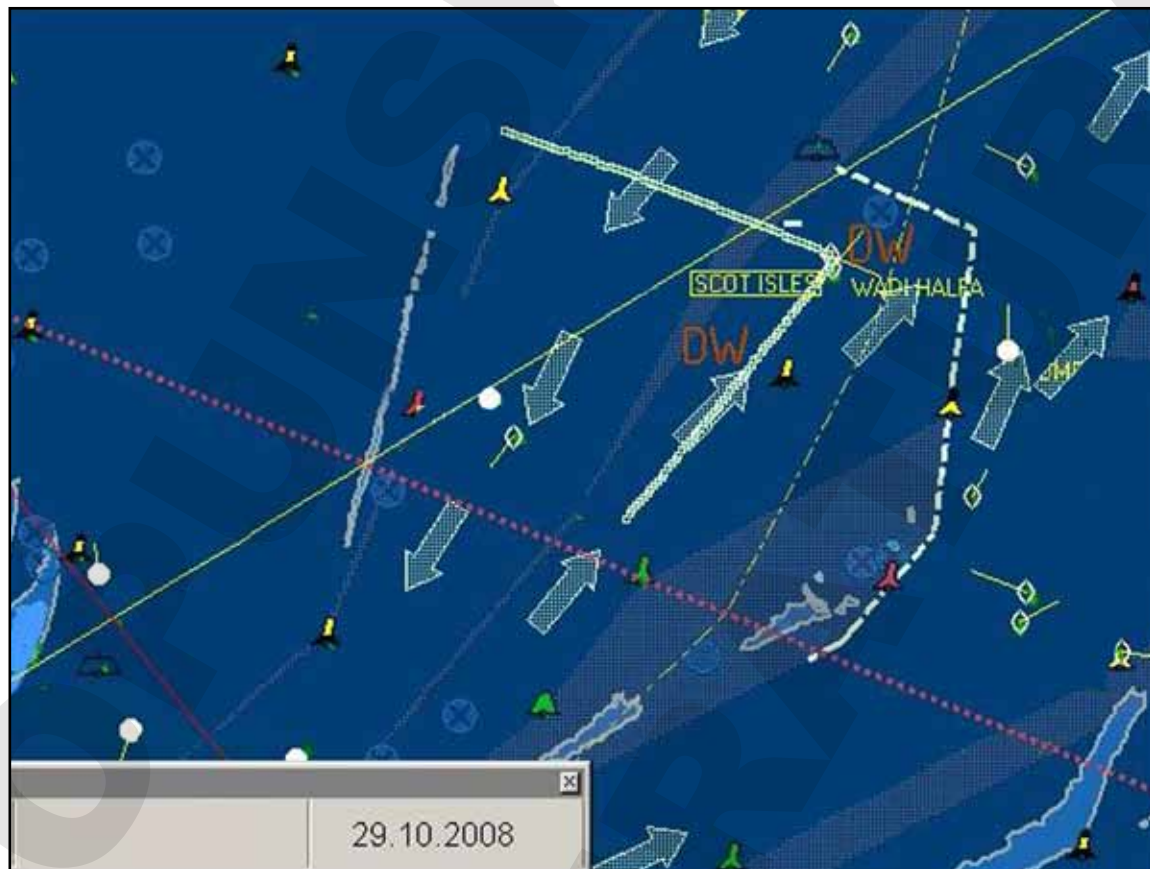
Figure 2

Radar replay screen shot from CNIS, 0449 29 October 2008

The tracks of both vessels were recorded on radar by CNIS at Dover and the radar plot for 0449, 29 October (**Figure 2**) shows their historic tracks at the time of the collision.

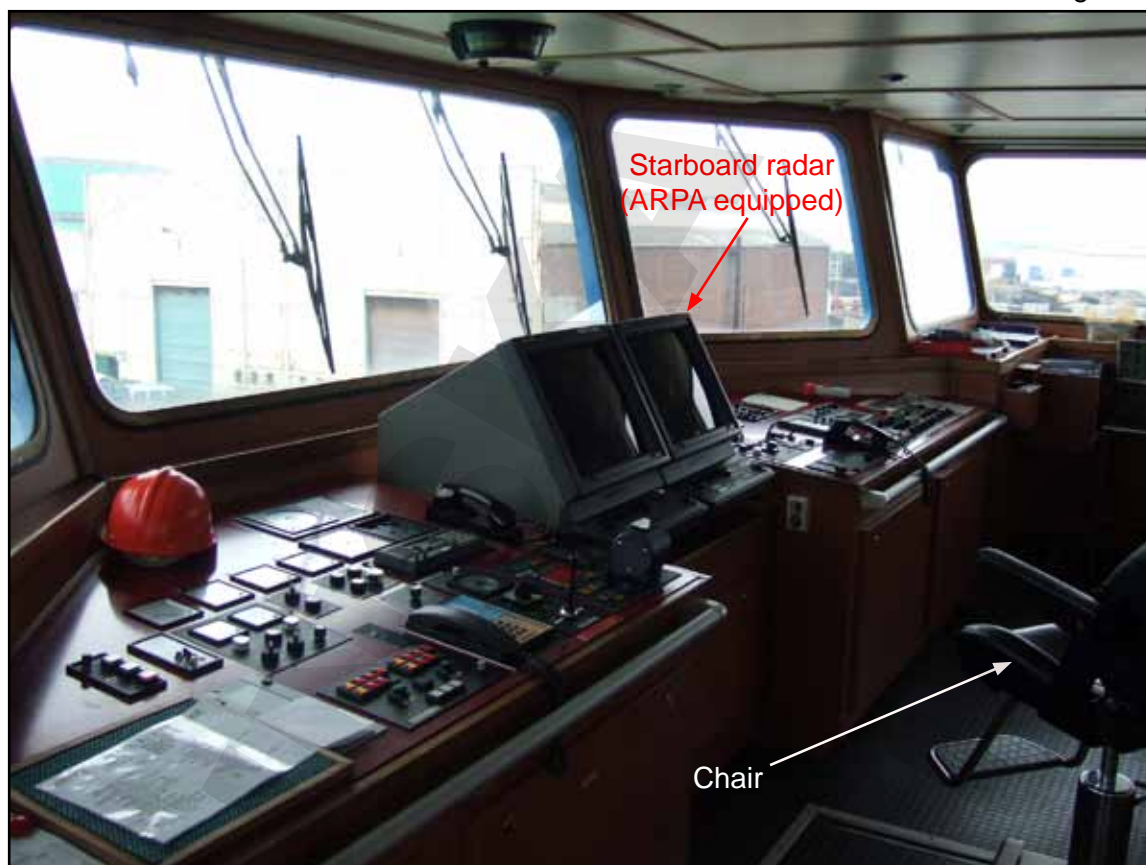
At about 0435 the lookout reported to the chief officer, who was sitting in the wheelhouse chair (**Figure 3**), the red navigation light of a vessel at about 3 points (34°) to starboard of *Scot Isles*. The lookout then advised the chief officer, who made no comment, that he was leaving the bridge to undertake his safety rounds. The chief officer had not registered the lookout's report of the other vessel.

Scot Isles - interior of wheelhouse

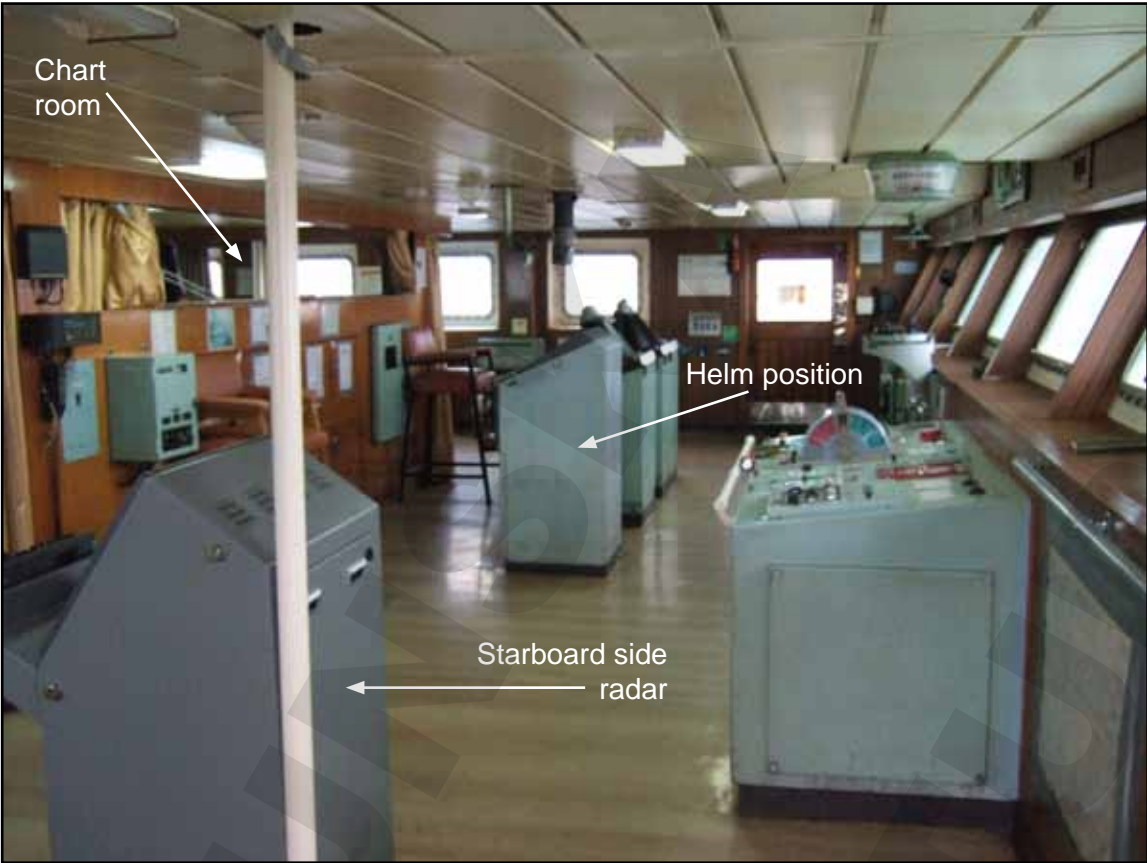
Wadi Halfa - interior of wheelhouse

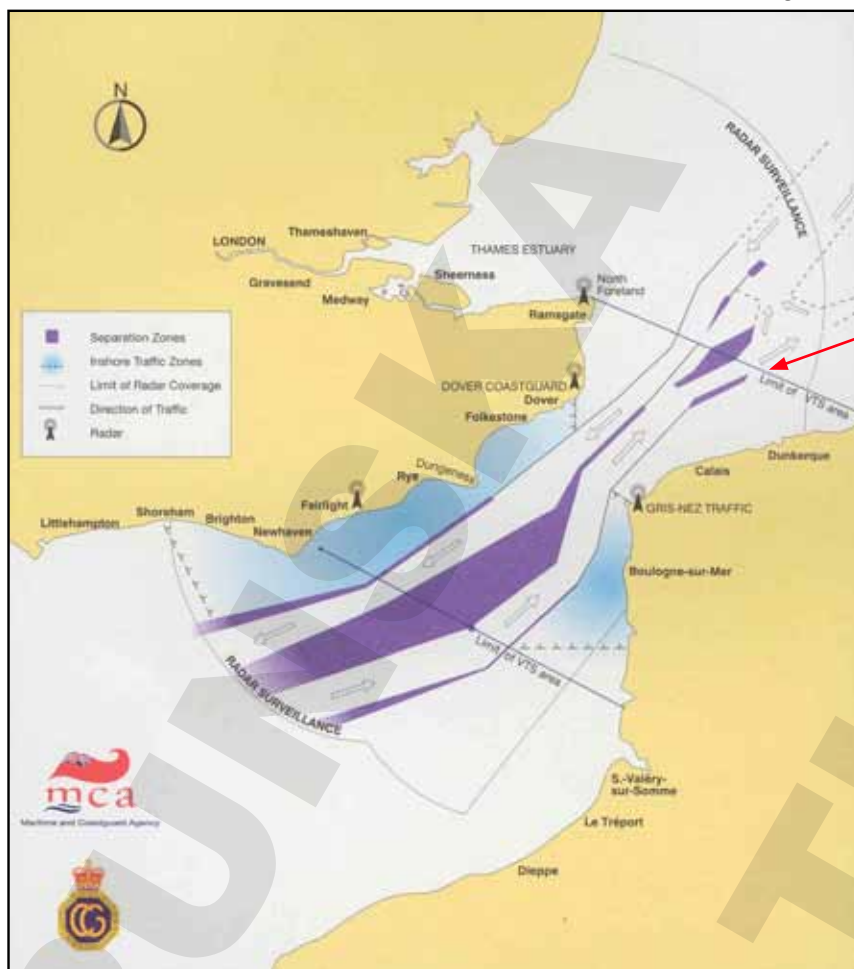
Wadi Halfa reported to Cap Gris Nez when she entered the NE bound traffic lane, while *Scot Isles* was not required to make a report as her passage was conducted outside of the mandatory reporting area (**Figure 9**).

Northern limit of mandatory reporting area

Dover Strait TSS - mandatory reporting area

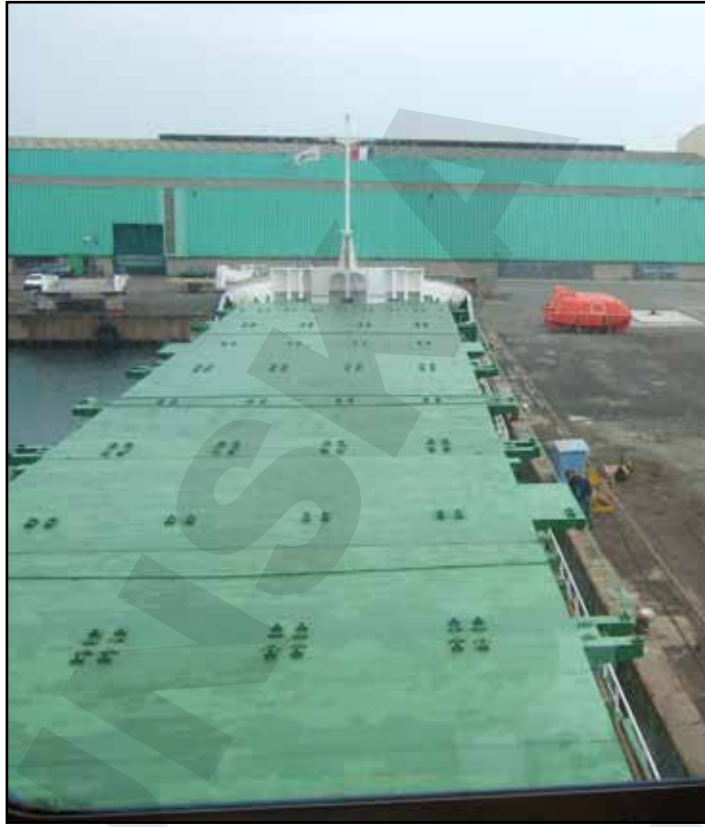
In assuming that only *Scot Isles*' starboard bridgewing had been damaged during the collision, the master relied on information provided to him by the chief officer, who was in a state of shock, and on what could be seen from the wheelhouse (**Figure 11**). A thorough inspection of the entire vessel, which should have included sounding all tanks and spaces, should have been undertaken following the collision.

Scot Isles - view looking forward from wheelhouse
