National Transportation Safety Board

Marine Accident Brief

Overpressurization and Rupture of Cargo Tank on Cargo Vessel *Fairchem Filly*

Accident type	Hull/Machinery/Equipment Damage	No. DCA19FM037
Vessel name	<i>Fairchem Filly</i>	
Location	Vopak Terminal, Ship dock 5, Houston Ship Channel, Deer Park, Texas 29°44.95' N, 95°05.76' W	
Date	May 30, 2019	
Time	0750 central daylight time (coordinated universal time – 5 hours)	
Injuries	None	
Property damage	Est. \$750,000 to vessel and \$100,000 in cargo	
Environmental damage	None	
Weather	Temperature 83°F, winds from the north at about 5 miles per hour, clear visibility	
Waterway information	Houston Ship Channel at the Vopak Tank Terminal facility. The terminal has four deep-draft tanker berths and eight barge docks located on the south side of the channel.

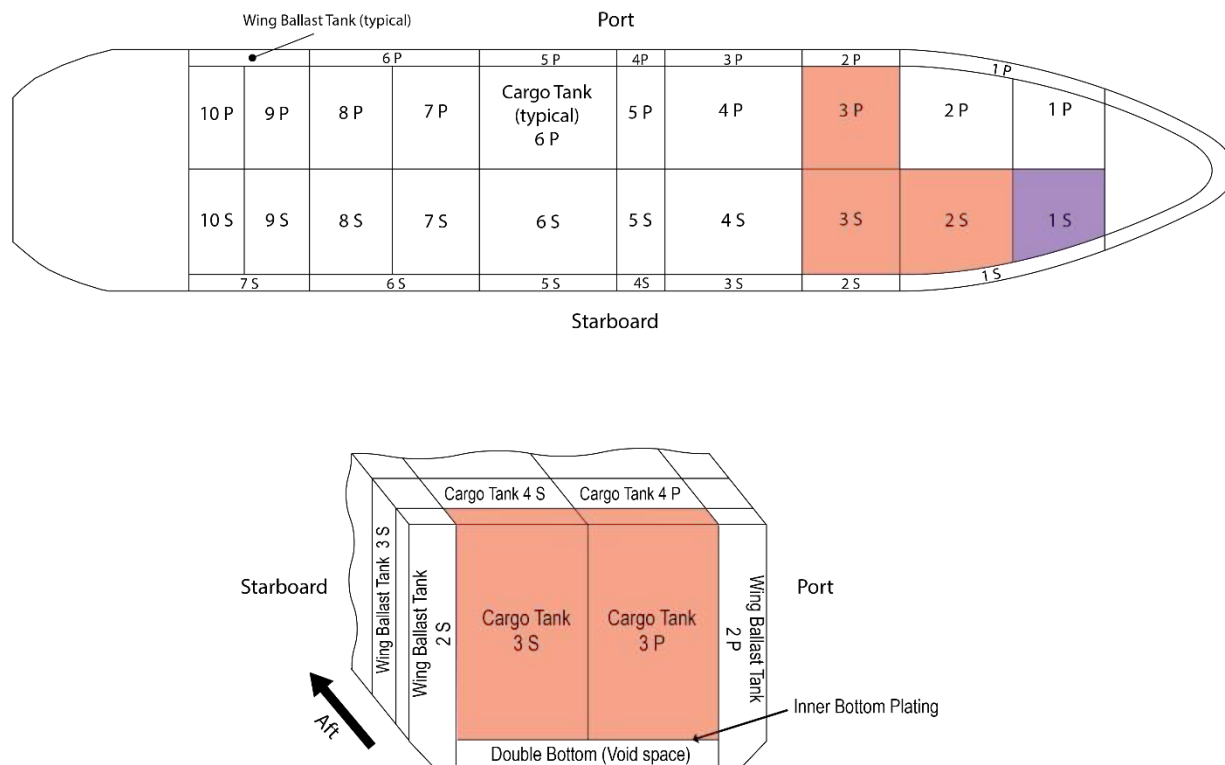
The tanker's number 1 starboard (1S), number 2 starboard (2S), and number 3 port and starboard (3P and 3S, respectively) cargo tanks contained product and were all scheduled to be discharged to the terminal. Tank 1S was approximately 38% full and contained 65,171 gallons of methyl isobutyl ketone (MIBK) in a liquid state. Tanks 2S, 3P, and 3S were each 93% full and, combined, contained about 914,563 gallons of liquid hexene. All other cargo tanks aboard the *Fairchem Filly* were empty.

Simplified diagram of the cargo tanks and wing ballast tanks on board the *Fairchem Filly*. The cargo tanks carrying hexene are marked in orange, and the cargo tank carrying MIBK is marked in purple.
