SAFETY INVESTIGATION REPORT

REPORT NO.: 23/2020

MV LA SOLOGNAIS

**Serious injury to a crew member
in the grey water tank
in position 07° 43.5' N 076° 08.0' E,
26 December 2019**

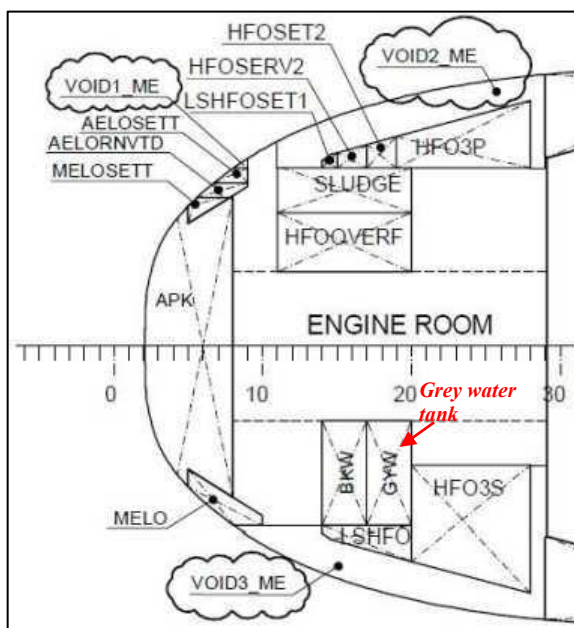
The grey water¹ tank on board *La Solognais* was fitted in the engine-room, between frame nos. 17 and 20 (Figures 2 and 3). This tank's bulkheads separated it from the main engine space, a heavy fuel oil (HFO) tank, a low-sulphur heavy fuel oil (LSHFO) tank and the black water² tank.

Figure 2: Location of the grey water tank – Bird's eye view

The tank had a volume of 42.80 m³, and a maximum depth of about 3.10 m. The depth of the tank in way of its access ladder was 3.00 m. It was fitted with only one access manhole, at the top of the tank, which corresponded to the bottom platform of the engine-room. The tank's air vent opening was located on the vessel's funnel deck, at a height of 26.08 m from the top of the tank.

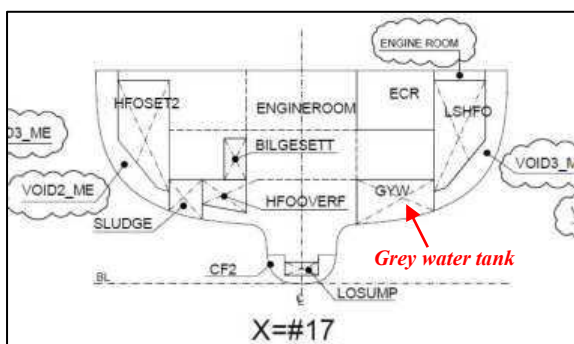
Figure 3: Cross-section of the grey water tank, at frame no. 17 (seen from aft)
