**Final Report**

**FIRE**

**ON BOARD MAERSK HONAM**

MIB/MAI/CAS.035

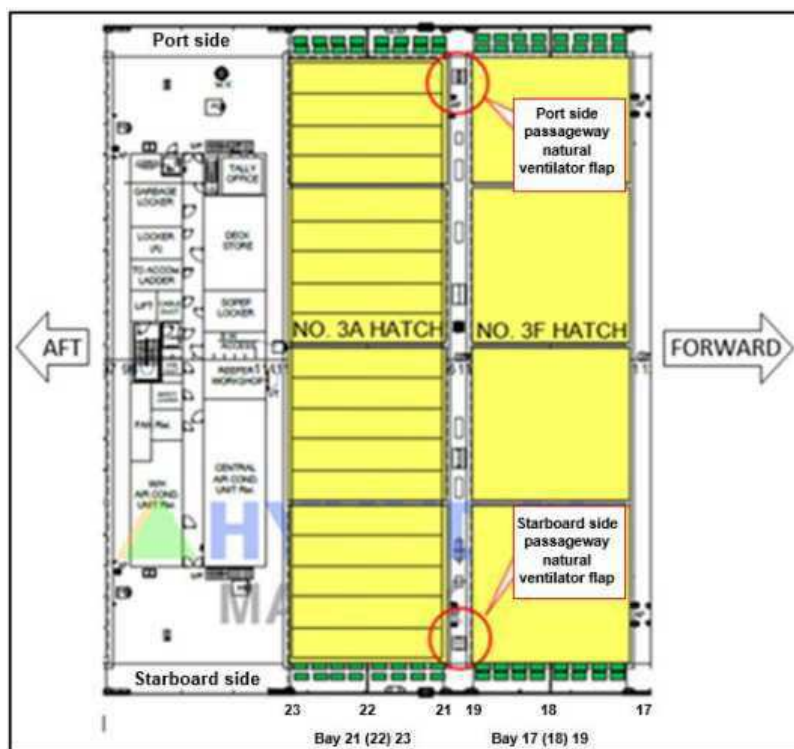
Figure 5 - Plan view showing locations of the natural ventilator flaps for the passageway as marked by the red circle (port and starboard side) annotated by TSIB

- 1.2.11 Overhearing the conversation, the 3E-1 responded and advised the 2E over the walkie-talkie to use the starboard passageway which was clear of smoke at the time the 3E-1 was going to the ECR. The 2E followed the 3E-1's advice and did not encounter any smoke or unusual smell on the way to the FCS (see **figure 5** showing the locations of the port and starboard natural ventilator flaps<sup>64</sup> for the passageway).

<sup>64</sup> These flaps were open at the time of the occurrence allowing for a flow of air within the passageway.

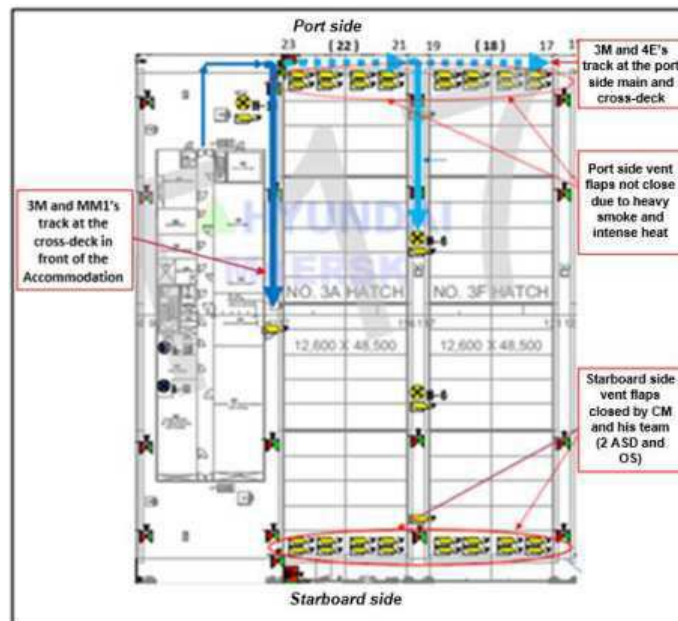
Figure 8 - AT-1's track for closing the ventilator flaps

- 1.2.26 The CM also instructed the crew doing boundary cooling at the port side main deck to provide a water curtain for aiding the 3M, and later the 4E, to minimise the effects of heat and smoke. Although the 3M reported a slight improvement in the visibility, the area near the port side natural ventilator flaps was still inaccessible due to the intense heat and huge amount of smoke. Unable to close the natural ventilator flaps at the side of the hatch cover, the 3M walked further forward and ascended the second vertical ladder leading to the cross-deck, identified later as bay 19/ 21. The 3M located and successfully closed the no.3 cargo hold exhaust ventilator flap at the port side cross-deck. (See **figure 8** - showing AT-1's track for locating the port side flaps).

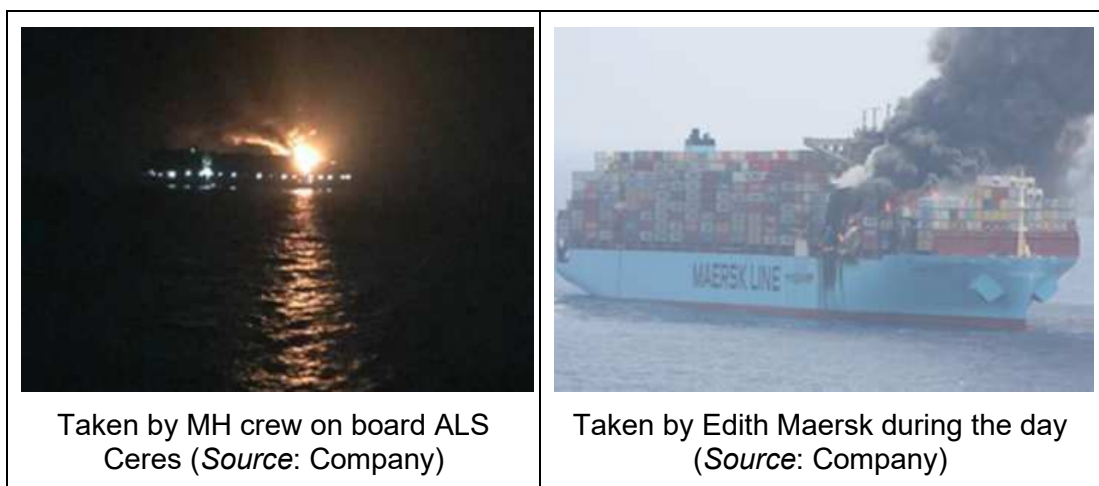
Figure 13 - Fire onboard the MH

- 1.5.3 By about 2230H, ALS arrived on scene and updated MRCC Mumbai.
- 1.5.4 Subsequently, the Master of ALS updated MRCC Mumbai that on 7 March 2018 at about 0130H, 23 crew members from MH had been recovered on board ALS and that four persons were unaccounted for. SAR operations of the nearby sea area to look out for the four missing persons continued with the assistance of several vessels. See **figures 13 and 14** - fire on board MH.

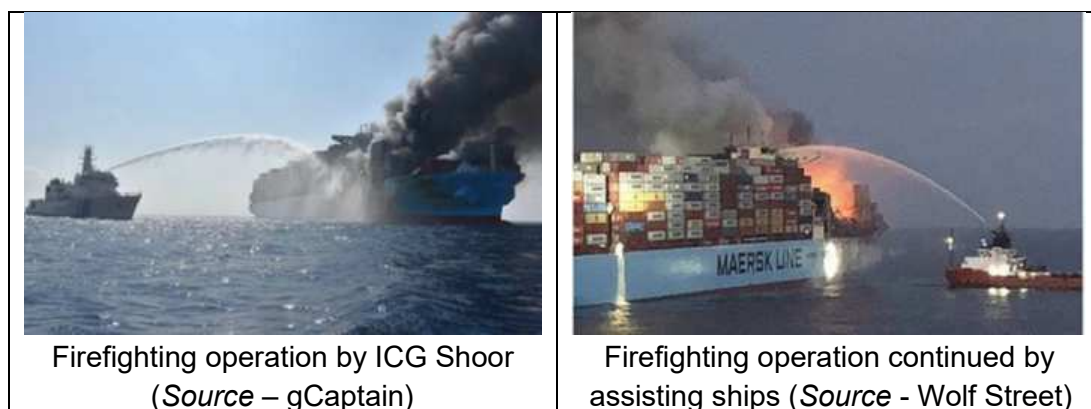
Figure 15 - Firefighting operation

- 1.5.9 On 8 March 2018, the ICG's ship (Shoor) commenced firefighting operations. Thereafter, the ICG Shoor was joined by other ships engaged by the Company for the firefighting operations. See **figure 15** - firefighting operation.

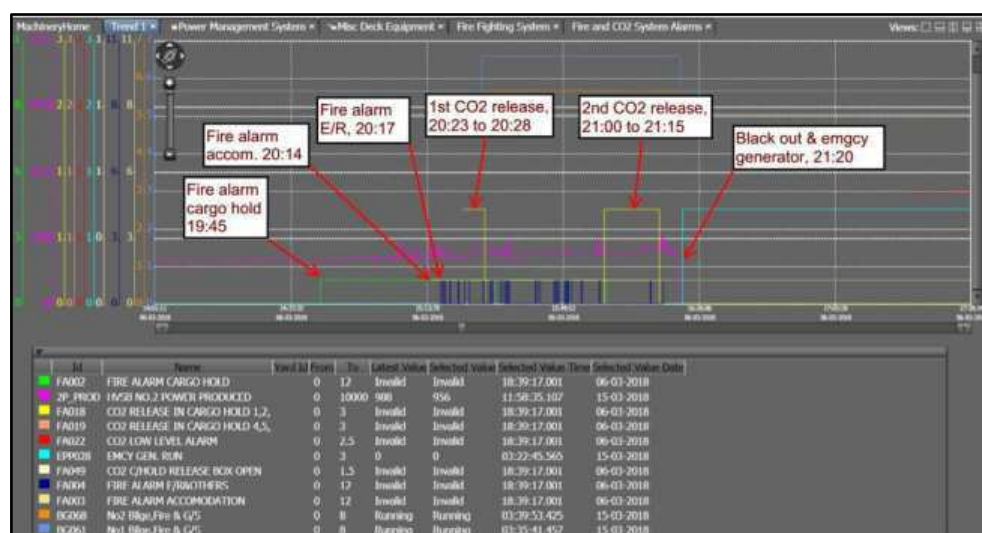
Figure 17 - CAMS data showing the alarms and events during the incident  
(Source – Annotated by the Fire Forensic Expert)

- 1.6.1 A screen shot of the CAMS console (see **figure 17**) showing the graphical representation of some of the key alarms that occurred during the incident indicating the onset of the smoke alarm, the release of CO<sub>2</sub> and the blackout.

- b. Electrical source - Correlating the sequence of events (see **figure 17 and table 2**) and the examination and tests carried out on the electrical remnants by the Fire Forensic Expert, seems to suggest that an electrical

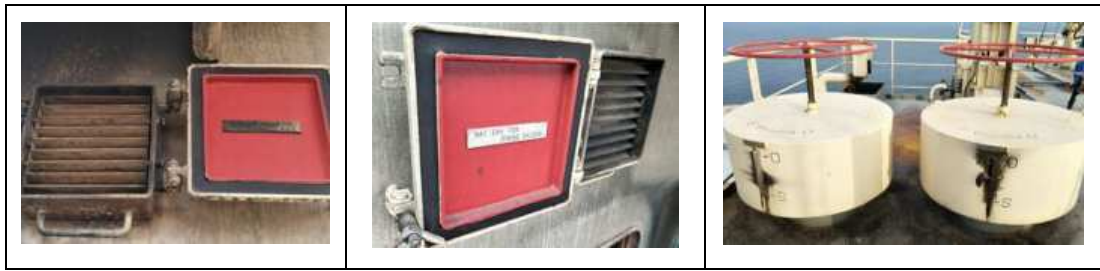
Figure 20 - Ventilation covers and mushroom ventilators for the accommodation

- 1.8.7 In addition to the fire dampers, the accommodation block was also fitted with a total of 27 manually operated ventilation closing appliance<sup>117</sup> (hereinafter referred to as exterior ventilation vents). These exterior ventilation vents were meant for exchanging of fresh air with exterior environment when opened and for preventing entry of smoke or gases into the accommodation when closed.
- 1.8.8 The investigation team was able to access and check the condition of the exterior ventilation vents for the accommodation. Most of these were found<sup>118</sup> in an open position (see **figure 20** on ventilation closing appliance of cover type and mushroom type).

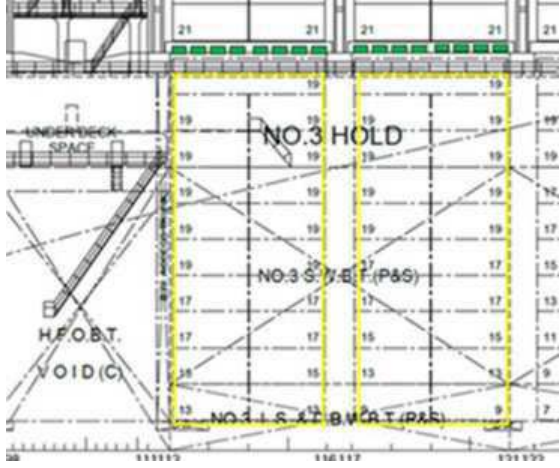
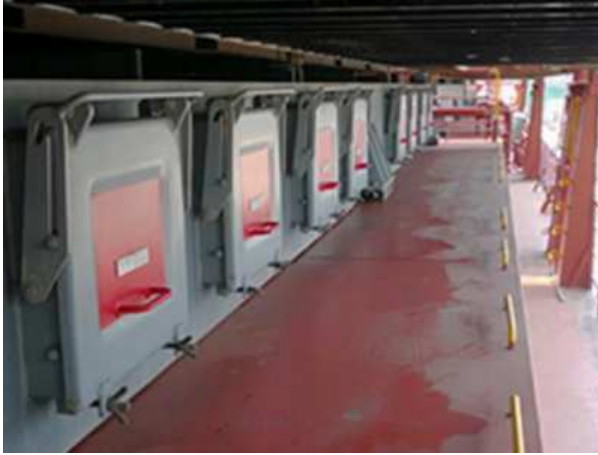
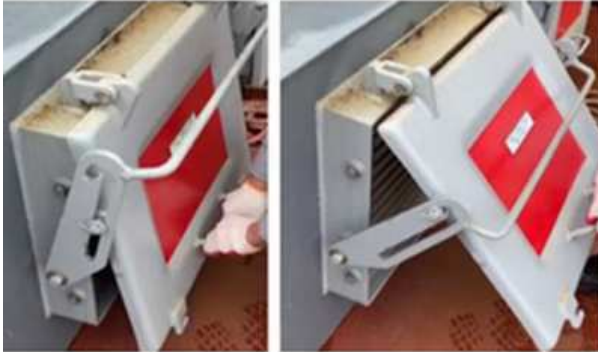
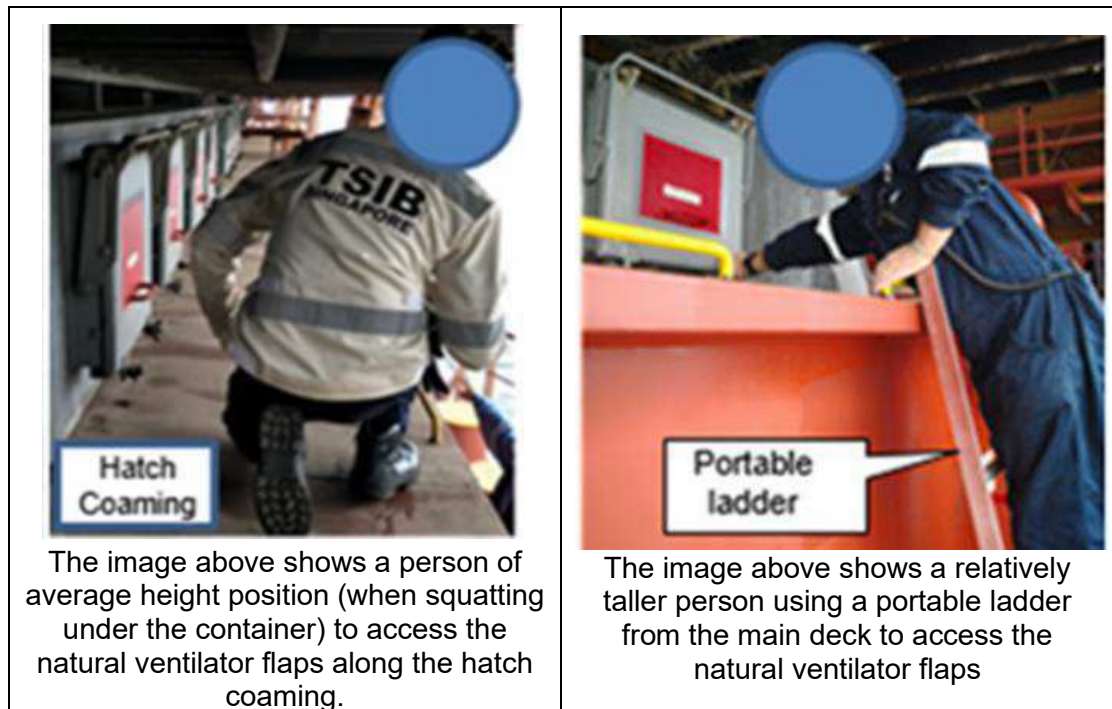
Figure 25 – Natural ventilator flaps

<ul style="list-style-type: none"> <li>• Side view of no.3 cargo hold (forward and aft part) indicated by yellow markings.</li> <li>• The illustration shows the location of the 16 natural ventilator flaps, annotated by TSIB in green, on the hatch cover (in this case the starboard side is depicted)</li> </ul>

<ul style="list-style-type: none"> <li>• The image shows the natural ventilator flaps of a sister ship in close position, located on the side of the hatch cover panel.</li> <li>• These flaps are located at a height of about 1.95m above the main deck. To access these flaps, the crew must either use a portable ladder on the main deck to reach the flaps or climb on to the hatch coaming and squat under the container.</li> </ul>

<ul style="list-style-type: none"> <li>• The image shows the flap in the process of being opened (with two hands) and then hooked in an open position.</li> <li>• To close the flap, it must be first lifted in the upward direction to release the “locking hook” before closing and securing with a wing nut</li> </ul>

<sup>131</sup> It was noted that the natural ventilator flaps for no.3 cargo hold (total 32nos.) were in open position.

- 1.8.21 The investigation team was able to confirm the account of the crew by an inspection of the ship post-incident, that the starboard side natural ventilator flaps were closed while those on the port side were open (see **figure 26**).

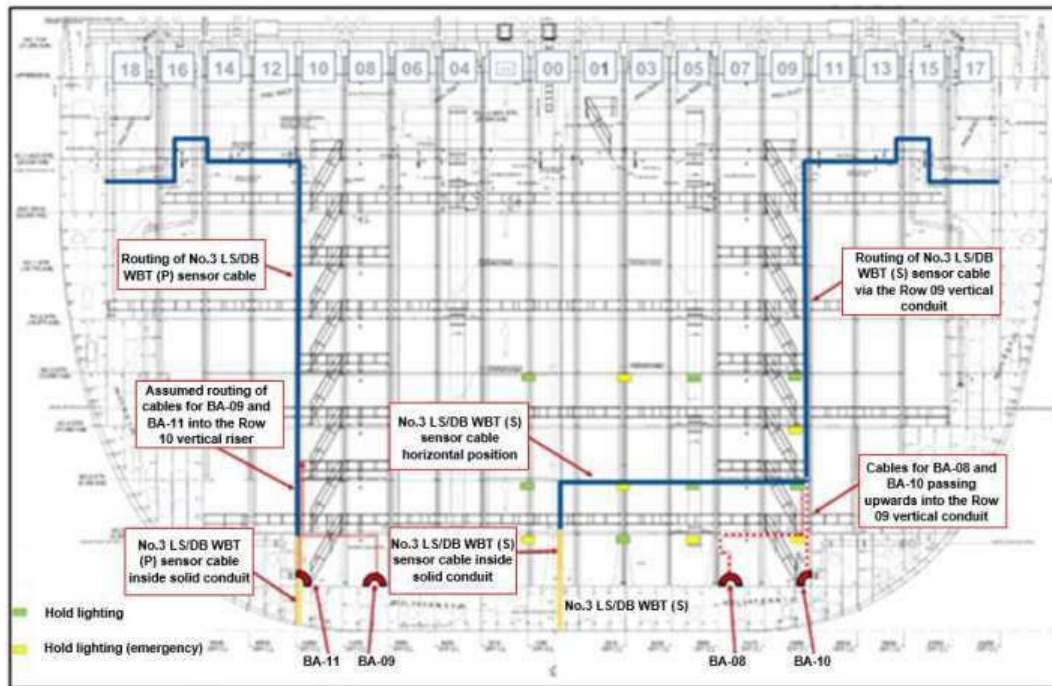
Figure 27 - Layout of no.3 cargo hold and the intermediate gallery at frame 116 ~ 117

- 1.9.1 No.3 cargo hold comprised two 40' bays, i.e. bay 17(18)19 in the forward section, and bay 21(22)23 in the aft, which were separated by a non-watertight bulkhead (hereinafter referred to as the intermediate gallery), at frames 116 and 117 (see **figure 27**). The hold was enclosed at the forward and aft, by watertight bulkheads (at frames 121 and 112 respectively).

- 1.9.8 The port side hydrostatic sensor was mounted in line with row 10<sup>134</sup> and the cable for this sensor passed vertically from where it exited the tank-top directly into the vertical conduit, before passing horizontally at no.1 additional stringer level into the port side passageway. The solid steel conduit in which the tank sensors were housed are shown with the yellow lines in **figure 27**.

<sup>134</sup> An error by the Fire Forensic Expert mis-identified No.3 LS/ DBT WBT (P) as No.3 LS/ DBT WBT (S) has been amended to read correctly in figure 27.

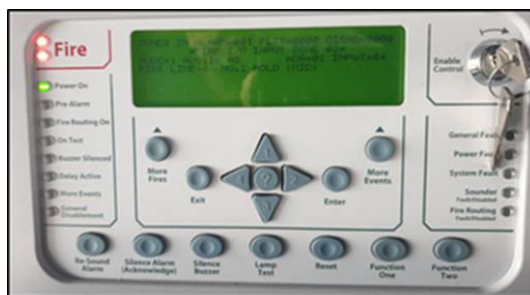
Figure 28 - Cargo hold smoke detection repeater panel on the bridge

- 1.11.2 At about 1945H, the bridge team was alerted by the smoke alarm on the bridge repeater panel indicating smoke being detected in the mid-section of no.3 cargo hold. See **figure 28** showing the repeater panel.

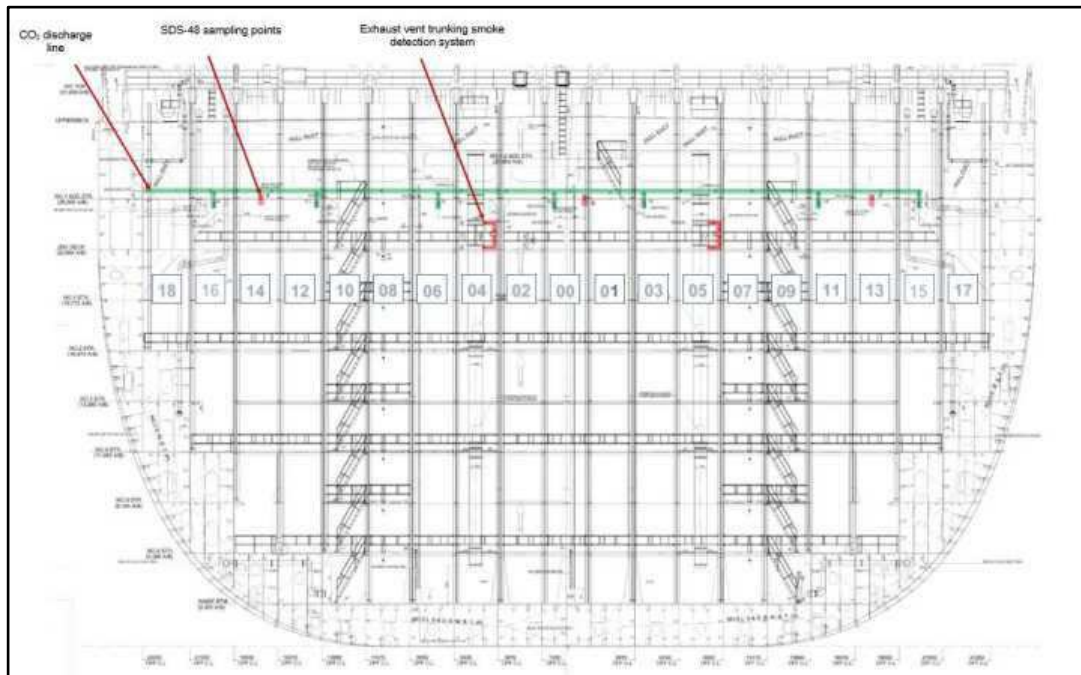
Figure 29 - Showing intermediate bay of no.3 cargo hold at frames 116-117<sup>145</sup>

- 1.11.3 The smoke detection system for MH's cargo holds consisted of the 'Smoke Detection System' (SDS-48) with 'Addressable Fire Detection System' (Synchro ASM<sup>144</sup>) provided by "Safetec". Each cargo hold had sample lines connected to sensors in a detector unit housed in the CO<sub>2</sub> room. A fan unit would draw air from the cargo hold through the system while the detector monitored the air. Each cargo holds exhaust ventilation ducts were also fitted with individual smoke detectors. See **figure 29** – showing intermediate bay of no.3 cargo hold at frames 116 -117.

- 1.12.3 Each cargo hold on board MH was protected by CO<sub>2</sub> fire suppression system by means of multiple discharge heads located at high level across the intermediate gallery of each hold (also shown on **figure 29**). As CO<sub>2</sub> enters<sup>151</sup> the space and mixes with the atmosphere, the percentage of oxygen in the atmosphere is reduced (space is inert) and results in extinguishing the fire. The enclosed space must be sealed as reasonably tight as possible to maintain the concentration of CO<sub>2</sub> and the reduction in oxygen. Spaces must be kept filled with CO<sub>2</sub> until it has been established that the fire has been extinguished and reduction of hot spots is verified.

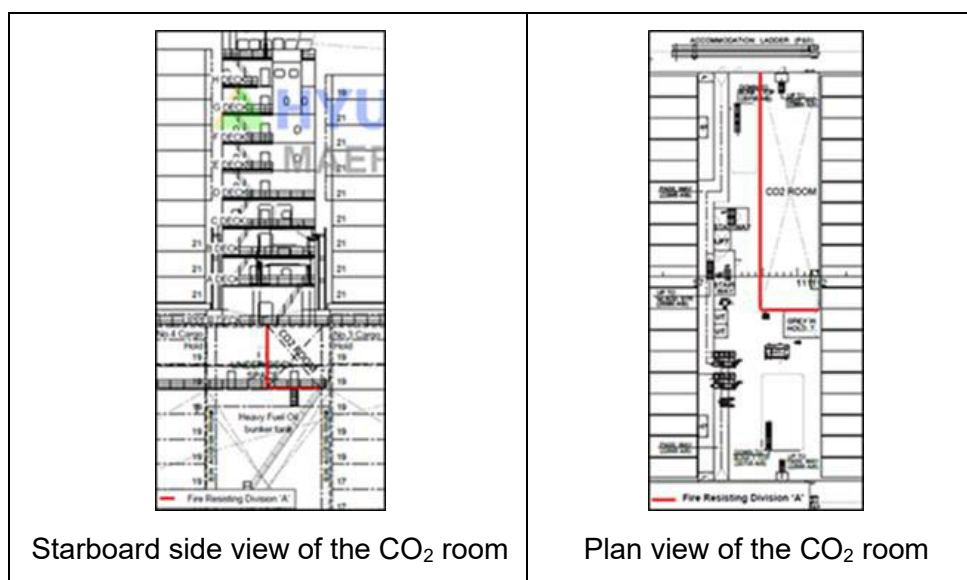
Figure 30 - CO<sub>2</sub> room boundary (annotated by TSIB with red marking)

1.12.6 MH was fitted with an approved low-pressure CO<sub>2</sub> fixed fire extinguishing system, manufactured by “Danfoss Semco”. The main components of the system were fitted at the under-deck space below the accommodation and were protected by fire-resisting Division ‘A’ as annotated by TSIB with a red colour (see **figure 30** as annotated by TSIB).

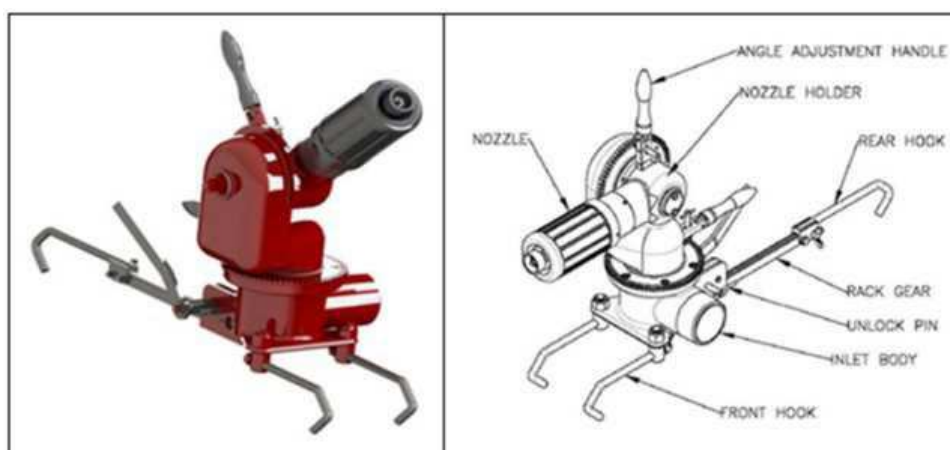
Figure 32 - Mobile Water Monitor

- 1.13.1 MH was also provided with portable firefighting equipment that included eight Mobile Water Monitors (MWM)<sup>155</sup> with flexible fire hoses (see **figure 32**).

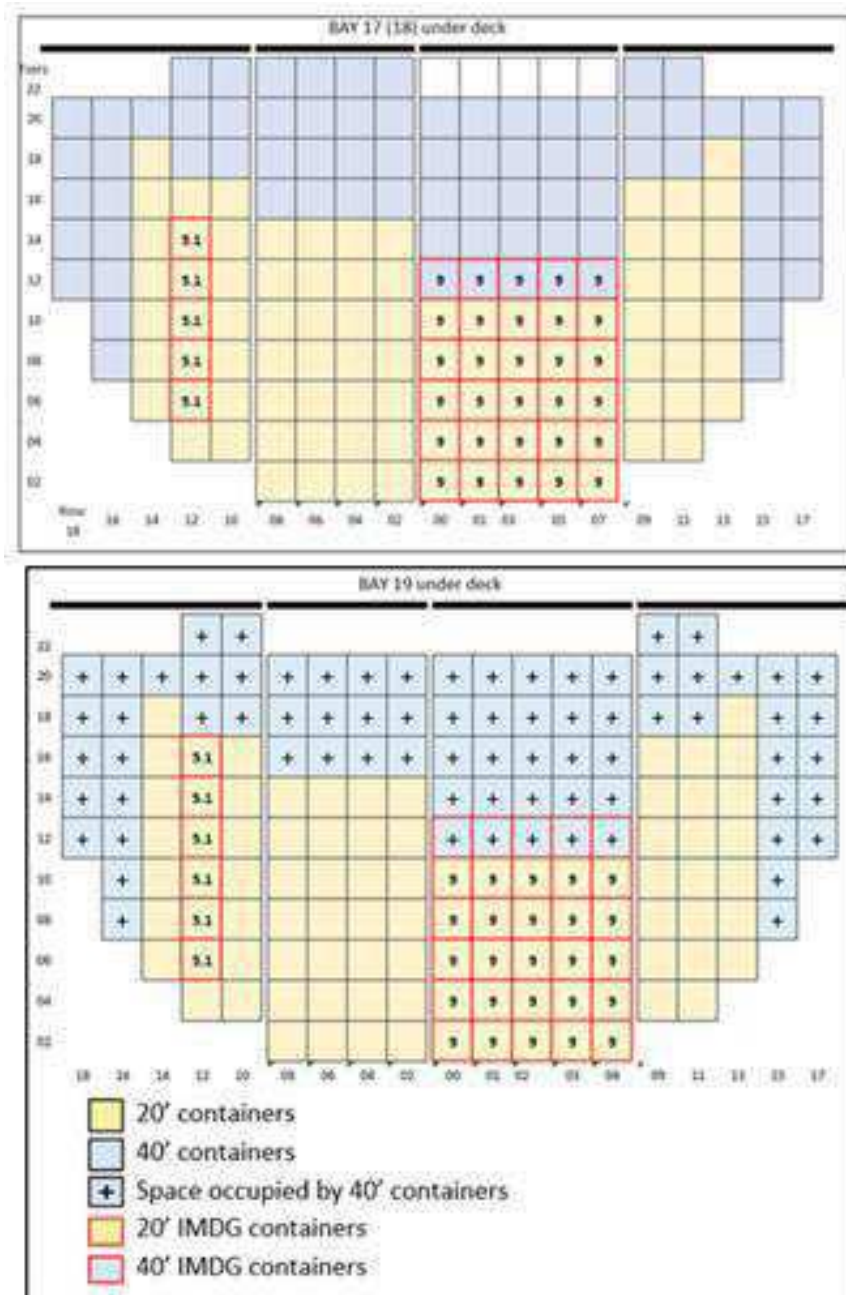
Figure 34 – Showing containers at bay 17 (18) 19

- 1.15.11 As per the cargo spotting plan, there were 269 containers inside no.3 cargo hold (Forward) in-way of bay 17 (18) 19. The breakup of numbers and type of containers stowed as a block stowage<sup>166</sup> (see **figure 34**) were as follows:

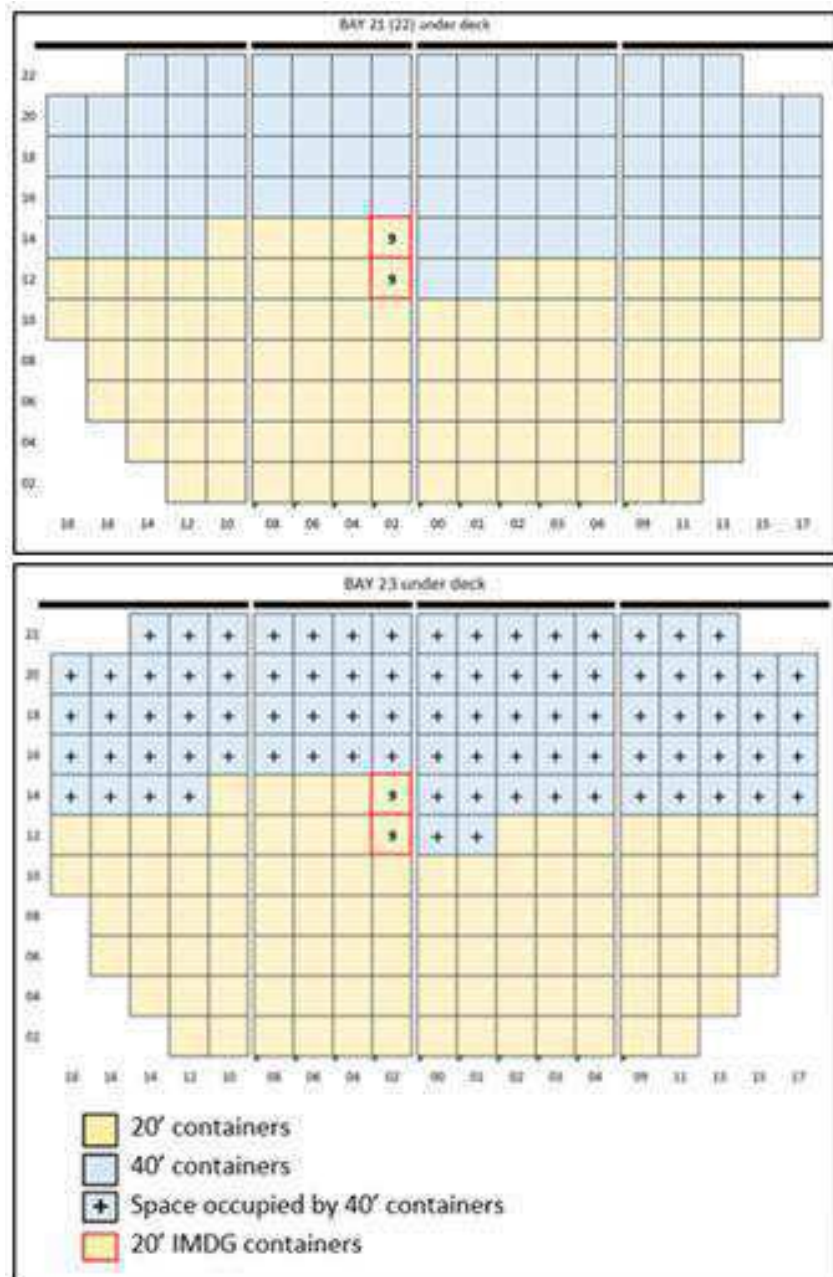
Figure 35 - Showing containers at bay 21 (22) 23 – annotated by TSIB

1.15.12 Similarly, there were 294 containers inside no.3 cargo hold (Aft) in-way of bay 21 (22) 23. The breakup of the numbers and type of containers (see **figure 35**) were as follows:

Nos. of Containers	Type	Remarks
a.	88 x 40'	Dry general cargo

b.	202 x 20	Dry general cargo	
c.	4 x 20'	IMDG Class 9	Miscellaneous

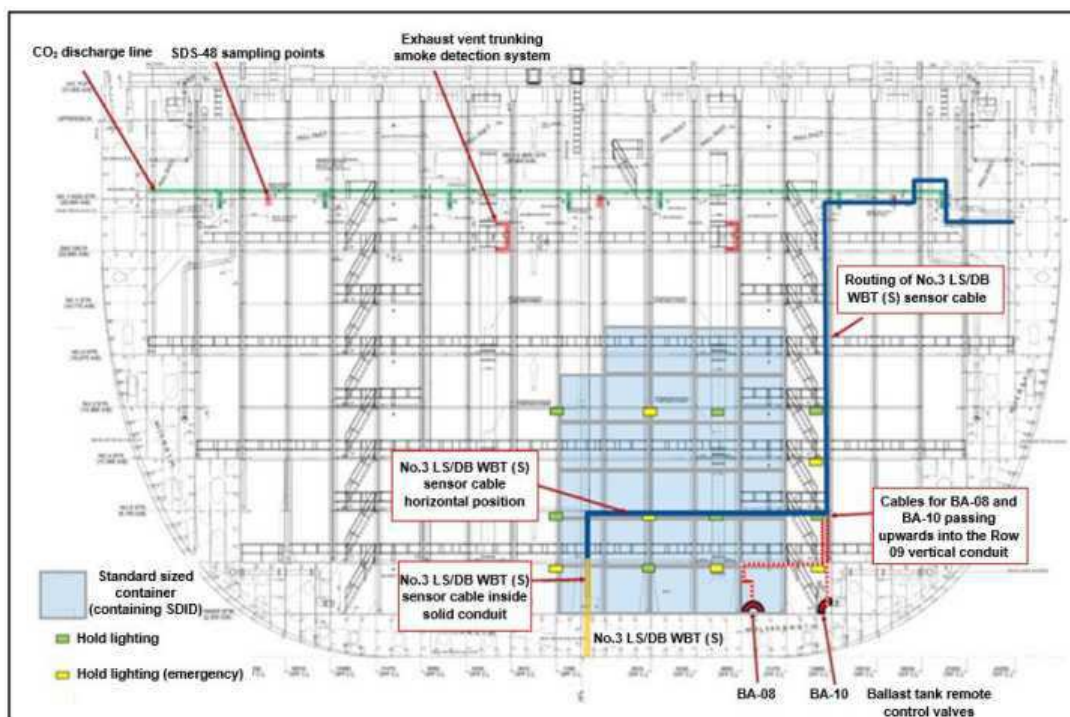
Figure 36 - Cross-section of no.3 cargo hold showing the routing of water ballast tank hydrostatic sensor cabling, the position of lighting, and the approximate outline of the 54-container block stow of SDID – Source: The Fire Forensic Expert

1.15.13 Section view of no.3 cargo hold superimposed with the routing of water ballast tank hydrostatic sensor cabling, the position of lighting, and the approximate outline of the 54-container block stow of SDID in **figure 36**.
